NPS Wildland Fire Risk Assessment - Community Assessment

Community: Aspenglen Campground
Unit - Location: ROMO - North Entrance
Field Crew: Dave Frey
Last Site Visit Date:

Community Description: Aspenglen campground is located south of the Fall River Entrance station. It is open from late May to late September and has 53 sites in three loops. There are both tent and RV sites in the campground. It is in a ponderosa forest and is a popular tourist destination.

Description of Factors Driving the Ratings: The factors driving the ratings are the access to the community in conjunction with the building materials.

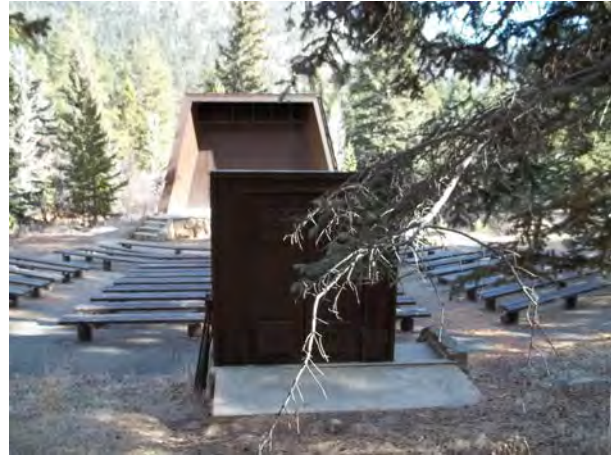
2013_ROMO_Projection Booth Aspenglen Campground_Projection Booth Aspenglen Campground_D.jpg

Triage Category	Tactic Description	Pers Hours	Equipment Description	Equip Qty
	Handline -	3.00	-	
	Fuels reduction -	3.00	-	
	Burnout, no line construction necessary -	3.00	-	
	Fuels reduction -	3.00	-	
	Handline and burnout -	3.00	-

Zone	Treatment Description	Pers Hours	Treatment Cycle	Treatment Priority	Treatment Status	Date Next Treatment Recommended	Equipment Description	Equip Qty
1	Limb trees 6 to 15 feet above ground -	2		Unknown	Planned		-	
	Flammable ground cover such as leaf litter, woody debris or highly flammable vegetation should be removed -	2		Unknown	Planned		-	
2	Flammable ground cover should be removed or isolated -	2		Unknown	Planned		-

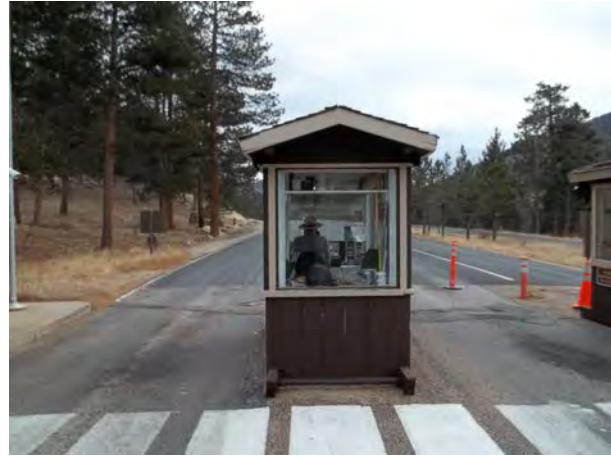
2013_ROMO_24050_B-0670-N Kiosk - Entrance Station Fall River_D.jpg

Triage Category	Tactic Description	Pers Hours	Equipment Description	Equip Qty
	Engine on scene - Time required would change with fire conditions.	3.00	-

Zone	Treatment Description	Pers Hours	Treatment Cycle	Treatment Priority	Treatment Status	Date Next Treatment Recommended	Equipment Description	Equip Qty
2	Mow dead/dying grass to less than 4 inches -	3		Unknown	Planned		-

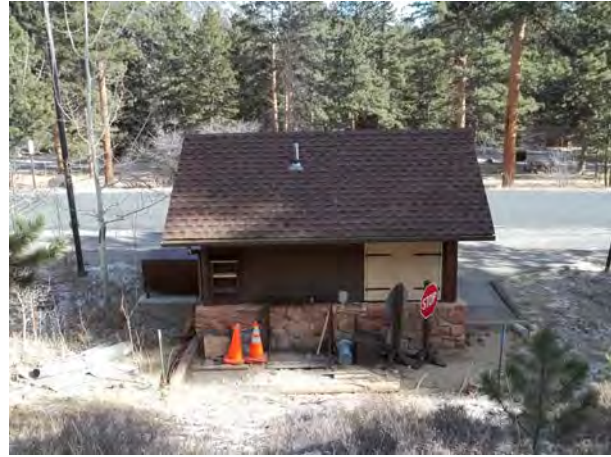
2013_ROMO_25288_B-0992-N Kiosk Aspenglen Campground_D.jpg

Score: 50
Rating: Moderate

Zone	Treatment Description	Pers Hours	Treatment Cycle	Treatment Priority	Treatment Status	Date Next Treatment Recommended	Equipment Description	Equip Qty
1	Roof and gutters should be cleared of vegetative debris -	3		Unknown	Planned		-	
	Limb trees 6 to 15 feet above ground -	3		Unknown	Planned		-

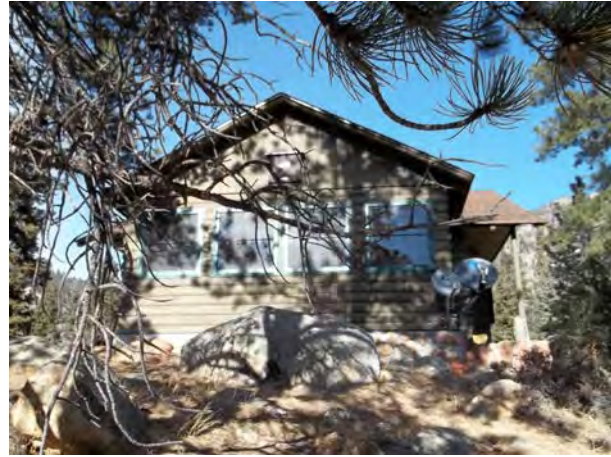
2013_ROMO_24065_Q-0748-N S 1 Bdrm House by AGCG 00000748_D.jpg

Score: 35
Rating: High

Zone	Treatment Description	Pers Hours	Treatment Cycle	Treatment Priority	Treatment Status	Date Next Treatment Recommended	Equipment Description	Equip Qty
1	Firewood should be moved at least 50 ft from the facility and 15 horizontal feet from tree canopies -	3		Unknown	Planned		-	
	Limb trees 6 to 15 feet above ground -	3		Unknown	Planned		-	
	Flammable ground cover such as leaf litter, woody debris or highly flammable vegetation should be removed -	3		Unknown	Planned		-	
2	Flammable ground cover should be removed or isolated -	3		Unknown	Planned		-

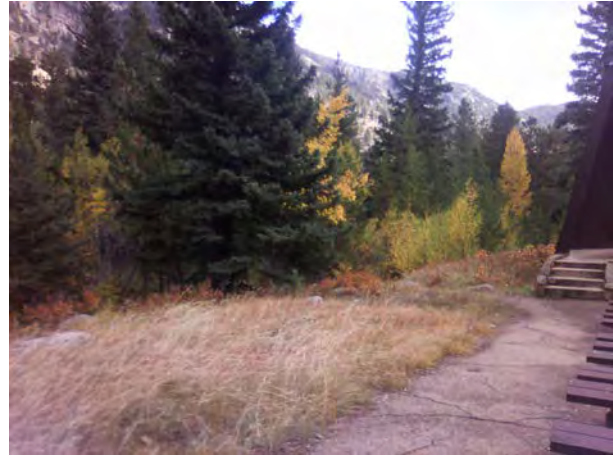
ROMO_25287_B-0825-N Stage & Screen (amphitheater) AGCG_Front.jpg

Score: 84
Rating: High
