NPS Wildland Fire Risk Assessment - Community Assessment

Community: Wild Basin Entrance Station

Unit - Location: ROMO - Wild Basin

Last Site Visit Date: 9/24/2014

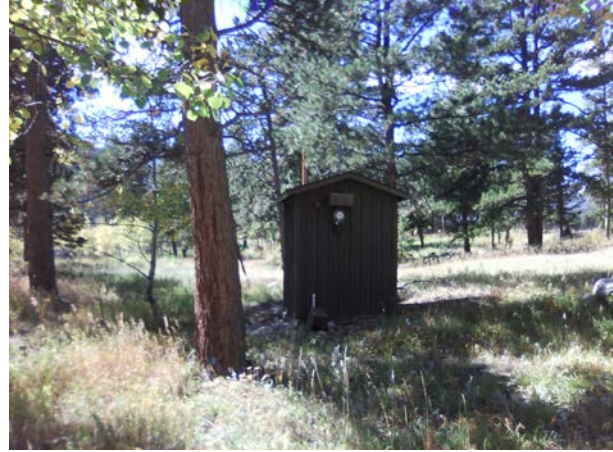
ROMO__WILDBASIN LODGE CISTERN PUMPHOUSE_Front2.jpg

Score: 63
Rating: High

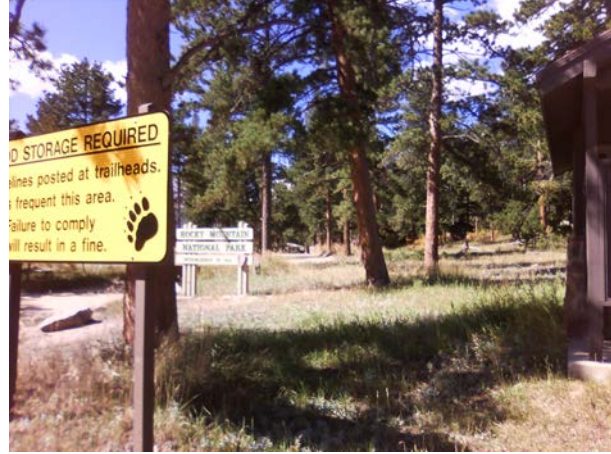
ROMO_23682_B-0996-N Sandbeach TrIHd Vault Toilet_Front.jpg

Score: 60
Rating: Moderate

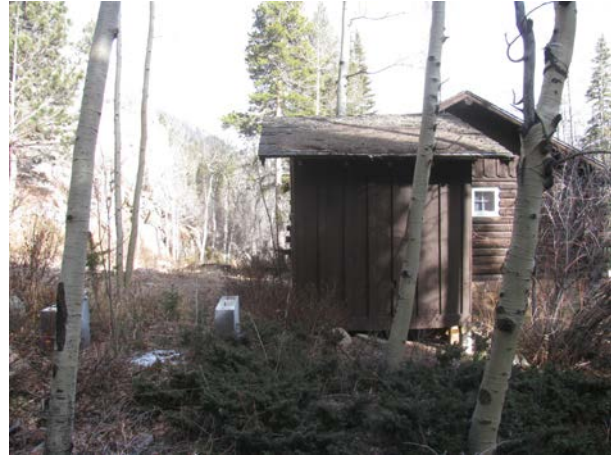
2013_ROMO_97844_B-0253-N Pumphouse by 0032, Wild Basin_D.jpg

Score: 78
Rating: High

Zone	Treatment Description	Pers Hours	Treatment Cycle	Treatment Priority	Treatment Status	Date Next Treatment Recommended	Equipment Description	Equip Qty
1	Roof and gutters should be cleared of vegetative debris -	3		Unknown	Planned		-	
	Clear adjacent and overhanging fuels to create 10 feet spacing between canopy and structure or chimney openings -	3		Unknown	Planned		-	
	Firewood should be moved at least 50 ft from the facility and 15 horizontal feet from tree canopies -	3		Unknown	Planned		-	
2	Flammable ground cover should be removed or isolated -	3		Unknown	Planned		-	
	Mow dead/dying grass to less than 4 inches -	3		Unknown	Planned		-	
3	Remove heavy ground fuels such as logs and stumps -	3		Unknown	Planned		-

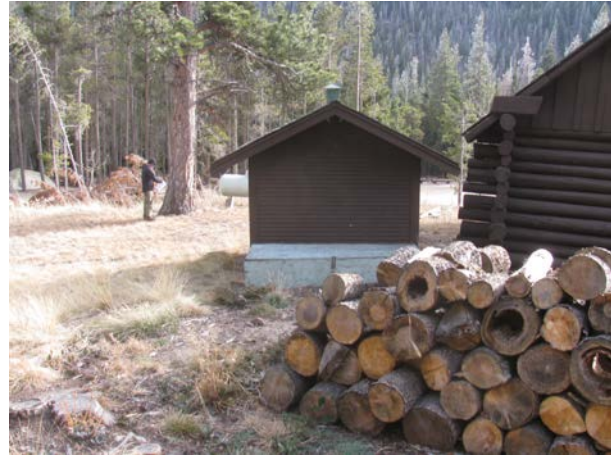
2013_ROMO_23677_B-0819-N Tackroom/Storage @ Ranger Station_D.jpg

Score: 70
Rating: High

Zone	Treatment Description	Pers Hours	Treatment Cycle	Treatment Priority	Treatment Status	Date Next Treatment Recommended	Equipment Description	Equip Qty
1	Roof and gutters should be cleared of vegetative debris -	3		Unknown	Planned		-	
	Firewood should be moved at least 50 ft from the facility and 15 horizontal feet from tree canopies -	3		Unknown	Planned		-	
	Flammable ground cover such as leaf litter, woody debris or highly flammable vegetation should be removed -	3		Unknown	Planned		-	
	Clear adjacent and overhanging fuels to create 10 feet spacing between canopy and structure or chimney openings -	3		Unknown	Planned		-	
2	Mow dead/dying grass to less than 4 inches -	3		Unknown	Planned		-	
	Flammable ground cover should be removed or isolated -	3		Unknown	Planned		-

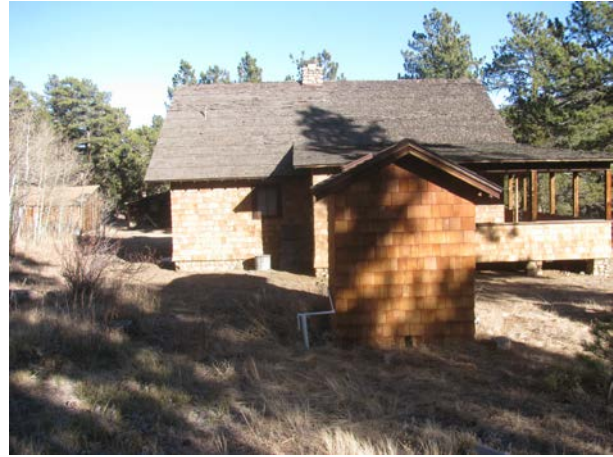
2013_ROMO_98016_B-0851-N Pumphouse, Deer Haven_D.jpg

Score: 66
Rating: High

Zone	Treatment Description	Pers Hours	Treatment Cycle	Treatment Priority	Treatment Status	Date Next Treatment Recommended	Equipment Description	Equip Qty
1	Remove dead or dying component of shrubs and trees -	5		Unknown	Planned		-	
2	Flammable ground cover should be removed or isolated -	5		Unknown	Planned		-	
3	Remove standing dead or dying trees or limb 6 to 15 feet above ground - within 30' clearance good, beyond needs work	15		Unknown	Planned		-	
	Remove heavy ground fuels such as logs and stumps -	5		Unknown	Planned		-

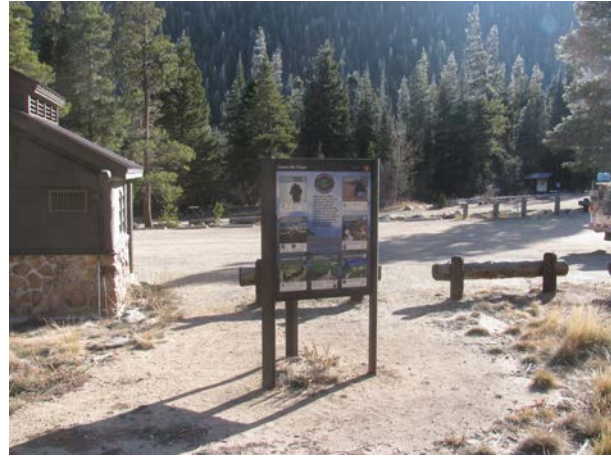
2013_ROMO_Wild Basin Bathroom Kiosk_Wild Basin Bathroom Kiosk_D.jpg

Score: 46
Rating: Moderate

Zone	Treatment Description	Pers Hours	Treatment Cycle	Treatment Priority	Treatment Status	Date Next Treatment Recommended	Equipment Description	Equip Qty
1	Flammable ground cover such as leaf litter, woody debris or highly flammable vegetation should be removed -	5		Unknown	Planned		-	
2	Mow dead/dying grass to less than 4 inches -	5		Unknown	Planned		-	
3	Remove heavy ground fuels such as logs and stumps -	5		Unknown	Planned		-

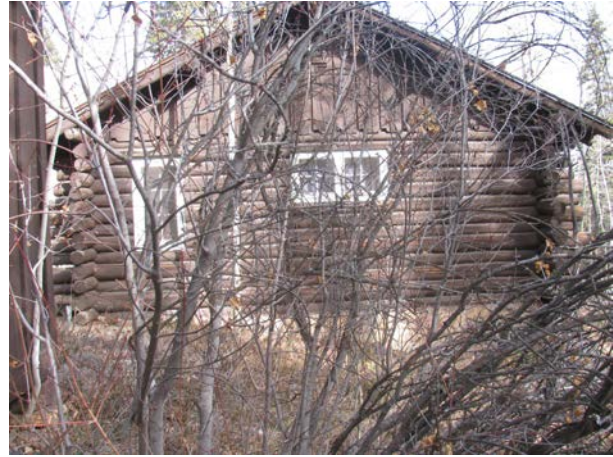
ROMO_23657_Wild Basin Seasonal Cabin 32 (D).JPG

Score: 78
Rating: High

Zone	Treatment Description	Pers Hours	Treatment Cycle	Treatment Priority	Treatment Status	Date Next Treatment Recommended	Equipment Description	Equip Qty
1	Firewood should be moved at least 50 ft from the facility and 15 horizontal feet from tree canopies -	5		Unknown	Planned		-	
	Clear adjacent and overhanging fuels to create 10 feet spacing between canopy and structure or chimney openings -	5		Unknown	Planned		-	
	Roof and gutters should be cleared of vegetative debris -	5		Unknown	Planned		-	
2	Mow dead/dying grass to less than 4 inches -	5		Unknown	Planned		-	
	Flammable ground cover should be removed or isolated -	5		Unknown	Planned		-
