Location: 100 Castle Creek Rd, WILDERNESS STREAMS FILING NO. 2

Coordinates (DDM): 38° 46.291' N, 107° 04.891' W

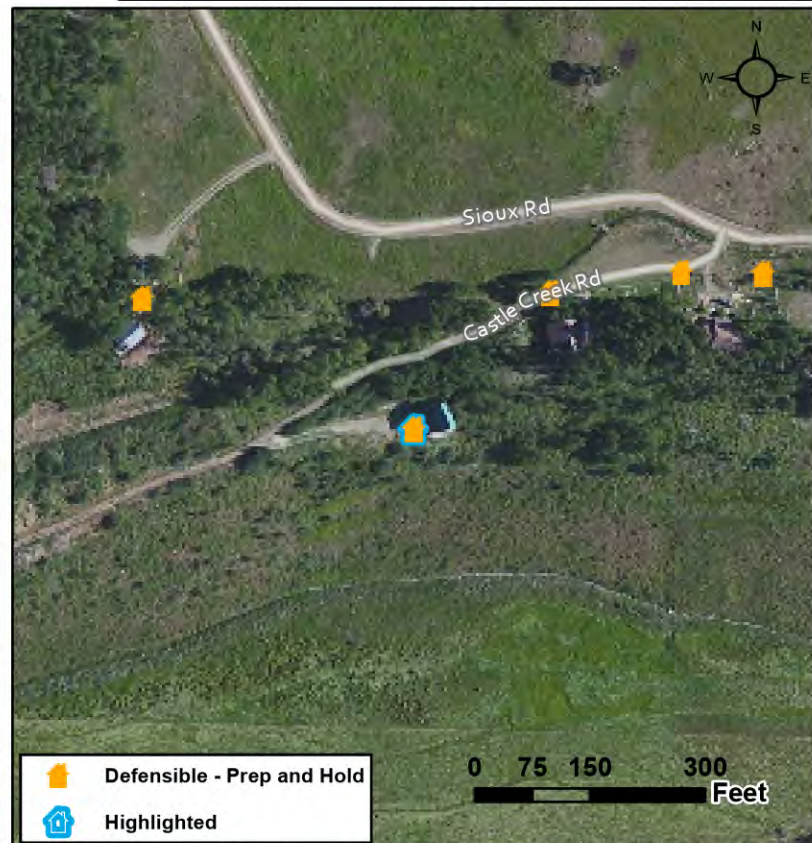
Triage Category: Defensible, Prep and Hold
FIRESCOPE Triage Category: Threatened Defensible
Structure Number: 100 Castle Creek Rd
Collected Date/Time: 8/3/2023 8:23:02 PM
Collected By: Jesse Gallup
Inspector's Position: FFTI
Type of Structure: Residential
Primary Structures: 1
Is the building Occupied?: Yes
Outbuildings: 0
Fuel Surrounding Structure: Shrub or timber
Defensible Space: 30 ft treated
Roof Material: Noncombustible or not applicable
Siding Material: Wood or open sided
Electrical Power: Yes
Gas to Structure: Yes
Hazards: Tight escape route,
Access to Site: T6 Engine
Describe Access: Narrow improved driveway with switchback
Comm With ICP: Yes
Water Source: No reliable water source nearby
Safety Zone Present:
Mitigation Time (in hours): 1
Mitigation Description: Removing combustibles below home
Resources Needed to Protect Structure: 1 engine
FIRESCOPE Tactics: Prep and Defend
Notes: Wood paneling on 2nd and 3rd floor cement garage, old wood porch

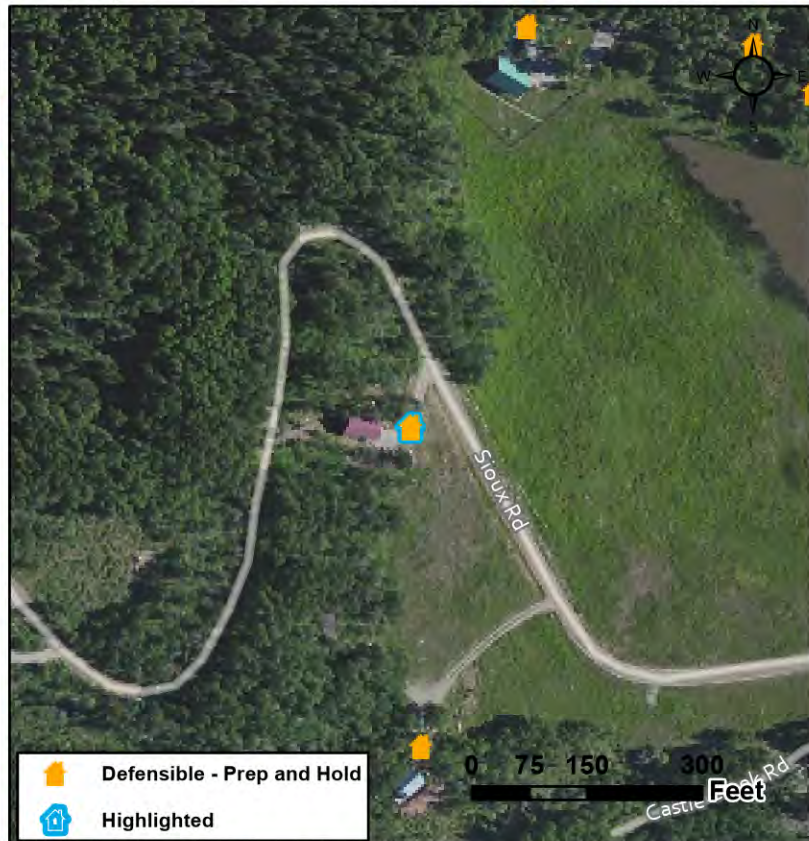
Location: 1022 Sioux Rd, WILDERNESS STREAMS FILING NO. 2

Triage Category: Defensible, Prep and Hold
FIRESCOPE Triage Category: Threatened Defensible
Structure Number: 1022 Sioux Rd
Collected Date/Time: 8/3/2023 8:07:35 PM
Collected By: Cody Peterson
Inspector's Position: ENGB
Type of Structure: Residential
Primary Structures: 1
Is the building Occupied?: No
Outbuildings: 0
Fuel Surrounding Structure: Grass and shrub, hardwood litter
Defensible Space: 100 ft treated
Roof Material: Noncombustible or not applicable
Siding Material: Wood or open sided
Electrical Power: Yes
Gas to Structure: No
Hazards:
Access to Site: T1 Engine
Describe Access: Maintained gravel
Comm With ICP: Yes
Water Source: Reliable water source nearby
Safety Zone Present:
Mitigation Time (in hours): 1
Mitigation Description: Weed eat
Resources Needed to Protect Structure: Engine
FIRESCOPE Tactics: Prep and Defend
Notes:

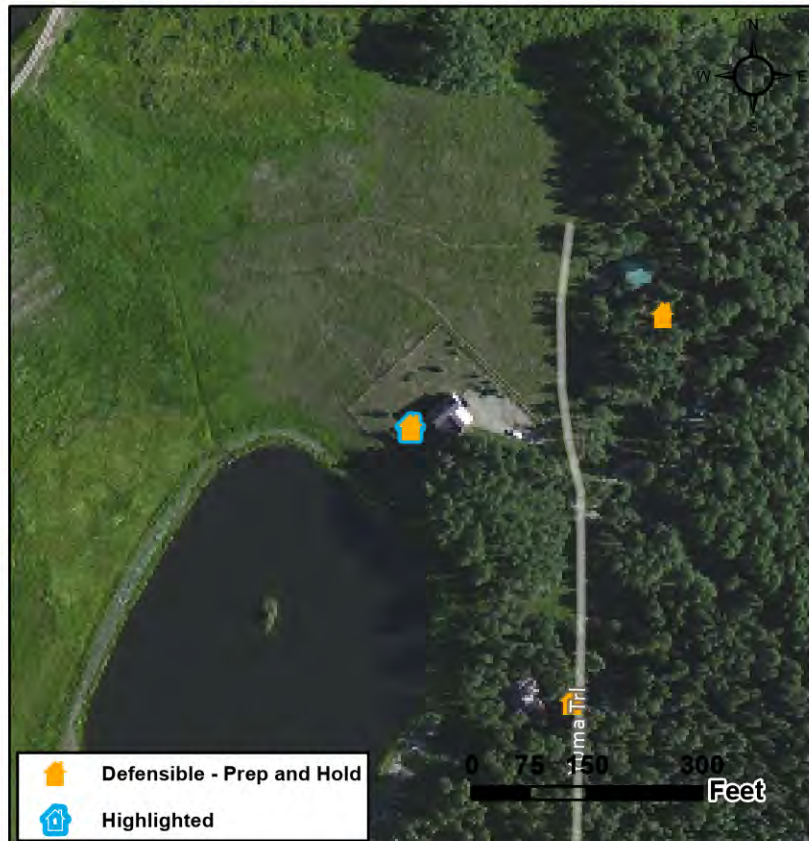
Location: 113 Yuma Trl, WILDERNESS STREAMS FILING NO. 2

Triage Category: Defensible, Prep and Hold
FIRESCOPE Triage Category: Threatened Defensible
Structure Number: 113 Yuma Trl
Collected Date/Time: 8/3/2023 7:09:55 PM
Collected By: Cody Peterson
Inspector's Position: ENGB
Type of Structure: Residential
Primary Structures: 1
Is the building Occupied?: No
Outbuildings: 0
Fuel Surrounding Structure: Grass and shrub, hardwood litter
Defensible Space: 100 ft treated
Roof Material: Noncombustible or not applicable
Siding Material: Log construction
Electrical Power: Yes
Gas to Structure: No
Hazards:
Access to Site: T3/4 Engine
Describe Access: Maintained Gravel
Comm With ICP: Yes
Water Source: Reliable water source nearby
Safety Zone Present:
Mitigation Time (in hours): 1
Mitigation Description: Weed eat
Resources Needed to Protect Structure: Engine
FIRESCOPE Tactics: Prep and Defend
Notes:

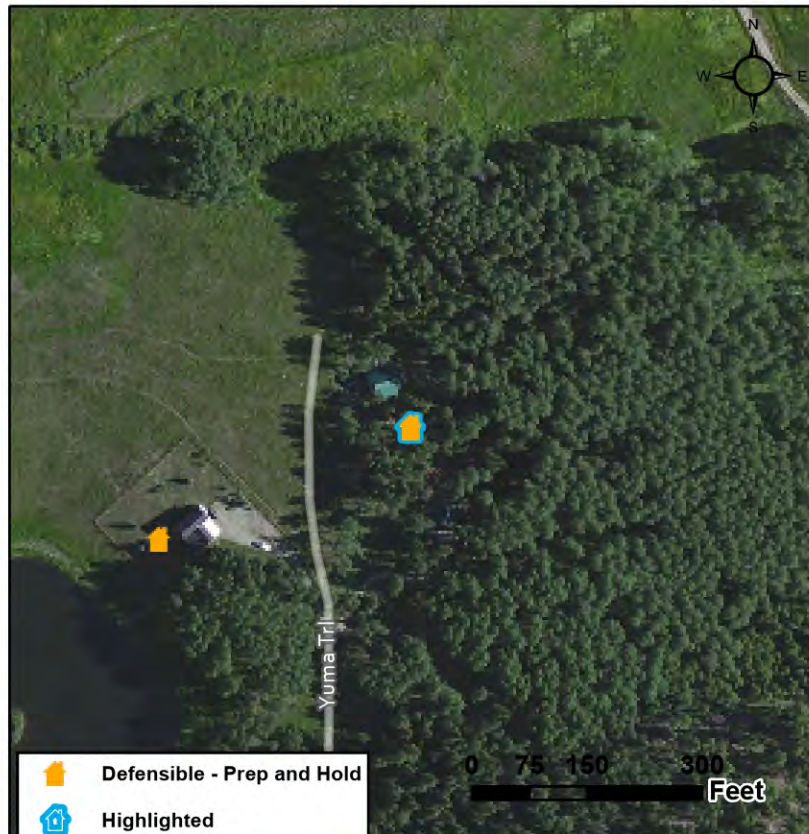
Location: 114 Yuma Trl, WILDERNESS STREAMS FILING NO. 2

Triage Category: Defensible, Prep and Hold
FIRESCOPE Triage Category: Threatened Defensible
Structure Number: 114 Yuma Trl
Collected Date/Time: 8/3/2023 7:17:52 PM
Collected By: Cody Peterson
Inspector's Position: ENGB
Type of Structure: Residential
Primary Structures: 1
Is the building Occupied?: Yes
Outbuildings: 1
Fuel Surrounding Structure: Grass and shrub, hardwood litter
Defensible Space: More than 100ft treated
Roof Material: Noncombustible or not applicable
Siding Material: Wood or open sided
Electrical Power: Yes
Gas to Structure: No
Hazards:
Access to Site: T3/4 Engine
Describe Access: Maintained gravel
Comm With ICP: Yes
Water Source: Reliable water source nearby
Safety Zone Present:
Mitigation Time (in hours): 1
Mitigation Description: Weed eat,
Resources Needed to Protect Structure: Engine
FIRESCOPE Tactics: Prep and Defend
Notes:

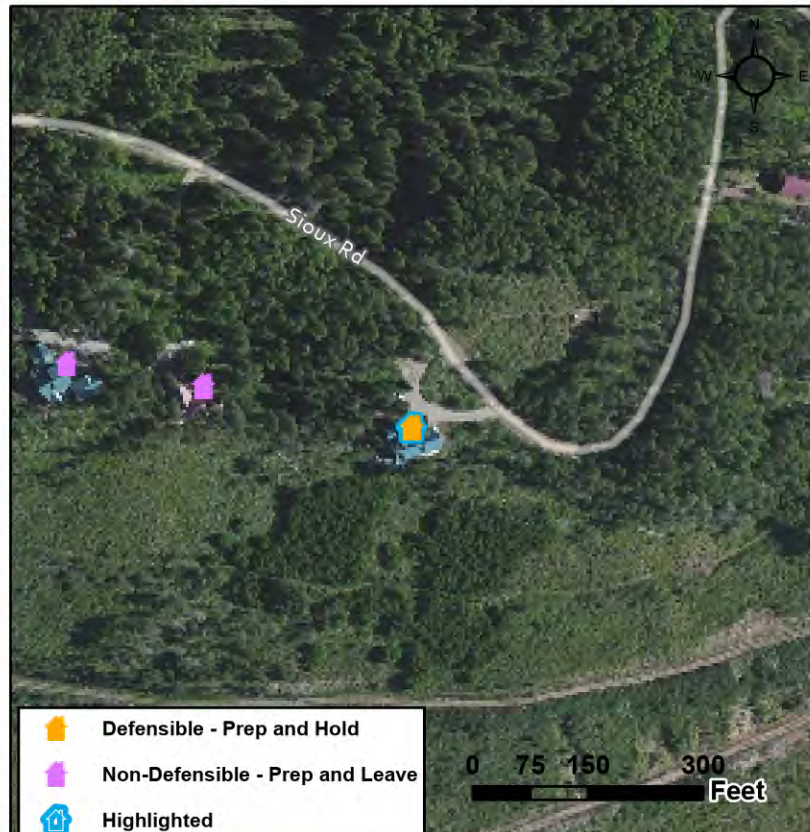
Location: 1142 Sioux Rd, WILDERNESS STREAMS FILING NO. 2

Triage Category: Defensible, Prep and Hold
FIRESCOPE Triage Category: Threatened Defensible
Structure Number: 1142 Sioux Rd
Collected Date/Time: 8/3/2023 8:00:50 PM
Collected By: Bo Knickman
Inspector's Position: Engb
Type of Structure: Residential
Primary Structures: 1
Is the building Occupied?: No
Outbuildings: 1
Fuel Surrounding Structure: Shrub or timber
Defensible Space: Less than 30 ft treated
Roof Material: Noncombustible or not applicable
Siding Material: Wood or open sided
Electrical Power: Yes
Gas to Structure: No
Hazards:
Access to Site: T1 Engine
Describe Access: Short pull through driveway with minimal fuels
Comm With ICP: Yes
Water Source: No reliable water source nearby
Safety Zone Present:
Mitigation Time (in hours): 1
Mitigation Description: Oak brush on south side needs to be cut back, other small grass and shrub around the home, flammable items to be removed against home
Resources Needed to Protect Structure: 1 engine

FIRESCOPE Tactics: Prep and Defend
Notes: 1 shed across the street

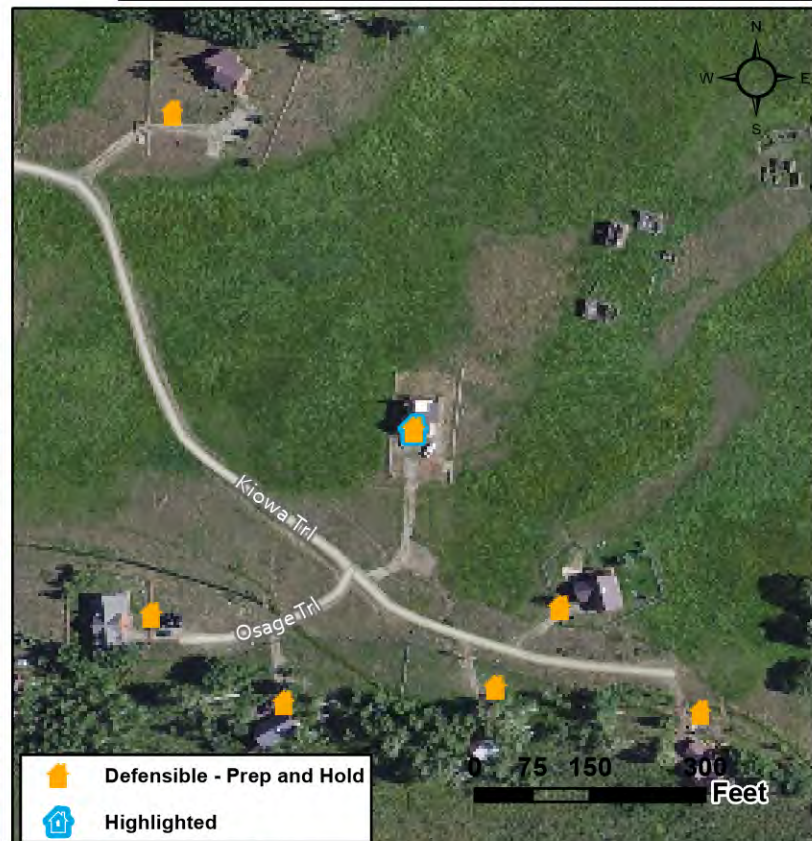
Location: 115 Kiowa Trl, WILDERNESS STREAMS FILING NO. 2

Triage Category: Defensible, Prep and Hold
FIRESCOPE Triage Category: Threatened Defensible
Structure Number: 115 Kiowa Trl
Collected Date/Time: 8/3/2023 9:21:02 PM
Collected By: Bo Knickman
Inspector's Position: Engb
Type of Structure: Residential
Primary Structures: 1
Is the building Occupied?: No
Outbuildings: 1
Fuel Surrounding Structure: Grass and shrub, hardwood litter
Defensible Space: More than 100ft treated
Roof Material: Noncombustible or not applicable
Siding Material: Log construction
Electrical Power: Yes
Gas to Structure: No
Hazards:
Access to Site: T1 Engine
Describe Access: Short wide improved driveway
Comm With ICP: Yes
Water Source: No reliable water source nearby
Safety Zone Present:
Mitigation Time (in hours): 1
Mitigation Description: Removing combustibles from and below deck
Resources Needed to Protect Structure: 1 engine
FIRESCOPE Tactics: Prep and Defend
Notes: 2 car detached garage

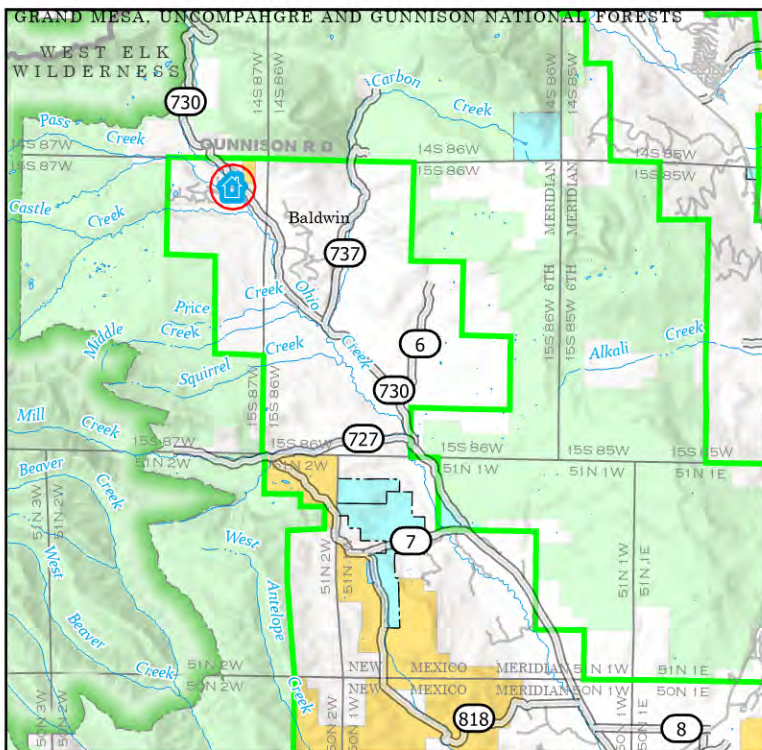
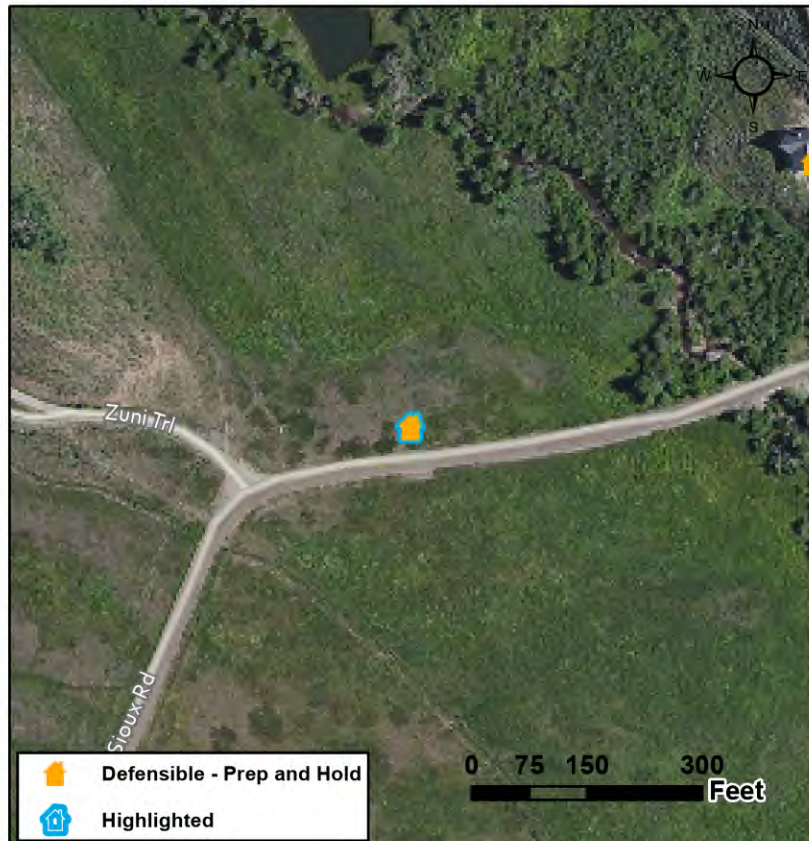
Location: 129 Sioux Rd, WILDERNESS STREAMS FILING NO. 2

Triage Category: Defensible, Prep and Hold
FIRESCOPE Triage Category: Not Threatened
Structure Number: 129 Sioux Rd
Collected Date/Time: 8/3/2023 6:00:32 PM
Collected By: Adam Altergott
Inspector's Position: ENGB
Type of Structure: Residential
Primary Structures: 1
Is the building Occupied?: Yes
Outbuildings: 1
Fuel Surrounding Structure: Grass and shrub, hardwood litter
Defensible Space: Less than 30 ft treated
Roof Material: Noncombustible or not applicable
Siding Material: Rock, concrete, metal
Electrical Power: Yes
Gas to Structure: Yes
Hazards: Propane tank next to garage
Access to Site: T1 Engine
Describe Access: Level gravel access, along rd.
Comm With ICP: Yes
Water Source: Reliable water source nearby
Safety Zone Present:
Mitigation Time (in hours): 1
Mitigation Description: Needs grass cut 30 foot minimum
Resources Needed to Protect Structure: 1 any type Engine
FIRESCOPE Tactics: Prep and Defend
Notes: Newer, hardy construction

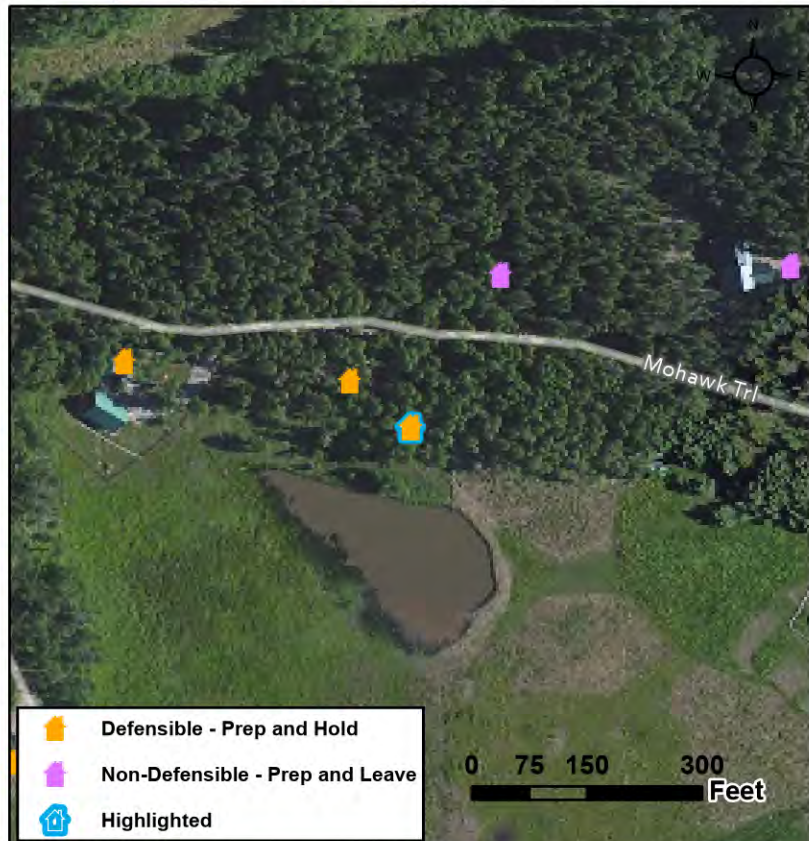
Triage Category: Defensible, Prep and Hold
FIRESCOPE Triage Category: Not Threatened
Structure Number: 136 Mohawk Trl - 1
Collected Date/Time: 8/3/2023 10:05:54 PM
Collected By: Adam Altergott
Inspector's Position: EngB
Type of Structure: Residential
Primary Structures: 1
Is the building Occupied?: No
Outbuildings: 2
Fuel Surrounding Structure: Grass and shrub, hardwood litter
Defensible Space: 100 ft treated
Roof Material: Noncombustible or not applicable
Siding Material: Log construction
Electrical Power: Yes
Gas to Structure: No
Hazards: Live electric fence
Access to Site: T3/4 Engine
Describe Access: Driveway blocked by live electric fence gate
Comm With ICP: Yes
Water Source: Reliable water source nearby
Safety Zone Present:
Mitigation Time (in hours): 2
Mitigation Description: Move firewood away from home and weed wack around woodshed
Resources Needed to Protect Structure: 1 type 3 or 6 engine
FIRESCOPE Tactics: Prep and Defend

Notes: Log home with metal roof, garage with same construction and woodshed

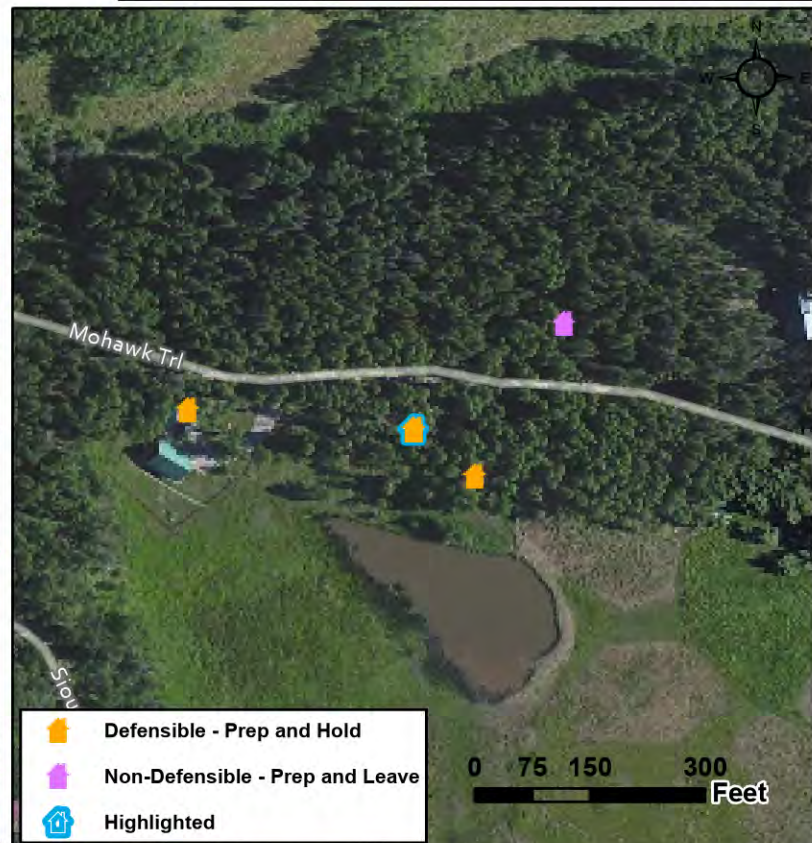
Triage Category: Defensible, Prep and Hold
FIRESCOPE Triage Category: Not Threatened
Structure Number: 136 Mohawk Trl - 2
Collected Date/Time: 8/3/2023 10:05:54 PM
Collected By: Adam Altergott
Inspector's Position: EngB
Type of Structure: Residential
Primary Structures: 1
Is the building Occupied?: No
Outbuildings: 0
Fuel Surrounding Structure: Grass and shrub, hardwood litter
Defensible Space: 100 ft treated
Roof Material: Noncombustible or not applicable
Siding Material: Log construction
Electrical Power: Yes
Gas to Structure: No
Hazards: Live electric fence
Access to Site: T3/4 Engine
Describe Access: Driveway blocked by live electric fence gate
Comm With ICP: Yes
Water Source: Reliable water source nearby
Safety Zone Present:
Mitigation Time (in hours): 1
Mitigation Description: Move wood away from garage
Resources Needed to Protect Structure: 1 type 3 or 6 engine
FIRESCOPE Tactics: Prep and Defend
Notes: Garage with log construction and metal roof

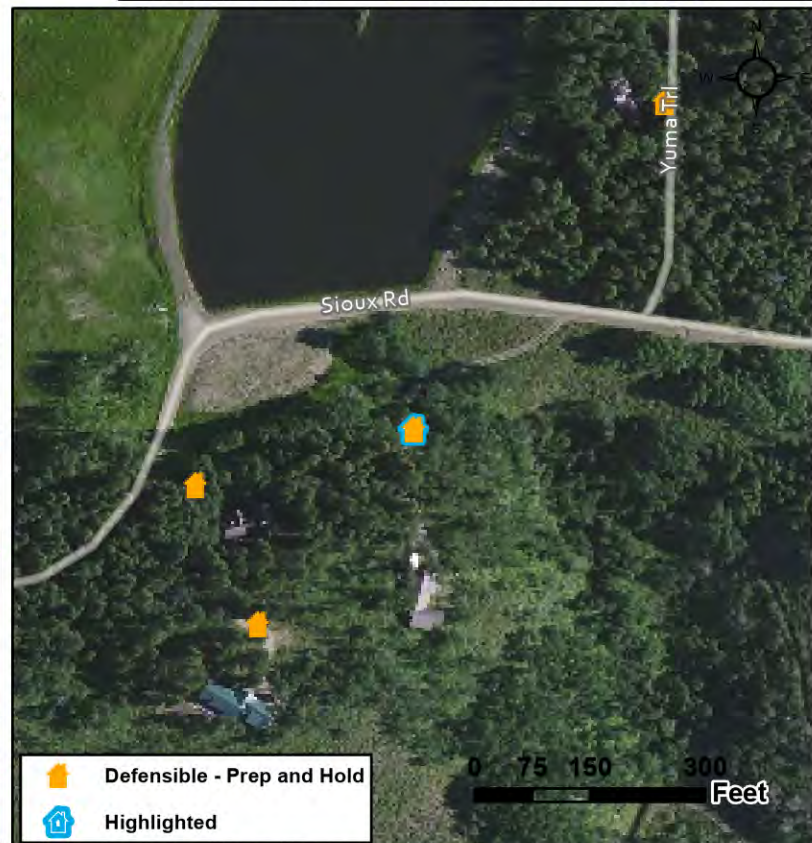
Triage Category: Defensible, Prep and Hold
FIRESCOPE Triage Category: Threatened Defensible
Structure Number: 1400 Sioux Rd
Collected Date/Time: 8/3/2023 6:54:38 PM
Collected By: Cody Peterson
Inspector's Position: ENGB
Type of Structure: Residential
Primary Structures: 1
Is the building Occupied?: Yes
Outbuildings: 2
Fuel Surrounding Structure: Shrub or timber
Defensible Space: 30 ft treated
Roof Material: Noncombustible or not applicable
Siding Material: Log construction
Electrical Power: Yes
Gas to Structure: No
Hazards: No
Access to Site: T3/4 Engine
Describe Access: Maintained gravel
Comm With ICP: Yes
Water Source: Reliable water source nearby
Safety Zone Present:
Mitigation Time (in hours): 1
Mitigation Description: Weed eat
Resources Needed to Protect Structure: Eng,mod
FIRESCOPE Tactics: Prep and Defend
Notes: Tight turn around for larger apparatus

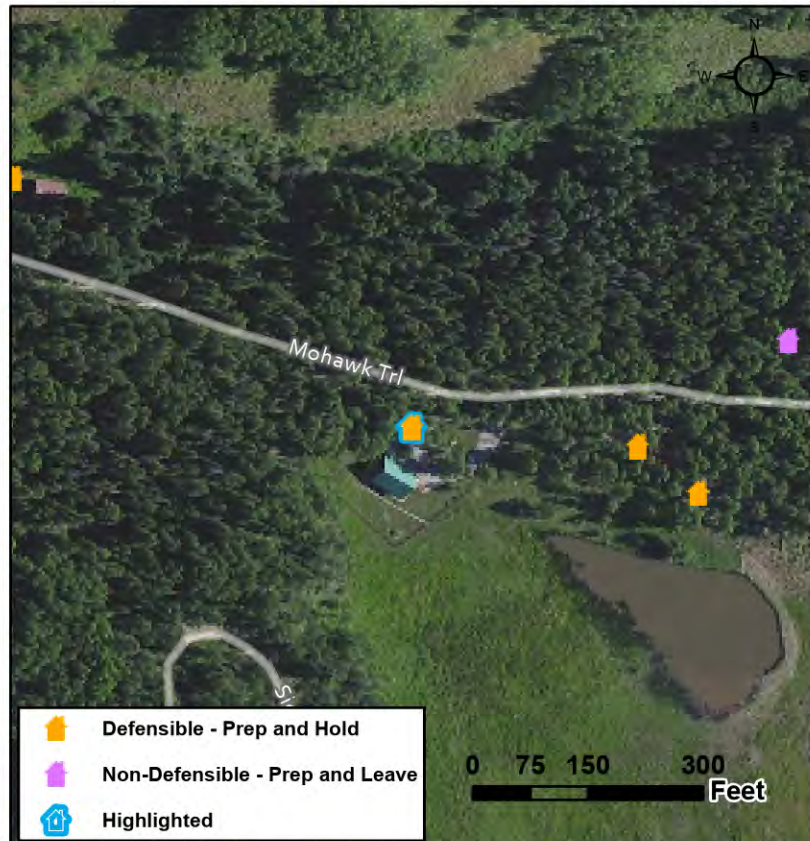
Triage Category: Defensible, Prep and Hold
FIRESCOPE Triage Category: Not Threatened
Structure Number: 148 Mohawk Trl
Collected Date/Time: 8/3/2023 10:07:30 PM
Collected By: Kevin Brueck
Inspector's Position: EngB t
Type of Structure: Residential
Primary Structures: 1
Is the building Occupied?: Yes
Outbuildings: 1
Fuel Surrounding Structure: Grass and shrub, hardwood litter
Defensible Space: 30 ft treated
Roof Material: Noncombustible or not applicable
Siding Material: Wood or open sided
Electrical Power: Yes
Gas to Structure: Yes
Hazards: Above ground ~500 gal propane
Access to Site: T3/4 Engine
Describe Access: Off the main road
Comm With ICP: Yes
Water Source: Reliable water source nearby
Safety Zone Present:
Mitigation Time (in hours): 1
Mitigation Description: Sprinklers
Resources Needed to Protect Structure: Type 6
FIRESCOPE Tactics: Prep and Defend
Notes: Wood porch, pond on adjacent property

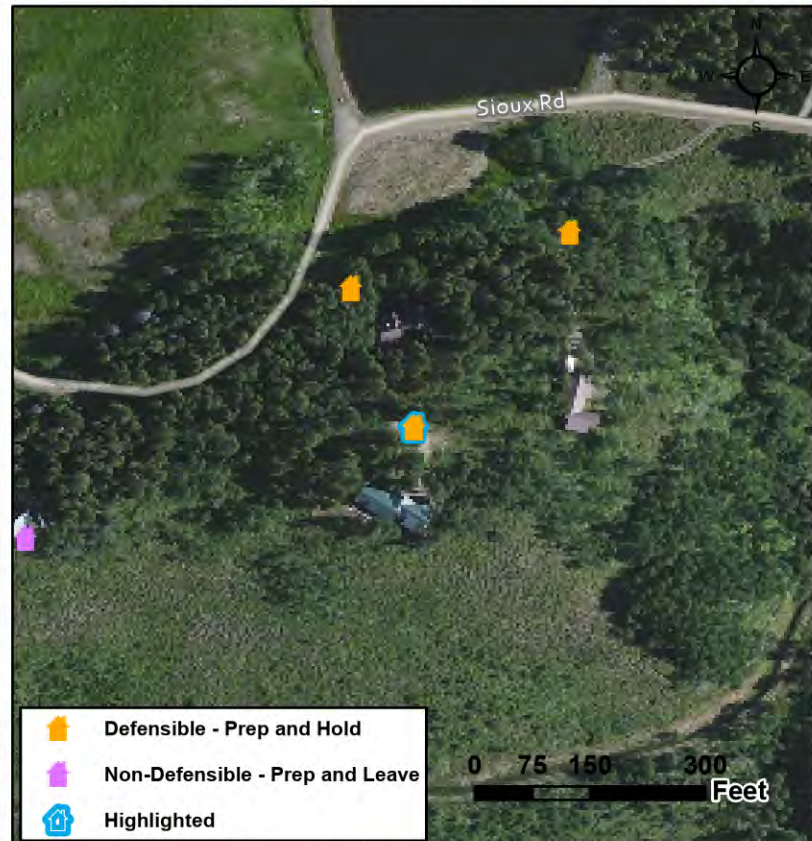
Triage Category: Defensible, Prep and Hold
FIRESCOPE Triage Category: Threatened Defensible
Structure Number: 1532 Sioux Rd
Collected Date/Time: 8/3/2023 6:34:43 PM
Collected By: Cody Peterson
Inspector's Position: ENGB
Type of Structure: Residential
Primary Structures: 1
Is the building Occupied?: Yes
Outbuildings: 1
Fuel Surrounding Structure: Grass and shrub, hardwood litter
Defensible Space: 30 ft treated
Roof Material: Noncombustible or not applicable
Siding Material: Log construction
Electrical Power: Yes
Gas to Structure: No
Hazards: Saddle
Access to Site: T3/4 Engine
Describe Access: Maintained gravel
Comm With ICP: Yes
Water Source: Reliable water source nearby
Safety Zone Present:
Mitigation Time (in hours): 2
Mitigation Description: Limb trees, weed eat,
Resources Needed to Protect Structure: Engine, Mod
FIRESCOPE Tactics: Prep and Defend
Notes: Structure in a saddle

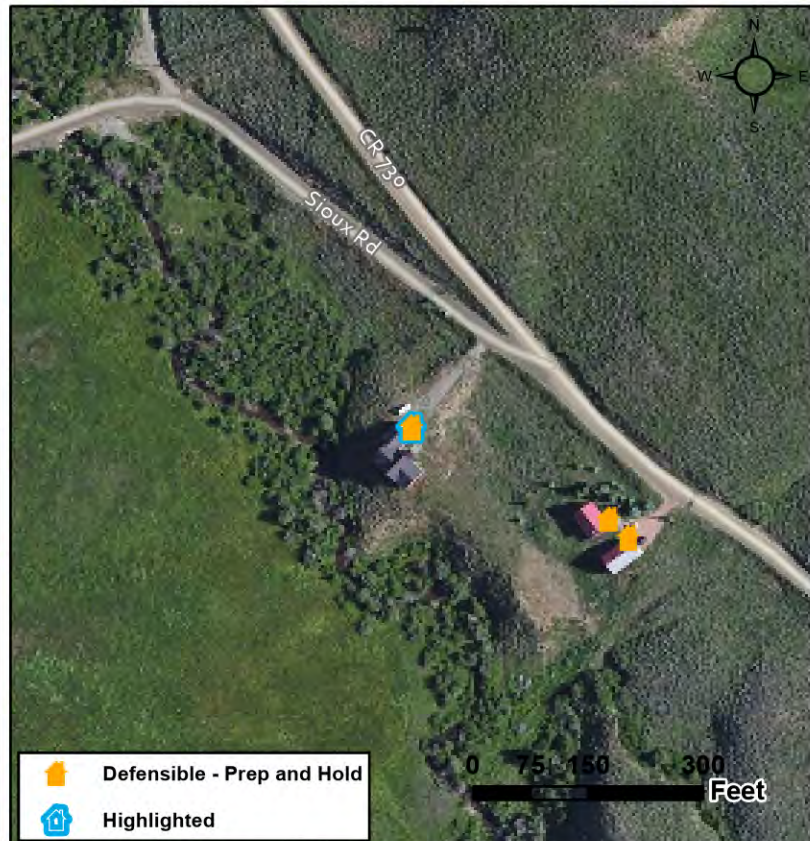
Triage Category: Defensible, Prep and Hold
FIRESCOPE Triage Category: Threatened Defensible
Structure Number: 15671 County Road 730
Collected Date/Time: 8/2/2023 10:53:18 PM
Collected By: Adam Altergott
Inspector's Position: Engb
Type of Structure: Residential
Primary Structures: 1
Is the building Occupied?: No
Outbuildings: 0
Fuel Surrounding Structure: Grass and shrub, hardwood litter
Defensible Space: Less than 30 ft treated
Roof Material: Noncombustible or not applicable
Siding Material: Log construction
Electrical Power: Yes
Gas to Structure: Unknown
Hazards: None
Access to Site: T1 Engine
Describe Access: Gravel driveway
Comm With ICP: Yes
Water Source: Reliable water source nearby
Safety Zone Present:
Mitigation Time (in hours): 1
Mitigation Description: Weed wack around house
Resources Needed to Protect Structure: 1 Any engine
FIRESCOPE Tactics: Prep and Defend
Notes: Big deck on back, log construction and metal roof

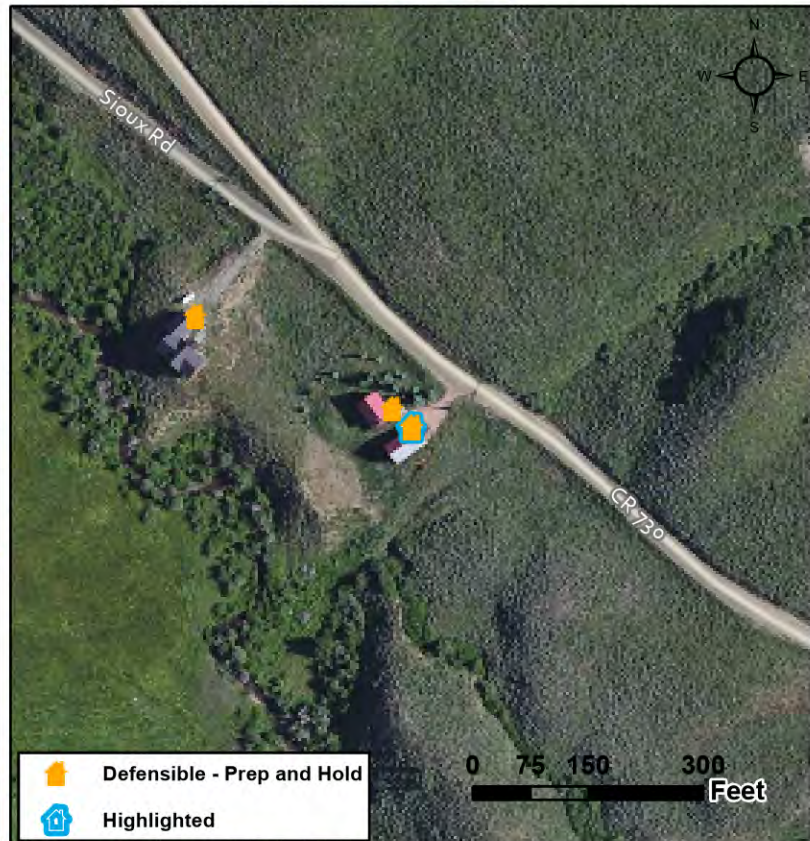
Triage Category: Defensible, Prep and Hold
FIRESCOPE Triage Category: Threatened Defensible
Structure Number: 15789 County Road 730 - 1
Collected Date/Time: 8/2/2023 10:34:17 PM
Collected By: Adam Altergott
Inspector's Position: EngB
Type of Structure: Outbuilding
Primary Structures: 1
Is the building Occupied?: No
Outbuildings: 1
Fuel Surrounding Structure: Shrub or timber
Defensible Space: 30 ft treated
Roof Material: Noncombustible or not applicable
Siding Material: Log construction
Electrical Power: Yes
Gas to Structure: No
Hazards:
Access to Site: T1 Engine
Describe Access: Driveway
Comm With ICP: Yes
Water Source: Reliable water source nearby
Safety Zone Present:
Mitigation Time (in hours): 1
Mitigation Description: Weed wacking tall grasses and lumber removal
Resources Needed to Protect Structure: Any type engine
FIRESCOPE Tactics: Prep and Defend
Notes: Cinder block foundation log siding

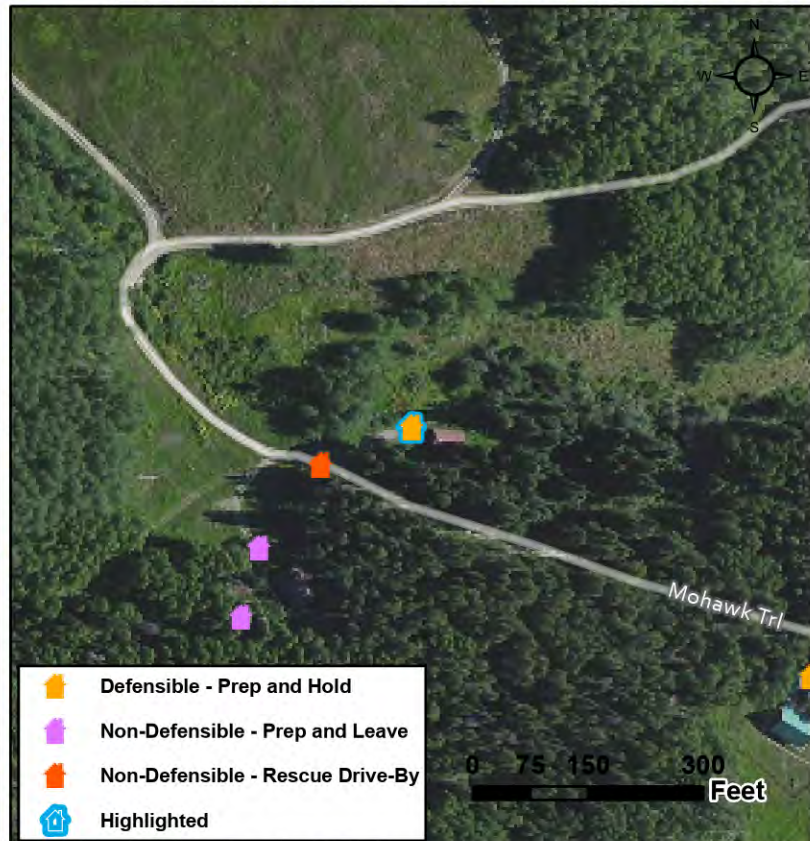
Triage Category: Defensible, Prep and Hold
FIRESCOPE Triage Category: Not Threatened
Structure Number: 159 Mohawk Trl - 1
Collected Date/Time: 8/3/2023 8:12:59 PM
Collected By: Adam Altergott
Inspector's Position: EngB
Type of Structure: Residential
Primary Structures: 1
Is the building Occupied?: Yes
Outbuildings: 1
Fuel Surrounding Structure: Shrub or timber
Defensible Space: Less than 30 ft treated
Roof Material: Noncombustible or not applicable
Siding Material: Log construction
Electrical Power: Yes
Gas to Structure: Unknown
Hazards: Lots of conifer and pines feet from structures
Access to Site: T3/4 Engine
Describe Access: Back into driveway
Comm With ICP: Yes
Water Source: Reliable water source nearby
Safety Zone Present:
Mitigation Time (in hours): 1
Mitigation Description: Rake leaves pine needles. remove wood, firewood, cut shrubs out
Resources Needed to Protect Structure: 1 any 3/4 type engine
FIRESCOPE Tactics: Prep and Defend

Notes: Log structure metal roof, deck off the north end of structure open ended cabin underneath

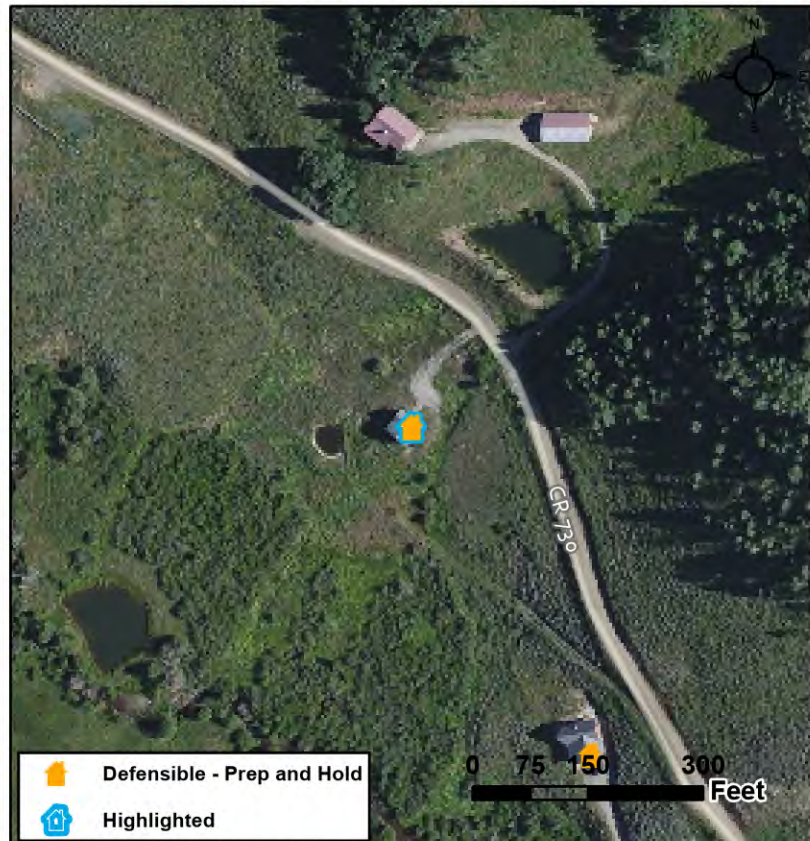
Triage Category: Defensible, Prep and Hold
FIRESCOPE Triage Category: Threatened Defensible
Structure Number: 15953 County Road 730
Collected Date/Time: 8/3/2023 10:06:00 PM
Collected By: Bela Harrington
Inspector's Position: DIVS t
Type of Structure: Residential
Primary Structures: 1
Is the building Occupied?: No
Outbuildings: 0
Fuel Surrounding Structure: Grass/tundra,northern hardwood litter
Defensible Space: Less than 30 ft treated
Roof Material: Noncombustible or not applicable
Siding Material: Log construction
Electrical Power: Yes
Gas to Structure: Yes
Hazards: Power lines, propane tank
Access to Site: T3/4 Engine
Describe Access: Narrow gravel driveway off of CR730
Comm With ICP: Yes
Water Source: Reliable water source nearby
Safety Zone Present:
Mitigation Time (in hours): 2
Mitigation Description: Mowing and brushing
Resources Needed to Protect Structure: 1 engine any type
FIRESCOPE Tactics: Prep and Defend

Notes: Good access all around, deck on south side.
 Looks like vacation home.

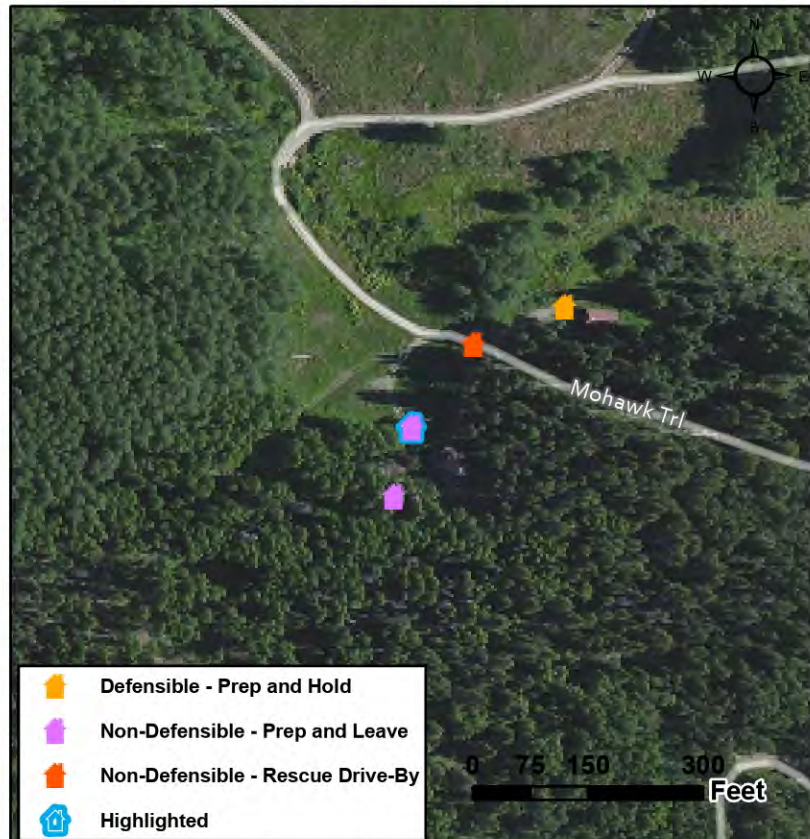
Triage Category: Non-Defensible, Prep and Leave
FIRESCOPE Triage Category: Not Threatened
Structure Number: 160 Mohawk Trl
Collected Date/Time: 8/3/2023 9:42:00 PM
Collected By: Adam Altergott
Inspector's Position: ENGB
Type of Structure: Residential
Primary Structures: 1
Is the building Occupied?: Yes
Outbuildings: 1
Fuel Surrounding Structure: Shrub or timber
Defensible Space: Less than 30 ft treated
Roof Material: Noncombustible or not applicable
Siding Material: Log construction
Electrical Power: Yes
Gas to Structure: No
Hazards: Unstable deck surrounding building lots of gas cans
Access to Site: T3/4 Engine
Describe Access: Turn around access
Comm With ICP: Yes
Water Source: Reliable water source nearby
Safety Zone Present:
Mitigation Time (in hours): 3
Mitigation Description: Removal of firewood gas cans lumber and dead trees surrounding house
Resources Needed to Protect Structure: 1 type 3 or 4 engine
FIRESCOPE Tactics: Prep and Go

Notes: Unstable deck

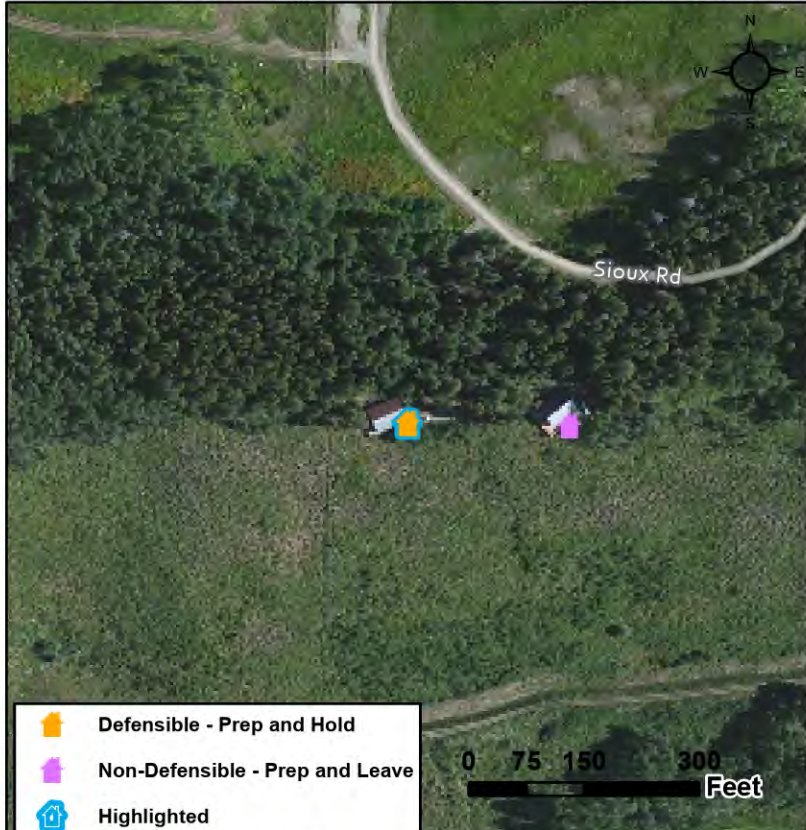
Triage Category: Defensible, Prep and Hold
FIRESCOPE Triage Category: Threatened Defensible
Structure Number: 1730 Sioux Rd
Collected Date/Time: 8/3/2023 6:30:43 PM
Collected By: Bo Knickman
Inspector's Position: Engb
Type of Structure: Residential
Primary Structures: 1
Is the building Occupied?: Yes
Outbuildings: 1
Fuel Surrounding Structure: Shrub or timber
Defensible Space: Less than 30 ft treated
Roof Material: Noncombustible or not applicable
Siding Material: Wood or open sided
Electrical Power: Yes
Gas to Structure: No
Hazards: No safety zone at home, safety zone at base of driveway, tactical maneuver to the bottom of driveway will be highly likely.
Access to Site: T3/4 Engine
Describe Access: 300 foot steep driveway, small turn around at top, driveway is in timber and is not tenable in fire conditions
Comm With ICP: Yes
Water Source: No reliable water source nearby
Safety Zone Present:
Mitigation Time (in hours): 1

Mitigation Description: Removing fuels adjacent to home, especially down slope on south side. Sprinkler kit recommended.
Resources Needed to Protect Structure: 1 engine
FIRESCOPE Tactics: Bump and Run
Notes: Timber bumping the home to the north, steep slope with grass/shrub component directly below structure

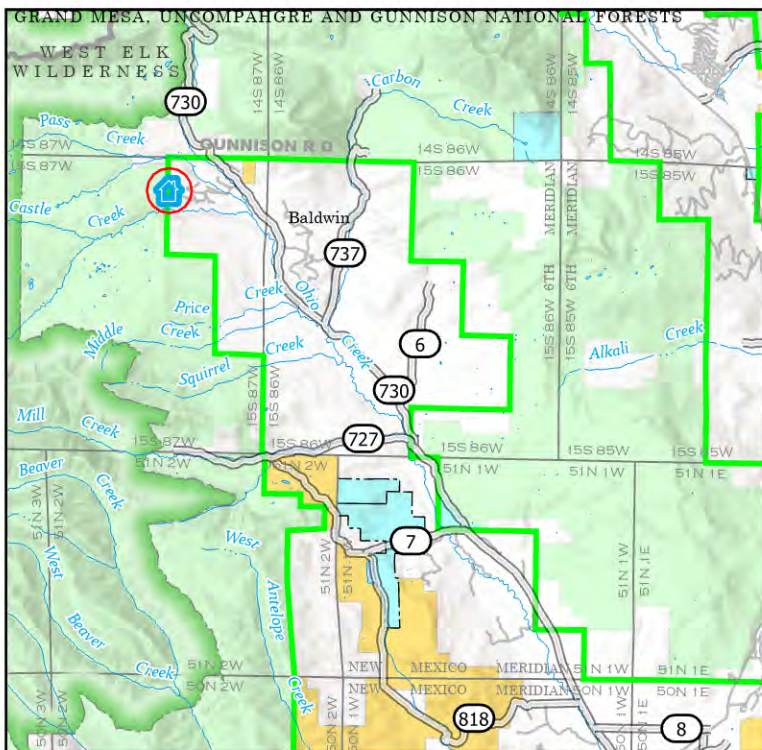
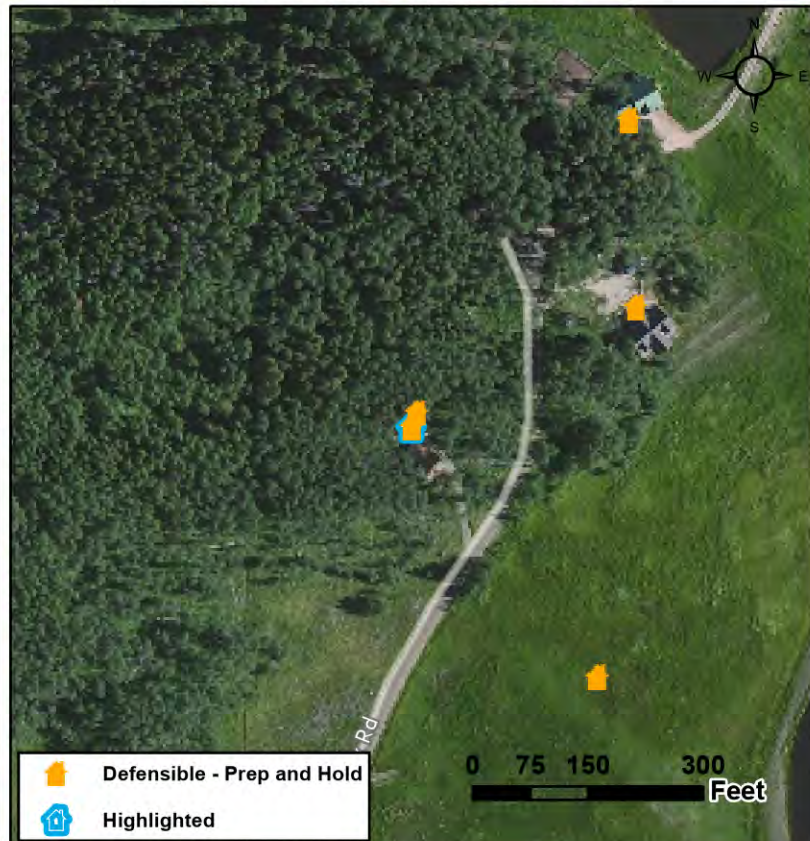
Triage Category: Defensible, Prep and Hold
FIRESCOPE Triage Category: Threatened Defensible
Structure Number: 1796 Sioux Rd - 1
Collected Date/Time: 8/3/2023 5:53:39 PM
Collected By: Jesse Gallup
Inspector's Position: FFTI
Type of Structure: Residential
Primary Structures: 1
Is the building Occupied?: Yes
Outbuildings: 1
Fuel Surrounding Structure: Grass and shrub, hardwood litter
Defensible Space: More than 100ft treated
Roof Material: Noncombustible or not applicable
Siding Material: Log construction
Electrical Power: Yes
Gas to Structure: No
Hazards: Active logging area, heavy equipment
Access to Site: T3/4 Engine
Describe Access: Unimproved dirt driveway
Comm With ICP: Yes
Water Source: Limited or dependent on electricity
Safety Zone Present:
Mitigation Time (in hours): 1
Mitigation Description: Remove combustible material from under porch
Resources Needed to Protect Structure: 1 engine
FIRESCOPE Tactics: Prep and Defend

Notes: Log cabin like structure with defensible area. Logging operation behind main structure.

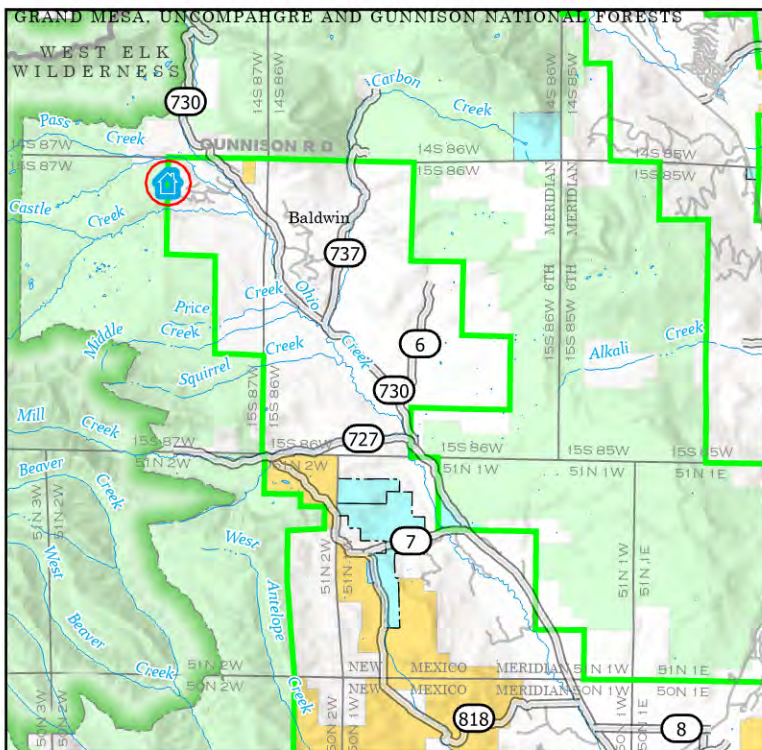
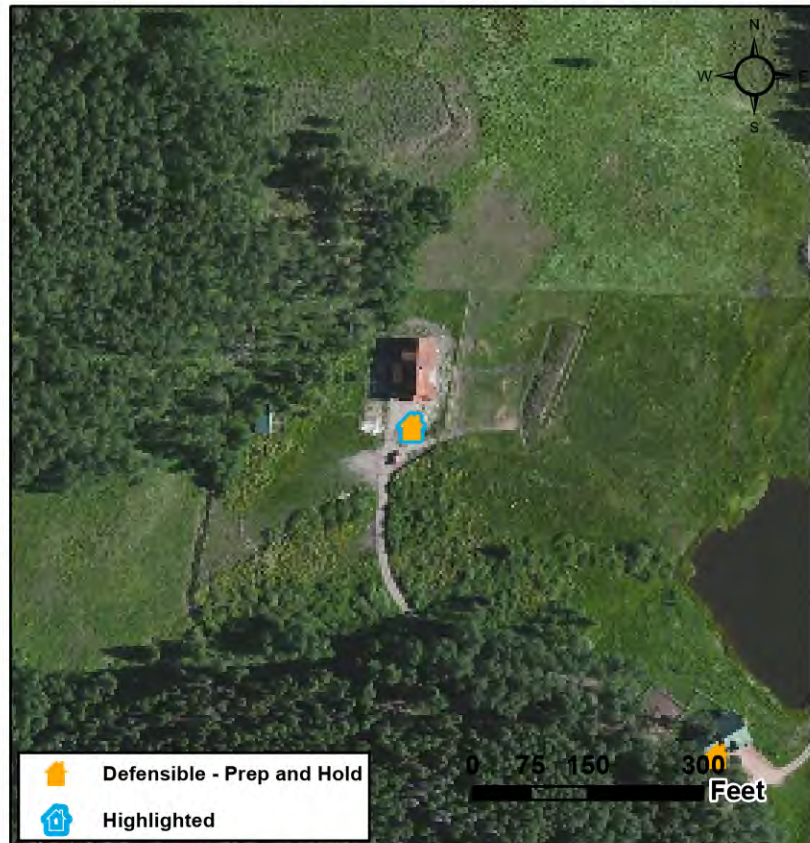
Triage Category: Defensible, Prep and Hold
FIRESCOPE Triage Category: Threatened Defensible
Structure Number: 1800 Sioux Rd
Collected Date/Time: 8/3/2023 5:40:59 PM
Collected By: Zak Slutzky
Inspector's Position: EngB(t)
Type of Structure: Residential
Primary Structures: 1
Is the building Occupied?: No
Outbuildings: 0
Fuel Surrounding Structure: Shrub or timber
Defensible Space: 30 ft treated
Roof Material: Noncombustible or not applicable
Siding Material: Wood or open sided
Electrical Power: Yes
Gas to Structure: Yes
Hazards: Adjacent above ground propane tank, Electric fence, livestock
Access to Site: T3/4 Engine
Describe Access: Semi improved long driveway, with turnarounds - not tenable egress under fire conditions
Comm With ICP: Yes
Water Source: No reliable water source nearby
Safety Zone Present:
Mitigation Time (in hours): 1
Mitigation Description: Brushing, grass mowing
Resources Needed to Protect Structure: 1 engine

FIRESCOPE Tactics: Prep and Defend
Notes: 3 story residential type 4 construction

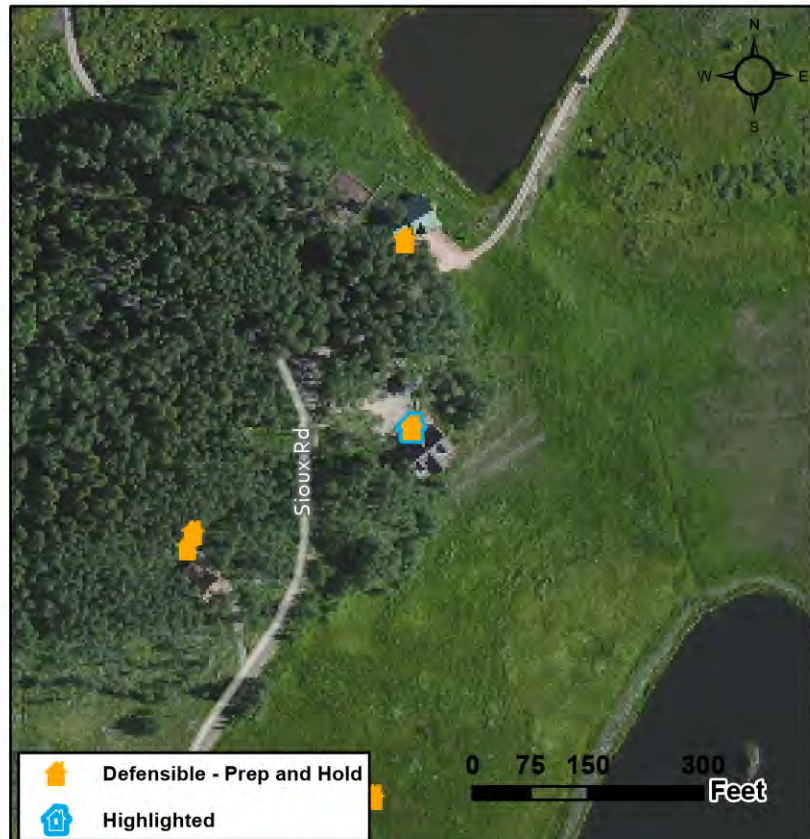
Triage Category: Defensible, Prep and Hold
FIRESCOPE Triage Category: Threatened Defensible
Structure Number: 1815 Sioux Rd
Collected Date/Time: 8/3/2023 6:06:36 PM
Collected By: Fritz Rogowski
Inspector's Position: Engb
Type of Structure: Residential
Primary Structures: 1
Is the building Occupied?: Yes
Outbuildings: 2
Fuel Surrounding Structure: Grass and shrub, hardwood litter
Defensible Space: 100 ft treated
Roof Material: Noncombustible or not applicable
Siding Material: Log construction
Electrical Power: Yes
Gas to Structure: Yes
Hazards: Underground propane tank
Access to Site: T3/4 Engine
Describe Access: Improved drieway
Comm With ICP: Yes
Water Source: Limited or dependent on electricity
Safety Zone Present:
Mitigation Time (in hours): 1
Mitigation Description: Remove minor fuels, handline, sprinkler kit
Resources Needed to Protect Structure: 1 engine crew
FIRESCOPE Tactics: Prep and Defend
Notes: Heavy timber construction with fuel mitigation in place
