Location: 100 Castle Creek Rd, WILDERNESS STREAMS FILING NO. 2

Coordinates (DDM): 38° 46.291' N, 107° 04.891' W

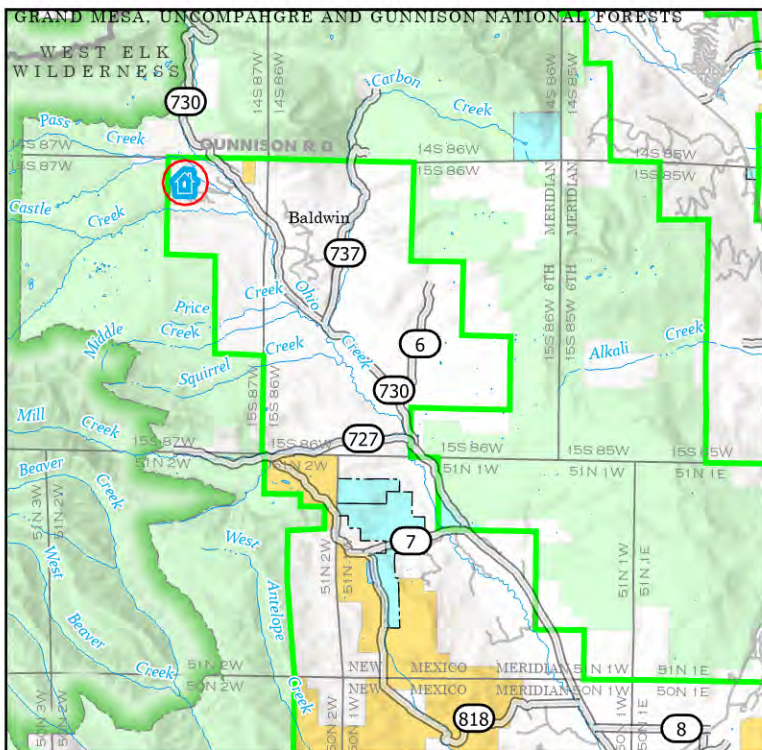
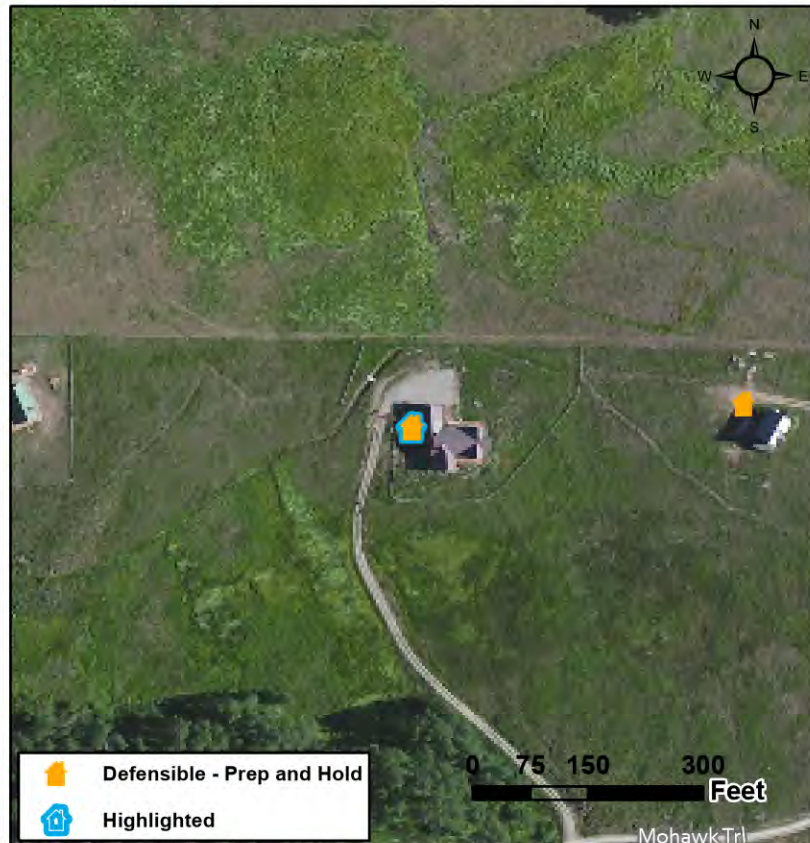
Triage Category: Defensible, Prep and Hold
FIRESCOPE Triage Category: Not Threatened
Structure Number: 184 Mohawk Trl
Collected Date/Time: 8/3/2023 9:23:22 PM
Collected By: Adam Altergott
Inspector's Position: EngB
Type of Structure: Residential
Primary Structures: 1
Is the building Occupied?: No
Outbuildings: 0
Fuel Surrounding Structure: Grass and shrub, hardwood litter
Defensible Space: Less than 30 ft treated
Roof Material: Noncombustible or not applicable
Siding Material: Wood or open sided
Electrical Power: Yes
Gas to Structure: No
Hazards: None
Access to Site: T3/4 Engine
Describe Access: Narrow gravel road with tight turnaround
Comm With ICP: Yes
Water Source: No reliable water source nearby
Safety Zone Present:
Mitigation Time (in hours): 1
Mitigation Description: Weedwack weeds and grass and move material from under deck.
Resources Needed to Protect Structure: 1 type 3 or 6 engine
FIRESCOPE Tactics: Prep and Defend

Notes: Metal roof with wood siding and large deck

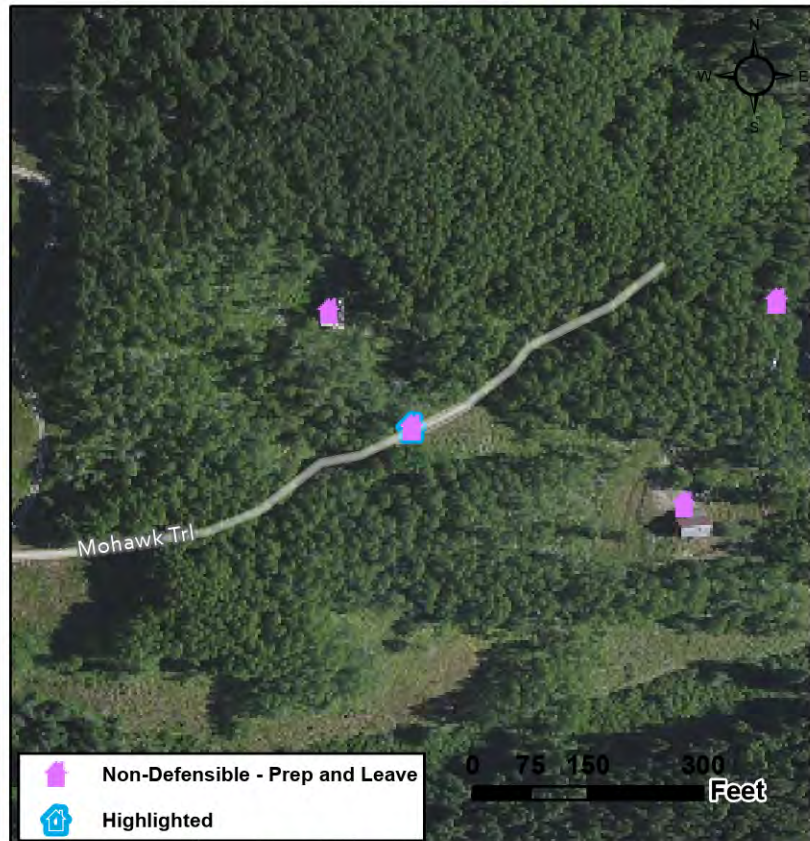
Triage Category: Non-Defensible, Prep and Leave
FIRESCOPE Triage Category: Not Threatened
Structure Number: 201 Mohawk Trl
Collected Date/Time: 8/3/2023 8:51:54 PM
Collected By: Kevin Brueck
Inspector's Position: EngB t
Type of Structure: Residential
Primary Structures: 1
Is the building Occupied?: Yes
Outbuildings: 0
Fuel Surrounding Structure: Shrub or timber
Defensible Space: 30 ft treated
Roof Material: Noncombustible or not applicable
Siding Material: Rock, concrete, metal
Electrical Power: Yes
Gas to Structure: Unknown
Hazards: Solar panels
Access to Site: T3/4 Engine
Describe Access: Narrow dirt road
Comm With ICP: Yes
Water Source: No reliable water source nearby
Safety Zone Present:
Mitigation Time (in hours): 1
Mitigation Description: Remove combustibles that are close to the house
Resources Needed to Protect Structure: Type 6
FIRESCOPE Tactics: Prep and Go
Notes: Walk out basement and porch on Charlie side

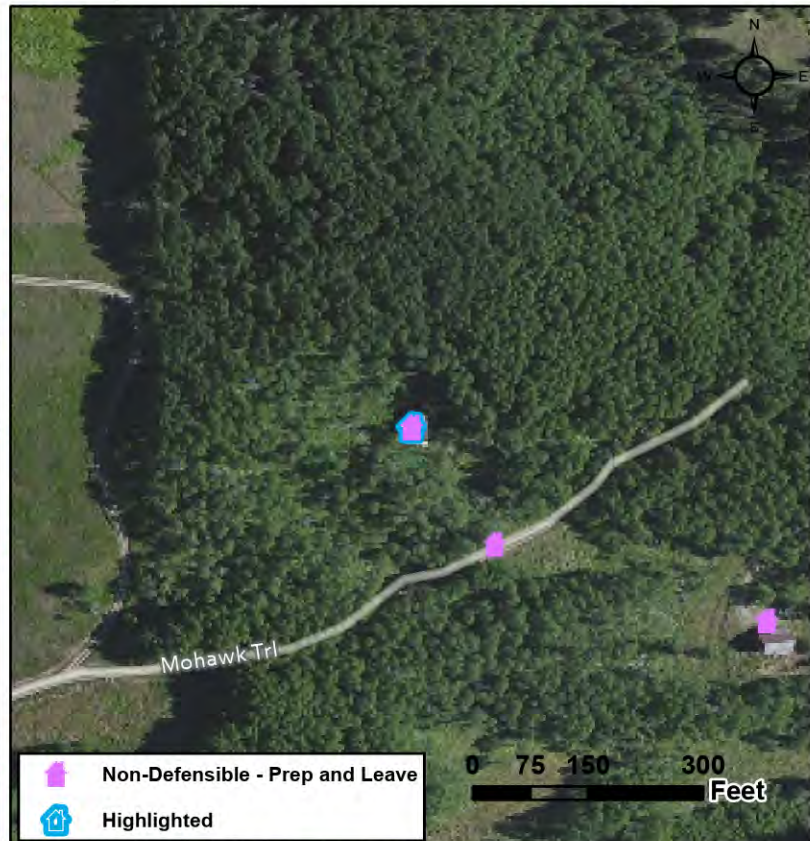
Triage Category: Non-Defensible, Prep and Leave
FIRESCOPE Triage Category: Not Threatened
Structure Number: 204 Mohawk Trl
Collected Date/Time: 8/3/2023 9:46:47 PM
Collected By: Kevin Brueck
Inspector's Position: EngB t
Type of Structure: Residential
Primary Structures: 1
Is the building Occupied?: No
Outbuildings: 1
Fuel Surrounding Structure: Shrub or timber
Defensible Space: Less than 30 ft treated
Roof Material: Combustible or no roof
Siding Material: Wood or open sided
Electrical Power: Unknown
Gas to Structure: Unknown
Hazards: Pile of propane cans on the porch
Access to Site: T6 Engine
Describe Access: Narrow, two track, entrance is easy to miss
Comm With ICP: Yes
Water Source: No reliable water source nearby
Safety Zone Present:
Mitigation Time (in hours): 5
Mitigation Description: Limping trees, clearing scrap and other combustibles materials away from structure, sprinklers
Resources Needed to Protect Structure: Type 6

FIRESCOPE Tactics: Prep and Go
Notes: Hunting cabin

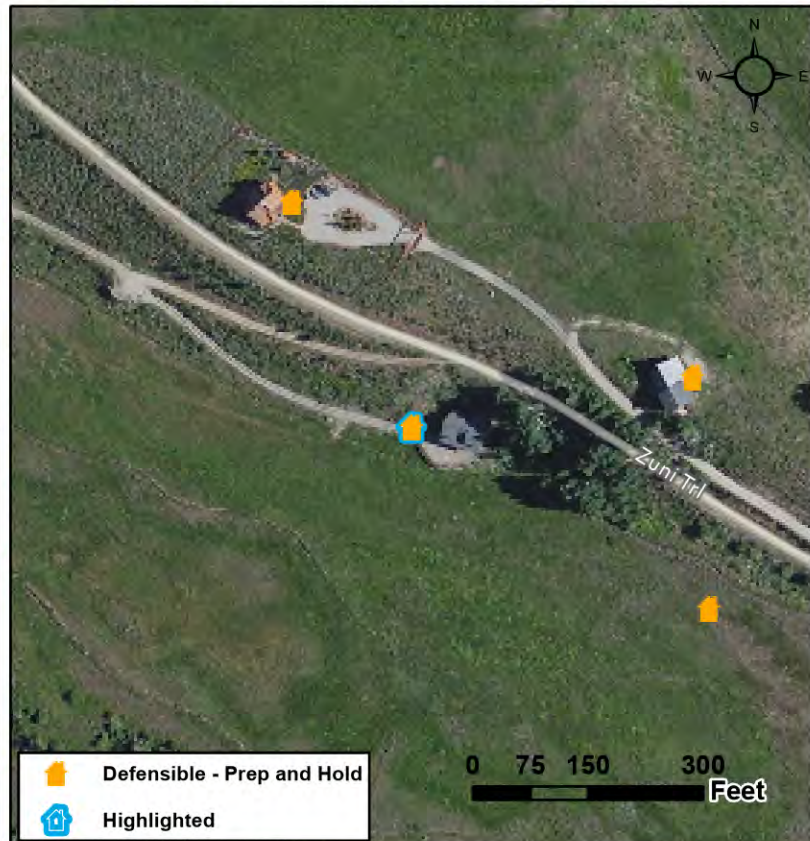
Triage Category: Defensible, Prep and Hold
FIRESCOPE Triage Category: Not Threatened
Structure Number: 214 Zuni Trl
Collected Date/Time: 8/3/2023 6:39:23 PM
Collected By: Adam Altergott
Inspector's Position: EngB
Type of Structure: Residential
Primary Structures: 1
Is the building Occupied?: No
Outbuildings: 0
Fuel Surrounding Structure: Grass and shrub, hardwood litter
Defensible Space: Less than 30 ft treated
Roof Material: Noncombustible or not applicable
Siding Material: Log construction
Electrical Power: Yes
Gas to Structure: Yes
Hazards:
Access to Site: T3/4 Engine
Describe Access: Tight gravel road no turn around in driveway, back down driveway
Comm With ICP: Yes
Water Source: Reliable water source nearby
Safety Zone Present:
Mitigation Time (in hours): 2
Mitigation Description: Weed whacking around home move the firewood and lumber away and cut the snag behind home
Resources Needed to Protect Structure: 1 Type 3 or 6

FIRESCOPE Tactics: Prep and Defend
Notes: Propane tank with enclosed fence

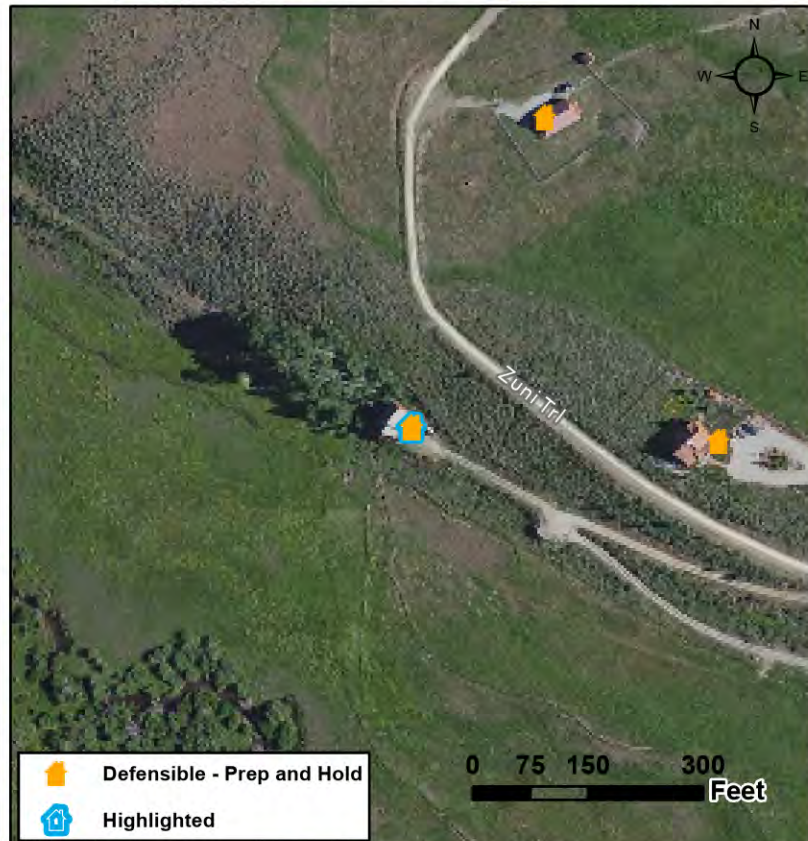
Triage Category: Defensible, Prep and Hold
FIRESCOPE Triage Category: Not Threatened
Structure Number: 256 Zuni Trl
Collected Date/Time: 8/3/2023 6:39:23 PM
Collected By: Adam Altergott
Inspector's Position: EngB
Type of Structure: Residential
Primary Structures: 1
Is the building Occupied?: No
Outbuildings: 0
Fuel Surrounding Structure: Grass and shrub, hardwood litter
Defensible Space: Less than 30 ft treated
Roof Material: Noncombustible or not applicable
Siding Material: Log construction
Electrical Power: Yes
Gas to Structure: No
Hazards: Snag tree on north end of home
Access to Site: T3/4 Engine
Describe Access: Tight gravel road no turn around in driveway
Comm With ICP: Yes
Water Source: Reliable water source nearby
Safety Zone Present:
Mitigation Time (in hours): 2
Mitigation Description: Weed whacking around home move the firewood and lumber away and cut the snag behind home
Resources Needed to Protect Structure: Type 3 or 6

FIRESCOPE Tactics: Prep and Defend
Notes: Large deck around 3/4 of home built into hillside

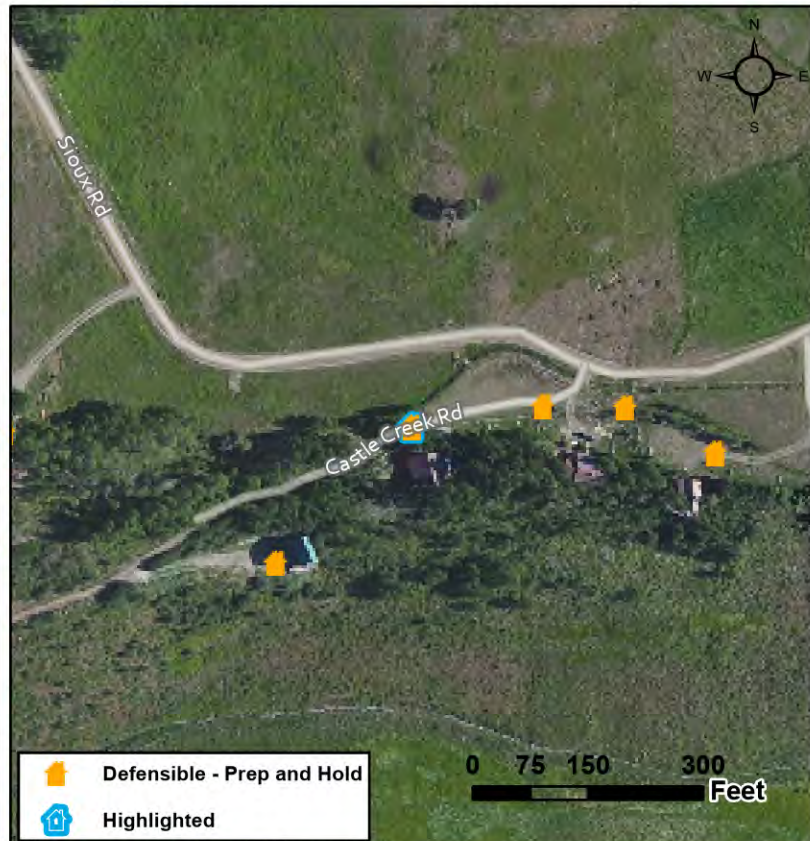
Triage Category: Defensible, Prep and Hold
FIRESCOPE Triage Category: Threatened Defensible
Structure Number: 52 Castle Creek Rd
Collected Date/Time: 8/3/2023 8:32:43 PM
Collected By: Jesse Gallup
Inspector's Position: FFTI
Type of Structure: Residential
Primary Structures: 1
Is the building Occupied?: Yes
Outbuildings: 0
Fuel Surrounding Structure: Grass and shrub, hardwood litter
Defensible Space: Less than 30 ft treated
Roof Material: Noncombustible or not applicable
Siding Material: Log construction
Electrical Power: Yes
Gas to Structure: Unknown
Hazards: Brush around home , steep hill behind structure
Access to Site: T3/4 Engine
Describe Access: Gravel 2 track with easy access
Comm With ICP: Yes
Water Source: Limited or dependent on electricity
Safety Zone Present:
Mitigation Time (in hours): 1
Mitigation Description: Removal of combustibles around structure, sprinklers around home
Resources Needed to Protect Structure: 1 engine

FIRESCOPE Tactics: Prep and Defend
Notes: New build log construction with lots of small fuels around structure

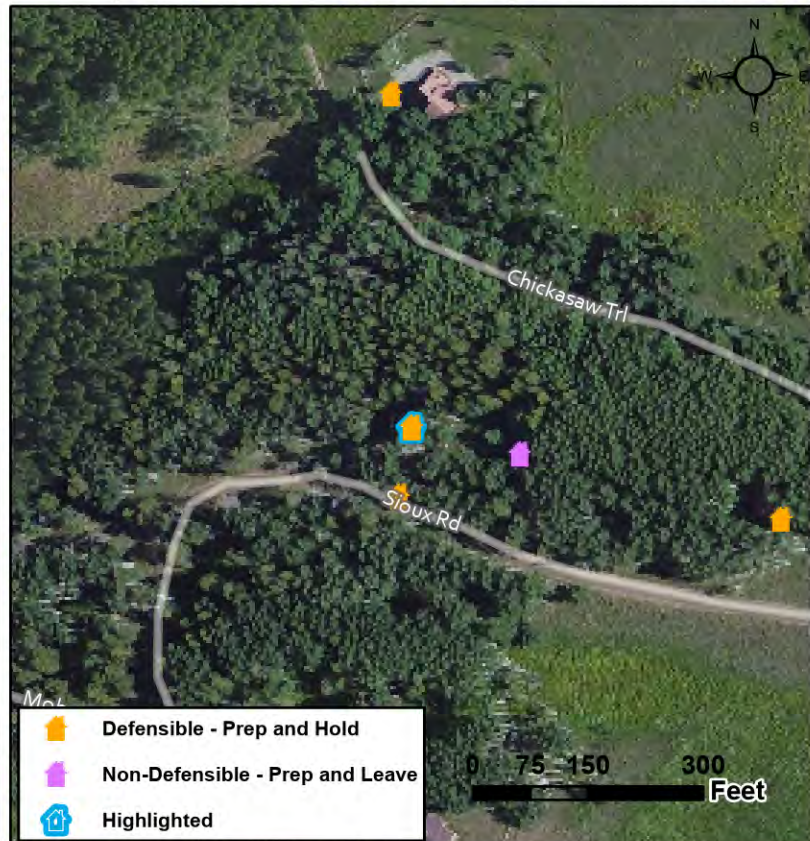
Triage Category: Defensible, Prep and Hold
FIRESCOPE Triage Category: Not Threatened
Structure Number: 591 Sioux Rd - 2
Collected Date/Time: 8/3/2023 8:12:59 PM
Collected By: Adam Altergott
Inspector's Position: EngB
Type of Structure: Residential
Primary Structures: 1
Is the building Occupied?: No
Outbuildings: 0
Fuel Surrounding Structure: Shrub or timber
Defensible Space: 30 ft treated
Roof Material: Noncombustible or not applicable
Siding Material: Wood or open sided
Electrical Power: Yes
Gas to Structure: Unknown
Hazards: Nearby dead standing aspen snags
Access to Site: T1 Engine
Describe Access: Back into driveway, 9 foot gate entrance
Comm With ICP: Yes
Water Source: Reliable water source nearby
Safety Zone Present:
Mitigation Time (in hours): 2
Mitigation Description: Rake leaves, remove wood, firewood, cut grass
Resources Needed to Protect Structure: 1 any type engine
FIRESCOPE Tactics: Prep and Defend
Notes: A frame build Suspended floor plan, large heat, fire access to underneath structure

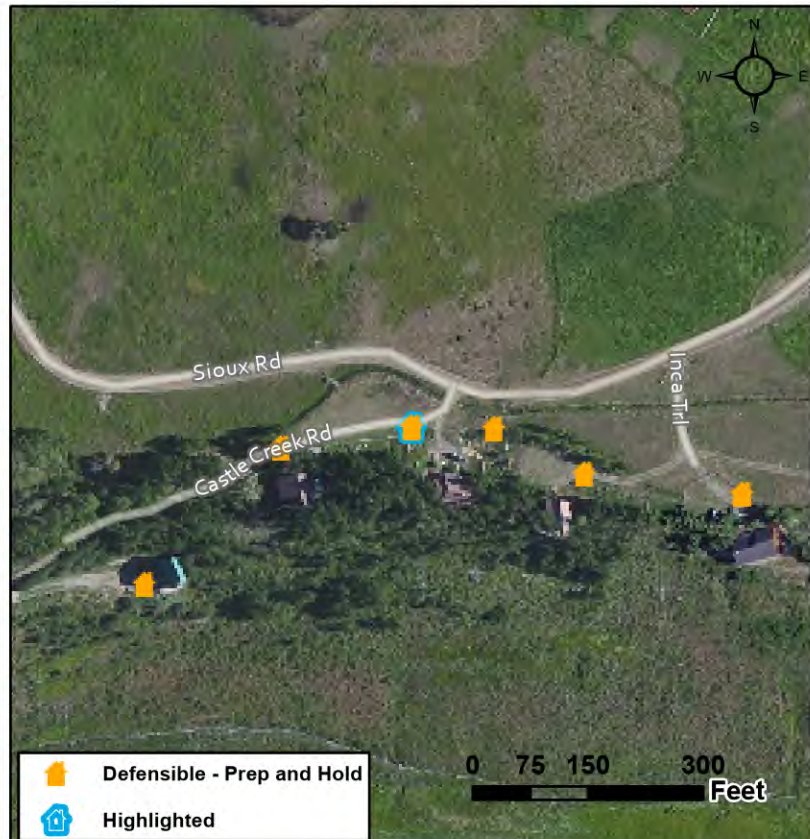
Triage Category: Defensible, Prep and Hold
FIRESCOPE Triage Category: Threatened Defensible
Structure Number: 846 Sioux Rd
Collected Date/Time: 8/3/2023 8:39:56 PM
Collected By: Jesse Gallup
Inspector's Position: FFTI
Type of Structure: Residential
Primary Structures: 1
Is the building Occupied?: Yes
Outbuildings: 1
Fuel Surrounding Structure: Grass and shrub, hardwood litter
Defensible Space: 30 ft treated
Roof Material: Noncombustible or not applicable
Siding Material: Log construction
Electrical Power: Yes
Gas to Structure: Yes
Hazards: Steep hill on back side of structure
Access to Site: T3/4 Engine
Describe Access: Dirt driveway with easy access
Comm With ICP: Yes
Water Source: Limited or dependent on electricity
Safety Zone Present:
Mitigation Time (in hours): 1
Mitigation Description: Removal of combustibles from structure , sprinkler set up
Resources Needed to Protect Structure: 1 engine
FIRESCOPE Tactics: Prep and Defend

Notes: Modern log construction with fire wood on porch. Small combustible material around home

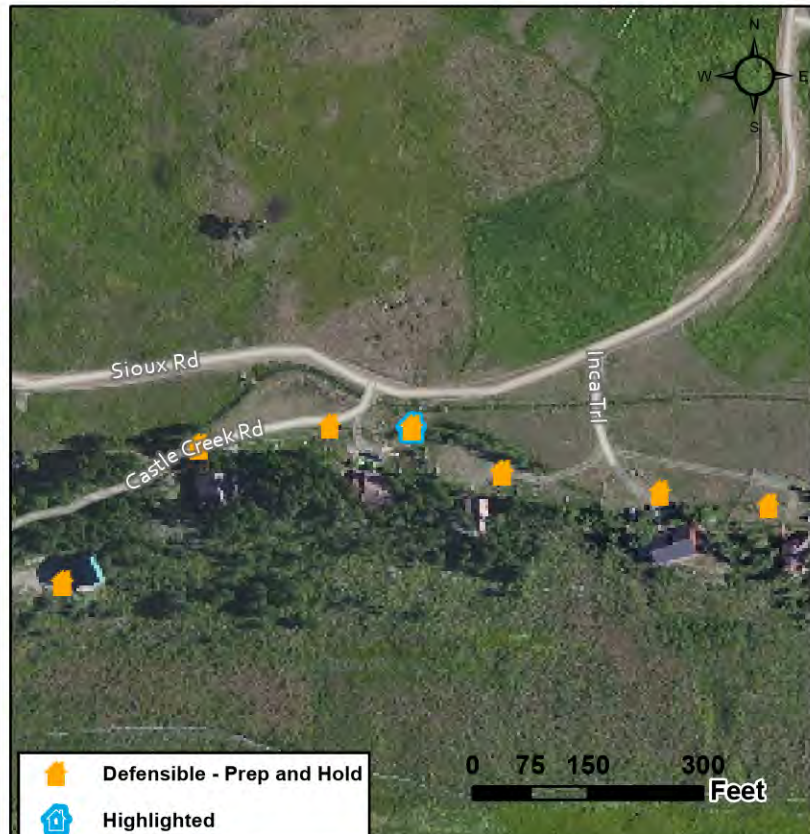
Triage Category: Defensible, Prep and Hold
FIRESCOPE Triage Category: Threatened Defensible
Structure Number: 846 Sioux Rd - ?
Collected Date/Time: 8/3/2023 8:39:56 PM
Collected By: Jesse Gallup
Inspector's Position: FFTI
Type of Structure: Residential
Primary Structures: 1
Is the building Occupied?: Yes
Outbuildings: 1
Fuel Surrounding Structure: Grass and shrub, hardwood litter
Defensible Space: 30 ft treated
Roof Material: Noncombustible or not applicable
Siding Material: Log construction
Electrical Power: Yes
Gas to Structure: Yes
Hazards: Steep hill on back side of structure
Access to Site: T1 Engine
Describe Access: Dirt driveway with easy access
Comm With ICP: Yes
Water Source: Limited or dependent on electricity
Safety Zone Present:
Mitigation Time (in hours): 1
Mitigation Description: Removal of combustibles from structure , sprinkler set up
Resources Needed to Protect Structure: 1 engine
FIRESCOPE Tactics: Prep and Defend

Notes: Modern log construction with fire wood on porch. Small combustible material around home

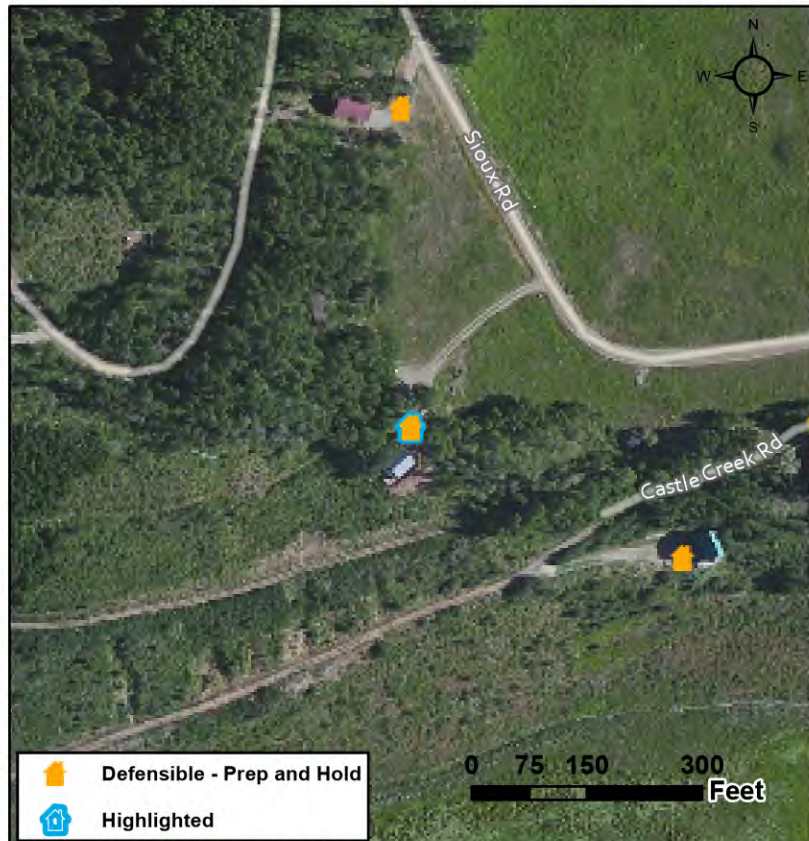
Triage Category: Defensible, Prep and Hold
FIRESCOPE Triage Category: Threatened Defensible
Structure Number: 964 Sioux Rd
Collected Date/Time: 8/3/2023 7:46:49 PM
Collected By: Cody Peterson
Inspector's Position: ENGB
Type of Structure: Residential
Primary Structures: 1
Is the building Occupied?: Yes
Outbuildings: 2
Fuel Surrounding Structure: Grass and shrub, hardwood litter
Defensible Space: 30 ft treated
Roof Material: Noncombustible or not applicable
Siding Material: Log construction
Electrical Power: Yes
Gas to Structure: Yes
Hazards:
Access to Site: T3/4 Engine
Describe Access: Maintained gravel
Comm With ICP: Yes
Water Source: Reliable water source nearby
Safety Zone Present:
Mitigation Time (in hours): 1
Mitigation Description: Weed eat
Resources Needed to Protect Structure:
FIRESCOPE Tactics: Prep and Defend
Notes: Mid-slope; wood frame and log combo
