Spring Creek

CO-GFX-230097

Structure Triage Assessment
3 July 2023

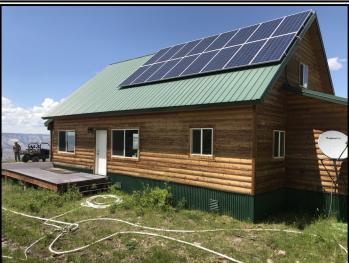
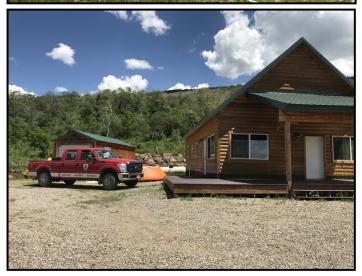
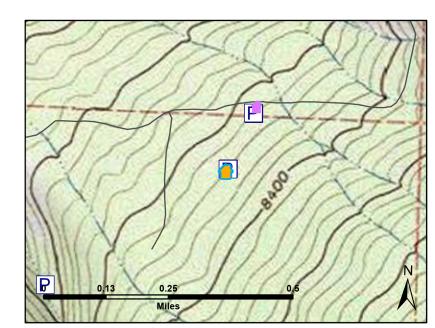
Structure Number: 1

Triage Category: Defensible, Prep and Hold

Siding Material: Wood or open sided

Hazards: Propane tank with plastic cord to house

Notes: Tin around base, trex decking, wood siding, solar

panels, power cannot be confirmed.

Mitigation Description: Thin and brush shrubs, set up sprinkler system, turn on pump, move propane tanks etc

from garage

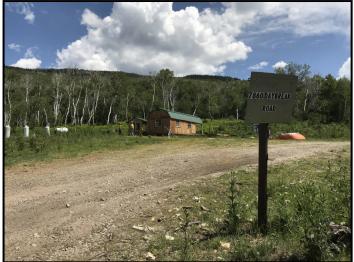
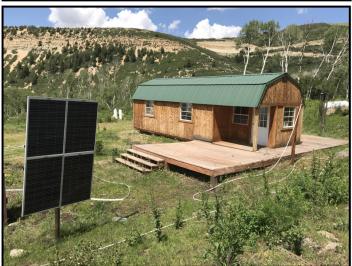
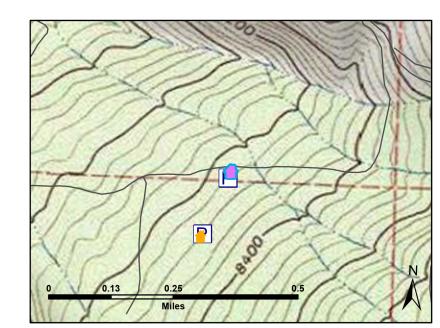
Structure Number: 2

Triage Category: Non-Defensible, Prep and Leave

Hazards: Propane tanks, large slash pile, oil and gas,

solar power

Notes: Wood siding, continuous fuel to structure, wood

decking, no foundation with open space beneath

structure.

Mitigation Description: Sprinklers from Mark 3 pump setup from pumpkin. Hazards set up away from structure

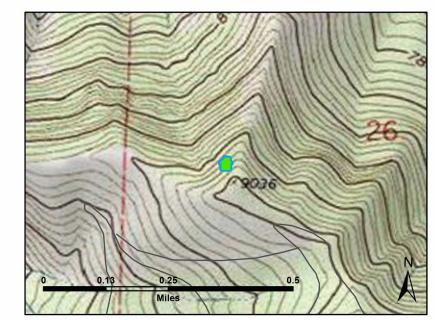
Structure Number: 3

Triage Category: Defensible, Stand Alone

Notes: 35 ft. Callahan Oil Company radio tower. No prep

needed.

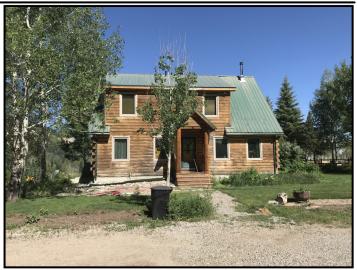
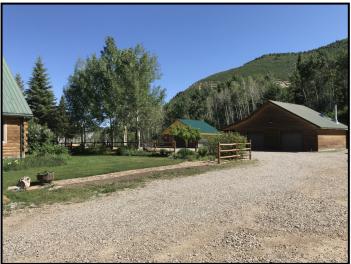
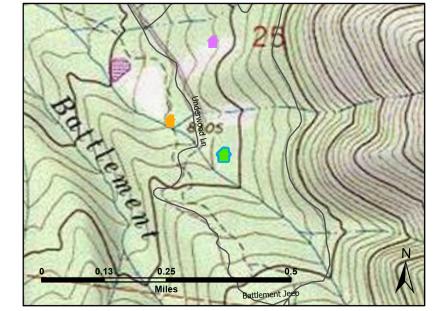
Structure Number: 4

Triage Category: Defensible, Stand Alone

Hazards: Phosphorus, propane, gunpowder, overhead

power lines

Mitigation Description: Mark 3, mark 3 kit, 3 sprinkler kits, 2 5 gallon Jerry's full mixed fuel, pounder, 10001.5 inchs hose, 500 1 inch hose, 5 red barrel 1 inch nozzle, 5 1.5 inch eye, 5 1 inch eye, 10 1.5-1 reducer, 10 t post *Resources Needed to Protect Structure:* Type 3 4

Notes: Mark 3 on creek, clean gutters, remove fabric

from porch

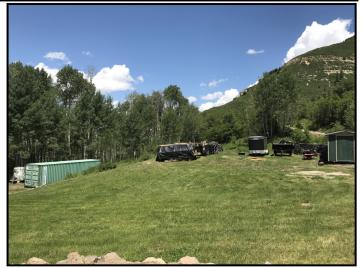
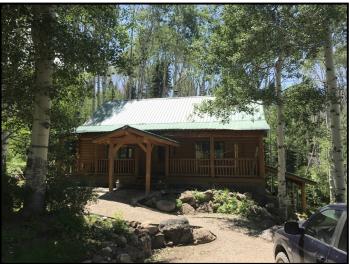
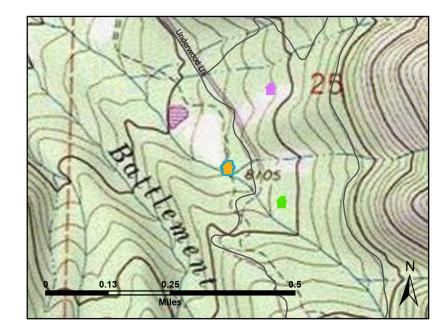
Structure Number: 5

Triage Category: Defensible, Prep and Hold

Hazards: Propane tank upslope of property

Notes: Shed and conex box counted as structures. Also on property: hardwood storage, skid steer, trailer, and

riding lawnmower.

Mitigation Description: Brush mitigation, removal of combustible debris from base of structure, pump and sprinkler kit installation. Equipment needs: 1 mark 3, 1 pump kit, 2 Gerry cans with mixed fuel, 400' of 1.5", 4 x 1.5" gated wyes, 400' of 1" hose, 4 x 1" gated wyes, 4 red

nozzles, 2 sprinkler kits

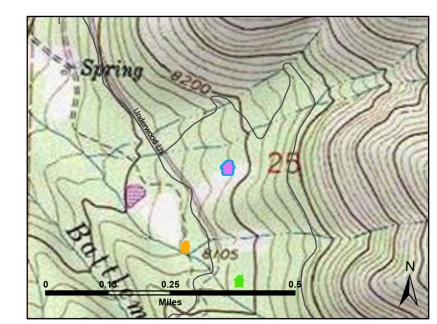
Structure Number: 6

Triage Category: Non-Defensible, Prep and Leave

Fuel Surrounding Structure: Shrub or timber Defensible Space: Less than 30 ft treated Roof Material: Combustible or no roof Siding Material: Log construction

Notes: Covered deck full of combustibles, 3 foot grass

around structures

Mitigation Description: Saw work, dozer line, weed

wack, sprinkler kits
