# Suppression Repair

Turner Gulch  
CO-GRD-250194  
08/23/2025 Day

31,699 acres at 8/22/2025 - 0016 hrs

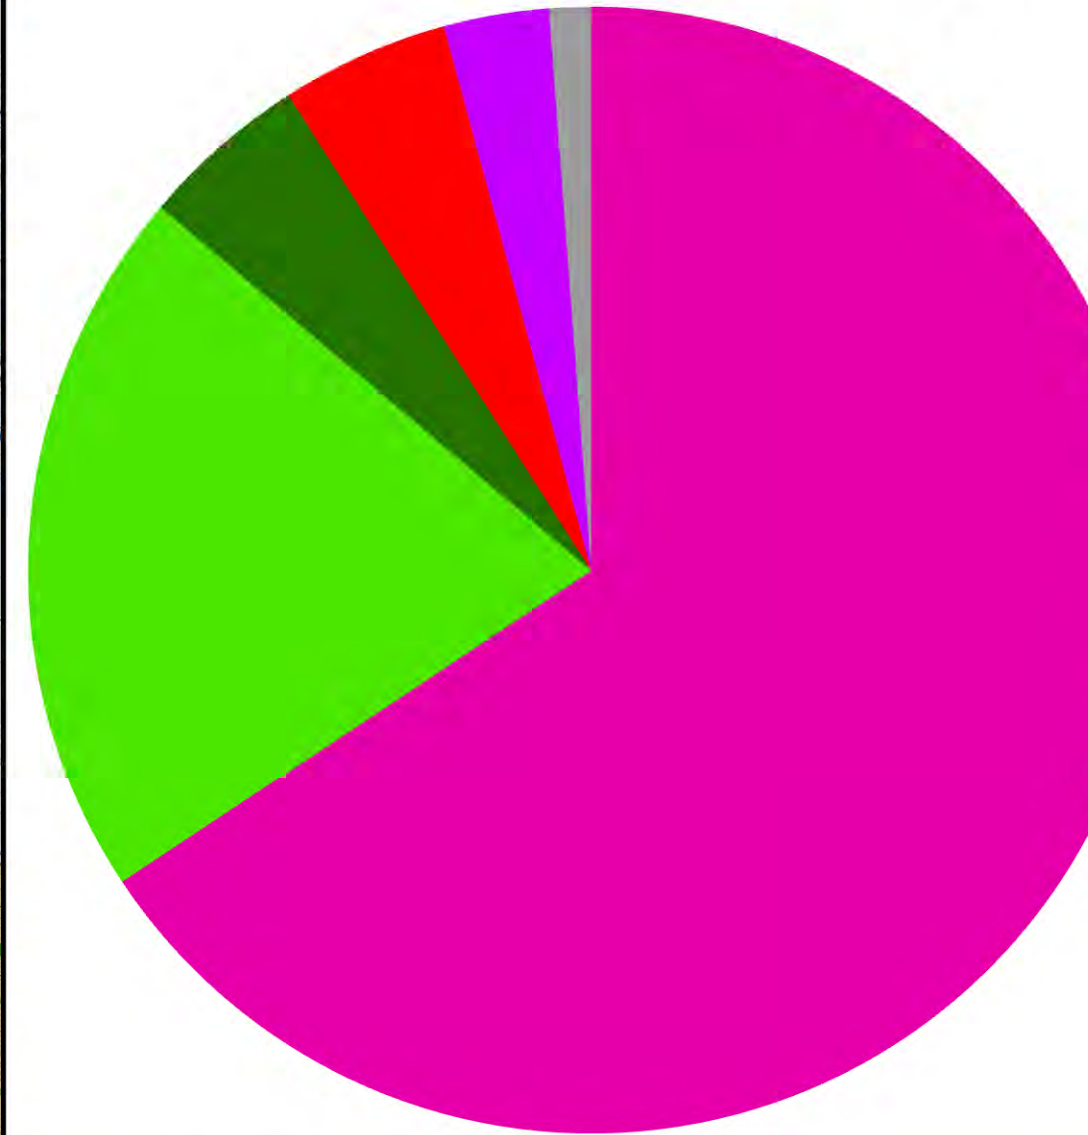
## Point Repair Status

In Use - Fire Management 65.7%  
Completed - Inspected 20.5%  
No Repair Needed 4.8%  
Repair Needed 4.8%  
Needs Assessment 3.0%  
Other - See Comments 1.2%

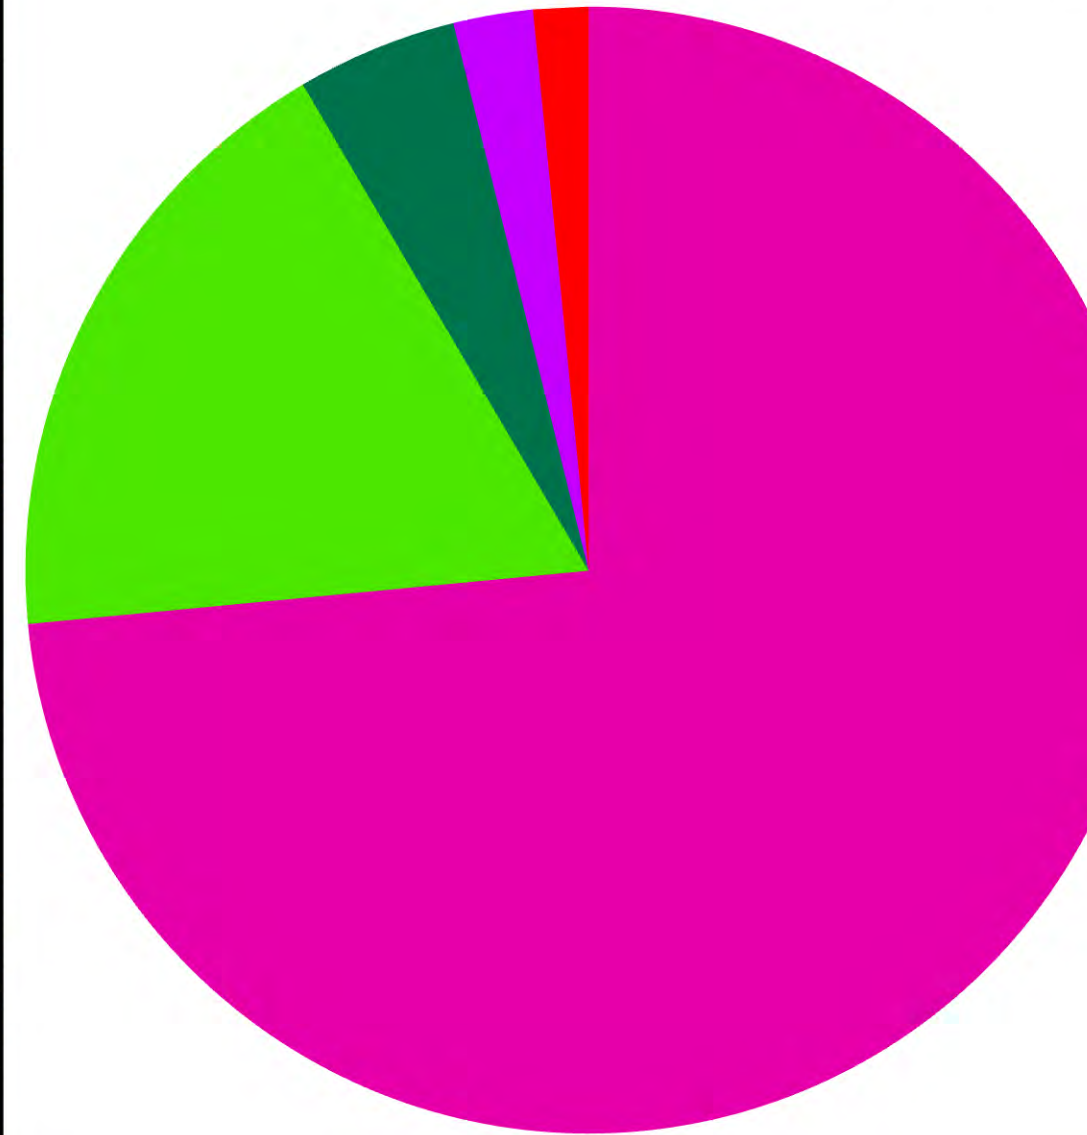
## Line Repair Status

In Use - Fire Management 73.5%  
Completed - Inspected 18.0%  
No Repair Needed 4.6%  
Needs Assessment 2.3%  
Repair Needed 1.6%
