# SUPPRESSION REPAIR North

Rafael  
AZ-PNF-863  
7/1/2021  
78,065 acres  
at 7/1/2021 1200

# SUPPRESSION REPAIR South

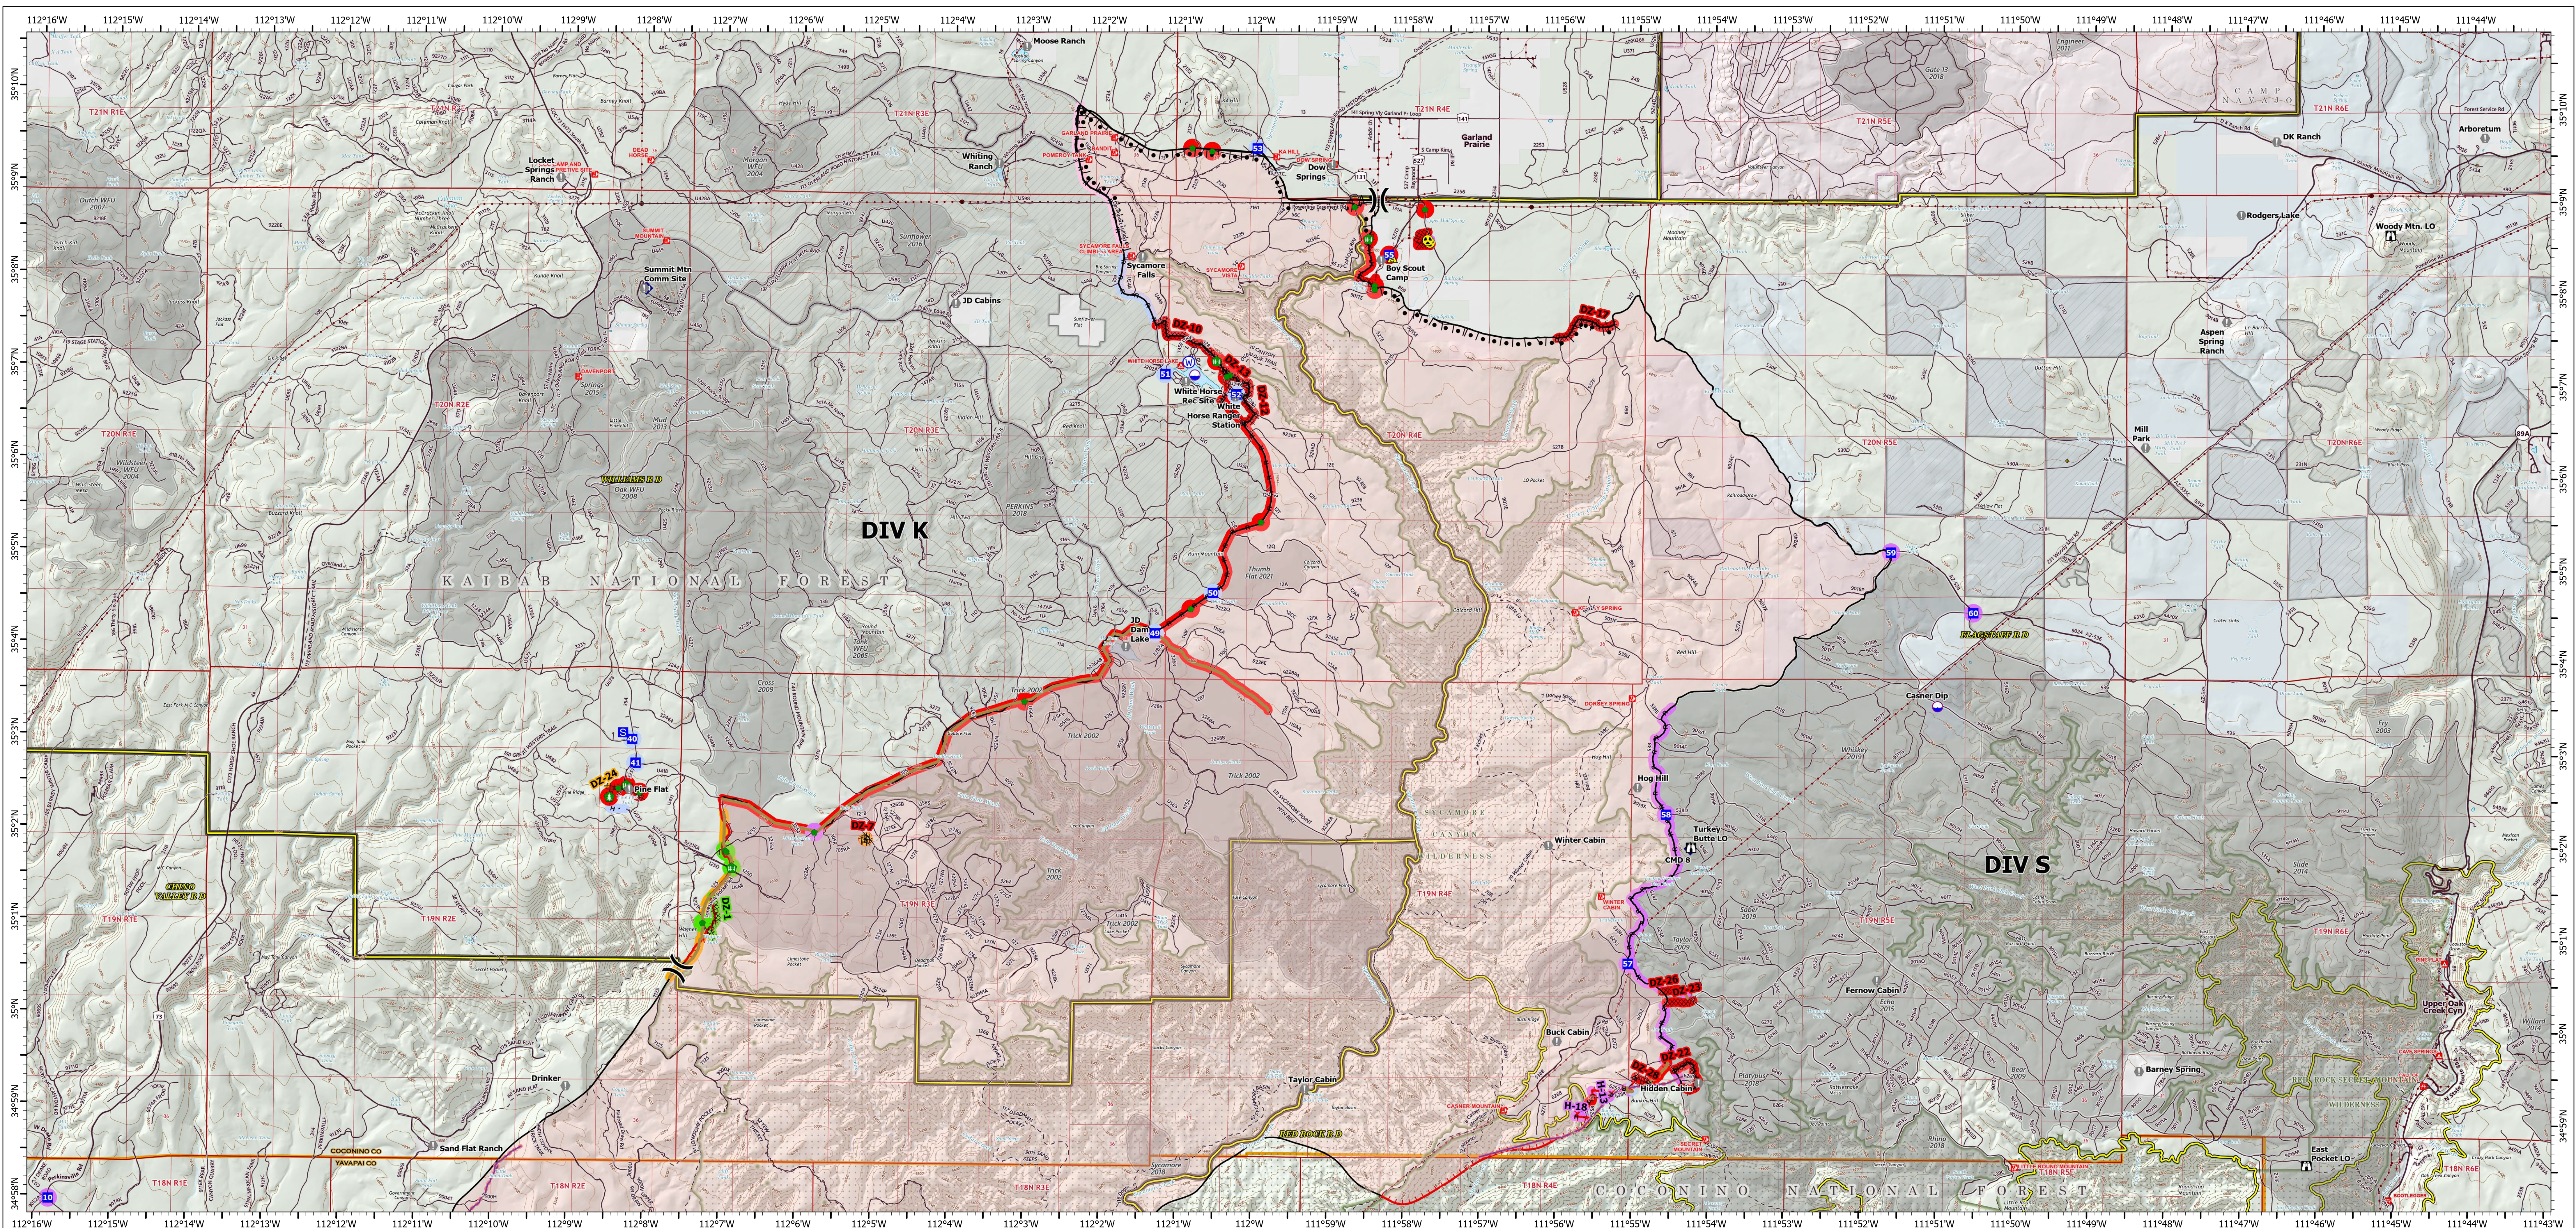
EC Point Type	Label	Repair Status	Repair Comments	Comments	Latitude	Longitude	EC Line Type	Label	Repair Status	Repair Comments	Comments	Length Feet
Drop Point	10	Unknown			34° 57.565' N	112° 15.795' W	Completed Dozer Line	302-1	Completed - Inspected			1539
Drop Point	40	No Repair Needed			35° 03.001' N	112° 08.183' W	Completed Dozer Line	302-1	Completed - Inspected			1539
Drop Point	41	No Repair Needed			35° 02.743' N	112° 08.130' W	Completed Dozer Line	302-1	Completed - Inspected			1539
Drop Point	49	No Repair Needed	No repair		35° 04.258' N	112° 01.320' W	Completed Dozer Line	302-1	Completed - Inspected			8075
Drop Point	50	No Repair Needed		Gravelled pullout along 105 road, for sycamore canyon bike trail.	35° 04.648' N	112° 00.563' W	Completed Dozer Line	302-1	Completed - Inspected			4812
Drop Point	51	No Repair Needed		No disturbance	35° 07.013' N	112° 01.217' W	Completed Dozer Line	302-1	Completed - Inspected			4812

Drop Point	53	No Repair Needed	Minimal slash in this area, no repair needed.		35° 06.599' N	112° 00.282' W	Completed Dozer Line	302-1	Completed - Inspected			4812
Drop Point	53	No Repair Needed		White Horse Rec. Devidences	35° 09.463' N	112° 00.032' W	Completed Dozer Line	302-1	Completed - Inspected			4812
Drop Point	55	Repair Needed	trash and flagging needs to be pulled		35° 08.324' N	111° 58.289' W	Completed Dozer Line	302-1	Completed - Inspected			4812
Drop Point	57	Unknown		Boy Scout Camp	35° 06.079' N	111° 55.067' W	Completed Dozer Line	302-1	Completed - Inspected			4812
Drop Point	58	Unknown			35° 02.178' N	111° 54.576' W	Completed Dozer Line	302-1	Completed - Inspected			4812
Drop Point	59	Unknown			35° 05.153' N	111° 51.644' W	Completed Dozer Line	302-1	Completed - Inspected			4812
Drop Point	60	Unknown			35° 04.505' N	111° 50.554' W	Completed Dozer Line	302-1	Completed - Inspected			4812

Fence - Cut/Damaged		Repair Needed	Burnout operation damaged fence. Needs supplies for repairs.		35° 08.496' N	111° 58.561' W	Completed Dozer Line	302-1	Completed - Inspected			4812
Fence - Cut/Damaged		Repair Needed	Need minimal supplies.		35° 07.159' N	112° 08.545' W	Completed Dozer Line	302-1	Completed - Inspected			4812
Fence - Cut/Damaged		Repair Needed		outside private boundary/in permittee horse pasture?	35° 02.502' N	112° 08.253' W	Completed Dozer Line	302-1	Completed - Inspected			4812
Fence - Cut/Damaged		Completed - Inspected	cut fence along 125 rd at cartquard		35° 01.020' N	112° 08.858' W	Completed Dozer Line	302-1	Completed - Inspected			4812
Hazard Tree		Repair Needed	Please back and remove trees from rock outcrop.		35° 02.178' N	112° 08.476' W	Completed Dozer Line	302-1	Completed - Inspected			4812
Repair Point		Repair Needed	end state: disguise to not look like connector trail; pull rocks, duff over intersection and down to edge of rocks approx. 50'		35° 08.842' N	111° 58.746' W	Completed Dozer Line	302-1	Completed - Inspected			4812

Repair Point		Repair Needed	Log and scatter interior		35° 09.460' N	112° 00.891' W	Completed Dozer Line	302-1	Completed - Inspected			4812
Repair Point		Repair Needed	Flagged pink w. black outline dots. Disguise dozer line from designated trail.		35° 07.066' N	112° 08.267' W	Completed Dozer Line	302-1	Completed - Inspected			4812
Repair Point		Repair Needed	Ensure private gate is closed or left as before at entrance to BSC		35° 07.997' N	111° 58.494' W	Completed Dozer Line	302-1	Completed - Inspected			4812
Repair Point		Repair Needed	Slash should be scattered, partially cut. Jumi should be felled and kipped/scattered		35° 07.947' N	111° 58.471' W	Completed Dozer Line	302-1	Completed - Inspected			4812
Repair Point		Repair Needed	Log and scatter in old log landing		35° 09.428' N	112° 00.629' W	Completed Dozer Line	302-1	Completed - Inspected			4812
Repair Point		Repair Needed	Flagged pink w. black outline dots. Sycamore Point trail was obliterated by dozer line here.		35° 02.178' N	112° 08.476' W	Completed Dozer Line	302-1	Completed - Inspected			4812

Repair Point		Repair Needed		Gable drive around	35° 08.820' N	111° 57.821' W	Completed Dozer Line	302-1	Completed - Inspected			4812
Repair Point		Repair Needed	heavy slash chipping needed from this point to JD dam		35° 03.455' N	112° 03.026' W	Completed Dozer Line	302-1	Completed - Inspected			4812
Repair Point		Repair Needed	remove tree and replace if post		35° 02.468' N	112° 08.258' W	Completed Dozer Line	302-1	Completed - Inspected			4812
Repair Point		Repair Needed	ensure closure to avoid vehicle use towards private parcel		35° 02.408' N	112° 08.079' W	Completed Dozer Line	302-1	Completed - Inspected			4812
Repair Point		Completed - Inspected	Disguise the line running downhill toward the old road, pull rocks across.		35° 01.020' N	112° 07.233' W	Completed Dozer Line	302-1	Completed - Inspected			4812
Repair Point		Repair Needed	chip slash along road		35° 05.418' N	111° 59.941' W	Completed Dozer Line	302-1	Completed - Inspected			4812

Repair Point		Completed - Inspected	disguise small handline around spot along W side 125 rd		35° 01.808' N	112° 06.946' W	Completed Dozer Line	302-1	Completed - Inspected			4812
Repair Point		Repair Needed	chip slash		35° 04.474' N	112° 00.852' W	Completed Dozer Line	302-1	Completed - Inspected			4812
Repair Point		Completed - Inspected	small handline by 125 m around spot		35° 01.792' N	112° 06.931' W	Completed Dozer Line	302-1	Completed - Inspected			4812
Repair Point		Unknown		replace burned over road closure signpost. (BAER?)	35° 02.014' N	112° 05.775' W	Completed Dozer Line	302-1	Completed - Inspected			4812

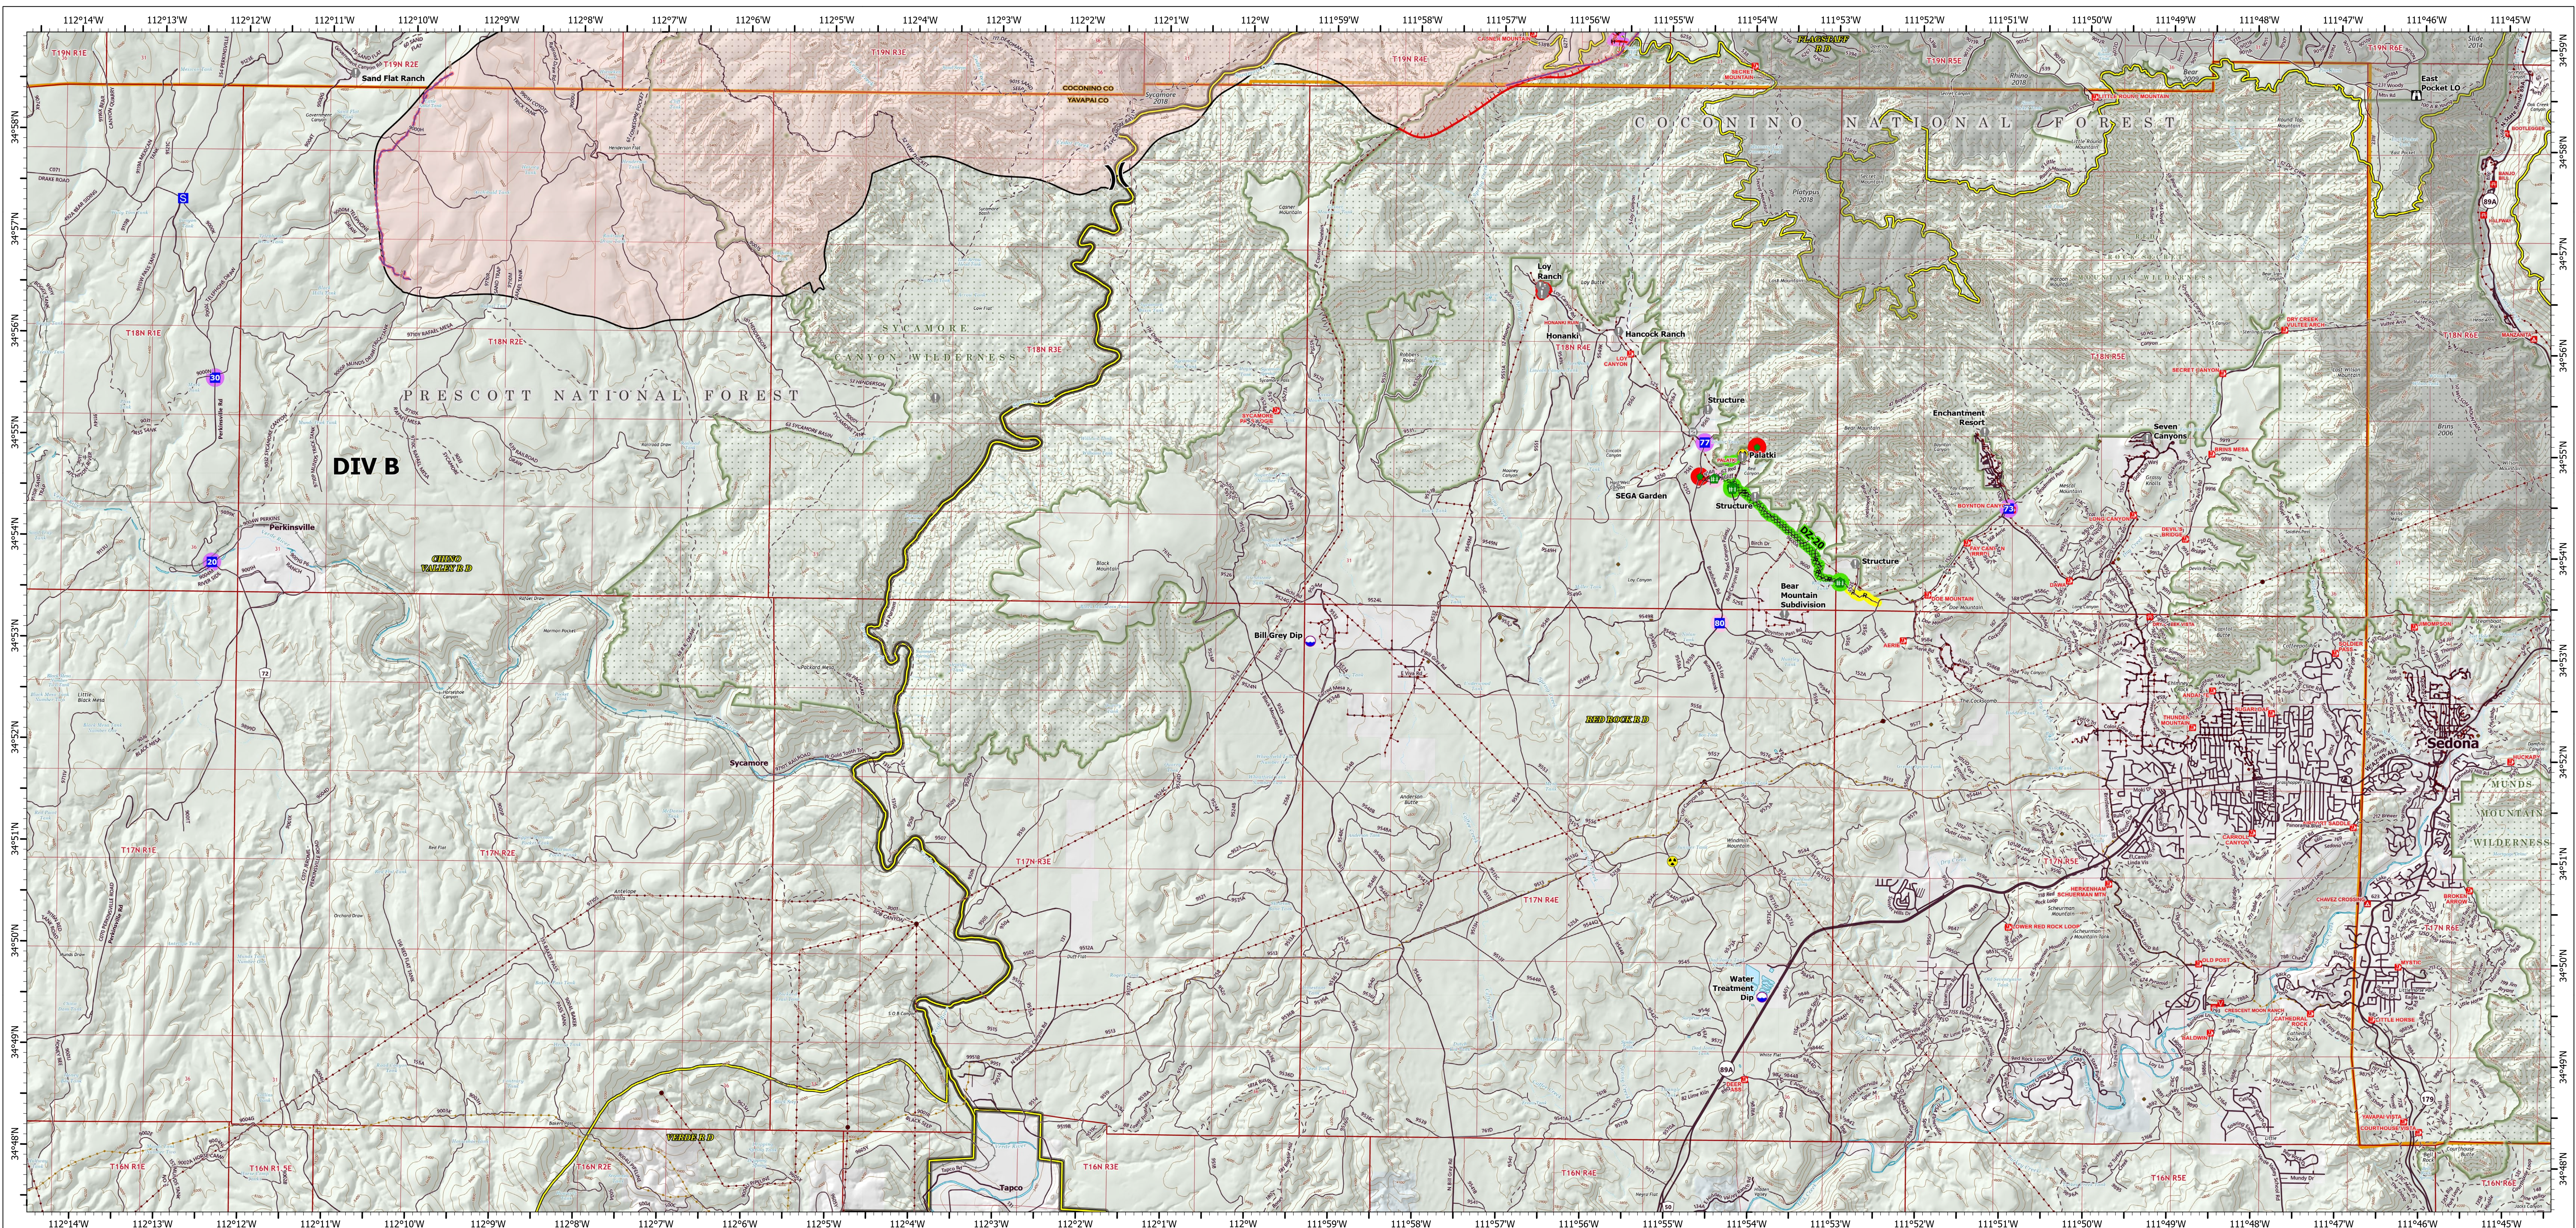
IC Point Type	Label	Repair Status	Repair Comments	Comments	Latitude	Longitude	IC Line Type	Label	Repair Status	Repair Comments	Comments	Length Feet
Drop Point	20	Unknown			34° 53.749' N	112° 12.386' W	Completed Dozer Line	D2-20	Completed - Inspected	will need water bars, berms pulled, slash pulled back across line, repaired per local specs, all slash, road drivable. JNez. All repair work done. No pumps or hose. Inspected and completed.	multiple drainage crossings, banded telephones JNez	9241
Drop Point	30	Unknown			34° 55.563' N	112° 12.375' W						
Drop Point	73	Unknown			34° 54.456' N	111° 50.943' W						
Drop Point	77	Unknown			34° 55.081' N	111° 54.583' W						
Drop Point	80	In Use - Fire Management		JNez for Pat Moore MESA JNez proposed drop point.	34° 53.304' N	111° 54.385' W						
Fence - Cut/Damaged	Completed - Inspected		fence repaired, mounded and boulders placed, trail gate not damaged, great work	Cut fence for dozer access JNez ARCH, repaired 6/29	34° 53.717' N	111° 52.950' W	Completed Dozer Line	D2-21	Completed - Inspected	obliterate berm, pull slash overline, needs ARCH monitor	maasticated 6/25, repaired on 6/30 per local specs - JNez	2165

Fence - Cut/Damaged	Completed - Inspected			needs repair	34° 54.726' N	111° 54.464' W	Completed Hand Line	H-10	Completed - Inspected	obliterate berm, scatter slash on line	repaired on 6/30 per local specs - JNez	235
Fence - Cut/Damaged	Completed - Inspected			needs repair JNez ARCH, repaired 6/30	34° 54.647' N	111° 54.249' W	Completed Hand Line	H-11	Completed - Inspected	needs ARCH	needs arch to repair, repaired 6/28 JNez	104
Fence - Cut/Damaged	Completed - Inspected			dozer rolled over, wooden lathes need to be replaced, repaired 6/29 was already in bad shape JNez	34° 54.627' N	111° 54.249' W	Completed Hand Line	H-14	Unknown		Cold trail	971
Repair Point	Repair Needed		Scatter over wider area or remove	scatter slash	34° 55.040' N	111° 53.957' W	Completed Hand Line	H-15	Unknown		Cold trail	1
Repair Point	Repair Needed			Place boulders to prevent OHV	34° 54.744' N	111° 54.636' W	Completed Hand Line	H-16	Unknown		Cold trail	9

Completed Hand Line	H-17	Unknown		Cold trail	708
							Completed Hand Line	H-18	Unknown		Cold trail	821
							Completed Hand Line	H-5	Repair Needed			1657
							Completed Hand Line	H-6	Repair Needed			315
							Completed Hand Line	H-9	Completed - Inspected		no sediment to cover line, repaired 6/30 JNez	73
							Completed Road as Line		In Use - Fire Management	scatter or chip slash		2656
							Completed Road as Line		In Progress		scatter or chip slash	2831
							Other	Completed - Inspected	None		Trail as line, fuel break, repaired and scattered, some slash piled because of veg density - barely noticeable - JNez	1373
