SUPPRESSION REPAIR *South*

Rafael
 AZ-PNF-863
 7/4/2021
 78,065 acres
 at 7/1/2021 1200

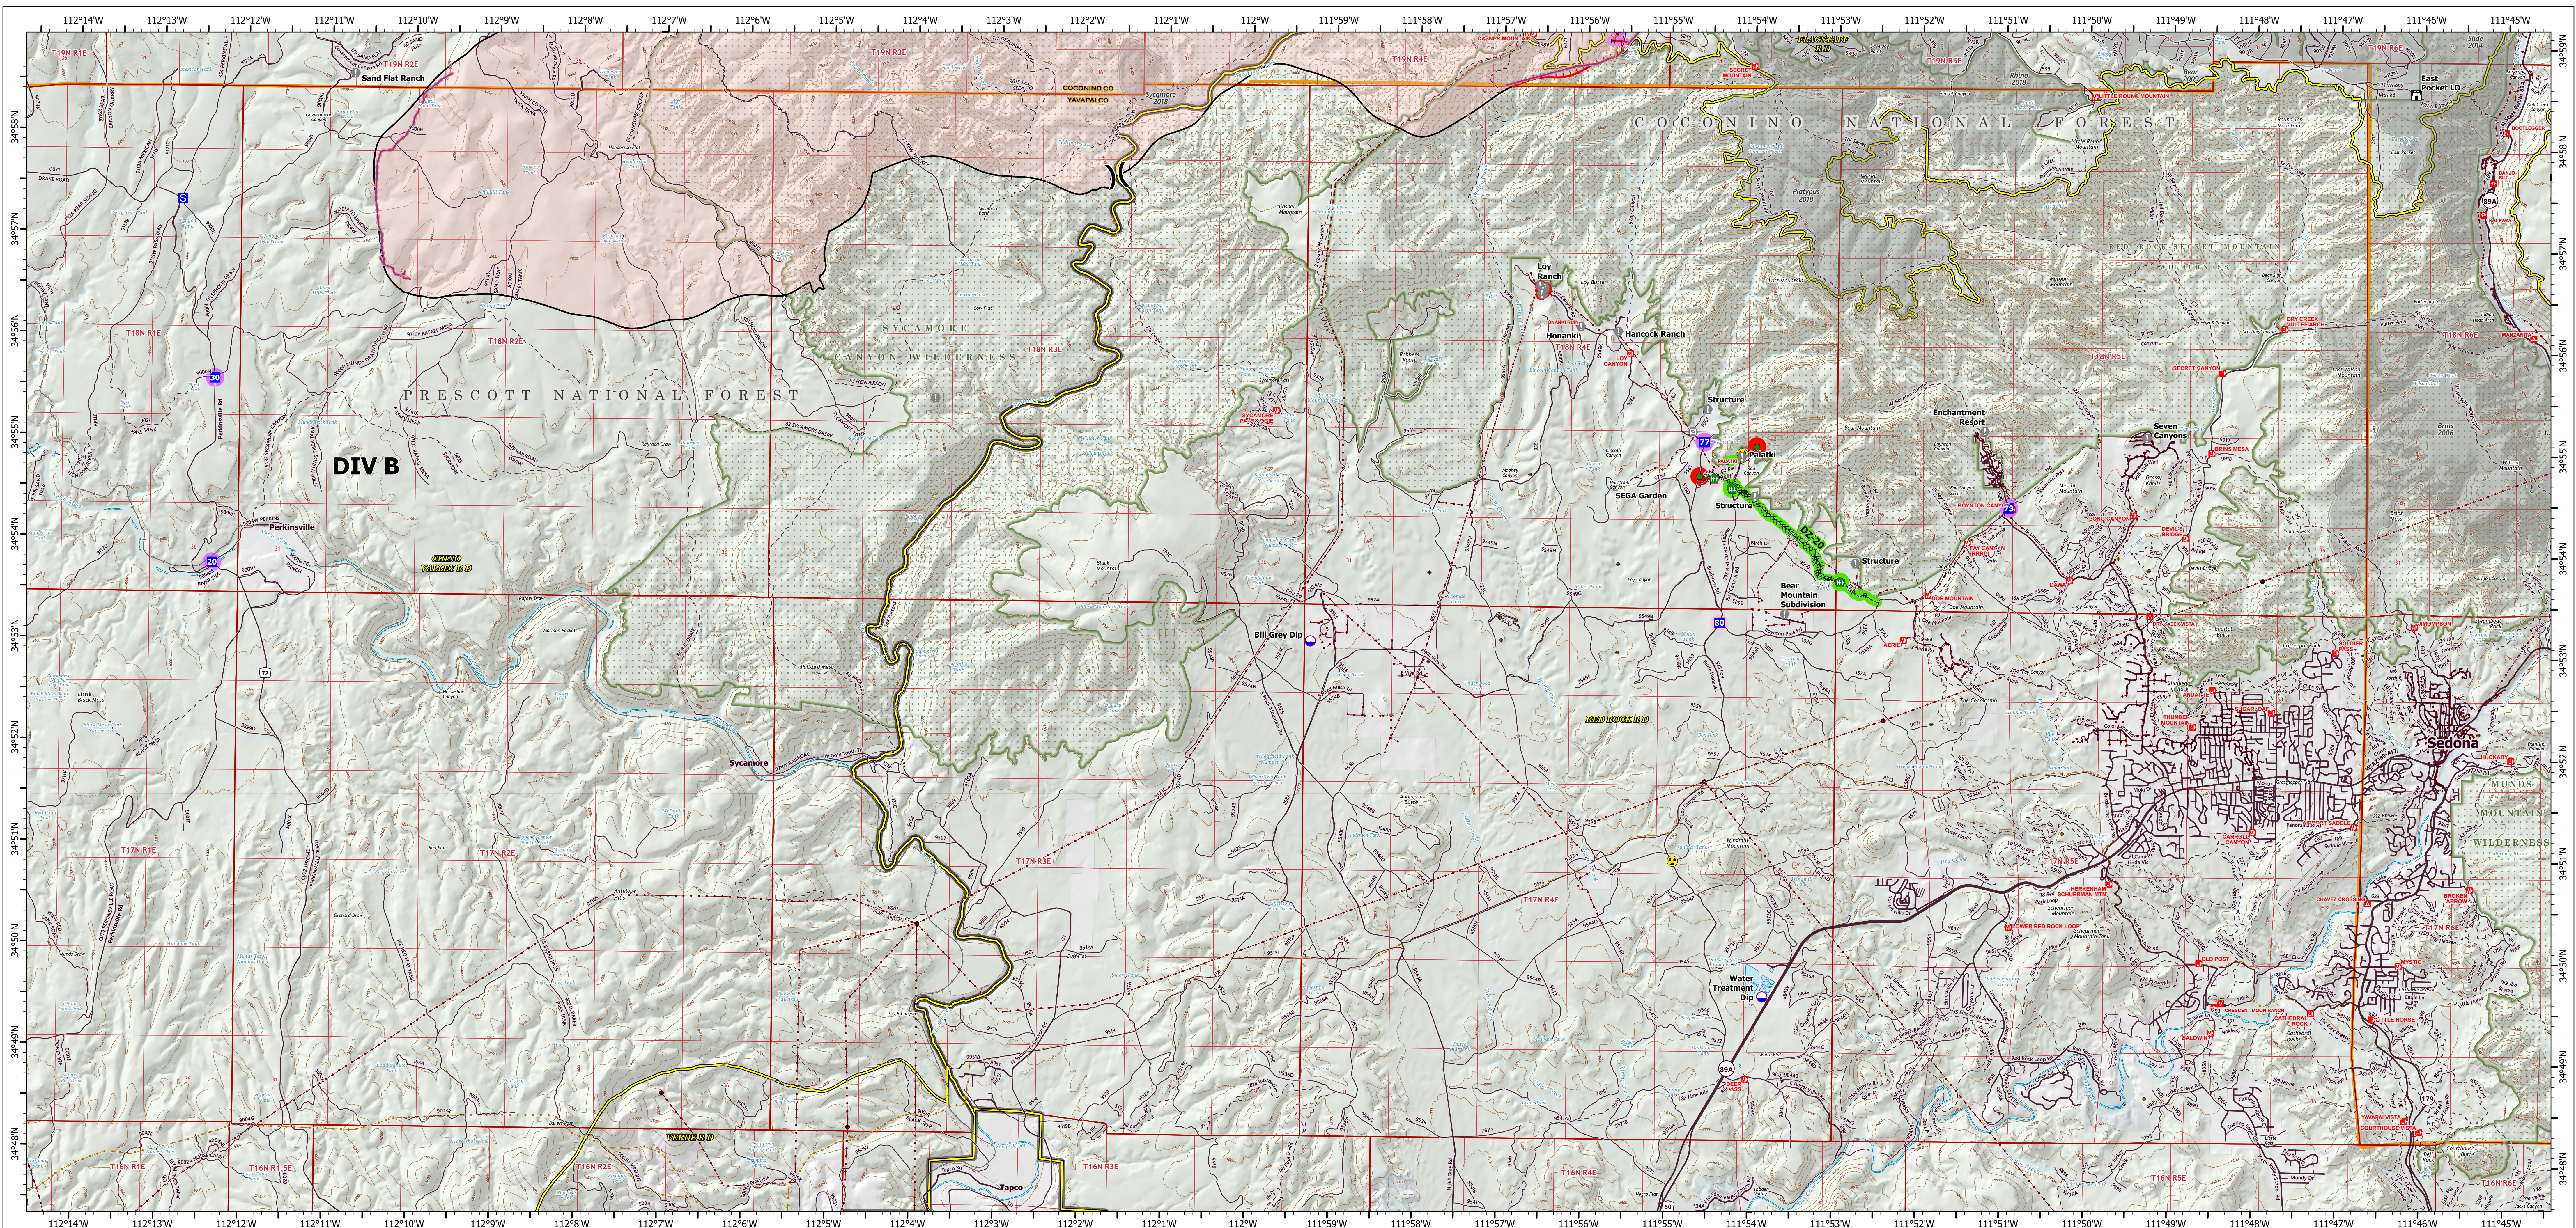
FC Point Type	Label	Repair Status	Repair Comments	Comments	Latitude	Longitude
Drop Point	20	Unknown			34° 53.749' N	112° 12.386' W
Drop Point	30	Unknown			34° 55.563' N	112° 12.375' W
Drop Point	73	Unknown			34° 54.456' N	111° 50.943' W
Drop Point	77	Unknown			34° 55.081' N	111° 54.583' W
Drop Point	80	In Use - Fire Management		JNez for Pat Moore MESA JNez proposed drop point.	34° 53.304' N	111° 54.385' W
Fence - Cut/Damaged	Completed - Inspected	Completed - Inspected	fence repaired, mounded and boulders placed, trail gate not damaged, great work	Cut fence for dozer access JNez ARCH, repaired 6/29	34° 53.717' N	111° 52.952' W
Fence - Cut/Damaged	Completed - Inspected	Completed - Inspected	needs repair JNez ARCH, repaired 6/30		34° 54.726' N	111° 54.464' W
Fence - Cut/Damaged	Completed - Inspected	Completed - Inspected	dozer rolled over, wooden lathes need to be replaced, repaired 6/29 was already in bad shape JNez		34° 54.647' N	111° 54.249' W

Repair Point	Repair Needed	Repair Needed	Scatter over wider area or remove	scatter slash	34° 55.040' N	111° 53.957' W
Repair Point	Repair Needed	Repair Needed		Place boulders to prevent OHV	34° 54.744' N	111° 54.636' W

FC Line Type	Label	Repair Status	Repair Comments	Comments	Length Feet
Completed Dozer Line	DZ-20	Completed - Inspected	Will need water bars, berms pulled, slash pulled back across line, repaired per local specs, still slash, road drivable. JNez. All repair work done. No pumps or hose. Inspected and completed.	multiple drainage crossings, buried telephones JNez	9341
Completed Dozer Line	DZ-21	Completed - Inspected	obliterate berm, pull slash overline, needs ARCH monitor	masticated 6/25, repaired on 6/30 per local specs JNez	2165
Completed Hand Line	H-10	Completed - Inspected	obliterate berm, scatter slash on line	repaired on 6/30 per local specs JNez	235
Completed Hand Line	H-11	Completed - Inspected	needs ARCH	needs arch to repair, repaired 6/28 JNez	104
Completed Hand Line	H-14	Unknown		Cold trail	971
Completed Hand Line	H-15	Unknown		Cold trail	1
Completed Hand Line	H-16	Unknown		Cold trail	9
Completed Hand Line	H-17	Unknown		Cold trail	708

Completed Hand Line	H-18	Unknown		Cold trail	821
Completed Hand Line	H-5	Repair Needed			1657
Completed Hand Line	H-6	Repair Needed			315
Completed Hand Line	H-9	Completed - Inspected		no sediment to cover line, repaired 6/30 JNez	73
Completed Road as Line		In Use - Fire Management	scatter or chip slash		2656
Completed Road as Line		Completed - Inspected		scatter or chip slash	2831
Other		Completed - Inspected	None	Trail as line, fuel break, repaired and scattered, some slash piled because of veg density, barely noticeable - JNez	1373
