STRUCTURE
PROTECTION PLAN
FOR
ELK CREEK BLOCK
07/27/2017

Structure Protection Plan

OZ Ranch

Structure Protection Plan Elk Meadows Ranch

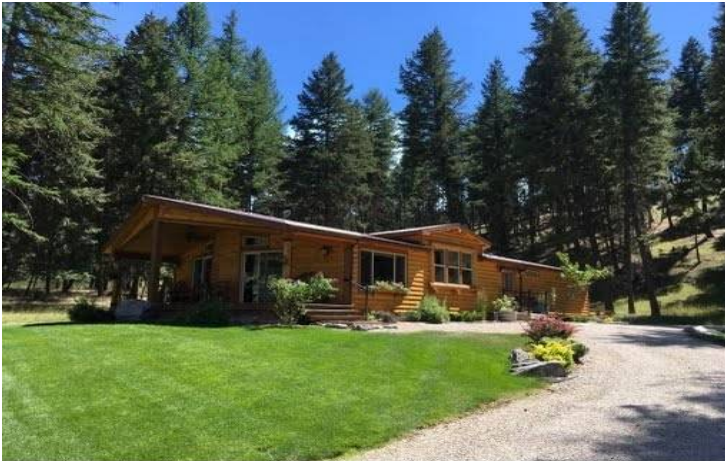
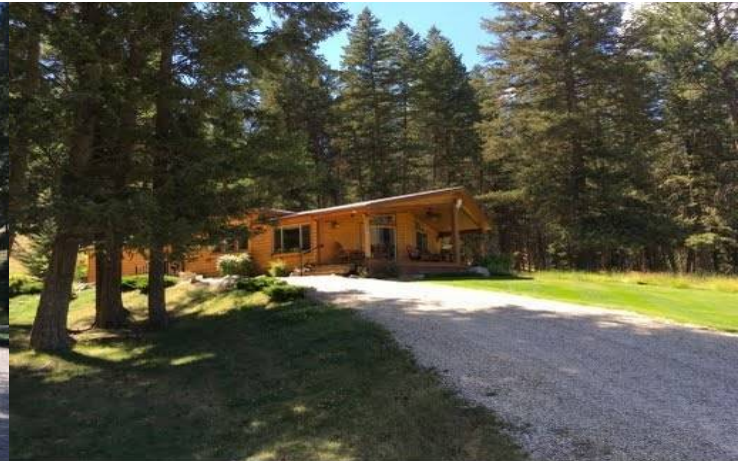
Structure Number: 3787
Structure Name: Two guest houses
SubDivision: OZ Ranch
GPS Location, Lat. 46 45.26808
GPS Location, Long. 114 15.68802
Safety Zone Present: Yes
Type of Structure: Residential
Surrounding Fuels: Grass, Timber
Structure Triage Category: Defensible, Prep and Hold
Roof Material: Metal
Heat Traps: Wood Deck
Electrical Power: Underground
Hazards:
Access to Site: T1 Engine
Comm with ICP: Radio
Water Source: Creek
Mitigation Time: More Than 5 Hours
Other Resources Needed to Protect: Falling team, handcrew
Notes: These are two workers houses at the OZ Ranch, continue past the main house to the west. Back up to the forest and will need a lot of timber clearing behind them.

Where is Safety Zone: Irrigated fields to the North
Primary Structures: 2
Defensible Space: None
Outbuildings: 0
Siding Material: Wood
Gas to Structure: None
Best Access From: Hwy 12

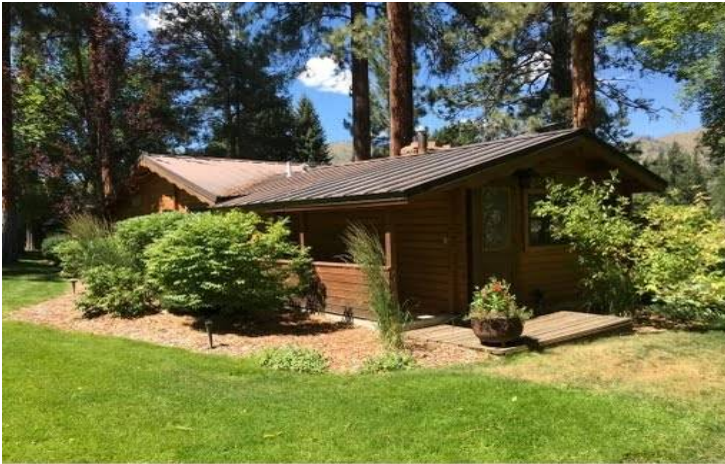
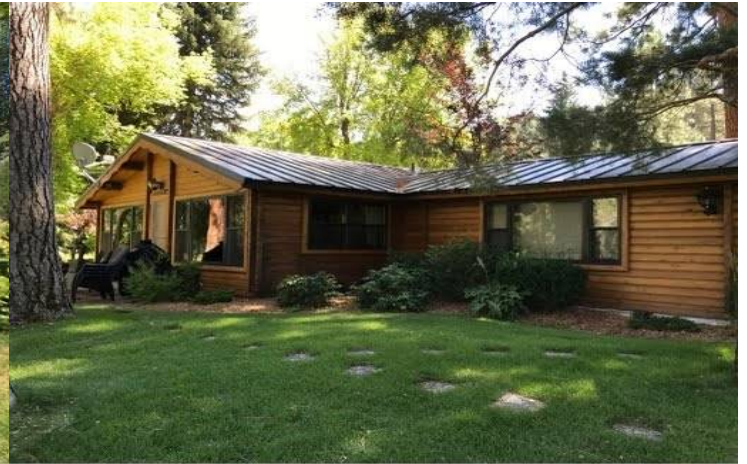
Structure Number: 3784
Structure Name: 2nd House on the right from egress
SubDivision: OZ Ranch
GPS Location, Lat. 46 45.27882
GPS Location, Long. 114 15.53574
Safety Zone Present: Yes **Where is Safety Zone:** Large open field just east of residence.
Type of Structure: Residential **Primary Structures:** 1 **Outbuildings:** 0
Surrounding Fuels: Grass, Timber **Defensible Space:** 30-50 Feet
Structure Triage Category: Defensible, Stand Alone
Roof Material: Metal **Siding Material:** Wood
Heat Traps: Rain Gutters
Electrical Power: Overhead, Underground **Gas to Structure:** Underground
Hazards:
Access to Site: T1 Engine **Best Access From:** HWY 12, OZ Ranch driveway
Comm with ICP: Radio
Water Source: Large Pond, Creek
Mitigation Time: Less Than An Hour
Notes: Needle cast on roof.

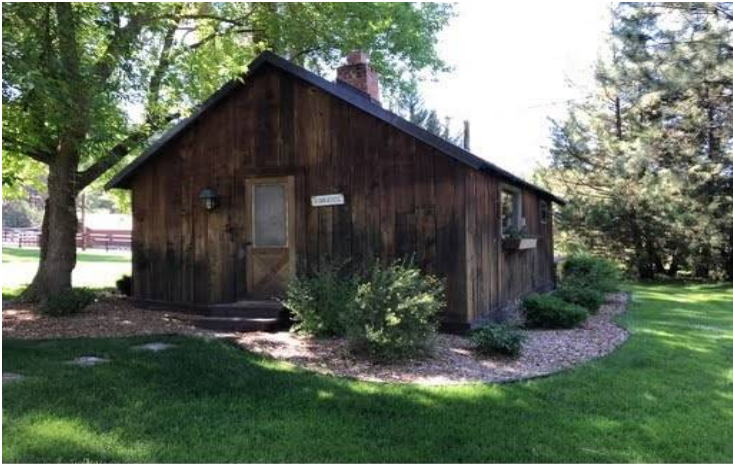
Structure Number: 3788
Structure Name: Bunkhouse - 3rd house on right from egress
SubDivision: OZ Ranch
GPS Location, Lat. 46 45.29046
GPS Location, Long. 114 15.55404
Safety Zone Present: Yes **Where is Safety Zone:** Large field east of structure. Another just north of structure.
Type of Structure: Residential **Primary Structures:** 1 **Outbuildings:** 2
Surrounding Fuels: Grass, Timber **Defensible Space:** 30-50 Feet
Structure Triage Category: Defensible, Stand Alone
Roof Material: Metal **Siding Material:** Wood
Heat Traps:
Electrical Power: Overhead **Gas to Structure:** Aboveground
Hazards:
Access to Site: T1 Engine **Best Access From:** HWY 12, OZ Ranch driveway.
Comm with ICP: Radio
Water Source:
Mitigation Time: Less Than An Hour
Notes: Needle cast on roof.

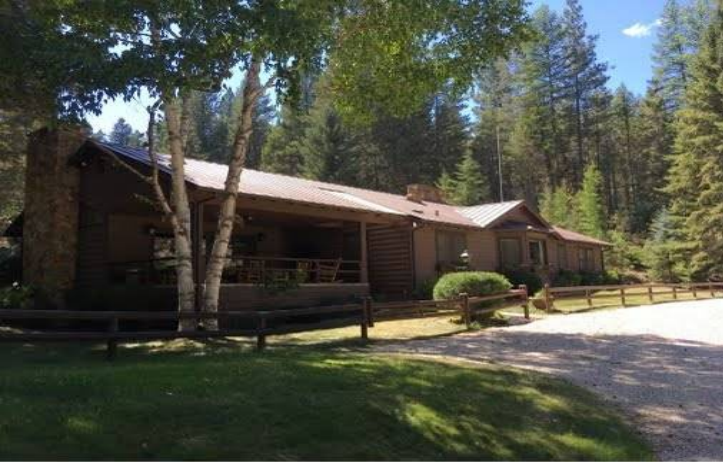
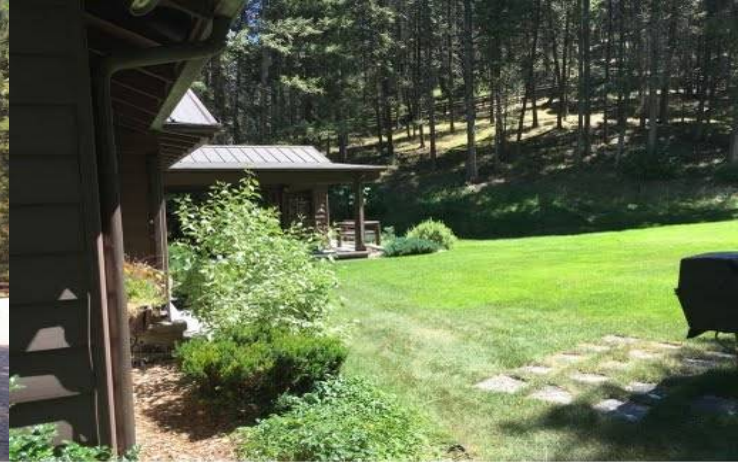
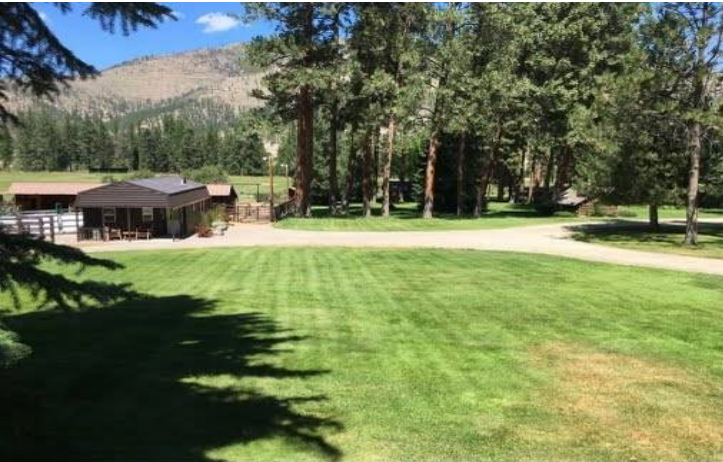
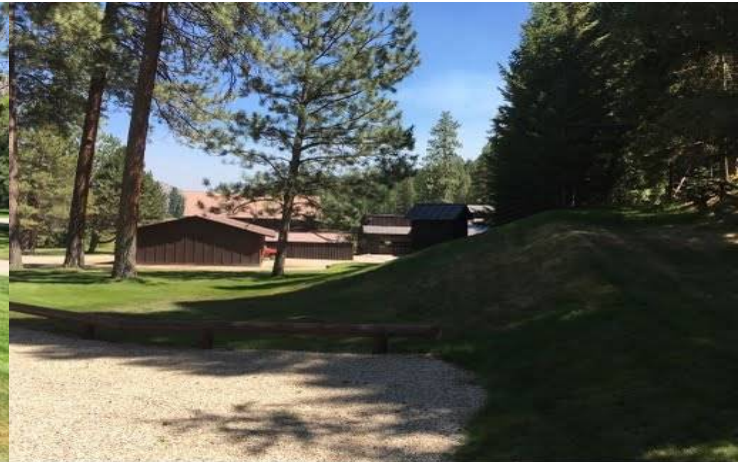
Structure Number: 3786
Structure Name: Guest house
SubDivision: OZ Ranch
GPS Location, Lat. 46 45.23664
GPS Location, Long. 114 15.57756
Safety Zone Present: Yes
Type of Structure: Residential
Surrounding Fuels: Grass, Timber
Structure Triage Category: Defensible, Prep and Hold
Roof Material: Metal
Heat Traps: Wood Deck
Electrical Power: Underground
Hazards:
Access to Site: T1 Engine
Comm with ICP: Radio
Water Source: Large Pond
Mitigation Time: More Than 5 Hours
Other Resources Needed to Protect: Type 2 handcrew. Buildings to the South of the property are right up against the trees, in some cases within 10 ft. Main house is away from trees.
Notes: One of four houses on property

Where is Safety Zone: Irrigated Meadows to north of the structures
Primary Structures: 1
Defensible Space: None
Outbuildings: 5
Siding Material: Wood
Gas to Structure: None
Best Access From: Hwy 12

Once the fuelbreak is cut in place a Mark 3 pump in the ditch by the barn (Dam Up) to a sprinkler system behind the barn (4 sprinklers) and to the Guest House (2 sprinklers on each corner). The two houses further west are stand alone and should have an engine patrol as fire approaches.

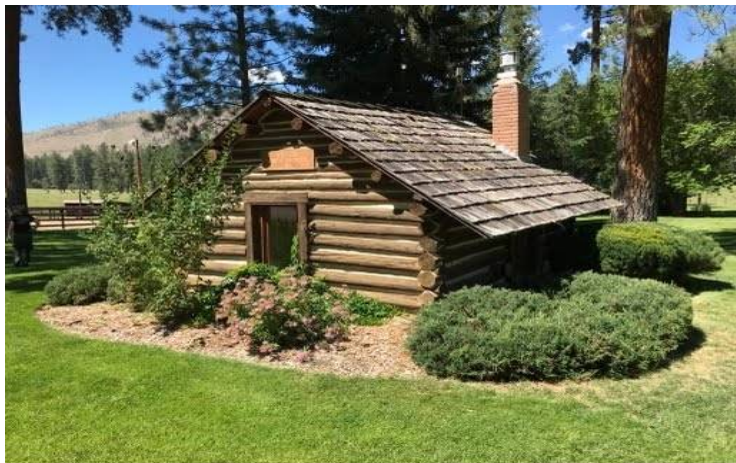
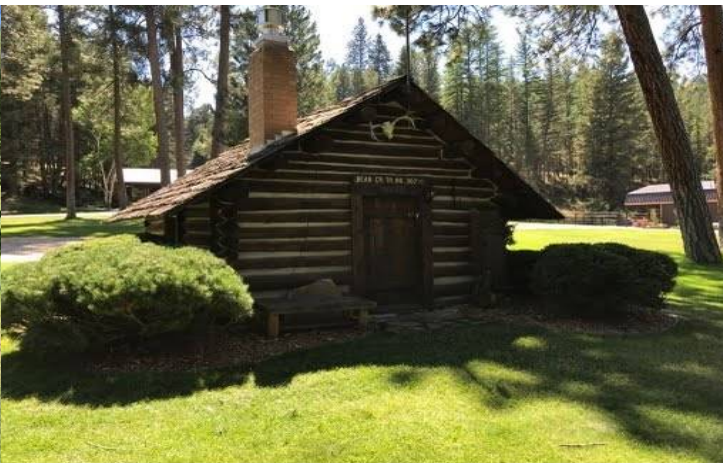
Structure Number: 3789
Structure Name: Office - 4th structure on the right of egress
SubDivision: OZ Ranch
GPS Location, Lat. 46 45.25998
GPS Location, Long. 114 15.56814
Safety Zone Present: Yes **Where is Safety Zone:** Large arena and pasture to the west of structure.
Type of Structure: Mixed Use **Primary Structures:** 1 **Outbuildings:** 0
Surrounding Fuels: Grass, Timber **Defensible Space:** 30-50 Feet
Structure Triage Category: Defensible, Prep and Hold
Roof Material: Wood **Siding Material:** Wood
Heat Traps: **Gas to Structure:** None
Electrical Power: Underground
Hazards: Fuels
Hazard Notes: Old wood shingled roof with needle cast on top.
Access to Site: T1 Engine **Best Access From:** HWY 12, OZ Ranch driveway.
Comm with ICP: Radio
Water Source: Large Pond, Creek
Mitigation Time: Less Than An Hour
Collected By: E 27 Florence Fire **Collected Date/Time:** 07/23/2017 15:05:08
Photo 1 Photo 2

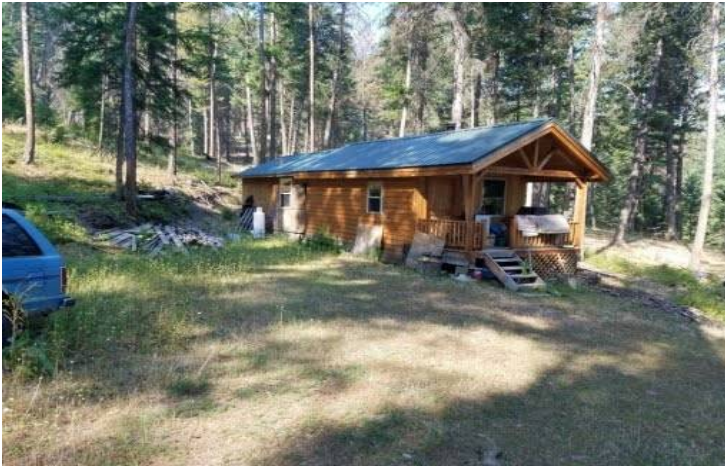
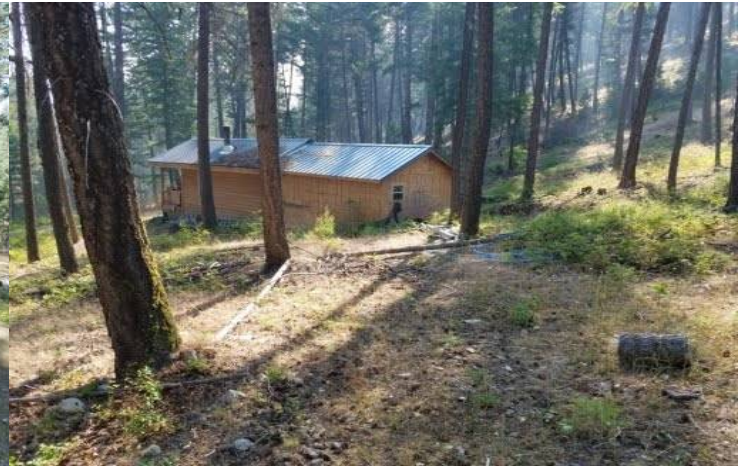
Structure Number: 3912
Structure Name: Cabin behind OZ ranch
SubDivision: OZ ranch
GPS Location, Lat. 46 44.90532
GPS Location, Long. 114 14.28624
Safety Zone Present: No **Where is Safety Zone:** Downhill to grassy field
Type of Structure: Residential **Primary Structures:** 1 **Outbuildings:** 0
Surrounding Fuels: Grass, Timber **Defensible Space:** 50-100 Feet
Structure Triage Category: Non-Defensible, Prep and Leave
Roof Material: Metal **Siding Material:** Wood
Heat Traps: Open Eaves, Wood Deck
Electrical Power: None **Gas to Structure:** Aboveground
Hazards: Terrain
Hazard Notes: Back in south of dozer Line in fire area
Access to Site: T6 Engine **Best Access From:** OZ Ranch east by pond. East on dozer line
Comm with ICP: Radio
Water Source: None
Mitigation Time: 3-4 Hours
Other Resources Needed to Protect: Engine true, sprinklers, pumpkin
Collected By: R. Beery **Collected Date/Time:** 07/25/2017 10:22:34

The structure labeled “Cabin” has a double blade width dozer line around it and should have an engine patrol.

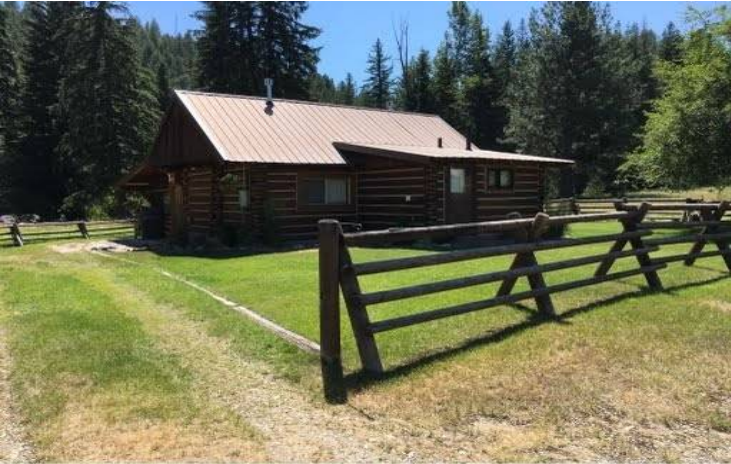
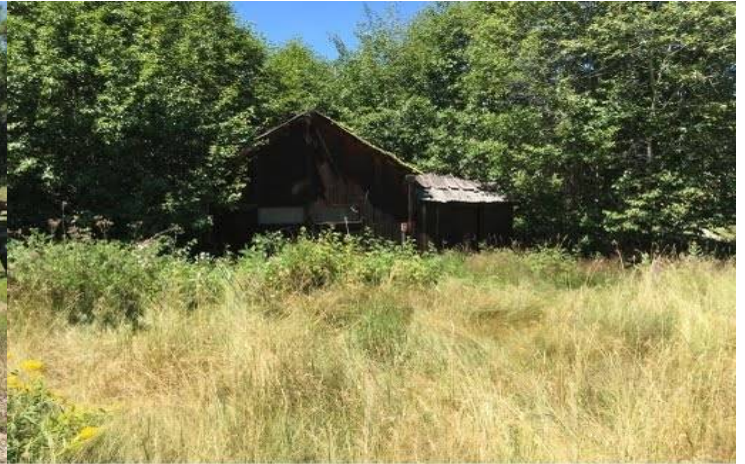
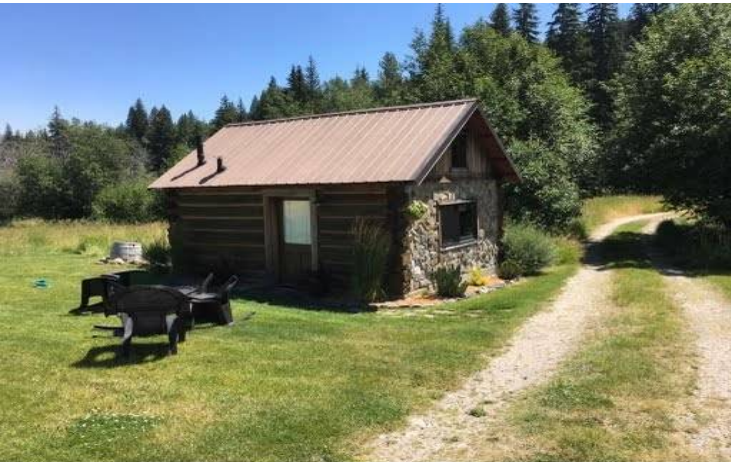
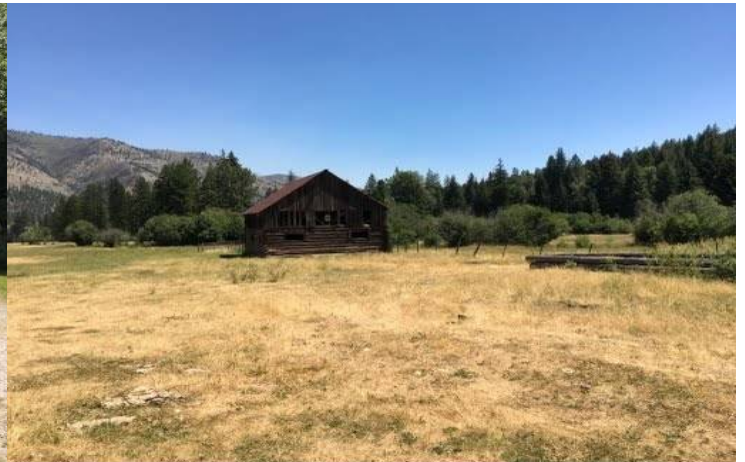
Structure Number: 3771
Structure Name: Elk Meadows Ranch, second residence for OZ Ranch
SubDivision: Elk Creek Meadows
GPS Location, Lat. 46 45.40194
GPS Location, Long. 114 16.77516
Safety Zone Present: Yes **Where is Safety Zone:** Irrigated field on site
Type of Structure: Residential **Primary Structures:** 2 **Outbuildings:** 2
Surrounding Fuels: Grass, Timber **Defensible Space:** 50-100 Feet
Structure Triage Category: Defensible, Prep and Hold
Roof Material: Metal **Siding Material:** Wood
Heat Traps: Open Eaves
Electrical Power: Underground **Gas to Structure:** None
Hazards: Bridge Load Limits
Hazard Notes: Bridge on Elk Creek RD. may not support a water tender
Access to Site: T3/4 Engine **Best Access From:** Elk Creek RD 451. Second metal gate on east side
Comm with ICP: Radio
Water Source: Creek
Mitigation Time: 2-3 Hours
Other Resources Needed to Protect: Engine, sprinklers and pump
Notes: 2 primary residences and 2 historic outbuildings. Creek on one side irrigated fields on the other. Defensible with 4 sprinklers and one pump. Gate may be dummy locked. This is a second residence for OZ Ranch on Hwy 12.

Plan: Creek is directly behind main residence, set up to pump from creek. Four sprinklers at main residence, two sprinklers on downstream bridge.

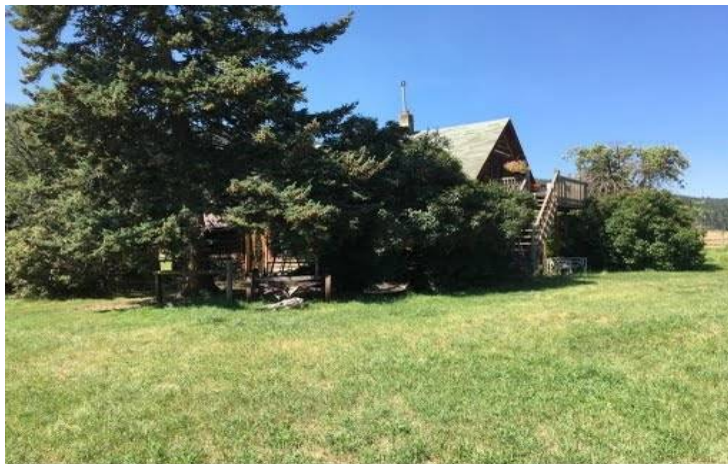
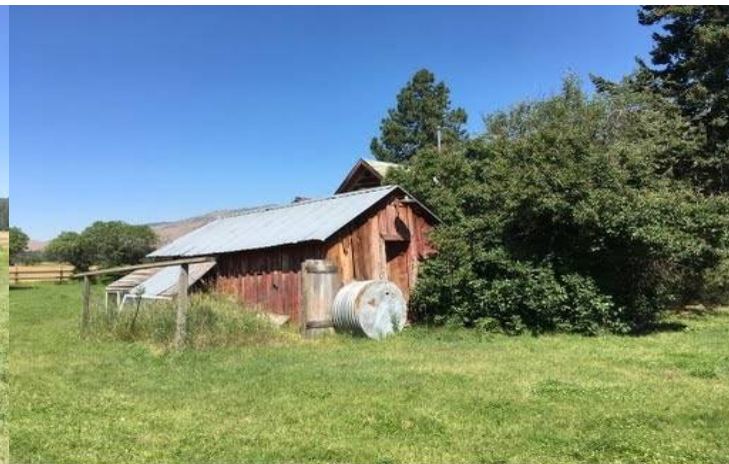
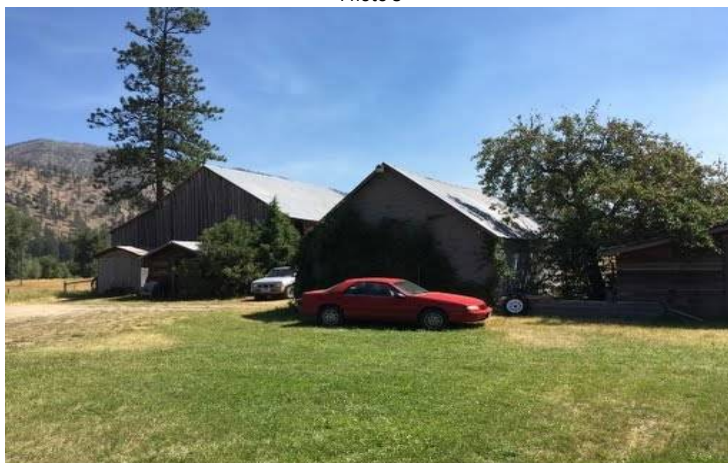
Heat Traps: Open Eaves, Wood Deck

Hazards: Bridge Load Limits

Hazard Notes: Pickup only can access from the OZ Ranch

Notes: Nothing needed, in middle of irrigated field
