STRUCTURE  
PROTECTION PLAN  
FOR SWEENY  
BLOCK

07/30/2017

# Structure Protection Plan

## Sweeny Creek

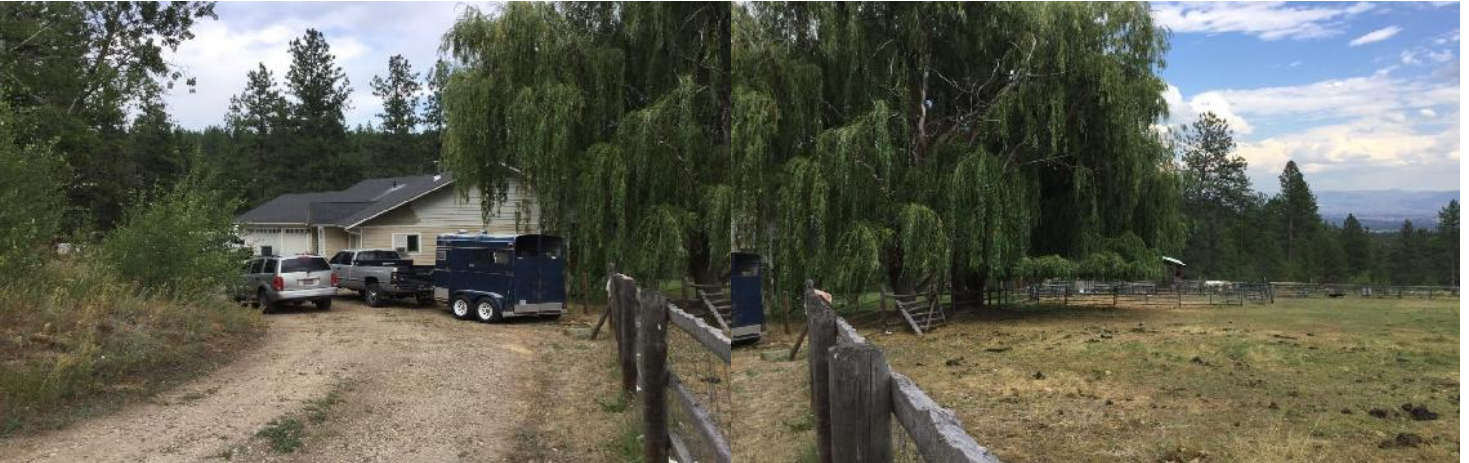
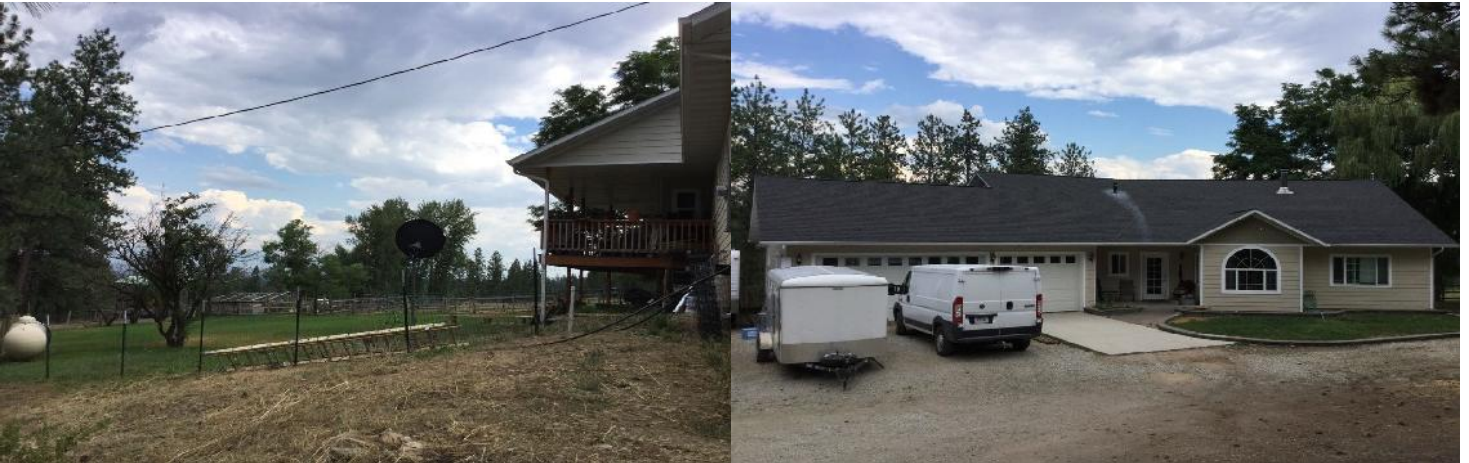
**Structure Number:**  
**Structure Name:** ?, Sweeney Creek Road  
**SubDivision:** Sweeny  
**GPS Location, Lat.** 46 36.72714  
**GPS Location, Long.** 114 7.13706  
**Safety Zone Present:** Yes  
**Type of Structure:** Residential  
**Surrounding Fuels:** Timber  
**Structure Triage Category:** Defensible, Stand Alone  
**Roof Material:** Composite  
**Heat Traps:** Wood Deck  
**Electrical Power:** Overhead  
**Hazards:** Terrain,Animals  
**Access to Site:** T3/4 Engine  
**Comm with ICP:** Radio,Cell Service  
**Water Source:** Faucet / Hose  
**Mitigation Time:** 1-2 Hours  
**Other Resources Needed to Protect:** Raking around main structure. Scratching line around outside structure.  
**Collected By:** Engine 951
