STRUCTURE
PROTECTION PLAN
FOR LOLO CREEK
BLOCK

07/27/2017

Structure Protection Plan Lolo Creek Rd.

Location: Hwy 12 and Lolo Creek Dr.

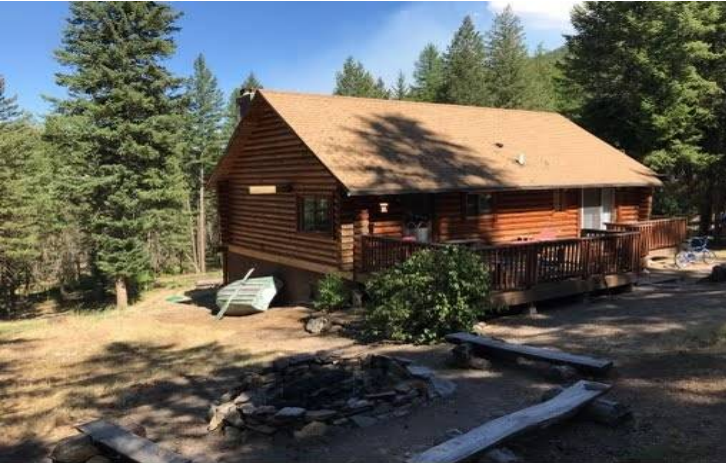
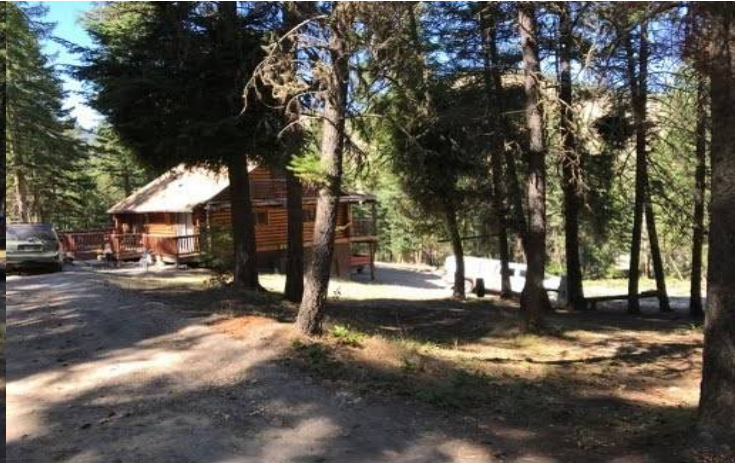
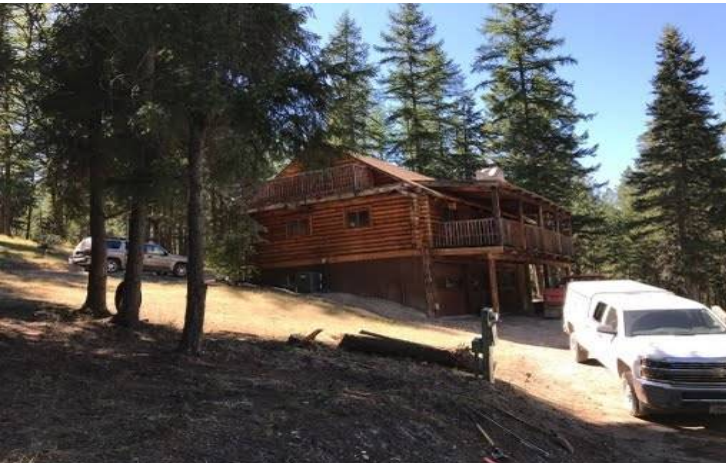
Structure Number: 3885
Structure Name: 13299 Lolo Creek Dr
SubDivision: LoLo creek drive
GPS Location, Lat. 46 44.51412
GPS Location, Long. 114 11.70492

Safety Zone Present: No
Type of Structure: Residential
Surrounding Fuels: Grass, Shrub, Timber
Structure Triage Category: Defensible, Prep and Hold
Roof Material: Composite
Heat Traps: Wood Deck
Electrical Power: Overhead
Hazards: Terrain, Fuels
Hazard Notes: Structure on slope, burnable material next to outbuilding
Access to Site: T6 Engine
Comm with ICP: Radio
Water Source: Faucet / Hose, Large Pond
Mitigation Time: Less Than An Hour
Collected By: LoLo 632

Escape route down and out to hwy 12 then possible safety zone west on hwy 12 to field across from mill creek road
Where is Safety Zone: hwy 12 to field across from mill creek road
Primary Structures: 1
Outbuildings: 1
Defensible Space: 30-50 Feet
Siding Material: Wood
Gas to Structure: None
Best Access From: Hwy 12 onto lolo creek drive

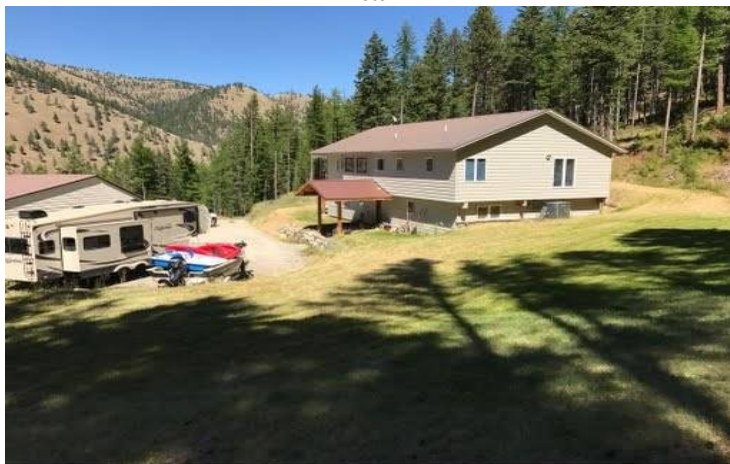
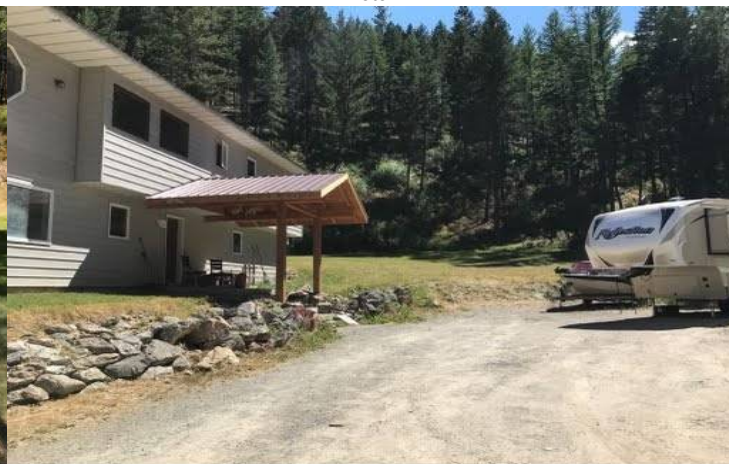
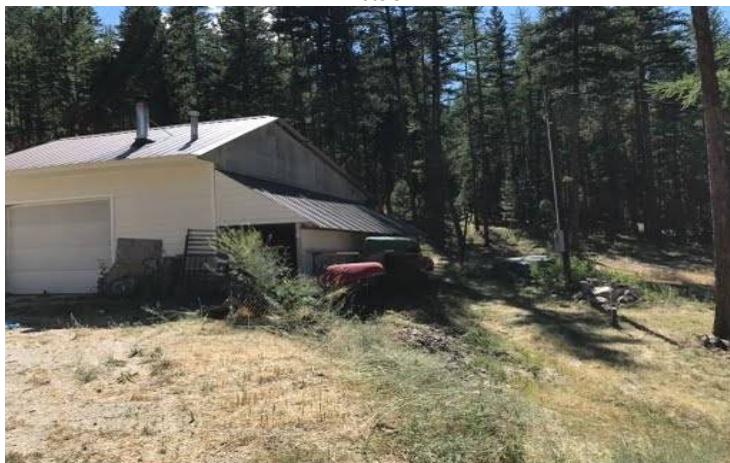
Structure Number: 3887
Structure Name: 13207 Lolo Creek Dr
SubDivision: LoLo creek drive
GPS Location, Lat. 46 44.44044
GPS Location, Long. 114 11.68644

Hazards: Bridge Load Limits

Hazard Notes: Might not hold type 4 and larger

Other Resources Needed to Protect: Structure wrap/construction material need to cover exposed siding on outbuilding

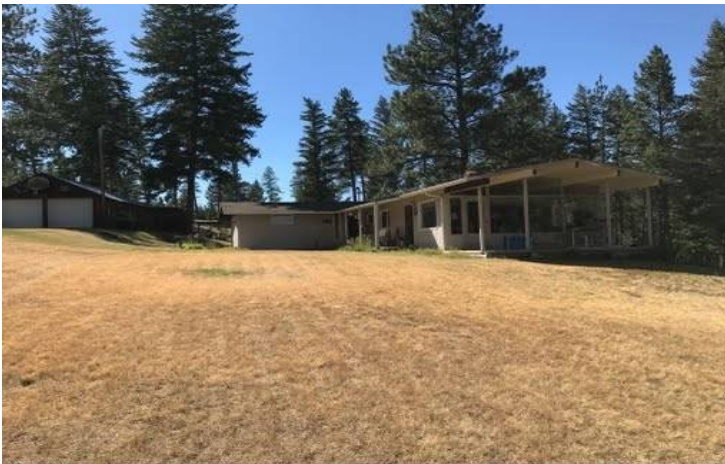
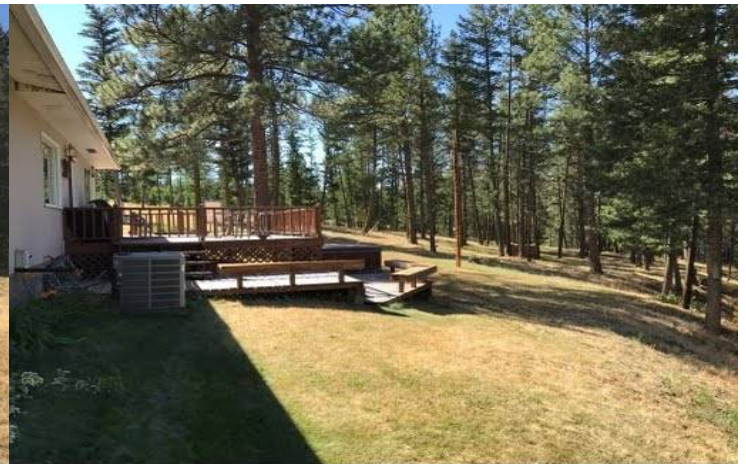
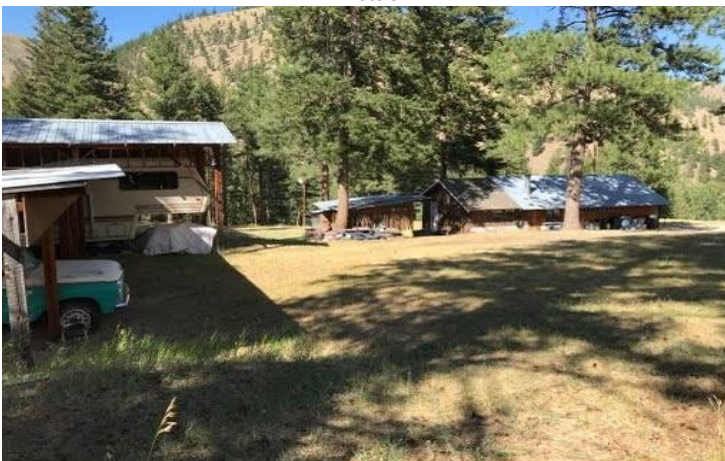
Structure Number: 3890
Structure Name: 12990 LoLo creek drive
SubDivision: LoLo creek drive
GPS Location, Lat. 46 44.51844
GPS Location, Long. 114 11.71074

Safety Zone Present: No
Type of Structure: Residential
Surrounding Fuels: Grass,Shrub,Timber
Structure Triage Category: Defensible, Prep and Hold
Roof Material: Composite
Heat Traps: Wood Deck,Other Receptor
Electrical Power: Overhead
Hazards: Terrain,Fuels,HazMat
Hazard Notes: Wood piles near buildings
Access to Site: T6 Engine
Comm with ICP: Radio
Water Source: Faucet / Hose
Mitigation Time: 1-2 Hours
Other Resources: Structure wrap
Collected By: LoLo 632

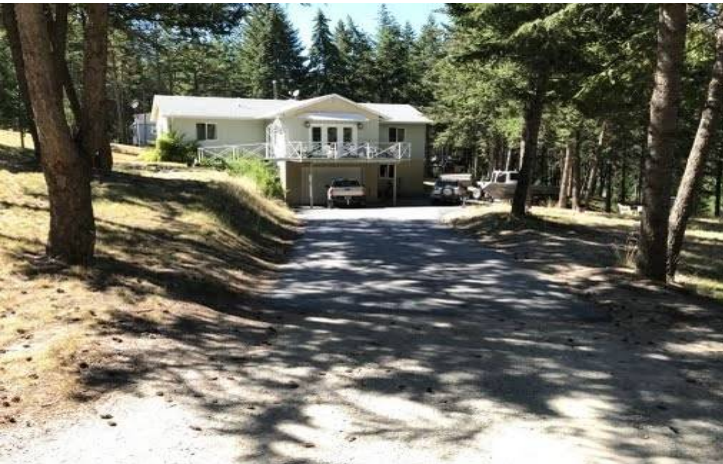
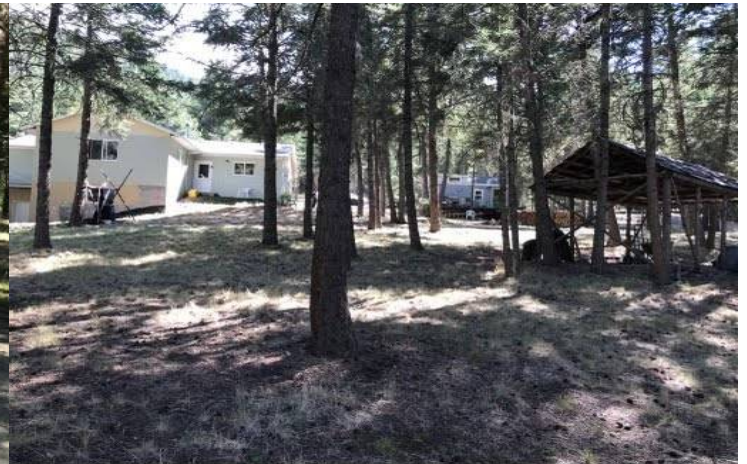
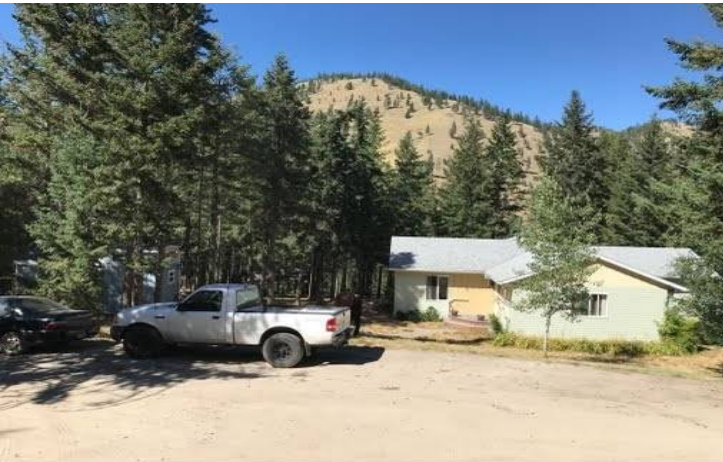
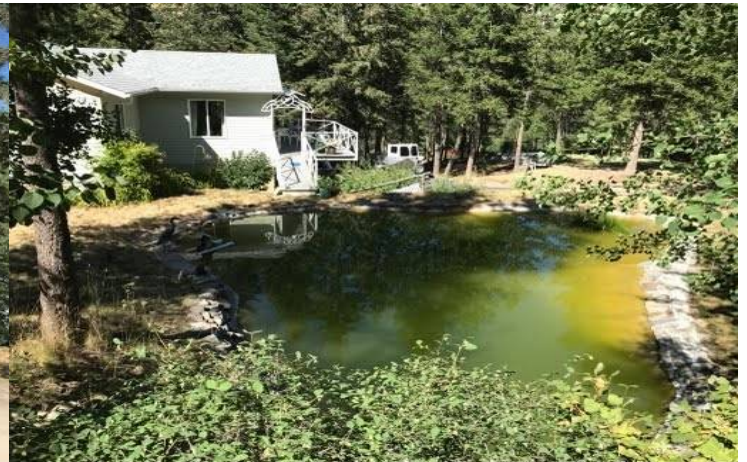
Structure Number: 3871
Structure Name: 13254 LoLo Creek Rd
SubDivision: LoLo Creek
GPS Location, Lat. 46 44.57178
GPS Location, Long. 114 11.66112
Safety Zone Present: No
Type of Structure: Residential
Surrounding Fuels: Grass,Shrub,Timber

Hazard Notes: Propane tanks, gas, and logs out in the open.

Notes: Lifted tiny home with exposed wood floor underneath. Trees lined up to 20ft and sparse ground fuels. Large, man-made pond on property.

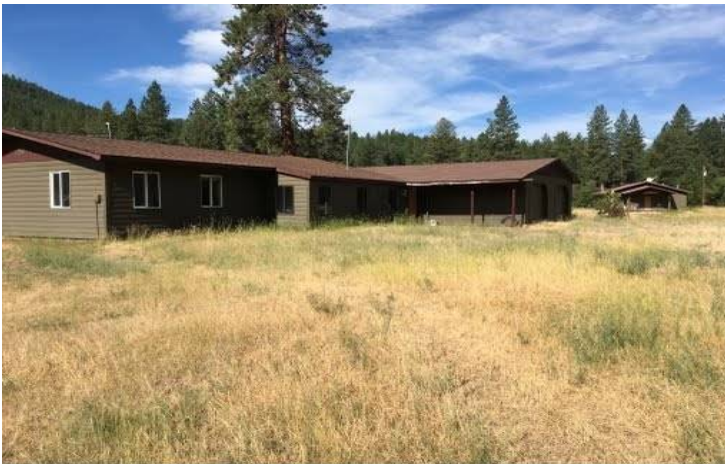
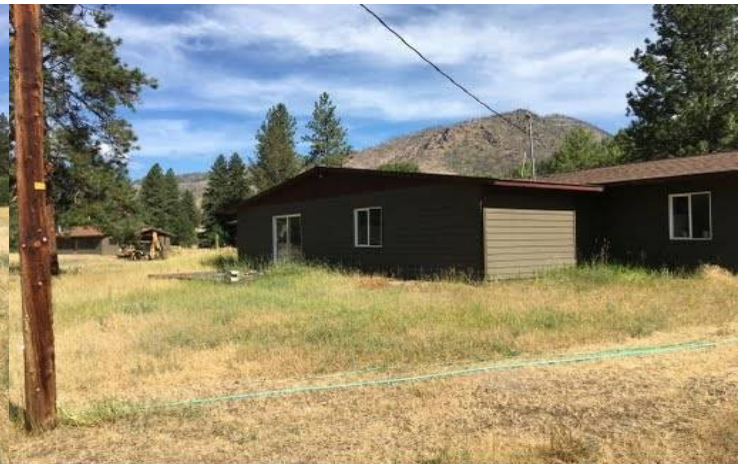
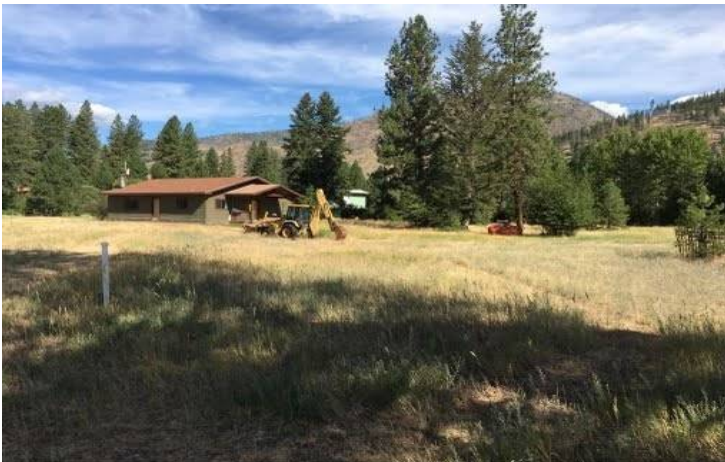
Notes: Two abandoned houses, gate at bridge is locked with private lock. Unknown address, this is first driveway east of Mill Creek RD.

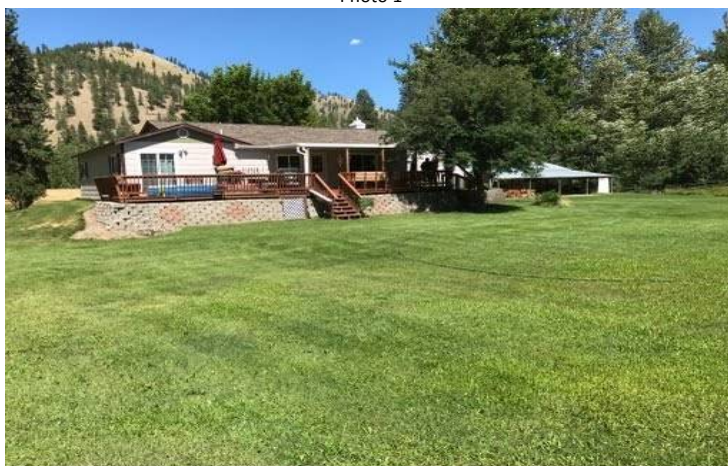
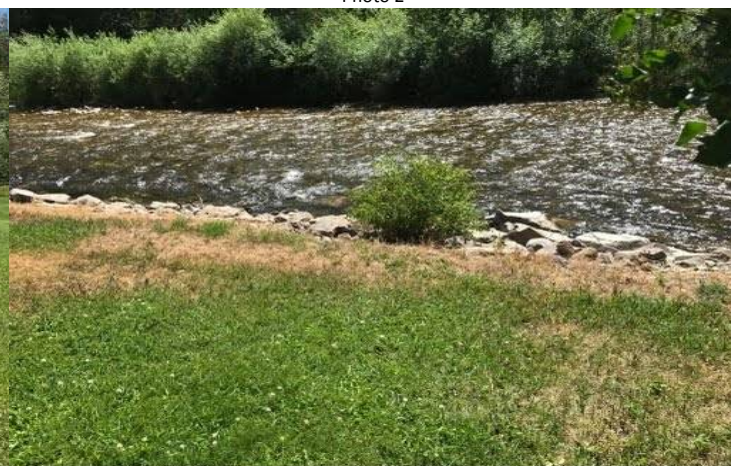
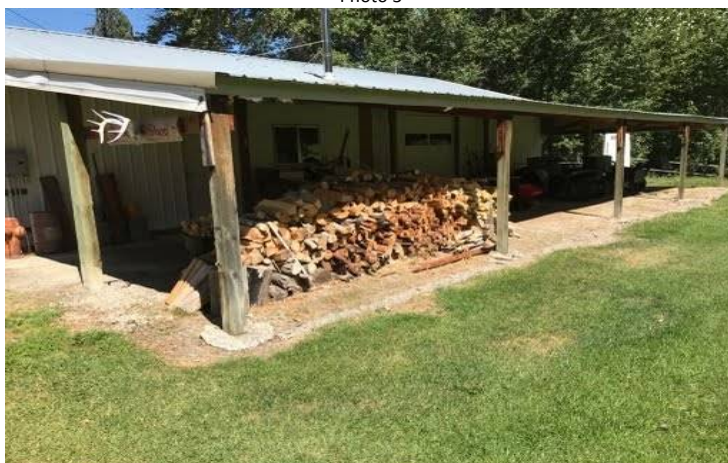
Structure Number: 3867
Structure Name: 13737 Hwy 12
SubDivision: HWY 12
GPS Location, Lat. 46 44.67414

Heat Traps: Open Eaves, Wood Deck, Rain Gutters, Other Receptor

Notes: Direct water source from river behind residential structure.

Woodpile by garage.
