STRUCTURE  
PROTECTION PLAN  
FOR ONE HORSE  
BLOCK

07/30/2017

## One Horse

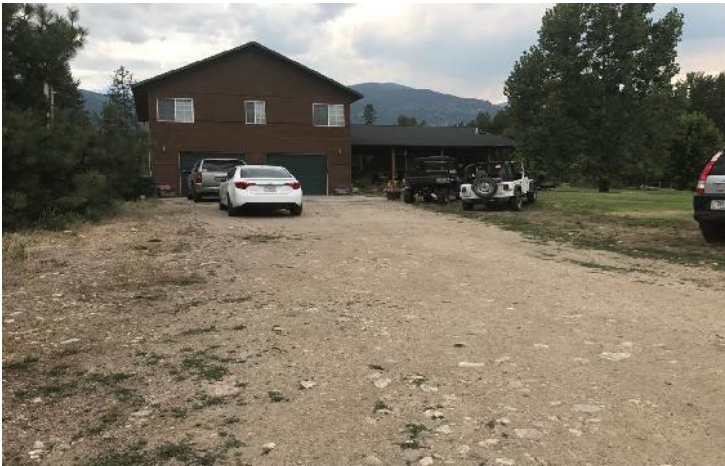
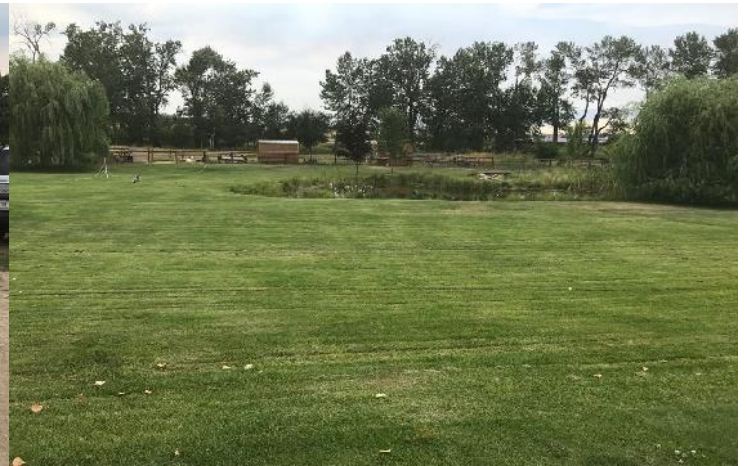
**Safety Zone Present:** Yes  
**Type of Structure:** Residential  
**Surrounding Fuels:** Grass, Timber  
**Structure Triage Category:** Defensible, Prep and Hold  
**Roof Material:** Composite  
**Heat Traps:** Wood Deck, Rain Gutters  
**Electrical Power:** Underground  
**Hazards:**  
**Access to Site:** T3/4 Engine  
**Comm with ICP:** Radio, Cell Service  
**Water Source:** Faucet / Hose, Large Pond, Creek  
**Mitigation Time:** Less Than An Hour  
**Notes:** Pond could be used as water source, ground is soft. Creek runs through north end of property. Swimming pool on north end.

**Where is Safety Zone:** One engine, large green yard. Access to pasture on the north side of the property, possibly swampy.

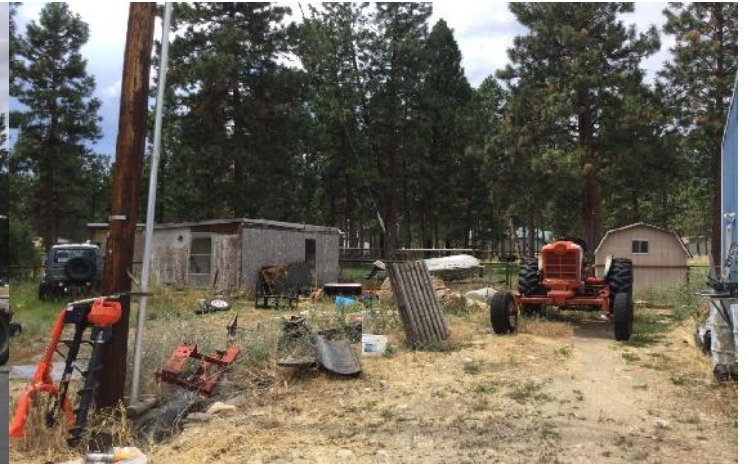
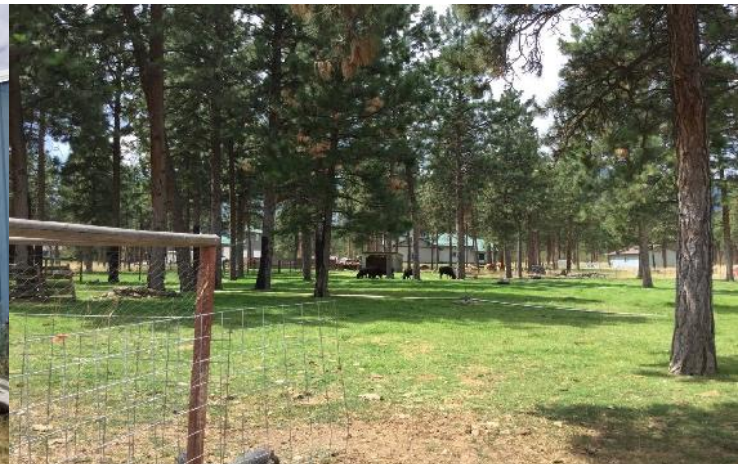
**Structure Number:**  
**Structure Name:** 303 Rocky Road  
**SubDivision:** One Horse  
**GPS Location, Lat.** 46 38.06778  
**GPS Location, Long.** 114 5.13906  
**Safety Zone Present:** Yes  
**Type of Structure:** Mixed Use  
**Surrounding Fuels:** Grass, Timber  
**Structure Triage Category:** Defensible, Prep and Hold  
**Roof Material:** Metal  
**Heat Traps:** Other Receptor  
**Electrical Power:** Overhead, Underground  
**Hazards:** Fuels, Animals  
**Access to Site:** T1 Engine  
**Comm with ICP:** Radio, Cell Service  
**Water Source:** Faucet / Hose  
**Mitigation Time:** More Than 5 Hours  
**Other Resources Needed to Protect:** Removal of wood and hay from around the house, Lots of clutter. But surrounded by green grass  
**Notes:** Cows in the backyard

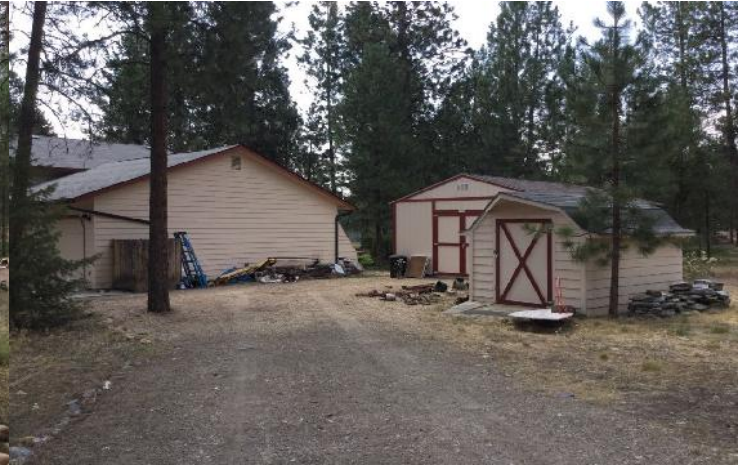
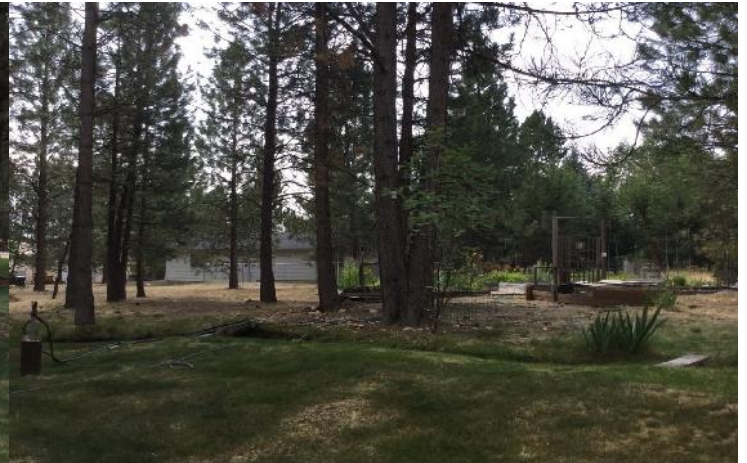
**Structure Number:**  
**Structure Name:** 313 Wickiup Drive  
**SubDivision:** One Horse  
**GPS Location, Lat.** 46 38.2743  
**GPS Location, Long.** 114 5.17362  
**Safety Zone Present:** Yes  
**Type of Structure:** Residential  
**Surrounding Fuels:** Timber  
**Structure Triage Category:** Defensible, Stand Alone  
**Roof Material:** Composite  
**Heat Traps:** Wood Deck  
**Electrical Power:** Underground  
**Hazards:** Fuels  
**Access to Site:** T1 Engine  
**Comm with ICP:** Radio, Cell Service  
**Water Source:** Faucet / Hose  
**Mitigation Time:** Less Than An Hour  
**Other Resources Needed to Protect:** Wood around the house could be removed. Thinning in the backyard  
**Collected By:** Engine 951

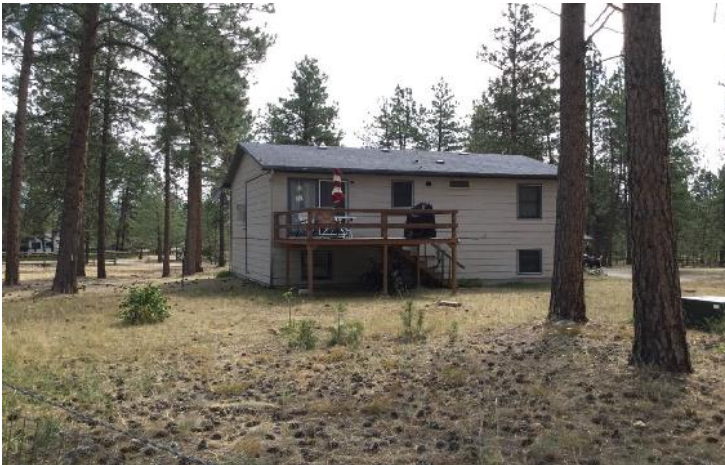
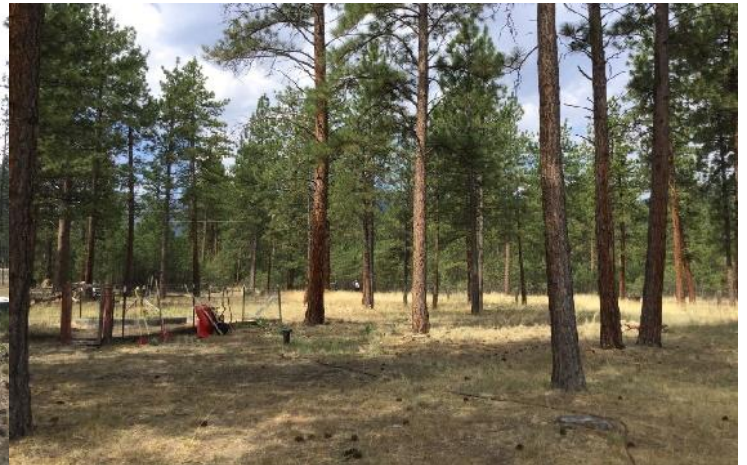
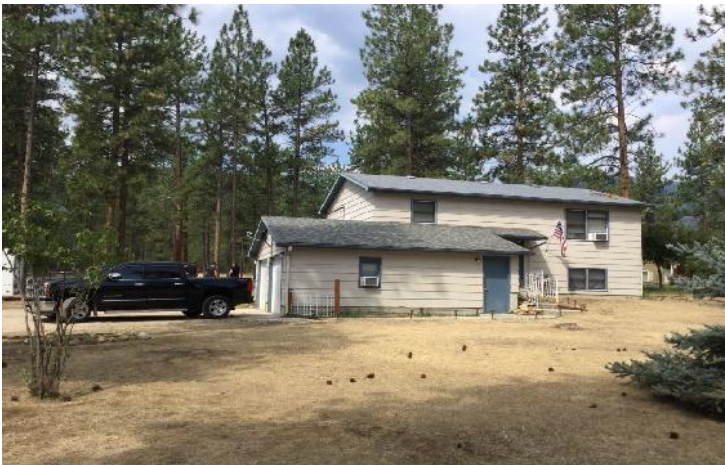
**Structure Number:**  
**Structure Name:** 317/319 Wickiup Drive  
**SubDivision:** One Horse  
**GPS Location, Lat.** 46 38.27484  
**GPS Location, Long.** 114 5.24748  
**Safety Zone Present:** Yes  
**Type of Structure:** Residential  
**Surrounding Fuels:** Timber  
**Structure Triage Category:** Defensible, Stand Alone  
**Roof Material:** Composite  
**Heat Traps:** Wood Deck,Rain Gutters  
**Electrical Power:** Underground  
**Hazards:** Fuels  
**Access to Site:** T1 Engine  
**Comm with ICP:** Radio,Cell Service  
**Water Source:** Faucet / Hose  
**Mitigation Time:** 1-2 Hours  
**Other Resources Needed to Protect:** Mowing grass in backyard  
**Collected By:** Engine 951  
Photo 1

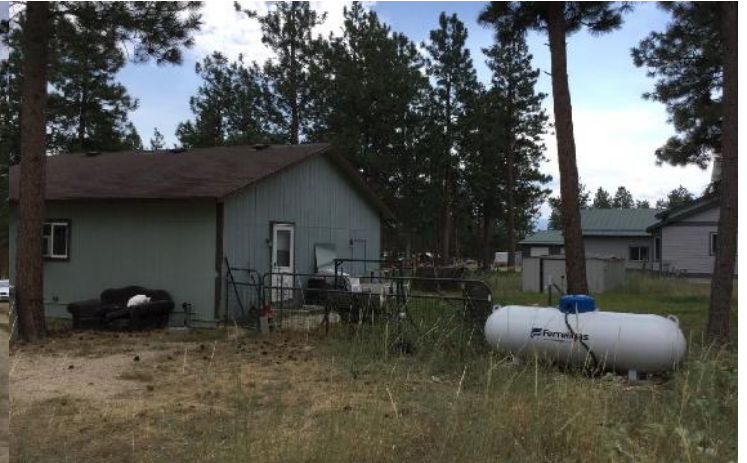
Hazards: Fuels

Other Resources: Needs some mowing around back, and propane tank

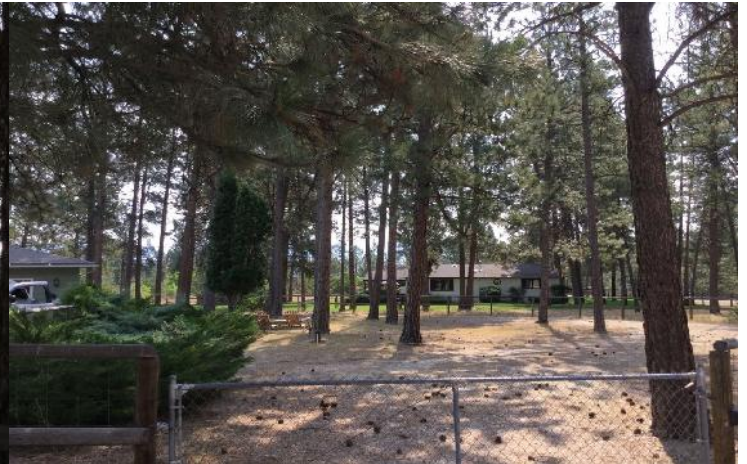
**Structure Number:**  
**Structure Name:** 320 Wickiup Drive  
**SubDivision:** One Horse  
**GPS Location, Lat.** 46 38.30922  
**GPS Location, Long.** 114 5.21058  
**Safety Zone Present:** Yes  
**Type of Structure:** Residential  
**Surrounding Fuels:** Timber  
**Structure Triage Category:** Defensible, Stand Alone  
**Roof Material:** Composite  
**Heat Traps:** Rain Gutters  
**Electrical Power:** Underground  
**Hazards:**  
**Access to Site:** T1 Engine  
**Comm with ICP:** Radio, Cell Service  
**Water Source:** Faucet / Hose  
**Mitigation Time:** Less Than An Hour  
**Other Resources Needed to Protect:** Tall grasses around 2 outbuildings, need Mowing or line  
**Notes:** Timber with no ladder fuels

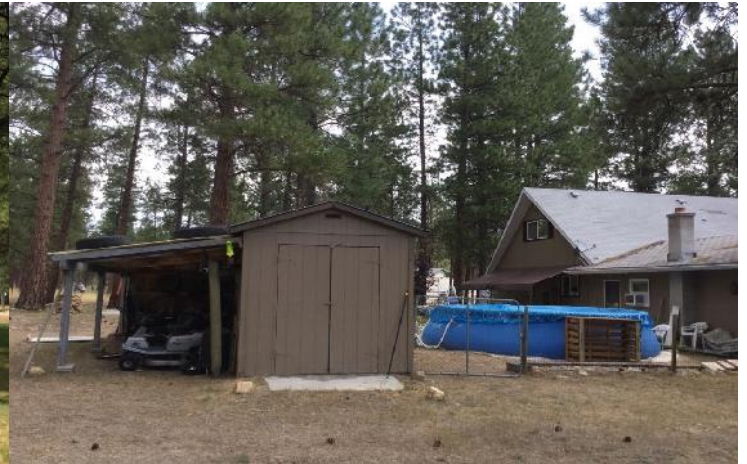
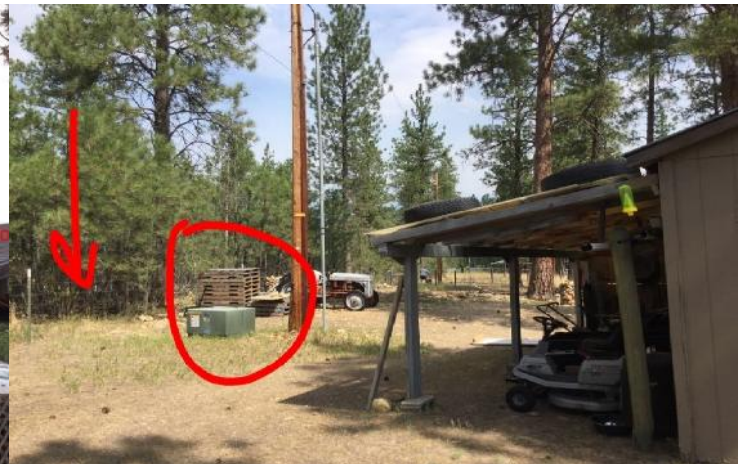
Structure Number: 321 Wickiup Drive  
Structure Name: 321 Wickiup Drive  
SubDivision: One Horse  
GPS Location, Lat. 46 38.24742  
GPS Location, Long. 114 5.22738  
Safety Zone Present: Yes      Where is Safety Zone: Down the road Florence  
Type of Structure: Residential      Primary Structures:      Outbuildings:  
Surrounding Fuels: Timber      Defensible Space: 30-50 Feet  
Structure Triage Category: Defensible, Prep and Hold  
Roof Material: Composite      Siding Material: Wood  
Heat Traps: Rain Gutters  
Electrical Power: Underground      Gas to Structure: Underground  
Hazards: Fuels  
Access to Site: T1 Engine      Best Access From: Wickiup Drive  
Comm with ICP: Radio, Cell Service  
Water Source: Faucet / Hose, Porta-Tank/Pumpkin  
Mitigation Time: Less Than An Hour  
Other Resources: Clean gutters and roof, remove wood from around house, thinning along back fence  
Needed to Protect:  
Notes: Pool in the back

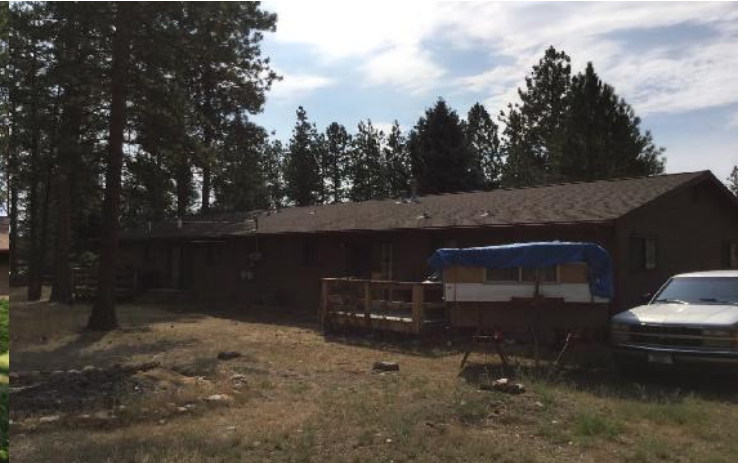
**Structure Number:**  
**Structure Name:** 322 /324 Wickiup Drive  
**SubDivision:** One Horse  
**GPS Location, Lat.** 46 38.31804  
**GPS Location, Long.** 114 5.22462  
**Safety Zone Present:** Yes  
**Type of Structure:** Residential  
**Surrounding Fuels:** Timber  
**Structure Triage Category:** Defensible, Stand Alone  
**Roof Material:** Composite  
**Heat Traps:** Rain Gutters  
**Electrical Power:** Overhead  
**Hazards:** Septic Tank  
**Access to Site:** T1 Engine  
**Comm with ICP:** Radio, Cell Service  
**Water Source:** Faucet / Hose  
**Mitigation Time:** 1-2 Hours  
**Other Resources Needed to Protect:** Clean under decks, gutters  
**Collected By:** Engine 951

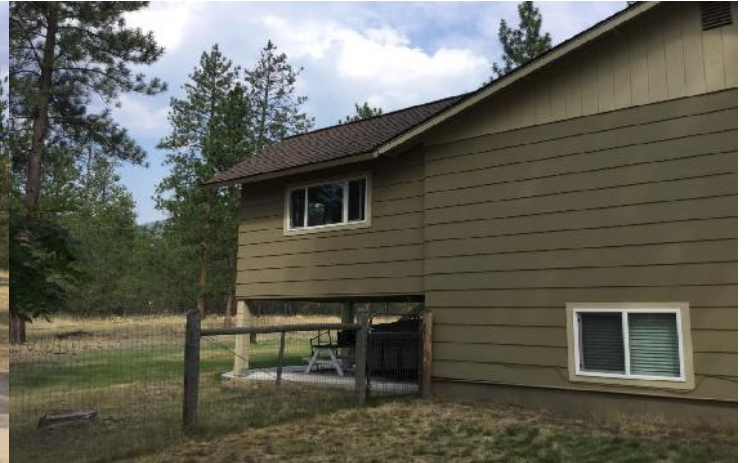
**Structure Number:**  
**Structure Name:** 323 Wickiup Drive  
**SubDivision:** One Horse  
**GPS Location, Lat.** 46 38.29566  
**GPS Location, Long.** 114 5.21862  
**Safety Zone Present:** Yes  
**Type of Structure:** Residential  
**Surrounding Fuels:** Timber  
**Structure Triage Category:** Defensible, Stand Alone  
**Roof Material:** Composite  
**Heat Traps:** Wood Deck  
**Electrical Power:** Overhead  
**Hazards:** Fuels  
**Access to Site:** T1 Engine  
**Comm with ICP:** Radio, Cell Service  
**Water Source:** Faucet / Hose  
**Mitigation Time:** 2-3 Hours  
**Other Resources Needed to Protect:** Limbing and thinning behind property  
**Collected By:** Engine 951

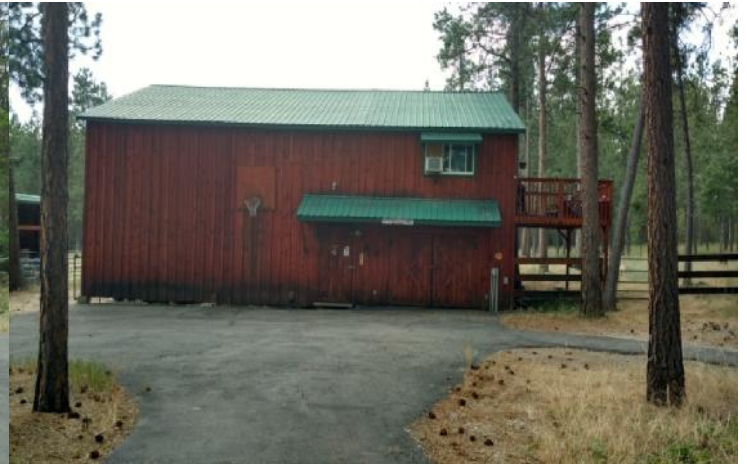
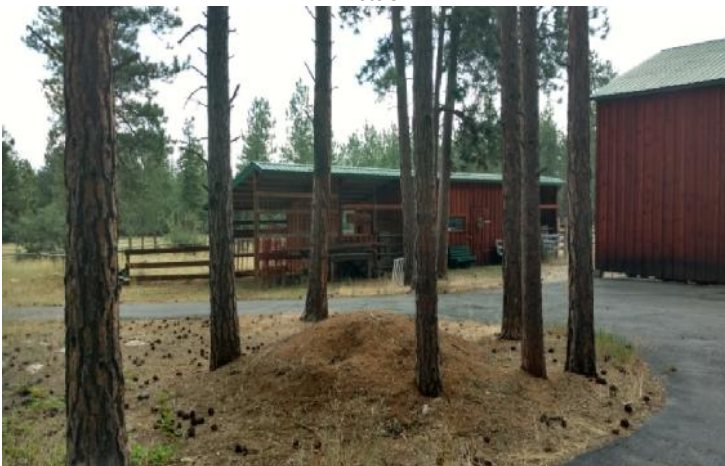
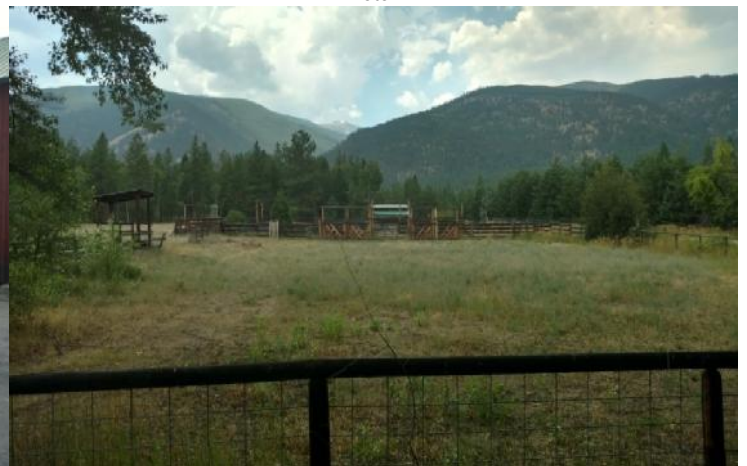
**Structure Triage Category:** Defensible, Prep and Hold  
**Roof Material:** Metal  
**Heat Traps:** Wood Deck  
**Electrical Power:** Underground  
**Hazards:** Fuels  
**Access to Site:** T3/4 Engine  
**Comm with ICP:** Radio  
**Water Source:** Faucet / Hose  
**Mitigation Time:** 4-5 Hours  
**Other Resources Needed to Protect:** One engine crew, sprinkler kit and portable water source. 4 to 5 hours worth of work. line structures, set up sprinklers.

**Notes:** 100 to 200 ft space around the structures has been thinned. Layer of pine litter remains. The driveway is tight for a Type 3 with a good turn around near the house. No other water source other than the on-site well was found. Corral and Barn North of the

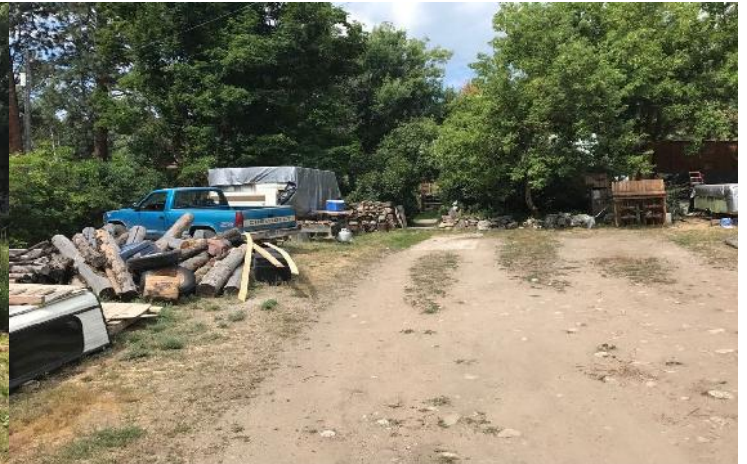
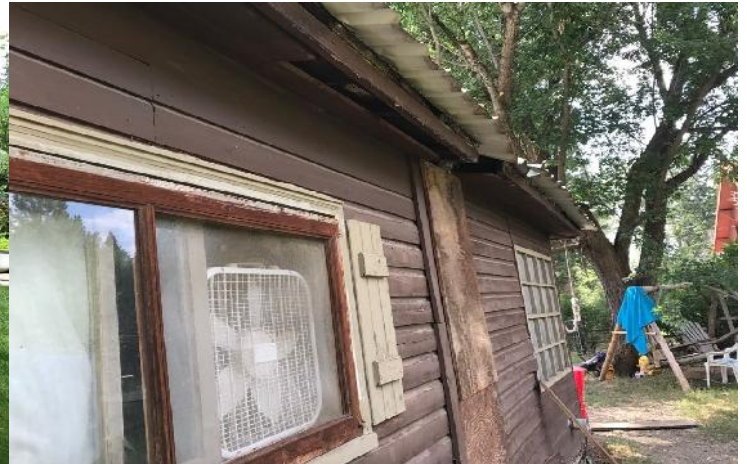
**Heat Traps:** Open Eaves,Rain Gutters,Other Receptor  
**Electrical Power:** Overhead **Gas to Structure:**  
**Hazards:** Fuels,HazMat  
**Access to Site:** T3/4 Engine **Best Access From:** Hwy 93 to Holloway Lane

**Notes:** Multiple areas around main residence and out buildings are open and damaged.

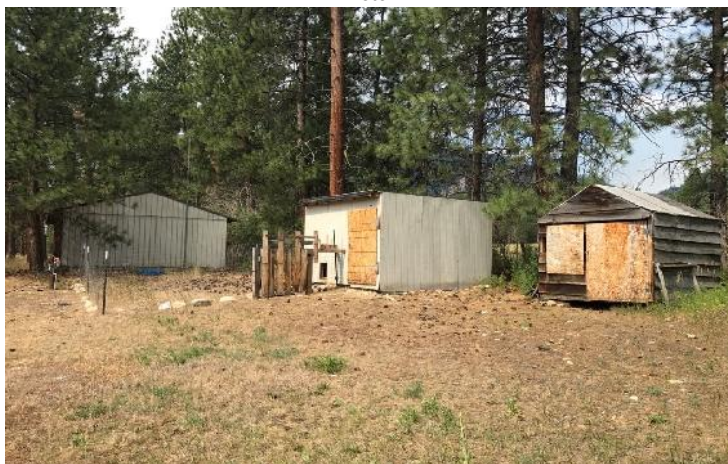
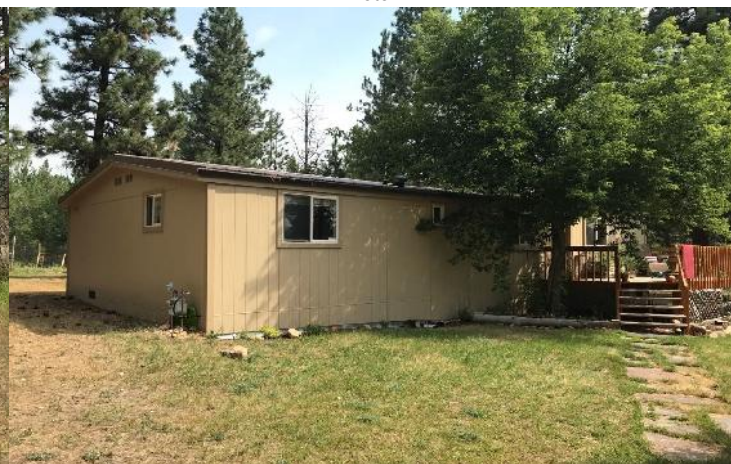
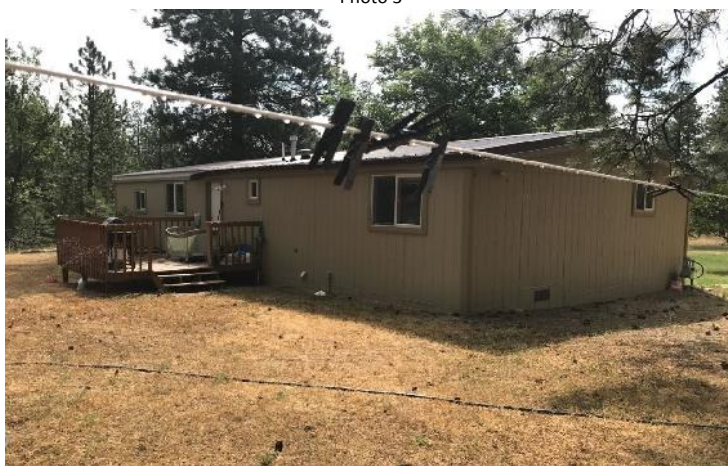
**Structure Number:**  
**Structure Name:** 620 Trenk way  
**SubDivision:** One Horse  
**GPS Location, Lat.** 46 38.15292  
**GPS Location, Long.** 114 5.92956  
**Safety Zone Present:** Yes  
**Type of Structure:** Residential  
**Surrounding Fuels:** Grass, Timber  
**Structure Triage Category:** Defensible, Prep and Hold  
**Roof Material:** Metal  
**Heat Traps:** Wood Deck, Rain Gutters  
**Electrical Power:** Underground  
**Hazards:** HazMat  
**Access to Site:** T1 Engine  
**Comm with ICP:** Radio, Cell Service  
**Water Source:** Faucet / Hose  
**Mitigation Time:** Less Than An Hour  
**Other Resources Needed to Protect:** None  
**Notes:** Fuel in gutters. Two wood decks.

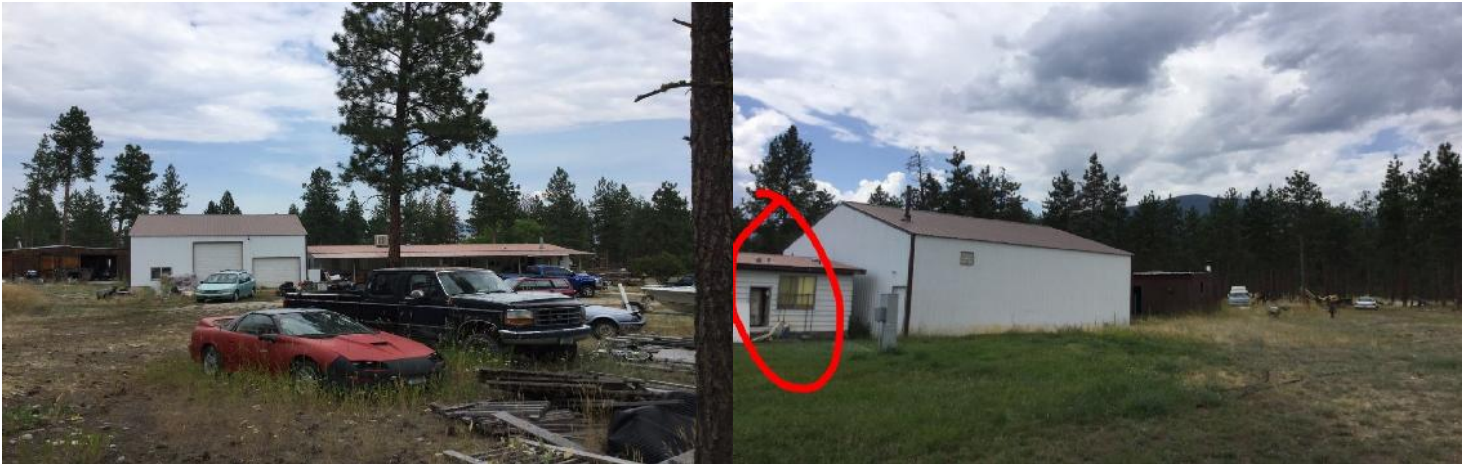
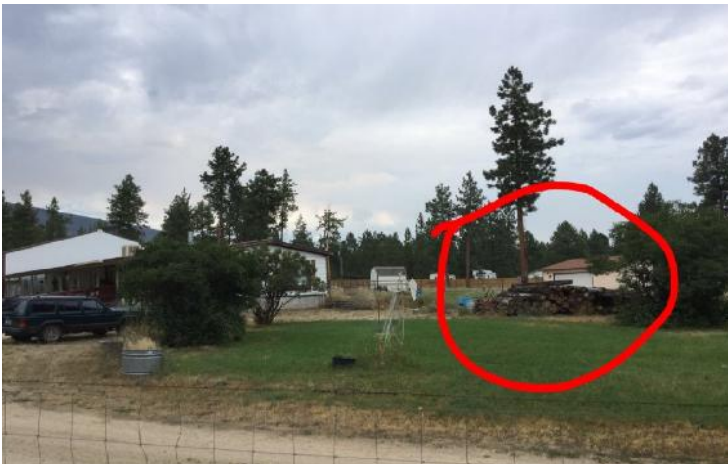
**Structure Number:**  
**Structure Name:** ? Hughs Lane  
**SubDivision:** One Horse  
**GPS Location, Lat.** 46 38.06784  
**GPS Location, Long.** 114 5.26632  
**Safety Zone Present:** Yes  
**Type of Structure:** Residential  
**Surrounding Fuels:** Grass, Timber  
**Structure Triage Category:** Defensible, Prep and Hold  
**Roof Material:** Metal  
**Heat Traps:** Other Receptor  
**Electrical Power:** Underground  
**Hazards:** Fuels  
**Access to Site:** T1 Engine  
**Comm with ICP:** Radio, Cell Service  
**Water Source:** Faucet / Hose  
**Mitigation Time:** More Than 5 Hours  
**Other Resources Needed to Protect:** Heavy pile, needs to be covered. lots of weedwacking in the back, continuous fuels to the house.  
**Notes:** Could not find property number
