MQ-9 SAR for Fire Damage Assessment

12 Oct 2017, Vichy Springs, Napa County

163d Attack Wing (163 ATKW), MQ-9

MQ-9 crew collected SAR imagery to demonstrate the ability or inability to detect structural damage due to fire, 1ft GeoRef

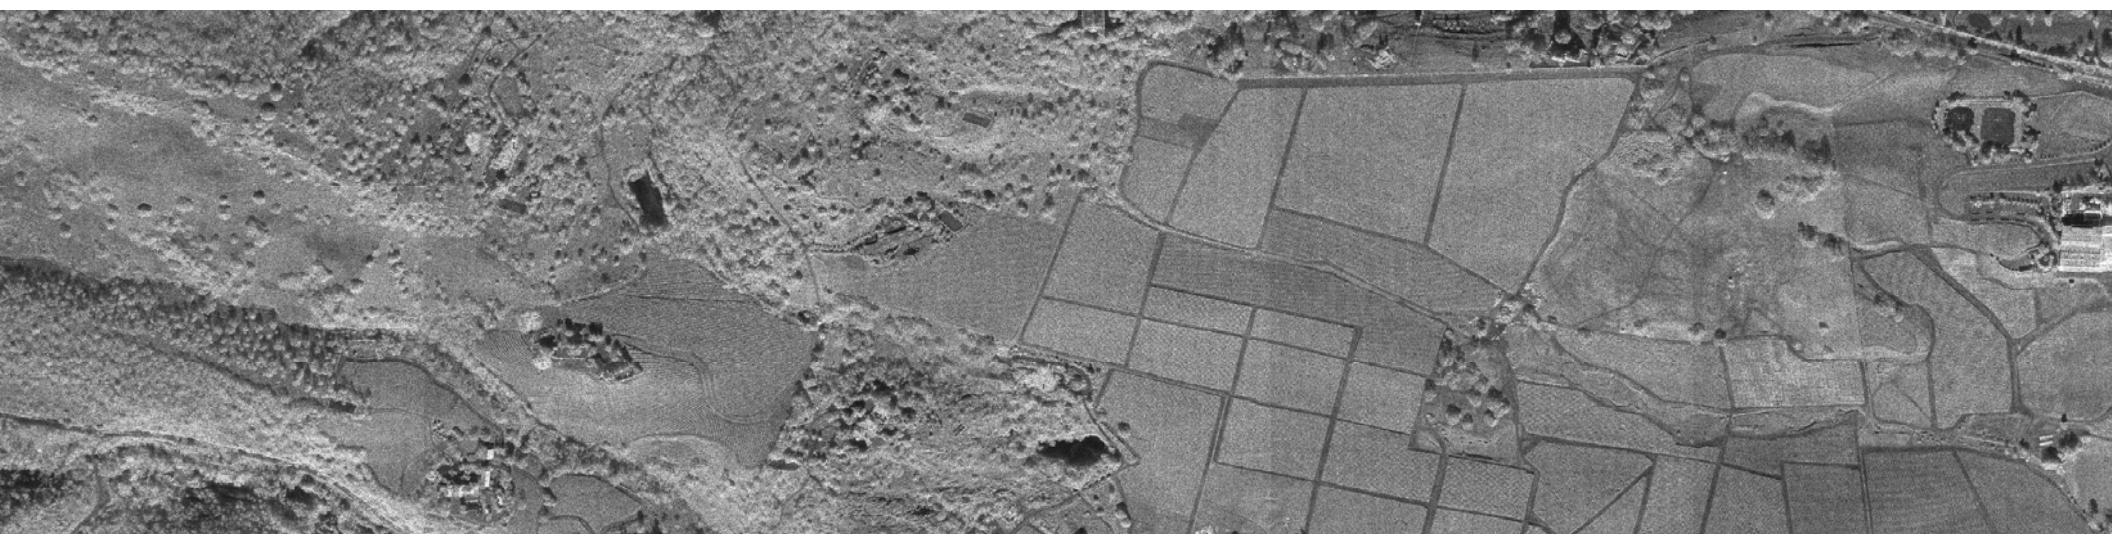
Initial spot analysis showed possible structural damage, but not confident since this capability was untested by the 163 ATKW

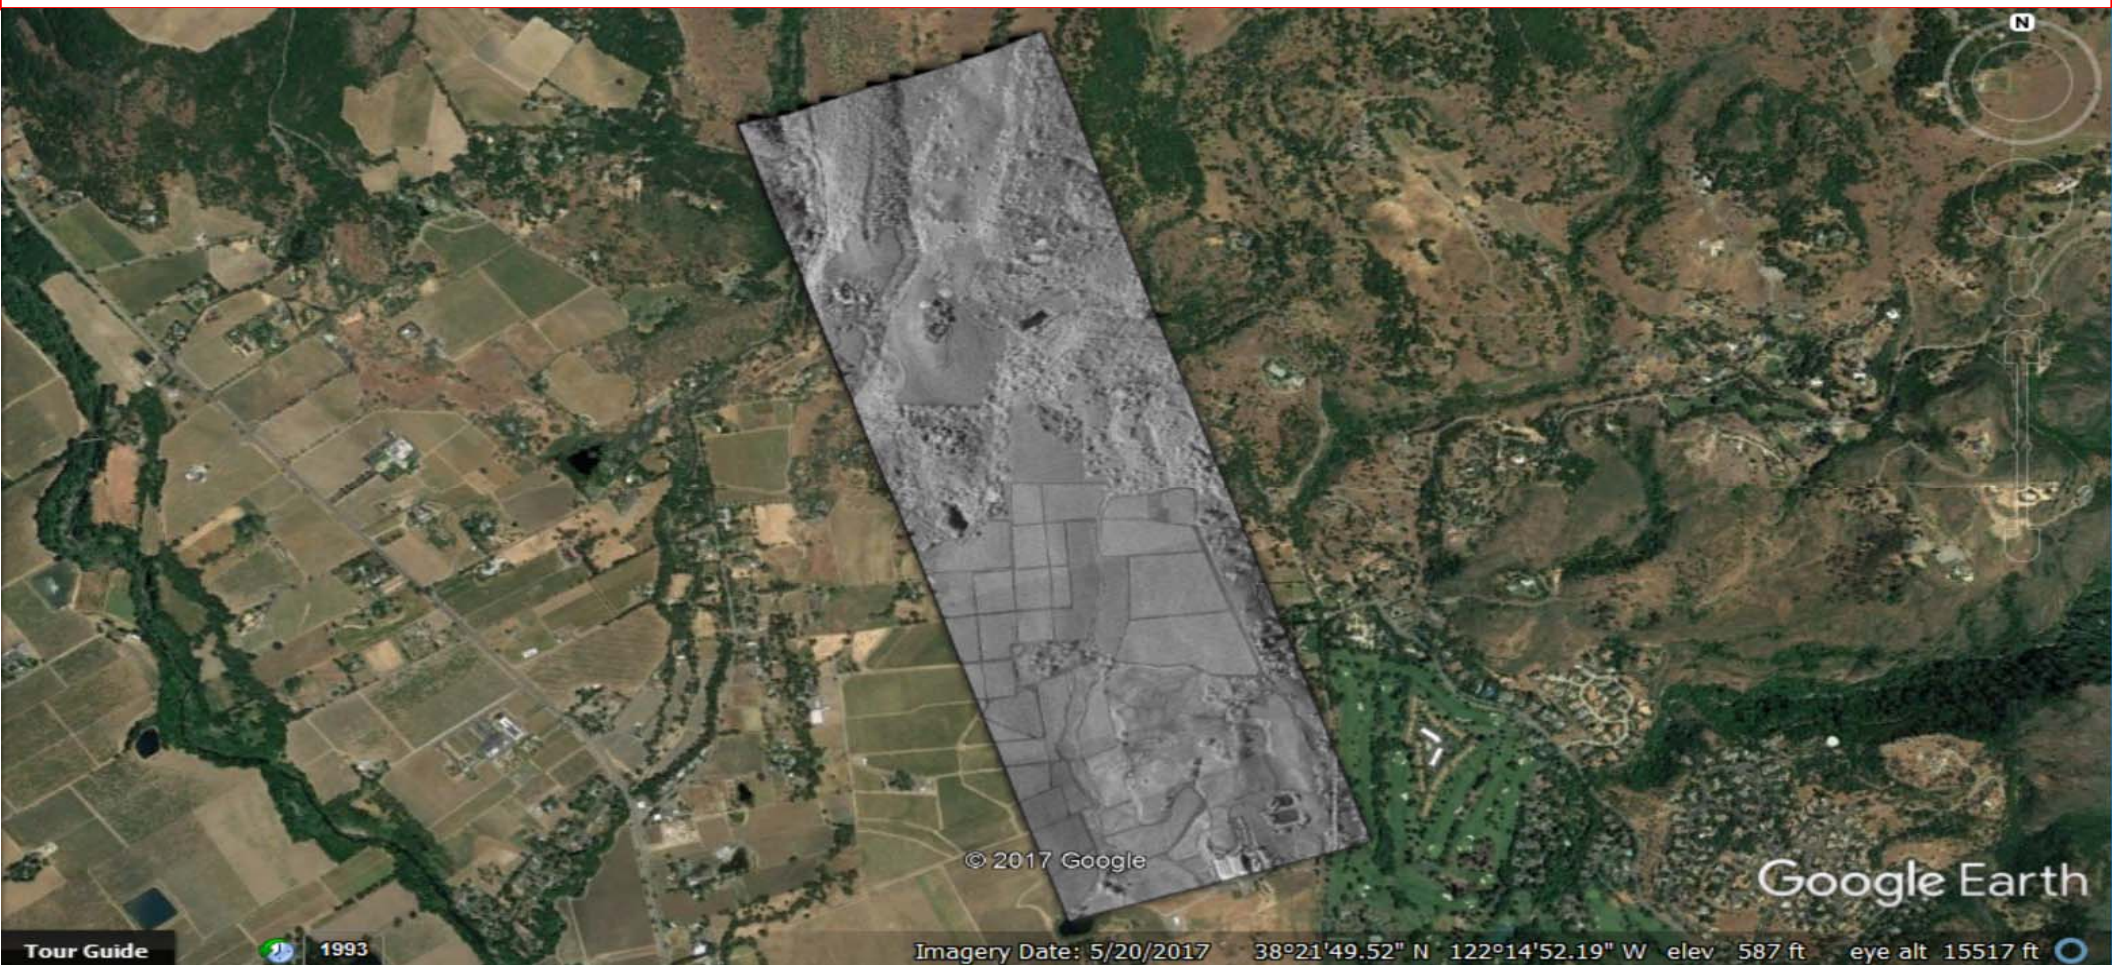
The MQ-9 crew stitched together the mosaic and converted to GeoTIFF format, then loaded into Google Earth for analysis

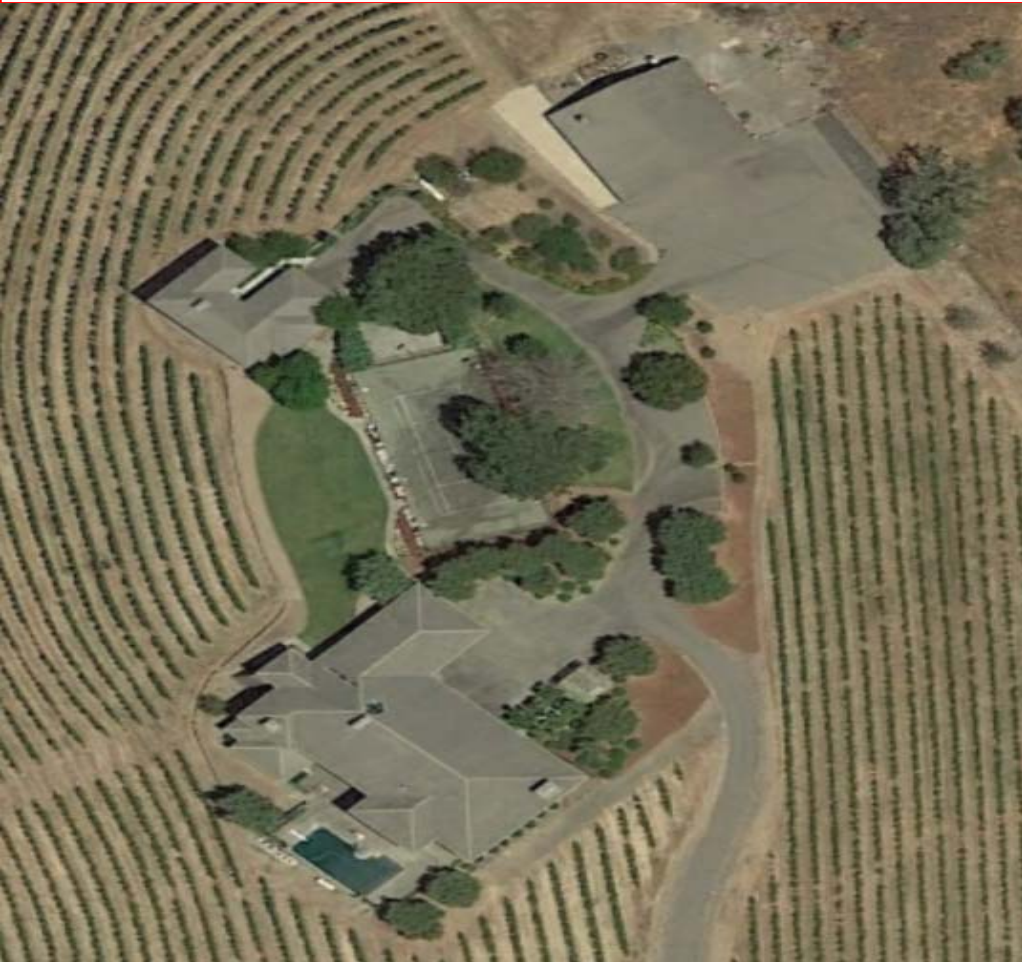
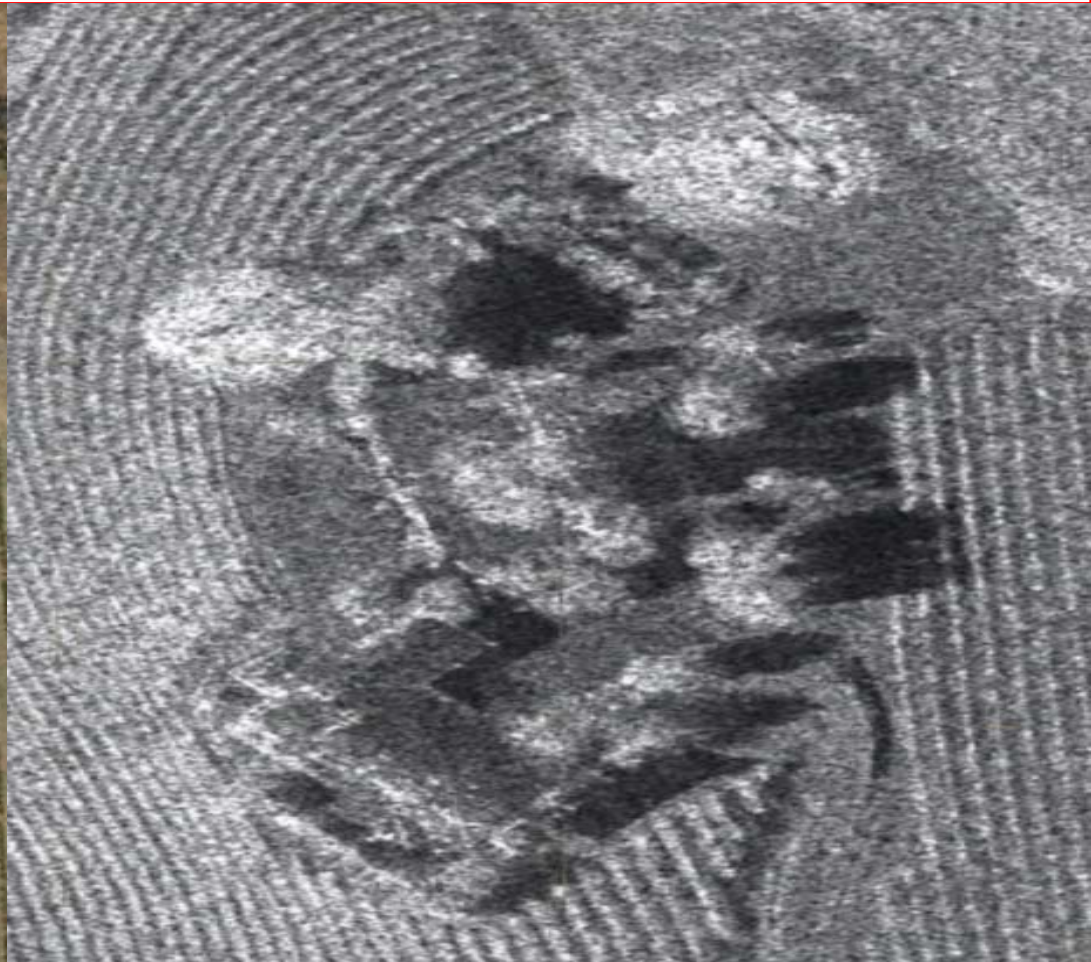
By toggling between native globe imagery and the SAR image, Google Earth allowed the crew to determine whether structures previously existed
