**STRUCTURE
PROTECTION PLAN
FOR TIE CHUTE
BLOCK**

Structure Protection Plan

Tie Chute

Location: On Old Hwy 93 between County Line Rd. and Tie Chute Ln.

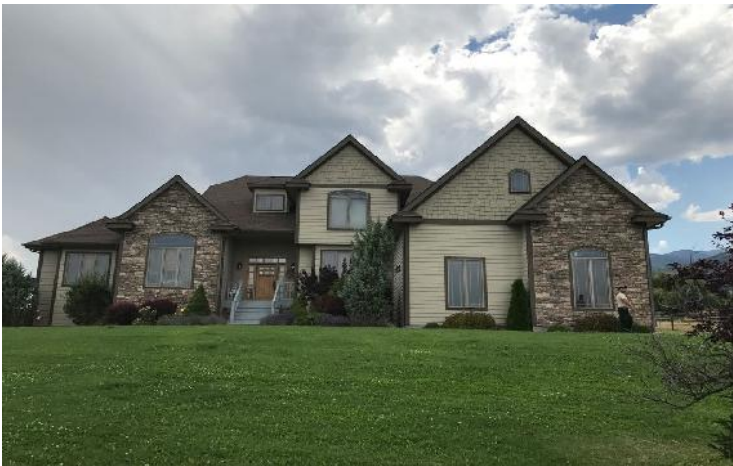
Collected Date/Time: 07/30/2017 08:58:16
Photo 2

Structure Number:
Structure Name: 225 Mountain Shadow Trail
SubDivision: Tie Chute
GPS Location, Lat. 46 39.13626
GPS Location, Long. 114 4.7832
Safety Zone Present: No **Where is Safety Zone:** Highway 93
Type of Structure: Residential **Primary Structures:** **Outbuildings:**
Surrounding Fuels: Grass,Shrub **Defensible Space:** 50-100 Feet
Structure Triage
Category: Defensible, Stand Alone
Roof Material: Composite **Siding Material:** Masonry
Heat Traps: Open Eaves,Rain Gutters,Other Receptor
Electrical Power: Underground **Gas to Structure:** Underground
Hazards: No Turn Around
Access to Site: T3/4 Engine **Best Access From:** Old Highway 93 to Mountain Shadow Trail
Comm with ICP: Radio,Cell Service
Water Source: Faucet / Hose
Mitigation Time: Less Than An Hour
Notes: Underground irrigation system.

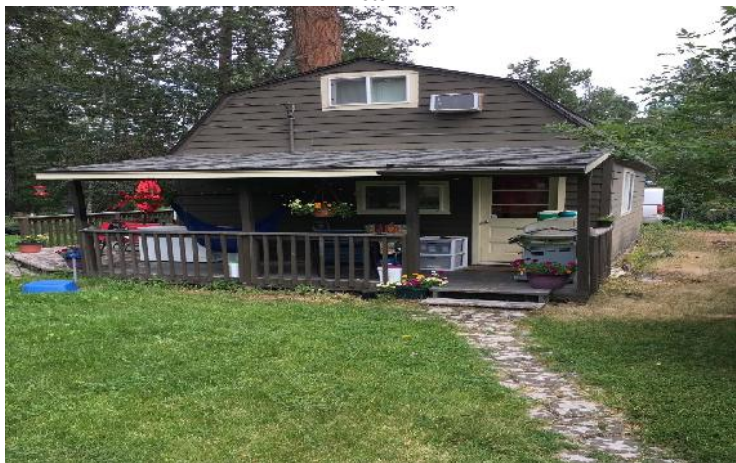
Structure Number:
Structure Name: 234 Tie Chute Ln
SubDivision: Tie Chute
GPS Location, Lat. 46 38.55018
GPS Location, Long. 114 4.7025
Safety Zone Present: No **Where is Safety Zone:** 1-2 minutes to the Florence school.
Type of Structure: Residential **Primary Structures:** **Outbuildings:**
Surrounding Fuels: Grass **Defensible Space:** 30-50 Feet
Structure Triage
Category: Defensible, Prep and Hold
Roof Material: Composite **Siding Material:** Wood
Heat Traps: Open Eaves, Wood Deck, Rain Gutters
Electrical Power: Overhead **Gas to Structure:**
Hazards:
Access to Site: T6 Engine **Best Access From:** Old Hwy 93
Comm with ICP: Radio, Cell Service
Water Source: Faucet / Hose
Mitigation Time: Less Than An Hour
Collected By: E-27 Florence **Collected Date/Time:** 07/30/2017 08:58:17

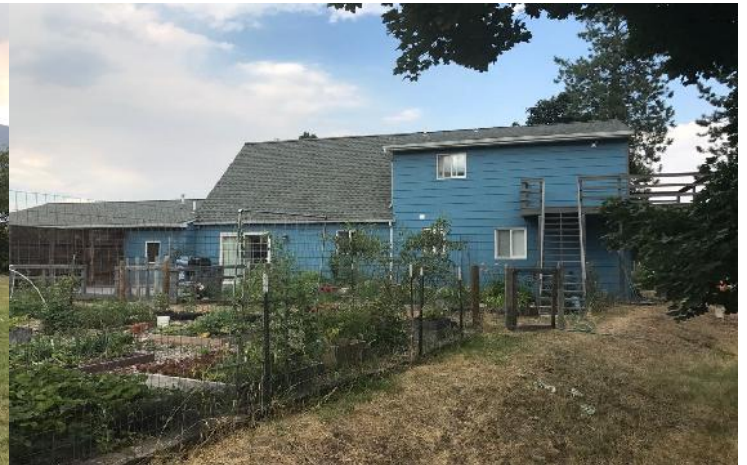
Photo 3

Structure Number:
Structure Name: 239 Rogers Way
SubDivision: Tie Chute
GPS Location, Lat. 46 38.63454
GPS Location, Long. 114 4.65288
Safety Zone Present: Yes
Type of Structure: Residential
Surrounding Fuels: Grass
Structure Triage Category: Defensible, Stand Alone
Roof Material: Composite
Heat Traps: Wood Deck,Rain Gutters
Electrical Power: Underground
Hazards:
Access to Site: T1 Engine
Comm with ICP: Radio,Cell Service
Water Source: Faucet / Hose
Mitigation Time: None Needed
Other Resources Needed to Protect: None
Collected By: AZ-TNF 1265
Photo 1

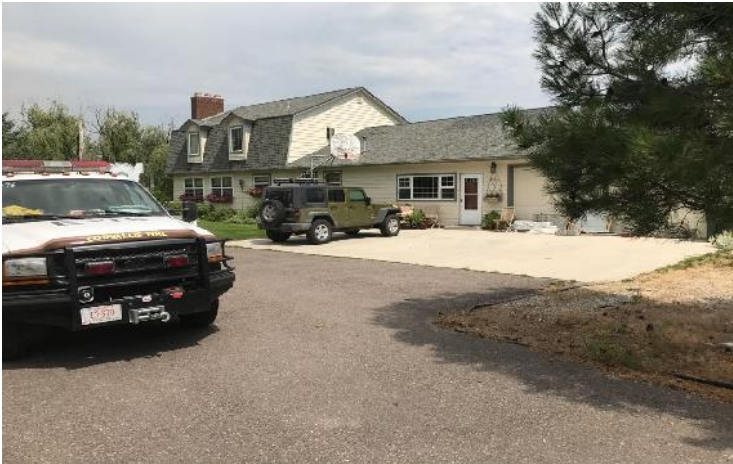
Structure Number:
Structure Name: 251 Mountain Shadow Trail
SubDivision: Tie Chute
GPS Location, Lat. 46 39.10026
GPS Location, Long. 114 4.85346
Safety Zone Present: Yes **Where is Safety Zone:** Old US Hwy 93
Type of Structure: Residential **Primary Structures:** **Outbuildings:**
Surrounding Fuels: Grass,Shrub **Defensible Space:** 30-50 Feet
Structure Triage Category: Defensible, Prep and Hold
Roof Material: Composite **Siding Material:** Wood
Heat Traps: Rain Gutters,Other Receptor
Electrical Power: Overhead **Gas to Structure:** Underground
Hazards:
Access to Site: T3/4 Engine **Best Access From:** Old Highway 93
Comm with ICP: Radio,Cell Service
Water Source: Faucet / Hose
Mitigation Time: None Needed
Notes: Road is gated at this residence but does loop around property to another gate back out to Mountain Shadow Trail.

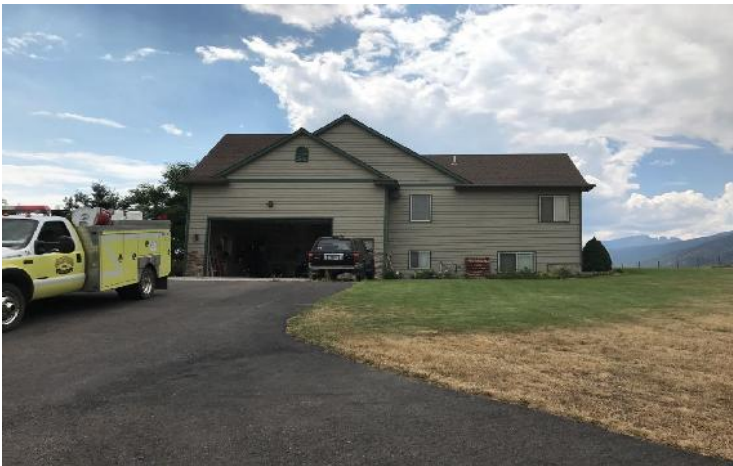
Collected Date/Time: 07/30/2017 08:58:05
Photo 2

Structure Number:
Structure Name: 256 Mountain Shadow Trail
SubDivision: Tie Chute
GPS Location, Lat. 46 39.12582
GPS Location, Long. 114 4.87314
Safety Zone Present: Yes **Where is Safety Zone:** Highway 93
Type of Structure: Residential **Primary Structures:** **Outbuildings:**
Surrounding Fuels: Grass,Shrub **Defensible Space:** 50-100 Feet
Structure Triage
Category: Defensible, Stand Alone
Roof Material: Composite **Siding Material:** Masonry
Heat Traps: Open Eaves,Wood Deck,Rain Gutters,Other Receptor
Electrical Power: Underground **Gas to Structure:** Underground
Hazards: No Turn Around
Access to Site: T3/4 Engine **Best Access From:** Old US Highway 93
Comm with ICP: Radio,Cell Service
Water Source: Faucet / Hose,Creek
Mitigation Time: None Needed
Notes: Creek 150 yards to the north of structure

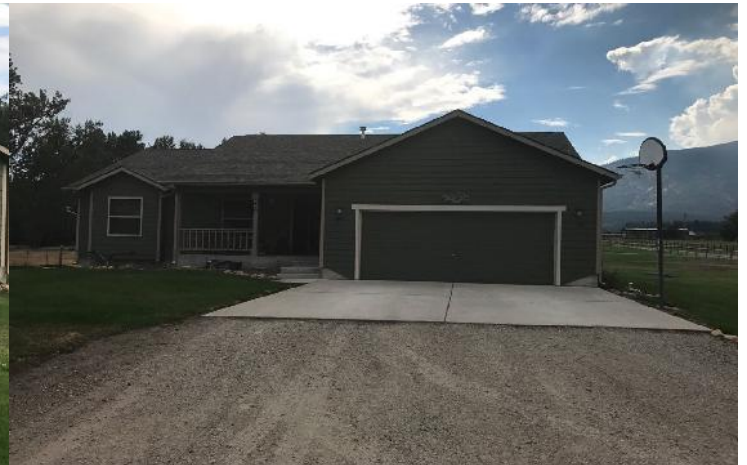
Photo 3

Structure Number:
Structure Name: 267 Rogers Way
SubDivision: Tie Chute
GPS Location, Lat. 46 38.62536
GPS Location, Long. 114 4.76094
Safety Zone Present: Yes
Type of Structure: Residential
Surrounding Fuels: Grass
Structure Triage Category: Defensible, Stand Alone
Roof Material: Composite
Heat Traps: Rain Gutters
Electrical Power: Underground
Hazards:
Access to Site: T1 Engine
Comm with ICP: Radio, Cell Service
Water Source: Faucet / Hose
Mitigation Time: None Needed
Other Resources Needed to Protect: Sprinkler system
Collected By: AZ-TNF 1265
Photo 1

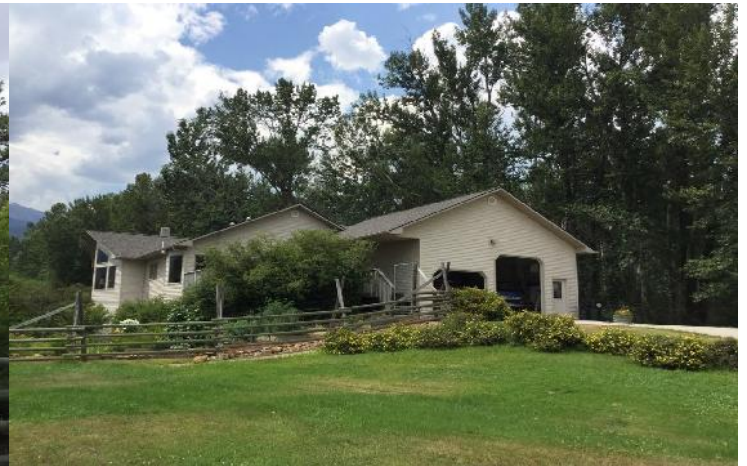
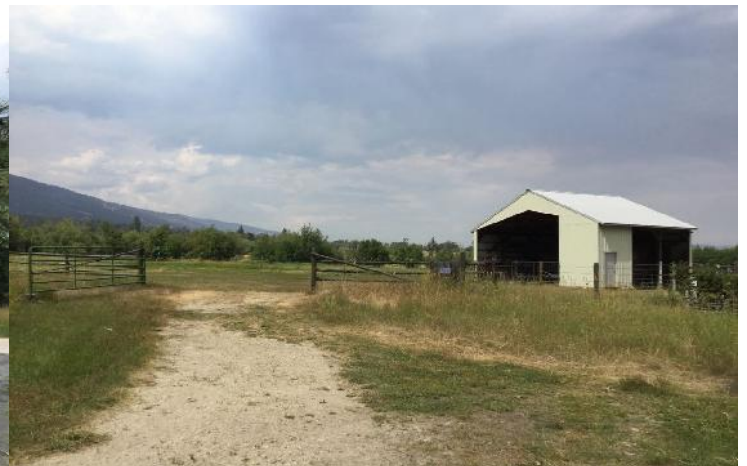
Safety Zone Present: Yes
Type of Structure: Residential
Surrounding Fuels: Grass, Timber
Structure Triage Category: Defensible, Prep and Hold
Roof Material: Composite
Heat Traps: Wood Deck, Rain Gutters
Electrical Power: Overhead, Underground
Hazards: Fuels, Animals, Septic Tank
Access to Site: T3/4 Engine
Comm with ICP: Radio, Cell Service
Water Source: Faucet / Hose, Creek
Mitigation Time: 1-2 Hours
Other Resources Needed to Protect: Sprinklers.

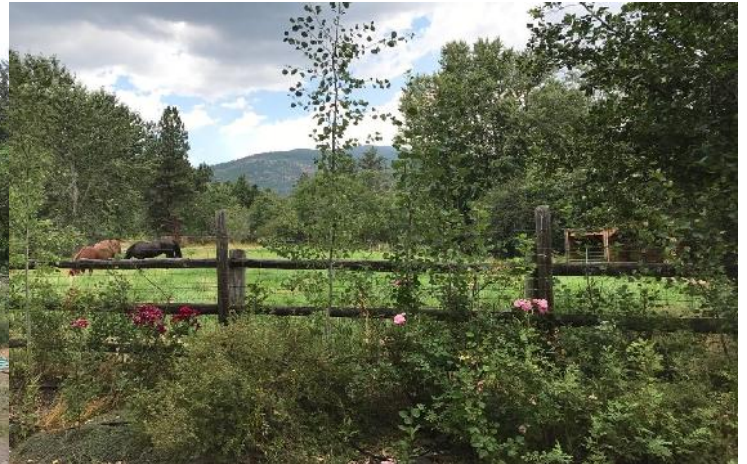
Collected Date/Time: 07/30/2017 08:58:28
Photo 2

Structure Number:
Structure Name: 362 Tie Chute
SubDivision: Tie Chute
GPS Location, Lat. 46 38.56566
GPS Location, Long. 114 5.5155
Safety Zone Present: Yes
Type of Structure: Residential
Surrounding Fuels: Grass, Timber
Structure Triage Category: Defensible, Prep and Hold
Roof Material: Composite
Heat Traps: Wood Deck
Electrical Power: Underground
Hazards:
Access to Site: T3/4 Engine
Comm with ICP: Radio, Cell Service
Water Source: Faucet / Hose, Creek
Mitigation Time: 1-2 Hours
Notes: Two entrances/drive thru. Creek behind house.

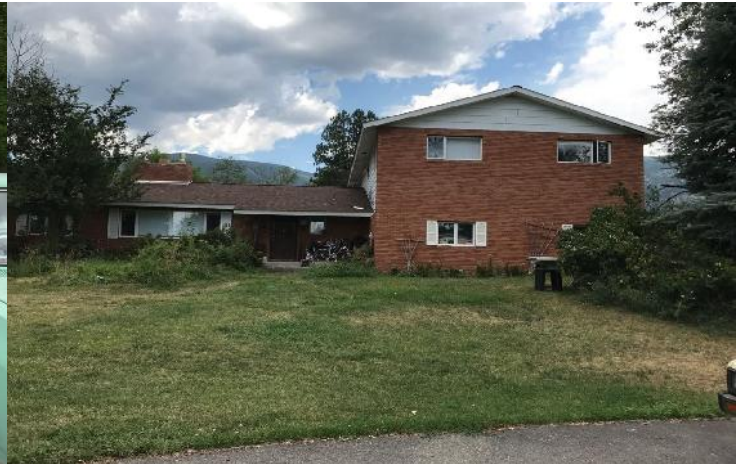
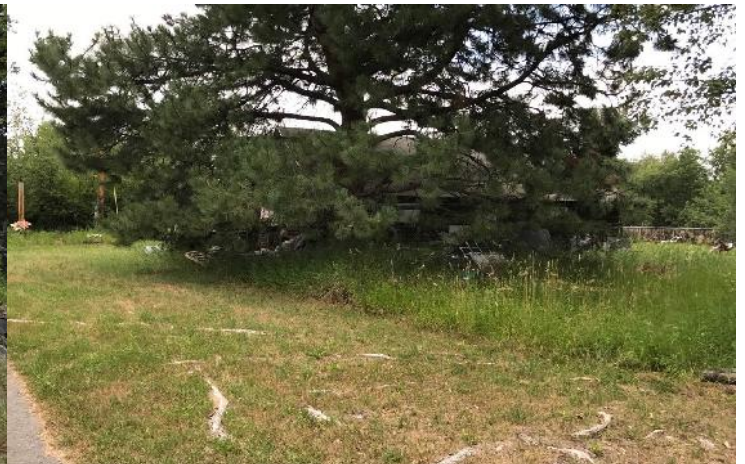
Structure Number:
Structure Name: 382 Tie Chute Ln
SubDivision: Tie Chute
GPS Location, Lat. 46 38.60688
GPS Location, Long. 114 5.63538
Safety Zone Present: No **Where is Safety Zone:** Tie Chute to Old Hwy 93
Type of Structure: Residential **Primary Structures:** **Outbuildings:**
Surrounding Fuels: Grass, Timber **Defensible Space:** 30-50 Feet
Structure Triage Category: Non-Defensible, Prep and Leave
Roof Material: Composite **Siding Material:** Masonry
Heat Traps:
Electrical Power: Underground **Gas to Structure:** Underground
Hazards: HazMat
Access to Site: T6 Engine **Best Access From:** Tie Chute.
Comm with ICP: Radio, Cell Service
Water Source: Faucet / Hose
Mitigation Time: Less Than An Hour
Other Resources Needed to Protect: None
Notes: Narrow driveway. Multiple vehicles.

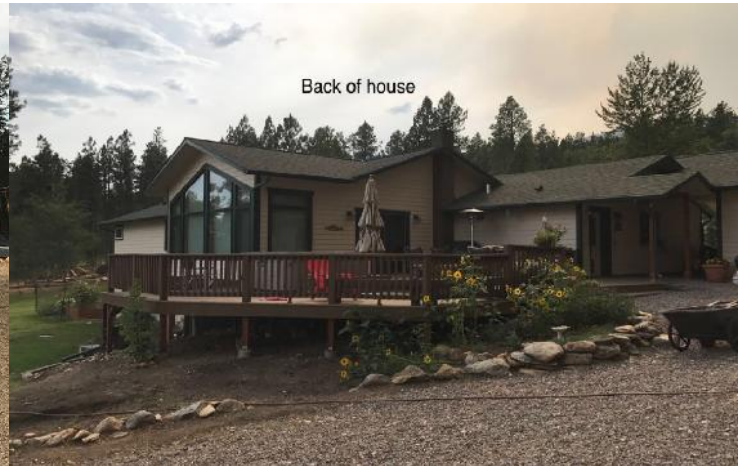
Photo 3

Structure Number:
Structure Name: 418 Aster Lane
SubDivision: Tie Chute
GPS Location, Lat. 46 39.26346
GPS Location, Long. 114 5.99916
Safety Zone Present: No **Where is Safety Zone:** Highway 93
Type of Structure: Mixed Use **Primary Structures:** **Outbuildings:**
Surrounding Fuels: Grass,Shrub,Timber,Slash **Defensible Space:** 30-50 Feet
Structure Triage Category: Defensible, Prep and Hold
Roof Material: Composite **Siding Material:** Masonry
Heat Traps: Wood Deck,Rain Gutters,Other Receptor
Electrical Power: Overhead,Underground **Gas to Structure:** Aboveground
Hazards: Animals,Septic Tank
Access to Site: T3/4 Engine **Best Access From:** Old Highway 93 to Wagner Ln. To Jones Rd. West County Line Road, left onto Daisy Lane. Stay left onto Aster Lane.
Comm with ICP: Radio,Cell Service
Water Source: Faucet / Hose,Large Pond
Mitigation Time: 1-2 Hours
Other Resources Needed to Protect: Mark 3 pump, 2 sprinkler kits, 600' 11/2" hose, with hose and appliances.

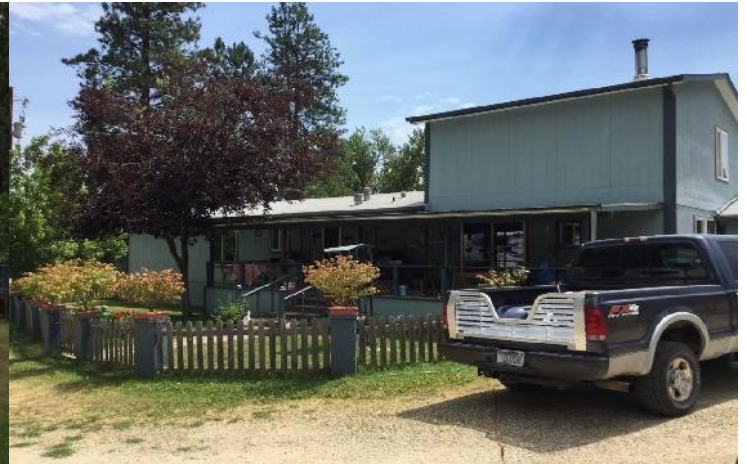
Photo 3

Structure Number:
Structure Name: 418 Tie Chute Lane
SubDivision: Tie Chute
GPS Location, Lat. 46 38.58096
GPS Location, Long. 114 5.85924
Safety Zone Present: No
Type of Structure: Residential
Surrounding Fuels: Grass, Timber
Structure Triage Category: Defensible, Prep and Hold
Roof Material: Composite
Heat Traps: Wood Deck, Rain Gutters
Electrical Power: Overhead, Underground
Hazards: Animals, Septic Tank
Access to Site: T3/4 Engine
Comm with ICP: Radio, Cell Service
Water Source: Faucet / Hose
Mitigation Time: 1-2 Hours
Other Resources Needed to Protect: Sprinklers.
Notes: Creek on North side of house.

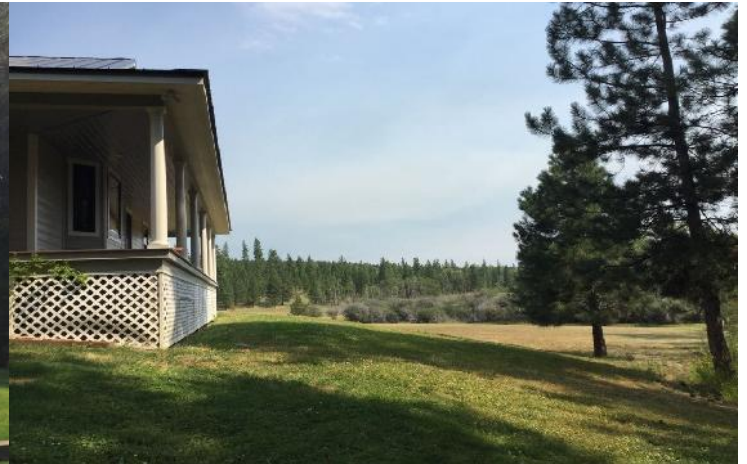
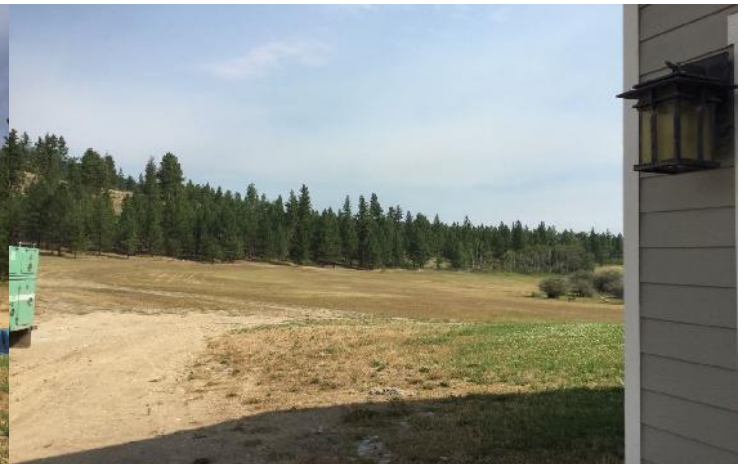
Structure Number:			
Structure Name:	552 Tie Chute Lane		
SubDivision:	Tie Chute		
GPS Location, Lat.	46 38.66148		
GPS Location, Long.	114 6.65718		
Safety Zone Present:	Yes	Where is Safety Zone:	Large low cut grass field to the north of the house.
Type of Structure:	Residential	Primary Structures:	
Surrounding Fuels:	Grass, Timber	Defensible Space:	30-50 Feet
Structure Triage Category:	Defensible, Prep and Hold		
Roof Material:	Metal	Siding Material:	Wood
Heat Traps:	Wood Deck, Other Receptor		
Electrical Power:	Underground, Generator	Gas to Structure:	Underground
Hazards:	Bridge Load Limits, Septic Tank		
Access to Site:	T6 Engine	Best Access From:	Tie Chute Lane
Comm with ICP:	Radio, Cell Service		
Water Source:	Faucet / Hose, Creek		
Mitigation Time:	1-2 Hours		
Other Resources Needed to Protect:	1-2 sprinkler kits		
Notes:	Garage has addition under construction with standing plywood sheets exposed.

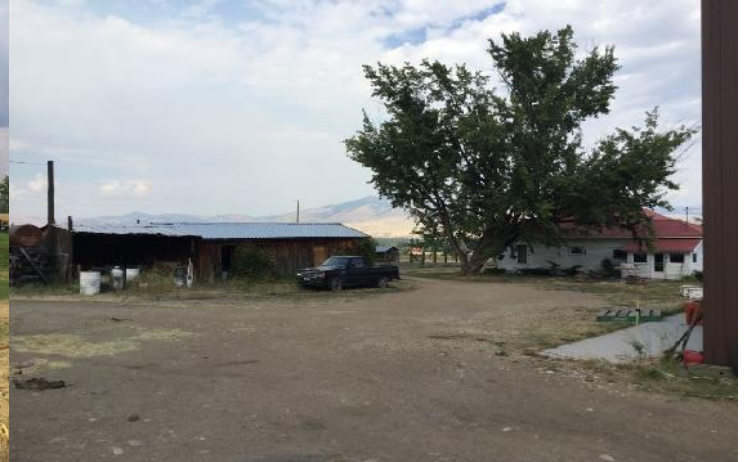
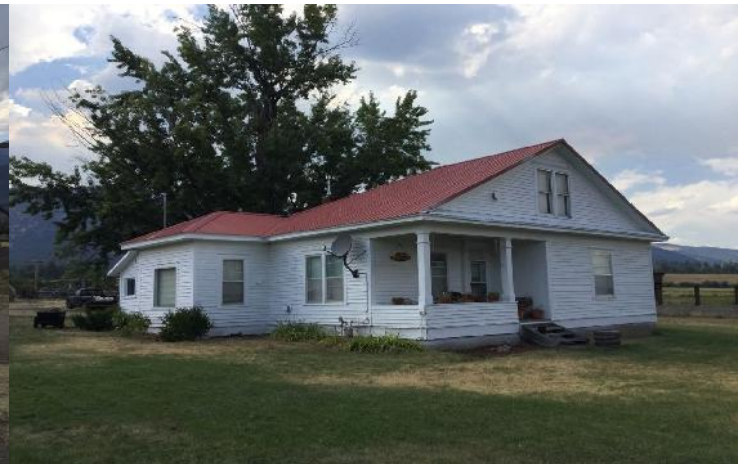
Structure Number:
Structure Name: 5613 One Horse Lane
SubDivision: Tie Chute
GPS Location, Lat. 46 38.68698
GPS Location, Long. 114 4.99332
Safety Zone Present: Yes **Where is Safety Zone:** Surrounding grass pastures
Type of Structure: Residential **Primary Structures:** **Outbuildings:**
Surrounding Fuels: Grass **Defensible Space:** >100 Feet
Structure Triage Category: Defensible, Stand Alone
Roof Material: Metal **Siding Material:** Wood
Heat Traps: Wood Deck, Other Receptor
Electrical Power: Overhead, Underground **Gas to Structure:** Underground
Hazards: Animals, Septic Tank, HazMat
Access to Site: T3/4 Engine **Best Access From:** One Horse Lane off of Tie Chute Lane.
Comm with ICP: Radio, Cell Service
Water Source: Faucet / Hose, Creek
Mitigation Time: None Needed
Other Resources Needed to Protect: None
Notes: Large private farm. Various livestock and livestock buildings. Green irrigated pasture surrounding home. Small creek south of property.

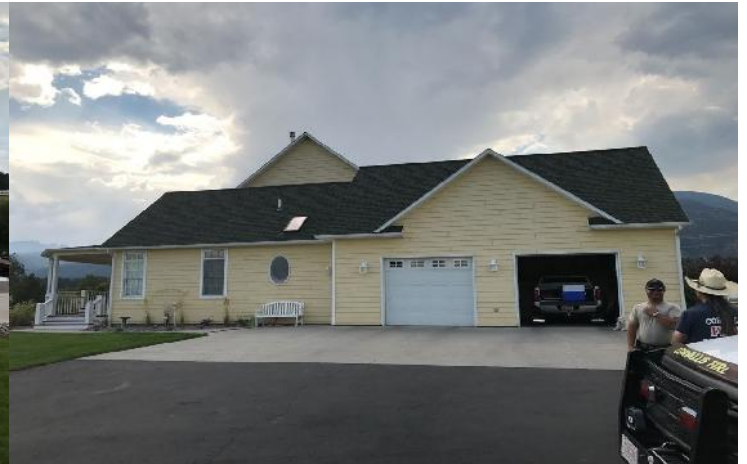
Photo 3

Structure Number:
Structure Name: 5697 Old US Highway 93
SubDivision: Tie Chute
GPS Location, Lat. 46 38.96796
GPS Location, Long. 114 4.66926
Safety Zone Present: Yes **Where is Safety Zone:** Old US Highway 93
Type of Structure: Residential **Primary Structures:** **Outbuildings:**
Surrounding Fuels: Grass,Shrub **Defensible Space:** 30-50 Feet
Structure Triage Category: Defensible, Stand Alone
Roof Material: Composite **Siding Material:** Masonry
Heat Traps: Open Eaves,Wood Deck,Rain Gutters,Other Receptor
Electrical Power: Underground **Gas to Structure:** Underground
Hazards:
Access to Site: T1 Engine **Best Access From:** Old US Highway 93
Comm with ICP: Radio,Cell Service
Water Source: Faucet / Hose,Hydrant,Large Pond
Mitigation Time: Less Than An Hour
Notes: Large pond to South of structure. One hydrant to the South West corner of structure. One hydrant to North West property corner. Wrap around asphalt driveway on east side of structure

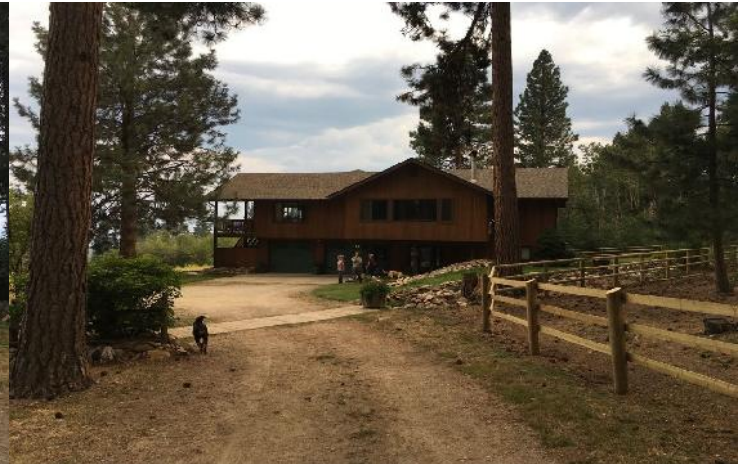
Photo 3

Structure Number:
Structure Name: 5710 Yarrow Dr.
SubDivision: Tie Chute
GPS Location, Lat. 46 39.42768
GPS Location, Long. 114 6.05268
Safety Zone Present: Yes **Where is Safety Zone:** Below horse and hay shed near tennis court
Type of Structure: Residential **Primary Structures:** **Outbuildings:**
Surrounding Fuels: Grass, Timber **Defensible Space:** 30-50 Feet
Structure Triage Category: Defensible, Prep and Hold
Roof Material: Composite **Siding Material:** Wood
Heat Traps: Wood Deck, Rain Gutters
Electrical Power: Underground **Gas to Structure:** Aboveground
Hazards: Animals, Septic Tank
Access to Site: T3/4 Engine **Best Access From:** West county line road
Comm with ICP: Radio, Cell Service
Water Source: Faucet / Hose, Large Pond
Mitigation Time: 1-2 Hours
Other Resources Needed to Protect: Mark 3 pump(s) to plug into pond 200 yards below structure with at least eight sprinklers on structure, and at least five on both hay barns (one is pictured)..

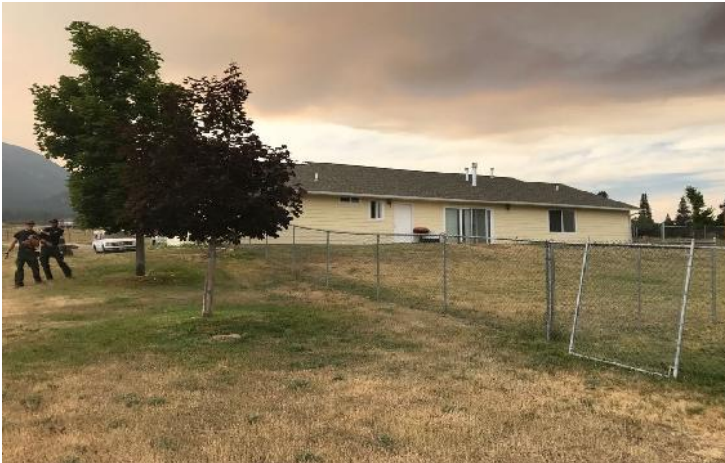
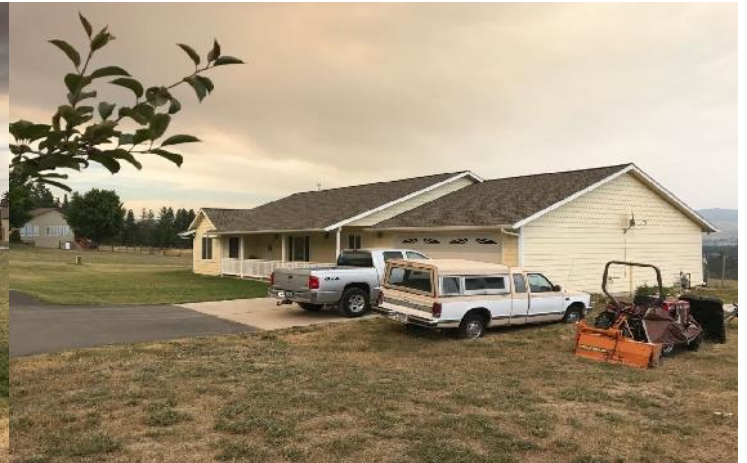
Safety Zone Present: Yes
Type of Structure: Residential
Surrounding Fuels: Grass
Structure Triage Category: Defensible, Stand Alone
Roof Material: Composite
Heat Traps: Rain Gutters
Electrical Power: Underground
Hazards: HazMat
Access to Site: T1 Engine
Comm with ICP: Radio, Cell Service
Water Source: Faucet / Hose
Mitigation Time: None Needed
Other Resources Needed to Protect: None
Collected By: Lolo 632

Escape route: Homestead Place, (L) Wagner Ln., to Old Hwy 93.

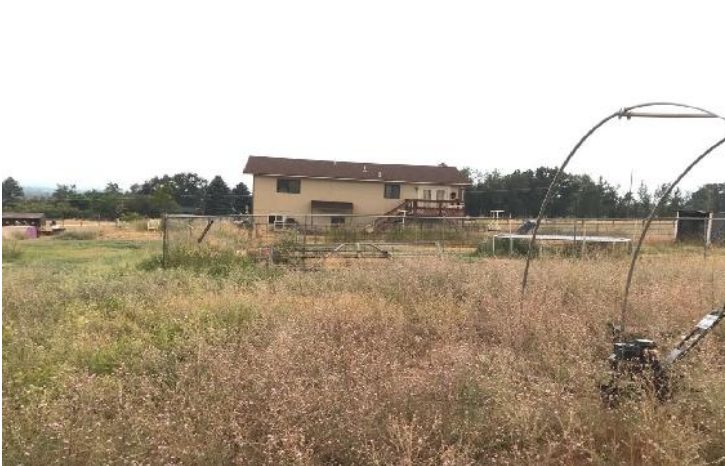
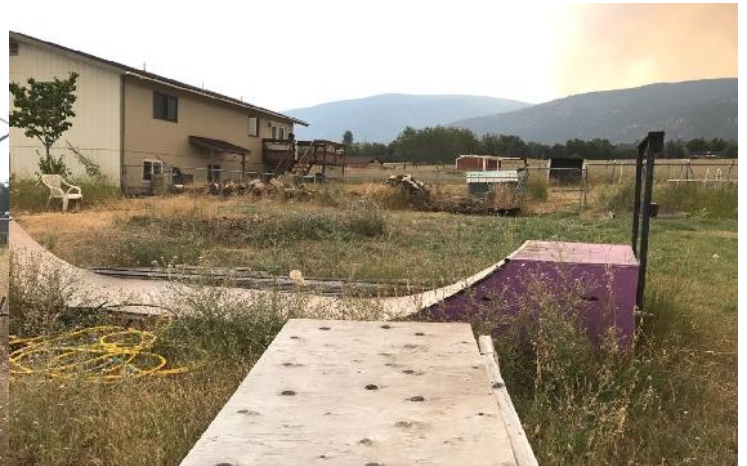
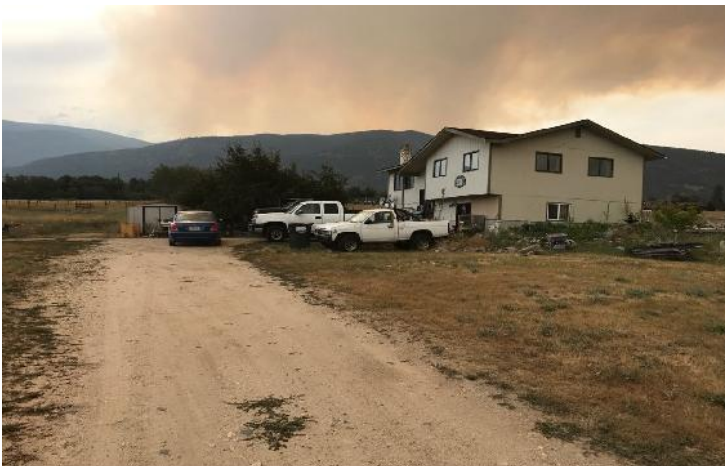
Safety Zone Present: Yes
Type of Structure: Residential
Surrounding Fuels: Grass, Shrub
Structure Triage Category: Defensible, Prep and Hold
Roof Material: Wood
Heat Traps: Wood Deck, Rain Gutters
Electrical Power: Underground
Hazards: Fuels, HazMat
Access to Site: T1 Engine
Comm with ICP: Radio, Cell Service
Water Source: Faucet / Hose
Mitigation Time: 1-2 Hours
Other Resources Needed to Protect: None.
Notes: Prep work just mowing down.

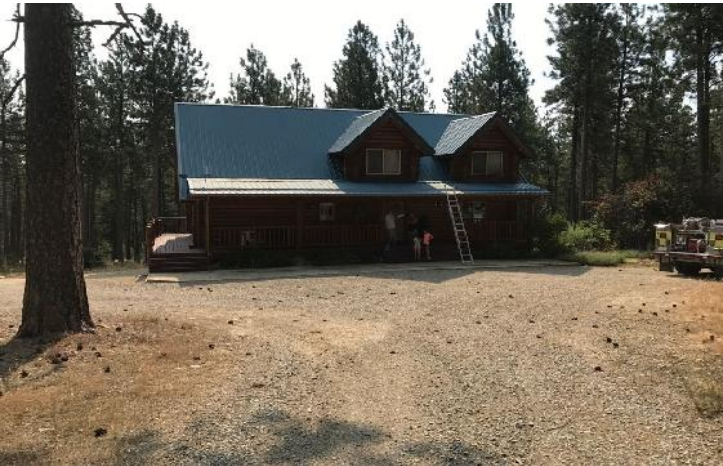
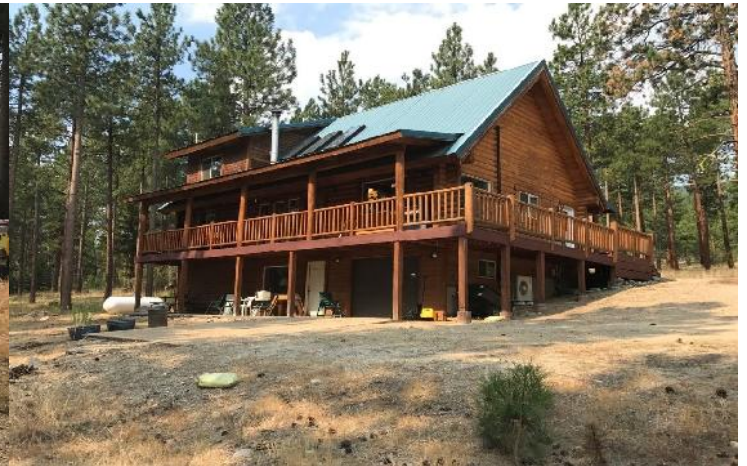
Structure Number:
Structure Name: 5810 Daisy Lane
SubDivision: Tie Chute
GPS Location, Lat. 46 39.48258
GPS Location, Long. 114 6.16872
Safety Zone Present: No
Type of Structure: Residential
Surrounding Fuels: Grass,Shrub,Timber
Structure Triage Category: Defensible, Prep and Hold
Roof Material: Metal
Heat Traps: Open Eaves,Wood Deck,Rain Gutters,Other Receptor
Electrical Power: Overhead,Underground
Hazards:

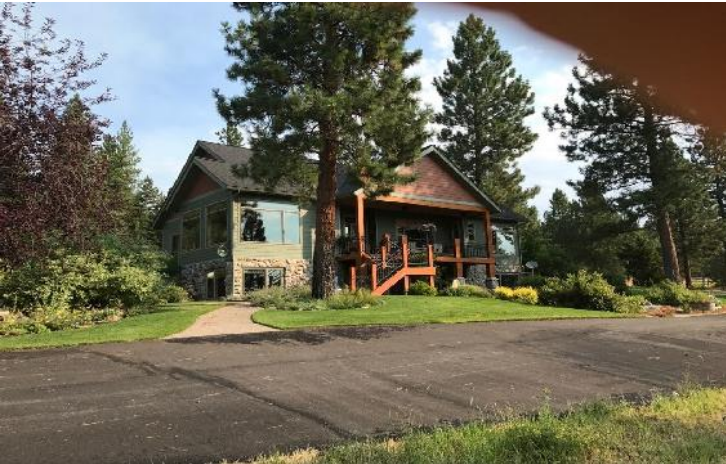
Structure Number:
Structure Name: 5814 Lichenstone Lane
SubDivision: Tie Chute
GPS Location, Lat. 46 39.11592
GPS Location, Long. 114 6.75
Safety Zone Present: No
Type of Structure: Residential
Surrounding Fuels: Grass,Shrub,Timber
Structure Triage Category: Defensible, Prep and Hold
Roof Material: Composite
Heat Traps: Wood Deck,Rain Gutters,Other Receptor
Electrical Power: Underground
Hazards:

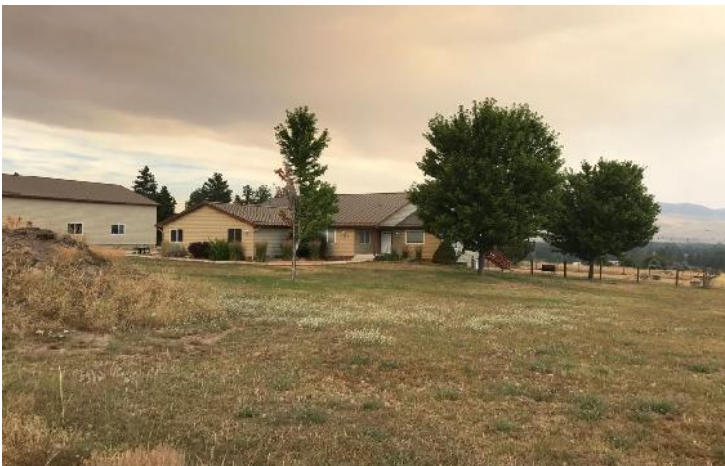
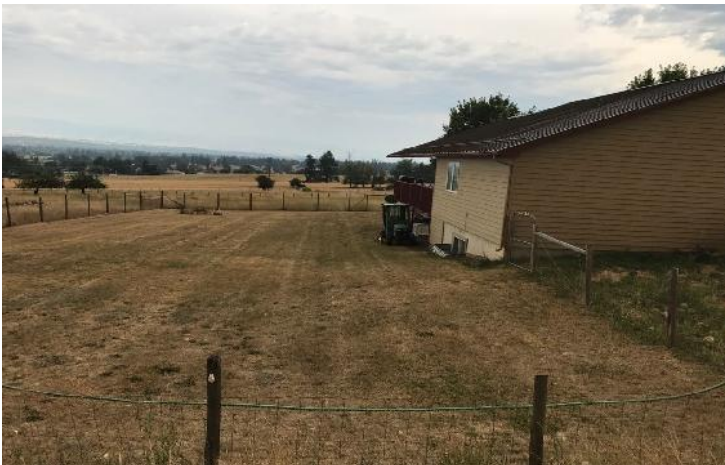
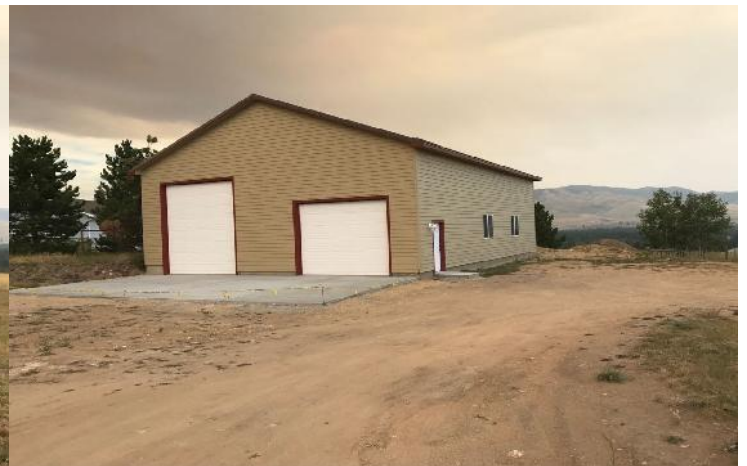
Safety Zone Present: Yes
Type of Structure: Residential
Surrounding Fuels: Grass
Structure Triage Category: Defensible, Stand Alone
Roof Material: Metal
Heat Traps: Rain Gutters
Electrical Power: Underground
Hazards: HazMat
Access to Site: T1 Engine
Comm with ICP: Radio, Cell Service
Water Source: Faucet / Hose
Mitigation Time: None Needed
Other Resources Needed to Protect: None
Collected By: Lolo 632

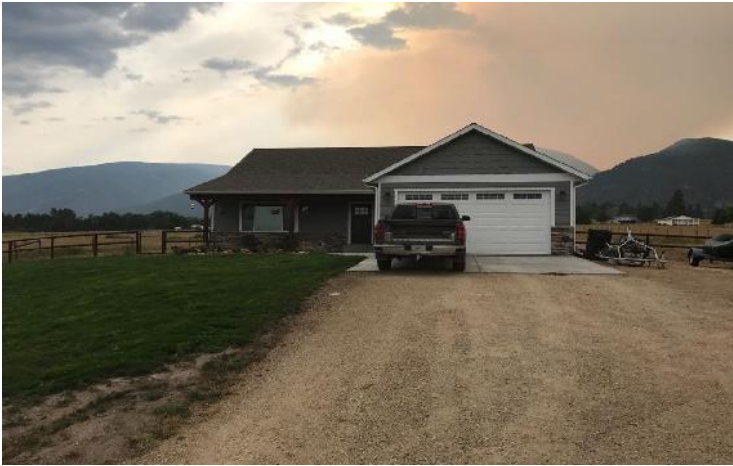
Safety Zone Present: Yes
Type of Structure: Residential
Surrounding Fuels: Grass
Structure Triage Category: Defensible, Stand Alone
Roof Material: Composite
Heat Traps: Rain Gutters
Electrical Power: Underground
Hazards: HazMat
Access to Site: T1 Engine
Comm with ICP: Radio, Cell Service
Water Source: Faucet / Hose
Mitigation Time: None Needed
Other Resources Needed to Protect: None
Collected By: Lolo 632

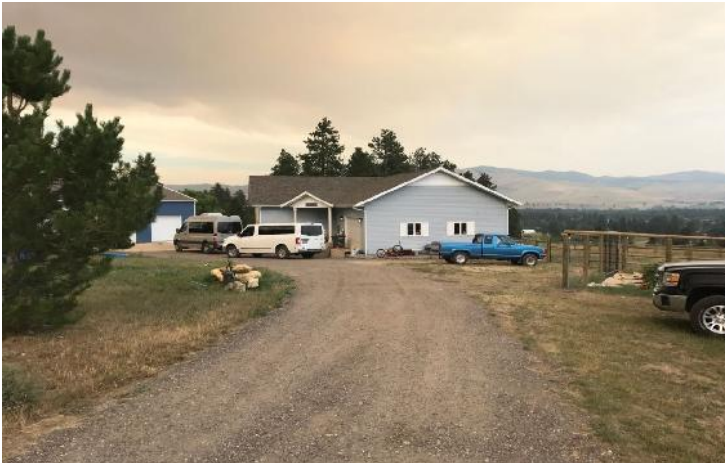
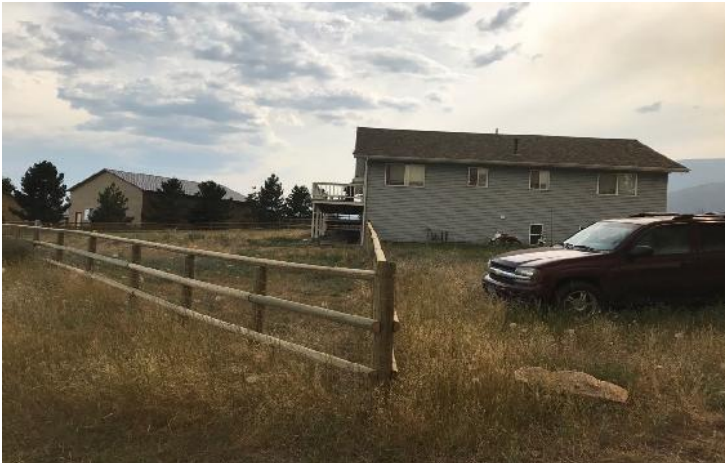
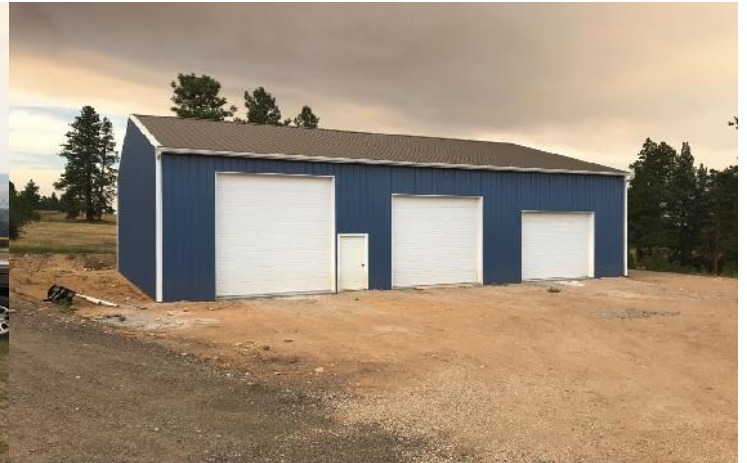
Safety Zone Present: Yes
Type of Structure: Residential
Surrounding Fuels: Grass
Structure Triage Category: Defensible, Stand Alone
Roof Material: Composite
Heat Traps: Rain Gutters
Electrical Power: Underground
Hazards: HazMat
Access to Site: T1 Engine
Comm with ICP: Radio, Cell Service
Water Source: Faucet / Hose
Mitigation Time: None Needed
Other Resources Needed to Protect: None
Collected By: Lolo 632

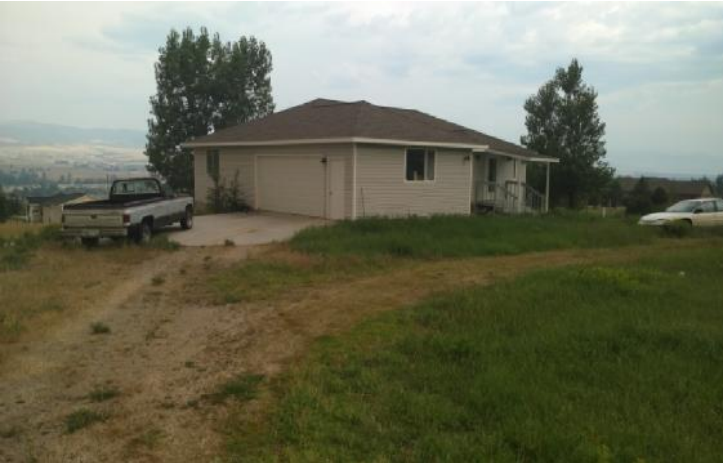
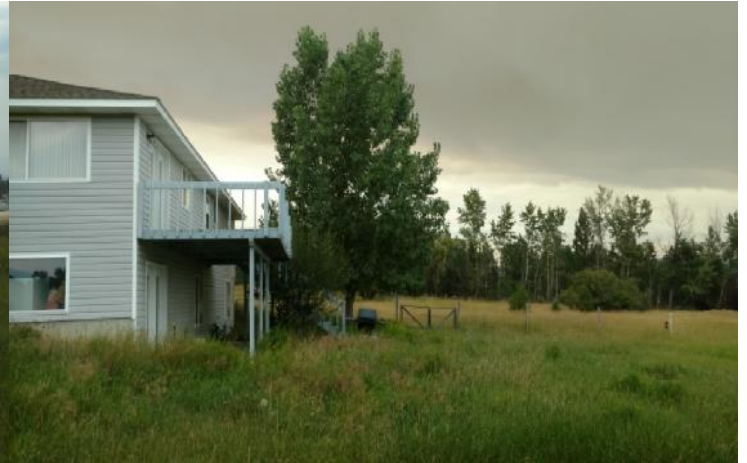
Structure Number:
Structure Name: 5828 Jones Rd
SubDivision: Tie Chute
GPS Location, Lat. 46 39.60552
GPS Location, Long. 114 5.24304
Safety Zone Present: Yes
Type of Structure: Residential
Surrounding Fuels: Grass
Structure Triage Category: Defensible, Stand Alone
Roof Material: Composite
Heat Traps:
Electrical Power: Underground
Hazards:
Access to Site: T1 Engine
Comm with ICP: Radio, Cell Service
Water Source: Faucet / Hose
Mitigation Time: Less Than An Hour
Other Resources Needed to Protect: One engine to patrol
Collected By: COCO 482

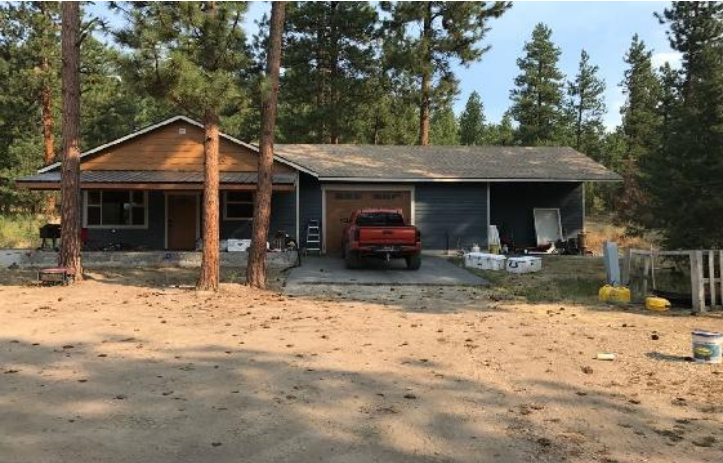
Photo 3

Structure Number:
Structure Name: 620 Tie Chute Ln
SubDivision: Tie Chute
GPS Location, Lat. 46 38.5788
GPS Location, Long. 114 7.16718
Safety Zone Present: No
Type of Structure: Residential
Surrounding Fuels: Grass, Timber
Structure Triage Category: Non-Defensible, Prep and Leave
Roof Material: Composite
Heat Traps:
Electrical Power: Underground
Hazards: Septic Tank
Access to Site: T6 Engine
Comm with ICP: Radio, Cell Service
Water Source: Faucet / Hose
Mitigation Time: 2-3 Hours
Other Resources Needed to Protect: Hand crew
Collected By: AZ-TNF 1265

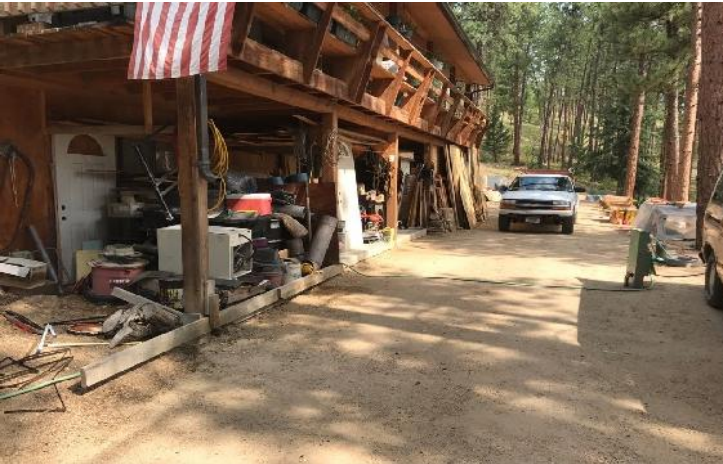
Photo 3

Structure Number:
Structure Name: 860 Tie Chute Ln
SubDivision: Tie Chute
GPS Location, Lat. 46 38.6733
GPS Location, Long. 114 6.9849
Safety Zone Present: No
Type of Structure: Residential
Surrounding Fuels: Grass, Timber
Structure Triage Category: Non-Defensible, Rescue, Drive By
Roof Material: Metal
Heat Traps: Open Eaves, Wood Deck, Rain Gutters
Electrical Power: Underground
Hazards: Owners
Access to Site: T3/4 Engine
Comm with ICP: Radio, Cell Service
Water Source: Faucet / Hose
Mitigation Time: 1-2 Hours
Other Resources Needed to Protect: None
Notes: Careful with homeowners, not friendly.

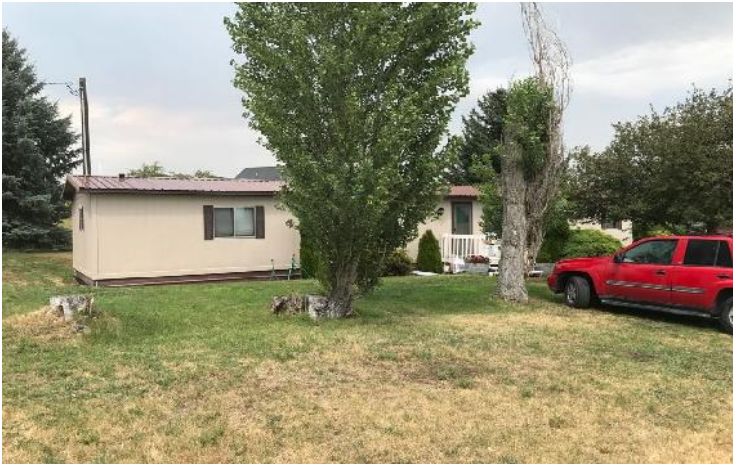
Structure Number:
Structure Name: Angie Pollard, 5723 Old Highway 93
SubDivision: Tie Chute
GPS Location, Lat. 46 39.06018
GPS Location, Long. 114 4.72236
Safety Zone Present: Yes
Type of Structure: Residential
Surrounding Fuels: Grass,Shrub
Structure Triage Category: Defensible, Prep and Hold
Roof Material: Metal
Heat Traps: Open Eaves,Wood Deck
Electrical Power: Overhead
Hazards:
Access to Site: T1 Engine
Comm with ICP: Radio,Cell Service
Water Source: Faucet / Hose
Mitigation Time: Less Than An Hour
Notes: Angie Pollard 406-274-5748

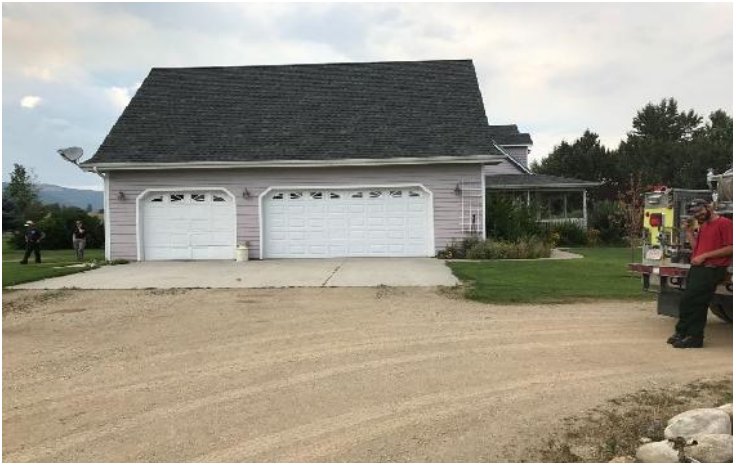
Structure Number:
Structure Name: Banister Residents 5675 Old Highway 93
SubDivision: Tie Chute
GPS Location, Lat. 46 38.78172
GPS Location, Long. 114 4.71396
Safety Zone Present: Yes **Where is Safety Zone:** Old Highway 93
Type of Structure: Residential **Primary Structures:** **Outbuildings:**
Surrounding Fuels: Grass,Shrub **Defensible Space:** 30-50 Feet
Structure Triage Category: Defensible, Stand Alone
Roof Material: Composite **Siding Material:** Masonry
Heat Traps: Wood Deck,Rain Gutters,Other Receptor
Electrical Power: Underground **Gas to Structure:** Underground
Hazards: Animals
Access to Site: T1 Engine **Best Access From:** Old Highway 93
Comm with ICP: Radio,Cell Service
Water Source: Faucet / Hose,Creek
Mitigation Time: None Needed
Collected By: E-96 Corvallis **Collected Date/Time:** 07/30/2017 08:58:26

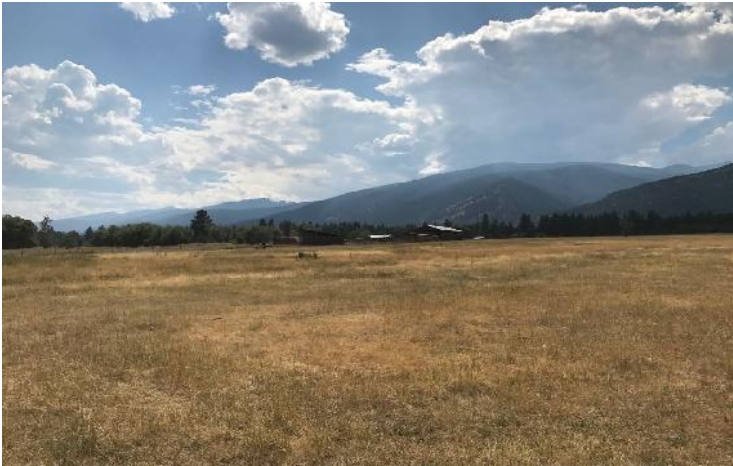
Structure Number:
Structure Name: Bennet property 323 Old Bentham Lane
SubDivision: Tie Chute
GPS Location, Lat. 46 38.99088
GPS Location, Long. 114 5.27334
Safety Zone Present: Yes **Where is Safety Zone:** Old Highway 93
Type of Structure: Other **Primary Structures:** **Outbuildings:**
Other Type of Structure: Barns
Surrounding Fuels: Grass,Shrub **Defensible Space:** 30-50 Feet
Structure Triage
Category: Defensible, Stand Alone
Roof Material: Metal **Siding Material:** Wood
Heat Traps: Other Receptor
Electrical Power: Overhead **Gas to Structure:** None
Hazards: Animals
Access to Site: T3/4 Engine **Best Access From:** Old Highway 93 to Old Bentham
Comm with ICP: Radio,Cell Service
Water Source: Faucet / Hose
Mitigation Time: Less Than An Hour
Notes: Unoccupied property

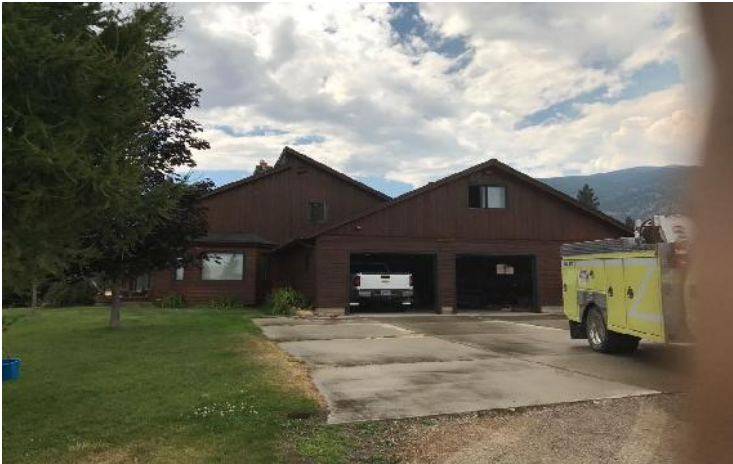
Structure Number:
Structure Name: Swendsen residents 360 old Bentham Lane
SubDivision: Tie Chute
GPS Location, Lat. 46 39.05154
GPS Location, Long. 114 5.61834
Safety Zone Present: Yes **Where is Safety Zone:** Old Highway 93
Type of Structure: Residential **Primary Structures:** **Outbuildings:**
Surrounding Fuels: Grass,Shrub **Defensible Space:** 30-50 Feet
Structure Triage Category: Defensible, Stand Alone
Roof Material: Composite **Siding Material:** Wood
Heat Traps: Open Eaves,Wood Deck,Rain Gutters,Other Receptor
Electrical Power: Overhead **Gas to Structure:** Underground
Hazards: Animals
Access to Site: T3/4 Engine **Best Access From:** Old Highway 93 to Old Bentham Lane
Comm with ICP: Radio,Cell Service
Water Source: Faucet / Hose,Large Pond,Creek
Mitigation Time: Less Than An Hour
Notes: Pond at North end of property. Creek on South end of property.

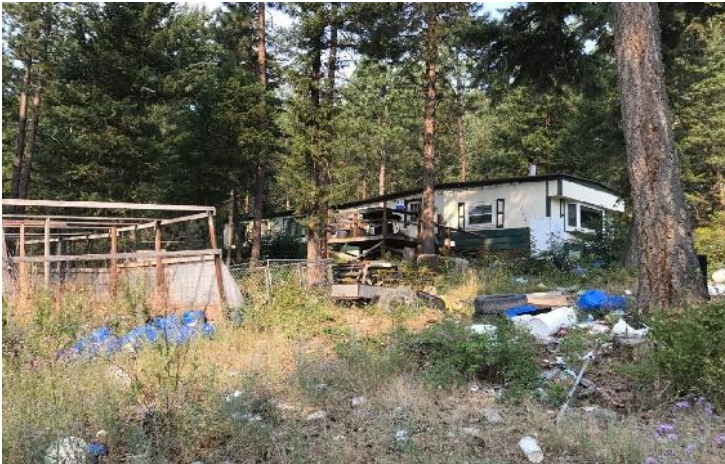
Photo 3

Structure Number:
Structure Name: Tie Chute no address number
SubDivision: Tie Chute
GPS Location, Lat. 46 38.6178
GPS Location, Long. 114 7.2327
Safety Zone Present: No **Where is Safety Zone:** Down tie Chute to Old 93
Type of Structure: Residential **Primary Structures:** **Outbuildings:**
Surrounding Fuels: Grass, Timber **Defensible Space:** 30-50 Feet
Structure Triage Category: Non-Defensible, Rescue, Drive By
Roof Material: Metal **Siding Material:** Wood
Heat Traps: Open Eaves, Wood Deck, Rain Gutters
Electrical Power: Overhead **Gas to Structure:** Aboveground
Hazards: HazMat
Access to Site: T3/4 Engine **Best Access From:** Tie Chute Rd
Comm with ICP: Radio, Cell Service
Water Source: Faucet / Hose
Mitigation Time: More Than 5 Hours
Notes: Too much work to be able to do anything effective.

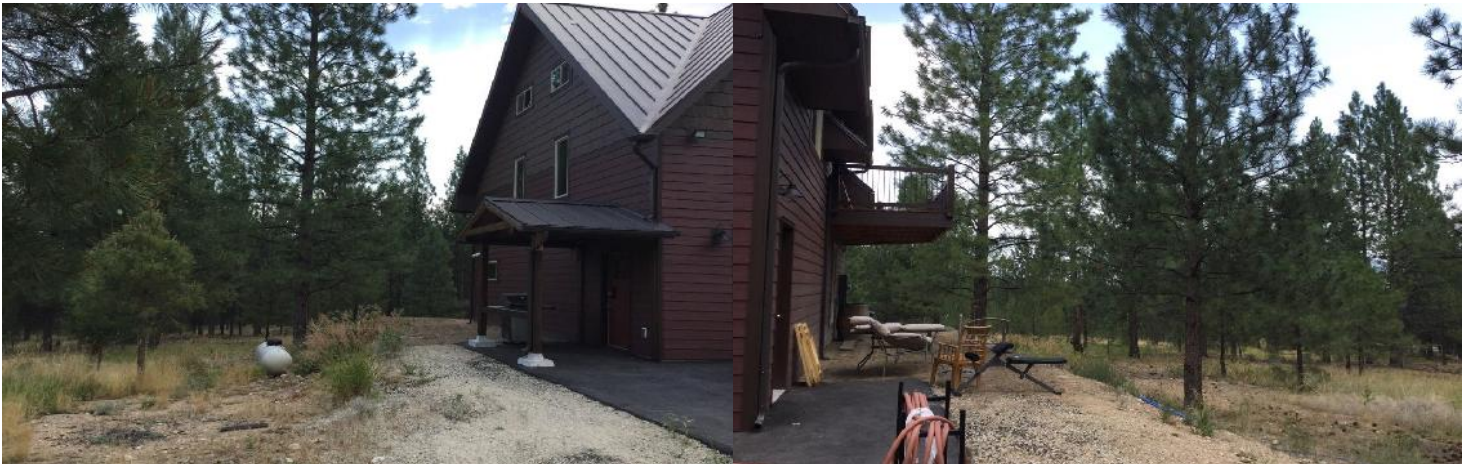
Category: Non-Defensible, Prep and Leave
Roof Material: Metal
Heat Traps: Wood Deck, Rain Gutters, Other Receptor
Electrical Power: Underground
Hazards: Fuels, Septic Tank
Access to Site: T3/4 Engine
Comm with ICP: Radio, Cell Service
Water Source: Faucet / Hose
Mitigation Time: 1-2 Hours
Other Resources Needed to Protect: Sprinklers
