**STRUCTURE
PROTECTION PLAN
FOR TIE CHUTE
BLOCK**

Structure Protection Plan

Tie Chute

Location: On Old Hwy 93 between County Line Rd. and Tie Chute Ln.

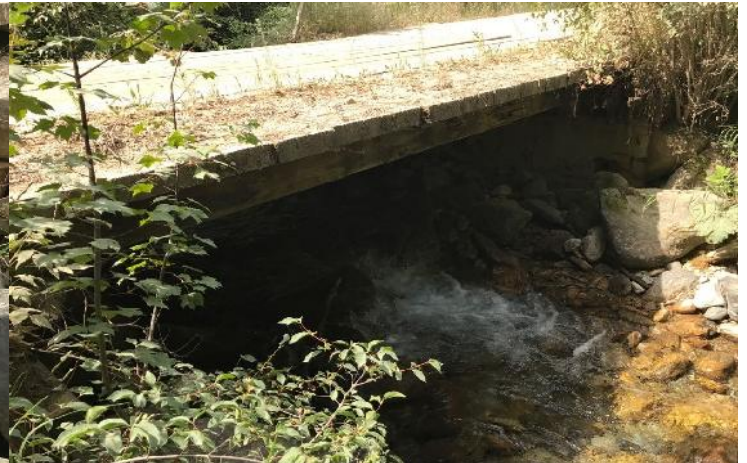
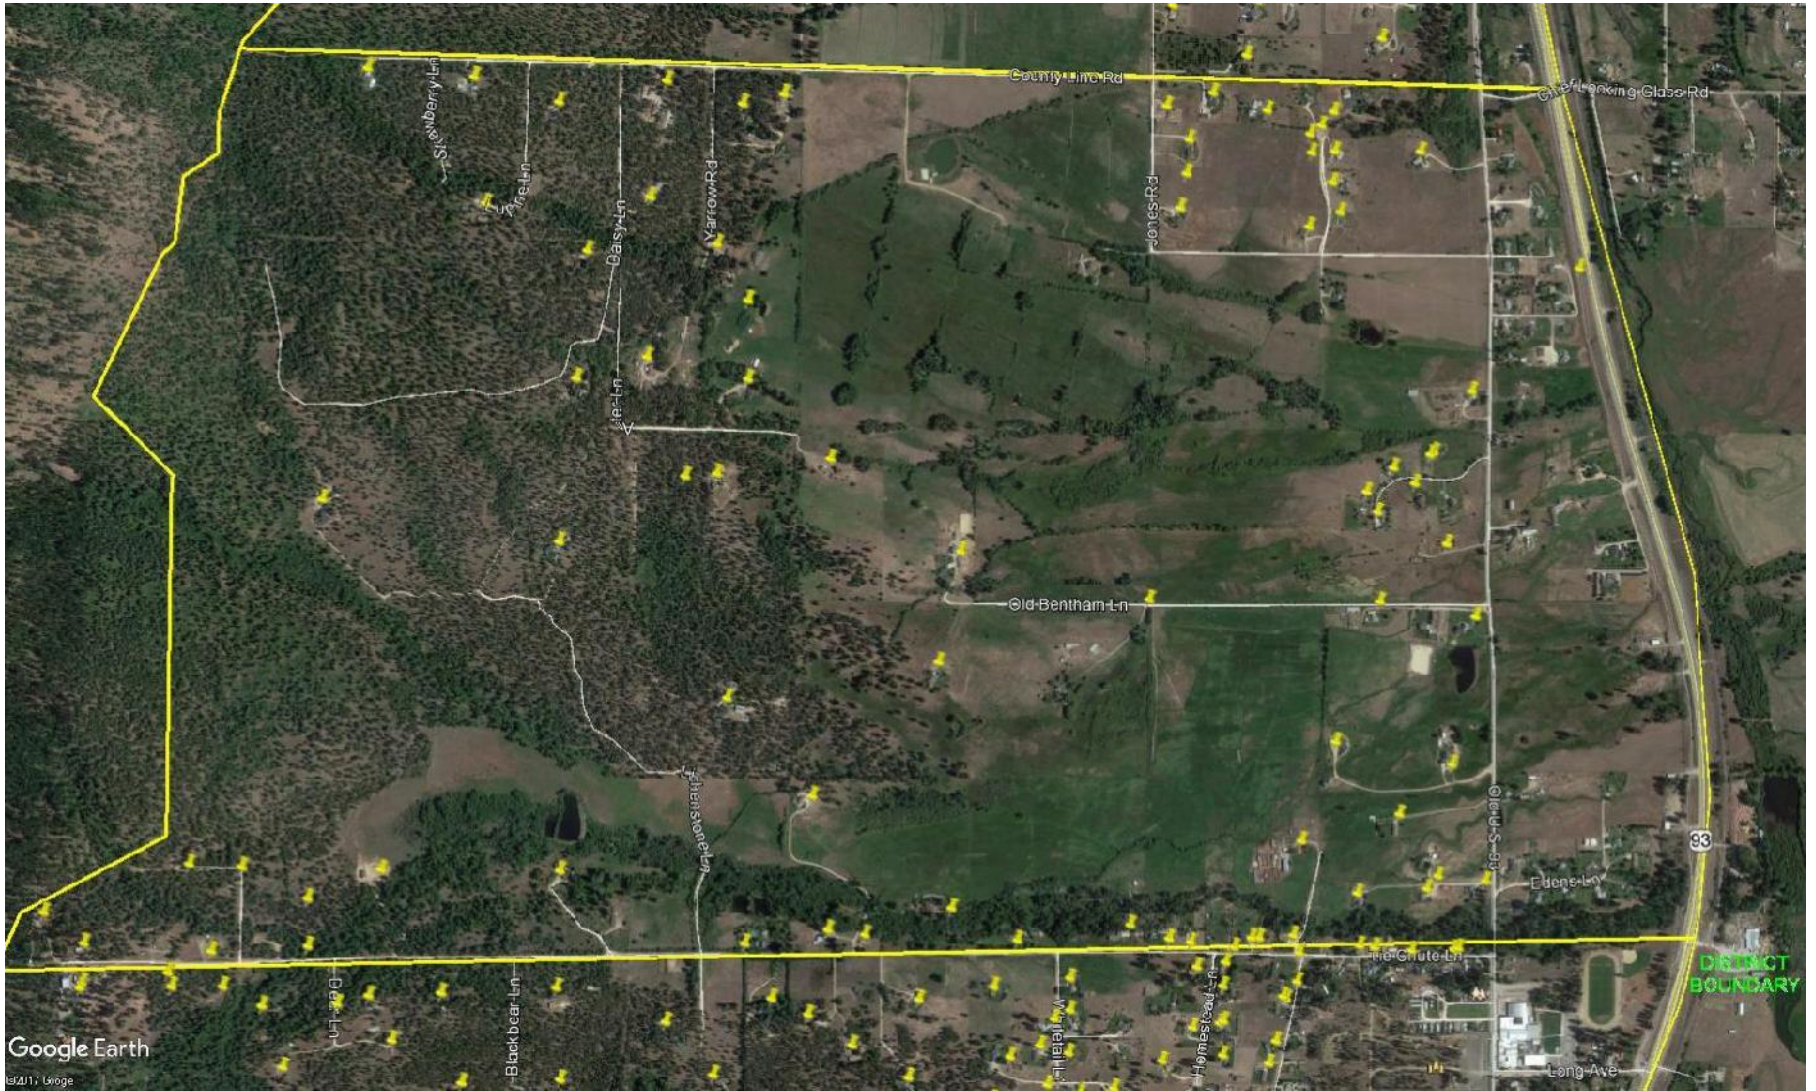
Structure Number:
Structure Name: Wood Bridge--Tie Chute Ln
SubDivision: Tie Chute
GPS Location, Lat. 46 38.56968
GPS Location, Long. 114 6.78444
Safety Zone Present: No **Where is Safety Zone:** No safety zone.
Type of Structure: Other **Primary Structures:**
Other Type of Structure: Wooden bridge **Outbuildings:**
Surrounding Fuels: Grass,Shrub,Timber **Defensible Space:** None
Structure Triage Category: Defensible, Stand Alone
Roof Material: Wood **Siding Material:** Wood
Heat Traps:
Electrical Power: **Gas to Structure:**
Hazards: Fuels,Bridge Load Limits,No Turn Around
Access to Site: T3/4 Engine **Best Access From:** Old highway 93 to Tie shoots Rd
Comm with ICP: Radio,Cell Service
Water Source: Creek
Mitigation Time: 1-2 Hours
Other Resources Needed to Protect: Engine crew could prep bridge by cutting back brush and put sprinklers in.
Collected By: COCO 482 **Collected Date/Time:** 07/30/2017 08:58:21

The entire West half of this block has houses imbedded in the timber with narrow long roads. These houses for the most part will need a lot of work clearing around them and most will need sprinklers and pumpkins. For most of the structures this will be a prep. turn on sprinklers and leave operation. The two houses with a lot of debris that are identified above should have a dozer line cut around them and firefighters kept out of the area. There is a wood bridge toward the end of Tie Chute Rd. that will need sprinklers.
