Suppression Repair
CALDOR INCIDENT
CA ENF 024030
August 28, 2021

Suppression Repair

Caldor Incident

CA ENF 024030

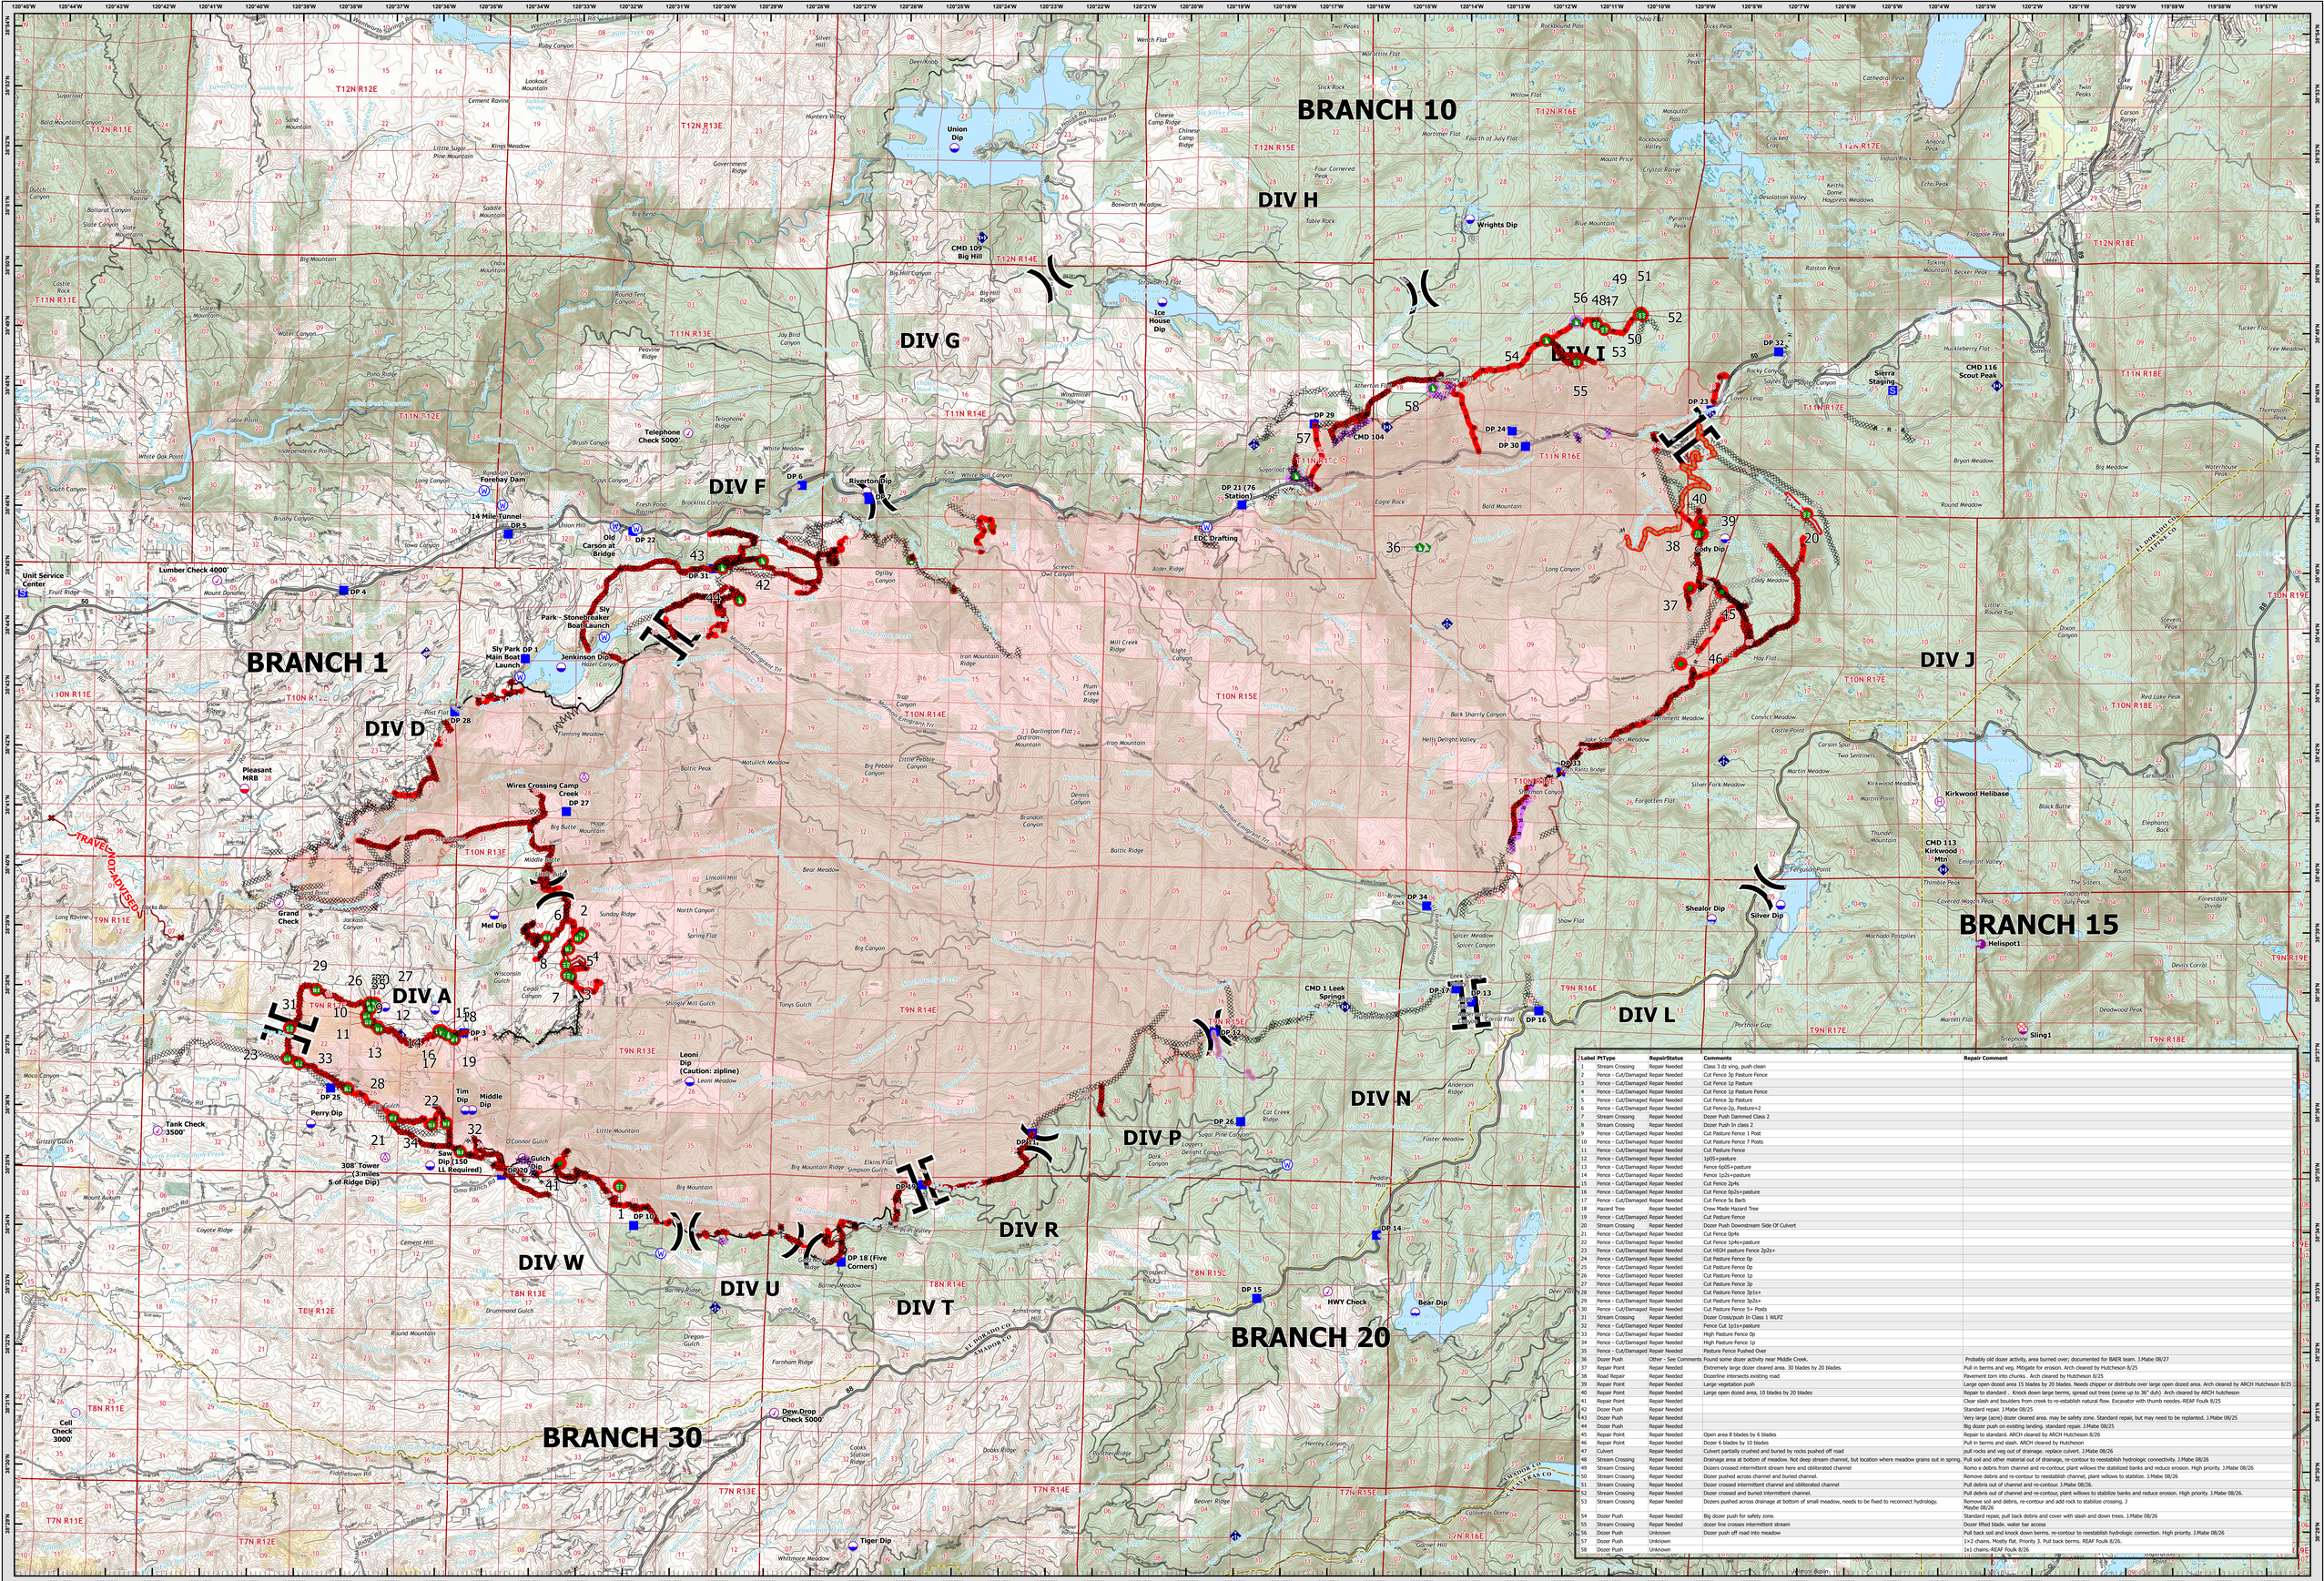
Label	PtType	RepairStatus	Comments	Repair Comment
1	Stream Crossing	Repair Needed	Class 3 dz sing, push clean	
2	Fence - Cut/Damaged	Repair Needed	Cut Fence 3p Pasture Fence	
3	Fence - Cut/Damaged	Repair Needed	Cut Fence 1p Pasture	
4	Fence - Cut/Damaged	Repair Needed	Cut Fence 1p Pasture Fence	
5	Fence - Cut/Damaged	Repair Needed	Cut Fence 3p Pasture	
6	Fence - Cut/Damaged	Repair Needed	Cut Fence 2p, Pasture+2	
7	Stream Crossing	Repair Needed	Dozer Push Dammed Class 2	
8	Stream Crossing	Repair Needed	Dozer Push fn class 2	
9	Fence - Cut/Damaged	Repair Needed	Cut Pasture Fence 1 Post	
10	Fence - Cut/Damaged	Repair Needed	Cut Pasture Fence 7 Posts	
11	Fence - Cut/Damaged	Repair Needed	Cut Pasture Fence	
12	Fence - Cut/Damaged	Repair Needed	1p05+pasture	
13	Fence - Cut/Damaged	Repair Needed	Fence 6p05+pasture	
14	Fence - Cut/Damaged	Repair Needed	Fence 1p2s+pasture	
15	Fence - Cut/Damaged	Repair Needed	Cut Fence 2p4s

16	Fence - Cut/Damaged	Repair Needed	Cut Fence 0p2s+pasture	
17	Fence - Cut/Damaged	Repair Needed	Cut Fence 5s Barb	
18	Hazard Tree	Repair Needed	Crew Made Hazard Tree	
19	Fence - Cut/Damaged	Repair Needed	Cut Pasture Fence	
20	Stream Crossing	Repair Needed	Dozer Push Downstream Side Of Culvert	
21	Fence - Cut/Damaged	Repair Needed	Cut Fence 0p4s	
22	Fence - Cut/Damaged	Repair Needed	Cut Fence 1p4s+pasture	
23	Fence - Cut/Damaged	Repair Needed	Cut HIGH pasture Fence 2p2s+	
24	Fence - Cut/Damaged	Repair Needed	Cut Pasture Fence 0p	
25	Fence - Cut/Damaged	Repair Needed	Cut Pasture Fence 0p	
26	Fence - Cut/Damaged	Repair Needed	Cut Pasture Fence 1p	
27	Fence - Cut/Damaged	Repair Needed	Cut Pasture Fence 3p	
28	Fence - Cut/Damaged	Repair Needed	Cut Pasture Fence 3p1s+	
29	Fence - Cut/Damaged	Repair Needed	Cut Pasture Fence 3p2s+	
30	Fence - Cut/Damaged	Repair Needed	Cut Pasture Fence 5+ Posts	
31	Stream Crossing	Repair Needed	Dozer Cross/push In Class 1 WLPZ

32	Fence - Cut/Damaged	Repair Needed	Fence Cut 1p1s+pasture	
33	Fence - Cut/Damaged	Repair Needed	High Pasture Fence 0p	
34	Fence - Cut/Damaged	Repair Needed	High Pasture Fence 1p	
35	Fence - Cut/Damaged	Repair Needed	Pasture Fence Pushed Over	
36	Dozer Push	Other - See Comments	Found some dozer activity near Middle Creek.	Probably old dozer activity, area burned over; documented for BAER team. J.Mabe 08/27
37	Repair Point	Repair Needed	Extremely large dozer cleared area. 30 blades by 20 blades.	Pull in berms and veg. Mitigate for erosion. Arch cleared by Hutcheson 8/25
38	Road Repair	Repair Needed	Dozerline intersects existing road	Pavement torn into chunks . Arch cleared by Hutcheson 8/25
39	Repair Point	Repair Needed	Large vegetation push	Large open dozed area 15 blades by 20 blades. Needs chipper or distribute over large open dozed area. Arch cleared by ARCH Hutcheson 8/25
40	Repair Point	Repair Needed	Large open dozed area, 10 blades by 20 blades	Repair to standard . Knock down large berms, spread out trees (some up to 36" duh) Arch cleared by ARCH hutcheson

41	Repair Point	Repair Needed		Clear slash and boulders from creek to re-establish natural flow. Excavator with thumb needed.-REAF Foulk 8/25
42	Dozer Push	Repair Needed		Standard repair. J.Mabe 08/25
43	Dozer Push	Repair Needed		Very large (acre) dozer cleared area. may be safety zone. Standard repair, but may need to be replanted. J.Mabe 08/25
44	Dozer Push	Repair Needed		Big dozer push on existing landing. standard repair. J.Mabe 08/25
45	Repair Point	Repair Needed	Open area 8 blades by 6 blades	Repair to standard. ARCH cleared by ARCH Hutcheson 8/26
46	Repair Point	Repair Needed	Dozer 6 blades by 10 blades	Pull in berms and slash. ARCH cleared by Hutcheson
47	Culvert	Repair Needed	Culvert partially crushed and buried by rocks pushed off road	pull rocks and veg out of drainage. replace culvert. J.Mabe 08/26
48	Stream Crossing	Repair Needed	Drainage area at bottom of meadow. Not deep stream channel, but location where meadow grains out in spring.	Pull soil and other material out of drainage, re-contour to reestablish hydrologic connectivity. J.Mabe 08/26

49	Stream Crossing	Repair Needed	Dozers crossed intermittent stream here and obliterated channel	Romo e debris from channel and re-contour, plant willows the stabilized banks and reduce erosion. High priority. J.Mabe 08/26
50	Stream Crossing	Repair Needed	Dozer pushed across channel and buried channel.	Remove debris and re-contour to reestablish channel, plant willows to stabilize. J.Mabe 08/26
51	Stream Crossing	Repair Needed	Dozer crossed intermittent channel and obliterated channel	Pull debris out of channel and re-contour. J.Mabe 08/26.
52	Stream Crossing	Repair Needed	Dozer crossed and buried intermittent channel.	Pull debris out of channel and re-contour, plant willows to stabilize banks and reduce erosion. High priority. J.Mabe 08/26.
53	Stream Crossing	Repair Needed	Dozers pushed across drainage at bottom of small meadow, needs to be fixed to reconnect hydrology.	Remove soil and debris, re-contour and add rock to stabilize crossing. J Mabe 08/26

54	Dozer Push	Repair Needed	Big dozer push for safety zone.	Standard repair, pull back debris and cover with slash and down trees. J.Mabe 08/26
55	Stream Crossing	Repair Needed	dozer line crosses intermittent stream	Dozer lifted blade. water bar access
56	Dozer Push	Unknown	Dozer push off road into meadow	Pull back soil and knock down berms. re-contour to reestablish hydrologic connection. High priority. J.Mabe 08/26
57	Dozer Push	Unknown		1x2 chains. Mostly flat. Priority 3. Pull back berms. REAF Foulk 8/26.
58	Dozer Push	Unknown		1x1 chains.-REAF Foulk 8/26
