Suppression Repair

Beachie Creek
ORWIF-200299

Riverside
ORMHF-000859

Riverside 5

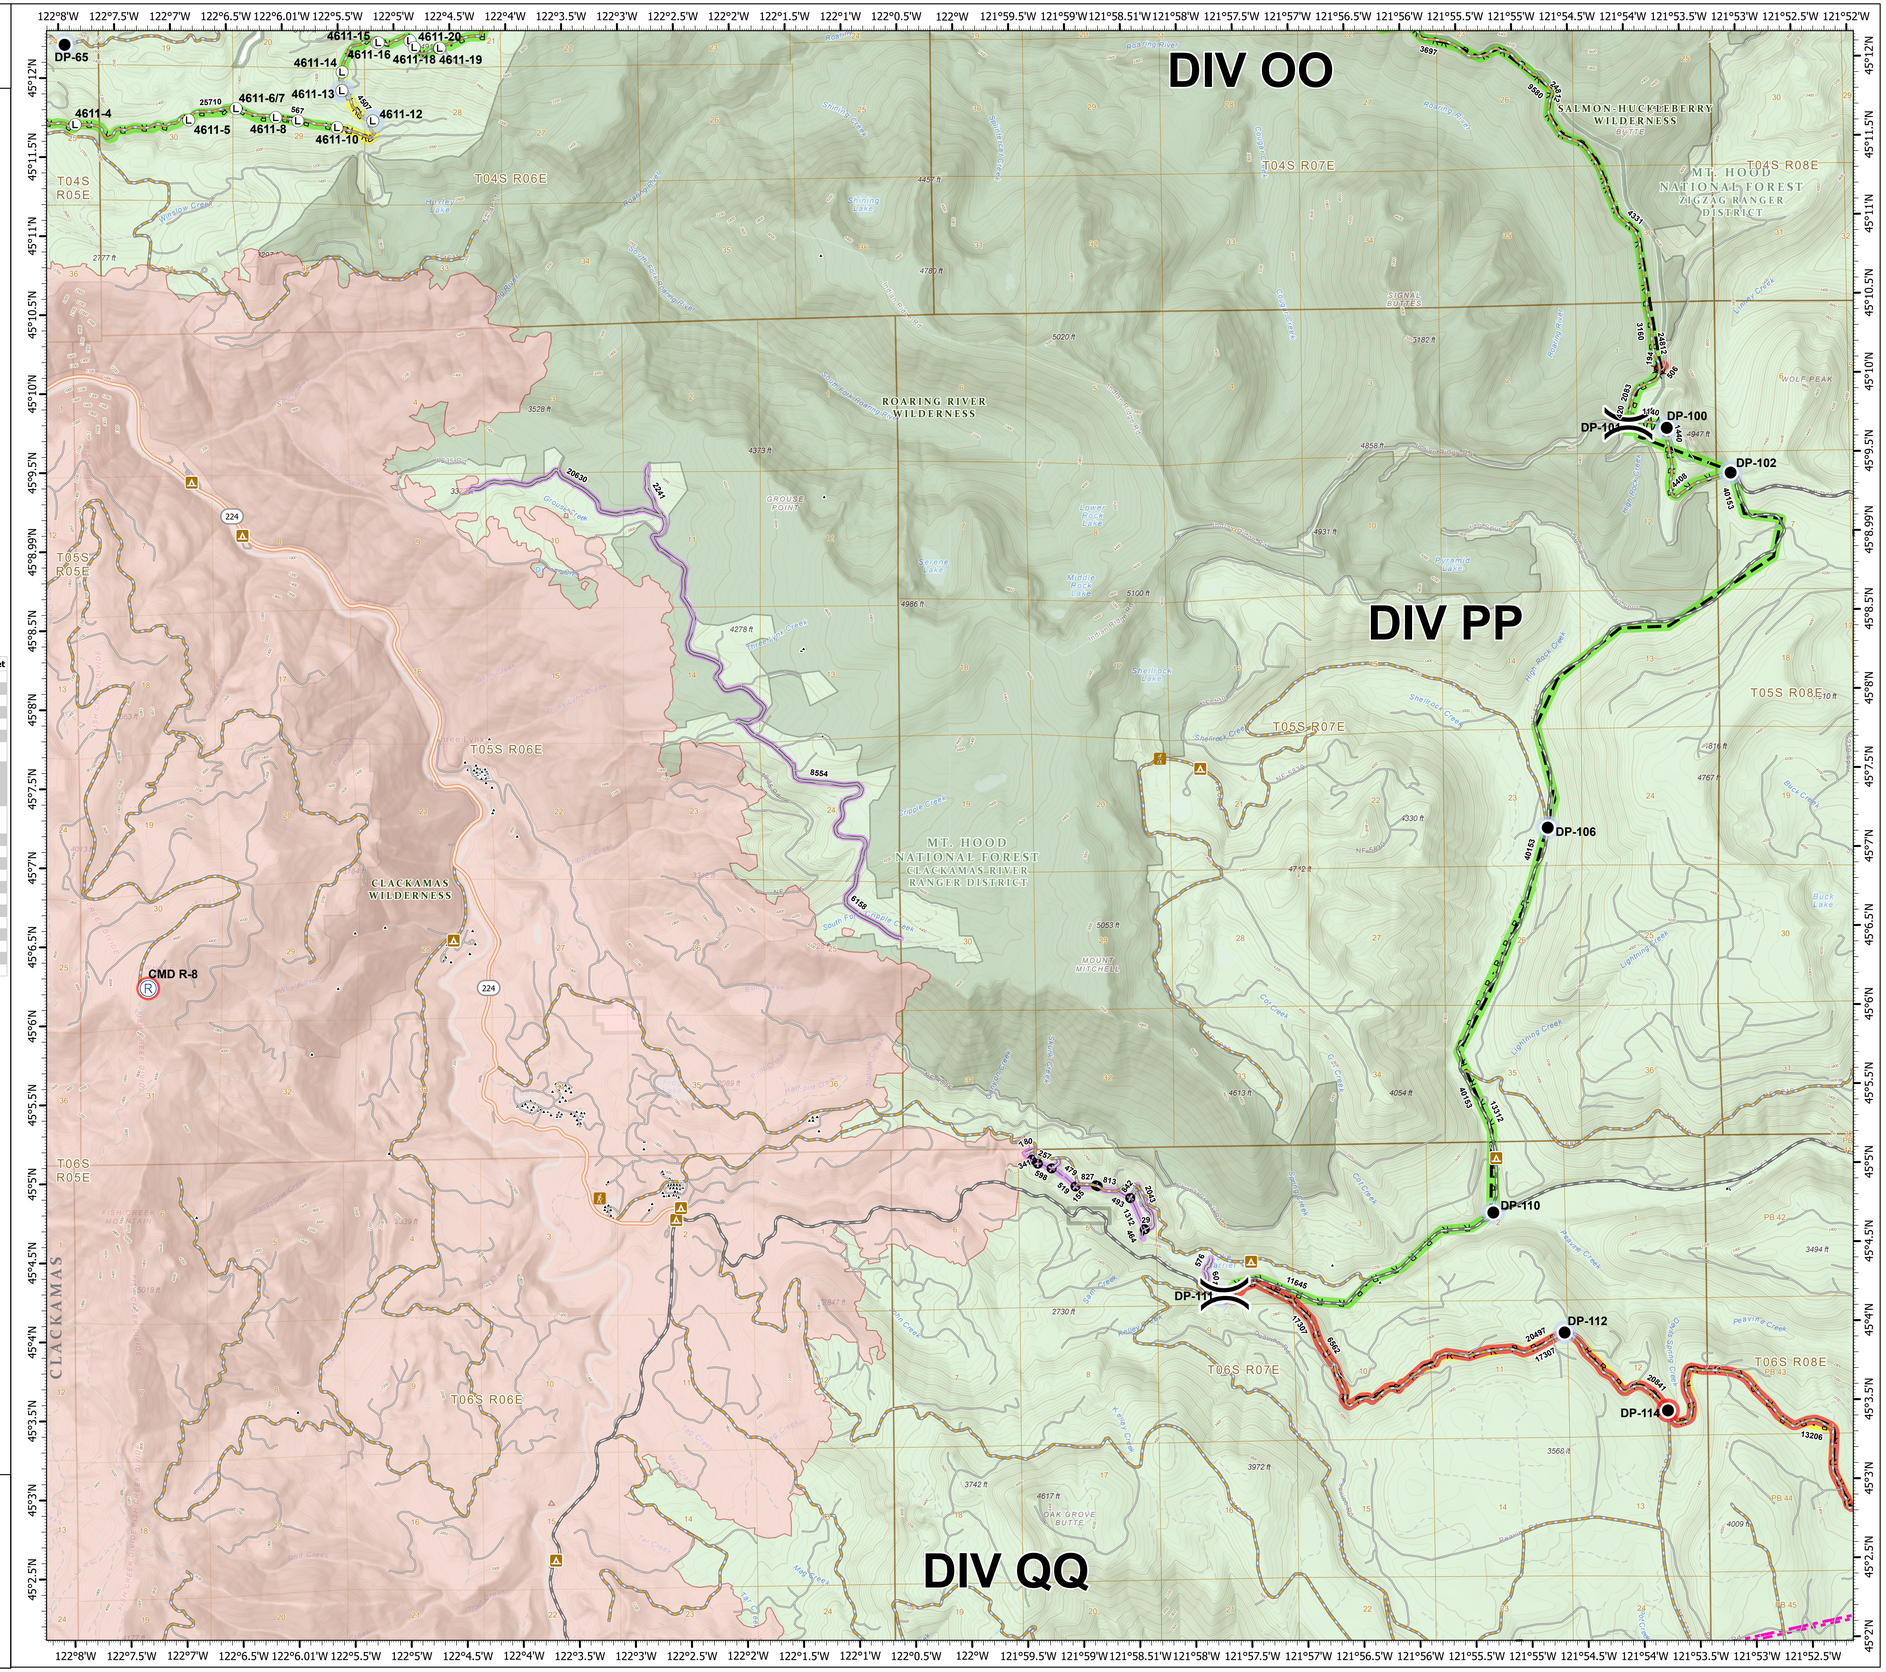
FC Point Type	Repair Status	Repair Comments	Label
Landing or Log Deck			4611-17
Landing or Log Deck			4611-18
Landing or Log Deck			4611-19
Landing or Log Deck			4611-20
Landing or Log Deck			4611-4
Landing or Log Deck			4611-5
Landing or Log Deck			4611-6/7
Landing or Log Deck			4611-8
Landing or Log Deck			4611-9
Landing or Log Deck	No Repair Needed		4611-12
Landing or Log Deck	No Repair Needed		4611-13
Repeater	Repair Needed		CMD R-8

FC Line Type	Repair Status	Repair Comments	Length Feet
Road as Completed Line	Unknown		780
Road as Completed Line	Repair Needed	Chipper needed after fire-M. DeAngelo Sep 19, 2020. Equipment currently mastiicating (9/28). Crews may be needed to break up and spread highly concentrated material in the ditch	6562
Road as Completed Line	In Progress	Significant merch. Slash piles will need to be disposed of. Flush cut pungees and stumps where needed. Chipping needed.	13206
Road as Completed Line	In Progress	Chipping needed	20497
Road as Completed Line	Completed - Inspected	10/10/2020mkeil_nifc-Per robertsanders_nifc Inspected 10/09/2020 Completed. unknown datesdillavou-Completed fuel break. Unknown date unkown collector-light chipping needed	420
Road as Completed Line	Completed - Inspected	Sweeping of debris	1440
Road as Completed Line	Completed - Inspected	Logs in ditch need to be removed. Chip smaller material. Berms need to be knocked down. Rocky debris behind shoulder needs additional repair	2083

Road as Completed Line	Completed - Inspected	10/10/2020mkeil_nifc-Per robertsanders_nifc Inspected 10/09/2020 Completed. unknown datesdillavou-Completed fuel break	3160
Road as Completed Line	Completed - Inspected	10/10/2020mkeil_nifc-Per robertsanders_nifc Inspected 10/09/2020 Completed. unknown datesdillavou-Completed fuel break	4331
Road as Completed Line	Completed - Inspected	Sweeping of debris and light chipping need at intersection of DP 102	4408
Road as Completed Line	Completed - Inspected	Chipping needed to clear ditches	11645
Road as Completed Line	Completed - Inspected	Chipping needed north of Shellrock Campground	13312
Planned Fire Line	Unknown		464
Planned Fire Line	Repair Needed	Equipment currently masticating (9/28). Crews may be needed to break up and spread highly concentrated material in the ditch	17307
Planned Fire Line	Repair Needed	Chipping needed	20841
Planned Fire Line	In Use - Fire Management	Road grading, remove berms, repair cut and fill slopes (marked separately), and chipping -Suing. Robert Sanders: stumps, slash, berm and grading underway 10/7/20. Div o.o says done by 10/9	24812

Planned Fire Line	In Progress	Chipping needed	20841
Planned Fire Line	Completed - Inspected	Equipment currently masticating (9/28). Crews may be needed to break up and spread highly concentrated material in the ditch	17307
Planned Fire Line	Completed - Inspected	Chipping needed throughout NF 58 and entry to NF 5830 and NF 150. Crews needed to sweep debris.	40153
Other	Unknown		257
Other	Unknown		479

FC Line Type	Repair Status	Repair Comments	Length Feet
Other	Unknown		493
Other	Unknown		519
Other	Unknown		598
Other	Unknown		813
Other	Unknown		827
Other	Unknown		1312
Line Break Completed	Completed - Inspected	Light chipping and sweeping needed	1140
Completed Dozer Line	Repair Needed	Robert Sanders: the road edge is chewed up from machines and parking. seed and/or slash. same treatment around log deck	506
Completed Dozer Line	Completed - Inspected	Pull in berms, may not be needed until log deck is removed	194
Access or Improved Road	Unknown		29
Access or Improved Road	Unknown		155
Access or Improved Road	Unknown		341
Access or Improved Road	Unknown		479
Access or Improved Road	Unknown		576
Access or Improved Road	Unknown		601
Access or Improved Road	Unknown		842
Access or Improved Road	Unknown		2043
Access or Improved Road	Unknown		2241
Access or Improved Road	Unknown		6158
Access or Improved Road	Unknown		8554
