Suppression Repair Tiles

Cedar Creek
OR-WIF-220180
10/20/2022 24 Hour
126,222 acres as of 10/18/2022 @ 1815
1:1,100,000

Div S

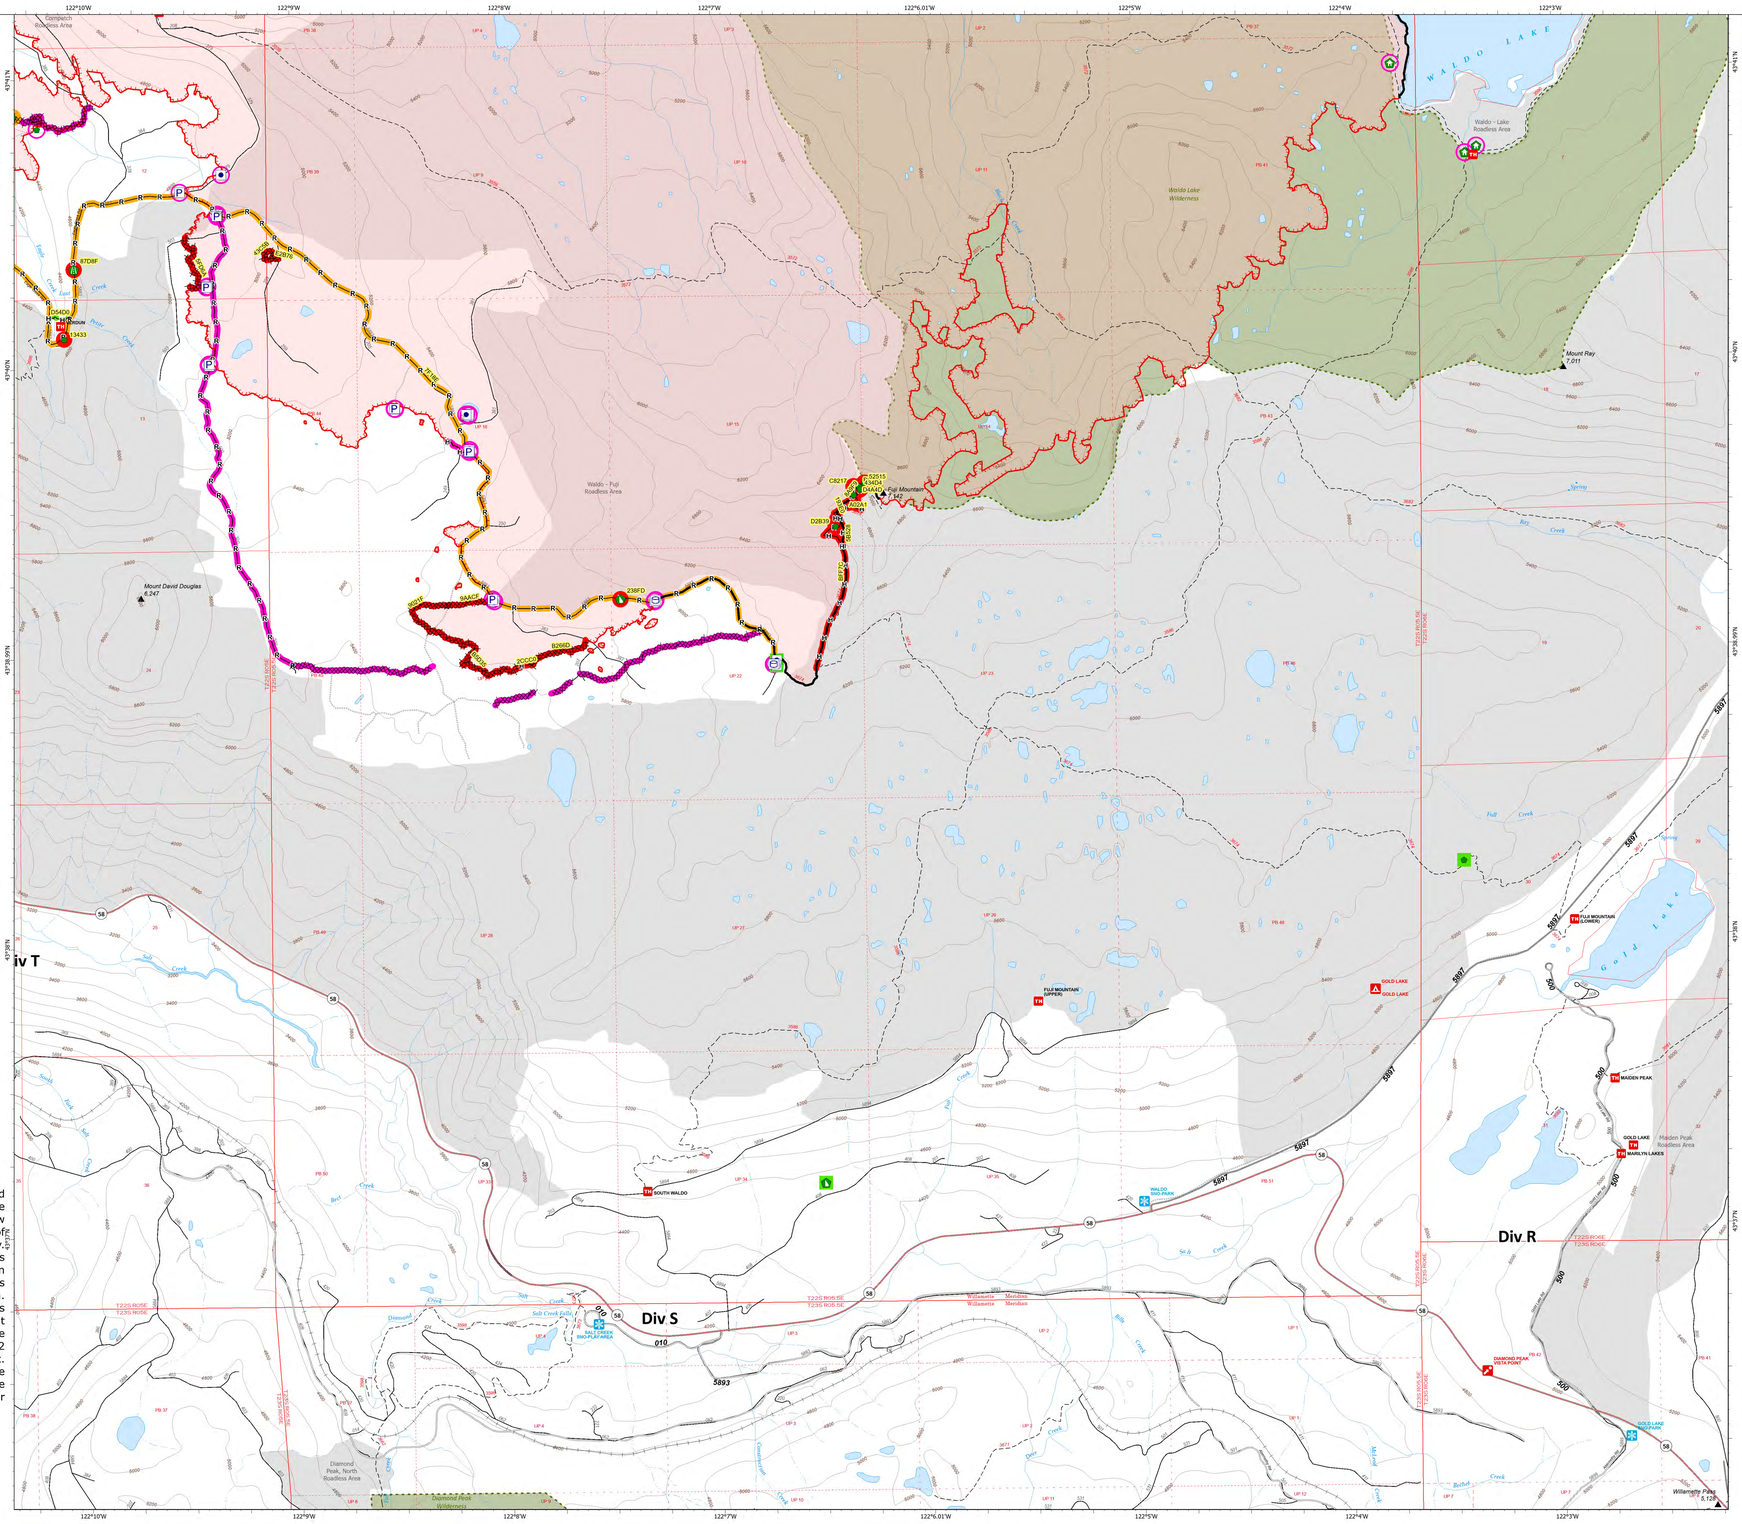
Repair ID	Priority	Point Type	Status	Repairs Needed	Repair Comments	Latitude	Longitude
A02A1	High	Repair Point	Repair Needed	Pull in berms, fill trench, disguise entrances, cover with slash, water bar as needed		43° 39.541' N	122° 06.339' W
8EF28	High	Repair Point	Repair Needed	Pull in berms, cover in slash, disguise entrances (REAF Johansen 10/5)		43° 39.572' N	122° 06.314' W
4D4D4	High	Repair Point	Repair Needed	FULL REPAIR. Pull in berms, cover in slash, disguise entrances, water bar as needed (REAF Johansen 10/5)		43° 39.560' N	122° 06.309' W
52515	High	Repair Point	Repair Needed	FULL REPAIR. Pull in berms, cover in slash, disguise entrances, water bar as needed (REAF Johansen 10/5)		43° 39.560' N	122° 06.290' W
02B39	High	Repair Point	Repair Needed		FULL REPAIR. Pull in berm, distribute slash to more natural levels. Trail needs Rox specialist (Johansen 10/5)	43° 39.410' N	122° 06.410' W
A38FD	Medium	Dozer Push	Repair Needed			43° 39.188' N	122° 07.452' W

04A4D	Medium	Repair Point	Repair Needed	LIGHT REPAIR NEEDED	REAF BERG 9/22. Pull back berm to trail and naturalize.	43° 39.559' N	122° 06.311' W
CR217	Medium	Repair Point	Repair Needed	FULL REPAIR. Distribute slash to more natural levels		43° 39.572' N	122° 06.340' W
13433	Medium	Repair Point	Repair Needed	FULL REPAIR. REAF GRANT 10/5: culvert inlet totally buried by dirt while excavator was clearing ditch, needs to be dug out		43° 40.103' N	122° 10.085' W
8C06F	Medium	Road Repair	Repair Needed	LIGHT REPAIR. clean ditch line		43° 40.343' N	122° 10.030' W

Repair ID	Priority	Line Type	Status	Repairs Needed	Repair Comments	Len (ft)
E2876	High	Completed Dozer Line	Repair Needed	FULL REPAIR		372
43C58	High	Completed Dozer Line	Repair Needed	FULL REPAIR		432
9A01F	High	Completed Dozer Line	Repair Needed	FULL REPAIR		1418
9AACF	High	Completed Dozer Line	Repair Needed	FULL REPAIR		1008
B266D	High	Completed Dozer Line	Repair Needed	FULL REPAIR		1435
8D035	High	Completed Dozer Line	Repair Needed	FULL REPAIR		3243
D54D0	High	Completed Hand Line	Completed - Inspected	LIGHT REPAIR READ /ARCH ROOD 9-18	10/2: repaire completed REAF Grant. Pull slash, seed to prevent erosion	782
F3F65	High	Completed Hand Line	Repair Needed	LIGHT REPAIR to prevent alt routes. Disperse slash : REAF/ARCH ROOD 9-18, Pull in berms, fill trench, cover in slash, disguise entrance, water bar as needed.	Disperse slash and cut rounds piled on the green side to more natural levels (REAF Johansen).	669

5B528	High	Completed Hand Line	Repair Needed	FULL REPAIR	Pull in berms, fill in trench, cover with slash, add water bars, disguise the entrances (REAF Johansen 10/5)	655
20B10	High	Completed Hand Line	Repair Needed	FULL REPAIR	Pull in berms, fill in trench, cover with slash, disguise entrances, add water bars,	221
B48F9	High	Completed Hand Line	Repair Needed	FULL REPAIR	REAF Johansen 10/5 Pull in berms, fill trench, disguise entrances, cover with slash, water bar as needed	496
2CC10	High	Completed Hand Line	Repair Needed	FULL REPAIR		262
5F06A	Medium	Completed Dozer Line	Repair Needed	FULL REPAIR		2344
BF37C	Medium	Completed Hand Line	Repair Needed	Cutwall with local recreation folks for future trail repair. REAF GRANT 10/5: scatter slash and rounds to a more natural density, trail tread should be assessed by recreation for repair needs.		3550
7F18E	Medium	Completed Road as Line	In Progress	Yes	FULL REPAIR. REAF GRANT 10/4: road was bladed and rolled 10/1, excavator was brought up the road to clean culverts and fix pushouts. Use small excavator with brush grapple to remove remaining slash, chips and logs from ditch, culvert inlets and shoulders. Use water trender to water road. Use motor grader to reshape road surface aggregate. Roller compact surface with vibratory roller after grading. 3 Hoppmann R19L 09/19 BKG: aggregate displaced from heavy traffic; place 400cy spot rock	42181
