Suppression Repair Tiles

Cedar Creek
OR-WIF-220180
10/20/2022 24 Hour
126,222 acres at 10/18/2022 @ 1815
1:1,100,000

Div Y

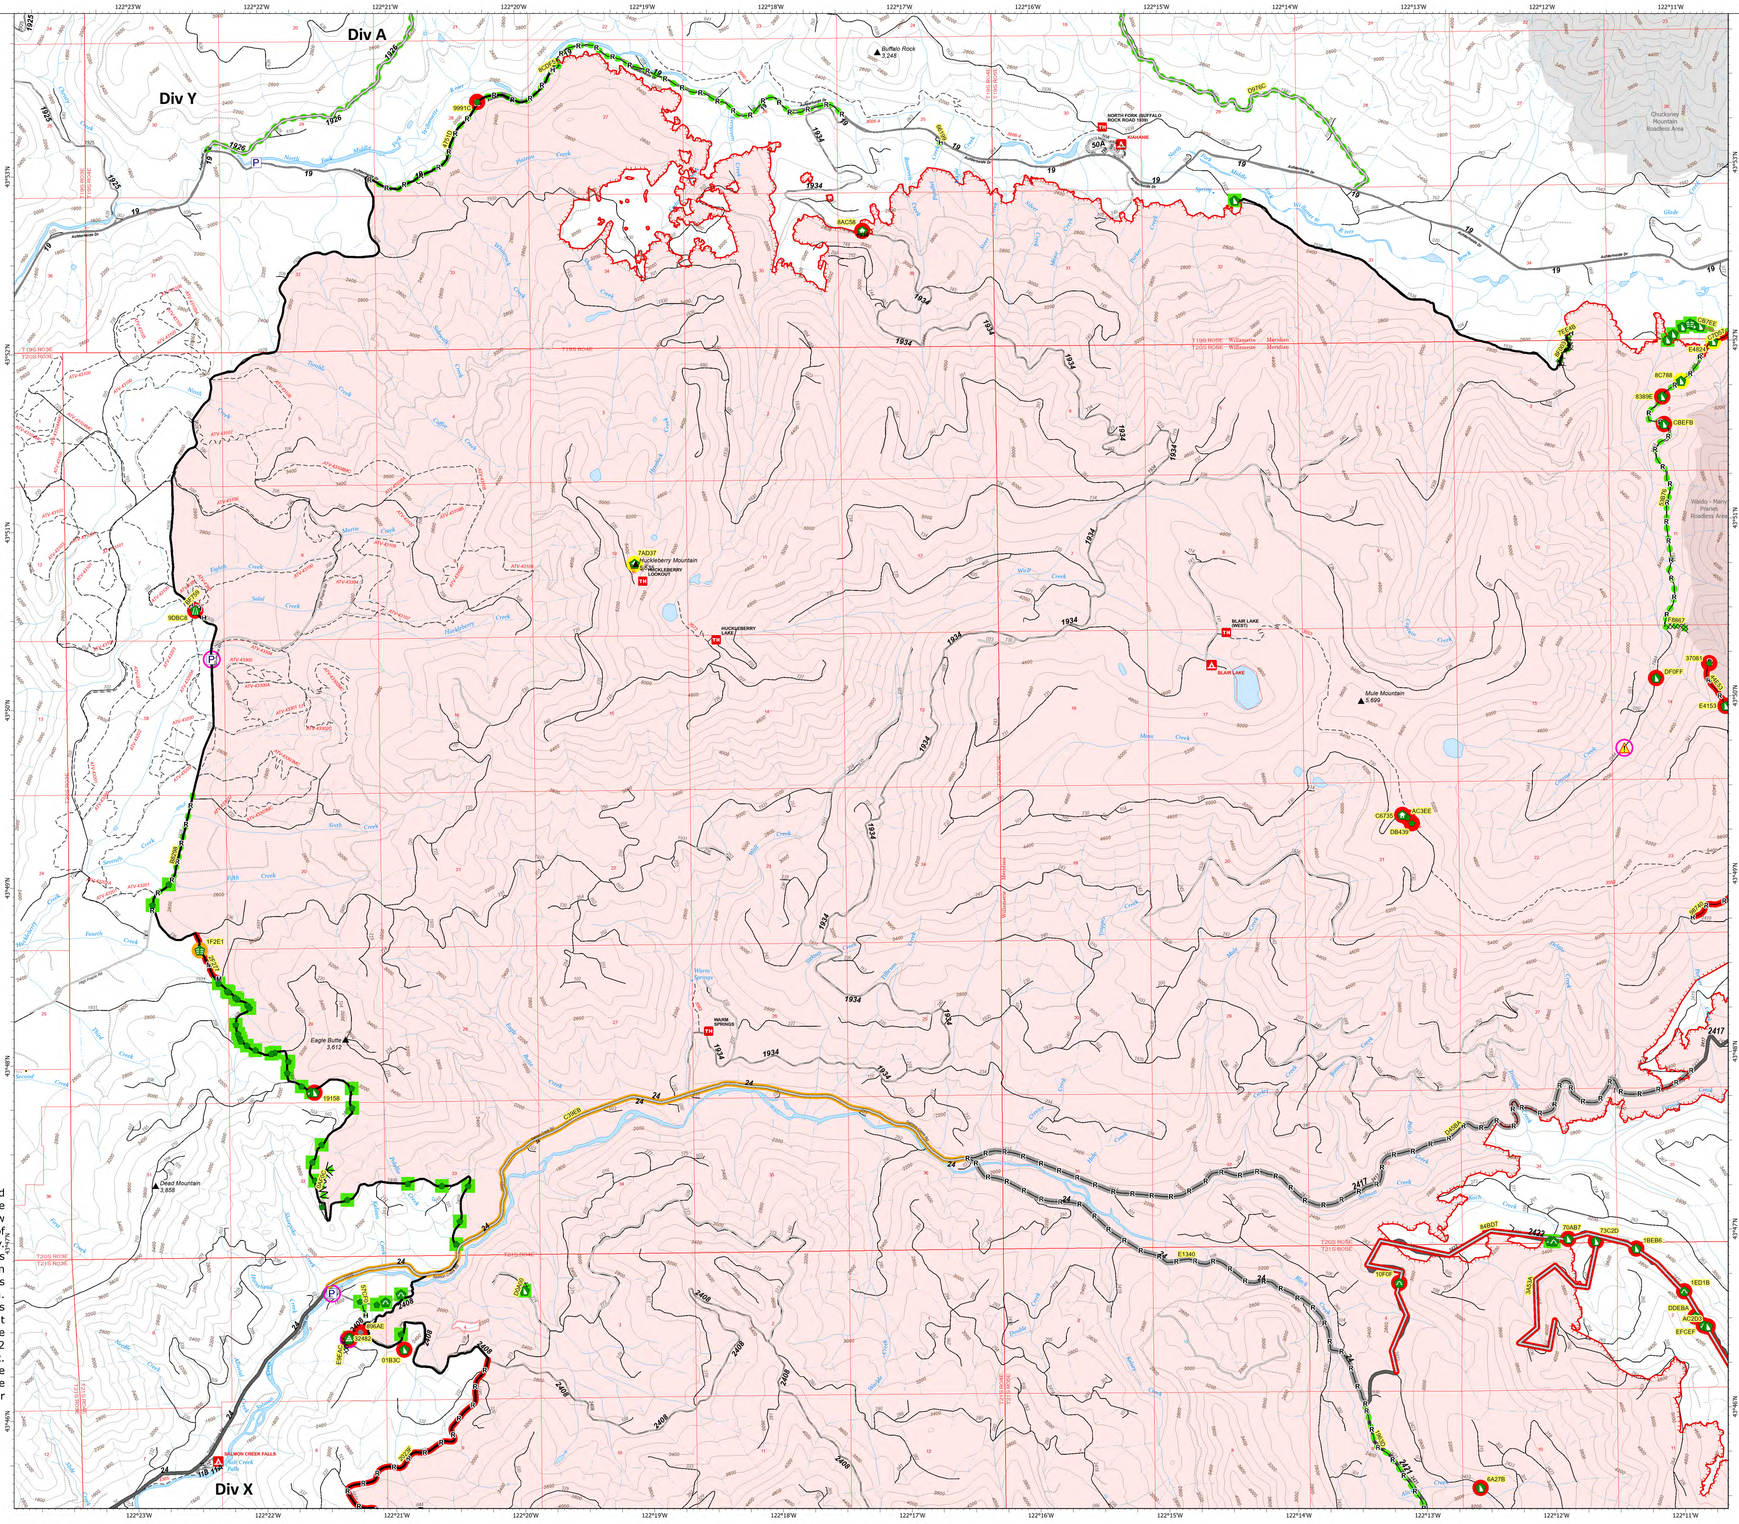
Repair ID	Priority	Point Type	Status	Repairs Needed	Repair Comments	Latitude	Longitude
0FC2F	High	Culvert	Repair Needed	Clear catch basin		43° 46.450' N	122° 10.844' W
10F0F	High	Culvert	Repair Needed	clear catch basin		43° 46.712' N	122° 13.205' W
5D4B2	High	Landing or Log Deck	Repair Needed	Rip, slash, seed and straw disturbed areas. Use ripped out stumps to block vehicle access. Reopen 2408-270 spur. CYSE in area. REAF Mickey/Cedric, 08/30/22. In use as log deck, repair after log removal REAF Davis 9/28		43° 46.453' N	122° 21.360' W
99A8E	High	Other	Repair Needed	Biohazard cleanup		43° 46.482' N	122° 21.273' W
5B4D9	High	Repair Point	Repair Needed	Bearpaw plugs in culs getting larger ecrhy site nearby	Rotary REAF must be present during repair	43° 49.301' N	122° 13.074' W
AC3EE	High	Repair Point	Repair Needed	replant bearpaw	replant bearpaw	43° 49.334' N	122° 13.157' W
1F2E1	High	Stream Crossing	In Progress	FULL REPAIR	REAF GUTHRIE 9/19. Clean bladed material out of stream crossing, slope to drain, seed and straw slope break to stream, 10x10.	43° 48.644' N	122° 22.457' W

C6735	High	Structure Wrap	Repair Needed	Remove shelter wrap, bring staple pullers to remove staples, bring at least one expendable ladder 20 to 40 ft, trash bags for glass fibers	4 person crew 2 hours to clean,; ROOF UNSTABLE	43° 49.348' N	122° 13.148' W
7AD37	High	Structure Wrap	Completed - Ready for Inspection	Yes	unwrap structure when safe, clean as much fiberglass as poossible	43° 50.798' N	122° 19.097' W
8388E	High	Structure Wrap	Repair Needed	Remove wrap		43° 52.660' N	122° 17.305' W
1E518	Medium	Culvert	Repair Needed	FULL REPAIR		43° 46.652' N	122° 10.994' W
72A87	Medium	Dozer Push	Repair Needed	FULL REPAIR	berm needs to be pulled back, seed and mulch (close to invasive weeds)	43° 46.954' N	122° 11.891' W
E4B24	Medium	Dozer Push	Completed - Ready for Inspection	FULL REPAIR	scatter vegetation, pull in berm, seed and straw	43° 51.993' N	122° 10.696' W
8C788	Medium	Dozer Push	Completed - Ready for Inspection	FULL REPAIR	scatter vegetation,pull in berm, seed and straw	43° 51.774' N	122° 10.948' W

838BE	Medium	Dozer Push	Repair Needed	FULL REPAIR	scatter vegetation,pull in berm, seed and straw	43° 51.087' N	122° 11.096' W
CBEFB	Medium	Dozer Push	Repair Needed	FULL REPAIR	scatter vegetation,pull in berm, seed and straw	43° 51.532' N	122° 11.088' W
0F0FF	Medium	Dozer Push	Repair Needed	FULL REPAIR	scatter vegetation,pull in berm, seed and straw	43° 50.104' N	122° 11.166' W
1BEB6	Medium	Dozer Push	Repair Needed	FULL REPAIR	pull in berms seed and mulch.	43° 46.893' N	122° 11.363' W
DDEBA	Medium	Dozer Push	Repair Needed	FULL REPAIR	pull in berms, seed and mulch	43° 46.509' N	122° 10.908' W
AC2D3	Medium	Dozer Push	Repair Needed	FULL REPAIR	pull in berms, seed and mulch	43° 46.453' N	122° 10.817' W
6A27B	Medium	Dozer Push	Repair Needed	FULL REPAIR	Pull back berms, seed/mulch. avoid culvert (flagged in pink) @ 09/01	43° 45.558' N	122° 12.589' W
01B3C	Medium	Dozer Push	Repair Needed	Pull in berms, cover in slash, add water bar at entrance		43° 46.388' N	122° 20.934' W

73C2D	Medium	Dozer Push	Repair Needed	FULL REPAIR		43° 46.939' N	122° 11.676' W
E4A19	Medium	Dozer Push	Repair Needed			43° 49.944' N	122° 10.627' W
1015B	Medium	Dozer Push	Repair Needed		Pull in berms, distribute slash (REAF Johannsen)	43° 47.817' N	122° 21.615' W
57081	Medium	Repair Point	Repair Needed	FULL REPAIR	Disperse slash or chip, smooth out dozer berms KRB 8/30.	43° 50.180' N	122° 10.752' W
9B92C	Medium	Repair Point	Repair Needed	FULL REPAIR; Dozer or excavator. recontour, mulch, seed.	REAF GUTHRIE 9/24 recontour, mulch, seed.	43° 51.403' N	122° 20.293' W
9D8C9	Medium	Road Repair	Repair Needed		Fill aggregate ditch dug into road bed with aggregate; blade; shape; roll. high traffic area. REAF Guthrie	43° 50.555' N	122° 22.513' W

Repair ID	Priority	Line Type	Status	Repairs Needed	Repair Comments	Len (ft)
C36EB	High	Access or Improved Road	In Progress	Cut Danger Trees, Clear Ditches	Needed to access all other repair work on 2417, 2410, 2421, 2422. Impacts TES Fish Habitat and Priority for District/Public access.	26255
3A5DA	High	Access or Improved Road	Repair Needed	clear ditches	Pull ditchlines and check culverts. Pullback aggregate that hasn't been contaminated back onto road prism	8423
84BD7	High	Access or Improved Road	Repair Needed	Clear ditches	High potential for failure during winter 22'. Water will not be able to stay in ditchline. Clean out ditch and culvert	30304
8F4D3	High	Completed Dozer Line	Completed - Inspected	FULL REPAIR	REAF Guenrot 10/4 needs special care, at the scarp of a landslide. Recommend mini excavator, Roaf Rickling 9-23-22	1666
F8B67	High	Completed Dozer Line	Completed - Inspected	Full repair	Berms knocked down, slash available applied, water bars dug in 10.15 adam. REAF Johannsen 10/11. Pull in berms, add water bars, cover in slash if possible, but not much available)	750

57C70	High	Completed Hand Line	Completed - Inspected	Pull back any berms and scraped material, water bar using hand tools every 50 feet for whole line. Cover with what slash can be found. seed and straw bottom 150ft. excavator and clear ditch line at road, pull back material and block entrance.	10/16, seeded. All work complete. 10/17, Line repair complete just needs seed and straw. READ RICHARDSON: 55% slope for entirety of line. scatch broom and thatbs present at entrance of old dozer line, if constructed treat weeds. seed and mulch	738
BF759	High	Completed Hand Line	Completed - Inspected	berm pullback, disguise entrance so it doesn't become a new trail (REAF Johannsen)		64
5E0A4	High	Completed Hand Line	Completed - Inspected	Full repair	Pull back berm, cover with grass, sticks, rocks etc to disguise entrance (REAF Johannsen)	16
43BEA	High	Completed Hand Line	Completed - Inspected	berm pullback	Seed and mulch (Johannsen) Pull back berms, cover in slash, disguise entrance to prevent new OHV trail creation (REAF Johannsen)	58

66199	High	Completed Hand Line	Completed - Inspected	Full repair	Pull in berms, cover in slash, disguise entrances, water bar where necessary. Handline crosses stream, avoid pulling material into stream crossing (REAF Johannsen 10/12)	351
3E24B	High	Completed Hand Line	Completed - Inspected			157
F1D7D	High	Completed Hand Line	Completed - Inspected	Pull back berm, cover in slash, disguise entrances (REAF Johannsen)		81
3F277	High	Completed Mixed Construction Line	Repair Needed	Light repair. Line is meant to be left for future fire use.	REAF Guenrot, 10/27/22: Pull in dozer berms, seed and mulch. Spread slash on sides of line but do not pull this line. No waterbars needed. Consider utilizing larger down trees to block entrance at the 2409 and 3701 road junction.	1873
19A3D	High	Completed Road as Line	Completed - Inspected	Snag, clear ditches	Clean ditch, shoulders and culvert inlets.	43305
33B76	High	Completed Road as Line	Completed - Inspected	drivable water bars approximately every 200ft, or as flagged, ensure drivable water bars are placed immediately downstream of ditch relief culverts. Ditches must be pulled, culvert catch basins cleaned out, berms on road knocked down to surface.	Slash jackpots exist on shoulder. Some ditch lines never existed in some portions of roadway. Natural rock screes and alsagha from cutbock. Dozer pushes need to be repaired. Ditchline pulled, culvert catch basins cleaned out 08-15 adam.	14599

44E53	High	Completed Road as Line	Repair Needed	FULL REPAIR	Remove berms and slash from edges of road. Reshape and compact, clean ditches where applicable. Install drivable waterbars where flagged. Consult engineering REAF prior to rehab. JDY 08/22/	3830
9A74B	High	Completed Road as Line	Repair Needed	FULL REPAIR	Clean ditches and culverts of slash and debris.	8781
2023F	High	Completed Road as Line	Repair Needed	Clean ditches and culvert inlets/outlets.1024 JHH	MP 1.57 construct armored dip. See drawings and specs. Clean ditch and culverts. 750 cy spot rock. Grade and roll. BOP at 58 jhc. 8/29 CP. Multiple invasive weeds along road. CYSCA, RULA, BRSY, VEDU. Will need to hand weeds post fire, seed and mulch disturbed and exposed soil. JIM 8/27.	40778
C7D57	High	Completed Road as Line	Repair Needed	FULL REPAIR	Clean culvert catch basins as flagged. Remove slash, debris and logs from ditches, culvert inlets, shoulders and roadway. Water road surface. Use grader to remove berms on shoulder and ditch line, and reshape surface to drain. Use vibratory roller to compact surface. Install drivable water bars as flagged. 8/22 J Hoganson. Many invasive weeds along road: BRDI, GERO, CYSCA. Monitor and treat weeds post fire actively. Seed and mulch bare soil and pullouts. JIM 8/31	3144

D97AC	Medium	Access or Improved Road	Completed - Inspected			39309
E9EAC	Medium	Completed Dozer Line	Completed - Inspected	pull back berms and adecuat material, disguise and block entrance from public access REAF Davis 10/2		646
ED016	Medium	Completed Dozer Line	Completed - Inspected	pull back berms, water bar to spec, spread slash and block entrances REAF Davis 10/2	10/15, completed including seed	141
0D000	Medium	Completed Dozer Line	Completed - Inspected	Rip, on fldgyellow. pull back berms and cover with available slash, there isn't much slash. berm or boulder entrance to block public access. seed and straw entire line due to minimal available slash	Completed 10/15, including seed	272
0A93C	Medium	Completed Fuel Break	Completed - Inspected	Mow slash	mowing slash off weathern half of completed fuel break to landing site along with road slash material from shaded fuel break.	1247
BCDF5	Medium	Completed Hand Line	Completed - Inspected	Full Repair	Pull in berms, cover in slash, water bar as needed, disguise entrances (REAF Johannsen 10/8)	539

8B29B	Medium	Completed Road as Line	Completed - Inspected	slash and cut vegetation needs to be either hand piled and covered or chipped. removed from ditchline .	REAF Maynard 9/19: vegetation and slash is either dispersed or in hand piles. hand pile and cover as needed or chip material along roadside and especially in ditchlines.	4546
47920	Medium	Completed Road as Line	Completed - Inspected	CHIPPING	READ Cole and Herrmann, 9/13, avoid chipping into running water. Keep culvert and ditching clear of chip piles or clean out post operations. Close proximity to middle fork and several perennial streams cross the road. No wildlife, roads, or recreation concerns. Invasive species on roadside include CYSCA and RUARS, treat and monitor post fire.	29043
D45BA	Medium	Completed Road as Line	Other - See Comments	Clear ditch	Unknown if fire team wants to get to interior work. Ditches and culverts cleaned out for winter functionality 10.16 adam.Clean ditch and culverts of slash and debris.	30480

E13A0	Medium	Completed Road as Line	Other - See Comments	Snag, clear ditches	Excavator pulled ditches and culverts for winterization 10.16 adam. Remove logs and slash from ditch. J Hoganson 8/29	17500
CB7EE	Medium	Road Repair	Completed - Inspected	Full repair	Knock down berms, chip slash, water bars (REAF Johannsen 10/11)	2965
