Suppression Repair Tiles

Cedar Creek
OR-WIF-220180
10/20/2022 24 Hour
126,222 acres at 10/18/2022 @ 1815
1:1,100,000

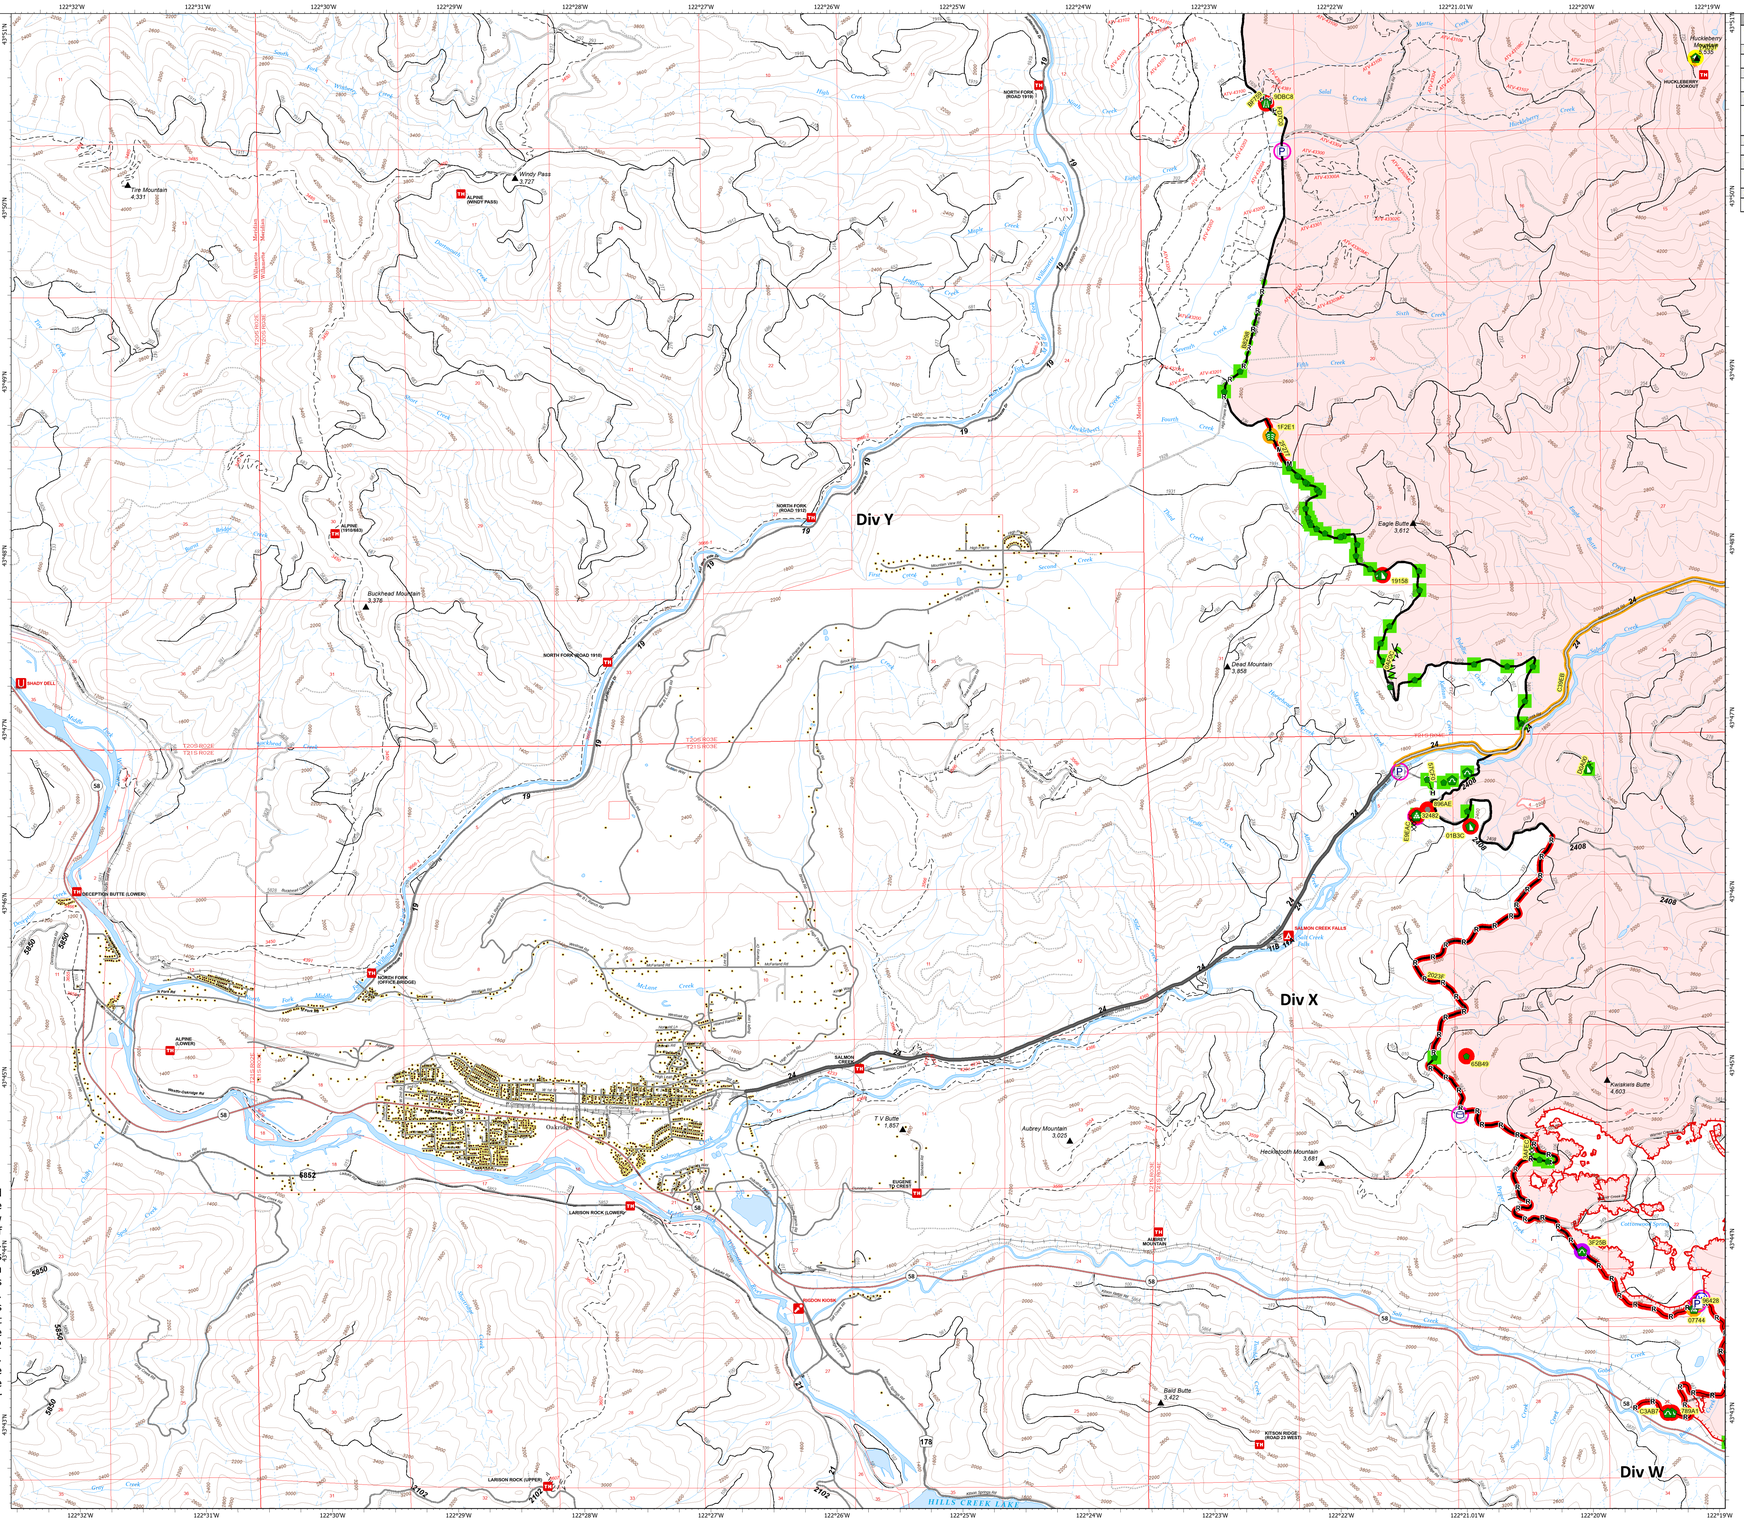
Repair ID	Priority	Point Type	Status	Repairs Needed	Repair Comments	Latitude	Longitude
32482	High	Landing or Log Deck	Repair Needed	Rip, slash, seed and straw disturbed area. Use ripped out stumps to block vehicle access. Reopen 2408 2J9 spur. CYSE in area. REAF McAvoy/Castro, 08/10/22. on use as log deck, repair after log removal REAF Davis 9/28		43° 46.453' N	122° 21.360' W
89A4E	High	Other	Repair Needed	Backyard cleanup		43° 46.487' N	122° 21.273' W
1F2E1	High	Stream Crossing	In Progress	FULL REPAIR	REAF GUTHRIE 9/19. Clean bladed material out of stream crossing, slope to drain, seed and straw slope break to stream. 1ft×10.	43° 48.644' N	122° 22.457' W
2A037	High	Structure Wrap	Completed - Ready for Inspection	Yes	unwrap structure when safe, clean as much fiberglass as possibale	43° 50.798' N	122° 19.057' W
78581	Medium	Culvert	Repair Needed	LIGHT REPAIR - ensure slash is cleared from inlet via chipping REAF Davis 10/3	READ BERG 9/17. Clean out culvert, remove slash.	43° 43.005' N	122° 19.373' W

C2A87	Medium	Culvert	Repair Needed	LIGHT REPAIR - ensure slash is removed from inlet and outlet REAF Davis 10/3	READ BERG 9/17. Clean out culvert, remove slash and debris from the uphill side	43° 43.005' N	122° 19.405' W
3F25B	Medium	Culvert	Needs Assessment	Inlet had tree fall on top of it, culvert ok but basin full of slash that needs removed REAF Davis 10/1	Update 10/23 log was moved to fiberpa and ended up rolling on top of outlet, culvert still intact and functioning but will need assessment from engineering BREA - Reef Goertzen (1 update 10/21) Culvert is good, but log needs removed from road pr4em3B5L. READ BERG 9/17. Clean out culvert and remove slash from downhill side.	43° 43.557' N	122° 20.076' W
018EC	Medium	Dozer Push	Repair Needed	Pull in berms, cover in slash, add water bar at entrance		43° 46.388' N	122° 20.934' W
19158	Medium	Dozer Push	Repair Needed		Pull in berms, distribute slash (REAF Johansen)	43° 47.837' N	122° 21.637' W

07744	Medium	Landing or Log Deck	In Progress	Cover in slash, block access by vehicles, back and process remaining logs and add to established deck. REAFs McAvoy/Castro 08/30/22.	Seeded and straw scattered on disturbed ground (Johansen 10/5)	43° 43.602' N	122° 19.192' W
96428	Medium	Repair Point	Repair Needed	Pull back berms on edge of wasp, pull back logs berm of material from dozer push, reshape to stable slope (max 1.5:1 (v):(h) and drain, seed and mulch REAF Davis 10/10		43° 43.648' N	122° 19.149' W
65B49	Medium	Repair Point	Repair Needed	Pull flagging. Block or Decommission Road REAF McAvoy/Castro 8/30/22 .	Need direction on blocking or decommissioning non-system road.	43° 45.067' N	122° 20.987' W
90BC8	Medium	Road Repair	Repair Needed		FB aggregate ditch dug into road bed with aggregate, blade, shape, roll. high traffic area. REAF Guthrie	43° 50.555' N	122° 22.515' W

Repair ID	Priority	Line Type	Status	Repairs Needed	Repair Comments	Len (ft)
C9BEB	High	Access or Improved Road	In Progress	Cut Danger Trees, Clear Ditches	Needed to access all other repair work on 2417, 2419, 2421, 2422. Impacts TES Fish Habitat and Priority for DNR/s/Public access.	26255
3AFEC	High	Completed Dozer Line	Completed - Inspected	Full repair dozer line, water bar and pull back berm. spread slash, disguise and recontour entrances, clear and reshape ditch REAF Davis 10/4	done reef mardiff 10.16.22. .READ BERG 9/17. Old dozer line reopened as contingency line.	527
57CF0	High	Completed Hand Line	Completed - Inspected	Pull back any berms and scraped material, water bar using hand tools every 50 feet fo whole line. Cover with what slash can be found. seed and straw bottom 150ft. recontour and clear ditch line at road, pull back material and block entrance.	10/16, seeded. All work complete. 10/13, Line repair complete just needs seed and straw. . READ REDWINDSON- 55% slope for entirety of line. scatch broom and thistle present at entrance of old dozer line, if constructed treat weeds, seed and mulch	738

BF759	High	Completed Hand Line	Completed - Inspected	berm pullback, disguise entrance so it doesn't become a new trail (REAF Johansen)		64
5E0B4	High	Completed Hand Line	Completed - Inspected	Full repair	Pull back berm, cover with grass, sticks, rocks etc to disguise entrance (REAF Johansen)	56
43XEA	High	Completed Hand Line	Completed - Inspected	berm pullback	Seed and mulch (Johansen) Pull back berm, cover in slash, disguise entrance to prevent new OHV trail creation (REAF Johansen)	58
FD7C0	High	Completed Hand Line	Completed - Inspected	Pull back berm, cover in slash, disguise entrances (REAF Johansen)		81
3F217	High	Completed Mixed Construction Line	Repair Needed	Light repair. Line is meant to be left for future fire use.	REAF Guerrant, 10/2/22: Pull in dozer berms, seed and mulch. Spread slash on sides of line but do not pull into line. No waterbars needed. Consider utilizing larger down trees to block entrance at the 2409 and 1911 road junction.	1873

202SF	High	Completed Road as Line	Repair Needed	Clean ditches and culvert inlets/outlets 10/4 JRH	RP 1.57 construct armored dip. See drawings and specs. Clean ditch and culverts. 750 cy spoil rock. Grade and roll. BOP at 58 jxc. 9/29 CP: Multiple invasive weeds along road: CYSCA, HULA, BRSY, VEDU. WB need to treat weeds post fire, seed and mulch disturbed and exposed soil. BM 8/22.	40378
D9EAC	Medium	Completed Dozer Line	Completed - Inspected	pull back berms and sidecast material, disguise and block entrance from public access REAF Davis 10/2		646
EDD66	Medium	Completed Dozer Line	Completed - Inspected	pull back berms, water bar to spec, spread slash and block entrances REAF Davis 10/2	10/15, completed including seed	141
D0A00	Medium	Completed Dozer Line	Completed - Inspected	flat, on Ridgeline. pull back berms and cover with available slash, there isn't much slash. berm or boulder entrance to block public access. seed and straw entire line due to minimal available slash	Completed 10/15, including seed	272

6AF0C	Medium	Completed Fuel Break	Completed - Inspected	Move slash	moving slash off southern half of completed fuel break to landing site along with road slash material from shaded fuel break.	1347
0B29B	Medium	Completed Road as Line	Completed - Inspected	slash and cut vegetation needs to be either hand piled and covered or chipped. removed from ditchline .	REAF Maynard 9/19 vegetation and slash is either dispersed or in hand piles. hand pile and cover as needed or chip material along roadside and especially in ditchlines.	4546
