Suppression Repair Tiles

Cedar Creek
OR-WIF-220180
10/21/2022 24 Hour
126,690 acres at 10/19/2022 @ 1948
1:1,100,000

Div P1

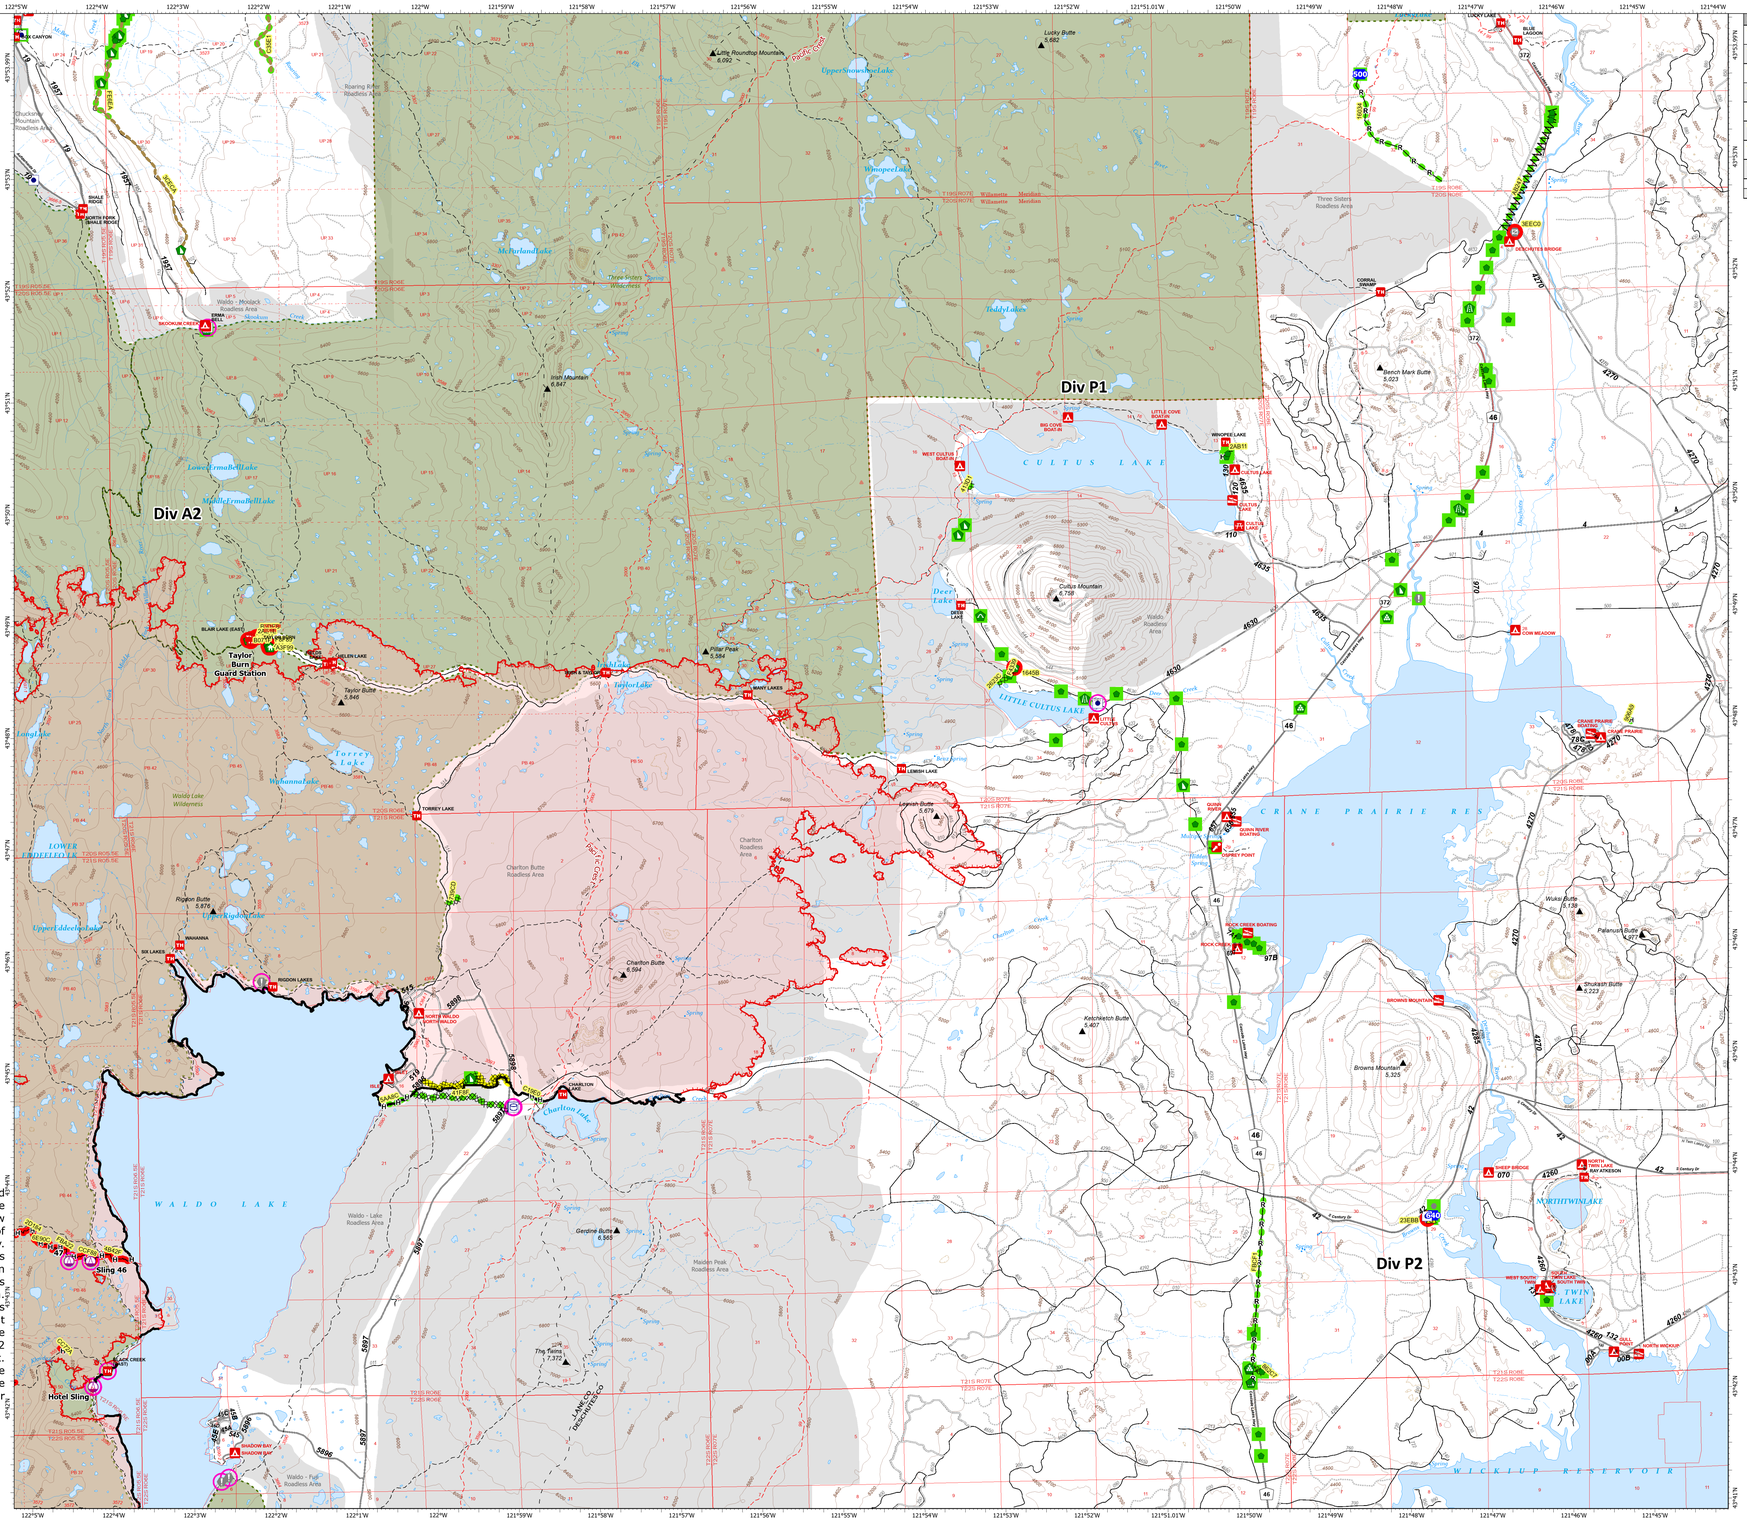
Div P1

Repair ID	Priority	Point Type	Status	Repairs Needed	Repair Comments	Latitude	Longitude
3EEC0	High	Gate	Repair Needed	outside post hit by trailer during suppression activities. either cut off bent/ split piece and weld on new or replace post. high priority repair as the gate might not be able to be secured with chain. REAF Jackson 10/5/2022		43° 52.238' N	121° 46.495' W
4AJ61	High	Structure Wrap	Repair Needed	Remove shelter wrap	Remove shelter wrap, bring staple pullers to remove staples, bring at least one expandable ladder 20 to 40 ft, trash bags for glass fibers, 10 person crew 2 hours to clean.	43° 48.802' N	122° 01.967' W
F8F89	High	Structure Wrap	Repair Needed	Remove shelter wrap	Remove shelter wrap, bring staple pullers to remove staples, bring at least one expandable ladder 20 to 40 ft, trash bags for glass fibers, 10 person crew 2 hours to clean.	43° 48.780' N	122° 01.961' W
A3F99	High	Structure Wrap	Repair Needed	Remove shelter wrap	Remove shelter wrap, bring staple pullers to remove staples, bring at least one expandable ladder 20 to 40 ft, trash bags for glass fibers, 2 person crew 1 hour to clean.	43° 48.789' N	122° 01.946' W

9DDE8	High	Structure Wrap	Repair Needed	Remove shelter wrap	Remove shelter wrap, bring staple pullers to remove staples, bring at least one expandable ladder 20 to 40 ft, trash bags for glass fibers, 2 person crew .05 hour to clean.	43° 48.861' N	122° 02.115' W
9G73F	High	Structure Wrap	Repair Needed	Remove shelter wrap	Remove shelter wrap, bring staple pullers to remove staples, bring at least one expandable ladder 20 to 40 ft, trash bags for glass fibers, 2 person crew .05 hour to clean.	43° 48.857' N	122° 02.218' W
A8H50	High	Structure Wrap	Repair Needed	Remove shelter wrap	Remove shelter wrap, bring staple pullers to remove staples, bring at least one expandable ladder 20 to 40 ft, trash bags for glass fibers, 2 person crew 1 hour to clean.	43° 48.849' N	122° 02.189' W
2AE3E	High	Structure Wrap	Repair Needed	Remove shelter wrap	Remove shelter wrap, bring staple pullers to remove staples, bring at least one expandable ladder 20 to 40 ft, trash bags for glass fibers, 2 person crew .05 hour to clean.	43° 48.860' N	122° 02.177' W

1645B	Medium	Culvert	Repair Needed	replacement. Inlet completely crimped	potential to cut and reform circular opening as opposed to replacement	43° 46.520' N	121° 52.756' W
23E9B	Medium	Gate	Repair Needed	Tele lock to be placed on gate when available. REAF BERNARDS 10/18		43° 43.542' N	121° 47.749' W

Repair ID	Priority	Line Type	Status	Repairs Needed	Repair Comments	Len (ft)
41F8F	High	Completed Dozer Line	Completed - Inspected		READ SCHUDER & READ Brewer inspected 9/24/2022	5594
A8D97	High	Completed Fuel Break	Completed - Inspected		all masticator and cone work done. A few random berms that will not create any issues but should be knocked down by snow weight over the winter. REAF Jackson 10/4/2022.	6883
966A9	High	Completed Hand Line	Completed - Inspected	Pull in burn		65
4B42F	High	Completed Hand Line	Repair Needed	pull flagging. pull hose lay . disperse large piles of stumps.low stumping, pull back berms and cups, disperse green material across scratch		3867
C2F98	High	Completed Hand Line	Repair Needed	FULL REPAIR	pull flagging.pull hose lay . disperse large piles of stumps.low stumping, pull back berms and cups, disperse green material across scratch	3852
F8A52	High	Completed Hand Line	Repair Needed	FULL REPAIR	pull flagging.pull hose lay . disperse large piles of stumps.low stumping, pull back berms and cups, disperse green material across scratch	2923

C8B75	High	Completed Hand Line	Repair Needed	FULL REPAIR		196
F8C71	High	Completed Road as Line	Completed - Inspected			19082
41E81	Medium	Completed Dozer Line	Completed - Inspected	knock back berms and spread logs and slash across line	needed repairs completed on 10/10/2022. REAF Jackson	96
2623C	Medium	Completed Dozer Line	Completed - Inspected	FULL REPAIR	soil berms not still present and too heavy on the slash pulled over dozer line	1227
739C0	Medium	Completed Dozer Line	Completed - Inspected	pull berms with handcrew.	minimal impact dozer line.	774
1A851	Medium	Completed Hand Line	Completed - Inspected	Pull back berm, scatter slash, low stump		712
5A48C	Medium	Completed Hand Line	Completed - Inspected	Pull berms, disperse slash, waterbar if appropriate		2422
C1E03	Medium	Completed Hand Line	Completed - Inspected	Pull berms and disperse slash and windrow. REAF schaefer, 10/18/22	Small section is hiking trail so return to original condition	772

7E7C7	Medium	Completed Hand Line	Completed - Inspected	Pull berms and disperse slash and windrow. REAF schaefer, 10/18/22	Small section of Handline on hiking trail, return to original condition	559
CC70A	Medium	Completed Hand Line	Repair Needed	FULL REPAIR		214
C4FD9	Medium	Completed Hand Line	Repair Needed	FULL REPAIR		173
16834	Medium	Completed Road as Line	Completed - Inspected	Chipping of slash along roadway	minimal chipping and daylighting. no further repair needed. REAF Jackson 10/6/2022	8183
3CE1A	Medium	Road Repair	No Repair Needed	Unable to get chipper in due to lack of turnaround.		15168
F4139	Medium	Road Repair	Repair Needed	Recontour fillslope to road by knocking back berms and scattering large woody debris		7
