Suppression Repair Tiles

Cedar Creek
OR-WIF-220180
10/23/2022 24 Hour
127,283 acres at 10/20/2022 @ 2027
1:1,100,000

Div X2

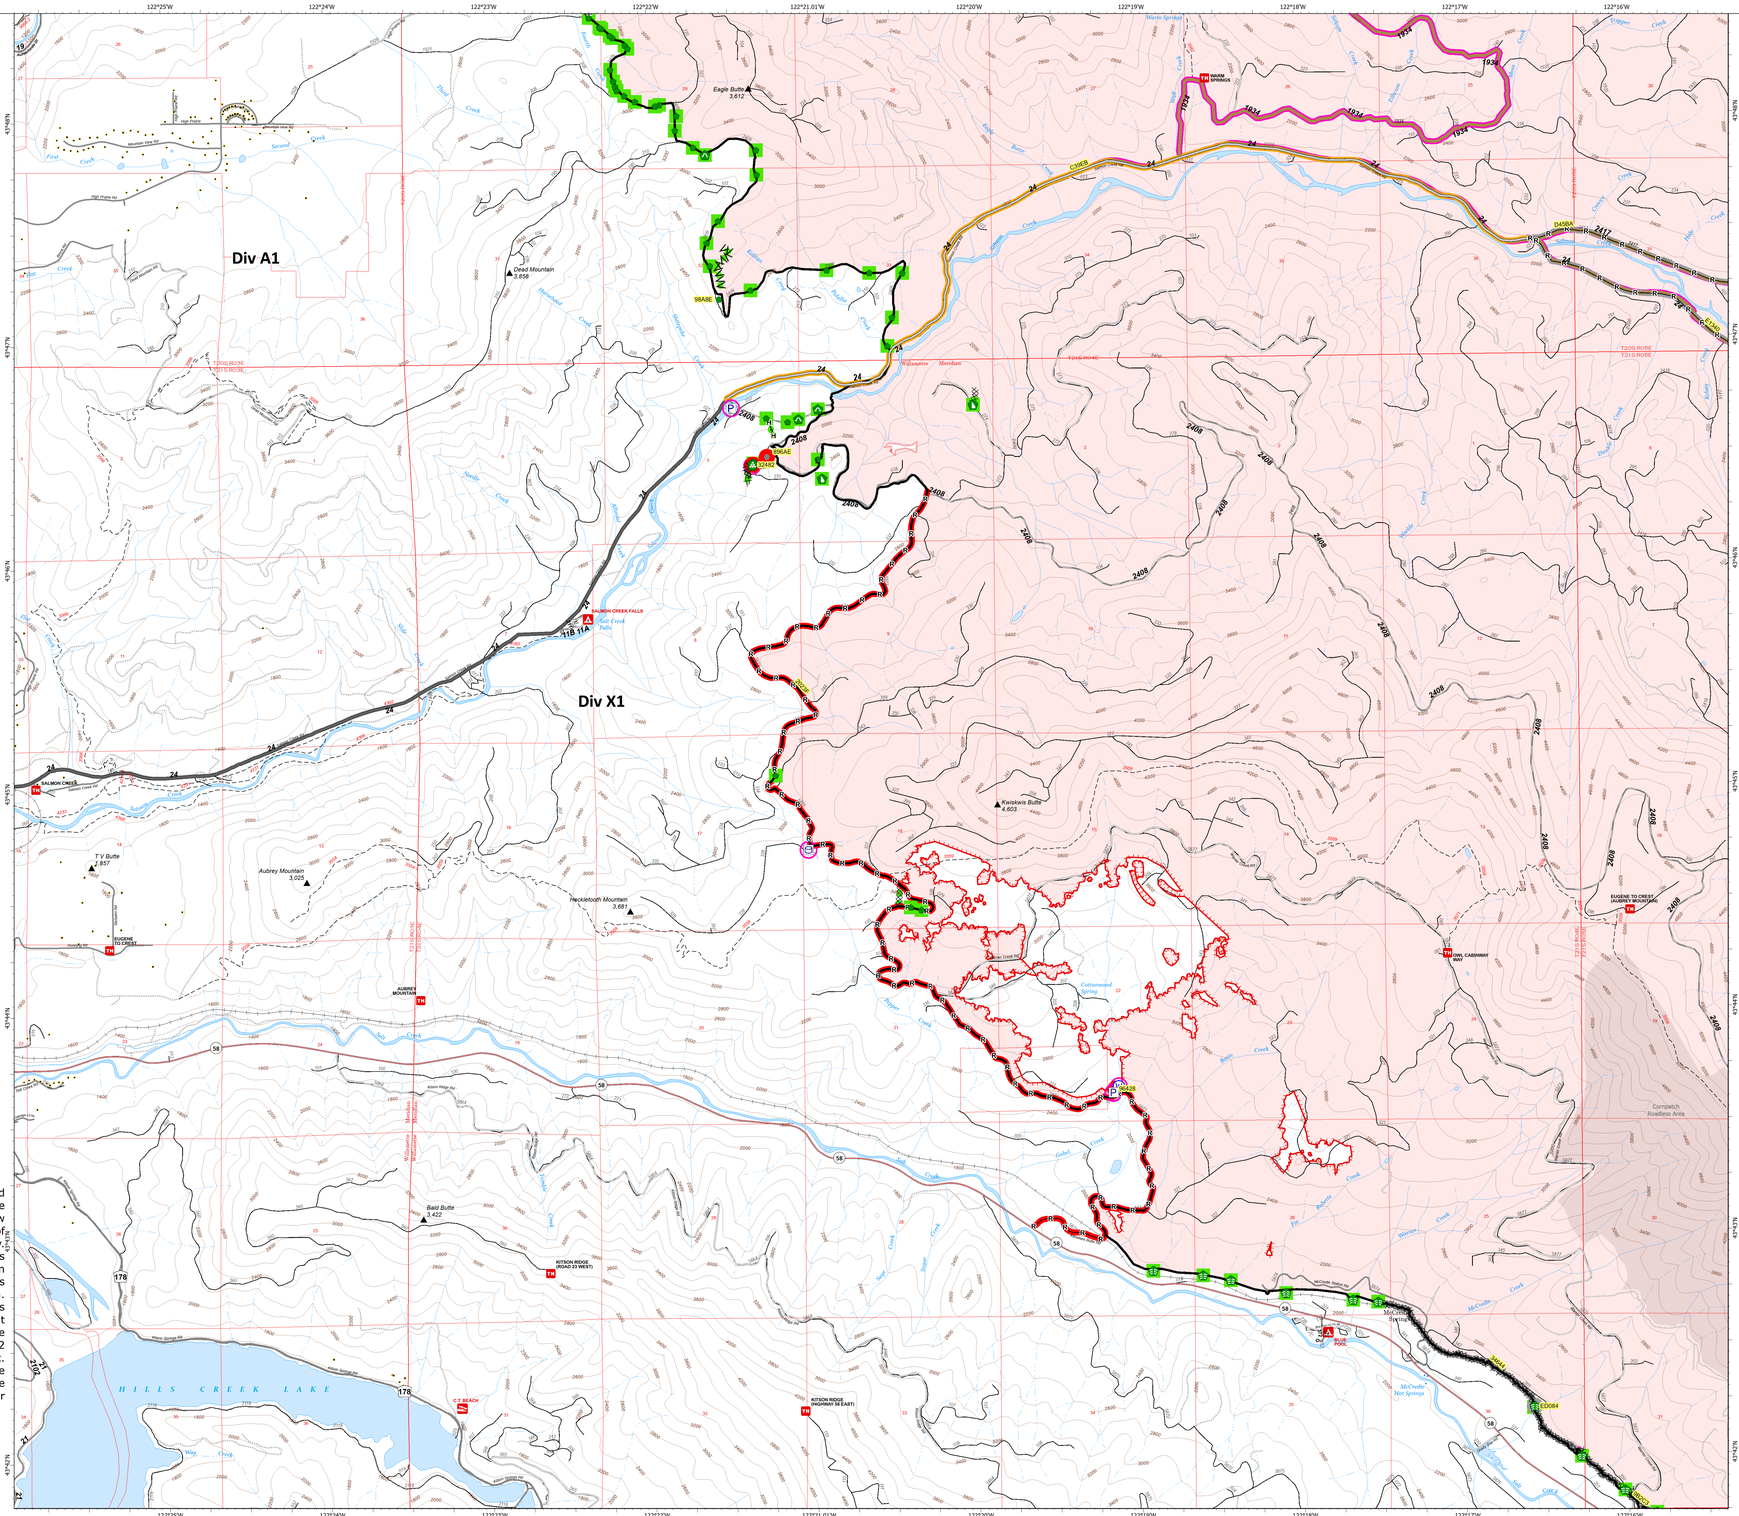
Repair ID	Priority	Point Type	Status	Repairs Needed	Repair Comments	Latitude	Longitude
32492	High	Landing or Log Deck	Repair Needed	Rip, slash, seed and straw disturbed area. Use ripped out stumps to block vehicle access. Recover 2408-270 spur. CYSE in area. REAF Mckay/Castro, 08/30/22. In use as log deck, repair after log removal REAF Davis 9/28		43° 46.457 N	122° 21.360' W
89AAE	High	Other	Repair Needed	Biohazard cleanup		43° 46.487 N	122° 21.277' W
96428	Medium	Repair Point	Repair Needed	Pull back berms on edge of wasp, pull back large berm of material from dozer push, reshape to stable slope (now 1.75:1x) and drain, seed and mulch REAF Davis 10/10		43° 43.648' N	122° 19.149' W
98ABE	Medium	Repair Point	No Repair Needed	potentially mulch/disperse chips to a thinner layer	REAF Jones, 9/21: 3 areas of deep (>4 to 6 inches) layers of wood chips	43° 47.194' N	122° 21.562' W
E3D84	Medium	Stream Crossing	Other - See Comments	no	Remove slash and rounds from side of road and channel, particularly south side of road, box class 3 stream) - Geertsen 10/11 / REAF ALLEN 9/25/22 - Clear slash and debris from stream bed.	43° 42.217 N	122° 16.580' W

Repair ID	Priority	Line Type	Status	Repairs Needed	Repair Comments	Len (ft)
CR6B	High	Access or Improved Road	In Progress	Cut Danger Trees, Clear Ditches	Needed to access all other repair work on 2417, 2419, 2421, 2422. Impacts TES Fish Habitat and Priority for District/Public access.	26255
2022F	High	Completed Road as Line	Repair Needed	Clean ditches and culvert blocks/outlets 10/4 JBH	MP 1.37 construct armored dip. See drawings and specs. Clean ditch and culverts. 750 cy spot rock. Grade and roll. BOF at 58 jw. 8/29 CP. Multiple invasive weeds along road. CYSCH, BULA, BROY, VEDU. Will need to treat weeds post fire, seed and mulch disturbed and exposed soil. BM 8/27.	40278
34644	Medium	Completed Dozer Line	Other - See Comments	As of 10/12 railroad will take responsibility of dozer line. they maintain it annually. .pset . FIRE MANAGEMENT 12/HT REPAIR	As of 10/12 rehab of dozer line from dp 70 to 77 will be done by railroad. . pset . Slope stream crossings to drain where labeled, seed and straw immediate banks of five (flowing) streams, put in water bars, pull slash over road -JG 8/28 READ DEMEO 9/17/22 Consult with District and Union Pacific about keeping this line open for use.	19811

D45WA	Medium	Completed Road as Line	Other - See Comments	Clear ditch	Unknown if fire team wants to get to interior work. Ditches and culverts cleaned out for winter functionality 10.16 adam Clean ditch and culverts of slash and debris.	20480
E33RB	Medium	Completed Road as Line	Other - See Comments	Snag, clear ditches	Excavator pulled ditches and culverts for winterization 10.16 adam. Remove logs and slash from ditch. J Hoganson 8/29	17500
