# McCash Fire Structure Triage Assessment

CASRF000651  
August 18, 2021

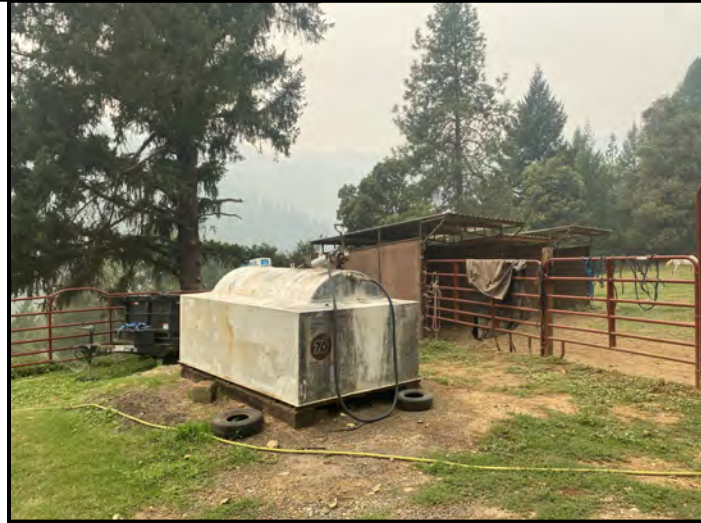
**Defensible, Stand Alone**

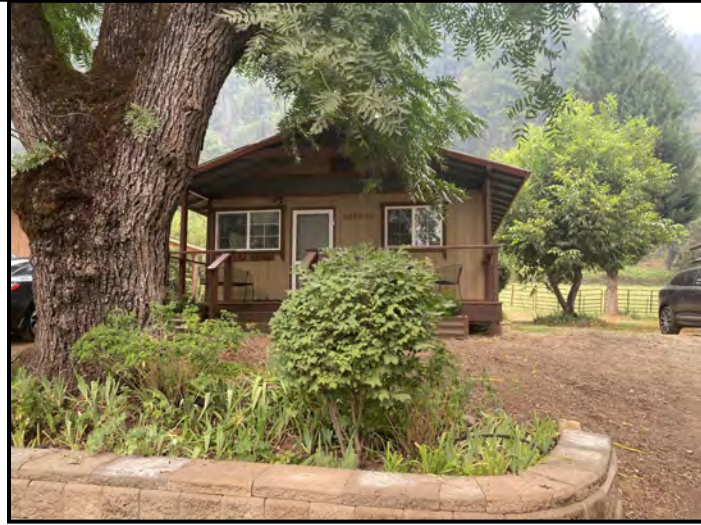
**Defensible, Prep and Hold**

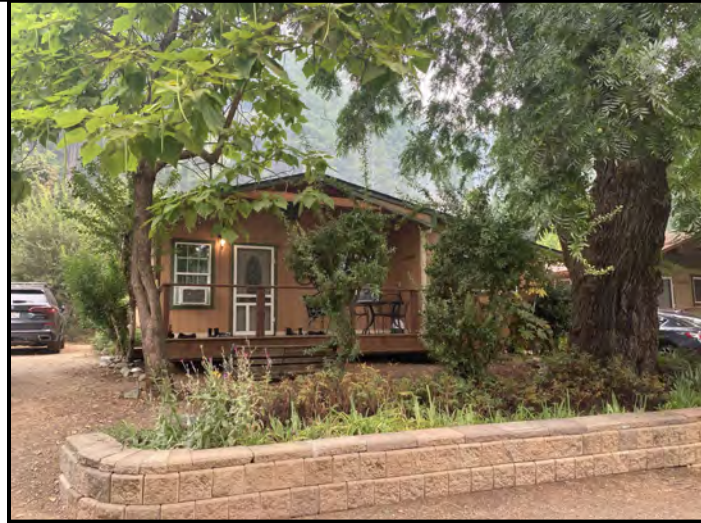
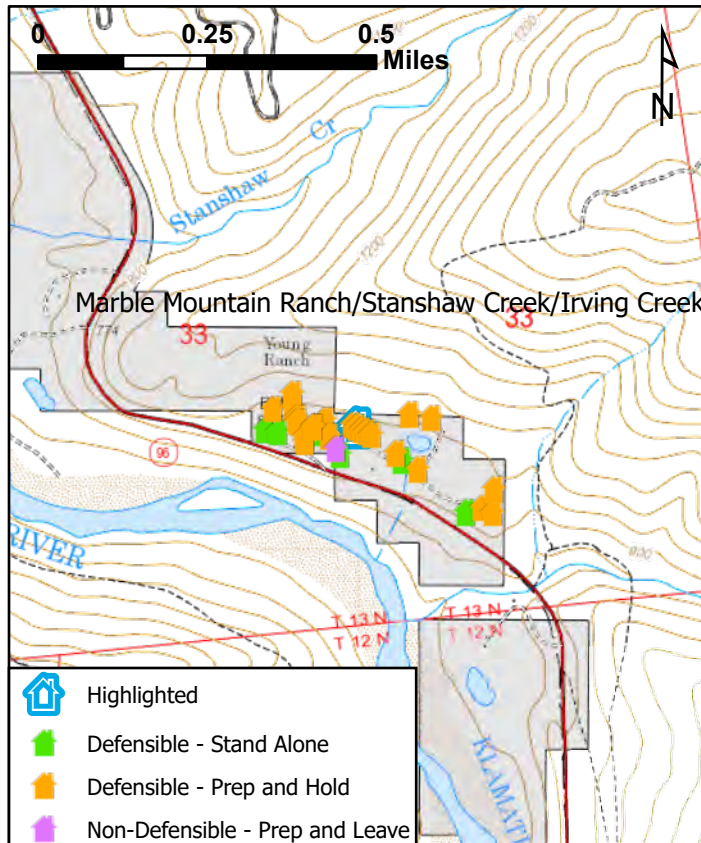
**Defensible, Prep and Hold**

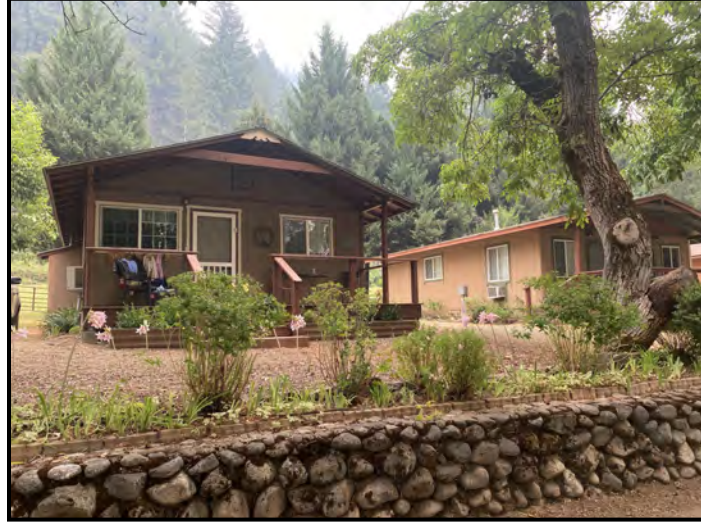
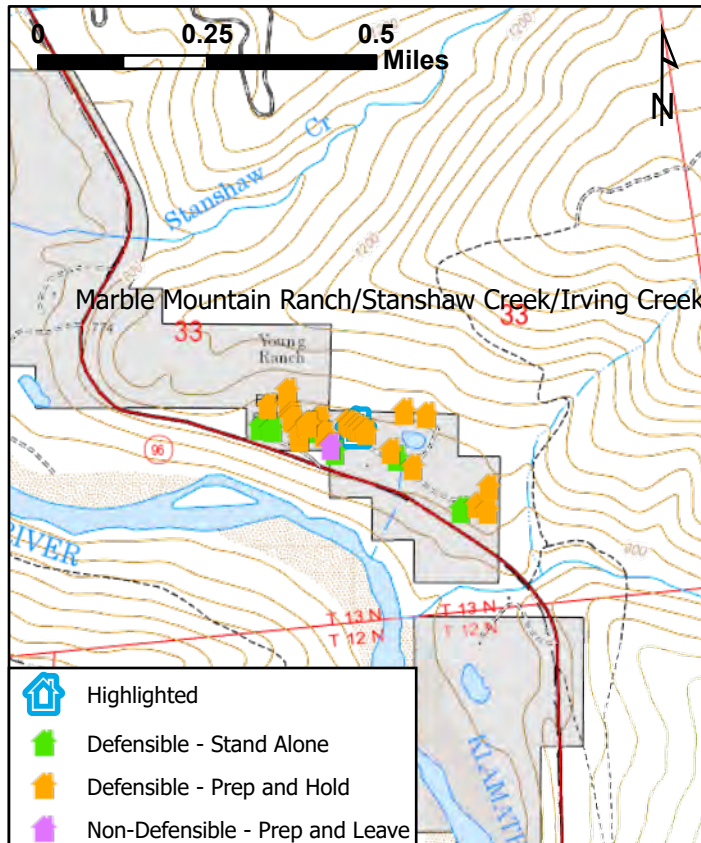
**Defensible, Prep and Hold**

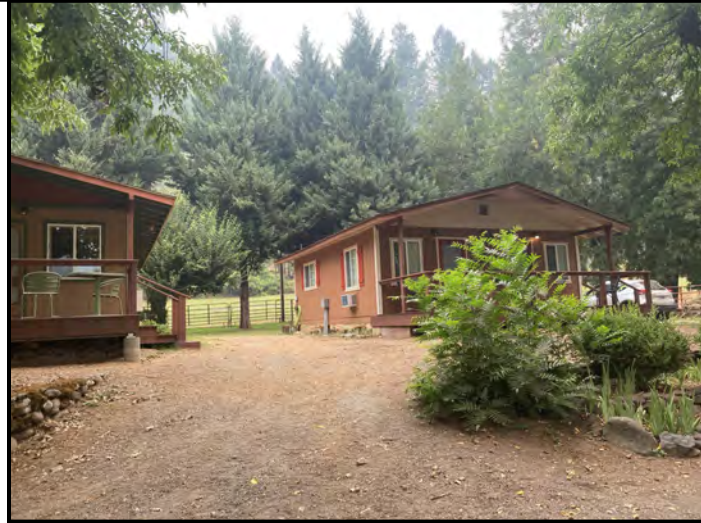
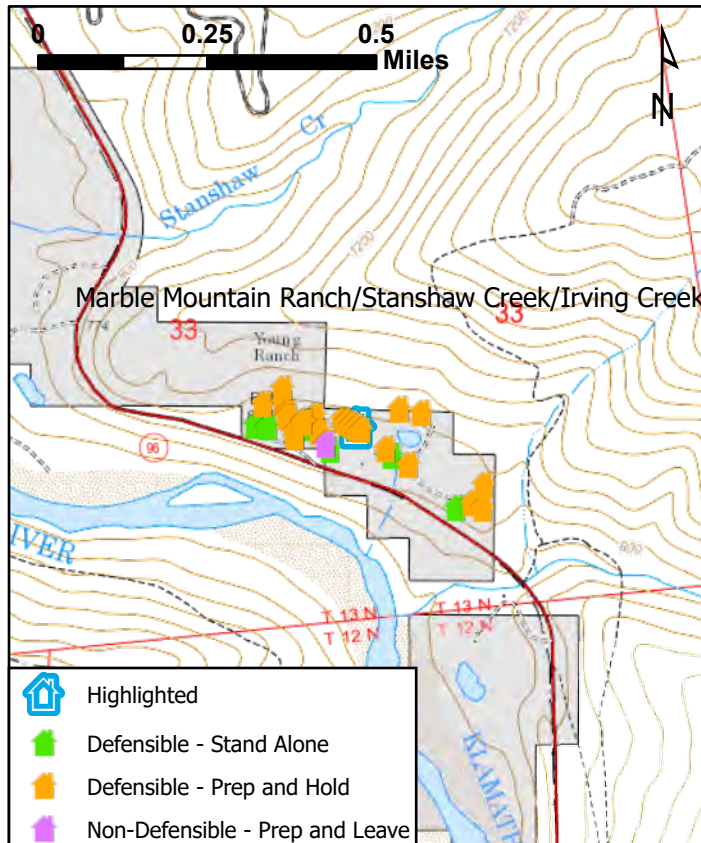
**Defensible, Prep and Hold**

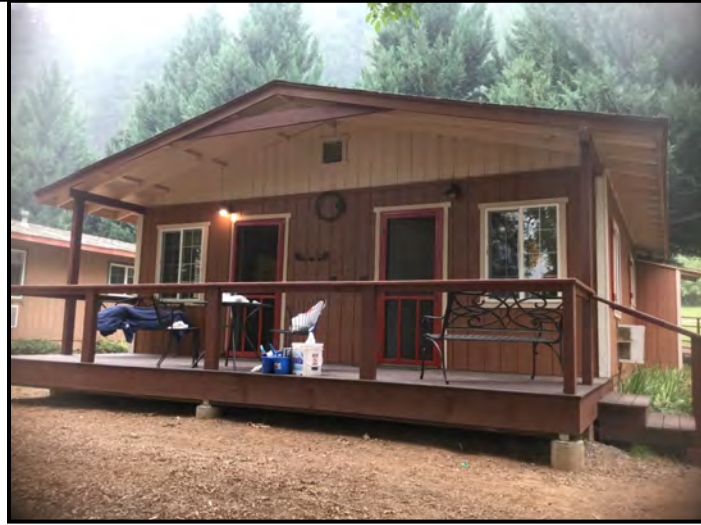
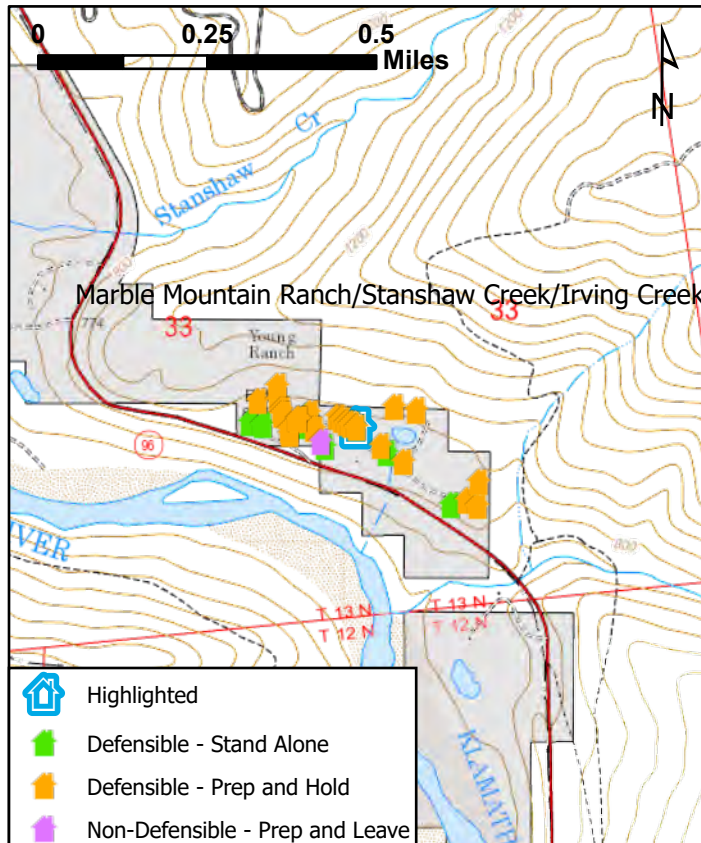
**Defensible, Prep and Hold**

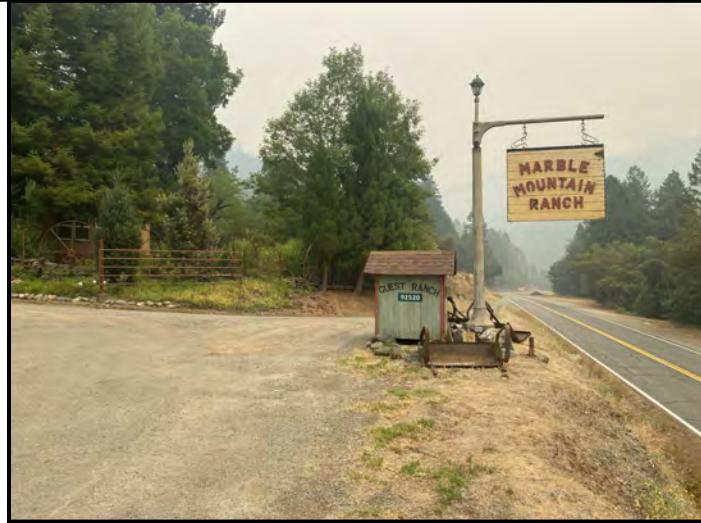
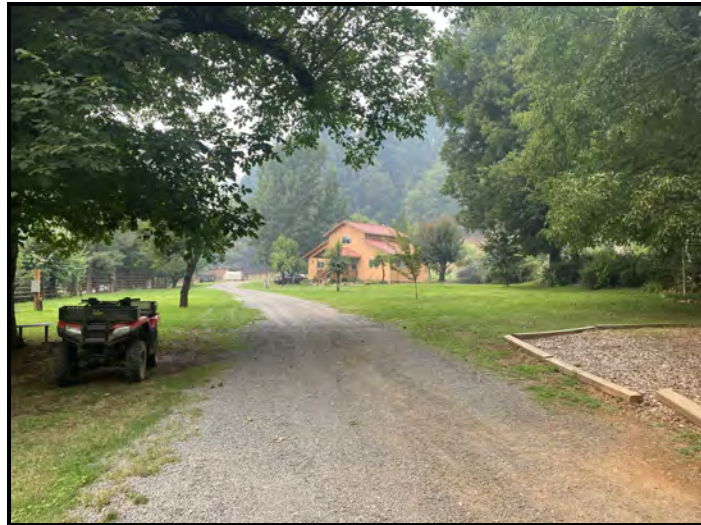
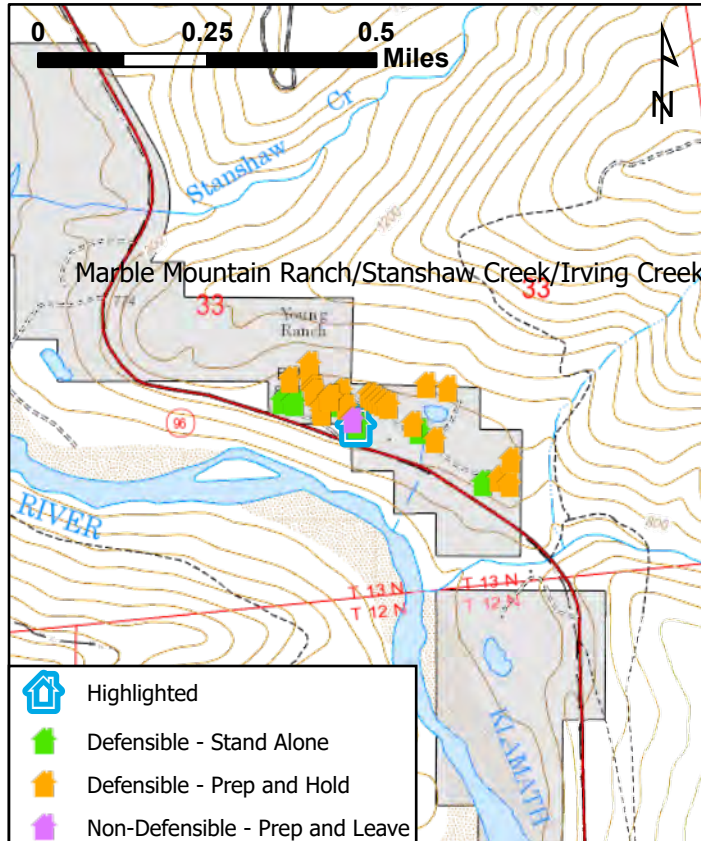
**Defensible, Stand Alone**

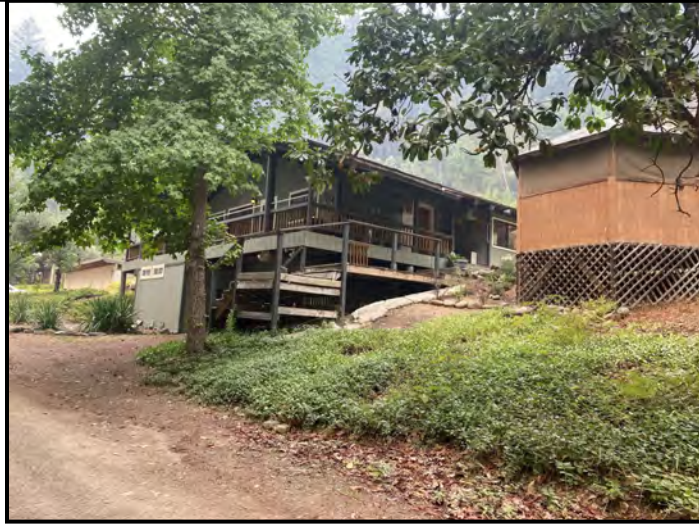
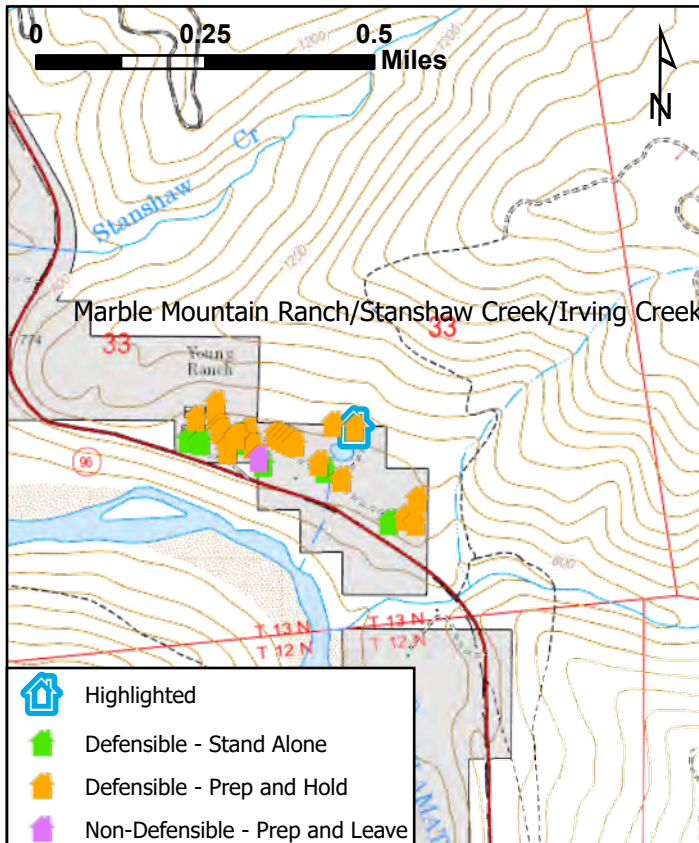
**Defensible, Prep and Hold**

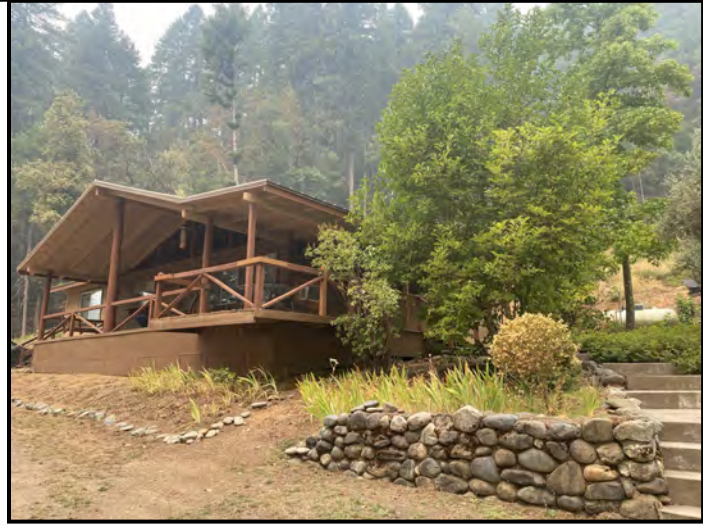
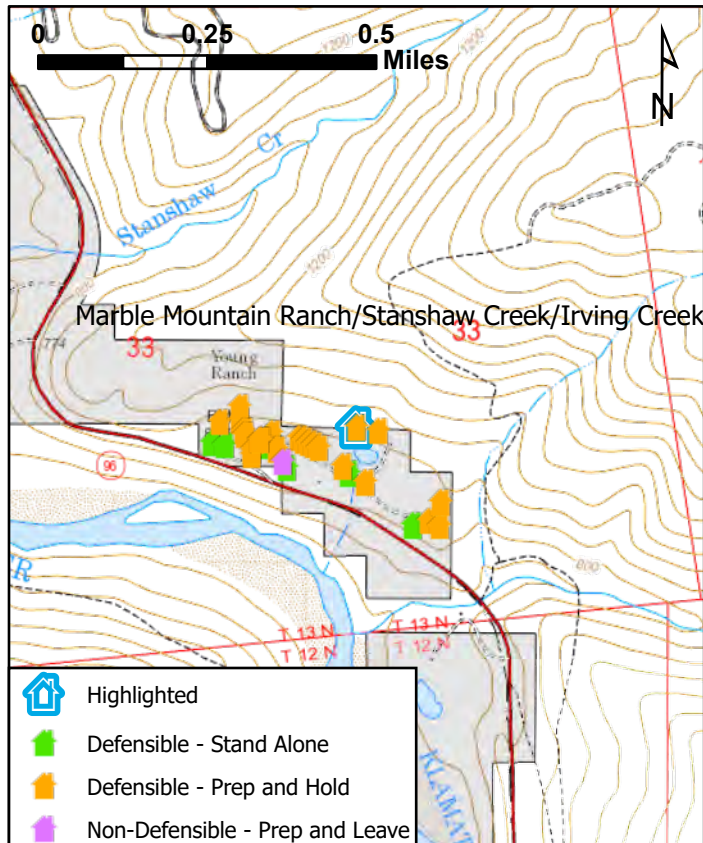
**Defensible, Prep and Hold**

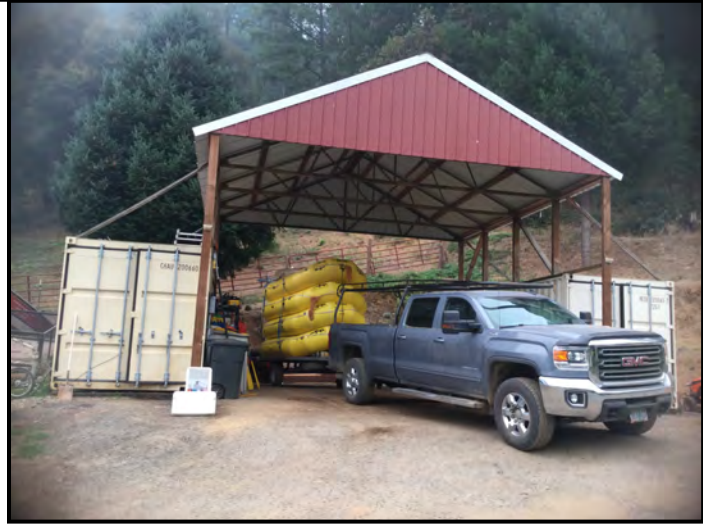
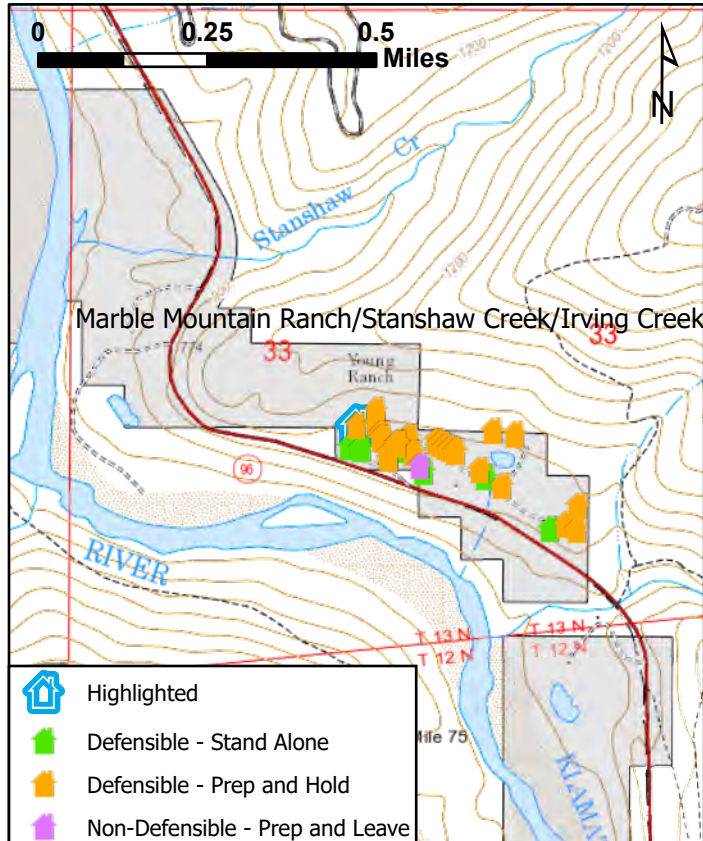
**Defensible, Prep and Hold**

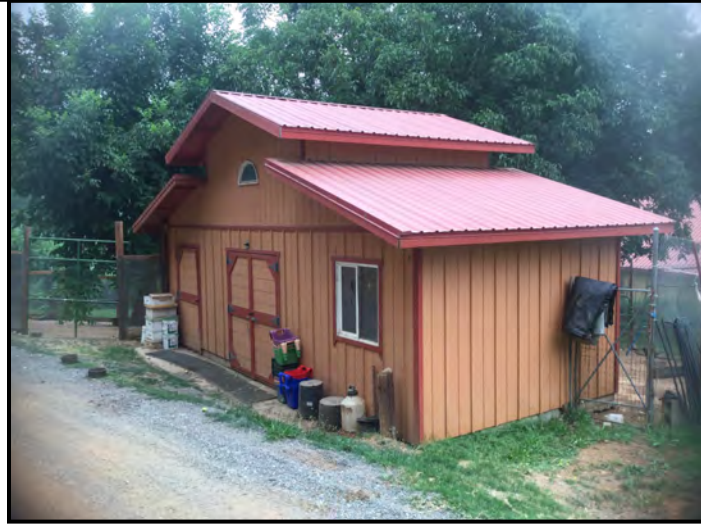
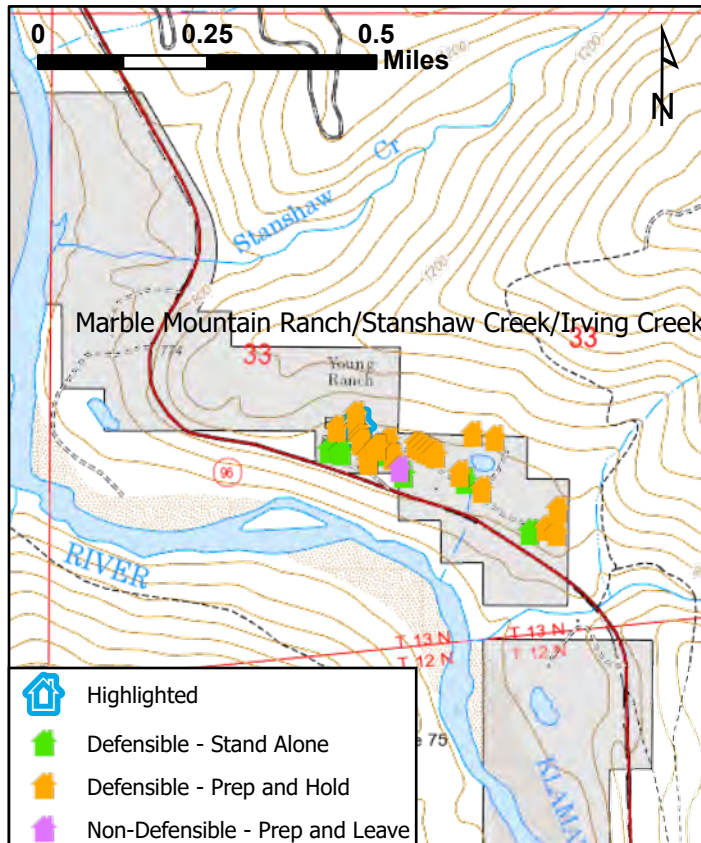
**Defensible, Prep and Hold**

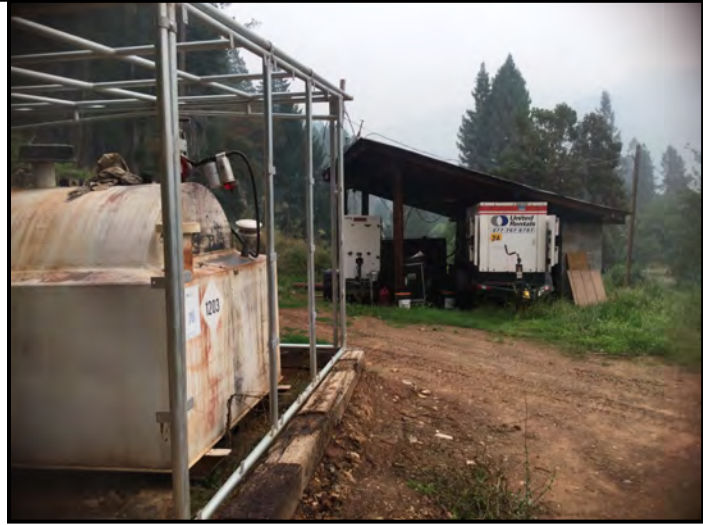
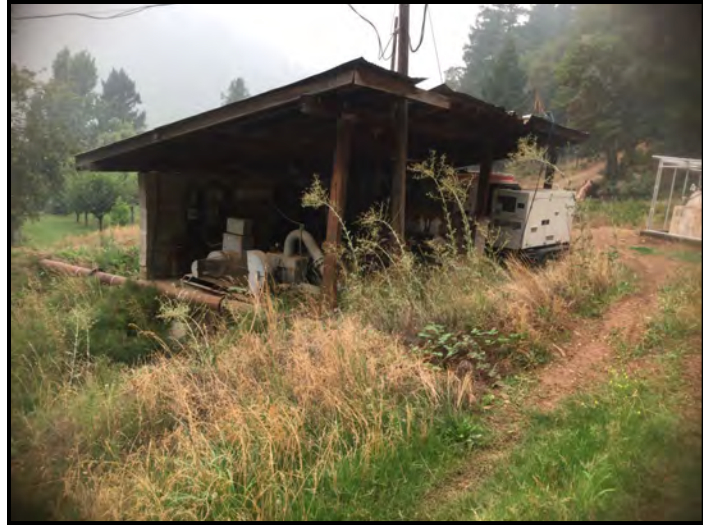
**Safety Zone(s):** Potential safety zone(s) in area  
**Comm With ICP:** Yes  
**Water Supply:** Reliable water source nearby  
**Fuel Type:**  
**Defensible Space:** 30 ft treated  
**Hazards:** Diesel tanks and generators

**Defensible, Prep and Hold**

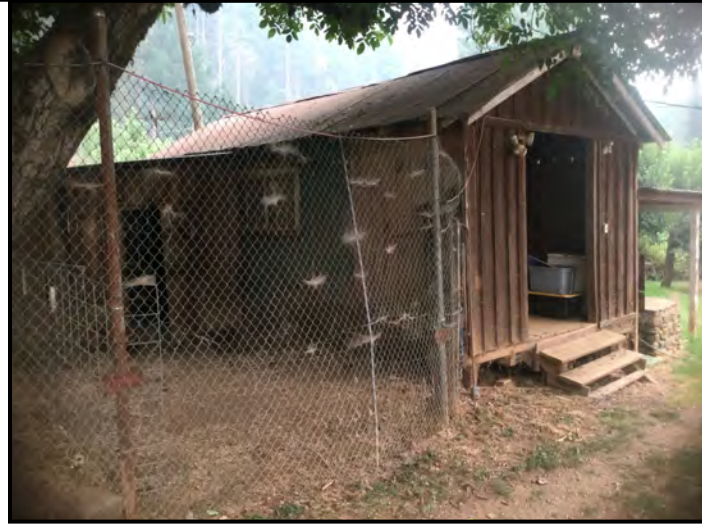
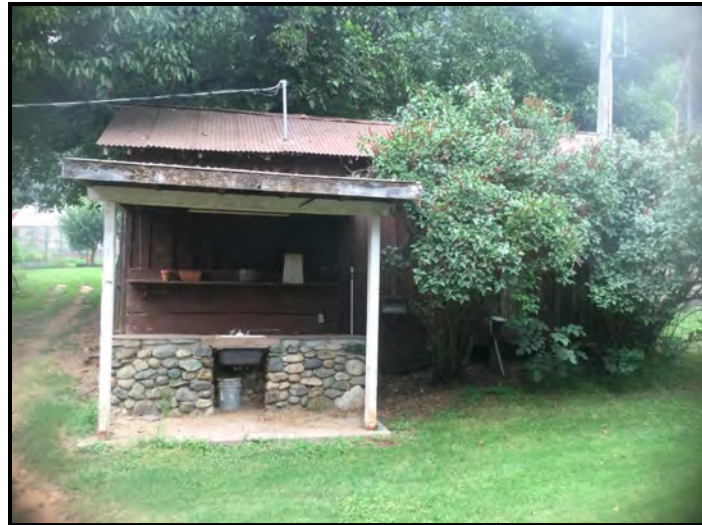
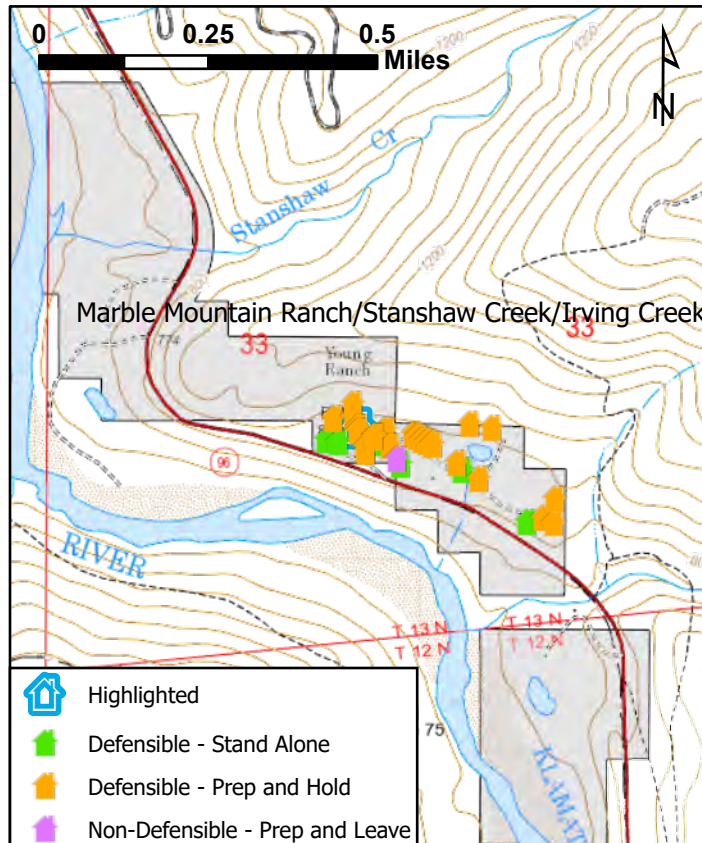
**Defensible, Prep and Hold**

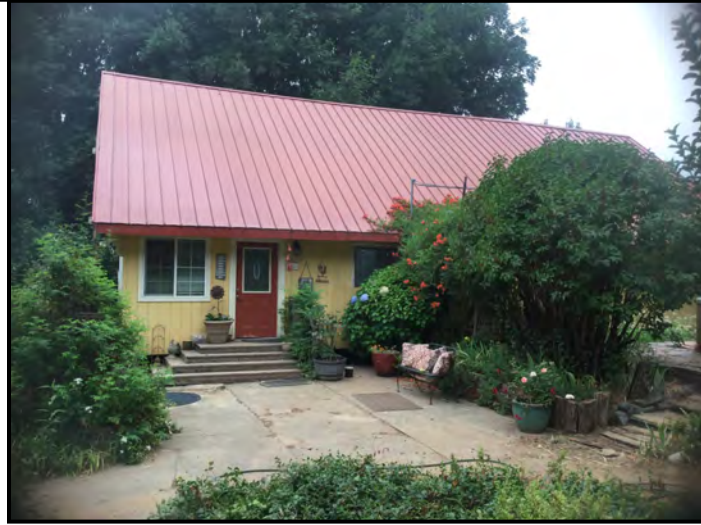
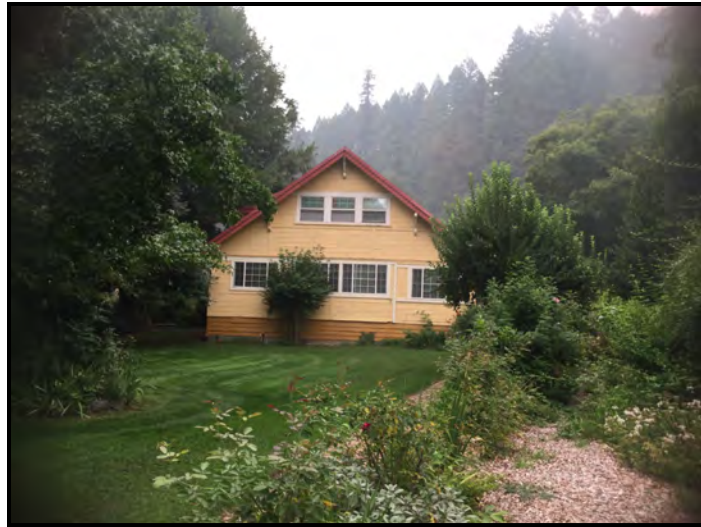
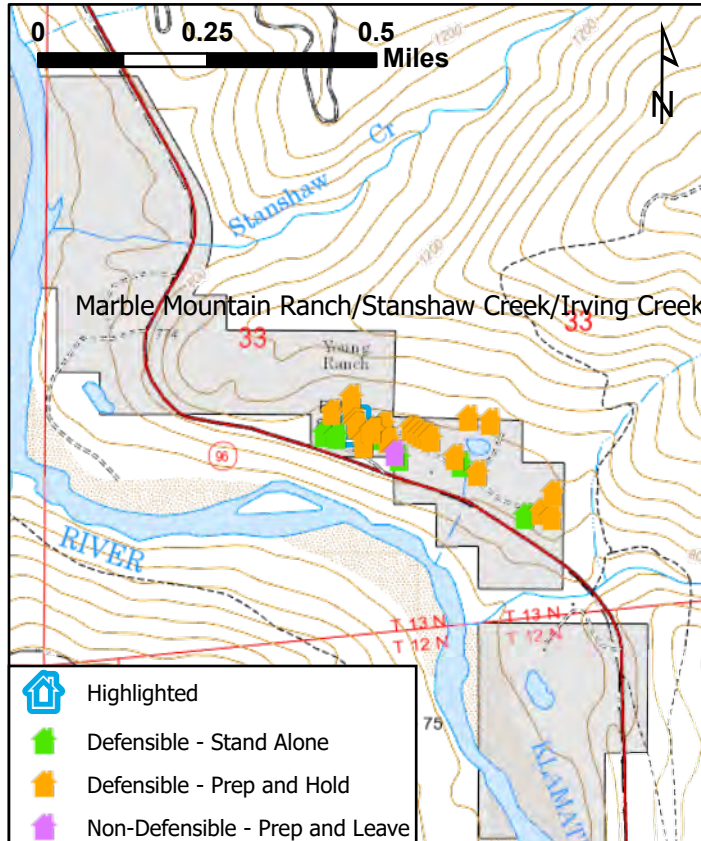
**Defensible, Prep and Hold**

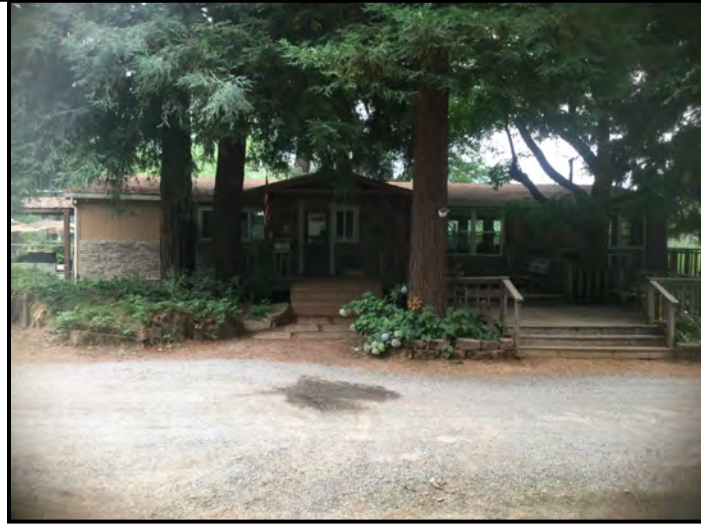
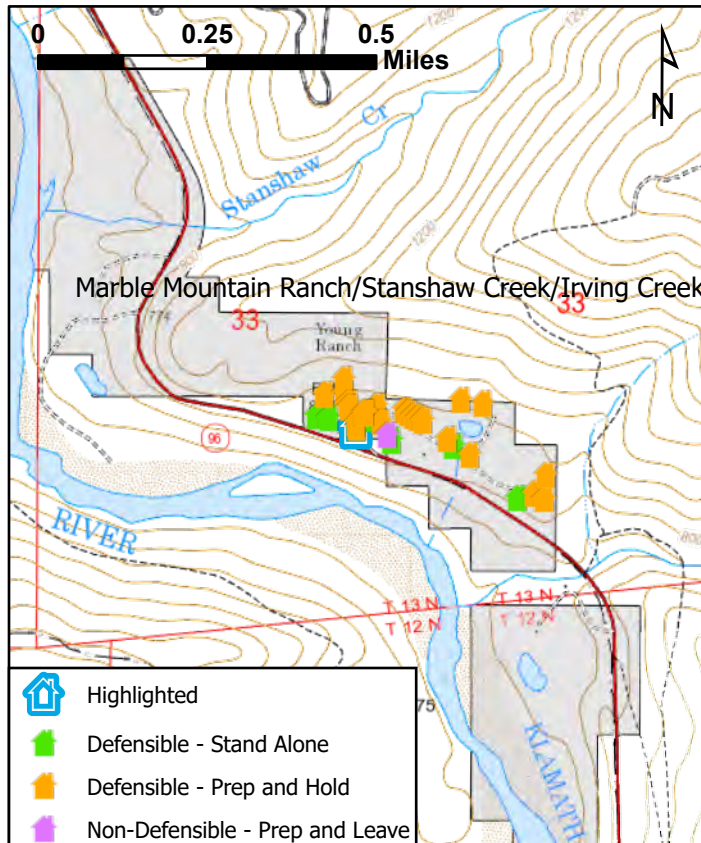
**Defensible, Prep and Hold**

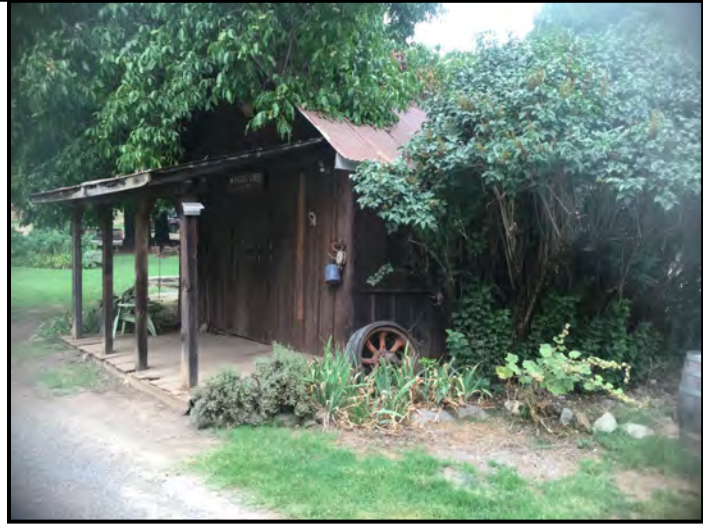
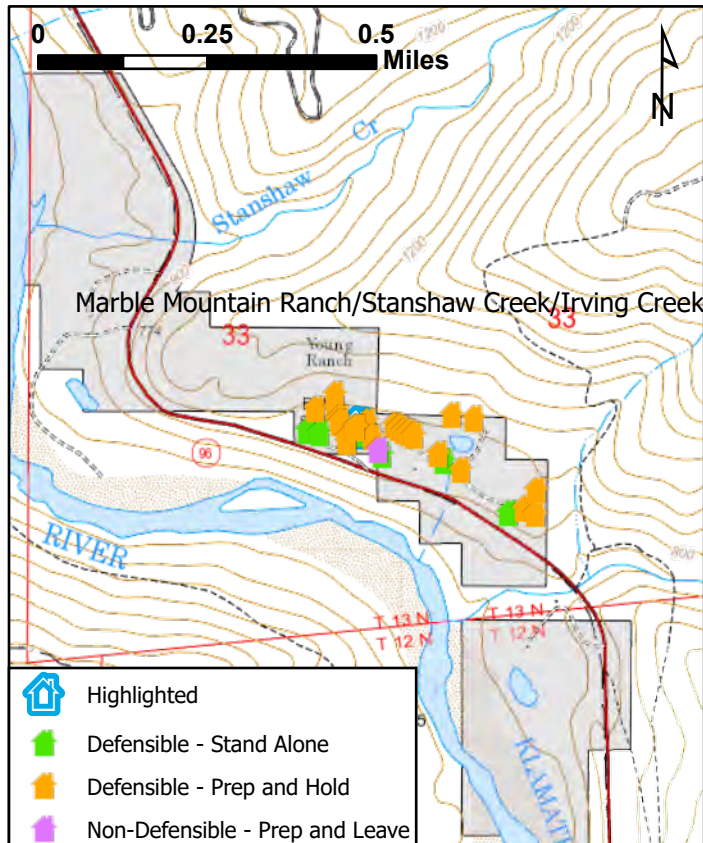
**Defensible, Prep and Hold**

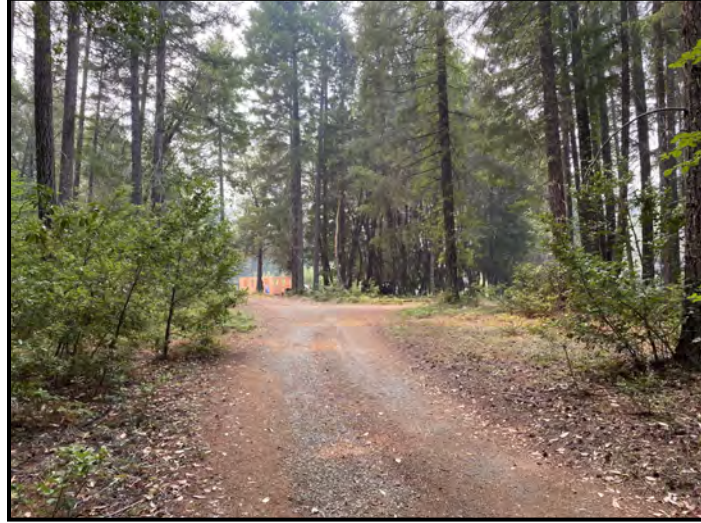
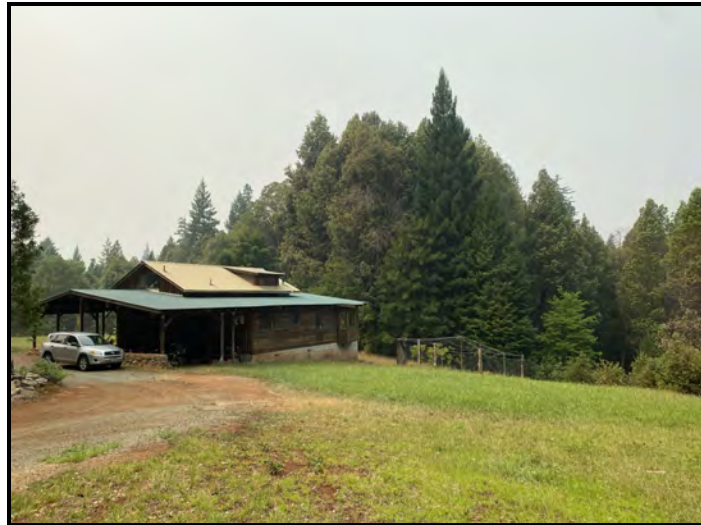
**Roof Material:** Noncombustible or not applicable  
**Siding Material:** Wood or open sided  
**Electrical Power:** No  
**Gas to Structure:** Yes  
**Comments:** Walt Simpson. Raised cinder block foundation, wood siding with metal roof.

**Safety Zone(s):** No safety zone(s) in area  
**Comm With ICP:** No  
**Water Supply:** Limited or dependent on electricity  
**Fuel Type:** Shrub or timber  
**Defensible Space:** 30 ft treated  
**Hazards:** Propane tank

**Defensible, Prep and Hold**

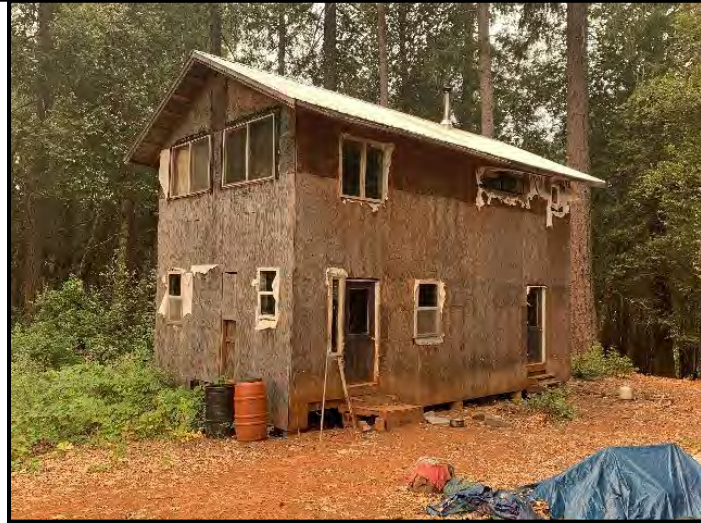
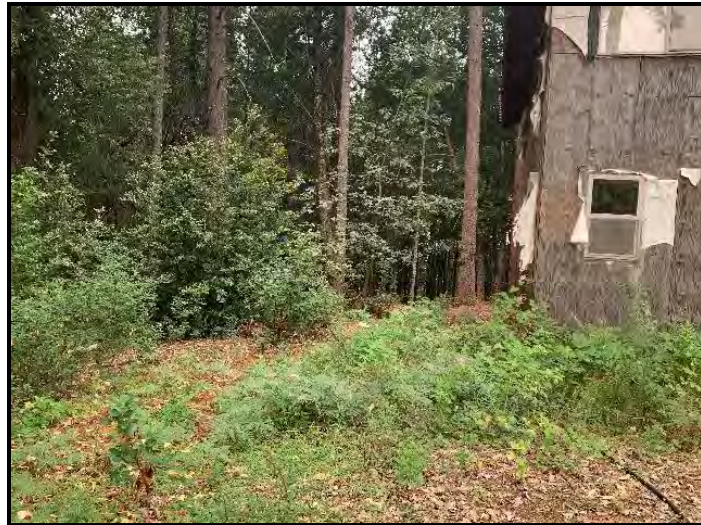
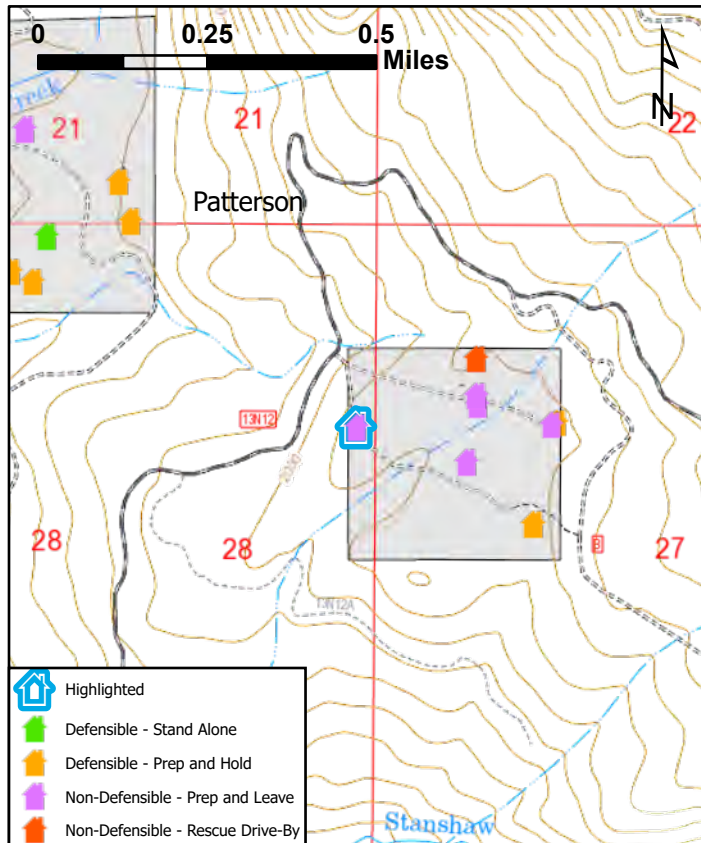
**Safety Zone(s):** No safety zone(s) in area  
**Comm With ICP:** Yes  
**Water Supply:** No reliable water source nearby  
**Fuel Type:** Shrub or timber  
**Defensible Space:** Less than 30 ft treated  
**Hazards:**

**Non-Defensible, Prep and Leave**

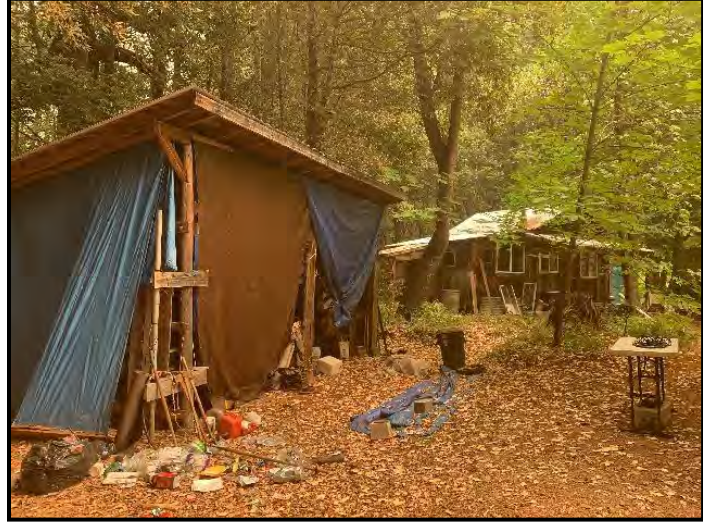
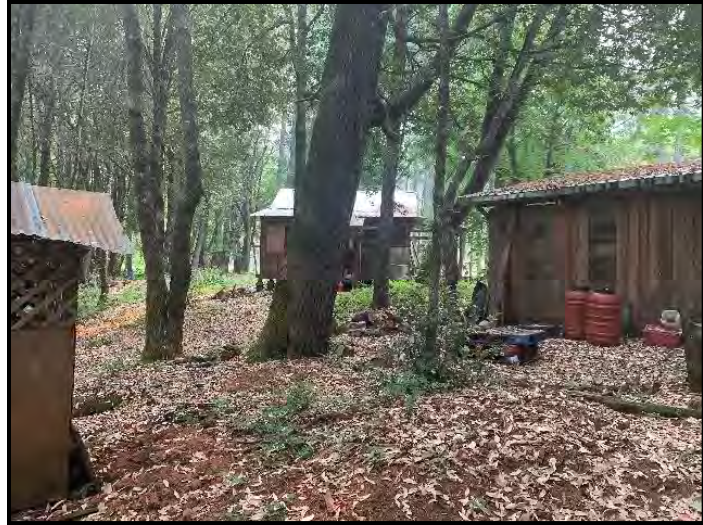
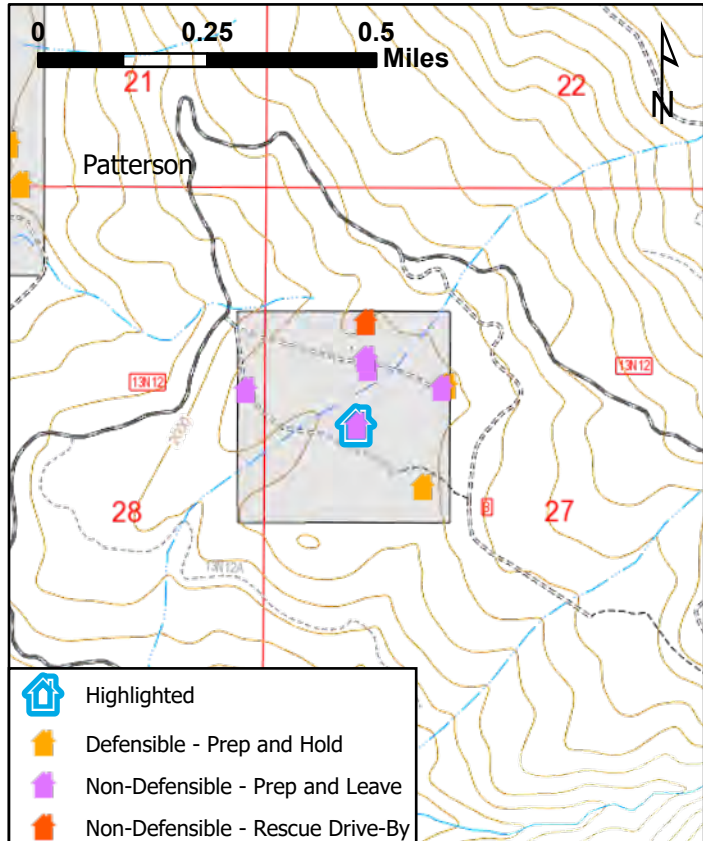
**Safety Zone(s):** No safety zone(s) in area  
**Comm With ICP:** Yes  
**Water Supply:** No reliable water source nearby  
**Fuel Type:** Shrub or timber  
**Defensible Space:** Less than 30 ft treated  
**Hazards:**

**Non-Defensible, Prep and Leave**

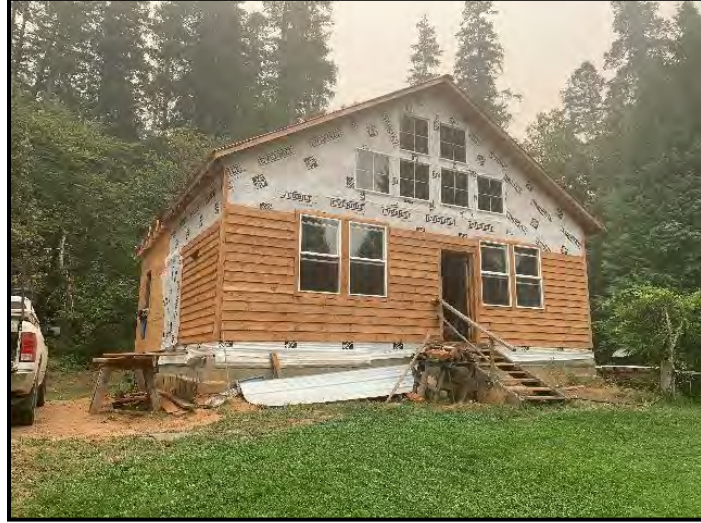
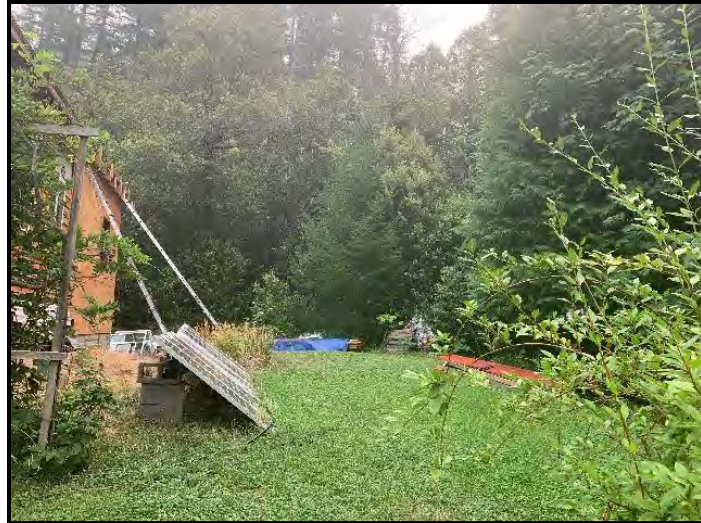
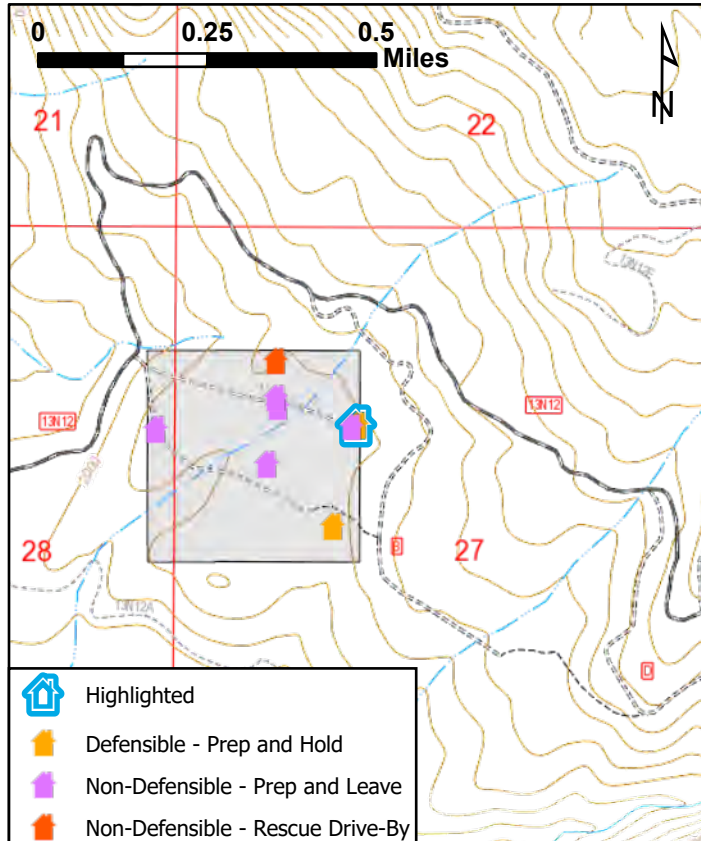
**Safety Zone(s):** Potential safety zone(s) in area  
**Comm With ICP:** Yes  
**Water Supply:** No reliable water source nearby  
**Fuel Type:** Shrub or timber  
**Defensible Space:** 30 ft treated  
**Hazards:**

**Defensible, Prep and Hold**

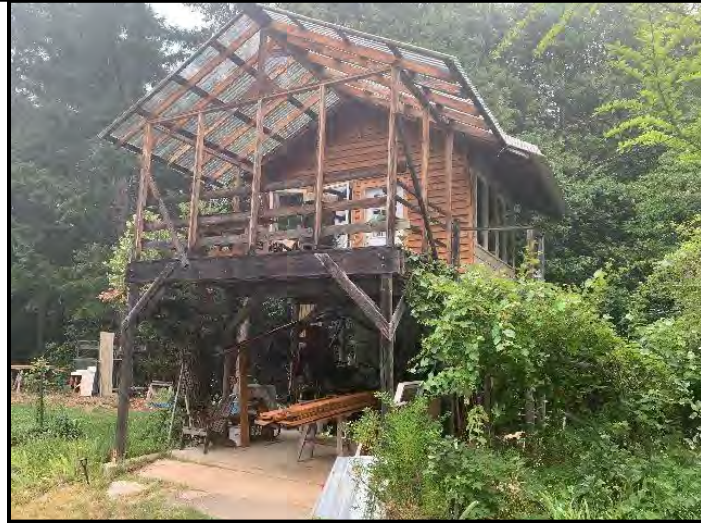
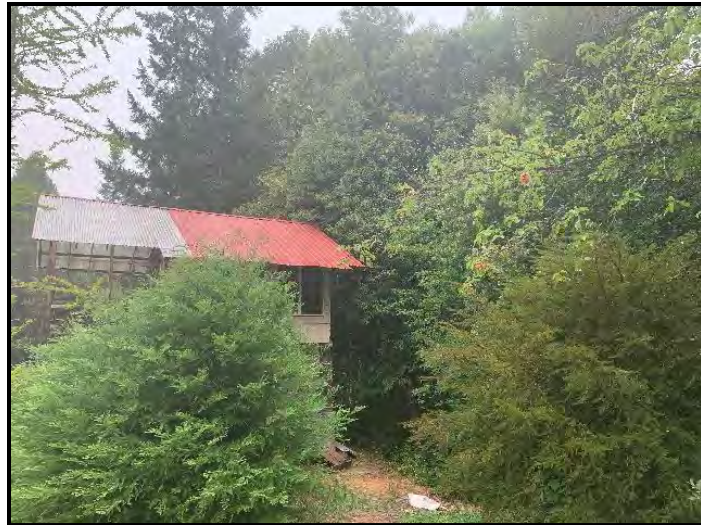
**Safety Zone(s):** No safety zone(s) in area  
**Comm With ICP:** Yes  
**Water Supply:** No reliable water source nearby  
**Fuel Type:** Shrub or timber  
**Defensible Space:** No defensible space  
**Hazards:** Heavy fuel load

**Non-Defensible, Prep and Leave**

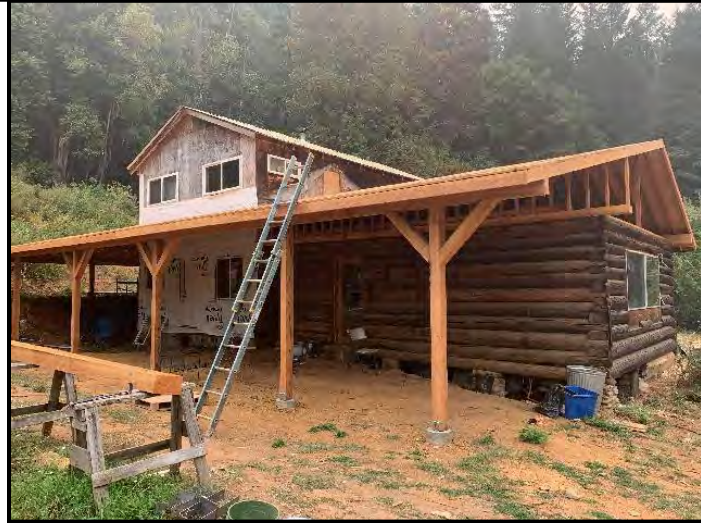
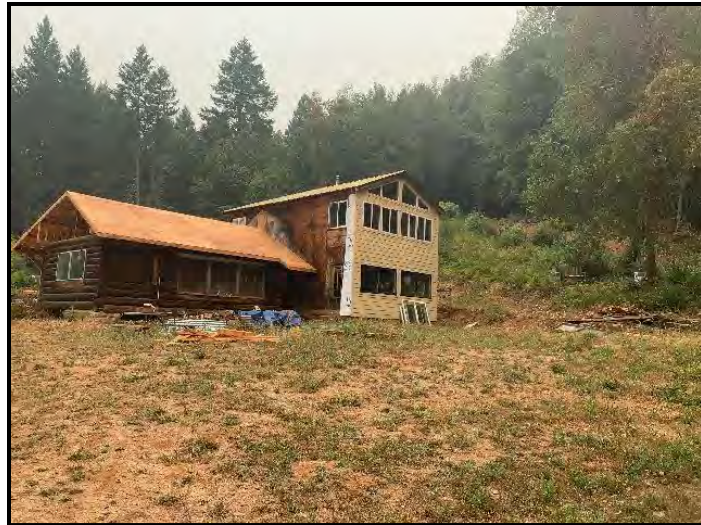
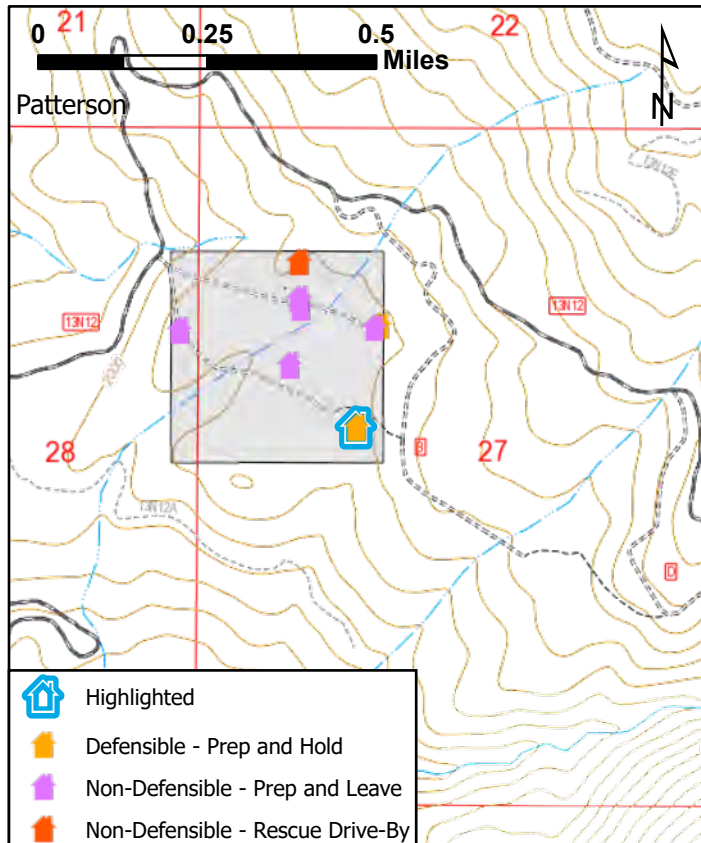
**Safety Zone(s):** Potential safety zone(s) in area  
**Comm With ICP:** Yes  
**Water Supply:** No reliable water source nearby  
**Fuel Type:** Shrub or timber  
**Defensible Space:** 30 ft treated  
**Hazards:**

**Defensible, Prep and Hold**
