# McCash Fire Structure Triage Assessment

CASRF000651  
August 18, 2021

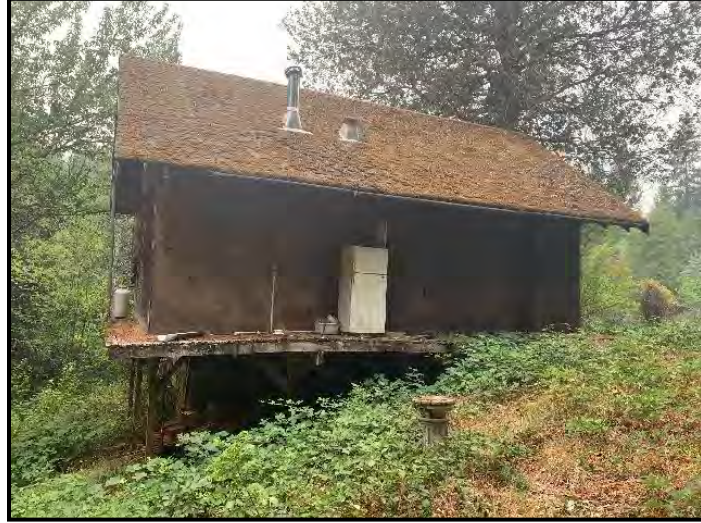
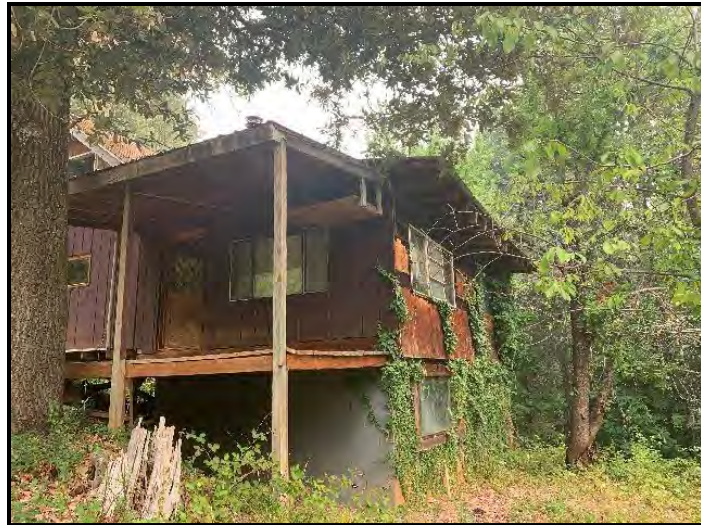
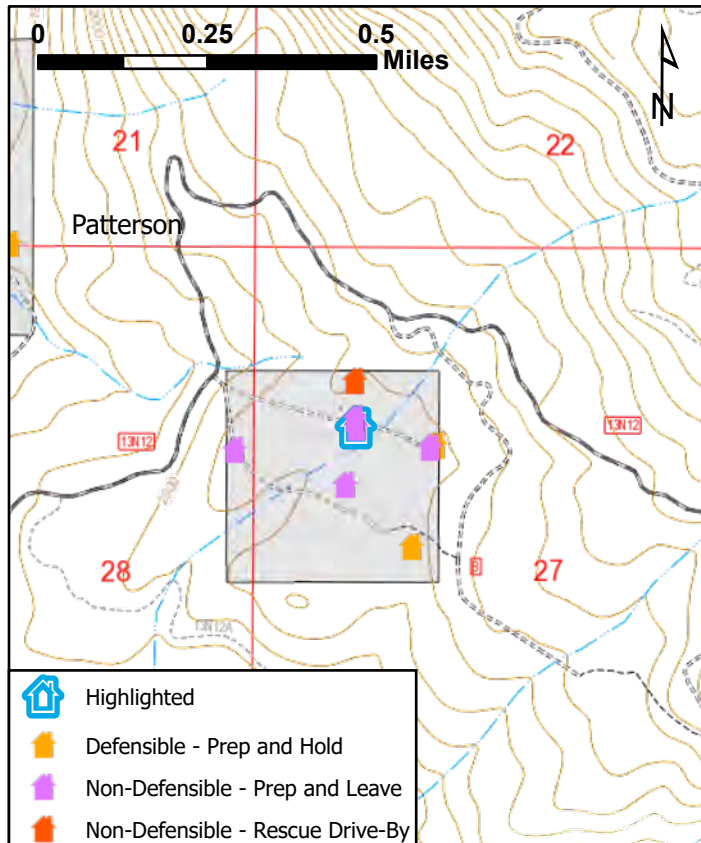
**Safety Zone(s):** No safety zone(s) in area  
**Comm With ICP:** Yes  
**Water Supply:** No reliable water source nearby  
**Fuel Type:** Shrub or timber  
**Defensible Space:** Less than 30 ft treated  
**Hazards:**

**Non-Defensible, Prep and Leave**

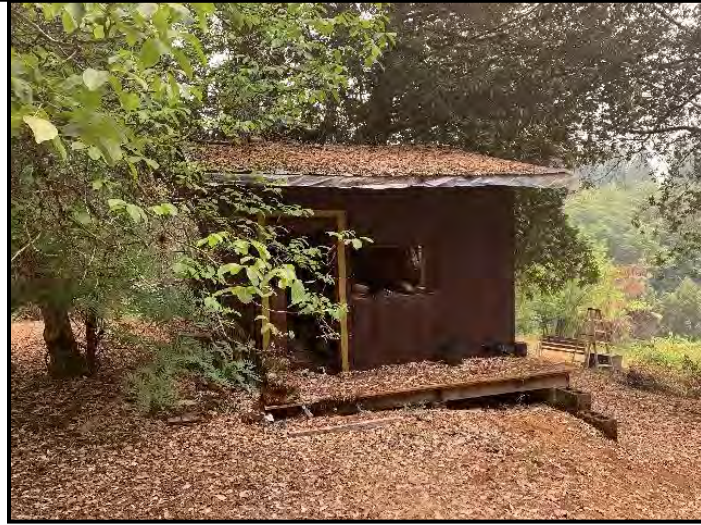
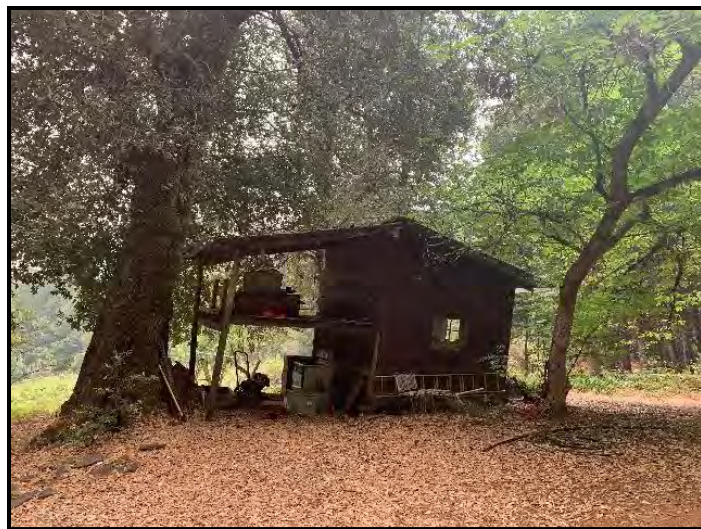
**Safety Zone(s):** No safety zone(s) in area  
**Comm With ICP:** Yes  
**Water Supply:** No reliable water source nearby  
**Fuel Type:** Shrub or timber  
**Defensible Space:** 30 ft treated  
**Hazards:** Collapse potential

**Non-Defensible, Prep and Leave**

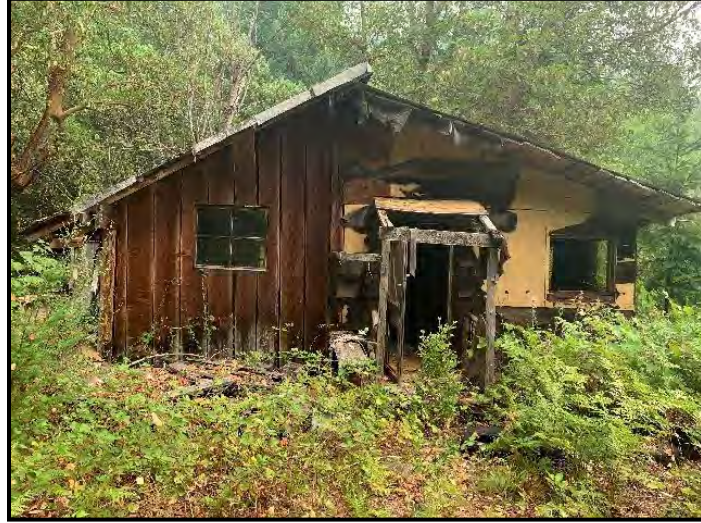
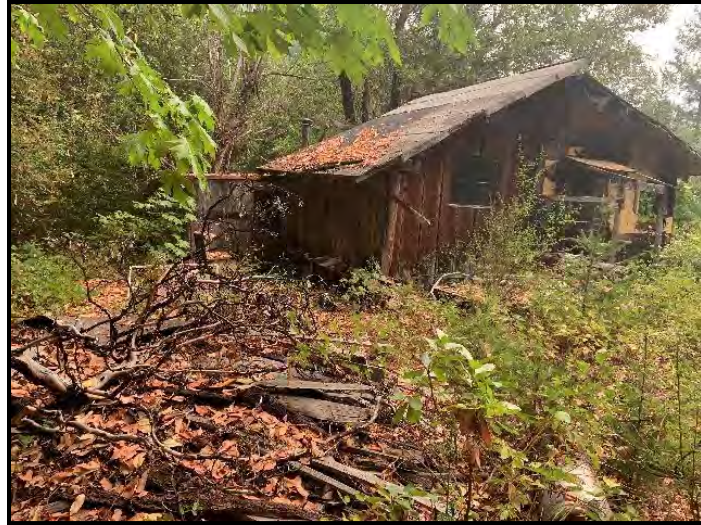
**Safety Zone(s):** No safety zone(s) in area  
**Comm With ICP:** Yes  
**Water Supply:** No reliable water source nearby  
**Fuel Type:** Shrub or timber  
**Defensible Space:** No defensible space  
**Hazards:** Structure itself and surrounding fuels

**Non-Defensible, Rescue, Drive By**

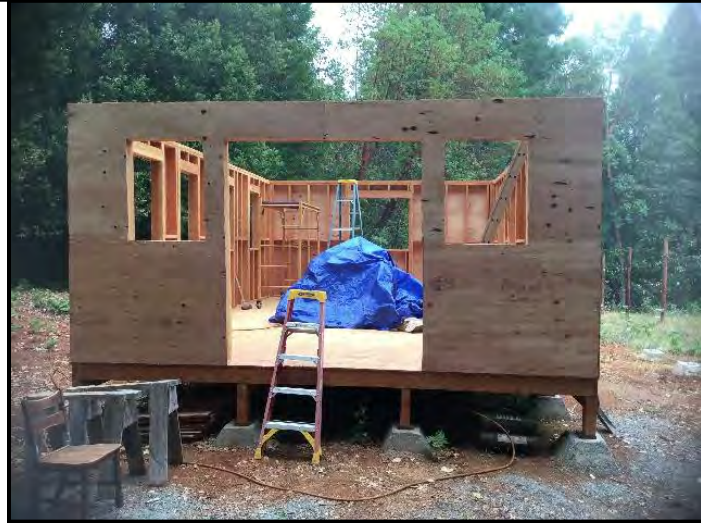
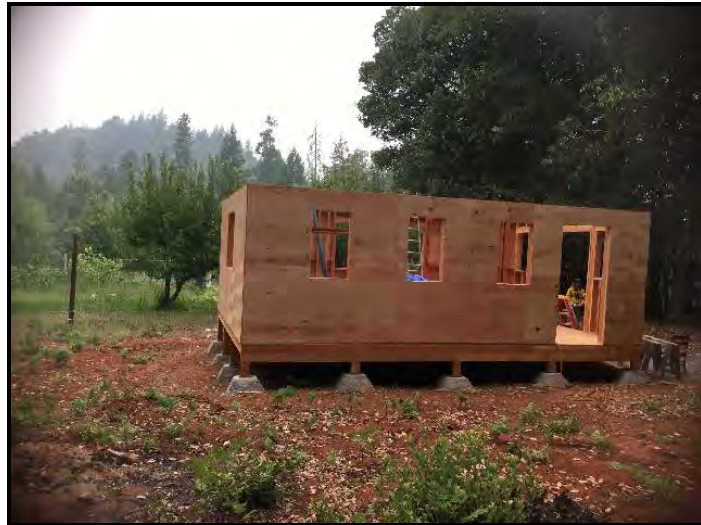
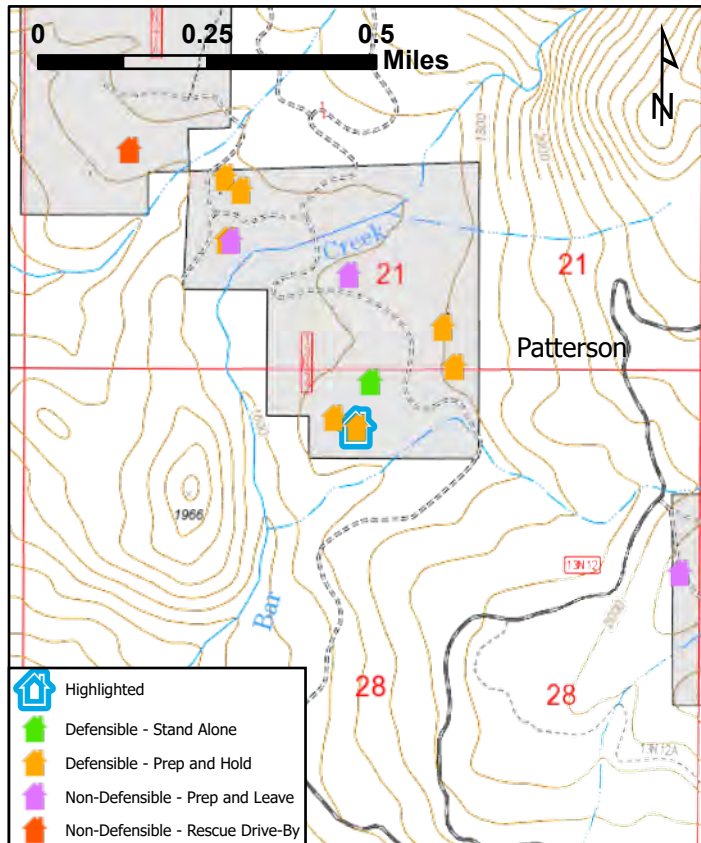
**Safety Zone(s):** No safety zone(s) in area  
**Comm With ICP:** Yes  
**Water Supply:** Limited or dependent on electricity  
**Fuel Type:** Shrub or timber  
**Defensible Space:** 30 ft treated  
**Hazards:**

**Defensible, Prep and Hold**

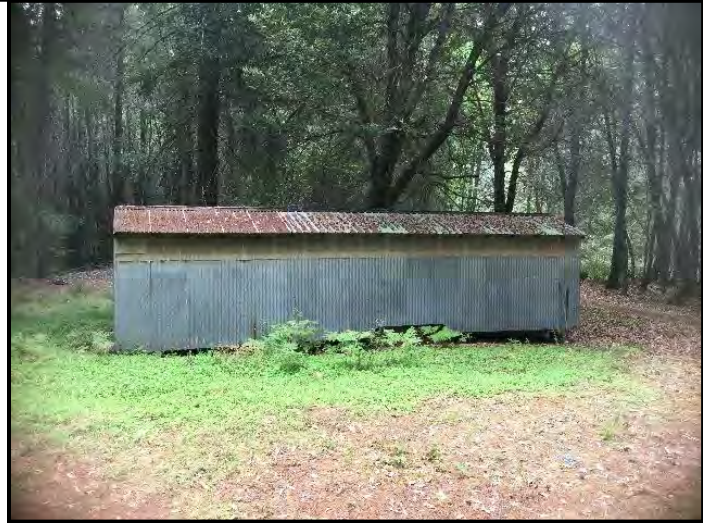
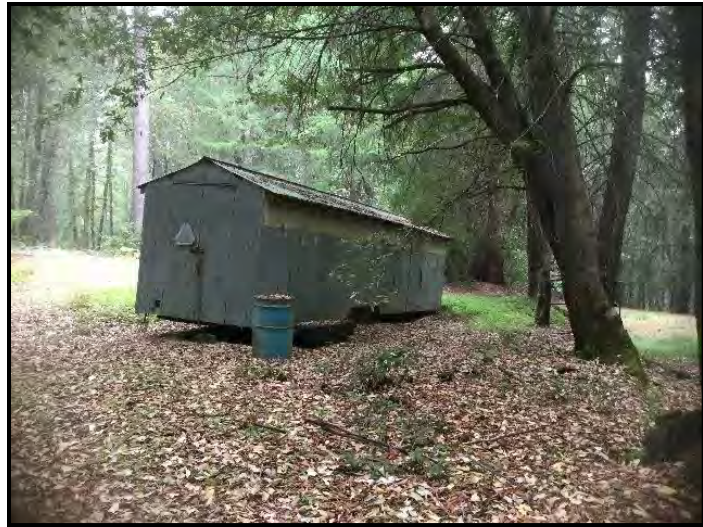
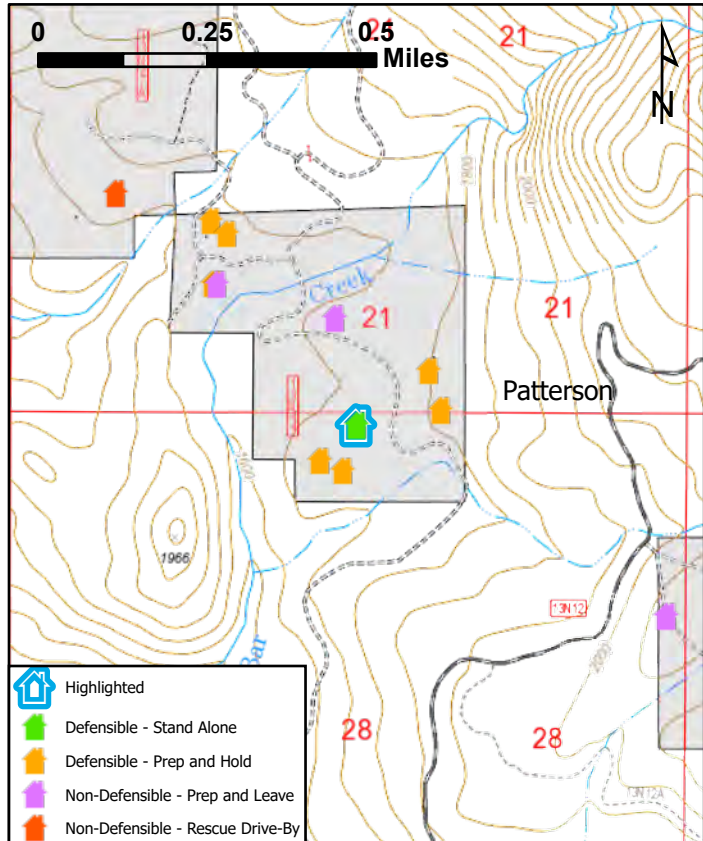
**Safety Zone(s):** No safety zone(s) in area  
**Comm With ICP:** Yes  
**Water Supply:** No reliable water source nearby  
**Fuel Type:** Shrub or timber  
**Defensible Space:** 30 ft treated  
**Hazards:**

**Defensible, Stand Alone**

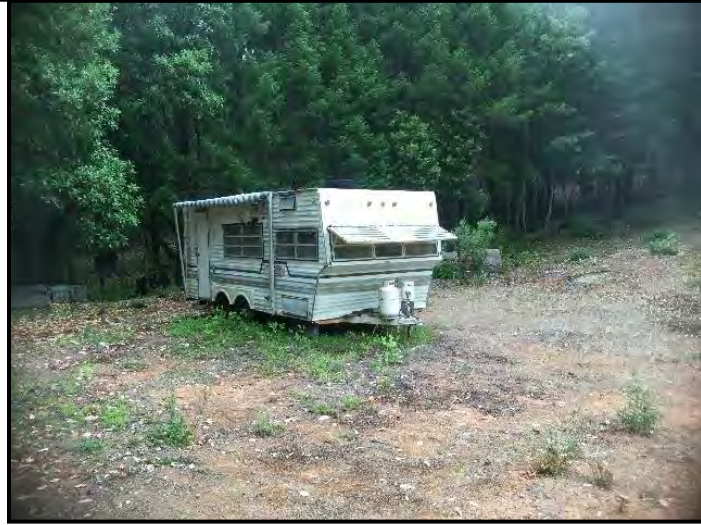
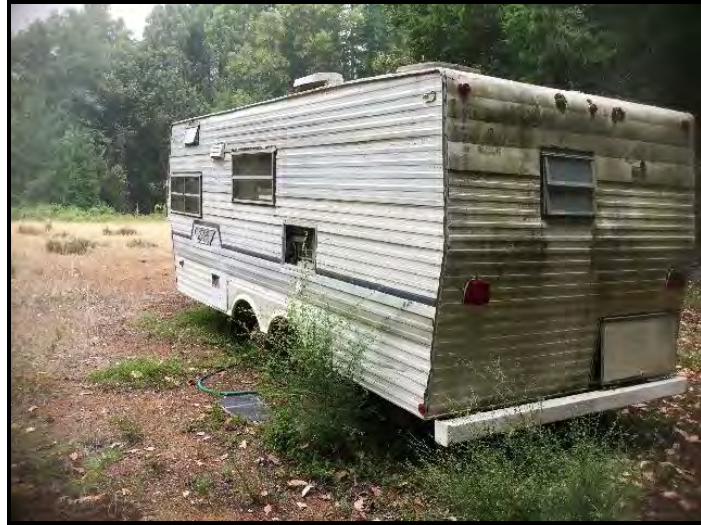
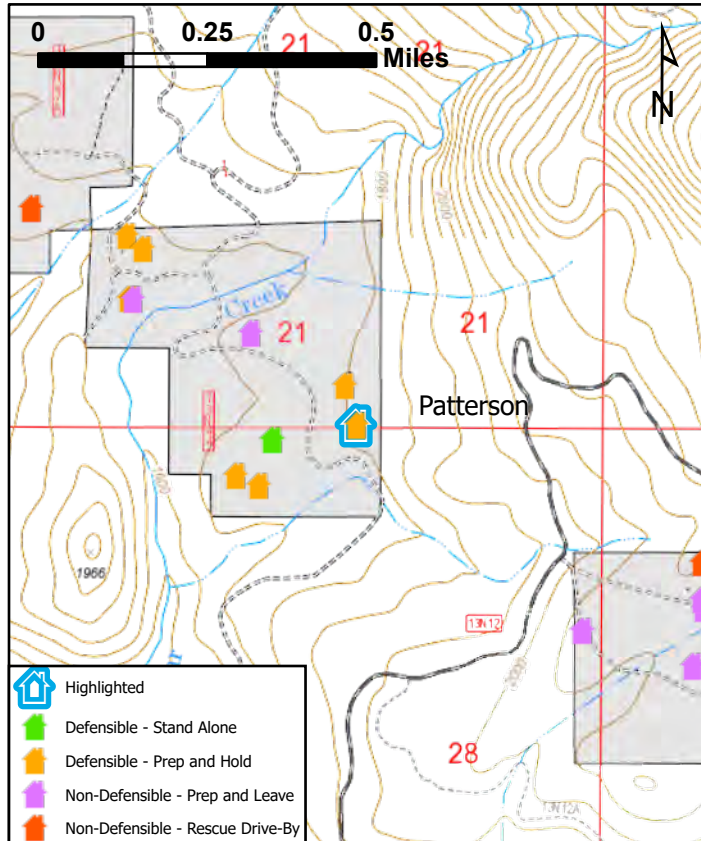
**Safety Zone(s):** Potential safety zone(s) in area  
**Comm With ICP:** Yes  
**Water Supply:** No reliable water source nearby  
**Fuel Type:** Shrub or timber  
**Defensible Space:** Less than 30 ft treated  
**Hazards:**

**Defensible, Prep and Hold**

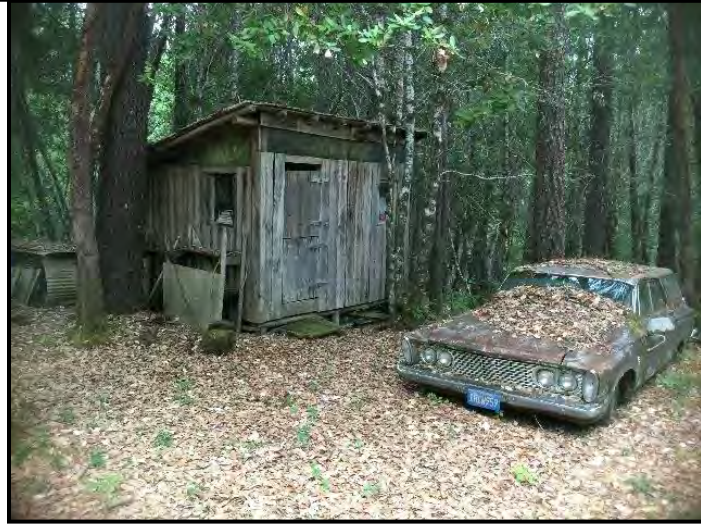
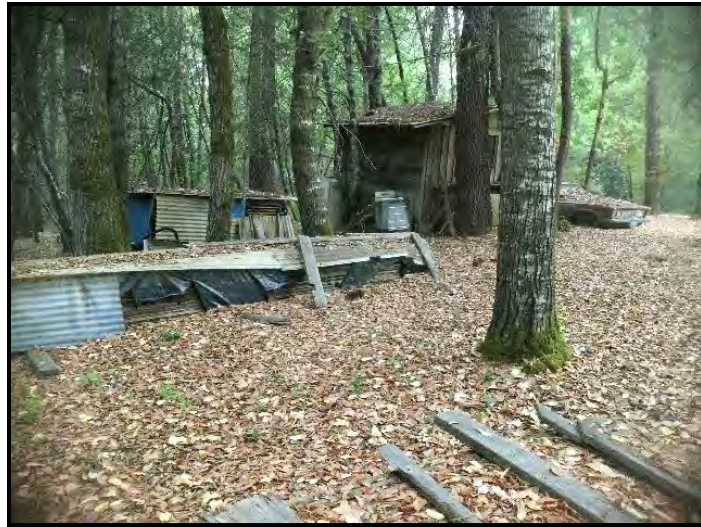
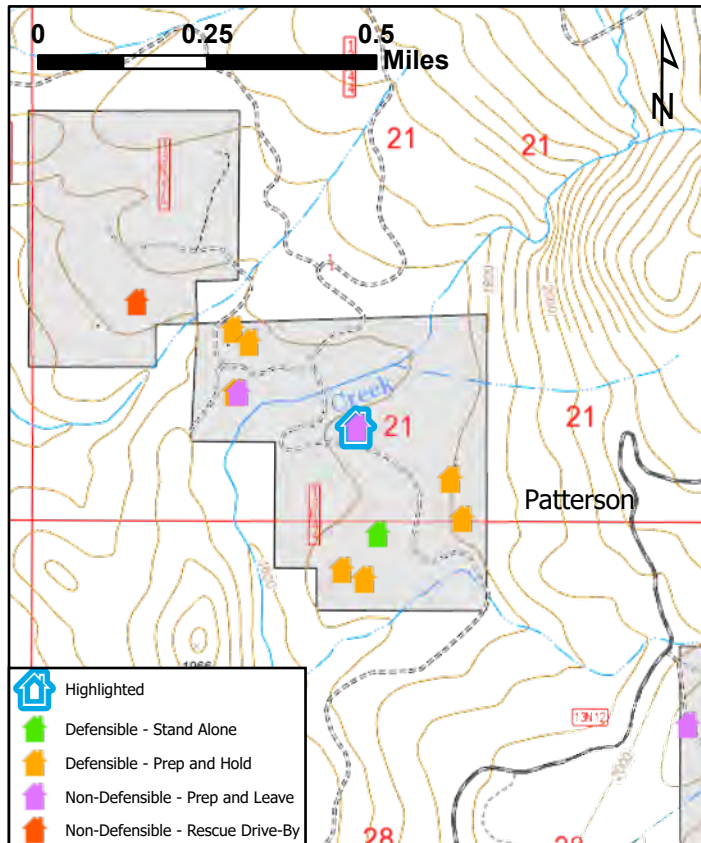
**Safety Zone(s):** No safety zone(s) in area  
**Comm With ICP:** Yes  
**Water Supply:** No reliable water source nearby  
**Fuel Type:** Shrub or timber  
**Defensible Space:** Less than 30 ft treated  
**Hazards:**

**Non-Defensible, Prep and Leave**

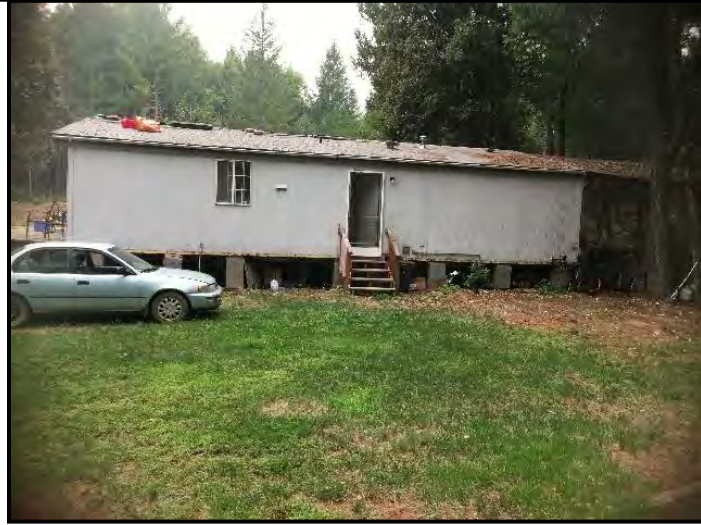
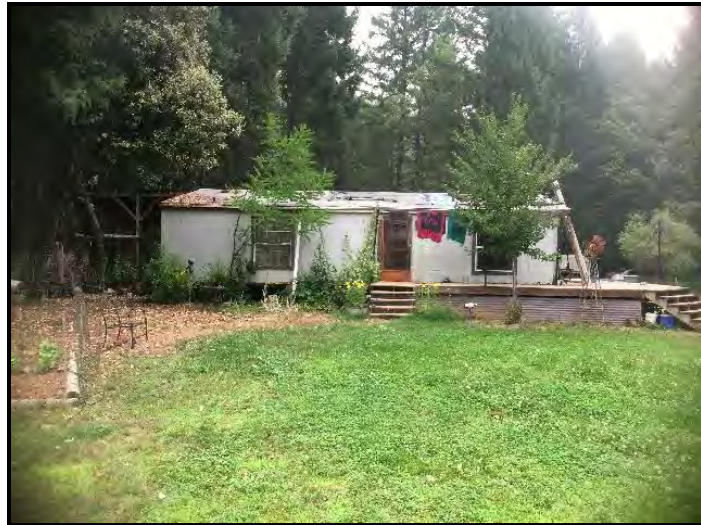
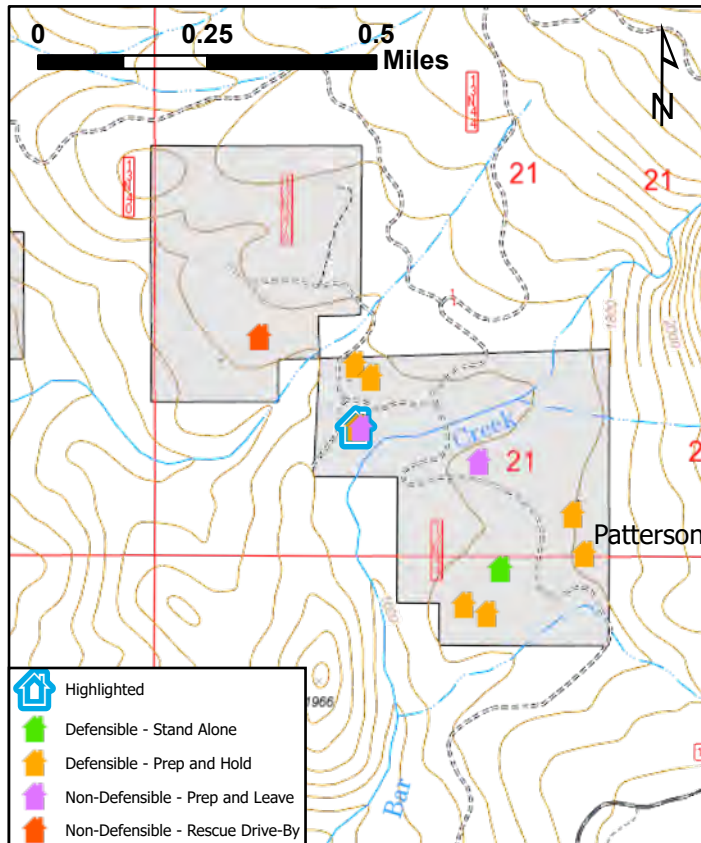
**Safety Zone(s):** No safety zone(s) in area  
**Comm With ICP:** Yes  
**Water Supply:** Reliable water source nearby  
**Fuel Type:** Shrub or timber  
**Defensible Space:** Less than 30 ft treated  
**Hazards:**

**Defensible, Prep and Hold**

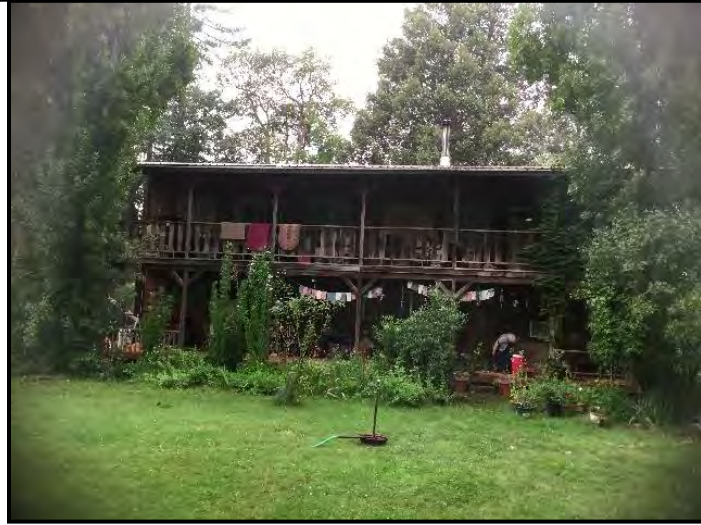
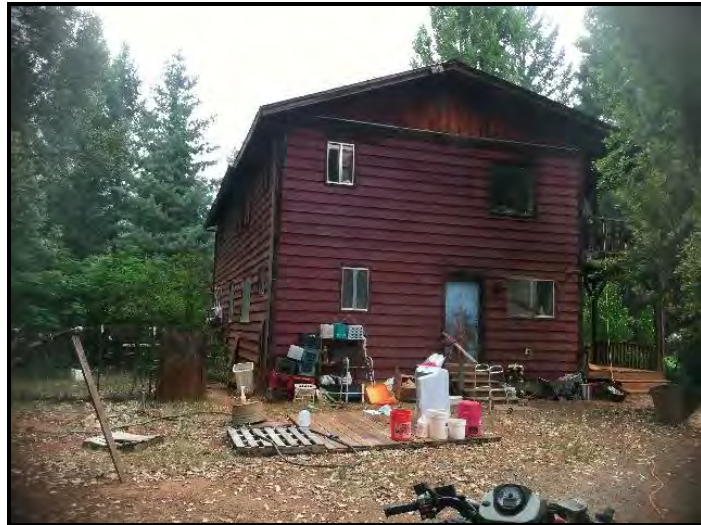
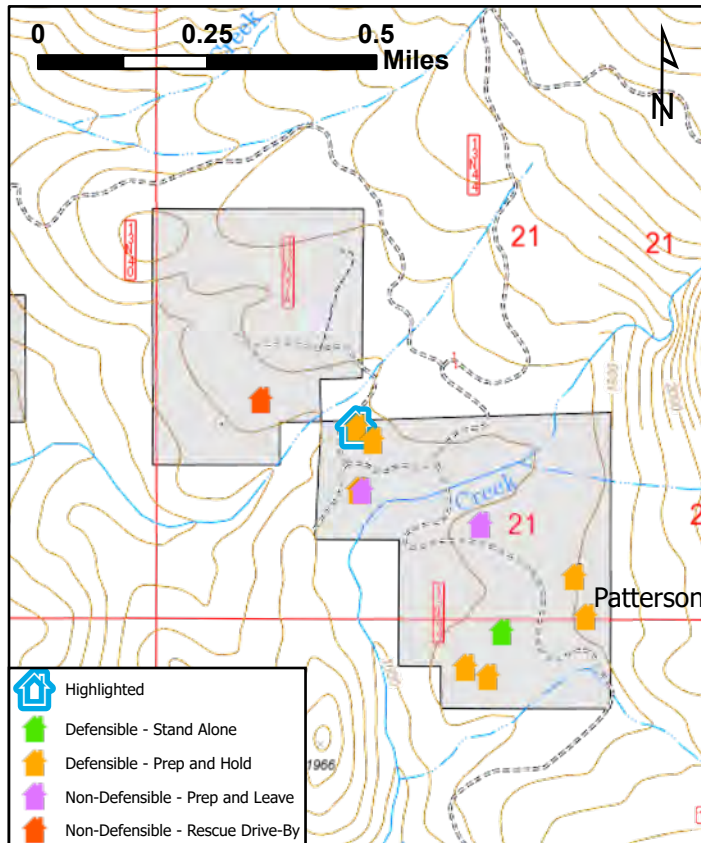
**Safety Zone(s):** No safety zone(s) in area  
**Comm With ICP:** Yes  
**Water Supply:** Limited or dependent on electricity  
**Fuel Type:** Shrub or timber  
**Defensible Space:** 30 ft treated  
**Hazards:**

**Defensible, Prep and Hold**

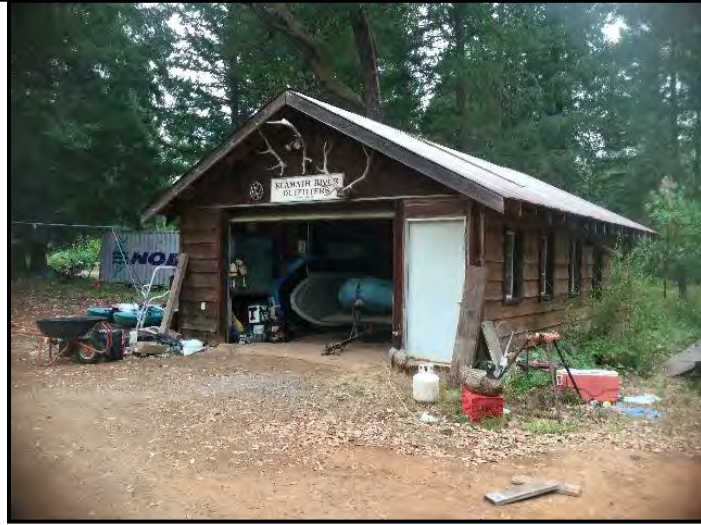
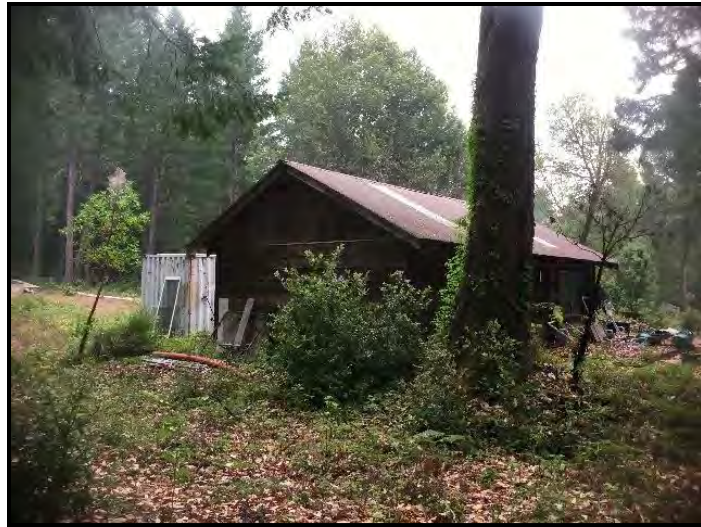
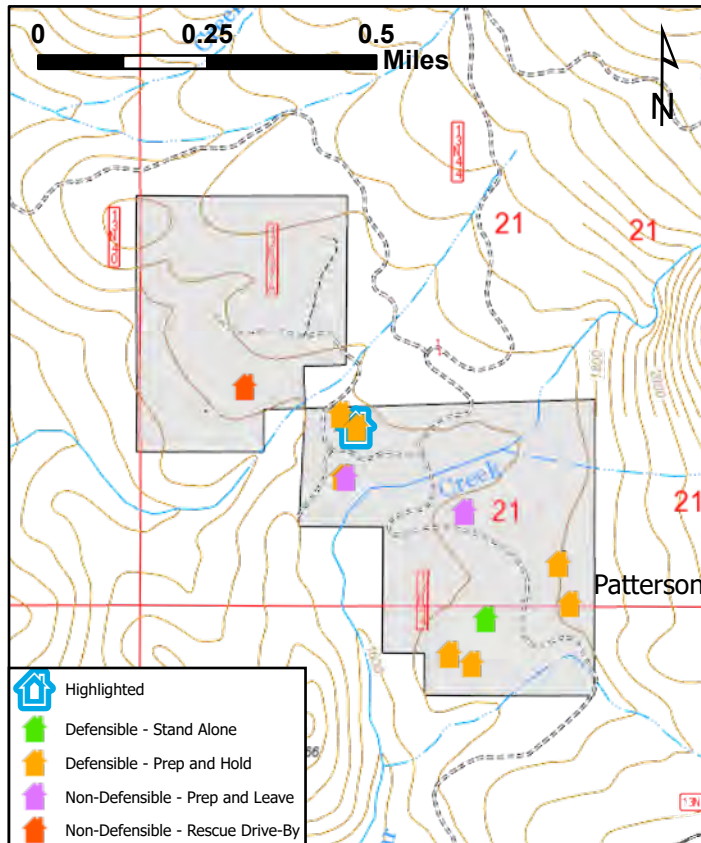
**Safety Zone(s):** No safety zone(s) in area  
**Comm With ICP:** Yes  
**Water Supply:** Limited or dependent on electricity  
**Fuel Type:** Shrub or timber  
**Defensible Space:** Less than 30 ft treated  
**Hazards:**

**Defensible, Prep and Hold**

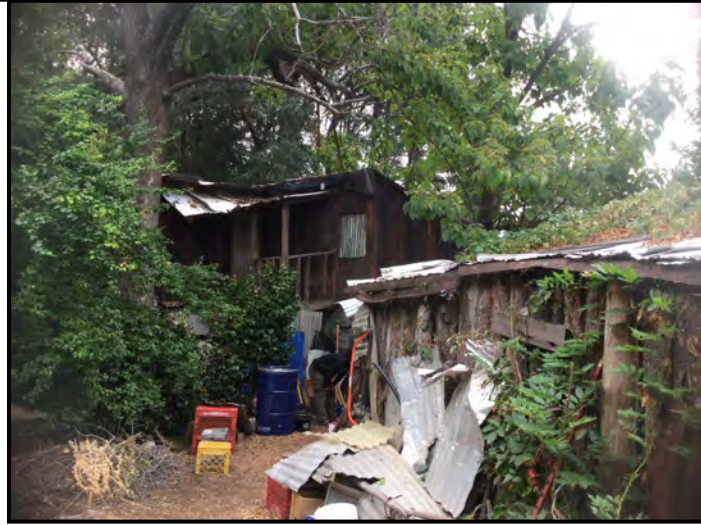
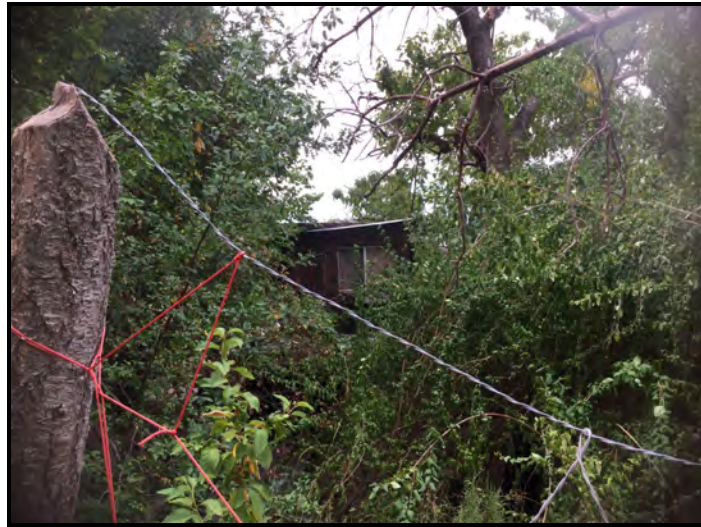
**Safety Zone(s):** No safety zone(s) in area  
**Comm With ICP:** Yes  
**Water Supply:** No reliable water source nearby  
**Fuel Type:** Shrub or timber  
**Defensible Space:** No defensible space  
**Hazards:** Overgrown vegetation around structure

**Non-Defensible, Rescue, Drive By**

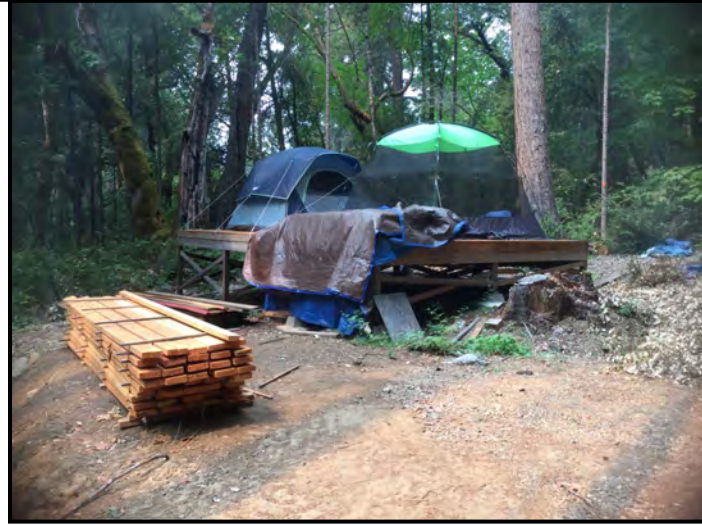
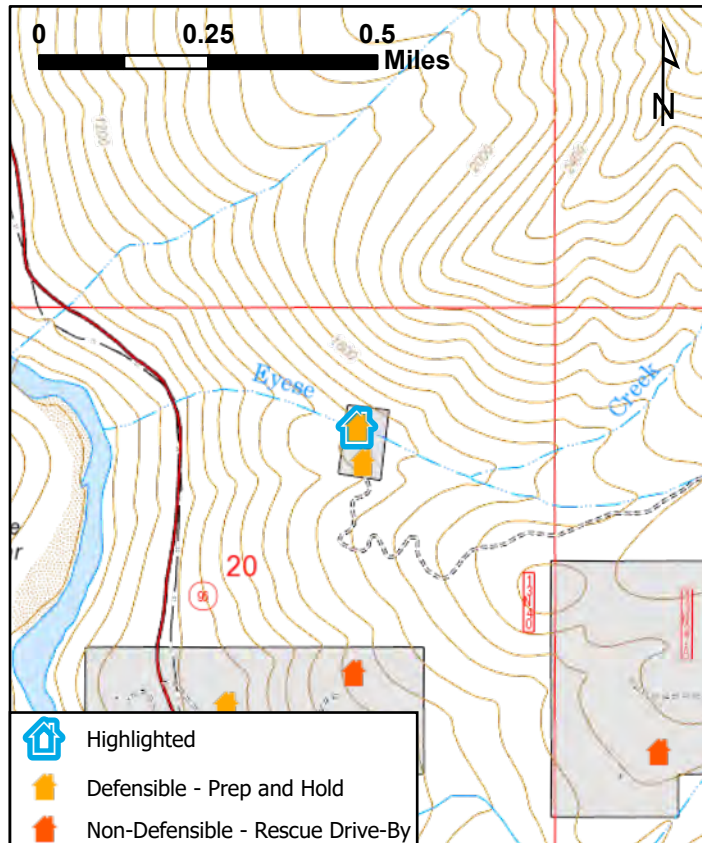
**Safety Zone(s):** No safety zone(s) in area  
**Comm With ICP:** Yes  
**Water Supply:** Reliable water source nearby  
**Fuel Type:** Shrub or timber  
**Defensible Space:** Less than 30 ft treated  
**Hazards:**

**Defensible, Prep and Hold**

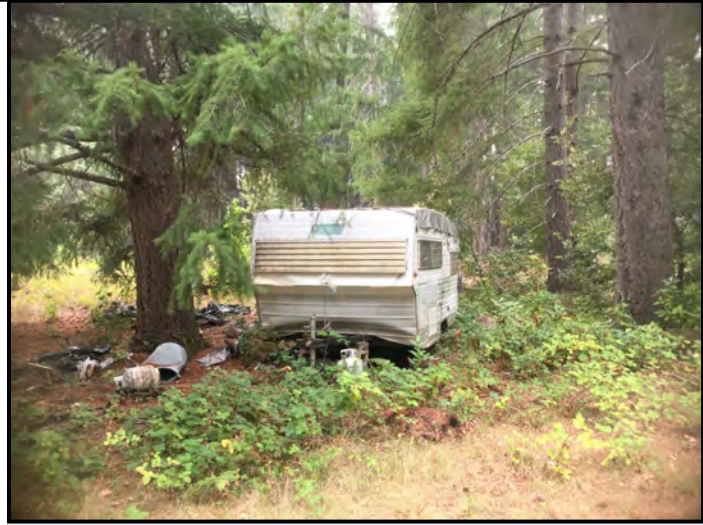
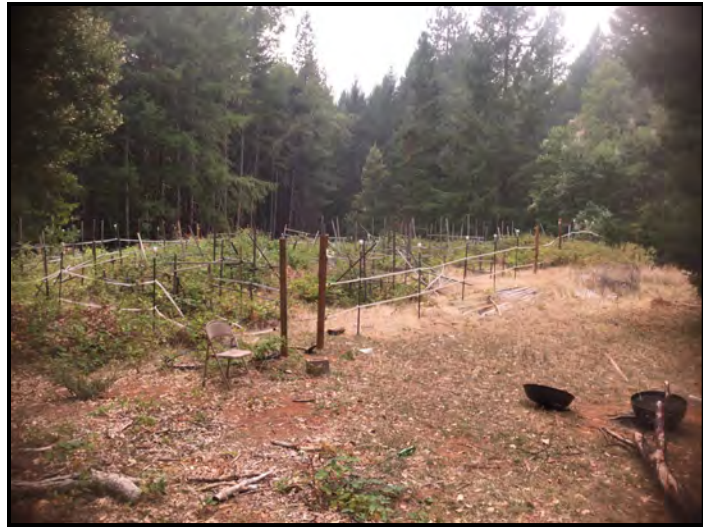
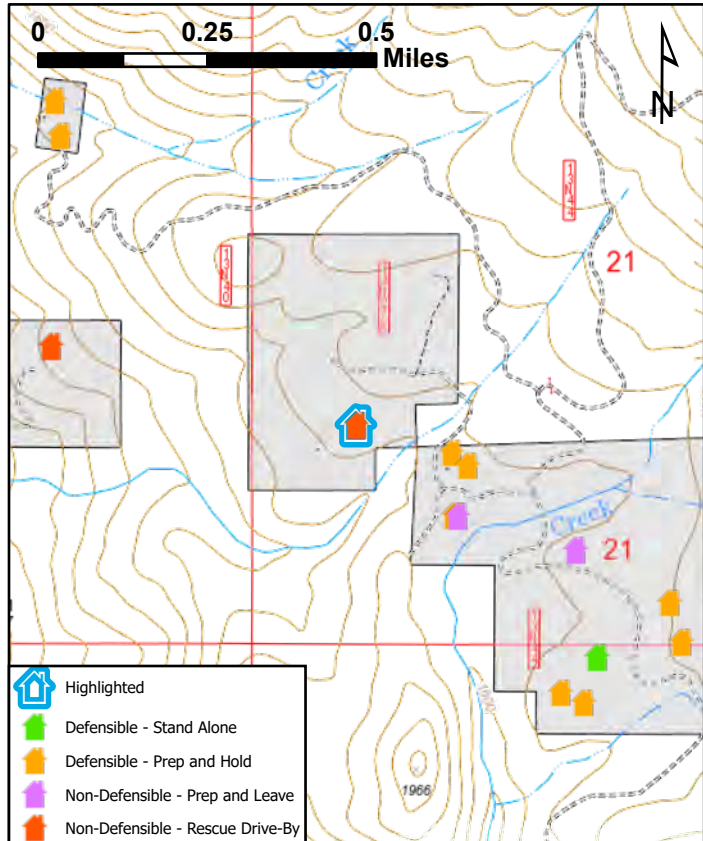
**Safety Zone(s):** No safety zone(s) in area  
**Comm With ICP:** Yes  
**Water Supply:** No reliable water source nearby  
**Fuel Type:** Shrub or timber  
**Defensible Space:** No defensible space  
**Hazards:**

**Non-Defensible, Rescue, Drive By**

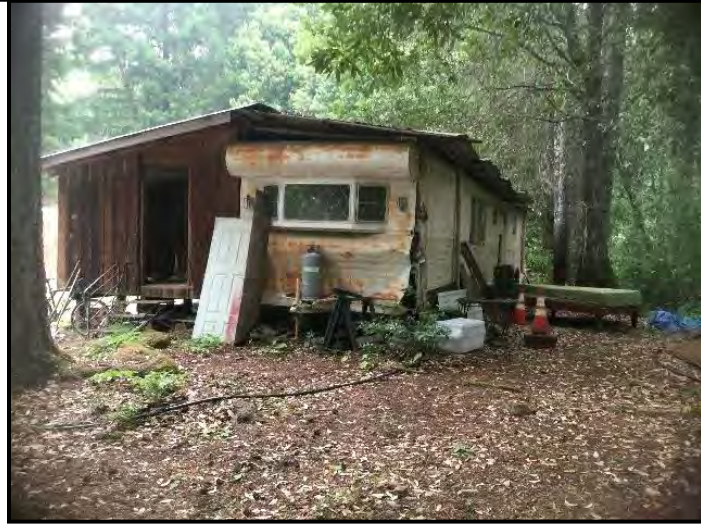
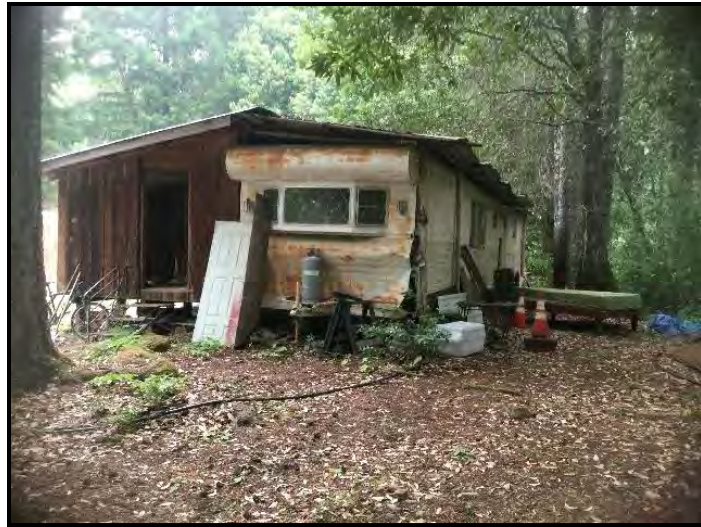
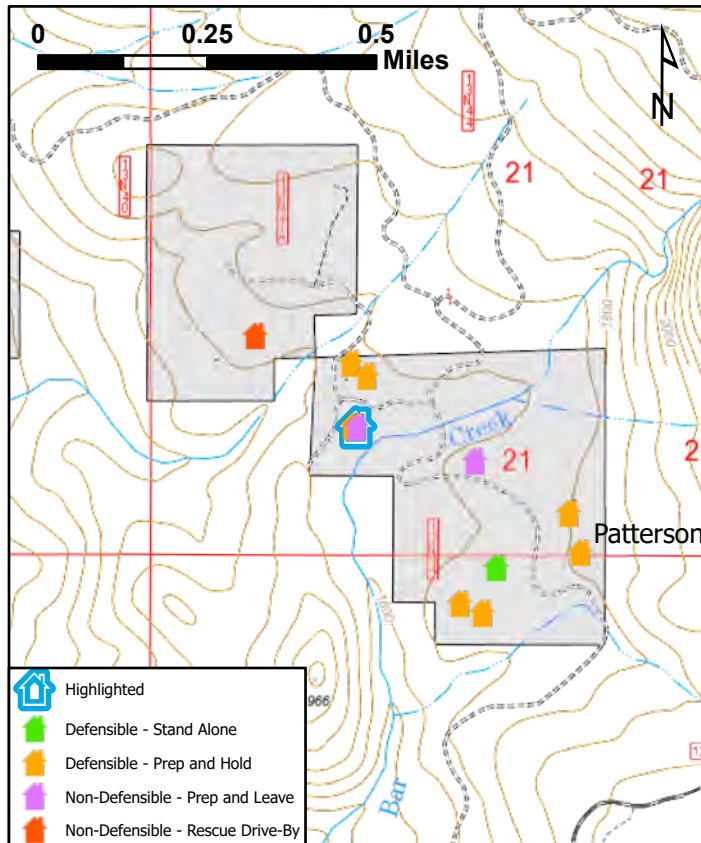
**Safety Zone(s):** No safety zone(s) in area  
**Comm With ICP:** Yes  
**Water Supply:** No reliable water source nearby  
**Fuel Type:** Shrub or timber  
**Defensible Space:** Less than 30 ft treated  
**Hazards:**

**Non-Defensible, Prep and Leave**

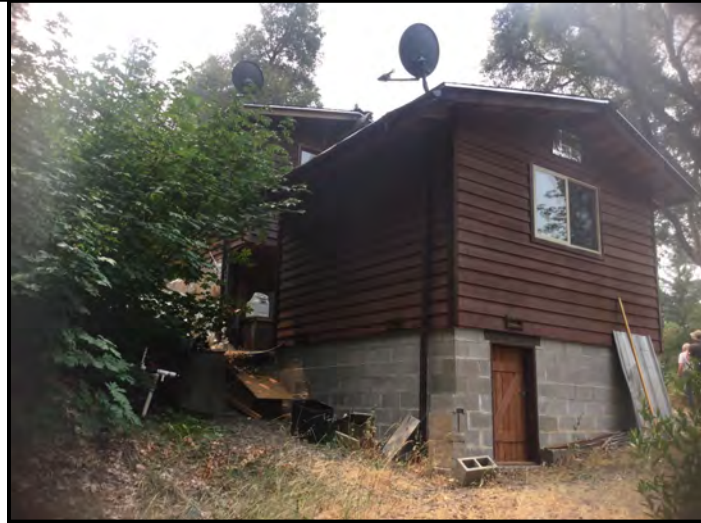
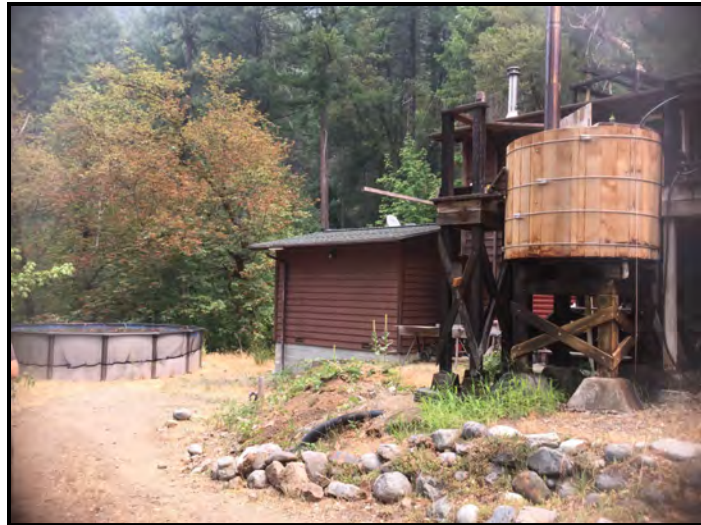
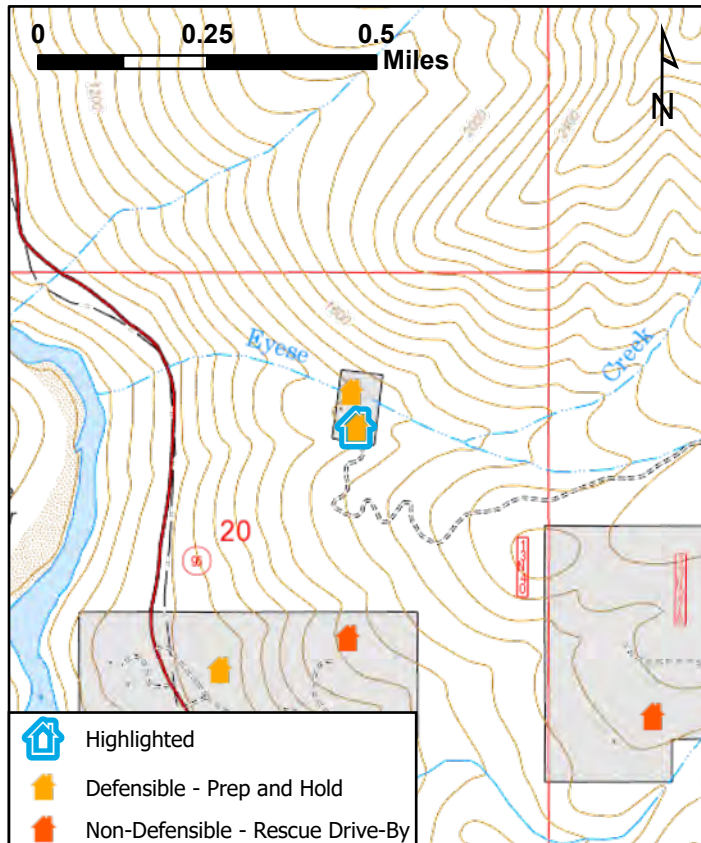
**Safety Zone(s):** No safety zone(s) in area  
**Comm With ICP:** Yes  
**Water Supply:** Reliable water source nearby  
**Fuel Type:** Shrub or timber  
**Defensible Space:** Less than 30 ft treated  
**Hazards:**

**Defensible, Prep and Hold**

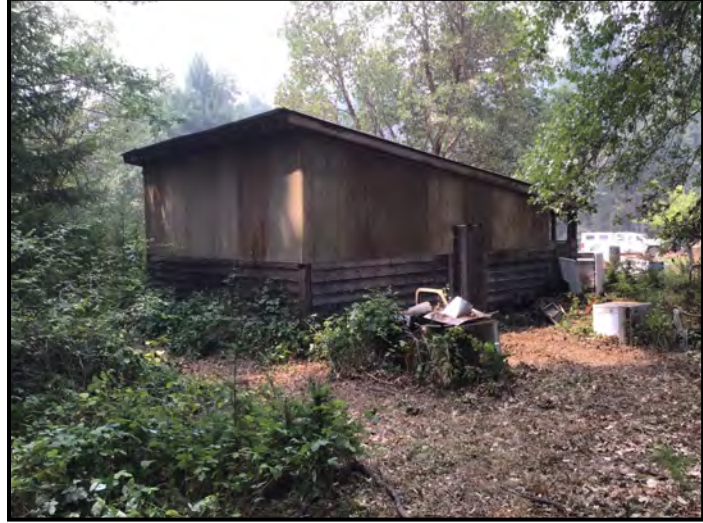
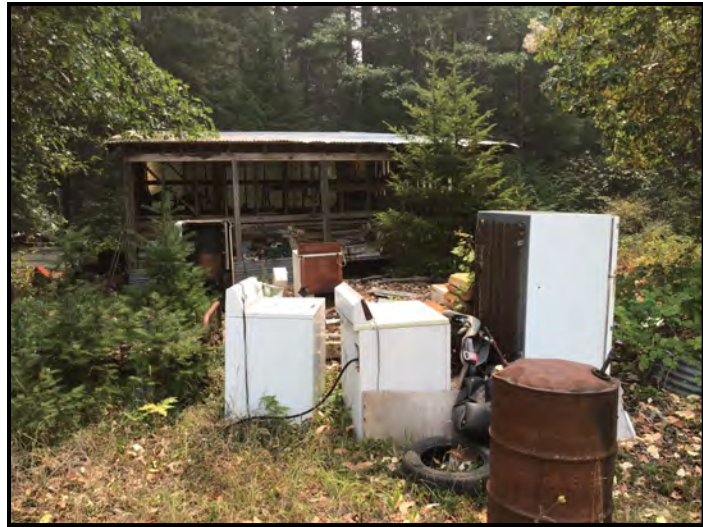
**Safety Zone(s):** Potential safety zone(s) in area  
**Comm With ICP:** Yes  
**Water Supply:** Reliable water source nearby  
**Fuel Type:**  
**Defensible Space:** No defensible space  
**Hazards:** Trash

**Non-Defensible, Prep and Leave**

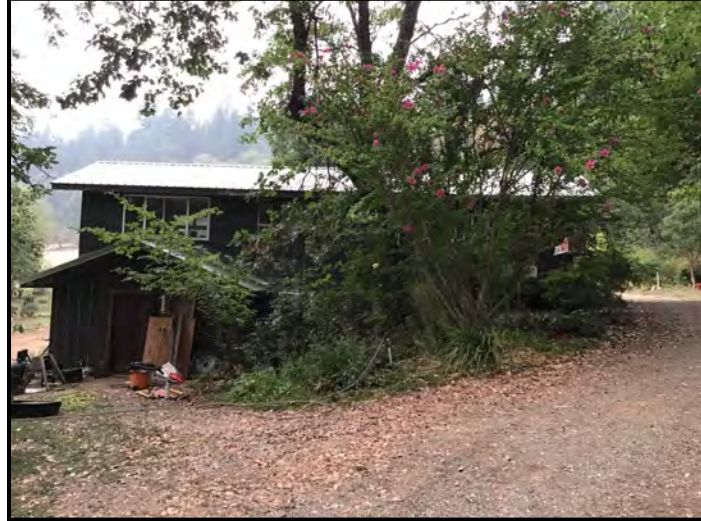
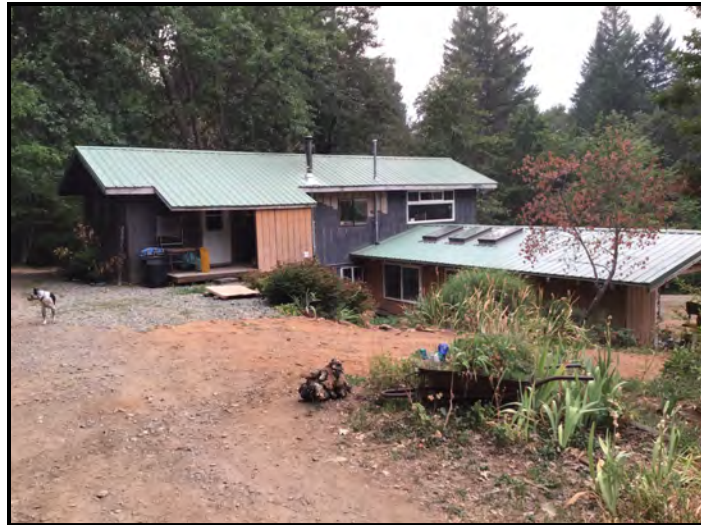
**Safety Zone(s):** Potential safety zone(s) in area  
**Comm With ICP:** Yes  
**Water Supply:** Pressurized hydrant(s) or fixed sprinkler system  
**Fuel Type:** Grass and shrub, hardwood litter  
**Defensible Space:** 100 ft treated  
**Hazards:** Propane tank 50 feet beyond structure

**Defensible, Stand Alone**

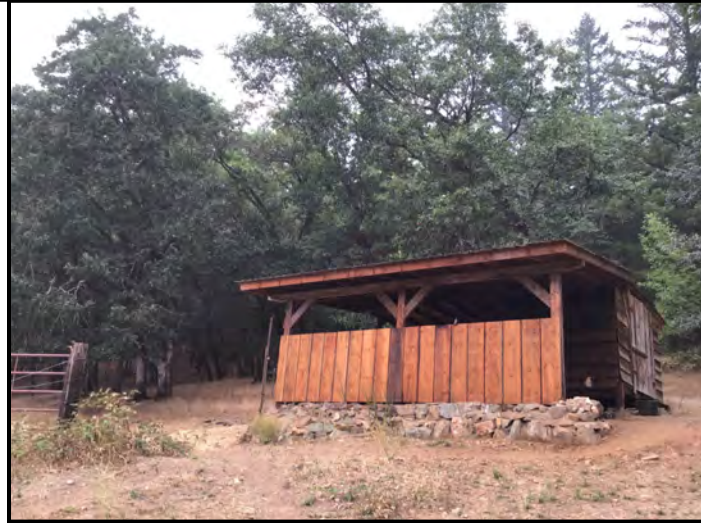
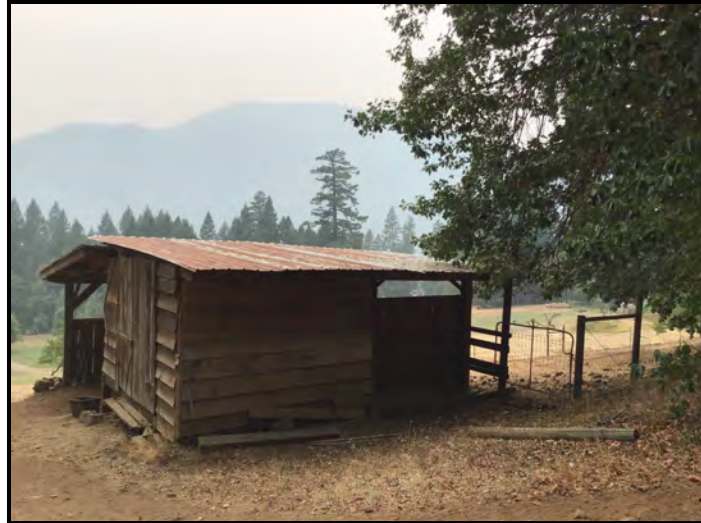
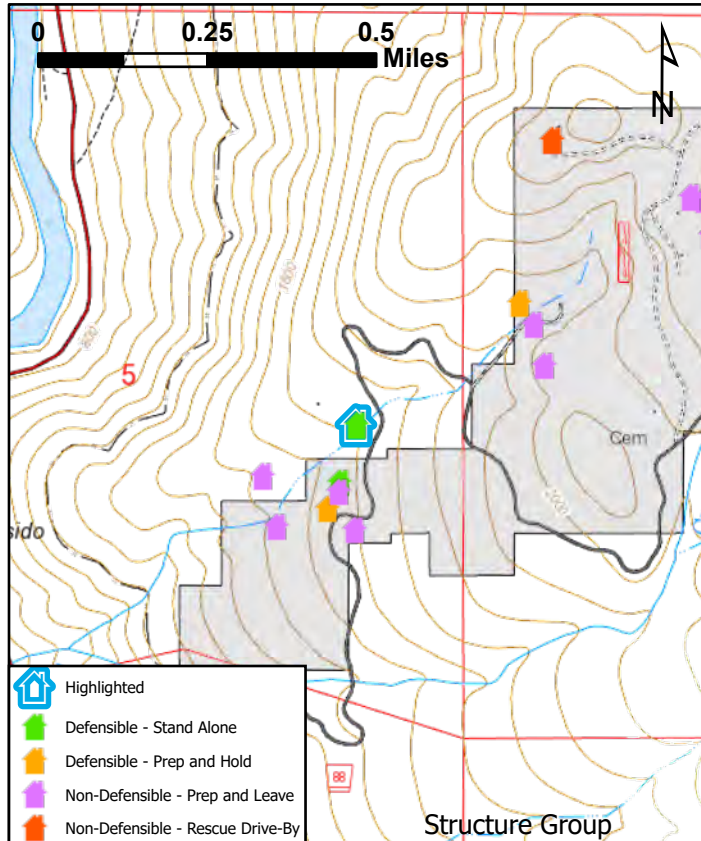
**Safety Zone(s):** Potential safety zone(s) in area  
**Comm With ICP:** Yes  
**Water Supply:** No reliable water source nearby  
**Fuel Type:** Grass and shrub, hardwood litter  
**Defensible Space:** No defensible space  
**Hazards:**

**Defensible, Stand Alone**

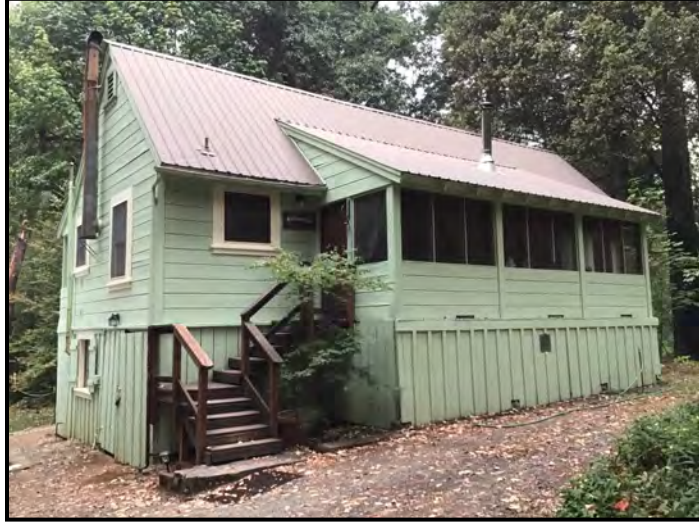
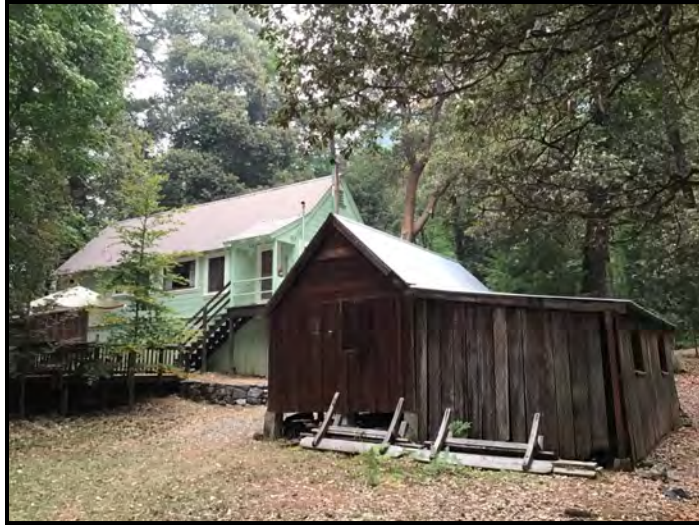
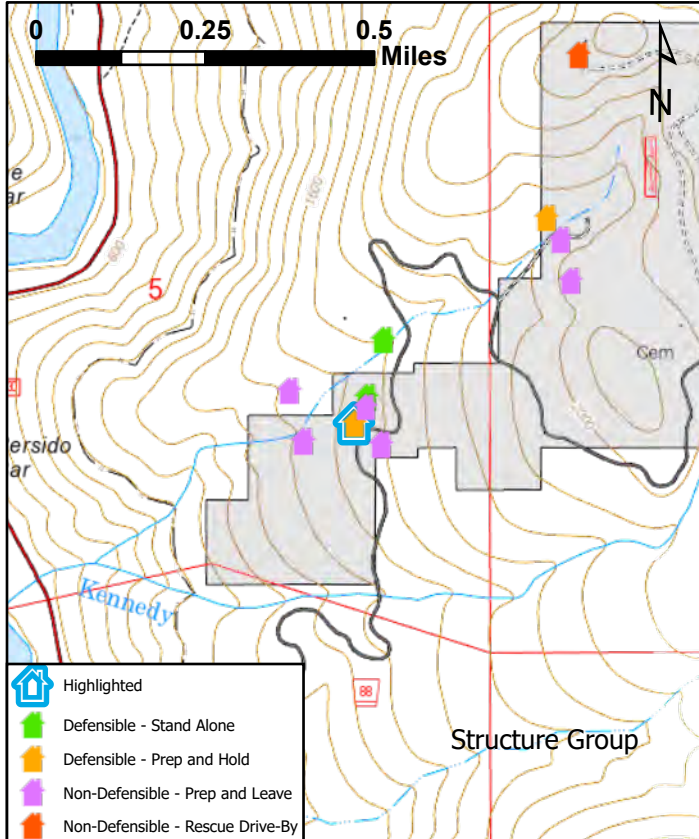
**Safety Zone(s):** Potential safety zone(s) in area  
**Comm With ICP:** Yes  
**Water Supply:** Pressurized hydrant(s) or fixed sprinkler system  
**Fuel Type:** Grass and shrub, hardwood litter  
**Defensible Space:** 100 ft treated  
**Hazards:**

**Defensible, Prep and Hold**
