# McCash Fire Structure Triage Assessment

CASRF000651  
August 18, 2021

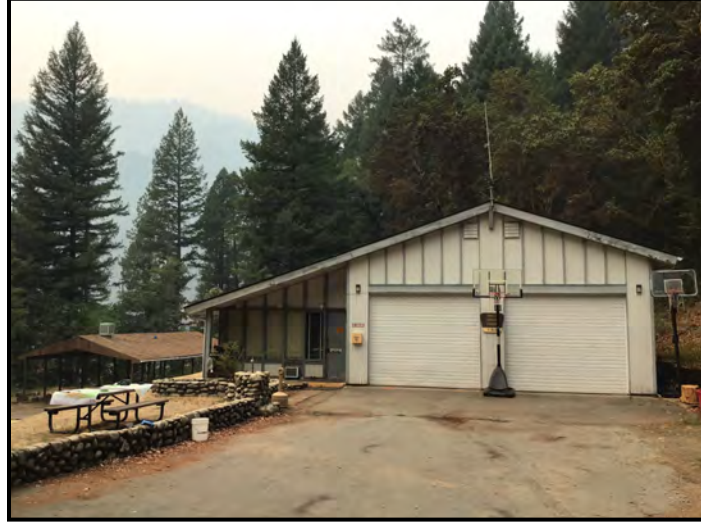
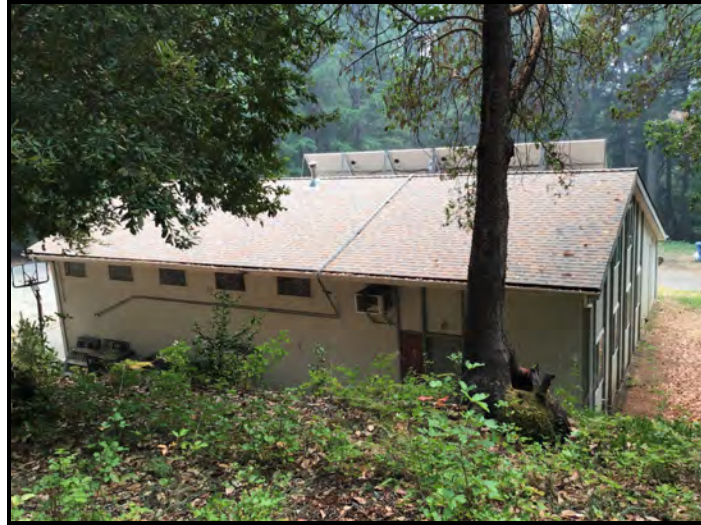
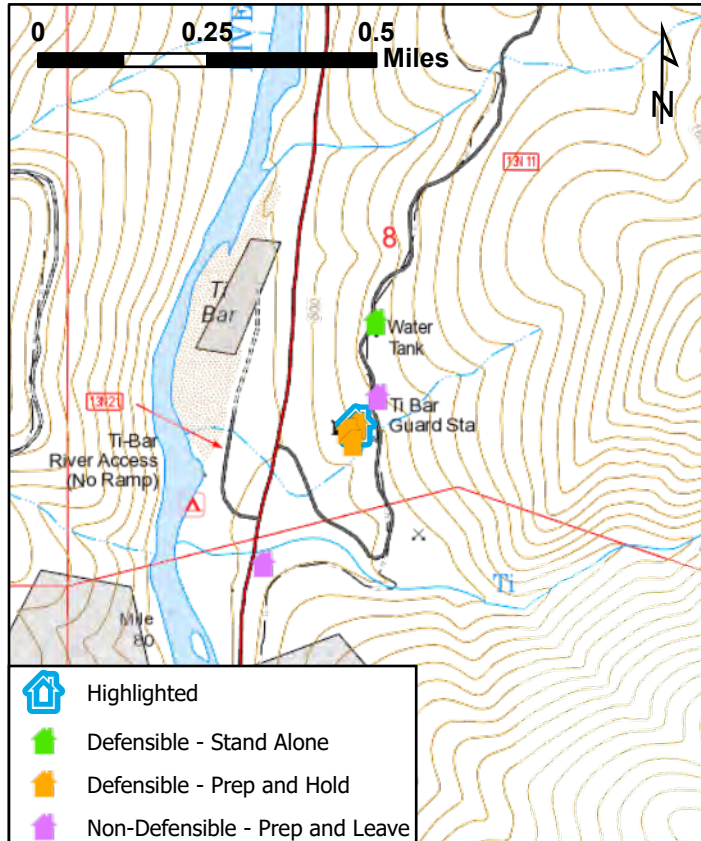
**Comm With ICP:** Yes  
**Water Supply:** Limited or dependent on electricity  
**Fuel Type:** Shrub or timber  
**Defensible Space:** 30 ft treated  
**Hazards:** Fuel shed within 20' of building

**Defensible, Prep and Hold**

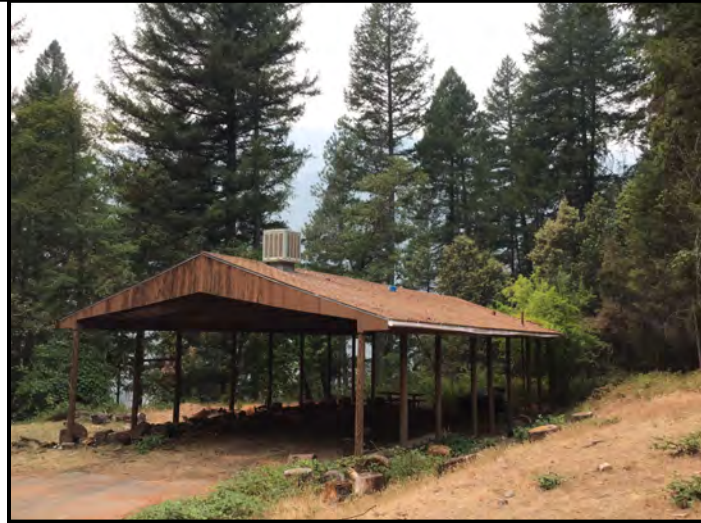
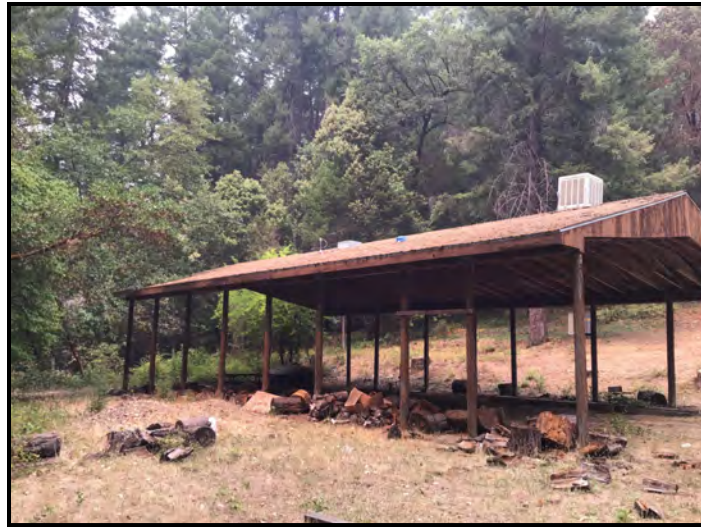
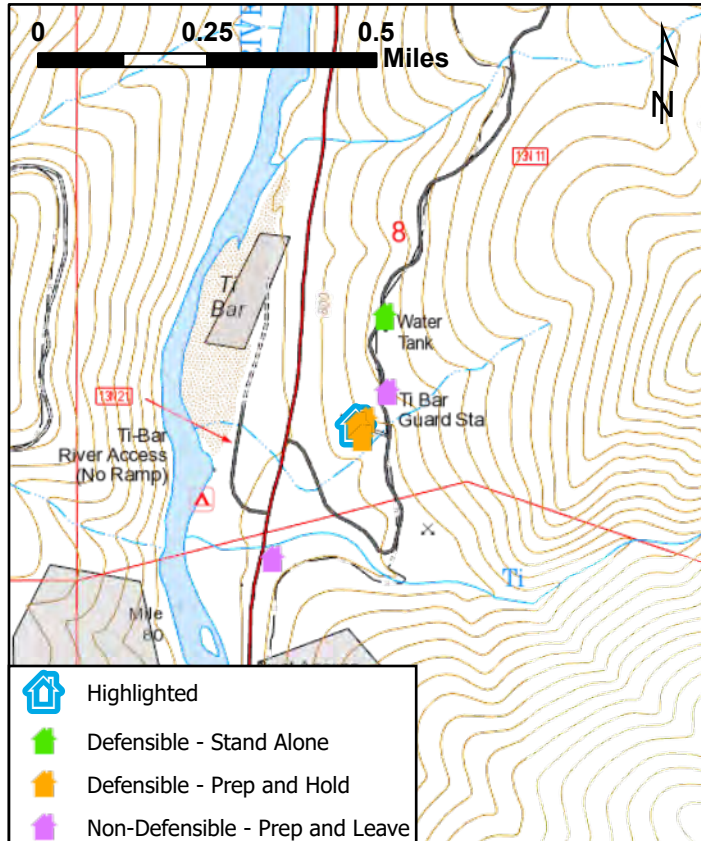
**Safety Zone(s):** Potential safety zone(s) in area  
**Comm With ICP:** Yes  
**Water Supply:** Limited or dependent on electricity  
**Fuel Type:** Shrub or timber  
**Defensible Space:** Less than 30 ft treated  
**Hazards:** None

**Defensible, Prep and Hold**

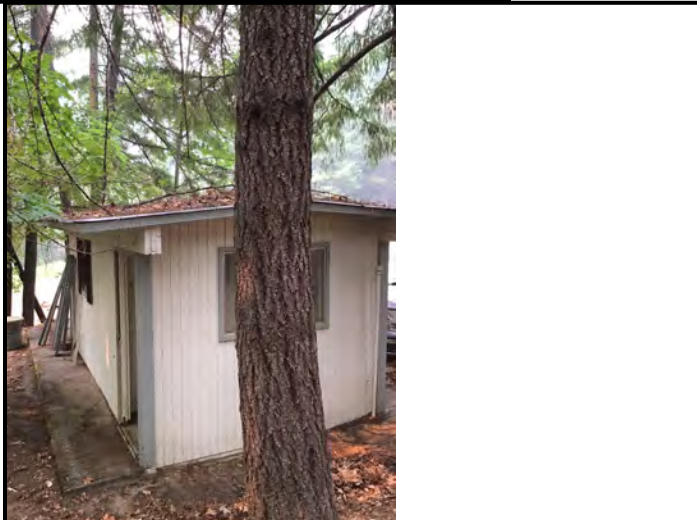
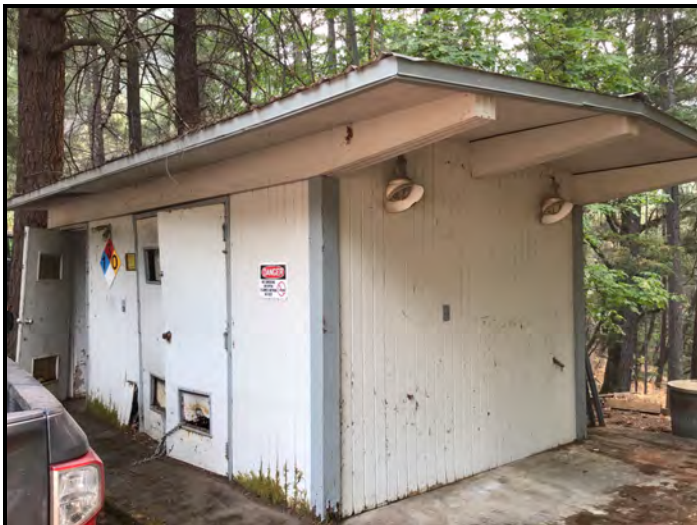
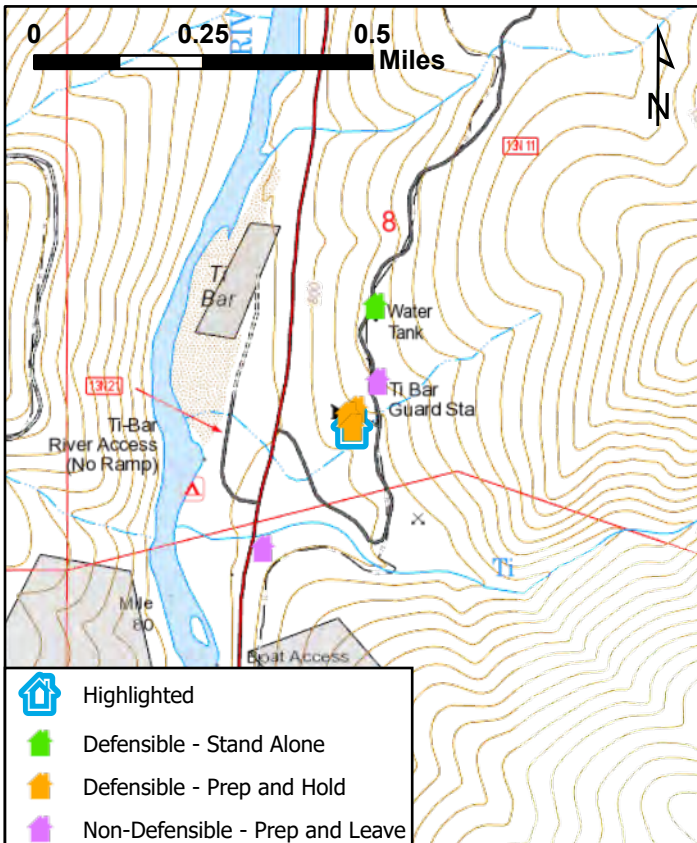
**Roof Material:** Noncombustible or not applicable  
**Siding Material:** Wood or open sided  
**Electrical Power:** Yes  
**Gas to Structure:** No  
**Comments:** Old gas house. Used as storage shed. Metal roof. Broken doors

**Safety Zone(s):** Potential safety zone(s) in area  
**Comm With ICP:** Yes  
**Water Supply:** Limited or dependent on electricity  
**Fuel Type:** Shrub or timber  
**Defensible Space:** Less than 30 ft treated  
**Hazards:**

**Defensible, Prep and Hold**

**Mitigation Time (in hours):** 1  
**Mitigation Description:** Clean off Roof leaf litter and from around shed. Seal broken doors with scrap plywood.

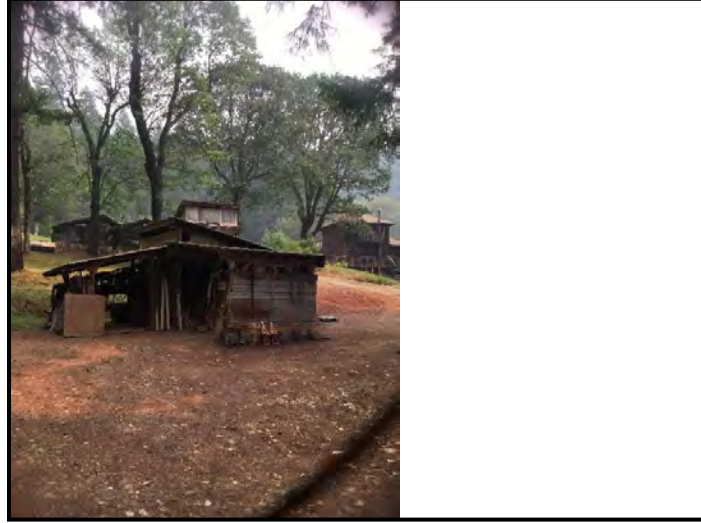
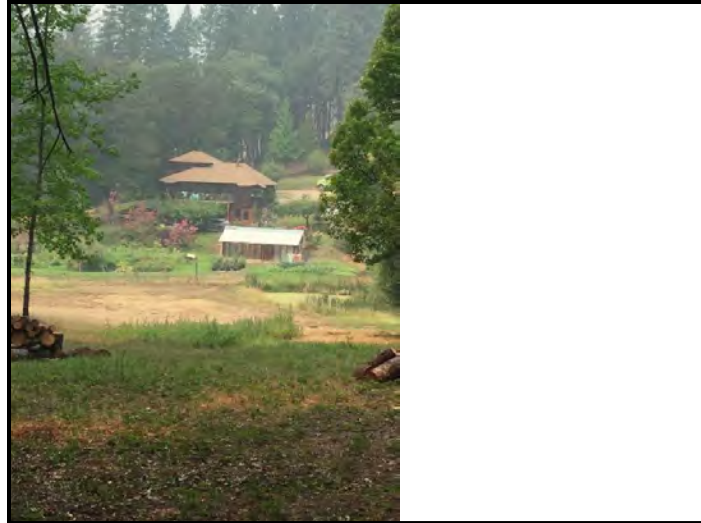
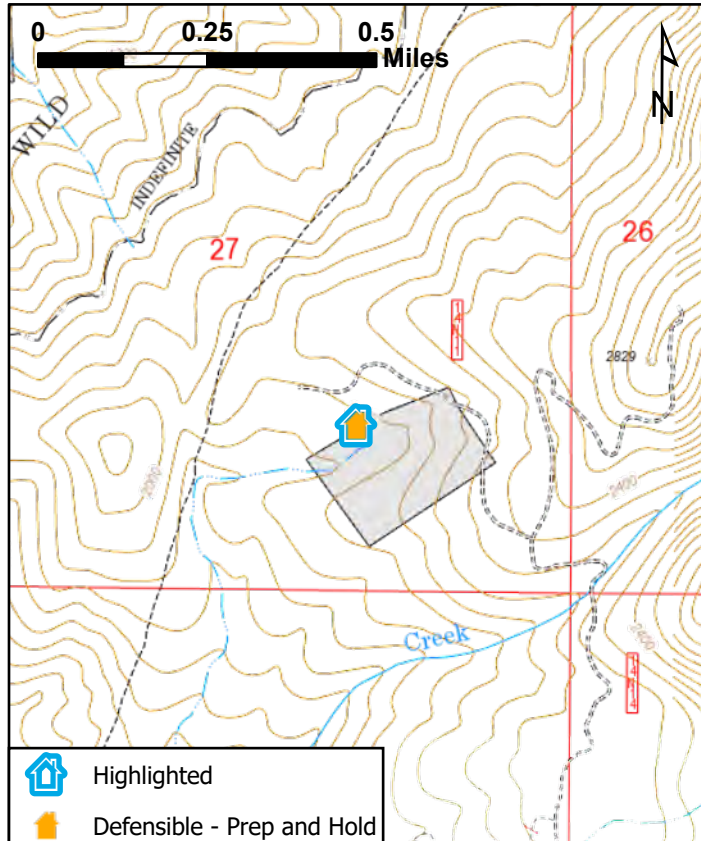
**Safety Zone(s):** Potential safety zone(s) in area  
**Comm With ICP:** Yes  
**Water Supply:** No reliable water source nearby  
**Fuel Type:** Grass and shrub, hardwood litter  
**Defensible Space:** 100 ft treated  
**Hazards:** Fuel (diesel/gas) in one of outbuildings 250 gallon propane tank

**Defensible, Prep and Hold**

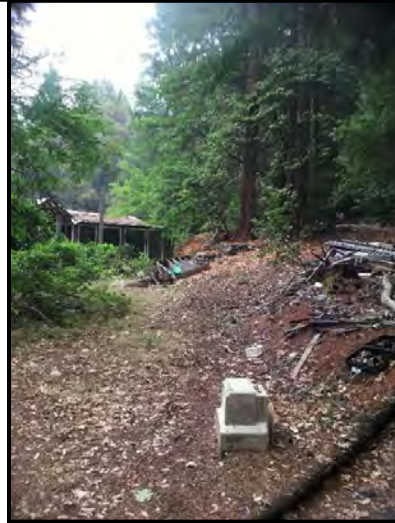
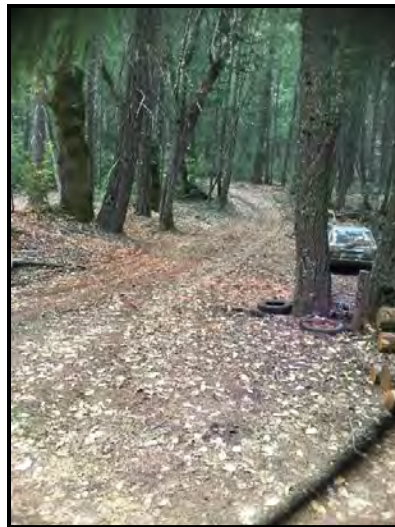
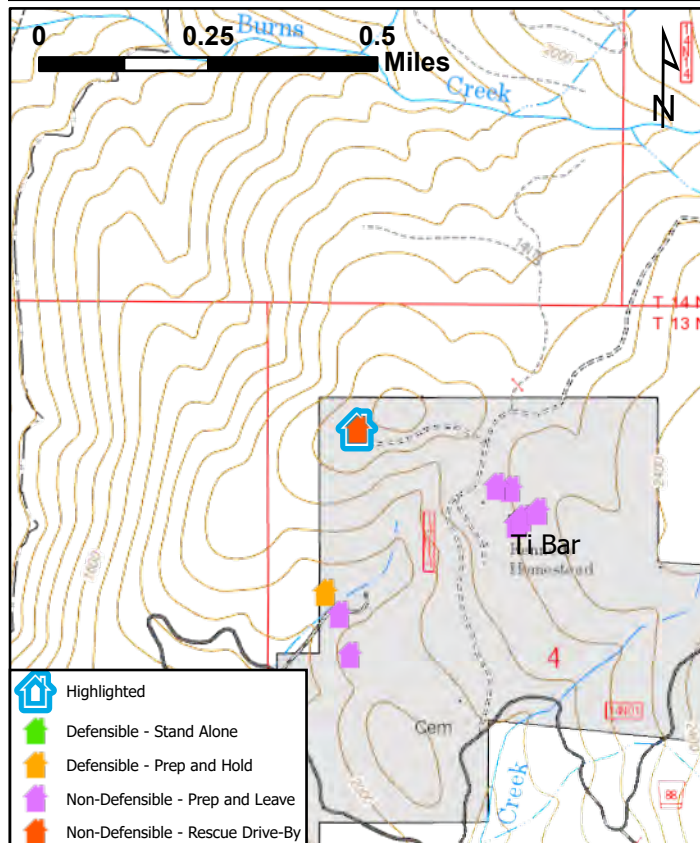
**Safety Zone(s):** No safety zone(s) in area  
**Comm With ICP:** Yes  
**Water Supply:** No reliable water source nearby  
**Fuel Type:** Shrub or timber  
**Defensible Space:** No defensible space  
**Hazards:** Multiple hazards, including vehicles, structures, yard debris etc 1

**Non-Defensible, Rescue, Drive By**

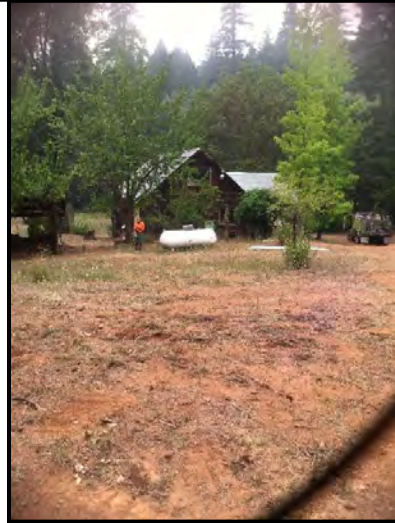
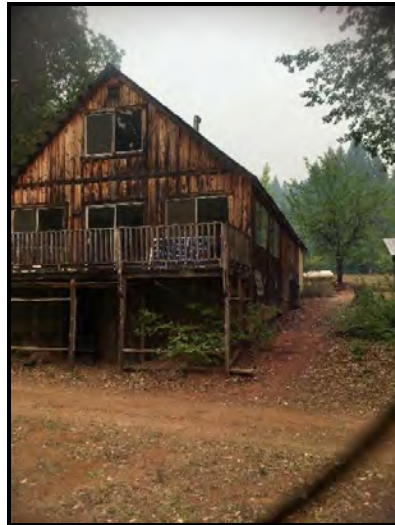
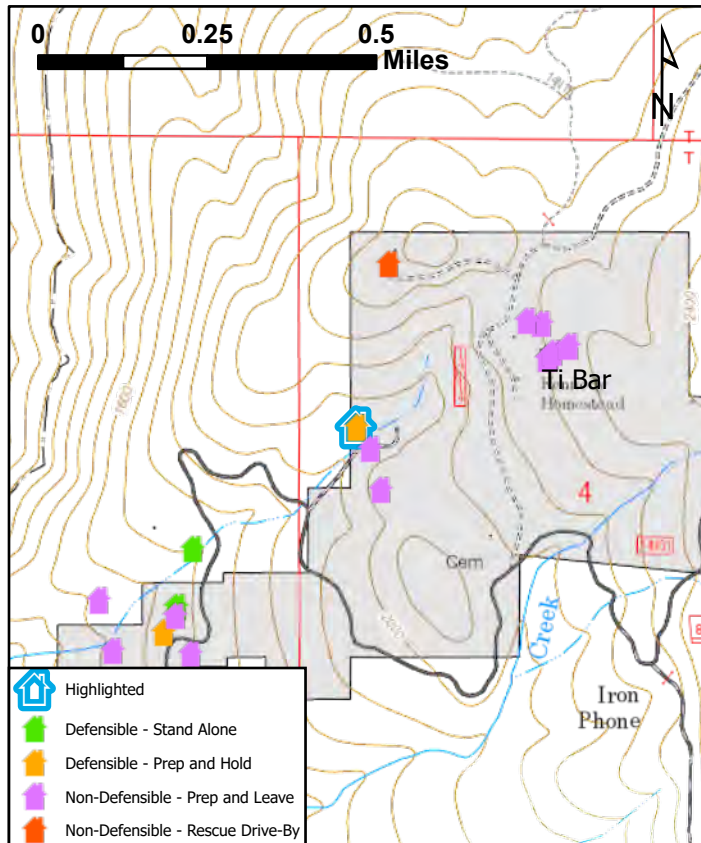
**Safety Zone(s):** Potential safety zone(s) in area  
**Comm With ICP:** Yes  
**Water Supply:** Reliable water source nearby  
**Fuel Type:** Shrub or timber  
**Defensible Space:** 100 ft treated  
**Hazards:** One way in/out

**Defensible, Prep and Hold**

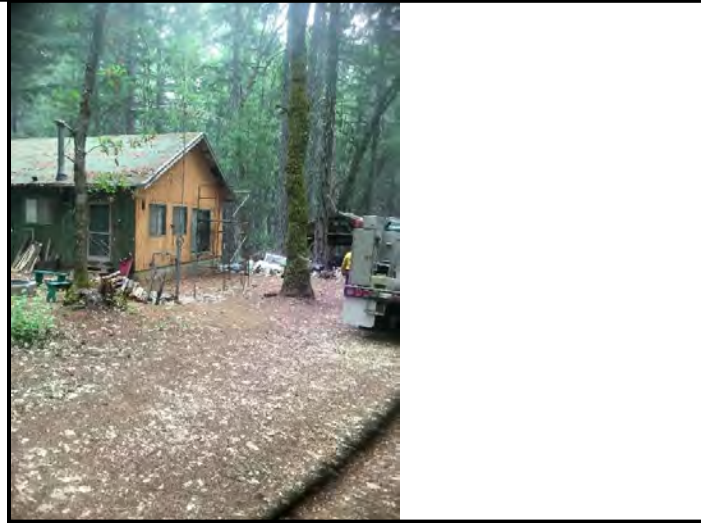
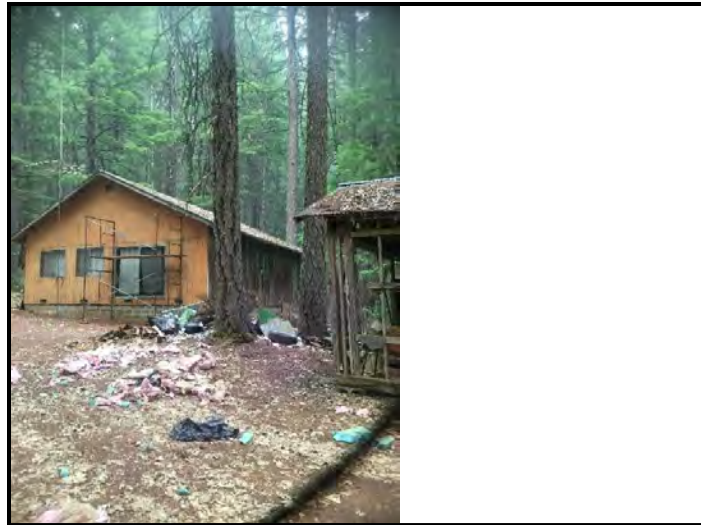
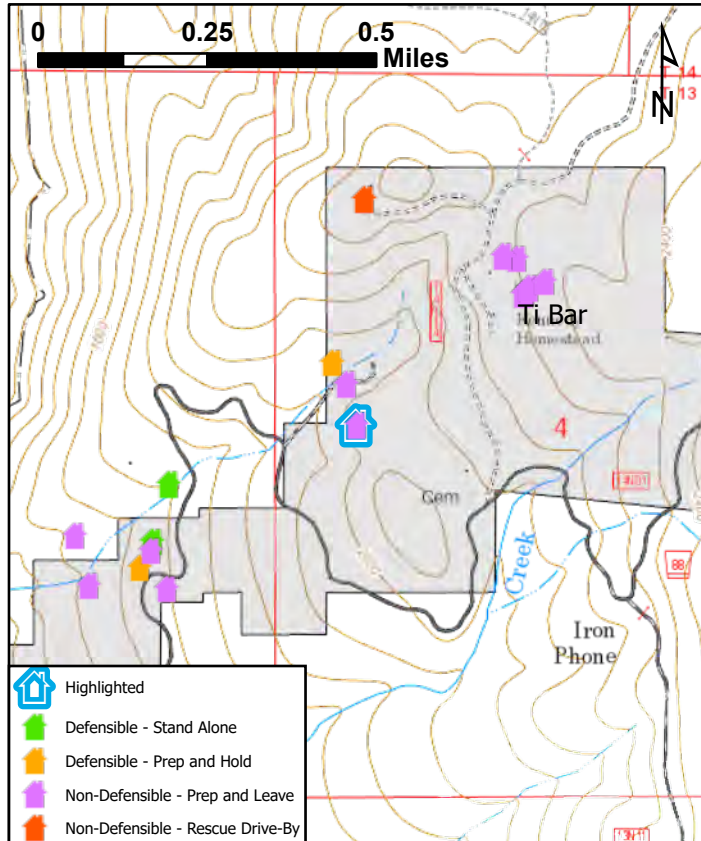
**Safety Zone(s):** No safety zone(s) in area  
**Comm With ICP:** Yes  
**Water Supply:** Reliable water source nearby  
**Fuel Type:** Shrub or timber  
**Defensible Space:** Less than 30 ft treated  
**Hazards:** Yard debris/timber

**Non-Defensible, Prep and Leave**

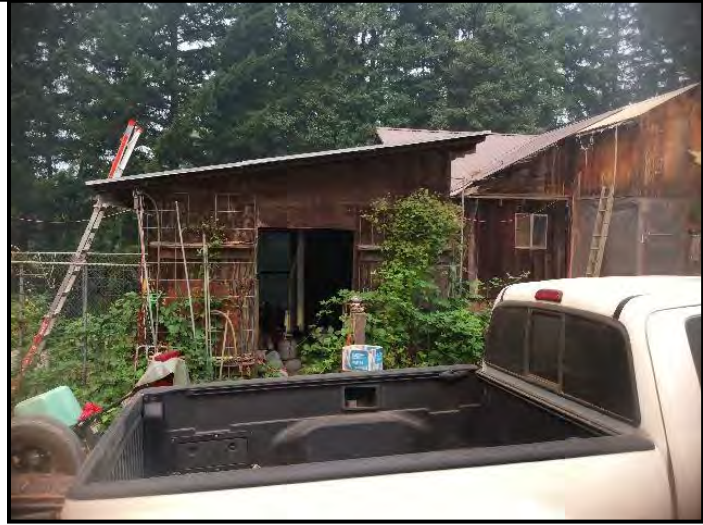
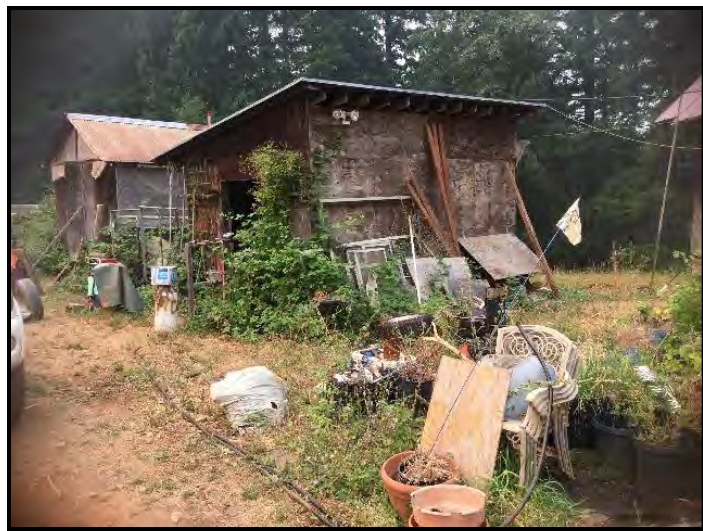
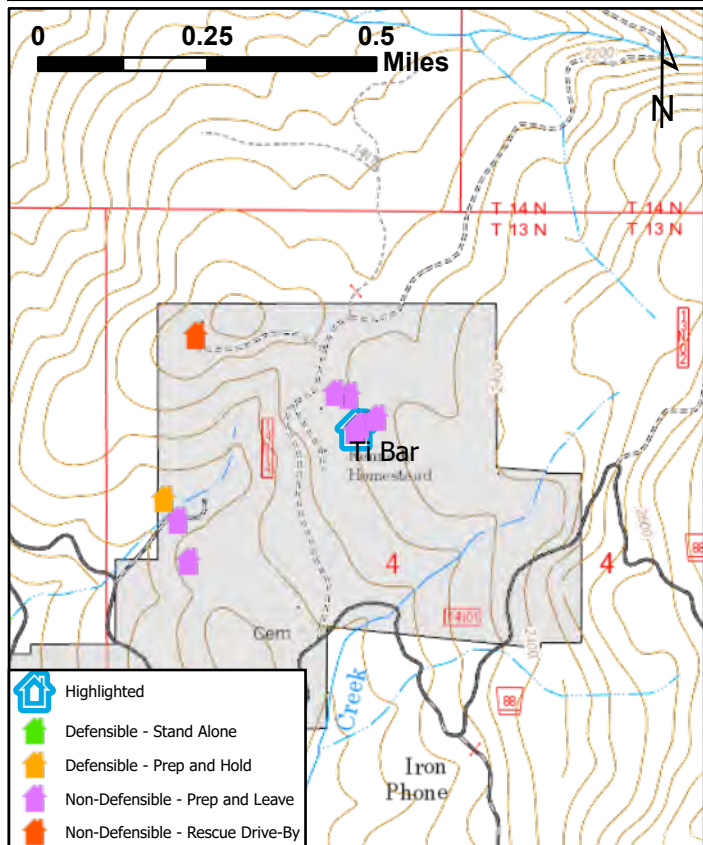
**Safety Zone(s):** No safety zone(s) in area  
**Comm With ICP:** Yes  
**Water Supply:** No reliable water source nearby  
**Fuel Type:** Shrub or timber  
**Defensible Space:** No defensible space  
**Hazards:** Household and agricultural debris, LP tanks, fuel cans, household and agricultural chemicals

**Non-Defensible, Prep and Leave**

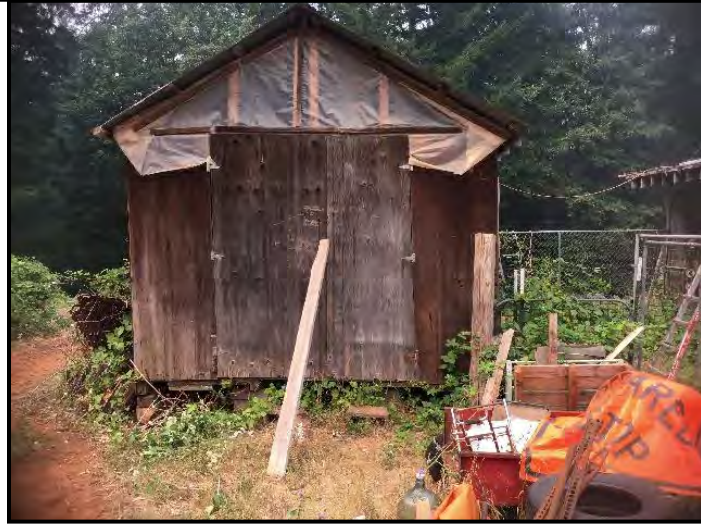
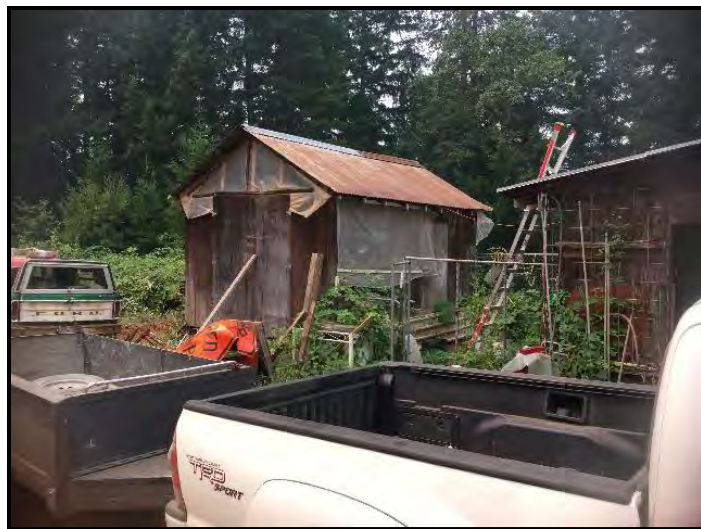
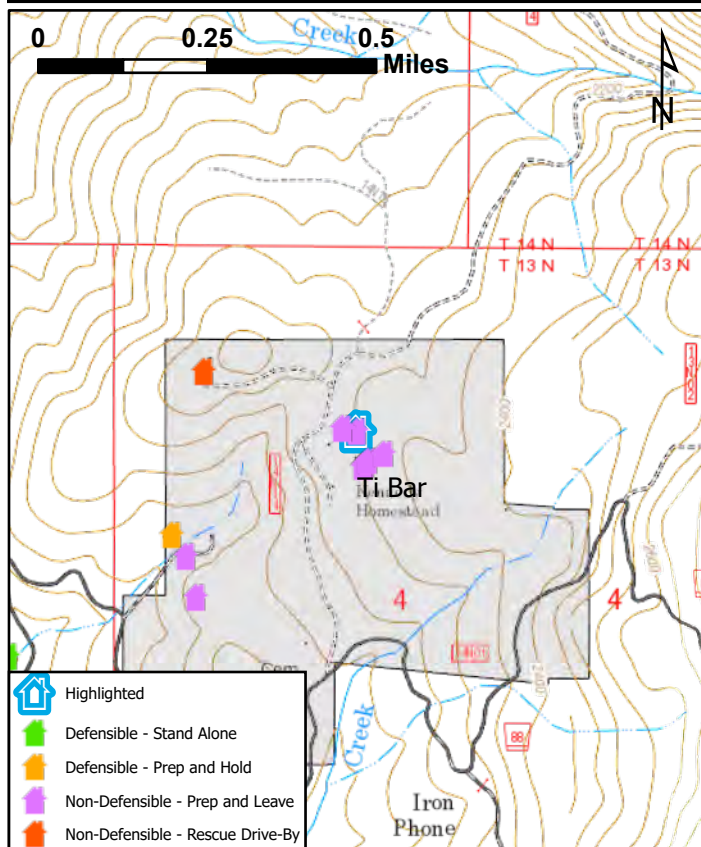
**Safety Zone(s):** No safety zone(s) in area  
**Comm With ICP:** Yes  
**Water Supply:** No reliable water source nearby  
**Fuel Type:** Shrub or timber  
**Defensible Space:** No defensible space  
**Hazards:** Adjacent fuels containing tires content of structure unknown

**Non-Defensible, Prep and Leave**

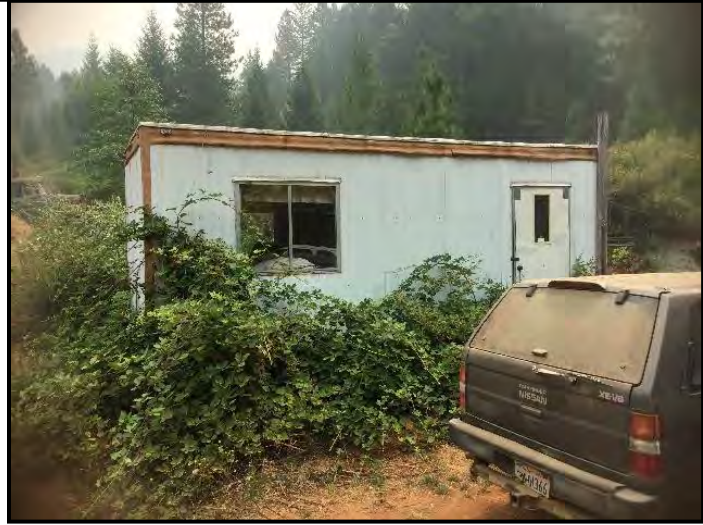
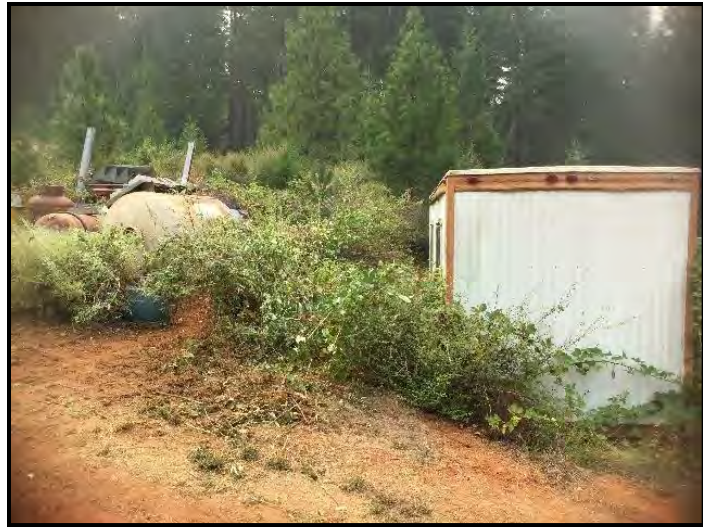
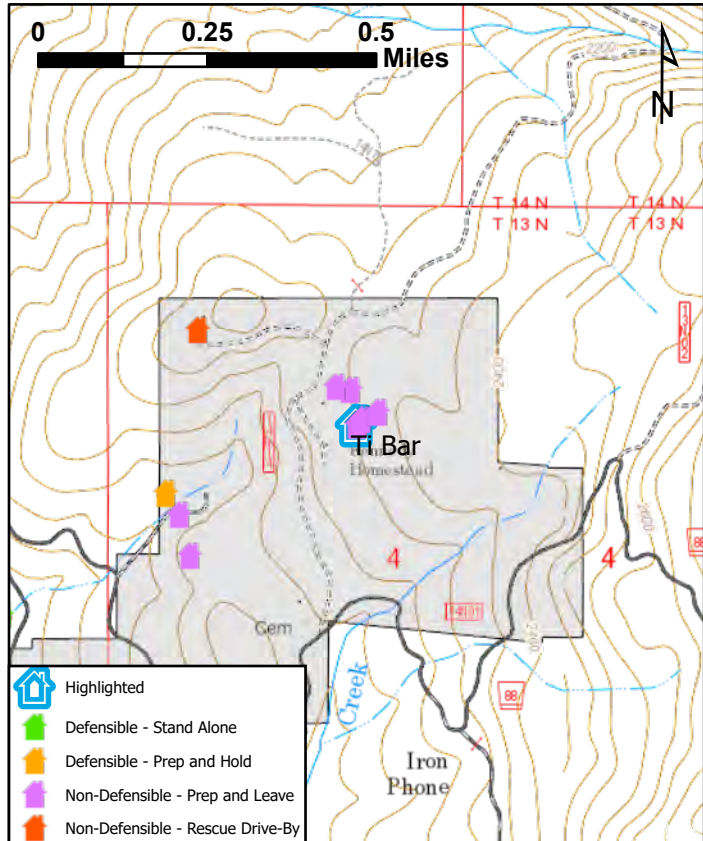
**Safety Zone(s):** No safety zone(s) in area  
**Comm With ICP:** Yes  
**Water Supply:** No reliable water source nearby  
**Fuel Type:** Grass and shrub, hardwood litter  
**Defensible Space:** No defensible space  
**Hazards:** Heavy fuel load, debris, LP tanks

**Non-Defensible, Prep and Leave**

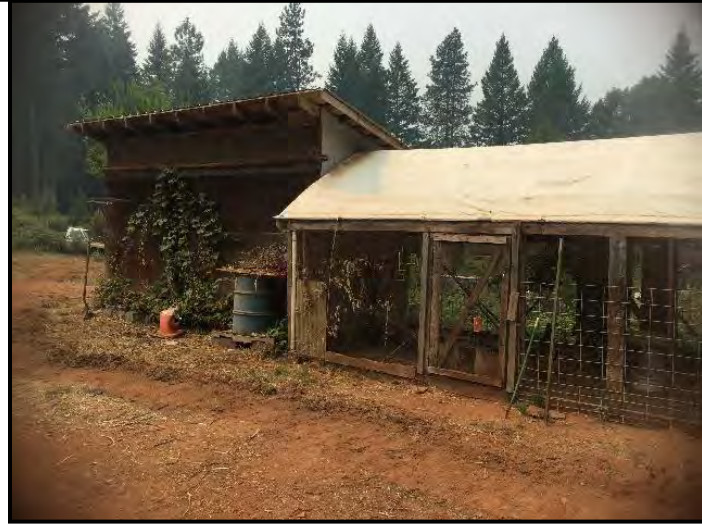
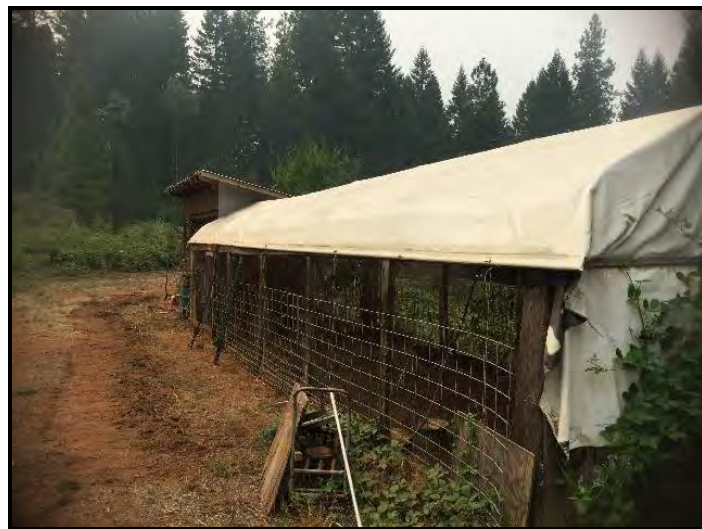
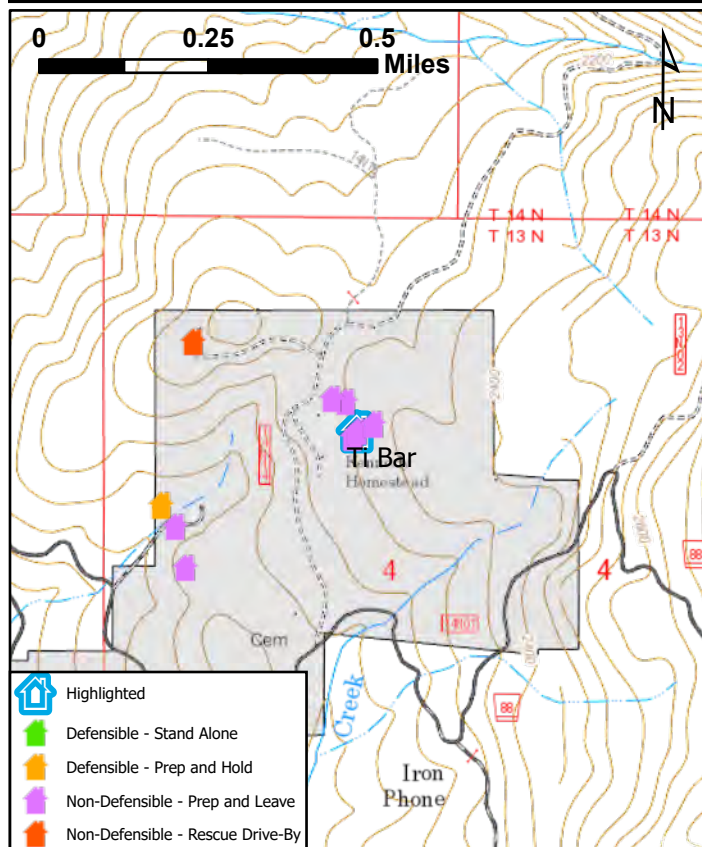
**Safety Zone(s):** No safety zone(s) in area  
**Comm With ICP:** Yes  
**Water Supply:** No reliable water source nearby  
**Fuel Type:** Grass and shrub, hardwood litter  
**Defensible Space:** Less than 30 ft treated  
**Hazards:** Fuel loading

**Non-Defensible, Prep and Leave**

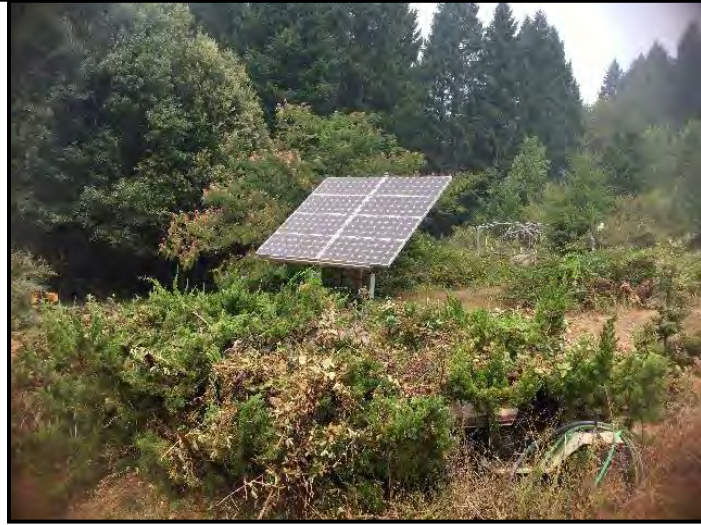
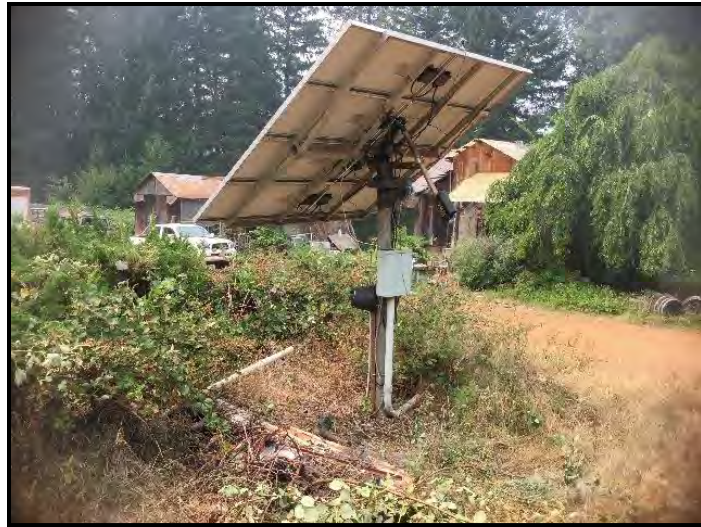
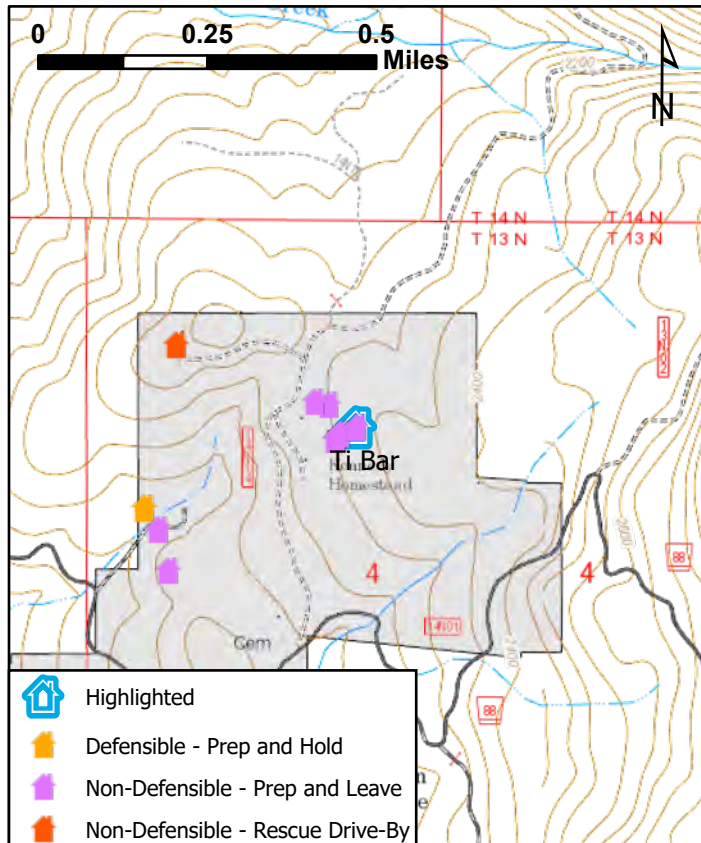
**Safety Zone(s):** No safety zone(s) in area  
**Comm With ICP:** Yes  
**Water Supply:** No reliable water source nearby  
**Fuel Type:** Grass and shrub, hardwood litter  
**Defensible Space:** Less than 30 ft treated  
**Hazards:** Adjacent fuel

**Non-Defensible, Prep and Leave**

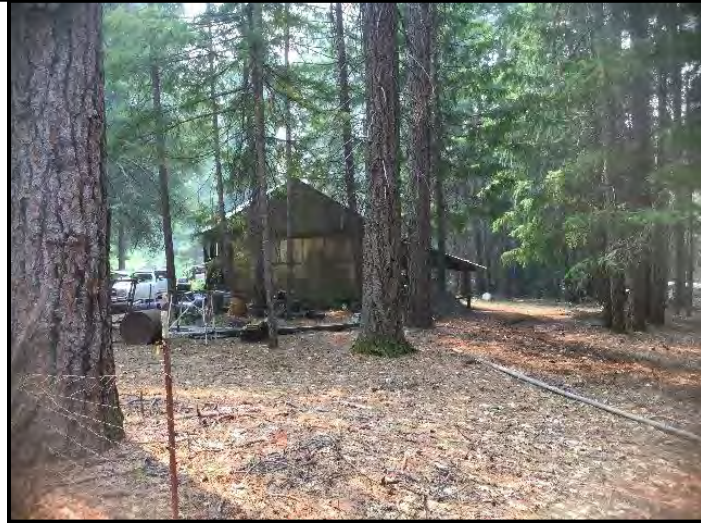
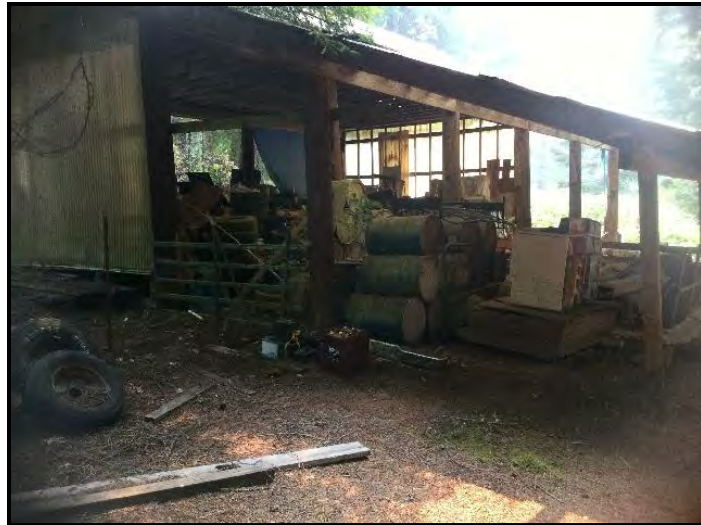
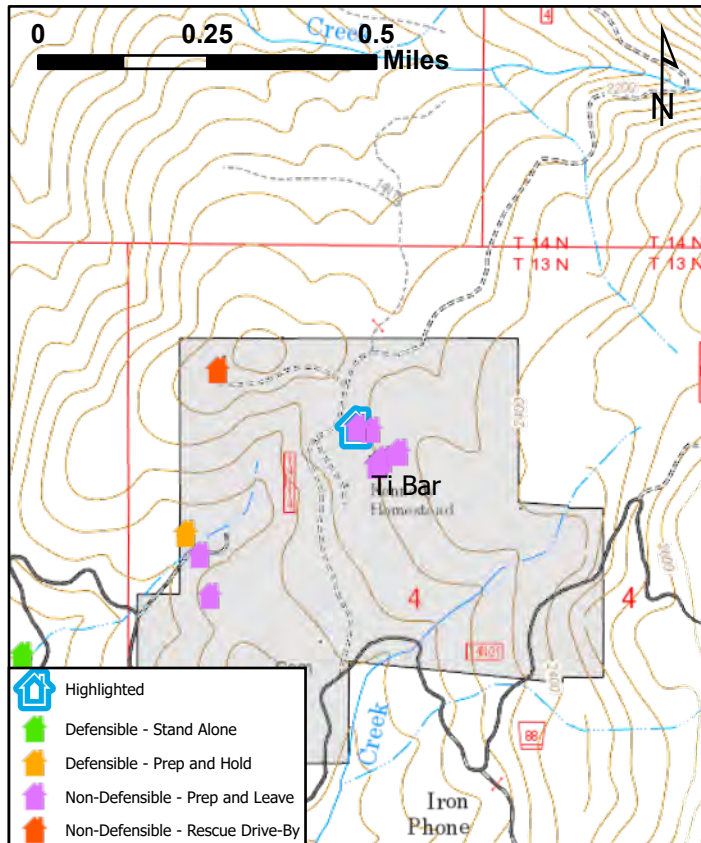
**Safety Zone(s):** No safety zone(s) in area  
**Comm With ICP:** Yes  
**Water Supply:** No reliable water source nearby  
**Fuel Type:** Shrub or timber  
**Defensible Space:** Less than 30 ft treated  
**Hazards:** Debris and contents of structure flammable

**Non-Defensible, Prep and Leave**

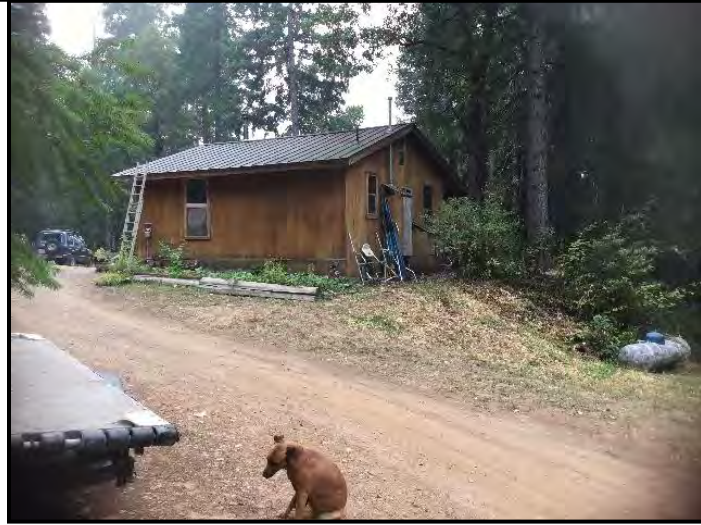
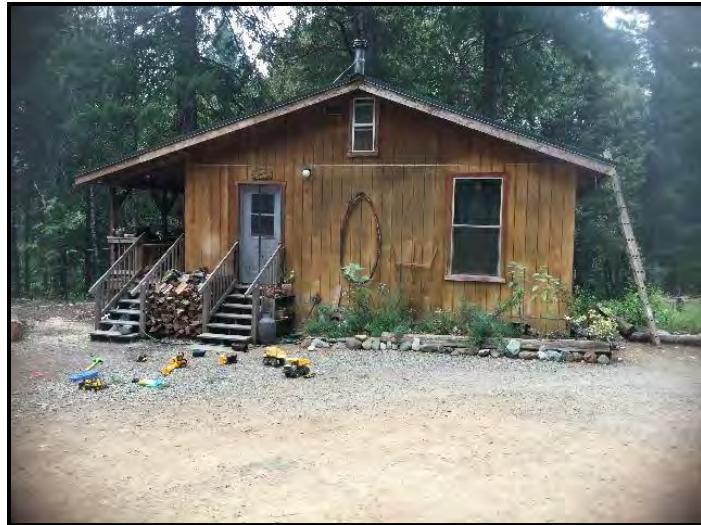
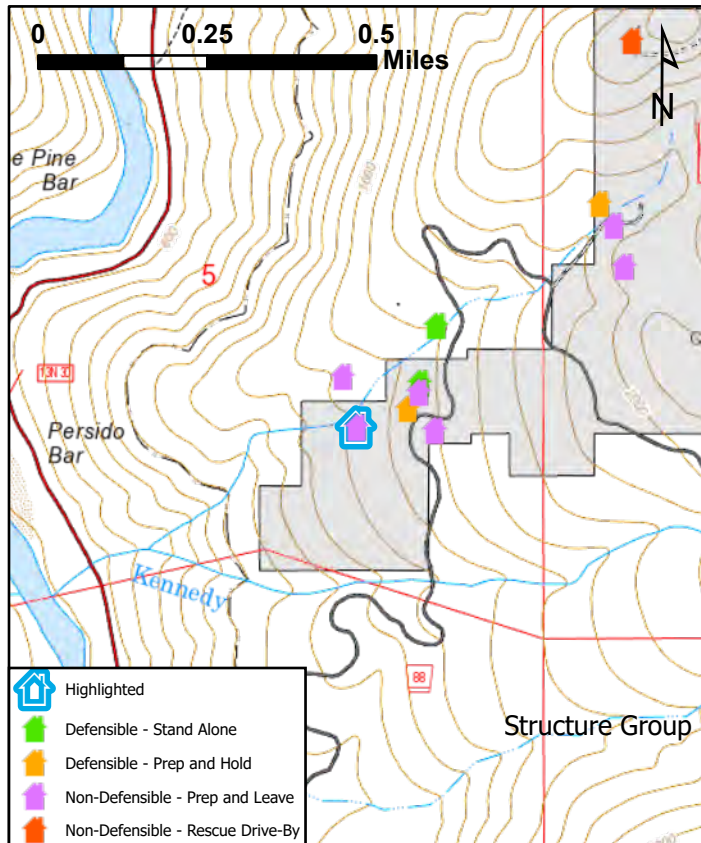
**Safety Zone(s):** No safety zone(s) in area  
**Comm With ICP:** Yes  
**Water Supply:** No reliable water source nearby  
**Fuel Type:** Shrub or timber  
**Defensible Space:** No defensible space  
**Hazards:**

**Non-Defensible, Prep and Leave**

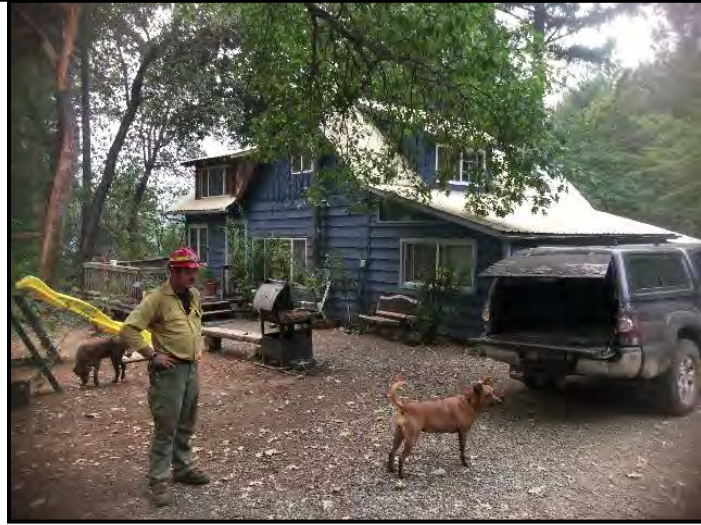
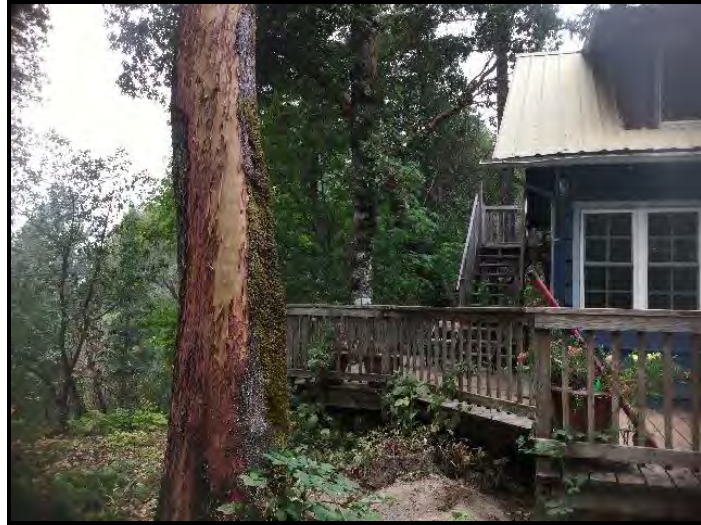
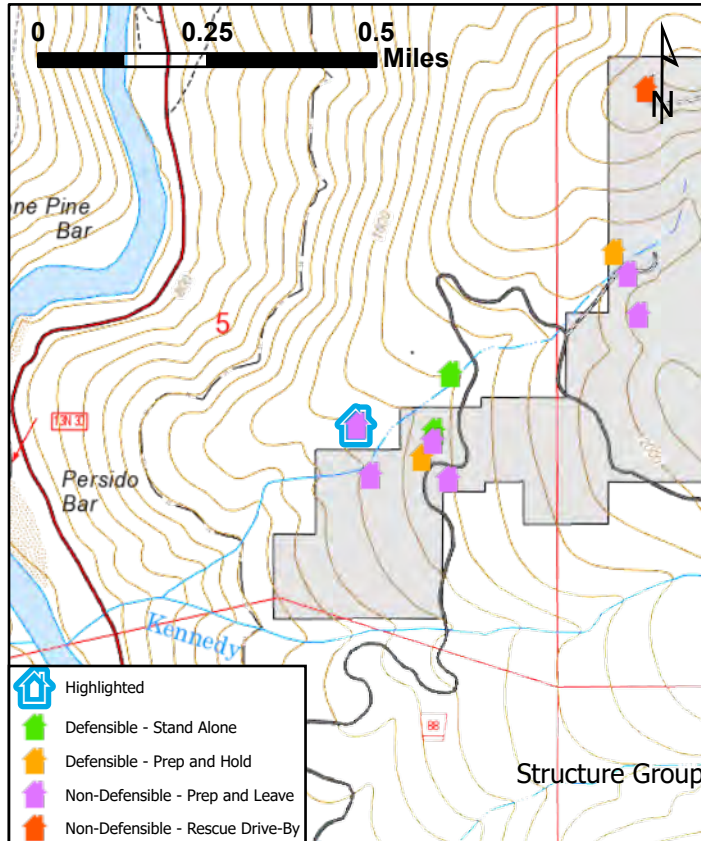
**Safety Zone(s):** No safety zone(s) in area  
**Comm With ICP:** Unknown  
**Water Supply:** No reliable water source nearby  
**Fuel Type:** Shrub or timber  
**Defensible Space:** Less than 30 ft treated  
**Hazards:** LP between house and garage

**Non-Defensible, Prep and Leave**

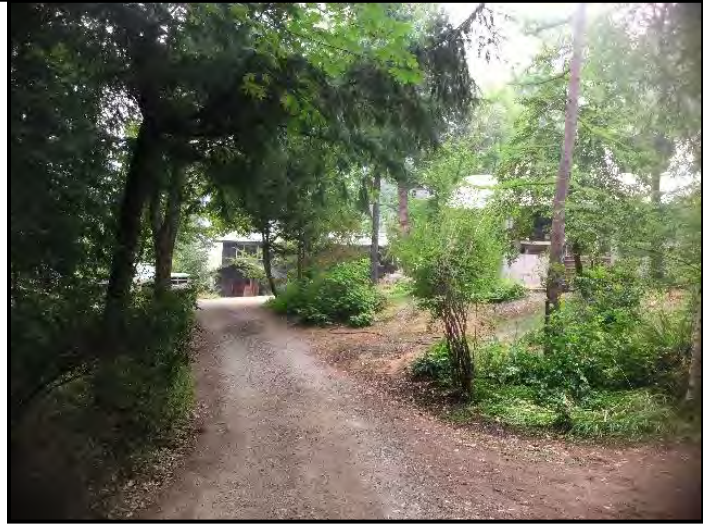
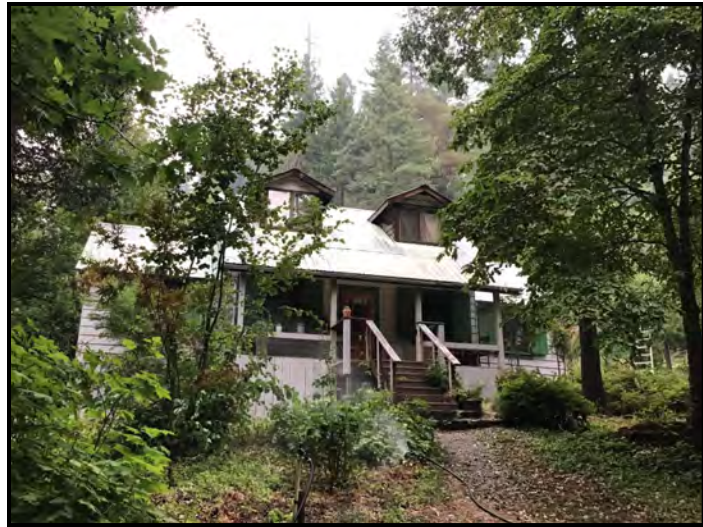
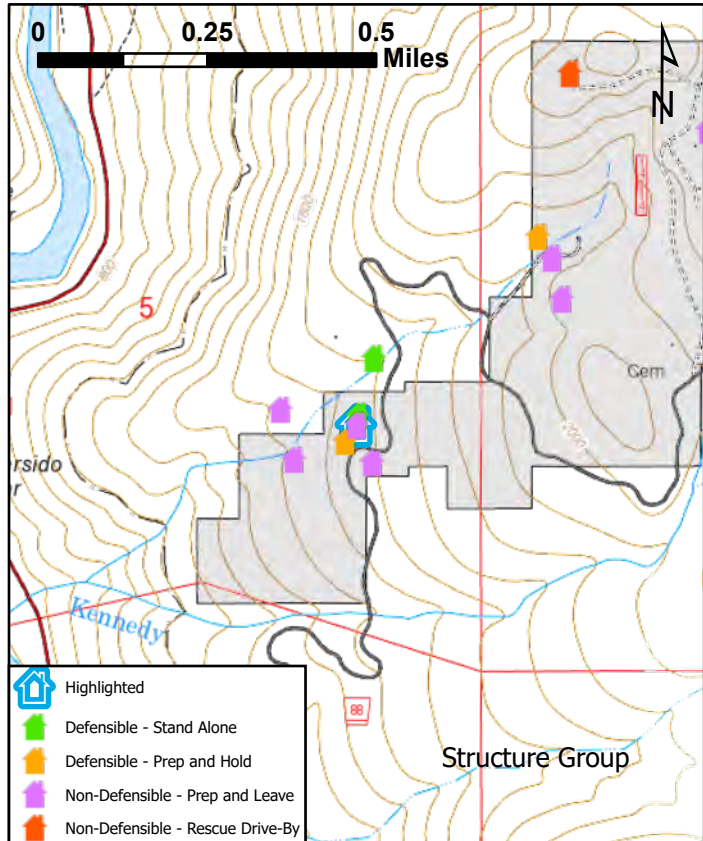
**Safety Zone(s):** Potential safety zone(s) in area  
**Comm With ICP:** Yes  
**Water Supply:** Pressurized hydrant(s) or fixed sprinkler system  
**Fuel Type:** Shrub or timber  
**Defensible Space:** Less than 30 ft treated  
**Hazards:** LP tank behind house

**Non-Defensible, Prep and Leave**
