# McCash Fire Structure Triage Assessment

CASRF000651  
August 18, 2021

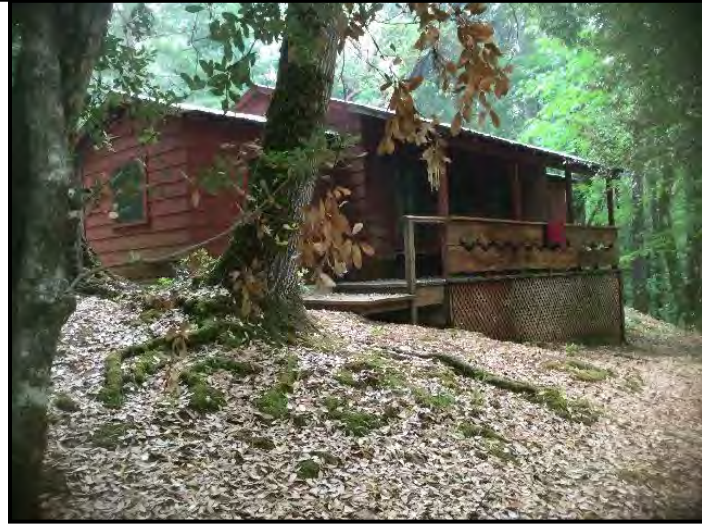
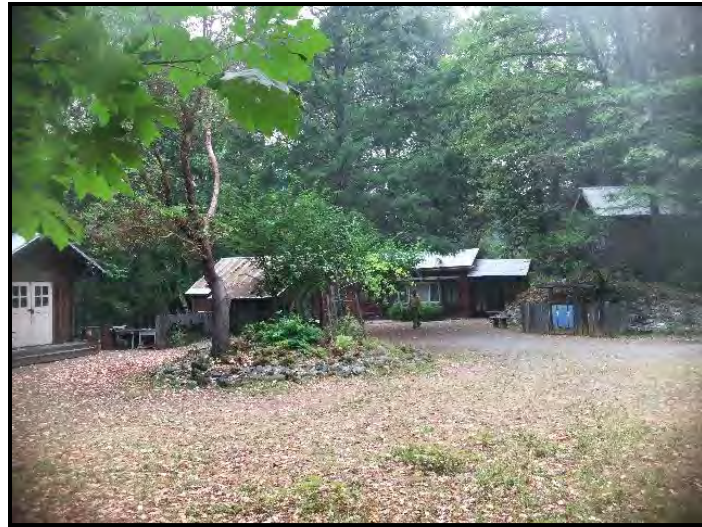
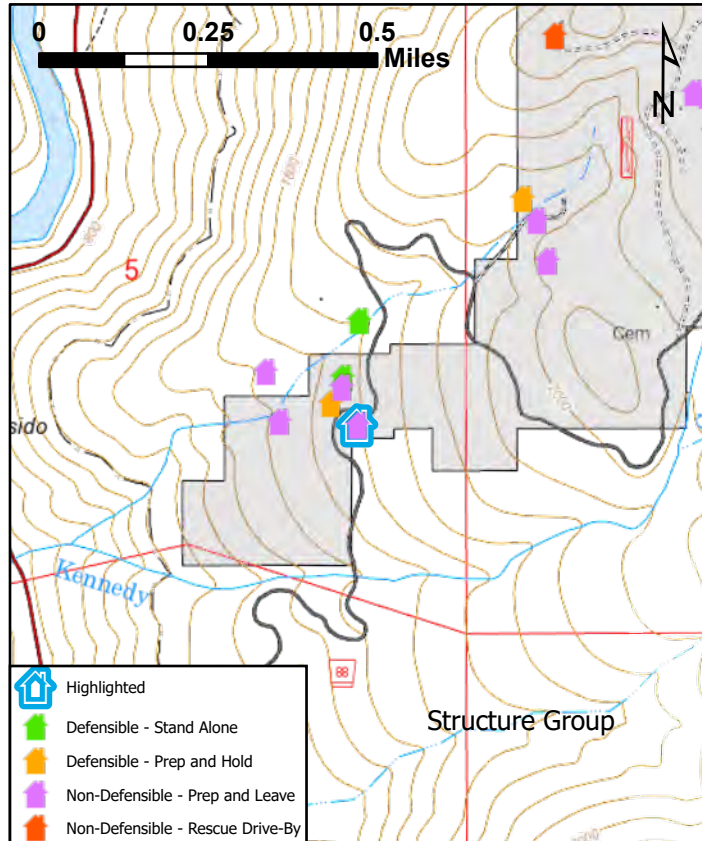
**Safety Zone(s):** No safety zone(s) in area  
**Comm With ICP:** Yes  
**Water Supply:** Limited or dependent on electricity  
**Fuel Type:** Shrub or timber  
**Defensible Space:** No defensible space  
**Hazards:** LP tank to the right of drive and one by outbuilding

**Non-Defensible, Prep and Leave**

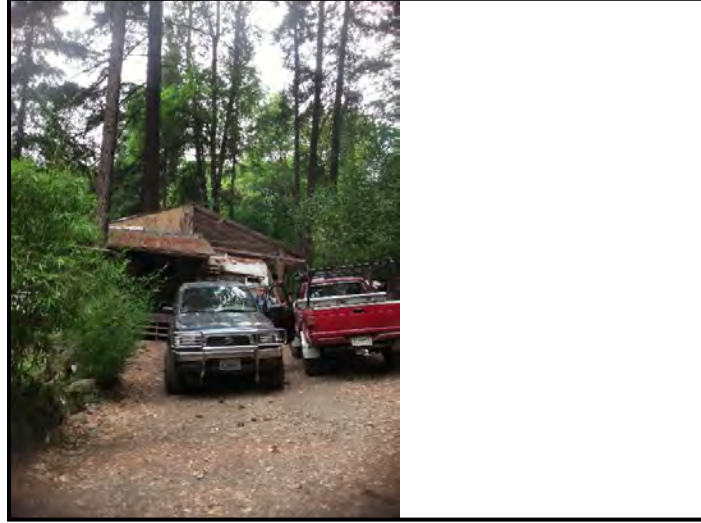
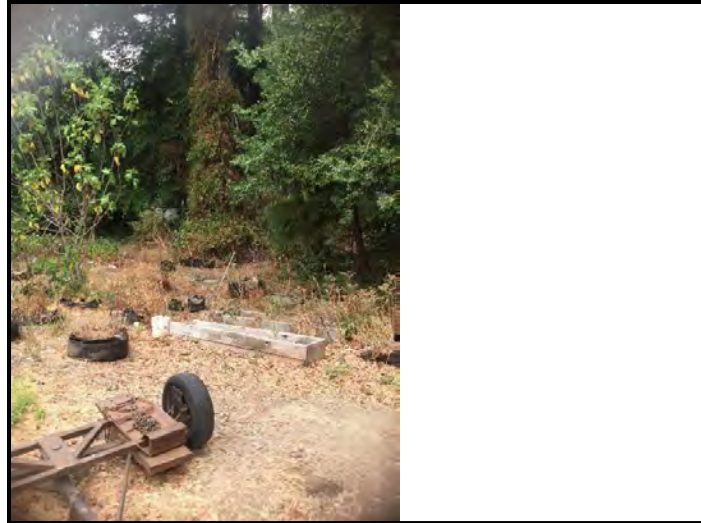
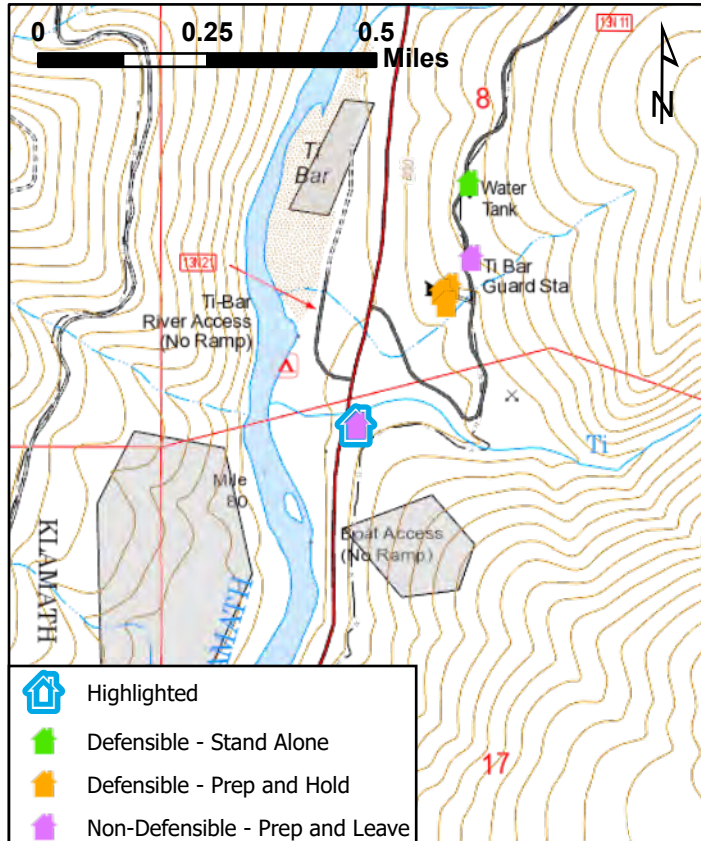
**Safety Zone(s):** No safety zone(s) in area  
**Comm With ICP:** Yes  
**Water Supply:** No reliable water source nearby  
**Fuel Type:** Grass and shrub, hardwood litter  
**Defensible Space:** No defensible space  
**Hazards:** Small hazmat less than 5 gallon containers, general trash and debris,

**Non-Defensible, Prep and Leave**
