McCash Fire Structure Triage Assessment

CASRF000651
August 20, 2021

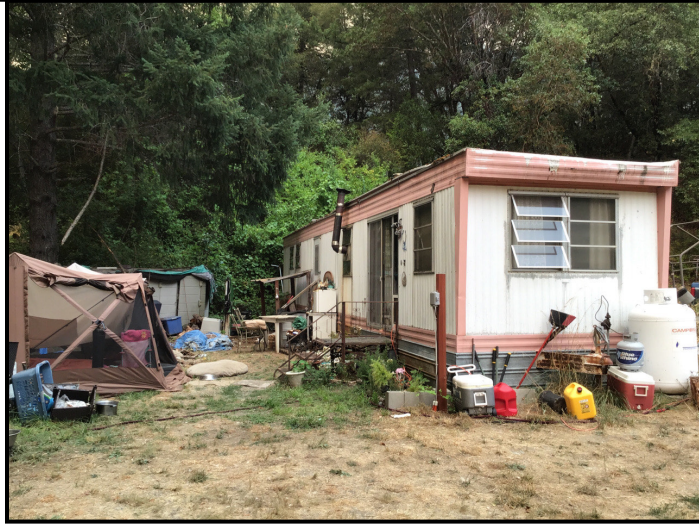
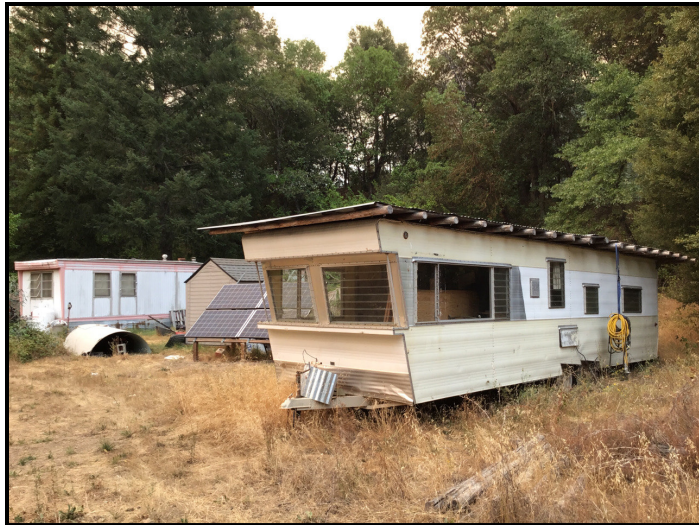
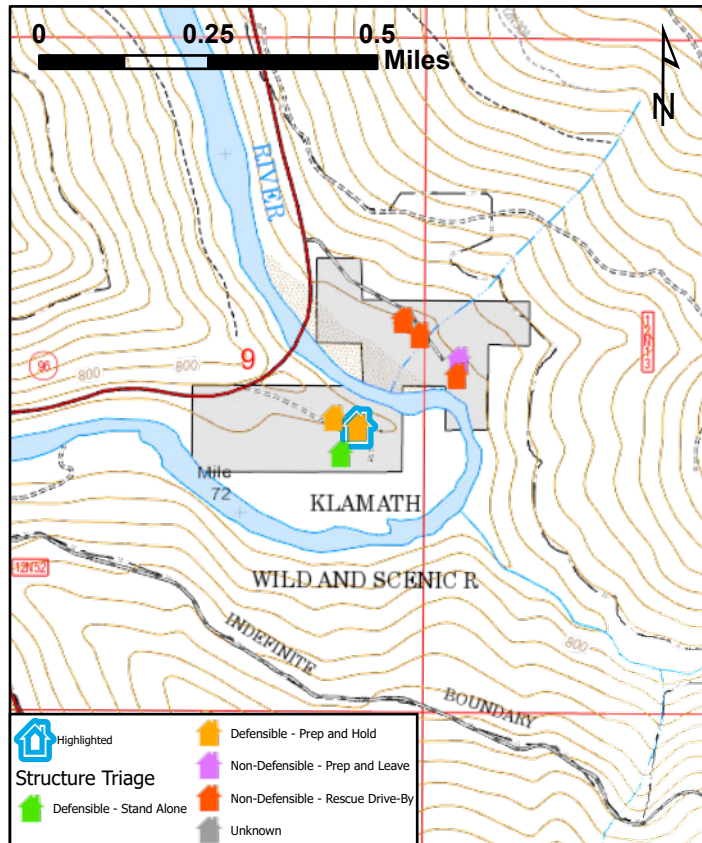
Safety Zone(s): Potential safety zone(s) in area
Comm With ICP:
Water Supply:
Fuel Type:
Defensible Space:
Hazards:

TRIAGE CATEGORY

Defensible, Prep and Hold
