McCash Fire Structure Triage Assessment

CASRF000651
August 20, 2021

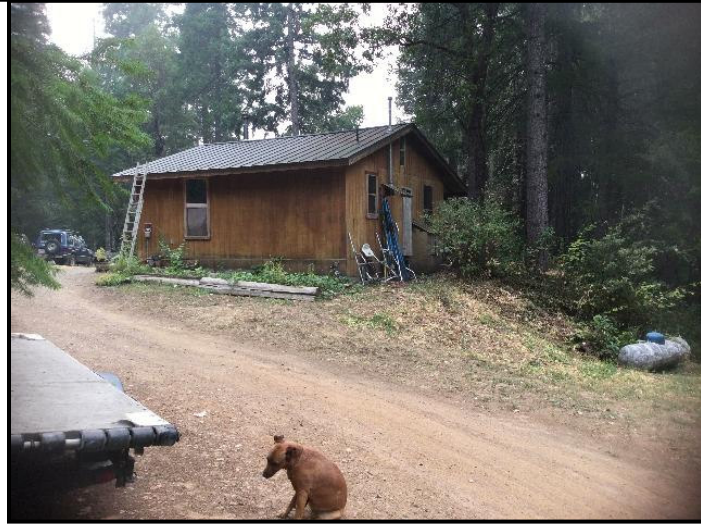
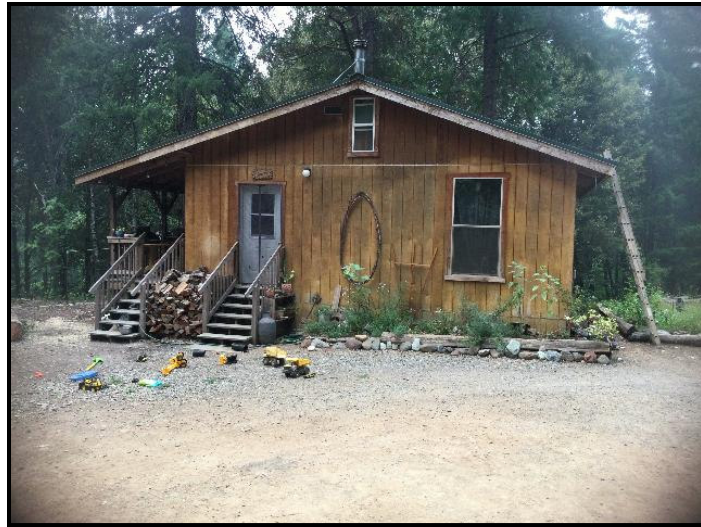
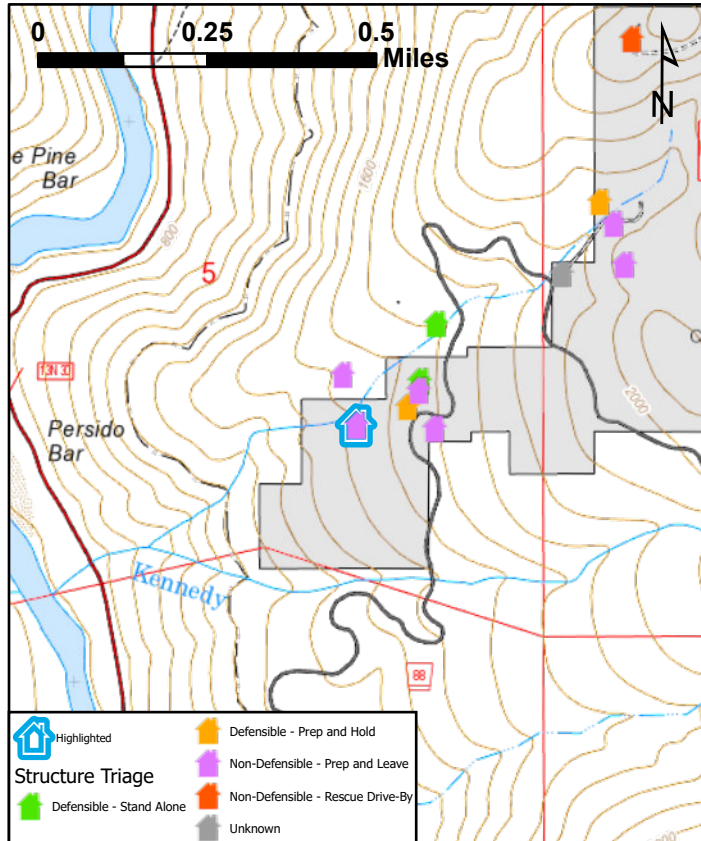
Safety Zone(s): No safety zone(s) in area
Comm With ICP: Yes
Water Supply: No reliable water source nearby
Fuel Type: Shrub or timber
Defensible Space: No defensible space
Hazards:

Non-Defensible, Prep and Leave

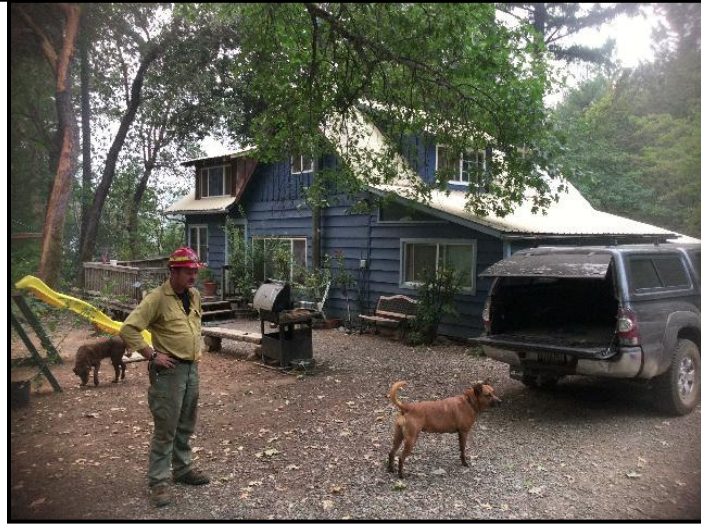
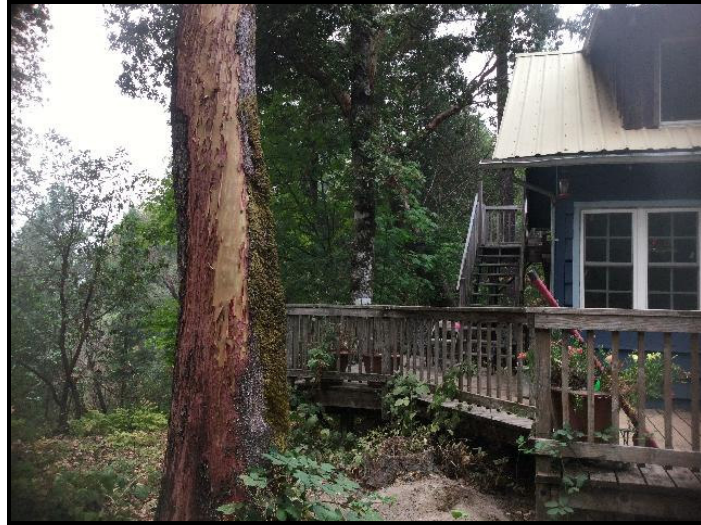
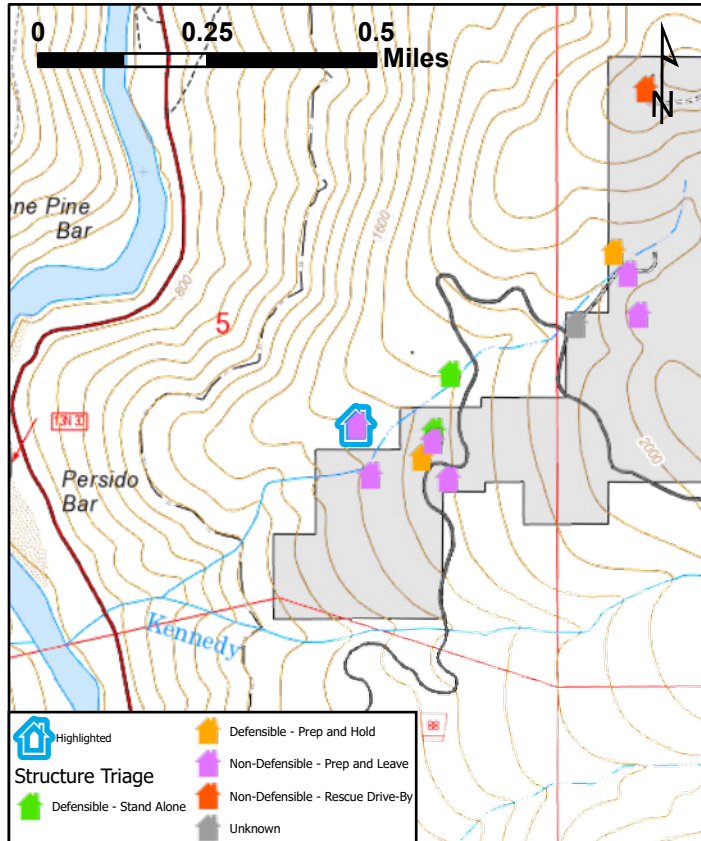
Safety Zone(s): No safety zone(s) in area
Comm With ICP: Unknown
Water Supply: No reliable water source nearby
Fuel Type: Shrub or timber
Defensible Space: Less than 30 ft treated
Hazards: LP between house and garage

Non-Defensible, Prep and Leave

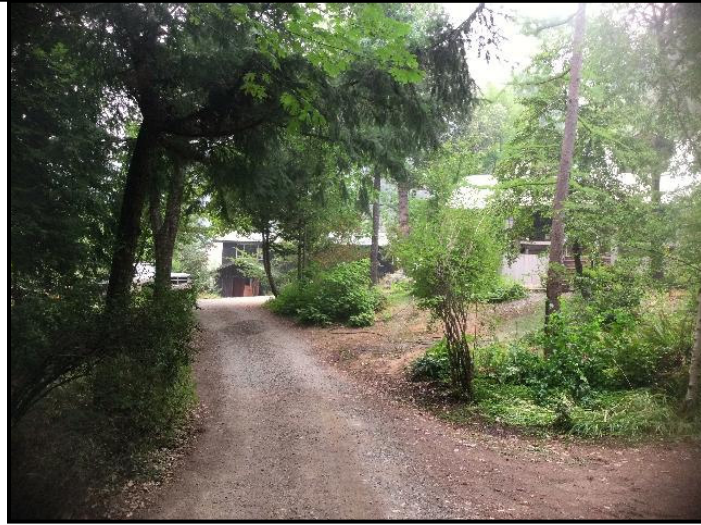
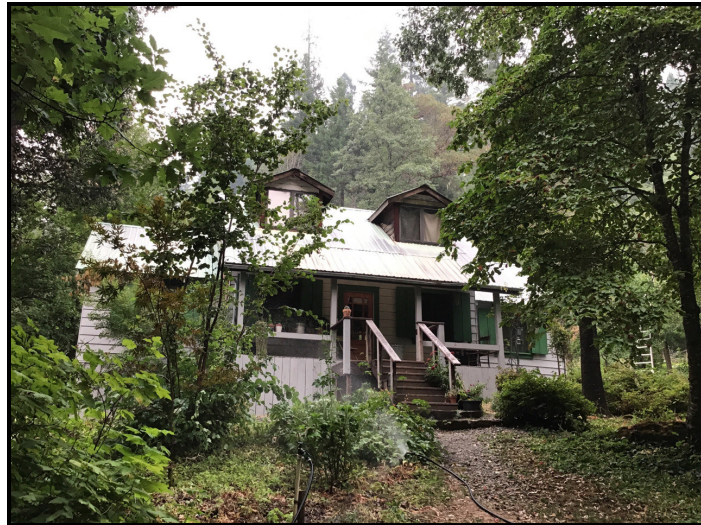
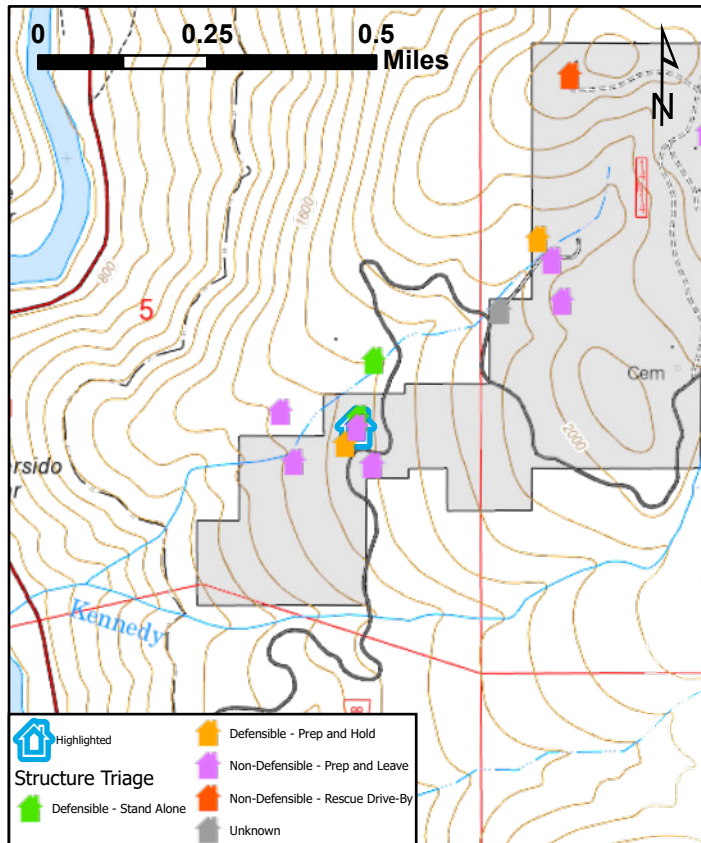
Safety Zone(s): Potential safety zone(s) in area
Comm With ICP: Yes
Water Supply: Pressurized hydrant(s) or fixed sprinkler system
Fuel Type: Shrub or timber
Defensible Space: Less than 30 ft treated
Hazards: LP tank behind house

Non-Defensible, Prep and Leave

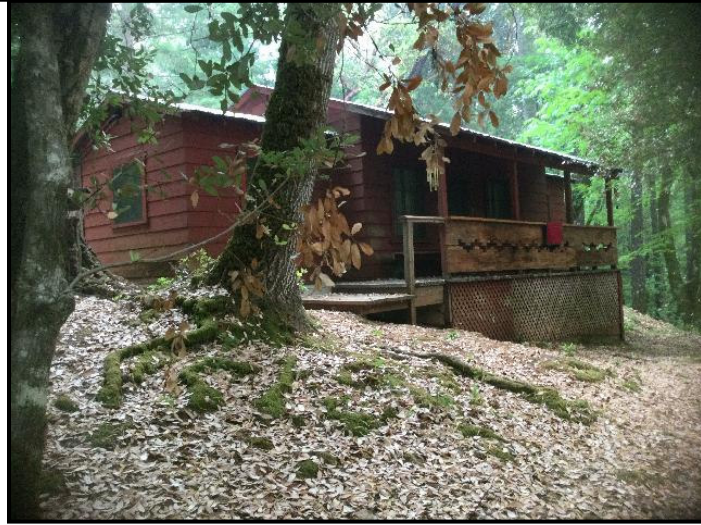
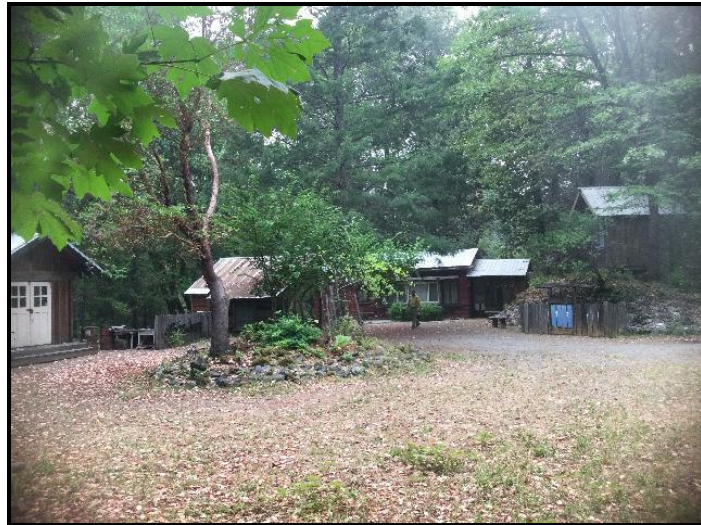
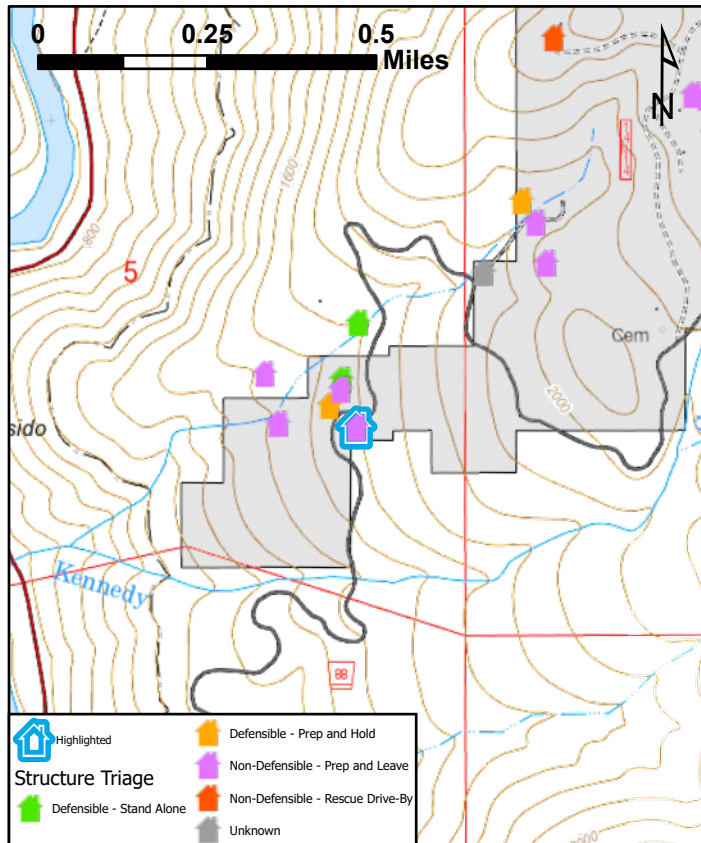
Safety Zone(s): No safety zone(s) in area
Comm With ICP: Yes
Water Supply: Limited or dependent on electricity
Fuel Type: Shrub or timber
Defensible Space: No defensible space
Hazards: LP tank to the right of drive and one by outbuilding

Non-Defensible, Prep and Leave

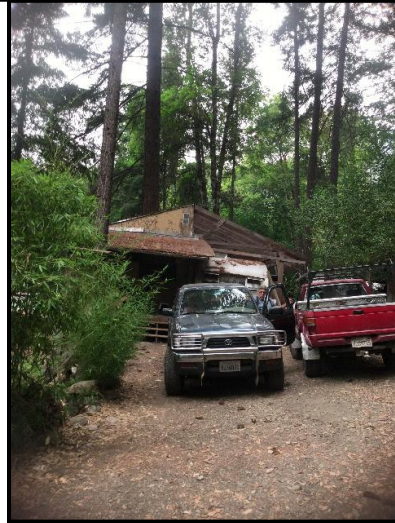
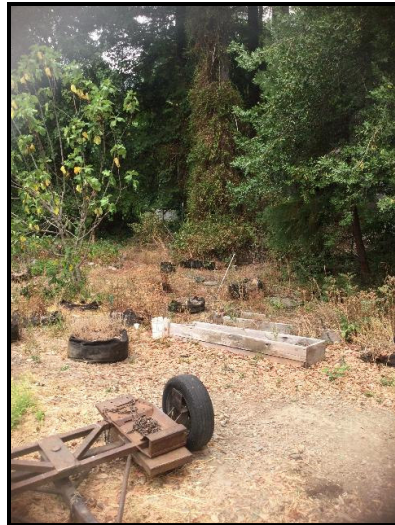
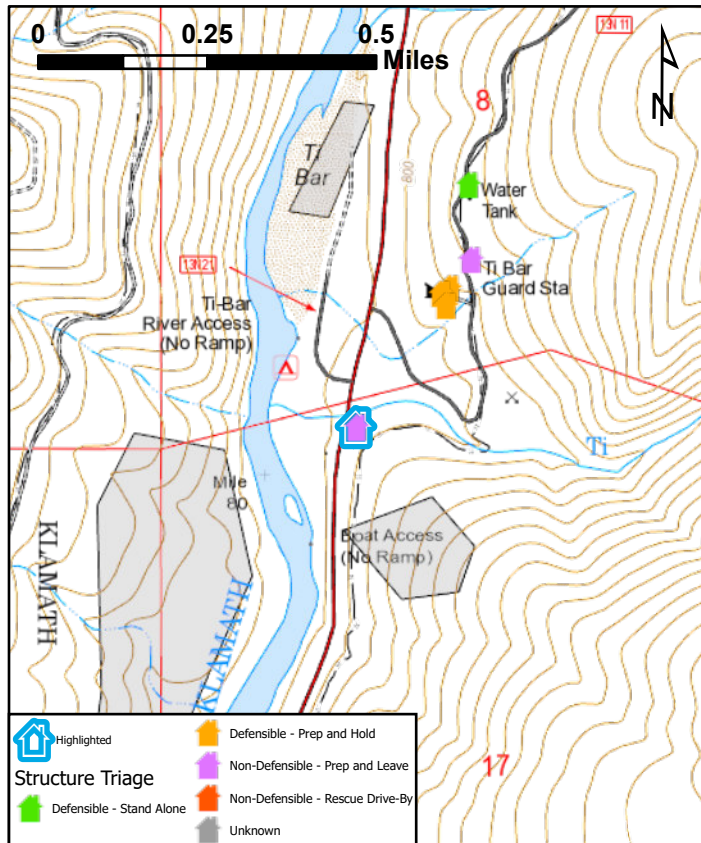
Safety Zone(s): No safety zone(s) in area
Comm With ICP: Yes
Water Supply: No reliable water source nearby
Fuel Type: Grass and shrub, hardwood litter
Defensible Space: No defensible space
Hazards: Small hazmat less than 5 gallon containers, general trash and debris,

Non-Defensible, Prep and Leave

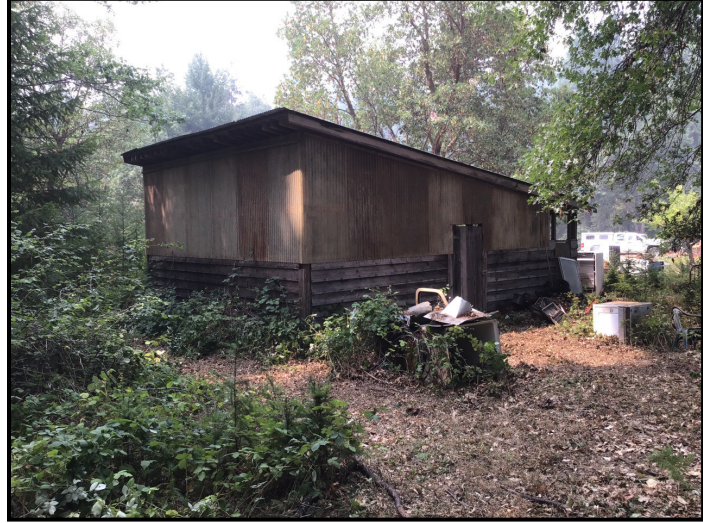
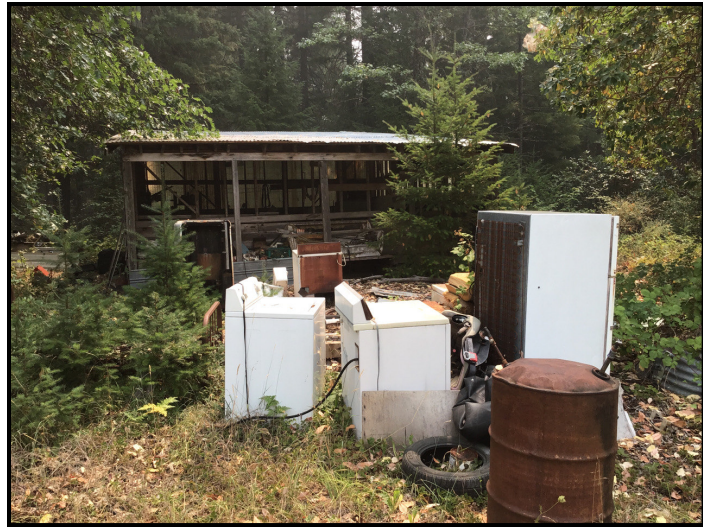
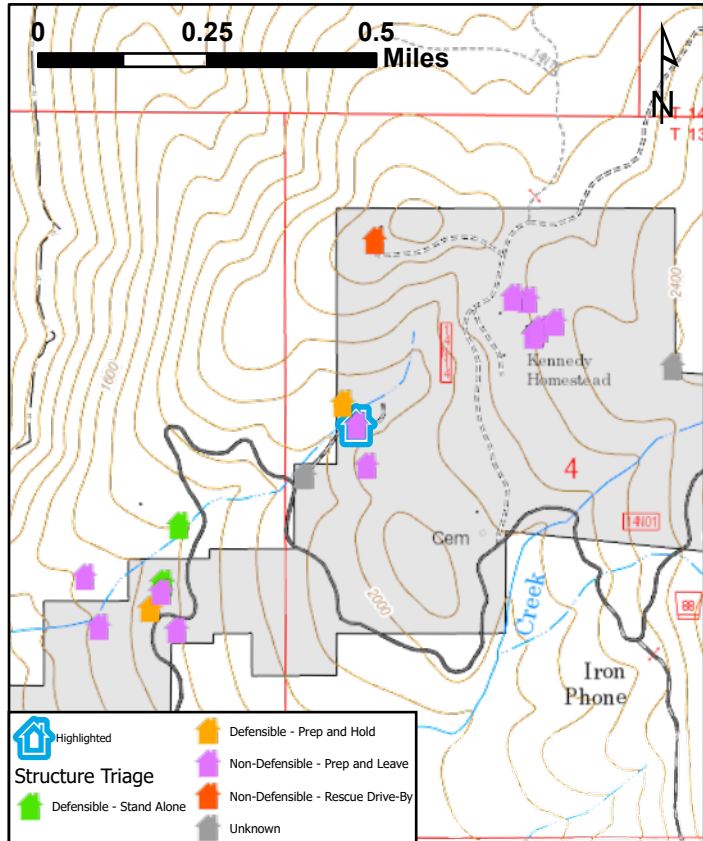
Safety Zone(s): Potential safety zone(s) in area
Comm With ICP: Yes
Water Supply: Reliable water source nearby
Fuel Type:
Defensible Space: No defensible space
Hazards: Trash

Non-Defensible, Prep and Leave

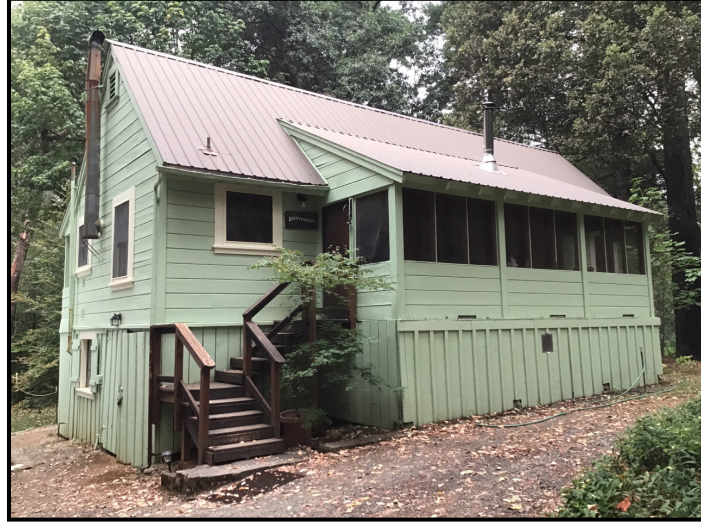
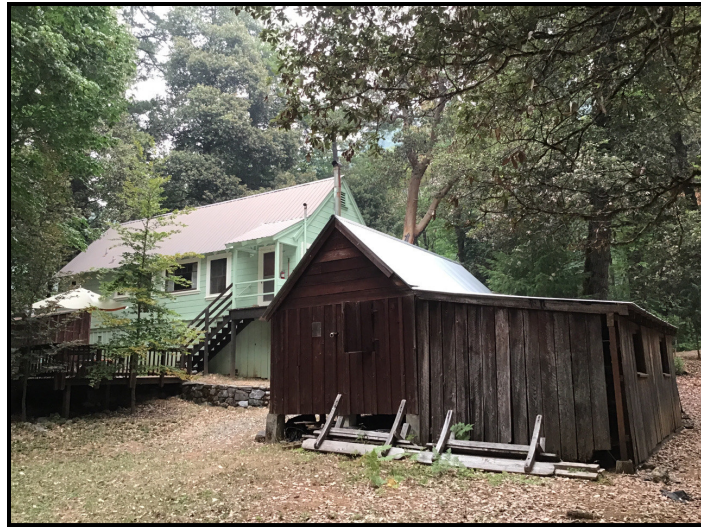
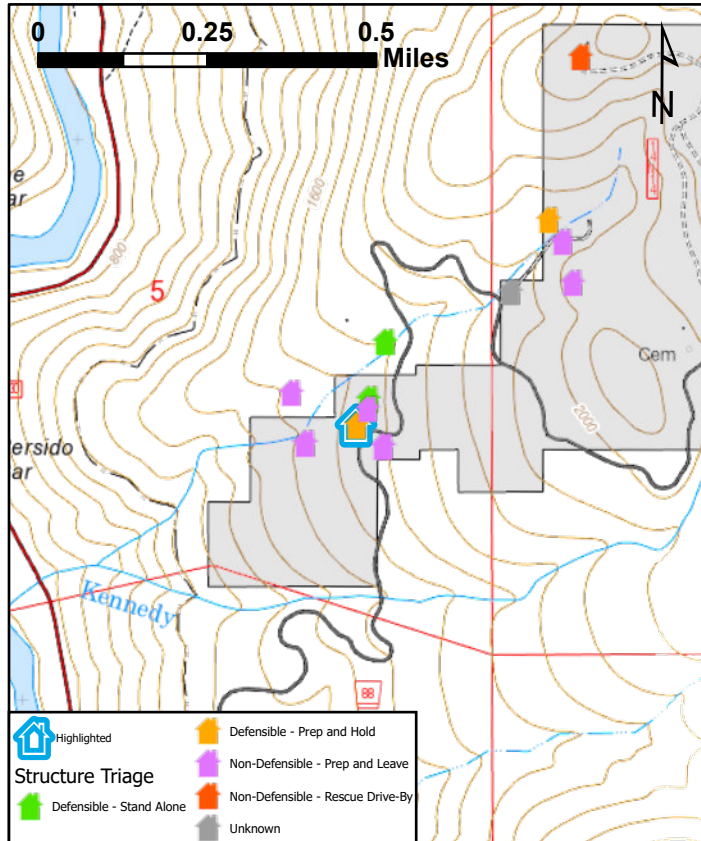
Safety Zone(s): Potential safety zone(s) in area
Comm With ICP: Yes
Water Supply: Pressurized hydrant(s) or fixed sprinkler system
Fuel Type: Grass and shrub, hardwood litter
Defensible Space: 100 ft treated
Hazards:

Defensible, Prep and Hold

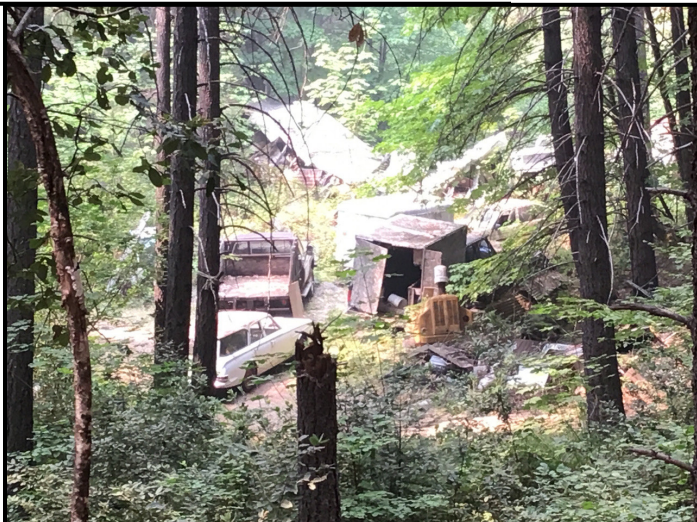
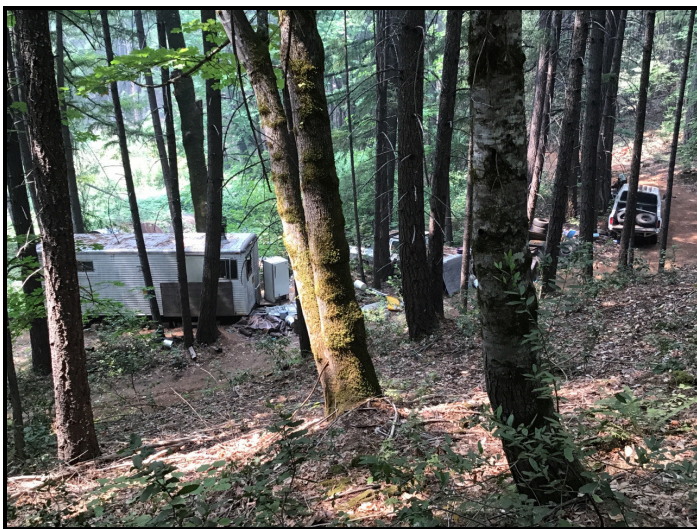
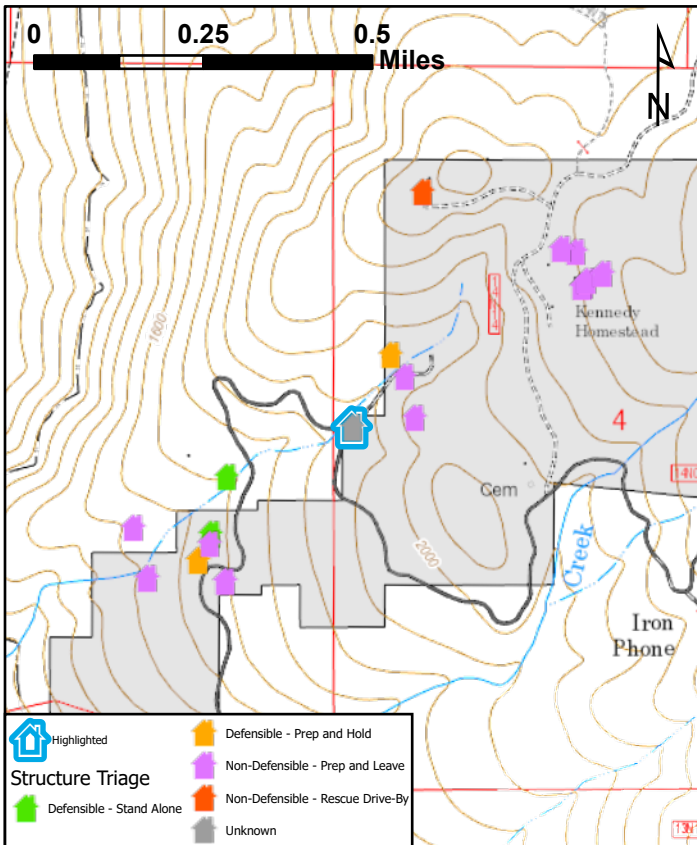
Safety Zone(s): No safety zone(s) in area
Comm With ICP: Yes
Water Supply:
Fuel Type:
Defensible Space: No defensible space
Hazards: Abandoned cars, trailers, trash piles

Unknown
