# McCash Fire Structure Triage Assessment

CASRF000651  
August 23, 2021

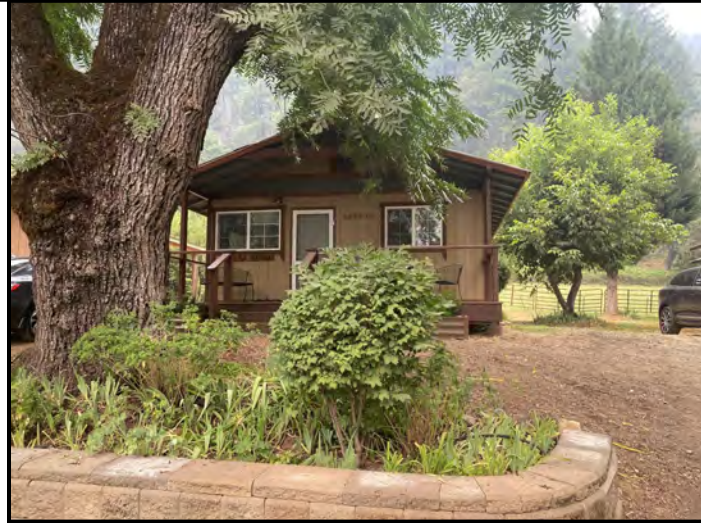
**Roof Material:** Noncombustible or not applicable  
**Siding Material:** Wood or open sided  
**Electrical Power:** Yes  
**Gas to Structure:** Yes  
**Comments:**

**Safety Zone(s):**  
**Comm With ICP:**  
**Water Supply:**  
**Fuel Type:** Shrub or timber  
**Defensible Space:** 30 ft treated  
**Hazards:**

**Defensible, Prep and Hold**

**FIRESCOPE Tactics:** Prep and Defend

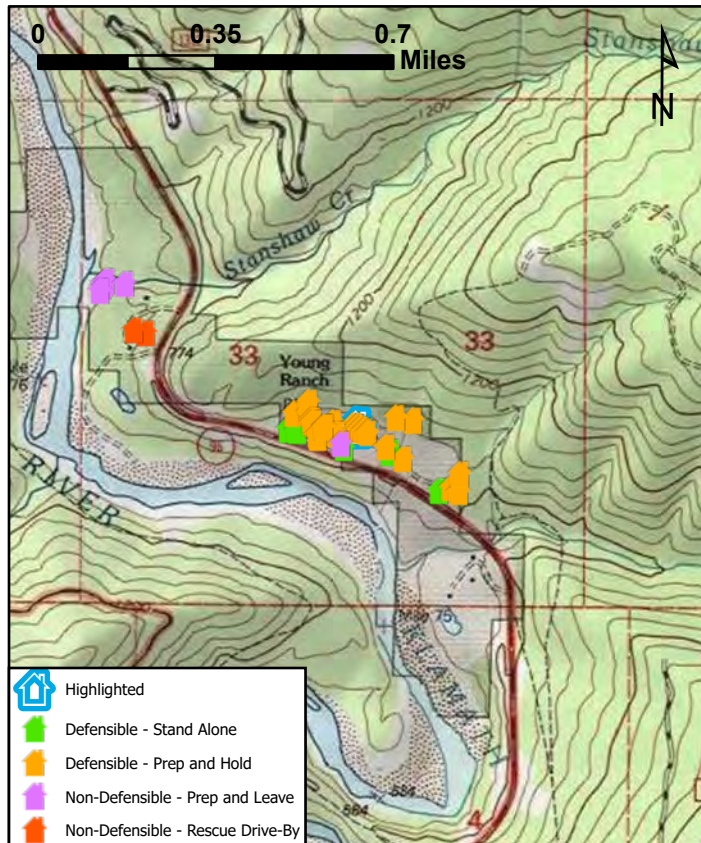
**Safety Zone(s):**  
**Comm With ICP:**  
**Water Supply:**  
**Fuel Type:** Shrub or timber  
**Defensible Space:**  
**Hazards:**

**Defensible, Prep and Hold**

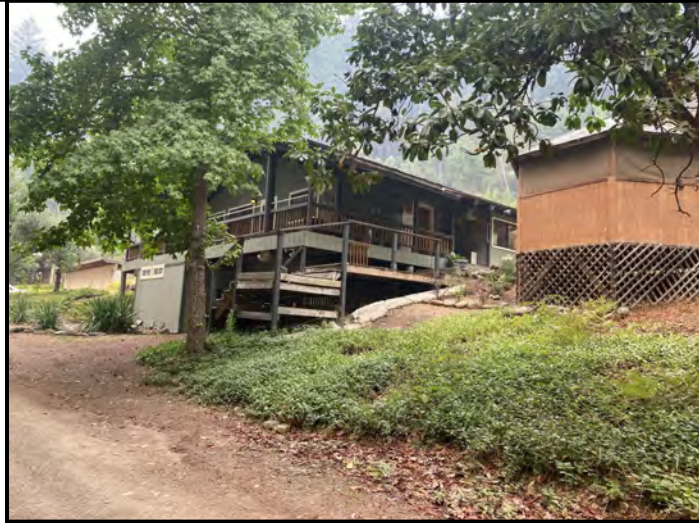
**Safety Zone(s):** Potential safety zone(s) in area  
**Comm With ICP:**  
**Water Supply:** Reliable water source nearby  
**Fuel Type:** Shrub or timber  
**Defensible Space:** 30 ft treated  
**Hazards:**

**Defensible, Prep and Hold**

**Mitigation Time (in hours):**  
**Mitigation Description:** Cleaned around structure for hazards

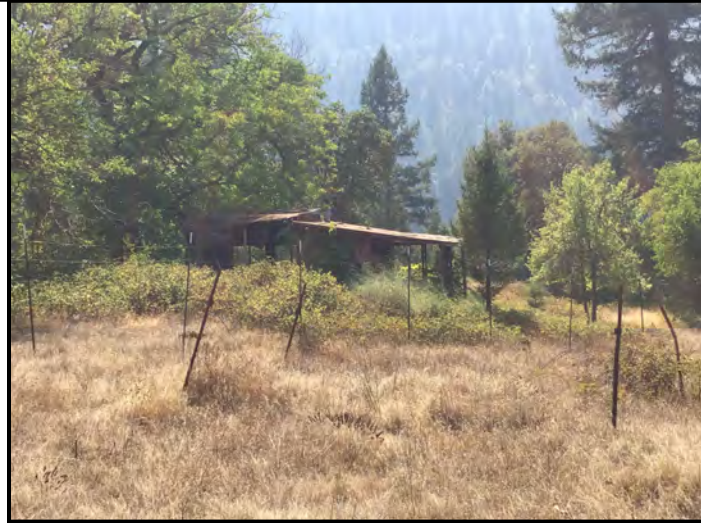
**Safety Zone(s):** No safety zone(s) in area  
**Comm With ICP:** Yes  
**Water Supply:** No reliable water source nearby  
**Fuel Type:**  
**Defensible Space:** No defensible space  
**Hazards:** Unknown

**Non-Defensible, Rescue, Drive By**

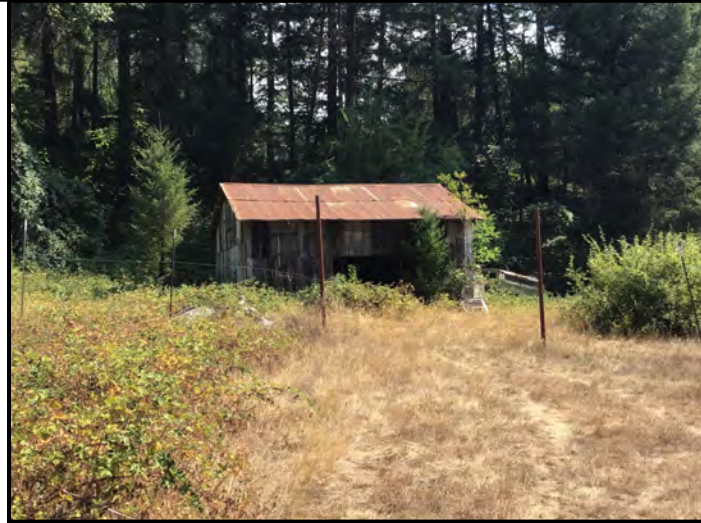
**Safety Zone(s):** No safety zone(s) in area  
**Comm With ICP:**  
**Water Supply:** No reliable water source nearby  
**Fuel Type:**  
**Defensible Space:** No defensible space  
**Hazards:** Unknown

**Non-Defensible, Rescue, Drive By**

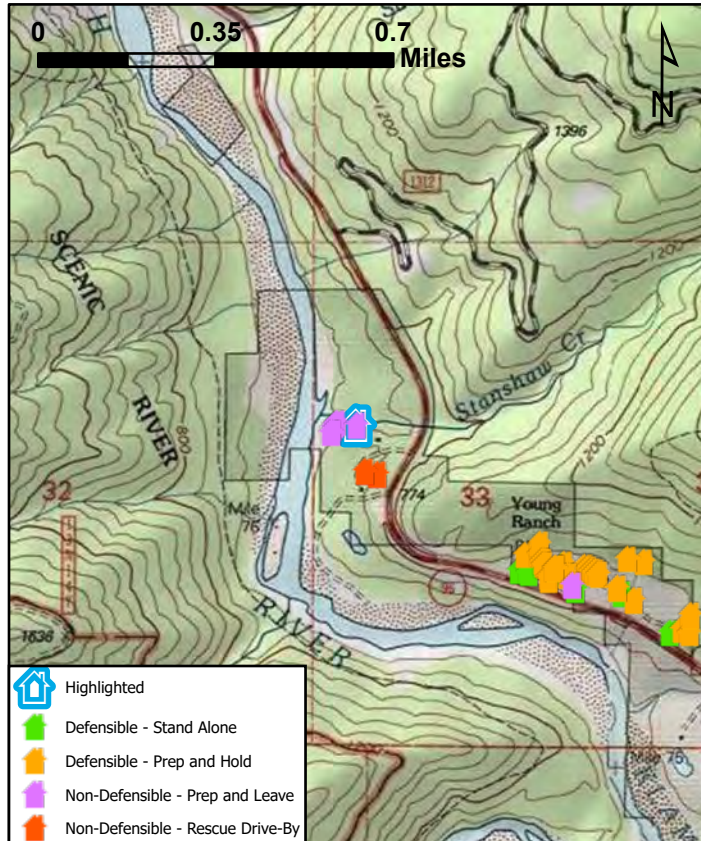
**Safety Zone(s):** Potential safety zone(s) in area  
**Comm With ICP:** Yes  
**Water Supply:** Reliable water source nearby  
**Fuel Type:** Shrub or timber  
**Defensible Space:** No defensible space  
**Hazards:**

**Non-Defensible, Prep and Leave**
