McCash Fire Structure Triage Assessment

CASRF000651
August 23, 2021

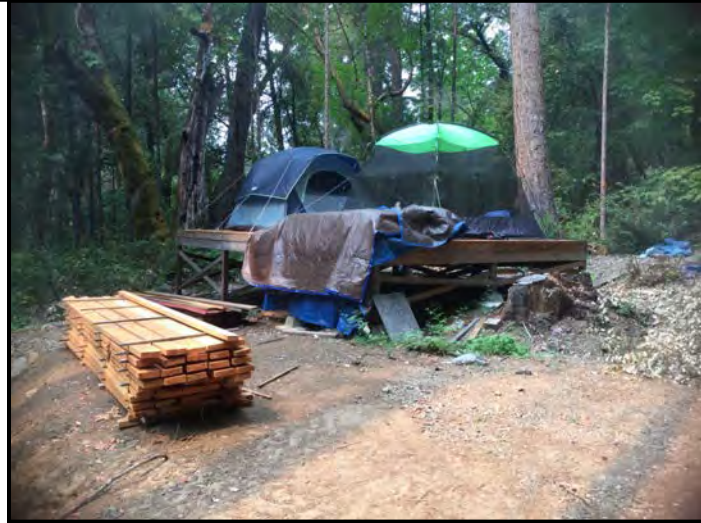
Safety Zone(s): No safety zone(s) in area
Comm With ICP: Yes
Water Supply: Reliable water source nearby
Fuel Type: Shrub or timber
Defensible Space: Less than 30 ft treated
Hazards:

TRIAGE CATEGORY

Defensible, Prep and Hold

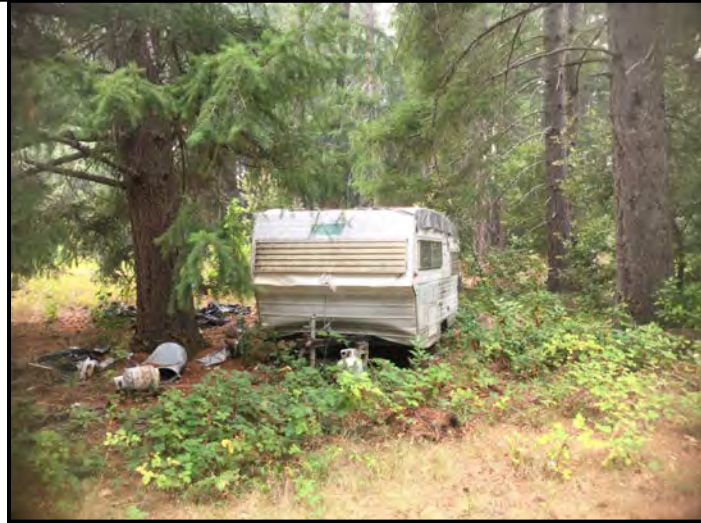
Safety Zone(s): No safety zone(s) in area
Comm With ICP: Yes
Water Supply: No reliable water source nearby
Fuel Type: Shrub or timber
Defensible Space: No defensible space
Hazards:

TRIAGE CATEGORY

Non-Defensible, Rescue, Drive By

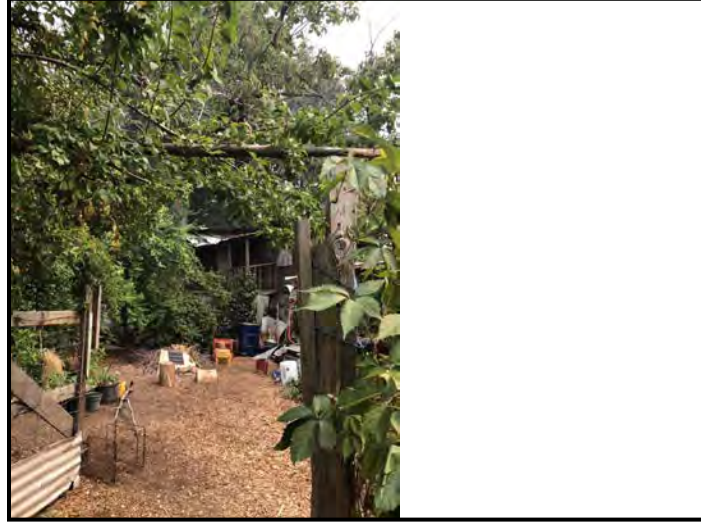
Safety Zone(s): No safety zone(s) in area
Comm With ICP: Yes
Water Supply: No reliable water source nearby
Fuel Type: Shrub or timber
Defensible Space: Less than 30 ft treated
Hazards: Bad access, brush close to structure, structures themselves have fuel right amongst them.

TRIAGE CATEGORY

Non-Defensible, Prep and Leave

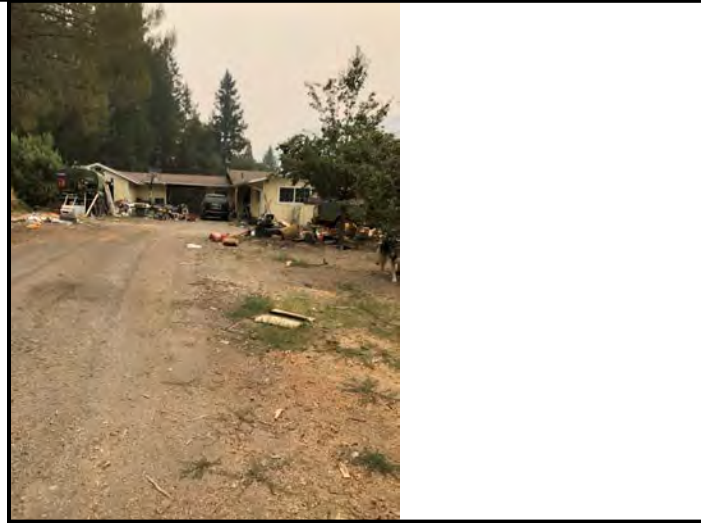
Safety Zone(s): Potential safety zone(s) in area
Comm With ICP: Yes
Water Supply: Limited or dependent on electricity
Fuel Type: Shrub or timber
Defensible Space: 100 ft treated
Hazards: Multiple vehicles on property that may or may not be operable, lots of excess debris around the structure.

TRIAGE CATEGORY

Defensible, Prep and Hold

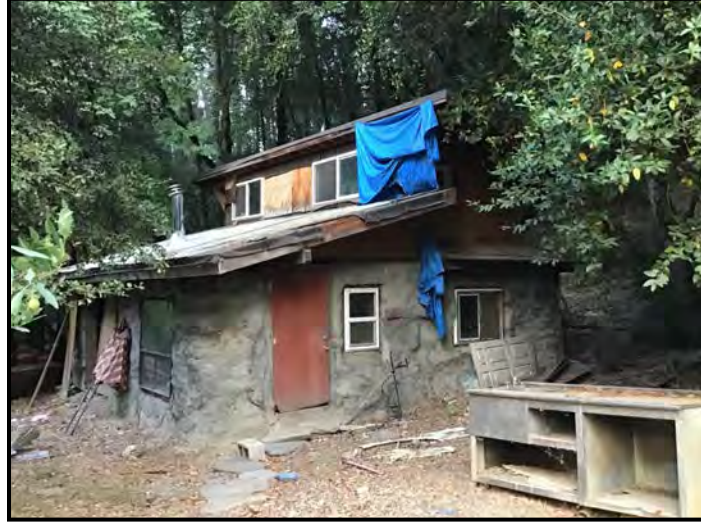
Safety Zone(s): No safety zone(s) in area
Comm With ICP: Yes
Water Supply: No reliable water source nearby
Fuel Type: Grass and shrub, hardwood litter
Defensible Space: 30 ft treated
Hazards: Terrain

TRIAGE CATEGORY

Non-Defensible, Prep and Leave

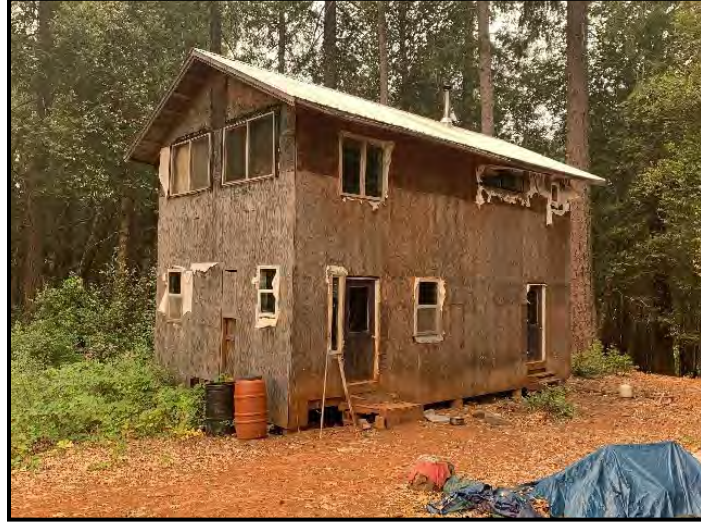
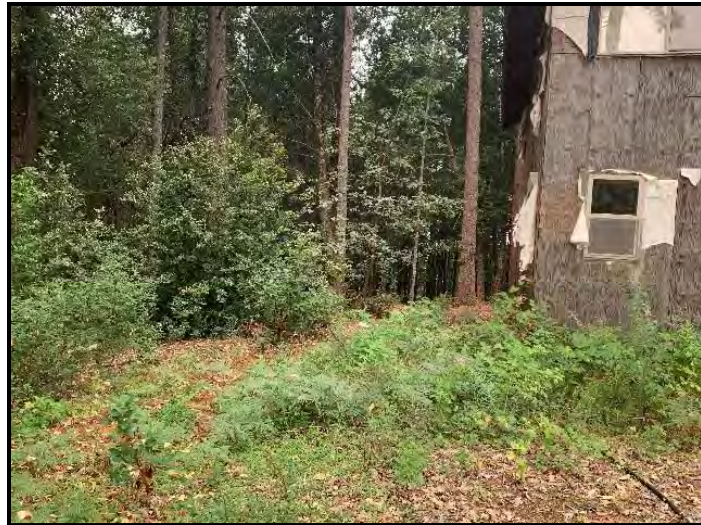
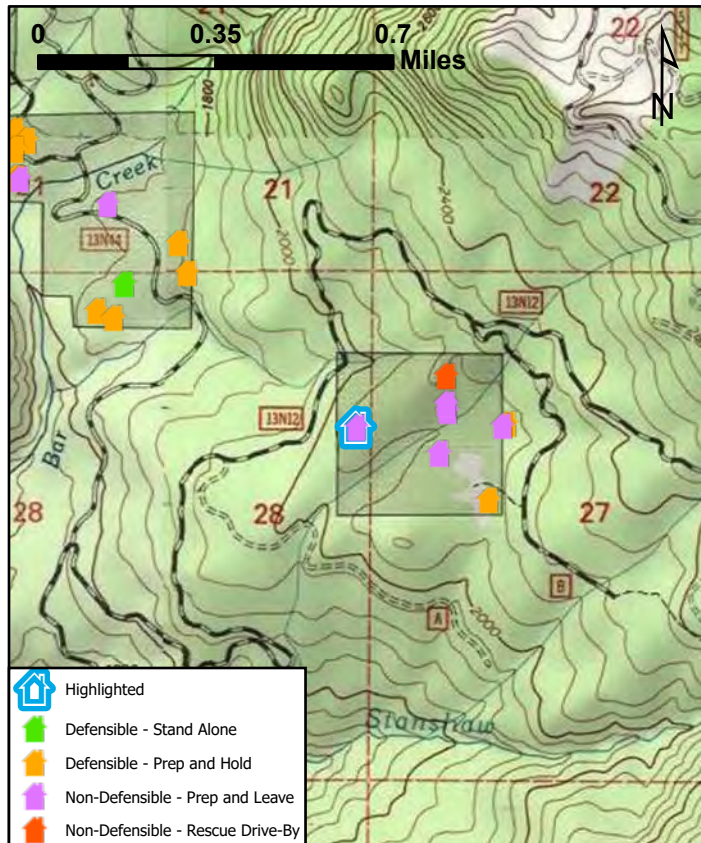
Safety Zone(s): No safety zone(s) in area
Comm With ICP: Yes
Water Supply: No reliable water source nearby
Fuel Type: Shrub or timber
Defensible Space: Less than 30 ft treated
Hazards:

TRIAGE CATEGORY

Non-Defensible, Prep and Leave

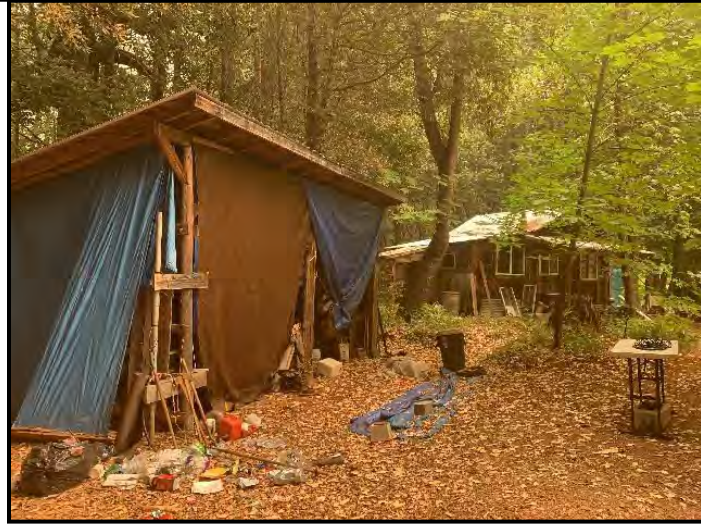
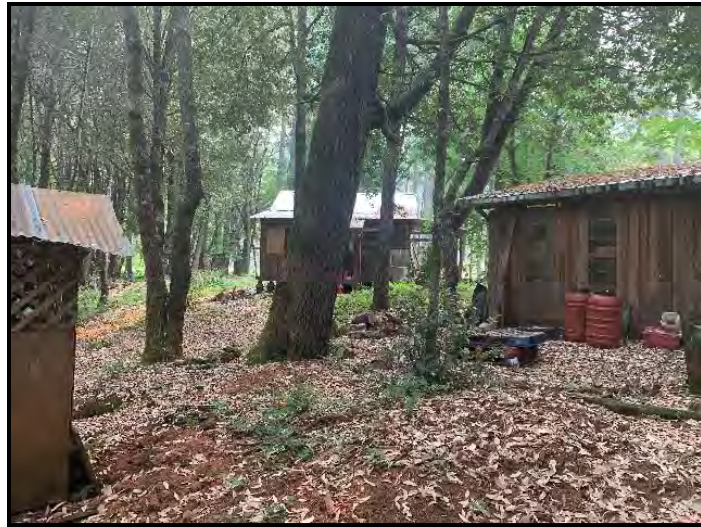
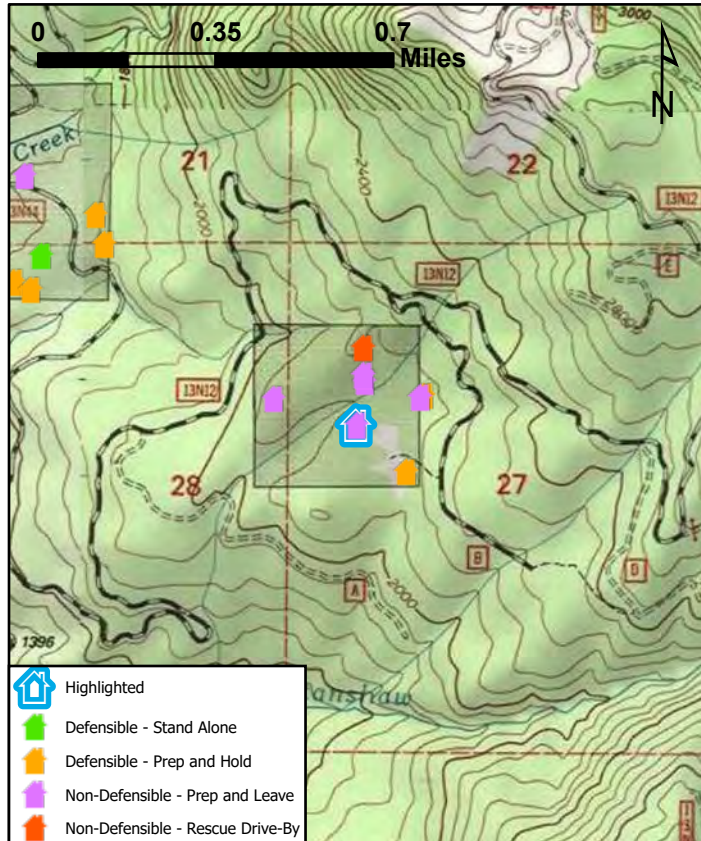
Safety Zone(s): No safety zone(s) in area
Comm With ICP: Yes
Water Supply: No reliable water source nearby
Fuel Type: Shrub or timber
Defensible Space: Less than 30 ft treated
Hazards:

TRIAGE CATEGORY

Non-Defensible, Prep and Leave

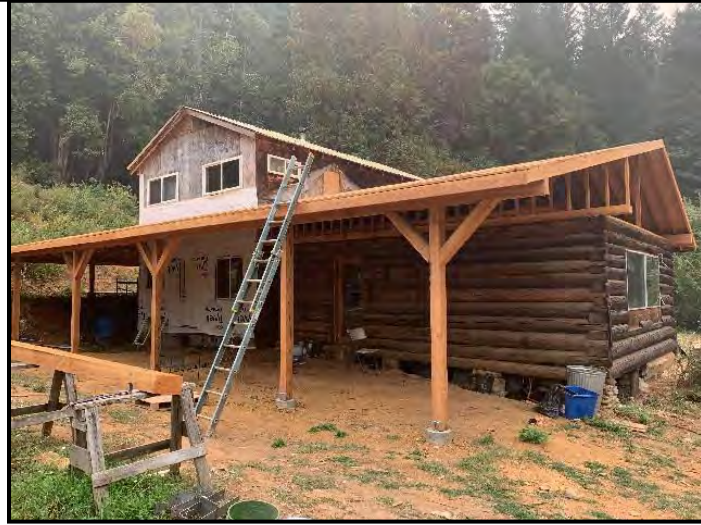
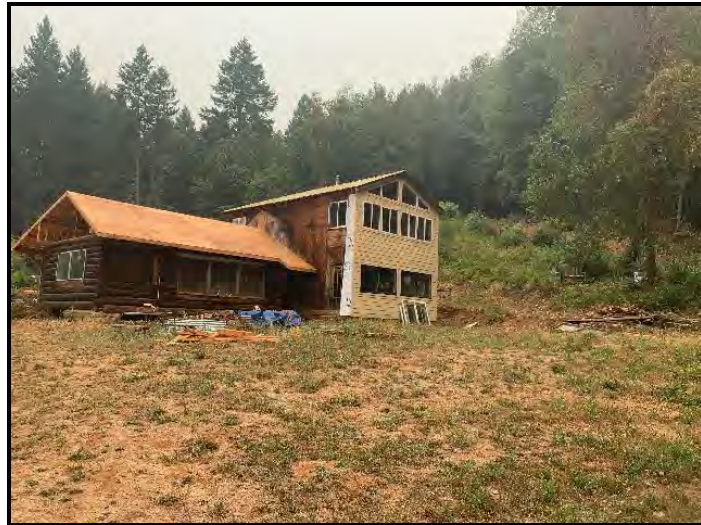
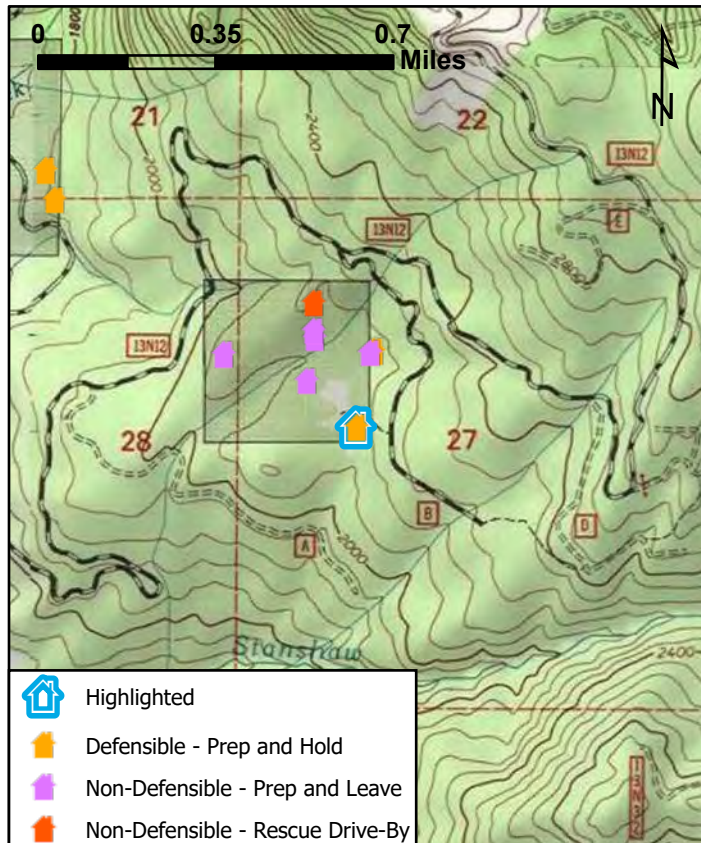
Safety Zone(s): Potential safety zone(s) in area
Comm With ICP: Yes
Water Supply: No reliable water source nearby
Fuel Type: Shrub or timber
Defensible Space: 30 ft treated
Hazards:

TRIAGE CATEGORY

Defensible, Prep and Hold

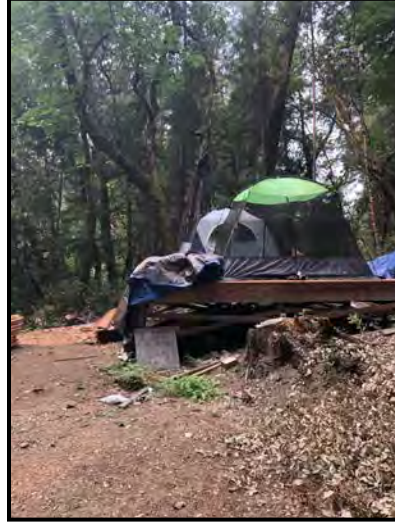
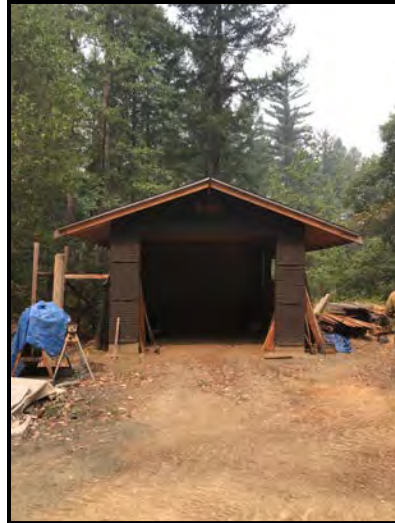
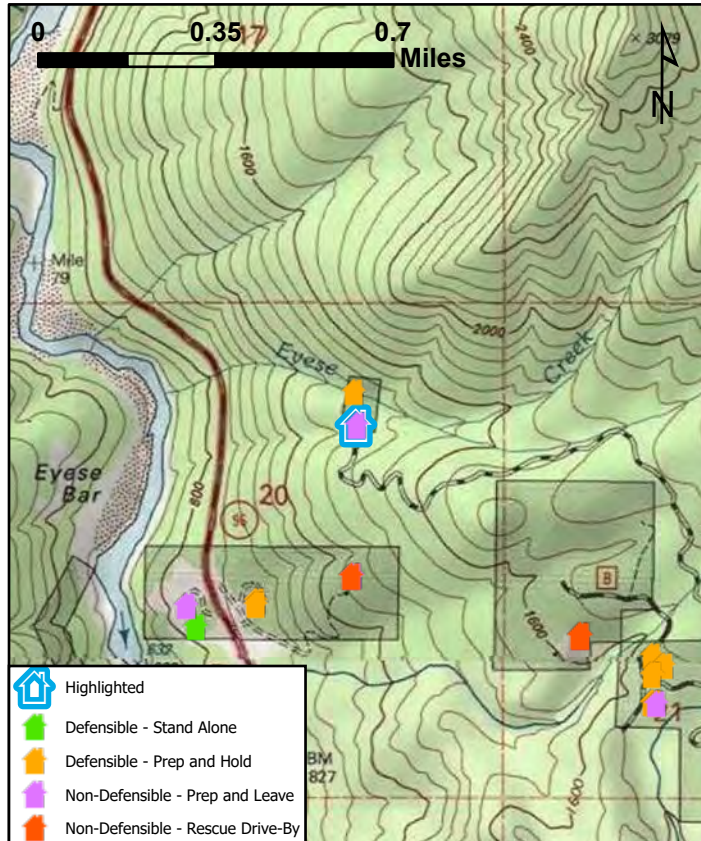
Safety Zone(s): No safety zone(s) in area
Comm With ICP: Unknown
Water Supply: Reliable water source nearby
Fuel Type: Shrub or timber
Defensible Space: 30 ft treated
Hazards: One way in/out.

TRIAGE CATEGORY

Non-Defensible, Prep and Leave

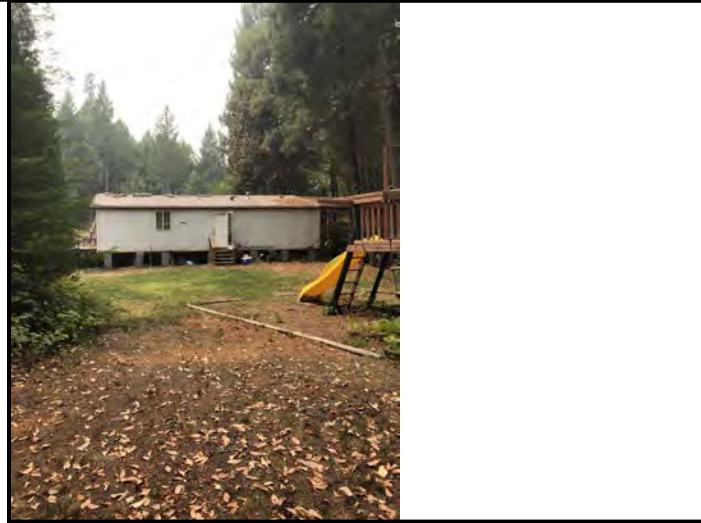
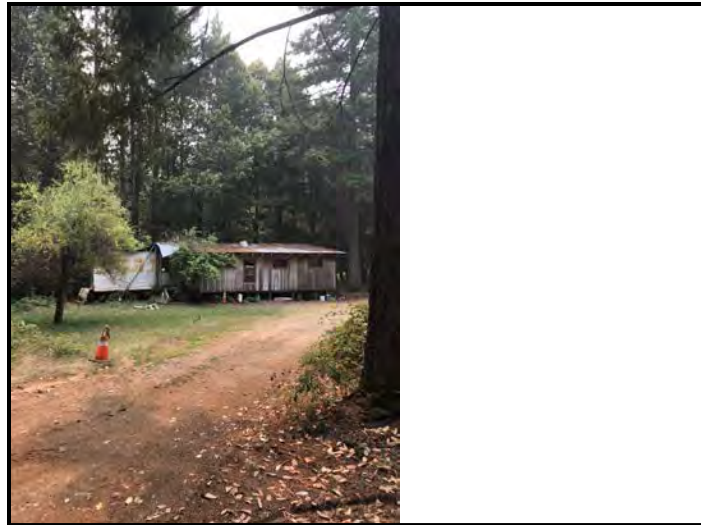
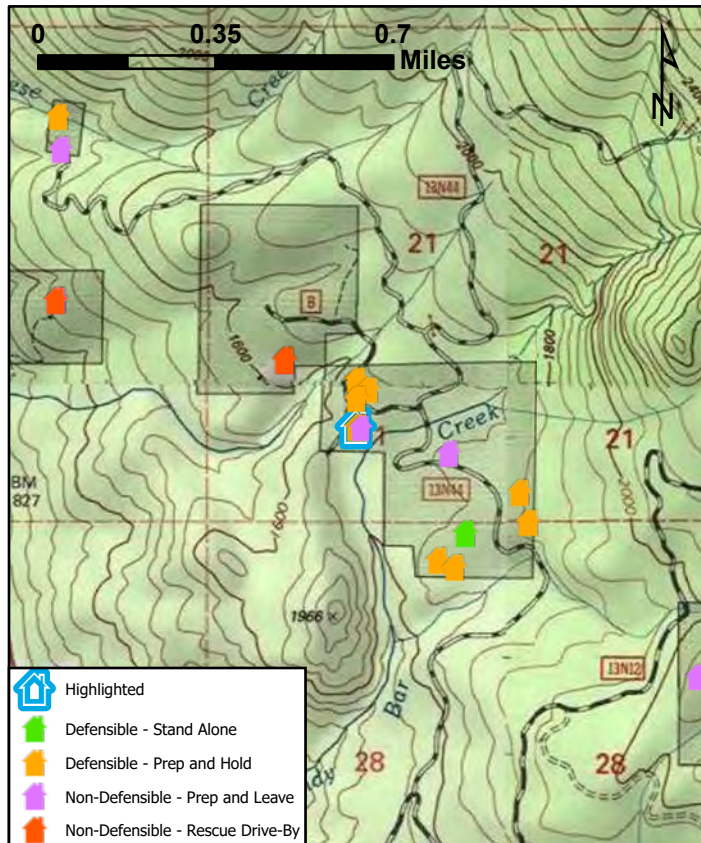
Safety Zone(s): Potential safety zone(s) in area
Comm With ICP: Unknown
Water Supply: Limited or dependent on electricity
Fuel Type: Shrub or timber
Defensible Space: 30 ft treated
Hazards: No special hazards noted.

TRIAGE CATEGORY

Defensible, Prep and Hold

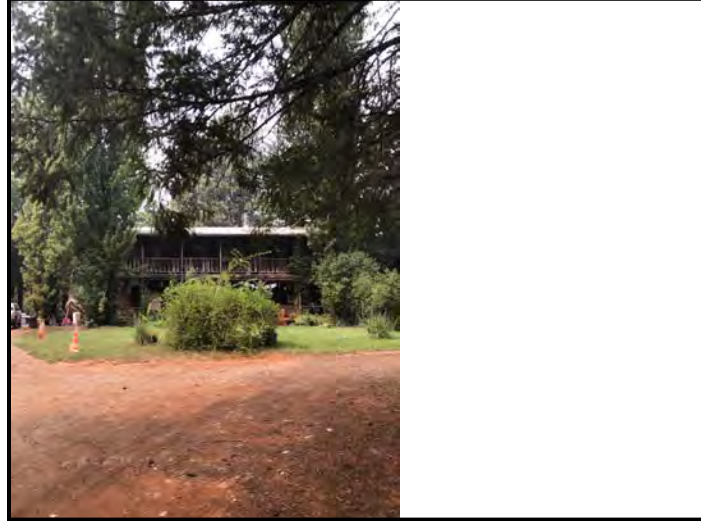
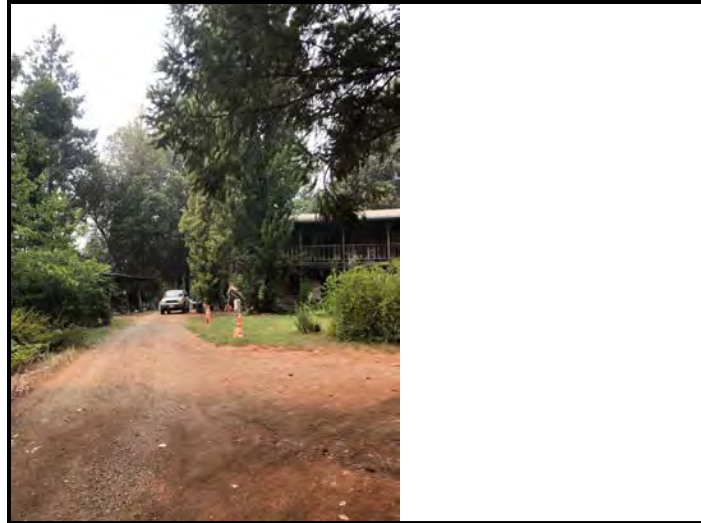
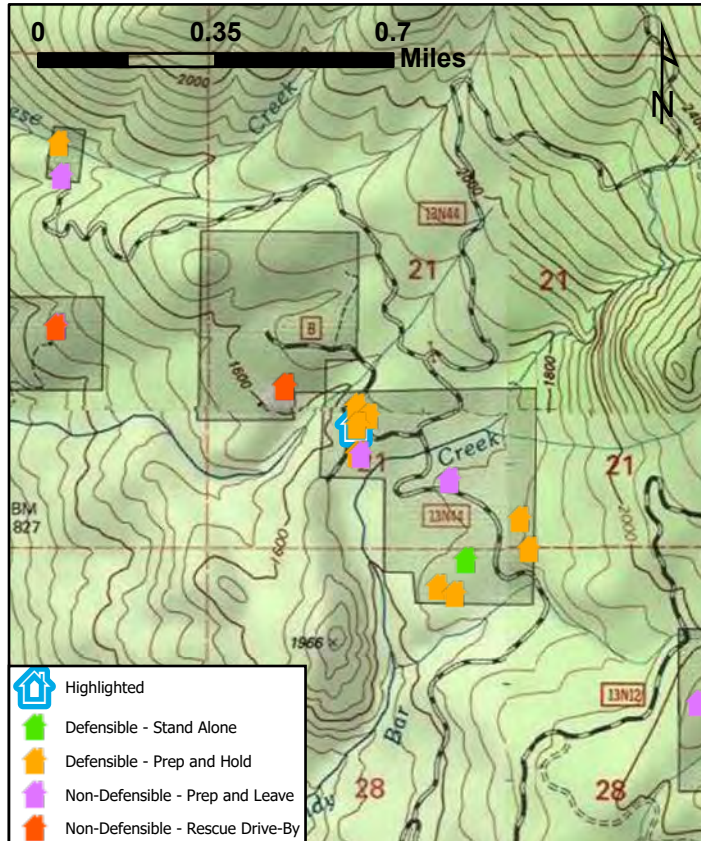
Safety Zone(s): Potential safety zone(s) in area
Comm With ICP: Unknown
Water Supply: Limited or dependent on electricity
Fuel Type: Shrub or timber
Defensible Space: 30 ft treated
Hazards: Open work space with multiple containers of gas or other hazmat, close to structure, highest risk of catching and transferring fire to main structure.

TRIAGE CATEGORY

Defensible, Prep and Hold

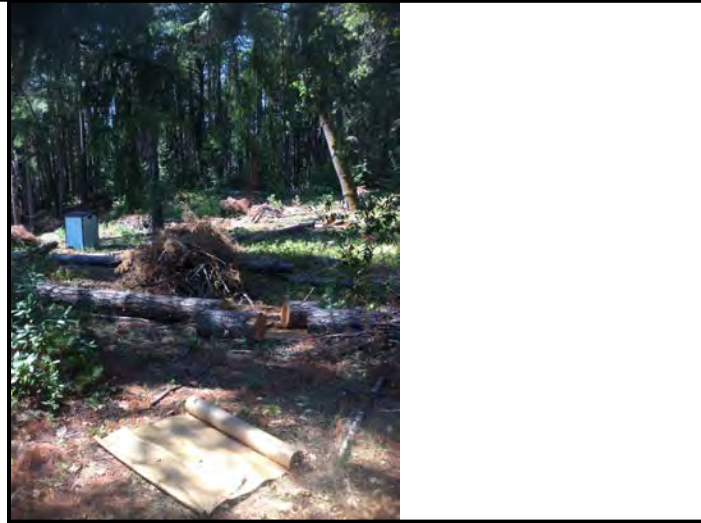
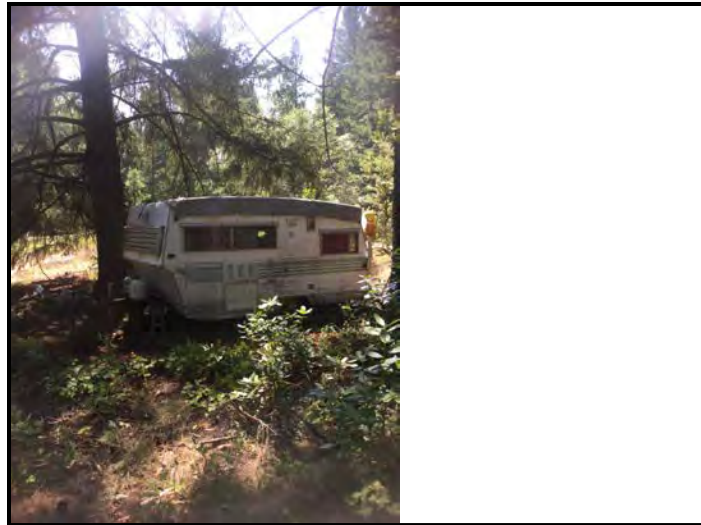
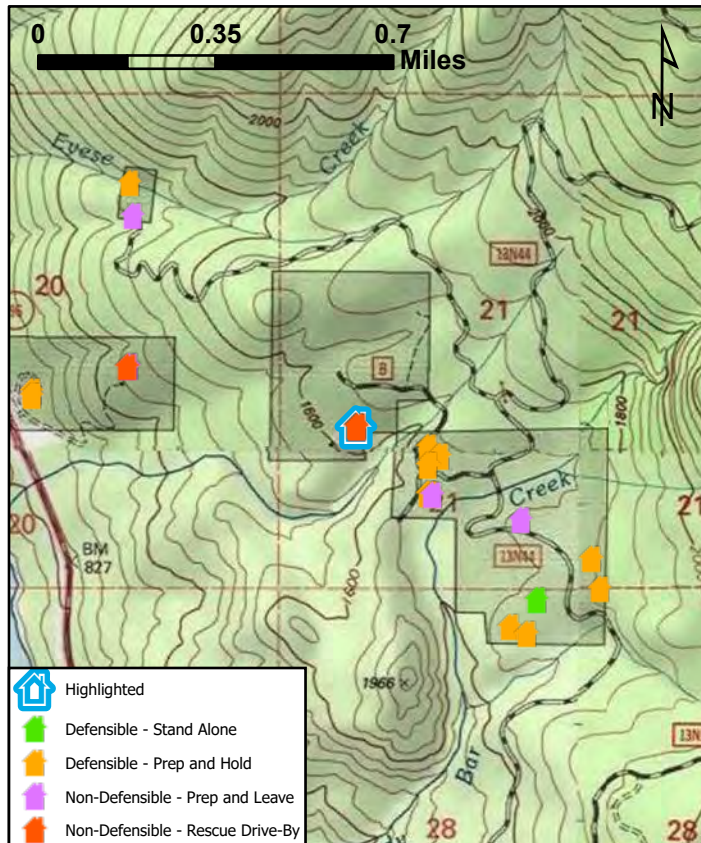
Safety Zone(s): No safety zone(s) in area
Comm With ICP: Yes
Water Supply: No reliable water source nearby
Fuel Type: Shrub or timber
Defensible Space: Less than 30 ft treated
Hazards: Small LP tank on trailer

TRIAGE CATEGORY

Non-Defensible, Rescue, Drive By

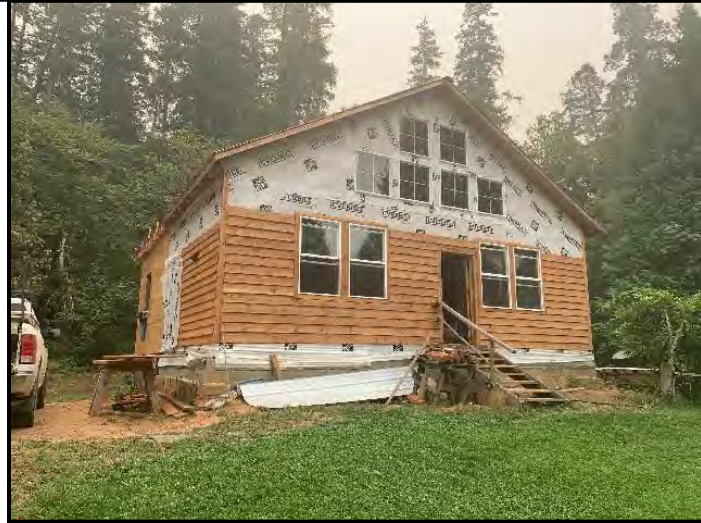
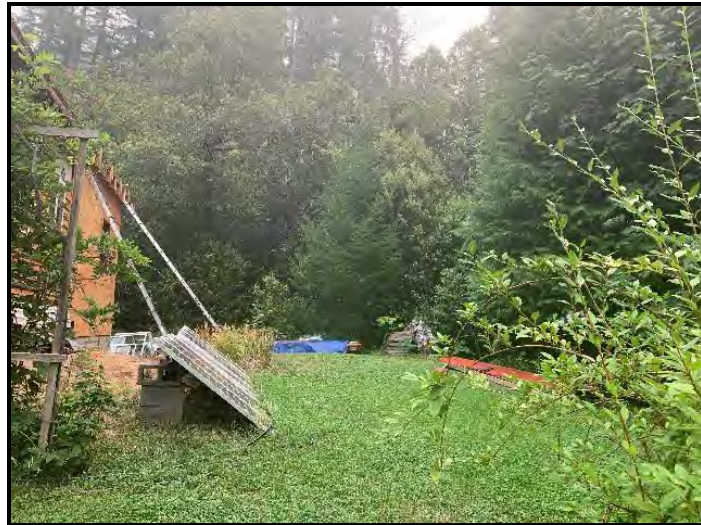
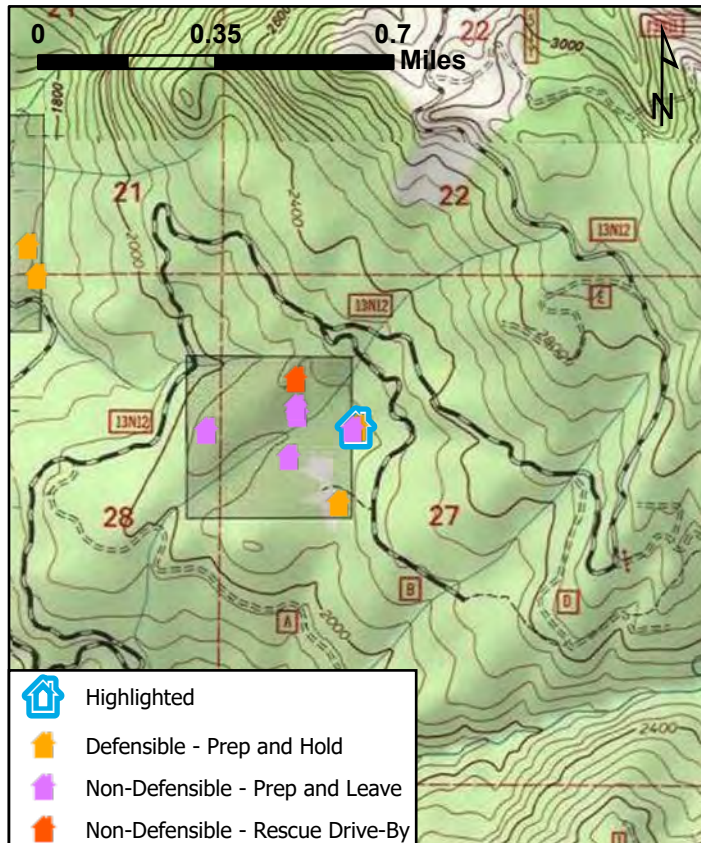
Safety Zone(s): Potential safety zone(s) in area
Comm With ICP: Yes
Water Supply: No reliable water source nearby
Fuel Type: Shrub or timber
Defensible Space: 30 ft treated
Hazards:

TRIAGE CATEGORY

Defensible, Prep and Hold

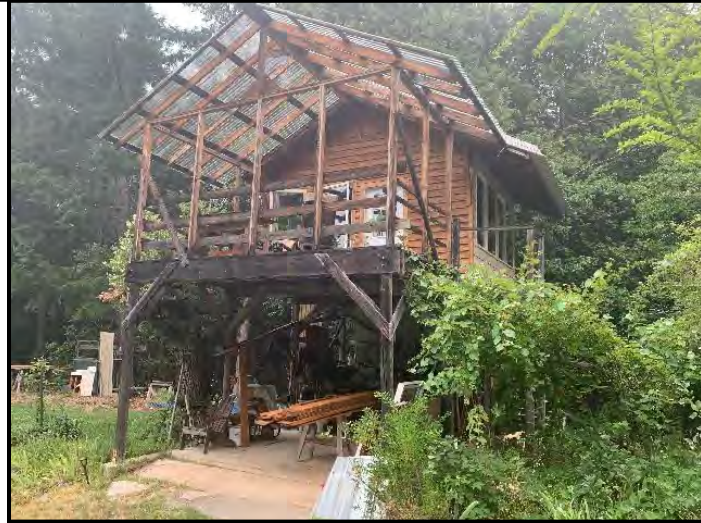
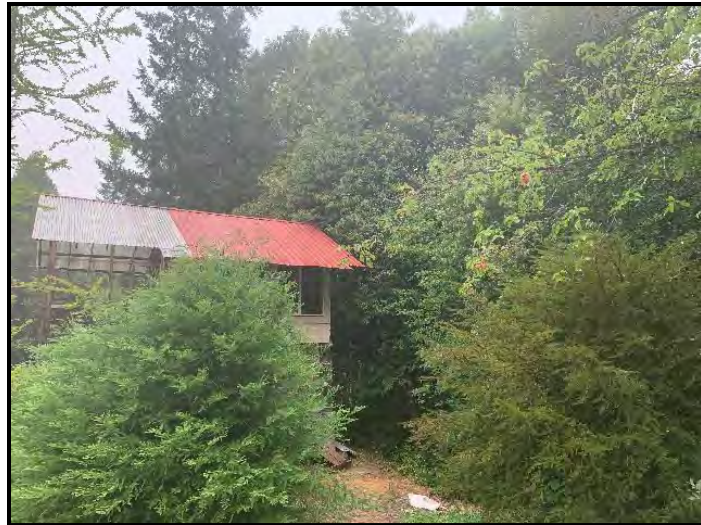
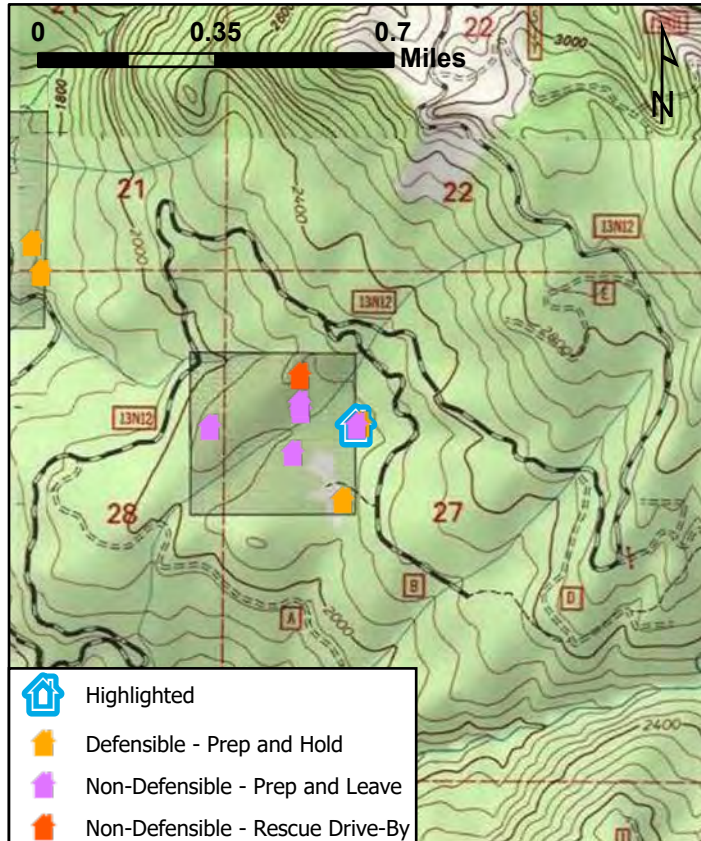
Safety Zone(s): No safety zone(s) in area
Comm With ICP: Yes
Water Supply: No reliable water source nearby
Fuel Type: Shrub or timber
Defensible Space: No defensible space
Hazards: Heavy fuel load

TRIAGE CATEGORY

Non-Defensible, Prep and Leave

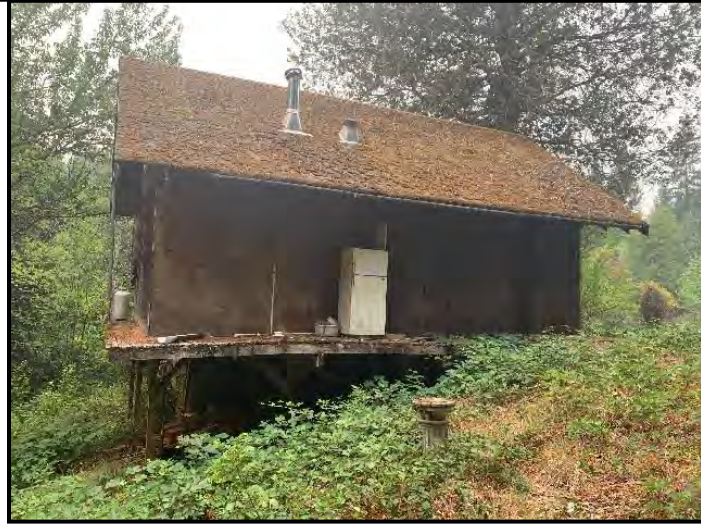
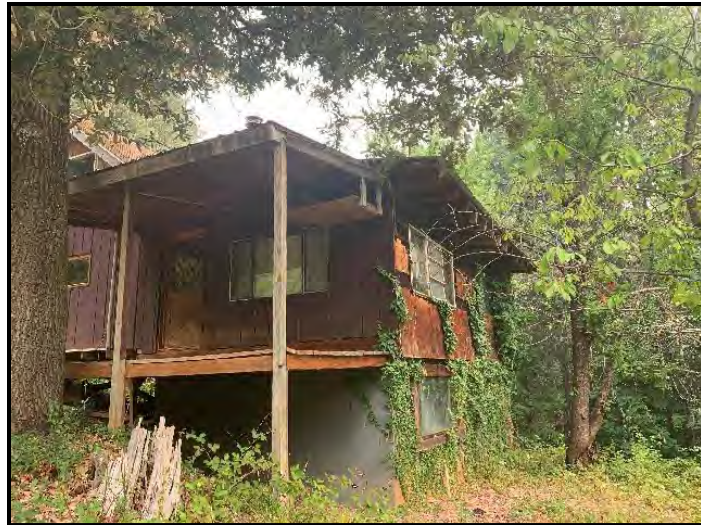
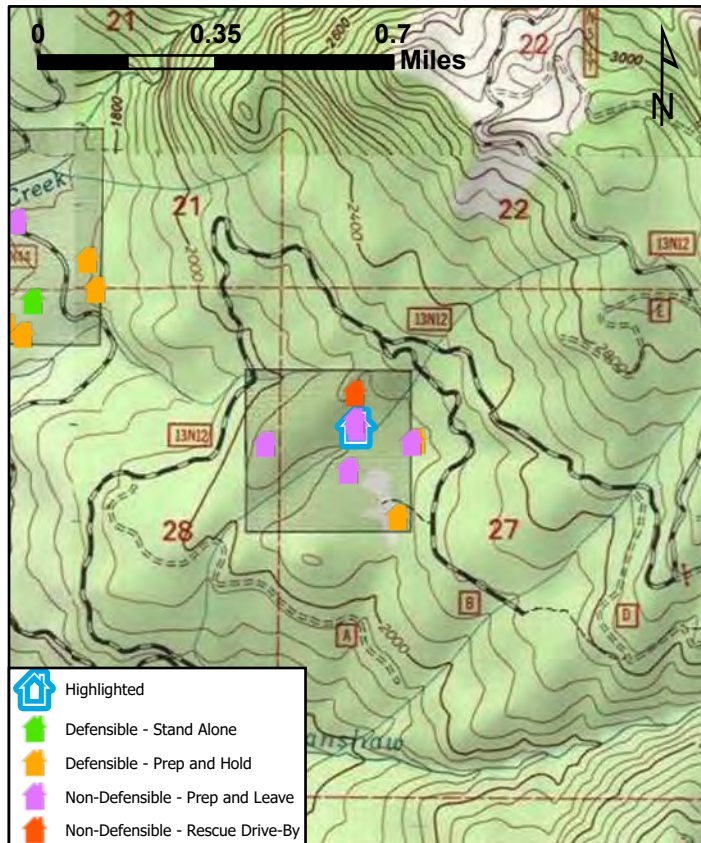
Safety Zone(s): No safety zone(s) in area
Comm With ICP: Yes
Water Supply: No reliable water source nearby
Fuel Type: Shrub or timber
Defensible Space: Less than 30 ft treated
Hazards:

TRIAGE CATEGORY

Non-Defensible, Prep and Leave

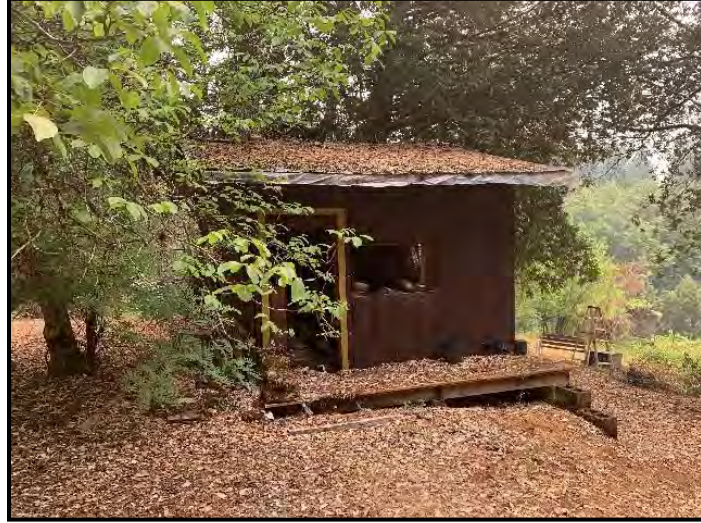
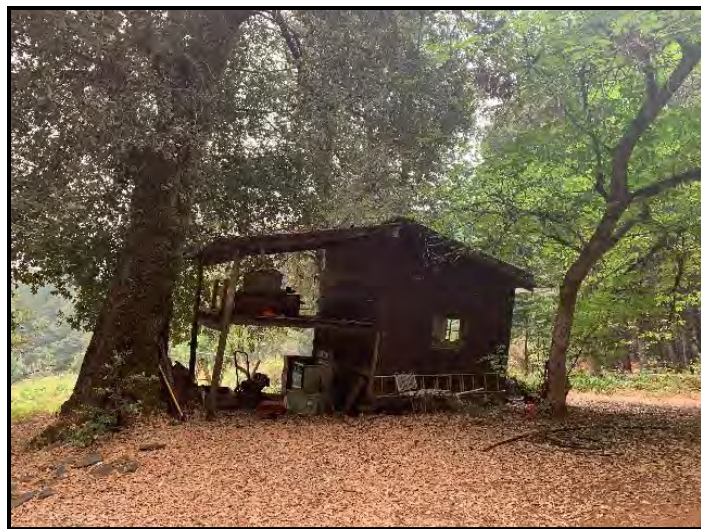
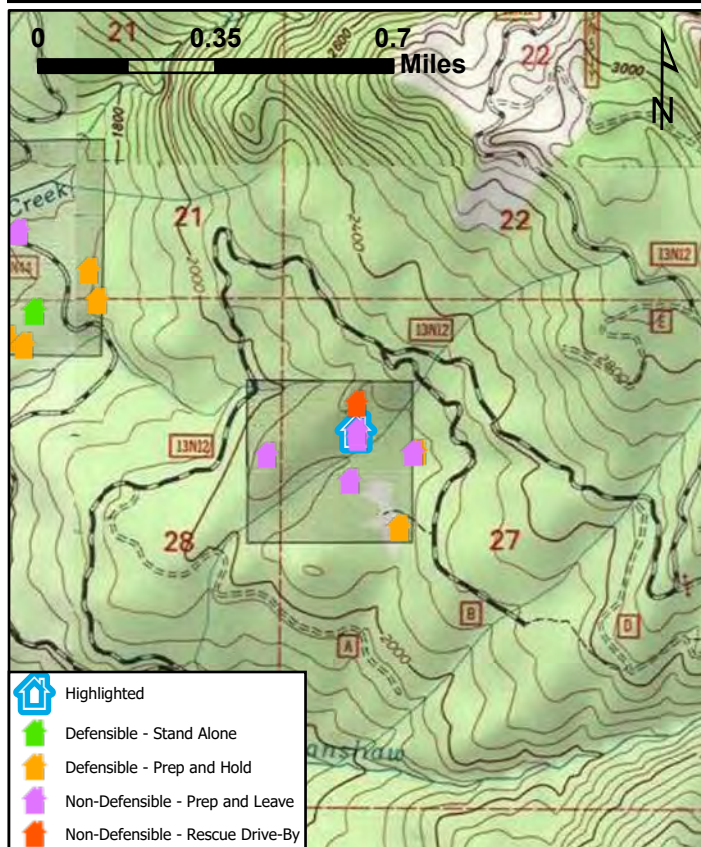
Safety Zone(s): No safety zone(s) in area
Comm With ICP: Yes
Water Supply: No reliable water source nearby
Fuel Type: Shrub or timber
Defensible Space: 30 ft treated
Hazards: Collapse potential

TRIAGE CATEGORY

Non-Defensible, Prep and Leave

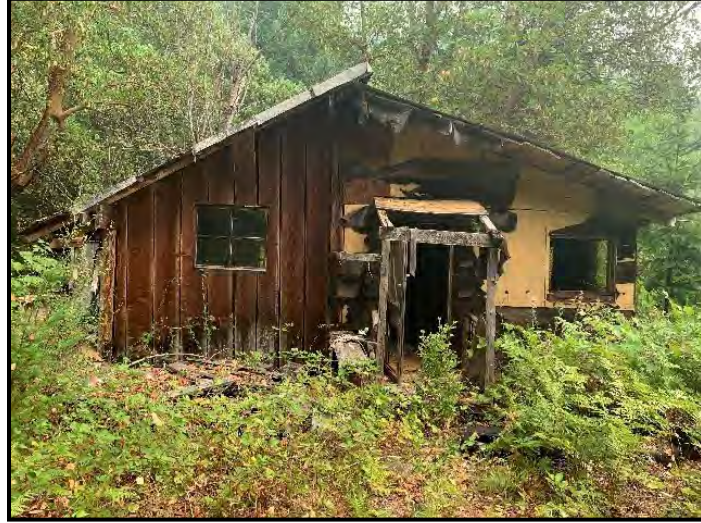
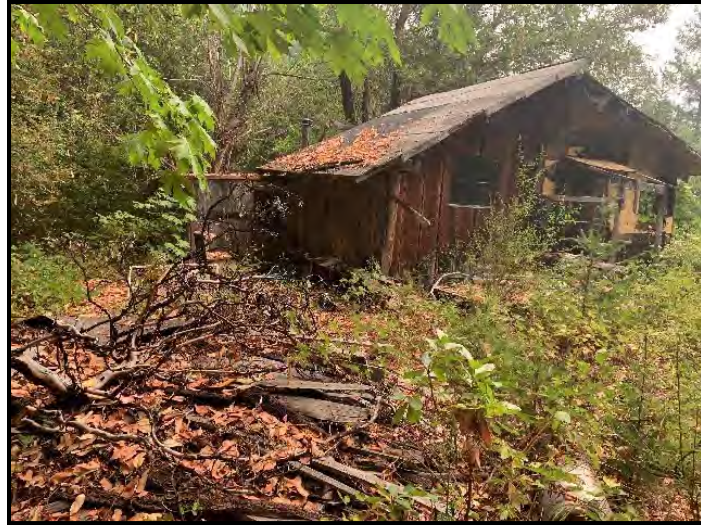
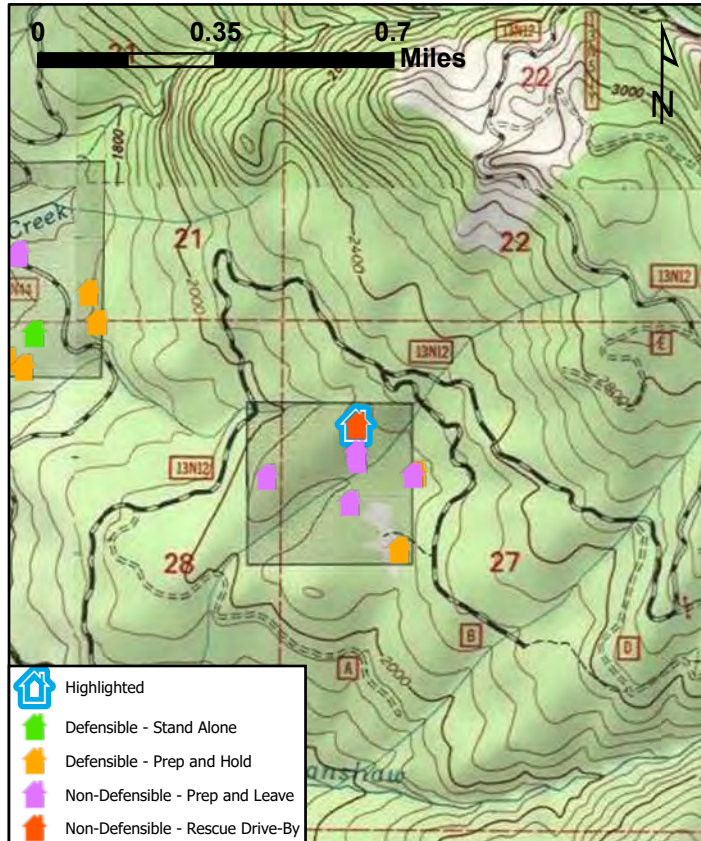
Safety Zone(s): No safety zone(s) in area
Comm With ICP: Yes
Water Supply: No reliable water source nearby
Fuel Type: Shrub or timber
Defensible Space: No defensible space
Hazards: Structure itself and surrounding fuels

TRIAGE CATEGORY

Non-Defensible, Rescue, Drive By

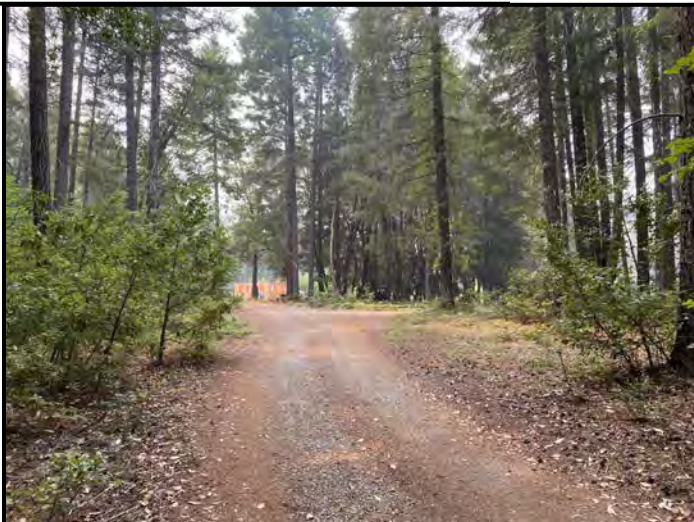
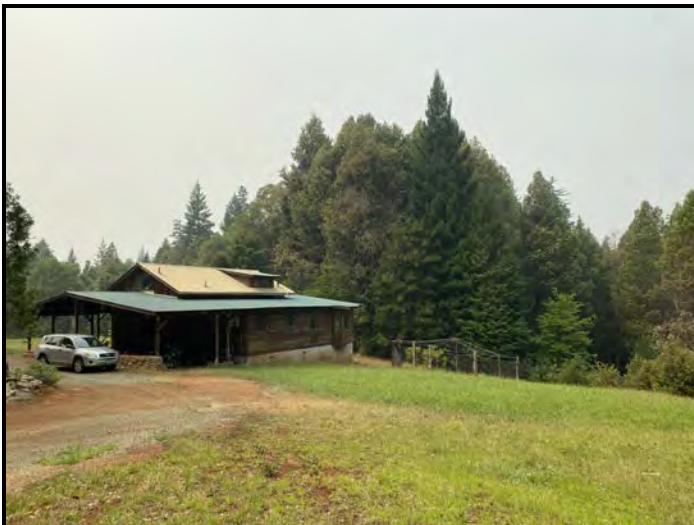
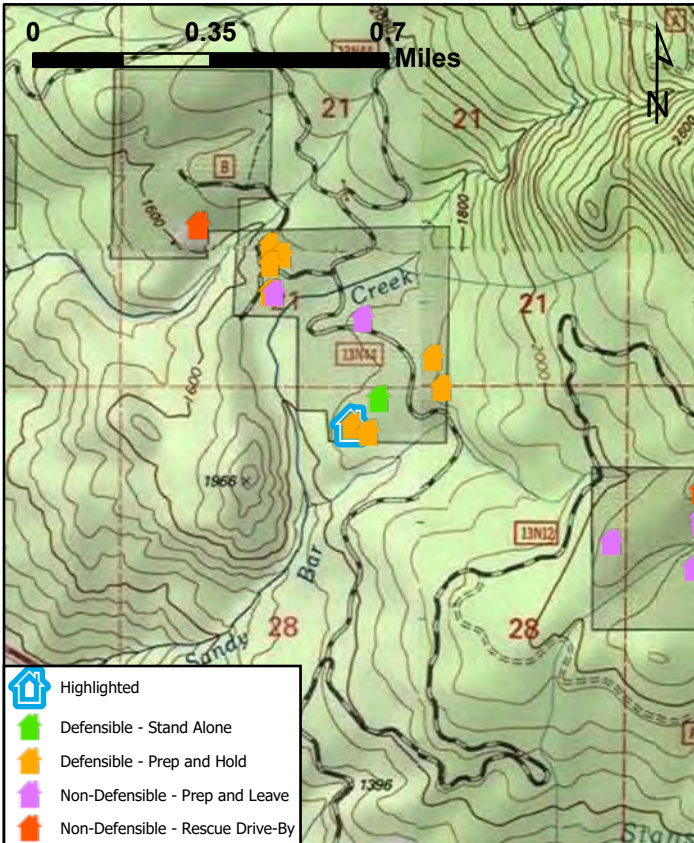
Comments: Walt Simpson. Raised cinder block foundation, wood siding with metal roof.

Hazards: Propane tank

TRIAGE CATEGORY

Defensible, Prep and Hold

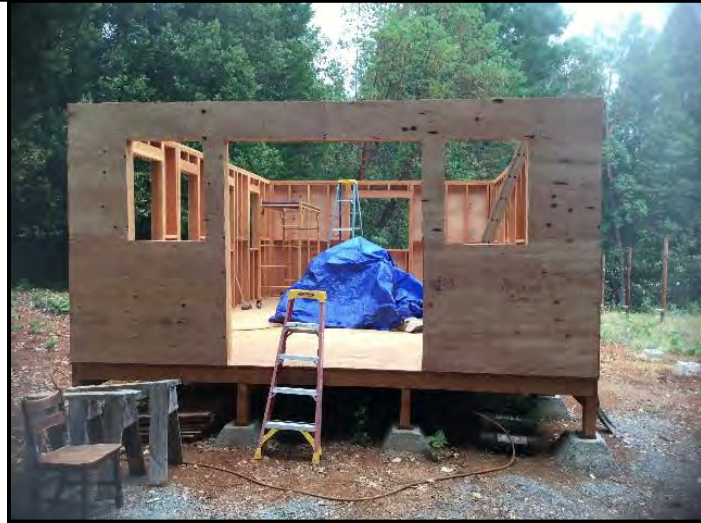
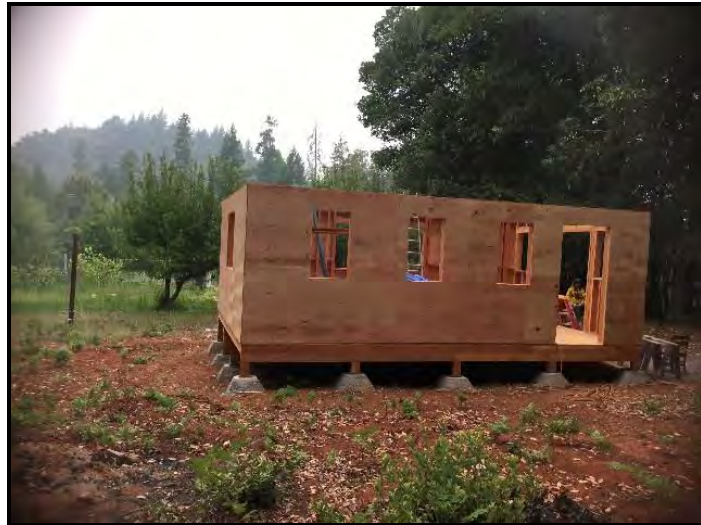
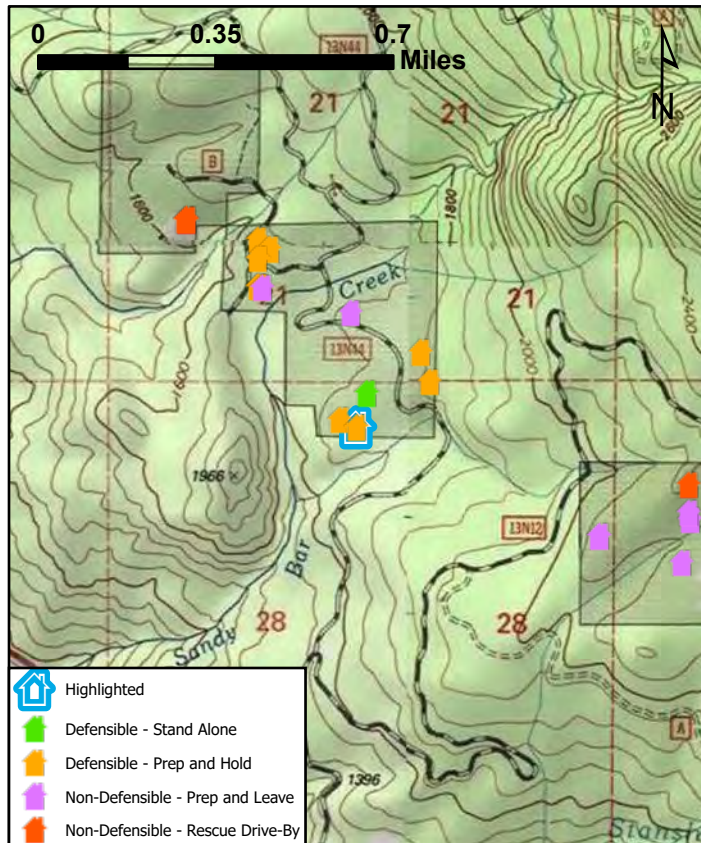
Safety Zone(s): No safety zone(s) in area
Comm With ICP: Yes
Water Supply: Limited or dependent on electricity
Fuel Type: Shrub or timber
Defensible Space: 30 ft treated
Hazards:

TRIAGE CATEGORY

Defensible, Prep and Hold

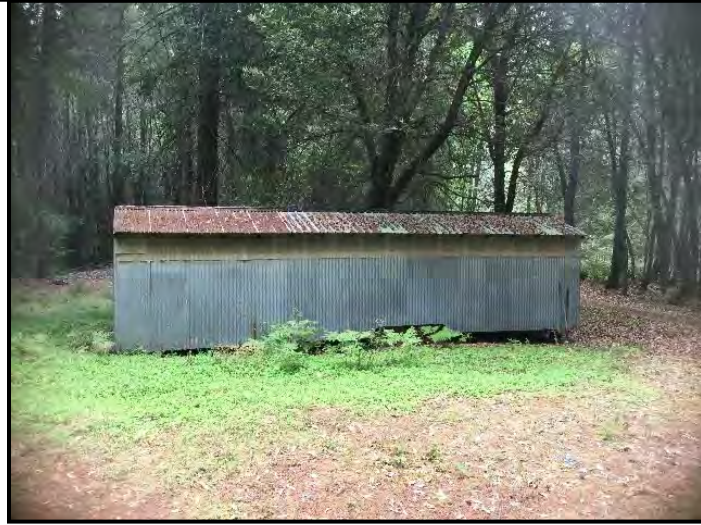
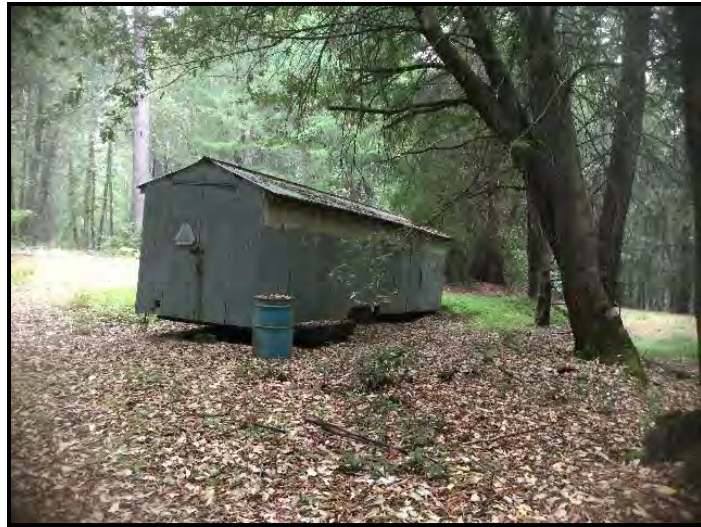
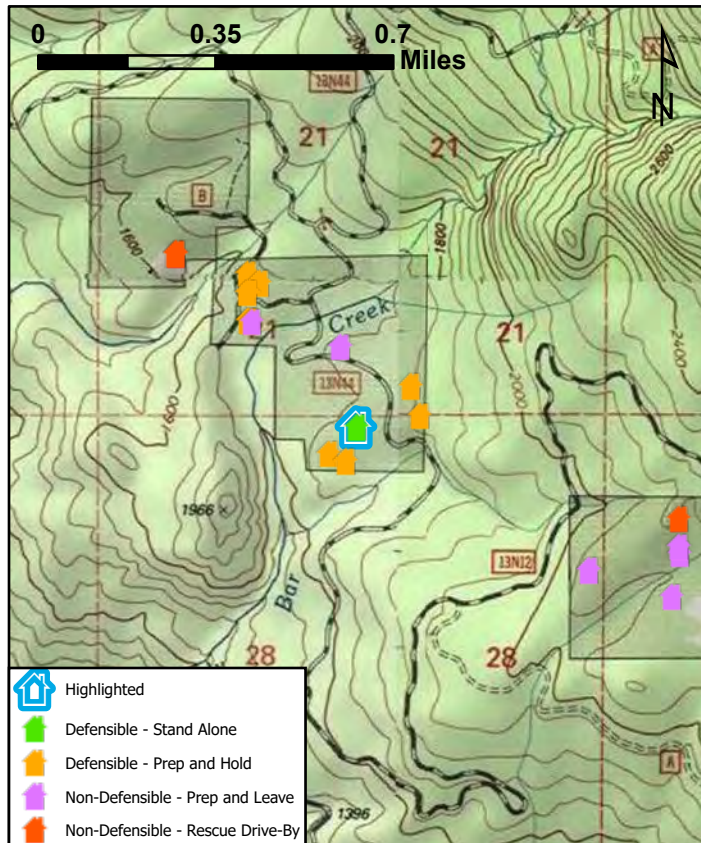
Safety Zone(s): No safety zone(s) in area
Comm With ICP: Yes
Water Supply: No reliable water source nearby
Fuel Type: Shrub or timber
Defensible Space: 30 ft treated
Hazards:

TRIAGE CATEGORY

Defensible, Stand Alone
