McCash Fire Structure Triage Assessment

CASRF000651
August 23, 2021

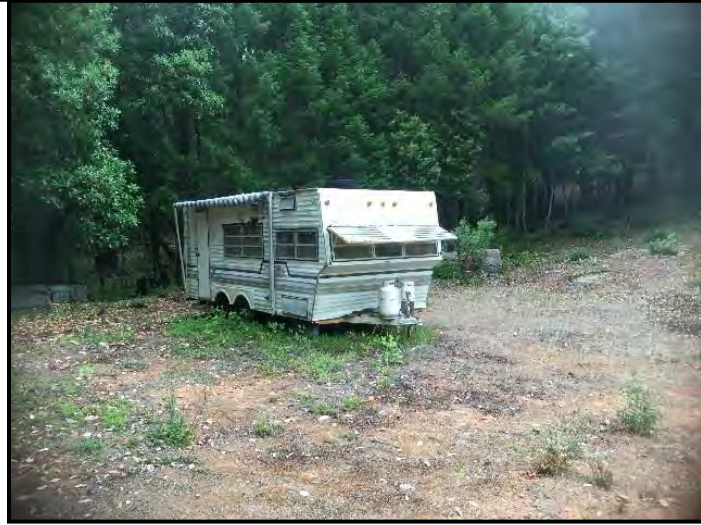
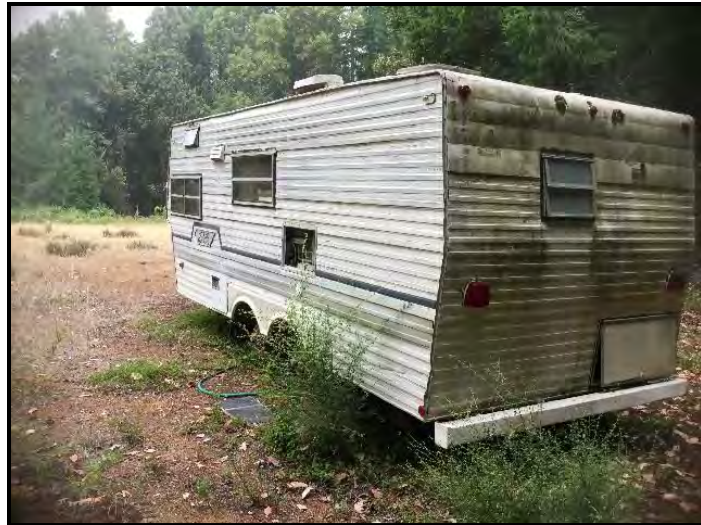
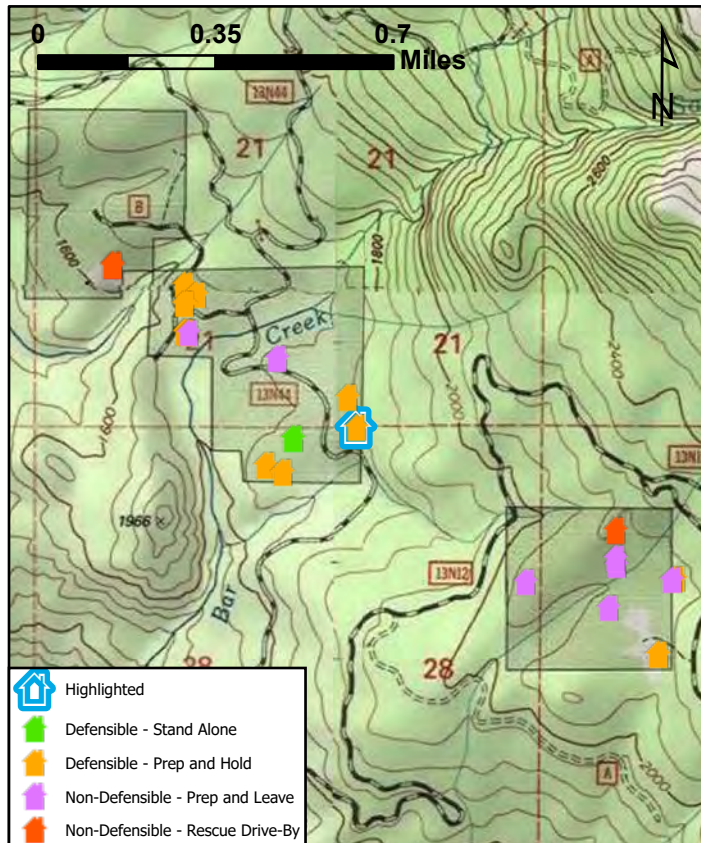
Safety Zone(s): Potential safety zone(s) in area
Comm With ICP: Yes
Water Supply: No reliable water source nearby
Fuel Type: Shrub or timber
Defensible Space: Less than 30 ft treated
Hazards:

TRIAGE CATEGORY

Defensible, Prep and Hold

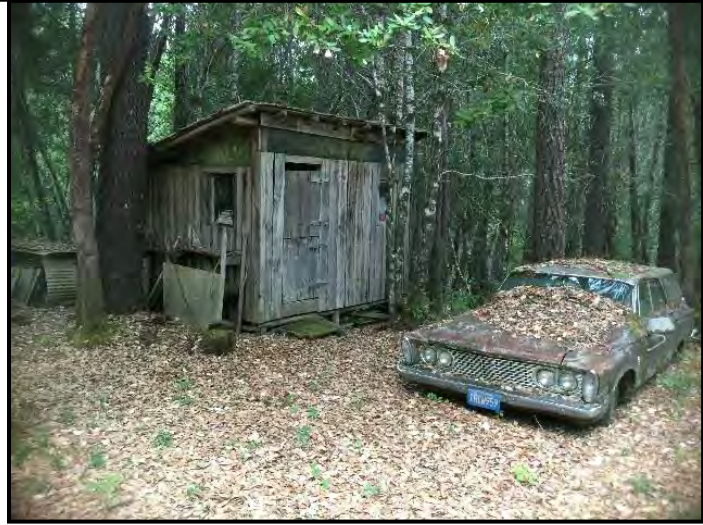
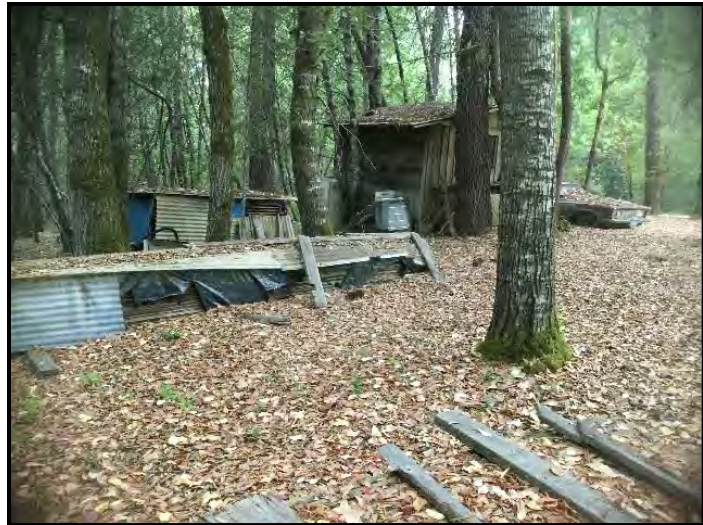
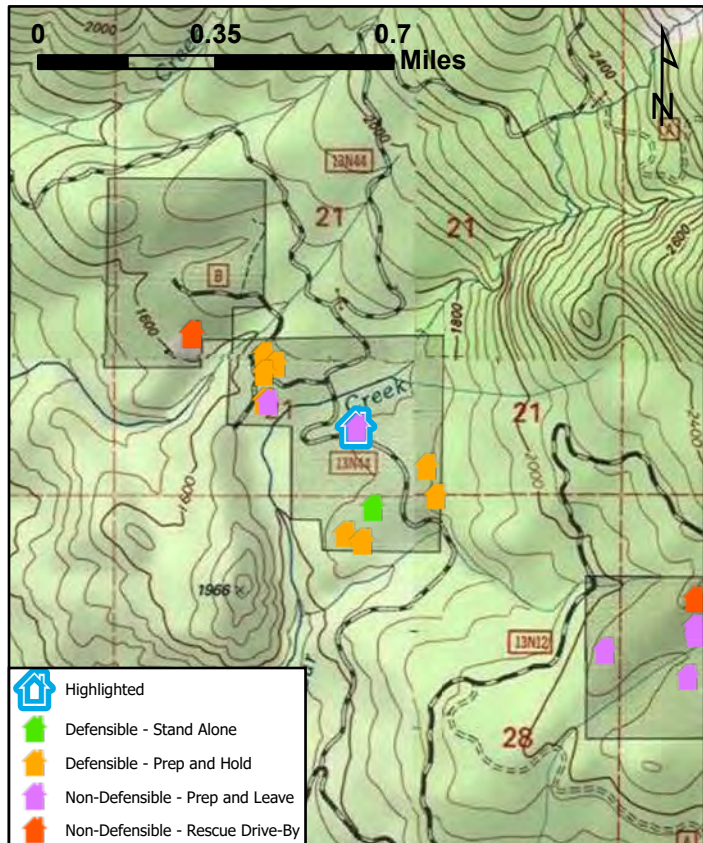
Safety Zone(s): No safety zone(s) in area
Comm With ICP: Yes
Water Supply: No reliable water source nearby
Fuel Type: Shrub or timber
Defensible Space: Less than 30 ft treated
Hazards:

TRIAGE CATEGORY

Non-Defensible, Prep and Leave
