McCash Fire Structure Triage Assessment

CASRF000651
August 23, 2021

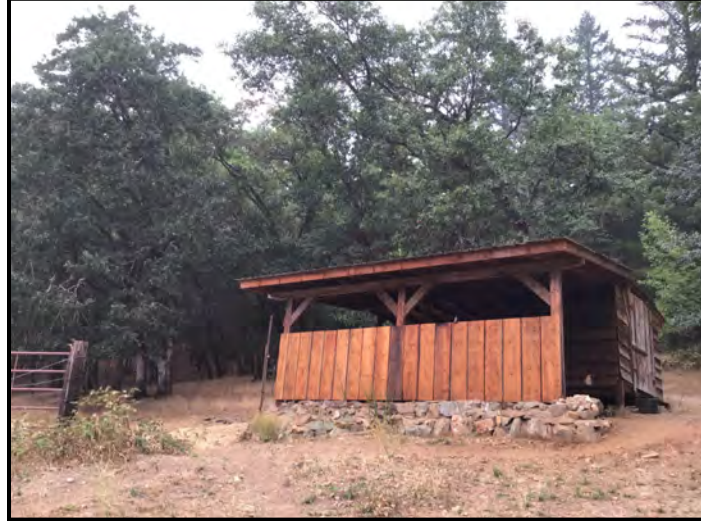
Access to Site: T3/4 Engine
Describe Access: Dirt driveway

Defensible, Stand Alone

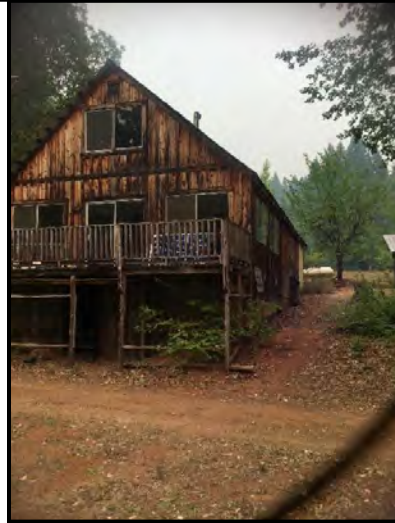
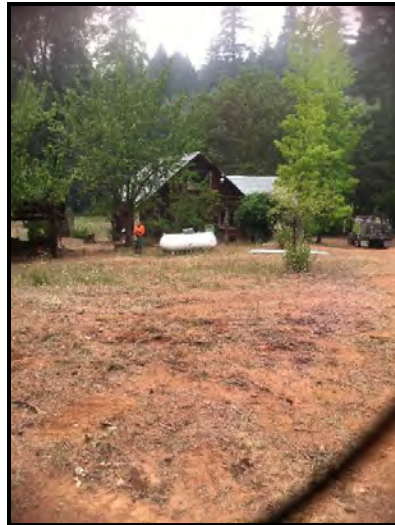
Safety Zone(s): Potential safety zone(s) in area
Comm With ICP: Yes
Water Supply: Reliable water source nearby
Fuel Type: Shrub or timber
Defensible Space: 100 ft treated
Hazards: One way in/out

Defensible, Prep and Hold

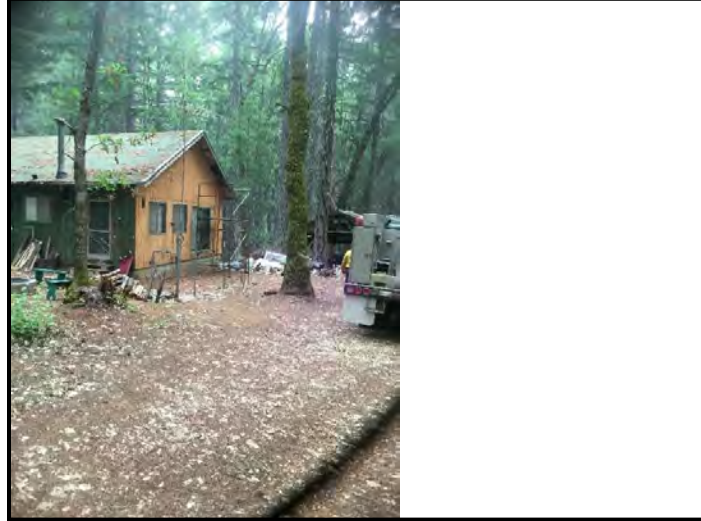
Safety Zone(s): No safety zone(s) in area
Comm With ICP: Yes
Water Supply: Reliable water source nearby
Fuel Type: Shrub or timber
Defensible Space: Less than 30 ft treated
Hazards: Yard debris/timber

Non-Defensible, Prep and Leave

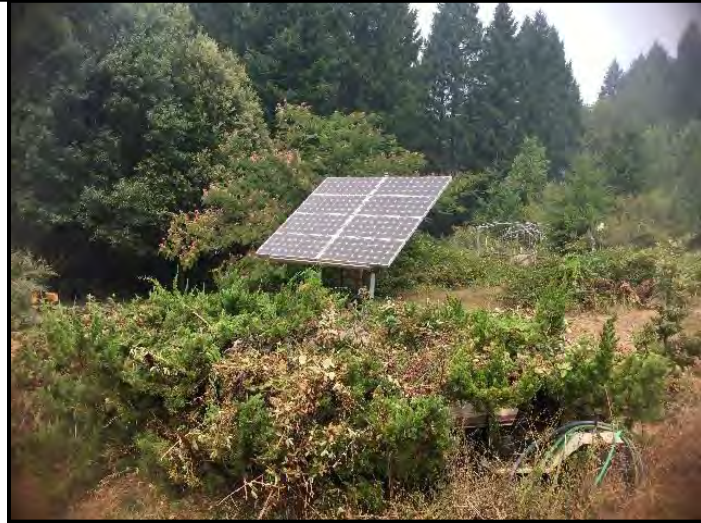
Safety Zone(s): No safety zone(s) in area
Comm With ICP: Yes
Water Supply: No reliable water source nearby
Fuel Type: Grass and shrub, hardwood litter
Defensible Space: Less than 30 ft treated
Hazards: Adjacent fuel

Non-Defensible, Prep and Leave

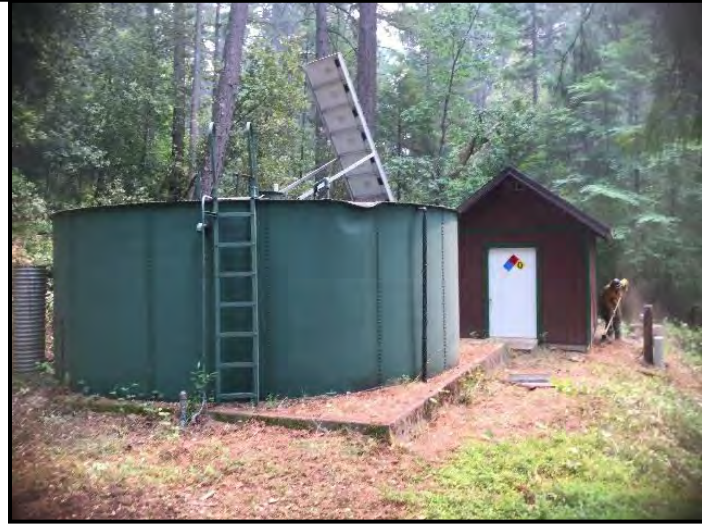
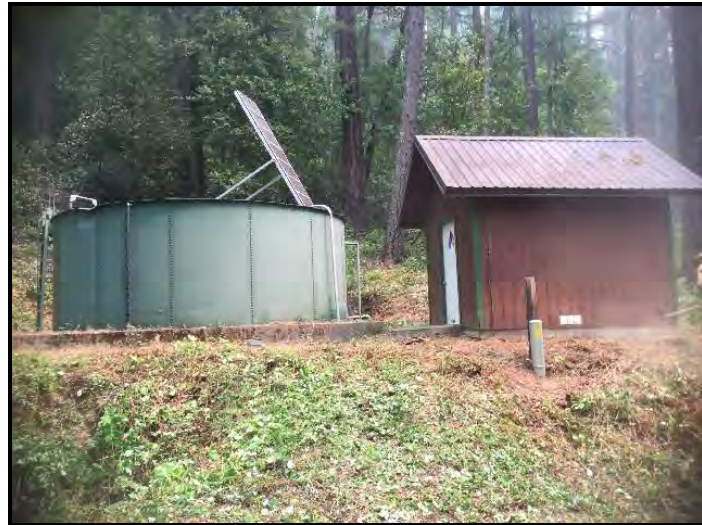
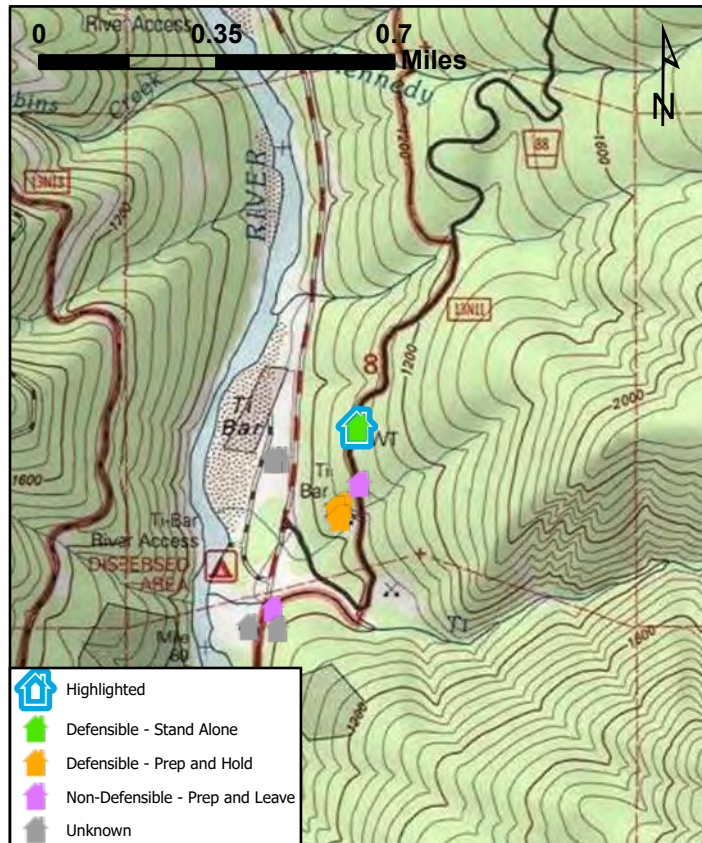
Safety Zone(s): No safety zone(s) in area
Comm With ICP: Yes
Water Supply: No reliable water source nearby
Fuel Type: Shrub or timber
Defensible Space: Less than 30 ft treated
Hazards: Flammable liquid in building, buried cable between building and road

Defensible, Stand Alone

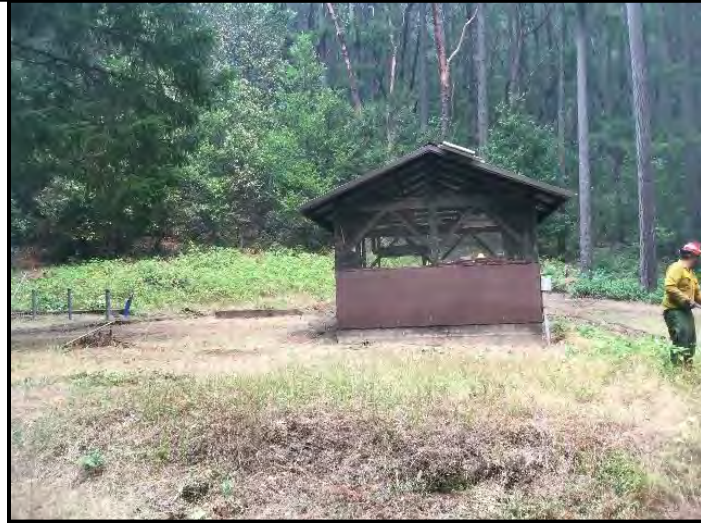
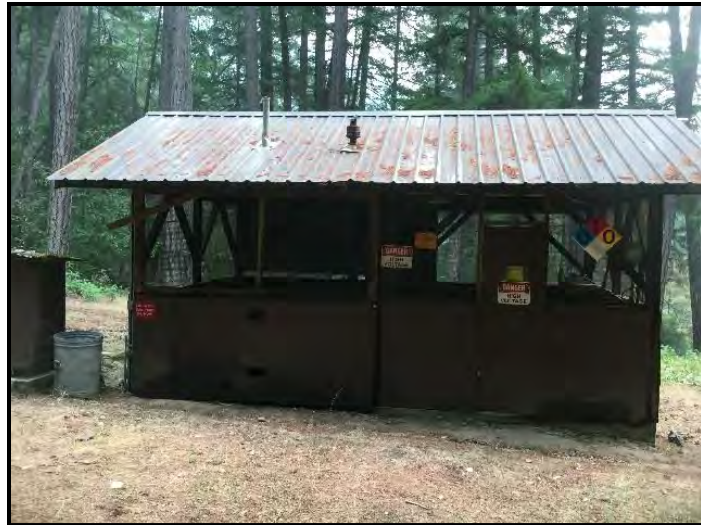
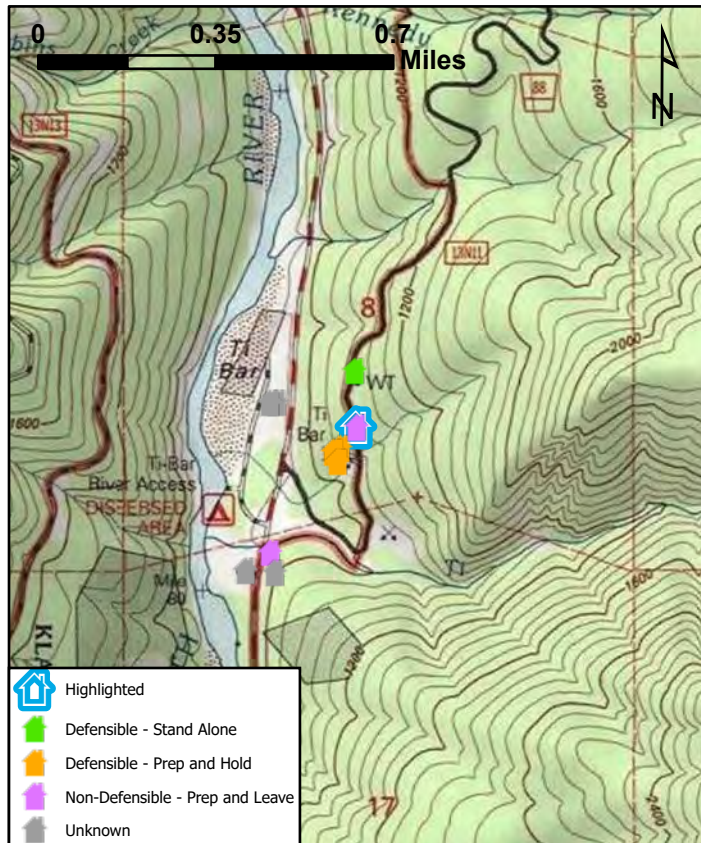
Safety Zone(s): No safety zone(s) in area
Comm With ICP: Yes
Water Supply: Reliable water source nearby
Fuel Type: Shrub or timber
Defensible Space: Less than 30 ft treated
Hazards: High voltage, flammable liquid, buried cable near road

Non-Defensible, Prep and Leave
