**Little Sur River Survey Area- Large Woody Debris Threat
Assessment - Pico Blanco Boy Scout Camp Area and Downstream**

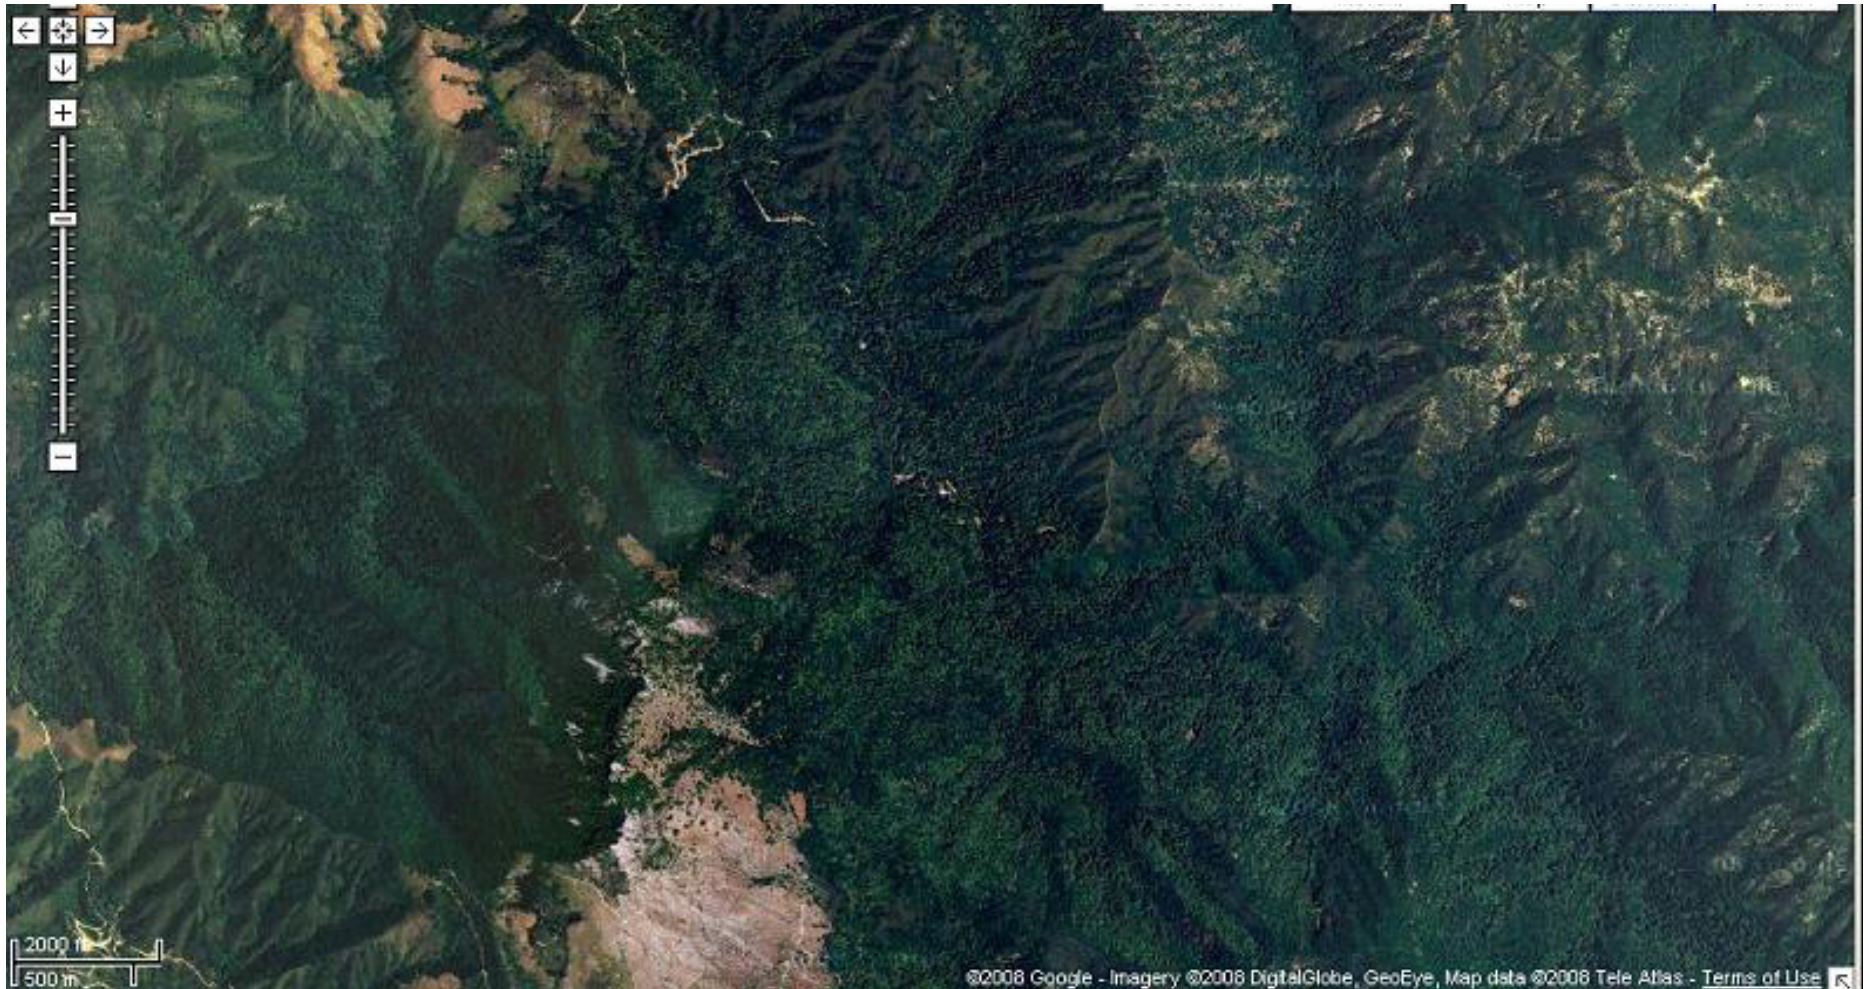
Figure 1: Little Sur River evaluation: Google Earth aerial photo of the survey area. Pico Blanco Boy Scout Camp and survey area is in middle of photo. Helicopter survey was conducted over the area. The area about 5 miles downstream of Pico Blanco Camp towards the Pacific Ocean was unburned in 2008 Basin-Indians Fire, vegetative ground cover is mostly intact. The river gradients lessen along the lower reaches to the Pacific and should be able to spread and slow peak flows and debris in flood prone areas, slowing potential impacts downstream. Large wood should have the ability to drop out along the reach and add to channel function and integrity.

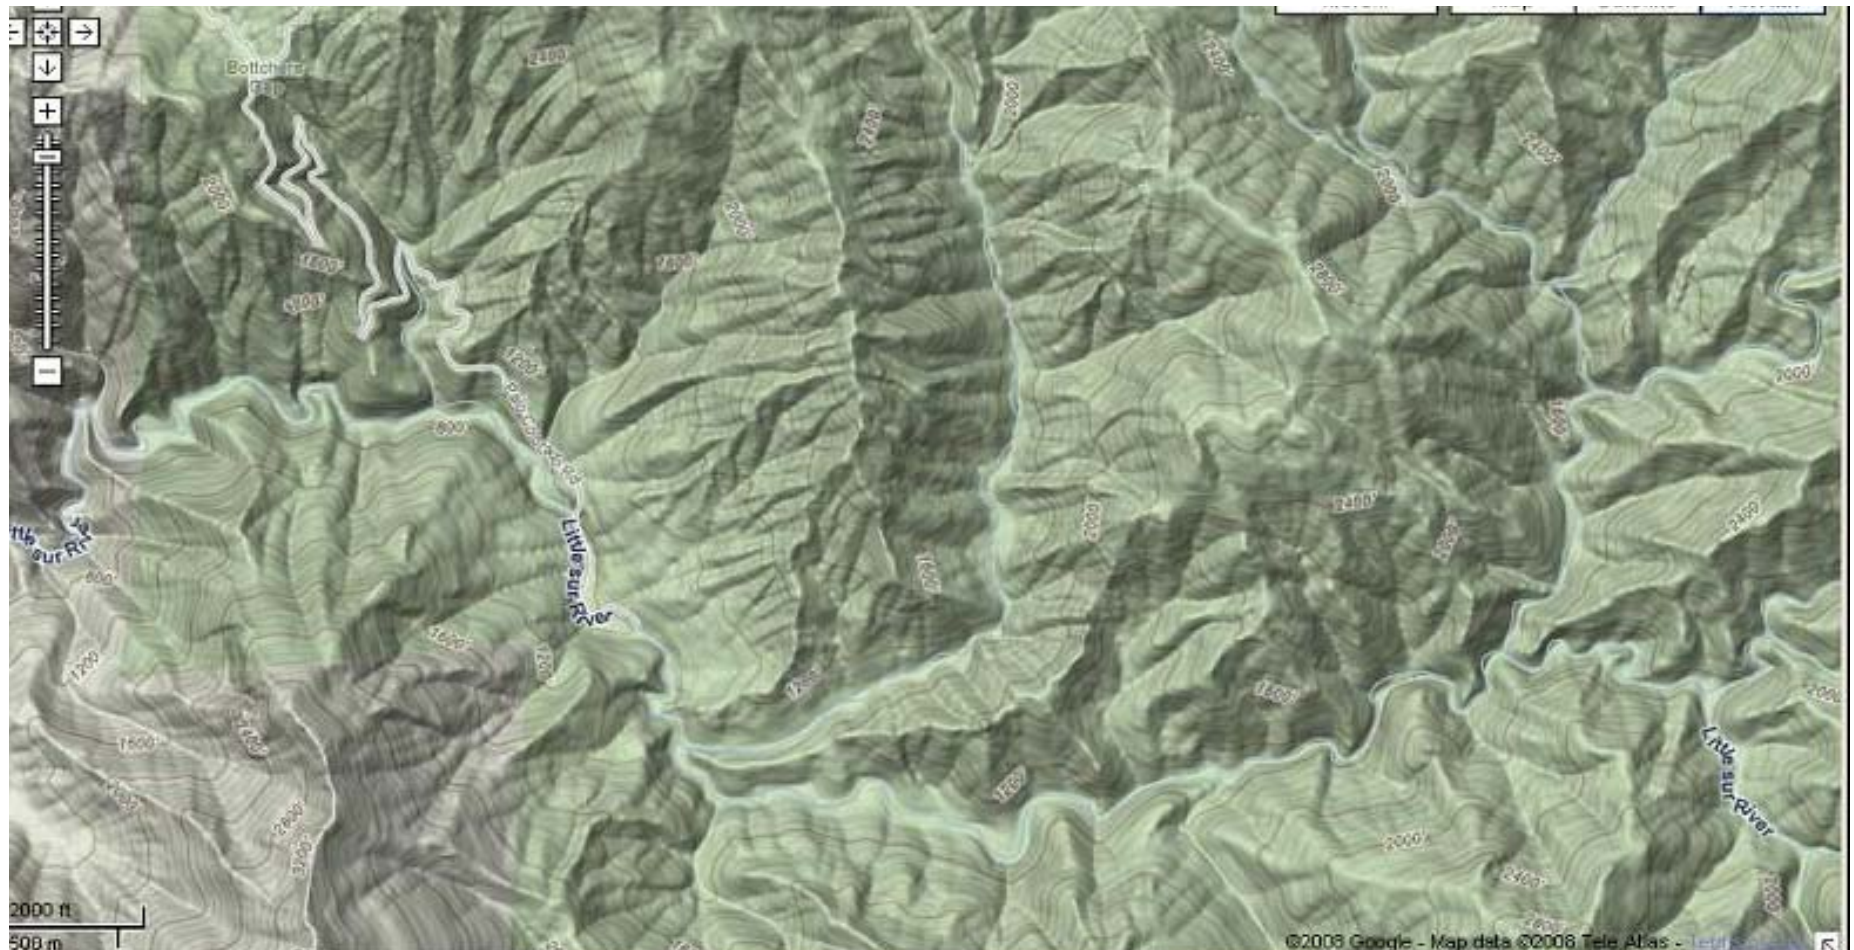
Figure 2: Topographic Map of the middle reaches of the Little Sur River, showing the same area as seen in Google earth image (Figure 1). Pico Blanco Boy Scout Camp is just south of the Little Sur River text in the middle left of map. Stream for ½ mile above camp was surveyed.
