Stream
Reaches
Surveyed
For Hazard
Analysis

10/2008

BAER

Phenegar Creek

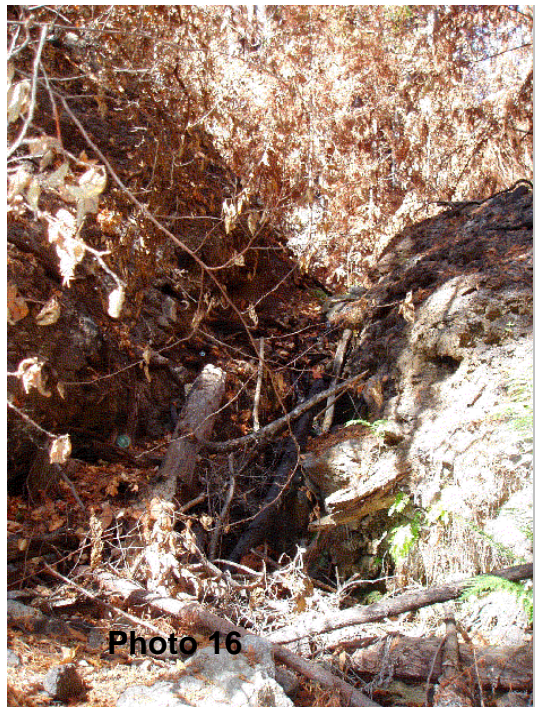
Photo 16

Photos 14, 15, and 16; represent the steep, 28% channel gradient and the steps that occur within this reach. Stored sediment occurs behind all structure but is easily mobilized due to gradient. Wood is being buried and storing sediments nicely.

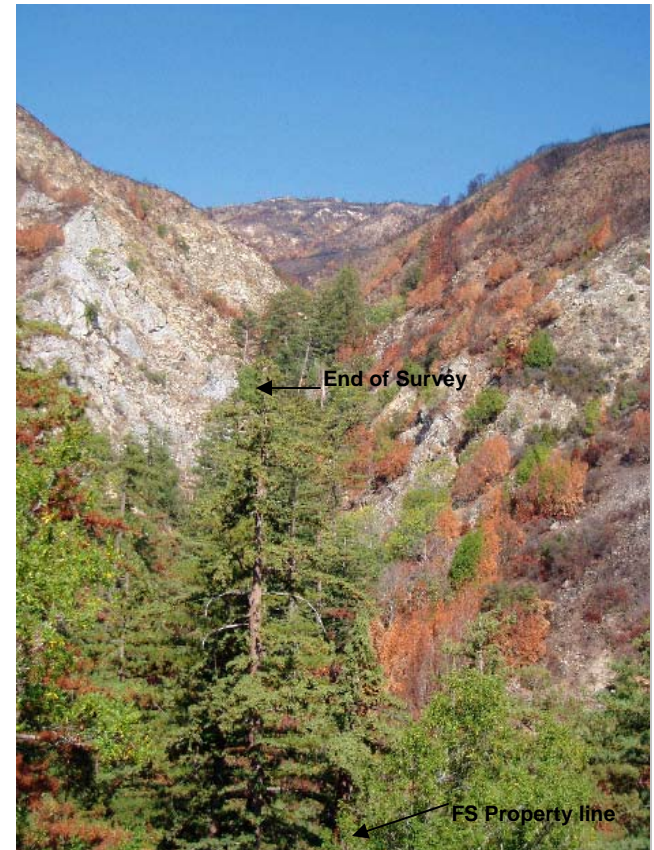
Photo 22/23:

Photo is taken from the road that access Michael Curtis property. Facing north one can see the inner gorge nature of the channel and the rock cliffs within the channel. End of survey.
