2022 Owl Fire (ID-SCF-022248) Structure Triage

Collected By: Owl Fire 2022 BR 32/ Div A

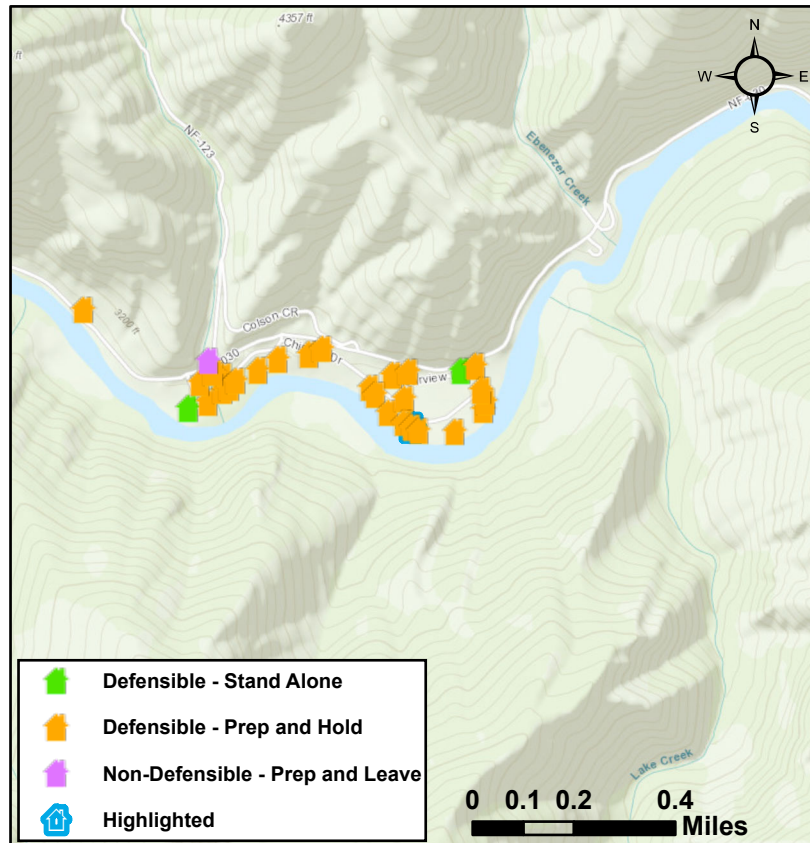
Triage Category: Defensible, Prep and Hold
FIRESCOPE Triage Category:
Structure Number: 37
Collected Date/Time: 9/12/2022 7:23:28 PM
Collected By: Owl Fire 2022 BR 32/ Div A
Inspector's Position:
Type of Structure: Residential
Primary Structures: 1
Is the building Occupied?: Yes
Outbuildings: 3
Fuel Surrounding Structure: Grass and shrub, hardwood litter
Defensible Space: 100 ft treated
Roof Material: Noncombustible or not applicable
Siding Material: Wood or open sided
Electrical Power: Yes
Gas to Structure: Yes
Hazards: Propane, Septic
Access to Site: T3/4 Engine
Describe Access:
Comm With ICP: Yes
Water Source: Pressurized hydrant(s) or fixed sprinkler system
Safety Zone Present:
Mitigation Time (in hours): 1
Mitigation Description: Remove duff, trim up bushes and trees
Resources Needed to Protect Structure:
FIRESCOPE Tactics:
Notes:

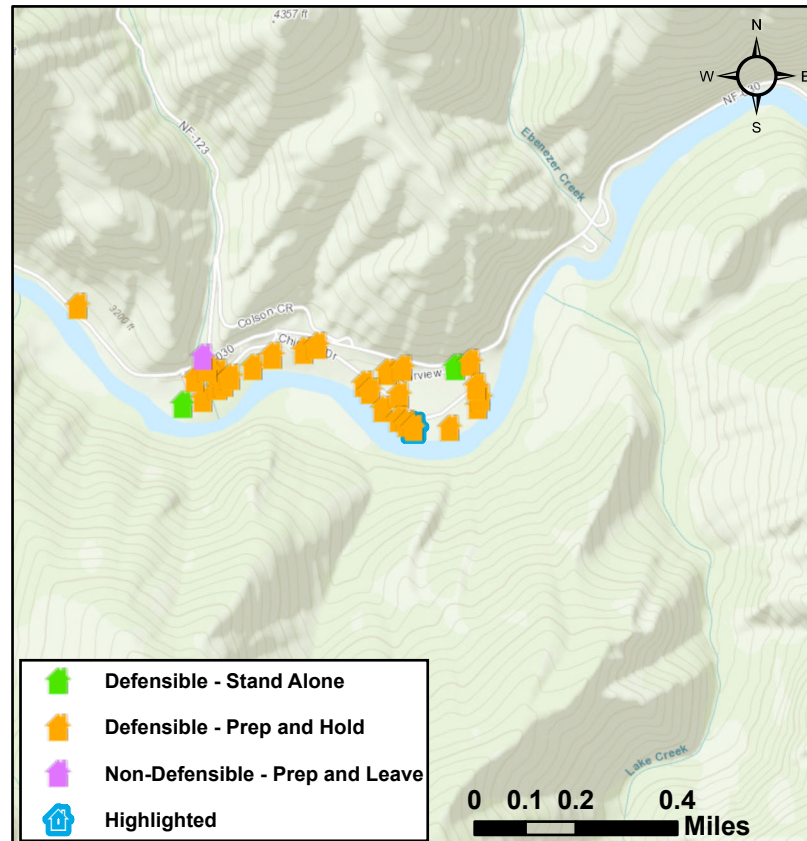
Triage Category: Defensible, Prep and Hold
FIRESCOPE Triage Category:
Structure Number: 38
Collected Date/Time: 9/12/2022 7:25:18 PM
Collected By: Owl Fire 2022 BR 32/ Div A
Inspector's Position:
Type of Structure: Residential
Primary Structures: 1
Is the building Occupied?: Yes
Outbuildings: 3
Fuel Surrounding Structure: Grass and shrub, hardwood litter
Defensible Space: 100 ft treated
Roof Material: Noncombustible or not applicable
Siding Material: Log construction
Electrical Power: Yes
Gas to Structure: Yes
Hazards: Propane, Septic
Access to Site: T3/4 Engine
Describe Access:
Comm With ICP: Yes
Water Source: Pressurized hydrant(s) or fixed sprinkler system
Safety Zone Present:
Mitigation Time (in hours): 1
Mitigation Description: Clear up brush and minimal limbing
Resources Needed to Protect Structure:
FIRESCOPE Tactics:
Notes:

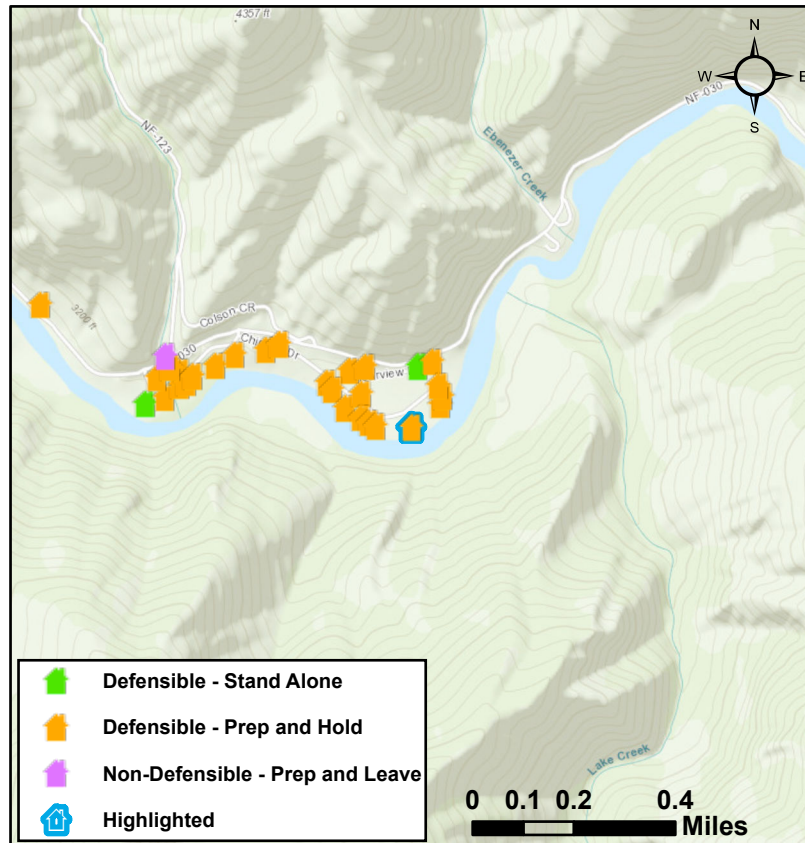
Triage Category: Defensible, Prep and Hold
FIRESCOPE Triage Category:
Structure Number: 39
Collected Date/Time: 9/12/2022 7:28:21 PM
Collected By: Owl Fire 2022 BR 32/ Div A
Inspector's Position:
Type of Structure: Residential
Primary Structures: 1
Is the building Occupied?: No
Outbuildings: 2
Fuel Surrounding Structure: Grass and shrub, hardwood litter
Defensible Space: 100 ft treated
Roof Material: Noncombustible or not applicable
Siding Material: Rock, concrete, metal
Electrical Power: Yes
Gas to Structure: Yes
Hazards: Propane, Septic
Access to Site: T3/4 Engine
Describe Access:
Comm With ICP: Yes
Water Source: Pressurized hydrant(s) or fixed sprinkler system
Safety Zone Present:
Mitigation Time (in hours): 2
Mitigation Description: Remove dry brush and grass
Resources Needed to Protect Structure:
FIRESCOPE Tactics:
Notes:

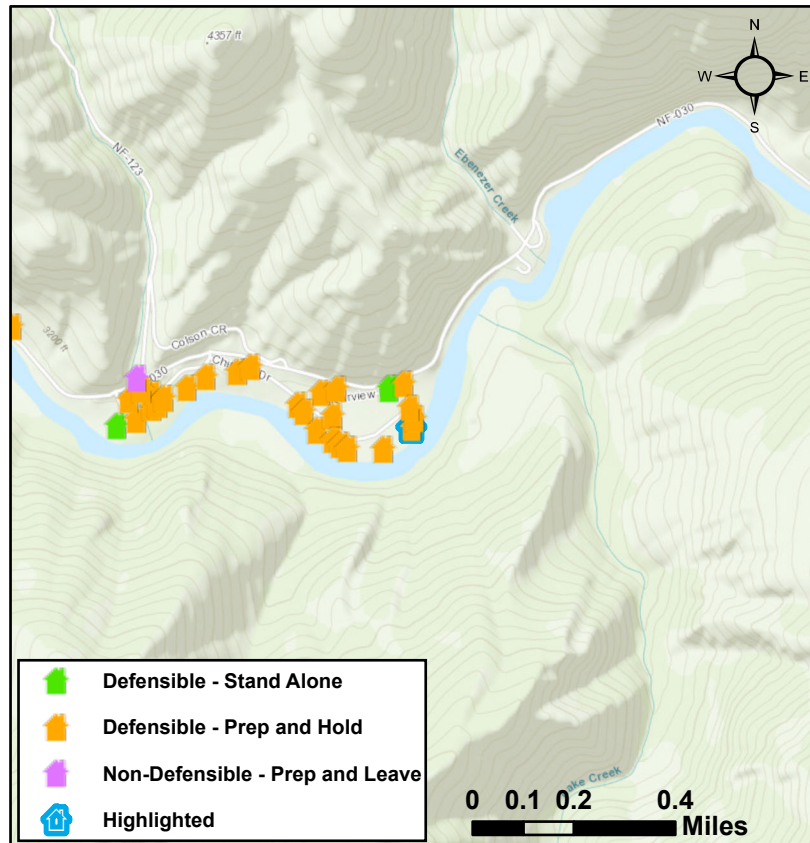
Triage Category: Defensible, Prep and Hold
FIRESCOPE Triage Category:
Structure Number: 40
Collected Date/Time: 9/12/2022 7:31:13 PM
Collected By: Owl Fire 2022 BR 32/ Div A
Inspector's Position:
Type of Structure: Residential
Primary Structures: 1
Is the building Occupied?: Unknown
Outbuildings: 1
Fuel Surrounding Structure: Grass and shrub, hardwood litter
Defensible Space: 100 ft treated
Roof Material: Noncombustible or not applicable
Siding Material: Wood or open sided
Electrical Power: Yes
Gas to Structure: Yes
Hazards: Propane, Septic
Access to Site: T3/4 Engine
Describe Access:
Comm With ICP: Yes
Water Source: Pressurized hydrant(s) or fixed sprinkler system
Safety Zone Present:
Mitigation Time (in hours): 1
Mitigation Description: Clear up brush and minimal limbing
Resources Needed to Protect Structure:
FIRESCOPE Tactics:
Notes:

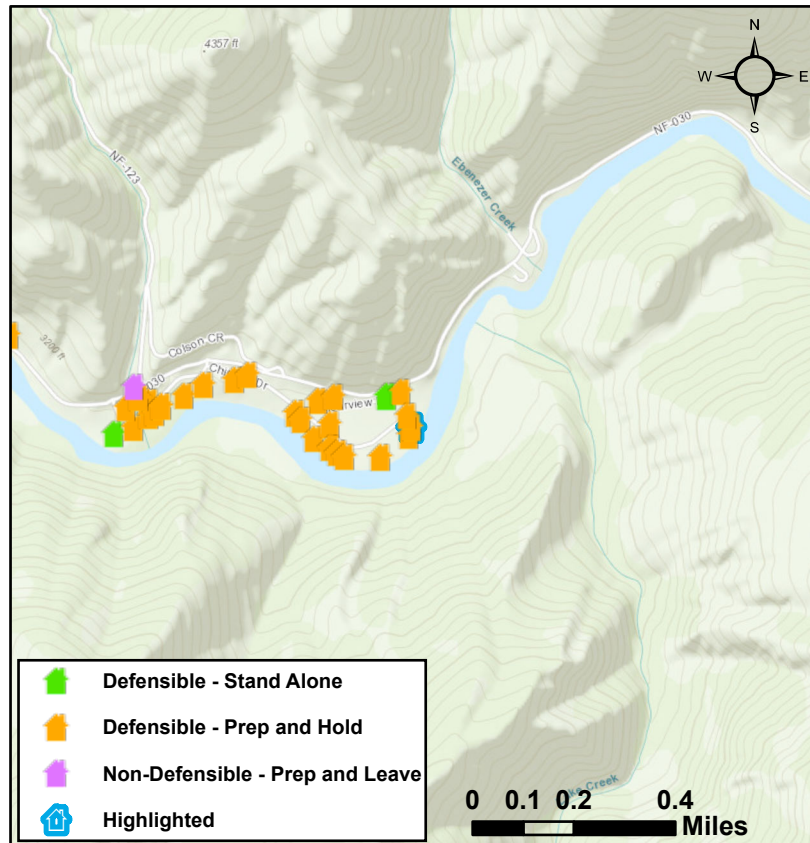
Triage Category: Defensible, Prep and Hold
FIRESCOPE Triage Category:
Structure Number: 41
Collected Date/Time: 9/12/2022 7:32:45 PM
Collected By: Owl Fire 2022 BR 32/ Div A
Inspector's Position:
Type of Structure: Residential
Primary Structures: 1
Is the building Occupied?: Unknown
Outbuildings: 1
Fuel Surrounding Structure: Grass and shrub, hardwood litter
Defensible Space: 100 ft treated
Roof Material: Noncombustible or not applicable
Siding Material: Wood or open sided
Electrical Power: Yes
Gas to Structure: Yes
Hazards: Propane, Septic
Access to Site: T3/4 Engine
Describe Access:
Comm With ICP: Yes
Water Source: Pressurized hydrant(s) or fixed sprinkler system
Safety Zone Present:
Mitigation Time (in hours): 1
Mitigation Description: Clear up brush and minimal limbing
Resources Needed to Protect Structure:
FIRESCOPE Tactics:
Notes:

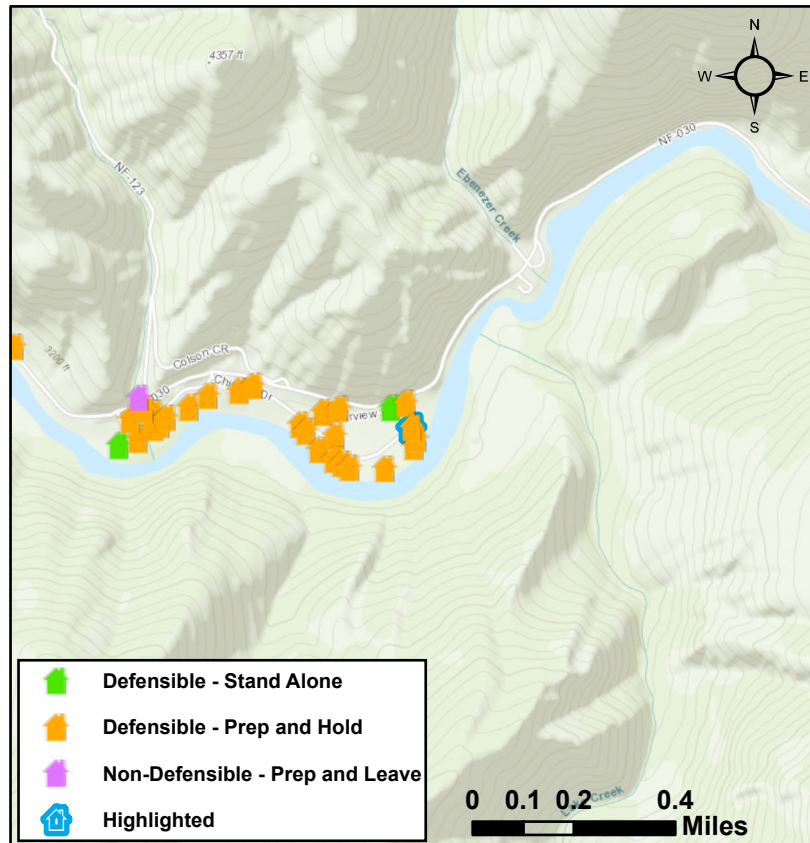
Triage Category: Defensible, Prep and Hold
FIRESCOPE Triage Category:
Structure Number: 42
Collected Date/Time: 9/12/2022 7:35:16 PM
Collected By: Owl Fire 2022 BR 32/ Div A
Inspector's Position:
Type of Structure: Residential
Primary Structures: 1
Is the building Occupied?: Yes
Outbuildings: 6
Fuel Surrounding Structure: Grass and shrub, hardwood litter
Defensible Space:
Roof Material: Noncombustible or not applicable
Siding Material: Wood or open sided
Electrical Power: Yes
Gas to Structure: Yes
Hazards: Propane, Septic
Access to Site: T3/4 Engine
Describe Access:
Comm With ICP: Yes
Water Source: Pressurized hydrant(s) or fixed sprinkler system
Safety Zone Present:
Mitigation Time (in hours): 2
Mitigation Description: Clear up brush and minimal limbing
Resources Needed to Protect Structure:
FIRESCOPE Tactics:
Notes:

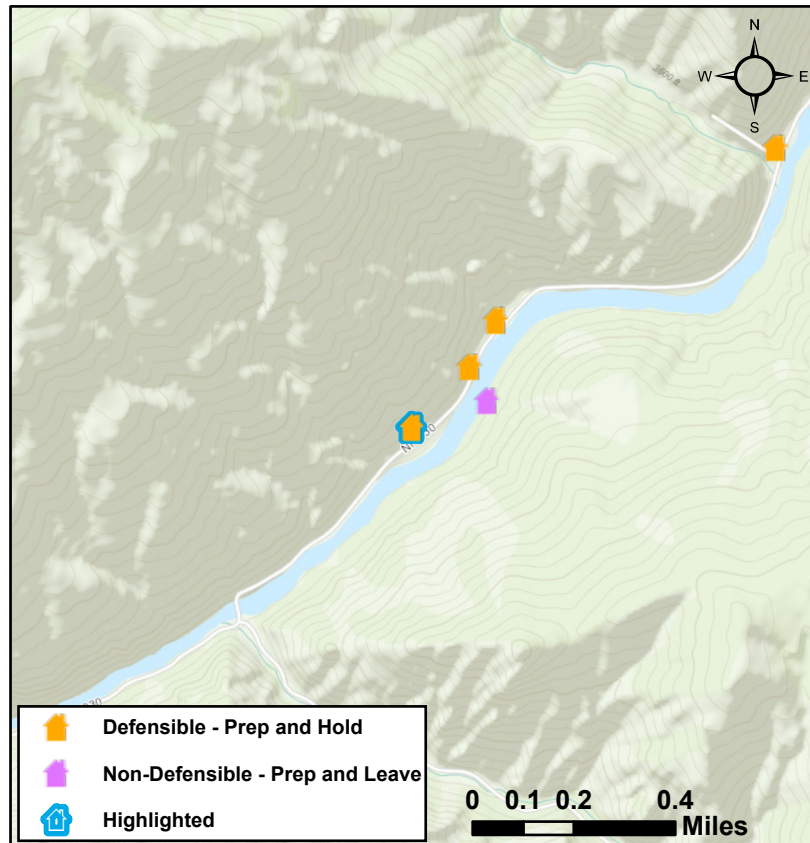
Triage Category: Defensible, Prep and Hold
FIRESCOPE Triage Category:
Structure Number: 46
Collected Date/Time: 9/13/2022 1:22:02 AM
Collected By: Owl Fire 2022 BR 32/ Div A
Inspector's Position:
Type of Structure: Residential
Primary Structures: 1
Is the building Occupied?: Yes
Outbuildings: 2
Fuel Surrounding Structure: Grass and shrub, hardwood litter
Defensible Space: 30 ft treated
Roof Material: Noncombustible or not applicable
Siding Material: Wood or open sided
Electrical Power: Yes
Gas to Structure: Yes
Hazards: Steep terrain, Propane
Access to Site: T6 Engine
Describe Access: Steep Route
Comm With ICP: Yes
Water Source: Reliable water source nearby
Safety Zone Present:
Mitigation Time (in hours): 1
Mitigation Description: Clear Brush, weeds, and duff away from structure
Resources Needed to Protect Structure:
FIRESCOPE Tactics:
Notes:

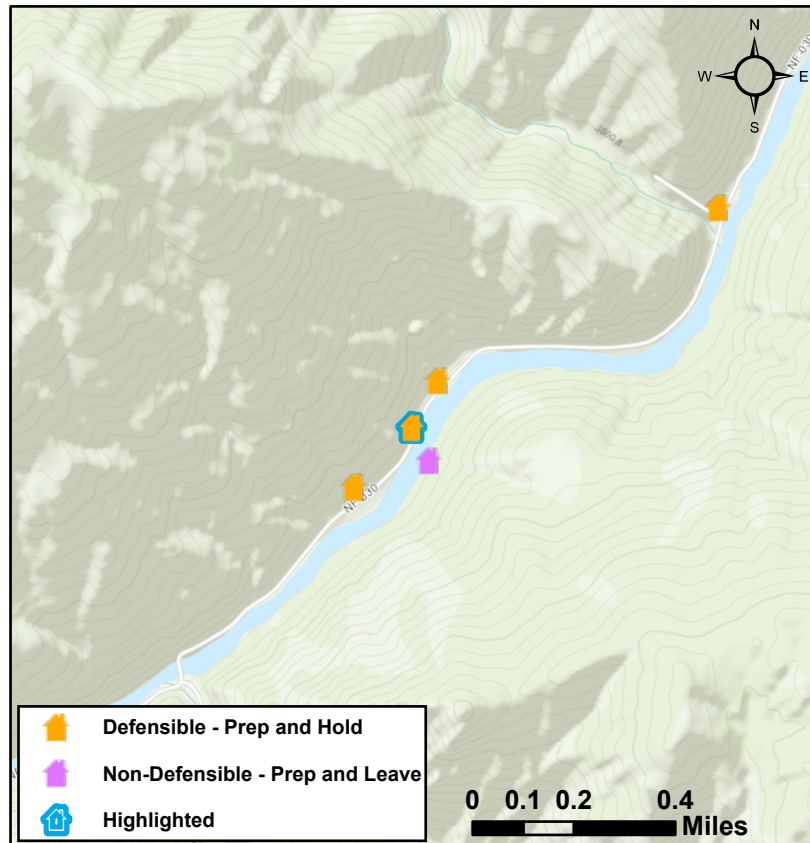
Triage Category: Defensible, Prep and Hold
FIRESCOPE Triage Category:
Structure Number: 48
Collected Date/Time: 9/13/2022 1:27:58 AM
Collected By: Owl Fire 2022 BR 32/ Div A
Inspector's Position:
Type of Structure: Residential
Primary Structures: 1
Is the building Occupied?: Yes
Outbuildings: 4
Fuel Surrounding Structure: Grass and shrub, hardwood litter
Defensible Space: 30 ft treated
Roof Material: Noncombustible or not applicable
Siding Material: Wood or open sided
Electrical Power: Yes
Gas to Structure: Yes
Hazards: Junk Piles, Fuel, Electric
Access to Site: T3/4 Engine
Describe Access:
Comm With ICP: Yes
Water Source: Pressurized hydrant(s) or fixed sprinkler system
Safety Zone Present:
Mitigation Time (in hours): 1
Mitigation Description: Clear Brush, weeds, and duff away from structure
Resources Needed to Protect Structure:
FIRESCOPE Tactics:
Notes:

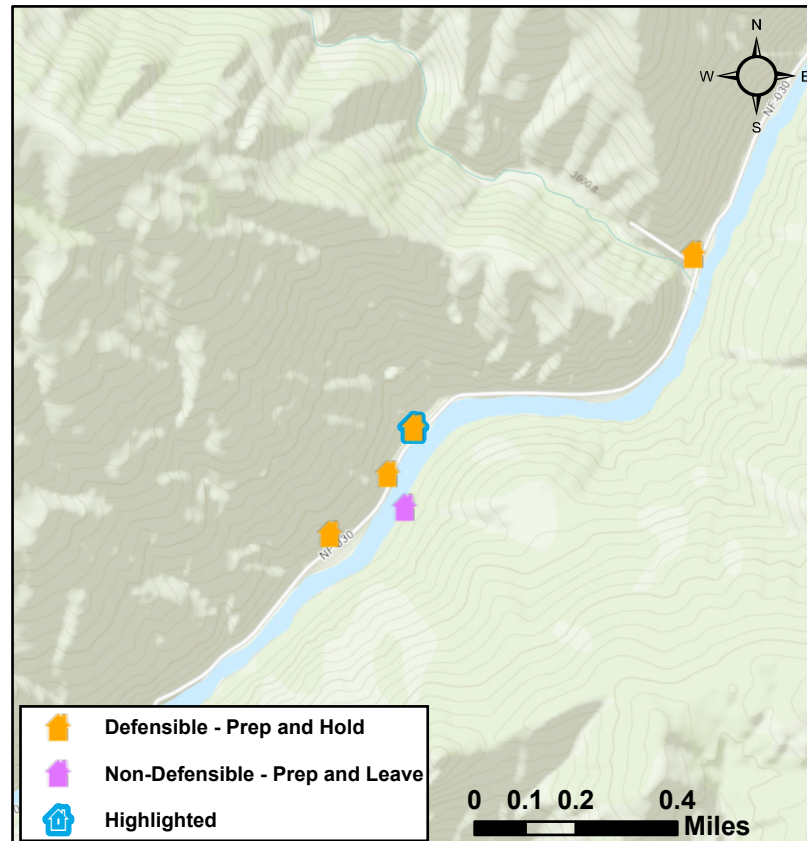
Triage Category: Defensible, Prep and Hold
FIRESCOPE Triage Category:
Structure Number: 49
Collected Date/Time: 9/13/2022 1:30:44 AM
Collected By: Owl Fire 2022 BR 32/ Div A
Inspector's Position:
Type of Structure: Residential
Primary Structures: 1
Is the building Occupied?: Yes
Outbuildings: 3
Fuel Surrounding Structure: Grass and shrub, hardwood litter
Defensible Space: 30 ft treated
Roof Material: Noncombustible or not applicable
Siding Material: Wood or open sided
Electrical Power: Yes
Gas to Structure: Yes
Hazards: Fuel, Propane, Septic
Access to Site: T3/4 Engine
Describe Access:
Comm With ICP: Yes
Water Source: Pressurized hydrant(s) or fixed sprinkler system
Safety Zone Present:
Mitigation Time (in hours): 2
Mitigation Description: Clear Brush, weeds, and duff away from structure
Resources Needed to Protect Structure:
FIRESCOPE Tactics:
Notes:

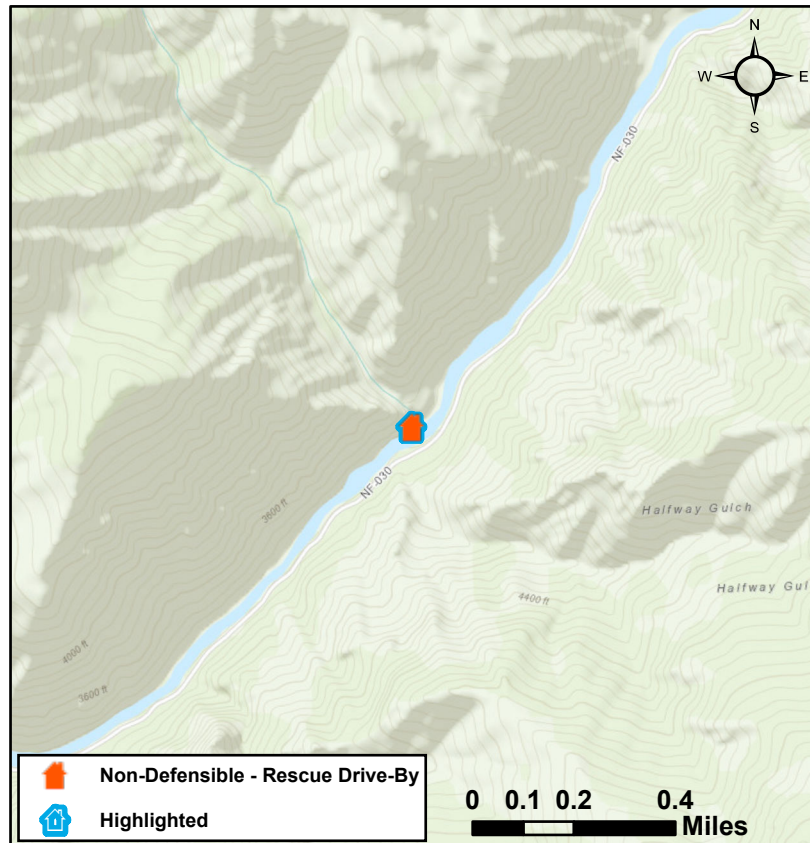
Notes: Fuel Type: Ponderosa, grass, Shrub; Defensible Space: None; Roof: Wood; Siding: Wood; Heat Traps: ; Notes:

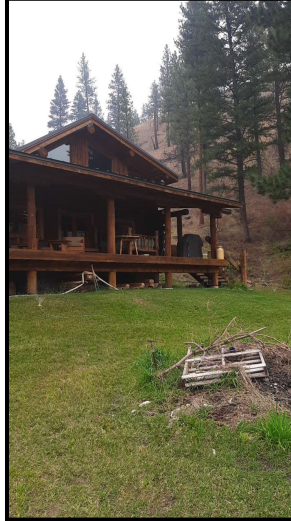
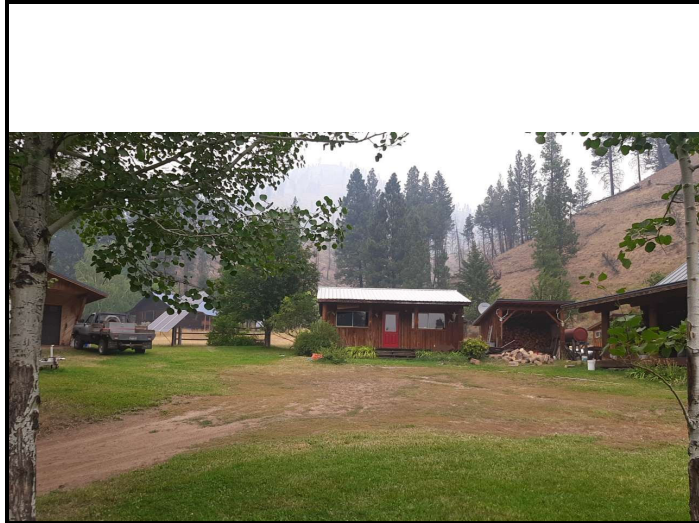
Triage Category: Defensible, Stand Alone
FIRESCOPE Triage Category:
Structure Number: 2
Collected Date/Time: 9/12/2022 10:36:00 PM
Collected By: Gary Hobbs
Inspector's Position: Division
Type of Structure: Residential
Primary Structures: 1
Is the building Occupied?: Yes
Outbuildings: 4
Fuel Surrounding Structure: Shrub or timber
Defensible Space: More than 100ft treated
Roof Material: Noncombustible or not applicable
Siding Material: Log construction
Electrical Power: Unknown
Gas to Structure: Yes
Hazards: Timber behind house. Propane tank
Access to Site: T3/4 Engine
Describe Access: Gravel driveway with turn around in yard
Comm With ICP: Yes
Water Source: Reliable water source nearby
Safety Zone Present:
Mitigation Time (in hours): 8
Mitigation Description: Set sprinklers and hose lay
Resources Needed to Protect Structure: 4 sprinkler kits one engine crew
FIRESCOPE Tactics:
Notes: Solar power ,has wood shed. Green grass in yard ..Pump and hose crosses road already established by homeowner

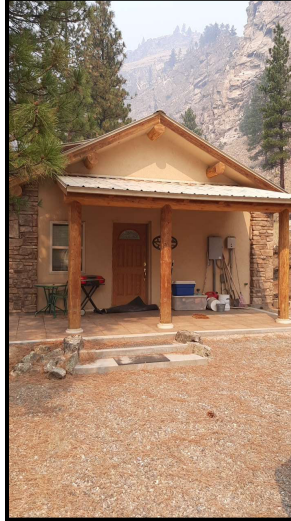
Triage Category: Defensible, Prep and Hold
FIRESCOPE Triage Category:
Structure Number: 1A
Collected Date/Time: 9/11/2022 6:18:00 PM
Collected By: Gary Hobbs
Inspector's Position: Division Alpha
Type of Structure: Residential
Primary Structures: 1
Is the building Occupied?: Unknown
Outbuildings: 1
Fuel Surrounding Structure: Shrub or timber
Defensible Space: No defensible space
Roof Material: Noncombustible or not applicable
Siding Material: Rock, concrete, metal
Electrical Power: Yes
Gas to Structure: Yes
Hazards: Located on slope river below
Access to Site: T6 Engine
Describe Access: Single lane road up to structure
Comm With ICP: Unknown
Water Source: Reliable water source nearby
Safety Zone Present:
Mitigation Time (in hours): 1
Mitigation Description: Needle raking from structure.
Sprinkler set up.
Resources Needed to Protect Structure: Sprinklers 1
type 6 engine or Type 4
FIRESCOPE Tactics:
Notes: Propane storage shed 500' east of structure

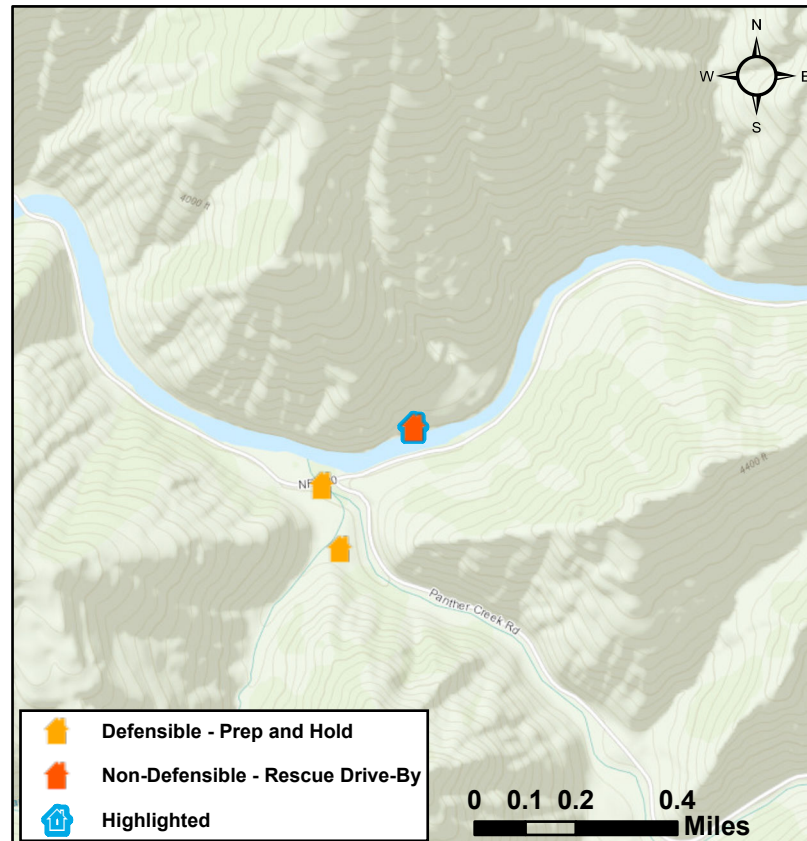
Hazards: Weakened Structure

Notes: Wood Historical Barn

Mitigation Description: Burn out around house/ handline

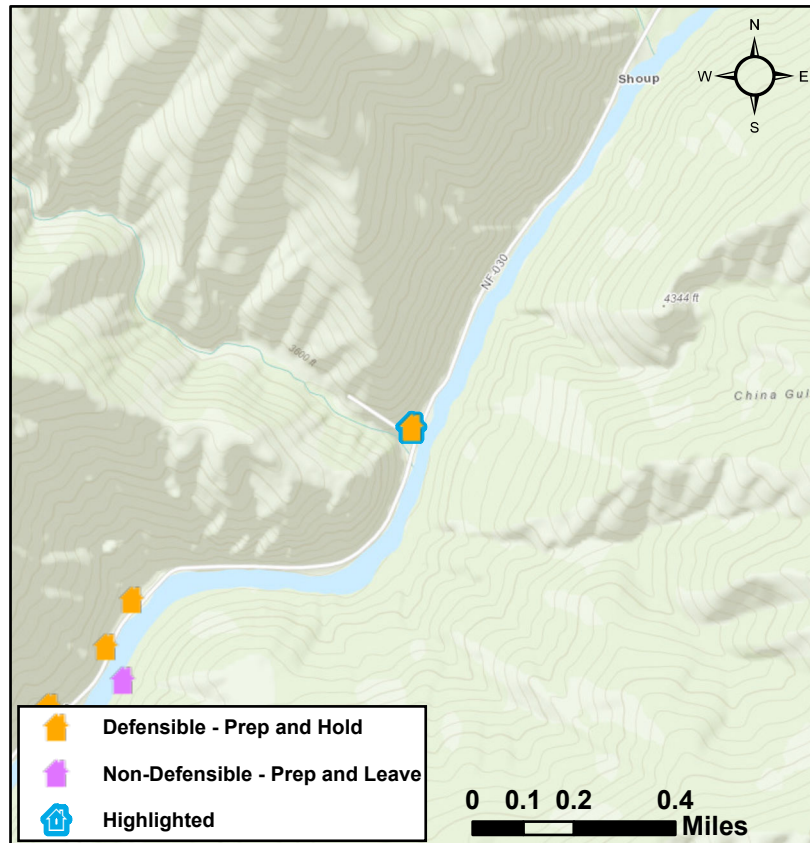
Triage Category: Defensible, Prep and Hold
FIRESCOPE Triage Category:
Structure Number: 50
Collected Date/Time: 9/13/2022 1:35:57 AM
Collected By: Owl Fire 2022 BR 32/ Div A
Inspector's Position:
Type of Structure: MixedUse
Primary Structures: 1
Is the building Occupied?: No
Outbuildings: 4
Fuel Surrounding Structure: Grass and shrub, hardwood litter
Defensible Space: 30 ft treated
Roof Material: Noncombustible or not applicable
Siding Material: Wood or open sided
Electrical Power: Yes
Gas to Structure: Yes
Hazards: Fuels,SepticTank
Access to Site: T34Engine
Describe Access: River Road
Comm With ICP: Yes
Water Source: Pressurized hydrant(s) or fixed sprinkler system
Safety Zone Present:
Mitigation Time (in hours): 2
Mitigation Description: Clear Brush, weeds, and duff away from structure
Resources Needed to Protect Structure:
FIRESCOPE Tactics:
Notes: Fuel Type: Grass,Shrub,Timber; Defensible Space: 3050Feet; Roof: Metal; Siding: Wood; Heat Traps: ; Notes:
