STRUCTURE  
PROTECTION PLAN  
FOR SWEENY  
BLOCK

07/30/2017

# Structure Protection Plan

## Sweeny Creek

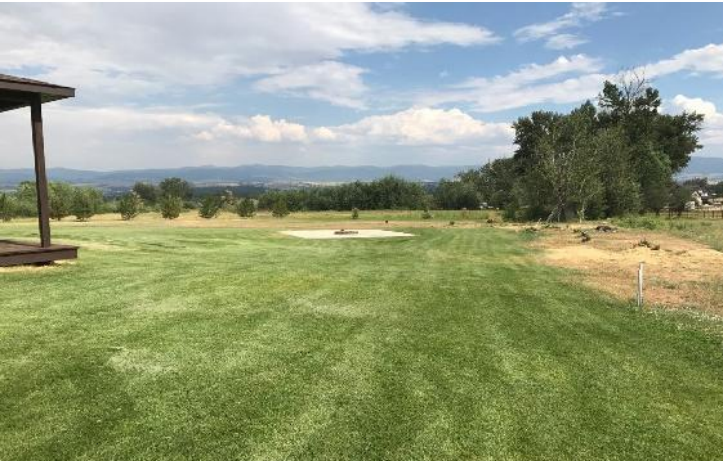
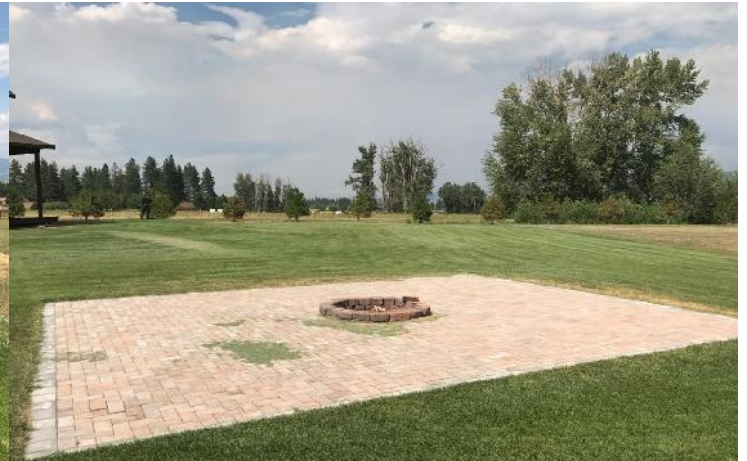
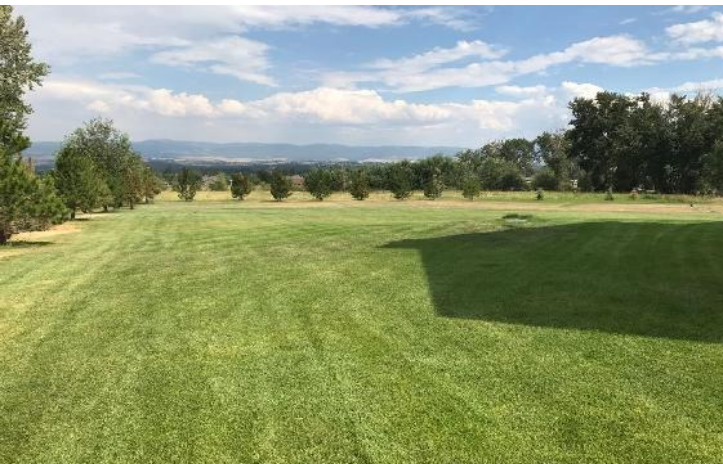
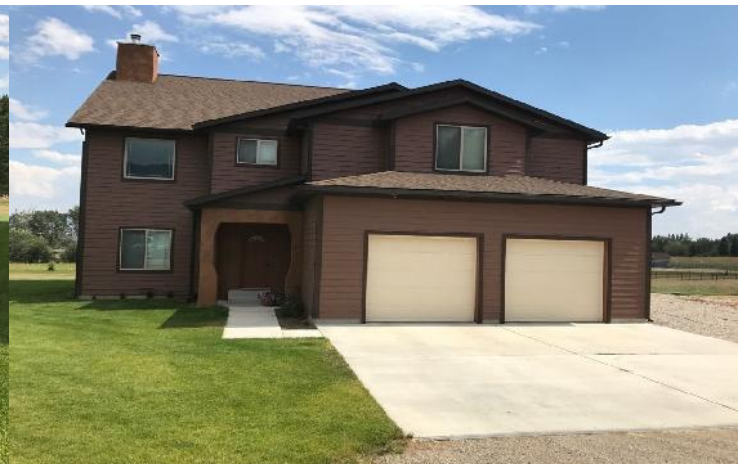
**Structure Number:**  
**Structure Name:** 183 Beck Ln  
**SubDivision:** Sweeny  
**GPS Location, Lat.** 46 37.01928  
**GPS Location, Long.** 114 5.89224  
**Safety Zone Present:** Yes  
**Type of Structure:** Residential  
**Surrounding Fuels:** Grass, Shrub  
**Structure Triage Category:** Defensible, Stand Alone  
**Roof Material:** Composite  
**Heat Traps:** Wood Deck, Rain Gutters, Other Receptor  
**Electrical Power:** Underground  
**Hazards:** Animals  
**Access to Site:** T1 Engine  
**Comm with ICP:** Radio, Cell Service  
**Water Source:** Faucet / Hose  
**Mitigation Time:** None Needed  
**Collected By:** Lolo 632

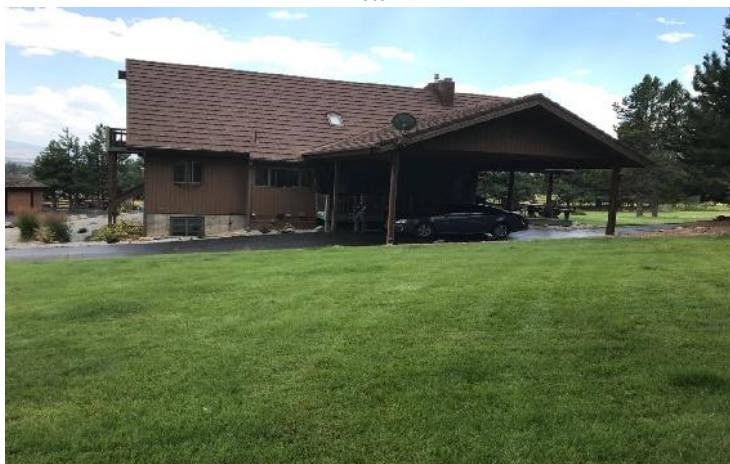
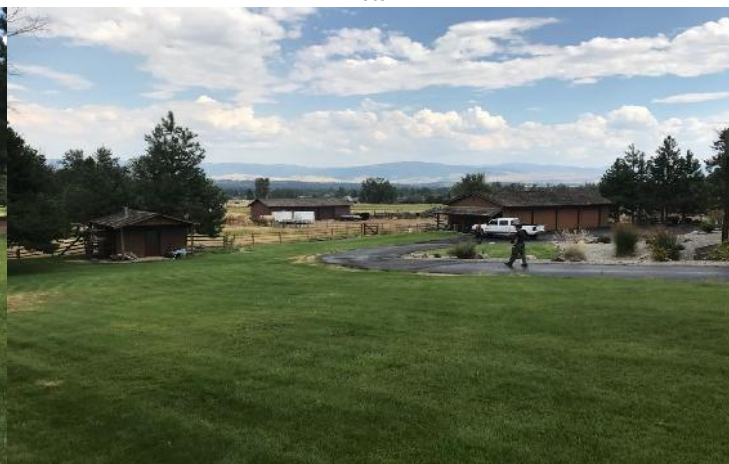
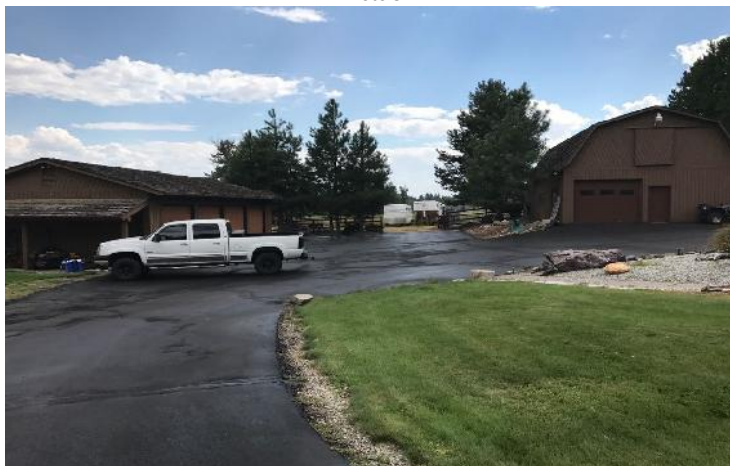
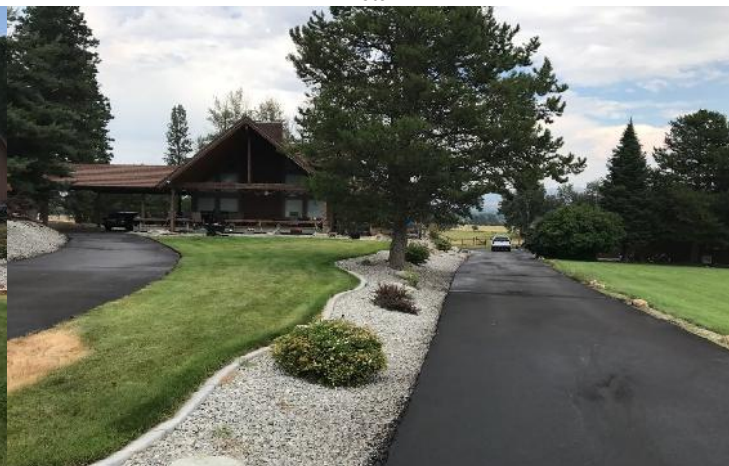
**Structure Number:**  
**Structure Name:** 184 Beck Ln  
**SubDivision:** Sweeny  
**GPS Location, Lat.** 46 37.18524  
**GPS Location, Long.** 114 5.8743  
**Safety Zone Present:** Yes  
**Type of Structure:** Residential  
**Surrounding Fuels:** Grass, Timber  
**Structure Triage Category:** Defensible, Stand Alone  
**Roof Material:**  
**Heat Traps:** Rain Gutters  
**Electrical Power:** Underground  
**Hazards:** Animals, HazMat  
**Access to Site:** T1 Engine  
**Comm with ICP:** Radio, Cell Service  
**Water Source:** Faucet / Hose  
**Mitigation Time:** Less Than An Hour  
**Other Resources Needed to Protect:** None  
**Notes:** Masonry roofing

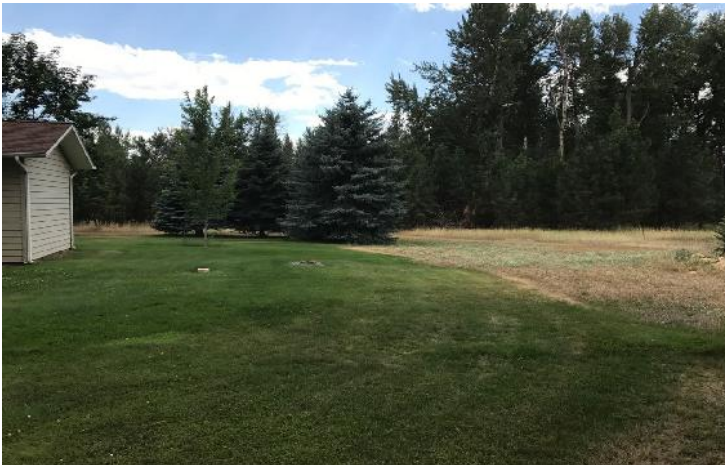
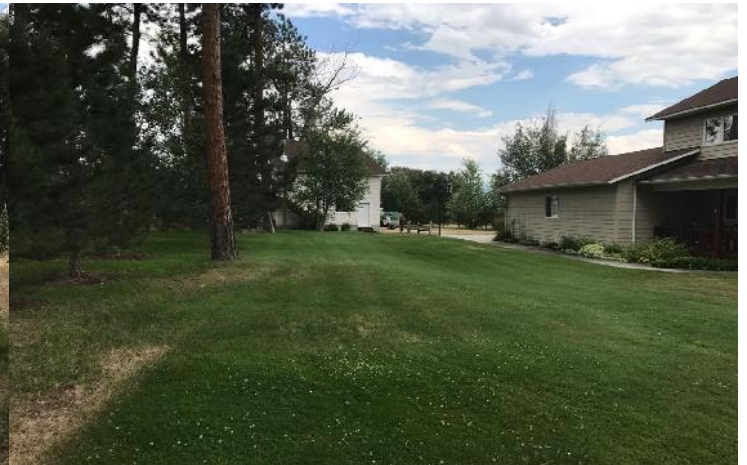
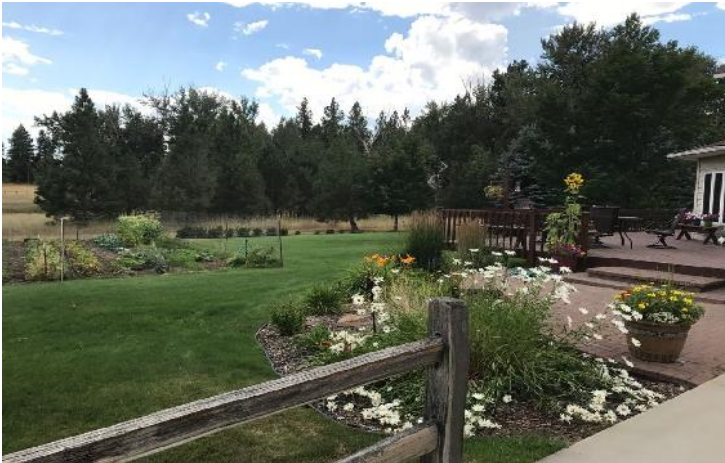
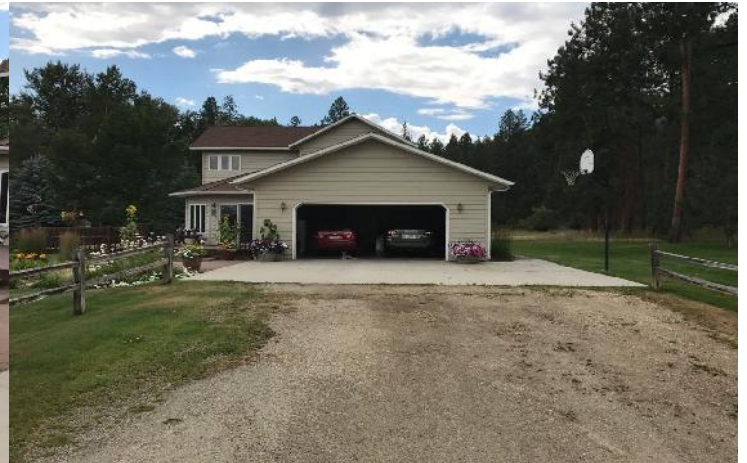
**Structure Number:**  
**Structure Name:** 187 Beck Ln.  
**SubDivision:** Sweeny  
**GPS Location, Lat.** 46 36.97212  
**GPS Location, Long.** 114 5.9466  
**Safety Zone Present:** Yes  
**Type of Structure:** Residential  
**Surrounding Fuels:** Grass, Shrub, Timber  
**Structure Triage Category:** Defensible, Stand Alone  
**Roof Material:** Composite  
**Heat Traps:** Wood Deck, Rain Gutters  
**Electrical Power:** Underground  
**Hazards:** Septic Tank  
**Access to Site:** T3/4 Engine  
**Comm with ICP:** Radio, Cell Service  
**Water Source:** Faucet / Hose  
**Mitigation Time:** 1-2 Hours  
**Other Resources Needed to Protect:** Type 3 engine to assist with cutting of tall grass and re-gen ponderosa  
**Collected By:** Lolo 632

**Where is Safety Zone:** East on Beck Lane to Hwy 93  
**Primary Structures:**  
**Defensible Space:** 30-50 Feet  
**Outbuildings:**  
**Siding Material:** Wood  
**Gas to Structure:**  
**Best Access From:** Hwy 93 to Beck Lane  
**Collected Date/Time:** 07/30/2017 11:29:43

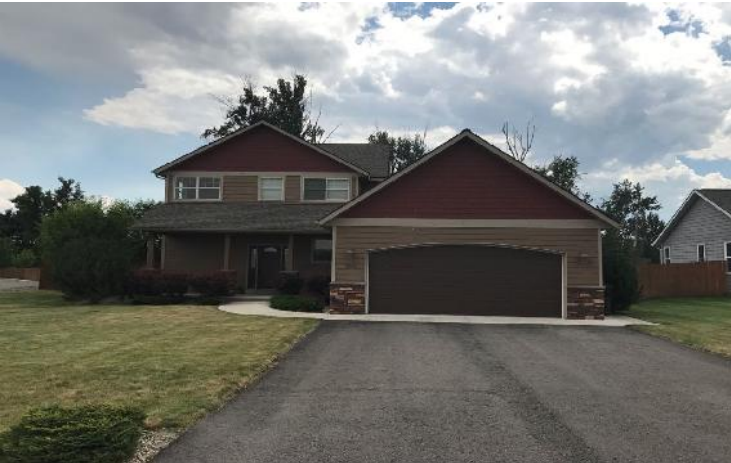
**Structure Number:**  
**Structure Name:** 205 South Creek Trail  
**SubDivision:** Sweeny  
**GPS Location, Lat.** 46 36.92226  
**GPS Location, Long.** 114 5.47614  
**Safety Zone Present:** Yes  
**Type of Structure:** Residential  
**Surrounding Fuels:** Grass, Shrub  
**Structure Triage Category:** Defensible, Stand Alone  
**Roof Material:** Composite  
**Heat Traps:** Rain Gutters  
**Electrical Power:** Underground  
**Hazards:** HazMat  
**Access to Site:** T1 Engine  
**Comm with ICP:** Radio, Cell Service  
**Water Source:** Faucet / Hose  
**Mitigation Time:** Less Than An Hour  
**Collected By:** Lolo 632

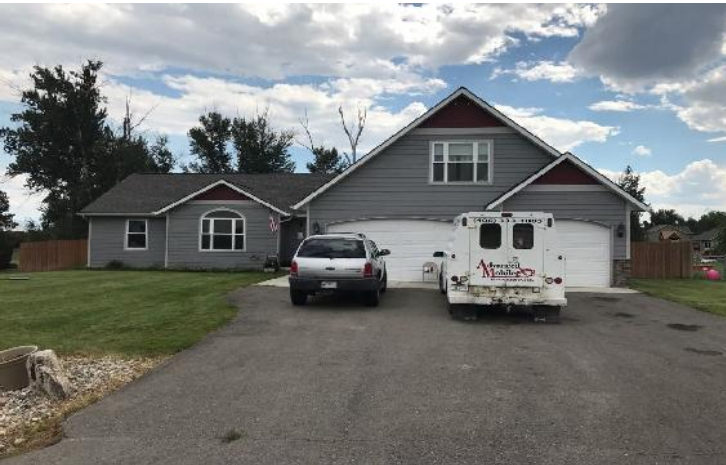
**Structure Number:**  
**Structure Name:** 213 North Creek Trail  
**SubDivision:** Sweeny  
**GPS Location, Lat.** 46 36.92484  
**GPS Location, Long.** 114 5.49114  
**Safety Zone Present:** Yes  
**Type of Structure:** Residential  
**Surrounding Fuels:** Grass  
**Structure Triage Category:** Defensible, Stand Alone  
**Roof Material:** Composite  
**Heat Traps:** Rain Gutters  
**Electrical Power:** Underground  
**Hazards:** HazMat  
**Access to Site:** T1 Engine  
**Comm with ICP:** Radio, Cell Service  
**Water Source:** Faucet / Hose  
**Mitigation Time:** None Needed  
**Other Resources Needed to Protect:** None  
**Collected By:** Lolo 632

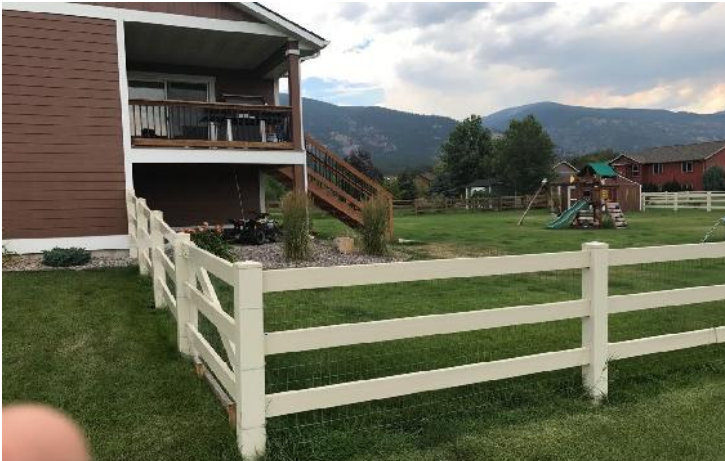
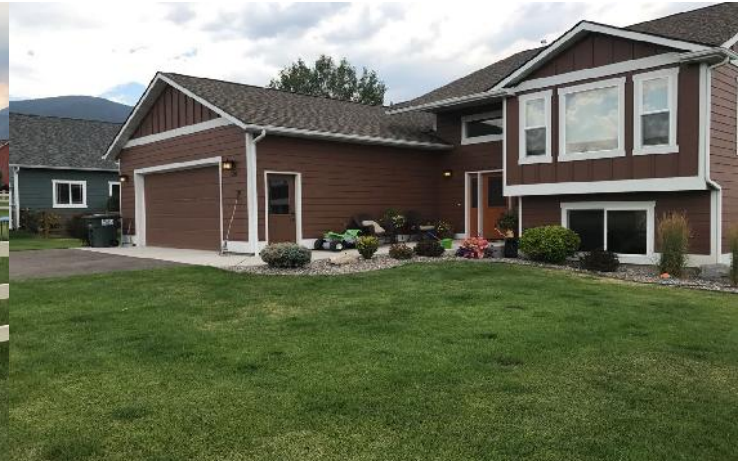
**Structure Number:**  
**Structure Name:** 226 North Creek Trail  
**SubDivision:** Sweeny  
**GPS Location, Lat.** 46 36.93342  
**GPS Location, Long.** 114 5.52906  
**Safety Zone Present:** Yes  
**Type of Structure:** Residential  
**Surrounding Fuels:** Grass  
**Structure Triage Category:** Defensible, Stand Alone  
**Roof Material:** Composite  
**Heat Traps:** Wood Deck,Rain Gutters  
**Electrical Power:** Underground  
**Hazards:**  
**Access to Site:** T1 Engine  
**Comm with ICP:** Radio,Cell Service  
**Water Source:** Faucet / Hose,Creek  
**Mitigation Time:** None Needed  
**Collected By:** Lolo 632

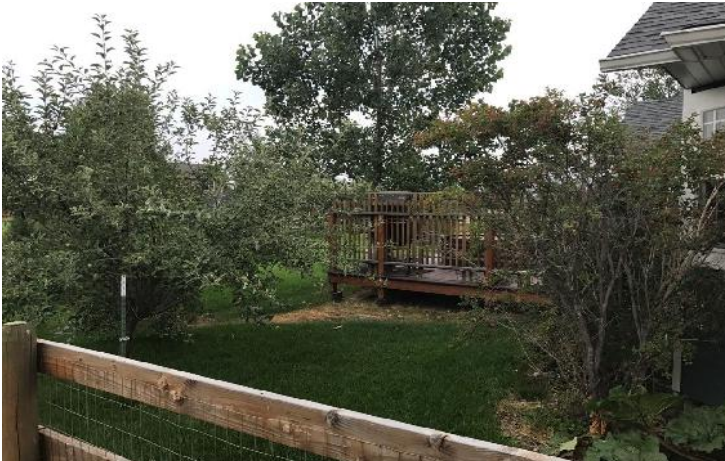
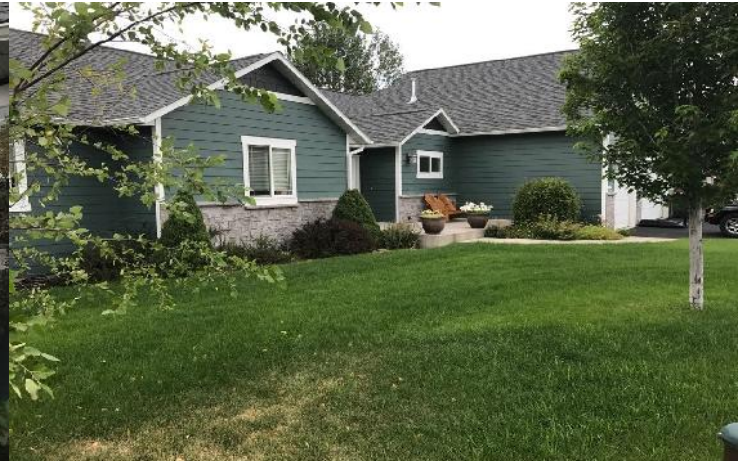
**Structure Number:**  
**Structure Name:** 232 North Creek Trail  
**SubDivision:** Sweeny  
**GPS Location, Lat.** 46 36.93408  
**GPS Location, Long.** 114 5.54598  
**Safety Zone Present:** Yes  
**Type of Structure:** Residential  
**Surrounding Fuels:** Grass  
**Structure Triage Category:** Defensible, Stand Alone  
**Roof Material:** Composite  
**Heat Traps:** Open Eaves, Wood Deck  
**Electrical Power:** Underground  
**Hazards:**  
**Access to Site:** T1 Engine  
**Comm with ICP:** Radio, Cell Service  
**Water Source:** Faucet / Hose, Hydrant, Creek  
**Mitigation Time:** None Needed  
**Collected By:** Lolo 632

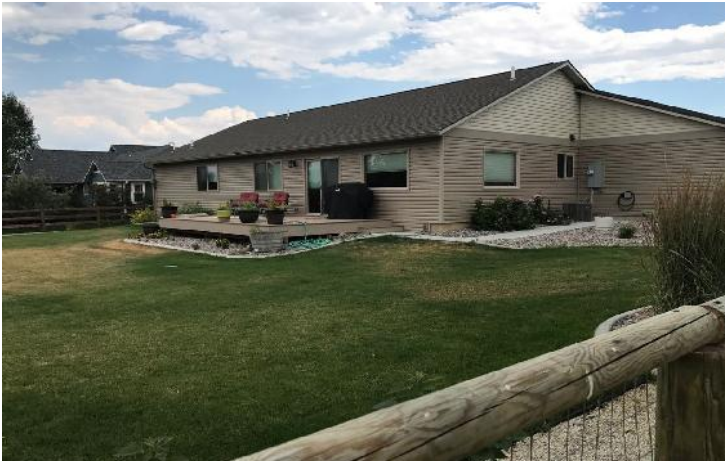
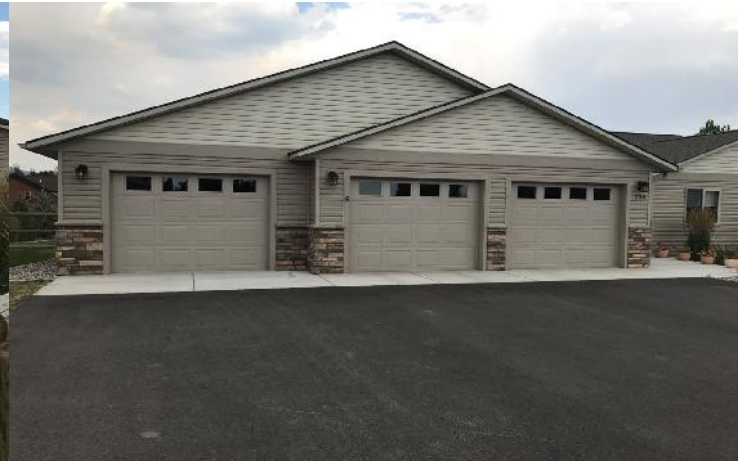
**Structure Number:**  
**Structure Name:** 238 South Creek Trail  
**SubDivision:** Sweeny  
**GPS Location, Lat.** 46 36.9342  
**GPS Location, Long.** 114 5.57586  
**Safety Zone Present:** Yes  
**Type of Structure:** Residential  
**Surrounding Fuels:** Grass  
**Structure Triage Category:** Defensible, Stand Alone  
**Roof Material:** Composite  
**Heat Traps:** Wood Deck  
**Electrical Power:** Underground  
**Hazards:**  
**Access to Site:** T1 Engine  
**Comm with ICP:** Radio, Cell Service  
**Water Source:** Faucet / Hose, Hydrant, Creek  
**Mitigation Time:** None Needed  
**Collected By:** Lolo 632

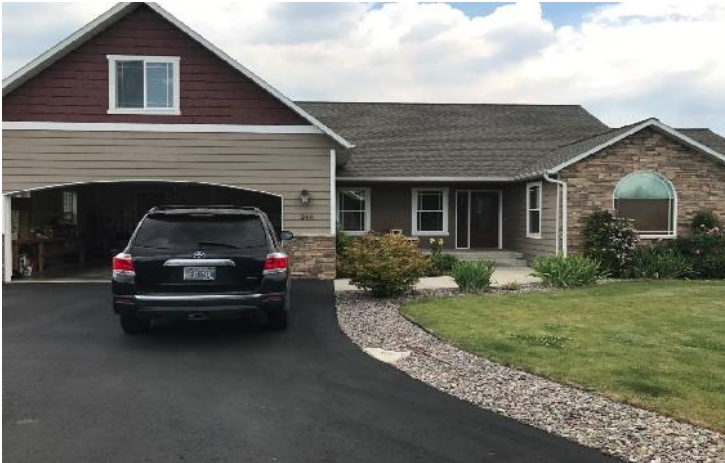
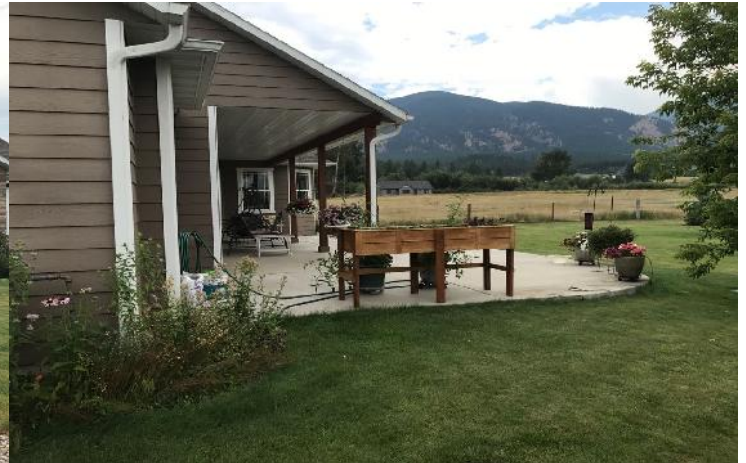
**Structure Number:**  
**Structure Name:** 240 South Creek Trail  
**SubDivision:** Sweeny  
**GPS Location, Lat.** 46 36.93606  
**GPS Location, Long.** 114 5.59536  
**Safety Zone Present:** Yes  
**Type of Structure:** Residential  
**Surrounding Fuels:** Grass  
**Structure Triage Category:** Defensible, Stand Alone  
**Roof Material:** Composite  
**Heat Traps:** Wood Deck,Rain Gutters  
**Electrical Power:** Underground  
**Hazards:**  
**Access to Site:** T1 Engine  
**Comm with ICP:** Radio,Cell Service  
**Water Source:** Faucet / Hose,Hydrant,Creek  
**Mitigation Time:** None Needed  
**Collected By:** Lolo 632

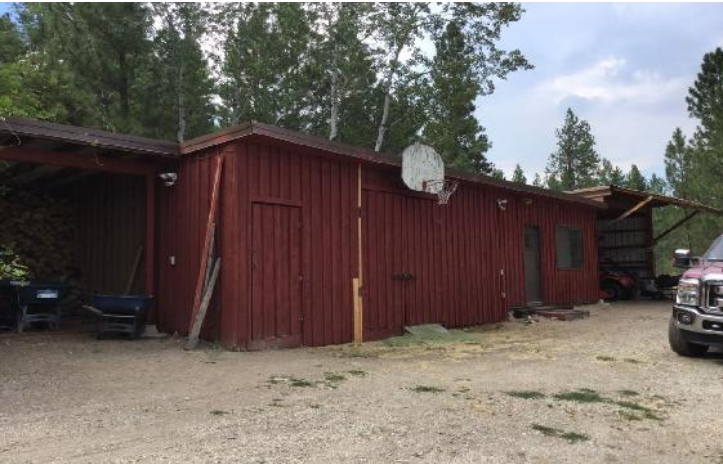
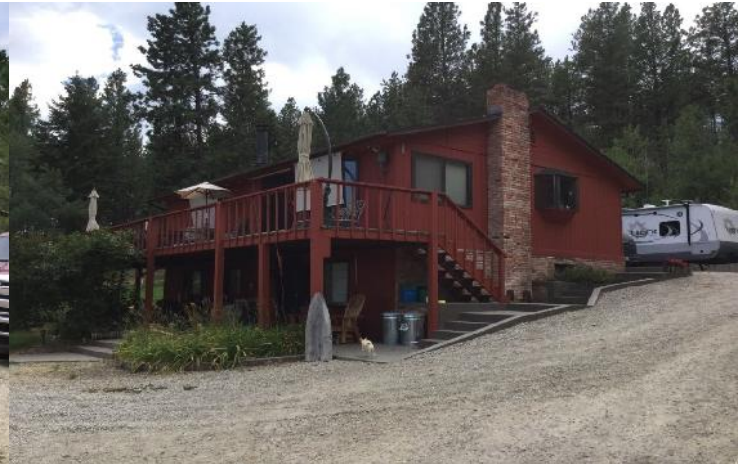
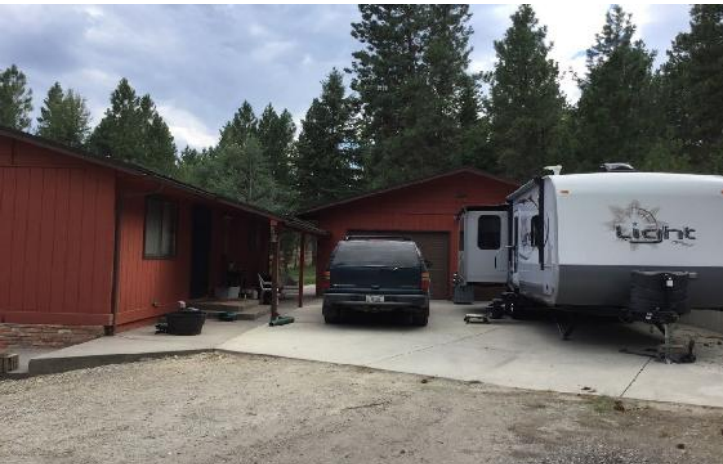
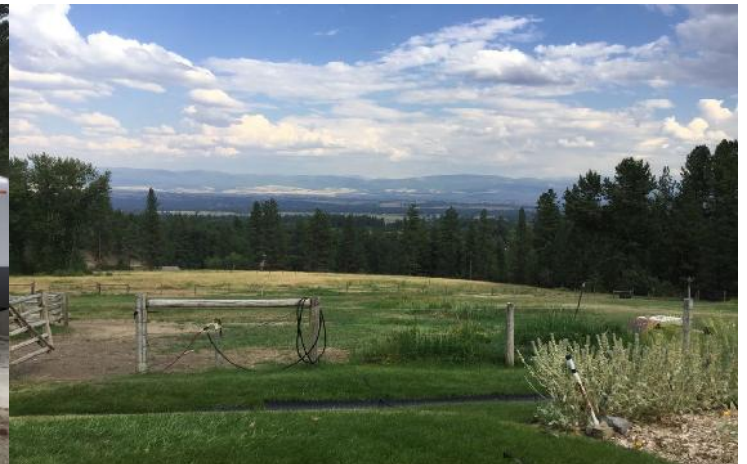
**Structure Number:**  
**Structure Name:** 5096 Sweeney Creek Road  
**SubDivision:** Sweeny  
**GPS Location, Lat.** 46 36.69828  
**GPS Location, Long.** 114 7.15926  
**Safety Zone Present:** Yes  
**Type of Structure:** Residential  
**Surrounding Fuels:** Grass, Timber  
**Structure Triage Category:** Defensible, Stand Alone  
**Roof Material:** Composite  
**Heat Traps:** Wood Deck, Rain Gutters  
**Electrical Power:** Overhead  
**Hazards:** Fuels, Animals, Septic Tank  
**Access to Site:** T3/4 Engine  
**Comm with ICP:** Radio, Cell Service  
**Water Source:** Faucet / Hose  
**Mitigation Time:** 3-4 Hours  
**Other Resources Needed to Protect:** Engine mod. Need to clear thick grass and brush behind house and garage  
**Notes:** Large field below house

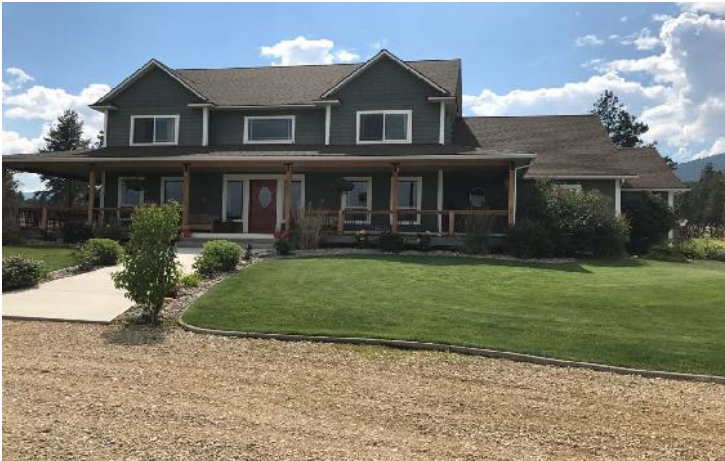
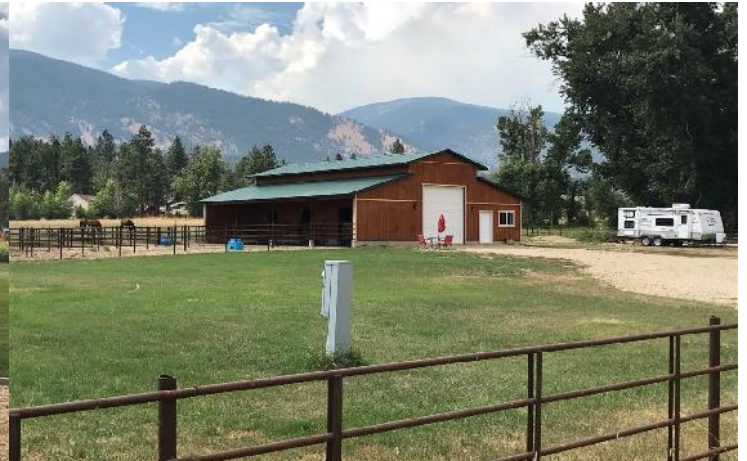
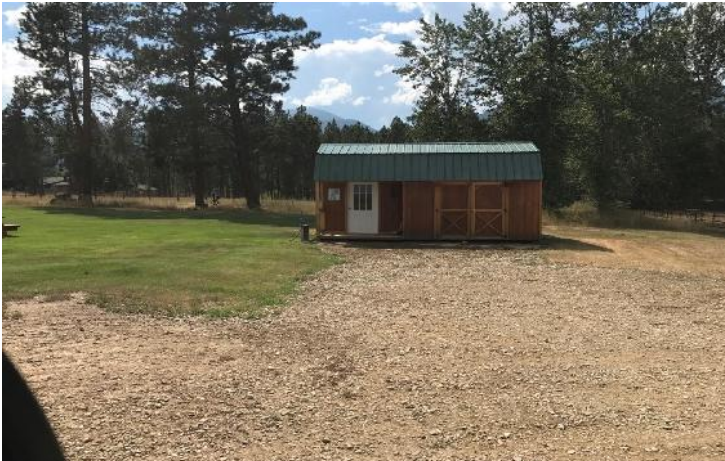
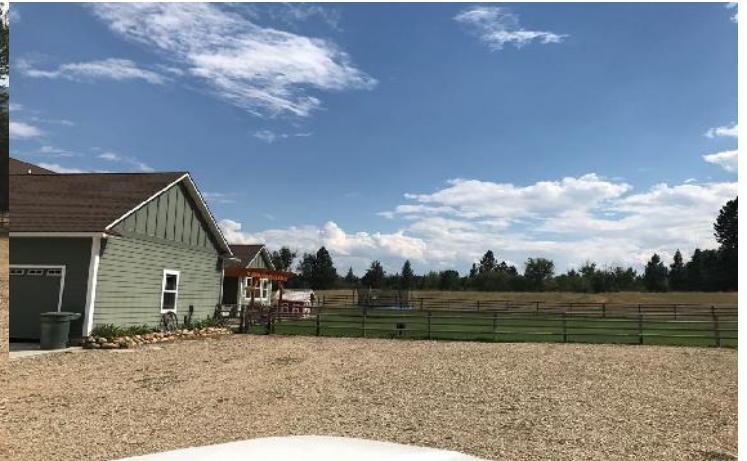
**Structure Number:**  
**Structure Name:** 5143 Lone Meadow Ct  
**SubDivision:** Sweeny  
**GPS Location, Lat.** 46 36.87636  
**GPS Location, Long.** 114 5.76984  
**Safety Zone Present:** Yes  
**Type of Structure:** Residential  
**Surrounding Fuels:** Grass, Shrub  
**Structure Triage Category:** Defensible, Stand Alone  
**Roof Material:** Composite  
**Heat Traps:** Rain Gutters  
**Electrical Power:** Underground  
**Hazards:** HazMat  
**Access to Site:** T1 Engine  
**Comm with ICP:** Radio, Cell Service  
**Water Source:** Faucet / Hose  
**Mitigation Time:** Less Than An Hour  
**Collected By:** Lolo 632

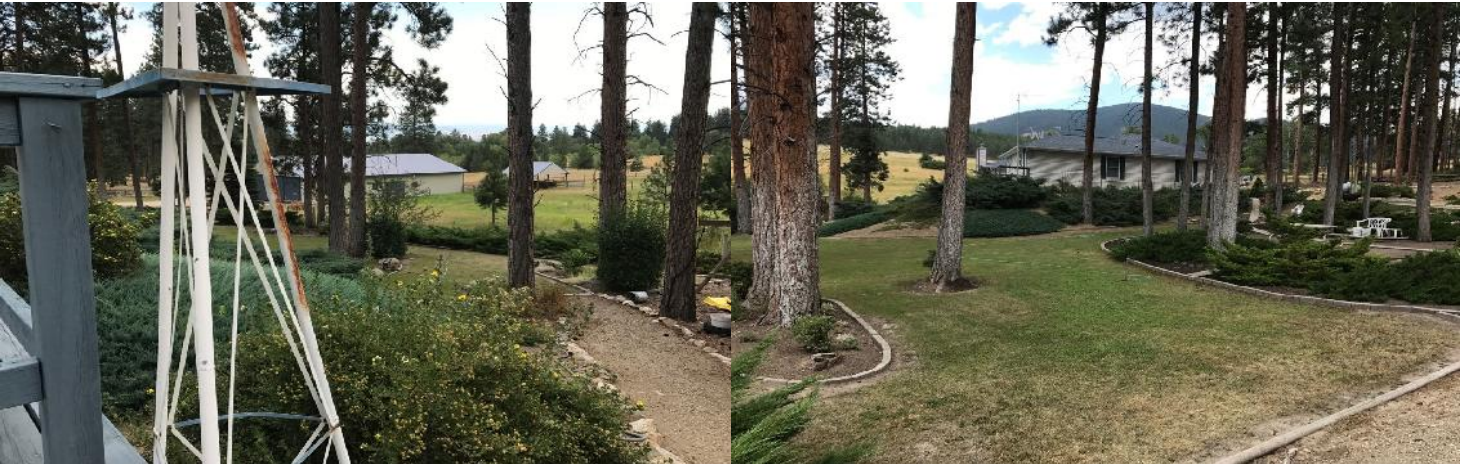
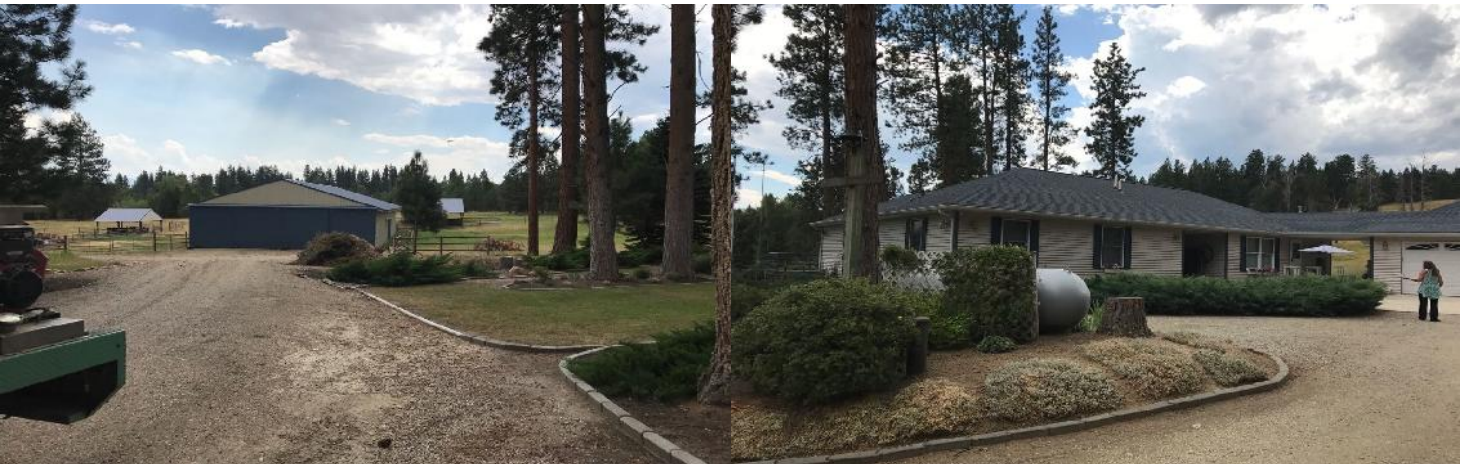
**Structure Number:**  
**Structure Name:** 5149 Briarwood Ln  
**SubDivision:** Sweeny  
**GPS Location, Lat.** 46 36.89208  
**GPS Location, Long.** 114 6.2031  
**Safety Zone Present:** Yes  
**Type of Structure:** Residential  
**Surrounding Fuels:** Grass,Shrub,Timber  
**Structure Triage Category:** Defensible, Stand Alone  
**Roof Material:** Composite  
**Heat Traps:** Wood Deck,Rain Gutters  
**Electrical Power:** Underground  
**Hazards:** Fuels  
**Access to Site:** T3/4 Engine  
**Comm with ICP:** Radio,Cell Service  
**Water Source:** Faucet / Hose  
**Mitigation Time:** Less Than An Hour  
**Other Resources Needed to Protect:** Type 3 or 4 engine.

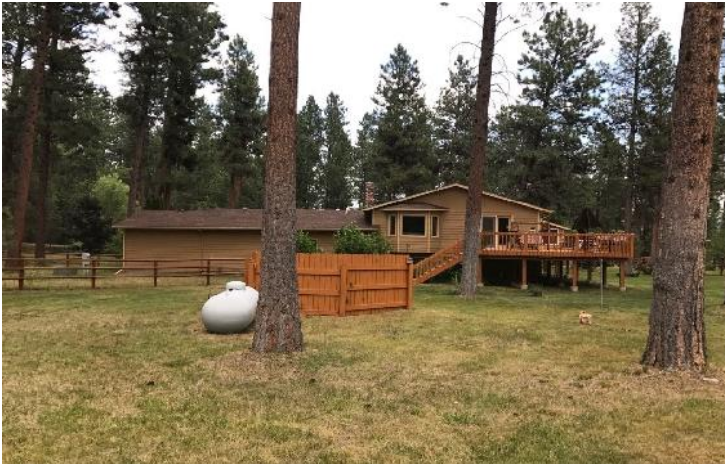
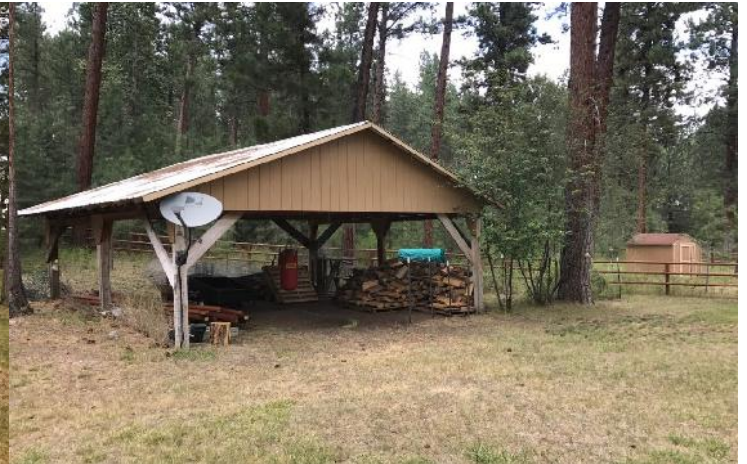
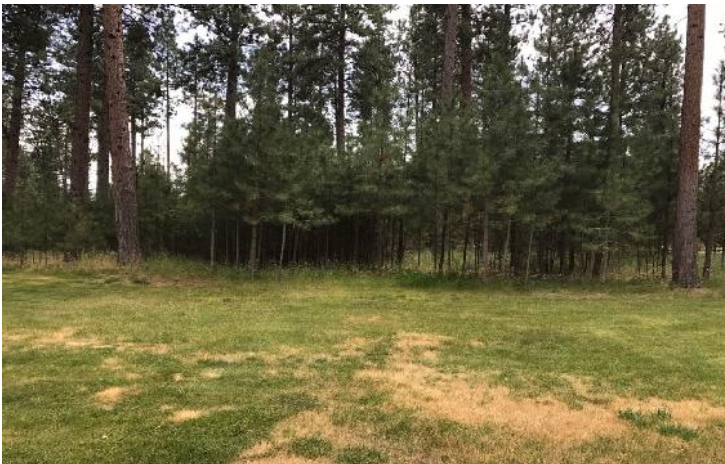
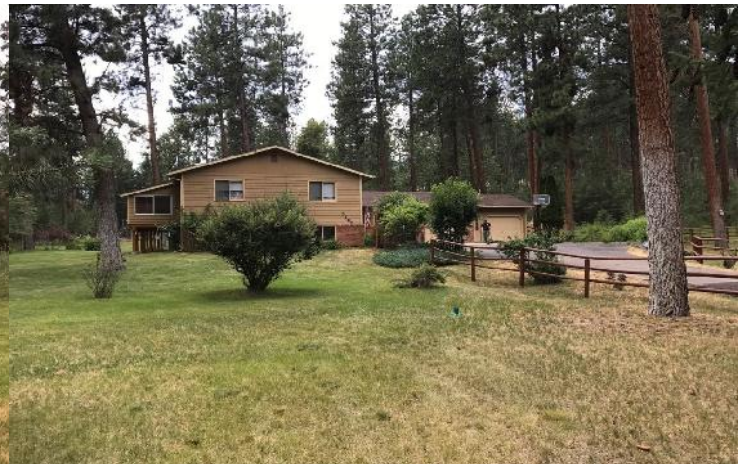
**Structure Number:**  
**Structure Name:** 5165 Briarwood Ln  
**SubDivision:** Sweeny  
**GPS Location, Lat.** 46 36.92898  
**GPS Location, Long.** 114 6.13194  
**Safety Zone Present:** No  
**Type of Structure:** Residential  
**Surrounding Fuels:** Grass, Timber  
**Structure Triage Category:** Defensible, Prep and Hold  
**Roof Material:** Composite  
**Heat Traps:** Wood Deck, Rain Gutters  
**Electrical Power:** Underground  
**Hazards:** Fuels, HazMat  
**Access to Site:** T3/4 Engine  
**Comm with ICP:** Radio, Cell Service  
**Water Source:** Faucet / Hose  
**Mitigation Time:** 4-5 Hours  
**Other Resources Needed to Protect:** None

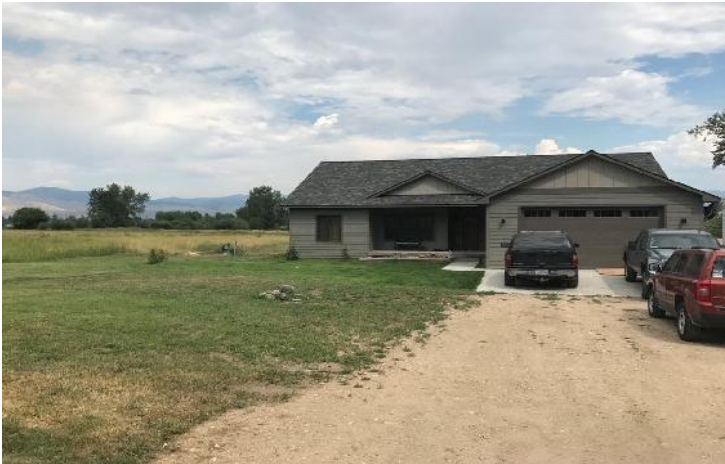
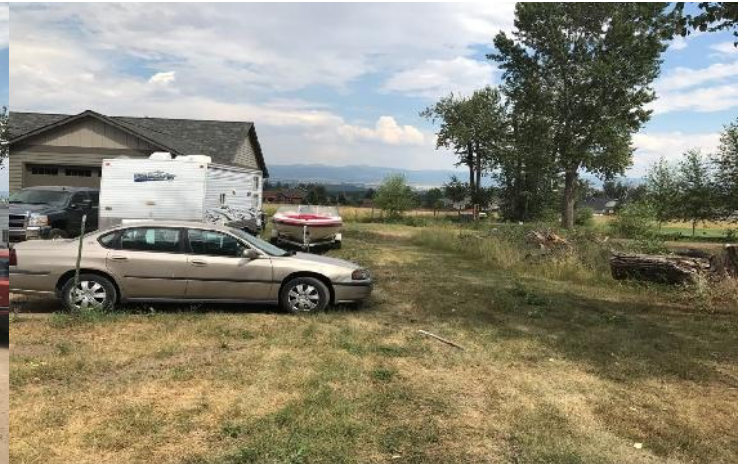
**Structure Number:**  
**Structure Name:** 5170 Lone Meadow Ct  
**SubDivision:** Sweeny  
**GPS Location, Lat.** 46 36.9723  
**GPS Location, Long.** 114 5.76396  
**Safety Zone Present:** Yes  
**Type of Structure:** Residential  
**Surrounding Fuels:** Grass  
**Structure Triage Category:** Defensible, Stand Alone  
**Roof Material:**  
**Heat Traps:** Rain Gutters  
**Electrical Power:** Underground  
**Hazards:** HazMat  
**Access to Site:** T1 Engine  
**Comm with ICP:** Radio, Cell Service  
**Water Source:** Faucet / Hose  
**Mitigation Time:** Less Than An Hour  
**Notes:** Pile next to house

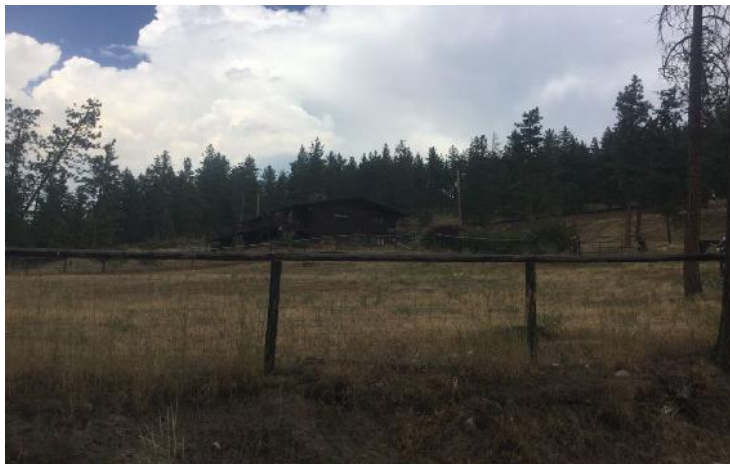
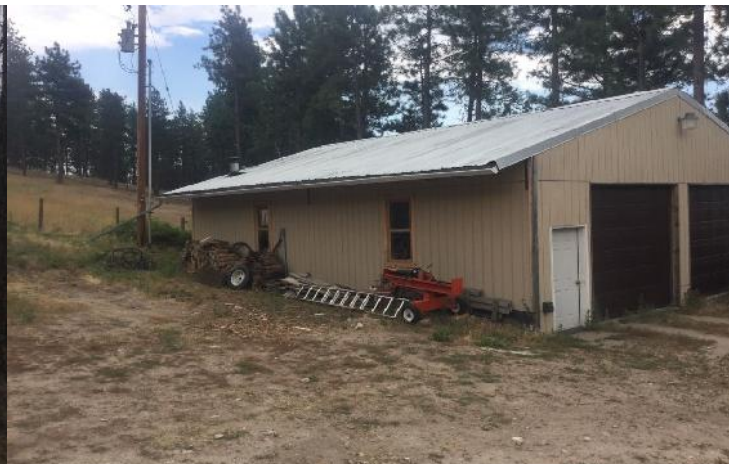
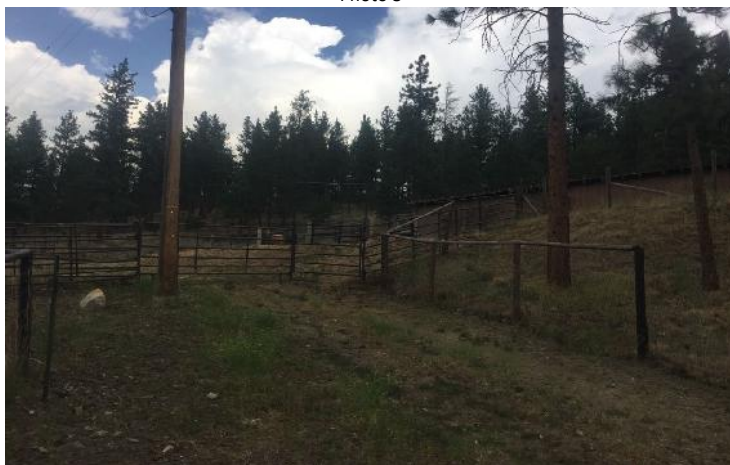
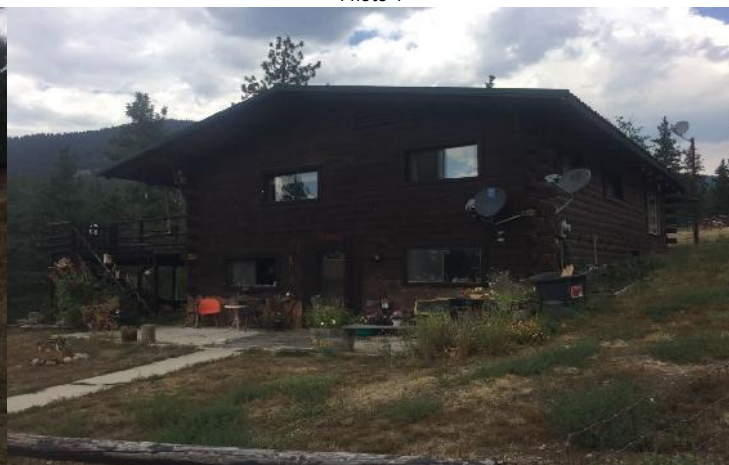
Safety Zone Present: No  
Type of Structure: Residential  
Surrounding Fuels: Grass, Shrub, Timber  
Structure Triage Category: Defensible, Prep and Hold  
Roof Material: Metal  
Heat Traps: Wood Deck, Rain Gutters  
Electrical Power: Overhead  
Hazards: Animals  
Access to Site: T1 Engine  
Comm with ICP: Radio, Cell Service  
Water Source: Faucet / Hose  
Mitigation Time: Less Than An Hour  
Notes: Wood pile next to shop.

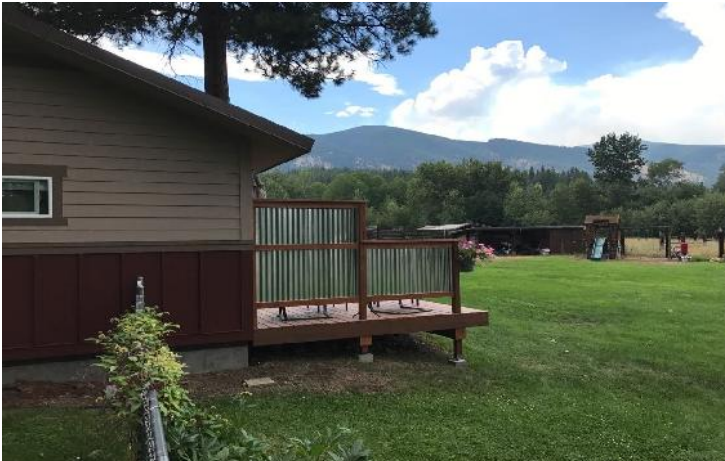
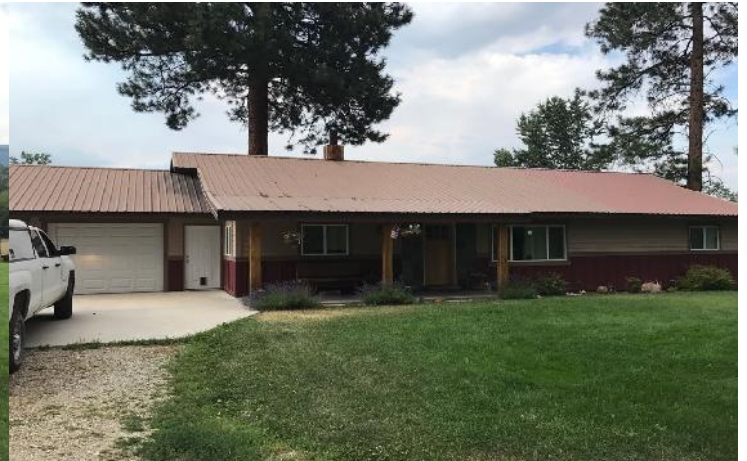
**Structure Number:**  
**Structure Name:** 520 Sweeney Creek Loop  
**SubDivision:** Sweeny  
**GPS Location, Lat.** 46 36.6345  
**GPS Location, Long.** 114 6.1452  
**Safety Zone Present:** Yes  
**Type of Structure:** Residential  
**Surrounding Fuels:** Grass  
**Structure Triage Category:** Defensible, Stand Alone  
**Roof Material:** Metal  
**Heat Traps:** Wood Deck  
**Electrical Power:** Underground  
**Hazards:**  
**Access to Site:** T1 Engine  
**Comm with ICP:** Radio, Cell Service  
**Water Source:** Faucet / Hose  
**Mitigation Time:** None Needed  
**Collected By:** Lolo 632

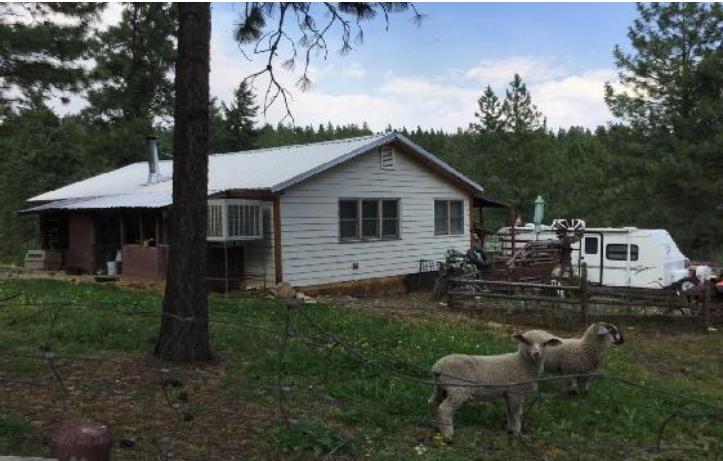
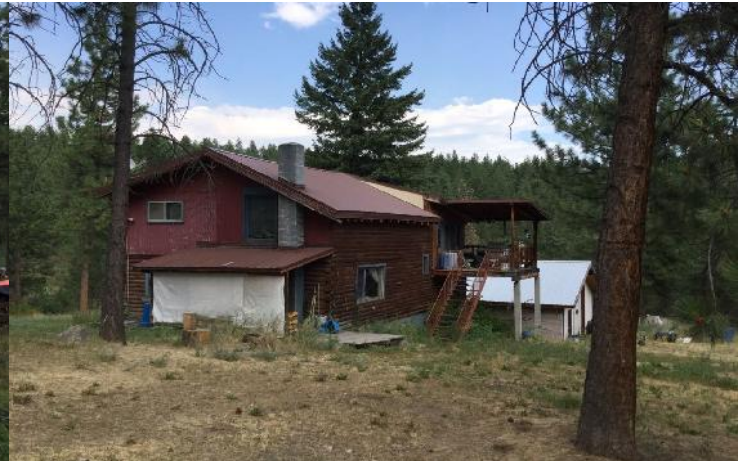
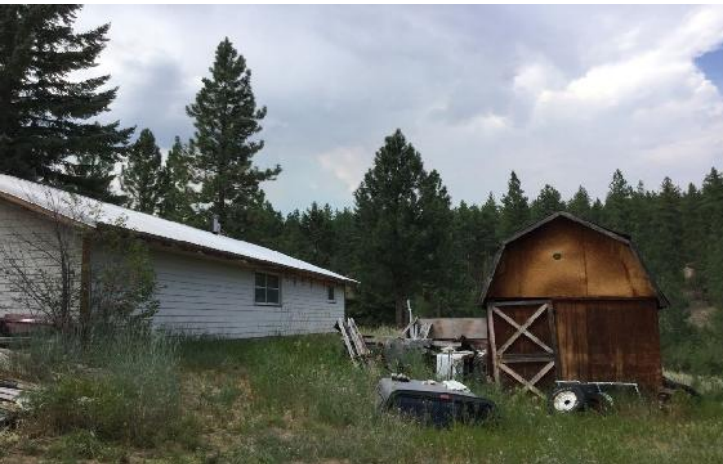
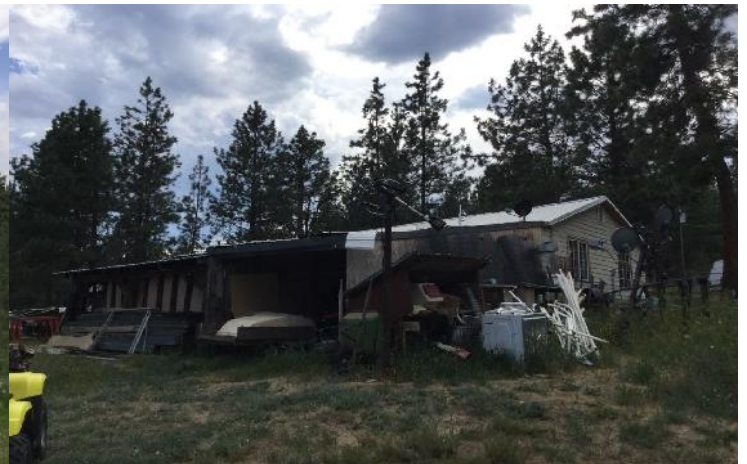
**Heat Traps:** Open Eaves, Wood Deck, Other Receptor  
**Electrical Power:** Overhead, Underground **Gas to Structure:** None  
**Hazards:** Fuels  
**Access to Site:** T3/4 Engine **Best Access From:** Sweeney Creek Road

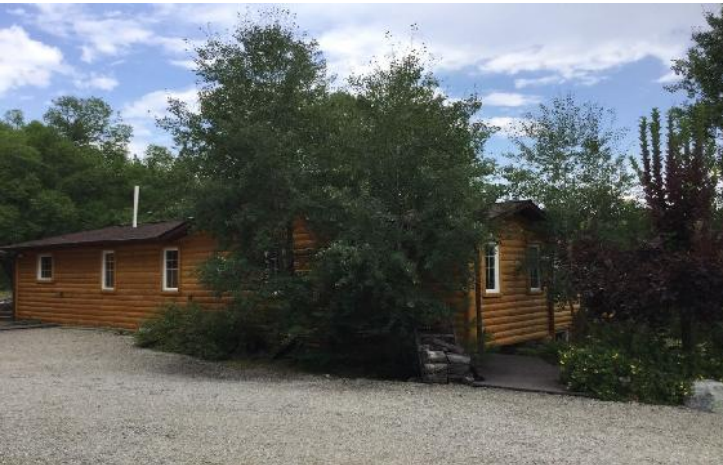
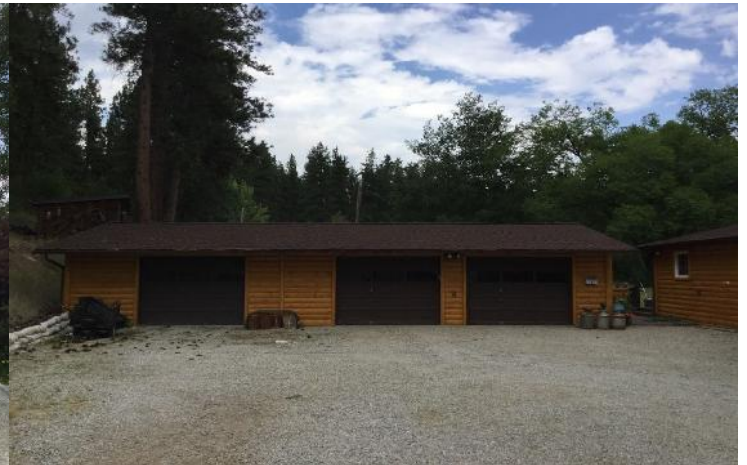
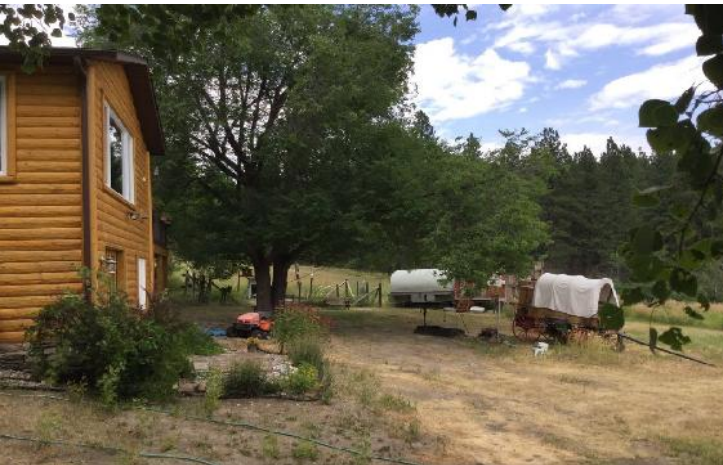
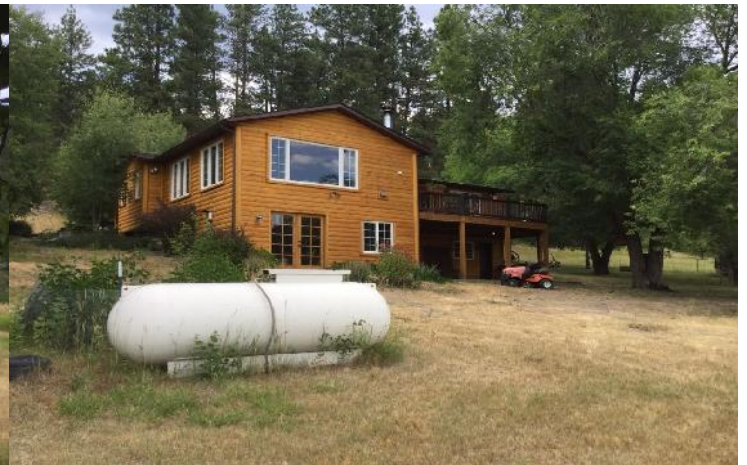
Structure Number:  
Structure Name: 5236 Smith Fork  
SubDivision: Sweeny  
GPS Location, Lat. 46 36.96084  
GPS Location, Long. 114 7.29918  
Safety Zone Present: Yes  
Type of Structure: Residential  
Surrounding Fuels: Grass, Timber  
Structure Triage Category: Defensible, Stand Alone  
Roof Material: Composite  
Heat Traps: Wood Deck, Rain Gutters  
Electrical Power: Overhead  
Hazards: Fuels  
Access to Site: T3/4 Engine  
Comm with ICP: Radio  
Water Source: Faucet / Hose  
Mitigation Time: 1-2 Hours  
Other Resources Needed to Protect: Weed walk, scratch line around garage and outbuilding on west side  
Collected By: Engine 951  
Photo 1

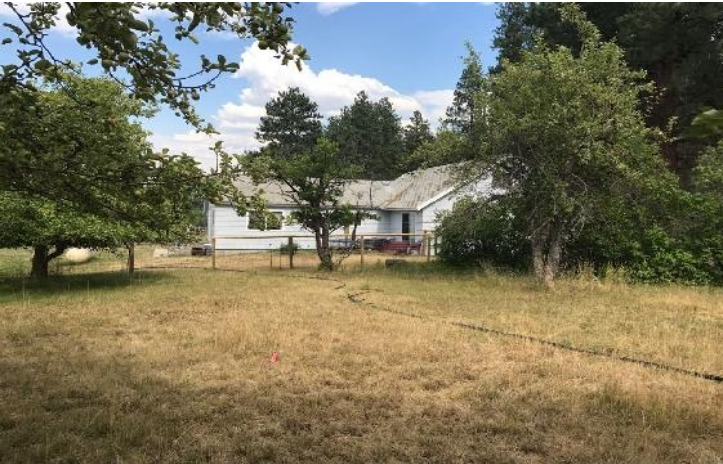
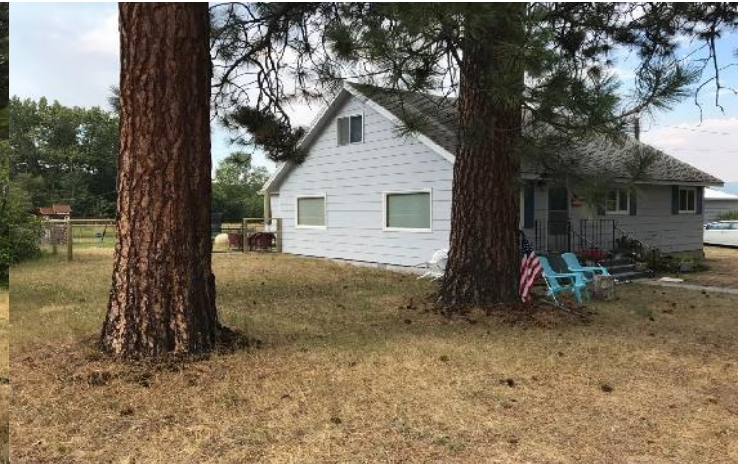
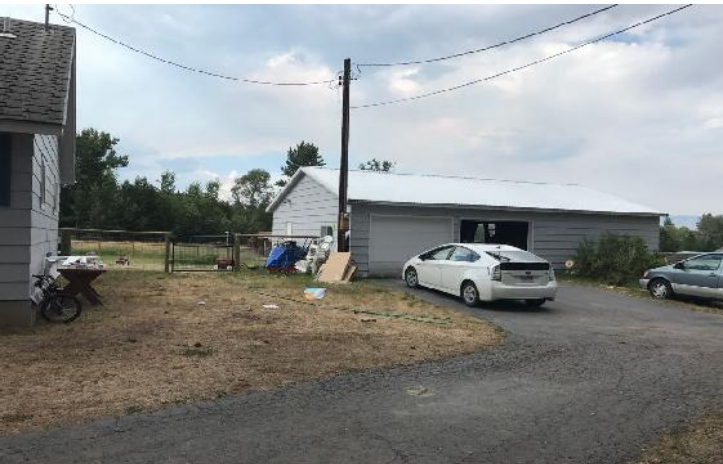
**Structure Number:**  
**Structure Name:** 524 Sweeney Creek Road  
**SubDivision:** Sweeny  
**GPS Location, Lat.** 46 36.63036  
**GPS Location, Long.** 114 6.17868  
**Safety Zone Present:** Yes  
**Type of Structure:** Residential  
**Surrounding Fuels:** Grass,Shrub,Timber  
**Structure Triage Category:** Defensible, Prep and Hold  
**Roof Material:** Composite  
**Heat Traps:**  
**Electrical Power:** Overhead  
**Hazards:** Fuels  
**Access to Site:** T1 Engine  
**Comm with ICP:** Radio  
**Water Source:** Faucet / Hose, Large Pond  
**Mitigation Time:** None Needed  
**Other Resources Needed to Protect:** -1 engine crew, sprinklers.  
**Notes:** -68gmp pump out of 25x15ft pond 180ft W of the house through trees.  
-Faucet on E side of house.
