STRUCTURE  
PROTECTION PLAN  
FOR SWEENY  
BLOCK

07/30/2017

# Structure Protection Plan

## Sweeny Creek

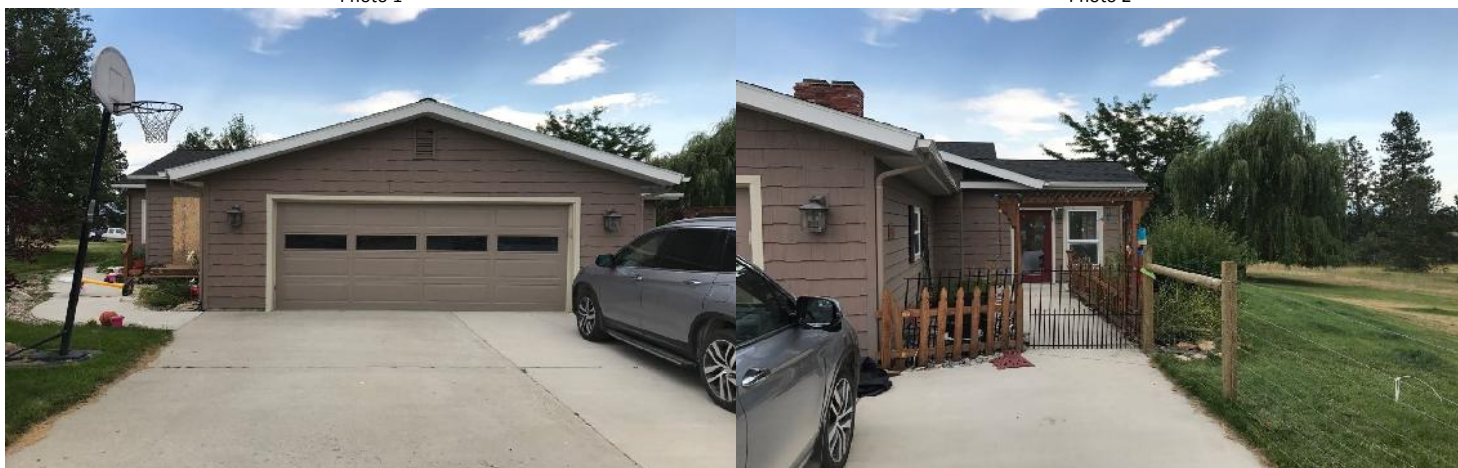
**Structure Number:**  
**Structure Name:** 5310 Montgomery Lane  
**SubDivision:** Sweeny  
**GPS Location, Lat.** 46 37.53654  
**GPS Location, Long.** 114 5.58792  
**Safety Zone Present:** Yes  
**Type of Structure:** Residential  
**Surrounding Fuels:** Grass, Timber  
**Structure Triage Category:** Defensible, Stand Alone  
**Roof Material:** Composite  
**Heat Traps:** Wood Deck, Rain Gutters  
**Electrical Power:** Underground  
**Hazards:** Fuels  
**Access to Site:** T3/4 Engine  
**Comm with ICP:** Radio, Cell Service  
**Water Source:** Faucet / Hose  
**Mitigation Time:** None Needed  
**Notes:** -Faucet on N side of house.

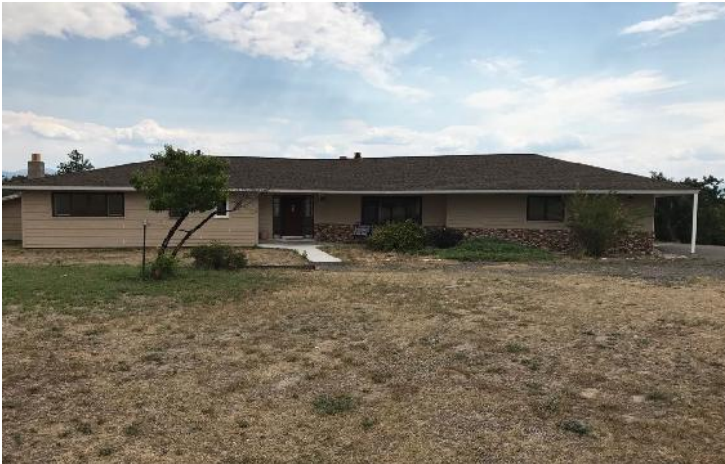
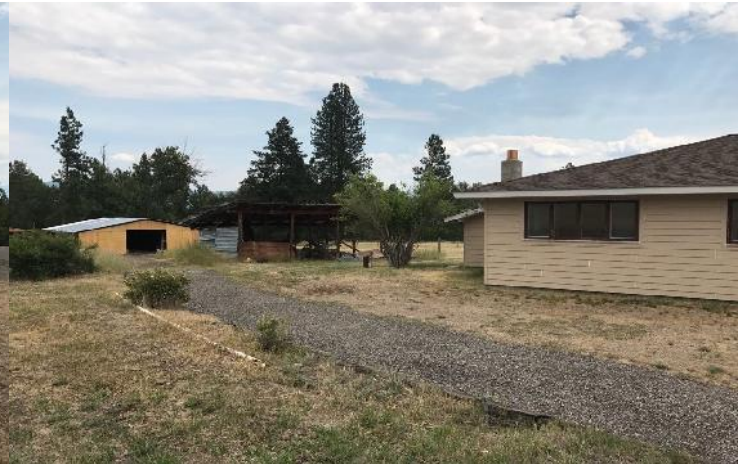
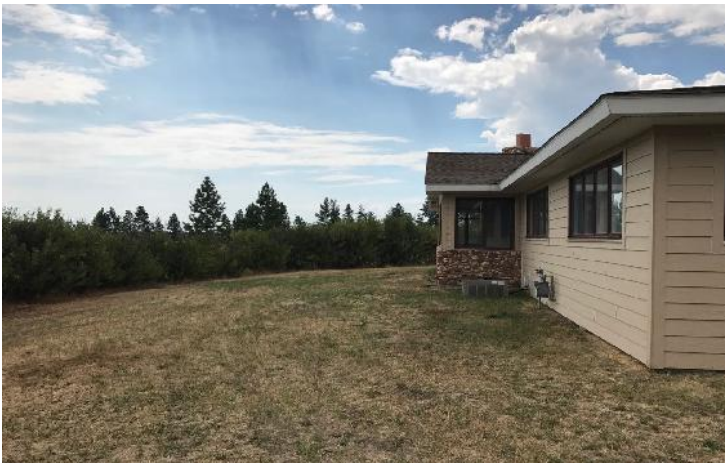
**Structure Number:**  
**Structure Name:** 5315 Florence Carlton Loop  
**SubDivision:** Sweeny  
**GPS Location, Lat.** 46 37.58922  
**GPS Location, Long.** 114 5.4522  
**Safety Zone Present:** Yes  
**Type of Structure:** Residential  
**Surrounding Fuels:** Grass, Shrub  
**Structure Triage Category:** Defensible, Stand Alone  
**Roof Material:** Composite  
**Heat Traps:**  
**Electrical Power:** Underground  
**Hazards:** Fuels, Septic Tank  
**Access to Site:** T1 Engine  
**Comm with ICP:** Radio, Cell Service  
**Water Source:** Faucet / Hose  
**Mitigation Time:** Less Than An Hour  
**Notes:** -Faucets on the N and S sides of the house.

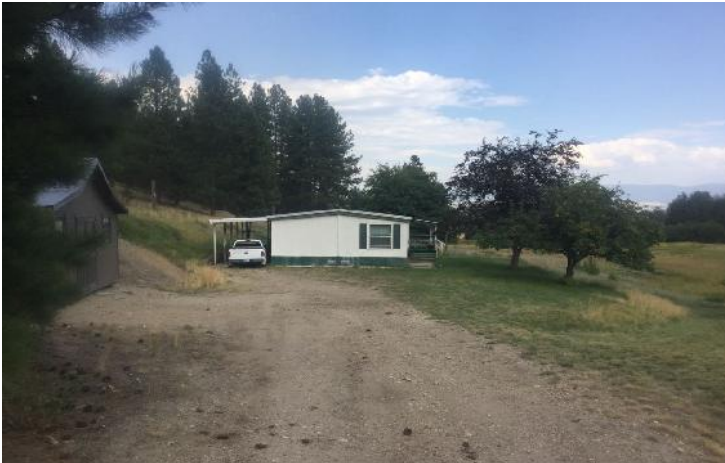
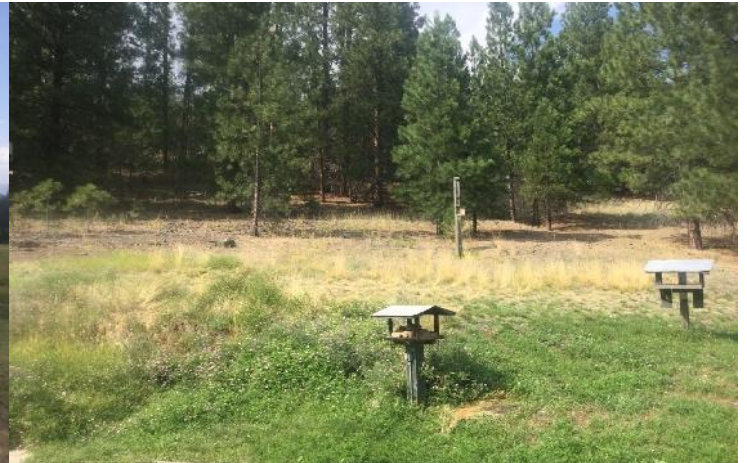
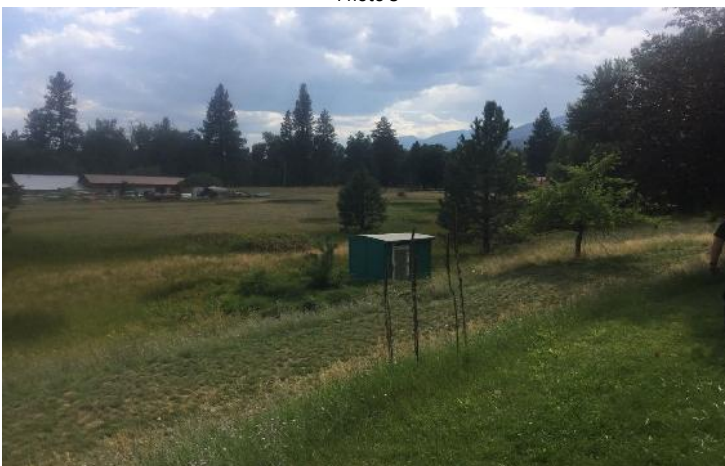
**Structure Number:**  
**Structure Name:** 5318 Sweeney CK Loop  
**SubDivision:** Sweeny  
**GPS Location, Lat.** 46 36.69624  
**GPS Location, Long.** 114 6.48456  
**Safety Zone Present:** No  
**Type of Structure:** Residential  
**Surrounding Fuels:** Grass, Timber  
**Structure Triage Category:** Defensible, Prep and Hold  
**Roof Material:** Metal  
**Heat Traps:** Wood Deck, Rain Gutters  
**Electrical Power:** Overhead  
**Hazards:** Septic Tank  
**Access to Site:** T1 Engine  
**Comm with ICP:** Radio, Cell Service  
**Water Source:** Faucet / Hose  
**Mitigation Time:** None Needed  
**Collected By:** Prescott 951

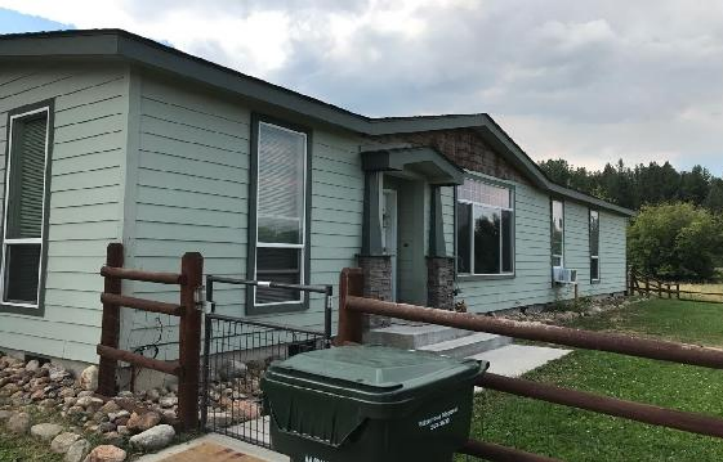
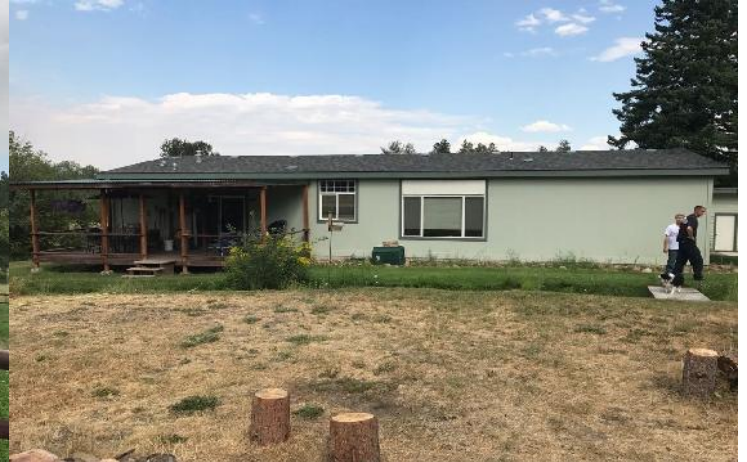
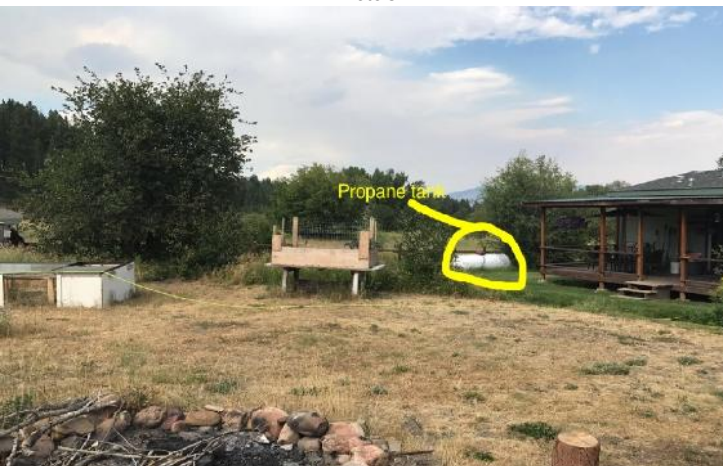
**Structure Number:**  
**Structure Name:** 532 Sweeney Creek Road  
**SubDivision:** Sweeny  
**GPS Location, Lat.** 46 36.62082  
**GPS Location, Long.** 114 6.37074  
**Safety Zone Present:** Yes  
**Type of Structure:** Residential  
**Surrounding Fuels:** Grass, Shrub  
**Structure Triage Category:** Defensible, Stand Alone  
**Roof Material:** Wood  
**Heat Traps:** Wood Deck  
**Electrical Power:** Underground  
**Hazards:** Fuels  
**Access to Site:** T1 Engine  
**Comm with ICP:** Radio, Cell Service  
**Water Source:** Faucet / Hose  
**Mitigation Time:** None Needed  
**Other Resources Needed to Protect:** -1 engine, sprinklers.  
**Notes:** -Faucet on E Side of house.

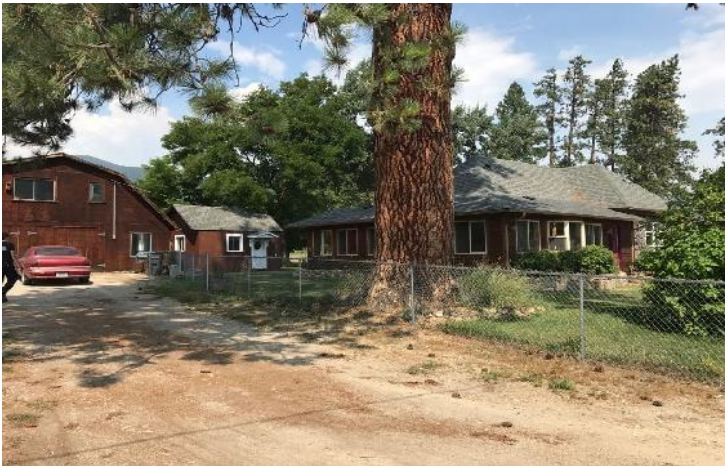
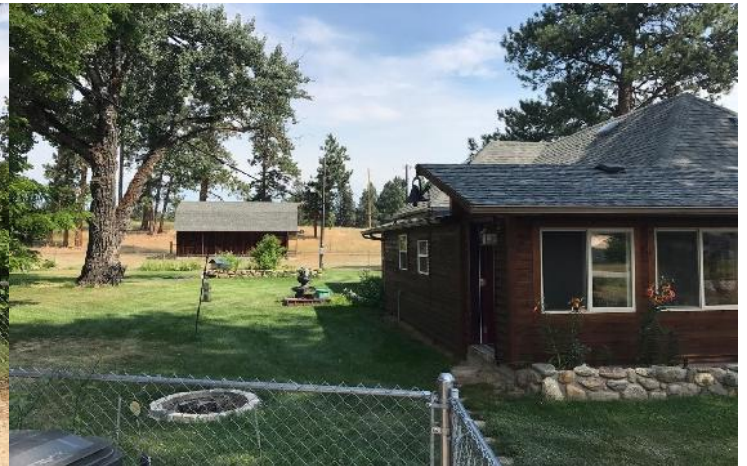
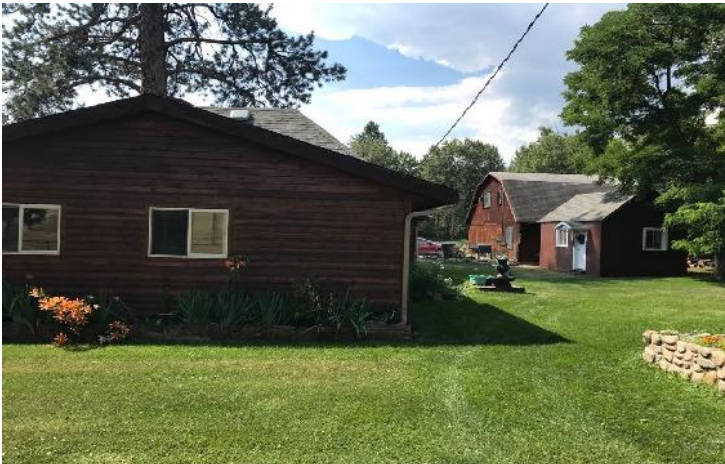
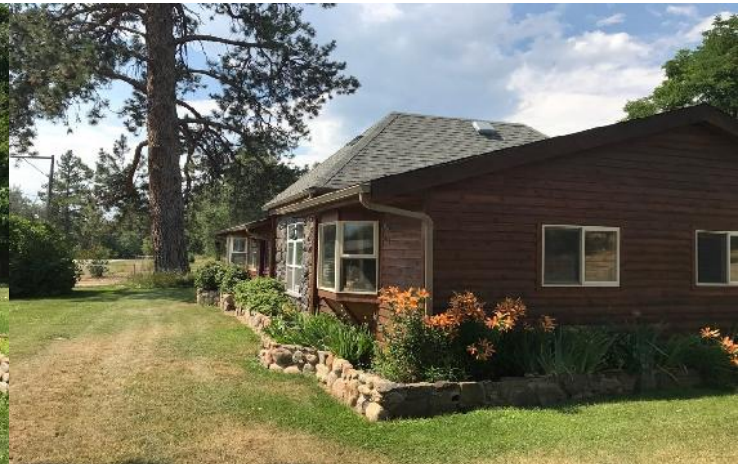
**Safety Zone Present:** Yes  
**Type of Structure:** Residential  
**Surrounding Fuels:** Grass, Timber  
**Structure Triage Category:** Defensible, Stand Alone  
**Roof Material:** Composite  
**Heat Traps:** Wood Deck  
**Electrical Power:** Overhead  
**Hazards:** Fuels, Septic Tank  
**Access to Site:** T1 Engine  
**Comm with ICP:** Radio  
**Water Source:** Faucet / Hose  
**Mitigation Time:** None Needed  
**Other Resources Needed to Protect:** None  
**Notes:** Water Fossett with hose connection on east and west side of house

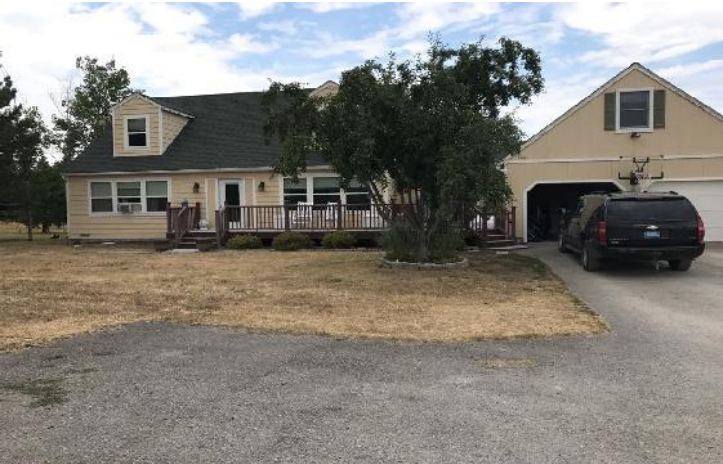
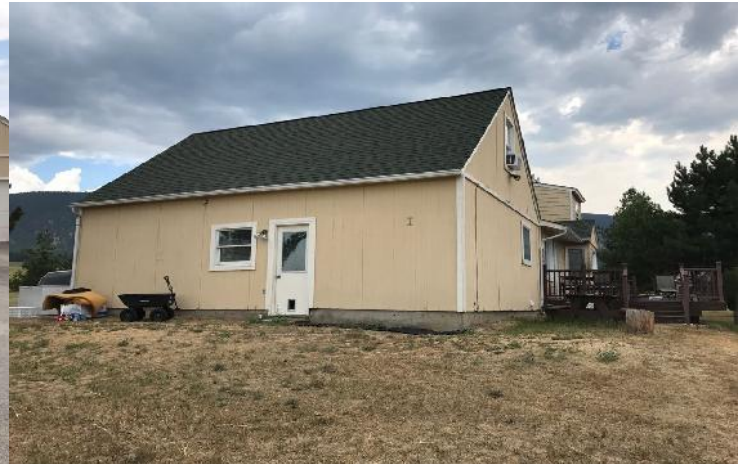
**Structure Number:**  
**Structure Name:** 5336 Montgomery Lane  
**SubDivision:** Sweeny  
**GPS Location, Lat.** 46 37.66008  
**GPS Location, Long.** 114 5.5923  
**Safety Zone Present:** Yes  
**Type of Structure:** Residential  
**Surrounding Fuels:** Grass, Timber  
**Structure Triage Category:** Defensible, Stand Alone  
**Roof Material:** Composite  
**Heat Traps:** Wood Deck, Rain Gutters  
**Electrical Power:** Underground  
**Hazards:** Fuels  
**Access to Site:** T3/4 Engine  
**Comm with ICP:** Radio, Cell Service  
**Water Source:** Faucet / Hose  
**Mitigation Time:** None Needed  
**Other Resources Needed to Protect:** -1 engine crew, sprinklers.

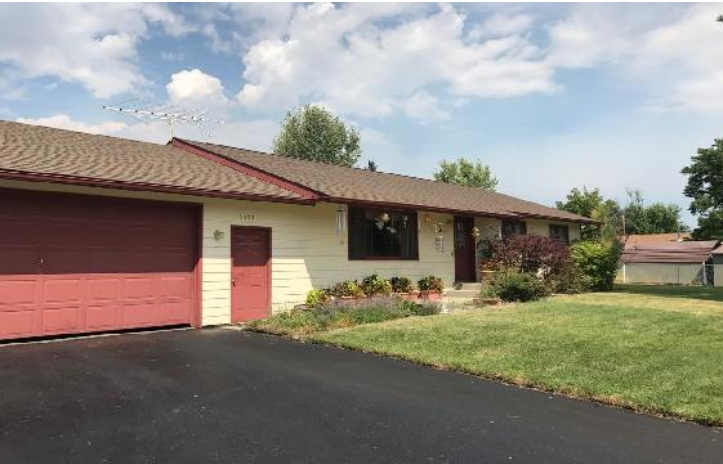
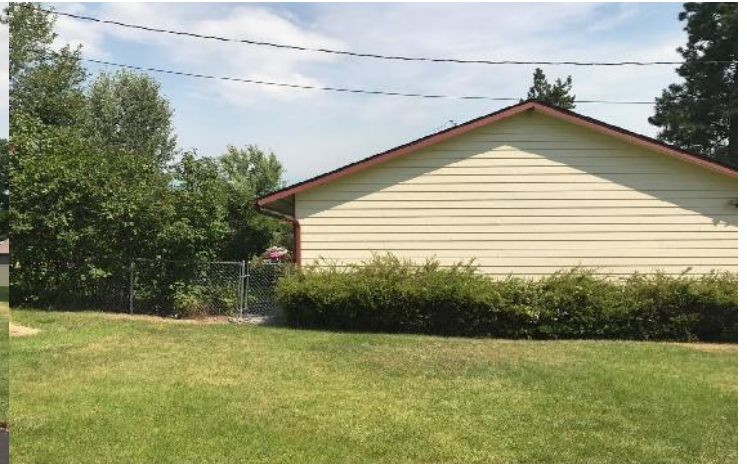
**Structure Number:**  
**Structure Name:** 5353 Florence Carlton Loop  
**SubDivision:** Sweeny  
**GPS Location, Lat.** 46 37.80612  
**GPS Location, Long.** 114 5.16708  
**Safety Zone Present:** Yes  
**Type of Structure:** Residential  
**Surrounding Fuels:** Grass, Shrub  
**Structure Triage Category:** Defensible, Stand Alone  
**Roof Material:** Composite  
**Heat Traps:** Rain Gutters  
**Electrical Power:** Overhead  
**Hazards:** Septic Tank  
**Access to Site:** T1 Engine  
**Comm with ICP:** Radio, Cell Service  
**Water Source:** Faucet / Hose  
**Mitigation Time:** None Needed  
**Other Resources Needed to Protect:** None

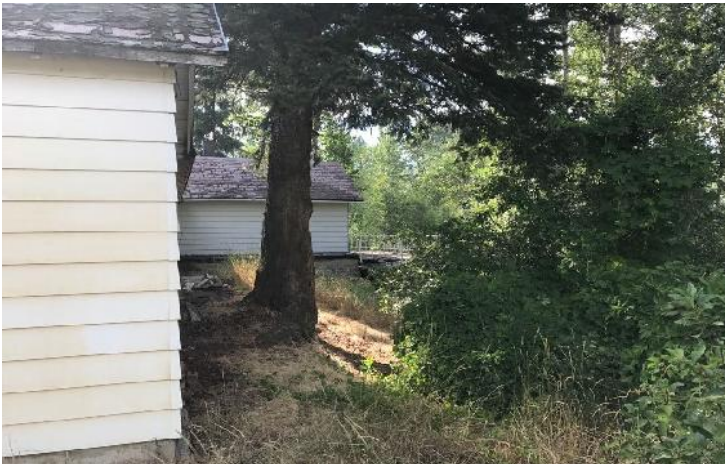
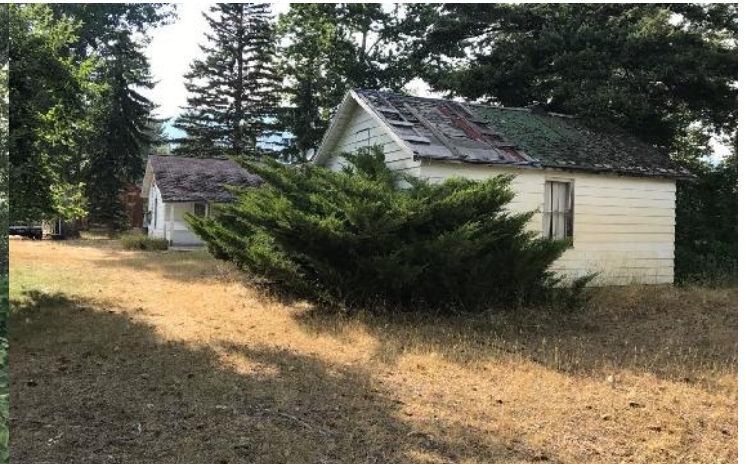
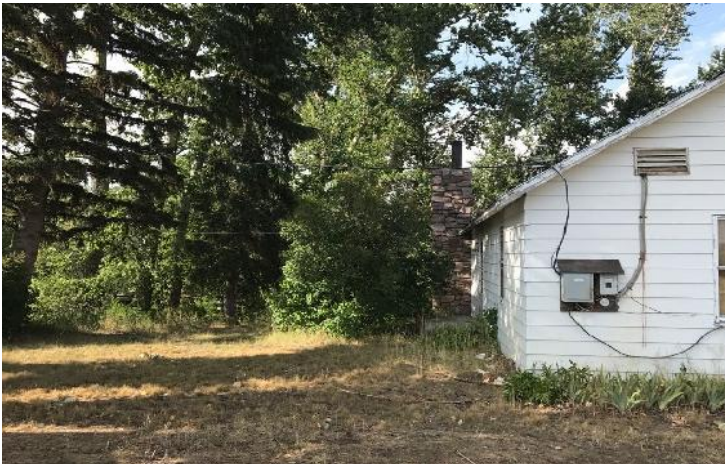
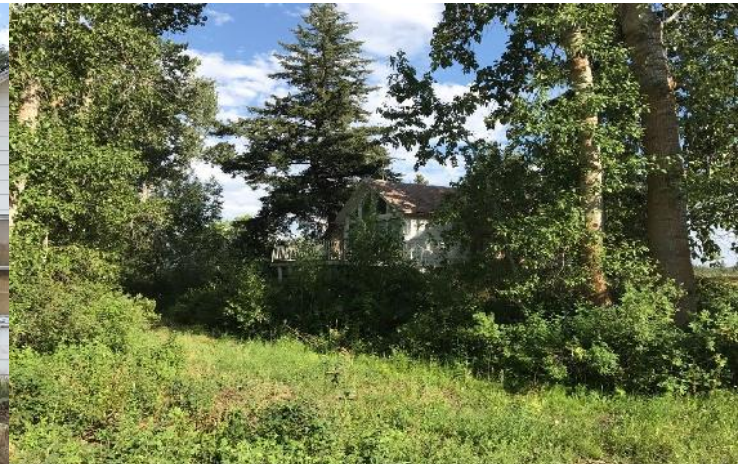
<b>Safety Zone Present:</b>	Yes	<b>Where is Safety Zone:</b>	Large fields surrounding house
<b>Type of Structure:</b>	Residential	<b>Primary Structures:</b>	
<b>Surrounding Fuels:</b>	Grass,Shrub,Timber	<b>Defensible Space:</b>	None
<b>Structure Triage Category:</b>	Non-Defensible, Prep and Leave		
<b>Roof Material:</b>	Composite	<b>Siding Material:</b>	Wood
<b>Heat Traps:</b>	Wood Deck,Rain Gutters	<b>Gas to Structure:</b>	Underground
<b>Electrical Power:</b>	Overhead,Underground		
<b>Hazards:</b>	Terrain,Fuels,Bridge Load Limits,Septic Tank		
<b>Access to Site:</b>	T6 Engine	<b>Best Access From:</b>	Sweeney Creek Road
<b>Comm with ICP:</b>	Radio,Cell Service		
<b>Water Source:</b>	Faucet / Hose,Creek		
<b>Mitigation Time:</b>	1-2 Hours		
<b>Other Resources Needed to Protect:</b>	When engine crew possibly 2 mitigating fuels around the structure and setting up sprinklers		
<b>Notes:</b>	Good creek access for drafting -Creek located down a 30 foot in bank off of the north side of house water faucet on South and northside Home is in rough shape old and roof sagging with moss growing on it

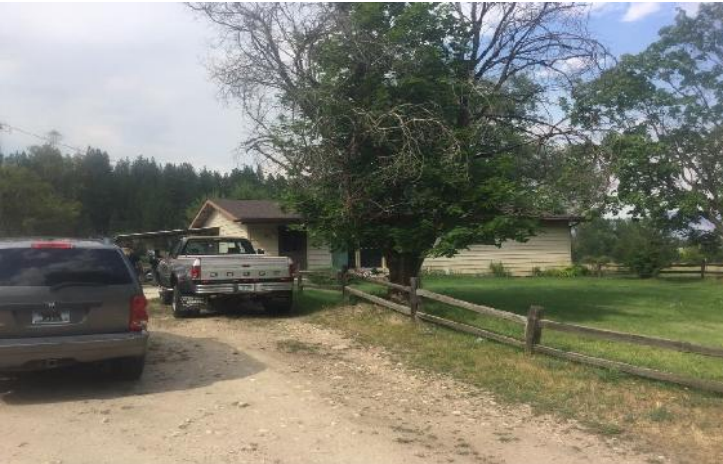
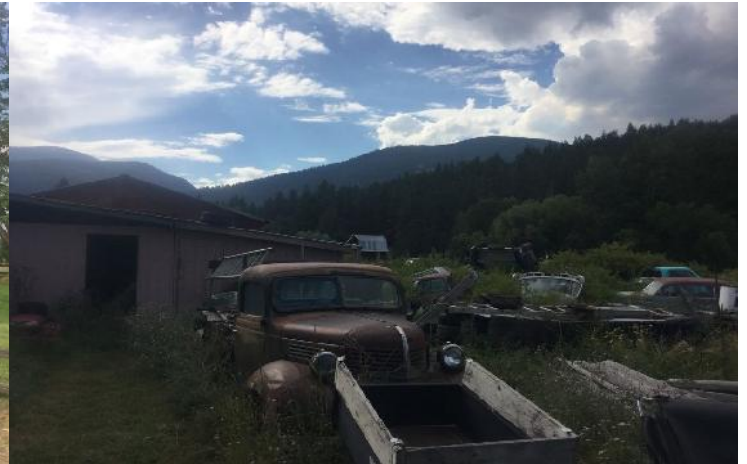
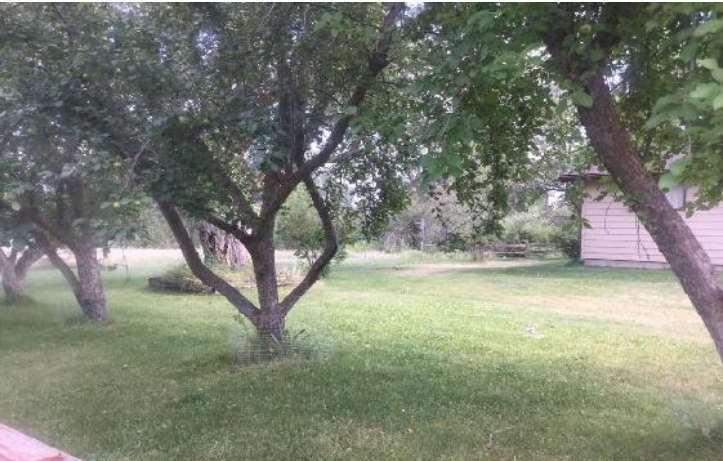
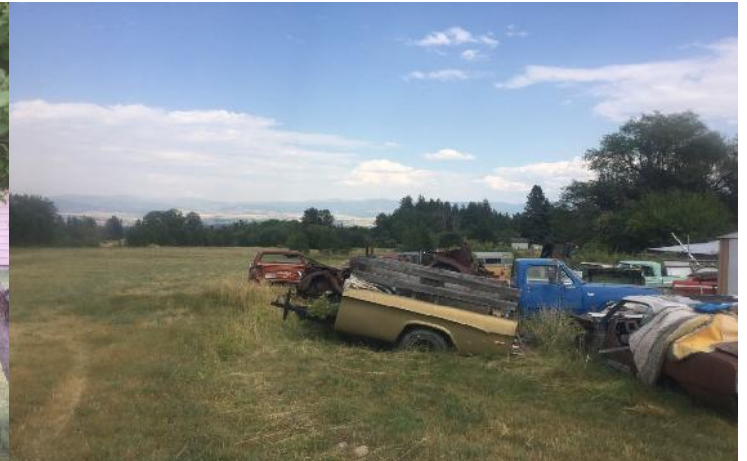
**Structure Triage Category:** Defensible, Prep and Hold  
**Roof Material:** Composite  
**Heat Traps:** Rain Gutters  
**Electrical Power:** Overhead  
**Hazards:** Septic Tank  
**Access to Site:** T1 Engine  
**Comm with ICP:** Radio, Cell Service  
**Water Source:** Faucet / Hose  
**Mitigation Time:** Less Than An Hour  
**Notes:** Most vehicles on site are not operational.

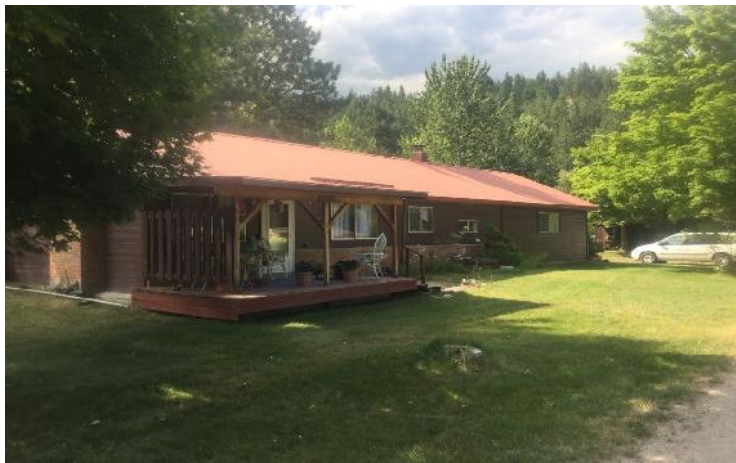
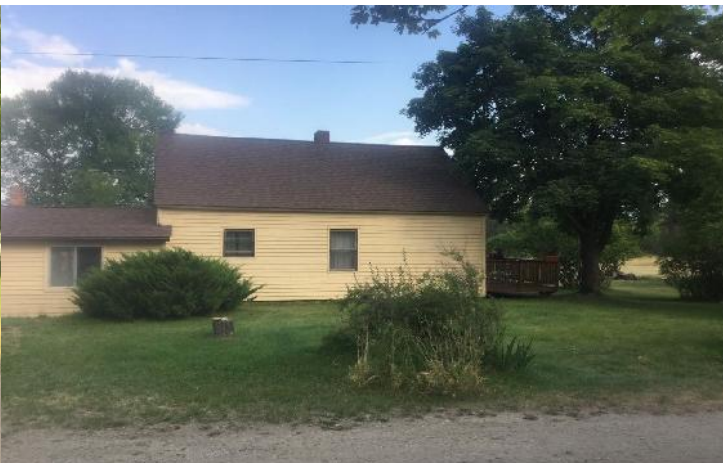
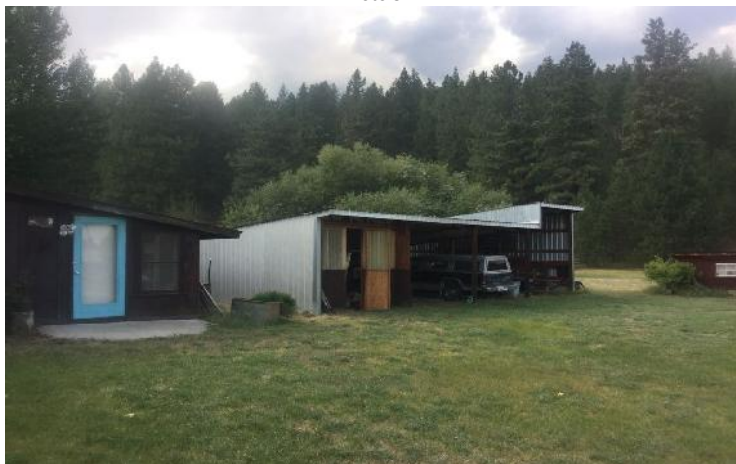
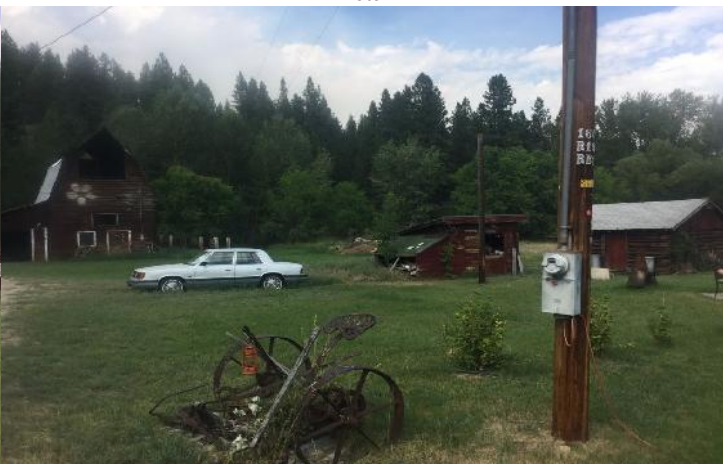
Safety Zone Present: No  
 Type of Structure: Residential  
 Surrounding Fuels: Grass, Timber  
 Structure Triage Category: Defensible, Prep and Hold  
 Roof Material: Metal  
 Heat Traps: Open Eaves, Wood Deck  
 Electrical Power: Overhead  
 Hazards: Septic Tank  
 Access to Site: T1 Engine  
 Comm with ICP: Radio, Cell Service  
 Water Source: Faucet / Hose  
 Mitigation Time: Less Than An Hour  
 Collected By: Prescott 951

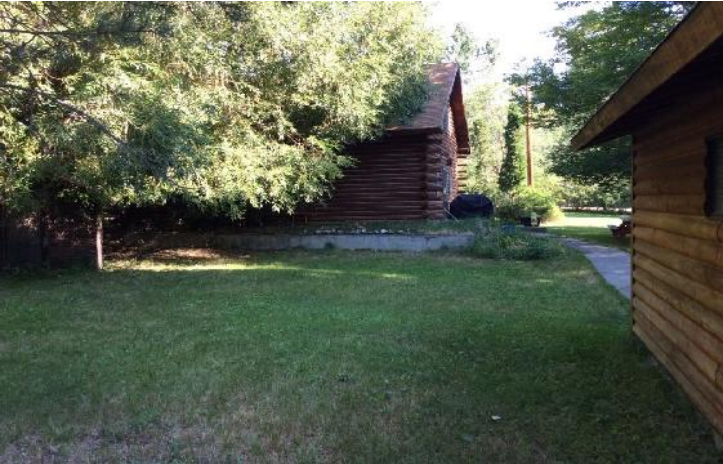
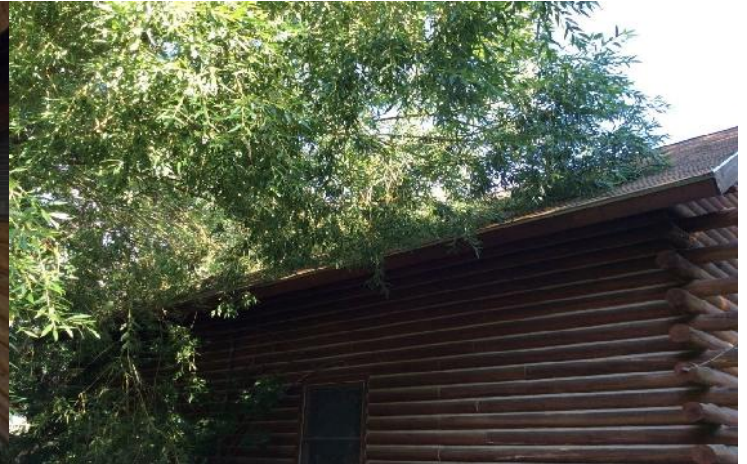
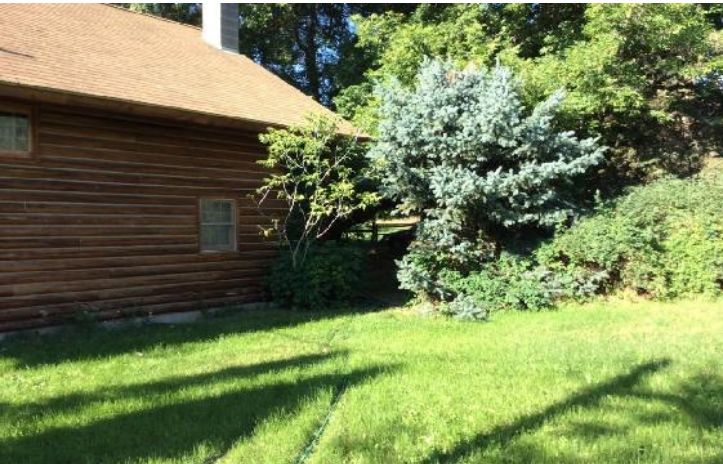
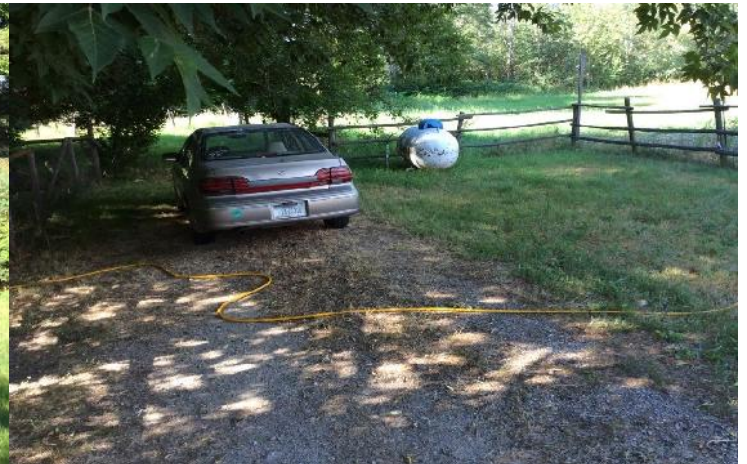
Safety Zone Present: No  
Type of Structure: Residential  
Surrounding Fuels: Grass, Timber  
Structure Triage Category: Non-Defensible, Prep and Leave  
Roof Material: Composite  
Heat Traps:  
Electrical Power: Overhead  
Hazards:  
Access to Site: T1 Engine  
Comm with ICP: Radio, Cell Service  
Water Source: Faucet / Hose, Creek  
Mitigation Time: 2-3 Hours  
Other Resources Needed to Protect: Additional type 6 or 3 engine  
Notes: Electric fence In front of creek.

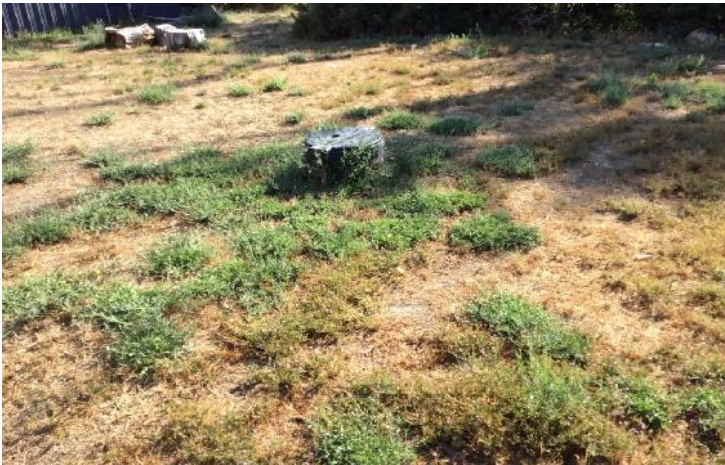
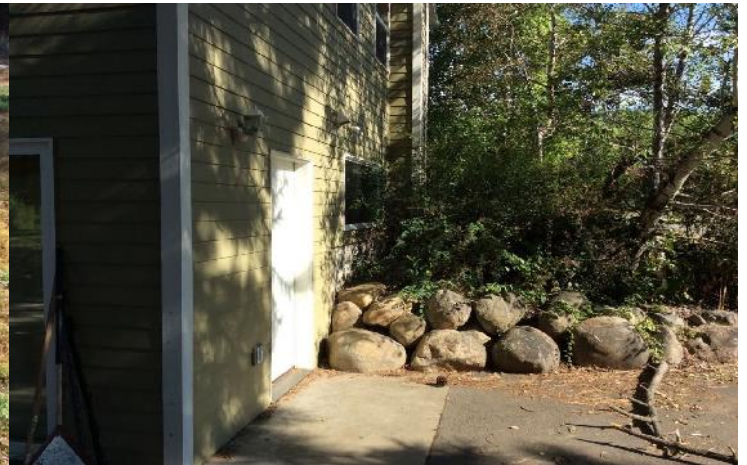
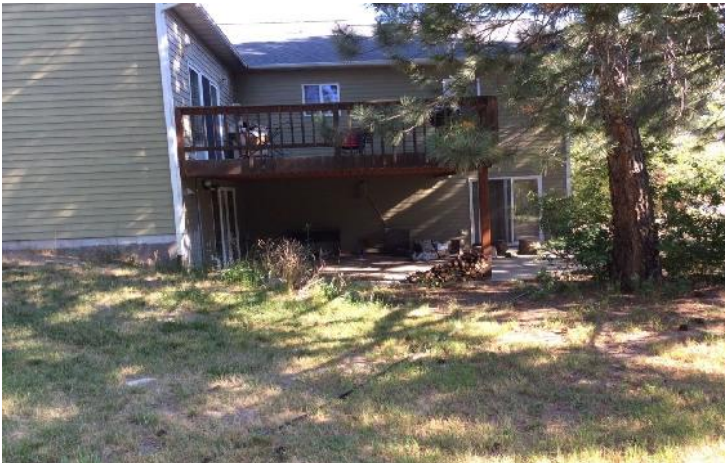
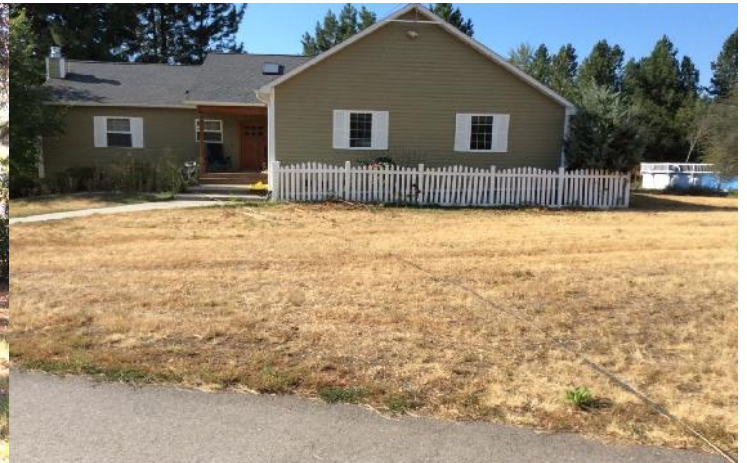
Safety Zone Present: No  
Type of Structure: Residential  
Surrounding Fuels: Grass, Timber  
Structure Triage Category: Non-Defensible, Prep and Leave  
Roof Material: Composite  
Heat Traps: Wood Deck, Rain Gutters  
Electrical Power: Underground  
Hazards: Septic Tank  
Access to Site: T1 Engine  
Comm with ICP: Radio, Cell Service  
Water Source: Faucet / Hose  
Mitigation Time: 1-2 Hours  
Collected By: AZ-TNF E65

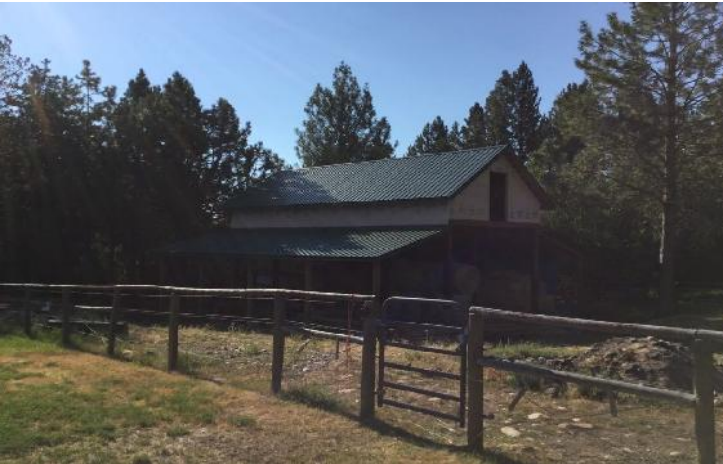
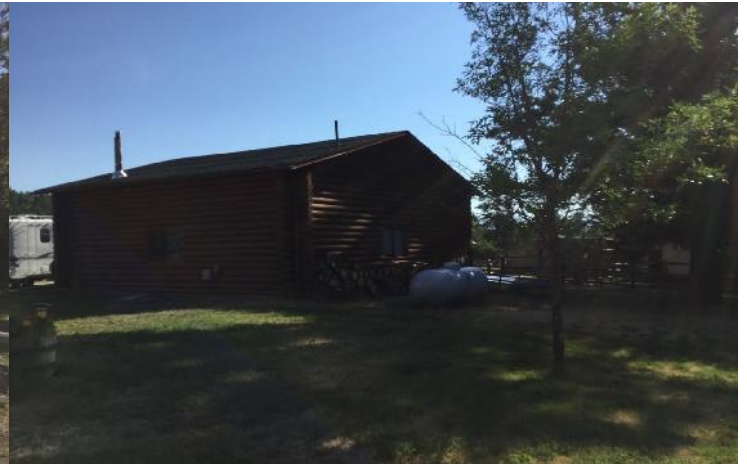
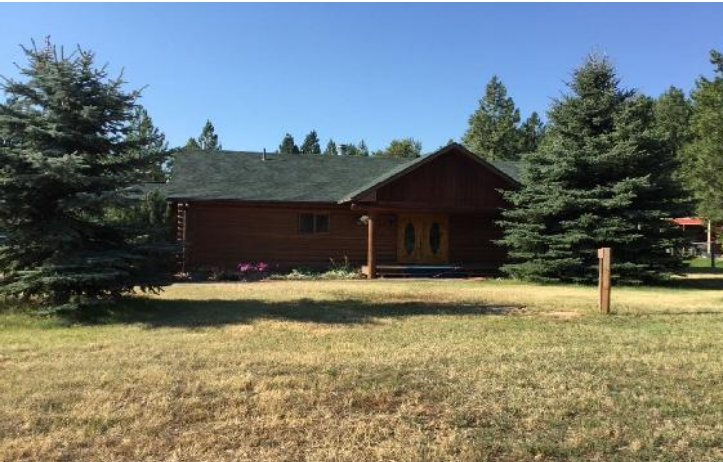
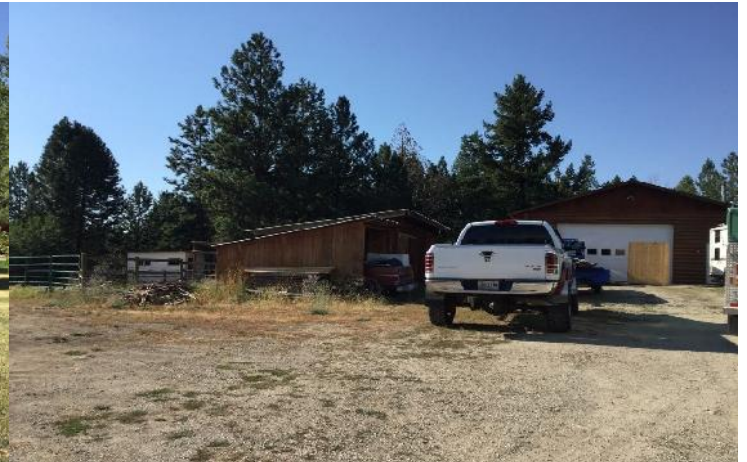
**Structure Number:**  
**Structure Name:** 630 Outback Rd  
**SubDivision:** Sweeny  
**GPS Location, Lat.** 46 36.49566  
**GPS Location, Long.** 114 6.93624  
**Safety Zone Present:** No  
**Type of Structure:** Residential  
**Surrounding Fuels:** Grass, Timber  
**Structure Triage Category:** Defensible, Prep and Hold  
**Roof Material:** Metal  
**Heat Traps:** Wood Deck  
**Electrical Power:** Overhead, Underground  
**Hazards:** Animals, Septic Tank, HazMat  
**Access to Site:** T1 Engine  
**Comm with ICP:** Radio, Cell Service  
**Water Source:** Faucet / Hose, Large Pond, Creek  
**Mitigation Time:** 2-3 Hours  
**Other Resources Needed to Protect:** Sprinklers  
**Notes:** Creek located 200 yards to the north of the house. Neighbor to the south has large pond.

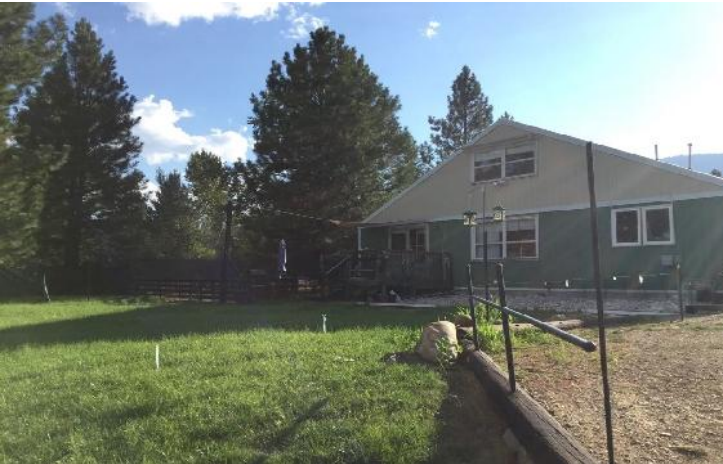
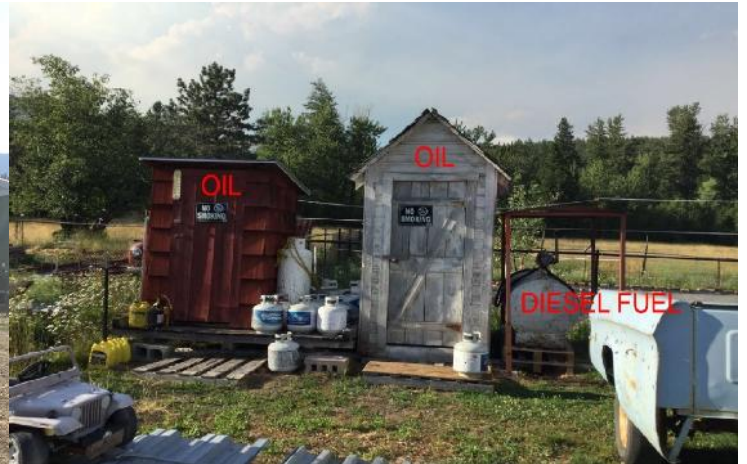
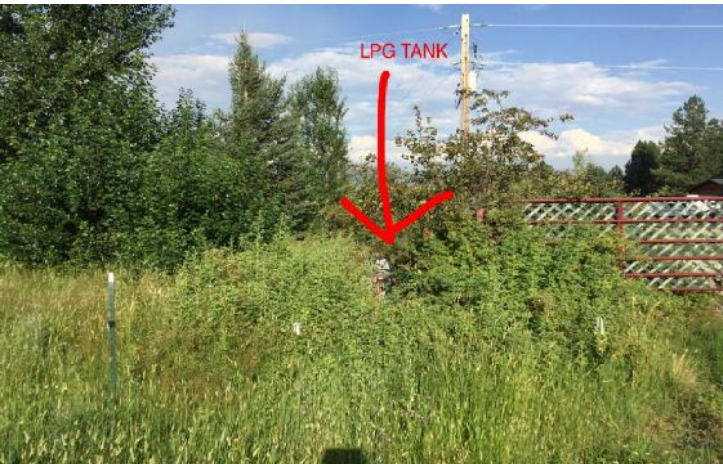
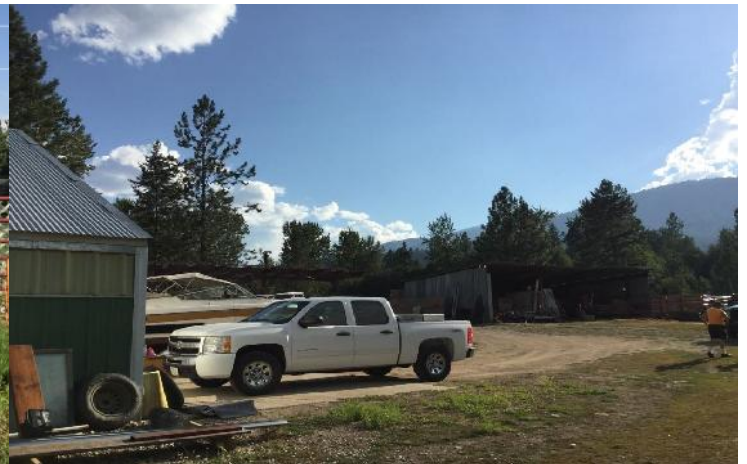
**Structure Number:**  
**Structure Name:** 633 Outback Rd  
**SubDivision:** Sweeny  
**GPS Location, Lat.** 46 36.54732  
**GPS Location, Long.** 114 6.99048  
**Safety Zone Present:** No  
**Type of Structure:** Residential  
**Surrounding Fuels:** Shrub, Timber, Slash  
**Structure Triage Category:** Non-Defensible, Prep and Leave  
**Roof Material:** Composite  
**Heat Traps:** Rain Gutters  
**Electrical Power:** Underground  
**Hazards:** Fuels, Septic Tank, HazMat  
**Access to Site:** T3/4 Engine  
**Comm with ICP:** Radio, Cell Service  
**Water Source:** Faucet / Hose, Creek  
**Mitigation Time:** 3-4 Hours  
**Other Resources Needed to Protect:** Sprinklers  
**Notes:** Property backs timber forest.

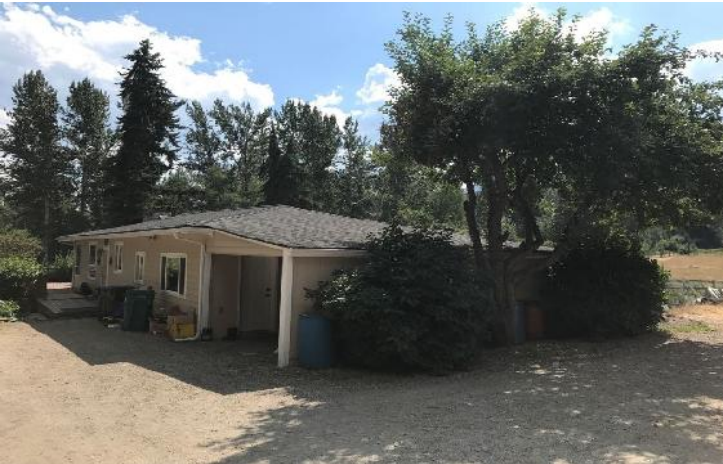
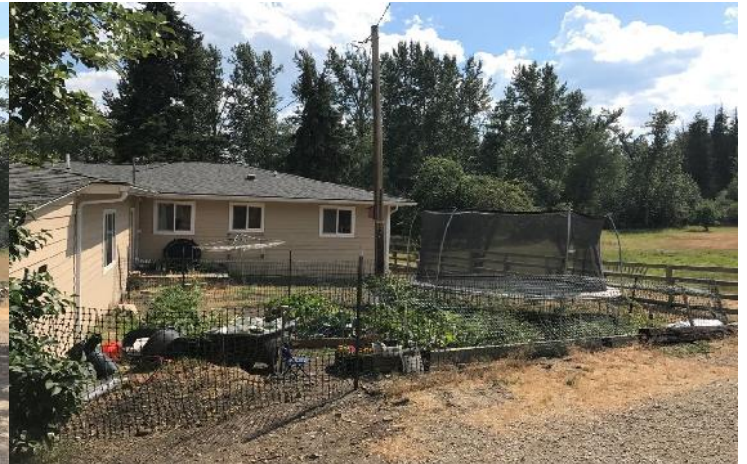
**Structure Number:**  
**Structure Name:** 650 Woodtick Hollow  
**SubDivision:** Sweeny  
**GPS Location, Lat.** 46 36.62598  
**GPS Location, Long.** 114 6.92388  
**Safety Zone Present:** Yes  
**Type of Structure:** Residential  
**Surrounding Fuels:** Grass, Shrub  
**Structure Triage Category:** Defensible, Prep and Hold  
**Roof Material:** Composite  
**Heat Traps:** Wood Deck, Rain Gutters  
**Electrical Power:** Overhead  
**Hazards:** Fuels  
**Access to Site:** T3/4 Engine  
**Comm with ICP:** Radio, Cell Service  
**Water Source:** Faucet / Hose, Large Pond  
**Mitigation Time:** Less Than An Hour  
**Other Resources Needed to Protect:** -1 engine crew, sprinklers.  
**Notes:** -Large pond 75ft S of the house.  
-Faucet on the N side of the house.

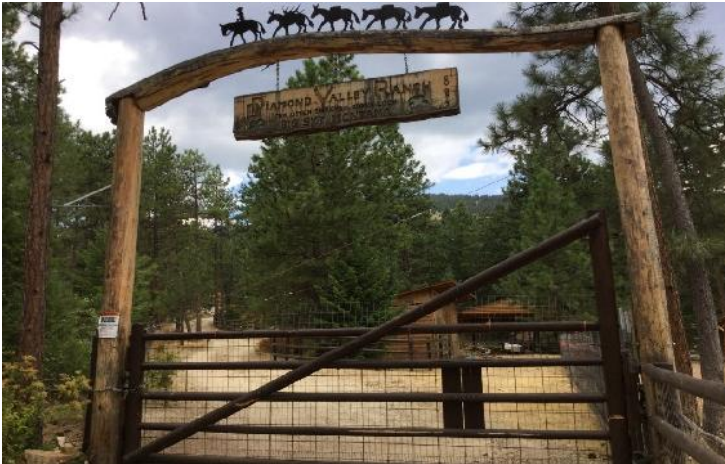
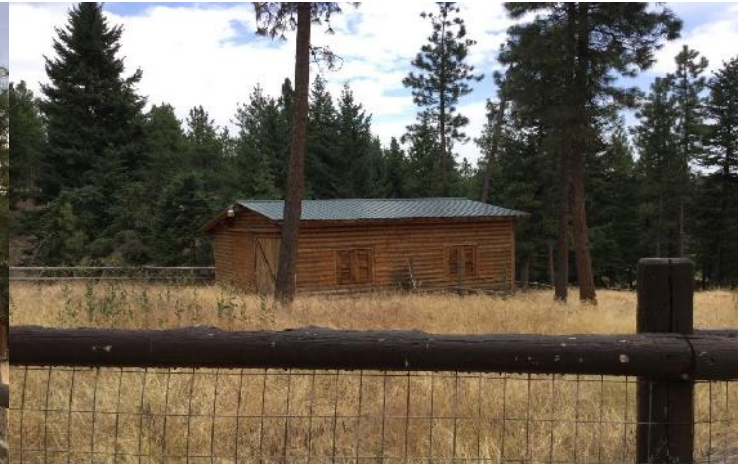
**Structure Number:**  
**Structure Name:** 758 Upper Sweeney Creek Loop  
**SubDivision:** Sweeny  
**GPS Location, Lat.** 46 36.92298  
**GPS Location, Long.** 114 7.4007  
**Safety Zone Present:** Yes **Where is Safety Zone:** Field below hill  
**Type of Structure:** Residential **Primary Structures:** **Outbuildings:**  
**Surrounding Fuels:** Grass, Timber **Defensible Space:** 30-50 Feet  
**Structure Triage Category:** Defensible, Prep and Hold  
**Roof Material:** Metal **Siding Material:** Wood  
**Heat Traps:**  
**Electrical Power:** **Gas to Structure:**  
**Hazards:**  
**Access to Site:** T3/4 Engine **Best Access From:**  
**Comm with ICP:**  
**Water Source:**  
**Mitigation Time:** More Than 5 Hours  
**Other Resources Needed to Protect:** Lots of grass, needs weed whacking. Locked gate, could not assess main house  
**Notes:** LOCKED GATE, COULD NOT ASSESS
