STRUCTURE  
PROTECTION PLAN  
FOR ONE HORSE  
BLOCK

07/30/2017

## One Horse

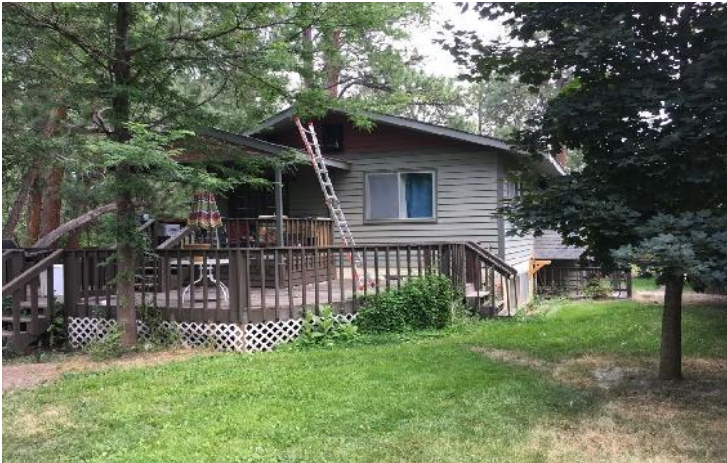
**Structure Number:**  
**Structure Name:** 246 Tie Chute lane  
**SubDivision:** One Horse  
**GPS Location, Lat.** 46 38.54802  
**GPS Location, Long.** 114 4.78968  
**Safety Zone Present:** No  
**Type of Structure:** Residential  
**Surrounding Fuels:** Grass  
**Structure Triage Category:** Defensible, Prep and Hold  
**Roof Material:** Composite  
**Heat Traps:** Wood Deck  
**Electrical Power:** Overhead  
**Hazards:**  
**Access to Site:** T1 Engine  
**Comm with ICP:** Radio, Cell Service  
**Water Source:** Faucet / Hose  
**Mitigation Time:** Less Than An Hour  
**Collected By:** E-27 Florence

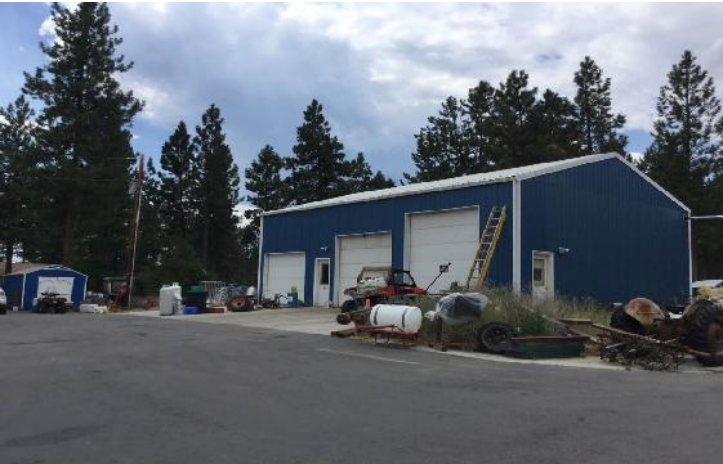
**Structure Number:**  
**Structure Name:** 303 Rocky Road  
**SubDivision:** One Horse  
**GPS Location, Lat.** 46 38.06778  
**GPS Location, Long.** 114 5.13906  
**Safety Zone Present:** Yes  
**Type of Structure:** Mixed Use  
**Surrounding Fuels:** Grass, Timber  
**Structure Triage Category:** Defensible, Prep and Hold  
**Roof Material:** Metal  
**Heat Traps:** Other Receptor  
**Electrical Power:** Overhead, Underground  
**Hazards:** Fuels, Animals  
**Access to Site:** T1 Engine  
**Comm with ICP:** Radio, Cell Service  
**Water Source:** Faucet / Hose  
**Mitigation Time:** More Than 5 Hours  
**Other Resources Needed to Protect:** Removal of wood and hay from around the house, Lots of clutter. But surrounded by green grass  
**Notes:** Cows in the backyard

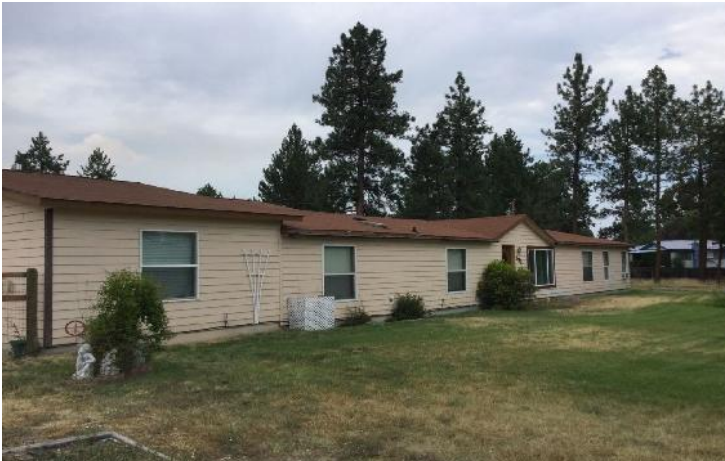
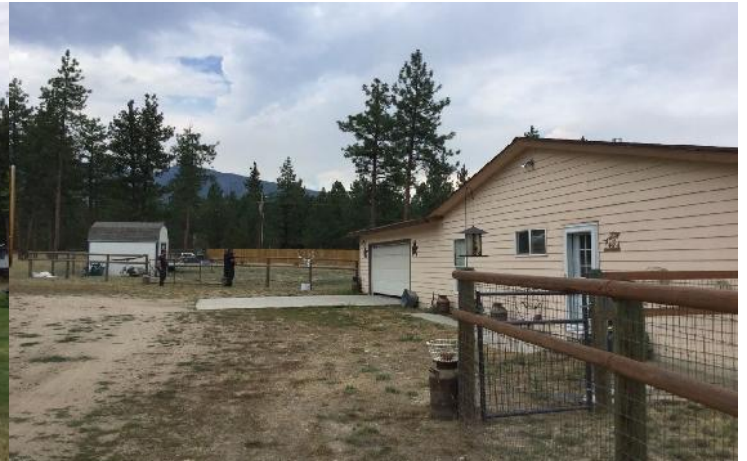
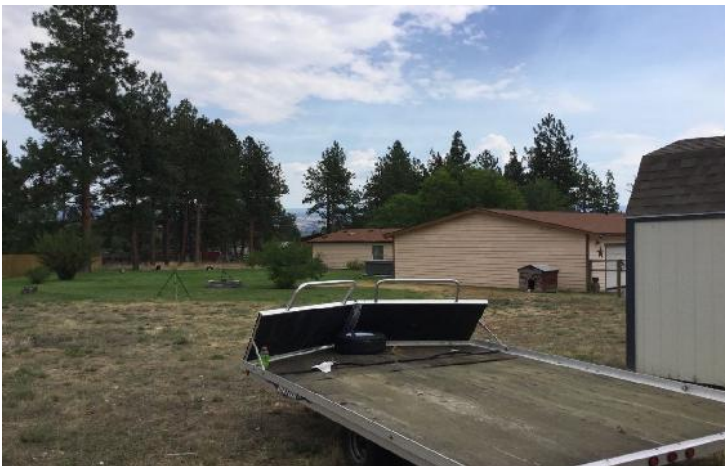
**Structure Number:**  
**Structure Name:** 312 Hughs Lane  
**SubDivision:** One Horse  
**GPS Location, Lat.** 46 38.0937  
**GPS Location, Long.** 114 5.2113  
**Safety Zone Present:** Yes  
**Type of Structure:** Residential  
**Surrounding Fuels:** Grass  
**Structure Triage Category:** Defensible, Stand Alone  
**Roof Material:** Composite  
**Heat Traps:** Rain Gutters  
**Electrical Power:** Overhead, Underground  
**Hazards:**  
**Access to Site:** T1 Engine  
**Comm with ICP:** Radio, Cell Service  
**Water Source:** Faucet / Hose  
**Mitigation Time:** None Needed  
**Collected By:** Engine 951

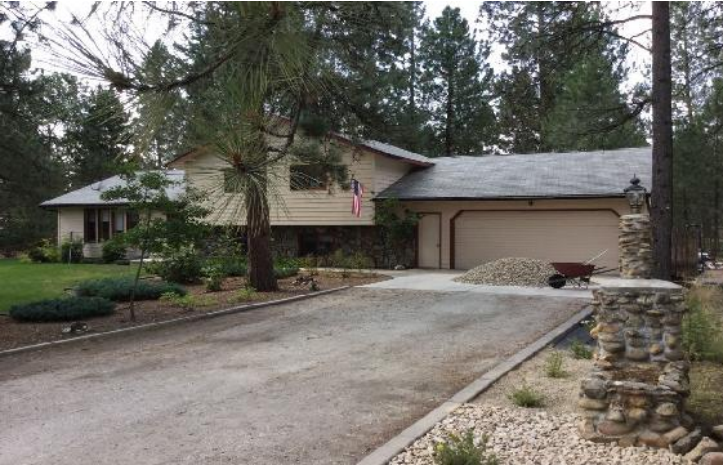
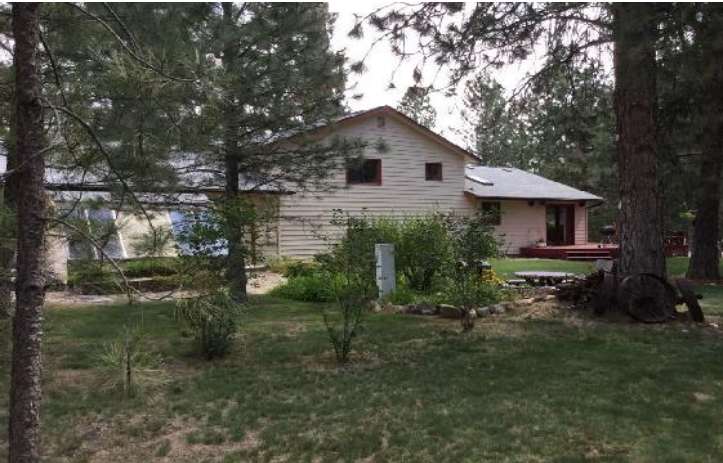
**Structure Number:**  
**Structure Name:** 313 Wickiup Drive  
**SubDivision:** One Horse  
**GPS Location, Lat.** 46 38.2743  
**GPS Location, Long.** 114 5.17362  
**Safety Zone Present:** Yes  
**Type of Structure:** Residential  
**Surrounding Fuels:** Timber  
**Structure Triage Category:** Defensible, Stand Alone  
**Roof Material:** Composite  
**Heat Traps:** Wood Deck  
**Electrical Power:** Underground  
**Hazards:** Fuels  
**Access to Site:** T1 Engine  
**Comm with ICP:** Radio, Cell Service  
**Water Source:** Faucet / Hose  
**Mitigation Time:** Less Than An Hour  
**Other Resources Needed to Protect:** Wood around the house could be removed. Thinning in the backyard  
**Collected By:** Engine 951

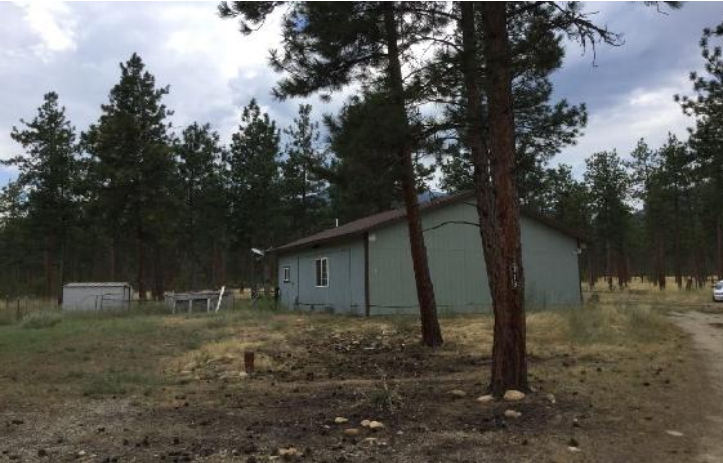
**Structure Number:**  
**Structure Name:** 317/319 Wickiup Drive  
**SubDivision:** One Horse  
**GPS Location, Lat.** 46 38.27484  
**GPS Location, Long.** 114 5.24748  
**Safety Zone Present:** Yes  
**Type of Structure:** Residential  
**Surrounding Fuels:** Timber  
**Structure Triage Category:** Defensible, Stand Alone  
**Roof Material:** Composite  
**Heat Traps:** Wood Deck,Rain Gutters  
**Electrical Power:** Underground  
**Hazards:** Fuels  
**Access to Site:** T1 Engine  
**Comm with ICP:** Radio,Cell Service  
**Water Source:** Faucet / Hose  
**Mitigation Time:** 1-2 Hours  
**Other Resources Needed to Protect:** Mowing grass in backyard  
**Collected By:** Engine 951  
Photo 1

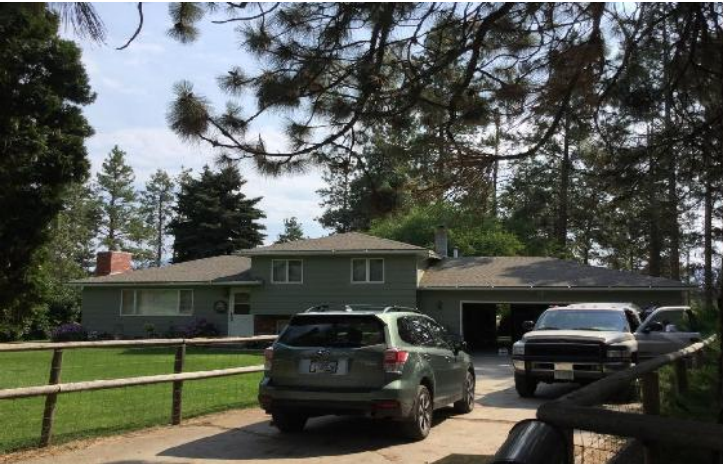
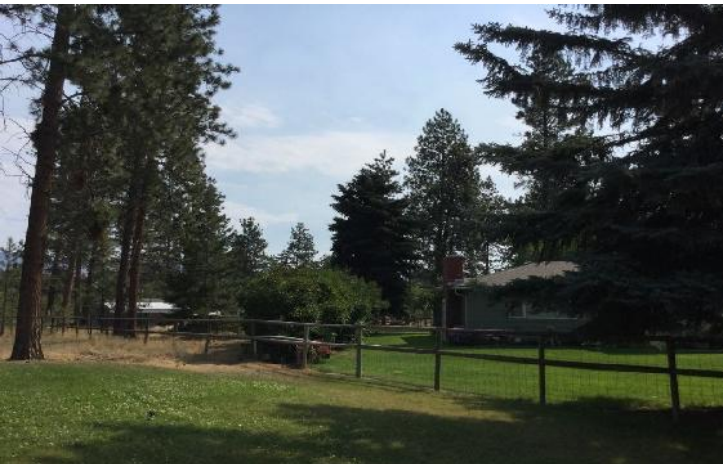
**Structure Number:**  
**Structure Name:** 320 Wickiup Drive  
**SubDivision:** One Horse  
**GPS Location, Lat.** 46 38.30922  
**GPS Location, Long.** 114 5.21058  
**Safety Zone Present:** Yes  
**Type of Structure:** Residential  
**Surrounding Fuels:** Timber  
**Structure Triage Category:** Defensible, Stand Alone  
**Roof Material:** Composite  
**Heat Traps:** Rain Gutters  
**Electrical Power:** Underground  
**Hazards:**  
**Access to Site:** T1 Engine  
**Comm with ICP:** Radio, Cell Service  
**Water Source:** Faucet / Hose  
**Mitigation Time:** Less Than An Hour  
**Other Resources Needed to Protect:** Tall grasses around 2 outbuildings, need Mowing or line  
**Notes:** Timber with no ladder fuels

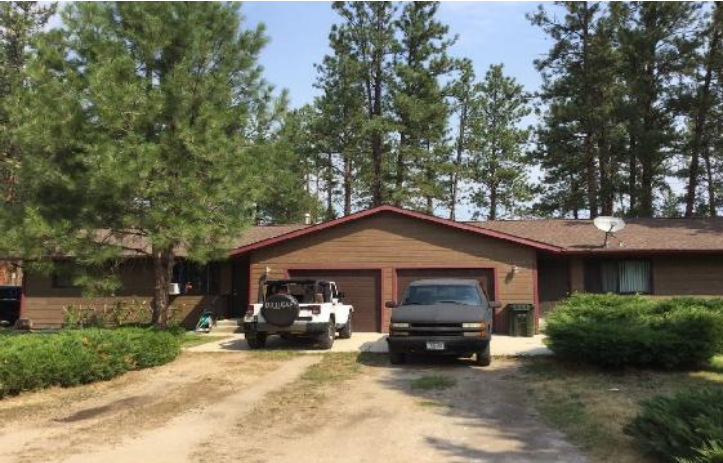
**Structure Number:**  
**Structure Name:** 322 /324 Wickiup Drive  
**SubDivision:** One Horse  
**GPS Location, Lat.** 46 38.31804  
**GPS Location, Long.** 114 5.22462  
**Safety Zone Present:** Yes  
**Type of Structure:** Residential  
**Surrounding Fuels:** Timber  
**Structure Triage Category:** Defensible, Stand Alone  
**Roof Material:** Composite  
**Heat Traps:** Rain Gutters  
**Electrical Power:** Overhead  
**Hazards:** Septic Tank  
**Access to Site:** T1 Engine  
**Comm with ICP:** Radio, Cell Service  
**Water Source:** Faucet / Hose  
**Mitigation Time:** 1-2 Hours  
**Other Resources Needed to Protect:** Clean under decks, gutters  
**Collected By:** Engine 951

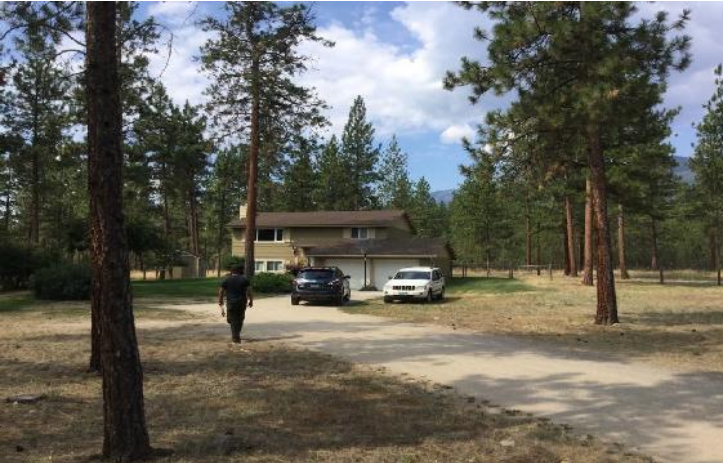
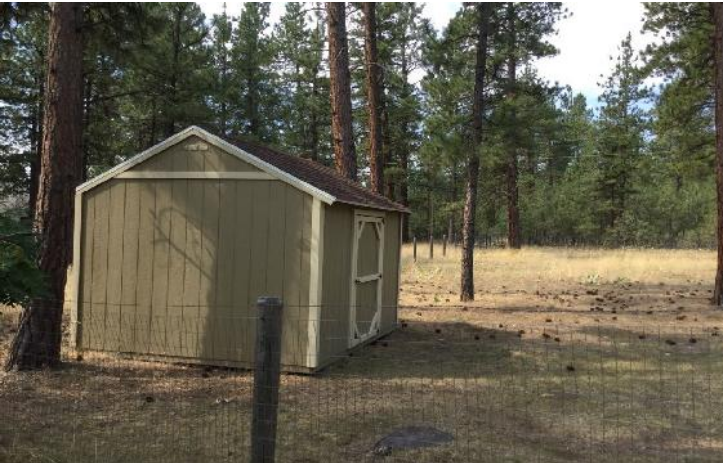
**Structure Number:**  
**Structure Name:** 323 Wickiup Drive  
**SubDivision:** One Horse  
**GPS Location, Lat.** 46 38.29566  
**GPS Location, Long.** 114 5.21862  
**Safety Zone Present:** Yes  
**Type of Structure:** Residential  
**Surrounding Fuels:** Timber  
**Structure Triage Category:** Defensible, Stand Alone  
**Roof Material:** Composite  
**Heat Traps:** Wood Deck  
**Electrical Power:** Overhead  
**Hazards:** Fuels  
**Access to Site:** T1 Engine  
**Comm with ICP:** Radio, Cell Service  
**Water Source:** Faucet / Hose  
**Mitigation Time:** 2-3 Hours  
**Other Resources Needed to Protect:** Limbing and thinning behind property  
**Collected By:** Engine 951

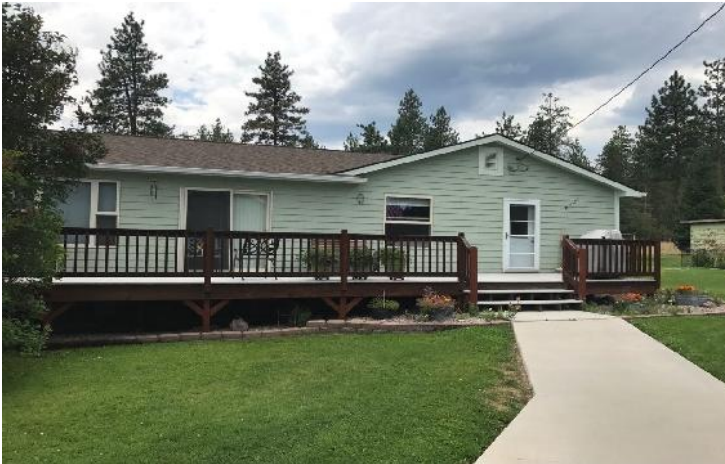
**Structure Number:**  
**Structure Name:** 340 Holloway Lane  
**SubDivision:** One Horse  
**GPS Location, Lat.** 46 37.93182  
**GPS Location, Long.** 114 5.24076  
**Safety Zone Present:** Yes  
**Type of Structure:** Residential  
**Surrounding Fuels:** Grass  
**Structure Triage Category:** Defensible, Stand Alone  
**Roof Material:** Composite  
**Heat Traps:** Rain Gutters  
**Electrical Power:** Overhead  
**Hazards:** HazMat  
**Access to Site:** T1 Engine  
**Comm with ICP:** Radio, Cell Service  
**Water Source:** Faucet / Hose  
**Mitigation Time:** None Needed  
**Other Resources Needed to Protect:** None  
**Notes:** Green grass all around.

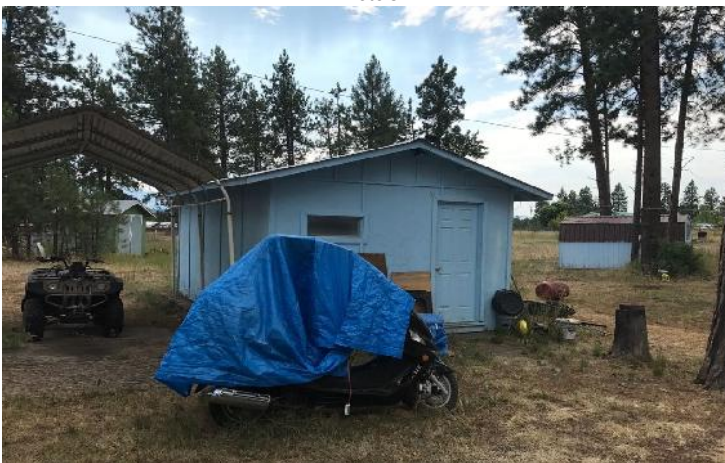
**Structure Number:**  
**Structure Name:** 341 Holloway Lane  
**SubDivision:** One Horse  
**GPS Location, Lat.** 46 37.89972  
**GPS Location, Long.** 114 5.27922  
**Safety Zone Present:** Yes  
**Type of Structure:** Residential  
**Surrounding Fuels:** Grass, Timber  
**Structure Triage Category:** Defensible, Stand Alone  
**Roof Material:** Metal  
**Heat Traps:** Wood Deck  
**Electrical Power:** Overhead, Solar/Wind  
**Hazards:** HazMat  
**Access to Site:** T1 Engine  
**Comm with ICP:** Radio, Cell Service  
**Water Source:** Faucet / Hose  
**Mitigation Time:** Less Than An Hour  
**Other Resources Needed to Protect:** None  
**Notes:** Several out buildings.

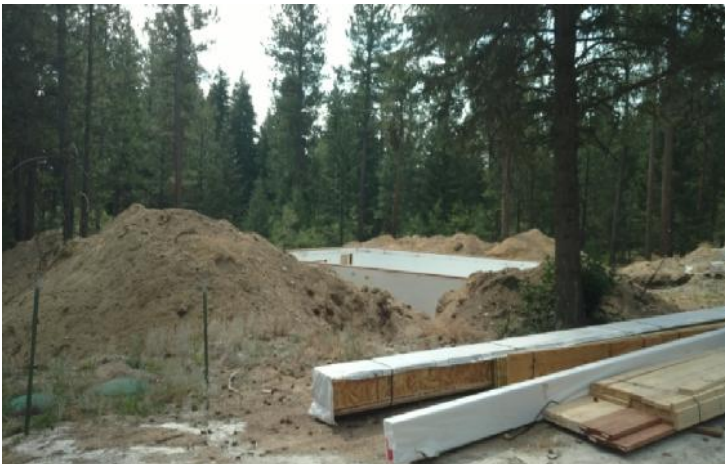
**Structure Number:**  
**Structure Name:** 620 Trenk way  
**SubDivision:** One Horse  
**GPS Location, Lat.** 46 38.15292  
**GPS Location, Long.** 114 5.92956  
**Safety Zone Present:** Yes  
**Type of Structure:** Residential  
**Surrounding Fuels:** Grass, Timber  
**Structure Triage Category:** Defensible, Prep and Hold  
**Roof Material:** Metal  
**Heat Traps:** Wood Deck, Rain Gutters  
**Electrical Power:** Underground  
**Hazards:** HazMat  
**Access to Site:** T1 Engine  
**Comm with ICP:** Radio, Cell Service  
**Water Source:** Faucet / Hose  
**Mitigation Time:** Less Than An Hour  
**Other Resources Needed to Protect:** None  
**Notes:** Fuel in gutters. Two wood decks.

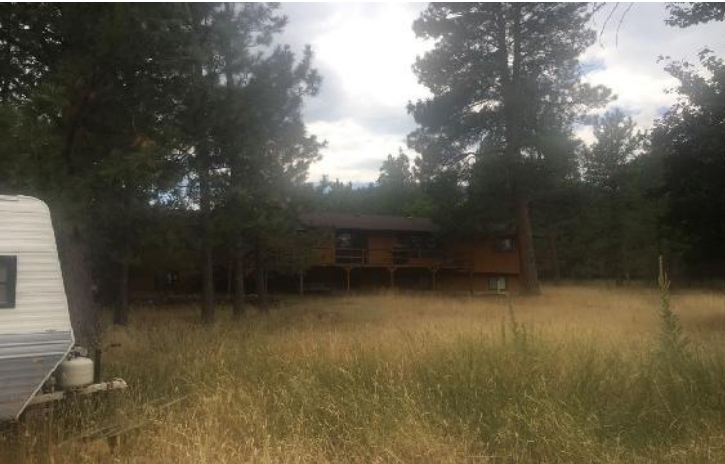
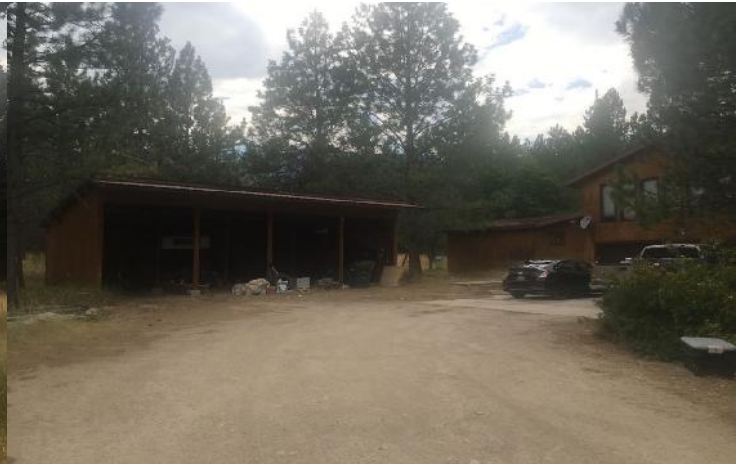
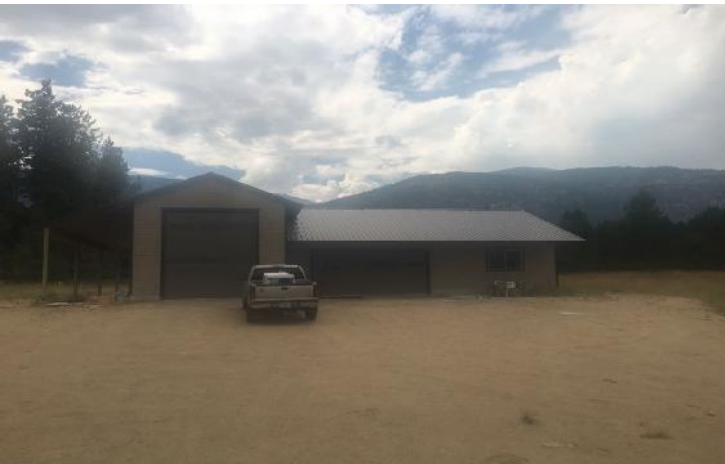
**Structure Number:**  
**Structure Name:** 625 Tie Chute Lane  
**SubDivision:** One Horse  
**GPS Location, Lat.** 46 38.47602  
**GPS Location, Long.** 114 5.89572  
**Safety Zone Present:** No  
**Type of Structure:** Residential  
**Surrounding Fuels:** Grass, Timber  
**Structure Triage Category:** Defensible, Prep and Hold  
**Roof Material:** Composite  
**Heat Traps:** Wood Deck, Rain Gutters  
**Electrical Power:** Overhead, Underground  
**Hazards:** Fuels  
**Access to Site:** T1 Engine  
**Comm with ICP:** Radio, Cell Service  
**Water Source:** Faucet / Hose  
**Mitigation Time:** 1-2 Hours  
**Other Resources Needed to Protect:** One sprinkler kit  
**Notes:** Metal roof garage is first building you come to on property... to the north of the main residence

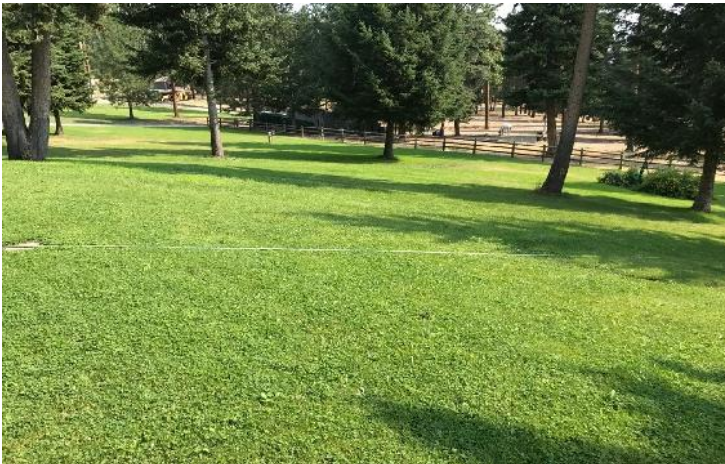
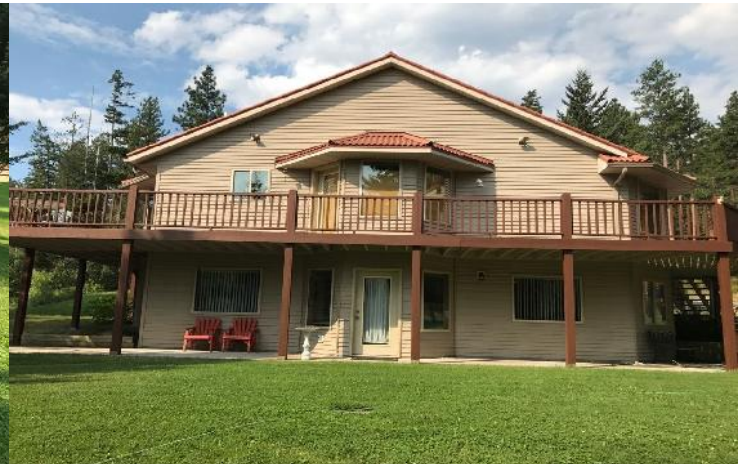
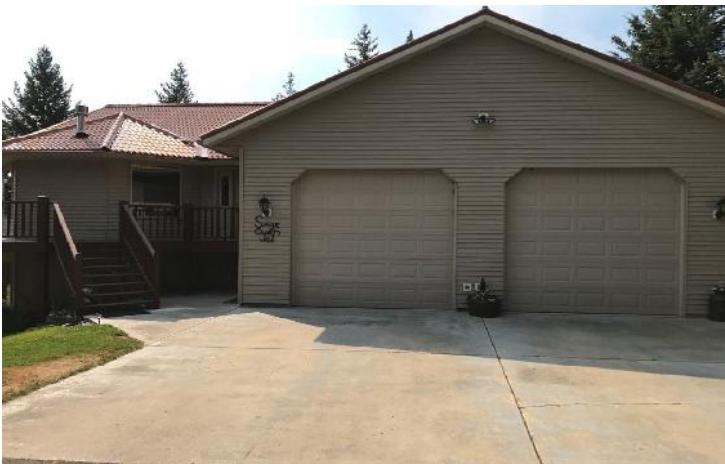
Category: Defensible, Prep and Hold  
Roof Material: Metal  
Heat Traps: Open Eaves, Wood Deck, Rain Gutters  
Electrical Power: Underground  
Hazards: Animals  
Access to Site: T3/4 Engine  
Comm with ICP: Radio, Cell Service  
Water Source: Faucet / Hose, Porta-Tank/Pumpkin, Creek  
Mitigation Time: 1-2 Hours  
Other Resources Needed to Protect: Type 3 Engine  
Notes: Water tank next door.
