STRUCTURE
PROTECTION PLAN
FOR
ELK CREEK BLOCK
07/27/2017

Structure Protection Plan

OZ Ranch

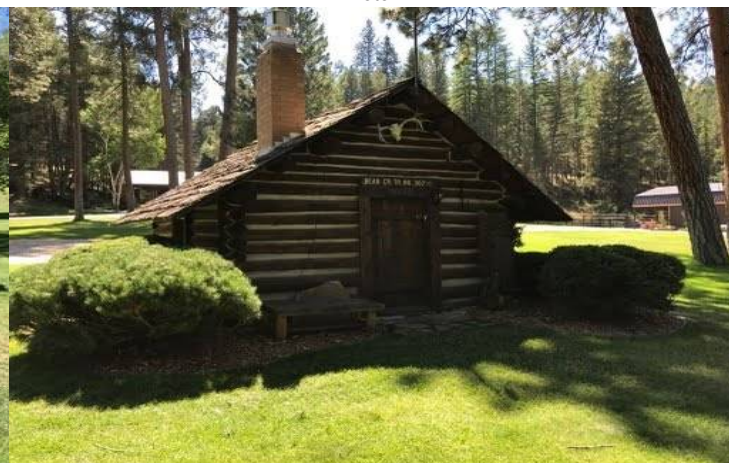
Structure Number: 3789
Structure Name: Office - 4th structure on the right of egress
SubDivision: OZ Ranch
GPS Location, Lat. 46 45.25998
GPS Location, Long. 114 15.56814
Safety Zone Present: Yes **Where is Safety Zone:** Large arena and pasture to the west of structure.
Type of Structure: Mixed Use **Primary Structures:** 1 **Outbuildings:** 0
Surrounding Fuels: Grass, Timber **Defensible Space:** 30-50 Feet
Structure Triage Category: Defensible, Prep and Hold
Roof Material: Wood **Siding Material:** Wood
Heat Traps: **Gas to Structure:** None
Electrical Power: Underground
Hazards: Fuels
Hazard Notes: Old wood shingled roof with needle cast on top.
Access to Site: T1 Engine **Best Access From:** HWY 12, OZ Ranch driveway.
Comm with ICP: Radio
Water Source: Large Pond, Creek
Mitigation Time: Less Than An Hour
Collected By: E 27 Florence Fire **Collected Date/Time:** 07/23/2017 15:05:08
Photo 1 Photo 2

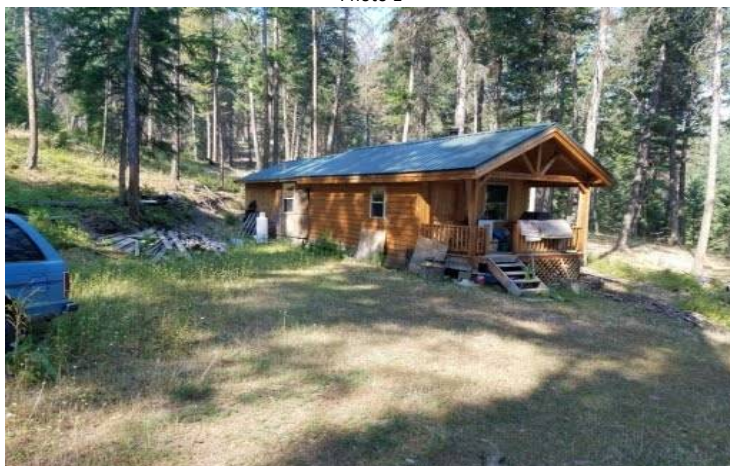
Photo 2

Structure Number: 3912
Structure Name: Cabin behind OZ ranch
SubDivision: OZ ranch
GPS Location, Lat. 46 44.90532
GPS Location, Long. 114 14.28624
Safety Zone Present: No **Where is Safety Zone:** Downhill to grassy field
Type of Structure: Residential **Primary Structures:** 1 **Outbuildings:** 0
Surrounding Fuels: Grass, Timber **Defensible Space:** 50-100 Feet
Structure Triage Category: Non-Defensible, Prep and Leave
Roof Material: Metal **Siding Material:** Wood
Heat Traps: Open Eaves, Wood Deck
Electrical Power: None **Gas to Structure:** Aboveground
Hazards: Terrain
Hazard Notes: Back in south of dozer Line in fire area
Access to Site: T6 Engine **Best Access From:** OZ Ranch east by pond. East on dozer line
Comm with ICP: Radio
Water Source: None
Mitigation Time: 3-4 Hours
Other Resources Needed to Protect: Engine true, sprinklers, pumpkin
Collected By: R. Beery **Collected Date/Time:** 07/25/2017 10:22:34

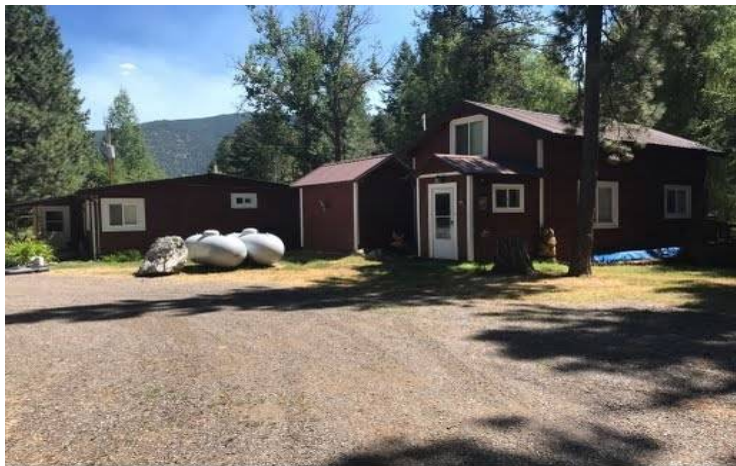
Collected Date/Time: 07/24/2017 14:55:57
Photo 2

Structure Number: 3830
Structure Name: 15295 Hwy 12
SubDivision: Hwy 12
GPS Location, Lat. 46 45.2451
GPS Location, Long. 114 12.59544
Safety Zone Present: No **Where is Safety Zone:** No safety zone....highway 12 borders property for escape route
Type of Structure: Residential **Primary Structures:** 2 **Outbuildings:** 4
Surrounding Fuels: Grass, Timber **Defensible Space:** 30-50 Feet
Structure Triage Category: Defensible, Prep and Hold
Roof Material: Metal **Siding Material:** Wood
Heat Traps: Wood Deck
Electrical Power: Overhead **Gas to Structure:** Aboveground
Hazards: Fuels, Septic Tank
Hazard Notes: Unsure location of septic...traffic from highway
Access to Site: T1 Engine **Best Access From:** Highway 12
Comm with ICP: Radio, Cell Service
Water Source: Faucet / Hose, Creek
Mitigation Time: Less Than An Hour
Other Resources Needed to Protect: Lolo Creek adjacent to property...sprinklers and mark 3

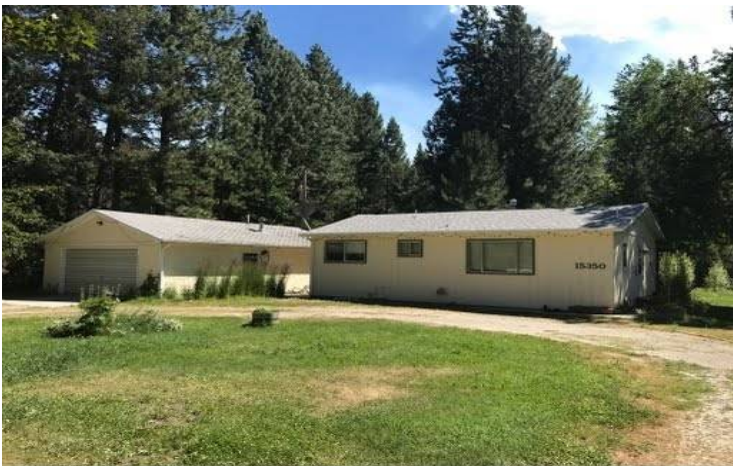
Photo 2

Structure Number: 3834
Structure Name: 15350 Hwy 12
SubDivision: Hwy 12
GPS Location, Lat. 46 45.25326
GPS Location, Long. 114 12.66144
Safety Zone Present: No
Type of Structure: Residential
Surrounding Fuels: Timber
Structure Triage Category: Defensible, Prep and Hold
Roof Material: Composite
Heat Traps: Wood Deck, Rain Gutters
Electrical Power: Overhead
Hazards: Septic Tank
Hazard Notes: Unsure septic location...propane east side...small horse shoe driveway
Access to Site: T3/4 Engine
Comm with ICP: Radio
Water Source: Creek
Mitigation Time: 1-2 Hours
Other Resources Needed to Protect: Lolo Creek access...shrubs along structure
Collected By: E 27 Florence Fire
Where is Safety Zone: Hwy 12 escape route
Primary Structures: 1
Defensible Space: 30-50 Feet
Outbuildings: 2
Siding Material: Wood
Gas to Structure: Aboveground
Best Access From: Hwy 12
Collected Date/Time: 07/24/2017 15:18:35

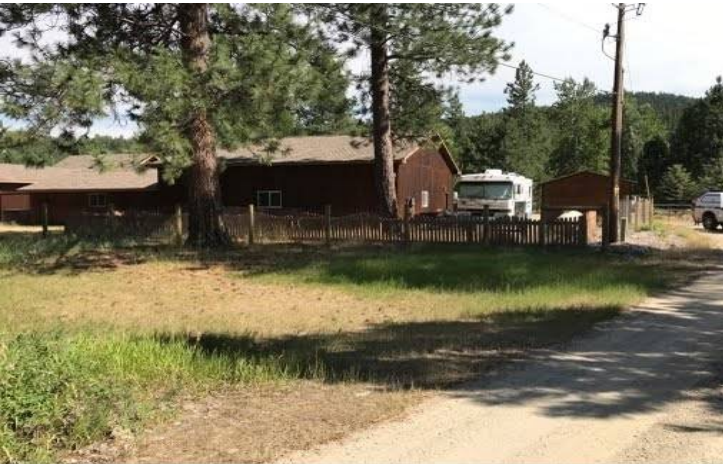
Photo 2

Structure Number: 3846
Structure Name: 9745 Highway 12
SubDivision: Mill Creek
GPS Location, Lat. 46 44.90478
GPS Location, Long. 114 7.96692
Safety Zone Present: Yes
Type of Structure: Residential
Surrounding Fuels: Grass,Shrub,Timber
Structure Triage Category: Defensible, Prep and Hold
Roof Material: Composite
Heat Traps:
Electrical Power: Overhead
Hazards: No Turn Around
Hazard Notes: Overhead power lines.
Access to Site: T3/4 Engine
Comm with ICP: Radio,Cell Service
Water Source: Faucet / Hose,Creek
Mitigation Time: Less Than An Hour
Other Resources Needed to Protect: One engine
Notes: River runs along the back edge of the property with access and ability to draft. Access through the property.

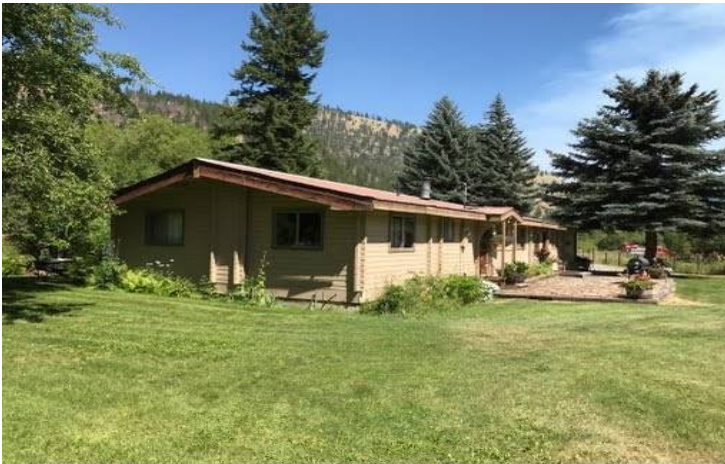
Collected Date/Time: 07/23/2017 15:55:01
Photo 2

Structure Number: 3791
Structure Name: 12285 Mill Creek
SubDivision: Mill Creek
GPS Location, Lat. 46 45.18258
GPS Location, Long. 114 12.5064
Safety Zone Present: No **Where is Safety Zone:** No good safety zone.
Type of Structure: Residential **Primary Structures:** 1 **Outbuildings:** 5
Surrounding Fuels: Grass,Shrub,Timber **Defensible Space:** 30-50 Feet
Structure Triage Category: Defensible, Stand Alone
Roof Material: Metal **Siding Material:** Wood
Heat Traps: Wood Deck
Electrical Power: Overhead **Gas to Structure:** None
Hazards: Fuels,No Turn Around
Hazard Notes: Lots of shrubs and small trees near home on north side. No turn around for larger engines. Could back a T 3/4 engine into driveway.
Access to Site: T6 Engine **Best Access From:** HWY 12 and Mill Creek Road.
Comm with ICP: Radio
Water Source: Creek
Mitigation Time: None Needed
Notes: Electric pump located on north west side of structure, on Mill Creek.

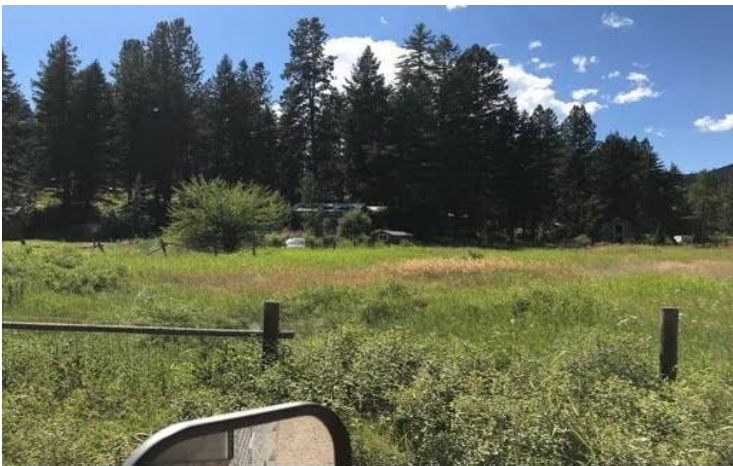
Photo 2

Structure Number: 3792
Structure Name: 12305 Mill Creek
SubDivision: Mill Creek
GPS Location, Lat. 46 45.19386
GPS Location, Long. 114 12.50028
Safety Zone Present: No
Type of Structure: Residential
Surrounding Fuels: Grass, Timber
Structure Triage Category: Non-Defensible, Prep and Leave
Roof Material: Wood
Heat Traps: Wood Deck, Rain Gutters
Electrical Power:
Hazards: Fuels, No Turn Around, Owners
Hazard Notes: Owners non-approachable, per information of neighbor.
Access to Site: T6 Engine
Comm with ICP: Radio
Water Source: None
Mitigation Time: More Than 5 Hours
Other Resources Needed to Protect: Crews, sawyers, possible law enforcement for aggressive owners.
Collected By: E 27 Florence Fire

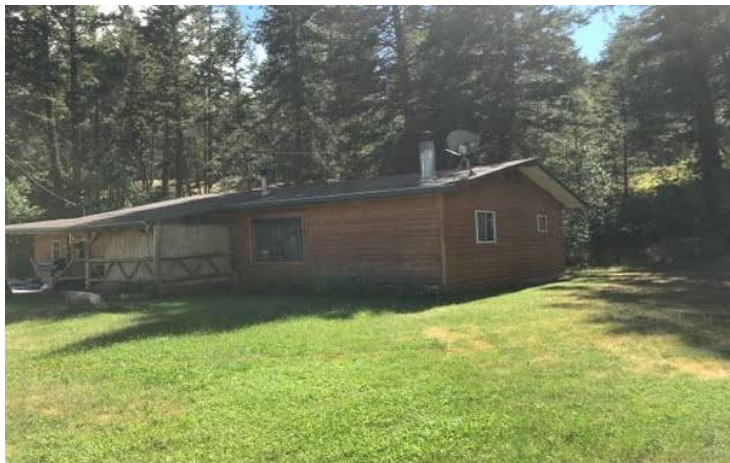
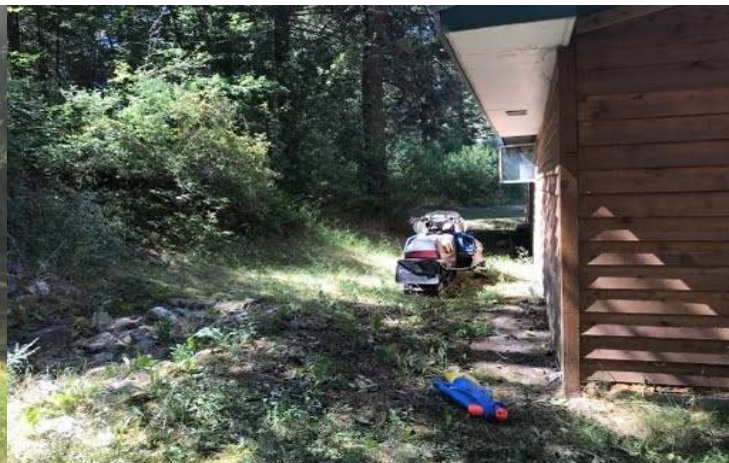
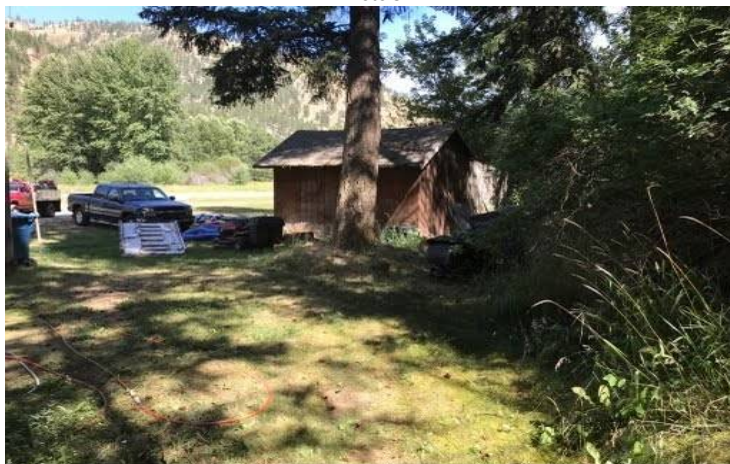
Structure Number: 3810
Structure Name: 12385 Mill Creek
SubDivision: Mill Creek
GPS Location, Lat. 46 45.14952
GPS Location, Long. 114 12.49836
Safety Zone Present: No **Where is Safety Zone:** No good safety zone.
Type of Structure: Residential **Primary Structures:** 1 **Outbuildings:** 1
Surrounding Fuels: Grass,Shrub,Timber **Defensible Space:** 30-50 Feet
Structure Triage Category: Non-Defensible, Prep and Leave
Roof Material: Metal **Siding Material:** Wood
Heat Traps: Wood Deck,Rain Gutters
Electrical Power: Overhead **Gas to Structure:** None
Hazards: Fuels,Septic Tank
Hazard Notes: Septic tank located on north side of structure. Buried, non-visible.
Access to Site: T1 Engine **Best Access From:** Mill Creek Rd
Comm with ICP: Radio
Water Source: None
Mitigation Time: Less Than An Hour
Collected By: E 27 Florence Fire **Collected Date/Time:** 07/23/2017 19:28:23

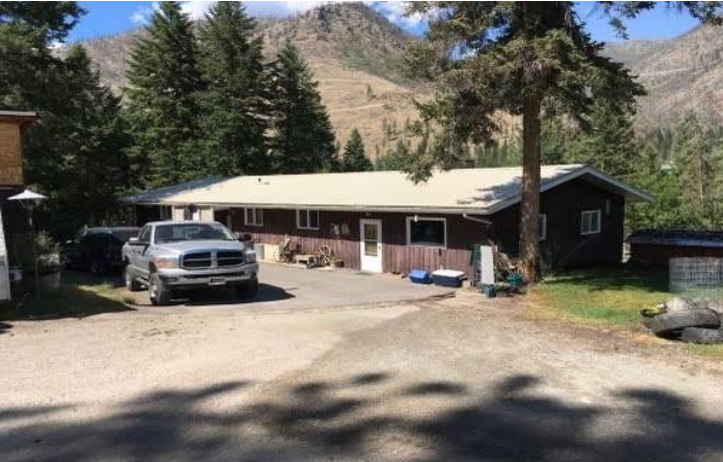
Photo 2

Structure Number: 3800
Structure Name: 12595 Mill Creek Rd
SubDivision: Mill Creek
GPS Location, Lat. 46 45.06006
GPS Location, Long. 114 12.47268
Safety Zone Present: No **Where is Safety Zone:** Out to Hwy 12
Type of Structure: Residential **Primary Structures:** 1 **Outbuildings:** 3
Surrounding Fuels: Timber **Defensible Space:** None
Structure Triage Category: Non-Defensible, Prep and Leave
Roof Material: Metal **Siding Material:** Wood
Heat Traps: Wood Deck
Electrical Power: Overhead **Gas to Structure:** None
Hazards: Fuels
Hazard Notes: Heavy timber right up to house, top of a short slope
Access to Site: T3/4 Engine **Best Access From:** Mill Creek RD.
Comm with ICP: Radio, Cell Service
Water Source: None
Mitigation Time: More Than 5 Hours
Other Resources Needed to Protect: Falling team, handcrew, sprinkler system
Notes: Heavy timber up to house. House is at top of slope. Lot of debris around structures. Will need lots of work, pumpkin and sprinklers.

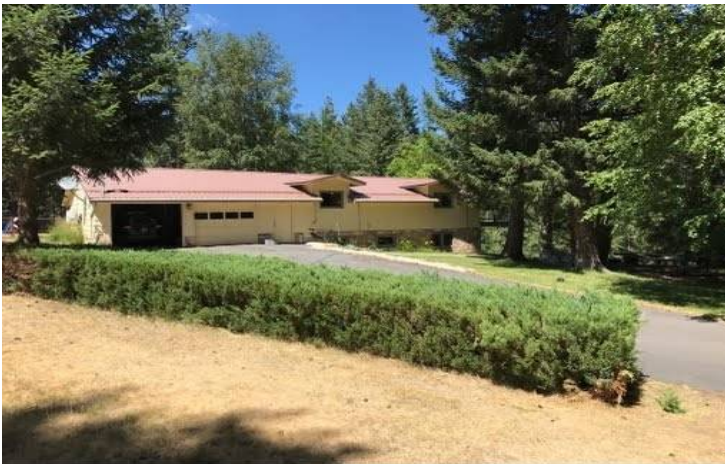
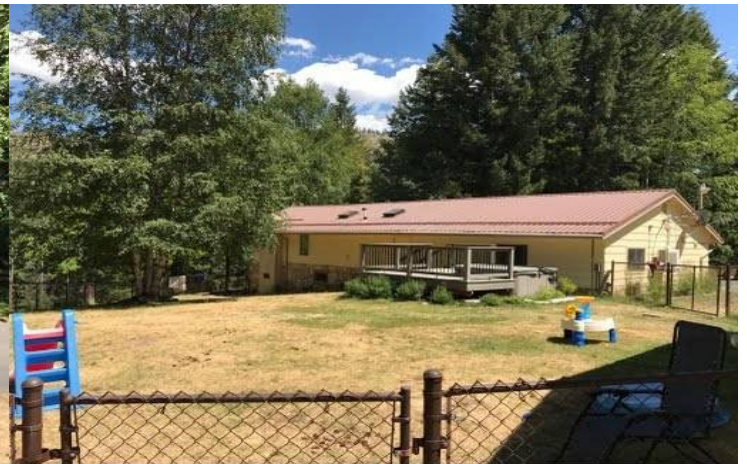
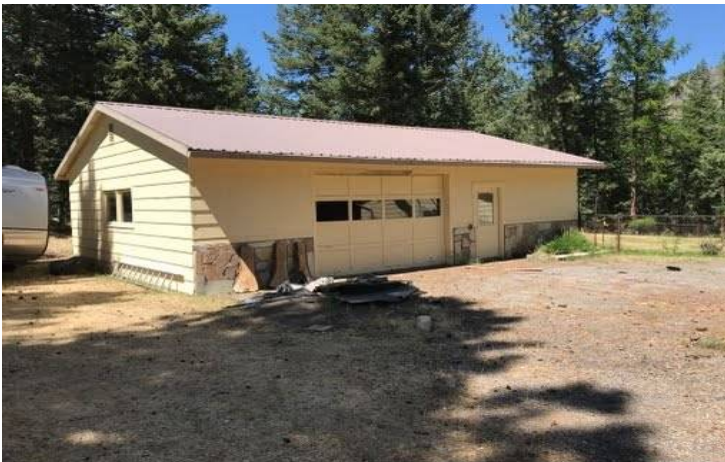
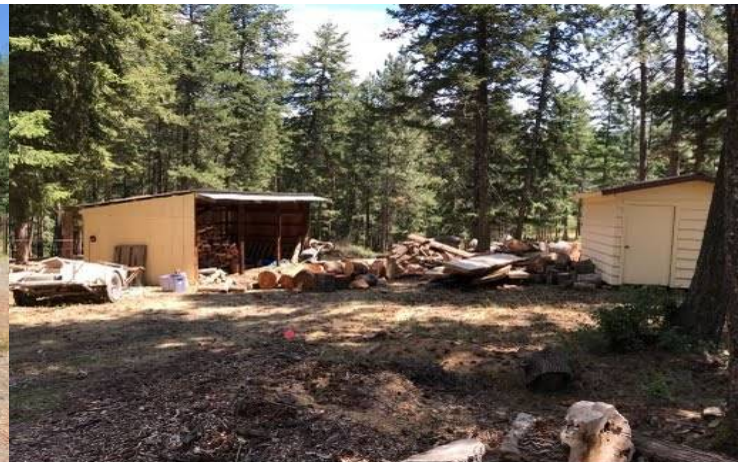
Structure Number: 3824
Structure Name: 12820 Mill Creek Road
SubDivision: Mill Creek
GPS Location, Lat. 46 44.83392
GPS Location, Long. 114 12.43944
Safety Zone Present: Yes
Type of Structure: Residential
Surrounding Fuels: Grass, Timber
Structure Triage Category: Defensible, Stand Alone
Roof Material: Metal
Heat Traps:
Electrical Power: Overhead
Hazards: Terrain, Fuels, HazMat

Hazard Notes: Slope leading up to home, mature trees next to home, large amount of firewood stored in outbuilding
Access to Site: T1 Engine
Comm with ICP: Radio
Water Source: Faucet / Hose, Large Pond
Mitigation Time: Less Than An Hour
Other Resources Needed to Protect: None
Notes: Home at the end of long narrow driveway, firewood shed 75 yards away from home, pond at bottom of driveway, good defensible space

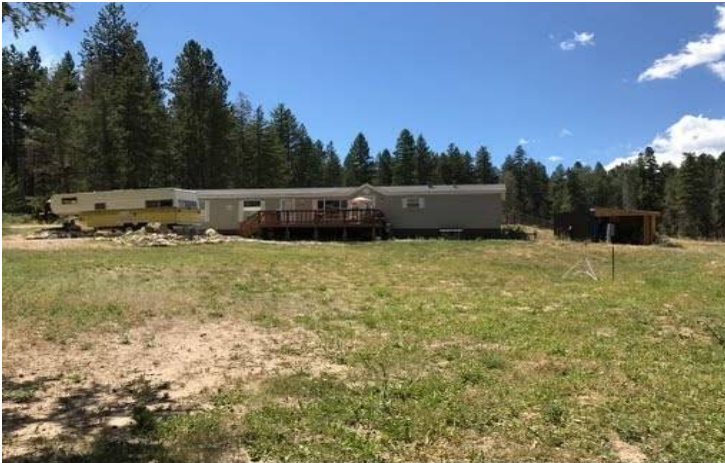
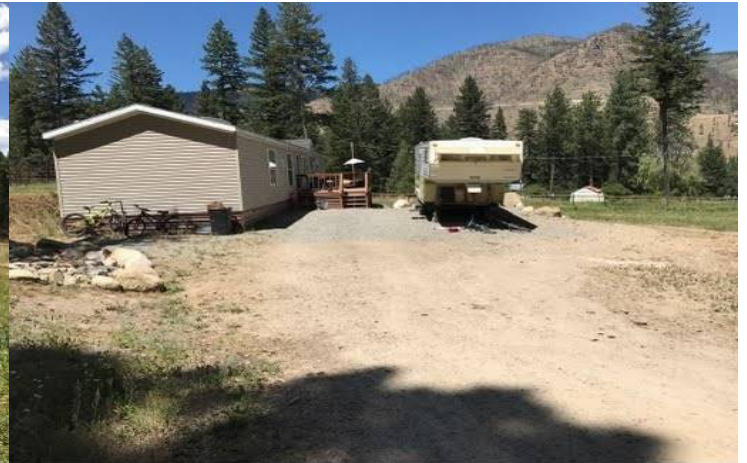
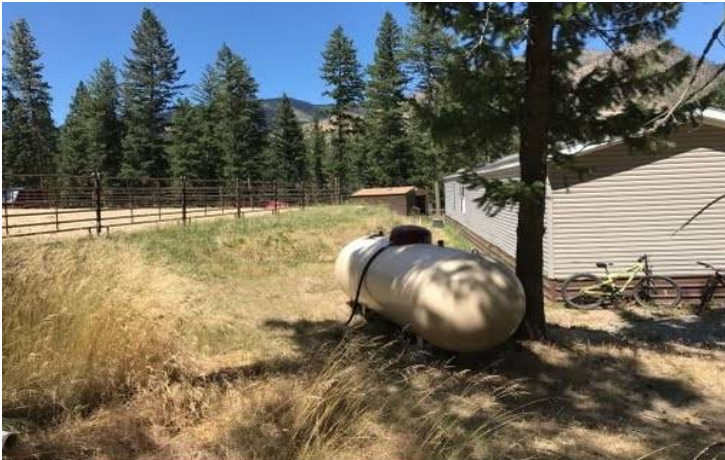
Structure Number: 3895
Structure Name: 12825 Mill Creek Road
SubDivision: Mill Creek
GPS Location, Lat. 46 44.88492
GPS Location, Long. 114 12.5181
Safety Zone Present: Yes
Type of Structure: Residential
Surrounding Fuels: Grass,Shrub,Timber
Structure Triage Category: Defensible, Stand Alone
Roof Material: Composite
Heat Traps: Other Receptor
Electrical Power: Overhead
Hazards: No Turn Around,HazMat
Hazard Notes: Propane tank in close proximity to house. No turn around.
Access to Site: T1 Engine
Comm with ICP: Radio
Water Source: Faucet / Hose
Mitigation Time: None Needed
Other Resources Needed to Protect: N/A
Collected By: LoLo 632

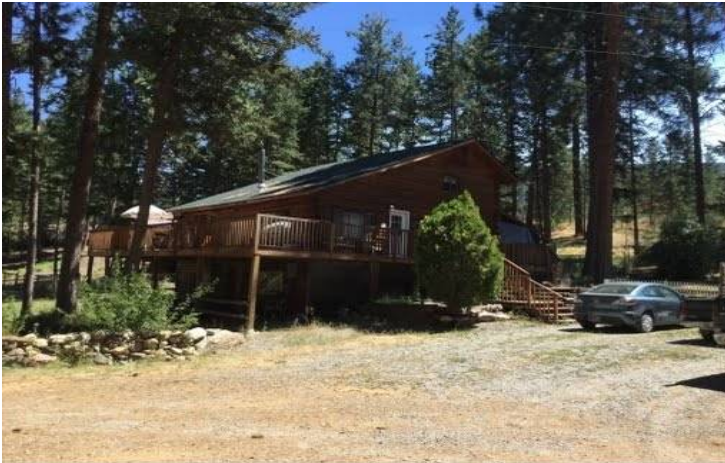
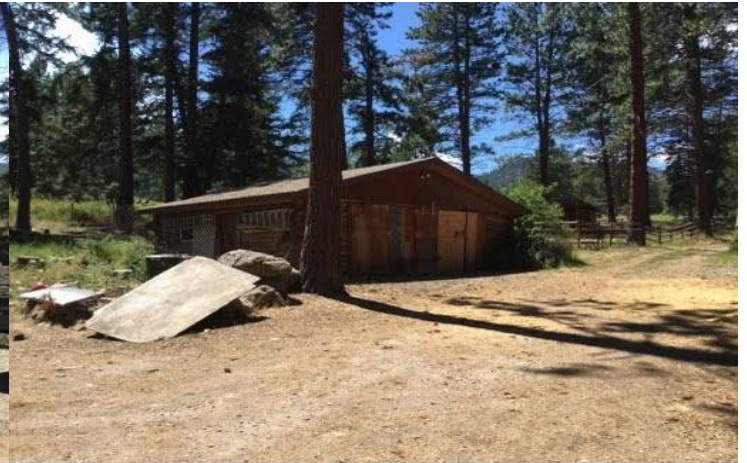
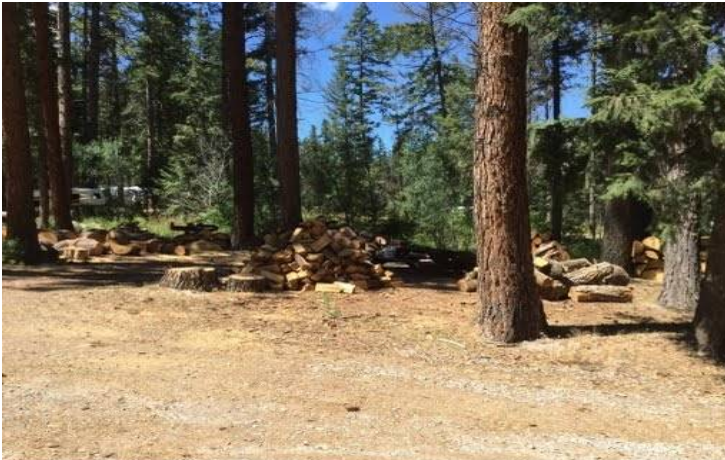
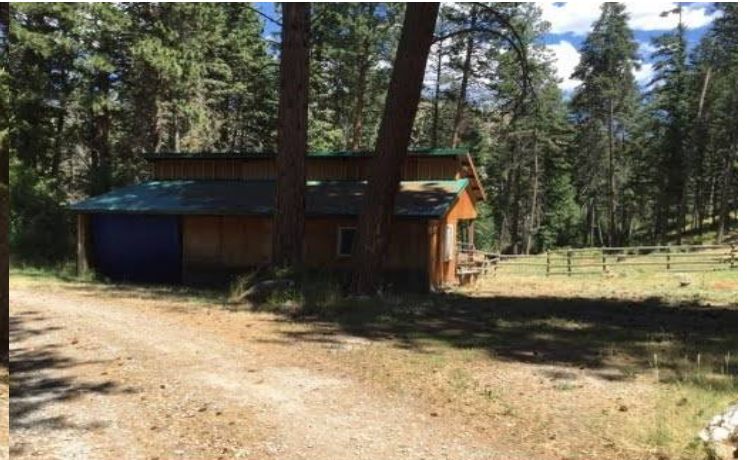
Structure Number: 3907
Structure Name: 12850 Mill Creek Road
SubDivision: Mill Creek
GPS Location, Lat. 46 44.83926
GPS Location, Long. 114 12.52488
Safety Zone Present: No
Type of Structure: Residential
Surrounding Fuels: Grass, Timber
Structure Triage Category: Defensible, Prep and Hold
Roof Material: Metal
Heat Traps: Open Eaves, Wood Deck, Other Receptor
Electrical Power: Overhead
Hazards: Animals, Septic Tank
Hazard Notes: Chickens. Very large wood pile. Pine needles on roof.
Access to Site: T3/4 Engine
Comm with ICP: Radio
Water Source: Faucet / Hose
Mitigation Time: 2-3 Hours
Other Resources Needed to Protect: Sprinklers, 1 crew.
Collected By: TNF-E65

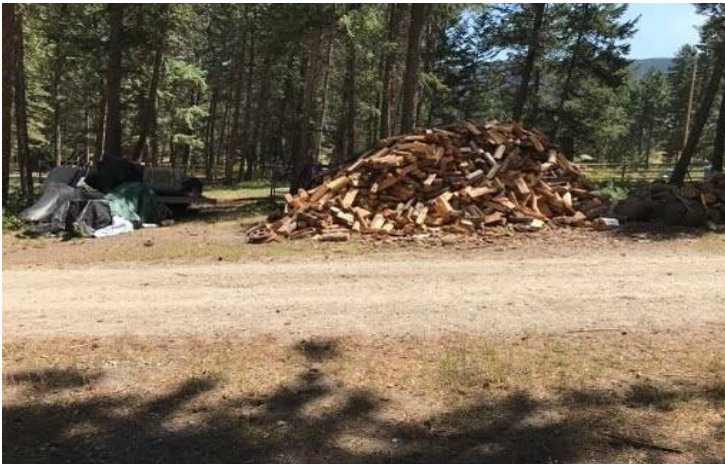
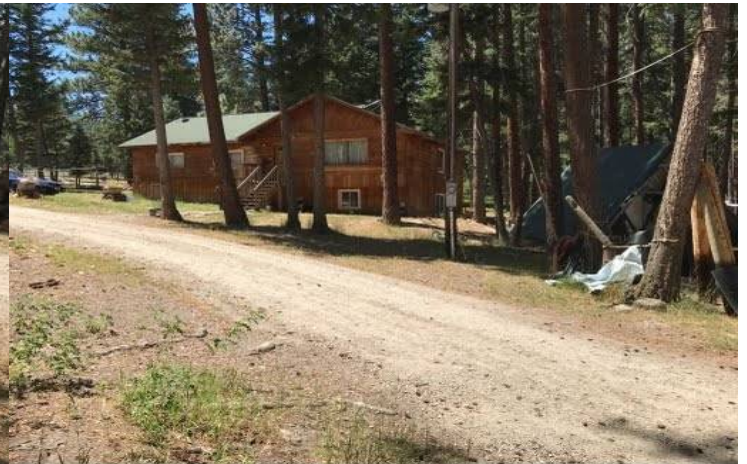
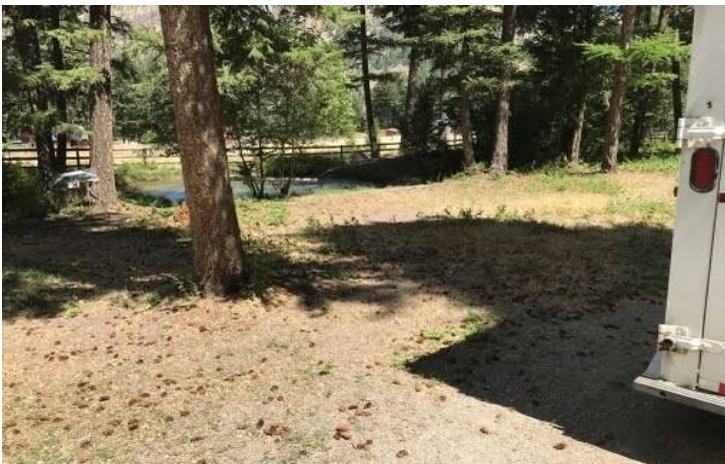
Structure Triage Category: Non-Defensible, Prep and Leave
Roof Material: Composite
Heat Traps: Open Eaves, Wood Deck, Other Receptor
Electrical Power: Underground
Hazards: Fuels, Animals
Bobcats in cage and dogs in cage.

Hazard Notes: Firewood stacks near home.

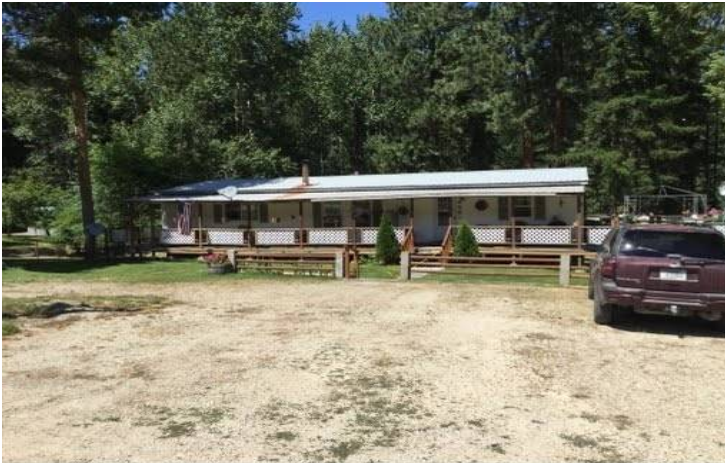
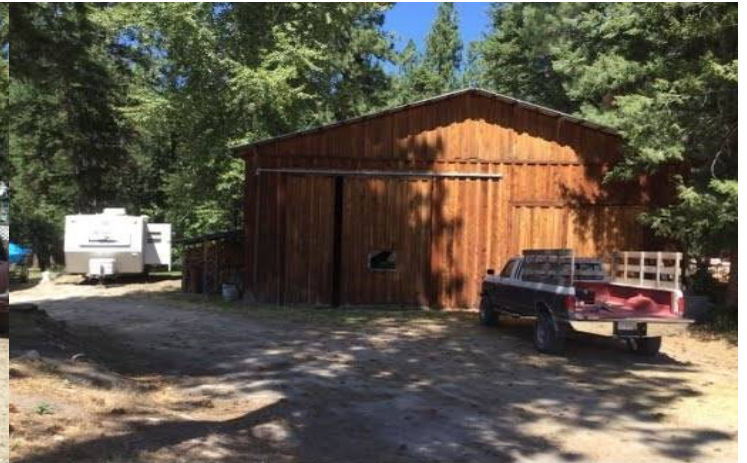
Structure Number: 3858
Structure Name: 12861 Mill Creek Road
SubDivision: Mill Creek
GPS Location, Lat. 46 44.83506
GPS Location, Long. 114 12.69462
Safety Zone Present: Yes
Type of Structure: Residential
Surrounding Fuels: Grass, Timber
Structure Triage Category: Defensible, Prep and Hold
Roof Material: Metal
Heat Traps: Open Eaves, Wood Deck, Other Receptor
Electrical Power: Underground
Hazards: Septic Tank, HazMat
Hazard Notes: LPG tank and septic back of home. Debris on roof of large wooden barn.
Access to Site: T1 Engine
Comm with ICP: Radio
Water Source: Faucet / Hose
Mitigation Time: 1-2 Hours
Other Resources Needed to Protect: Sprinklers on site.
Collected By: TNF-E65

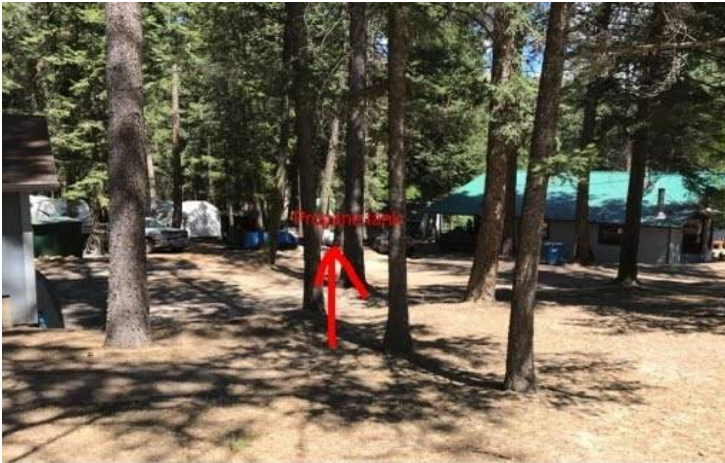
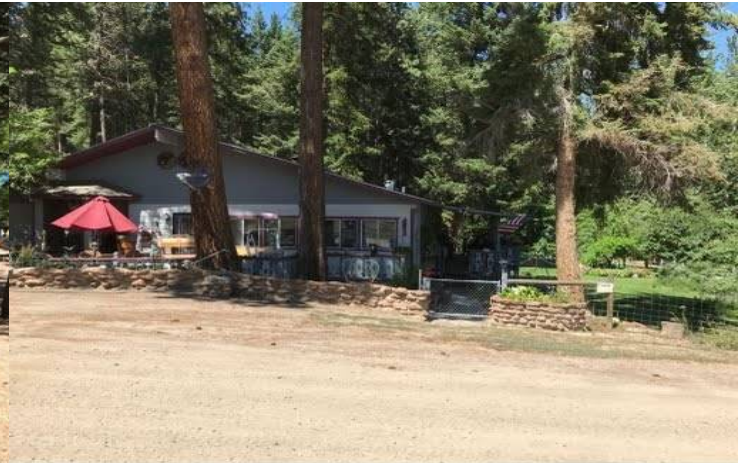
Structure Number: 3831
Structure Name: 12865 Mill Creek Rd
SubDivision: Mill Creek
GPS Location, Lat. 46 44.82636
GPS Location, Long. 114 12.74178
Safety Zone Present: No
Type of Structure: Residential
Surrounding Fuels: Timber
Structure Triage Category: Defensible, Prep and Hold
Roof Material: Metal
Heat Traps: Wood Deck
Electrical Power: Overhead
Hazards: No Turn Around, Animals
Hazard Notes: Propane tank 30ft NW of the house
Access to Site: T3/4 Engine
Comm with ICP: Radio
Water Source: Faucet / Hose, Creek
Mitigation Time: Less Than An Hour
Other Resources Needed to Protect: The property could be held by adjacent resources from other structures.
Collected By: COCO 482
Collected Date/Time: 07/24/2017 14:35:25

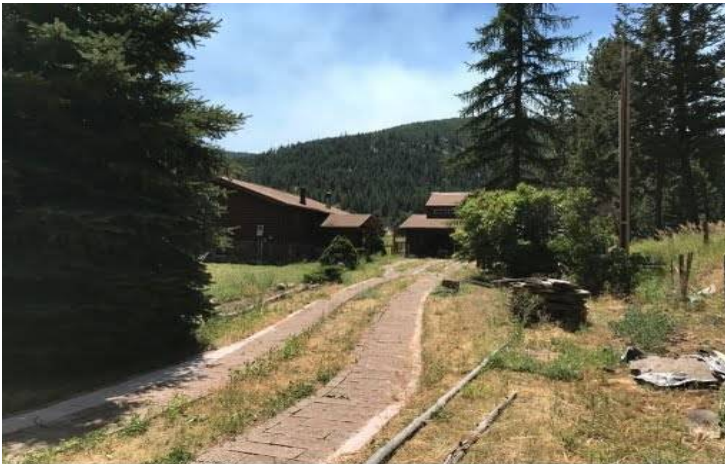
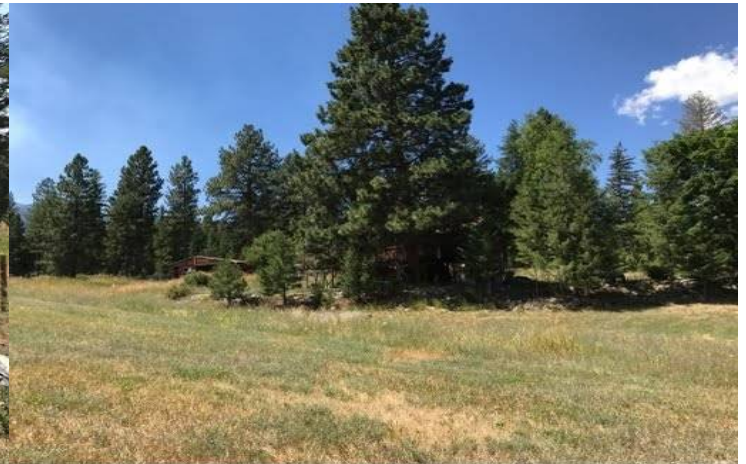
Structure Number: 3825
Structure Name: 12870 Mill Creek Rd
SubDivision: Mill Creek
GPS Location, Lat. 46 44.79966
GPS Location, Long. 114 12.76974
Safety Zone Present: Yes **Where is Safety Zone:** Out to Hwy 12
Type of Structure: Residential **Primary Structures:** 1 **Outbuildings:** 2
Surrounding Fuels: Grass, Timber **Defensible Space:** 30-50 Feet
Structure Triage Category: Defensible, Prep and Hold
Roof Material: Composite **Siding Material:** Wood
Heat Traps: Wood Deck, Rain Gutters
Electrical Power: Underground, Generator **Gas to Structure:** None
Hazards: Fuels, No Turn Around, HazMat
Hazard Notes: Narrow road, one way in and out. Tripping hazards. Wood stacked under wooden deck.
Access to Site: T6 Engine **Best Access From:** Hwy 12 to Mill Creek Rd
Comm with ICP: Radio
Water Source: Faucet / Hose, Creek
Mitigation Time: 1-2 Hours
Other Resources Needed to Protect: Pump and sprinklers.
Notes: Has sprinklers on roof and around property, did run water system dry during last fire in the area. Do not drive through gate and on rock driveway with heavy vehicles. Structures can be accessed through gate and across grass and field. Need for more sprinklers should be assessed.

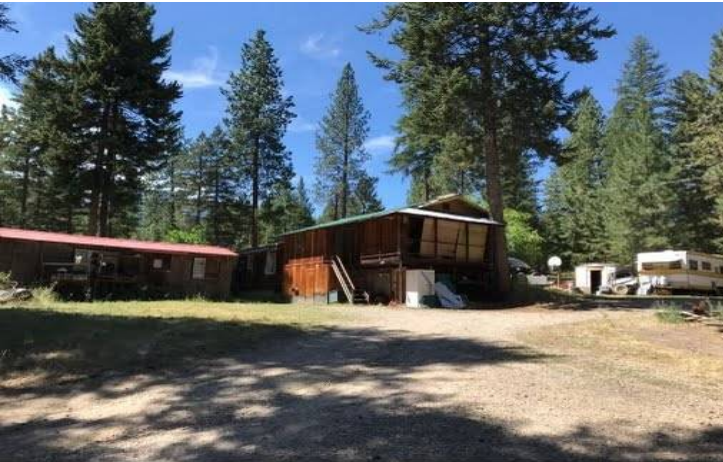
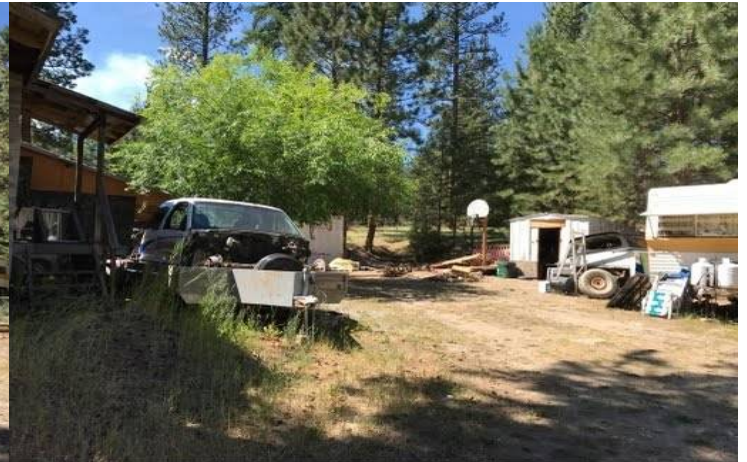
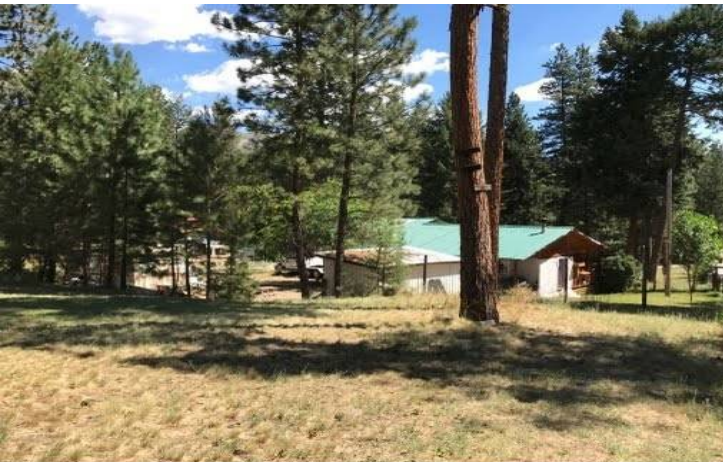
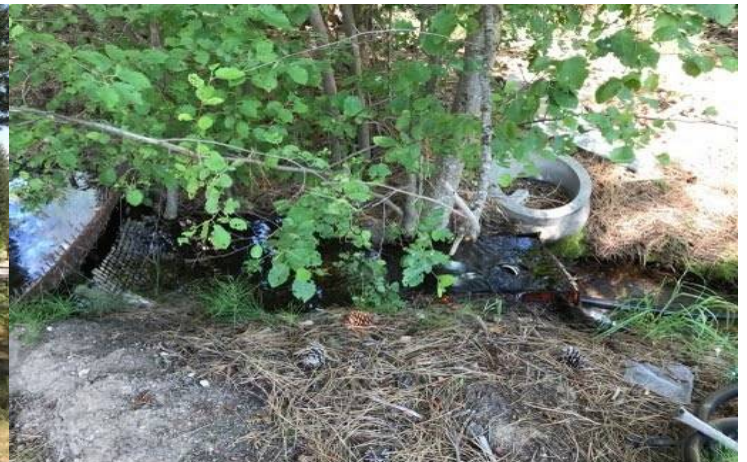
Structure Triage Category: Defensible, Prep and Hold
Roof Material: Metal
Heat Traps: Open Eaves,Wood Deck
Electrical Power: Overhead
Hazards: Fuels

Hazard Notes: Random debris around structures. Propane canisters spread around property. Overhead power lines attached to trees.

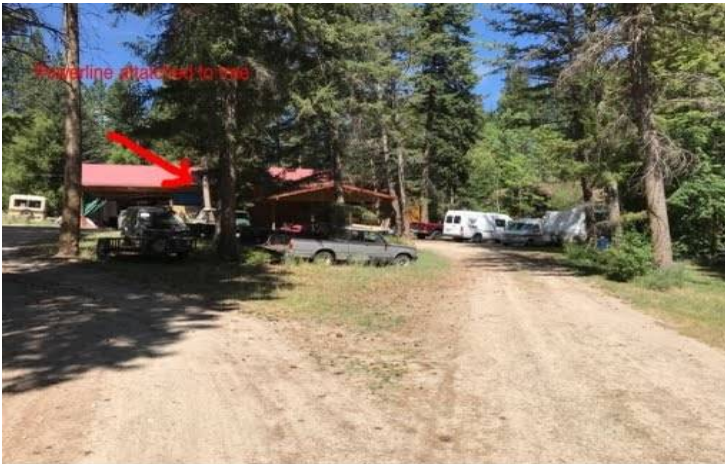
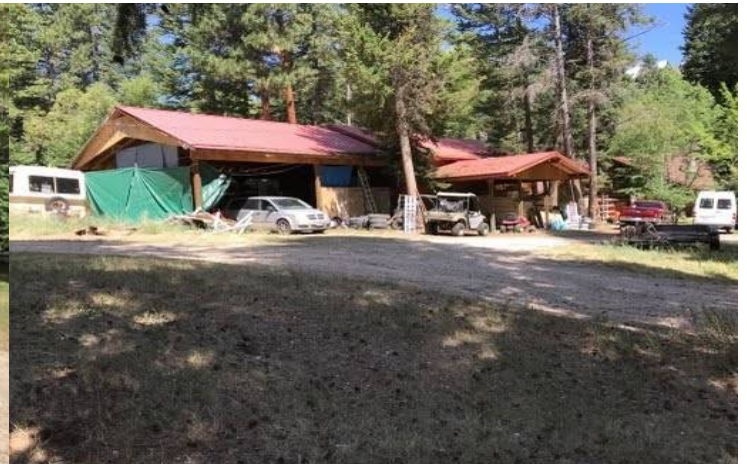
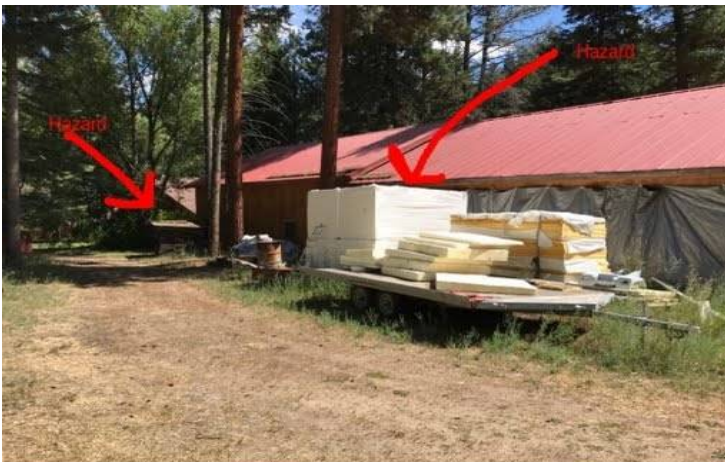
Hazard Notes: Lots of non woody debris. For example, old buses, styrofoam, building material.

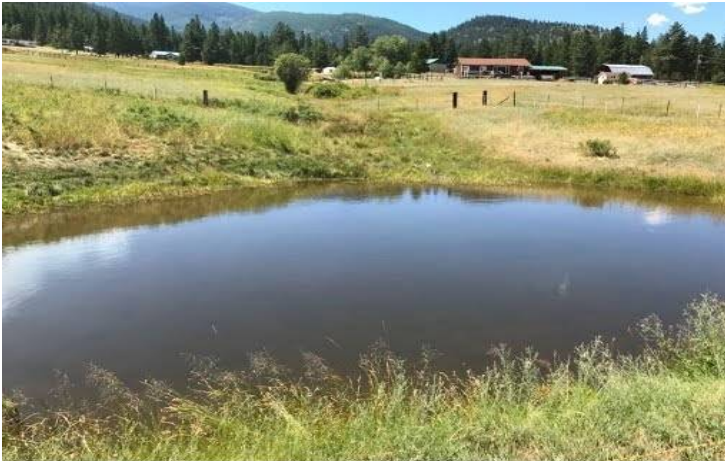
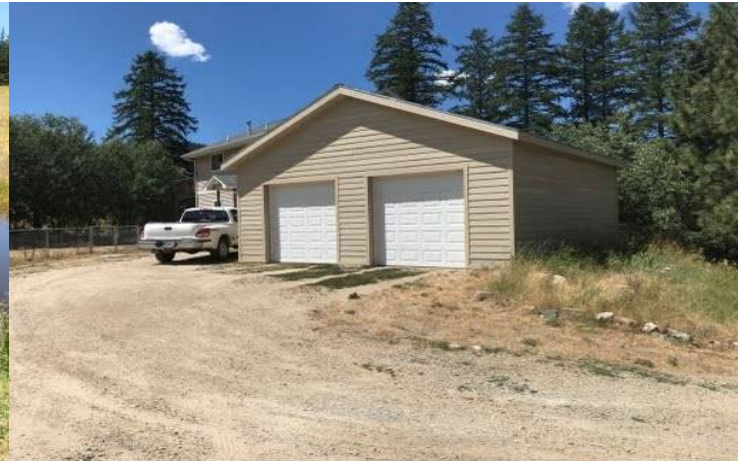
Structure Number: 3869
Structure Name: 12905 Severin RD
SubDivision: Mill creek
GPS Location, Lat. 46 44.81544
GPS Location, Long. 114 12.61104
Safety Zone Present: No
Type of Structure: Residential
Surrounding Fuels: Grass, Timber
Structure Triage Category: Non-Defensible, Prep and Leave
Roof Material: Composite
Heat Traps: Wood Deck, Rain Gutters
Electrical Power: Overhead
Hazards: Animals
Access to Site: T3/4 Engine
Comm with ICP: Radio
Water Source: Large Pond
Mitigation Time: 1-2 Hours
Other Resources Needed to Protect: Sprinklers, Type 3/4 Engine
Notes: Back barn

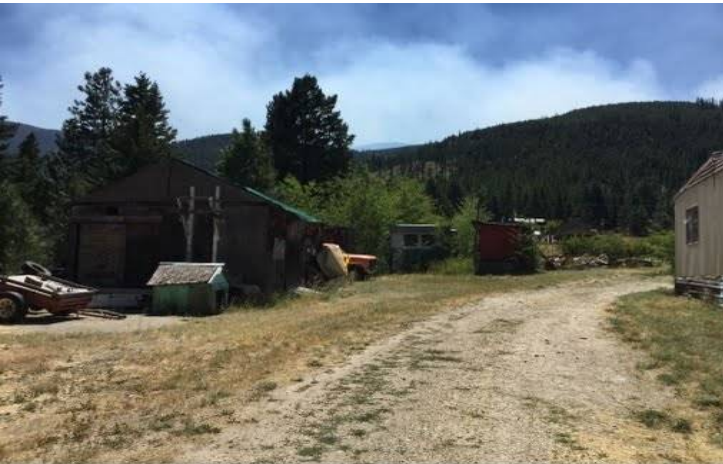
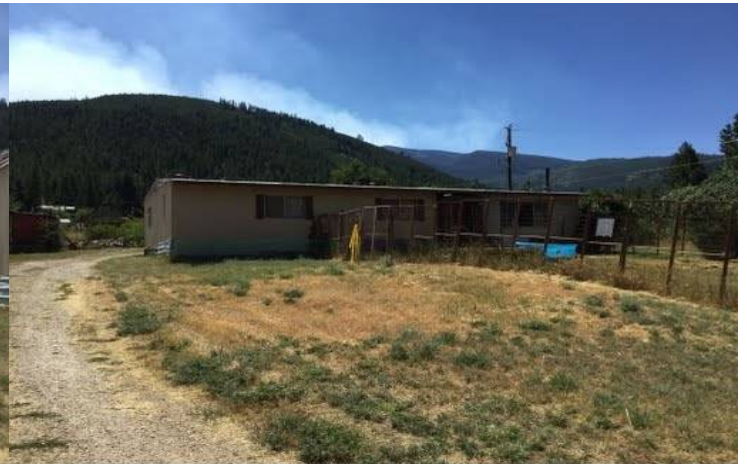
Structure Number: 3908
Structure Name: 12930 Severin
SubDivision: Mill Creek
GPS Location, Lat. 46 44.80548
GPS Location, Long. 114 12.49524
Safety Zone Present: No
Type of Structure: Residential
Surrounding Fuels: Grass, Timber
Structure Triage Category: Defensible, Prep and Hold
Roof Material: Metal
Heat Traps: Other Receptor
Electrical Power: Overhead
Hazards: Animals, Septic Tank, HazMat
Hazard Notes: Possible hazmat in sheds. Dog.
Access to Site: T3/4 Engine
Comm with ICP: Radio
Water Source: Faucet / Hose
Mitigation Time: 1-2 Hours
Other Resources Needed to Protect: None
Notes: Various, Cluttered items in yard.

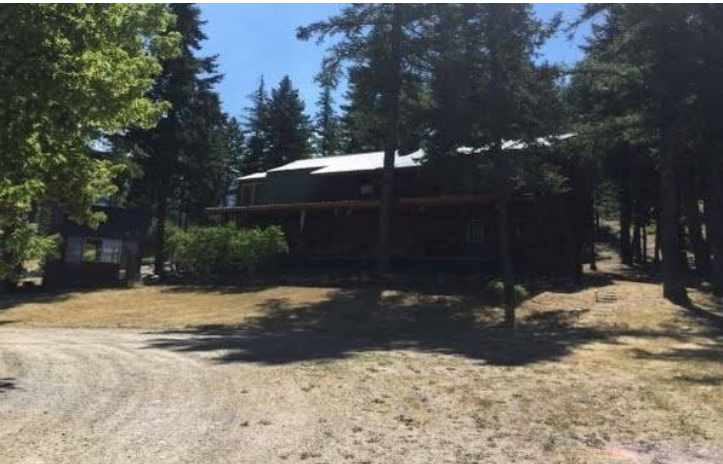
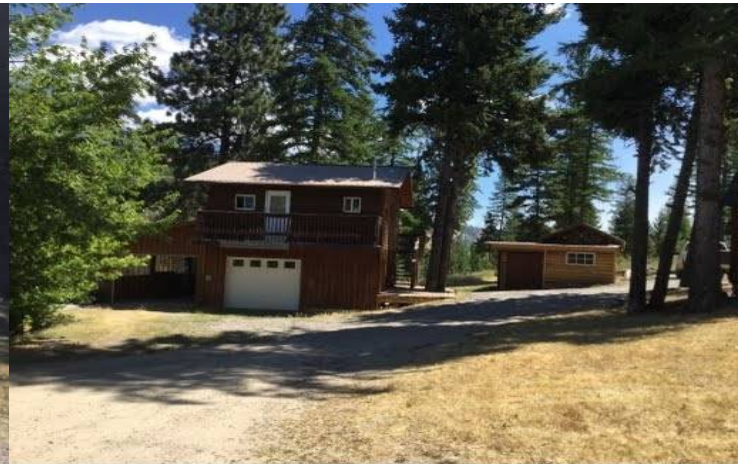
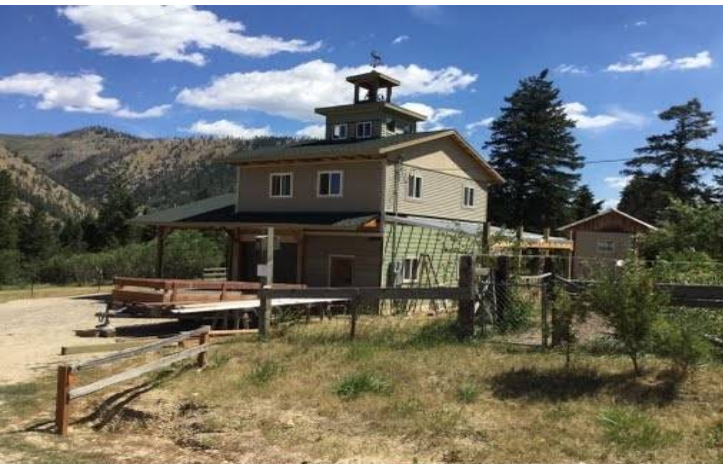
Structure Number: 3868
Structure Name: 13000 Thayer Dr
SubDivision: Mill creek
GPS Location, Lat. 46 44.65344
GPS Location, Long. 114 12.5529
Safety Zone Present: No
Type of Structure: Residential
Surrounding Fuels: Grass, Timber
Structure Triage Category: Non-Defensible, Prep and Leave
Roof Material: Composite
Heat Traps: Wood Deck, Rain Gutters
Electrical Power: Underground
Hazards: Animals
Hazard Notes: Dog, barked but was friendly.
Access to Site: T1 Engine
Comm with ICP: Radio, Cell Service
Water Source: None
Mitigation Time: 1-2 Hours
Other Resources Needed to Protect: 1 to 2 type 6 engines.
Collected By: TNF-E65

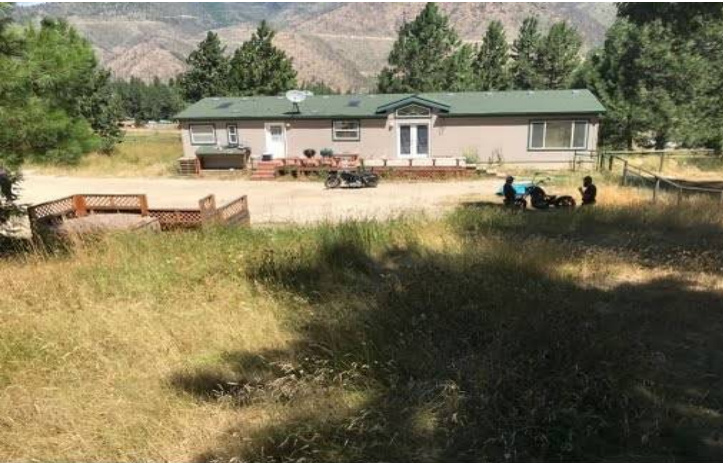
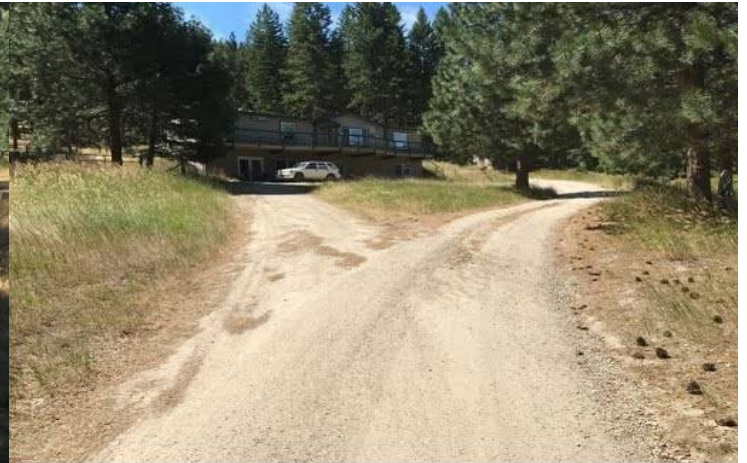
Structure Number: 3860
Structure Name: 13025 Severin
SubDivision: Mill Creek
GPS Location, Lat. 46 44.71668
GPS Location, Long. 114 12.58824
Safety Zone Present: Yes **Where is Safety Zone:** Behind home.
Type of Structure: Residential **Primary Structures:** 1 **Outbuildings:** 2
Surrounding Fuels: Grass **Defensible Space:** >100 Feet
Structure Triage Category: Defensible, Stand Alone
Roof Material: Composite **Siding Material:** Wood
Heat Traps: Wood Deck,Rain Gutters,Other Receptor
Electrical Power: Underground **Gas to Structure:**
Hazards: Animals,Septic Tank
Hazard Notes: Horses, barn and stalls need secured. Medium wood pile front of property.
Access to Site: T1 Engine **Best Access From:** Severin road off mill creek road.
Comm with ICP: Radio
Water Source: Faucet / Hose
Mitigation Time: Less Than An Hour
Notes: Neighboring structure has large pond.

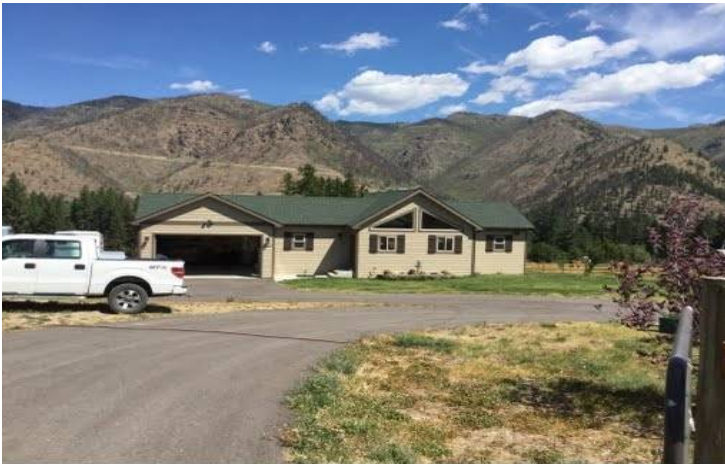
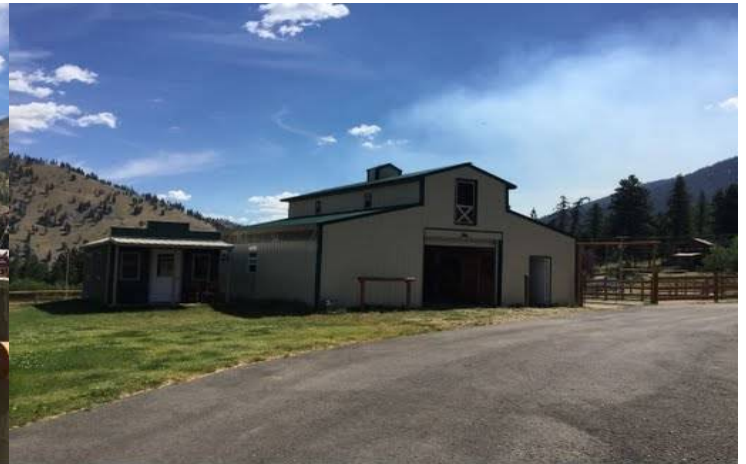
Structure Number: 3866
Structure Name: 13040 Severin
SubDivision: Mill creek
GPS Location, Lat. 46 44.68494
GPS Location, Long. 114 12.61188
Safety Zone Present: Yes
Type of Structure: Residential
Surrounding Fuels: Grass, Timber
Structure Triage Category: Defensible, Prep and Hold
Roof Material: Metal
Heat Traps: Rain Gutters
Electrical Power: Overhead
Hazards:
Hazard Notes: Power lines on property
Access to Site: T3/4 Engine
Comm with ICP: Radio
Water Source: Faucet / Hose
Mitigation Time: 3-4 Hours
Other Resources Needed to Protect: Hand crew 10-20 people
Collected By: TNF-E65

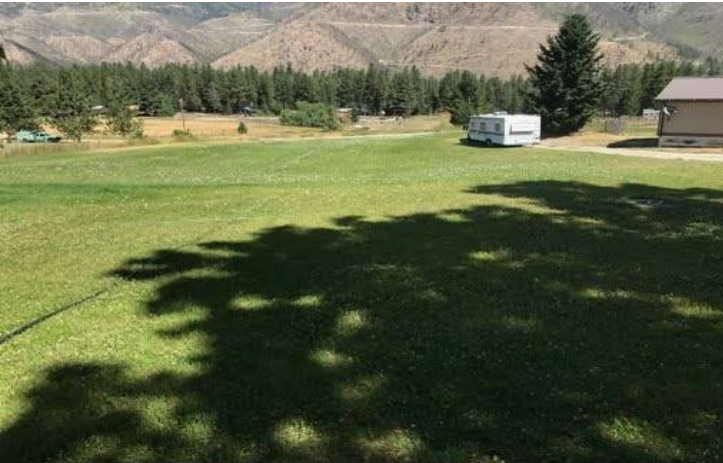
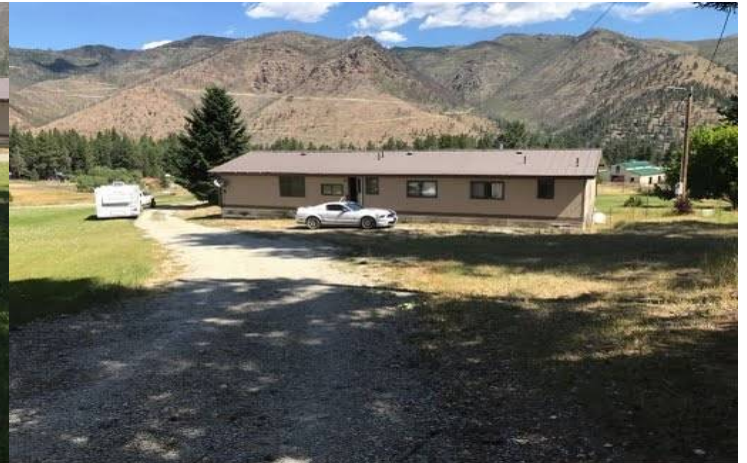
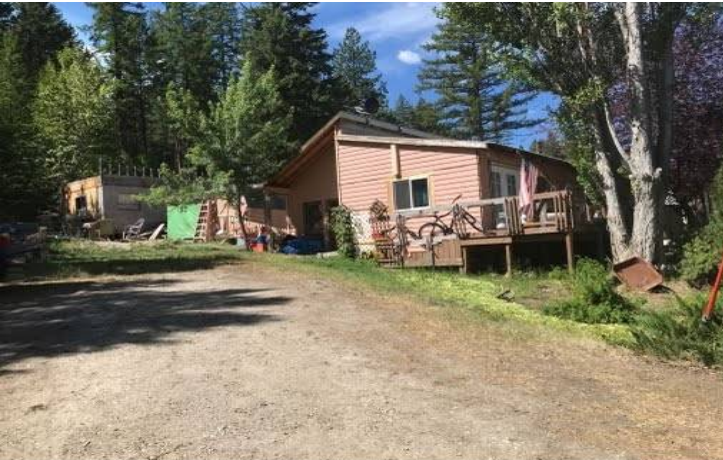
Structure Number: 3835
Structure Name: 13066 Tira Ln
SubDivision: Mill Creek
GPS Location, Lat. 46 44.72028
GPS Location, Long. 114 8.32614
Safety Zone Present: Yes
Type of Structure: Residential
Surrounding Fuels: Grass, Timber
Structure Triage Category: Defensible, Prep and Hold
Roof Material: Composite
Heat Traps: Wood Deck, Rain Gutters
Electrical Power: Underground
Hazards: Fuels
Hazard Notes: Dense fuels surrounding property
Access to Site: T1 Engine
Comm with ICP: Radio, Cell Service
Water Source: Faucet / Hose, Creek
Mitigation Time: Less Than An Hour
Notes: -property is surrounded by dense fuels 50-300 feet away on the outside of the yard
-gutters are full of pine needles
-**house says 13066 instead of 13055**
