STRUCTURE
PROTECTION PLAN
FOR
ELK CREEK BLOCK
07/27/2017

Structure Protection Plan

OZ Ranch

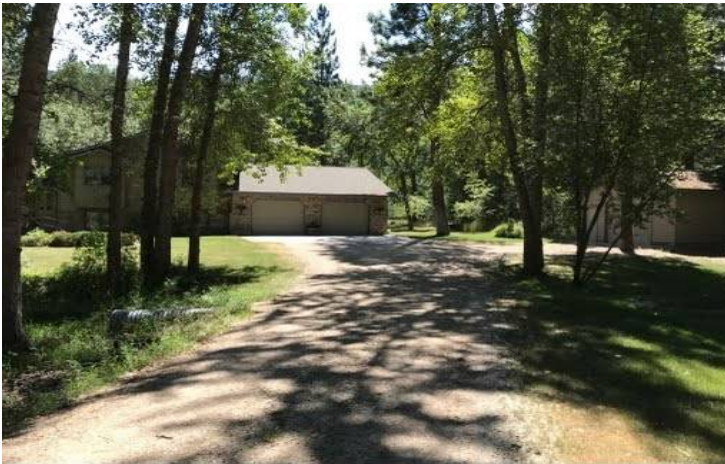
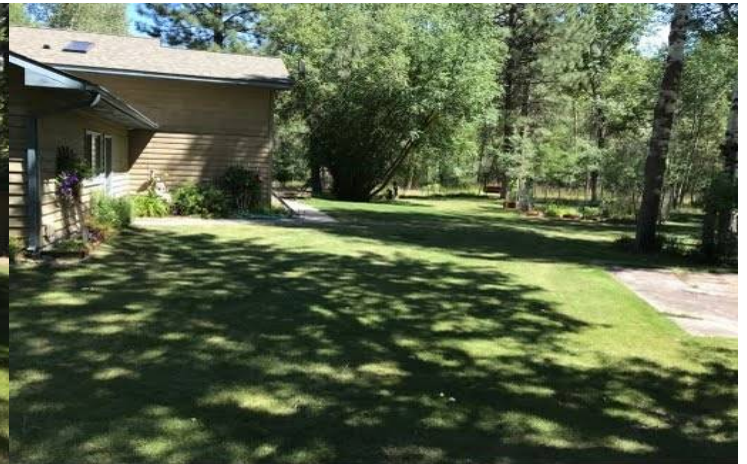
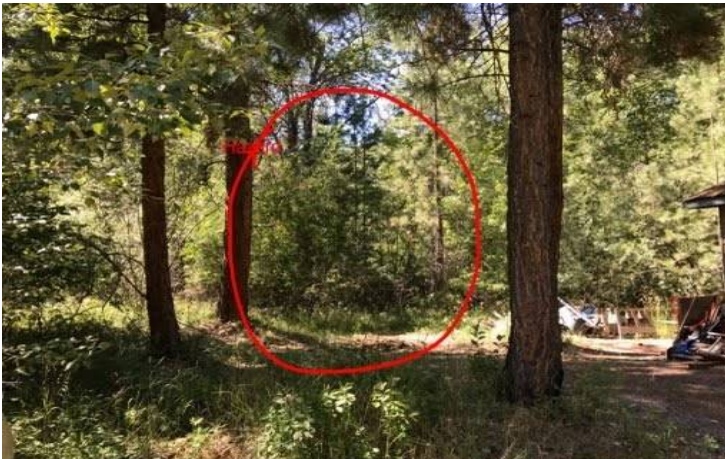
Structure Number: 3909
Structure Name: 13075 Severin
SubDivision: Mill Creek
GPS Location, Lat. 46 44.71596
GPS Location, Long. 114 12.7719
Safety Zone Present: Yes **Where is Safety Zone:** Large grass meadow in front of house.
Type of Structure: Residential **Primary Structures:** 1 **Outbuildings:** 3
Surrounding Fuels: Grass, Timber **Defensible Space:** 30-50 Feet
Structure Triage Category: Defensible, Prep and Hold
Roof Material: Metal **Siding Material:** Wood
Heat Traps: Wood Deck
Electrical Power: Overhead **Gas to Structure:** Aboveground
Hazards: Septic Tank, HazMat
Hazard Notes: LPG tank 500 gal. Owner states LPG tank empty. Septic in open field to the north.
Access to Site: T3/4 Engine **Best Access From:** Severin road off mill creek road.
Comm with ICP: Radio
Water Source: Faucet / Hose, Large Pond
Mitigation Time: 2-3 Hours
Other Resources Needed to Protect: Sprinklers or crew to assist in prep.

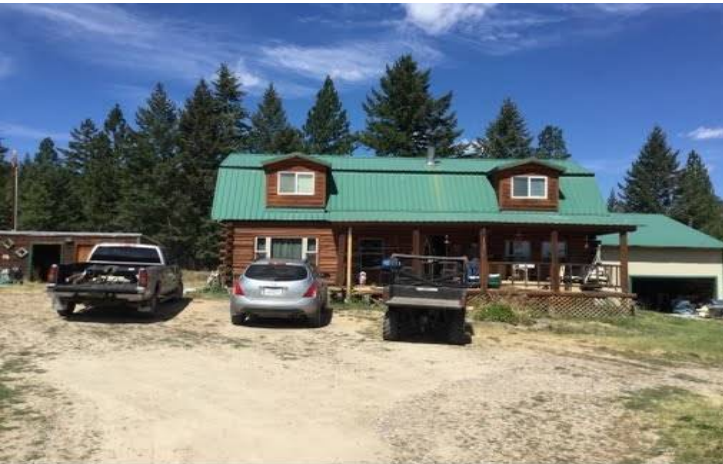
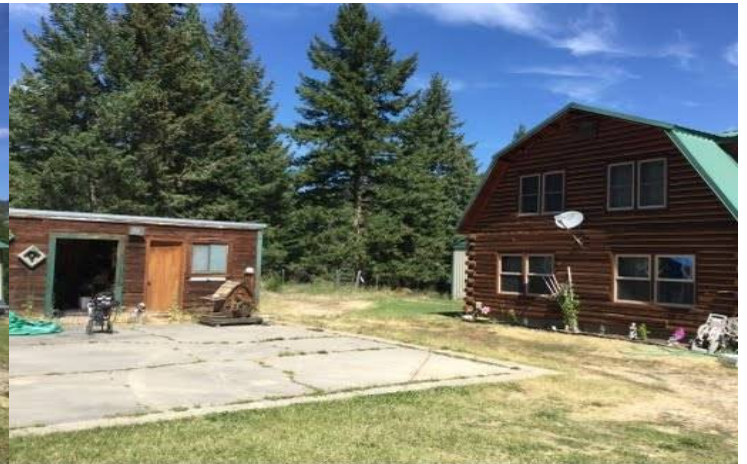
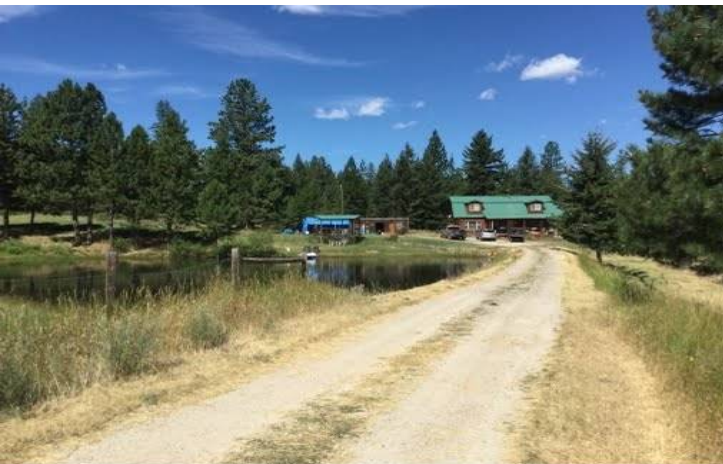
Structure Number: 3862
Structure Name: 13080 Thayer Rd
SubDivision: Mill Creek
GPS Location, Lat. 46 44.66592
GPS Location, Long. 114 12.73278
Safety Zone Present: No
Type of Structure: Residential
Surrounding Fuels: Grass, Timber
Structure Triage Category: Non-Defensible, Prep and Leave
Roof Material:
Heat Traps: Wood Deck, Rain Gutters
Electrical Power: Overhead
Hazards: HazMat
Hazard Notes: Multiple vehicles
Access to Site: T3/4 Engine
Comm with ICP: Radio
Water Source: Large Pond
Mitigation Time: 3-4 Hours
Other Resources Needed to Protect: Hand crew, Type 3/4 Engine
Notes: A boat is nearby the main structure.

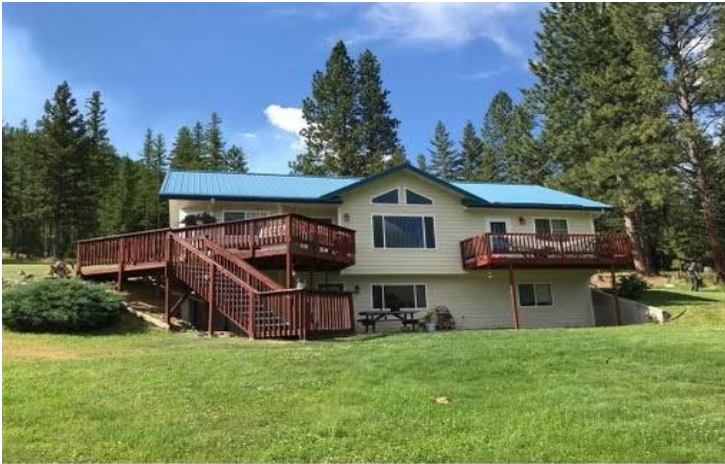
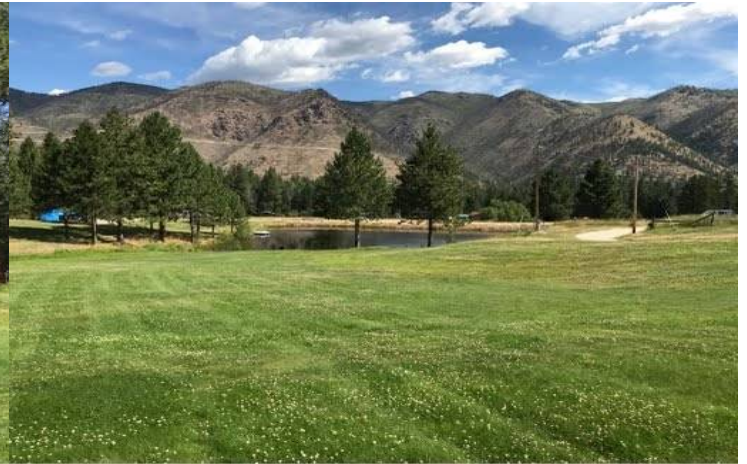
Structure Number: 3901
Structure Name: 14449 Neil Drive
SubDivision: Mill Creek
GPS Location, Lat. 46 44.93868
GPS Location, Long. 114 12.40428
Safety Zone Present: No
Type of Structure: Residential
Surrounding Fuels: Grass
Structure Triage Category: Defensible, Prep and Hold
Roof Material: Composite
Heat Traps:
Electrical Power: Overhead
Hazards: Fuels, HazMat
Hazard Notes: Hay bales near livestock stable, paint cans near shed, wood pile near shed
Access to Site: T1 Engine
Comm with ICP: Radio
Water Source: Faucet / Hose
Mitigation Time: 1-2 Hours
Collected By: LoLo 632

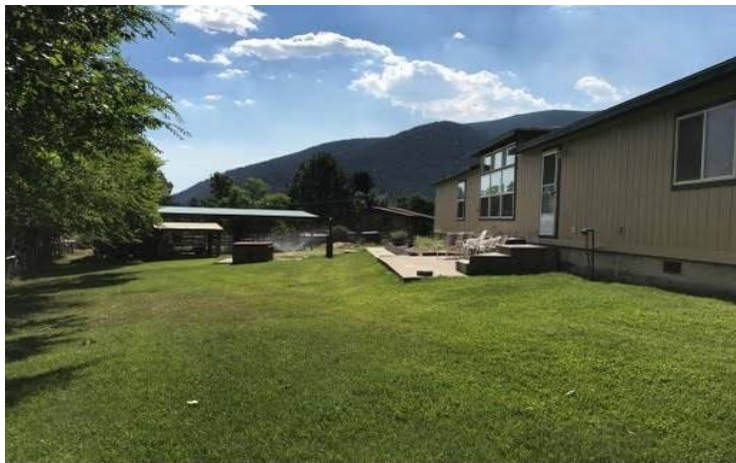
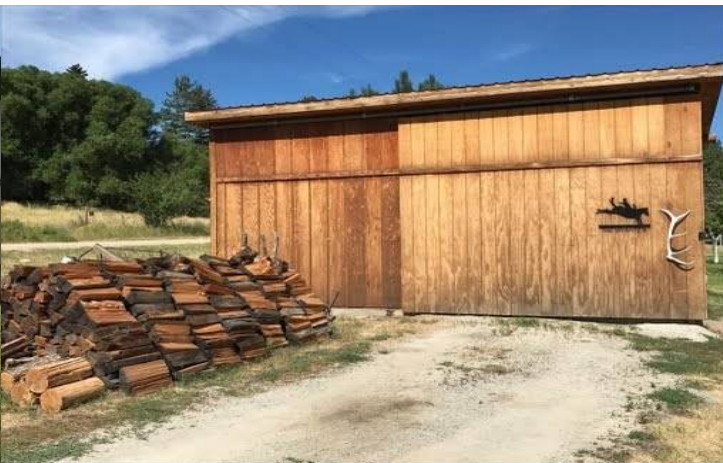
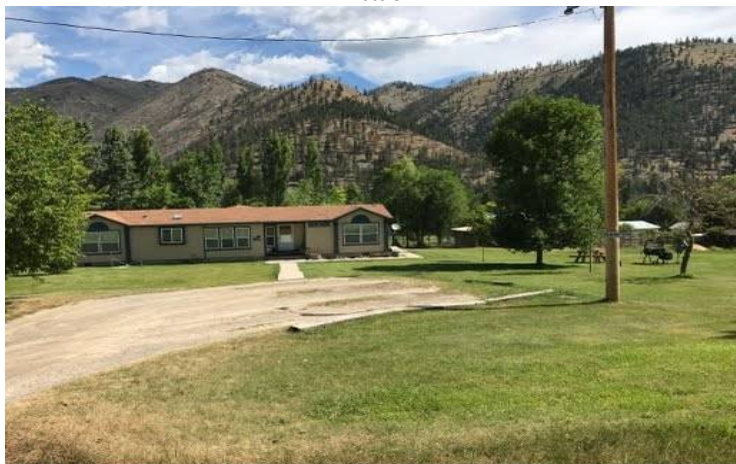
Structure Number: 3902
Structure Name: 14469 Neil Creek
SubDivision: Mill Creek
GPS Location, Lat. 46 44.93466
GPS Location, Long. 114 12.35958
Safety Zone Present: Yes
Type of Structure: Residential
Surrounding Fuels: Grass,Shrub
Structure Triage Category: Defensible, Prep and Hold
Roof Material: Metal
Heat Traps: Other Receptor
Electrical Power: Overhead
Hazards: Fuels,HazMat
Hazard Notes: Propane, large pile of lumber at entrance
Access to Site: T1 Engine
Comm with ICP: Radio
Water Source: Faucet / Hose,Creek
Mitigation Time: 3-4 Hours
Collected By: LoLo 632

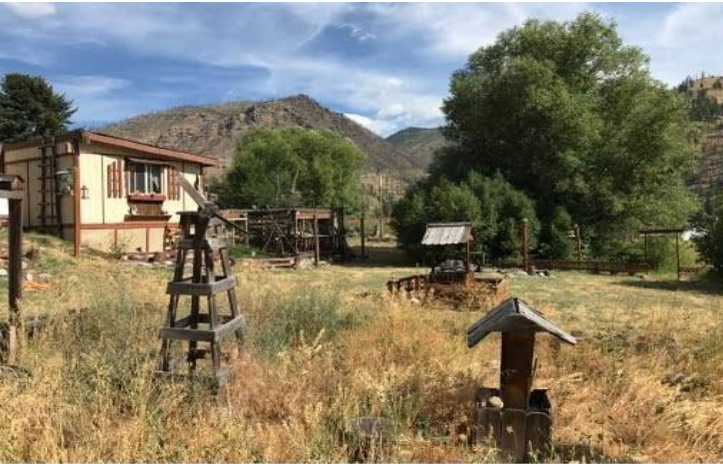
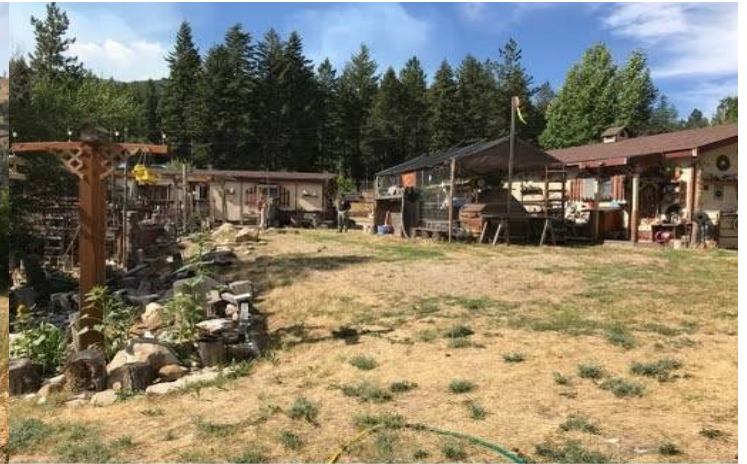
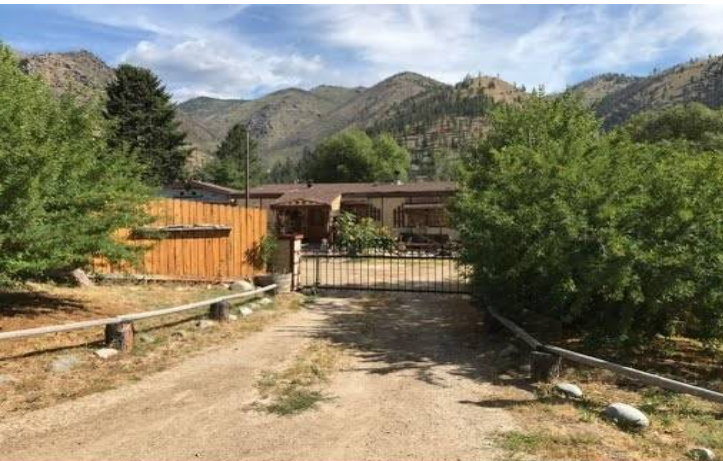
Structure Number: 3900
Structure Name: 14538 Neil Drive
SubDivision: Mill Creek
GPS Location, Lat. 46 44.88834
GPS Location, Long. 114 12.31518
Safety Zone Present: No
Type of Structure: Residential
Surrounding Fuels: Grass, Timber
Structure Triage Category: Defensible, Prep and Hold
Roof Material: Metal
Heat Traps:
Electrical Power: Overhead
Hazards:
Access to Site: T1 Engine
Comm with ICP: Radio
Water Source: Faucet / Hose
Mitigation Time: Less Than An Hour
Collected By: LoLo 632

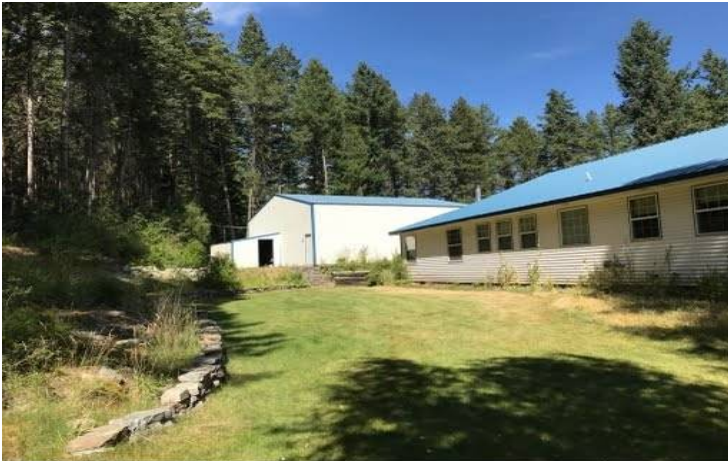
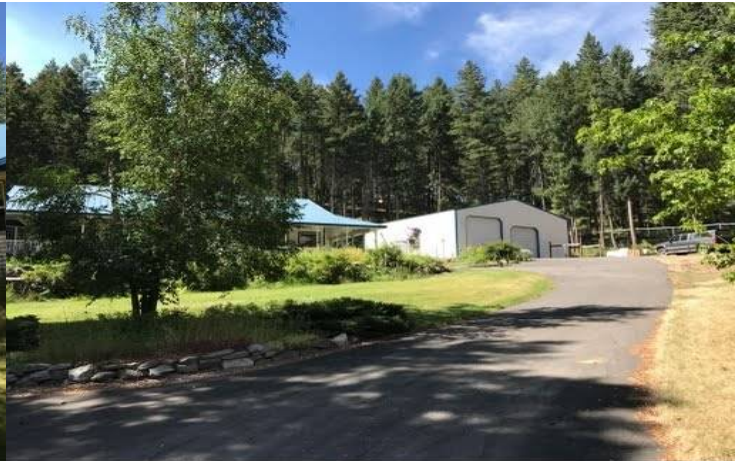
Structure Number: 3904
Structure Name: 14549 Neil Drive
SubDivision: Mill Creek
GPS Location, Lat. 46 44.94318
GPS Location, Long. 114 12.1947
Safety Zone Present: No **Where is Safety Zone:** Field to north across hwy 12, 3 minutes
Type of Structure: Residential **Primary Structures:** 1 **Outbuildings:** 5
Surrounding Fuels: Grass,Slash **Defensible Space:** 30-50 Feet
Structure Triage Category: Non-Defensible, Prep and Leave
Roof Material: Metal **Siding Material:** Metal
Heat Traps: Wood Deck
Electrical Power: Overhead **Gas to Structure:** Aboveground
Hazards: Fuels,HazMat
Hazard Notes: Tall grass, propane tank, 20 ft wide by 6 ft high slash piles
Access to Site: T1 Engine **Best Access From:** Hwy 12 to mill creek road left on Neil drive
Comm with ICP: Radio
Water Source: None
Mitigation Time: More Than 5 Hours
Other Resources Needed to Protect: 20 man crew needed to mitigate fuels around structures
Notes: Looks like mobile home is currently occupied with primary structure under construction

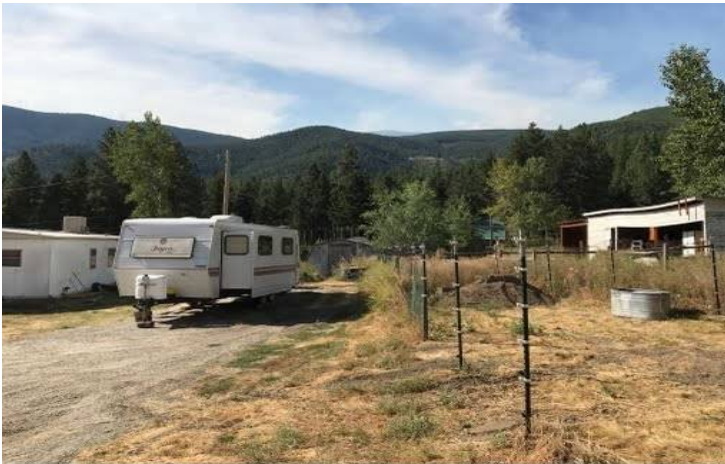
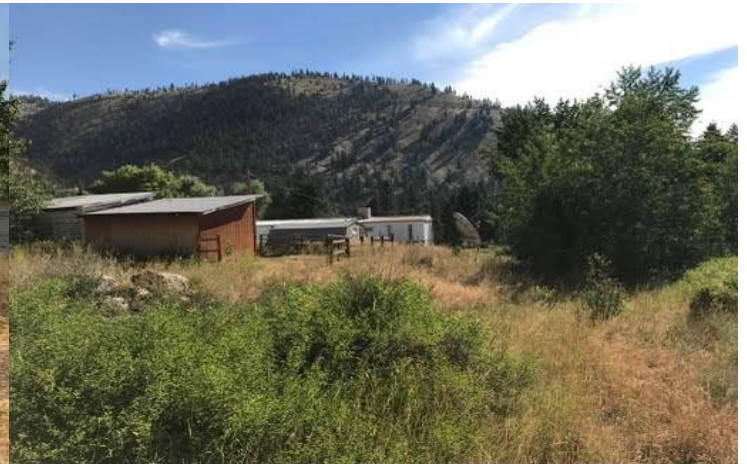
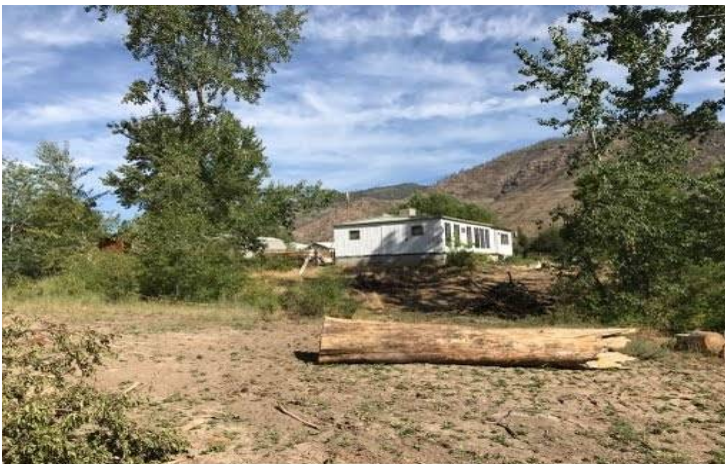
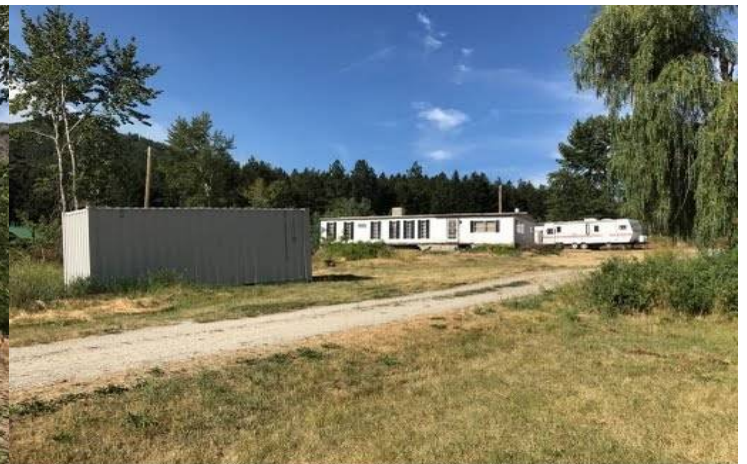
Structure Number: 3899
Structure Name: 1455 Neil Drive
SubDivision: Mill Creek
GPS Location, Lat. 46 44.90568
GPS Location, Long. 114 12.25284
Safety Zone Present: No
Type of Structure: Residential
Surrounding Fuels: Grass, Timber
Structure Triage Category: Defensible, Prep and Hold
Roof Material: Metal
Heat Traps: Other Receptor
Electrical Power: Underground
Hazards: Fuels
Hazard Notes: Wood piles
Access to Site: T1 Engine
Comm with ICP: Radio
Water Source: Faucet / Hose
Mitigation Time: 1-2 Hours
Collected By: LoLo 632

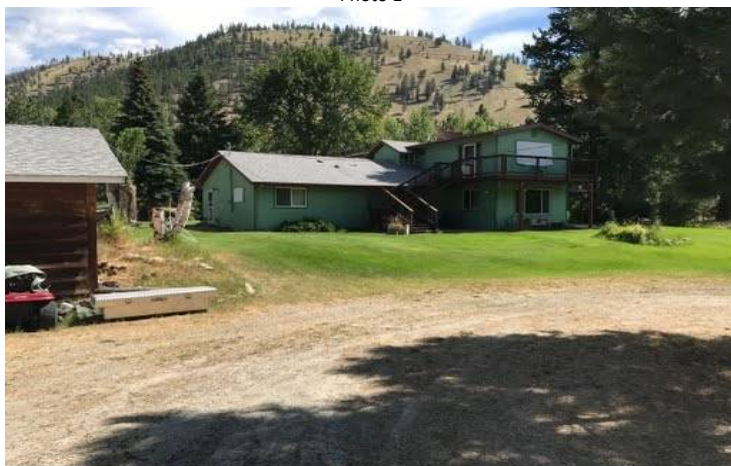
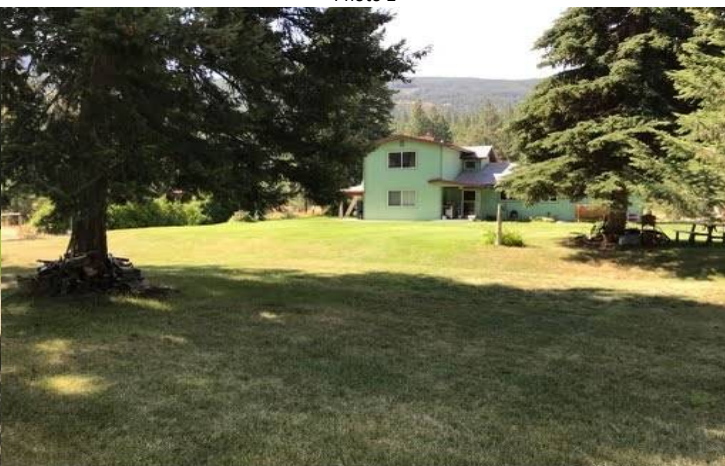
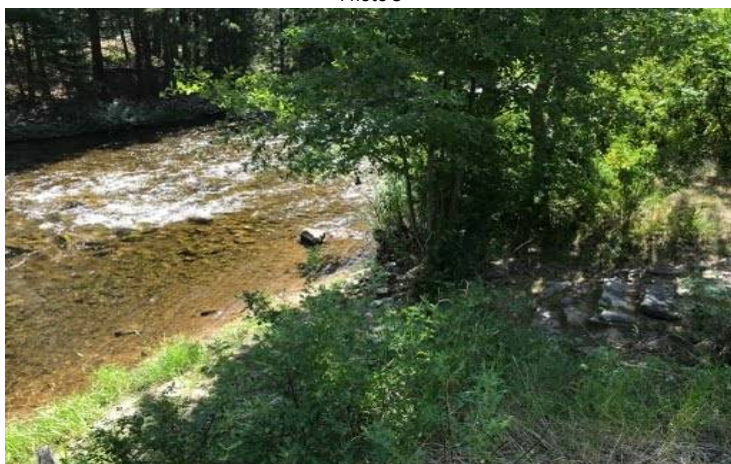
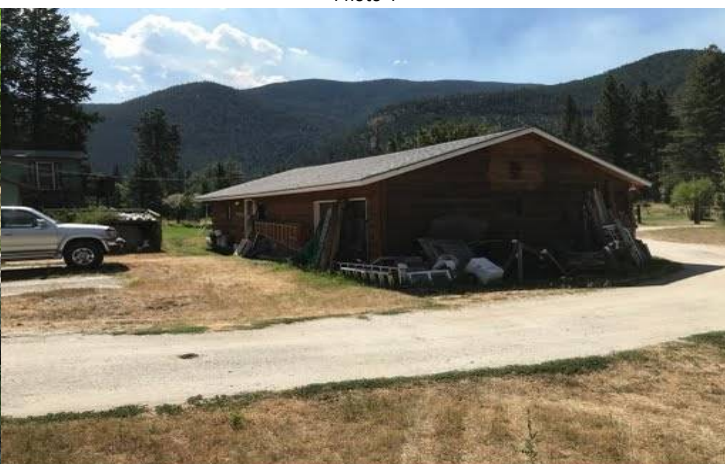
Safety Zone Present: Yes
Type of Structure: Residential
Surrounding Fuels: Grass
Structure Triage Category: Defensible, Stand Alone
Roof Material: Wood
Heat Traps:
Electrical Power: Overhead
Hazards: Fuels, HazMat
Firewood stacked near home, outbuilding wood siding and materials stacked along sides, wood stacked under trees
Hazard Notes:
Access to Site: T1 Engine
Comm with ICP: Radio
Water Source: Faucet / Hose, Creek
Mitigation Time: 1-2 Hours
Other Resources: None
Needed to Protect:
Notes: Clear fire wood from around building and from under trees, Creek 50 yards from home good access

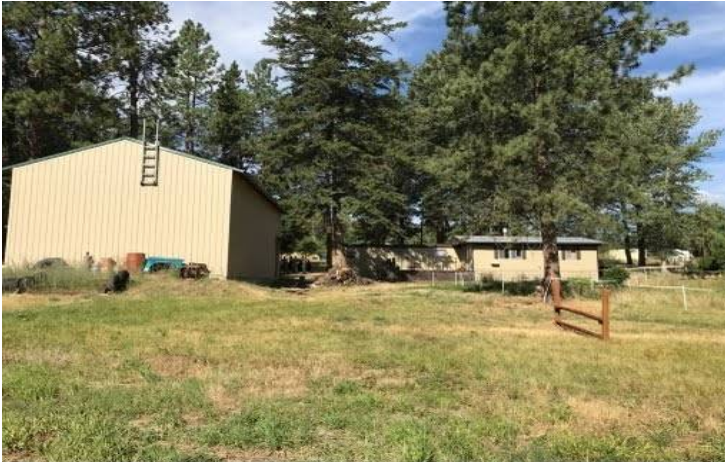
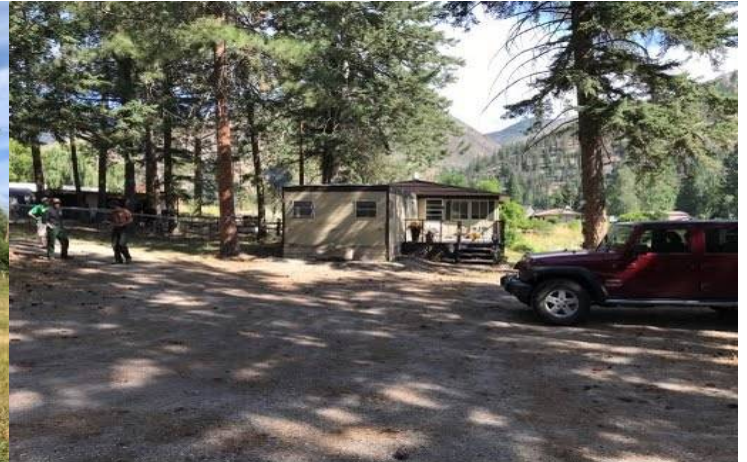
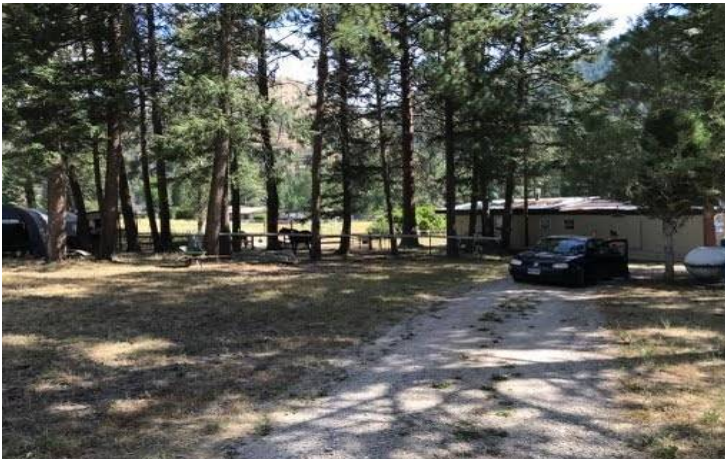
Safety Zone Present: Yes
Type of Structure: Residential
Surrounding Fuels: Grass
Structure Triage Category: Defensible, Prep and Hold
Roof Material: Metal
Heat Traps: Open Eaves, Wood Deck
Electrical Power: Overhead
Hazards: Fuels, Animals, HazMat
Hazard Notes: Propane tank, back side of outbuilding has un-marked tanks, heating oil tank, outbuilding stocked with hay, livestock present (horses)
Access to Site: T1 Engine
Comm with ICP: Radio
Water Source: Faucet / Hose
Mitigation Time: 1-2 Hours
Other Resources Needed to Protect: None
Notes: Some light work clearing around buildings. Would evacuate to safety zone as fire front passes

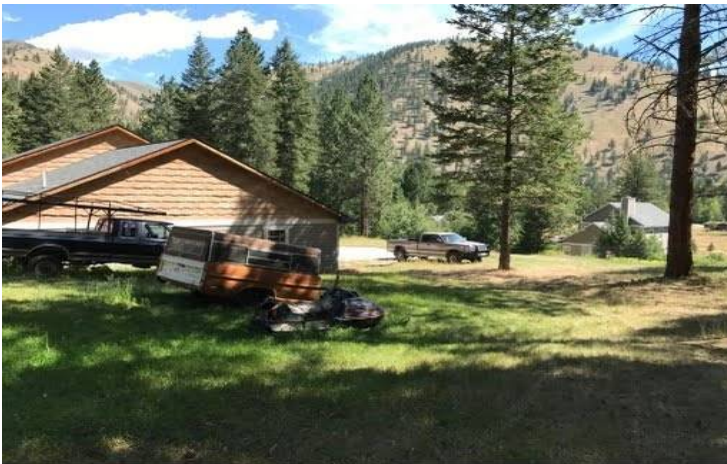
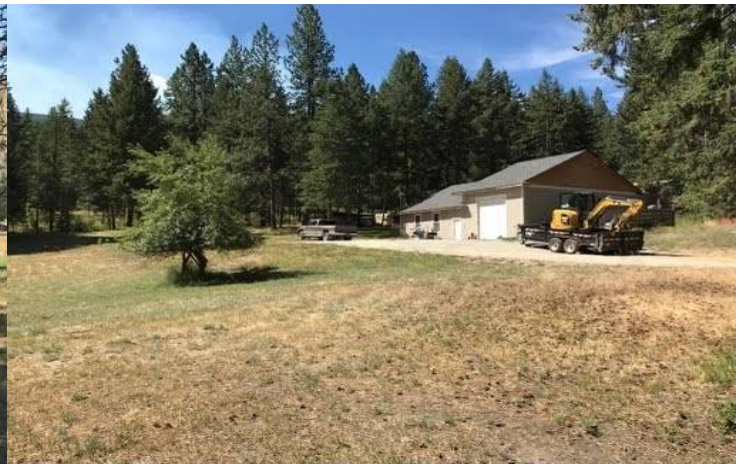
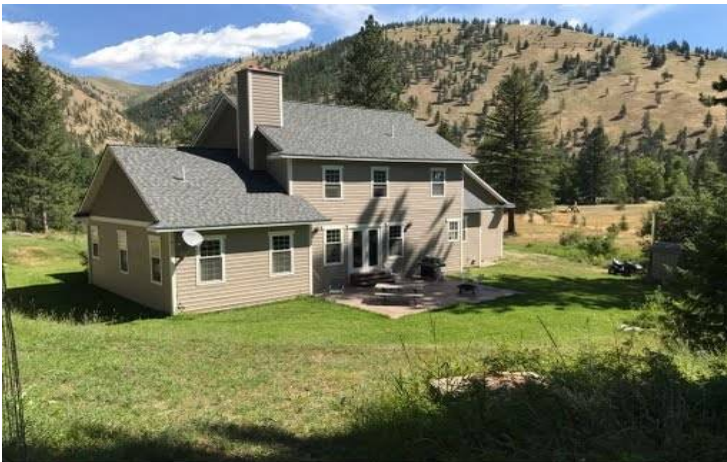
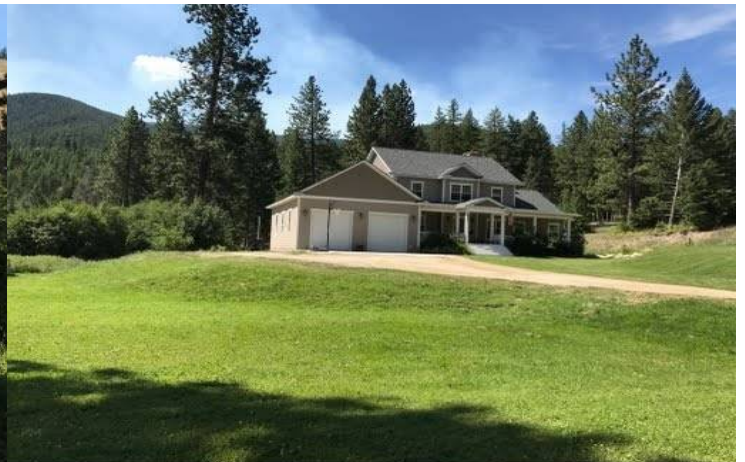
Safety Zone Present: Yes
Type of Structure: Residential
Surrounding Fuels: Grass, Shrub, Timber
Structure Triage Category: Defensible, Stand Alone
Roof Material: Composite
Heat Traps:
Electrical Power: Underground
Hazards: HazMat
Access to Site: T1 Engine
Comm with ICP: Radio
Water Source: Faucet / Hose
Mitigation Time: 1-2 Hours
Other Resources Needed to Protect: Some brush on the SE corner by the house could be removed if time allowed, 30 feet between brush and house.

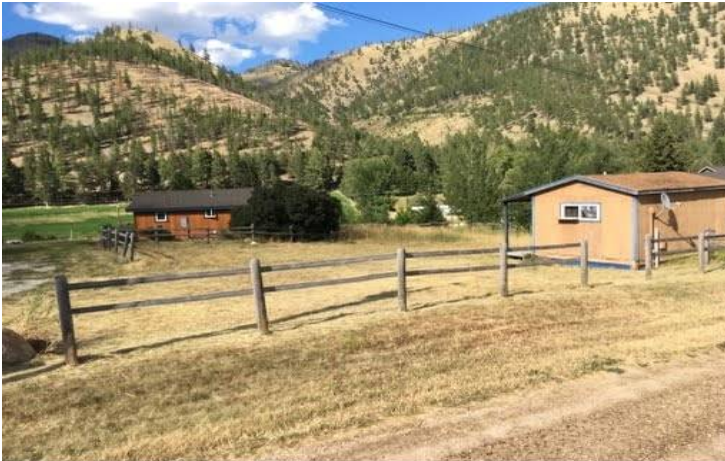
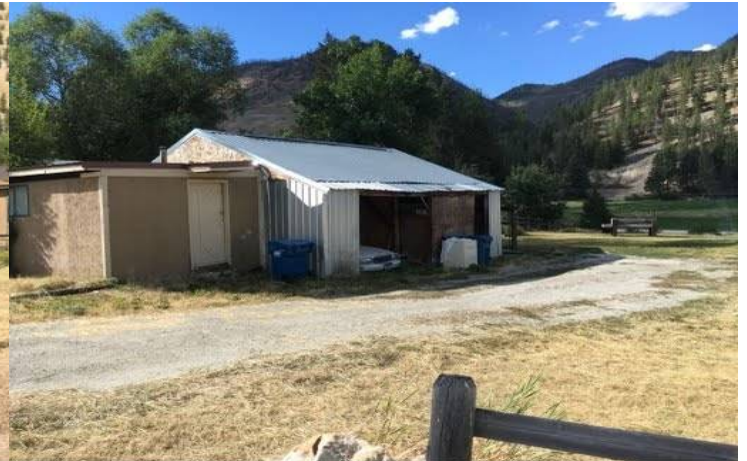
Structure Number: 3802
Structure Name: 14800 Neil Dr
SubDivision: Mill Creek
GPS Location, Lat. 46 45.03138
GPS Location, Long. 114 12.2181
Safety Zone Present: No **Where is Safety Zone:** Out to Hwy 12
Type of Structure: Residential **Primary Structures:** 1 **Outbuildings:** 2
Surrounding Fuels: Grass **Defensible Space:** None
Structure Triage Category: Defensible, Prep and Hold
Roof Material: Composite **Siding Material:** Wood
Heat Traps: Wood Deck
Electrical Power: Overhead **Gas to Structure:** None
Hazards:
Access to Site: T1 Engine **Best Access From:** Neil RD.
Comm with ICP: Radio
Water Source: Creek
Mitigation Time: 2-3 Hours
Other Resources Needed to Protect: Engine crew to cut weeds and clean up
Notes: Creek is directly behind structure.

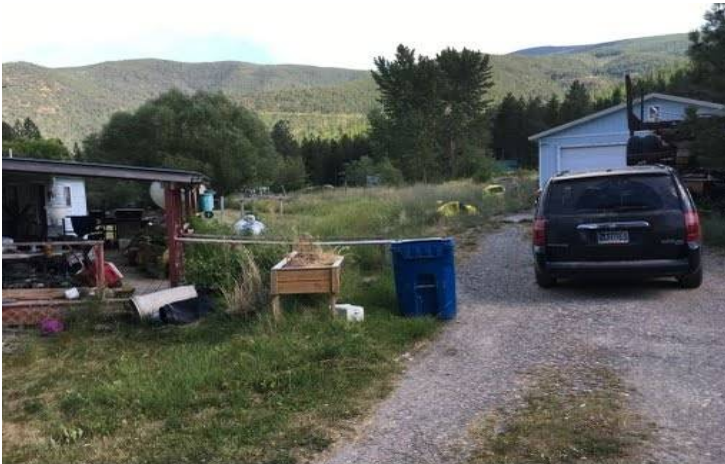
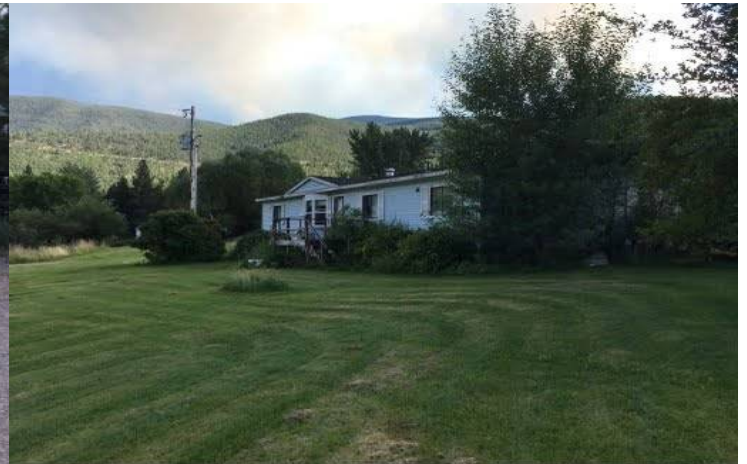
Structure Number: 3801
Structure Name: 14849 Neil Dr.
SubDivision: Mill Creek
GPS Location, Lat. 46 44.96844
GPS Location, Long. 114 12.27162
Safety Zone Present: Yes **Where is Safety Zone:** Front yard watered grass, 2 engines
Type of Structure: Residential **Primary Structures:** 1 **Outbuildings:** 1
Surrounding Fuels: Grass **Defensible Space:** 30-50 Feet
Structure Triage Category: Non-Defensible, Prep and Leave
Roof Material: Composite **Siding Material:** Wood
Heat Traps: Open Eaves, Wood Deck
Electrical Power: Overhead **Gas to Structure:** Aboveground
Hazards: HazMat
Hazard Notes: Lots of gas and diesel in garage. Several abandoned vehicles around structure
Access to Site: T1 Engine **Best Access From:** Neil Dr
Comm with ICP: Radio
Water Source: Faucet / Hose
Mitigation Time: More Than 5 Hours
Other Resources Needed to Protect: Engine crew most of one day to clean behind house, grass, trash and debris

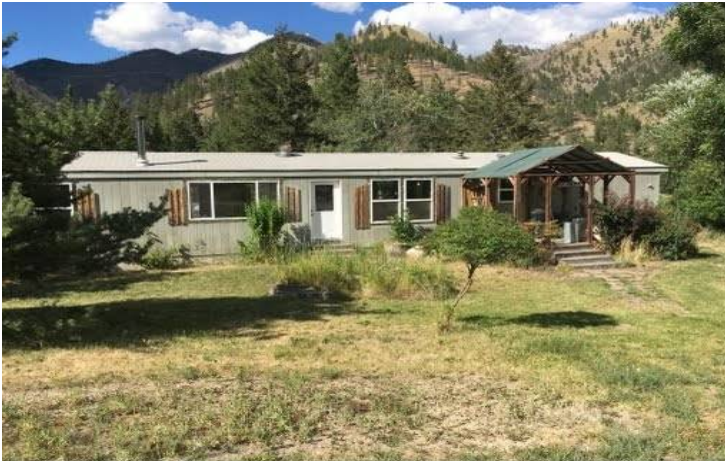
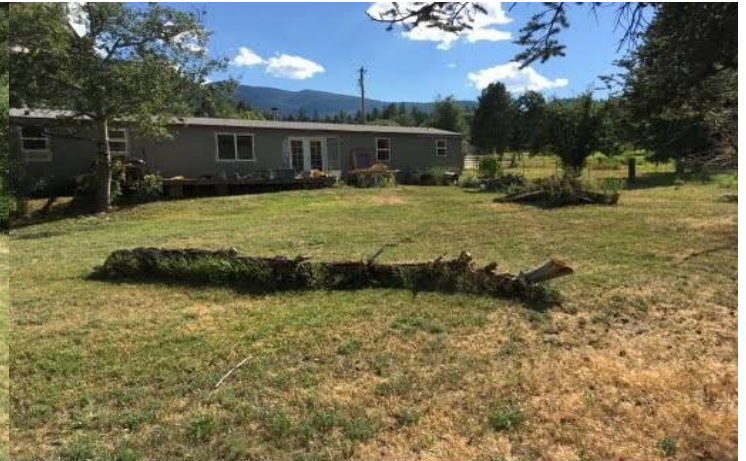
Structure Number: 3799
Structure Name: 14850 Neil Dr
SubDivision: Mill Creek
GPS Location, Lat. 46 45.00618
GPS Location, Long. 114 12.26532
Safety Zone Present: No **Where is Safety Zone:** Out to Hwy 12
Type of Structure: Residential **Primary Structures:** 1 **Outbuildings:** 1
Surrounding Fuels: Grass,Shrub,Timber **Defensible Space:** None
Structure Triage Category: Non-Defensible, Rescue, Drive By
Roof Material: Composite **Siding Material:** Wood
Heat Traps: Wood Deck
Electrical Power: Overhead **Gas to Structure:** Aboveground
Hazards:
Access to Site: T1 Engine **Best Access From:** Neil Dr.
Comm with ICP: Radio
Water Source: None
Mitigation Time: More Than 5 Hours
Other Resources Needed to Protect: Abandoned drive by
Notes: Abandoned single wide with travel trailer in back yard. Looks like someone is fixing it up to make it livable

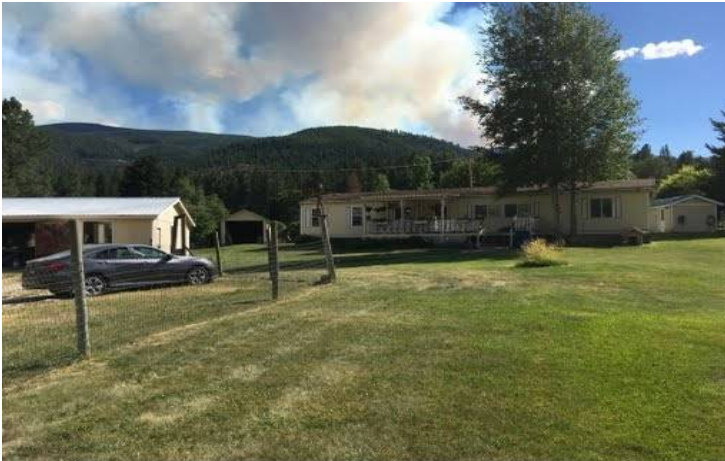
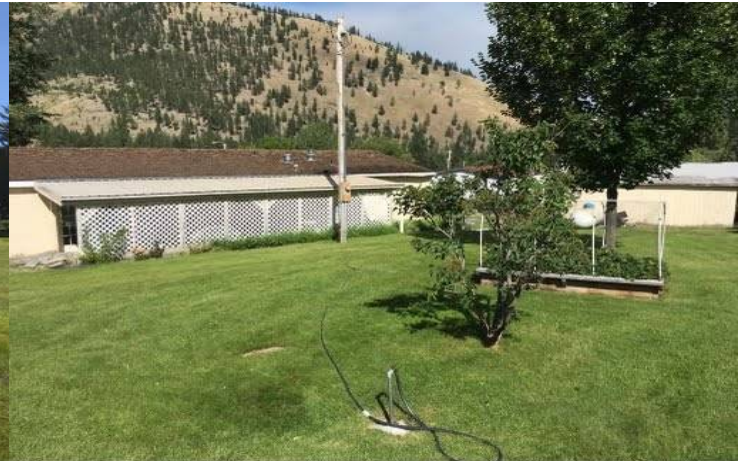
Structure Number: 3795
Structure Name: 14950 Neil Dr
SubDivision: Mill Creek
GPS Location, Lat. 46 45.03306
GPS Location, Long. 114 12.33864
Safety Zone Present: No
Type of Structure: Residential
Surrounding Fuels: Grass, Timber
Structure Triage Category: Defensible, Prep and Hold
Roof Material: Composite
Heat Traps: Wood Deck
Electrical Power: Overhead
Hazards:
Access to Site: T1 Engine
Comm with ICP: Radio
Water Source: Faucet / Hose
Mitigation Time: 2-3 Hours
Other Resources Needed to Protect: Engine crew to clean up weeds by garage. Sprinklers or mobile attack.
Notes: Front is watered grass, back is 30 ft to timbered area. Grass under propane tank next to garage.

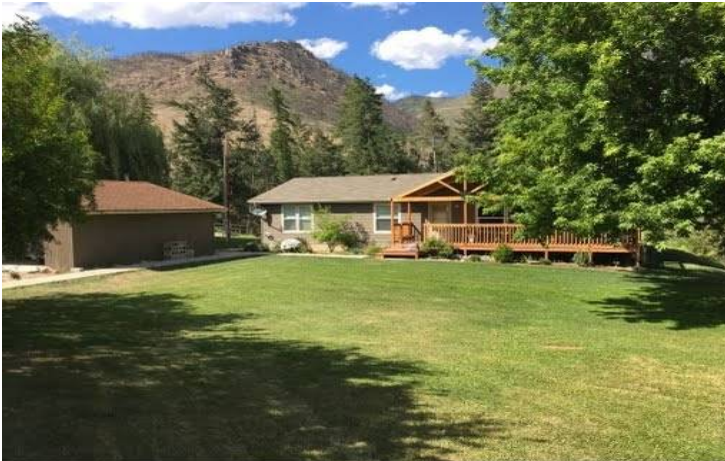
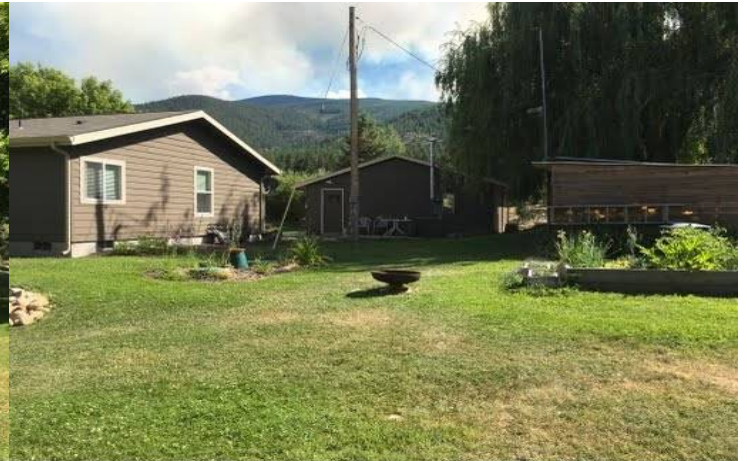
Structure Number: 3798
Structure Name: 14999 Neil Dr
SubDivision: Mill Creek
GPS Location, Lat. 46 44.99628
GPS Location, Long. 114 12.41694
Safety Zone Present: Yes
Type of Structure: Residential
Surrounding Fuels: Grass
Structure Triage Category: Defensible, Stand Alone
Roof Material: Composite
Heat Traps: Wood Deck
Electrical Power: Overhead
Hazards:
Access to Site: T1 Engine
Comm with ICP: Radio, Cell Service
Water Source: Faucet / Hose
Mitigation Time: Less Than An Hour
Notes: Minimal work needed

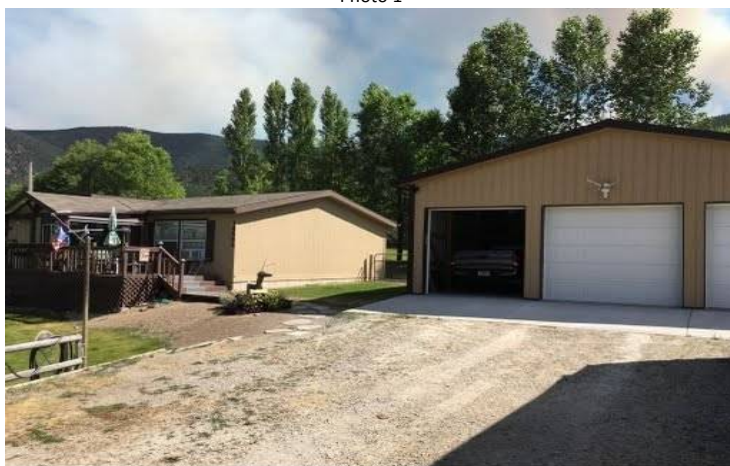
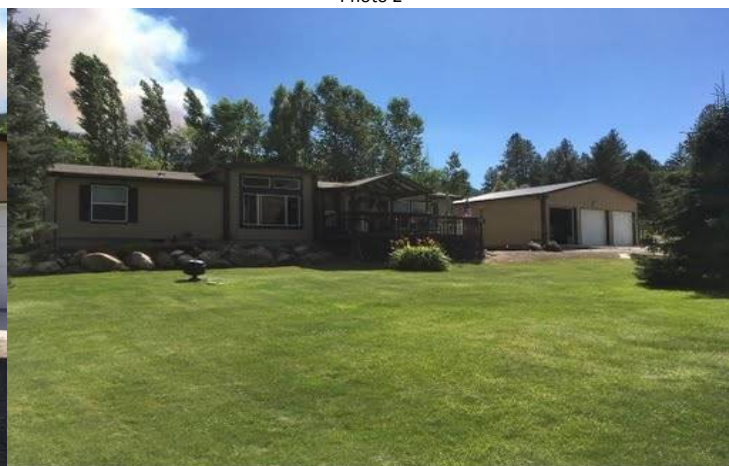
Structure Number: 3794
Structure Name: 15000 Neil Dr
SubDivision: Mill Creek
GPS Location, Lat. 46 45.03336
GPS Location, Long. 114 12.38418
Safety Zone Present: No
Type of Structure: Residential
Surrounding Fuels: Grass
Structure Triage Category: Defensible, Prep and Hold
Roof Material: Metal
Heat Traps: Wood Deck, Rain Gutters
Electrical Power: Overhead
Hazards:
Access to Site: T1 Engine
Comm with ICP: Radio
Water Source: Faucet / Hose
Mitigation Time: 1-2 Hours
Other Resources Needed to Protect: Sprinklers for wood deck, water will have to be from pumpkins. Will need an engine crew to clean out from beside garage
Notes: Garage has an accumulation of debris under porch.

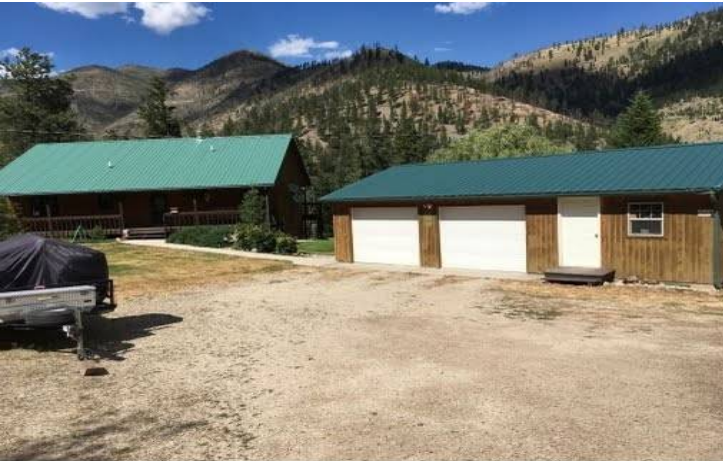
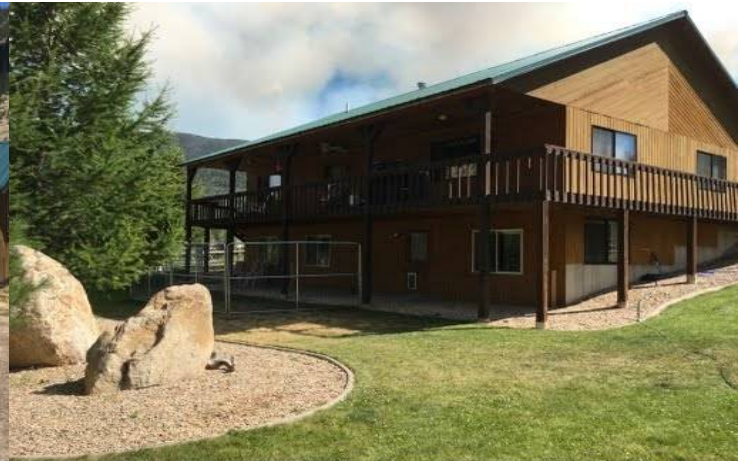
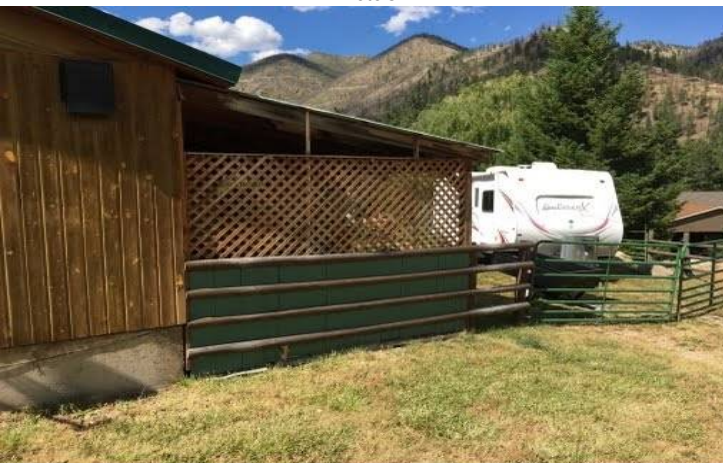
Structure Number: 3793
Structure Name: 15050 Mill Creek Rd
SubDivision: Mill Creek
GPS Location, Lat. 46 45.0192
GPS Location, Long. 114 12.41628
Safety Zone Present: Yes **Where is Safety Zone:** Front yard irrigated grass, one engine
Type of Structure: Residential **Primary Structures:** 1 **Outbuildings:** 1
Surrounding Fuels: Grass, Timber **Defensible Space:** >100 Feet
Structure Triage Category: Defensible, Stand Alone
Roof Material: Metal **Siding Material:** Wood
Heat Traps: Wood Deck, Other Receptor
Electrical Power: Underground **Gas to Structure:** None
Hazards:
Access to Site: T1 Engine **Best Access From:** Noel Dr
Comm with ICP: Radio, Cell Service
Water Source:
Mitigation Time: Less Than An Hour
Other Resources Needed to Protect: Engine to move wood by garage
Notes: Minimal work needed, pallets by garage.

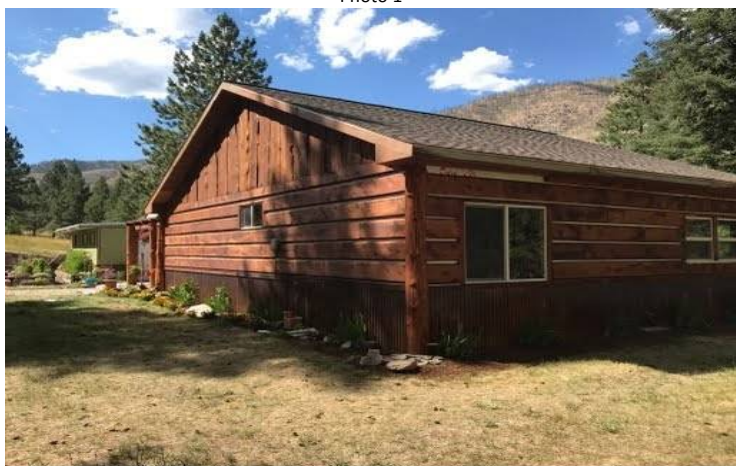
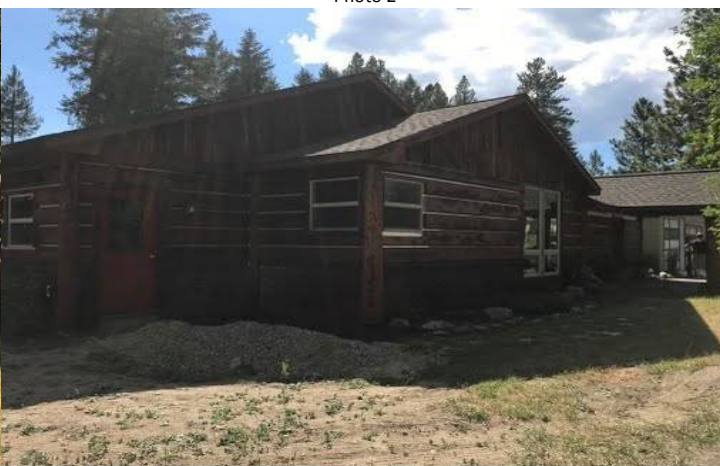
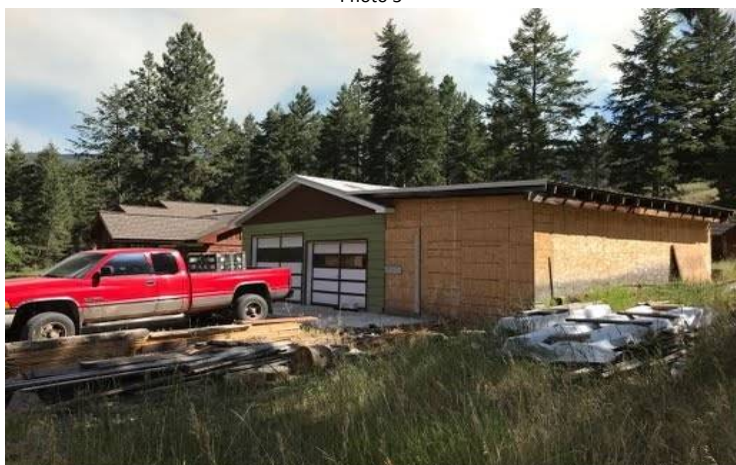
Hazard Notes: Needle cast in gutters on outbuilding directly west to residence. Lots of tall grass directly west of outbuilding.
Access to Site: T1 Engine
Comm with ICP: Radio
Water Source: None
Mitigation Time: Less Than An Hour
Collected By: E 27 Florence Fire

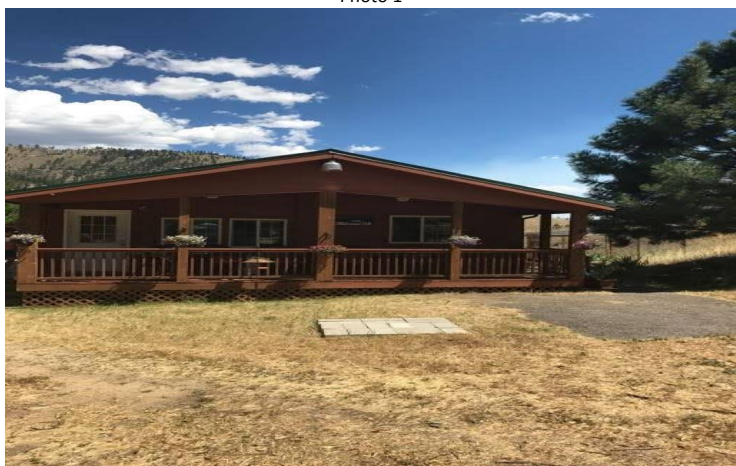
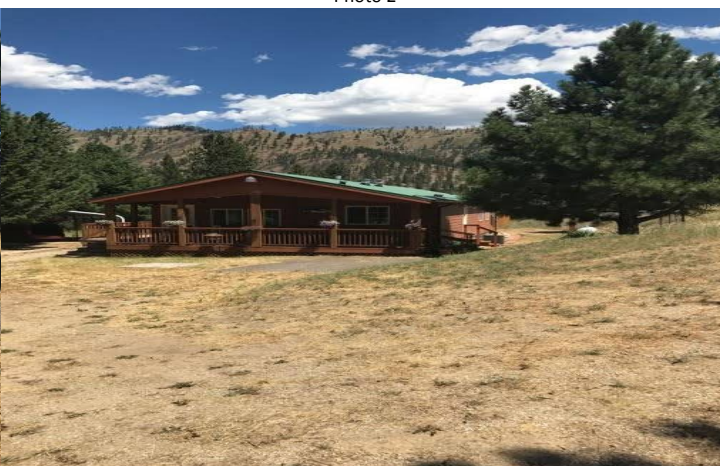
Hazard Notes: Limited turn around at end of driveway. Propane on southeast side, septic located on northwest side. Thayer road going south. Sharp turn into driveway if approaching from the

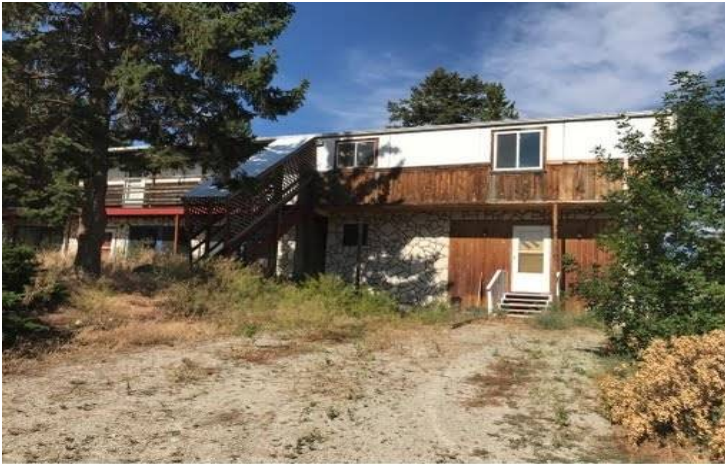
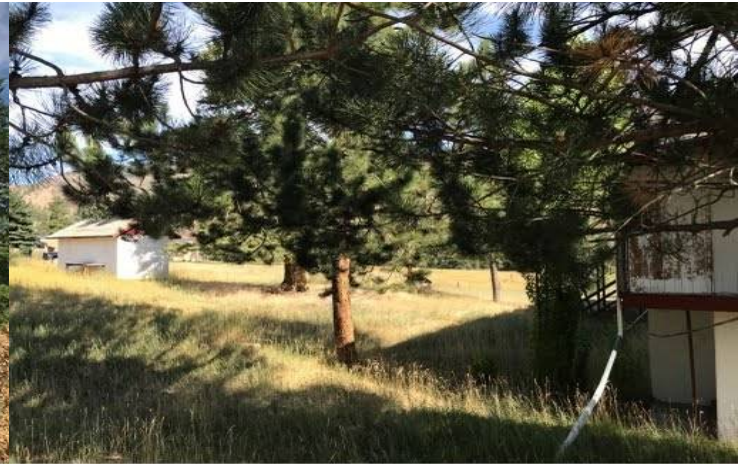
Hazard Notes: Unoccupied multi plex...various stages of disrepair....covered wooden stair case west side And east side of structure...septic and propane north side....several trees within ten feet all around....tall grass
Access to Site: T1 Engine
Comm with ICP: Radio
Water Source: None
Mitigation Time: 3-4 Hours
Other Resources Needed to Protect: Several type three engines needed
Collected By: E 27 Florence Fire
Collected Date/Time: 07/24/2017 09:59:40

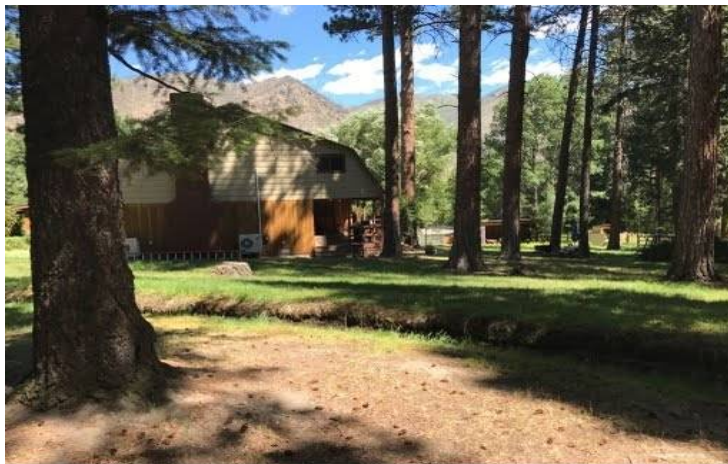
Photo 1

Structure Number: 3845
Structure Name: 15485 Thayer Rd
SubDivision: Mill Creek
GPS Location, Lat. 46 44.89752
GPS Location, Long. 114 12.7692
Safety Zone Present: Yes
Type of Structure: Residential
Surrounding Fuels: Grass, Timber
Structure Triage Category: Defensible, Prep and Hold
Roof Material: Composite
Heat Traps: Wood Deck, Rain Gutters
Electrical Power: Overhead
Hazards: Fuels, Septic Tank
Hazard Notes: Wood pile on south side of the mother in law, wood shed east side of primary residence
Access to Site: T6 Engine
Comm with ICP: Radio
Water Source: Faucet / Hose, Creek
Mitigation Time: 1-2 Hours
Notes: Mill Creek run through the property, but does not have sufficient water. Structure is located on the within the northern edge of mature ponderosa stand

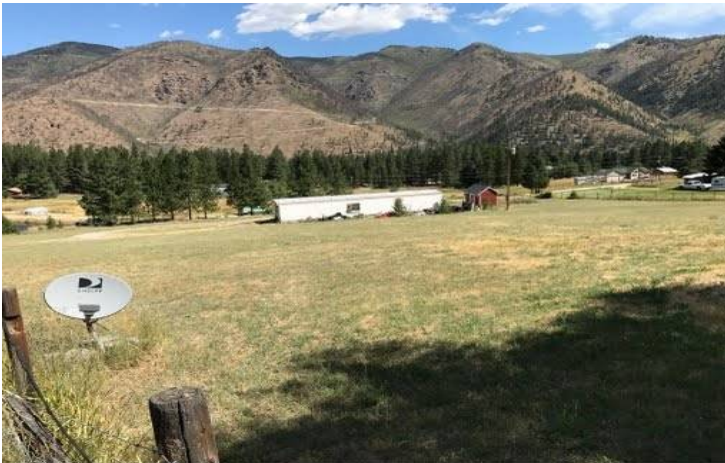
Photo 1

Structure Number: 3864
Structure Name: 3060 Severin RD
SubDivision: Mill creek
GPS Location, Lat. 46 44.61366
GPS Location, Long. 114 12.71028
Safety Zone Present: Yes
Type of Structure: Residential
Surrounding Fuels: Grass, Timber
Structure Triage Category: Defensible, Prep and Hold
Roof Material: Metal
Heat Traps: Wood Deck
Electrical Power: Overhead
Hazards: Animals
Access to Site: T1 Engine
Comm with ICP: Radio
Water Source: Large Pond
Mitigation Time: 1-2 Hours
Other Resources Needed to Protect: Type 1 Engine
Collected By: TNF-E65
