STRUCTURE
PROTECTION PLAN
FOR
ELK CREEK BLOCK
07/27/2017

Structure Protection Plan

OZ Ranch

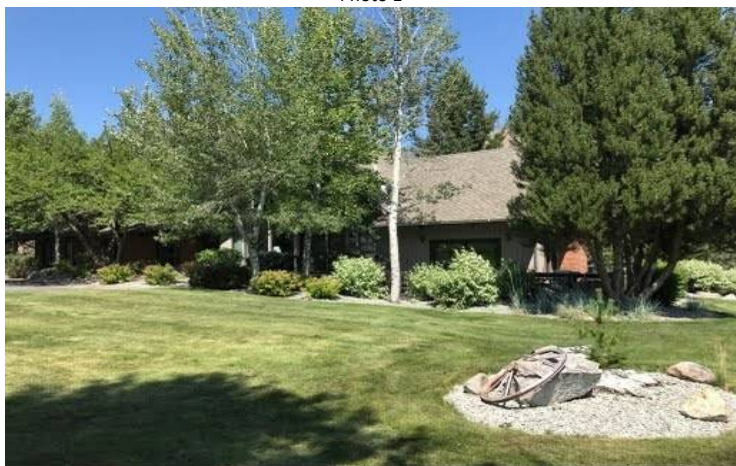
Photo 1

Structure Number: 3780
Structure Name: 12349 Arena Road
SubDivision: Arena Drive
GPS Location, Lat. 46 45.1911
GPS Location, Long. 114 13.32006
Safety Zone Present: Yes
Type of Structure: Residential
Surrounding Fuels: Grass, Timber
Structure Triage Category: Defensible, Stand Alone
Roof Material: Composite
Heat Traps: Wood Deck, Rain Gutters
Electrical Power: Underground
Hazards: Animals
Hazard Notes: Horses, cattle
Access to Site: T3/4 Engine
Comm with ICP: Radio
Water Source: Creek
Mitigation Time: None Needed
Notes: Propane tank located west of residence, 10-15 feet.

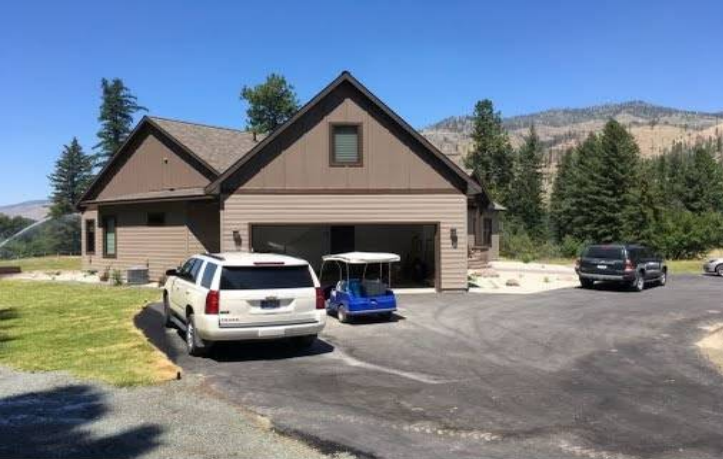
Structure Number: 3777
Structure Name: 12690 Arena Dr
SubDivision: Arena Drive
GPS Location, Lat. 46 44.99808
GPS Location, Long. 114 13.665
Safety Zone Present: Yes
Type of Structure: Residential
Surrounding Fuels: Grass, Timber
Structure Triage Category: Defensible, Prep and Hold
Roof Material: Composite
Heat Traps:
Electrical Power: Underground
Hazards:
Access to Site: T1 Engine
Comm with ICP: Radio
Water Source: Faucet / Hose
Mitigation Time: 1-2 Hours
Other Resources Needed to Protect: Engine crew to clean up area
Notes: New house and garage. Fairly good clearance from trees, owner has limbed up trees in the area.

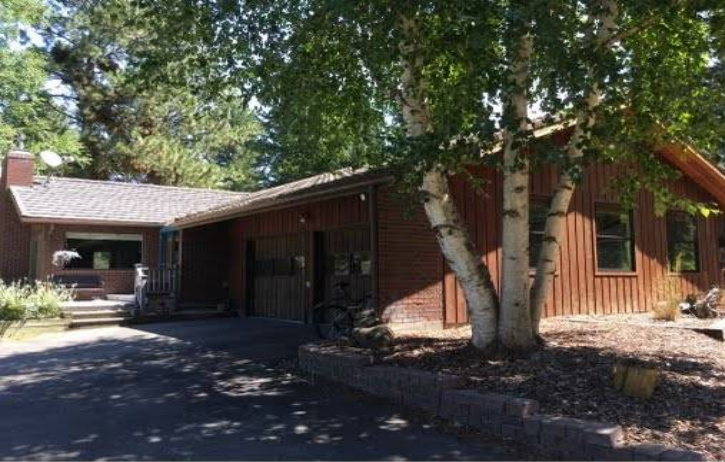
Structure Number: 3778
Structure Name: 12740 Arena Drive
SubDivision: Arena Drive
GPS Location, Lat. 46 44.95416
GPS Location, Long. 114 13.53366
Safety Zone Present: Yes
Type of Structure: Residential
Surrounding Fuels: Grass, Timber
Structure Triage Category: Defensible, Prep and Hold
Roof Material: Composite
Heat Traps: Wood Deck
Electrical Power: Overhead
Hazards:
Access to Site: T1 Engine
Comm with ICP: Radio
Water Source: Faucet / Hose
Mitigation Time: 2-3 Hours
Other Resources Needed to Protect: 1 engine crew with saws. 50 ft behind house is base of slope, heavy timber and understory
Notes: Irrigated lawn, back of house is 30 ft from base of slope with heavy timber and understory.

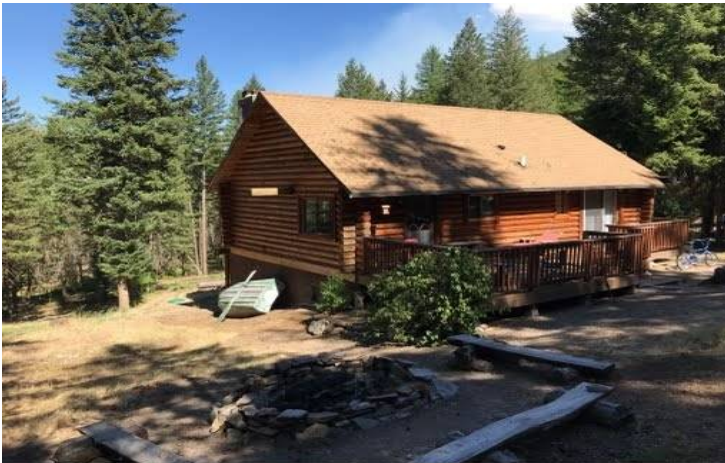
Photo 1

Safety Zone Present: No
Type of Structure: Residential
Surrounding Fuels: Grass, Shrub, Timber
Structure Triage Category: Defensible, Prep and Hold
Roof Material: Composite
Heat Traps: Wood Deck
Electrical Power: Overhead
Hazards: Terrain, Fuels
Hazard Notes: Structure on slope, burnable material next to outbuilding
Access to Site: T6 Engine
Comm with ICP: Radio
Water Source: Faucet / Hose, Large Pond
Mitigation Time: Less Than An Hour
Collected By: LoLo 632

Escape route down and out to hwy 12 then possible safety zone west on hwy 12 to field across from mill creek road
Where is Safety Zone: hwy 12 to field across from mill creek road
Primary Structures: 1
Outbuildings: 1
Defensible Space: 30-50 Feet
Siding Material: Wood
Gas to Structure: None
Best Access From: Hwy 12 onto lolo creek drive

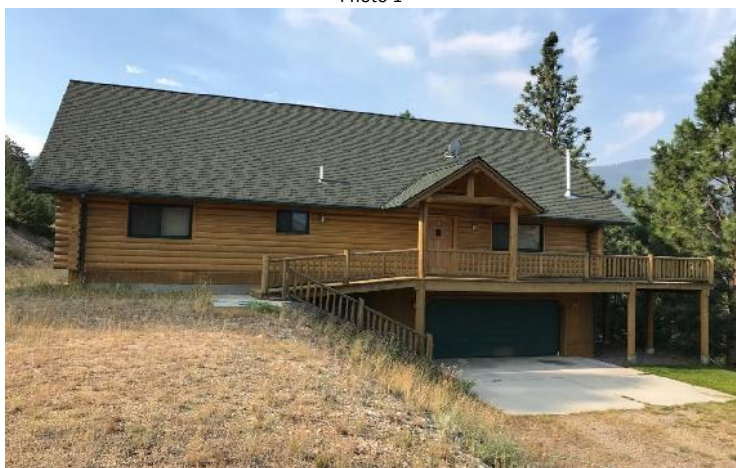
Collected Date/Time: 07/29/2017 14:47:37
Photo 2

Structure Number: 4730
Structure Name: 12970 balsam root
SubDivision: Travelers Rest
GPS Location, Lat. 46 44.82036
GPS Location, Long. 114 7.4673
Safety Zone Present: No
Type of Structure: Residential
Surrounding Fuels: Grass, Timber
Structure Triage Category: Non-Defensible, Prep and Leave
Roof Material: Composite
Heat Traps: Open Eaves, Wood Deck, Rain Gutters
Electrical Power: Underground
Hazards:
Access to Site: T3/4 Engine
Comm with ICP: Radio, Cell Service
Water Source: Faucet / Hose
Mitigation Time: Less Than An Hour
Notes: Deck wood is rotted

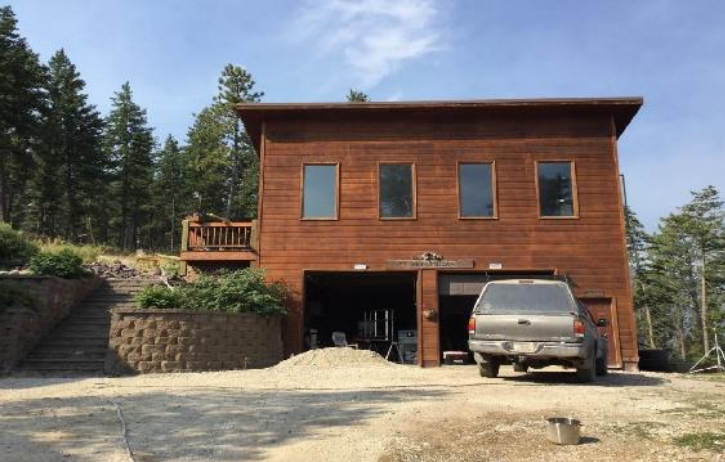
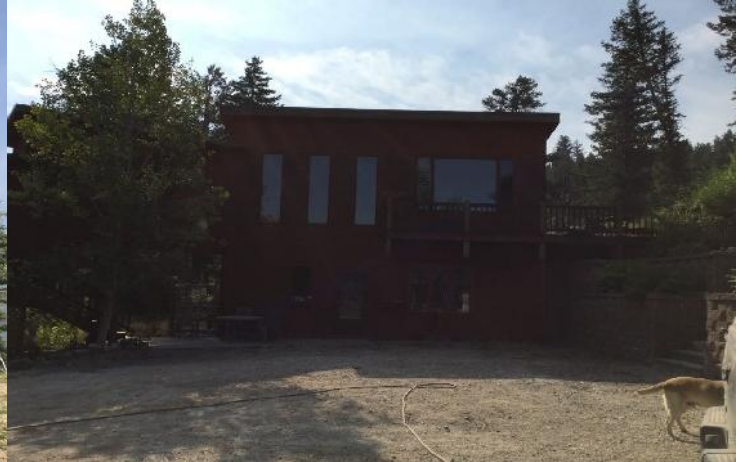
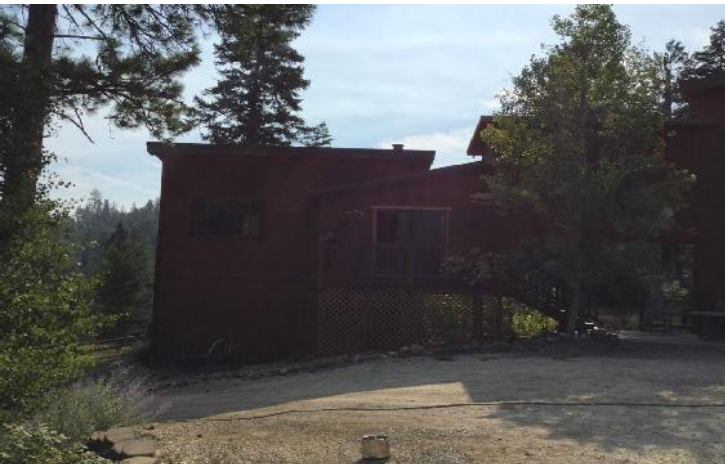
Structure Number: 4825
Structure Name: 13125 Labrador Way
SubDivision: Travelers Rest
GPS Location, Lat. 46 44.7189
GPS Location, Long. 114 7.61496
Safety Zone Present: No **Where is Safety Zone:** ER back to Hwy 12
Type of Structure: Residential **Primary Structures:** **Outbuildings:**
Surrounding Fuels: Grass, Timber **Defensible Space:** 50-100 Feet
Structure Triage Category: Non-Defensible, Prep and Leave
Roof Material: Metal **Siding Material:** Wood
Heat Traps: Wood Deck, Other Receptor
Electrical Power: Underground **Gas to Structure:** Aboveground
Hazards: Terrain, Fuels, Bridge Load Limits, Animals, Septic Tank, HazMat
Access to Site: T6 Engine **Best Access From:** Hwy 12 to Balsam Root road
Comm with ICP: Radio, Cell Service
Water Source: Faucet / Hose
Mitigation Time: 2-3 Hours
Other Resources: Sprinklers
Needed to Protect:
Notes: Tight turn around. Limited road access. Few snags in area near home.

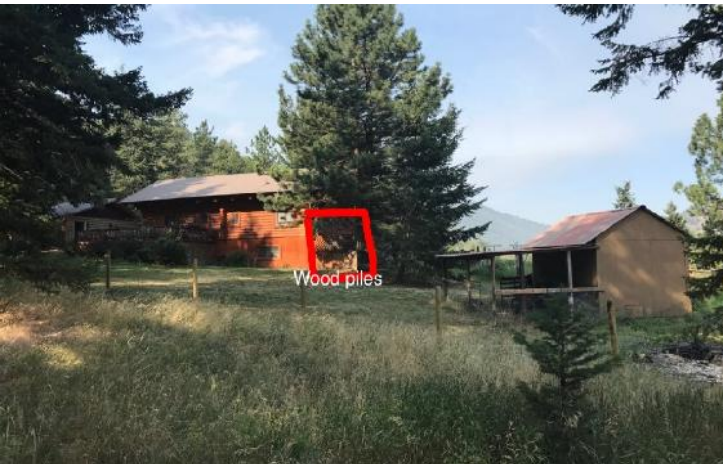
Wood piles

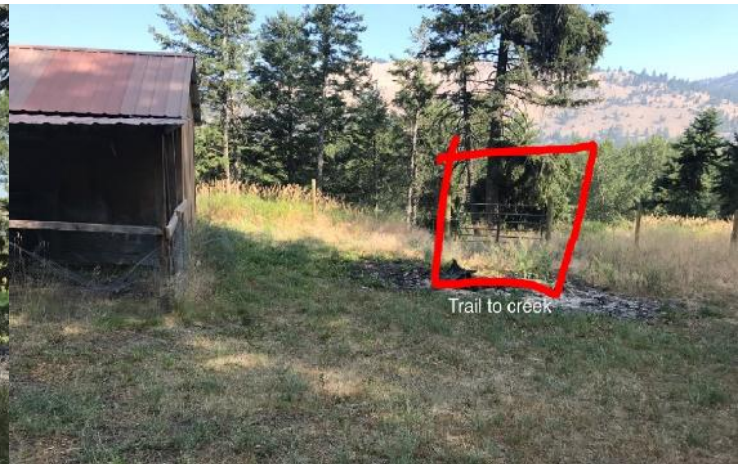
Trail to creek

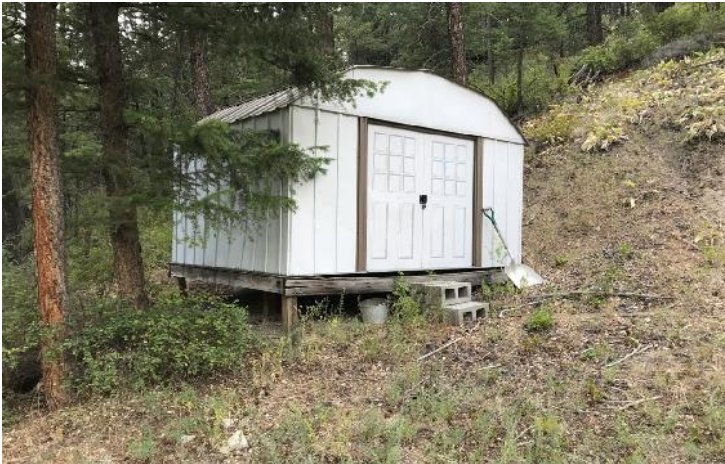
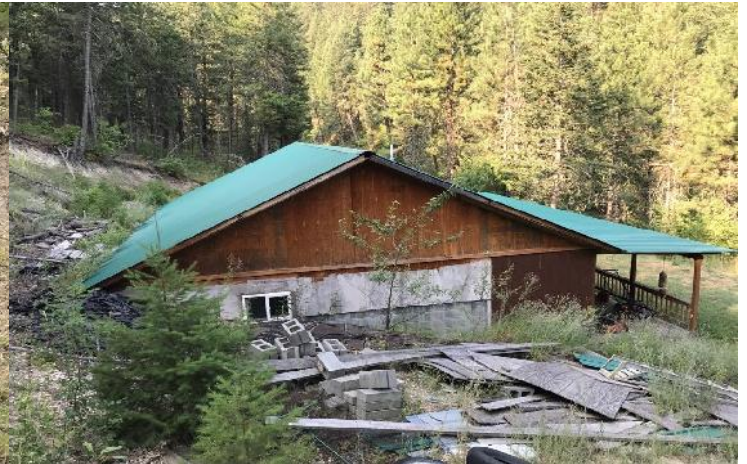
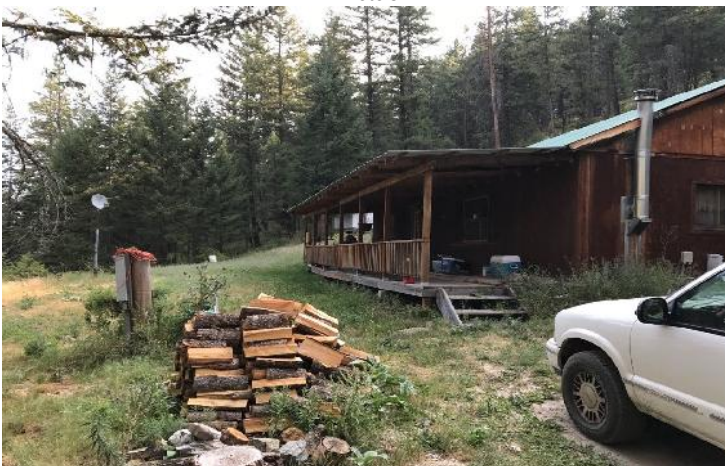
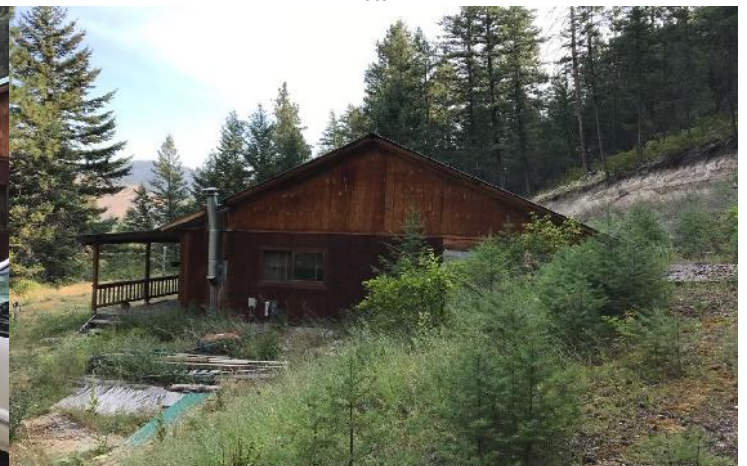
Structure Number: 4752
Structure Name: 13264 Balsam Root Road
SubDivision: Travelers Rest
GPS Location, Lat. 46 44.56062
GPS Location, Long. 114 7.88562
Safety Zone Present: No
Type of Structure: Residential
Surrounding Fuels: Grass,Shrub,Timber
Structure Triage Category: Defensible, Prep and Hold
Roof Material: Metal
Heat Traps: Wood Deck
Electrical Power: Underground
Hazards: Terrain,Fuels,No Turn Around,HazMat
Access to Site: T6 Engine
Comm with ICP: Radio
Water Source: Faucet / Hose
Mitigation Time: 3-4 Hours
Other Resources: None
Needed to Protect:
Notes: Abundance of material on east side of building needing mitigation

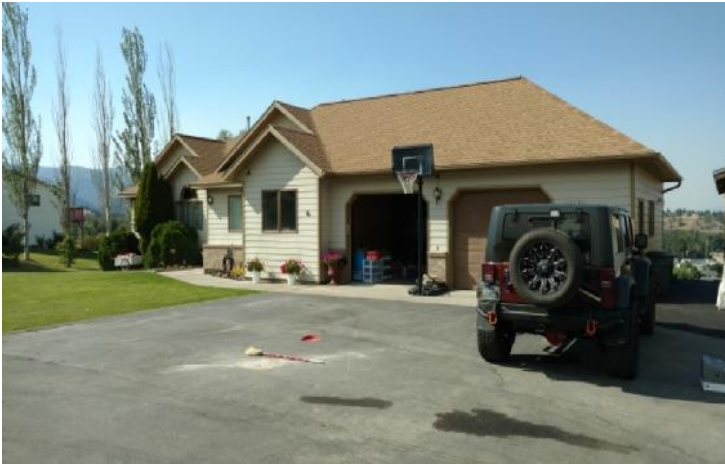
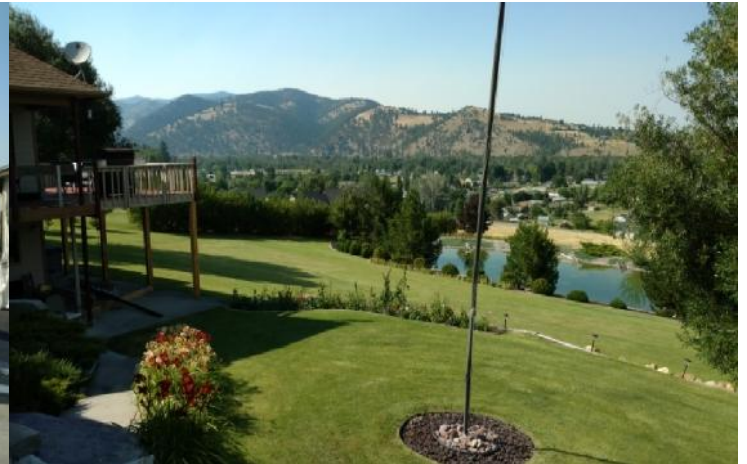
Safety Zone Present: No
Type of Structure: Residential
Surrounding Fuels: Grass, Timber
Structure Triage Category: Defensible, Prep and Hold
Roof Material: Composite
Heat Traps: Wood Deck
Electrical Power: Underground
Hazards:
Access to Site: T3/4 Engine
Comm with ICP: Radio, Cell Service
Water Source: Faucet / Hose
Mitigation Time: None Needed
Other Resources Needed to Protect: Engine crew
Collected By: COCO 482

Where is Safety Zone: Not viable in worst fire scenario. Safety zone: field behind house could be utilized if burnt out. Escape route: out to Hwy 93
Primary Structures:
Outbuildings:

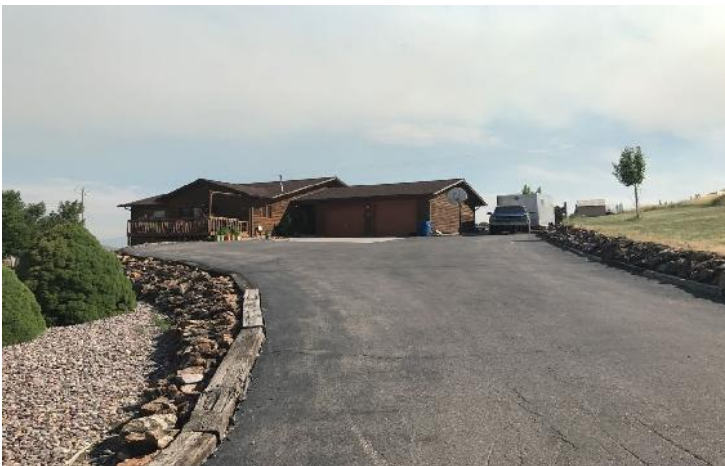
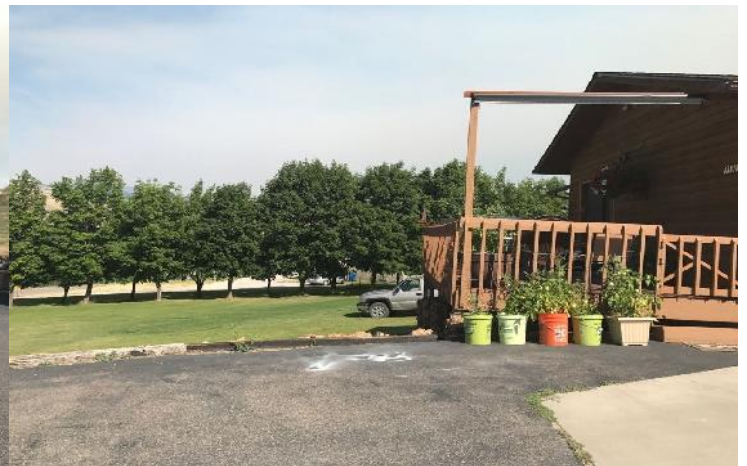
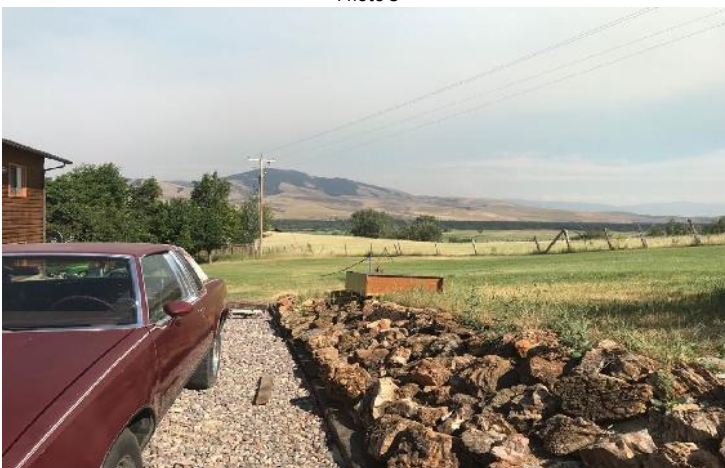
Safety Zone Present: Yes
Type of Structure: Residential
Surrounding Fuels: Grass, Timber
Structure Triage Category: Defensible, Stand Alone
Roof Material: Composite
Heat Traps: Wood Deck
Electrical Power: Overhead
Hazards:
Access to Site: T1 Engine
Comm with ICP: Radio, Cell Service
Water Source: Faucet / Hose
Mitigation Time: Less Than An Hour
Other Resources: One patrolling engine
Needed to Protect:
Collected By: COCO 482

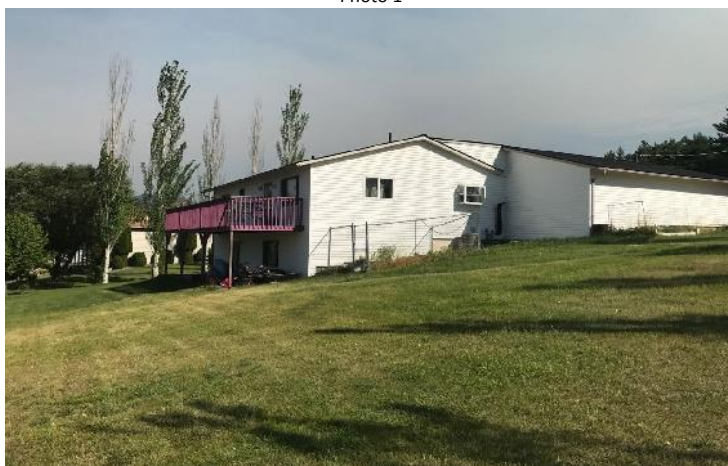
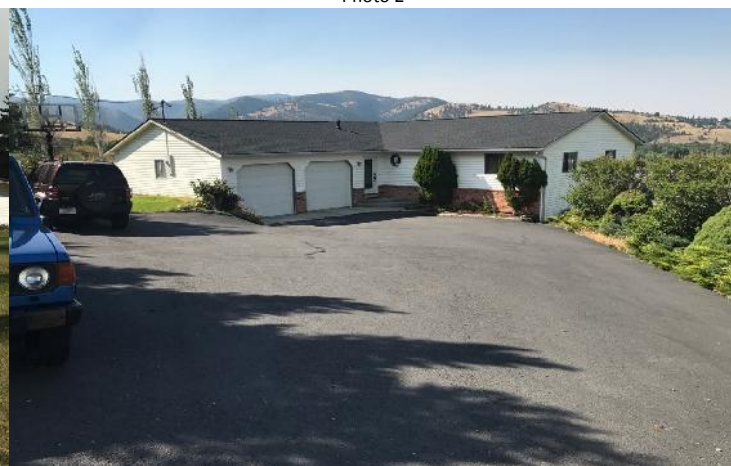
Structure Number: 4812
Structure Name: 13915 Sapphire Rd
SubDivision: Travelers Rest
GPS Location, Lat. 46 44.49564
GPS Location, Long. 114 5.55198
Safety Zone Present: Yes
Type of Structure: Residential
Surrounding Fuels: Grass
Structure Triage Category: Defensible, Stand Alone
Roof Material: Composite
Heat Traps: Wood Deck,Rain Gutters
Electrical Power: Overhead
Hazards: Septic Tank
Access to Site: T1 Engine
Comm with ICP: Radio,Cell Service
Water Source: Faucet / Hose
Mitigation Time: None Needed
Other Resources Needed to Protect: None
Notes: Structure is a duplex

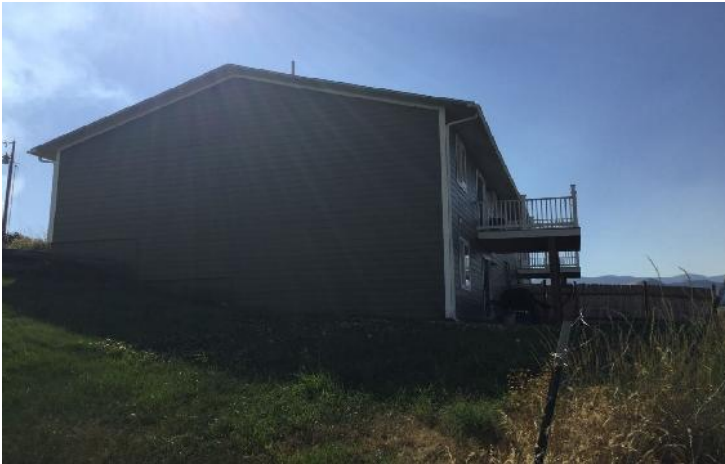
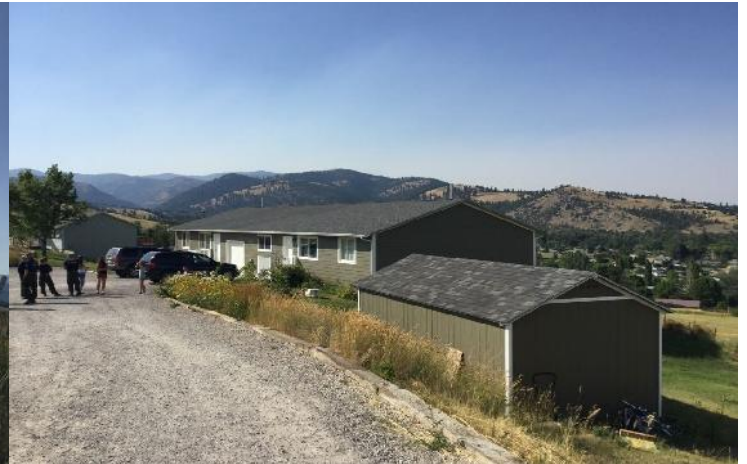
Structure Number: 4743
Structure Name: 13965 Sapphire Dr
SubDivision: Travelers Rest
GPS Location, Lat. 46 44.49354
GPS Location, Long. 114 5.56428
Safety Zone Present: Yes
Type of Structure: Residential
Surrounding Fuels: Grass
Structure Triage Category: Defensible, Stand Alone
Roof Material: Composite
Heat Traps: Wood Deck,Rain Gutters
Electrical Power: Underground
Hazards:
Access to Site: T1 Engine
Comm with ICP: Radio,Cell Service
Water Source: Faucet / Hose
Mitigation Time: None Needed
Other Resources Needed to Protect: None
Collected By: AZ-TNF 1265
Photo 1

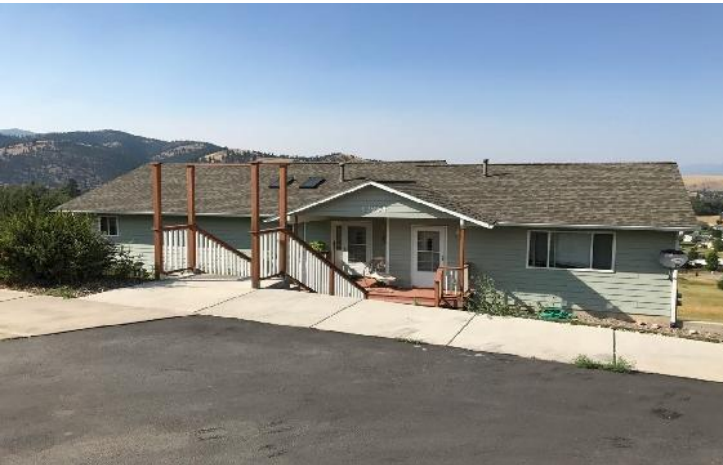
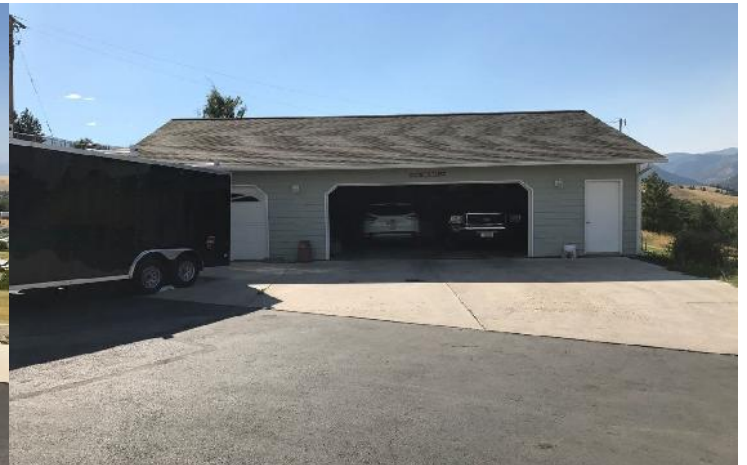
Structure Number: 4697
Structure Name: 13970
SubDivision: Travelers Rest
GPS Location, Lat. 46 44.4678
GPS Location, Long. 114 5.58486
Safety Zone Present: Yes
Type of Structure: Residential
Surrounding Fuels: Grass
Structure Triage Category: Defensible, Stand Alone
Roof Material: Composite
Heat Traps: Wood Deck, Rain Gutters
Electrical Power: Overhead
Hazards: Fuels
Access to Site: T1 Engine
Comm with ICP: Radio, Cell Service
Water Source: Faucet / Hose
Mitigation Time: None Needed
Notes:
-Faucet on N side of house.
-Faucet 15ft SW of house.

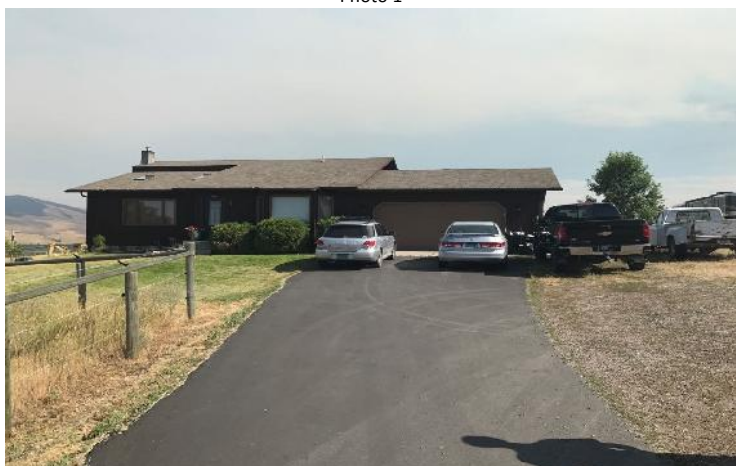
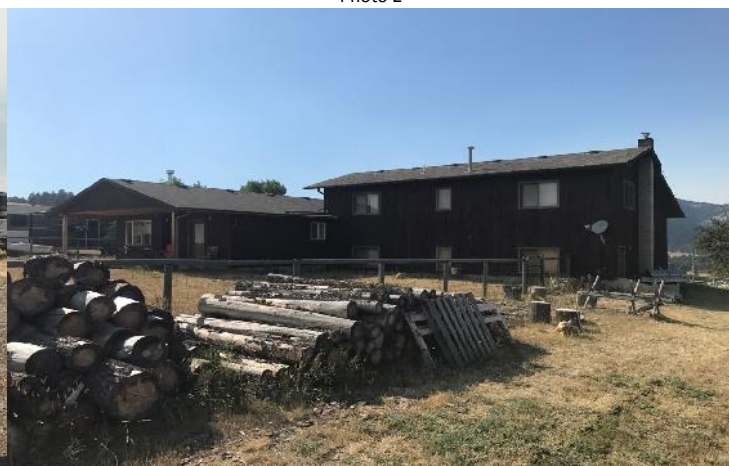
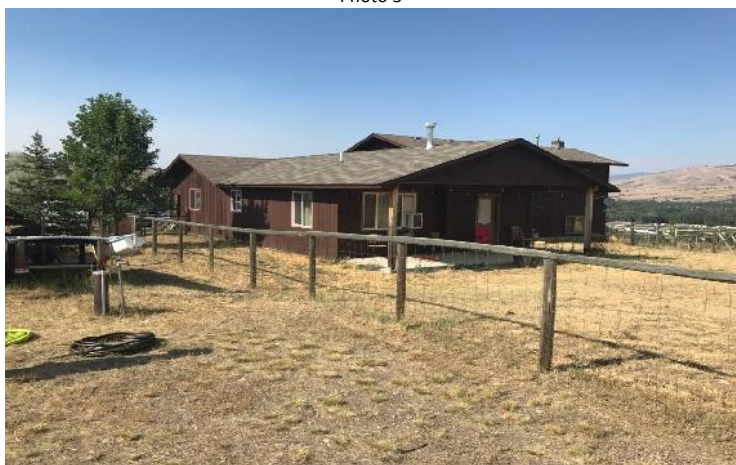
Structure Number: 4818
Structure Name: 13990 Sapphire Drive
SubDivision: Travelers Rest
GPS Location, Lat. 46 44.4996
GPS Location, Long. 114 5.62824
Safety Zone Present: Yes
Type of Structure: Residential
Surrounding Fuels: Grass, Timber
Structure Triage Category: Defensible, Stand Alone
Roof Material: Composite
Heat Traps: Wood Deck, Rain Gutters
Electrical Power: Overhead
Hazards: Fuels
Access to Site: T1 Engine
Comm with ICP: Radio, Cell Service
Water Source: Faucet / Hose
Mitigation Time: None Needed
Notes: -Faucet on N side of house.

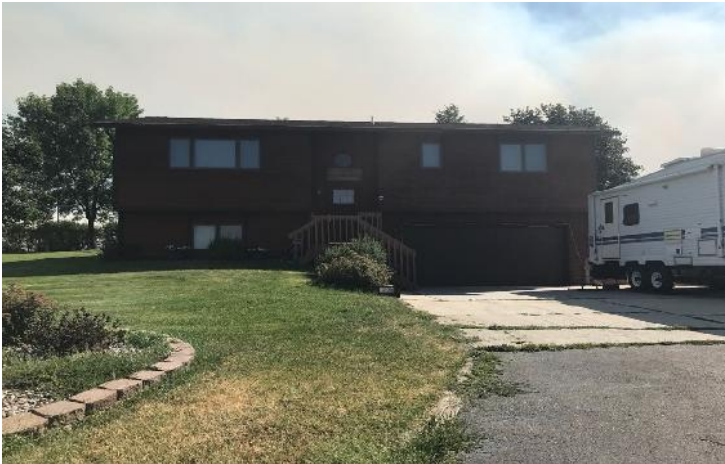
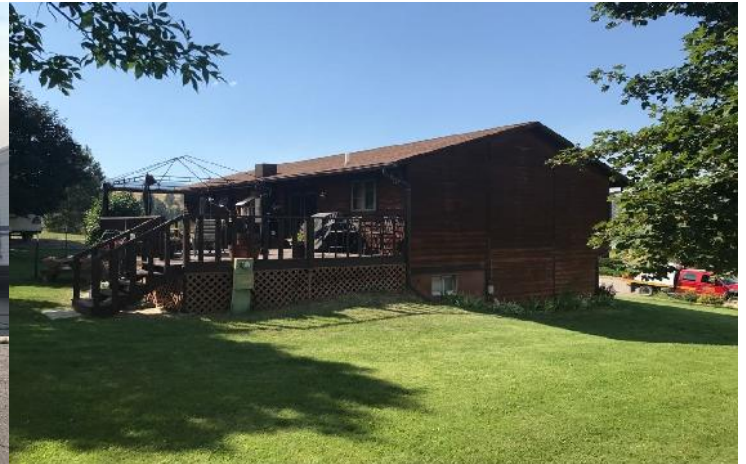
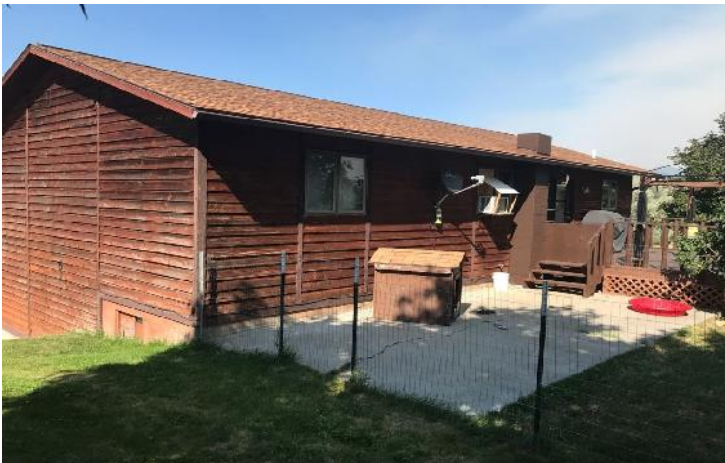
Safety Zone Present: Yes
Type of Structure: Residential
Surrounding Fuels: Timber
Structure Triage Category: Defensible, Prep and Hold
Roof Material: Wood
Heat Traps: Wood Deck
Electrical Power: Underground
Hazards:
Access to Site: T1 Engine
Comm with ICP: Radio, Cell Service
Water Source: Faucet / Hose, Large Pond, Creek
Mitigation Time: 3-4 Hours
Other Resources Needed to Protect: One engine crew to prep and hold
Notes: Currently under construction. Landscape changes planned for near future.

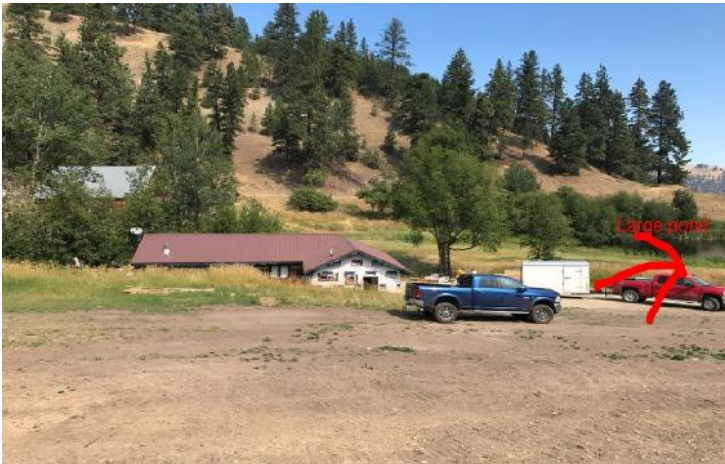
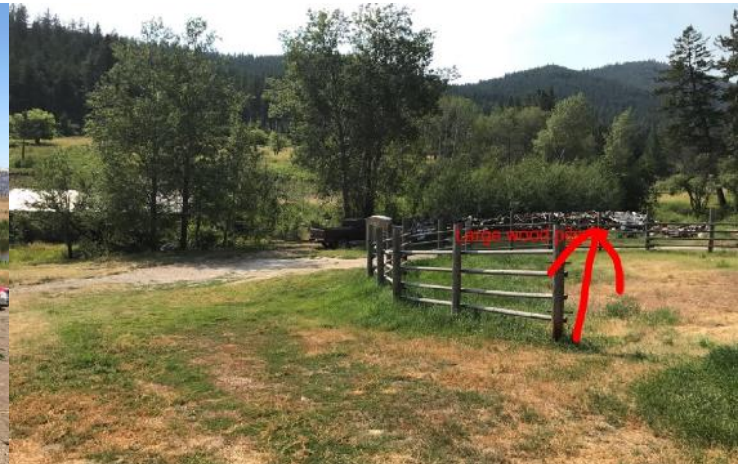
Safety Zone Present: Yes
Type of Structure: Residential
Surrounding Fuels: Grass
Structure Triage Category: Defensible, Stand Alone
Roof Material: Composite
Heat Traps: Wood Deck, Rain Gutters
Electrical Power: Underground
Hazards: Fuels
Access to Site: T1 Engine
Comm with ICP: Radio, Cell Service
Water Source: Faucet / Hose
Mitigation Time: None Needed
Notes: -Faucet located on S side of house.
-Faucet on N side of house.

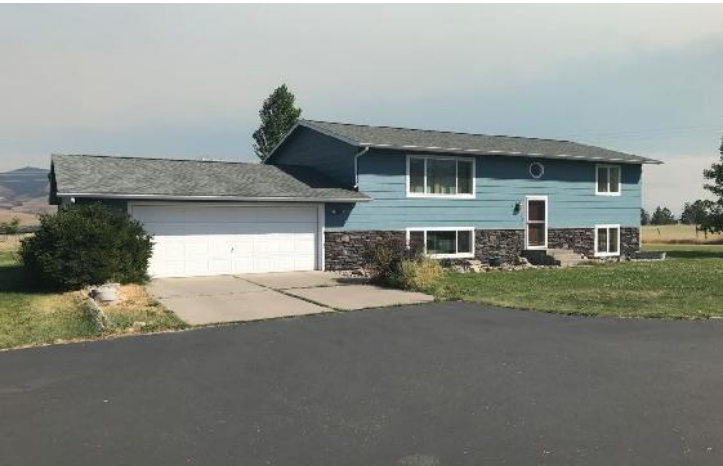
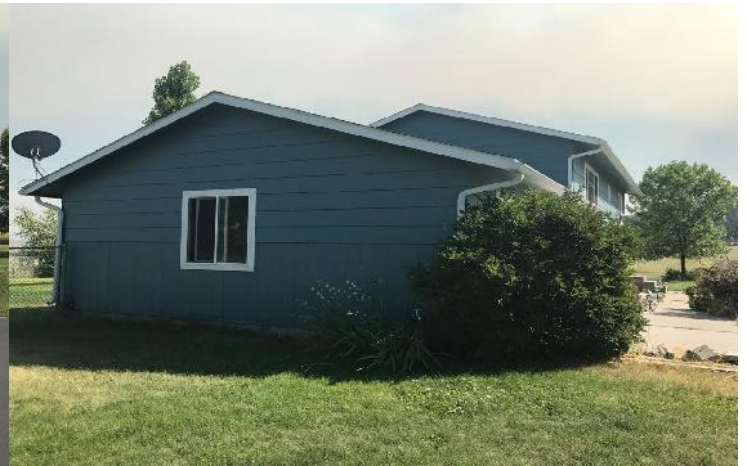
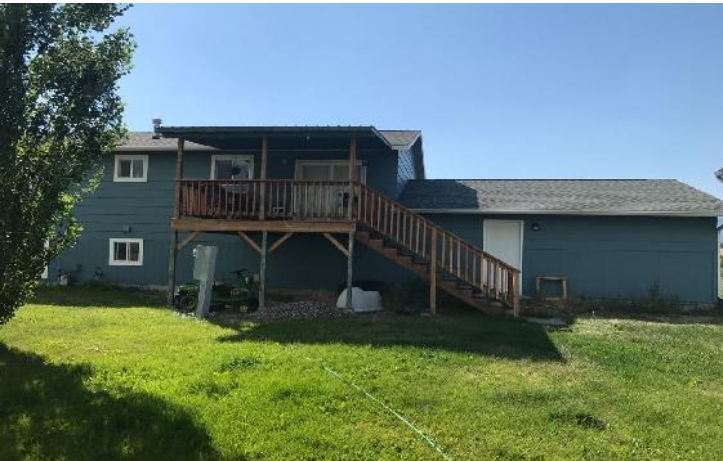
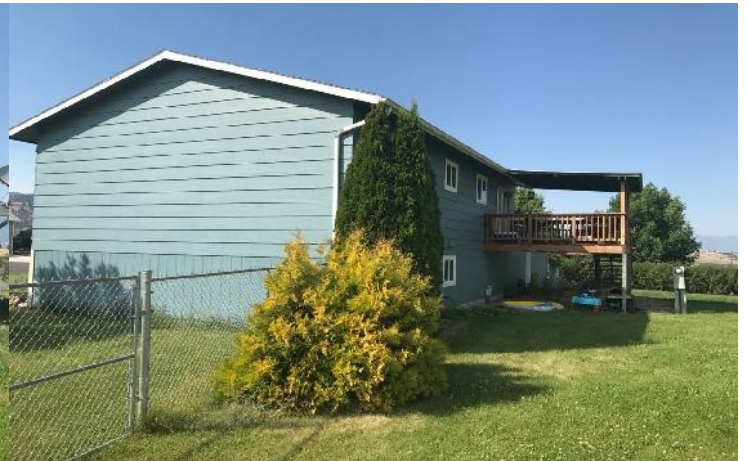
Structure Number: 4726
Structure Name: 14015 Sapphire Drive
SubDivision: Travelers Rest
GPS Location, Lat. 46 44.50128
GPS Location, Long. 114 5.63622
Safety Zone Present: No
Type of Structure: Residential
Surrounding Fuels: Grass
Structure Triage Category: Defensible, Stand Alone
Roof Material: Composite
Heat Traps: Wood Deck,Rain Gutters
Electrical Power: Overhead
Hazards:
Access to Site: T1 Engine
Comm with ICP: Radio,Cell Service
Water Source: Faucet / Hose
Mitigation Time: None Needed
Other Resources Needed to Protect: Type six patrol

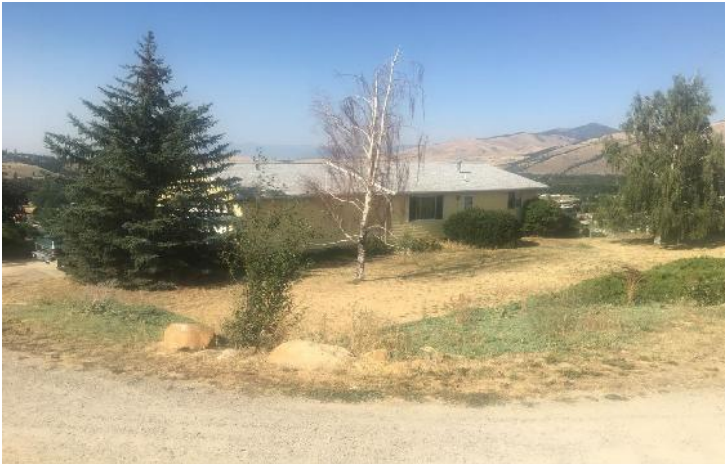
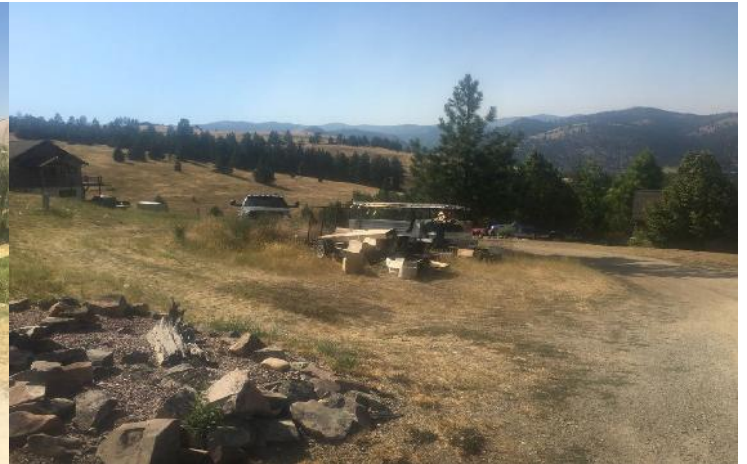
Structure Triage Category: Defensible, Stand Alone
Roof Material: Composite
Heat Traps: Wood Deck, Rain Gutters
Electrical Power: Underground
Hazards: Terrain, Fuels
Access to Site: T3/4 Engine
Comm with ICP: Radio, Cell Service
Water Source: Faucet / Hose
Mitigation Time: None Needed

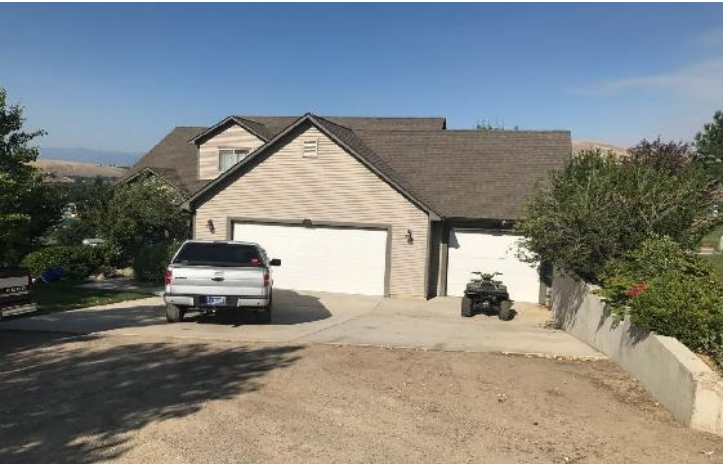
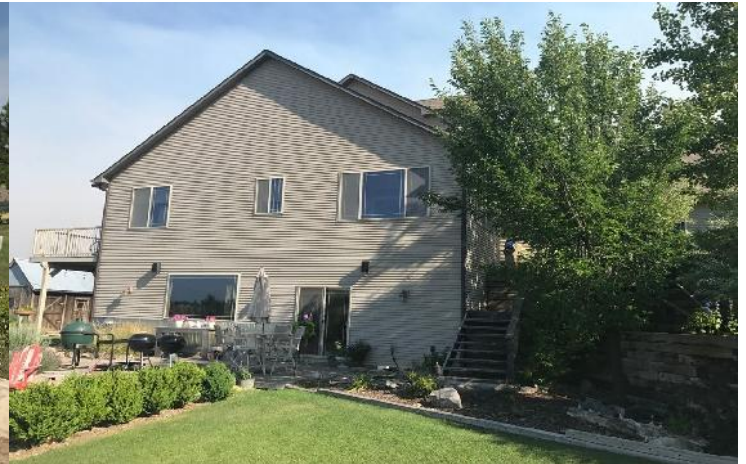
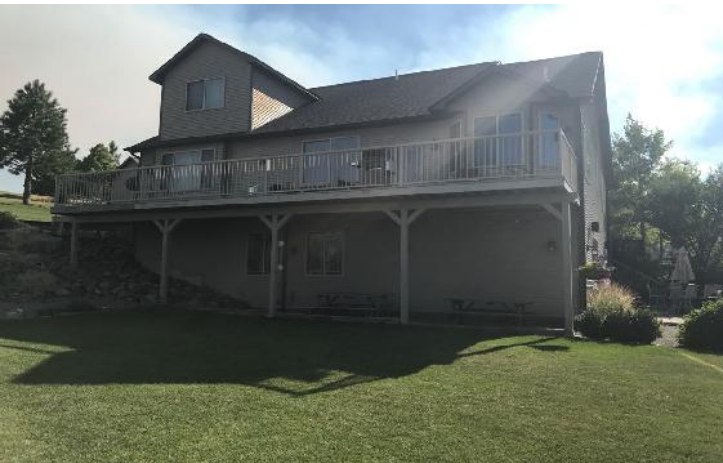
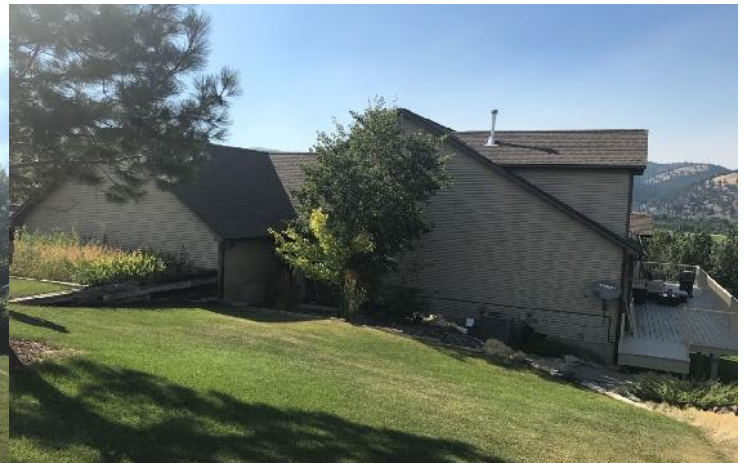
Structure Number: 4775
 Structure Name: 14025 Sapphire Drive
 SubDivision: Travelers Rest
 GPS Location, Lat. 46 44.53356
 GPS Location, Long. 114 5.66886
 Safety Zone Present: Yes
 Type of Structure: Residential
 Surrounding Fuels: Grass,Shrub,Timber
 Structure Triage Category: Defensible, Stand Alone
 Roof Material: Composite
 Heat Traps: Wood Deck,Rain Gutters
 Electrical Power: Underground
 Hazards: Terrain,Fuels
 Access to Site: T3/4 Engine
 Comm with ICP: Radio,Cell Service
 Water Source: Faucet / Hose
 Mitigation Time: None Needed
 Notes: -Faucet on W side of house.
 -Faucet on N side of house.
 -Faucet on SE side of house.
 -Faucet on S side of house.

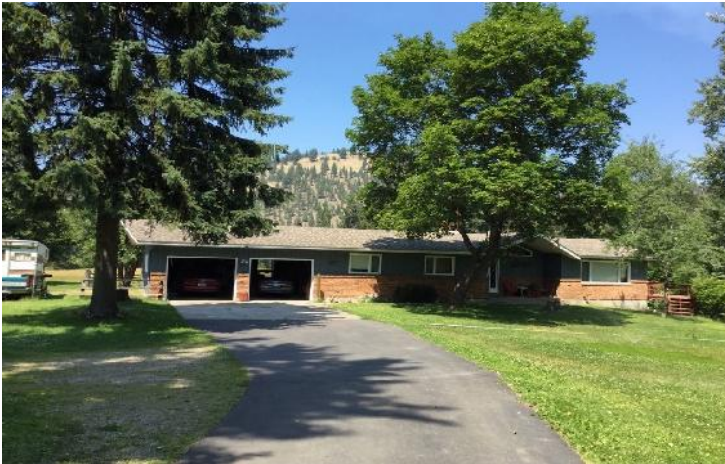
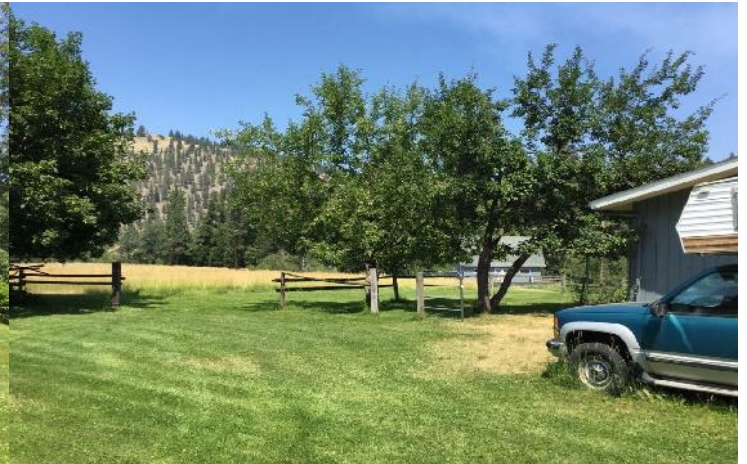
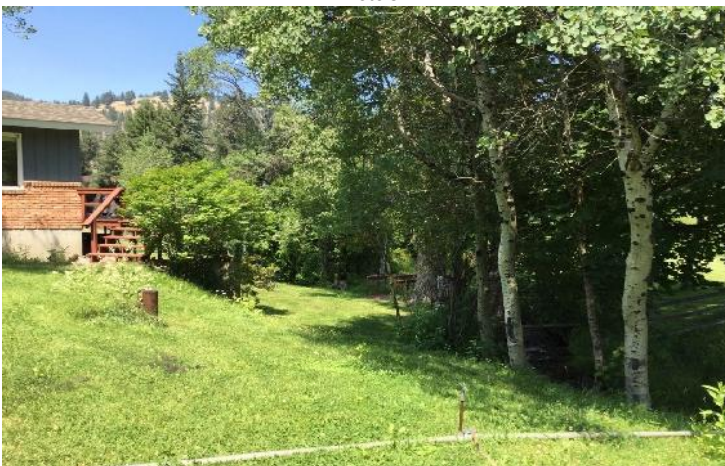
Structure Number: 4756
Structure Name: 8300 Mormon Creek Road
SubDivision: Travelers Rest
GPS Location, Lat. 46 45.16056
GPS Location, Long. 114 6.72408
Safety Zone Present: Yes **Where is Safety Zone:** -Directly W of the house.
Type of Structure: Residential **Primary Structures:** **Outbuildings:**
Surrounding Fuels: Shrub, Timber **Defensible Space:** None
Structure Triage Category: Non-Defensible, Prep and Leave
Roof Material: Composite **Siding Material:** Wood
Heat Traps: Wood Deck, Rain Gutters
Electrical Power: Underground **Gas to Structure:** Aboveground
Hazards: Fuels
Access to Site: T1 Engine **Best Access From:** Mormon Creek Road
Comm with ICP: Radio, Cell Service
Water Source: Faucet / Hose
Mitigation Time: 1-2 Hours
Other Resources Needed to Protect: -Movement of the woodpiles.
-Cutting down of nearby juniper trees and bushes that are physically touching the house.
Notes: -Faucet on NE side of house.

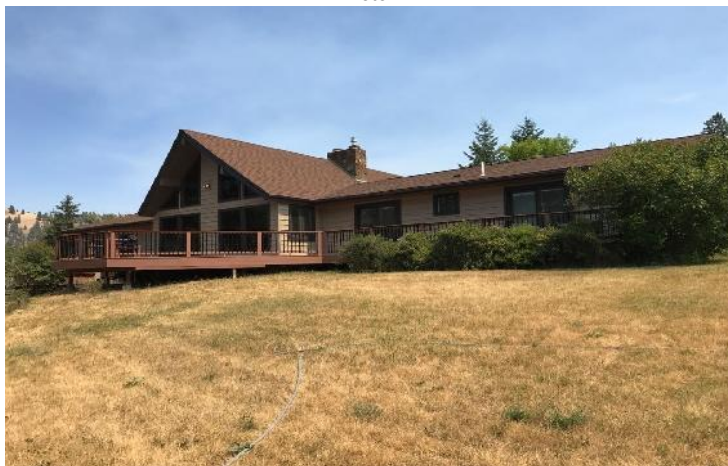
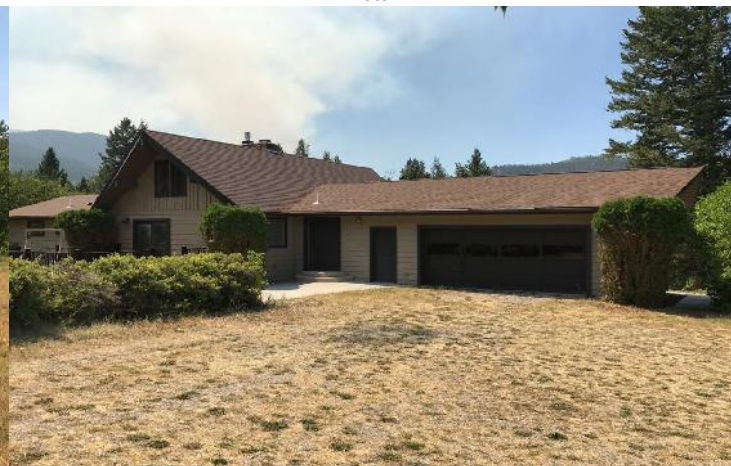
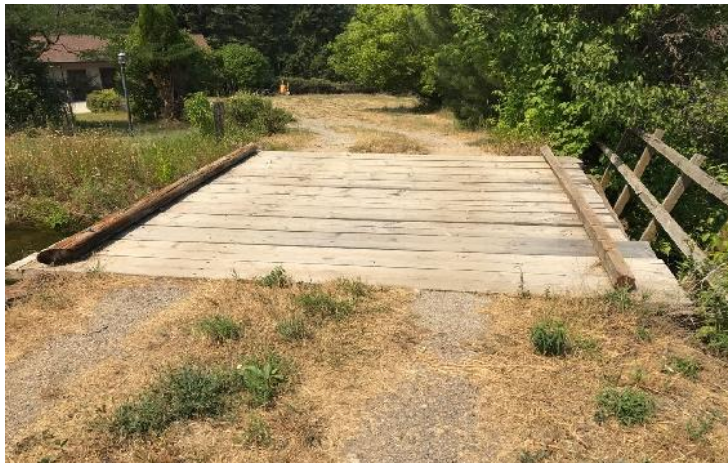
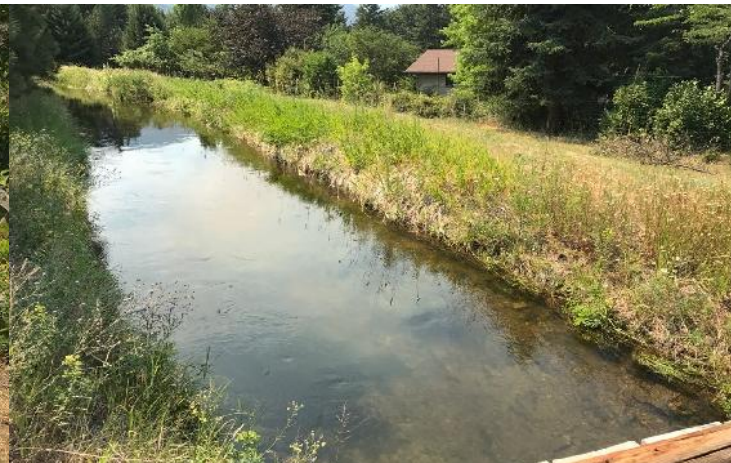
Structure Number: 4828
Structure Name: 8405 Vann Dr
SubDivision: Travelers Rest
GPS Location, Lat. 46 45.20106
GPS Location, Long. 114 6.8664
Safety Zone Present: No
Type of Structure: Residential
Surrounding Fuels: Grass, Timber
Structure Triage Category: Non-Defensible, Prep and Leave
Roof Material: Composite
Heat Traps: Wood Deck, Other Receptor
Electrical Power: Overhead
Hazards: HazMat
Access to Site: T3/4 Engine
Comm with ICP: Radio
Water Source: Faucet / Hose
Mitigation Time: 1-2 Hours
Other Resources: Sprinkler system set up.
Needed to Protect:
Notes: Travel trailer in yard.

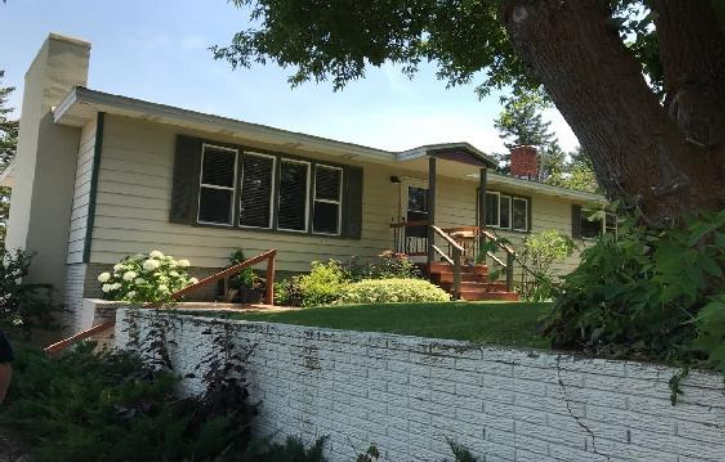
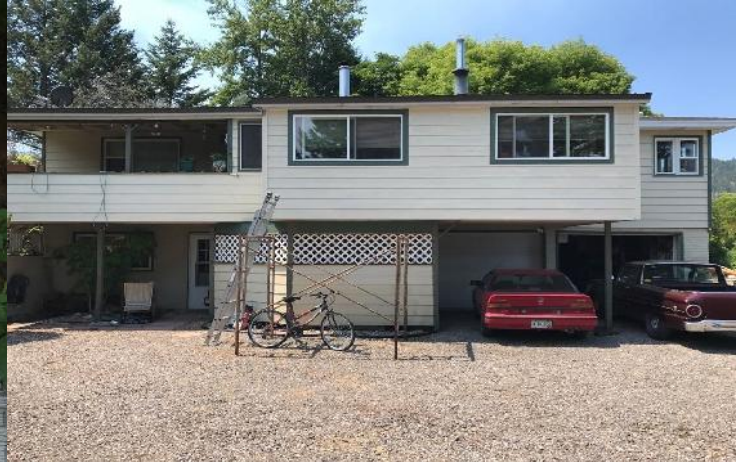
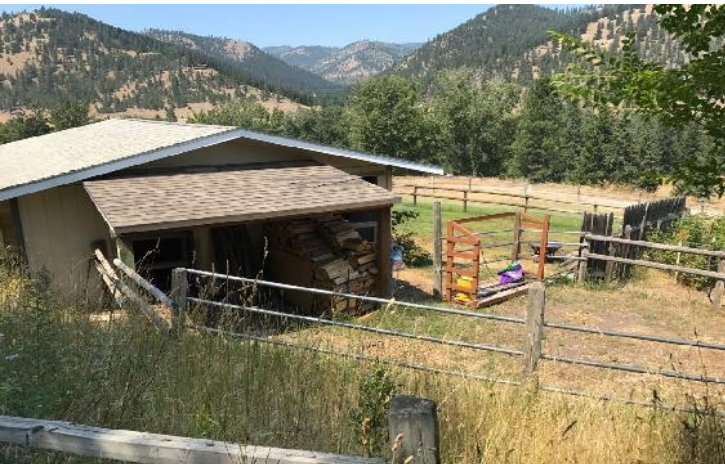
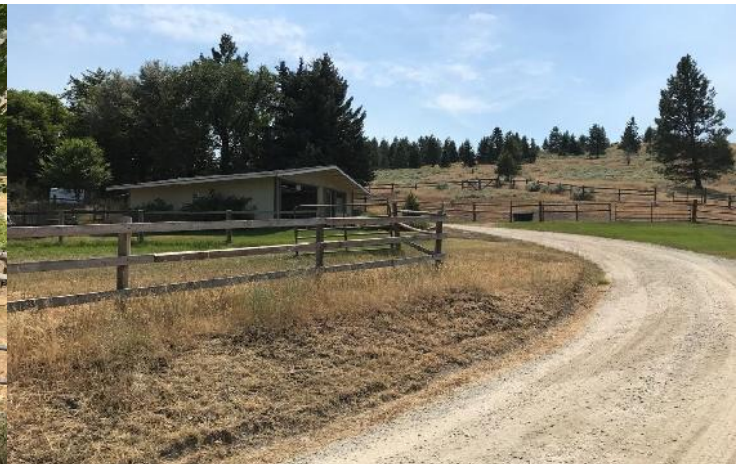
Structure Number: 4736
Structure Name: 8819 Mormon Creek Road
SubDivision: Travelers Rest
GPS Location, Lat. 46 44.93364
GPS Location, Long. 114 6.71706
Safety Zone Present: Yes
Type of Structure: Residential
Surrounding Fuels: Grass,Shrub,Timber,Slash
Structure Triage Category: Defensible, Prep and Hold
Roof Material: Metal
Heat Traps: Wood Deck,Rain Gutters
Electrical Power: Overhead
Hazards: Fuels,Septic Tank,HazMat
Access to Site: T1 Engine
Comm with ICP: Radio,Cell Service
Water Source: Faucet / Hose,Creek
Mitigation Time: Less Than An Hour
Other Resources Needed to Protect: -1 engine crew, sprinklers.
Notes: -Creek located 15ft W of house.
-Faucet on W side of house.

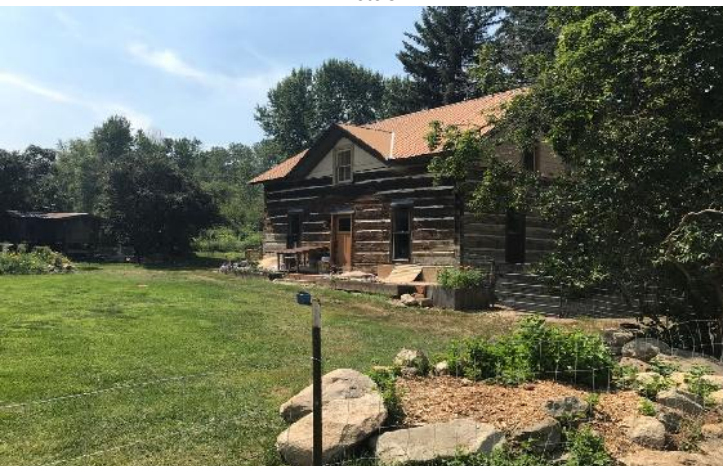
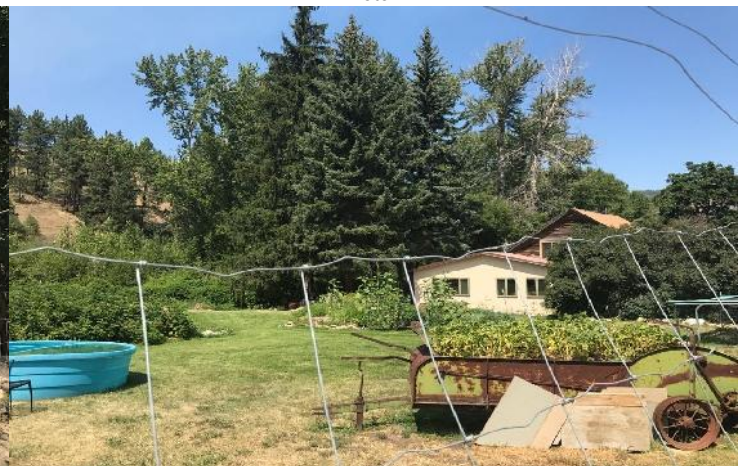
Photo 4

Structure Number: 4778
Structure Name: 8819 Mormon Creek Road
SubDivision: Travelers Rest
GPS Location, Lat. 46 44.93364
GPS Location, Long. 114 6.71706
Safety Zone Present: Yes
Type of Structure: Residential
Surrounding Fuels: Grass,Shrub,Timber,Slash
Structure Triage Category: Defensible, Prep and Hold
Roof Material: Metal
Heat Traps: Wood Deck,Rain Gutters
Electrical Power: Overhead
Hazards: Fuels,Septic Tank,HazMat
Access to Site: T1 Engine
Comm with ICP: Radio,Cell Service
Water Source: Faucet / Hose,Creek
Mitigation Time: Less Than An Hour
Other Resources Needed to Protect: -1 engine crew, sprinklers.
Notes: -Creek located 15ft W of house.
-Faucet on W side of house.
