STRUCTURE
PROTECTION PLAN
FOR
ELK CREEK BLOCK
07/27/2017

Structure Protection Plan

OZ Ranch

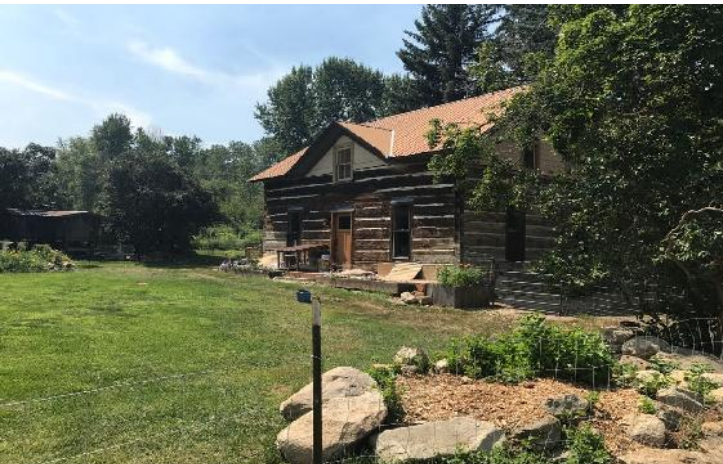
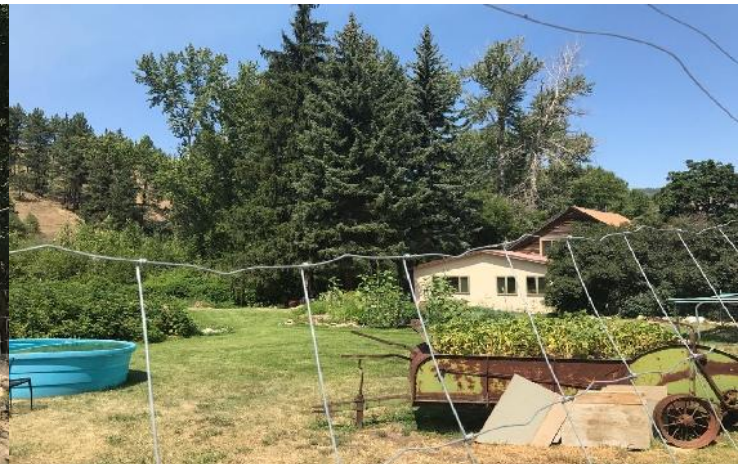
Photo 4

Structure Number: 4710
Structure Name: 8829 Mormon Creek Road
SubDivision: Travelers Rest
GPS Location, Lat. 46 44.64738
GPS Location, Long. 114 6.6468
Safety Zone Present: Yes
Type of Structure: Residential
Surrounding Fuels: Grass, Shrub, Timber, Slash
Structure Triage Category: Defensible, Prep and Hold
Roof Material: Composite
Heat Traps: Wood Deck, Rain Gutters
Electrical Power: Underground
Hazards: Fuels, HazMat
Access to Site: T3/4 Engine
Comm with ICP: Radio, Cell Service
Water Source: Faucet / Hose, Large Pond, Creek
Mitigation Time: Less Than An Hour
Other Resources Needed to Protect: -1 engine crew, sprinklers.
Notes: -Removing debris from next to home.
 -43,000 gallon pool 10ft W of house.
 -Faucet on E side of house.
 -Creek located 200ft W of house.
 -Elderly male. lives alone.

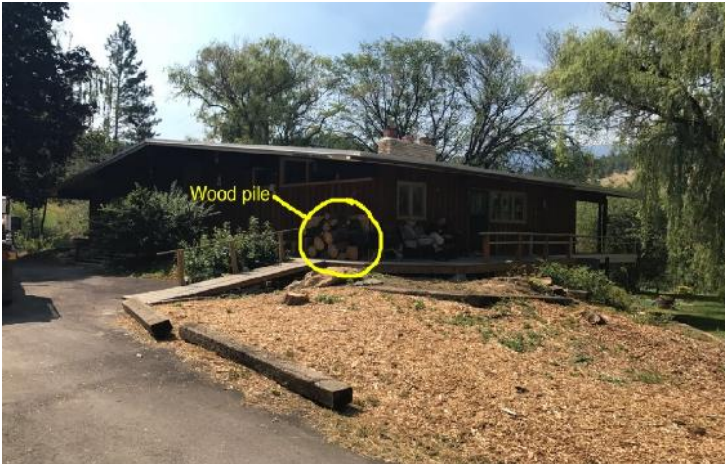
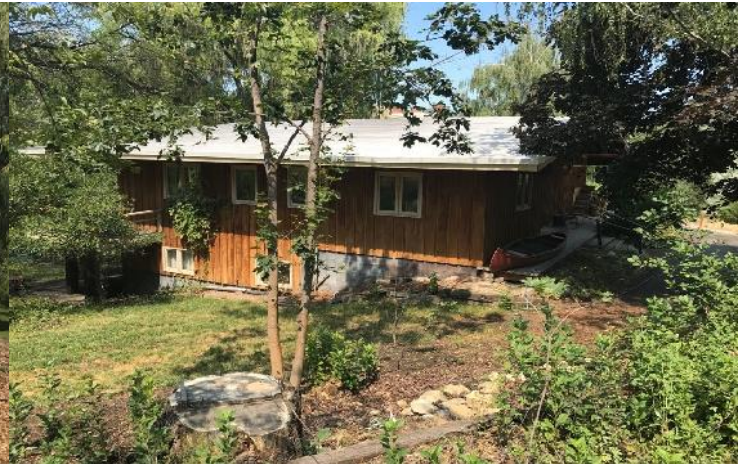
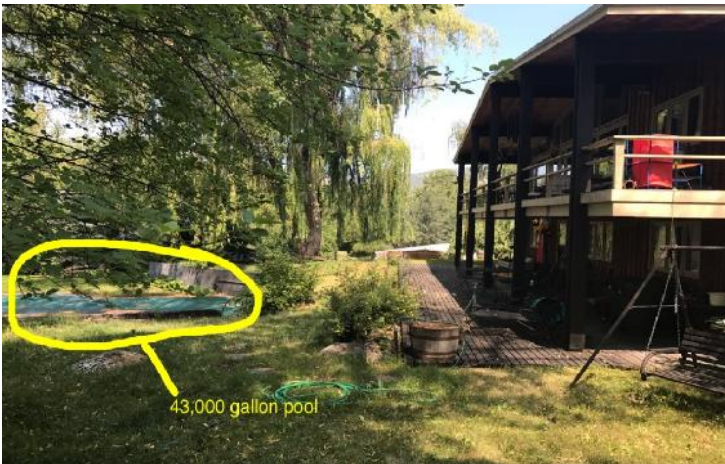
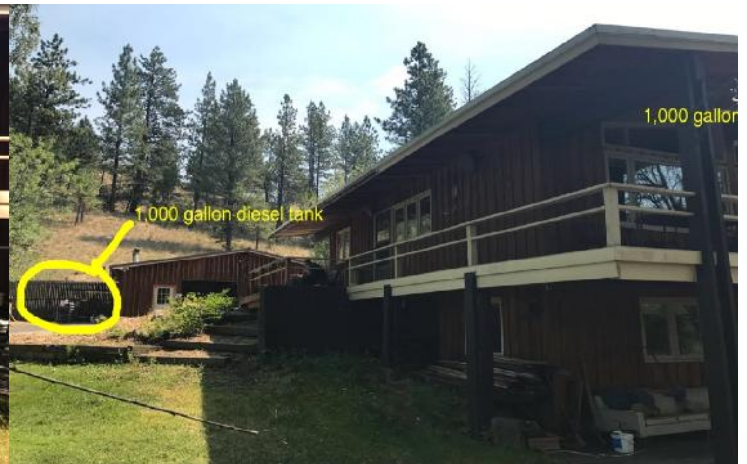
Structure Number: 4820
Structure Name: 8829 Mormon Creek Road
SubDivision: Travelers Rest
GPS Location, Lat. 46 44.64738
GPS Location, Long. 114 6.6468
Safety Zone Present: Yes
Type of Structure: Residential
Surrounding Fuels: Grass,Shrub,Timber,Slash
Structure Triage Category: Defensible, Prep and Hold
Roof Material: Composite
Heat Traps: Wood Deck,Rain Gutters
Electrical Power: Underground
Hazards: Fuels,HazMat
Access to Site: T3/4 Engine
Comm with ICP: Radio,Cell Service
Water Source: Faucet / Hose,Large Pond,Creek
Mitigation Time: Less Than An Hour
Other Resources Needed to Protect: -1 engine crew, sprinklers.
Notes: -Removing debris from next to home.
 -43,000 gallon pool 10ft W of house.
 -Faucet on E side of house.
 -Creek located 200ft W of house.
 -Elderly male. lives alone.

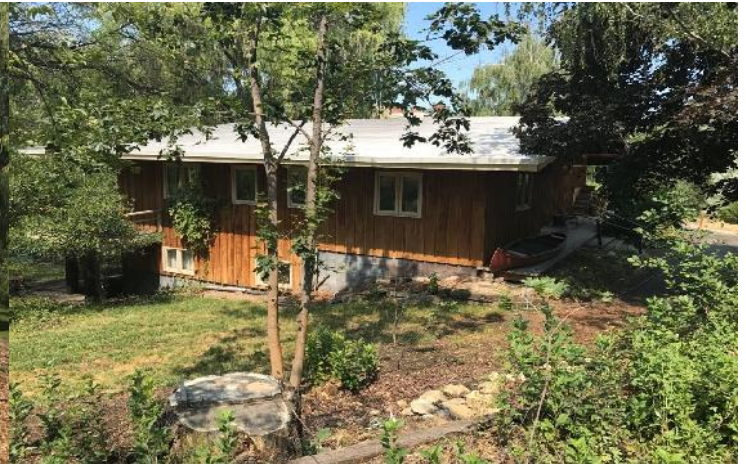
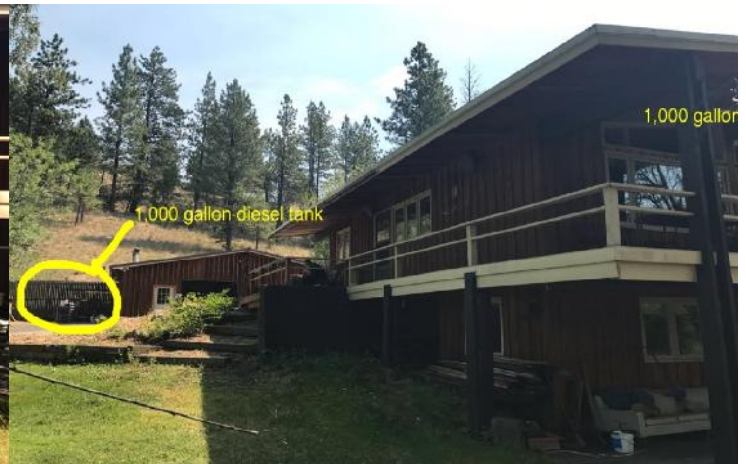
Structure Triage Category: Defensible, Prep and Hold
Roof Material: Composite
Heat Traps: Open Eaves, Wood Deck
Electrical Power: Underground
Hazards: Terrain, Fuels, Septic Tank
Access to Site: T1 Engine
Comm with ICP: Radio, Cell Service
Water Source: Faucet / Hose
Mitigation Time: Less Than An Hour
Other Resources Needed to Protect: 1 engine crew, sprinklers, scratch line.

Notes:
-Items and propane tank under SE side wood deck.
-Propane shut-off switch under SW side wood deck as well as a shut-off by underground septic tank 150ft N of house
-2 roof sprinklers.
-50gpm frost-free faucet 30ft W of house.

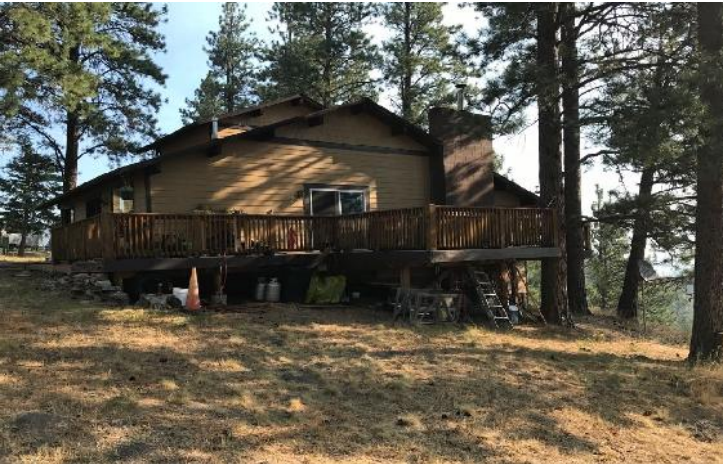
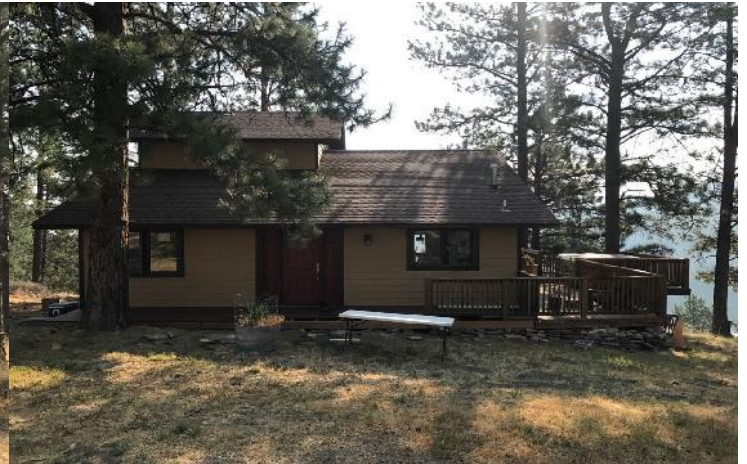
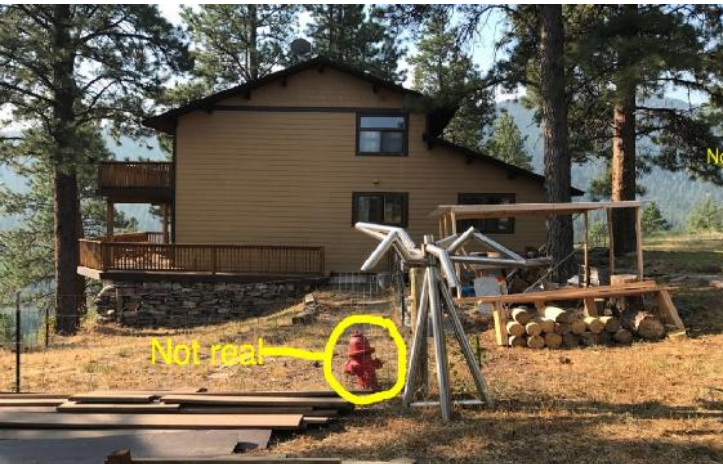
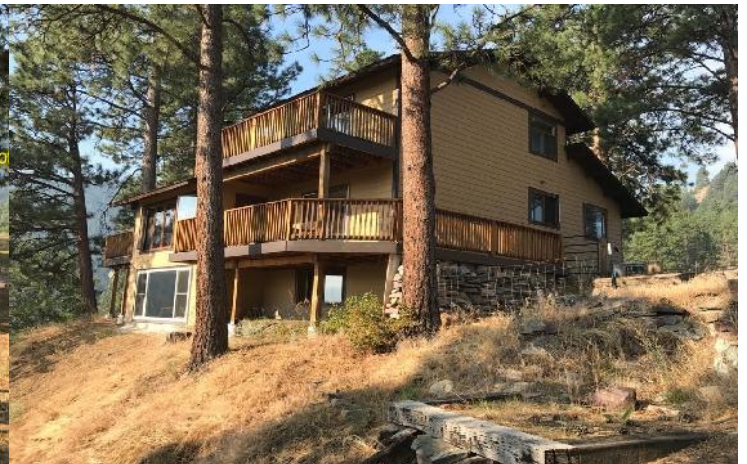
Structure Number: 4720
Structure Name: 9280 Mormon Creek Road
SubDivision: Travelers Rest
GPS Location, Lat. 46 44.35668
GPS Location, Long. 114 7.1802
Safety Zone Present: Yes
Type of Structure: Residential
Surrounding Fuels: Grass, Timber
Structure Triage Category: Defensible, Prep and Hold
Roof Material: Metal
Heat Traps: Wood Deck, Rain Gutters
Electrical Power: Underground
Hazards: Fuels, HazMat
Access to Site: T1 Engine
Comm with ICP: Radio, Cell Service
Water Source: Faucet / Hose
Mitigation Time: Less Than An Hour
Other Resources Needed to Protect: -1 engine crew, sprinklers, scratch line.
Notes: -Faucet on S side of house.
-Faucet 50ft N of house.

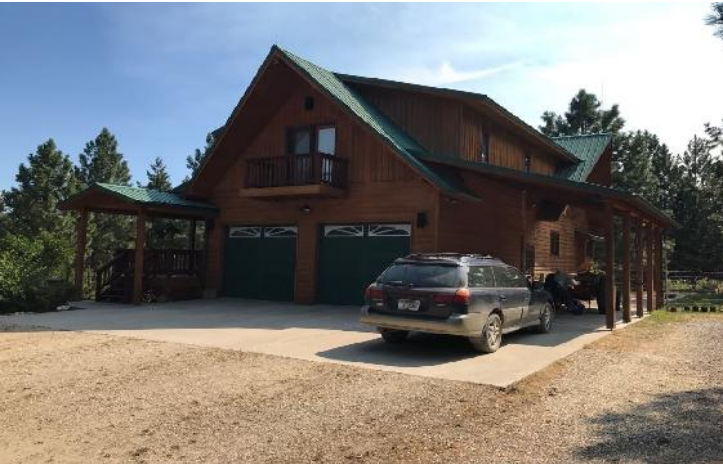
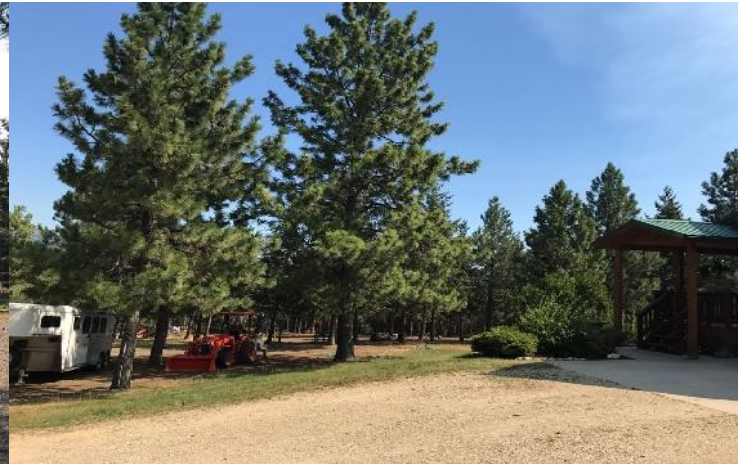
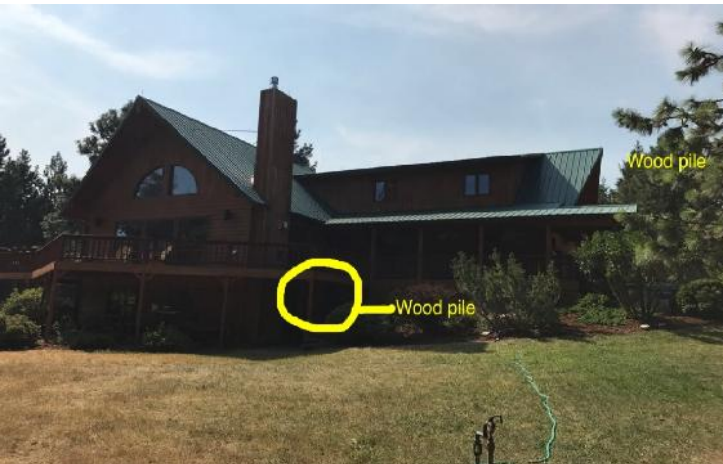
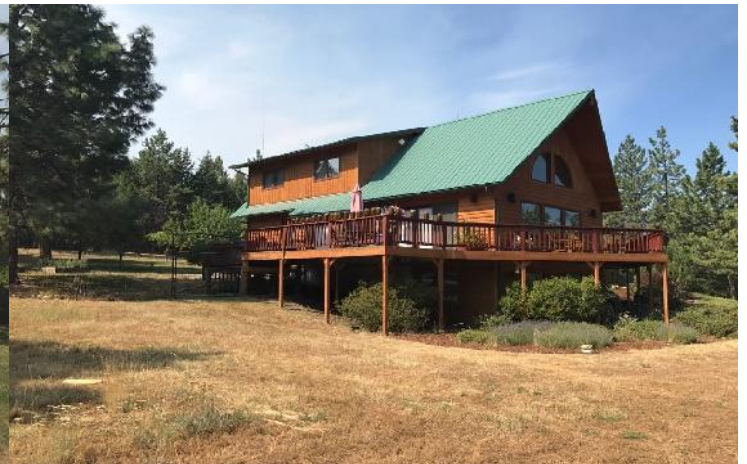
Structure Triage Category: Defensible, Stand Alone
Roof Material: Metal
Heat Traps: Wood Deck,Rain Gutters
Electrical Power: Underground
Hazards: Terrain,Fuels,No Turn Around
Access to Site: T6 Engine
Comm with ICP: Radio,Cell Service
Water Source: Faucet / Hose
Mitigation Time: Less Than An Hour
Other Resources Needed to Protect: -1 engine crew, sprinkler, scratch line.

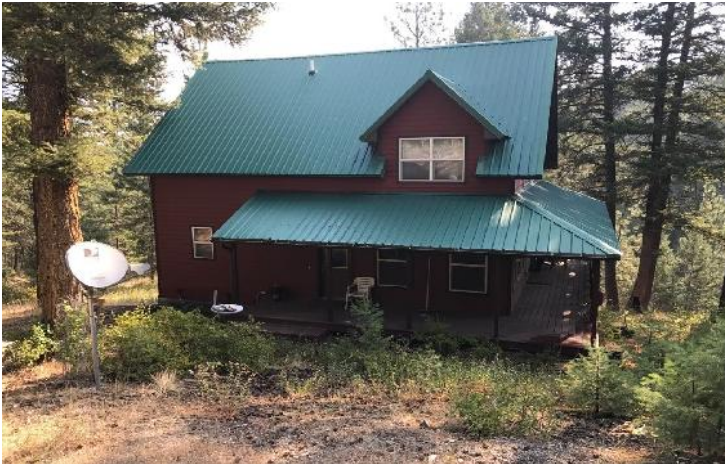
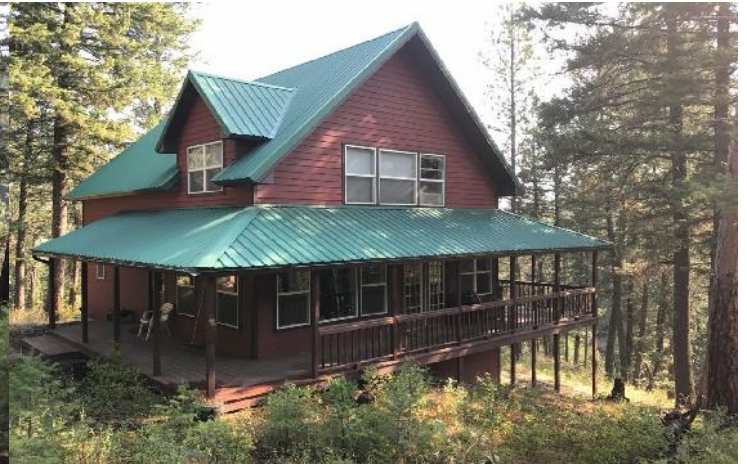
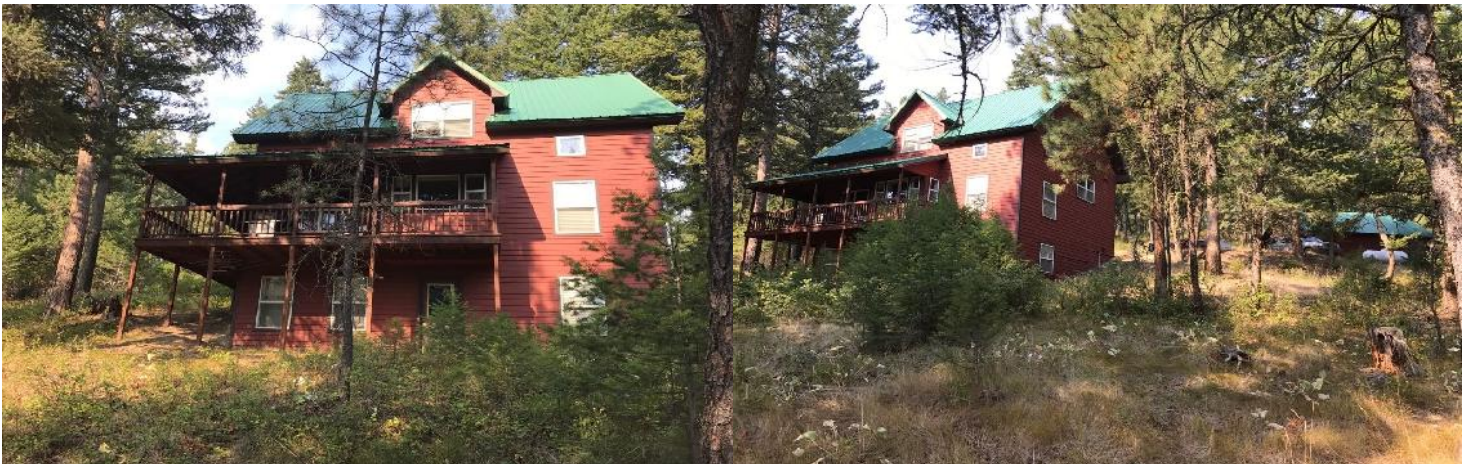
Safety Zone Present: Yes
Type of Structure: Residential
Surrounding Fuels: Grass
Structure Triage Category: Defensible, Prep and Hold
Roof Material: Composite
Heat Traps: Wood Deck
Electrical Power: Underground
Hazards: Fuels
Access to Site: T1 Engine
Comm with ICP: Radio, Cell Service
Water Source: Faucet / Hose
Mitigation Time: 1-2 Hours
Other Resources Needed to Protect: 1 Type 6 engine
Collected By: COCO 482

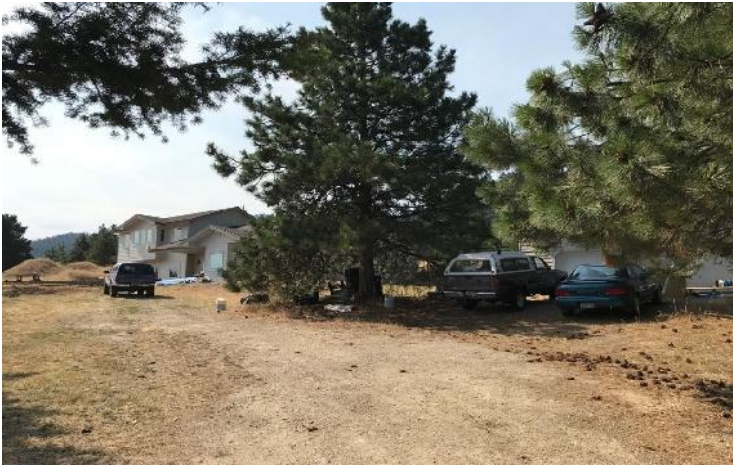
Photo 2

Structure Number: 4807
Structure Name: 9335 Hwy 12
SubDivision: Travelers Rest
GPS Location, Lat. 46 45.03186
GPS Location, Long. 114 7.54836
Safety Zone Present: Yes
Type of Structure: Residential
Surrounding Fuels: Grass
Structure Triage Category: Defensible, Stand Alone
Roof Material: Composite
Heat Traps: Open Eaves,Rain Gutters
Electrical Power: Overhead
Hazards: Septic Tank
Access to Site: T1 Engine
Comm with ICP: Radio,Cell Service
Water Source: Faucet / Hose
Mitigation Time: Less Than An Hour
Notes: Do not use pond for dip site...past history from previous Lolo fire

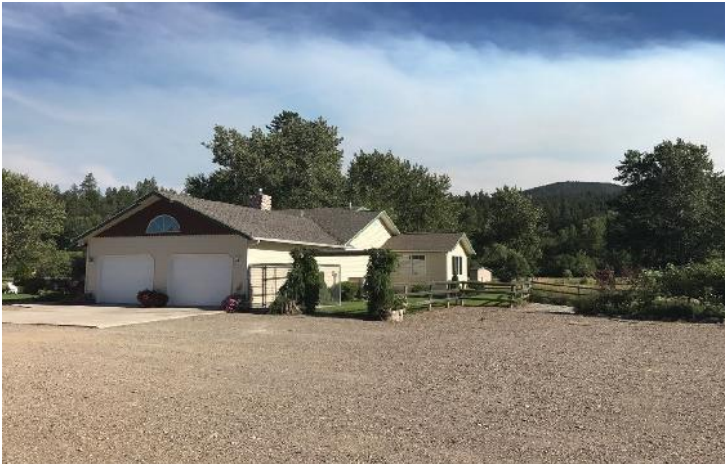
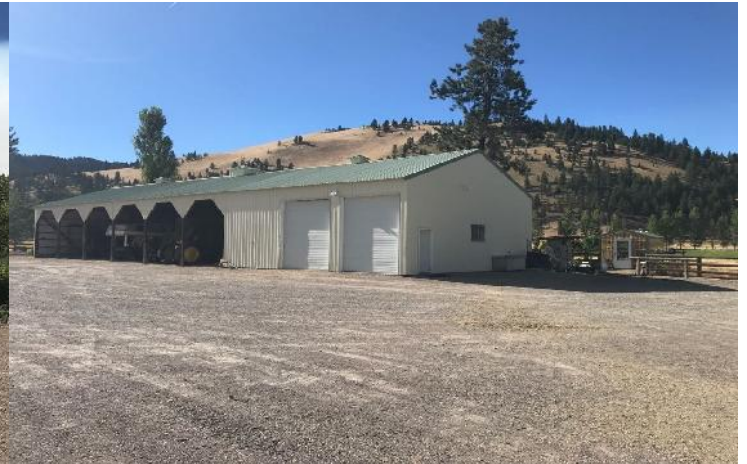
Structure Triage Category: Defensible, Prep and Hold
Roof Material: Composite
Heat Traps: Wood Deck, Rain Gutters
Electrical Power: Underground
Hazards: Terrain, Fuels
Access to Site: T1 Engine
Comm with ICP: Radio, Cell Service
Water Source: Faucet / Hose
Mitigation Time: 4-5 Hours
Other Resources Needed to Protect:
- A crew to prep around the home n remove snags
- Engine to hold

Notes:
-A crew will be needed to prep around home due to dense fuels
-After prep, an engine can be utilized to hold
-There are a few hazards surrounding property

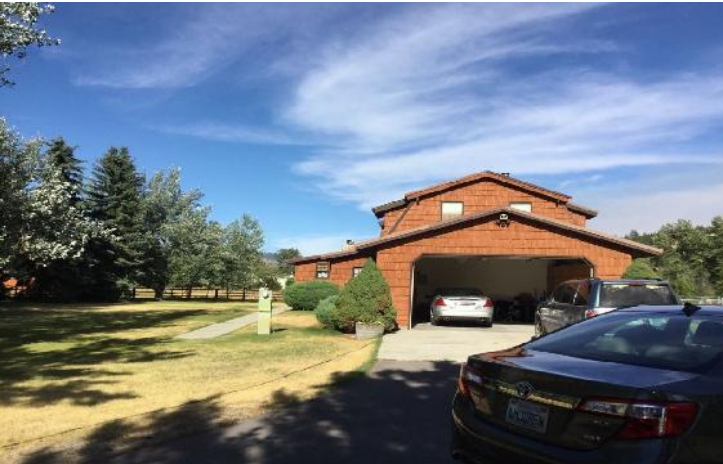
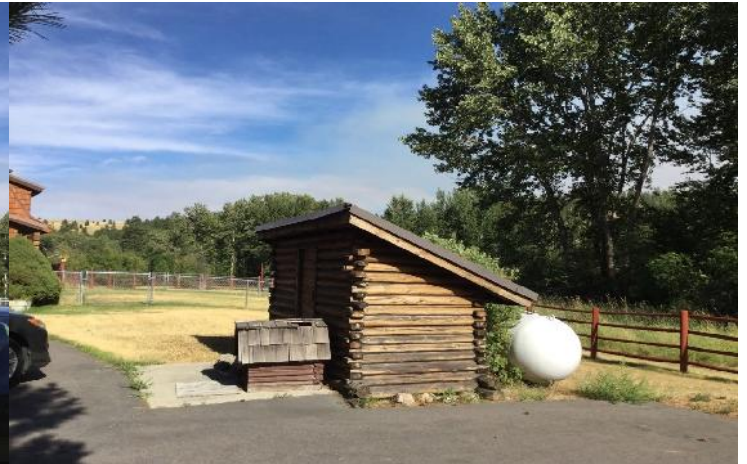
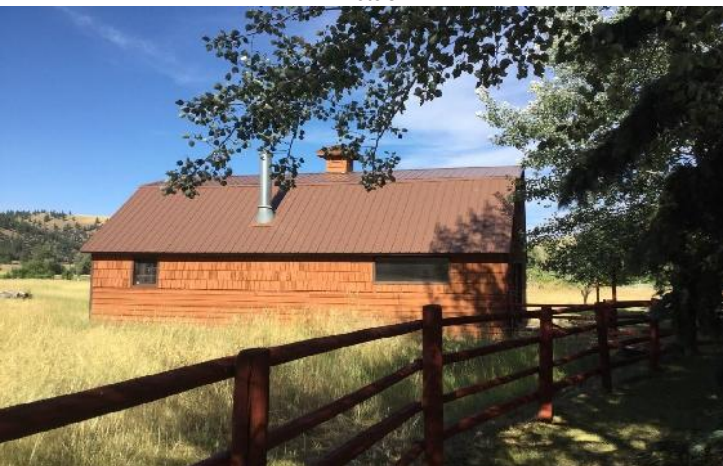
Structure Number: 4693
Structure Name: 9495 Hwy 12
SubDivision: Travelers Rest
GPS Location, Lat. 46 44.9553
GPS Location, Long. 114 7.7538
Safety Zone Present: No
Type of Structure: Residential
Surrounding Fuels: Grass, Timber
Structure Triage Category: Non-Defensible, Prep and Leave
Roof Material: Composite
Heat Traps: Wood Deck
Electrical Power: Underground
Hazards:
Access to Site: T3/4 Engine
Comm with ICP: Radio, Cell Service
Water Source: Faucet / Hose
Mitigation Time: 1-2 Hours
Collected By: TNF-E65

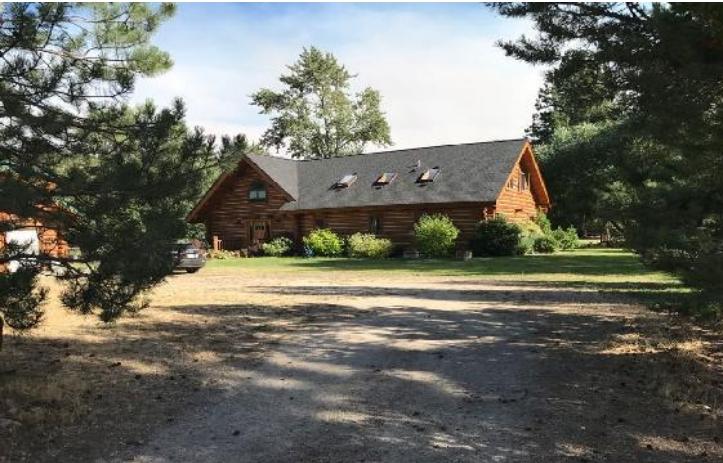
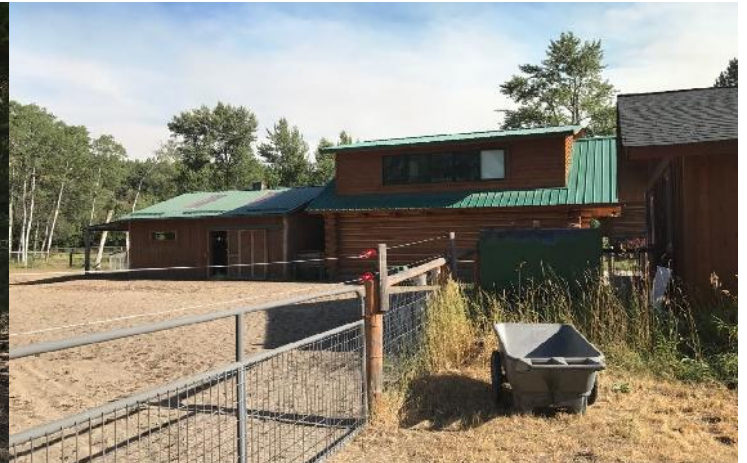
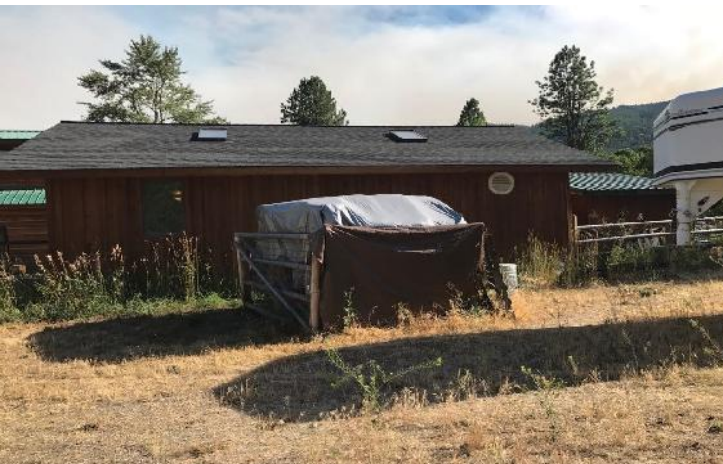
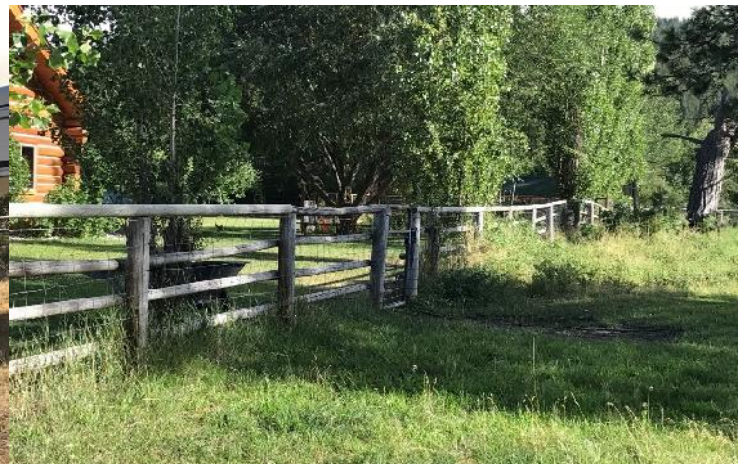
Structure Number: 4763
Structure Name: 9495 Hwy 12
SubDivision: Travelers Rest
GPS Location, Lat. 46 44.9553
GPS Location, Long. 114 7.7538
Safety Zone Present: No
Type of Structure: Residential
Surrounding Fuels: Grass, Timber
Structure Triage Category: Non-Defensible, Prep and Leave
Roof Material: Composite
Heat Traps: Wood Deck
Electrical Power: Underground
Hazards:
Access to Site: T3/4 Engine
Comm with ICP: Radio, Cell Service
Water Source: Faucet / Hose
Mitigation Time: 1-2 Hours
Collected By: TNF-E65

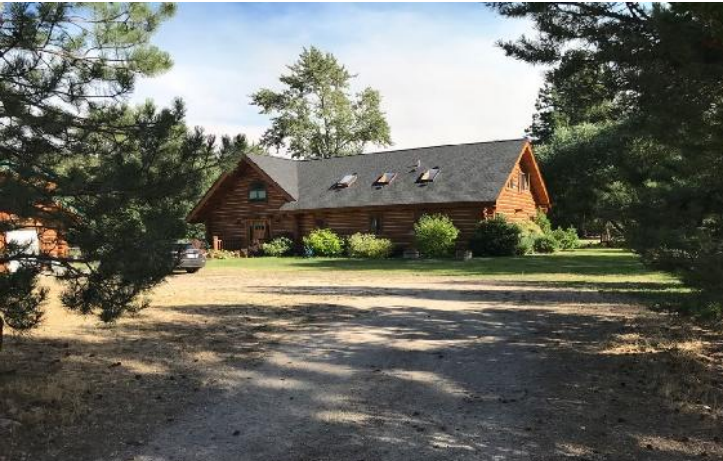
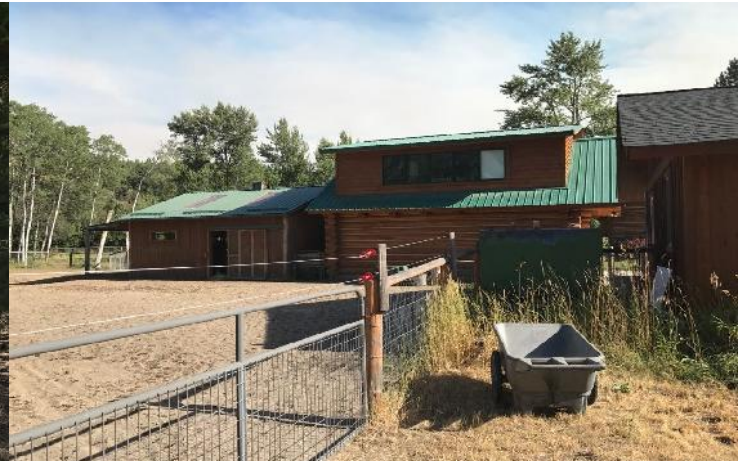
Structure Number: 4705
Structure Name: 9515 Hwy 12
SubDivision: Travelers Rest
GPS Location, Lat. 46 44.93184
GPS Location, Long. 114 7.83348
Safety Zone Present: No
Type of Structure: Residential
Surrounding Fuels: Grass, Timber
Structure Triage Category: Non-Defensible, Prep and Leave
Roof Material: Metal
Heat Traps: Rain Gutters
Electrical Power: Underground
Hazards:
Access to Site: T3/4 Engine
Comm with ICP: Radio, Cell Service
Water Source: Faucet / Hose
Mitigation Time: 1-2 Hours
Collected By: TNF-E65

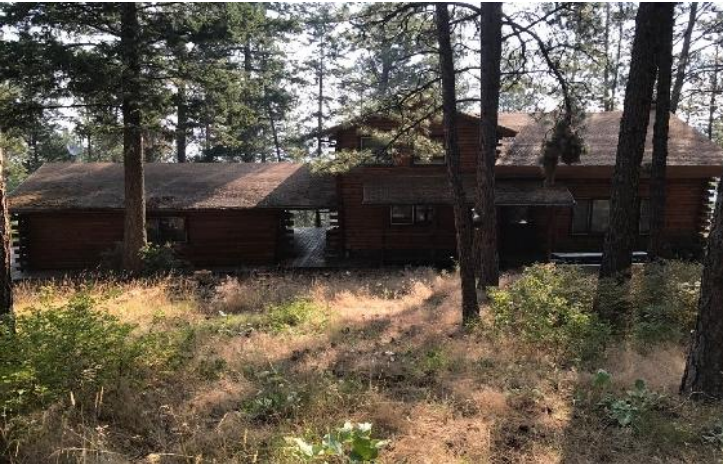
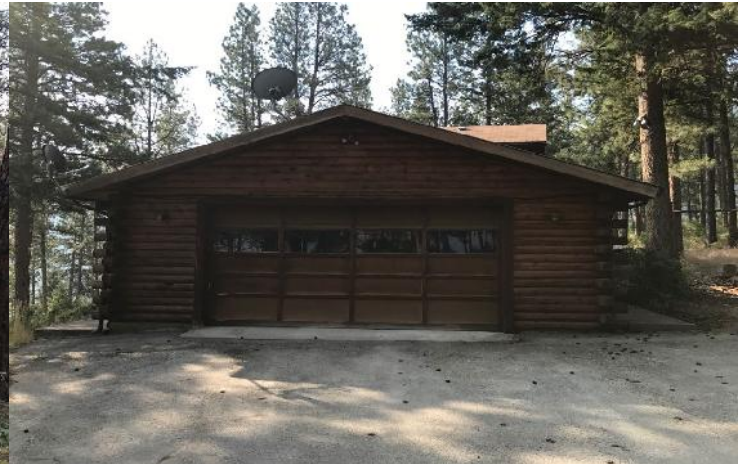
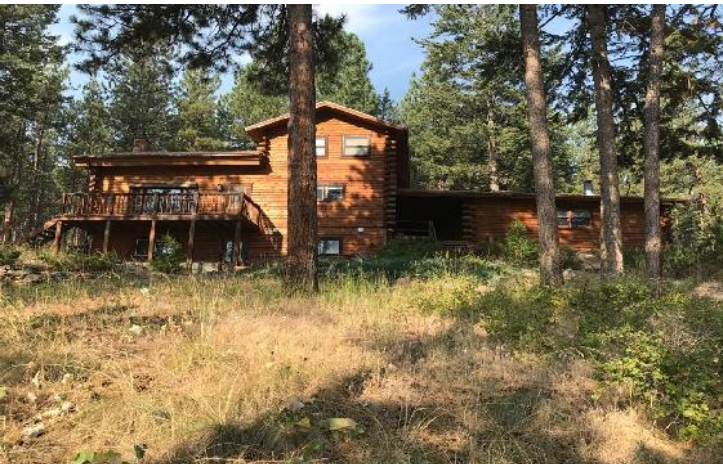
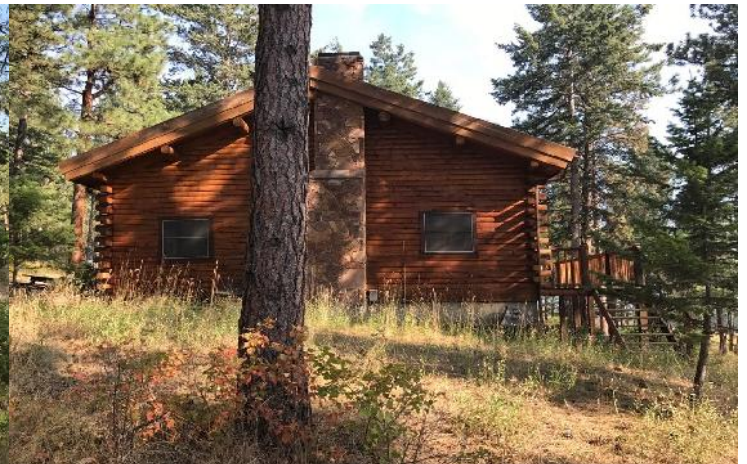
Structure Number: 4753
Structure Name: 9595 Hwy 12
SubDivision: Travelers Rest
GPS Location, Lat. 46 45.0618
GPS Location, Long. 114 7.84404
Safety Zone Present: Yes
Type of Structure: Residential
Surrounding Fuels: Grass
Structure Triage Category: Defensible, Prep and Hold
Roof Material: Composite
Heat Traps: Rain Gutters
Electrical Power: Overhead
Hazards: Septic Tank
Access to Site: T3/4 Engine
Comm with ICP: Radio, Cell Service
Water Source: Faucet / Hose
Mitigation Time: Less Than An Hour
Collected By: E 27 Florence Fire
Photo 1

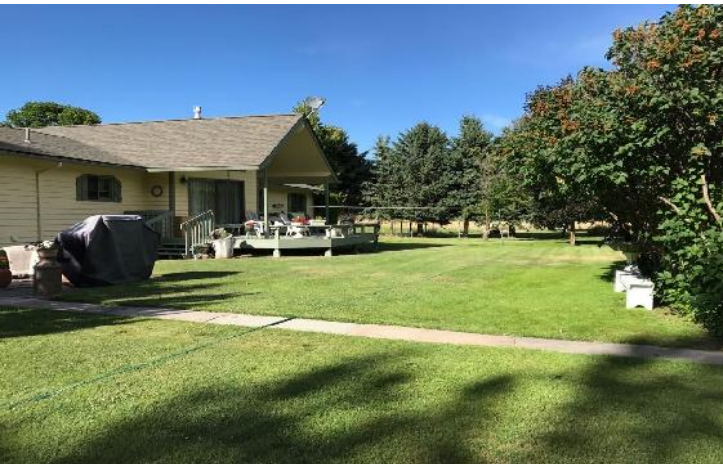
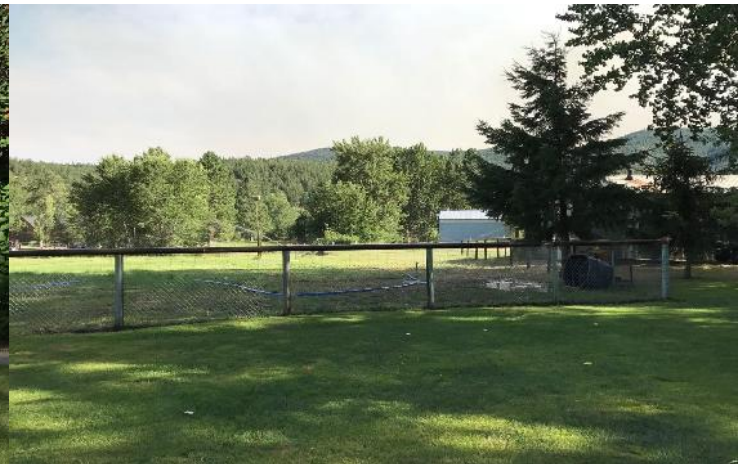
Structure Number: 4699
Structure Name: 9685 Highway 12 west
SubDivision: Travelers Rest
GPS Location, Lat. 46 44.99892
GPS Location, Long. 114 7.8732
Safety Zone Present: No
Type of Structure: Residential
Surrounding Fuels: Grass, Timber
Structure Triage Category: Defensible, Stand Alone
Roof Material: Composite
Heat Traps: Open Eaves, Wood Deck
Electrical Power: Underground
Hazards:
Access to Site: T1 Engine
Comm with ICP: Radio, Cell Service
Water Source: Faucet / Hose, Creek
Mitigation Time: Less Than An Hour
Other Resources Needed to Protect: 1 engine crew

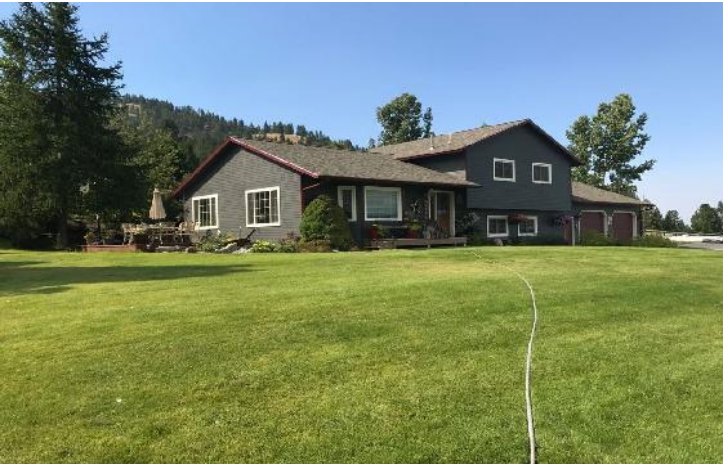
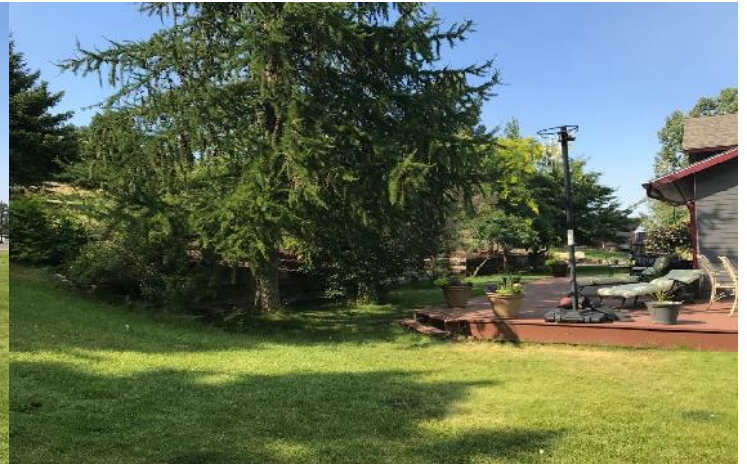
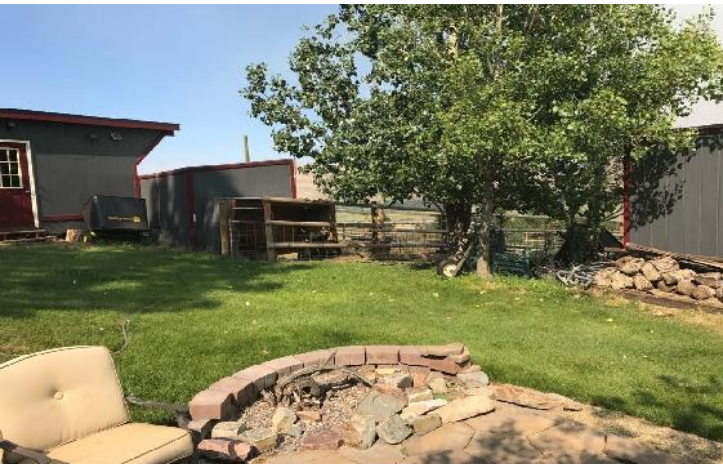
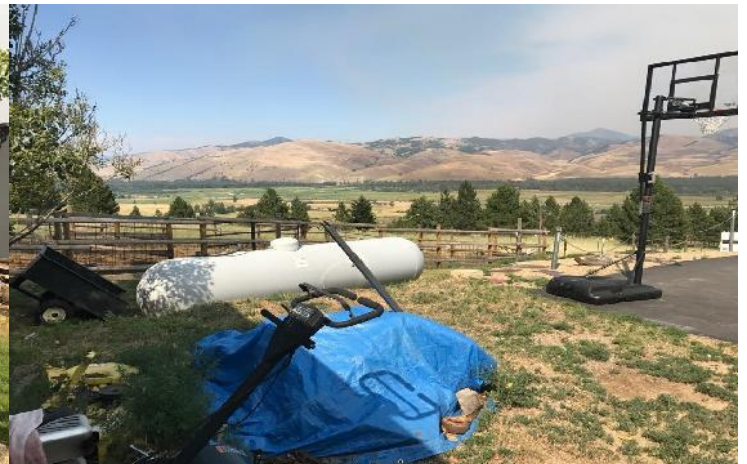
Access to Site: T1 Engine
Comm with ICP: Radio, Cell Service
Water Source: Faucet / Hose, Hydrant
Mitigation Time: None Needed
Notes: Unclear if hydrant in yard is in working condition.

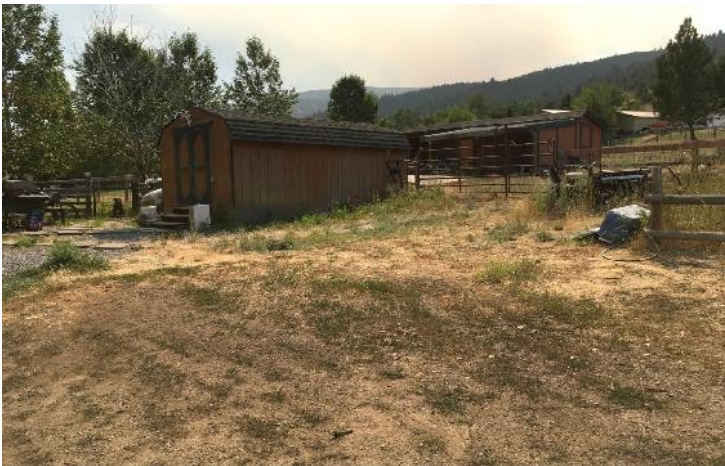
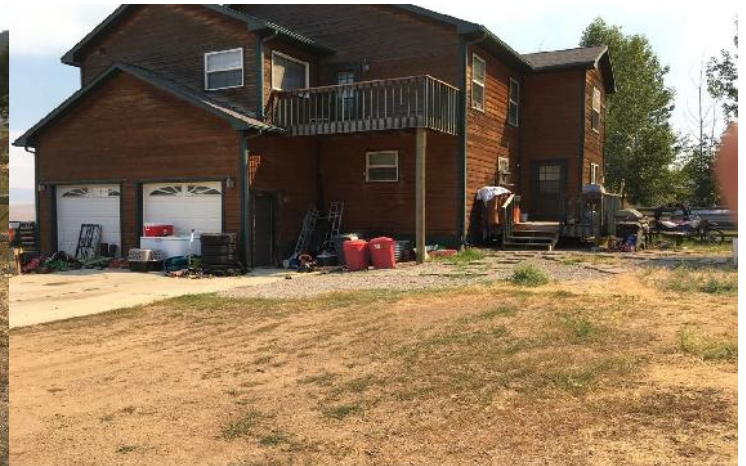
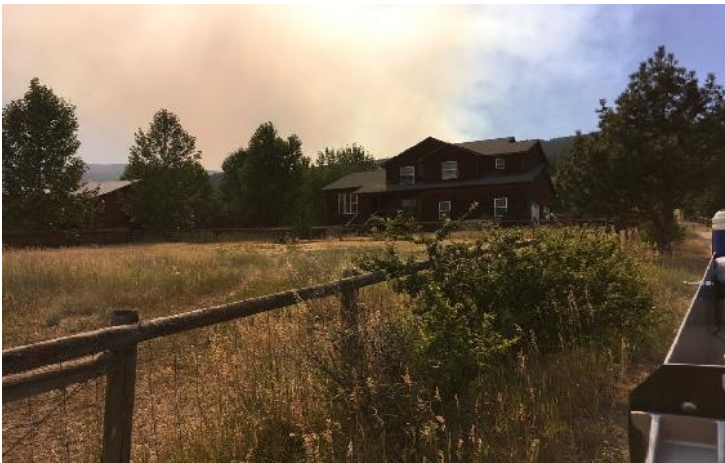
Structure Number:
Structure Name: 16123 Highland Dr.
SubDivision: Macintosh Manor
GPS Location, Lat. 46 42.99108
GPS Location, Long. 114 5.97468
Safety Zone Present: No
Type of Structure: Residential
Surrounding Fuels: Grass
Structure Triage Category: Non-Defensible, Prep and Leave
Roof Material: Composite
Heat Traps: Open Eaves, Wood Deck, Rain Gutters
Electrical Power: Underground
Hazards: Fuels, No Turn Around, Septic Tank
Access to Site: T6 Engine
Comm with ICP: Radio, Cell Service
Water Source: Faucet / Hose
Mitigation Time: More Than 5 Hours
Notes: Unkempt with small equipment, tires etc.

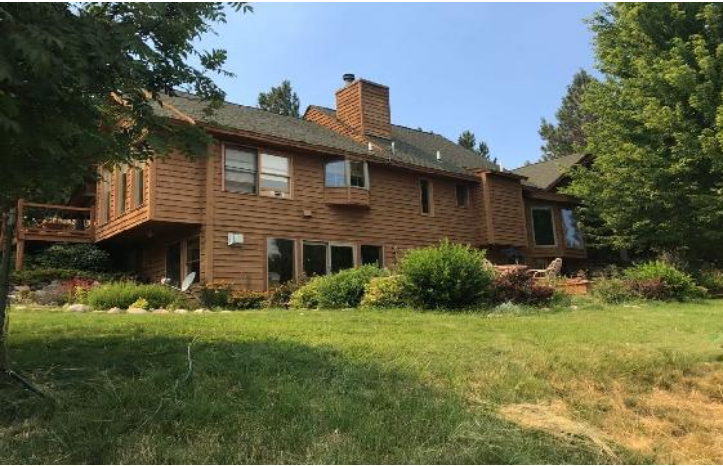
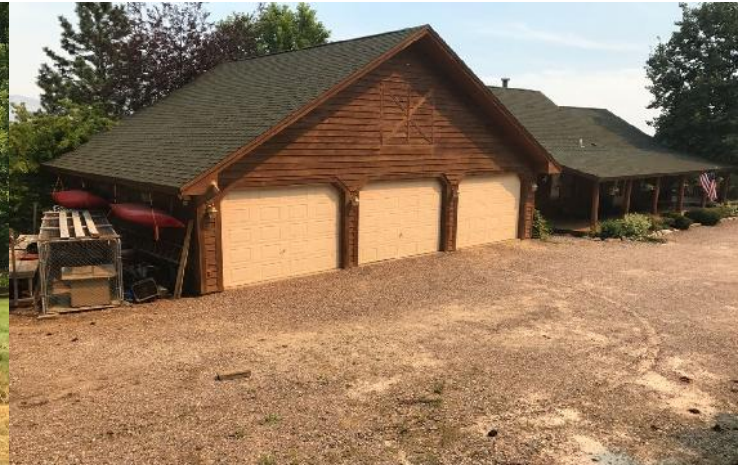
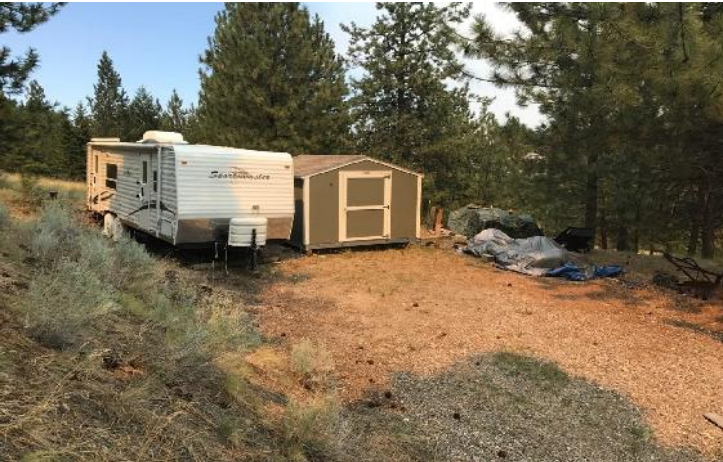
Safety Zone Present: No
Type of Structure: Residential
Surrounding Fuels: Grass, Shrub, Timber
Structure Triage Category: Defensible, Stand Alone
Roof Material: Composite
Heat Traps: Wood Deck
Electrical Power: Underground
Hazards: Terrain, Fuels, HazMat

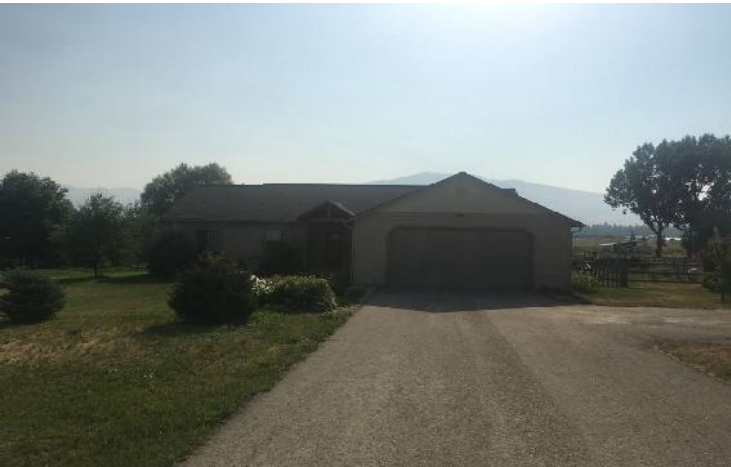
Photo 2

Structure Number:
Structure Name: 16476 Penny Lane
SubDivision: Macintosh Manor
GPS Location, Lat. 46 42.78594
GPS Location, Long. 114 4.98582
Safety Zone Present: Yes
Type of Structure: Residential
Surrounding Fuels: Grass
Structure Triage Category: Defensible, Stand Alone
Roof Material: Composite
Heat Traps: Rain Gutters
Electrical Power: Underground
Hazards:
Access to Site: T1 Engine
Comm with ICP: Radio, Cell Service
Water Source: Faucet / Hose
Mitigation Time: Less Than An Hour
Other Resources Needed to Protect: T6 patrol
Collected By: COCO 482
Photo 1

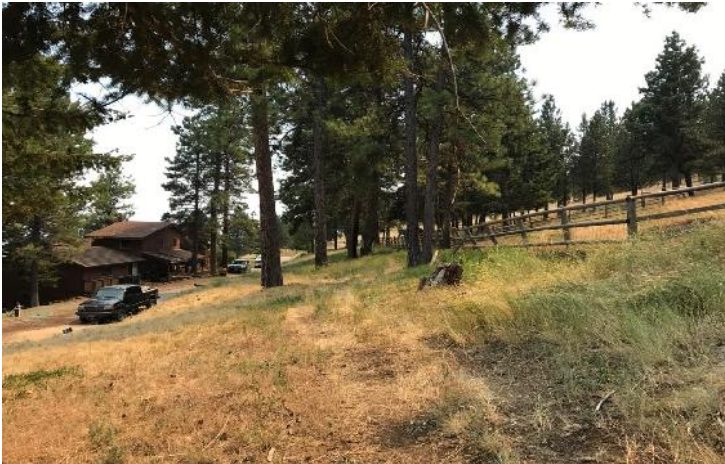
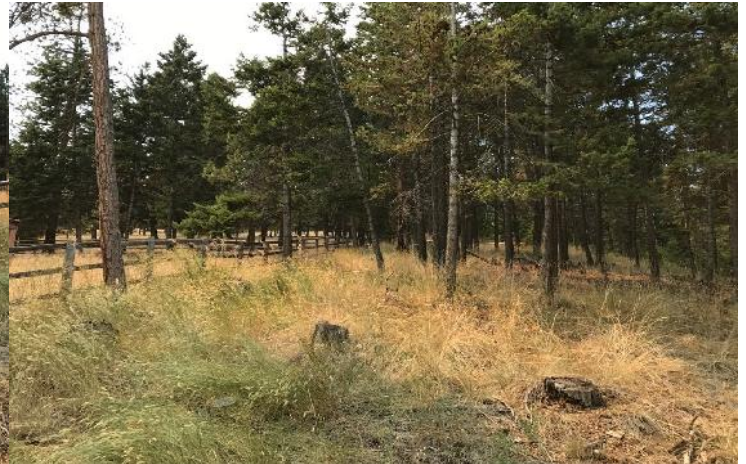
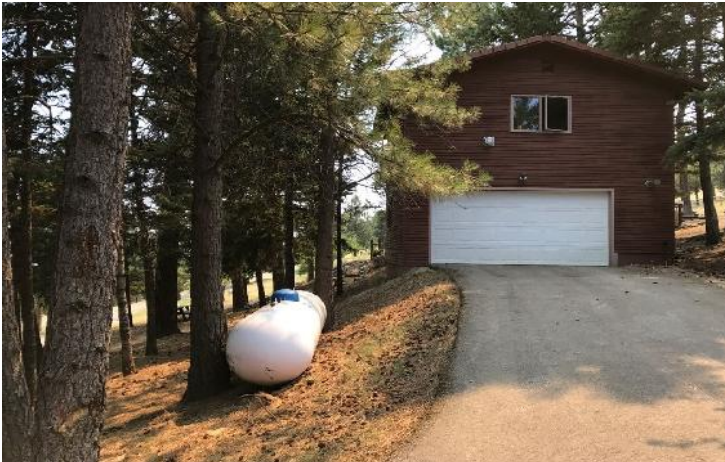
Safety Zone Present: Yes
Type of Structure: Residential
Surrounding Fuels: Grass, Timber
Structure Triage Category: Defensible, Stand Alone
Roof Material: Composite
Heat Traps: Wood Deck
Electrical Power: Underground
Hazards: Fuels, HazMat

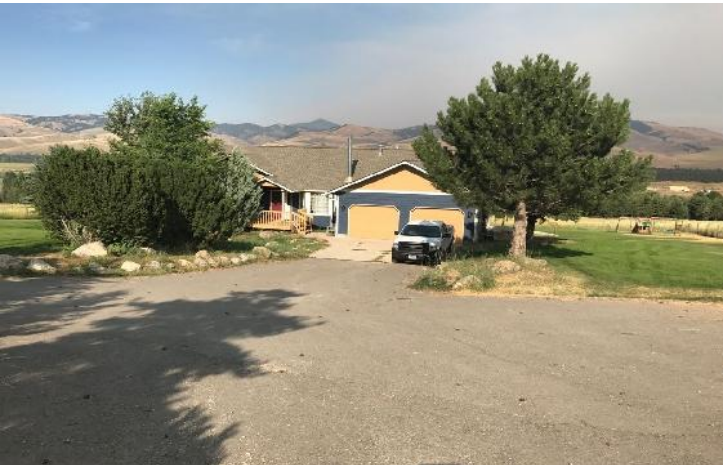
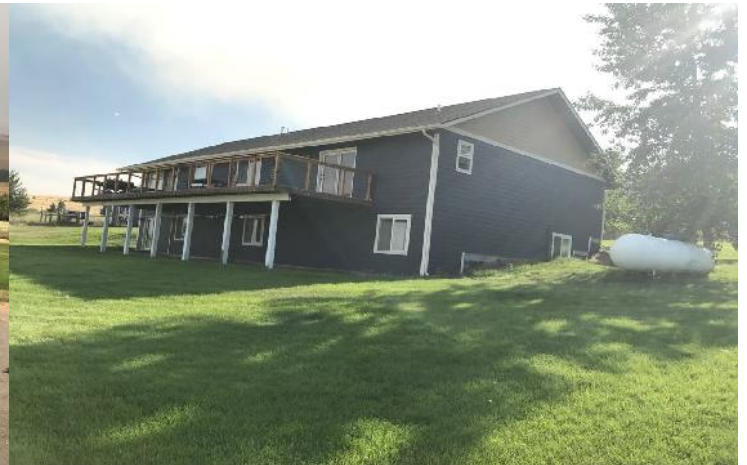
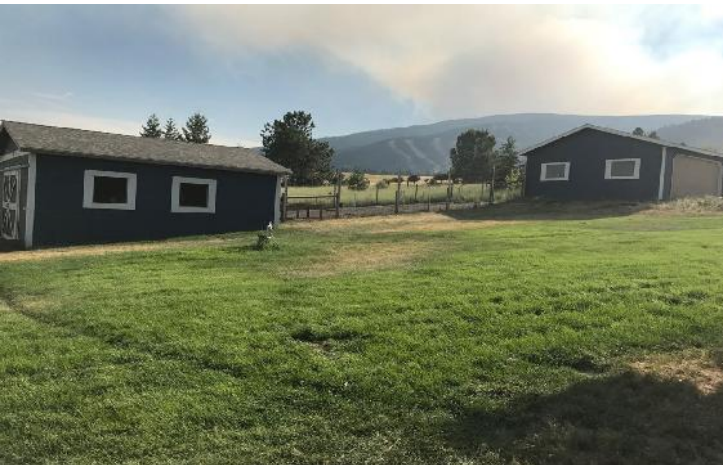
Structure Number:
Structure Name: 16490 Dundee Road
SubDivision: Macintosh Manor
GPS Location, Lat. 46 42.81636
GPS Location, Long. 114 5.57856
Safety Zone Present: Yes
Type of Structure: Residential
Surrounding Fuels: Grass, Timber
Structure Triage Category: Defensible, Stand Alone
Roof Material: Composite
Heat Traps: Wood Deck, Rain Gutters
Electrical Power: Underground
Hazards: Animals, HazMat
Access to Site: T1 Engine
Comm with ICP: Radio, Cell Service
Water Source: Faucet / Hose
Mitigation Time: None Needed
Other Resources Needed to Protect: None
Collected By: E 632

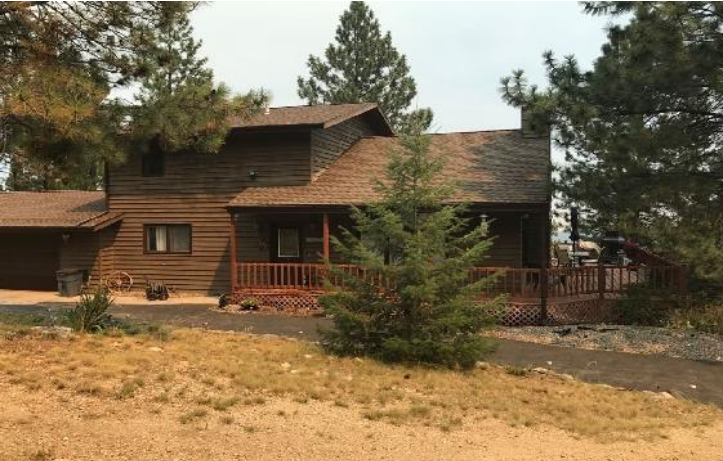
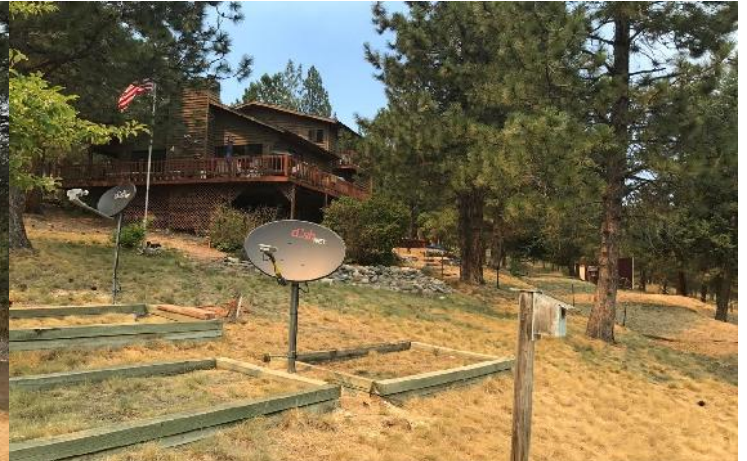
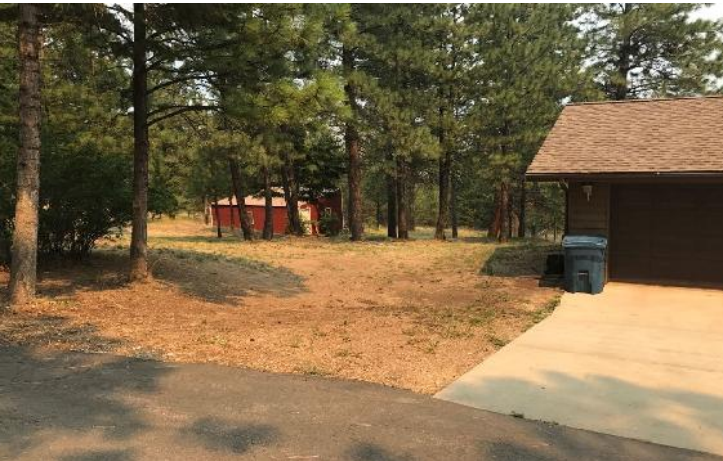
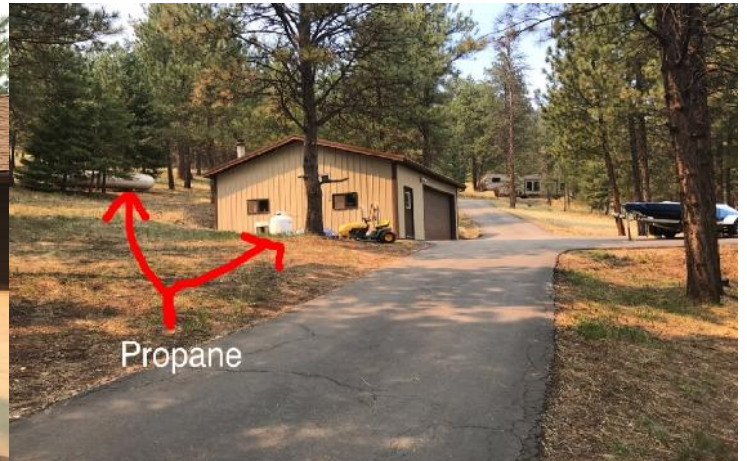
Structure Number:
Structure Name: 16490 Folsom RD
SubDivision: Macintosh Manor
GPS Location, Lat. 46 43.1643
GPS Location, Long. 114 6.22824
Safety Zone Present: No
Type of Structure: Residential
Surrounding Fuels: Grass, Timber
Structure Triage Category: Defensible, Stand Alone
Roof Material: Composite
Heat Traps: Wood Deck, Rain Gutters
Electrical Power: Underground
Hazards: HazMat
