STRUCTURE
PROTECTION PLAN
FOR
ELK CREEK BLOCK
07/27/2017

Structure Protection Plan

OZ Ranch

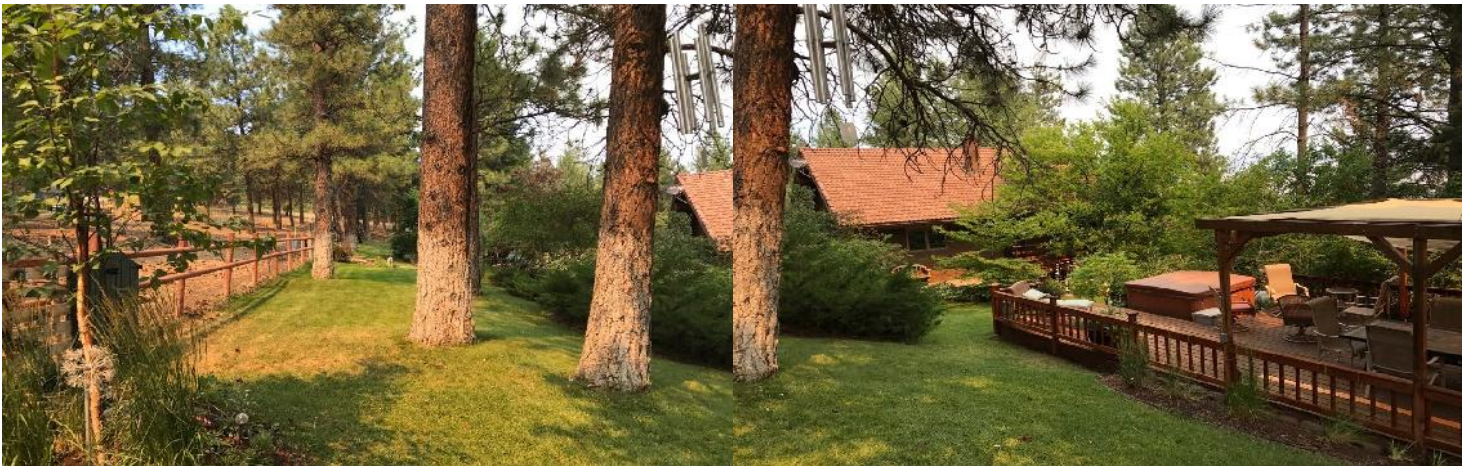
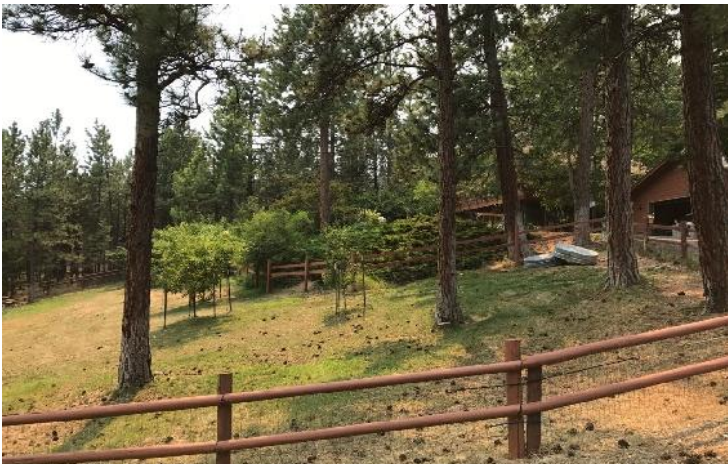
Safety Zone Present: Yes
Type of Structure: Residential
Surrounding Fuels: Grass, Timber
Structure Triage Category: Defensible, Stand Alone
Roof Material: Composite
Heat Traps: Wood Deck
Electrical Power: Underground
Hazards: HazMat

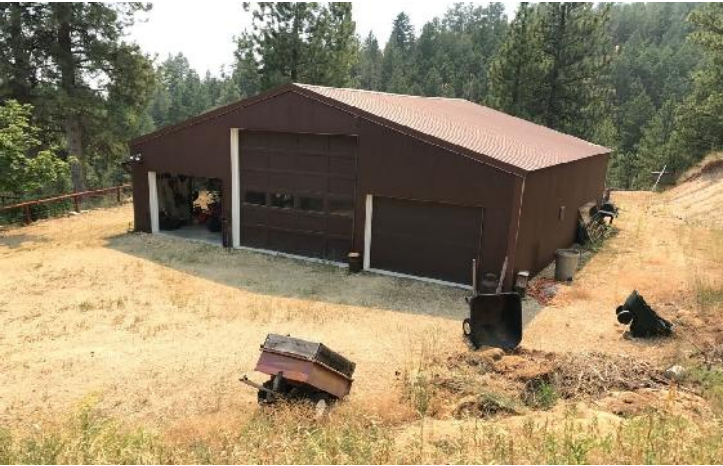
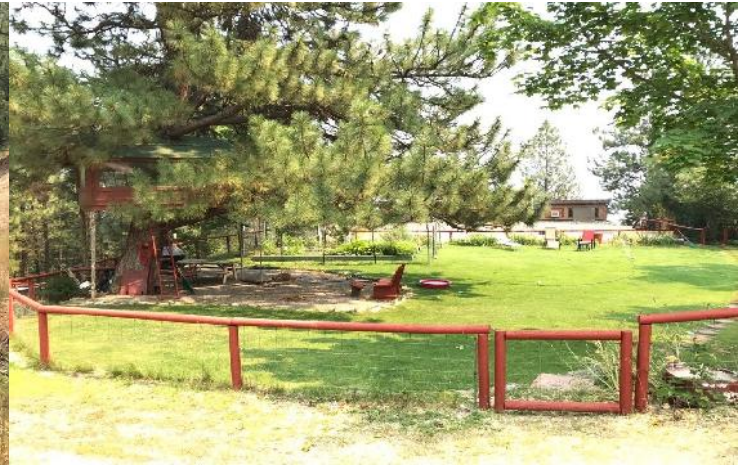
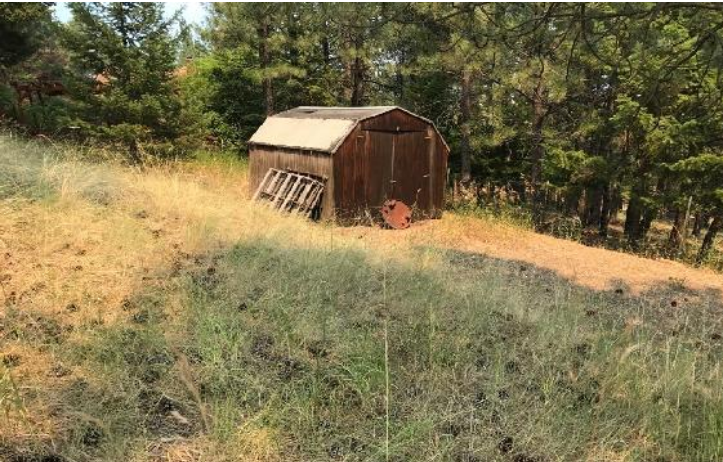
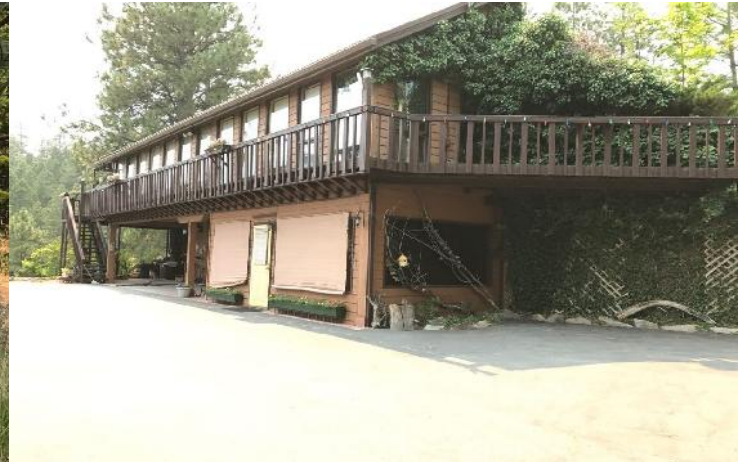
Safety Zone Present: No
Type of Structure: Residential
Surrounding Fuels: Grass, Shrub, Timber
Structure Triage Category: Non-Defensible, Prep and Leave
Roof Material: Wood
Heat Traps: Wood Deck
Electrical Power: Underground
Hazards: Terrain, Fuels, No Turn Around, HazMat

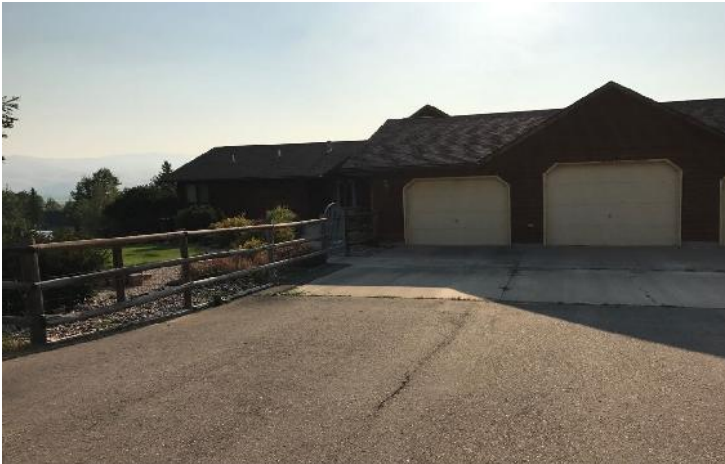
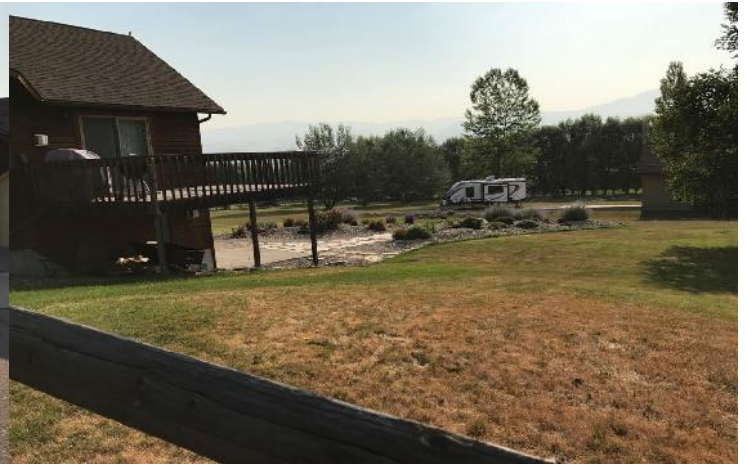
Structure Number:
Structure Name: 16530 Queen Anne's Ln
SubDivision: Macintosh Manor
GPS Location, Lat. 46 42.77148
GPS Location, Long. 114 5.2737
Safety Zone Present: Yes **Where is Safety Zone:** Well kept lawn to the east
Type of Structure: Residential **Primary Structures:** **Outbuildings:**
Surrounding Fuels: Grass **Defensible Space:** 30-50 Feet
Structure Triage Category: Defensible, Prep and Hold
Roof Material: Composite **Siding Material:** Wood
Heat Traps: Open Eaves, Wood Deck, Rain Gutters
Electrical Power: Underground **Gas to Structure:** Aboveground
Hazards: Septic Tank
Access to Site: T3/4 Engine **Best Access From:** Rowan Rd
Comm with ICP: Radio, Cell Service
Water Source: Faucet / Hose
Mitigation Time: Less Than An Hour
Notes: Limited turn around beyond this address to the south, with Queen Anne's Ln being a dead end. A type one would be able to fit in the driveway

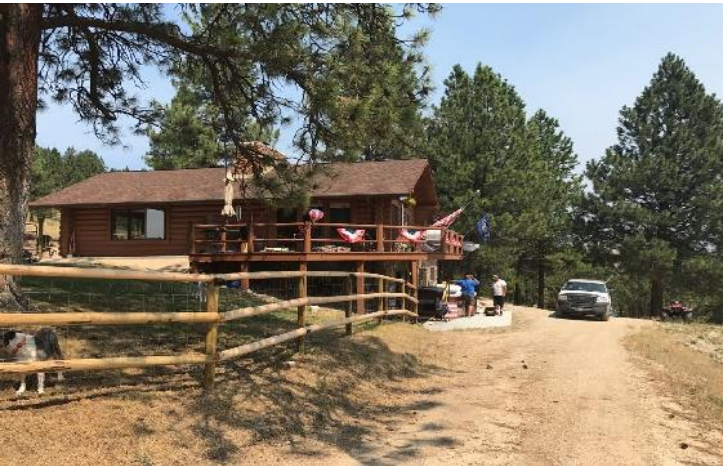
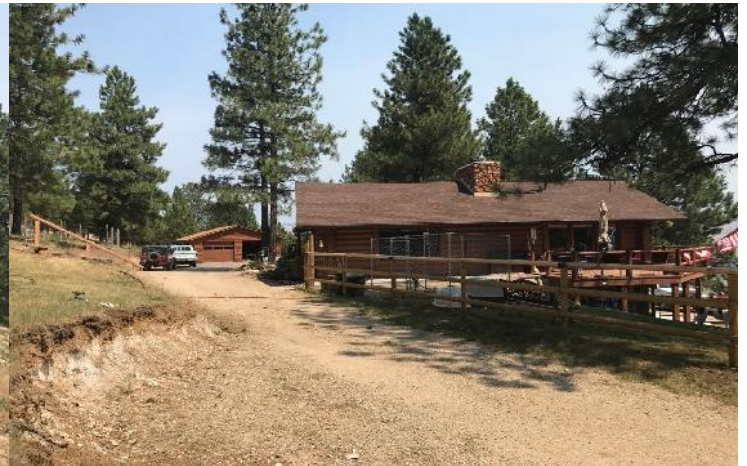
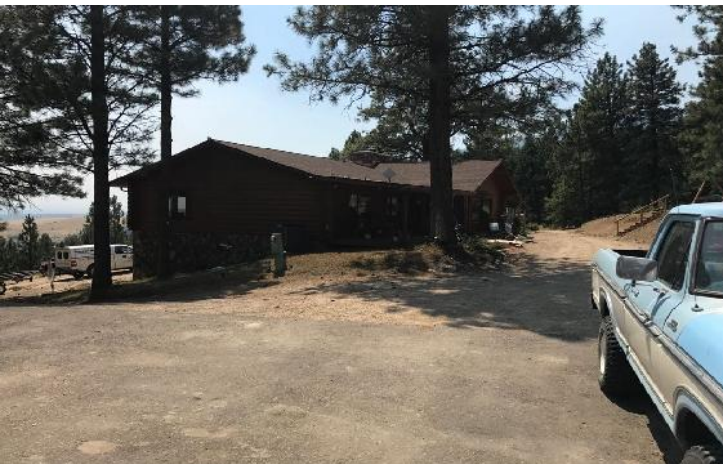
Structure Number:
Structure Name: 16535 Folsom Rd
SubDivision: Macintosh Manor
GPS Location, Lat. 46 43.29804
GPS Location, Long. 114 6.22938
Safety Zone Present: No
Type of Structure: Residential
Surrounding Fuels: Grass, Timber
Structure Triage Category: Defensible, Stand Alone
Roof Material: Composite
Heat Traps: Wood Deck, Rain Gutters
Electrical Power: Underground
Hazards: Terrain, Animals, HazMat

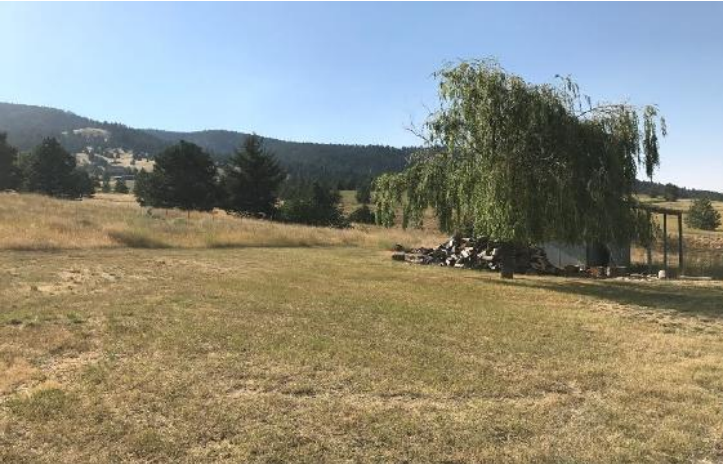
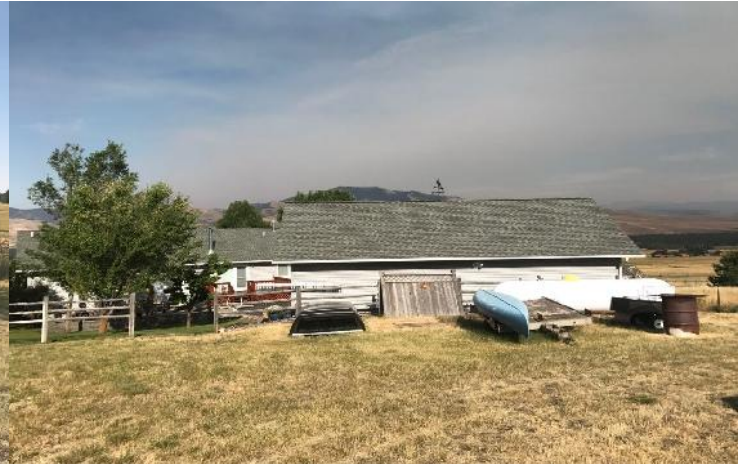
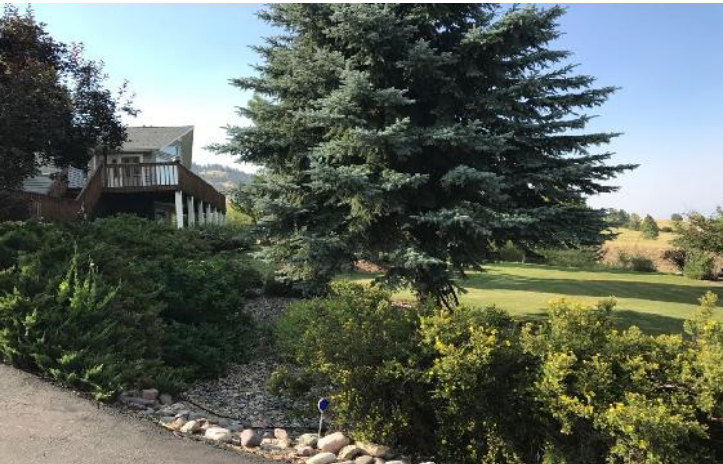
Safety Zone Present: Yes
Type of Structure: Residential
Surrounding Fuels: Grass, Timber
Structure Triage Category: Defensible, Stand Alone
Roof Material: Composite
Heat Traps:
Electrical Power: Underground
Hazards: HazMat
Access to Site: T1 Engine
Comm with ICP: Radio, Cell Service
Water Source: Faucet / Hose
Mitigation Time: Less Than An Hour
Notes: Wood pile out back near shed could be moved to reduce fuels near structure

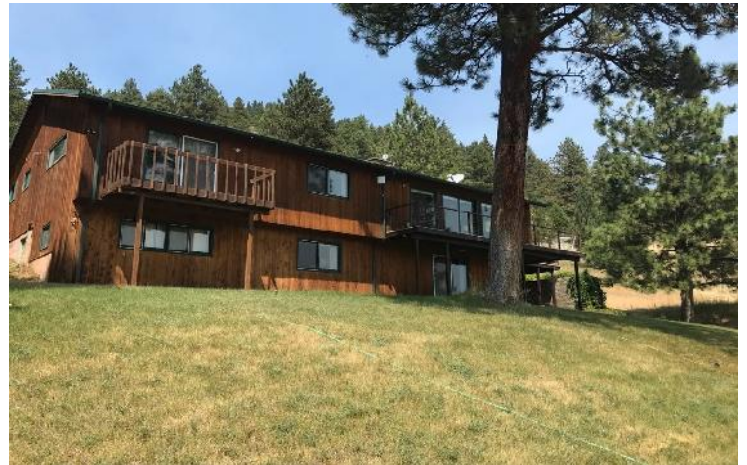
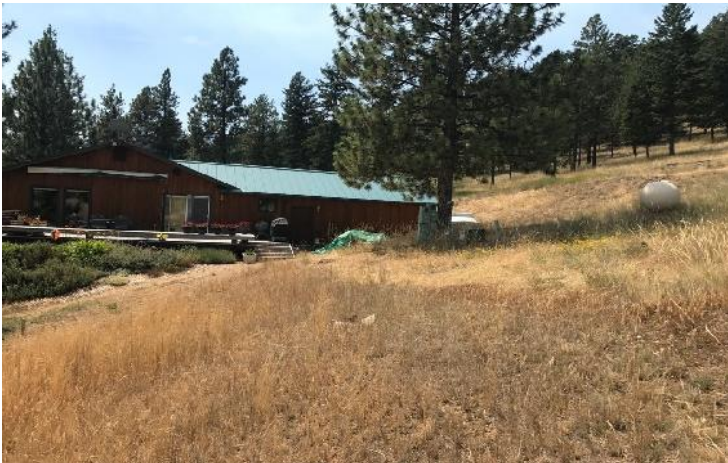
Structure Number:
Structure Name: 16545 Folsom Rd
SubDivision: Macintosh Manor
GPS Location, Lat. 46 43.32834
GPS Location, Long. 114 6.39456
Safety Zone Present: No
Type of Structure: Residential
Surrounding Fuels: Grass, Timber
Structure Triage Category: Defensible, Stand Alone
Roof Material: Metal
Heat Traps: Wood Deck, Rain Gutters
Electrical Power: Underground
Hazards: Fuels, HazMat

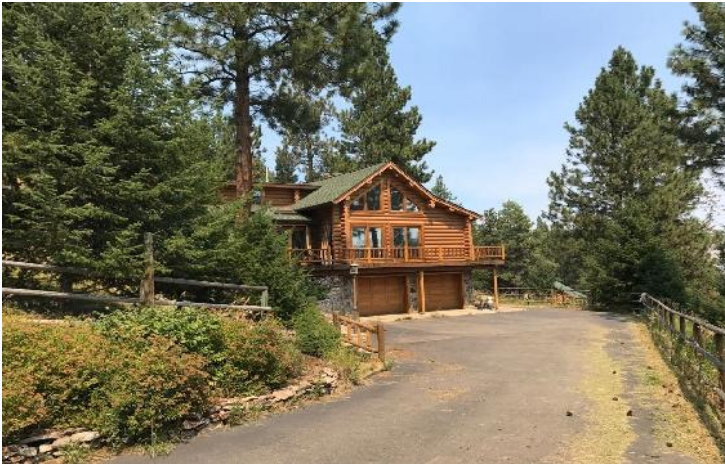
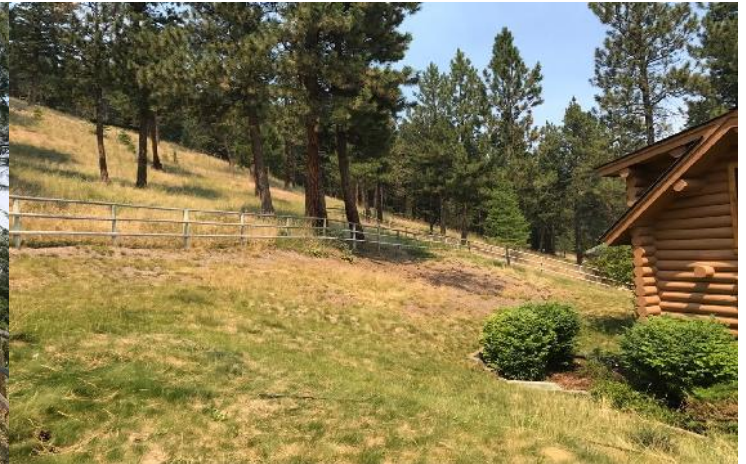
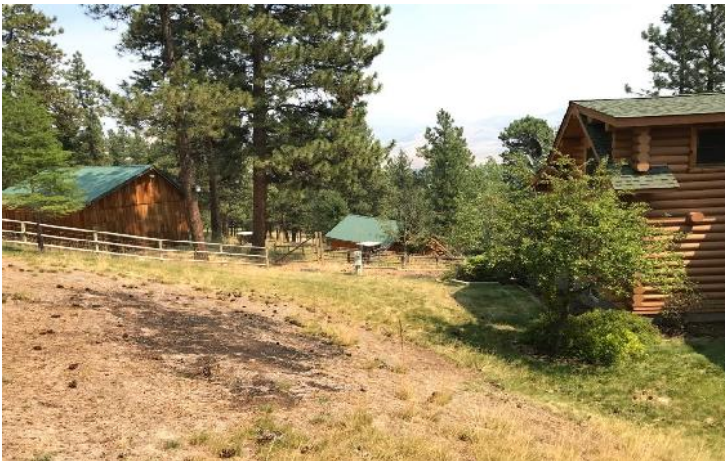
Safety Zone Present: Yes
Type of Structure: Residential
Surrounding Fuels: Grass, Timber
Structure Triage Category: Non-Defensible, Prep and Leave
Roof Material: Composite
Heat Traps: Wood Deck
Electrical Power: Underground
Hazards: Terrain

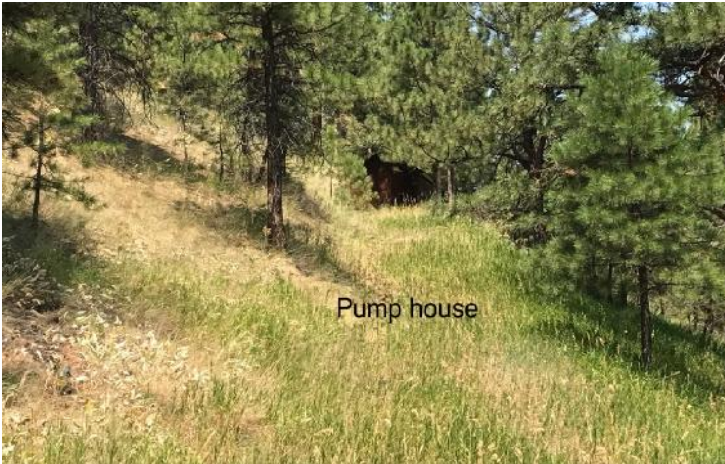
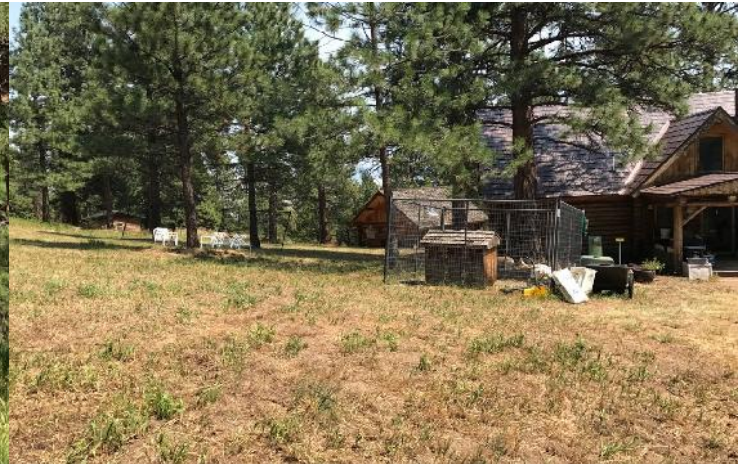
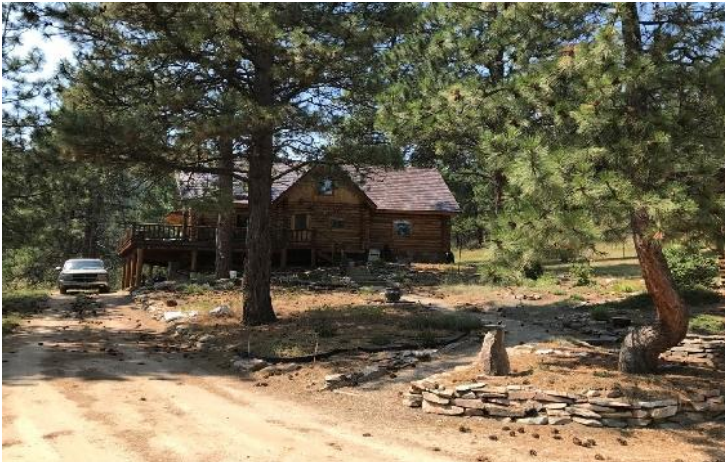
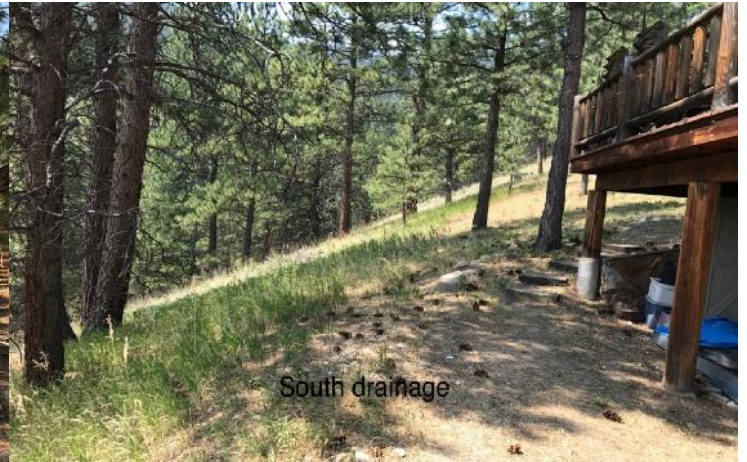
Safety Zone Present: No
Type of Structure: Residential
Surrounding Fuels: Grass, Shrub, Timber
Structure Triage Category: Non-Defensible, Prep and Leave
Roof Material: Composite
Heat Traps: Wood Deck, Other Receptor
Electrical Power:
Hazards: Terrain, Fuels, Septic Tank

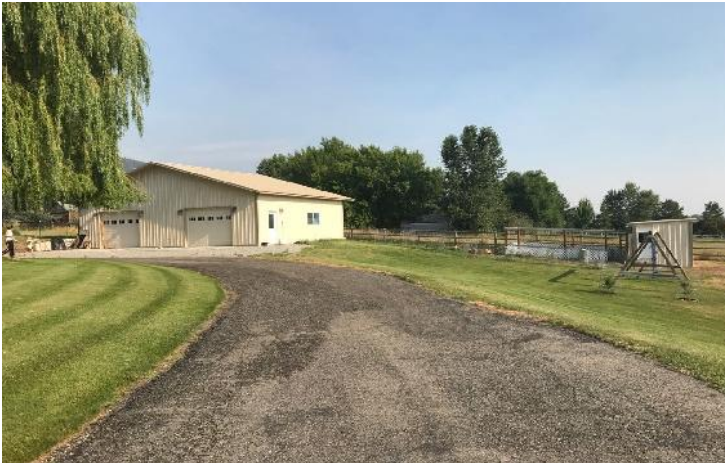
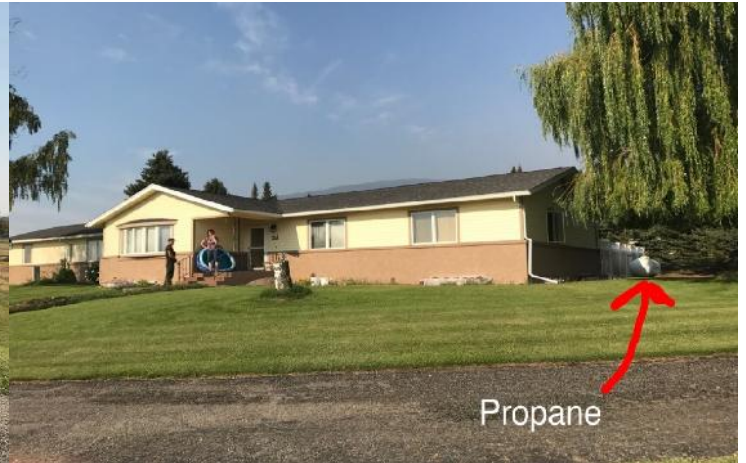
Structure Number:
Structure Name: 6235 Ray Lane
SubDivision: Macintosh Manor
GPS Location, Lat. 46 42.6867
GPS Location, Long. 114 5.04294
Safety Zone Present: Yes
Type of Structure: Residential
Surrounding Fuels: Grass
Structure Triage Category: Defensible, Stand Alone
Roof Material: Composite
Heat Traps: Wood Deck,Rain Gutters
Electrical Power: Underground
Hazards: HazMat
Access to Site: T1 Engine
Comm with ICP: Radio,Cell Service
Water Source: Faucet / Hose
Mitigation Time: None Needed
Other Resources Needed to Protect: None
Collected By: Lolo 632

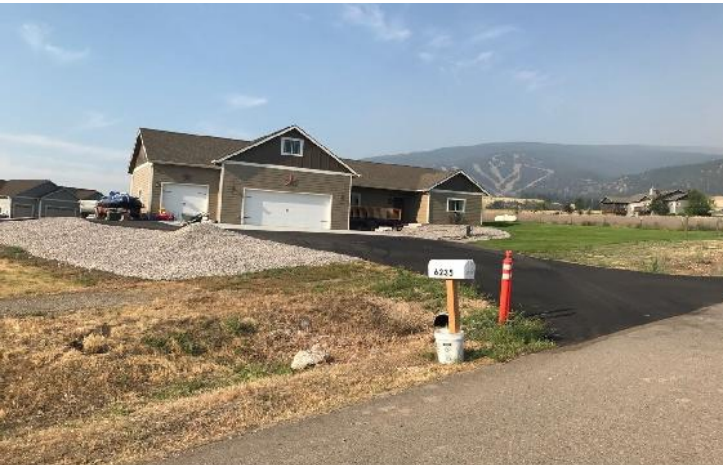
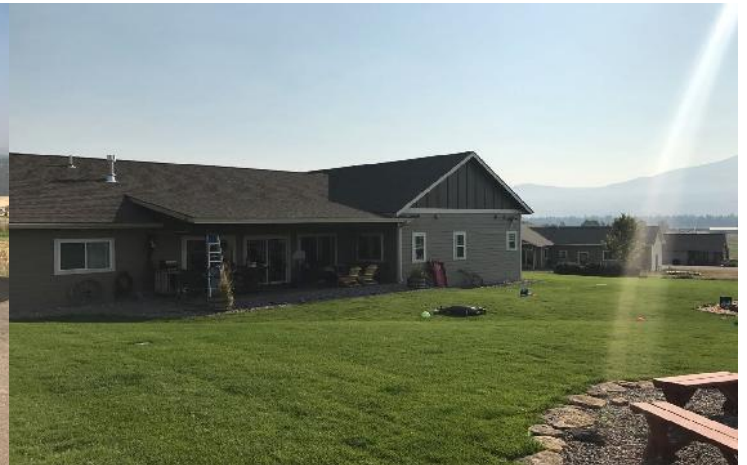
Safety Zone Present: Yes
Type of Structure: Residential
Surrounding Fuels: Grass
Structure Triage Category: Defensible, Stand Alone
Roof Material: Composite
Heat Traps: Wood Deck
Electrical Power: Underground
Hazards: HazMat
Access to Site: T1 Engine
Comm with ICP: Radio, Cell Service
Water Source: Faucet / Hose
Mitigation Time: None Needed
Other Resources Needed to Protect: None

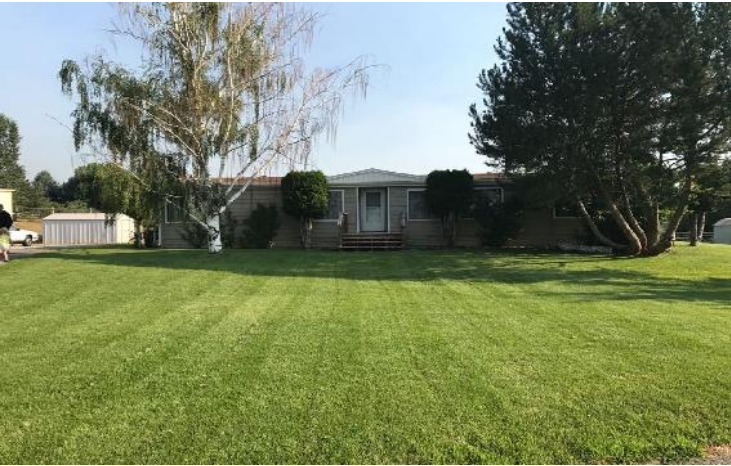
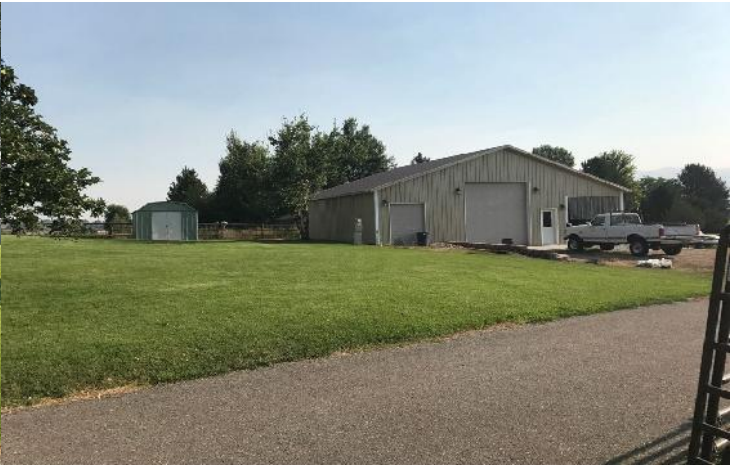
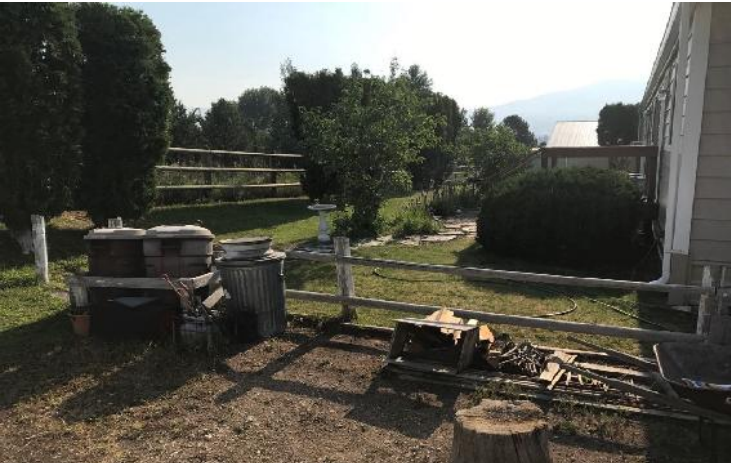
Safety Zone Present: Yes
Type of Structure: Residential
Surrounding Fuels: Grass
Structure Triage Category: Defensible, Stand Alone
Roof Material: Composite
Heat Traps: Wood Deck, Rain Gutters
Electrical Power: Underground
Hazards: HazMat
Access to Site: T1 Engine
Comm with ICP: Radio, Cell Service
Water Source: Faucet / Hose
Mitigation Time: None Needed
Other Resources Needed to Protect: None
Notes: Currently unoccupied.

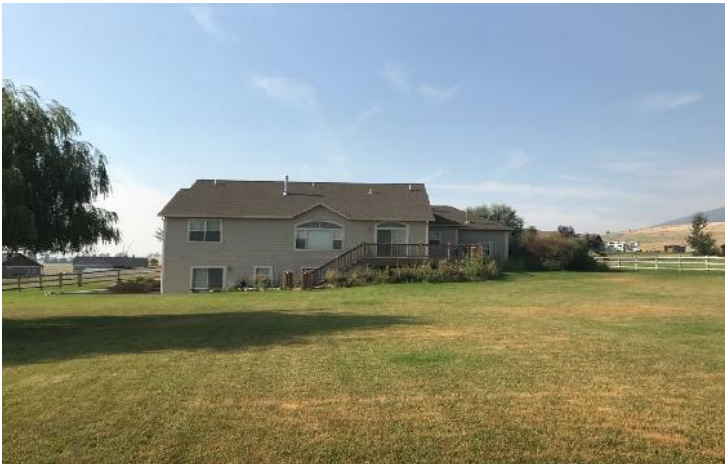
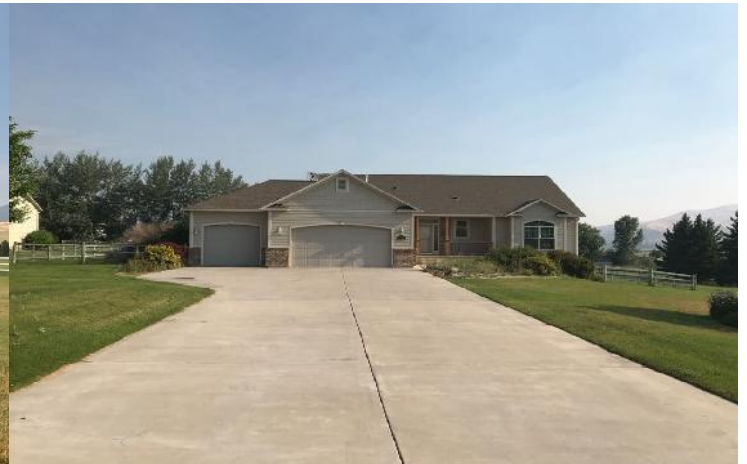
Structure Triage Category: Defensible, Prep and Hold
Roof Material: Metal
Heat Traps: Wood Deck, Rain Gutters
Electrical Power: Underground
Hazards: Animals, Septic Tank, HazMat
Access to Site: T1 Engine
Comm with ICP: Radio, Cell Service
Water Source: Faucet / Hose
Mitigation Time: Less Than An Hour
Other Resources Needed to Protect: None

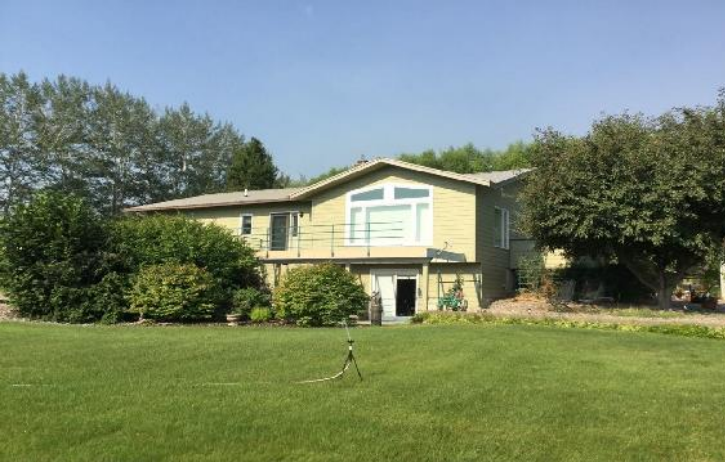
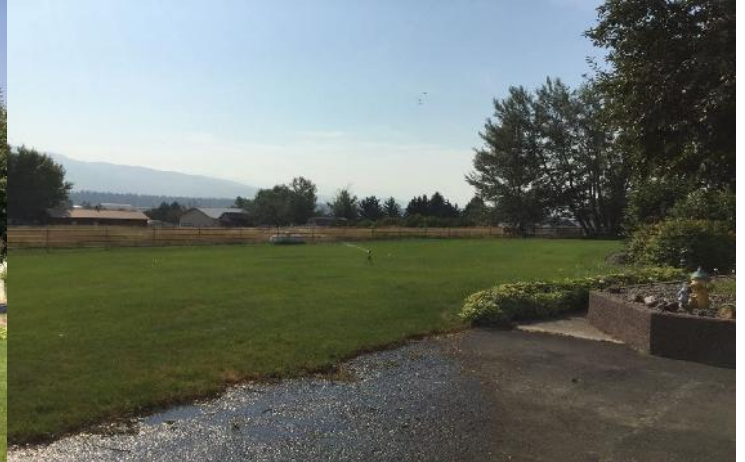
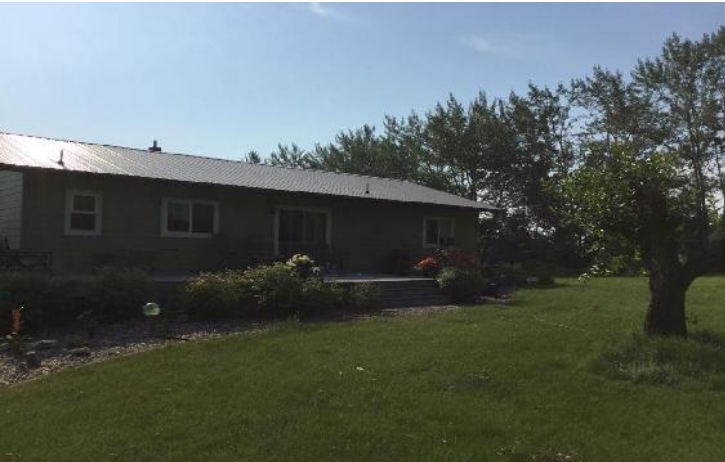
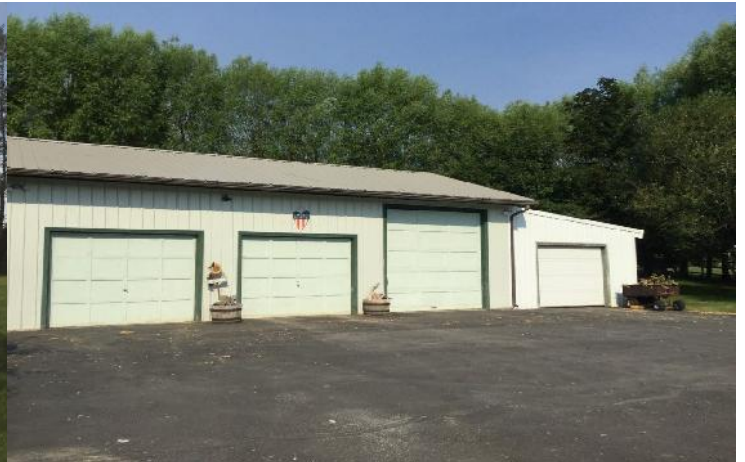
Safety Zone Present: Yes
Type of Structure: Residential
Surrounding Fuels: Shrub
Structure Triage Category: Defensible, Stand Alone
Roof Material: Composite
Heat Traps: Wood Deck, Rain Gutters
Electrical Power: Underground
Hazards: Animals, HazMat
Access to Site: T1 Engine
Comm with ICP: Radio, Cell Service
Water Source: Faucet / Hose
Mitigation Time: None Needed
Other Resources Needed to Protect: None.
Notes: None

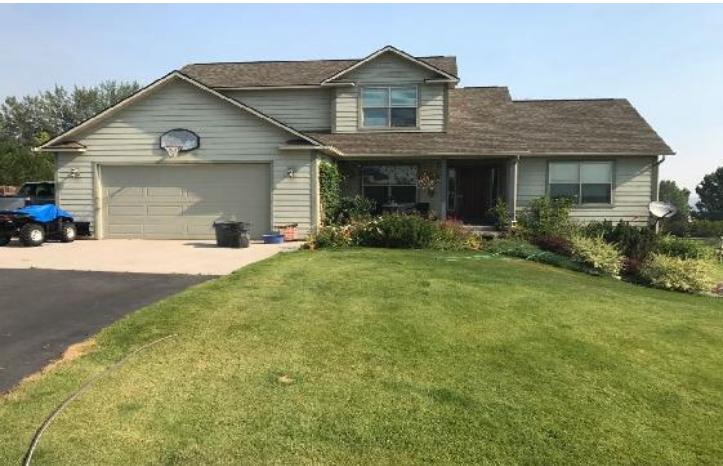
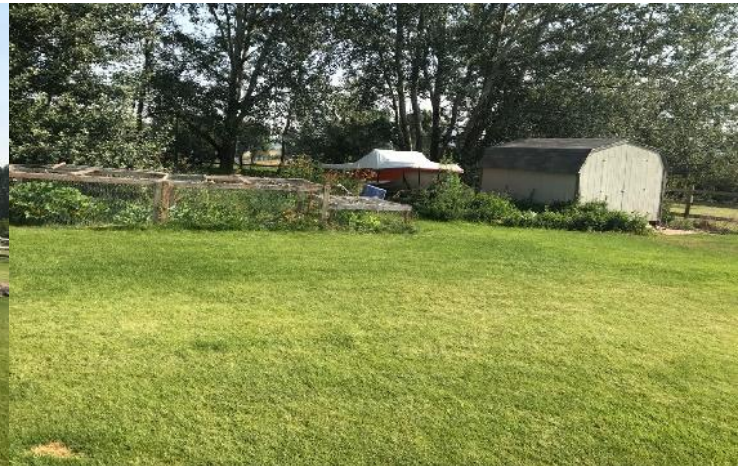
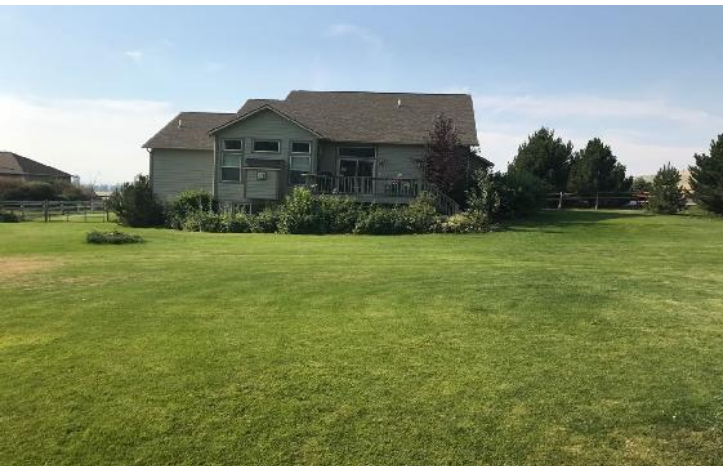
Structure Number:
Structure Name: 6350 Maiden Ln
SubDivision: Macintosh Manor
GPS Location, Lat. 46 43.1001
GPS Location, Long. 114 5.16282
Safety Zone Present: Yes
Type of Structure: Residential
Surrounding Fuels: Grass
Structure Triage Category: Defensible, Stand Alone
Roof Material: Composite
Heat Traps:
Electrical Power: Underground
Hazards: Septic Tank
Access to Site: T1 Engine
Comm with ICP: Radio, Cell Service
Water Source: Faucet / Hose
Mitigation Time: None Needed
Other Resources Needed to Protect: One engine to patrol
Collected By: COCO 482

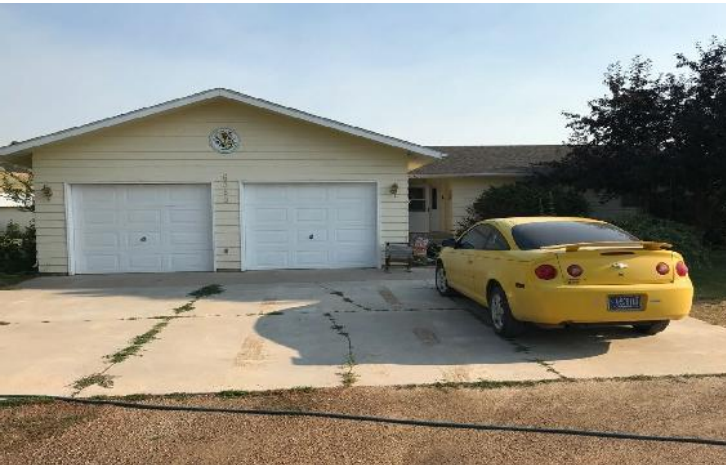
Safety Zone Present: Yes
Type of Structure: Residential
Surrounding Fuels: Shrub, Timber
Structure Triage Category: Defensible, Stand Alone
Roof Material: Composite
Heat Traps: Rain Gutters
Electrical Power: Underground
Hazards: HazMat
Access to Site: T1 Engine
Comm with ICP: Radio, Cell Service
Water Source: Faucet / Hose
Mitigation Time: None Needed
Other Resources Needed to Protect: None.
Notes: None.

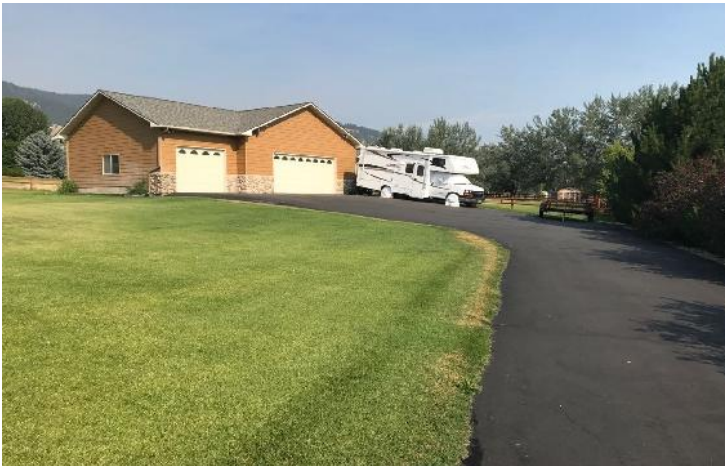
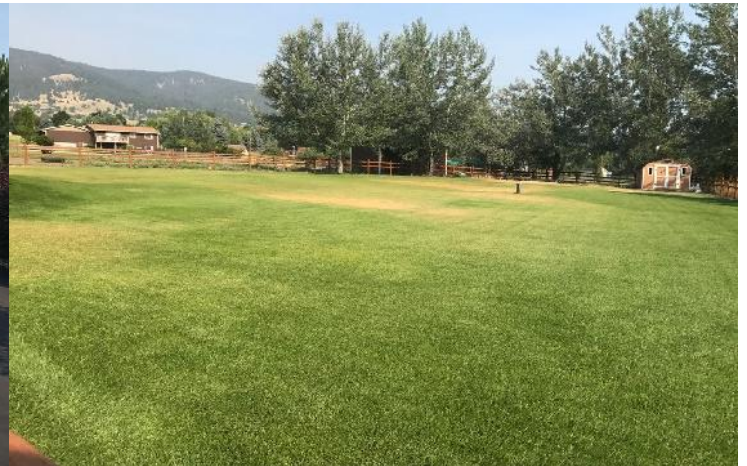
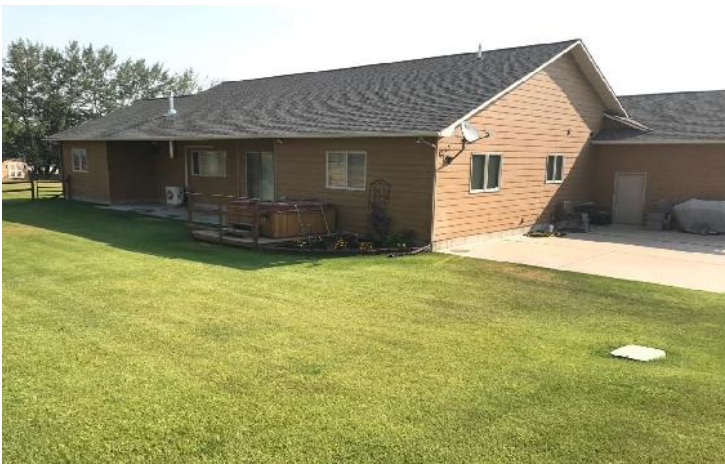
Structure Triage Category: Defensible, Stand Alone
Roof Material: Composite
Heat Traps: Rain Gutters
Electrical Power: Underground
Hazards: Septic Tank, HazMat
Access to Site: T1 Engine
Comm with ICP: Radio, Cell Service
Water Source: Faucet / Hose
Mitigation Time: 1-2 Hours
Other Resources Needed to Protect: None

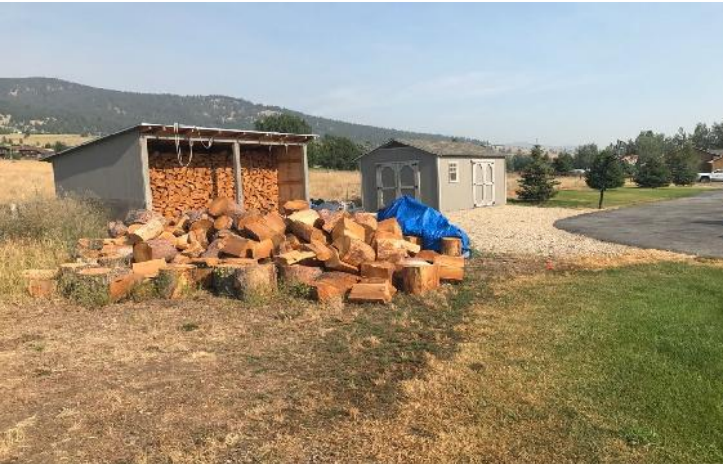
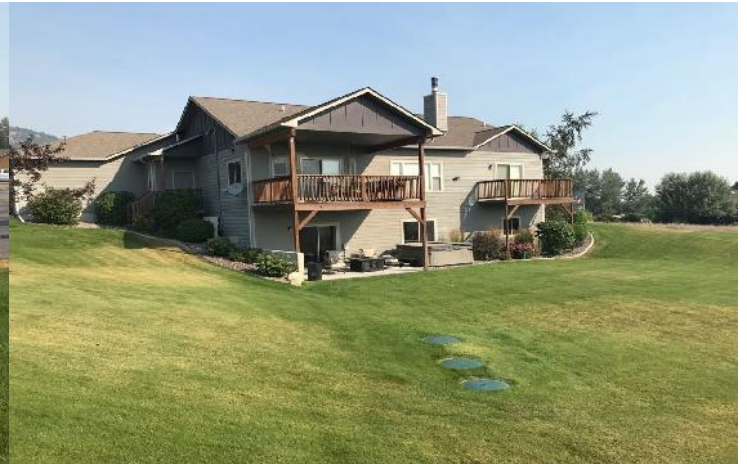
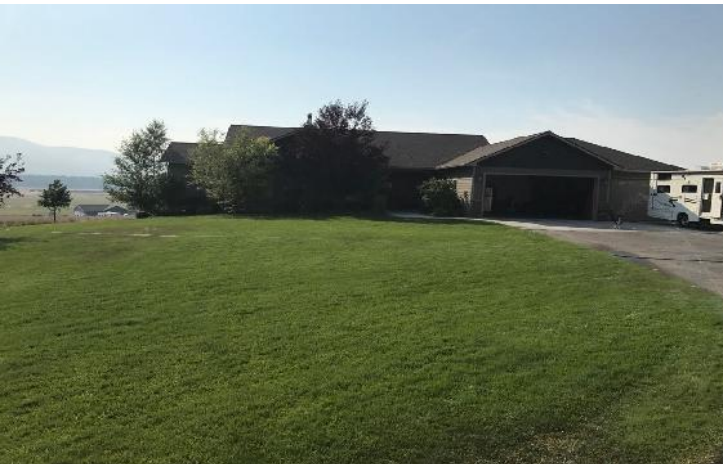
Structure Number:
Structure Name: 6407 McClaine Creek Road
SubDivision: Macintosh Manor
GPS Location, Lat. 46 41.76192
GPS Location, Long. 114 5.23506
Safety Zone Present: Yes
Type of Structure: Residential
Surrounding Fuels: Grass, Shrub
Structure Triage Category: Defensible, Stand Alone
Roof Material: Composite
Heat Traps: Wood Deck, Rain Gutters
Electrical Power: Underground
Hazards: Fuels, Septic Tank
Access to Site: T1 Engine
Comm with ICP: Radio, Cell Service
Water Source: Faucet / Hose
Mitigation Time: None Needed
Notes:
-Small pond 25ft NE of house.
-Faucet on N side of building.

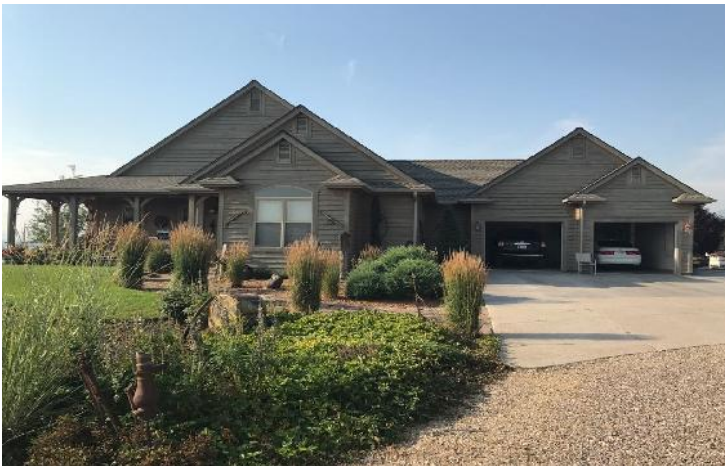
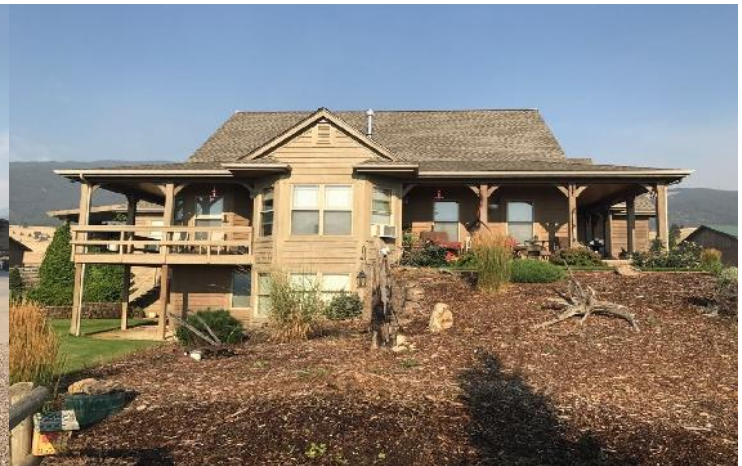
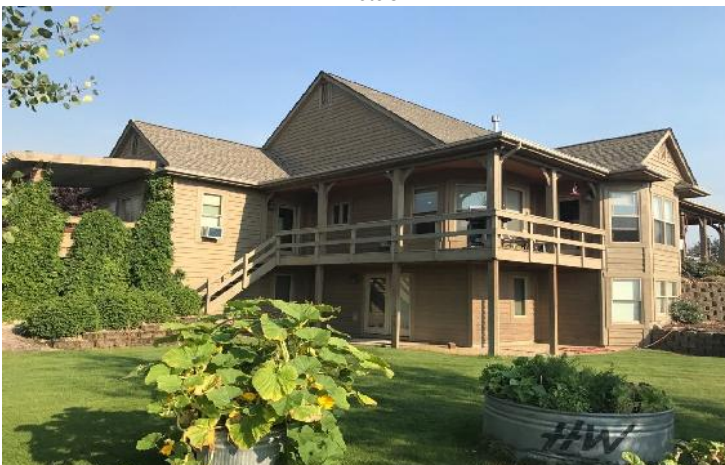
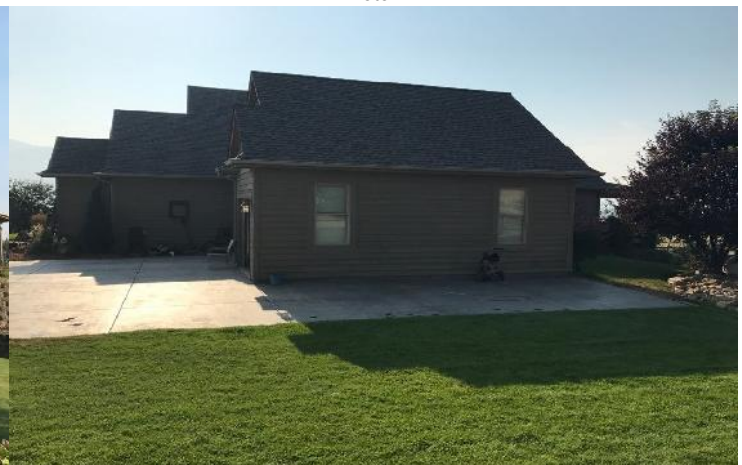
Safety Zone Present: No
Type of Structure: Residential
Surrounding Fuels: Grass, Shrub
Structure Triage Category: Defensible, Stand Alone
Roof Material: Composite
Heat Traps: Wood Deck
Electrical Power: Underground
Hazards: Fuels
Access to Site: T1 Engine
Comm with ICP: Radio, Cell Service
Water Source: Faucet / Hose
Mitigation Time: Less Than An Hour
Other Resources Needed to Protect: One patrolling engine
Collected By: COCO 482

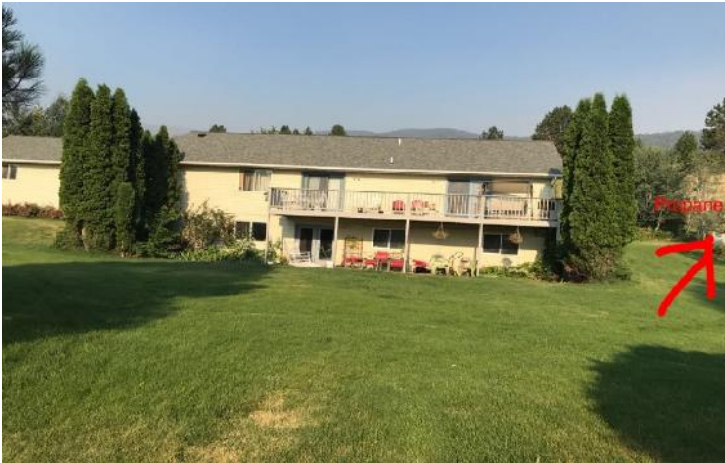
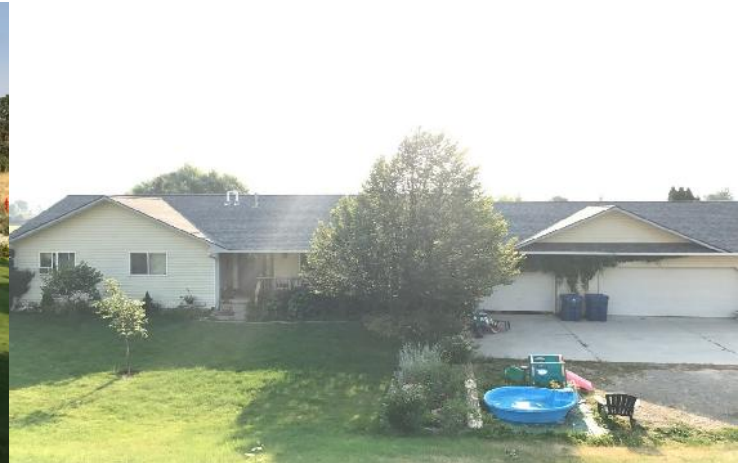
Structure Number:
Structure Name: 6659 Lamar Trail.
SubDivision: Macintosh Manor
GPS Location, Lat. 46 42.65148
GPS Location, Long. 114 5.41038
Safety Zone Present: Yes
Type of Structure: Residential
Surrounding Fuels: Grass, Shrub
Structure Triage Category: Defensible, Stand Alone
Roof Material: Composite
Heat Traps: Rain Gutters
Electrical Power: Underground
Hazards:
Access to Site: T1 Engine
Comm with ICP: Radio, Cell Service
Water Source: Faucet / Hose
Mitigation Time: None Needed
Collected By: Lolo 632

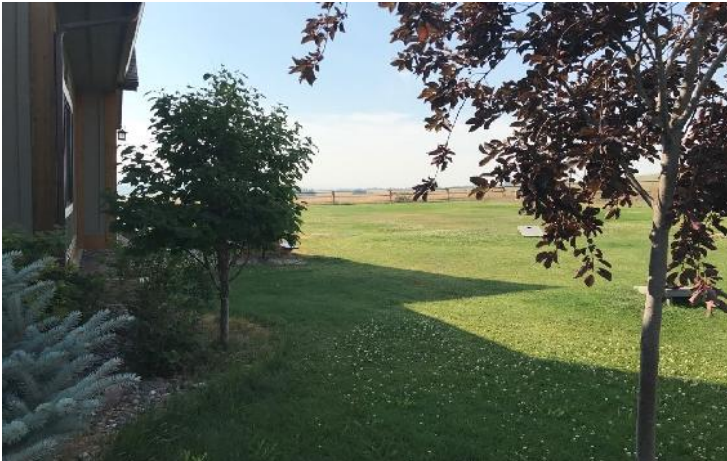
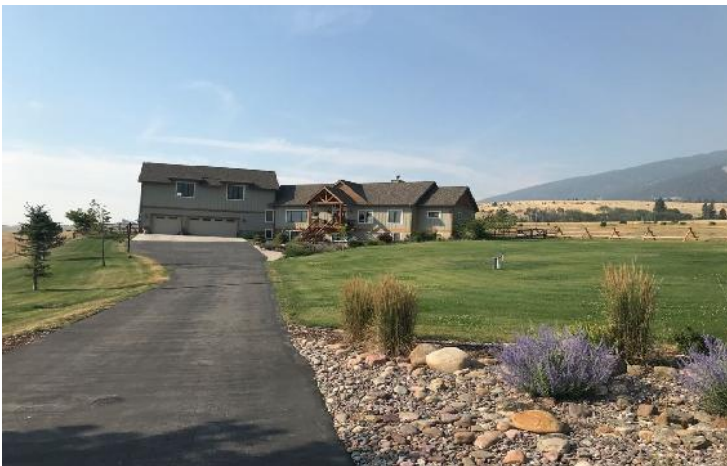
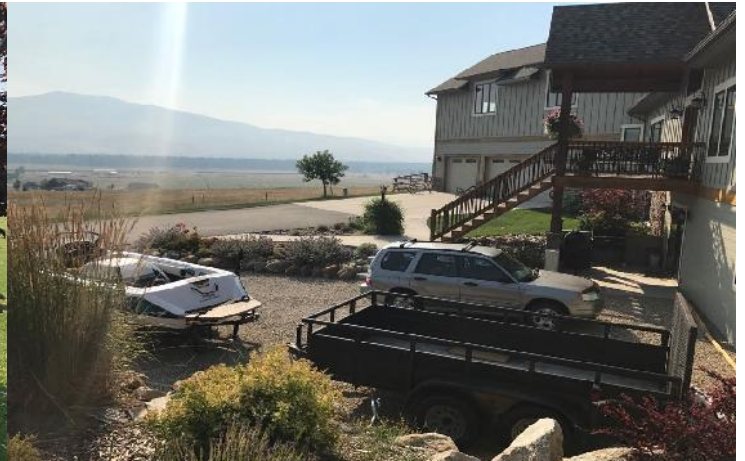
Safety Zone Present: No
Type of Structure: Residential
Surrounding Fuels: Grass, Timber
Structure Triage Category: Defensible, Stand Alone
Roof Material: Composite
Heat Traps: Wood Deck
Electrical Power: Underground
Hazards:
Access to Site: T1 Engine
Comm with ICP: Radio, Cell Service
Water Source: Faucet / Hose
Mitigation Time: Less Than An Hour
Other Resources Needed to Protect: One patrolling engine
Collected By: COCO 482

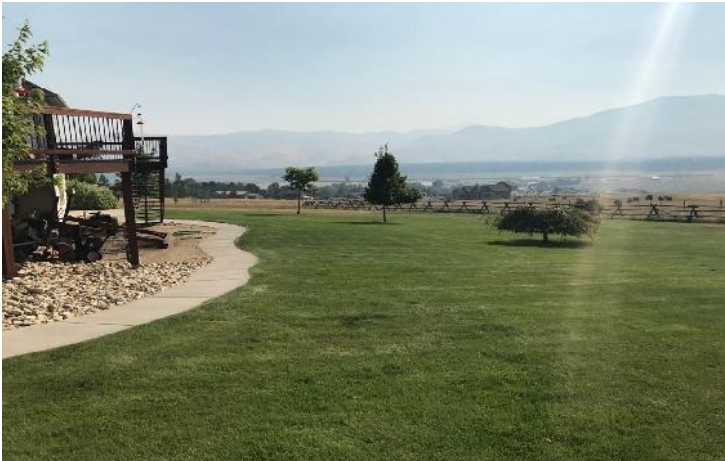
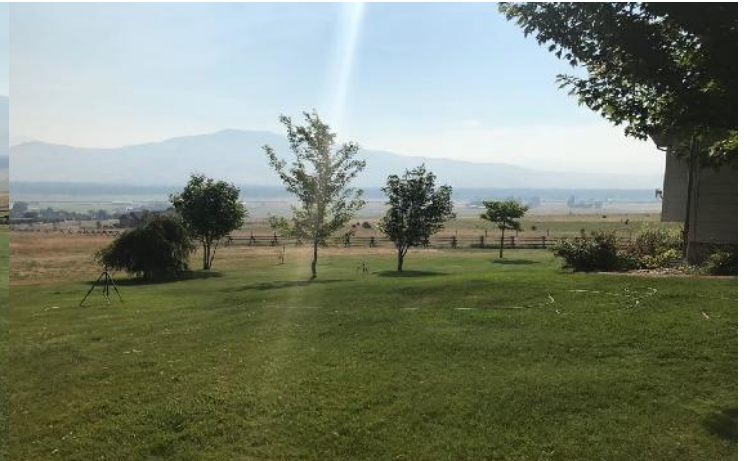
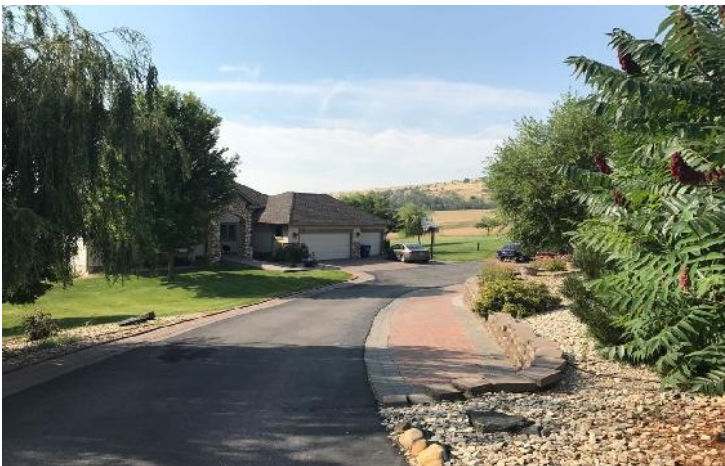
Structure Number:
Structure Name: 6899 Lamar Trail
SubDivision: Macintosh Manor
GPS Location, Lat. 46 42.63684
GPS Location, Long. 114 5.63238
Safety Zone Present: Yes
Type of Structure: Residential
Surrounding Fuels: Grass, Shrub
Structure Triage Category: Defensible, Stand Alone
Roof Material: Composite
Heat Traps: Rain Gutters
Electrical Power: Underground
Hazards:
Access to Site: T1 Engine
Comm with ICP: Radio, Cell Service
Water Source: Faucet / Hose
Mitigation Time: None Needed
Collected By: Lolo 632
