STRUCTURE
PROTECTION PLAN
FOR
ELK CREEK BLOCK
07/27/2017

Structure Protection Plan

OZ Ranch

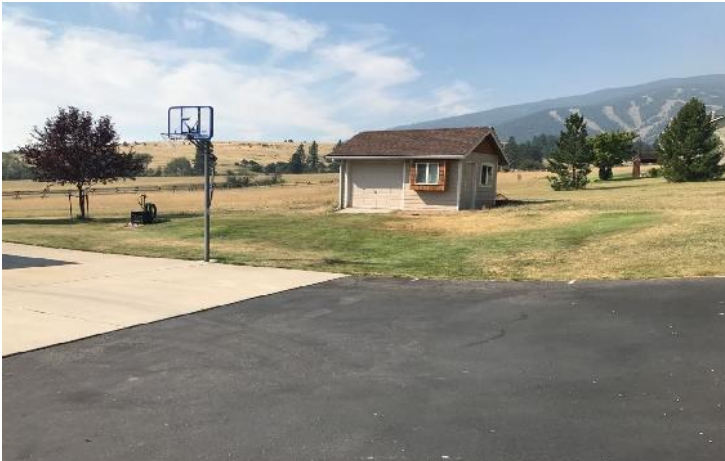
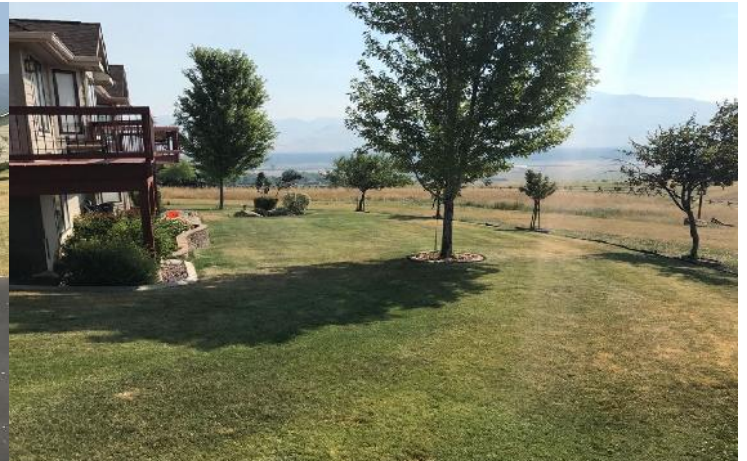
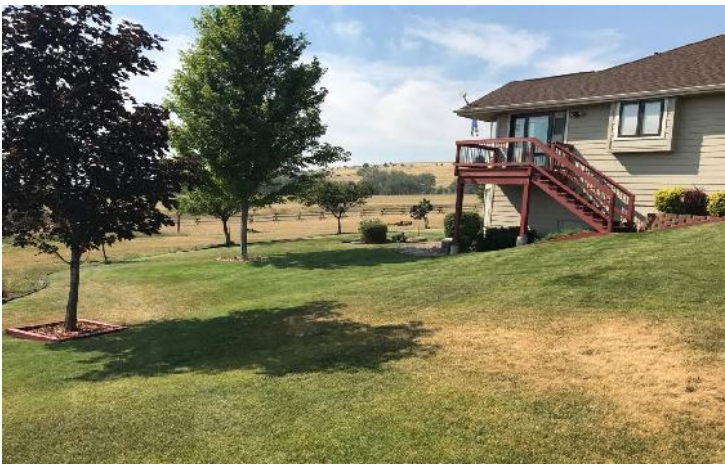
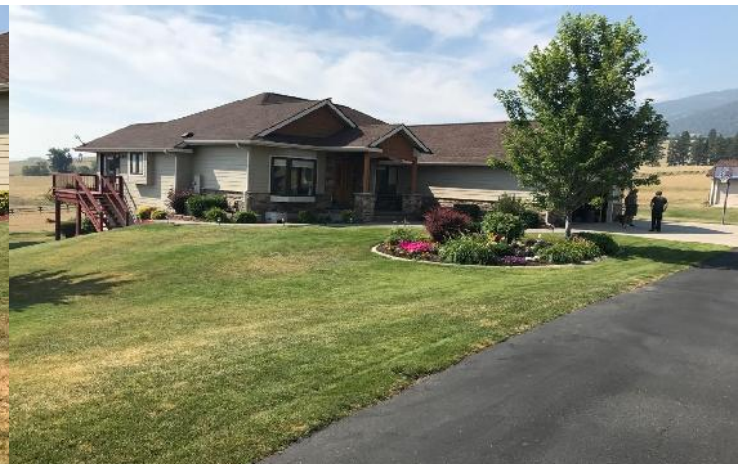
Structure Number:
Structure Name: 6955 Lamar Trail
SubDivision: Macintosh Manor
GPS Location, Lat. 46 42.60798
GPS Location, Long. 114 5.68656
Safety Zone Present: Yes
Type of Structure: Residential
Surrounding Fuels: Grass, Shrub
Structure Triage Category: Defensible, Stand Alone
Roof Material: Composite
Heat Traps: Wood Deck, Rain Gutters
Electrical Power: Underground
Hazards:
Access to Site: T1 Engine
Comm with ICP: Radio, Cell Service
Water Source: Faucet / Hose
Mitigation Time: None Needed
Collected By: Lolo 632

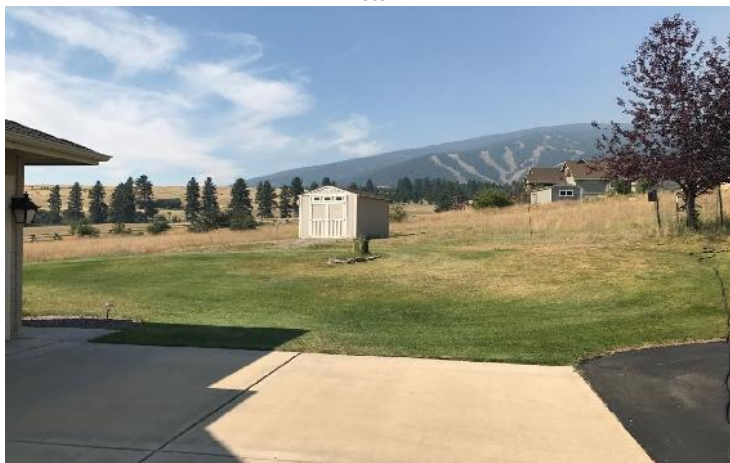
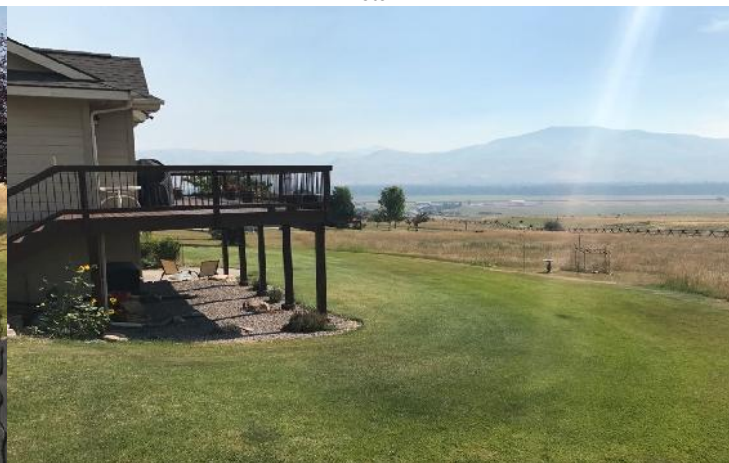
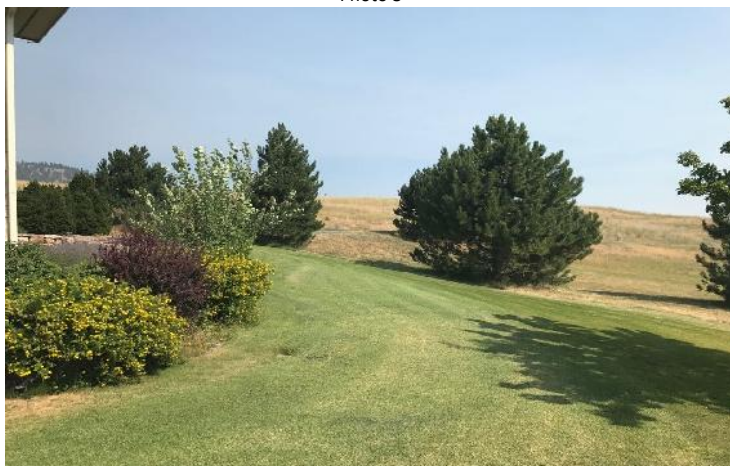
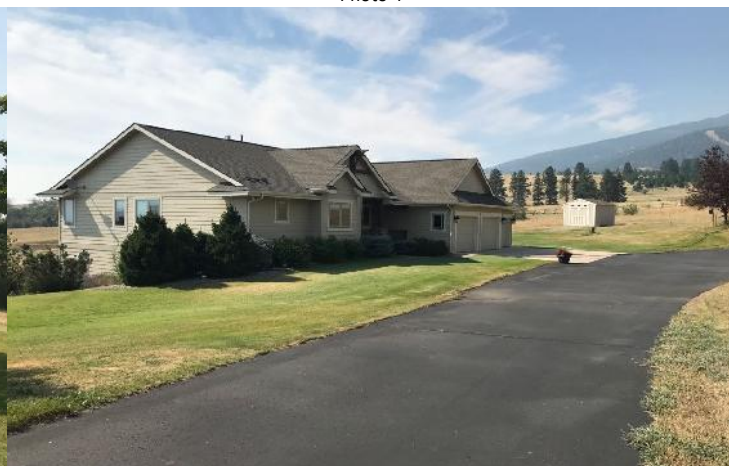
Structure Number:
Structure Name: 7023 Lamar Trail
SubDivision: Macintosh Manor
GPS Location, Lat. 46 42.5907
GPS Location, Long. 114 5.75316
Safety Zone Present: Yes
Type of Structure: Residential
Surrounding Fuels:
Structure Triage Category: Defensible, Stand Alone
Roof Material: Composite
Heat Traps: Wood Deck, Rain Gutters
Electrical Power: Underground
Hazards:
Access to Site: T1 Engine
Comm with ICP: Radio, Cell Service
Water Source: Faucet / Hose
Mitigation Time: None Needed
Collected By: Lolo 632

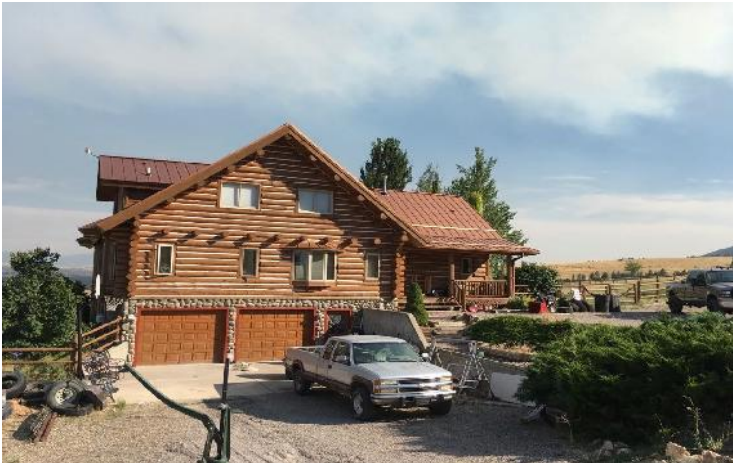
Structure Number:
Structure Name: 7160 Rowan Rd
SubDivision: Macintosh Manor
GPS Location, Lat. 46 42.95682
GPS Location, Long. 114 5.73168
Safety Zone Present: Yes
Type of Structure: Residential
Surrounding Fuels: Grass, Shrub
Structure Triage
Category: Defensible, Prep and Hold
Roof Material: Metal
Heat Traps: Open Eaves, Wood Deck, Rain Gutters
Electrical Power: Underground
Hazards:
Access to Site: T3/4 Engine
Comm with ICP: Radio, Cell Service
Water Source: Faucet / Hose
Mitigation Time: Less Than An Hour
Collected By: E-27 Florence
Photo 1

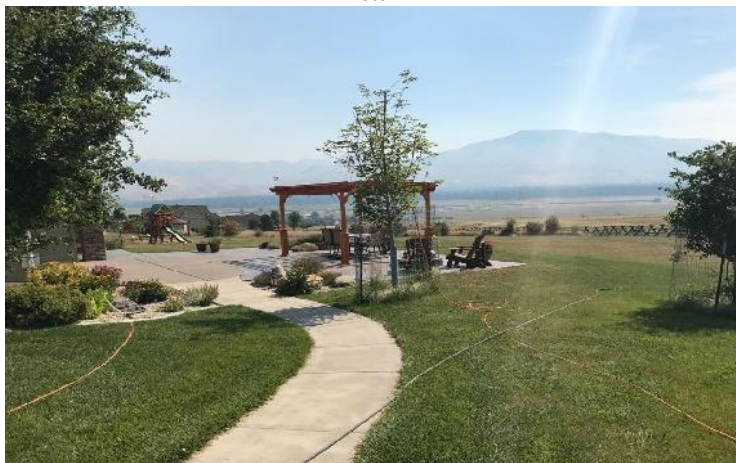
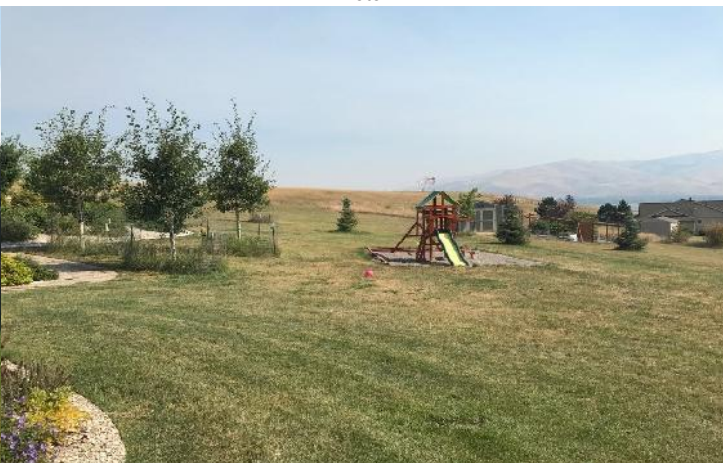
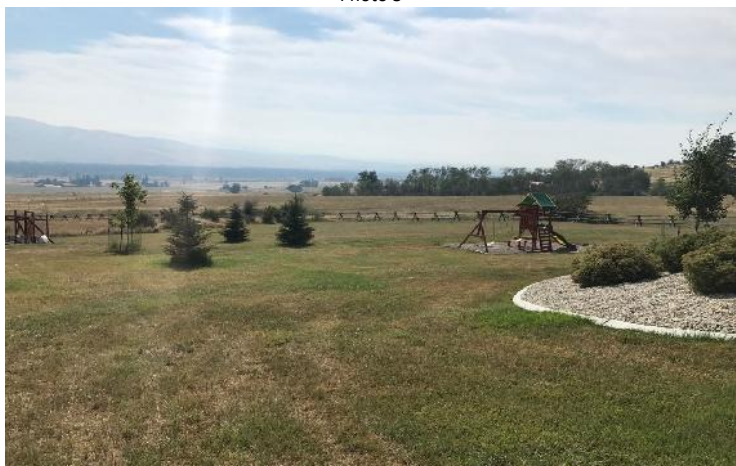
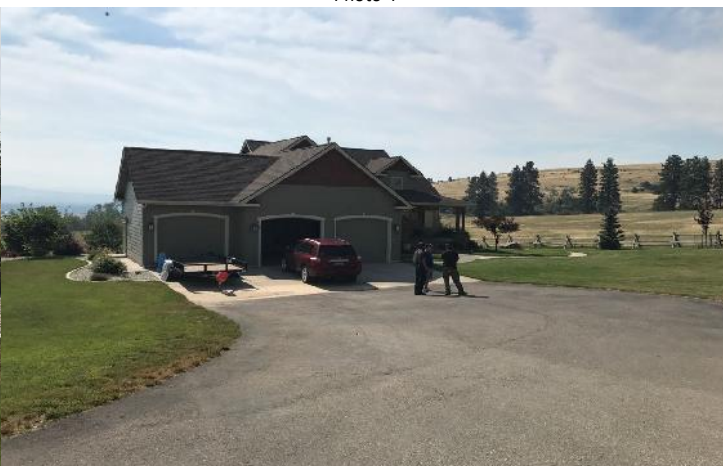
Structure Number:
Structure Name: 7181 Lamar Trail
SubDivision: Macintosh Manor
GPS Location, Lat. 46 42.55584
GPS Location, Long. 114 5.84406
Safety Zone Present: Yes
Type of Structure: Residential
Surrounding Fuels: Grass, Shrub
Structure Triage Category: Defensible, Stand Alone
Roof Material: Composite
Heat Traps: Other Receptor
Electrical Power: Underground
Hazards:
Access to Site: T1 Engine
Comm with ICP: Radio, Cell Service
Water Source: Faucet / Hose
Mitigation Time: None Needed
Collected By: Lolo 632

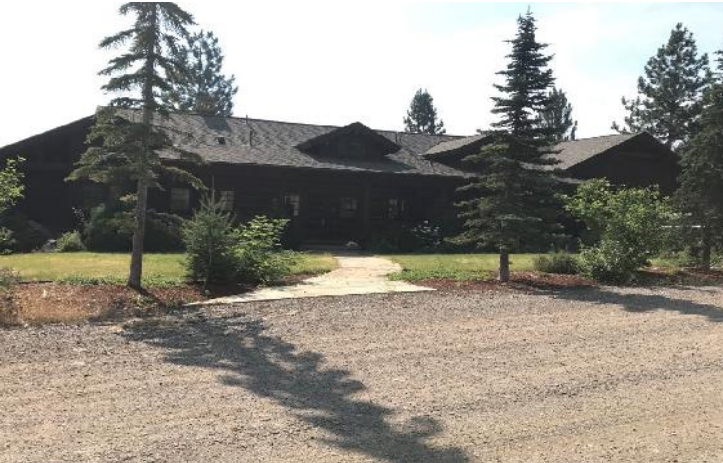
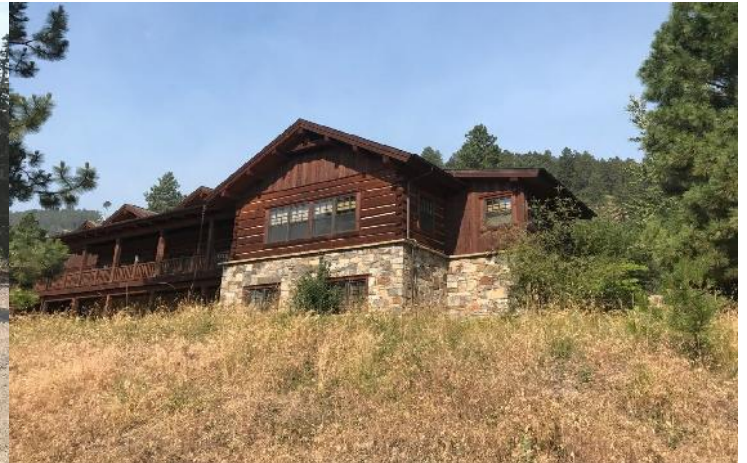
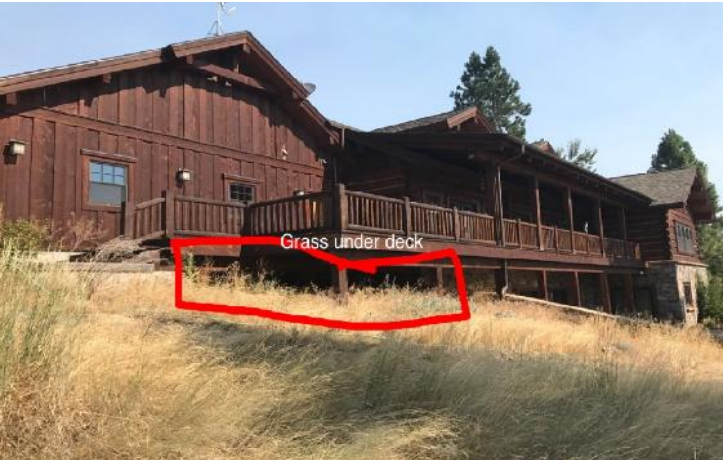
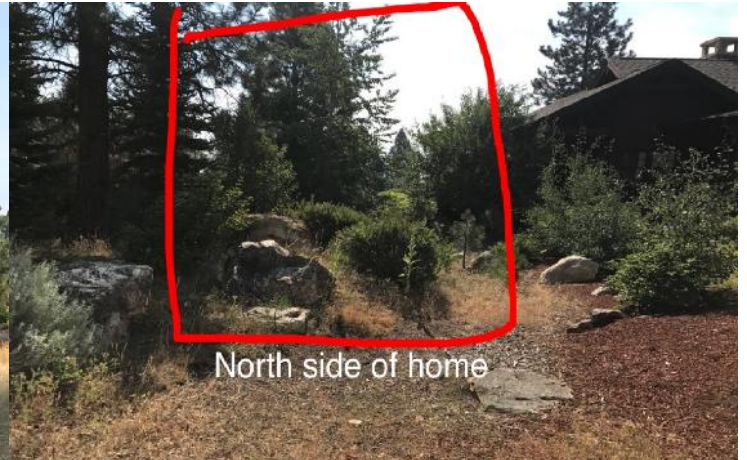
Hazards: Fuels, No Turn Around, HazMat

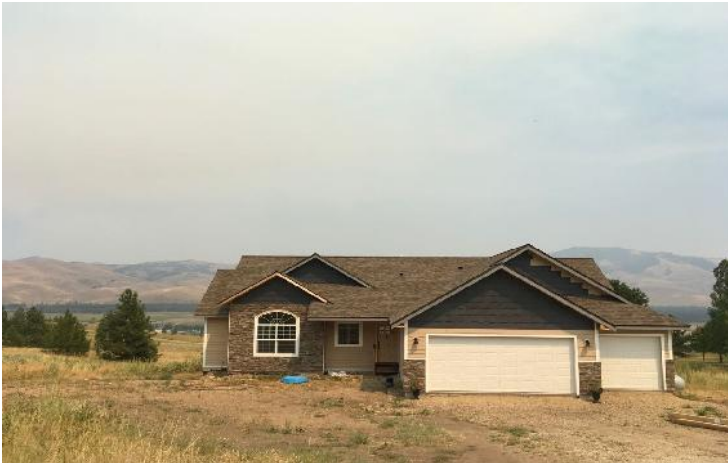
Structure Number:
Structure Name: ???? Highland drive
SubDivision: Macintosh Manor
GPS Location, Lat. 46 42.75636
GPS Location, Long. 114 5.90184
Safety Zone Present: No
Type of Structure: Residential
Surrounding Fuels: Grass
Structure Triage Category: Defensible, Prep and Hold
Roof Material: Composite
Heat Traps: Open Eaves, Wood Deck
Electrical Power: Underground
Hazards: Fuels
Access to Site: T1 Engine
Comm with ICP: Radio, Cell Service
Water Source:
Mitigation Time: Less Than An Hour
Collected By: E-27 Florence
Photo 1

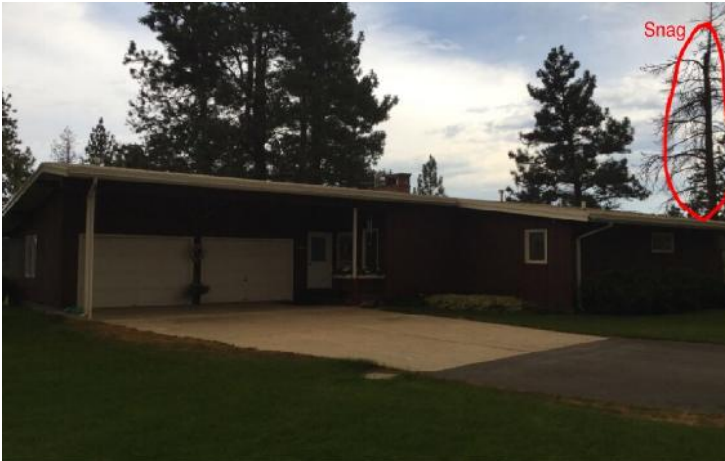
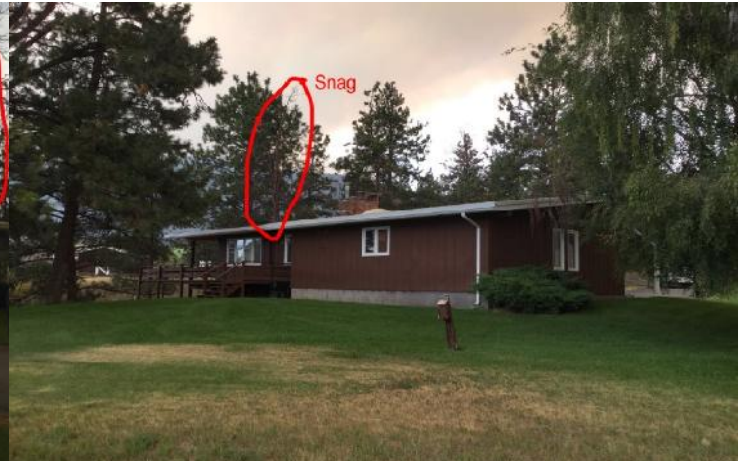
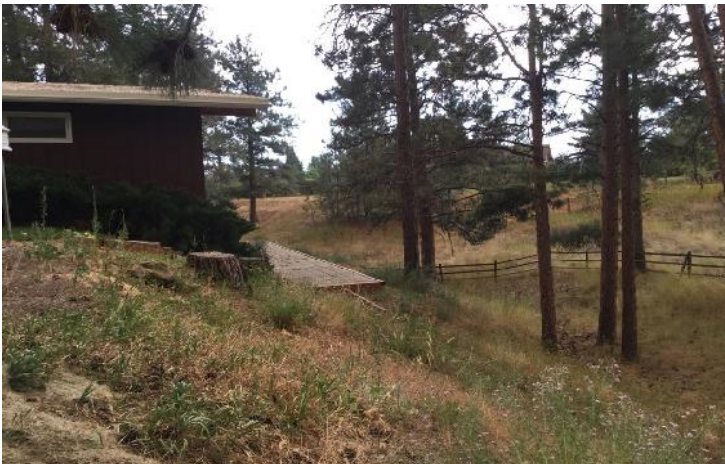
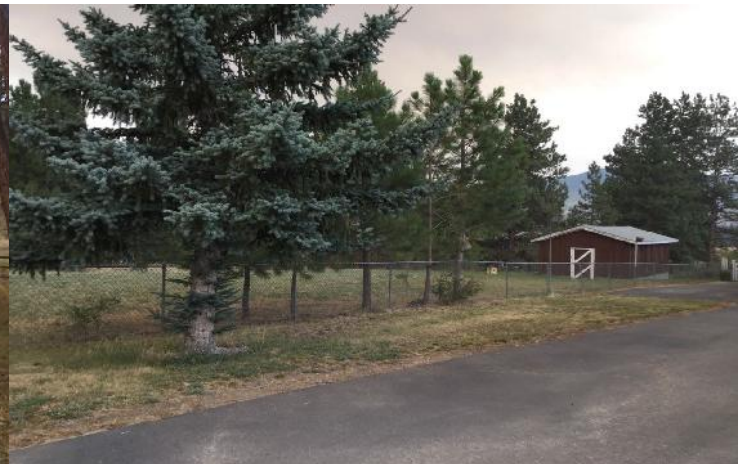
Structure Number:
Structure Name: 18900 Maple Lane
SubDivision: Maple Church
GPS Location, Lat. 46 41.30694
GPS Location, Long. 114 5.01042
Safety Zone Present: Yes
Type of Structure: Residential
Surrounding Fuels: Grass, Timber
Structure Triage Category: Defensible, Prep and Hold
Roof Material: Composite
Heat Traps: Wood Deck, Rain Gutters
Electrical Power: Overhead, Underground
Hazards: Fuels, Septic Tank
Access to Site: T3/4 Engine
Comm with ICP: Radio, Cell Service
Water Source: Faucet / Hose
Mitigation Time: 1-2 Hours
Other Resources Needed to Protect: None
Notes: Roof is tar and rock.

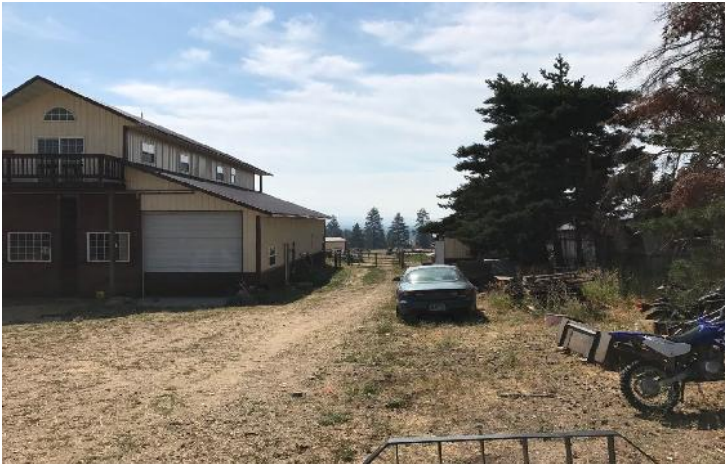
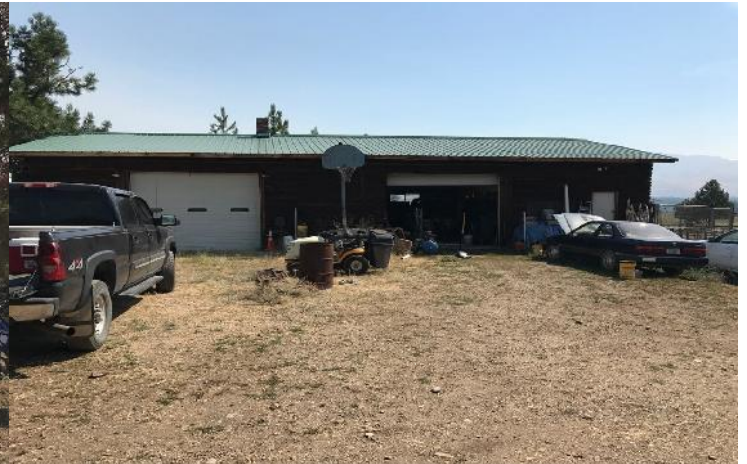
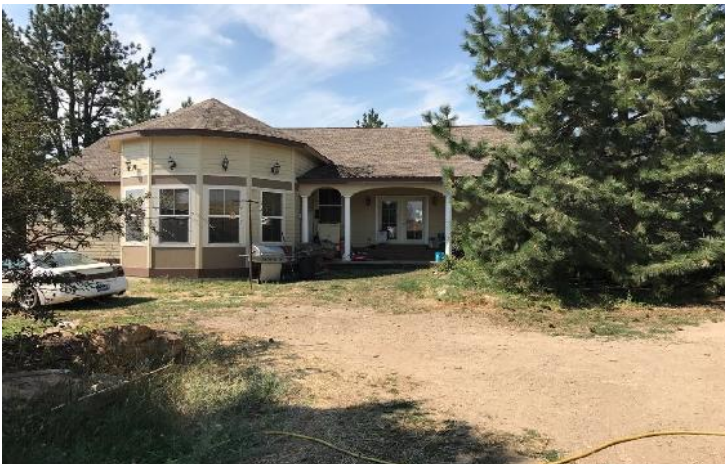
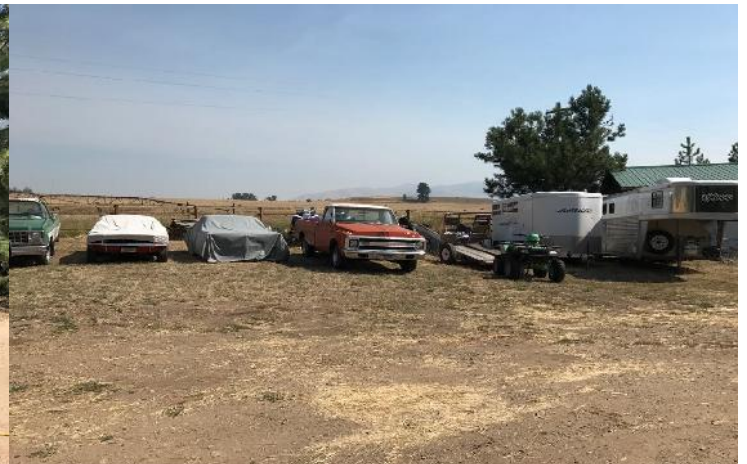
Structure Number:
Structure Name: 18908 Kings Rd
SubDivision: Maple Church
GPS Location, Lat. 46 41.38446
GPS Location, Long. 114 5.57946
Safety Zone Present: Yes
Type of Structure: Residential
Surrounding Fuels: Grass
Structure Triage Category: Defensible, Stand Alone
Roof Material: Composite
Heat Traps: Open Eaves, Wood Deck, Rain Gutters
Electrical Power: Overhead
Hazards: Animals, Septic Tank
Access to Site: T3/4 Engine
Comm with ICP: Radio, Cell Service
Water Source: Faucet / Hose
Mitigation Time: 2-3 Hours
Other Resources Needed to Protect: Hand crew, Type 3 Engine
Notes: Second driveway brings you down to the lower end of the property.

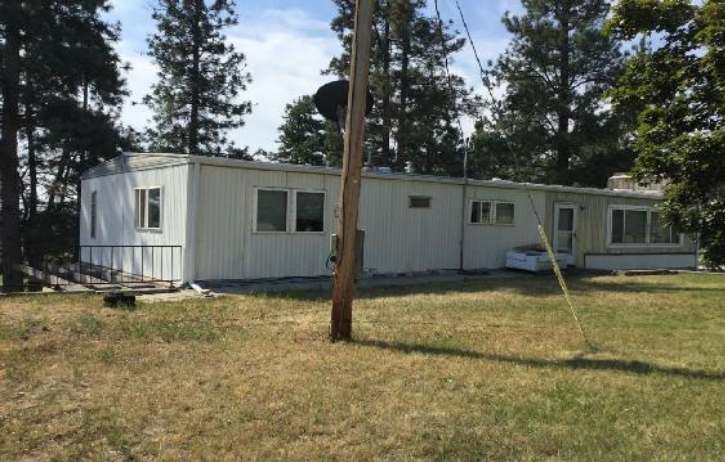
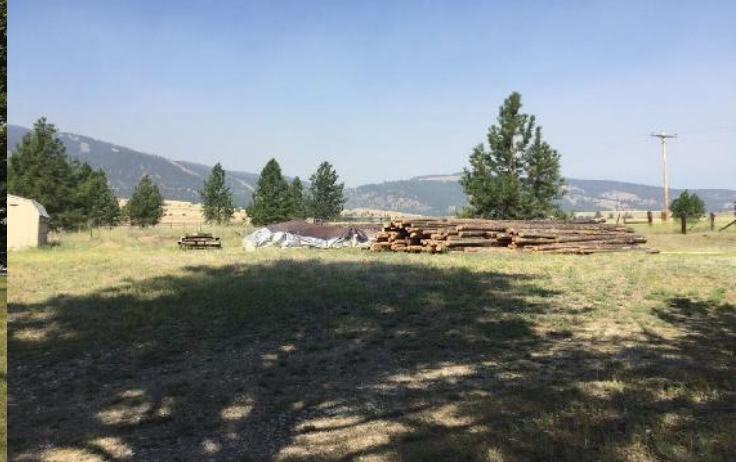
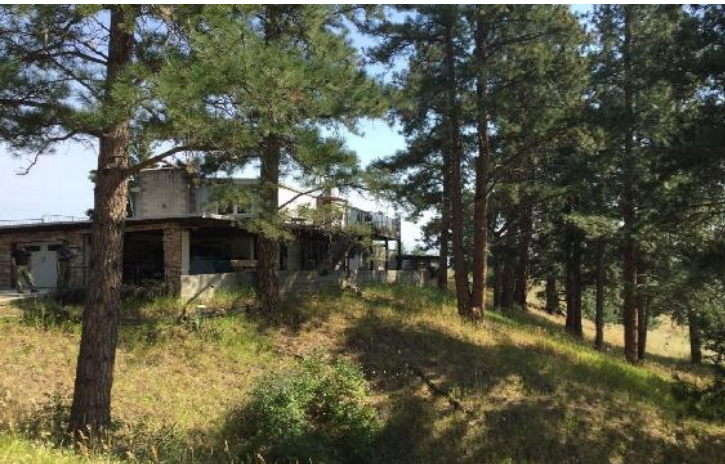
Structure Number:
Structure Name: 18950 Old HWY 93
SubDivision: Maple Church
GPS Location, Lat. 46 41.3658
GPS Location, Long. 114 4.9053
Safety Zone Present: Yes **Where is Safety Zone:** Large grass field around house
Type of Structure: Residential **Primary Structures:** **Outbuildings:**
Surrounding Fuels: Grass, Timber **Defensible Space:** 50-100 Feet
Structure Triage Category: Defensible, Prep and Hold
Roof Material: Metal **Siding Material:** Metal
Heat Traps: Wood Deck, Rain Gutters, Other Receptor
Electrical Power: Overhead **Gas to Structure:** Underground
Hazards:
Access to Site: T1 Engine **Best Access From:** From old highway 93 up long driveway
Comm with ICP: Radio, Cell Service
Water Source: Faucet / Hose
Mitigation Time: None Needed
Other Resources Needed to Protect: None
Notes: Home located upslope hillside of light grassy fuels

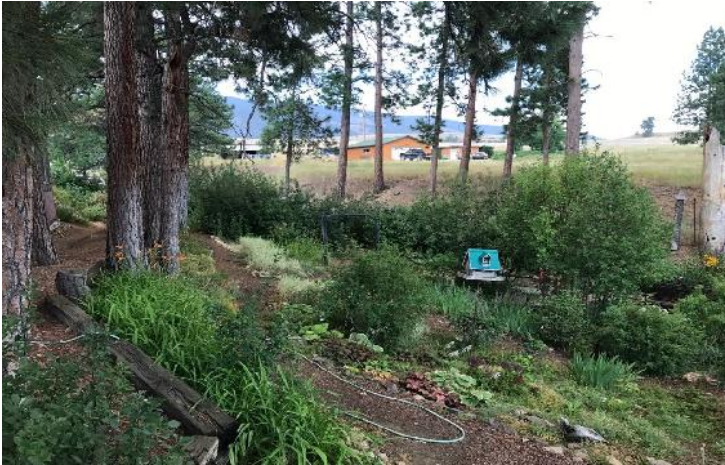
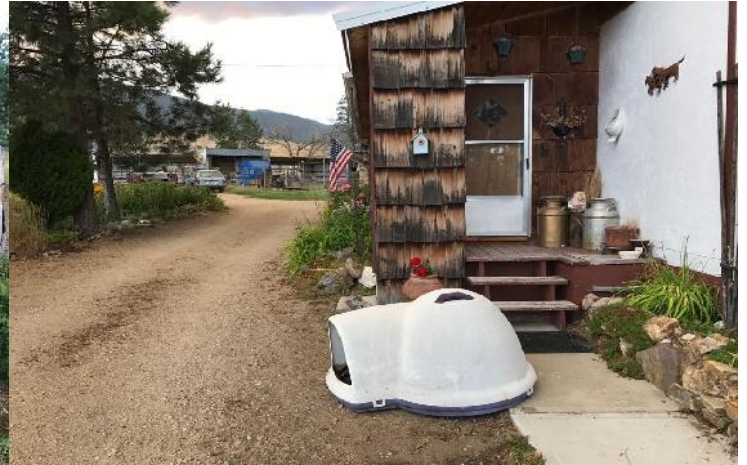
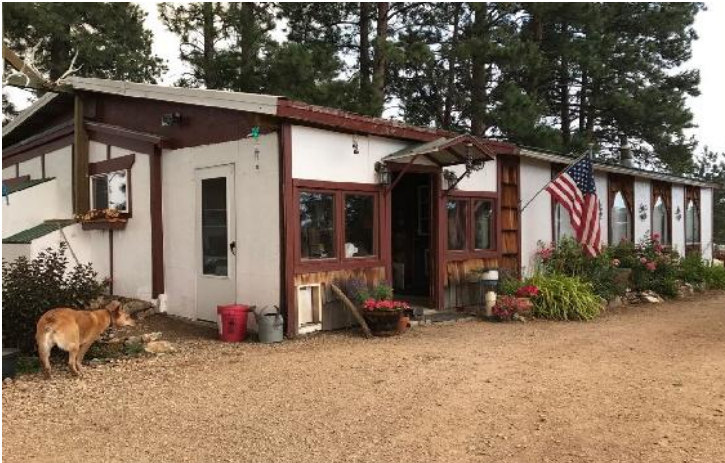
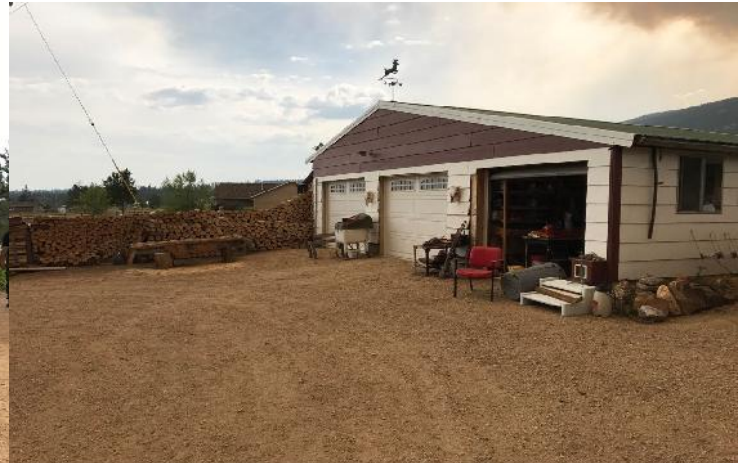
Structure Number:
Structure Name: 18955 Maple Ln
SubDivision: Maple Church
GPS Location, Lat. 46 41.28912
GPS Location, Long. 114 5.08962
Safety Zone Present: Yes
Type of Structure: Residential
Surrounding Fuels: Grass, Timber
Structure Triage Category: Defensible, Prep and Hold
Roof Material: Metal
Heat Traps: Rain Gutters
Electrical Power:
Hazards: Fuels, Animals
Access to Site: T3/4 Engine
Comm with ICP: Radio, Cell Service
Water Source: Faucet / Hose
Mitigation Time: 1-2 Hours
Other Resources Needed to Protect: Hand crew may be needed for quick prep
Collected By: TNF-65

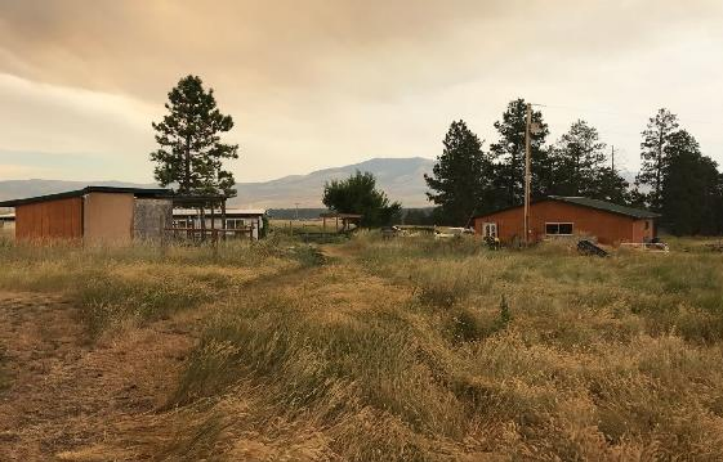
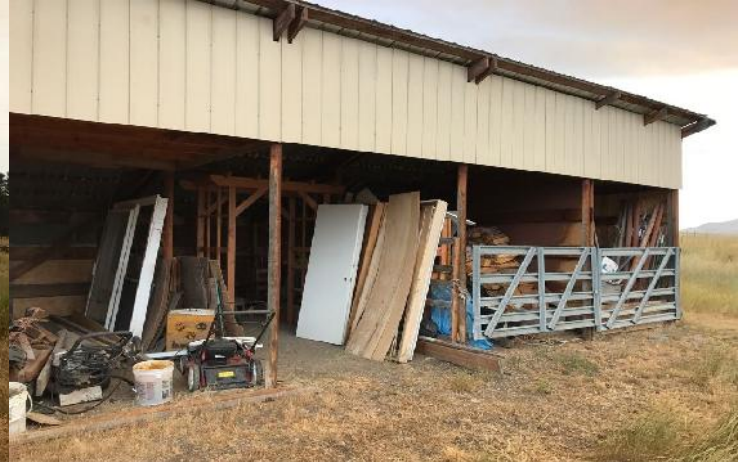
Structure Number:
Structure Name: 18960 Maple Ln
SubDivision: Maple Church
GPS Location, Lat. 46 41.31822
GPS Location, Long. 114 5.06484
Safety Zone Present: Yes
Type of Structure: Residential
Surrounding Fuels: Grass, Timber
Structure Triage Category: Defensible, Prep and Hold
Roof Material: Metal
Heat Traps: Rain Gutters
Electrical Power: Underground
Hazards:
Access to Site: T3/4 Engine
Comm with ICP: Radio, Cell Service
Water Source: Faucet / Hose
Mitigation Time: 1-2 Hours
Other Resources Needed to Protect: Hand crew may be required
Notes: 9 acres tall grass

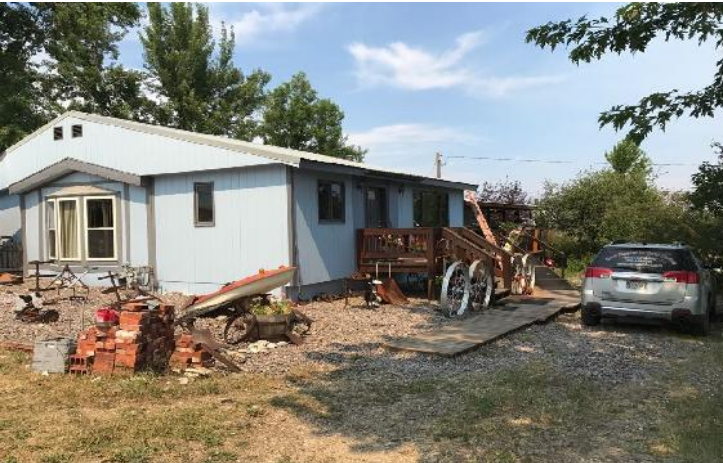
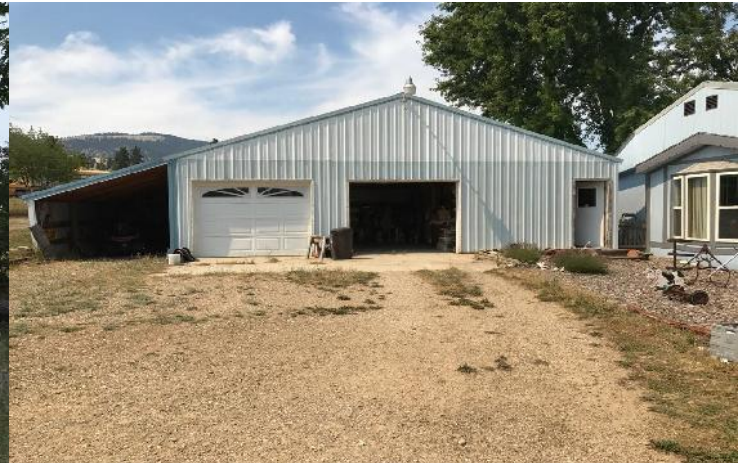
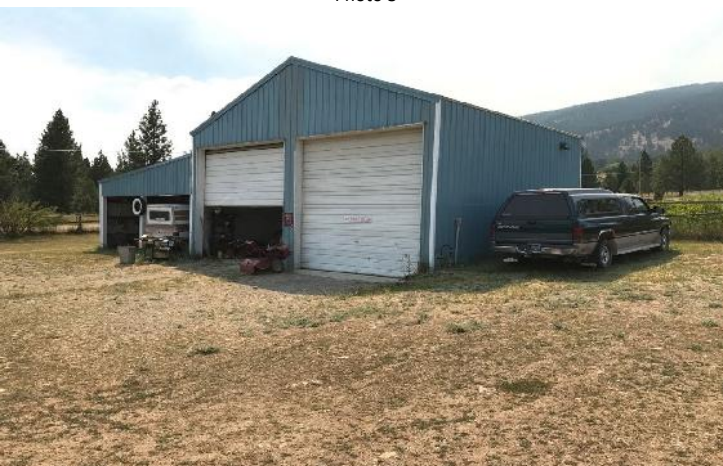
Safety Zone Present: Yes
Type of Structure: Residential
Surrounding Fuels: Grass
Structure Triage Category: Defensible, Stand Alone
Roof Material: Metal
Heat Traps: Open Eaves, Wood Deck
Electrical Power: Underground
Hazards:
Access to Site: T3/4 Engine
Comm with ICP: Radio, Cell Service
Water Source: Faucet / Hose
Mitigation Time: None Needed
Collected By: TNF-65

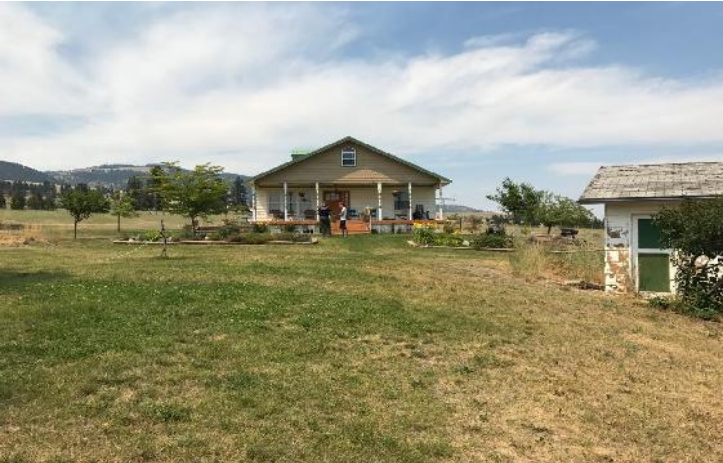
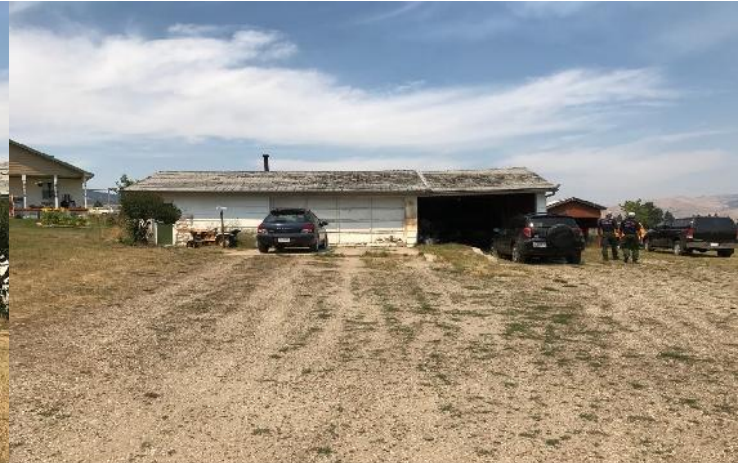
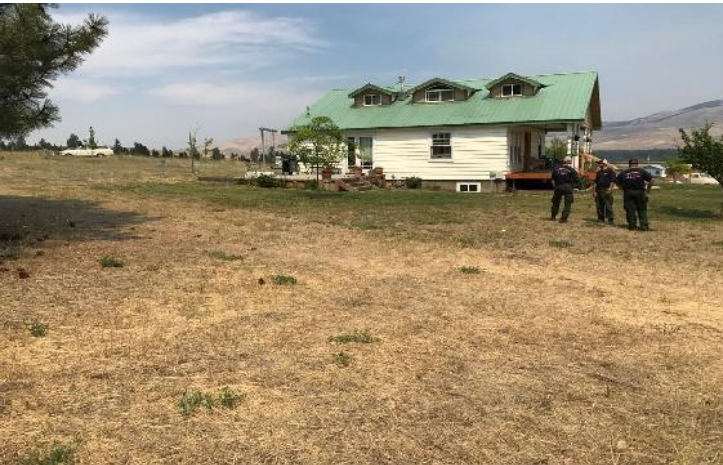
Structure Triage Category: Defensible, Stand Alone
Roof Material: Composite
Heat Traps: Wood Deck, Rain Gutters
Electrical Power: Underground
Hazards: Fuels, Septic Tank
Access to Site: T3/4 Engine
Comm with ICP: Radio, Cell Service
Water Source: Faucet / Hose
Mitigation Time: Less Than An Hour
Other Resources Needed to Protect: -1 engine crew, scratch line, brush thinning.

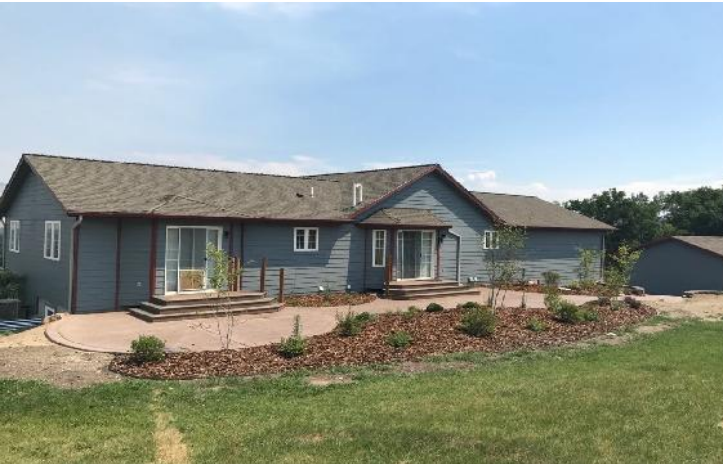
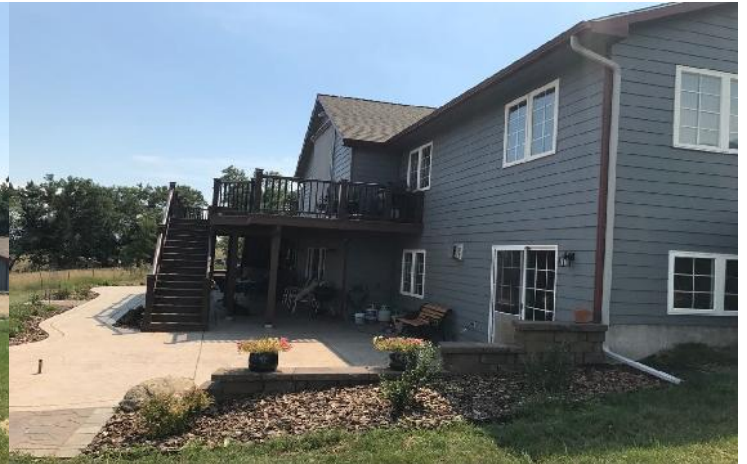
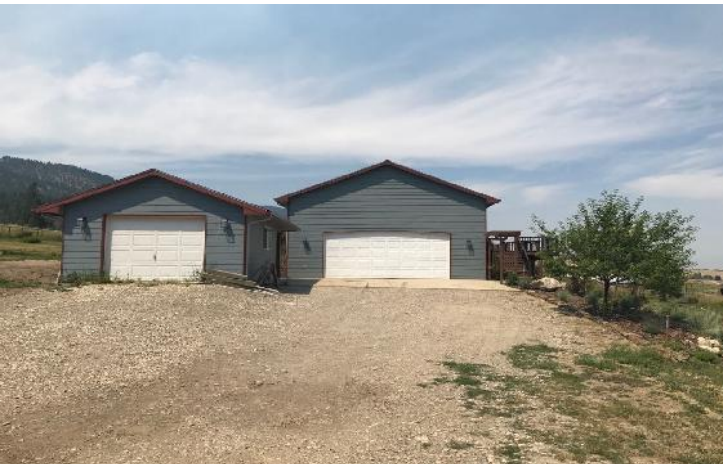
Structure Number:
Structure Name: 7020 Carlton Creek Road
SubDivision: Maple Church
GPS Location, Lat. 46 40.54116
GPS Location, Long. 114 5.69316
Safety Zone Present: Yes
Type of Structure: Residential
Surrounding Fuels: Grass
Structure Triage Category: Defensible, Stand Alone
Roof Material: Composite
Heat Traps: Wood Deck, Rain Gutters
Electrical Power: Underground
Hazards: HazMat
Access to Site: T1 Engine
Comm with ICP: Radio, Cell Service
Water Source: Faucet / Hose
Mitigation Time: None Needed
Other Resources Needed to Protect: None

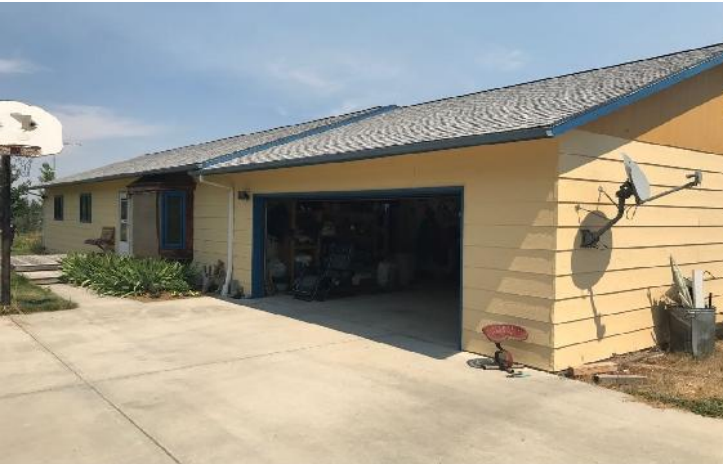
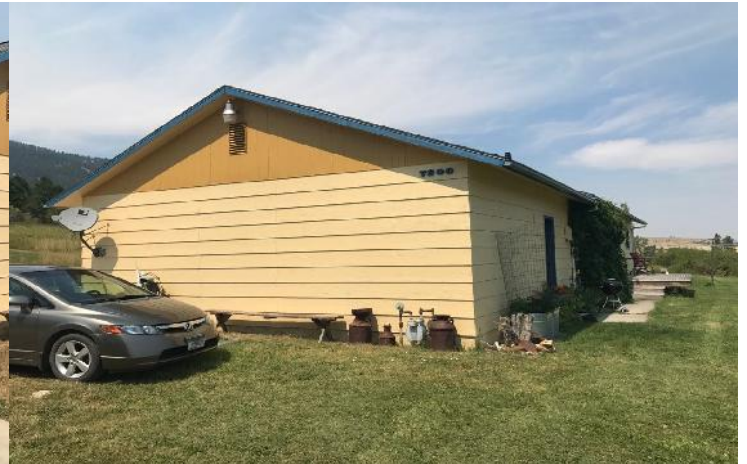
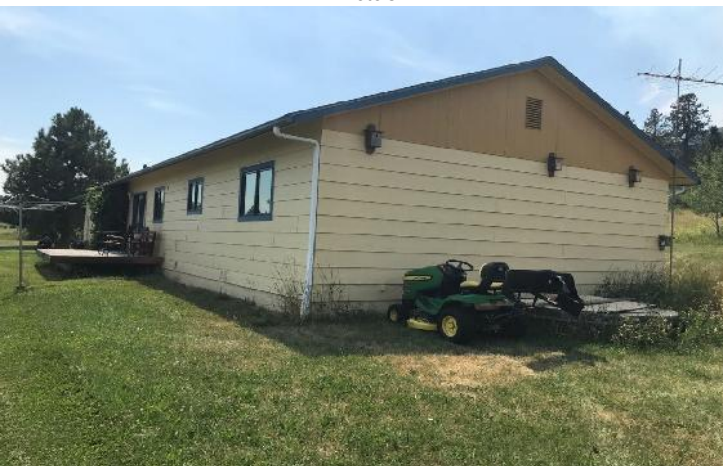
Structure Number:
Structure Name: 7200 Carlton Creek Road
SubDivision: Maple Church
GPS Location, Lat. 46 40.5381
GPS Location, Long. 114 5.84064
Safety Zone Present: Yes
Type of Structure: Residential
Surrounding Fuels: Grass
Structure Triage Category: Defensible, Stand Alone
Roof Material: Composite
Heat Traps: Wood Deck,Rain Gutters
Electrical Power: Underground
Hazards: Septic Tank
Access to Site: T1 Engine
Comm with ICP: Radio,Cell Service
Water Source: Faucet / Hose
Mitigation Time: None Needed
Other Resources Needed to Protect: None

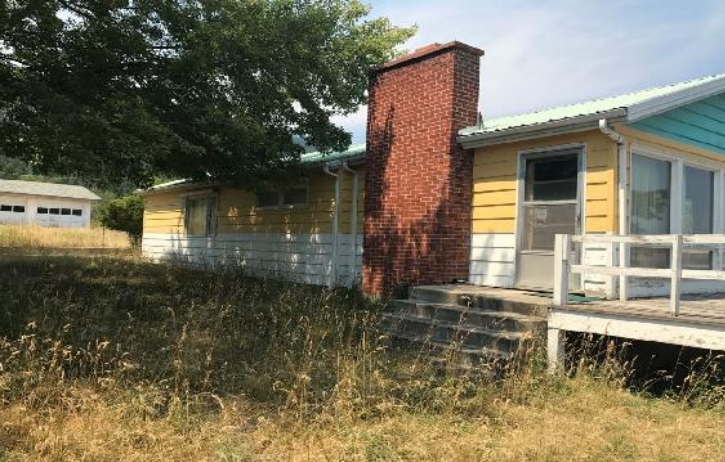
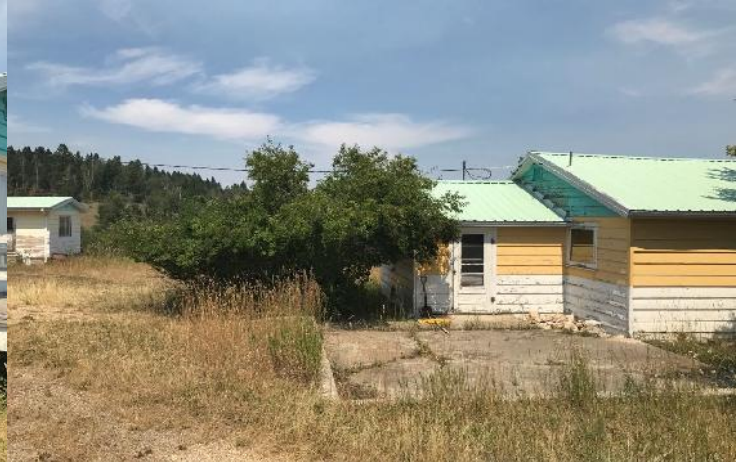
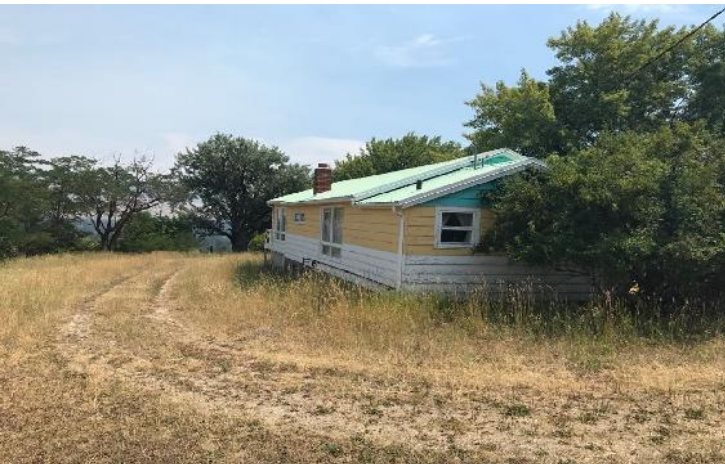
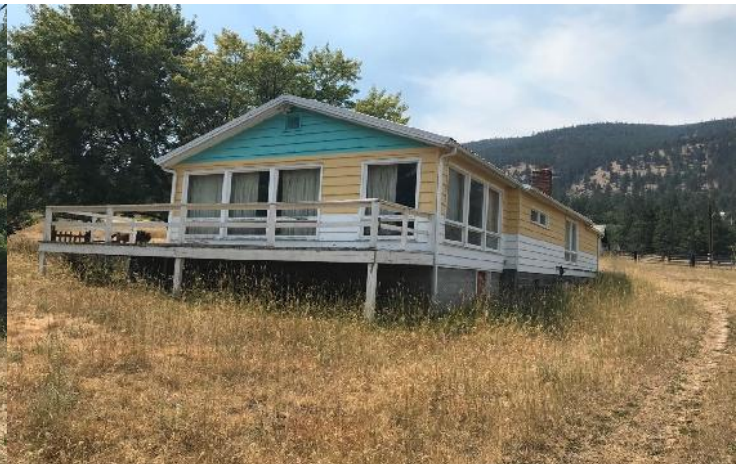
Structure Number:
Structure Name: 7250 W. Carlton Creek Rd.
SubDivision: Maple Church
GPS Location, Lat. 46 40.61628
GPS Location, Long. 114 5.96736
Safety Zone Present: Yes **Where is Safety Zone:** Large field on all sides of home
Type of Structure: Residential **Primary Structures:** **Outbuildings:**
Surrounding Fuels: Grass, Shrub **Defensible Space:** None
Structure Triage Category: Non-Defensible, Rescue, Drive By
Roof Material: Metal **Siding Material:** Wood
Heat Traps: Wood Deck, Rain Gutters
Electrical Power: Overhead **Gas to Structure:** Underground
Hazards: Fuels, Septic Tank
Access to Site: T3/4 Engine **Best Access From:** W. Carlton Creek Rd.
Comm with ICP: Radio, Cell Service
Water Source: Faucet / Hose
Mitigation Time: 1-2 Hours
Other Resources Needed to Protect: One engine crew to hook up sprinklers from on-site faucets
Notes: Home is vacant.
Water well with faucet next to it on the south west corner of house

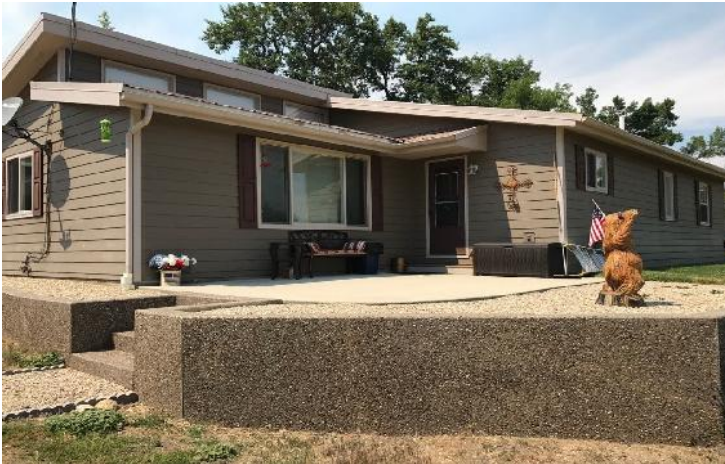
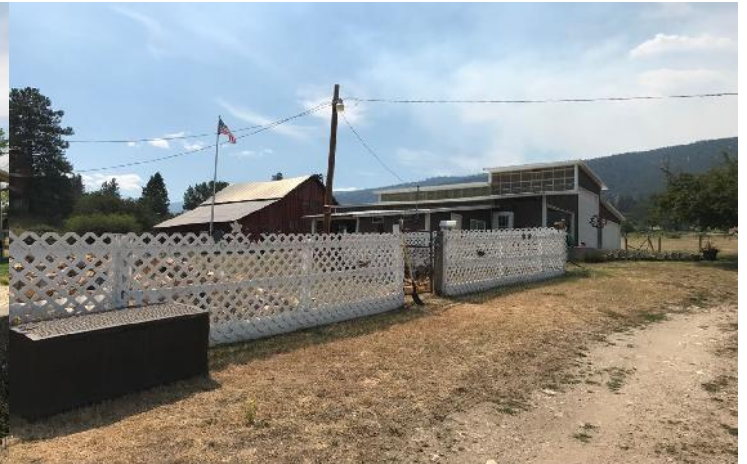
Structure Number:
Structure Name: 20255 W Carlton Creek Rd.
SubDivision: Carlton
GPS Location, Lat. 46 40.47972
GPS Location, Long. 114 5.63574
Safety Zone Present: No **Where is Safety Zone:** Out w Carlton Creek Road then to old highway 93
Type of Structure: Residential **Primary Structures:** **Outbuildings:**
Surrounding Fuels: Grass **Defensible Space:** 50-100 Feet
Structure Triage Category: Defensible, Stand Alone
Roof Material: Metal **Siding Material:** Wood
Heat Traps: Rain Gutters
Electrical Power: Overhead **Gas to Structure:** Aboveground
Hazards: No Turn Around,Septic Tank
Access to Site: T6 Engine **Best Access From:** W Carlton Creek Rd to old highway 93
Comm with ICP: Radio,Cell Service
Water Source: Faucet / Hose,Large Pond
Mitigation Time: Less Than An Hour
Other Resources Needed to Protect: Just a type 6 to patrol
Notes:
-Pond isn't being replenished
-Owner has cattle but they will be gone August 10th.

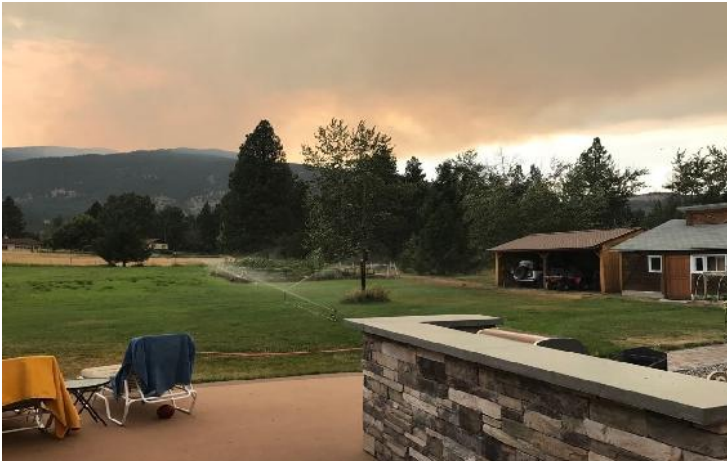
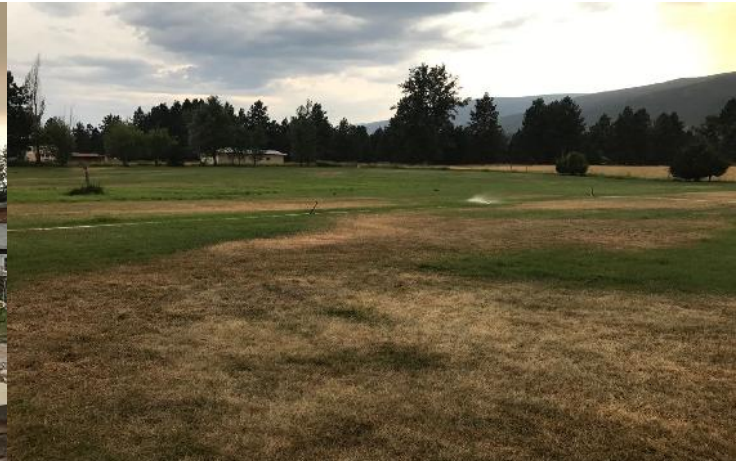
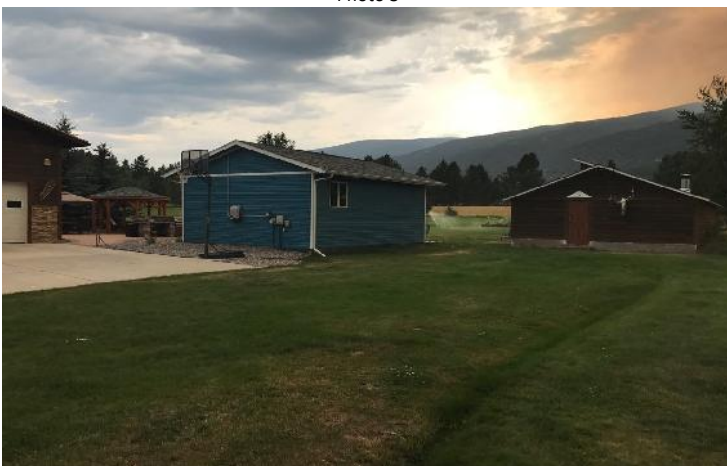
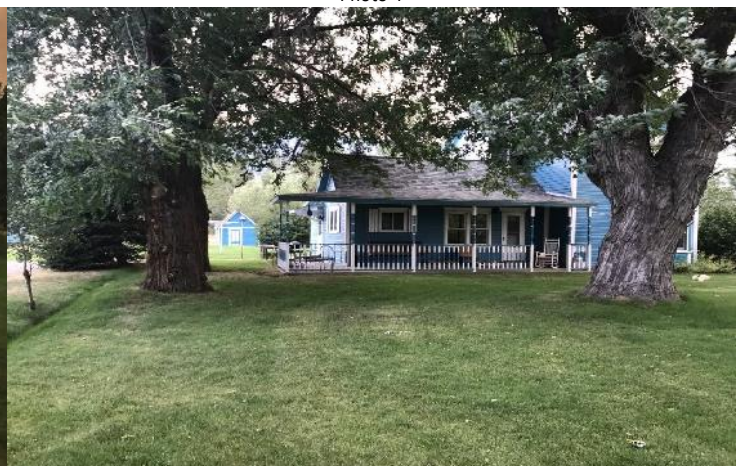
Structure Number:
Structure Name: 20501 old Hwy 93
SubDivision: Carlton
GPS Location, Lat. 46 40.49946
GPS Location, Long. 114 4.73862
Safety Zone Present: Yes
Type of Structure: Residential
Surrounding Fuels: Grass,Shrub,Timber
Structure Triage Category: Defensible, Stand Alone
Roof Material: Composite
Heat Traps: Wood Deck,Rain Gutters,Other Receptor
Electrical Power: Solar/Wind
Hazards: Animals
Access to Site: T1 Engine
Comm with ICP: Radio,Cell Service
Water Source: Faucet / Hose,Creek
Mitigation Time: None Needed
Collected By: Lolo 632

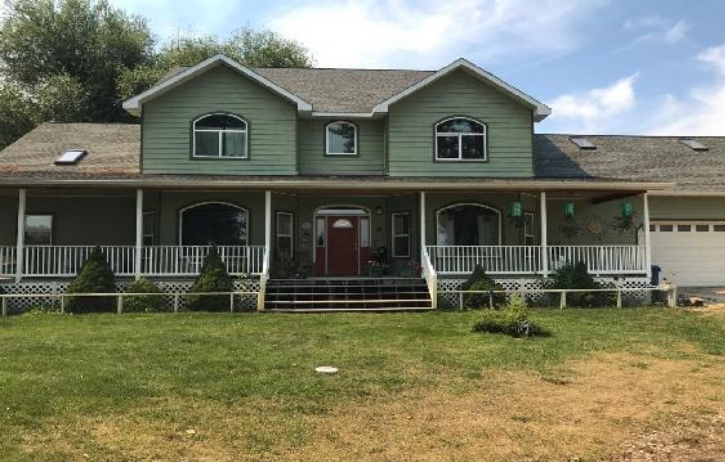
Structure Number:
Structure Name: 20605 Jones Rd
SubDivision: Carlton
GPS Location, Lat. 46 40.44768
GPS Location, Long. 114 5.31612
Safety Zone Present: No **Where is Safety Zone:** Large field near home
Type of Structure: Residential **Primary Structures:** **Outbuildings:**
Surrounding Fuels: Grass **Defensible Space:** 50-100 Feet
Structure Triage Category: Defensible, Stand Alone
Roof Material: Composite **Siding Material:** Wood
Heat Traps: Open Eaves, Wood Deck, Rain Gutters
Electrical Power: Underground **Gas to Structure:** Underground
Hazards: Septic Tank
Access to Site: T1 Engine **Best Access From:** Jones street to west Carlton Creek Rd to old highway 93
Comm with ICP: Radio, Cell Service
Water Source: Faucet / Hose, Large Pond
Mitigation Time: Less Than An Hour
Other Resources Needed to Protect: An engine to patrol house.
Notes: There is another home owner on site. They live in an RV to the south of house.
