STRUCTURE
PROTECTION PLAN
FOR
ELK CREEK BLOCK
07/27/2017

Structure Protection Plan

OZ Ranch

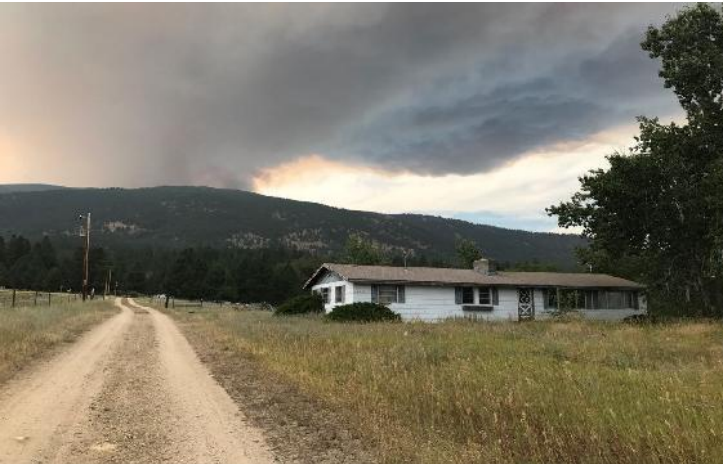
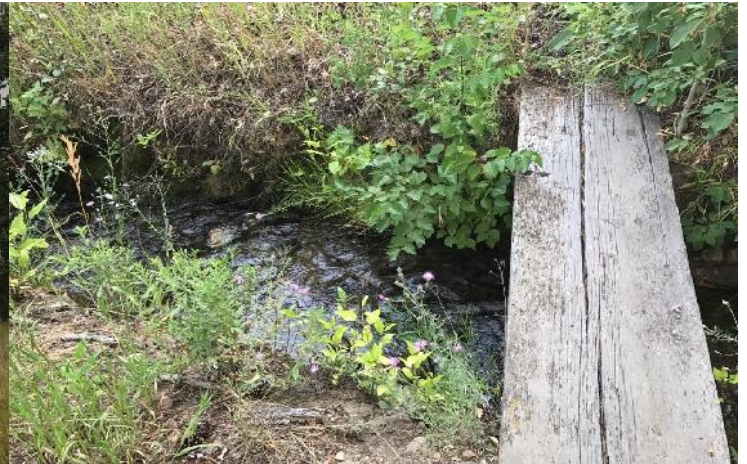
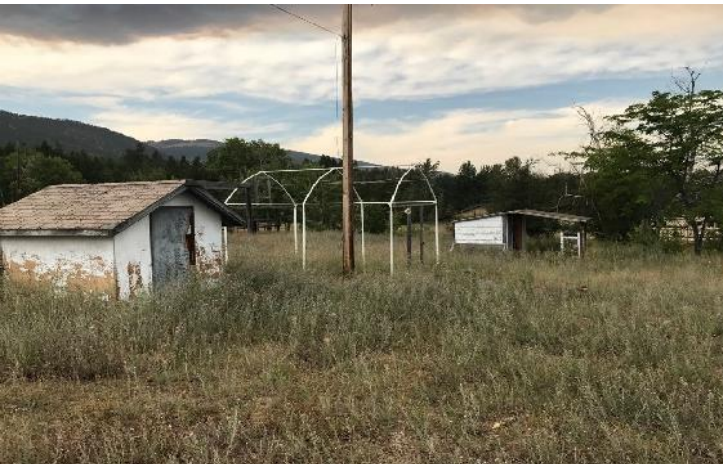
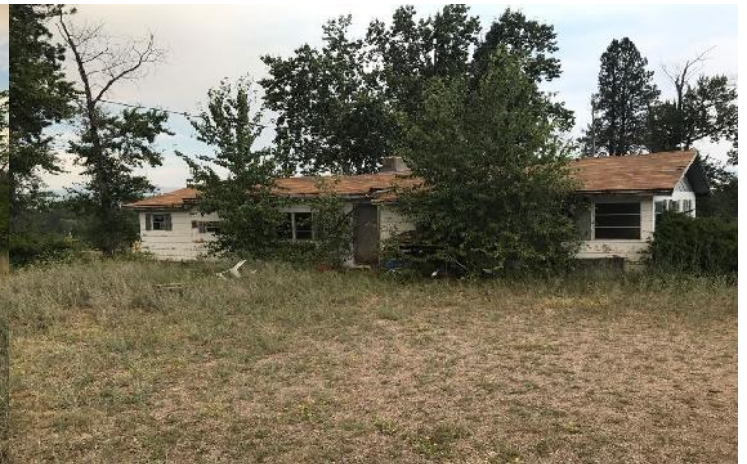
Structure Number:
Structure Name: 20755 Jones Road
SubDivision: Carlton
GPS Location, Lat. 46 40.30842
GPS Location, Long. 114 5.29728
Safety Zone Present: Yes
Type of Structure: Residential
Surrounding Fuels: Grass, Timber
Structure Triage Category: Defensible, Prep and Hold
Roof Material: Composite
Heat Traps: Open Eaves
Electrical Power: Overhead
Hazards: Fuels, HazMat
Access to Site: T1 Engine
Comm with ICP: Radio, Cell Service
Water Source: Faucet / Hose, Creek
Mitigation Time: 1-2 Hours
Other Resources Needed to Protect: Structure wrap for broken windows

Notes: Main structure appears abandoned, windows broken, overgrown grass, shallow creek adjacent, light brush work around main structure

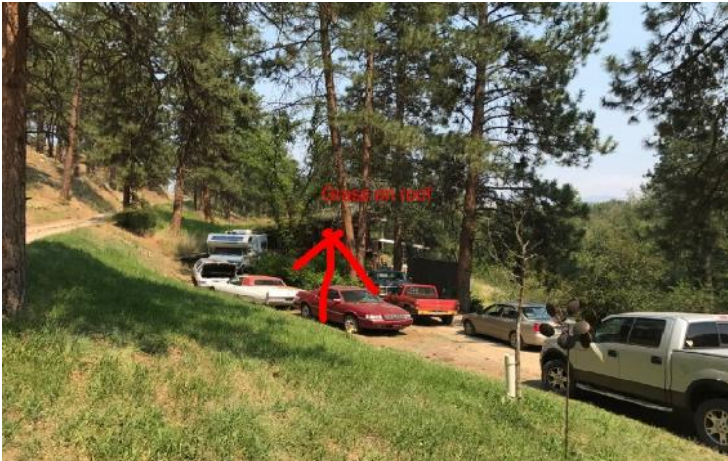
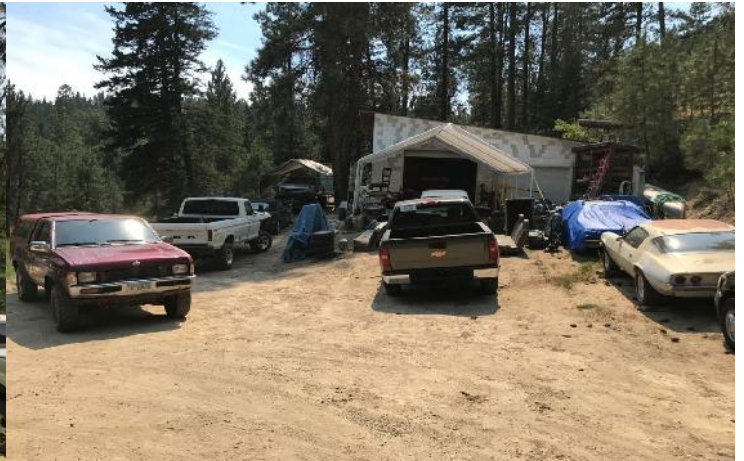
Structure Number:
Structure Name: 6895 W Carlton Creek Rd
SubDivision: Carlton
GPS Location, Lat. 46 40.33734
GPS Location, Long. 114 5.66898
Safety Zone Present: No **Where is Safety Zone:** Back out Carlton w Creek to old highway 93.
Type of Structure: Mixed Use **Primary Structures:** **Outbuildings:**
Surrounding Fuels: Grass, Timber **Defensible Space:** 30-50 Feet
Structure Triage Category: Defensible, Prep and Hold
Roof Material: Metal **Siding Material:** Wood
Heat Traps: Open Eaves, Wood Deck, Other Receptor
Electrical Power: Underground **Gas to Structure:** Underground
Hazards: Terrain, Fuels
Access to Site: T6 Engine **Best Access From:** Old highway 93 to Carlton w Creek Rd
Comm with ICP: Radio, Cell Service
Water Source: Faucet / Hose, Creek
Mitigation Time: 4-5 Hours
Other Resources Needed to Protect: Engine to hold property with crew to prep property.
Notes: House and business run out of same property. Not very good water pressure but better than most of the houses on the hill

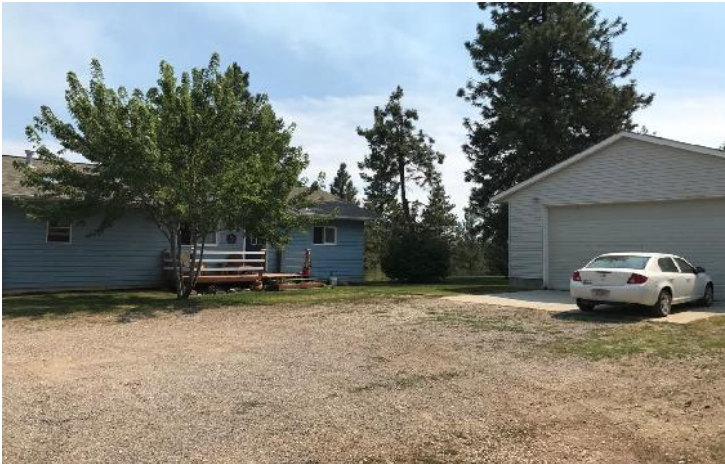
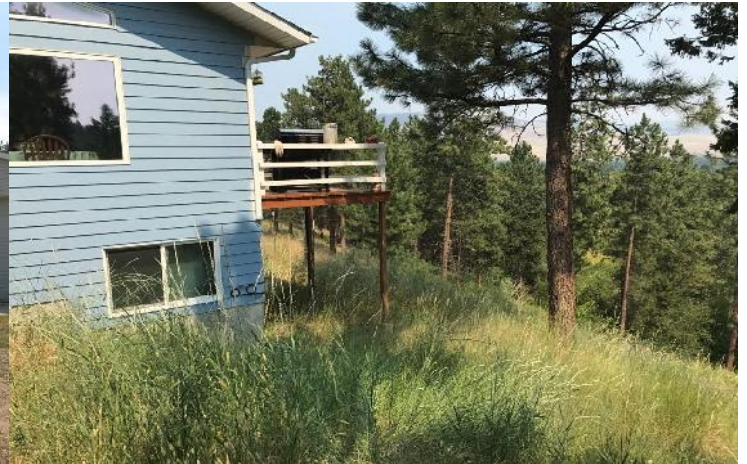
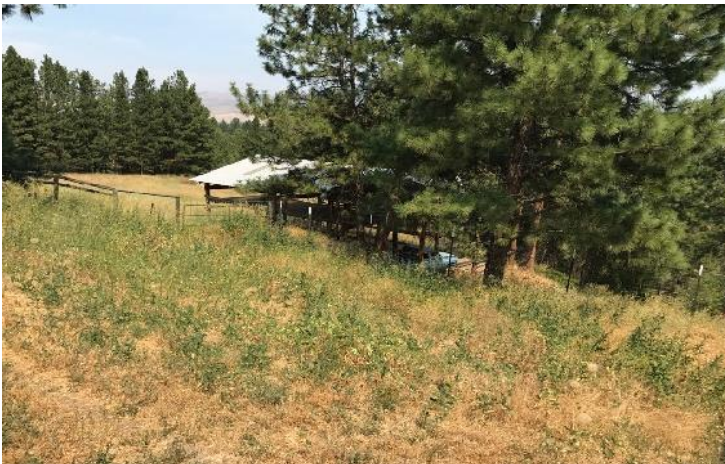
Structure Number:
Structure Name: 6901 W Carlton Creek Rd
SubDivision: Carlton
GPS Location, Lat. 46 40.45878
GPS Location, Long. 114 5.55552
Safety Zone Present: No **Where is Safety Zone:** Down Carlton Rd to Hwy 93
Type of Structure: Residential **Primary Structures:** **Outbuildings:**
Surrounding Fuels: Grass, Timber **Defensible Space:** 30-50 Feet
Structure Triage Category: Defensible, Prep and Hold
Roof Material: Composite **Siding Material:** Vinyl
Heat Traps: Open Eaves, Wood Deck, Rain Gutters
Electrical Power: Underground **Gas to Structure:** None
Hazards: Terrain, Fuels
Access to Site: T6 Engine **Best Access From:** Hwy 93 to Carlton Rd.
Comm with ICP: Radio, Cell Service
Water Source: Faucet / Hose
Mitigation Time: 1-2 Hours
Other Resources Needed to Protect: Engine crew
Notes: Steep slopes of tall grass leading up to wooden deck.

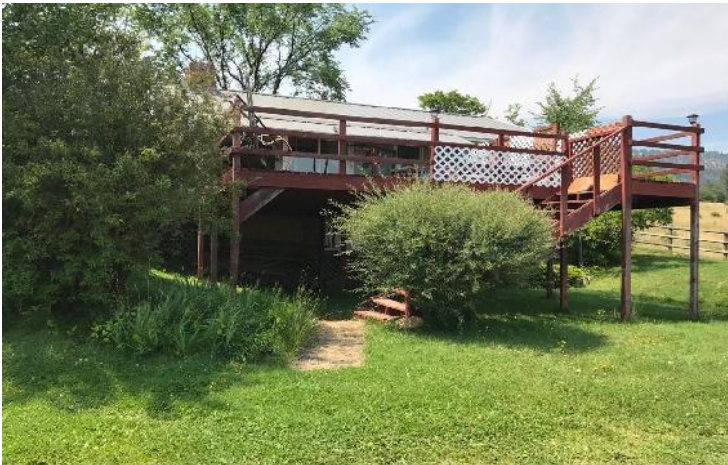
Structure Number:
Structure Name: 7287 W Carlton Creek Rd
SubDivision: Carlton
GPS Location, Lat. 46 40.38732
GPS Location, Long. 114 5.9157
Safety Zone Present: No
Type of Structure: Residential
Surrounding Fuels: Grass
Structure Triage Category: Defensible, Stand Alone
Roof Material: Composite
Heat Traps: Open Eaves, Wood Deck
Electrical Power: Underground
Hazards:
Access to Site: T6 Engine
Comm with ICP: Radio, Cell Service
Water Source: Faucet / Hose, Large Pond
Mitigation Time: Less Than An Hour
Other Resources Needed to Protect: A type 6 to patrol
Collected By: COCO 482

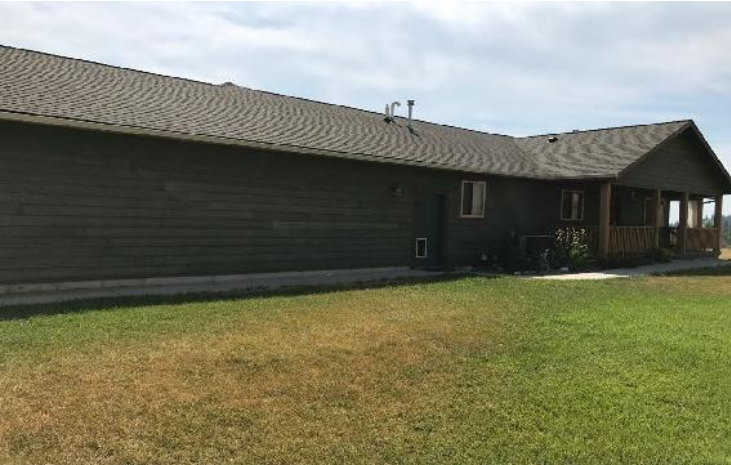
Structure Number:
Structure Name: 7337 W Carlton Creek Rd
SubDivision: Carlton
GPS Location, Lat. 46 40.50036
GPS Location, Long. 114 5.96028
Safety Zone Present: Yes
Type of Structure: Residential
Surrounding Fuels: Grass, Timber
Structure Triage Category: Defensible, Stand Alone
Roof Material: Composite
Heat Traps: Wood Deck, Rain Gutters
Electrical Power: Overhead
Hazards: Septic Tank
Access to Site: T3/4 Engine
Comm with ICP: Radio, Cell Service
Water Source: Faucet / Hose
Mitigation Time: Less Than An Hour
Other Resources Needed to Protect: Engine can patrol
Collected By: COCO 482

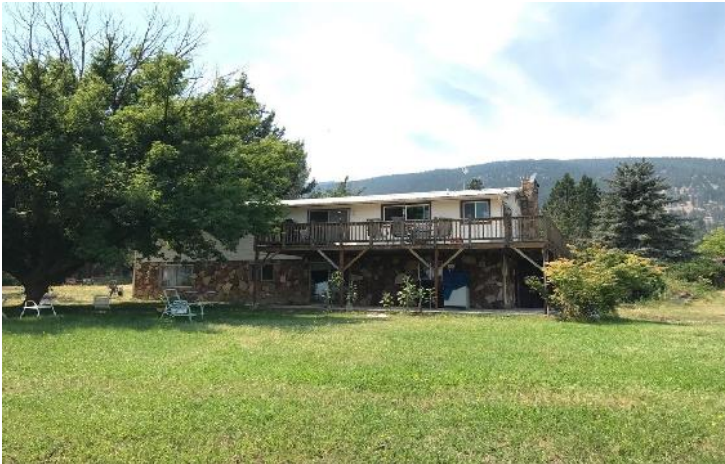
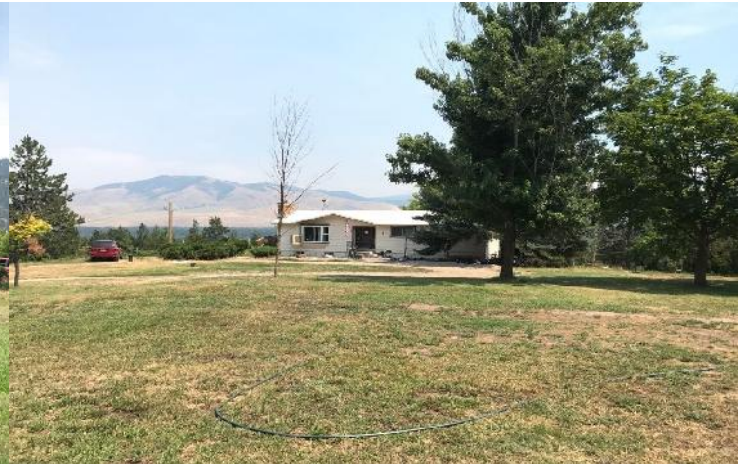
Structure Number:
Structure Name: 7501 W Carlton Creek Rd
SubDivision: Carlton
GPS Location, Lat. 46 40.4037
GPS Location, Long. 114 5.71632
Safety Zone Present: No **Where is Safety Zone:** Back out to Carlton Creek Rd to highway 93
Type of Structure: Residential **Primary Structures:** **Outbuildings:**
Surrounding Fuels: Grass, Timber **Defensible Space:** 50-100 Feet
Structure Triage Category: Defensible, Stand Alone
Roof Material: Metal **Siding Material:** Wood
Heat Traps: Wood Deck **Gas to Structure:** Underground
Electrical Power: Overhead, Underground
Hazards: Terrain, Bridge Load Limits
Access to Site: T3/4 Engine **Best Access From:** Highway 93 to old highway 93 to Carlton W Creek Rd
Comm with ICP: Radio, Cell Service
Water Source: Faucet / Hose, Creek
Mitigation Time: Less Than An Hour
Other Resources Needed to Protect: One engine crew to patrol house minimum prep needed around house
Notes: Bottom half of house is stone top half is wood. Small pond on property

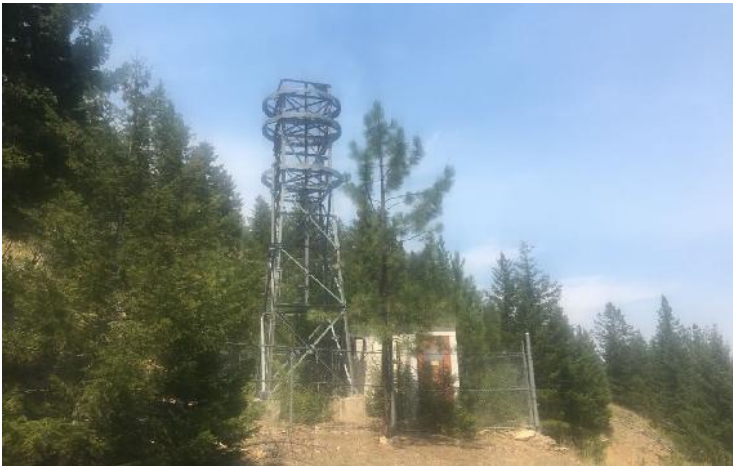
Structure Number:
Structure Name: Communication Site
SubDivision: Carlton
GPS Location, Lat. 46 40.16928
GPS Location, Long. 114 6.68748
Safety Zone Present: No
Type of Structure: Industrial
Surrounding Fuels: Timber
Structure Triage Category: Defensible, Stand Alone
Roof Material: Metal
Heat Traps:
Electrical Power: Overhead
Hazards: Fuels

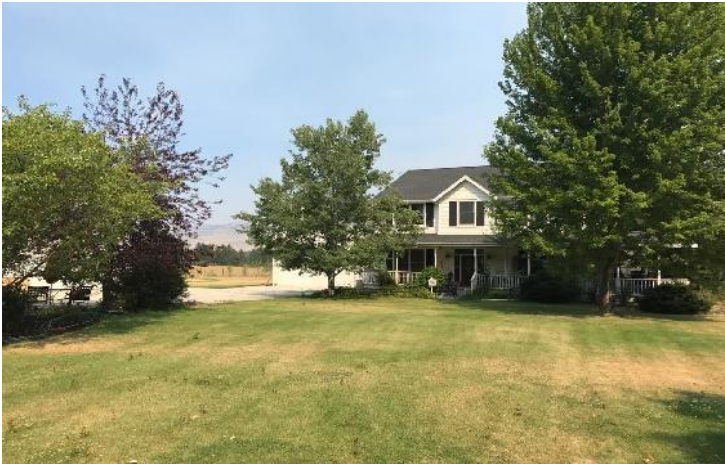
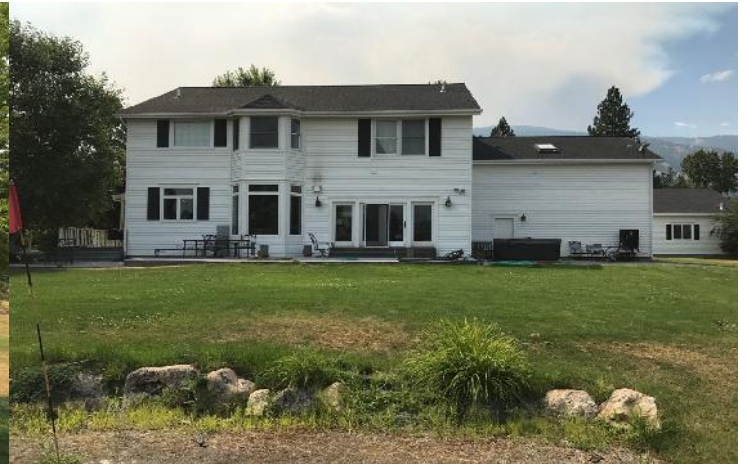
Safety Zone Present: No
Type of Structure: Residential
Surrounding Fuels: Grass, Timber
Structure Triage Category: Defensible, Prep and Hold
Roof Material: Composite
Heat Traps: Wood Deck
Electrical Power: Overhead, Underground
Hazards:
Access to Site: T1 Engine
Comm with ICP: Radio, Cell Service
Water Source: Faucet / Hose
Mitigation Time: Less Than An Hour
Other Resources: One engine to hold house but no prep needed
Needed to Protect:
Notes: *no address found*

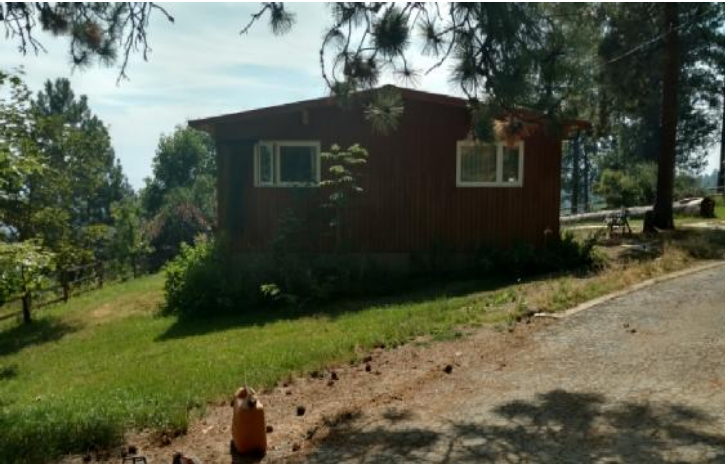
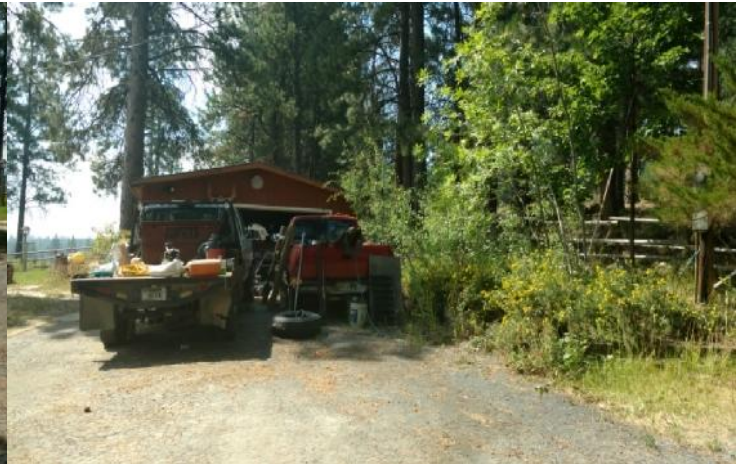
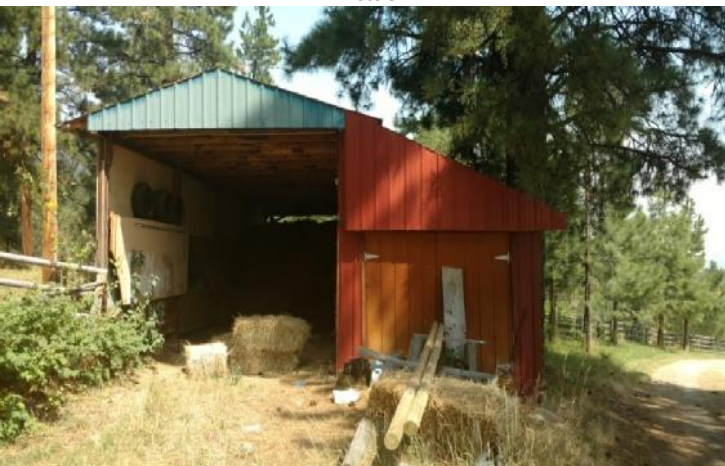
Structure Number:
Structure Name: ??? West Carlton Creek Rd
SubDivision: Carlton
GPS Location, Lat. 46 40.44018
GPS Location, Long. 114 6.1434
Safety Zone Present: Yes **Where is Safety Zone:** Large grass field adjacent to the structure
Type of Structure: Residential **Primary Structures:** **Outbuildings:**
Surrounding Fuels: Grass, Timber **Defensible Space:** 30-50 Feet
Structure Triage Category: Defensible, Prep and Hold
Roof Material: Metal **Siding Material:** Wood
Heat Traps: Wood Deck, Rain Gutters
Electrical Power: Overhead **Gas to Structure:** None
Hazards: Terrain, No Turn Around, Animals
Access to Site: T3/4 Engine **Best Access From:** Old highway 93 to Carlton Creek Rd
Comm with ICP: Radio, Cell Service
Water Source: Faucet / Hose, Creek
Mitigation Time: 1-2 Hours
Other Resources Needed to Protect: Type 3 engine, sprinkler kit
Notes: Forest adjacent property has been thinned. Large grass fields two sides of structures. Owner is Troy Maier

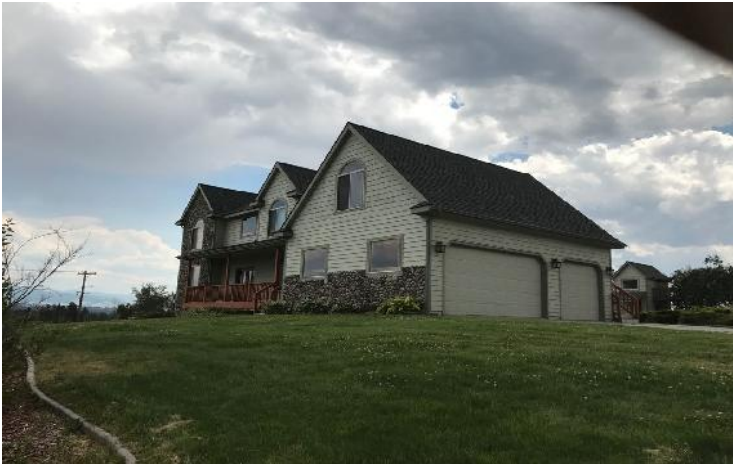
Structure Number:
Structure Name: 215 Mountain Shadow Trail
SubDivision: Tie Chute
GPS Location, Lat. 46 39.17304
GPS Location, Long. 114 4.75338
Safety Zone Present: Yes
Type of Structure: Residential
Surrounding Fuels: Grass,Shrub
Structure Triage Category: Defensible, Stand Alone
Roof Material: Composite
Heat Traps: Open Eaves,Rain Gutters,Other Receptor
Electrical Power: Underground
Hazards:
Access to Site: T3/4 Engine
Comm with ICP: Radio,Cell Service
Water Source: Faucet / Hose
Mitigation Time: Less Than An Hour
Notes: Rene Deming
951-551-7734I

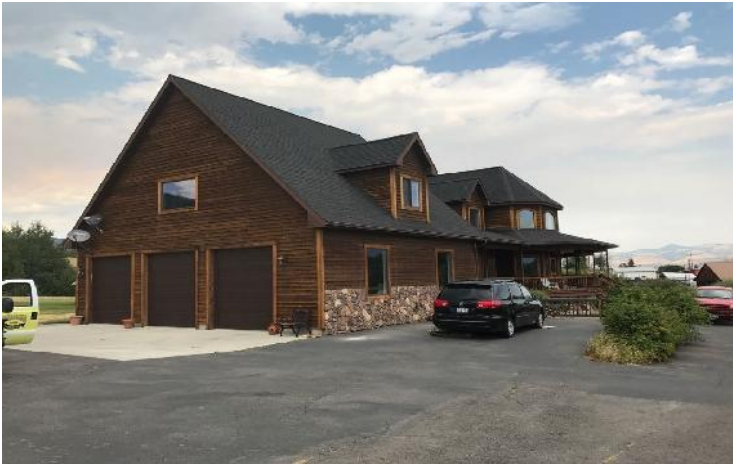
Structure Number:
Structure Name: 224 Mountain Shadow Trail
SubDivision: Tie Chute
GPS Location, Lat. 46 39.17598
GPS Location, Long. 114 4.7463
Safety Zone Present: Yes **Where is Safety Zone:** Old Highway 93
Type of Structure: Residential **Primary Structures:** **Outbuildings:**
Surrounding Fuels: Grass,Shrub **Defensible Space:** 30-50 Feet
Structure Triage
Category: Defensible, Stand Alone
Roof Material: Composite **Siding Material:** Wood
Heat Traps: Open Eaves,Wood Deck,Rain Gutters
Electrical Power: Underground **Gas to Structure:** Underground
Hazards:
Access to Site: T3/4 Engine **Best Access From:** Old Highway 93 to Mountain Shadow Trail
Comm with ICP: Radio,Cell Service
Water Source: Faucet / Hose,Creek
Mitigation Time: Less Than An Hour
Notes: Hot tub in deck on NW corner of structure. Running creek 25 yards from NW corner of structure. Fire wood stacked on west side of deck.

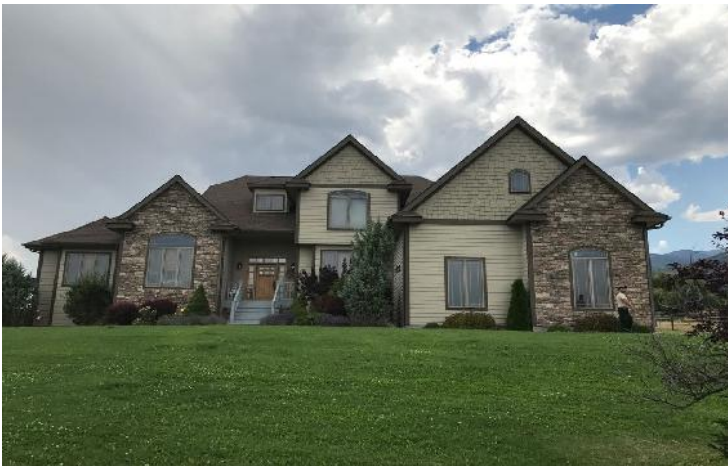
Structure Number:
Structure Name: 225 Mountain Shadow Trail
SubDivision: Tie Chute
GPS Location, Lat. 46 39.13626
GPS Location, Long. 114 4.7832
Safety Zone Present: No
Type of Structure: Residential
Surrounding Fuels: Grass,Shrub
Structure Triage Category: Defensible, Stand Alone
Roof Material: Composite
Heat Traps: Open Eaves,Rain Gutters,Other Receptor
Electrical Power: Underground
Hazards: No Turn Around
Access to Site: T3/4 Engine
Comm with ICP: Radio,Cell Service
Water Source: Faucet / Hose
Mitigation Time: Less Than An Hour
Notes: Underground irrigation system.

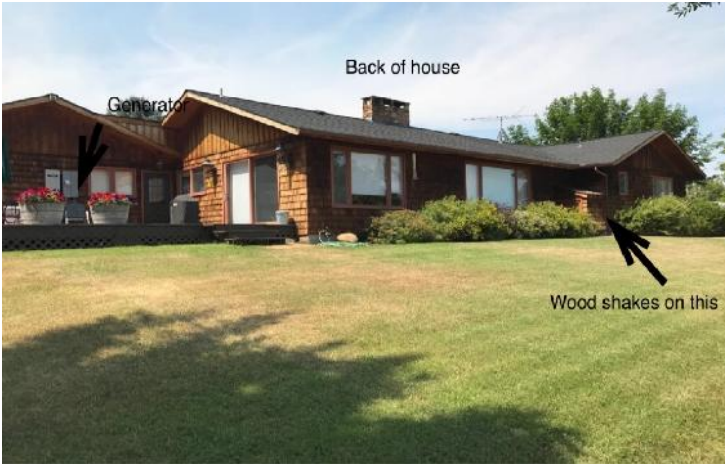
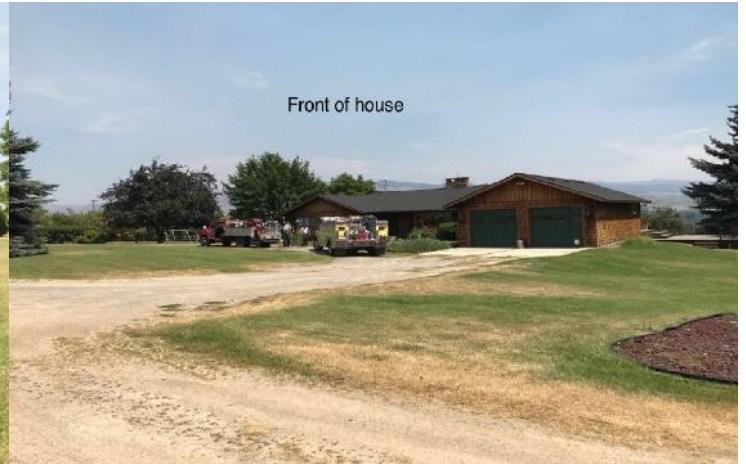
Structure Number:
Structure Name: 229 Wagner Ln
SubDivision: Tie Chute
GPS Location, Lat. 46 39.40932
GPS Location, Long. 114 4.47186
Safety Zone Present: Yes **Where is Safety Zone:** Hwy 93
Type of Structure: Residential **Primary Structures:** **Outbuildings:**
Surrounding Fuels: Grass,Shrub,Timber **Defensible Space:** 30-50 Feet
Structure Triage Category: Defensible, Prep and Hold
Roof Material: Composite **Siding Material:** Wood
Heat Traps: Open Eaves,Wood Deck,Rain Gutters,Other Receptor
Electrical Power: Underground,Generator **Gas to Structure:** Underground
Hazards:
Access to Site: T1 Engine **Best Access From:** Wagner Ln.
Comm with ICP: Radio,Cell Service
Water Source: Faucet / Hose,Large Pond
Mitigation Time: 1-2 Hours
Other Resources Needed to Protect: Sprinklers, mark 3 pump, 400' 11/2" hose, appliances to set up 6 sprinklers.
Notes: Pond is south east of structure on other property unsure of access.

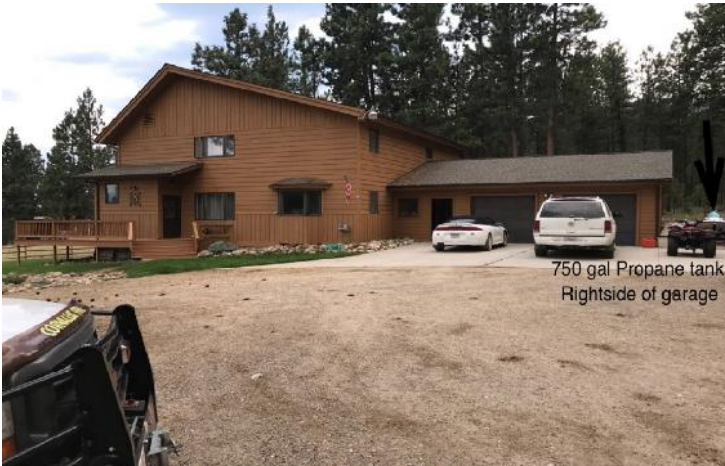
750 gal Propane tank
Rightside of garage

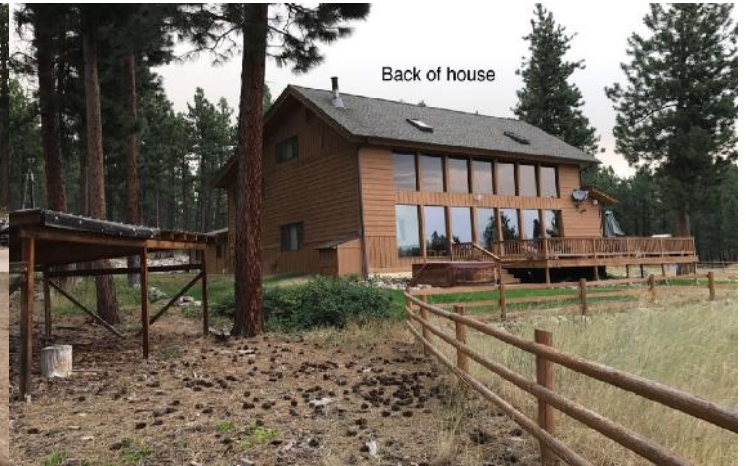
Back of house

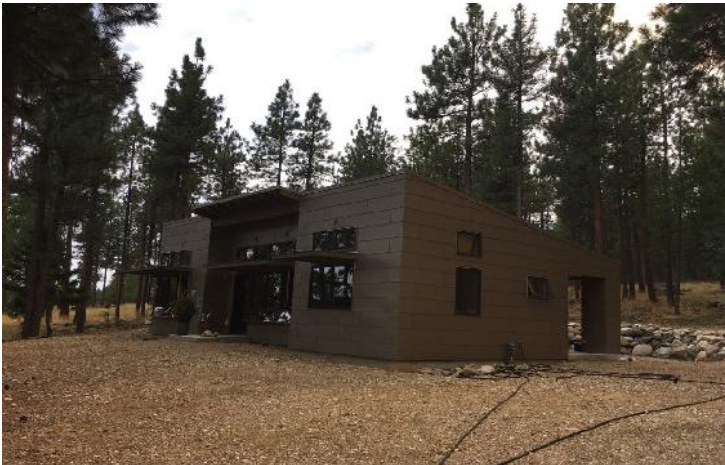
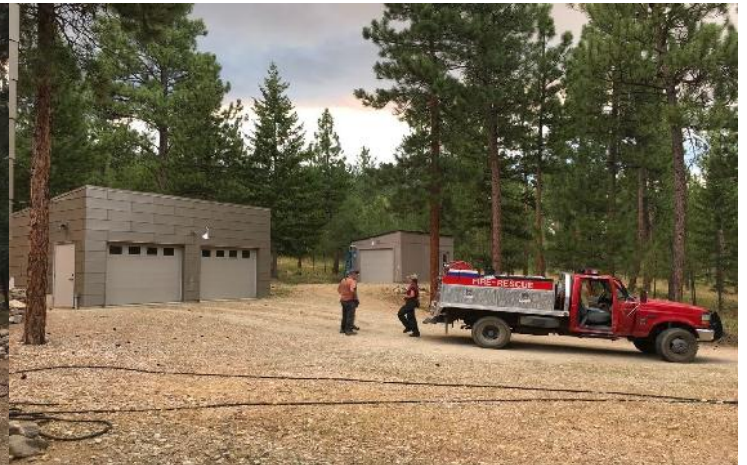
Structure Number:
Structure Name: 497 west county line Rd
SubDivision: Tie Chute
GPS Location, Lat. 46 39.59394
GPS Location, Long. 114 6.32514
Safety Zone Present: No
Type of Structure: Residential
Surrounding Fuels: Timber
Structure Triage Category: Defensible, Prep and Hold
Roof Material: Metal
Heat Traps:
Electrical Power: Underground
Hazards: Septic Tank
Access to Site: T3/4 Engine
Comm with ICP: Radio, Cell Service
Water Source: Faucet / Hose
Mitigation Time: Less Than An Hour
Other Resources Needed to Protect: All metal structures with concrete foundations...small gpm well...
Collected By: E-27 Florence
Photo 1

Where is Safety Zone: Down and out to Jones Rd to Wagner
Primary Structures:
Outbuildings:
Defensible Space: 30-50 Feet
Siding Material: Metal
Gas to Structure: Aboveground
Best Access From: West county line road

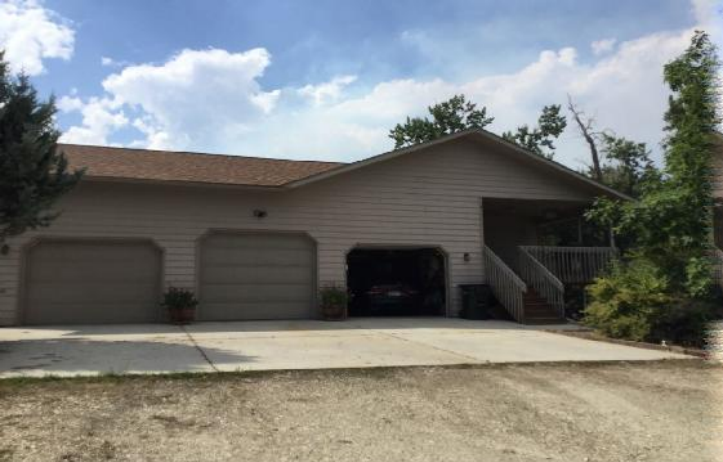
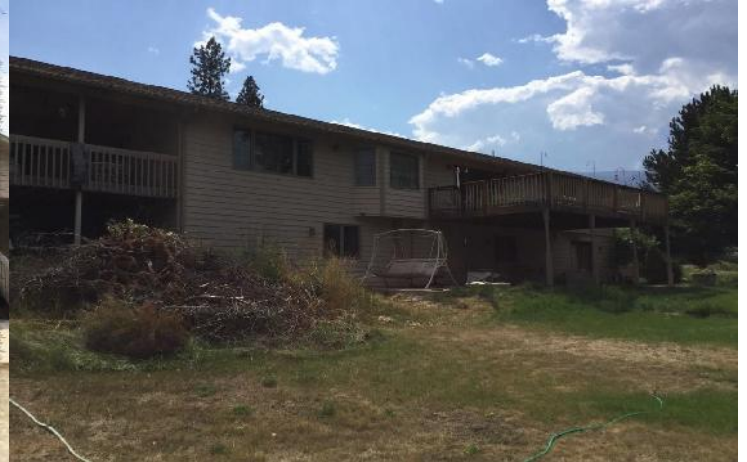
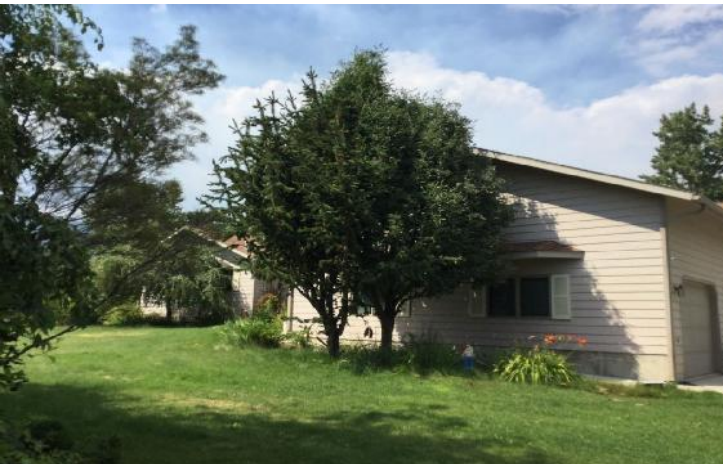
Structure Number:
Structure Name: 5607 One Horse Lane
SubDivision: Tie Chute
GPS Location, Lat. 46 38.56848
GPS Location, Long. 114 5.0091
Safety Zone Present: No **Where is Safety Zone:** In town, escape route out Tie Chute Lane.
Type of Structure: Residential **Primary Structures:** **Outbuildings:**
Surrounding Fuels: Grass, Timber **Defensible Space:** 50-100 Feet
Structure Triage Category: Defensible, Stand Alone
Roof Material: Composite **Siding Material:** Wood
Heat Traps: Wood Deck, Rain Gutters, Other Receptor
Electrical Power: Underground **Gas to Structure:** Underground
Hazards: Fuels, Septic Tank
Access to Site: T1 Engine **Best Access From:** One horse lane off of Tie Chute Lane
Comm with ICP: Radio, Cell Service
Water Source: Faucet / Hose, Creek
Mitigation Time: Less Than An Hour
Other Resources Needed to Protect: None.
Notes: Brush pile near house. Small creek north of house.

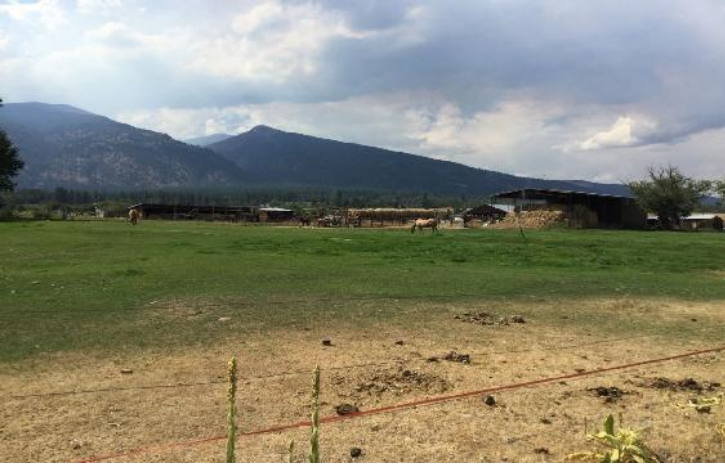
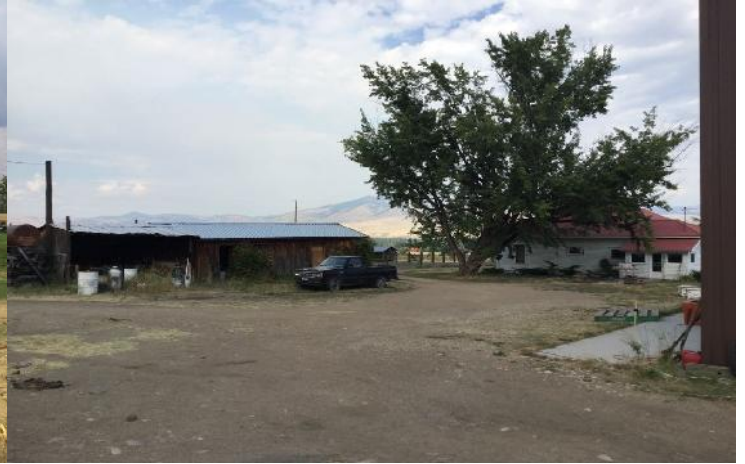
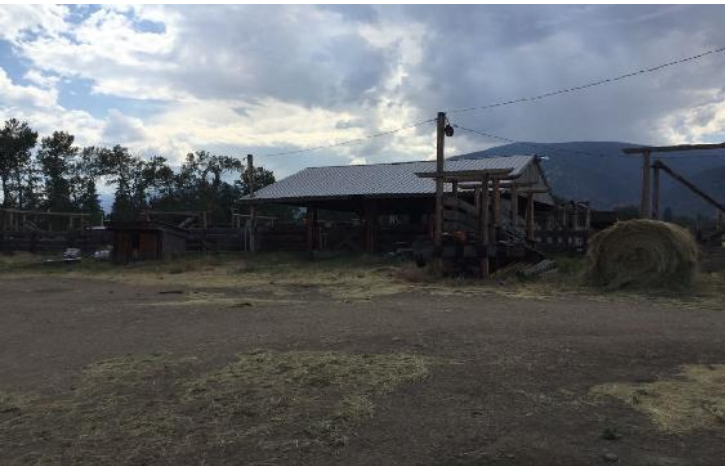
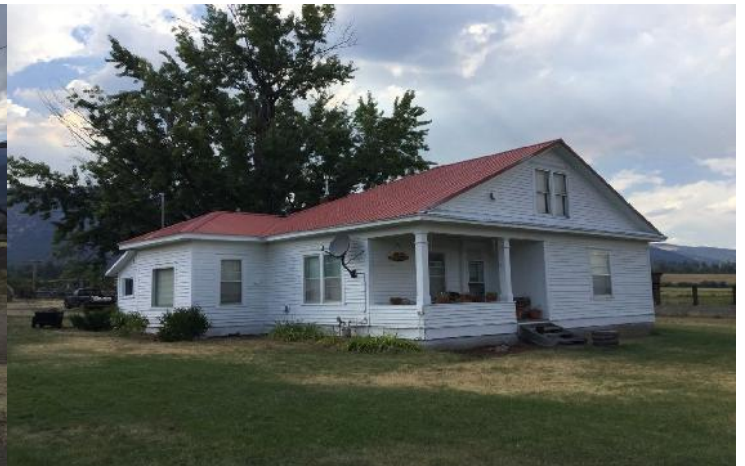
Structure Number:
Structure Name: 5613 One Horse Lane
SubDivision: Tie Chute
GPS Location, Lat. 46 38.68698
GPS Location, Long. 114 4.99332
Safety Zone Present: Yes **Where is Safety Zone:** Surrounding grass pastures
Type of Structure: Residential **Primary Structures:** **Outbuildings:**
Surrounding Fuels: Grass **Defensible Space:** >100 Feet
Structure Triage Category: Defensible, Stand Alone
Roof Material: Metal **Siding Material:** Wood
Heat Traps: Wood Deck, Other Receptor
Electrical Power: Overhead, Underground **Gas to Structure:** Underground
Hazards: Animals, Septic Tank, HazMat
Access to Site: T3/4 Engine **Best Access From:** One Horse Lane off of Tie Chute Lane.
Comm with ICP: Radio, Cell Service
Water Source: Faucet / Hose, Creek
Mitigation Time: None Needed
Other Resources Needed to Protect: None
Notes: Large private farm. Various livestock and livestock buildings. Green irrigated pasture surrounding home. Small creek south of property.

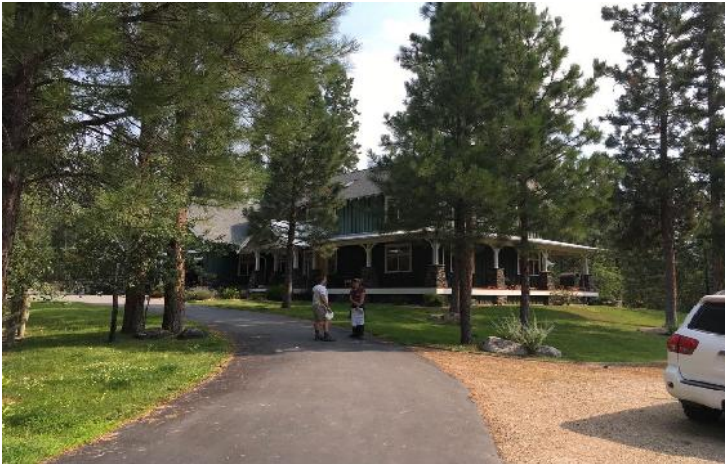
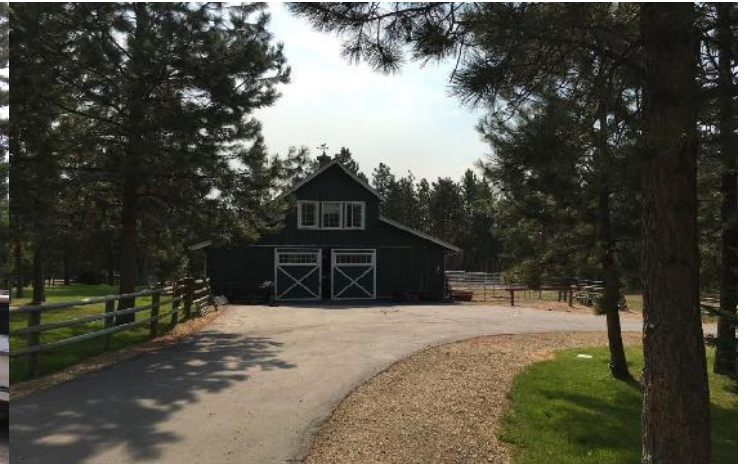
Structure Number:
Structure Name: 5668 Lichenstone Ln
SubDivision: Tie Chute
GPS Location, Lat. 46 38.87046
GPS Location, Long. 114 6.0399
Safety Zone Present: No **Where is Safety Zone:** Down and out to ICP. Travel time of 5-7 minutes
Type of Structure: Residential **Primary Structures:** **Outbuildings:**
Surrounding Fuels: Timber **Defensible Space:** 30-50 Feet
Structure Triage Category: Defensible, Prep and Hold
Roof Material: Composite **Siding Material:** Wood
Heat Traps: Open Eaves, Wood Deck, Rain Gutters
Electrical Power: Underground **Gas to Structure:** Underground
Hazards: Septic Tank
Access to Site: T3/4 Engine **Best Access From:** Tie Chute to Lichenstone Ln
Comm with ICP: Radio, Cell Service
Water Source: Faucet / Hose
Mitigation Time: 2-3 Hours
Other Resources Needed to Protect: At least twelve to fifteen sprinklers for structures...hand crew to cut small trees around structures...
Notes: Cul de sac asphalt driveway. Homeowner owns the pond on West County Line, just north of the Jones RD/West County Line Rd. He has granted access and use of pond, but would like to be contacted prior to use due to it being stocked with trout and it's behind

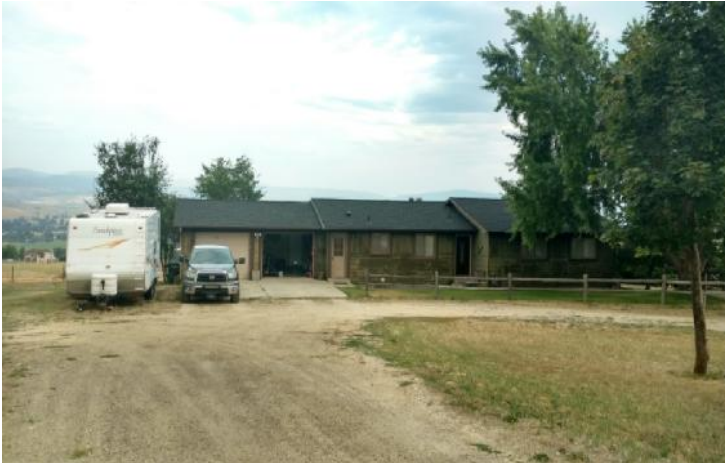
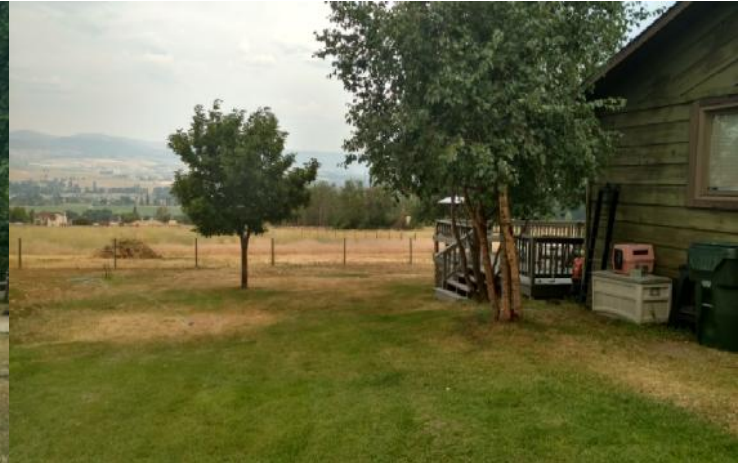
Structure Number:
Structure Name: 5804 Jones Rd
SubDivision: Tie Chute
GPS Location, Lat. 46 39.47946
GPS Location, Long. 114 5.21796
Safety Zone Present: Yes
Type of Structure: Residential
Surrounding Fuels: Grass
Structure Triage Category: Defensible, Stand Alone
Roof Material: Composite
Heat Traps: Wood Deck
Electrical Power: Underground
Hazards:
Access to Site: T1 Engine
Comm with ICP: Radio, Cell Service
Water Source: Faucet / Hose
Mitigation Time: None Needed
Other Resources Needed to Protect: One engine to patrol
Collected By: COCO 482
Photo 1

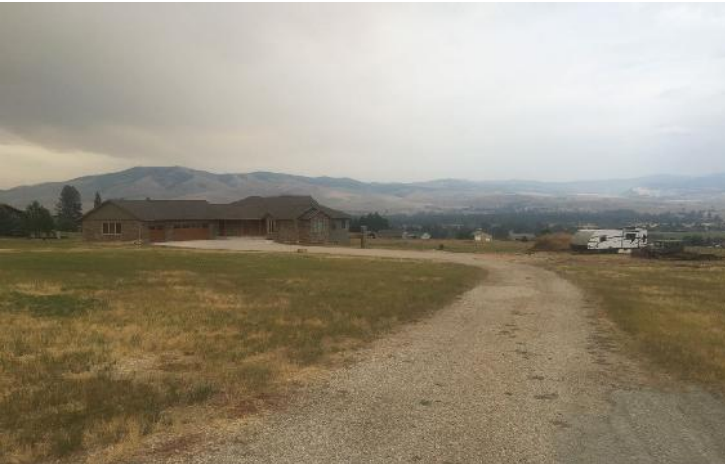
Structure Number:
Structure Name: 5816 Jones Rd
SubDivision: Tie Chute
GPS Location, Lat. 46 39.52212
GPS Location, Long. 114 5.20662
Safety Zone Present: Yes
Type of Structure: Residential
Surrounding Fuels: Grass, None
Structure Triage Category: Defensible, Stand Alone
Roof Material: Composite
Heat Traps: Wood Deck, Rain Gutters
Electrical Power: Underground
Hazards:
Access to Site: T1 Engine
Comm with ICP: Radio, Cell Service
Water Source: Faucet / Hose
Mitigation Time: None Needed
Other Resources Needed to Protect: T6 patrol
Notes: New construction, no vegetation near home

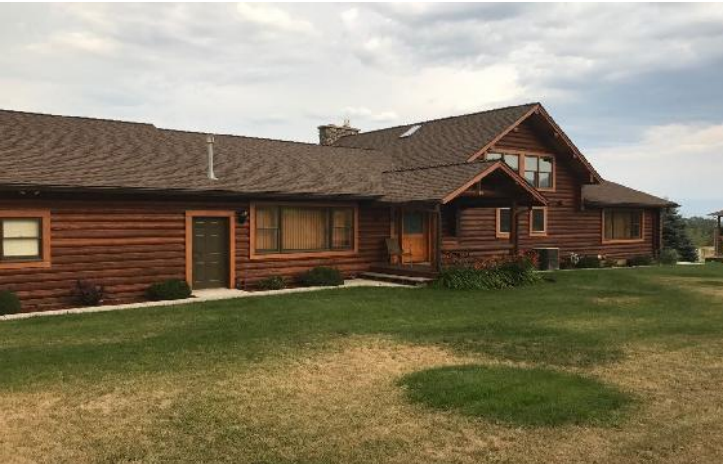
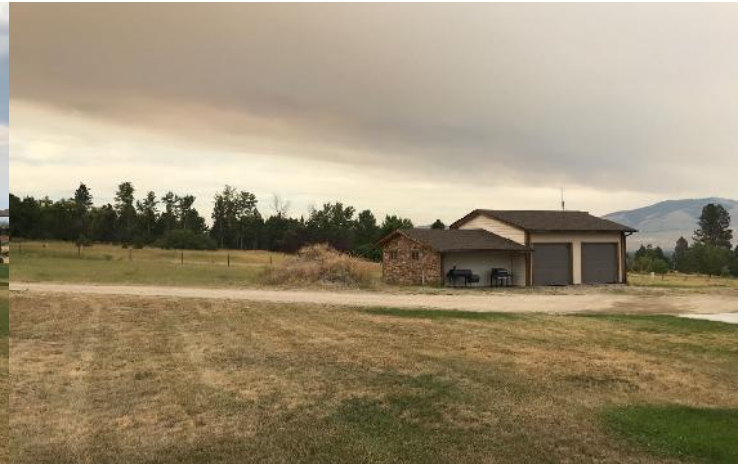
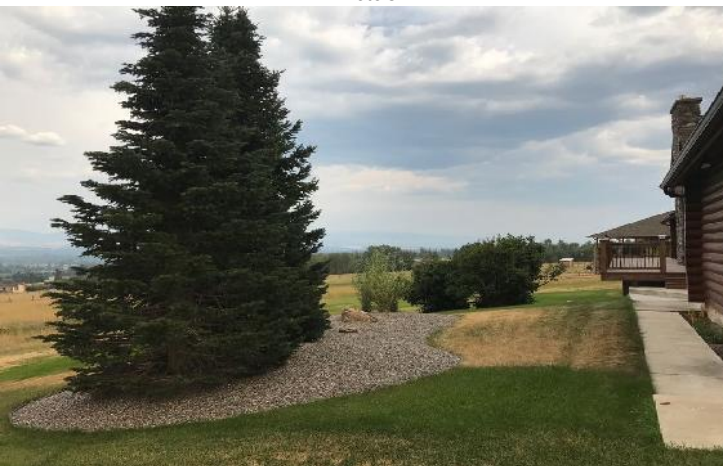
Structure Number:
Structure Name: 5820 Jones Rd
SubDivision: Tie Chute
GPS Location, Lat. 46 39.56436
GPS Location, Long. 114 5.20182
Safety Zone Present: Yes
Type of Structure: Residential
Surrounding Fuels: Grass, Timber
Structure Triage Category: Defensible, Prep and Hold
Roof Material: Composite
Heat Traps: Wood Deck
Electrical Power: Underground
Hazards: Septic Tank
Access to Site: T1 Engine
Comm with ICP: Radio, Cell Service
Water Source: Faucet / Hose
Mitigation Time: None Needed
Other Resources Needed to Protect: Engine to patrol
Notes: House for sale, currently vacant.

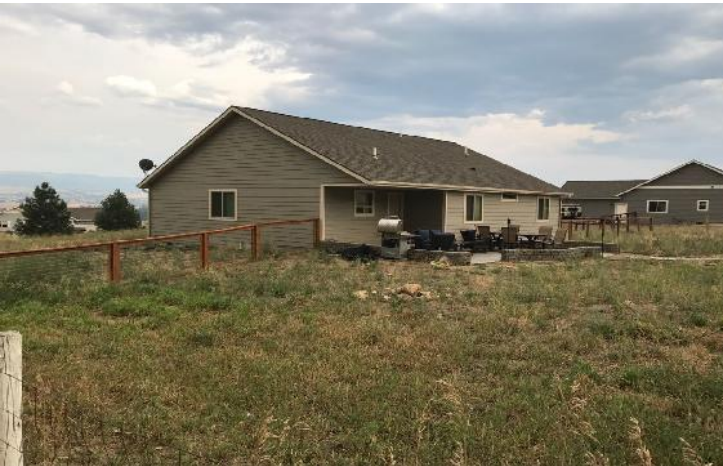
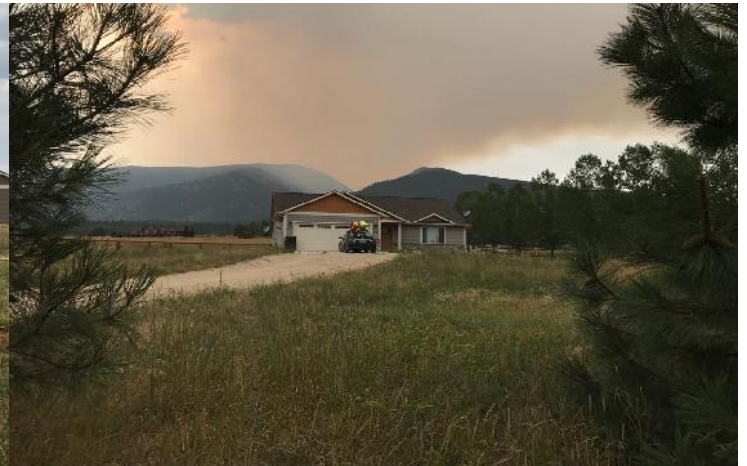
Safety Zone Present: Yes
Type of Structure: Residential
Surrounding Fuels: Grass
Structure Triage Category: Defensible, Stand Alone
Roof Material: Composite
Heat Traps: Rain Gutters
Electrical Power: Underground
Hazards: HazMat
Access to Site: T1 Engine
Comm with ICP: Radio, Cell Service
Water Source: Faucet / Hose
Mitigation Time: None Needed
Other Resources Needed to Protect: None
Notes: Grass needs to be mowed around the house.

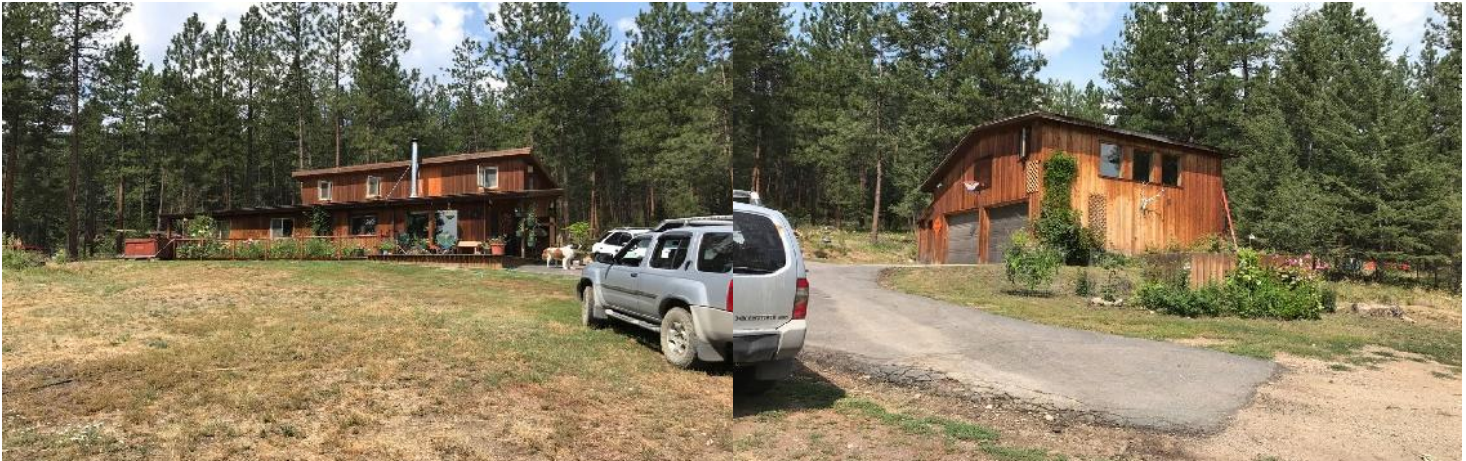
Structure Number:
Structure Name: 582 Tie Chute
SubDivision: Tie Chute
GPS Location, Lat. 46 38.66814
GPS Location, Long. 114 6.8967
Safety Zone Present: No
Type of Structure: Residential
Surrounding Fuels: Grass, Timber
Structure Triage Category: Non-Defensible, Prep and Leave
Roof Material: Metal
Heat Traps: Open Eaves, Wood Deck, Rain Gutters
Electrical Power: Underground
Hazards: Fuels
Access to Site: T3/4 Engine
Comm with ICP: Radio, Cell Service
Water Source: Faucet / Hose
Mitigation Time: 1-2 Hours
Collected By: AZ-TNF 1265

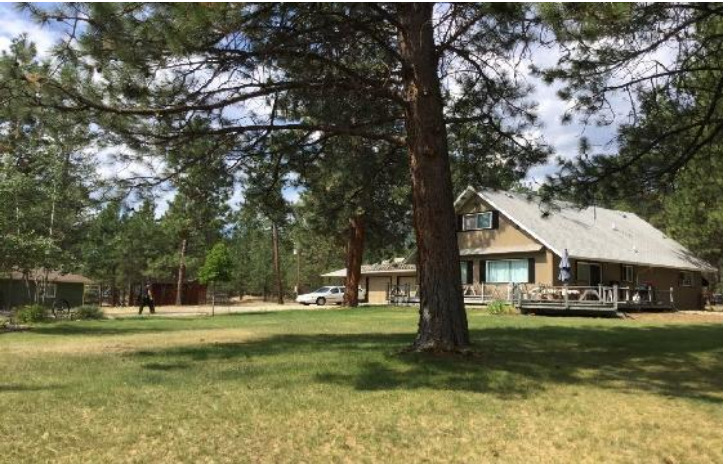
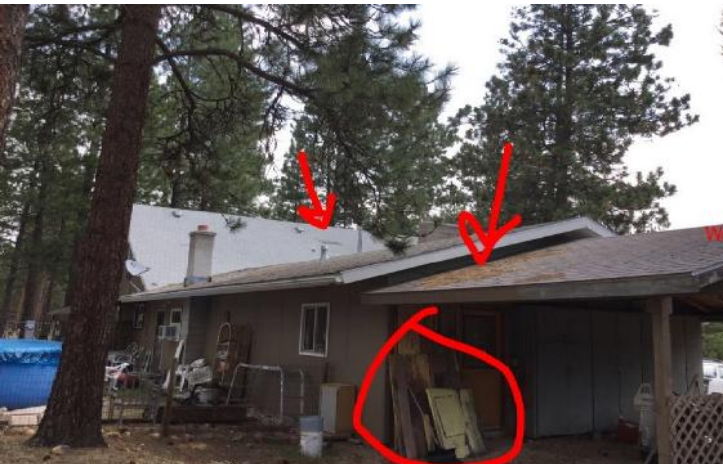
Structure Number: 321 Wickiup Drive
Structure Name: 321 Wickiup Drive
SubDivision: One Horse
GPS Location, Lat. 46 38.24742
GPS Location, Long. 114 5.22738
Safety Zone Present: Yes Where is Safety Zone: Down the road Florence
Type of Structure: Residential Primary Structures:
Surrounding Fuels: Timber Defensible Space: 30-50 Feet
Structure Triage Category: Defensible, Prep and Hold
Roof Material: Composite Siding Material: Wood
Heat Traps: Rain Gutters
Electrical Power: Underground Gas to Structure: Underground
Hazards: Fuels
Access to Site: T1 Engine Best Access From: Wickiup Drive
Comm with ICP: Radio, Cell Service
Water Source: Faucet / Hose, Porta-Tank/Pumpkin
Mitigation Time: Less Than An Hour
Other Resources: Clean gutters and roof, remove wood from around house, thinning along back fence
Needed to Protect:
Notes: Pool in the back

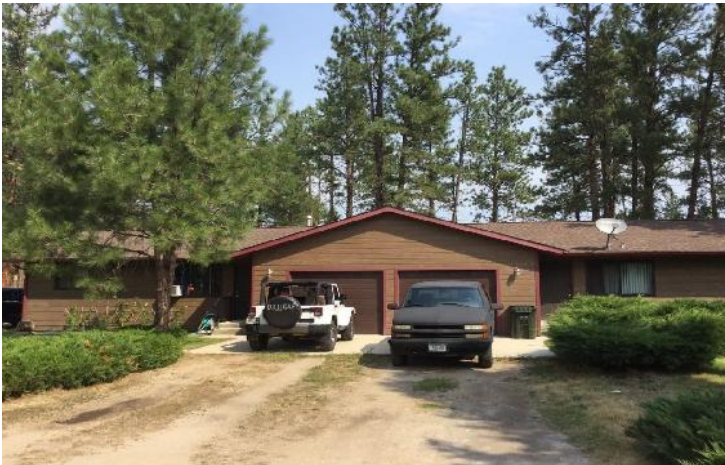
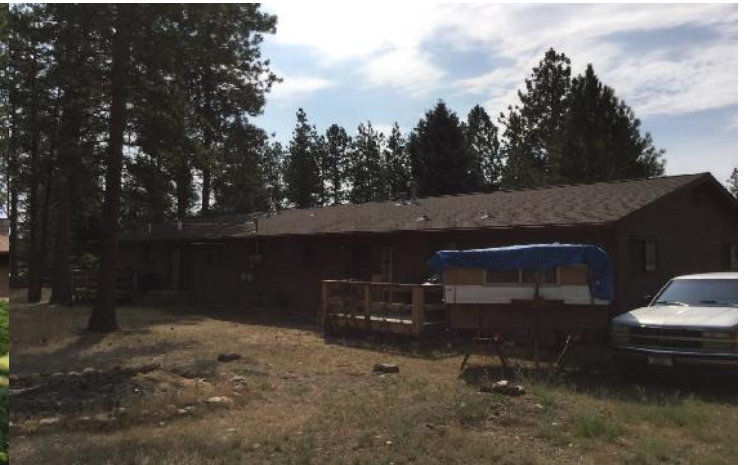
Structure Number:
Structure Name: 322 /324 Wickiup Drive
SubDivision: One Horse
GPS Location, Lat. 46 38.31804
GPS Location, Long. 114 5.22462
Safety Zone Present: Yes
Type of Structure: Residential
Surrounding Fuels: Timber
Structure Triage Category: Defensible, Stand Alone
Roof Material: Composite
Heat Traps: Rain Gutters
Electrical Power: Overhead
Hazards: Septic Tank
Access to Site: T1 Engine
Comm with ICP: Radio, Cell Service
Water Source: Faucet / Hose
Mitigation Time: 1-2 Hours
Other Resources Needed to Protect: Clean under decks, gutters
Collected By: Engine 951
