STRUCTURE
PROTECTION PLAN
FOR
ELK CREEK BLOCK
07/27/2017

Structure Protection Plan

OZ Ranch

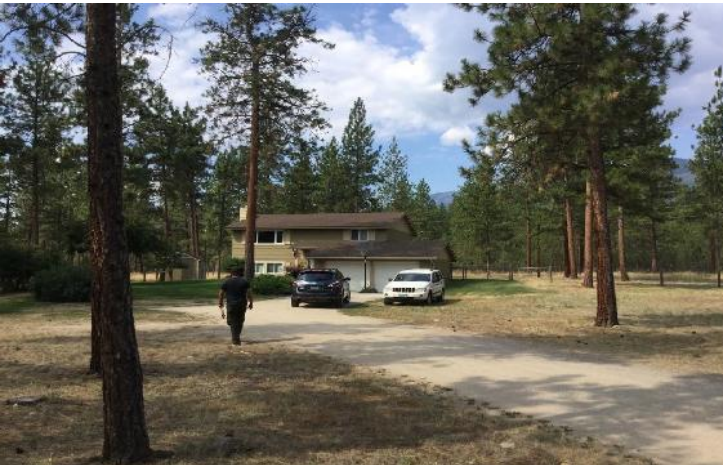
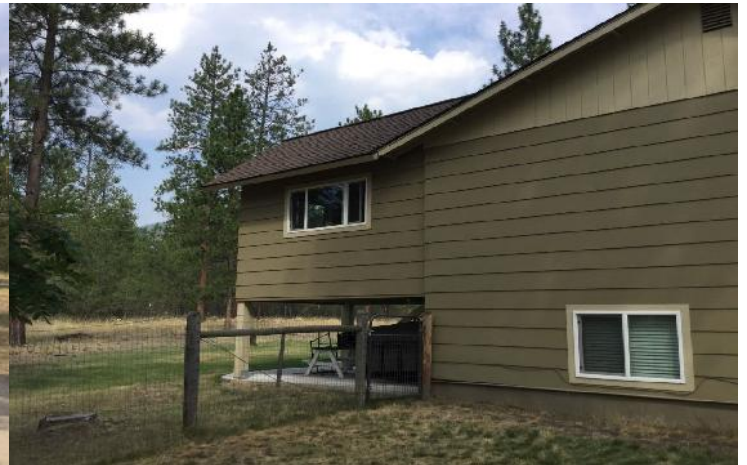
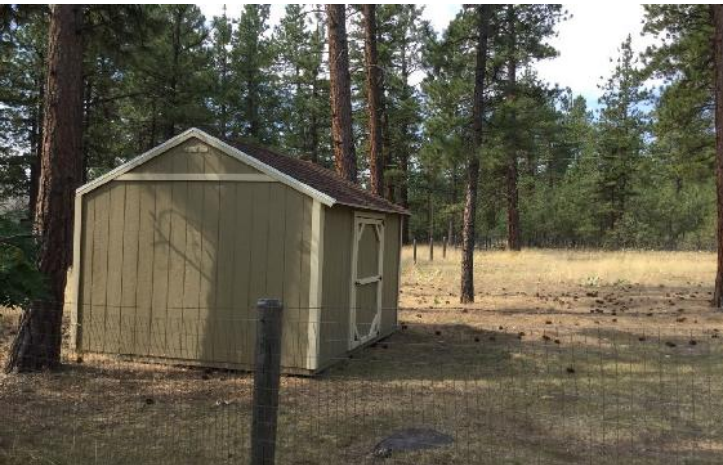
Structure Number:
Structure Name: 323 Wickiup Drive
SubDivision: One Horse
GPS Location, Lat. 46 38.29566
GPS Location, Long. 114 5.21862
Safety Zone Present: Yes
Type of Structure: Residential
Surrounding Fuels: Timber
Structure Triage Category: Defensible, Stand Alone
Roof Material: Composite
Heat Traps: Wood Deck
Electrical Power: Overhead
Hazards: Fuels
Access to Site: T1 Engine
Comm with ICP: Radio, Cell Service
Water Source: Faucet / Hose
Mitigation Time: 2-3 Hours
Other Resources Needed to Protect: Limbing and thinning behind property
Collected By: Engine 951

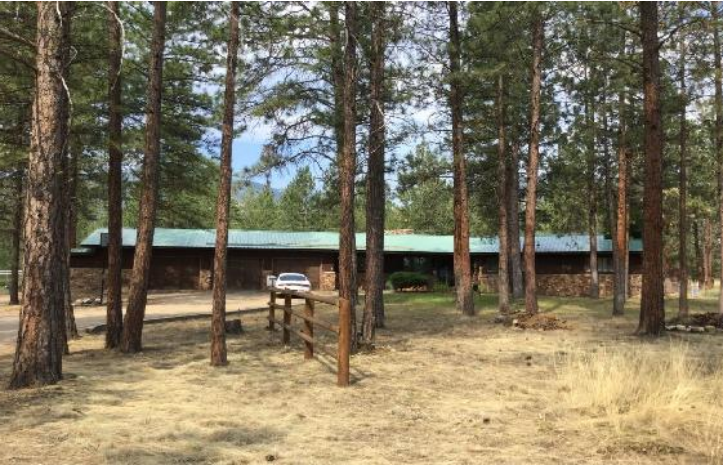
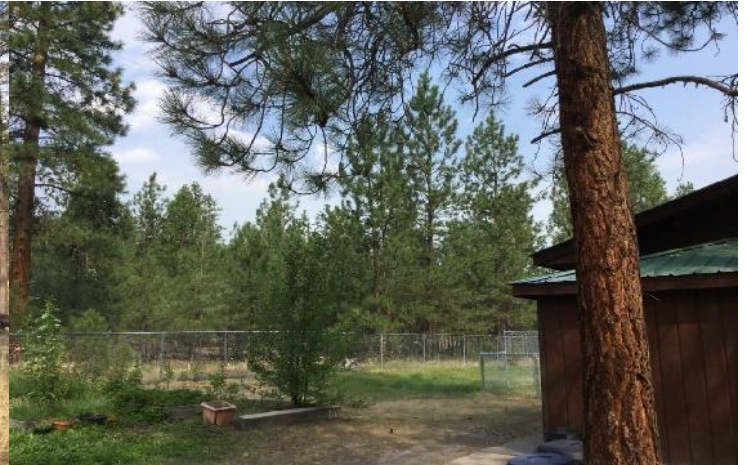
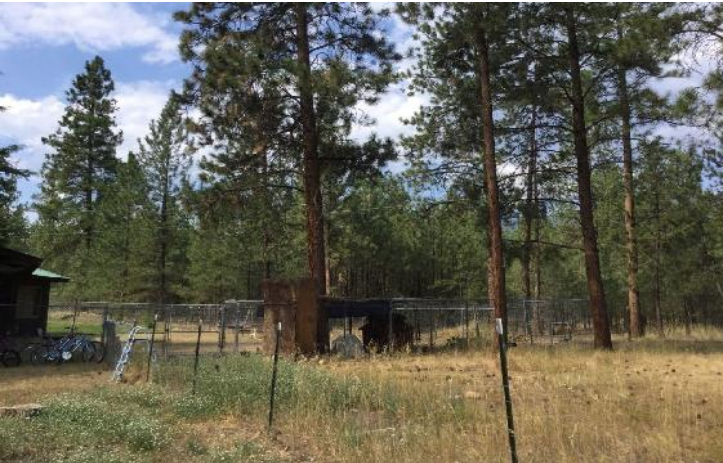
Structure Number:
Structure Name: 340 Holloway Lane
SubDivision: One Horse
GPS Location, Lat. 46 37.93182
GPS Location, Long. 114 5.24076
Safety Zone Present: Yes
Type of Structure: Residential
Surrounding Fuels: Grass
Structure Triage Category: Defensible, Stand Alone
Roof Material: Composite
Heat Traps: Rain Gutters
Electrical Power: Overhead
Hazards: HazMat
Access to Site: T1 Engine
Comm with ICP: Radio, Cell Service
Water Source: Faucet / Hose
Mitigation Time: None Needed
Other Resources Needed to Protect: None
Notes: Green grass all around.

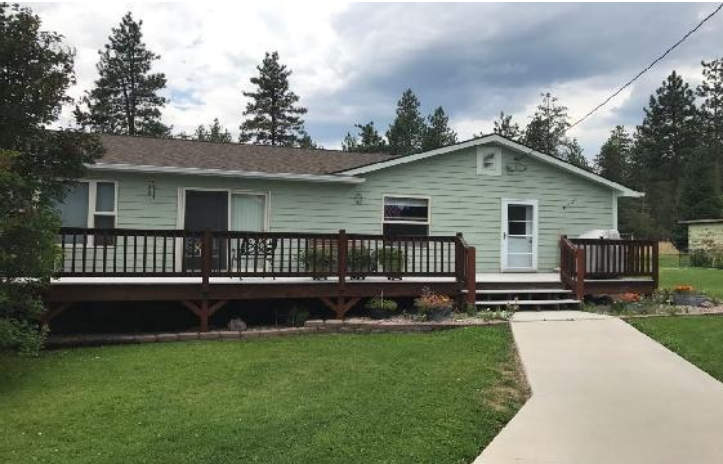
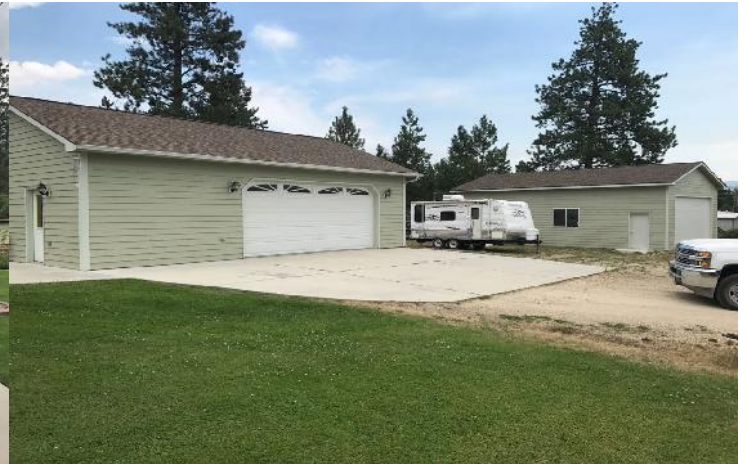
Structure Number:
Structure Name: 341 Holloway Lane
SubDivision: One Horse
GPS Location, Lat. 46 37.89972
GPS Location, Long. 114 5.27922
Safety Zone Present: Yes
Type of Structure: Residential
Surrounding Fuels: Grass, Timber
Structure Triage Category: Defensible, Stand Alone
Roof Material: Metal
Heat Traps: Wood Deck
Electrical Power: Overhead, Solar/Wind
Hazards: HazMat
Access to Site: T1 Engine
Comm with ICP: Radio, Cell Service
Water Source: Faucet / Hose
Mitigation Time: Less Than An Hour
Other Resources Needed to Protect: None
Notes: Several out buildings.

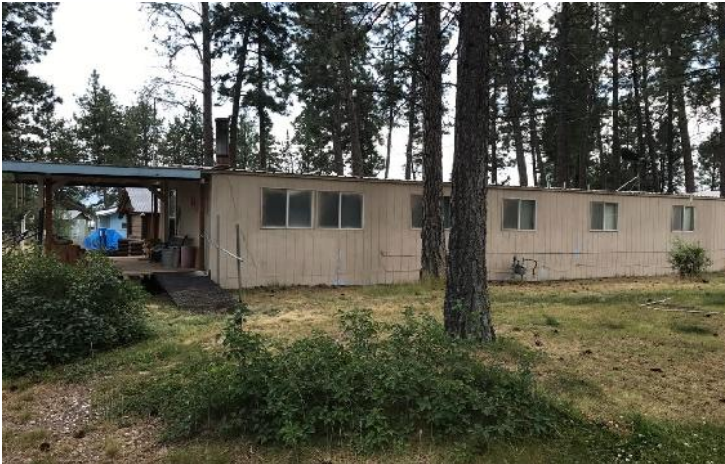
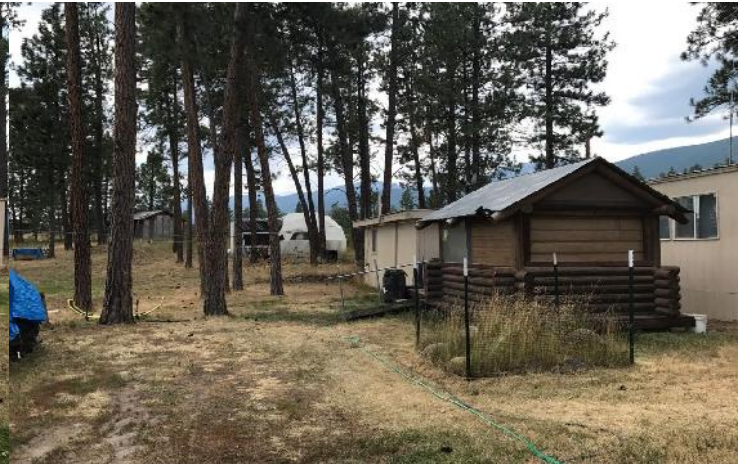
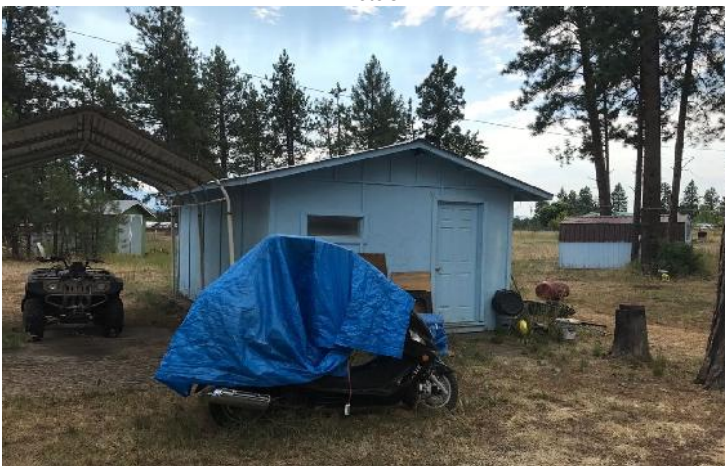
Structure Number:
Structure Name: 373 Tie Chute Ln
SubDivision: One Horse
GPS Location, Lat. 46 38.50782
GPS Location, Long. 114 5.55858
Safety Zone Present: No
Type of Structure: Residential
Surrounding Fuels: Grass,Shrub
Structure Triage Category: Defensible, Stand Alone
Roof Material: Composite
Heat Traps: Wood Deck,Rain Gutters
Electrical Power: Overhead,Underground
Hazards:
Access to Site: T1 Engine
Comm with ICP: Radio,Cell Service
Water Source: Faucet / Hose
Mitigation Time: Less Than An Hour
Other Resources Needed to Protect: T6 patrol

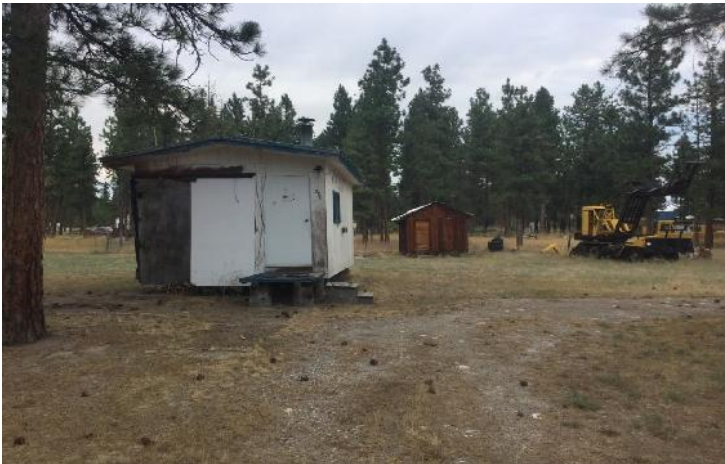
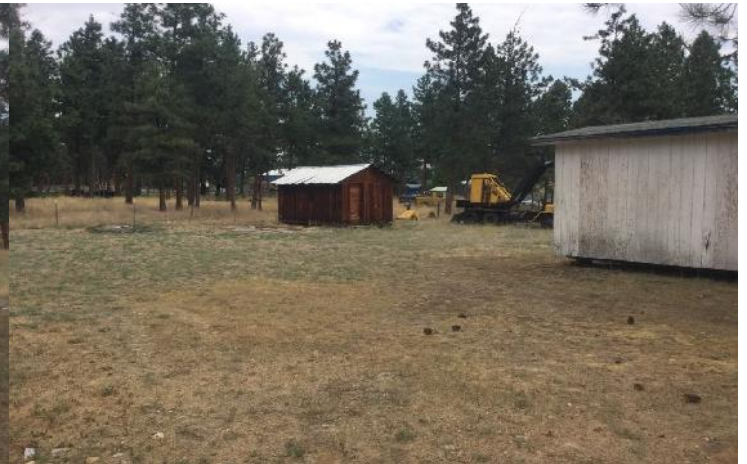
Structure Number:
Structure Name: 395 Tie Chute Ln
SubDivision: One Horse
GPS Location, Lat. 46 38.39562
GPS Location, Long. 114 5.7141
Safety Zone Present: No
Type of Structure: Residential
Surrounding Fuels: Timber
Structure Triage Category: Defensible, Prep and Hold
Roof Material: Composite
Heat Traps: Wood Deck, Rain Gutters
Electrical Power: Underground
Hazards:
Access to Site: T3/4 Engine
Comm with ICP: Radio, Cell Service
Water Source: Faucet / Hose
Mitigation Time: Less Than An Hour
Other Resources Needed to Protect: One engine crew to do minimal prep and hold the property
Notes: 2 wells on property

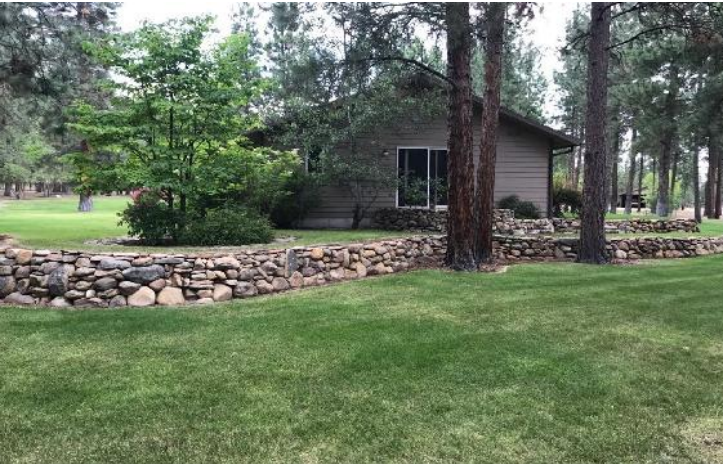
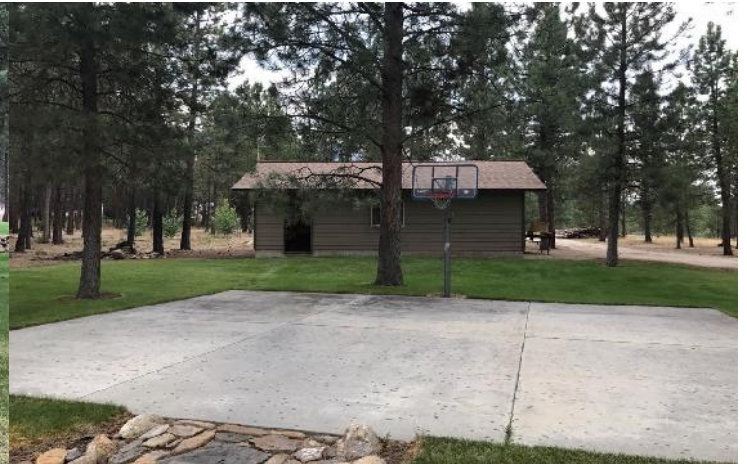
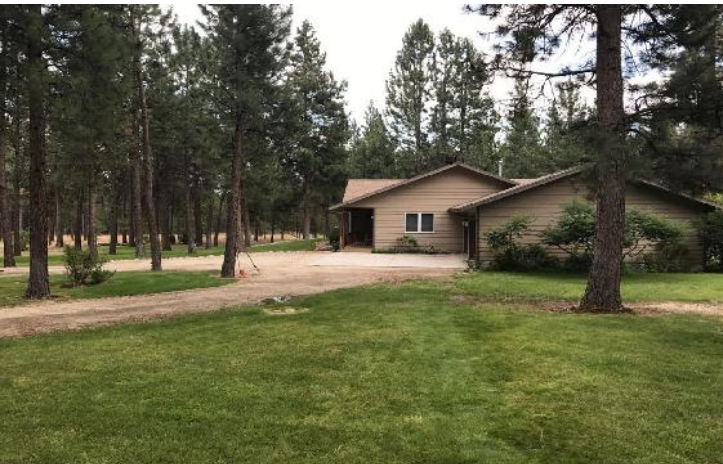
Safety Zone Present: No
Type of Structure: Residential
Surrounding Fuels: Grass, Timber
Structure Triage Category: Defensible, Prep and Hold
Roof Material: Composite
Heat Traps: Rain Gutters
Electrical Power: Overhead
Hazards: Septic Tank
Access to Site: T1 Engine
Comm with ICP: Radio, Cell Service
Water Source: Faucet / Hose
Mitigation Time: None Needed
Collected By: Prescott 951

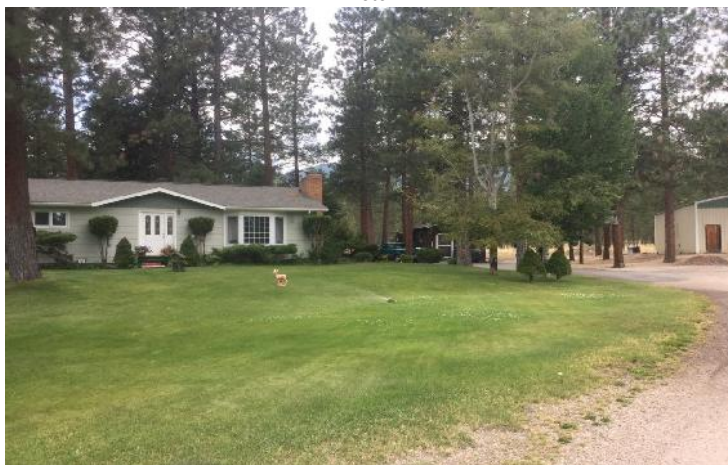
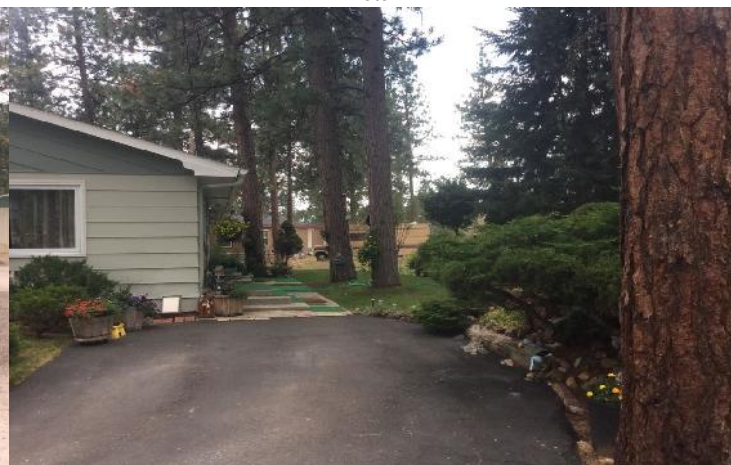
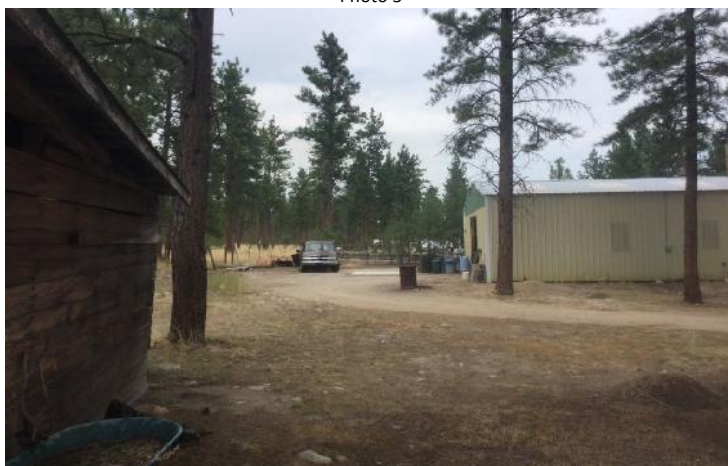
Structure Number:
Structure Name: 415 Tie Chute Rd
SubDivision: One Horse
GPS Location, Lat. 46 38.43732
GPS Location, Long. 114 5.81622
Safety Zone Present: No **Where is Safety Zone:** Out Tie Chute Rd to old highway 93.
Type of Structure: Residential **Primary Structures:** **Outbuildings:**
Surrounding Fuels: Grass, Timber **Defensible Space:** 30-50 Feet
Structure Triage Category: Defensible, Prep and Hold
Roof Material: Composite **Siding Material:** Wood
Heat Traps: Wood Deck, Rain Gutters
Electrical Power: Underground **Gas to Structure:** None
Hazards: Fuels
Access to Site: T1 Engine **Best Access From:** Old highway 93 to Tie Chute to
Comm with ICP: Radio, Cell Service
Water Source: Faucet / Hose
Mitigation Time: 2-3 Hours
Other Resources Needed to Protect: When Engine, one sprinkler kit, portable Pump kit, portable water source, some line put in around structures.
Notes: Owner states that if door is not answered right away proceed into the house due to medical problems he cannot reach the door quickly. Secondary garage located north of main structures.

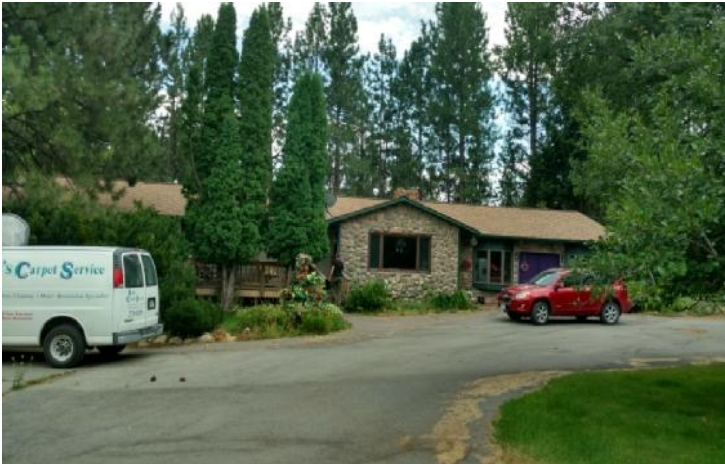
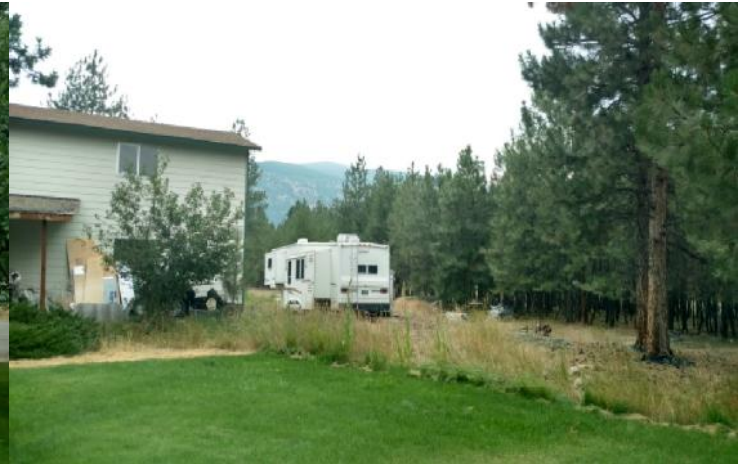
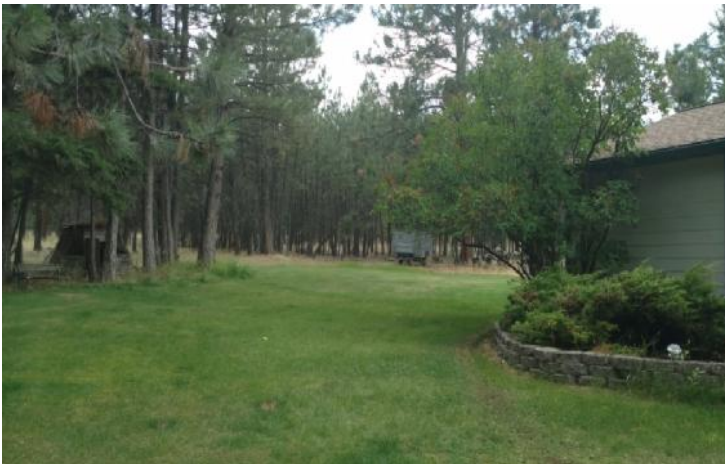
Structure Number:
Structure Name: 419 Tie Chute Ln
SubDivision: One Horse
GPS Location, Lat. 46 38.50992
GPS Location, Long. 114 6.55008
Safety Zone Present: No **Where is Safety Zone:** Down Tie shoots back to old highway 93 to highway 93
Type of Structure: Residential **Primary Structures:** **Outbuildings:**
Surrounding Fuels: Timber **Defensible Space:** 30-50 Feet
Structure Triage Category: Defensible, Prep and Hold
Roof Material: Composite **Siding Material:** Wood
Heat Traps: Open Eaves, Wood Deck, Rain Gutters
Electrical Power: Underground **Gas to Structure:** Aboveground
Hazards: Fuels, Septic Tank
Access to Site: T3/4 Engine **Best Access From:** Old highway 93 to Tie Shoots Rd
Comm with ICP: Radio, Cell Service
Water Source: Faucet / Hose
Mitigation Time: 1-2 Hours
Other Resources Needed to Protect: One engine crew to prep and hold property some fuel reduction and to place sprinklers
Collected By: COCO 482 **Collected Date/Time:** 07/30/2017 10:10:04

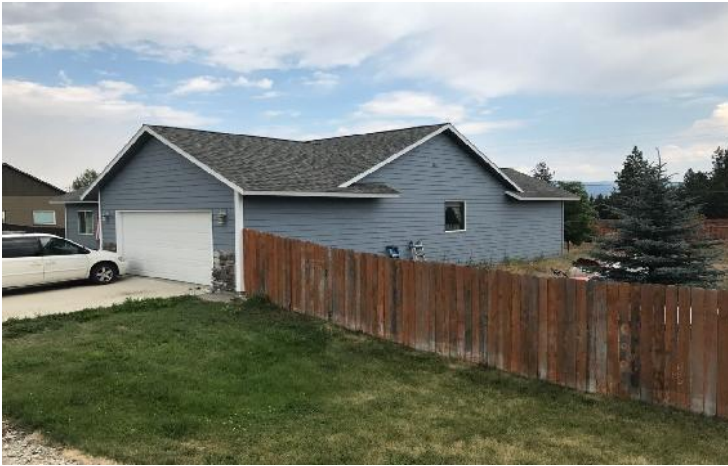
Photo 2

Structure Number:
Structure Name: 122 North Trail Creek Lane
SubDivision: Sweeny
GPS Location, Lat. 46 36.91692
GPS Location, Long. 114 5.44716
Safety Zone Present: Yes
Type of Structure: Residential
Surrounding Fuels: Grass
Structure Triage Category: Defensible, Stand Alone
Roof Material: Composite
Heat Traps: Rain Gutters
Electrical Power: Underground
Hazards: HazMat
Access to Site: T1 Engine
Comm with ICP: Radio, Cell Service
Water Source: Faucet / Hose
Mitigation Time: Less Than An Hour
Notes: Dead grass in back of structure.

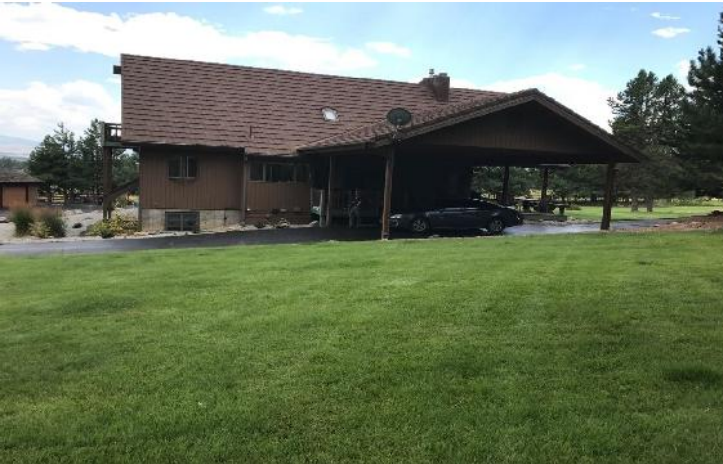
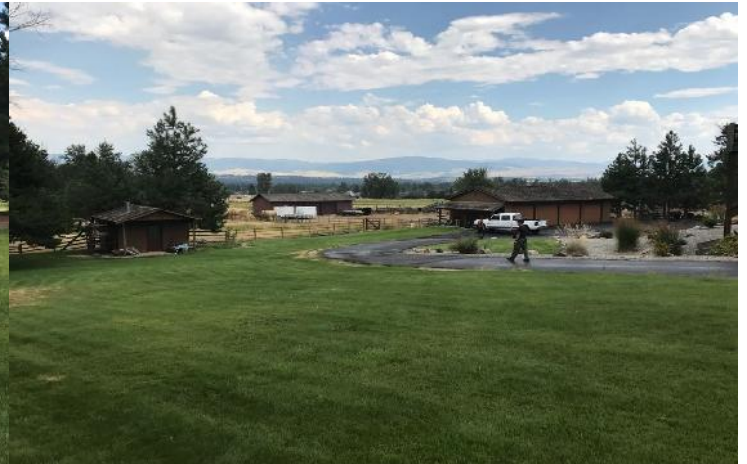
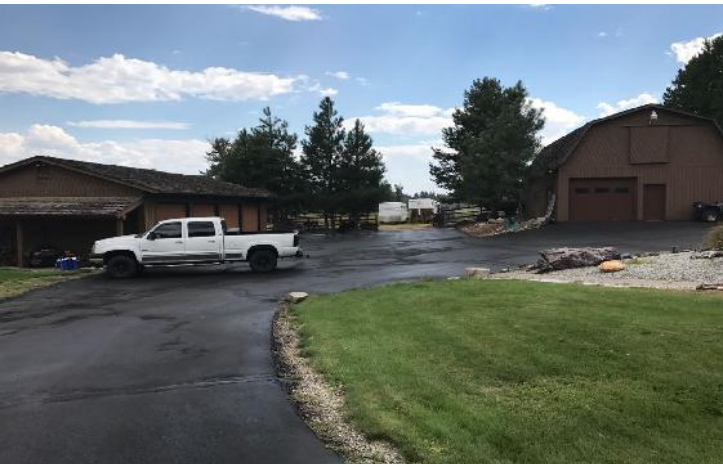
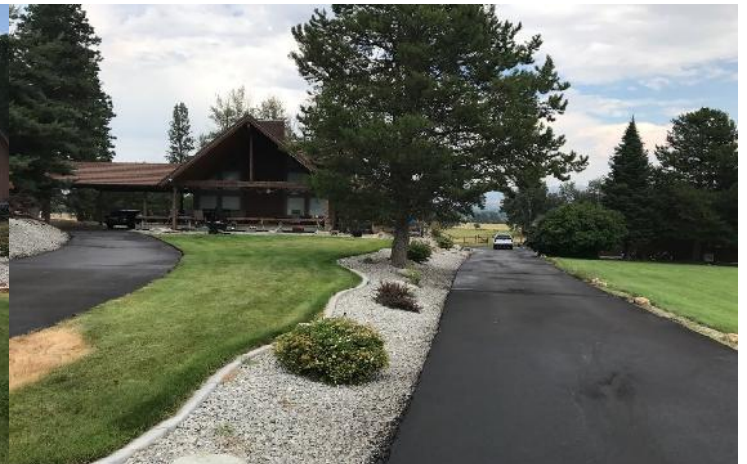
Structure Number:
Structure Name: 184 Beck Ln
SubDivision: Sweeny
GPS Location, Lat. 46 37.18524
GPS Location, Long. 114 5.8743
Safety Zone Present: Yes
Type of Structure: Residential
Surrounding Fuels: Grass, Timber
Structure Triage Category: Defensible, Stand Alone
Roof Material:
Heat Traps: Rain Gutters
Electrical Power: Underground
Hazards: Animals, HazMat
Access to Site: T1 Engine
Comm with ICP: Radio, Cell Service
Water Source: Faucet / Hose
Mitigation Time: Less Than An Hour
Other Resources Needed to Protect: None
Notes: Masonry roofing

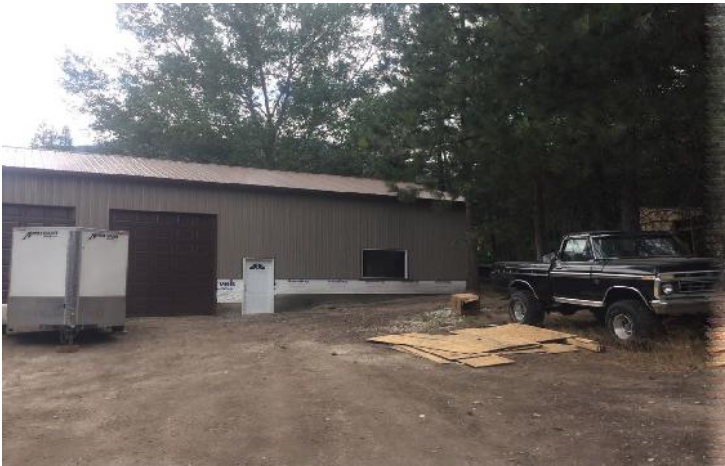
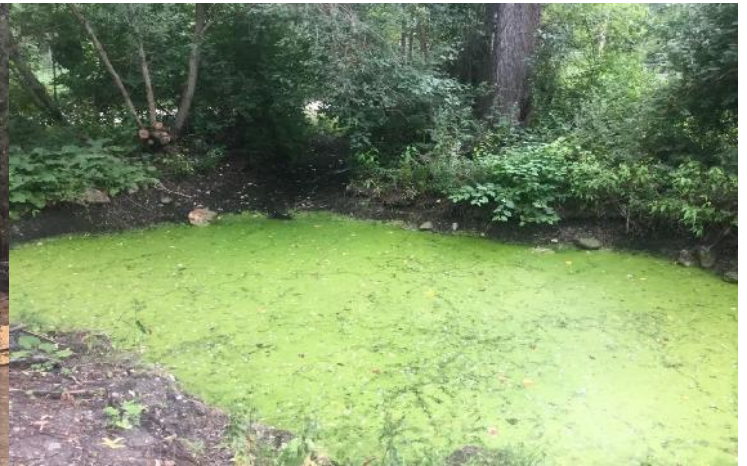
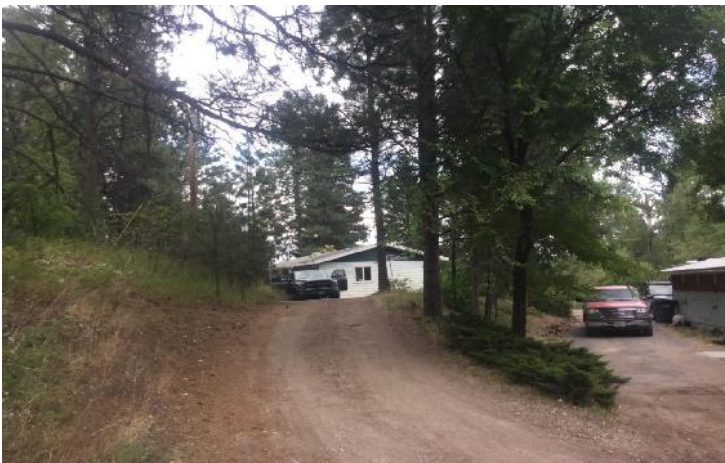
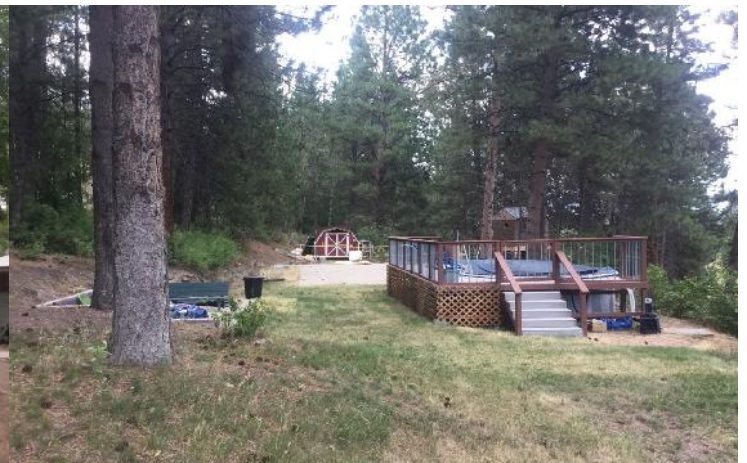
Safety Zone Present: No
Where is Safety Zone: Sweeney CK TRL to Sweeney CK Loop to Hwy 93 to designated safety zone.
Type of Structure: Residential
Primary Structures:
Outbuildings:
Surrounding Fuels: Grass,Shrub,Timber
Defensible Space: 30-50 Feet
Structure Triage Category: Defensible, Prep and Hold
Roof Material: Composite
Siding Material: Metal
Heat Traps: Open Eaves,Wood Deck,Rain Gutters
Electrical Power: Overhead
Gas to Structure: None
Hazards: Septic Tank
Access to Site: T1 Engine
Best Access From: Hwy 93 to Sweeney CK Loop to Sweeney CK TRL
Comm with ICP: Radio,Cell Service
Water Source: Faucet / Hose,Large Pond
Mitigation Time: 1-2 Hours
Notes: Pond fills off spring, roughly 6 ft deep.
Pool can be used to protect structures.
Wood piles near house by wood shed.

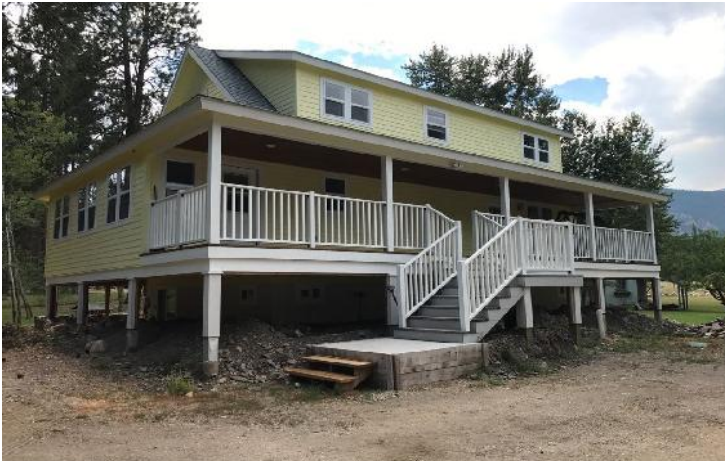
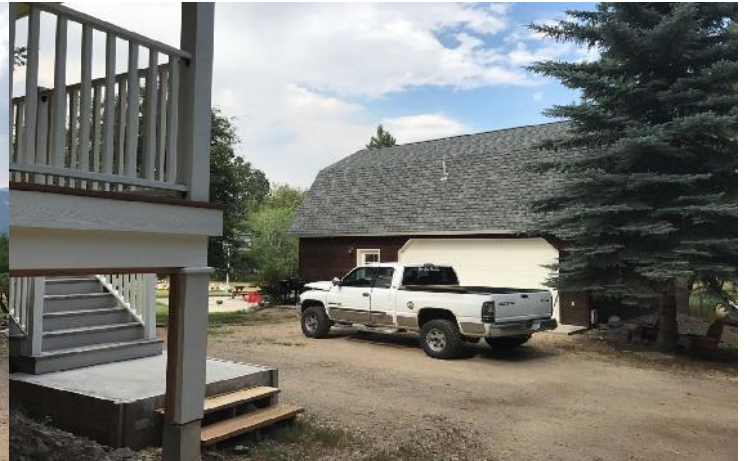
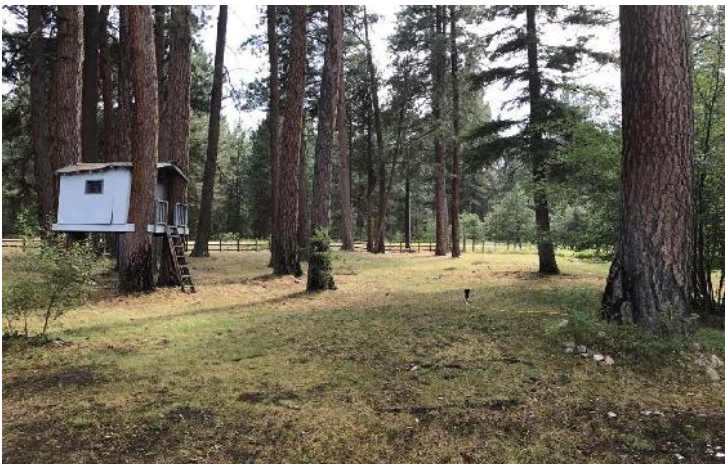
Structure Number:
Structure Name: 504 Sweeney Creek Loop
SubDivision: Sweeny
GPS Location, Lat. 46 36.6438
GPS Location, Long. 114 6.00456
Safety Zone Present: Yes
Type of Structure: Residential
Surrounding Fuels: Grass,Shrub,Timber
Structure Triage Category: Defensible, Prep and Hold
Roof Material: Composite
Heat Traps: Wood Deck,Rain Gutters
Electrical Power: Underground
Hazards: HazMat
Access to Site: T1 Engine
Comm with ICP: Radio,Cell Service
Water Source: Faucet / Hose
Mitigation Time: Less Than An Hour
Collected By: Lolo 632

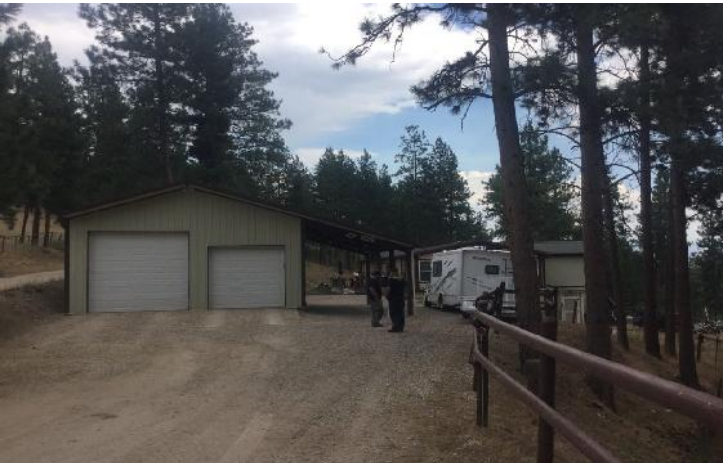
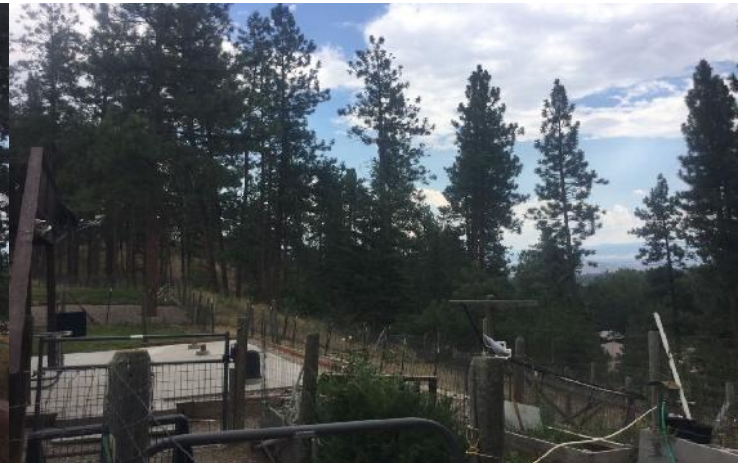
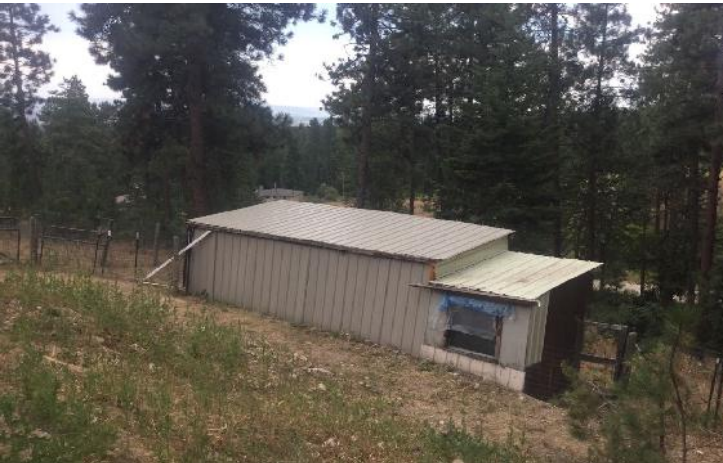
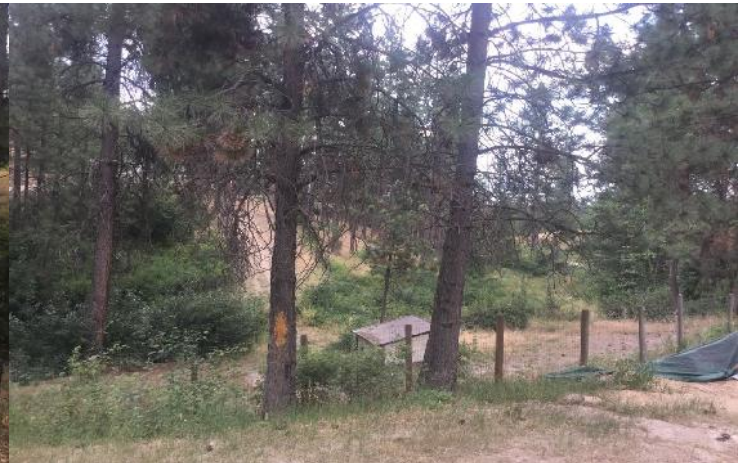
Safety Zone Present: No
Type of Structure: Residential
Surrounding Fuels: Grass, Shrub, Timber
Structure Triage Category: Defensible, Prep and Hold
Roof Material: Composite
Heat Traps: Wood Deck, Rain Gutters
Electrical Power: Underground
Hazards: Septic Tank
Access to Site: T1 Engine
Comm with ICP: Radio, Cell Service
Water Source: Faucet / Hose
Mitigation Time: None Needed
Collected By: Prescott 951

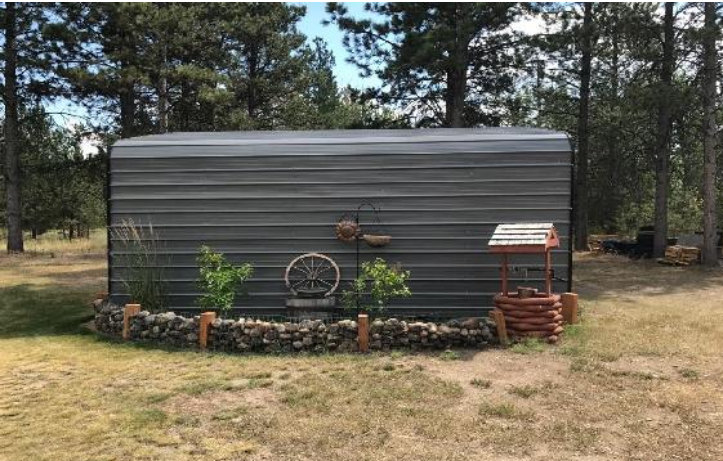
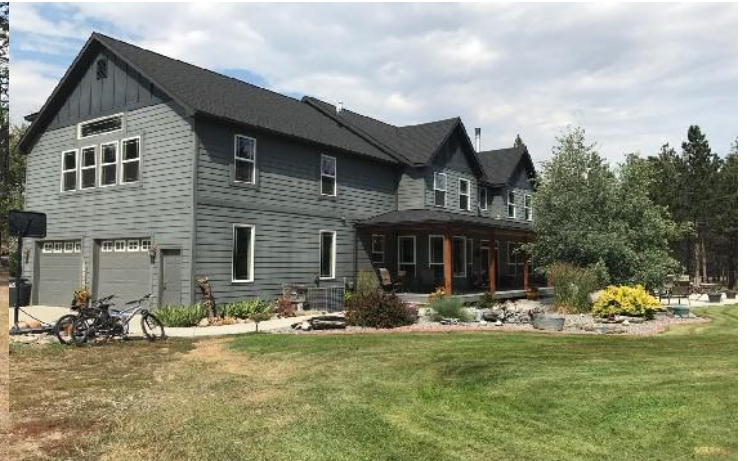
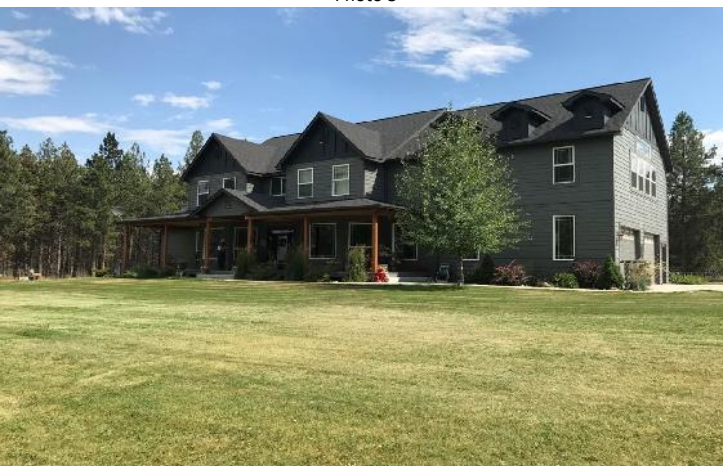
Structure Number:
Structure Name: 5124 Lone Meadow Ct
SubDivision: Sweeny
GPS Location, Lat. 46 36.82734
GPS Location, Long. 114 5.76072
Safety Zone Present: Yes
Type of Structure: Residential
Surrounding Fuels: Grass, Timber
Structure Triage Category: Defensible, Stand Alone
Roof Material: Composite
Heat Traps: Wood Deck, Rain Gutters
Electrical Power: Underground
Hazards: HazMat
Access to Site: T1 Engine
Comm with ICP: Radio, Cell Service
Water Source: Faucet / Hose
Mitigation Time: Less Than An Hour
Collected By: Lolo 632

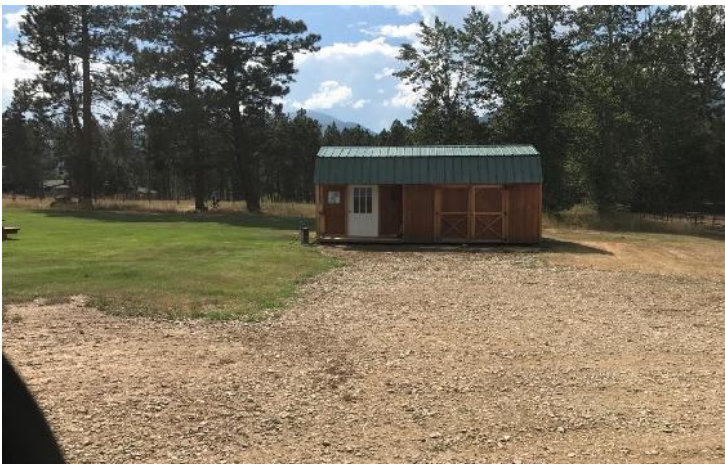
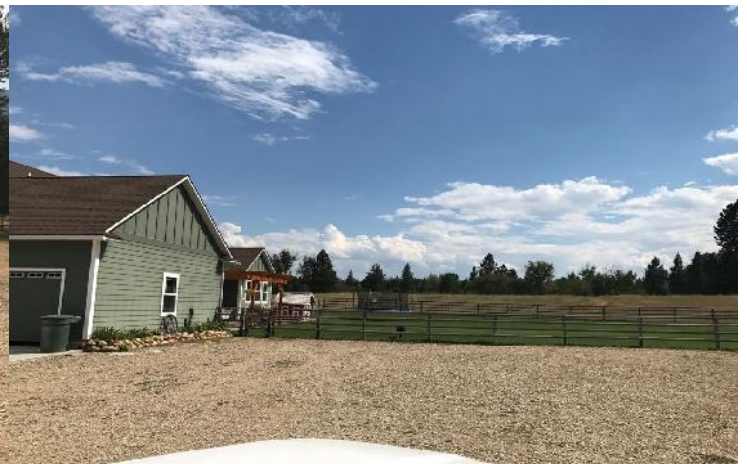
Structure Number:
Structure Name: 5143 Lone Meadow Ct
SubDivision: Sweeny
GPS Location, Lat. 46 36.87636
GPS Location, Long. 114 5.76984
Safety Zone Present: Yes
Type of Structure: Residential
Surrounding Fuels: Grass, Shrub
Structure Triage Category: Defensible, Stand Alone
Roof Material: Composite
Heat Traps: Rain Gutters
Electrical Power: Underground
Hazards: HazMat
Access to Site: T1 Engine
Comm with ICP: Radio, Cell Service
Water Source: Faucet / Hose
Mitigation Time: Less Than An Hour
Collected By: Lolo 632

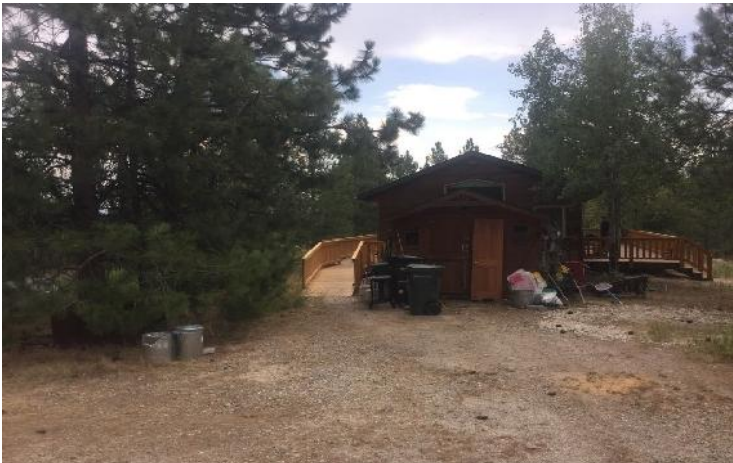
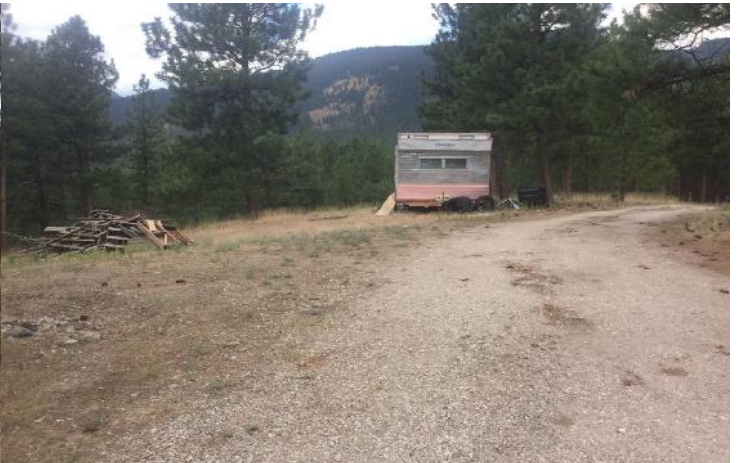
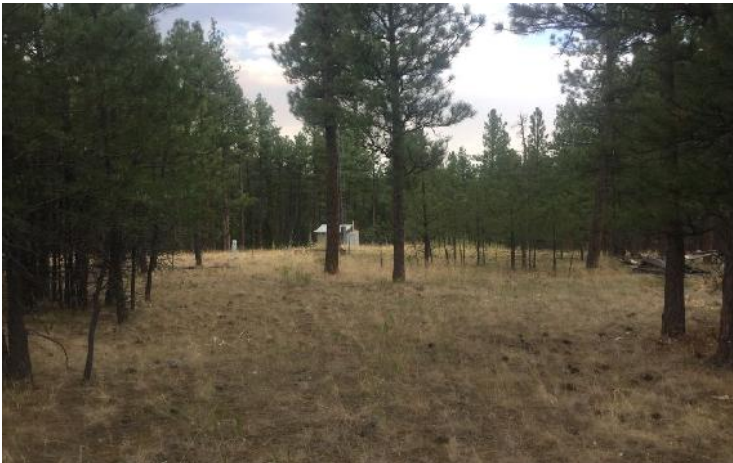
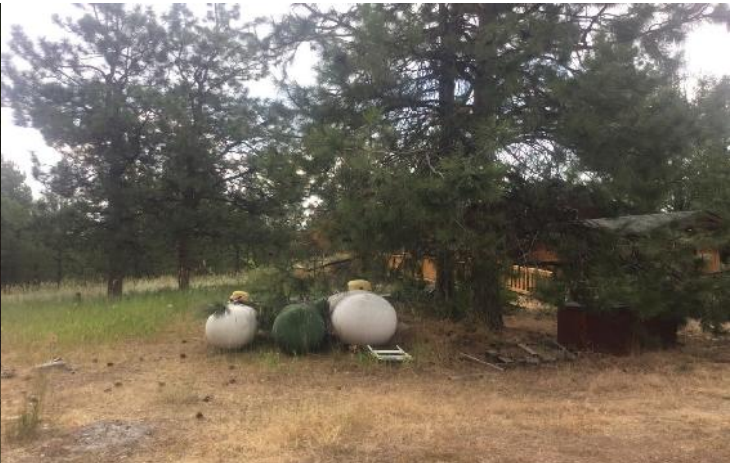
Safety Zone Present: No
Type of Structure: Residential
Surrounding Fuels: Grass, Timber
Structure Triage Category: Defensible, Prep and Hold
Roof Material: Metal
Heat Traps: Wood Deck, Rain Gutters
Electrical Power: Underground
Hazards: Septic Tank
Access to Site: T3/4 Engine
Comm with ICP: Radio, Cell Service
Water Source: Faucet / Hose
Mitigation Time: 2-3 Hours
Collected By: Prescott 951

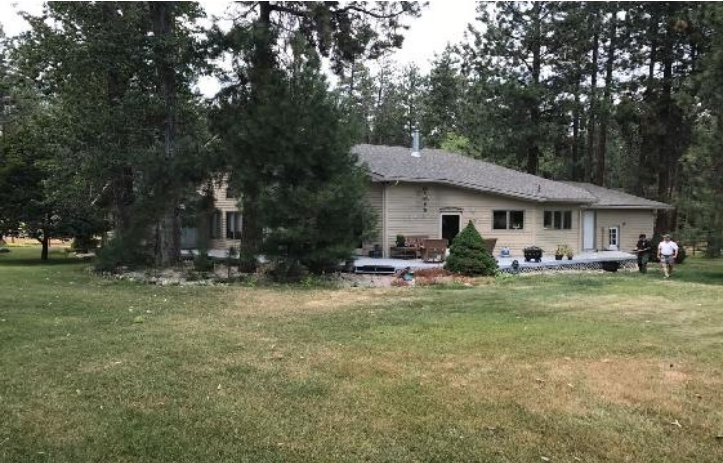
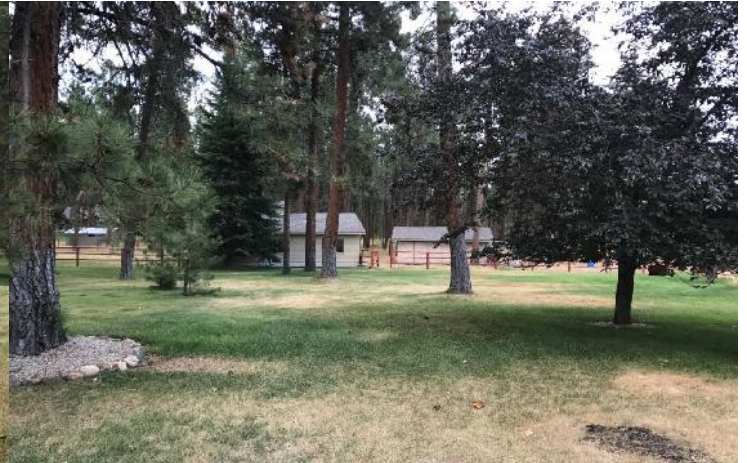
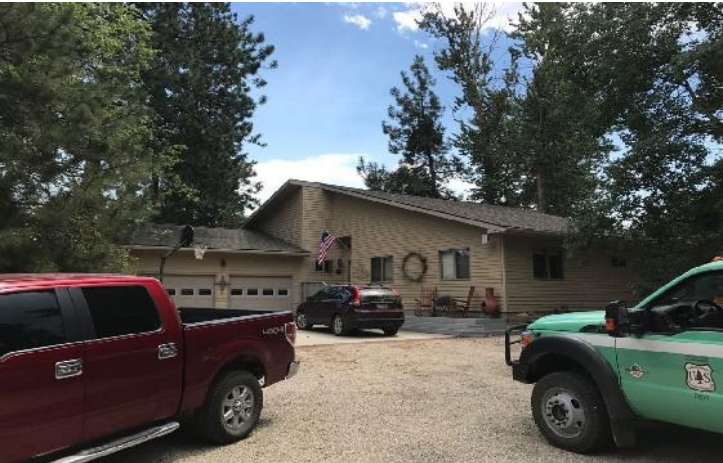
Structure Number:
Structure Name: 5148 Briarwood Lane
SubDivision: Sweeny
GPS Location, Lat. 46 36.84444
GPS Location, Long. 114 6.06708
Safety Zone Present: No
Type of Structure: Residential
Surrounding Fuels: Grass, Timber
Structure Triage Category: Defensible, Stand Alone
Roof Material: Composite
Heat Traps: Wood Deck, Rain Gutters
Electrical Power: Underground
Hazards: HazMat
Access to Site: T6 Engine
Comm with ICP: Radio, Cell Service
Water Source: Faucet / Hose
Mitigation Time: None Needed
Other Resources Needed to Protect: None
Collected By: Lolo 632

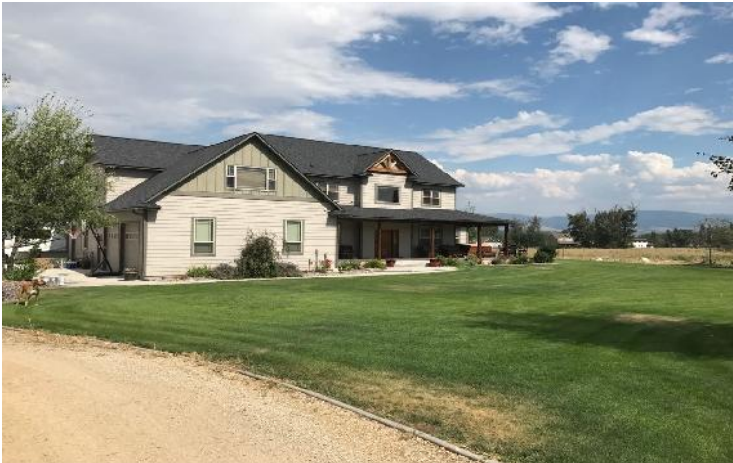
Structure Number:
Structure Name: 5162 Lone Meadow Ct
SubDivision: Sweeny
GPS Location, Lat. 46 36.95328
GPS Location, Long. 114 5.75616
Safety Zone Present: Yes
Type of Structure: Residential
Surrounding Fuels: Grass
Structure Triage Category: Defensible, Stand Alone
Roof Material: Composite
Heat Traps: Rain Gutters
Electrical Power: Underground
Hazards: HazMat
Access to Site: T1 Engine
Comm with ICP:
Water Source:
Mitigation Time:
Collected By: Lolo 632

Where is Safety Zone: East of structure
Primary Structures:
Outbuildings:
Defensible Space: >100 Feet
Siding Material: Wood
Gas to Structure: Underground
Best Access From: 93 to Beck to Lone meadow Ct

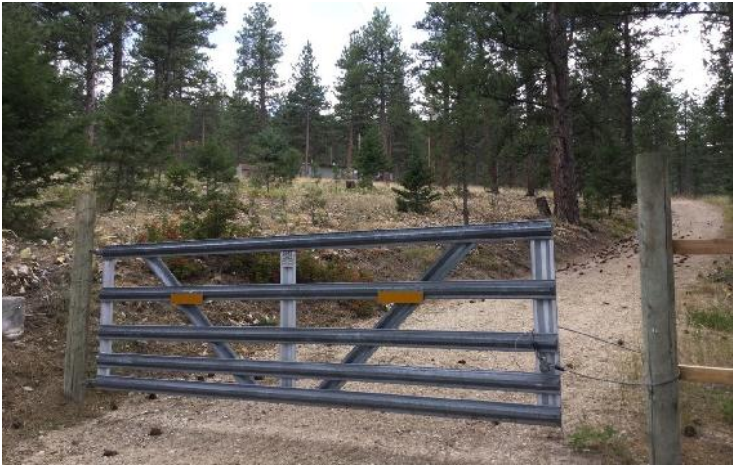
Structure Number: 5165
Structure Name: Sweeny
SubDivision: Sweeny
GPS Location, Lat. 46 36.94254
GPS Location, Long. 114 7.30008
Safety Zone Present: Yes
Type of Structure: Residential
Surrounding Fuels: Timber
Structure Triage Category: Defensible, Prep and Hold
Roof Material:
Heat Traps:
Electrical Power:
Hazards:
Access to Site: T3/4 Engine
Comm with ICP: Radio, Cell Service
Water Source:
Mitigation Time:
Notes: LOCKED GATE, did not assess house. Prep and hold at own discretion

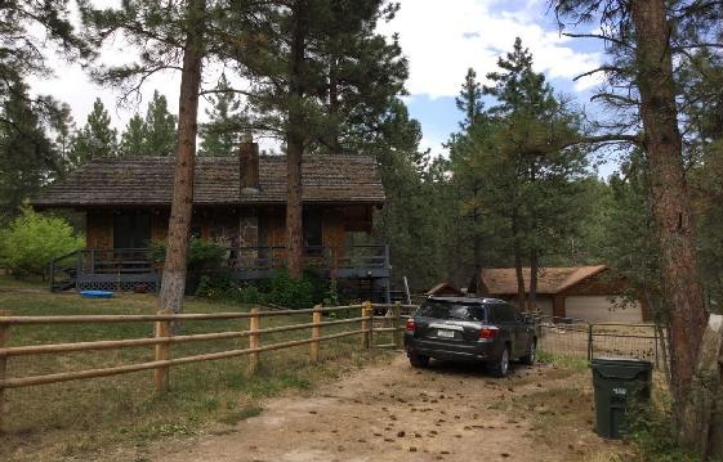
Collected Date/Time: 07/30/2017 11:29:18
Photo 2

Structure Number:
Structure Name: 720 Sweeney Creek Road
SubDivision: Sweeny
GPS Location, Lat. 46 36.83928
GPS Location, Long. 114 7.14738
Safety Zone Present: Yes **Where is Safety Zone:** Uphill to smith fork road, big field
Type of Structure: Residential **Primary Structures:** **Outbuildings:**
Surrounding Fuels: Grass, Timber **Defensible Space:** 30-50 Feet
Structure Triage Category: Non-Defensible, Prep and Leave
Roof Material: Wood **Siding Material:** Wood
Heat Traps: Wood Deck
Electrical Power: Underground **Gas to Structure:** Aboveground
Hazards: Fuels, Animals
Access to Site: T3/4 Engine **Best Access From:** Sweeney Creek Road
Comm with ICP: Radio, Cell Service
Water Source: Faucet / Hose
Mitigation Time: 1-2 Hours
Other Resources Needed to Protect: Engine mod. Clear brush around tanks and outside structures. Remove pine needles from all roofs
Notes: Hay barn across the street

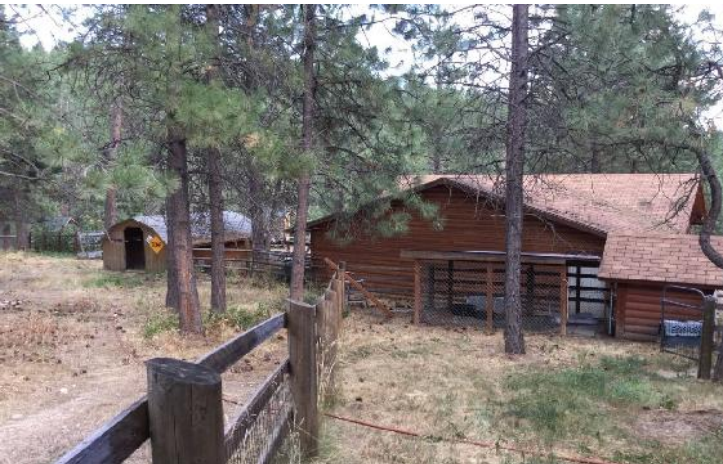
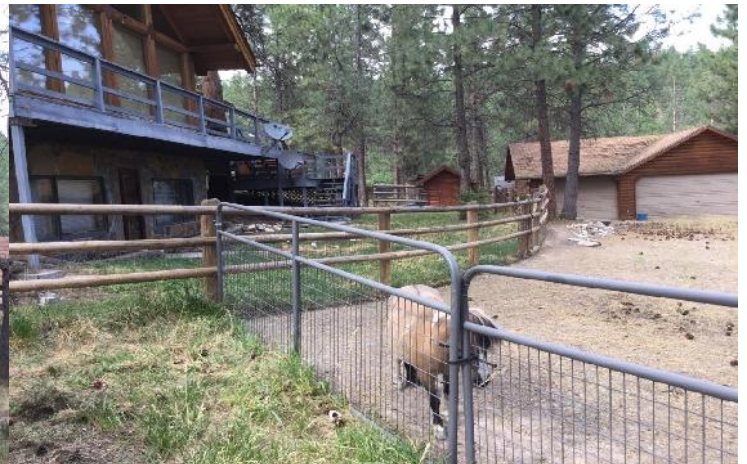
Photo 4

Structure Number:
Structure Name: 758 Upper Sweeney Creek Loop
SubDivision: Sweeny
GPS Location, Lat. 46 36.92298
GPS Location, Long. 114 7.4007
Safety Zone Present: Yes **Where is Safety Zone:** Field below hill
Type of Structure: Residential **Primary Structures:** **Outbuildings:**
Surrounding Fuels: Grass, Timber **Defensible Space:** 30-50 Feet
Structure Triage Category: Defensible, Prep and Hold
Roof Material: Metal **Siding Material:** Wood
Heat Traps:
Electrical Power: **Gas to Structure:**
Hazards:
Access to Site: T3/4 Engine **Best Access From:**
Comm with ICP:
Water Source:
Mitigation Time: More Than 5 Hours
Other Resources Needed to Protect: Lots of grass, needs weed whacking. Locked gate, could not assess main house
Notes: LOCKED GATE, COULD NOT ASSESS
