STRUCTURE
PROTECTION PLAN
FOR
ELK CREEK BLOCK
07/27/2017

Structure Protection Plan

OZ Ranch

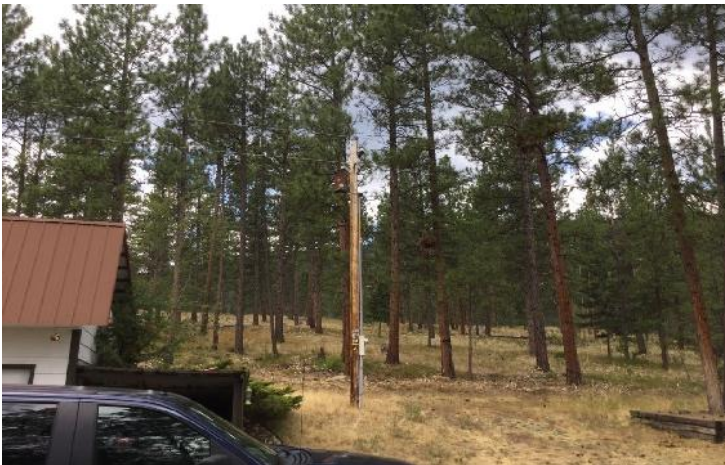
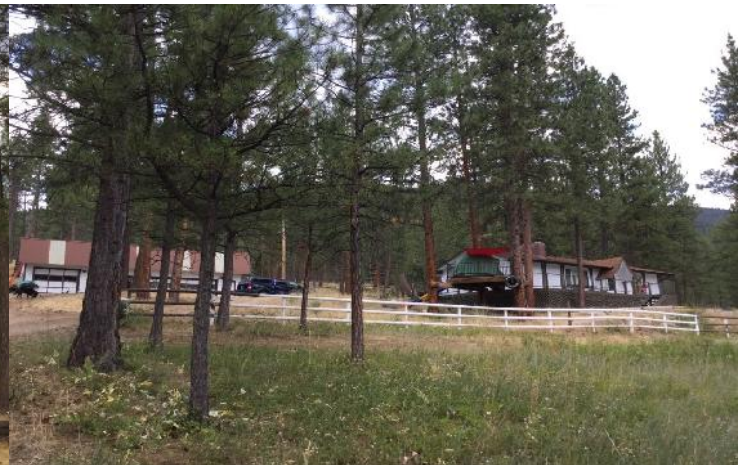
Photo 4

Structure Number:
Structure Name: 814 Upper Sweeney Creek Loop
SubDivision: Sweeny
GPS Location, Lat. 46 36.74814
GPS Location, Long. 114 7.50396
Safety Zone Present: Yes **Where is Safety Zone:** Field downhill on smith fork road
Type of Structure: Residential **Primary Structures:** **Outbuildings:**
Surrounding Fuels: Grass, Timber **Defensible Space:** 30-50 Feet
Structure Triage Category: Defensible, Prep and Hold
Roof Material: Metal **Siding Material:** Wood
Heat Traps: Wood Deck **Gas to Structure:** None
Electrical Power: Overhead
Hazards: Fuels
Access to Site: T3/4 Engine **Best Access From:** Upper Sweeney Creek Loop
Comm with ICP: Radio, Cell Service
Water Source: Faucet / Hose
Mitigation Time: 2-3 Hours
Other Resources Needed to Protect: Raking around property. Clearing brush, gras and wood around outbuildings
Collected By: Engine 951 **Collected Date/Time:** 07/30/2017 11:28:28

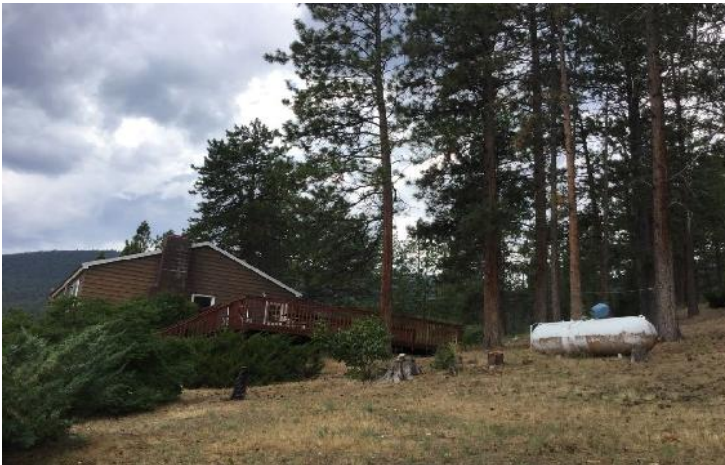
Photo 1

Structure Number:
Structure Name: 822 Upper Sweeney Creek Loop
SubDivision: Sweeny
GPS Location, Lat. 46 36.68748
GPS Location, Long. 114 7.44258
Safety Zone Present: Yes **Where is Safety Zone:** Safety zone is downhill on a field by smith fork road
Type of Structure: Residential **Primary Structures:** **Outbuildings:**
Surrounding Fuels: Grass, Timber **Defensible Space:** 30-50 Feet
Structure Triage Category: Defensible, Prep and Hold
Roof Material: Metal **Siding Material:** Wood
Heat Traps: Wood Deck **Gas to Structure:** Aboveground
Electrical Power: Overhead
Hazards: Terrain, Fuels
Access to Site: T3/4 Engine **Best Access From:** Upper Sweeney Creek Loop
Comm with ICP: Radio, Cell Service
Water Source: Faucet / Hose
Mitigation Time: More Than 5 Hours
Other Resources Needed to Protect: Engine module. Weedwacking and line around propane tank and raking around outbuildings. Garage needs to be picked up, closed up, and cleared around. Outbuilding below house needs line. Large deck

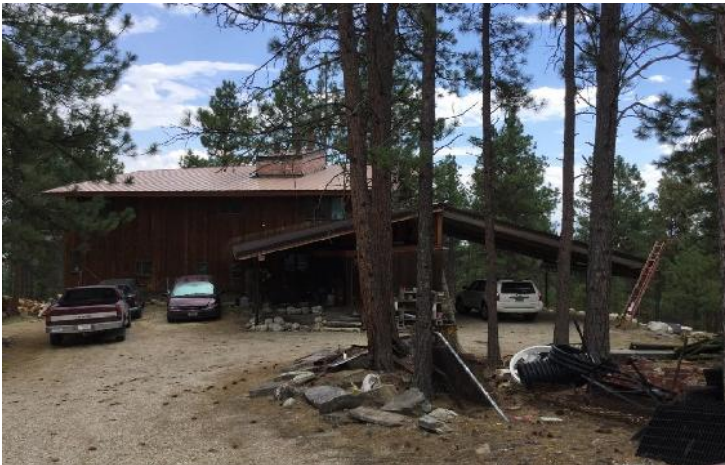
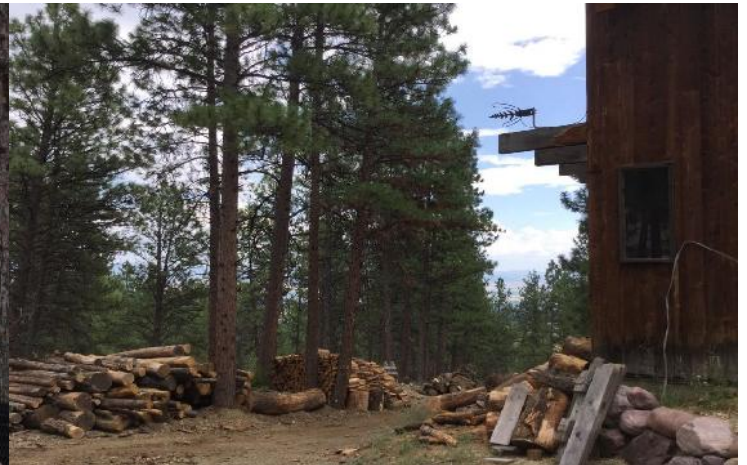
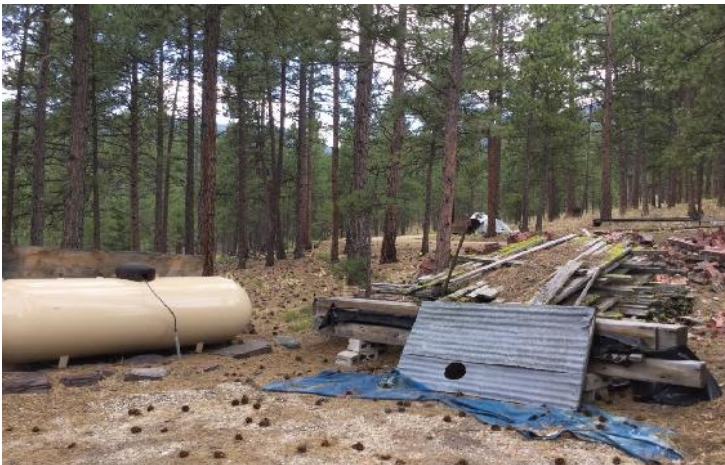
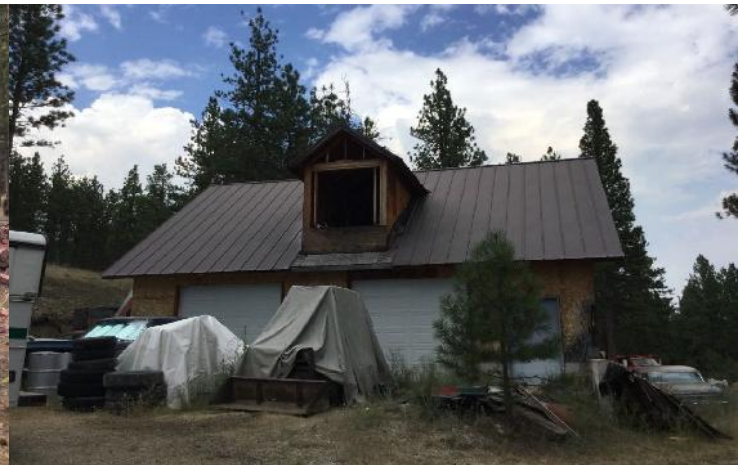
Structure Number:
Structure Name: 838 Upper Sweeney Creek Loop
SubDivision: Sweeny
GPS Location, Lat. 46 36.6486
GPS Location, Long. 114 7.29042
Safety Zone Present: Yes **Where is Safety Zone:** Downhill, field off of smith fork road
Type of Structure: Residential **Primary Structures:** **Outbuildings:**
Surrounding Fuels: Timber **Defensible Space:** 30-50 Feet
Structure Triage Category: Non-Defensible, Prep and Leave
Roof Material: Metal **Siding Material:** Wood
Heat Traps: Wood Deck,Other Receptor
Electrical Power: Underground **Gas to Structure:** Aboveground
Hazards: Fuels
Access to Site: T3/4 Engine **Best Access From:** Upper Sweeney Creek Loop
Comm with ICP: Radio,Cell Service
Water Source: Faucet / Hose
Mitigation Time: More Than 5 Hours
Other Resources Needed to Protect: Handcrew needed, lots of prep. Rake and clear wood around house, heavies near house need to to be removed.
Collected By: Engine 951 **Collected Date/Time:** 07/30/2017 11:29:05

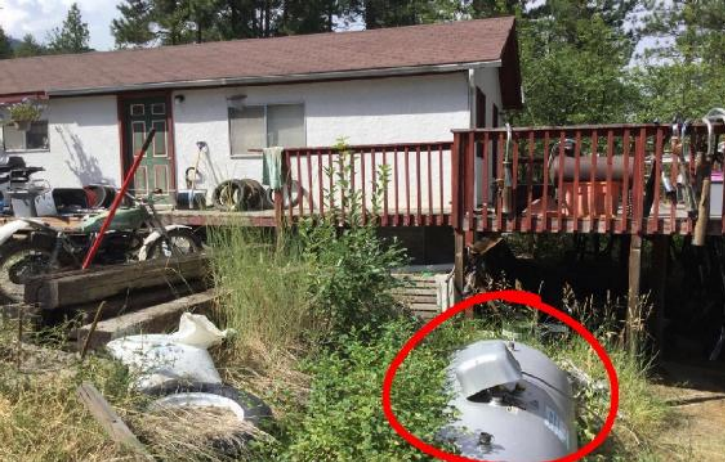
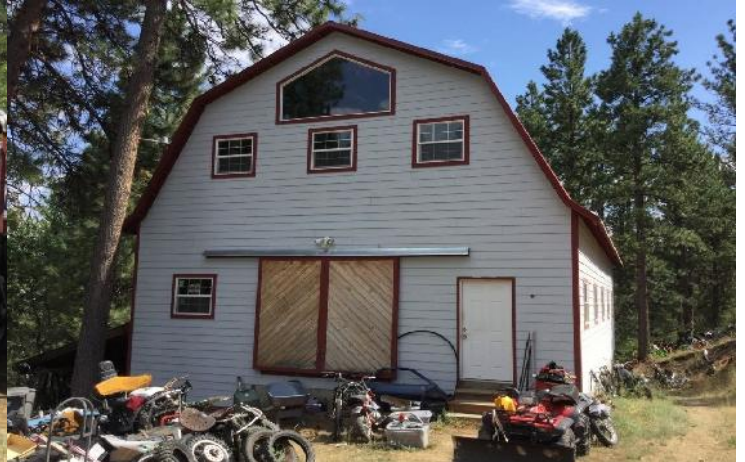
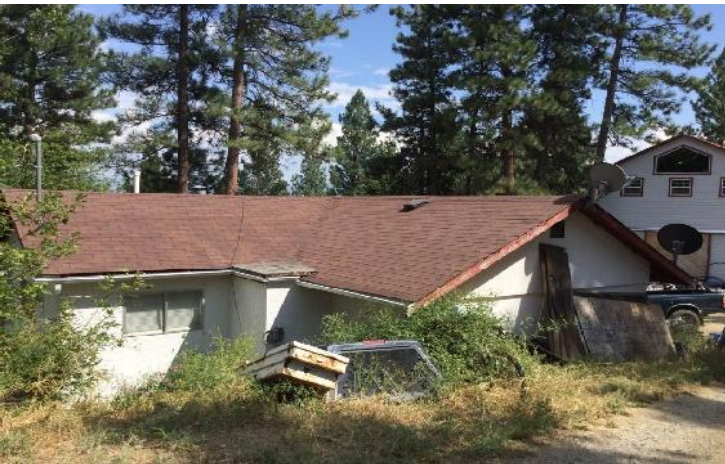
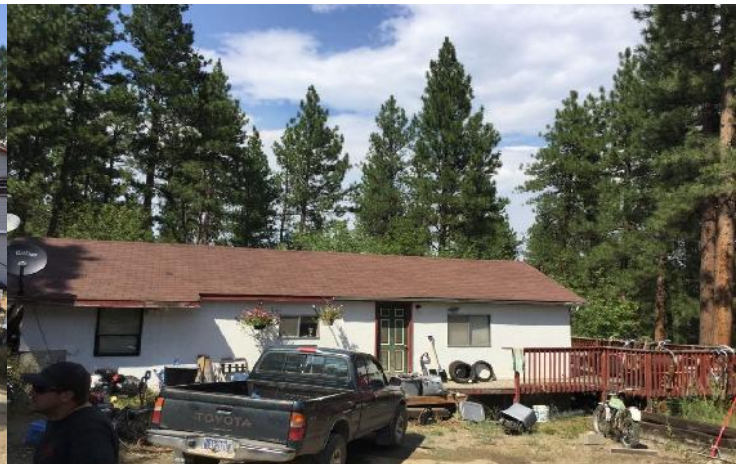
Structure Number:
Structure Name: 848 Upper Sweeney Creek Loop
SubDivision: Sweeny
GPS Location, Lat. 46 36.74862
GPS Location, Long. 114 7.25454
Safety Zone Present: Yes **Where is Safety Zone:** Field on Smith fork road
Type of Structure: Residential **Primary Structures:** **Outbuildings:**
Surrounding Fuels: Shrub, Timber **Defensible Space:** None
Structure Triage Category: Non-Defensible, Prep and Leave
Roof Material: Metal **Siding Material:** Masonry
Heat Traps: Wood Deck, Rain Gutters
Electrical Power: Overhead **Gas to Structure:** Aboveground
Hazards: Fuels
Access to Site: T6 Engine **Best Access From:** Upper Sweeney Creek Loop
Comm with ICP: Radio, Cell Service
Water Source: Faucet / Hose
Mitigation Time: More Than 5 Hours
Other Resources Needed to Protect: Handcrew. Lots of weedwacking and cutting around houses and out buildings, grass and shrubs. Propane tanks is surrounded by high weeds, but is empty

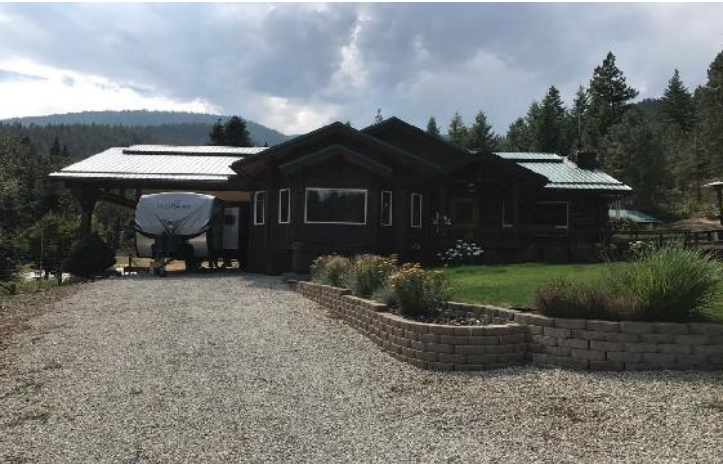
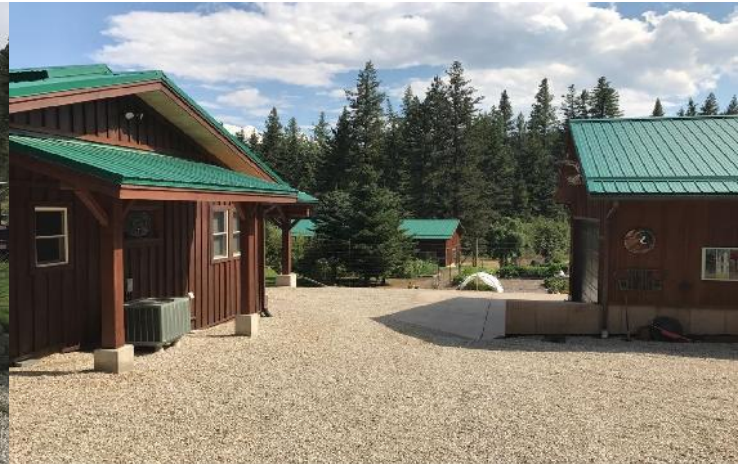
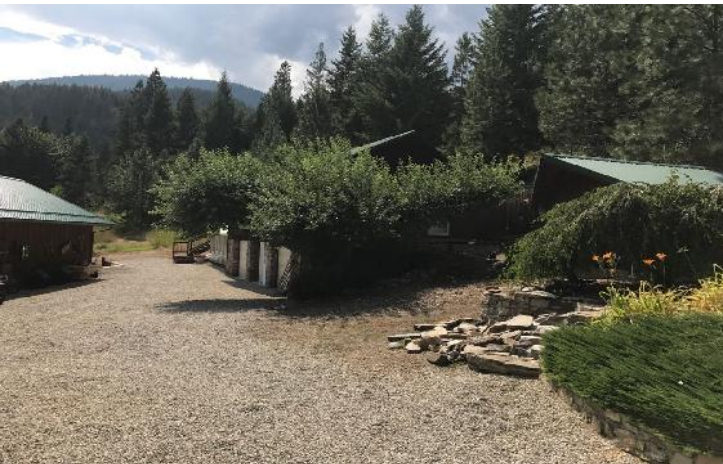
Structure Number:
Structure Name: 850 Woodtick Hollow
SubDivision: Sweeny
GPS Location, Lat. 46 36.55914
GPS Location, Long. 114 7.66896
Safety Zone Present: Yes **Where is Safety Zone:** -Safety zone: large field 100ft East of the house.
Type of Structure: Residential **Primary Structures:** **Outbuildings:**
Surrounding Fuels: Grass,Shrub,Timber **Defensible Space:** 50-100 Feet
Structure Triage Category: Defensible, Prep and Hold
Roof Material: Metal **Siding Material:** Wood
Heat Traps: Wood Deck,Rain Gutters
Electrical Power: Underground **Gas to Structure:** Aboveground
Hazards: Terrain,Fuels,Septic Tank,HazMat
Access to Site: T1 Engine **Best Access From:** Sweeney Creek Road -> Woodtick Hollow
Comm with ICP: Radio,Cell Service
Water Source: Faucet / Hose,Porta-Tank/Pumpkin,Large Pond,Creek
Mitigation Time: 1-2 Hours
Other Resources Needed to Protect: -1 engine crew assisting homeowner with setting up sprinklers around his property

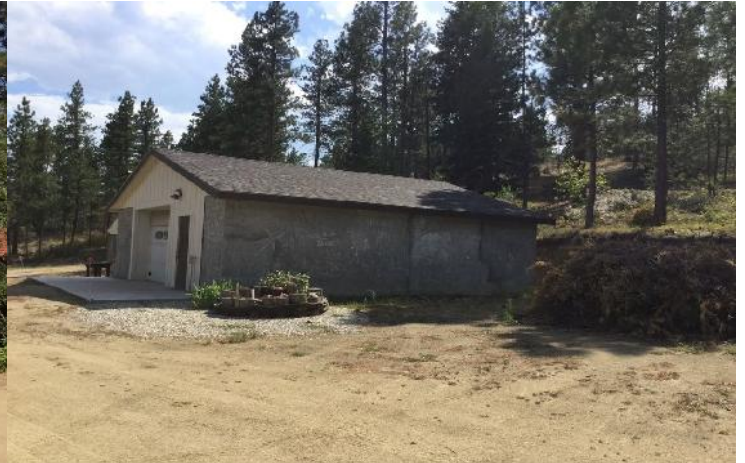
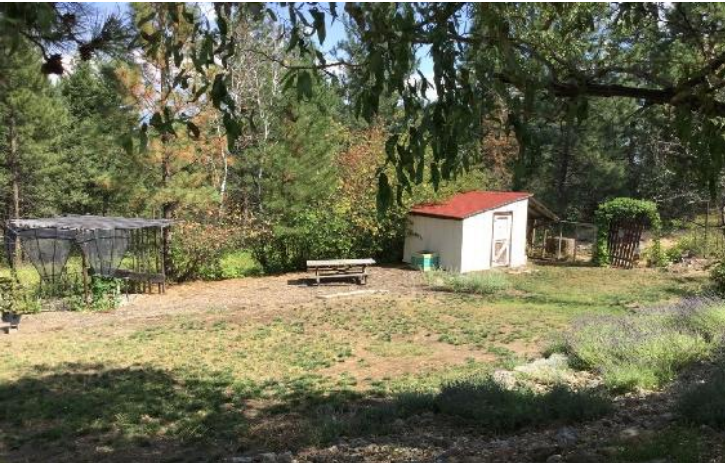
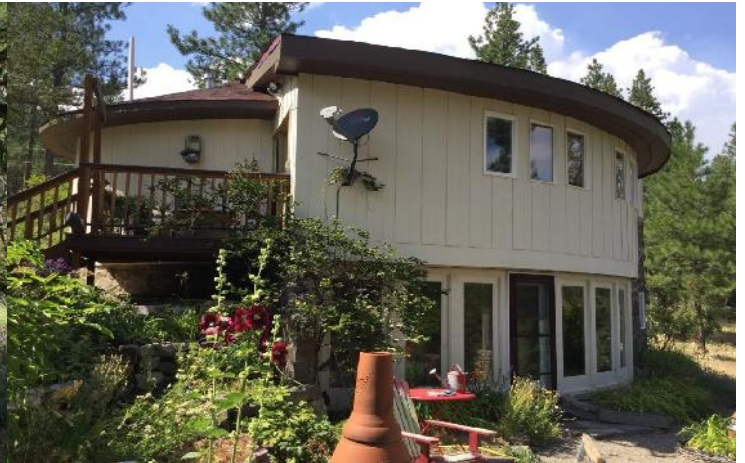
Structure Number:
Structure Name: 860 Upper Sweeney Creek Loop
SubDivision: Sweeny
GPS Location, Lat. 46 36.80106
GPS Location, Long. 114 7.28532
Safety Zone Present: Yes **Where is Safety Zone:** Field by smith fork road
Type of Structure: Residential **Primary Structures:** **Outbuildings:**
Surrounding Fuels: Grass, Timber **Defensible Space:** 30-50 Feet
Structure Triage Category: Non-Defensible, Prep and Leave
Roof Material: Composite **Siding Material:** Wood
Heat Traps: Wood Deck **Gas to Structure:** Aboveground
Electrical Power: Overhead, Underground
Hazards: Fuels
Access to Site: T3/4 Engine **Best Access From:** Upper Sweeney Creek Loop
Comm with ICP: Radio, Cell Service
Water Source: Faucet / Hose
Mitigation Time: 2-3 Hours
Other Resources Needed to Protect: Engine module, clear brush and wood piles near structures. Clear around propane tank
Collected By: Engine 951 **Collected Date/Time:** 07/30/2017 11:28:44

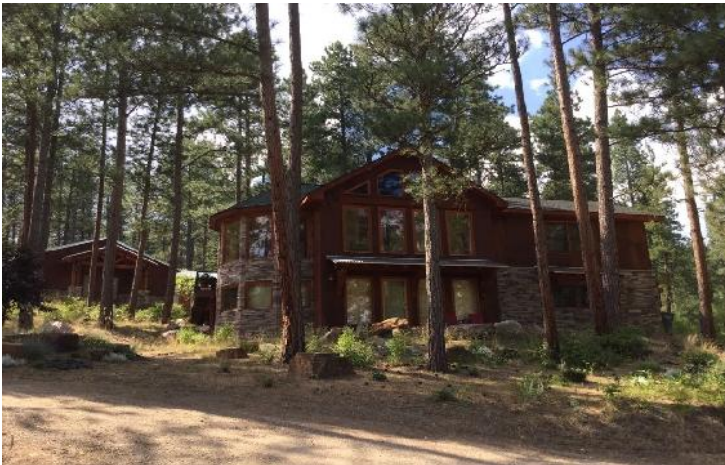
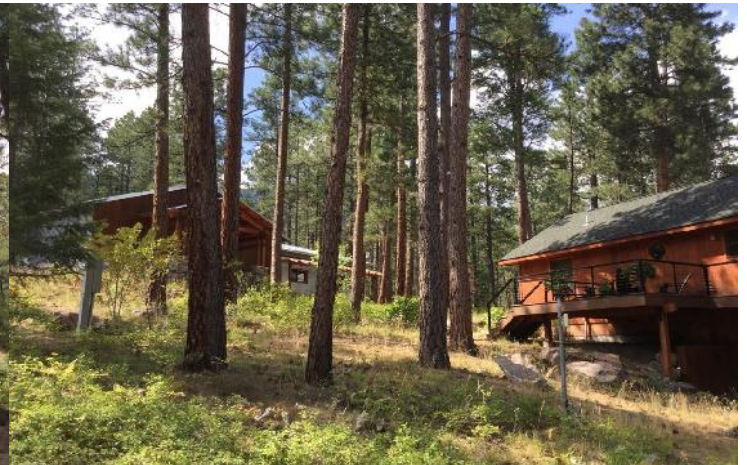
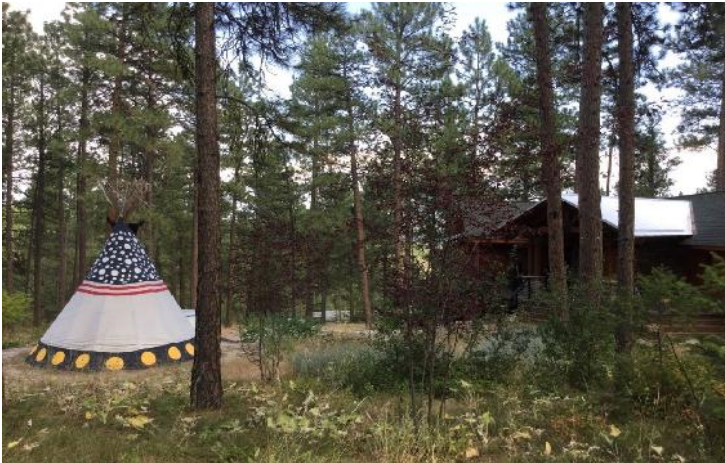
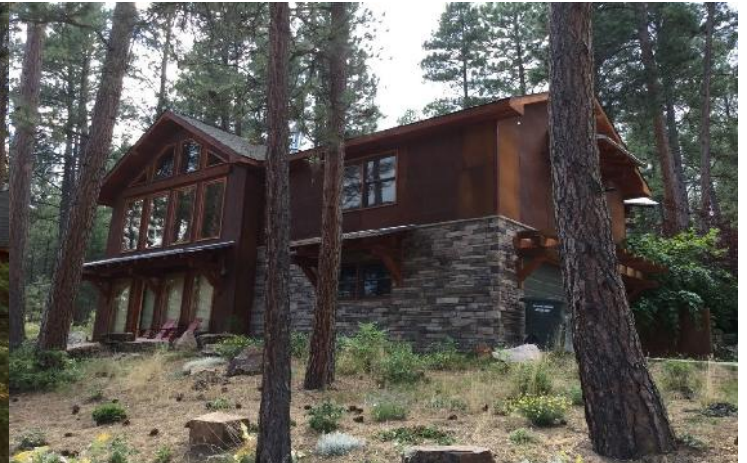
Structure Number:
Structure Name: 873 Upper Sweeney Creek Loop
SubDivision: Sweeny
GPS Location, Lat. 46 36.8457
GPS Location, Long. 114 7.31106
Safety Zone Present: Yes **Where is Safety Zone:** Field at smith fork road
Type of Structure: Residential **Primary Structures:** **Outbuildings:**
Surrounding Fuels: Grass,Shrub,Timber **Defensible Space:** 30-50 Feet
Structure Triage Category: Non-Defensible, Prep and Leave
Roof Material: Composite **Siding Material:** Metal
Heat Traps: Wood Deck
Electrical Power: Underground **Gas to Structure:** None
Hazards: Fuels
Access to Site: T3/4 Engine **Best Access From:** Upper Sweeney Creek Loop
Comm with ICP: Radio,Cell Service
Water Source: Faucet / Hose
Mitigation Time: 3-4 Hours
Other Resources Needed to Protect: Engine mod. Weedwacking around structures. Litter on roof
Collected By: Engine 951 **Collected Date/Time:** 07/30/2017 11:28:51

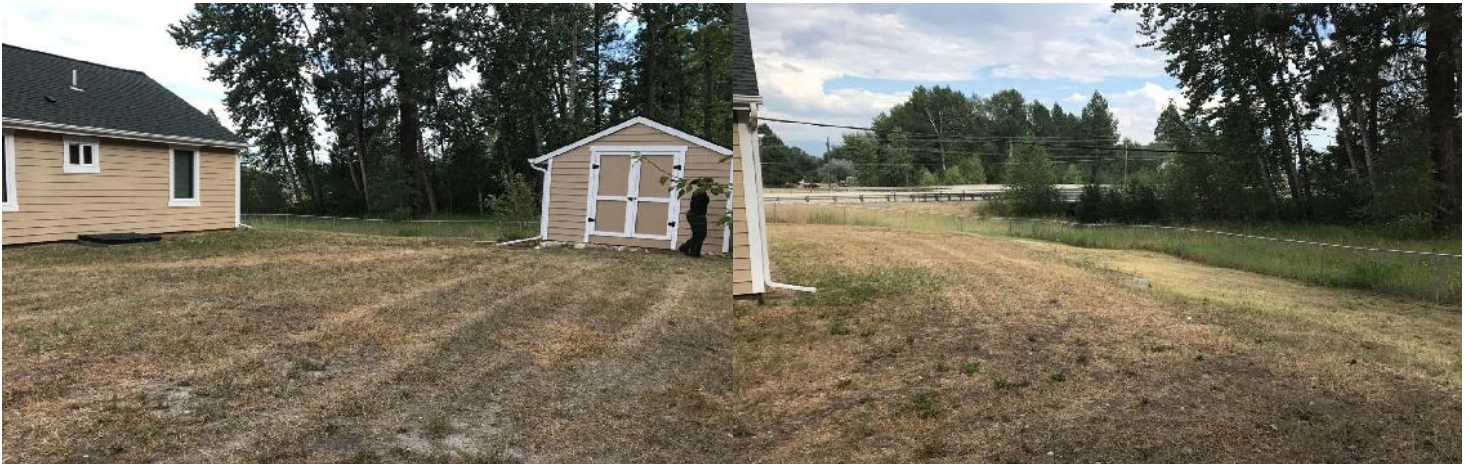
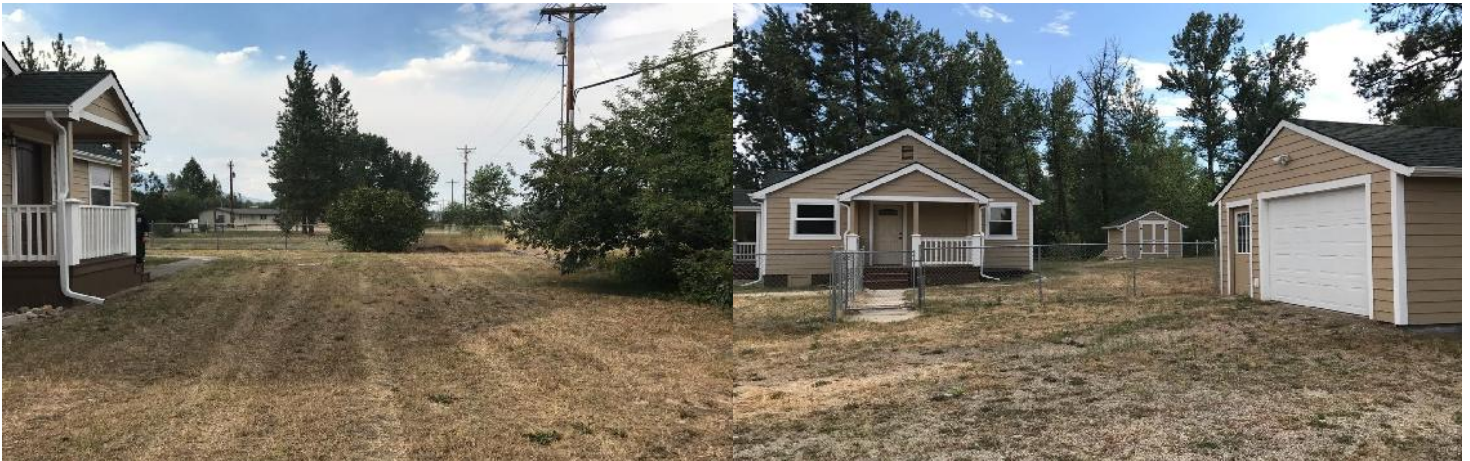
Safety Zone Present: Yes
Type of Structure: Residential
Surrounding Fuels: Grass, Shrub, Timber
Structure Triage Category: Defensible, Stand Alone
Roof Material: Composite
Heat Traps: Rain Gutters, Other Receptor
Electrical Power:
Hazards:
Access to Site: T1 Engine
Comm with ICP: Radio, Cell Service
Water Source: Faucet / Hose
Mitigation Time: None Needed
Notes: Home is unoccupied.

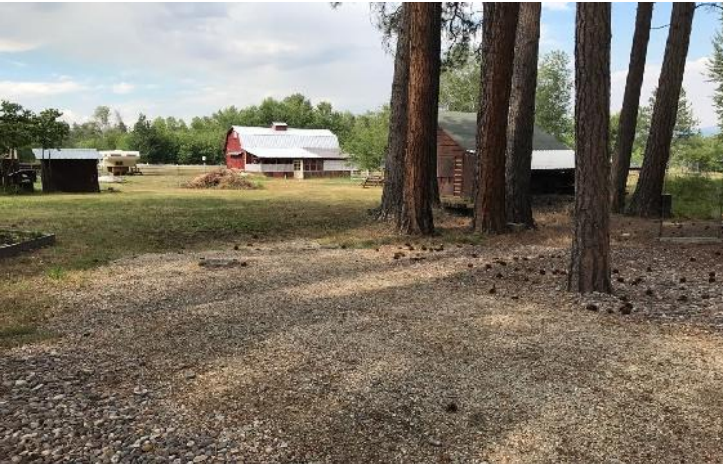
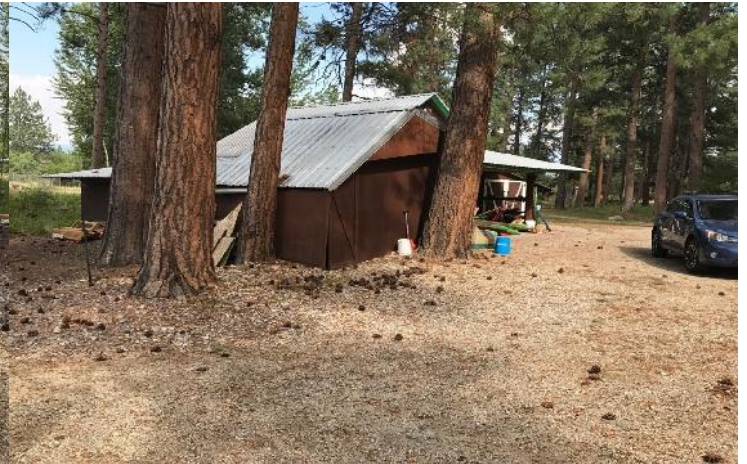
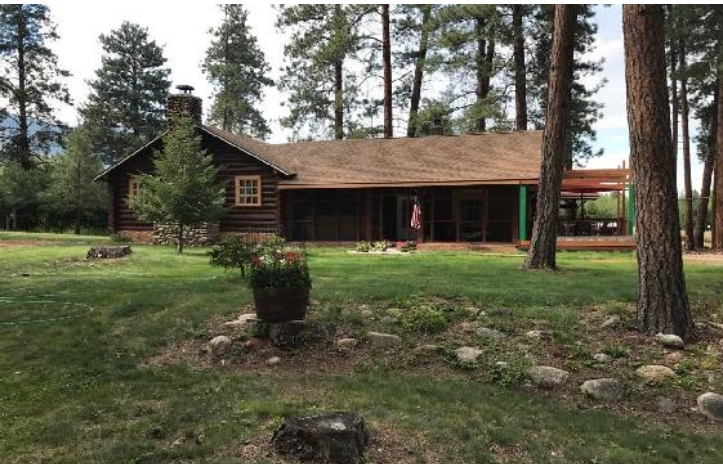
Structure Number:
Structure Name: Sweeney Creek Loop
SubDivision: Sweeny
GPS Location, Lat. 46 36.61626
GPS Location, Long. 114 6.09528
Safety Zone Present: Yes
Type of Structure: Residential
Surrounding Fuels: Grass, Timber
Structure Triage Category: Defensible, Prep and Hold
Roof Material: Composite
Heat Traps: Wood Deck
Electrical Power: Overhead
Hazards: HazMat
Access to Site: T3/4 Engine
Comm with ICP: Radio, Cell Service
Water Source: Faucet / Hose, Hydrant
Mitigation Time: 1-2 Hours
Other Resources Needed to Protect: 1 Type 6
Notes: Several piles of pine needles throughout the property.

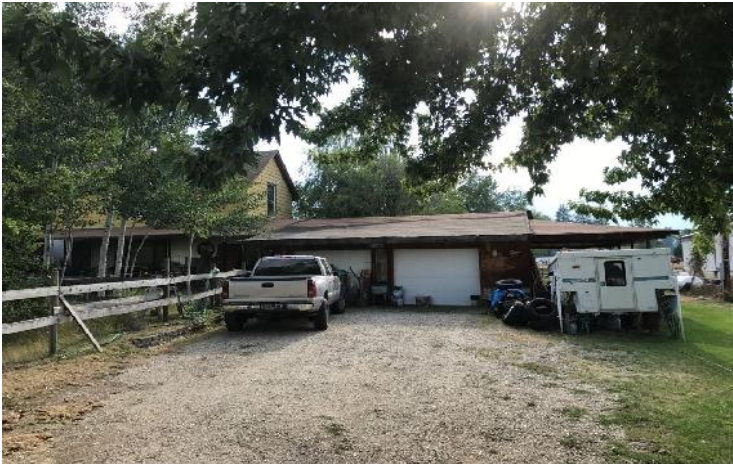
Structure Number:
Structure Name: 4885 Hoblit Lane
SubDivision: Larry Creek
GPS Location, Lat. 46 35.39478
GPS Location, Long. 114 5.6208
Safety Zone Present: Yes
Type of Structure: Residential
Surrounding Fuels: Grass,Shrub
Structure Triage Category: Non-Defensible, Rescue, Drive By
Roof Material: Composite
Heat Traps: Open Eaves,Other Receptor
Electrical Power: Overhead
Hazards: Fuels,Animals
Access to Site: T1 Engine
Comm with ICP: Radio,Cell Service
Water Source: Faucet / Hose
Mitigation Time: More Than 5 Hours
Notes: Limbs hanging on structure

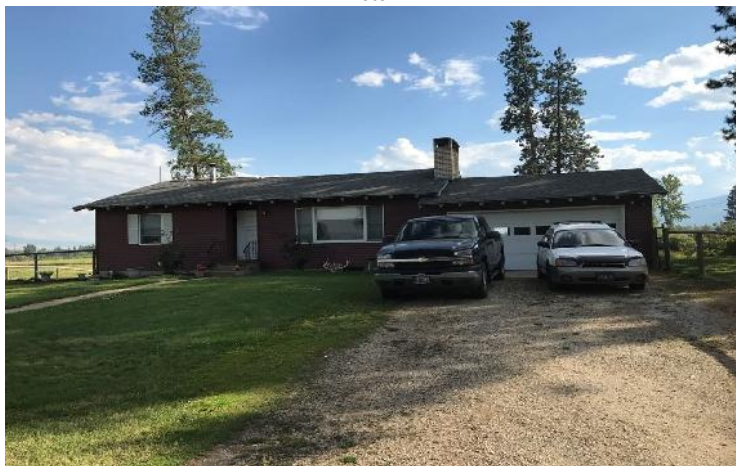
Structure Number:
Structure Name: 4898 Hoblit Lane
SubDivision: Larry Creek
GPS Location, Lat. 46 35.40426
GPS Location, Long. 114 5.5977
Safety Zone Present: Yes **Where is Safety Zone:** Highway 93
Type of Structure: Residential **Primary Structures:** **Outbuildings:**
Surrounding Fuels: Grass,Shrub **Defensible Space:** 30-50 Feet
Structure Triage
Category: Defensible, Stand Alone
Roof Material: Composite **Siding Material:** Metal
Heat Traps: Open Eaves,Rain Gutters,Other Receptor
Electrical Power: Underground **Gas to Structure:** Aboveground
Hazards:
Access to Site: T1 Engine **Best Access From:** Highway 93 to Hoblit Lane
Comm with ICP: Radio,Cell Service
Water Source: Faucet / Hose,Large Pond
Mitigation Time: Less Than An Hour
Notes: Pond to the west of structure with pump house hooked up to sprinklers throughout property.

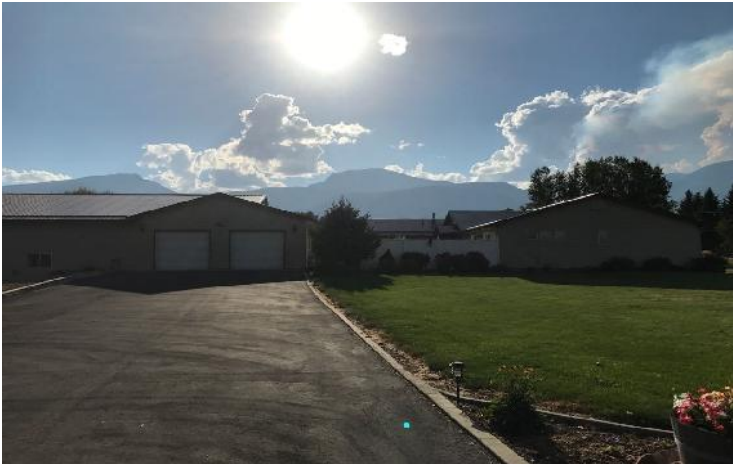
Structure Number:
Structure Name: 4901 Hoblitt Lane
SubDivision: Larry Creek
GPS Location, Lat. 46 35.43732
GPS Location, Long. 114 5.60466
Safety Zone Present: Yes
Type of Structure: Residential
Surrounding Fuels: Grass,Shrub
Structure Triage Category: Defensible, Stand Alone
Roof Material: Metal
Heat Traps: Open Eaves,Rain Gutters,Other Receptor
Electrical Power: Underground
Hazards:
Access to Site: T1 Engine
Comm with ICP: Radio,Cell Service
Water Source: Faucet / Hose
Mitigation Time: None Needed
Notes: Propane tank located south west of structure to the west of big shop.

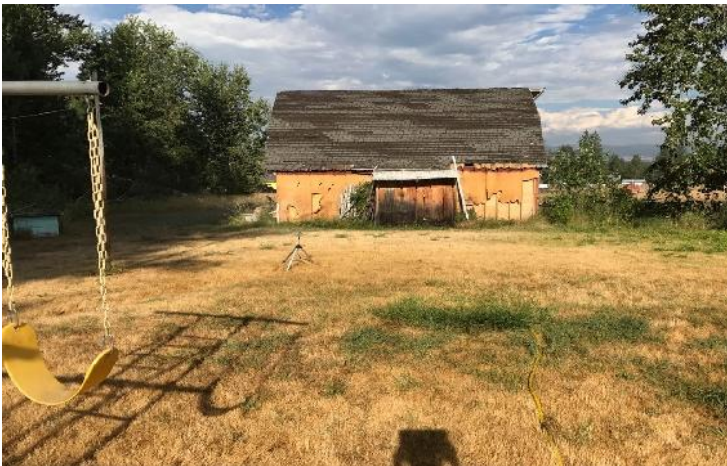
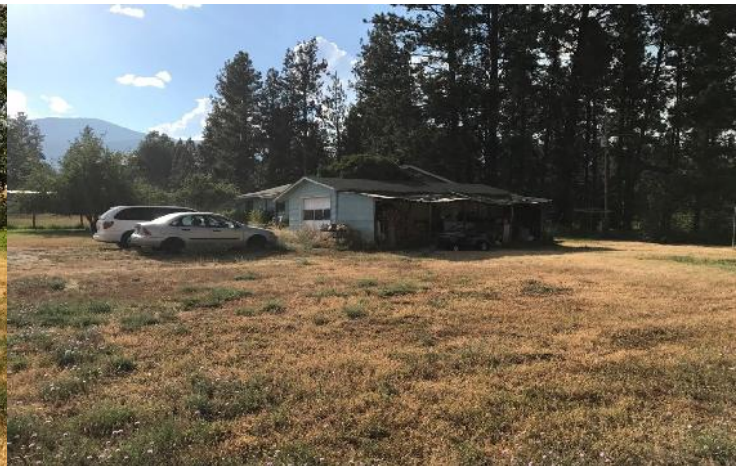
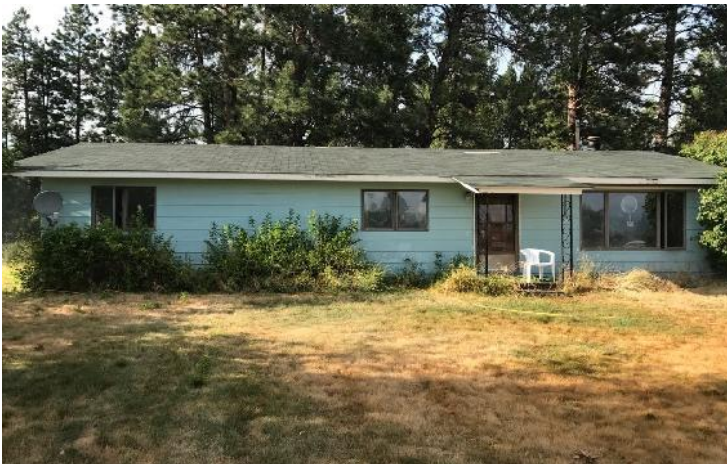
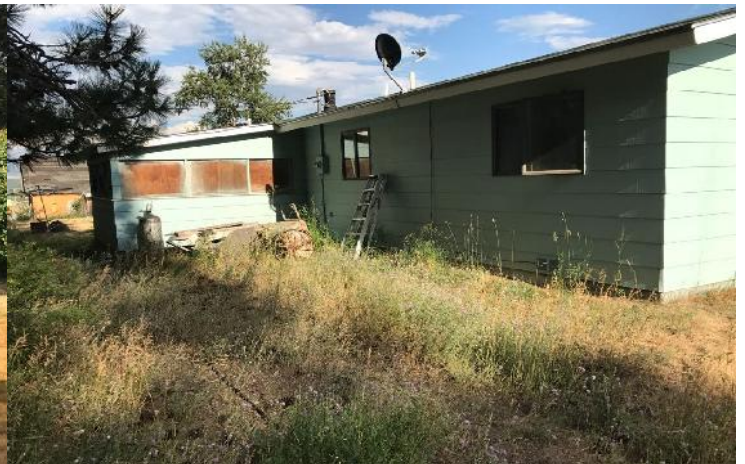
Safety Zone Present: Yes
Type of Structure: Residential
Surrounding Fuels: Grass,Shrub,Timber
Structure Triage Category: Defensible, Prep and Hold
Roof Material: Composite
Heat Traps: Other Receptor
Electrical Power: Underground
Hazards: HazMat
Access to Site: T1 Engine
Comm with ICP: Radio,Cell Service
Water Source: Faucet / Hose,Creek
Mitigation Time: 1-2 Hours
Other Resources Needed to Protect: Type 3 Engine, sprinklers. Construction material to cover 8 10 in. by 10 in. holes in out buildings.

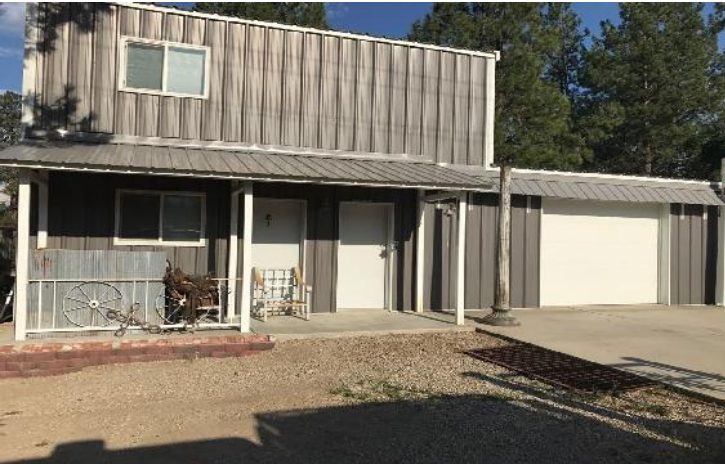
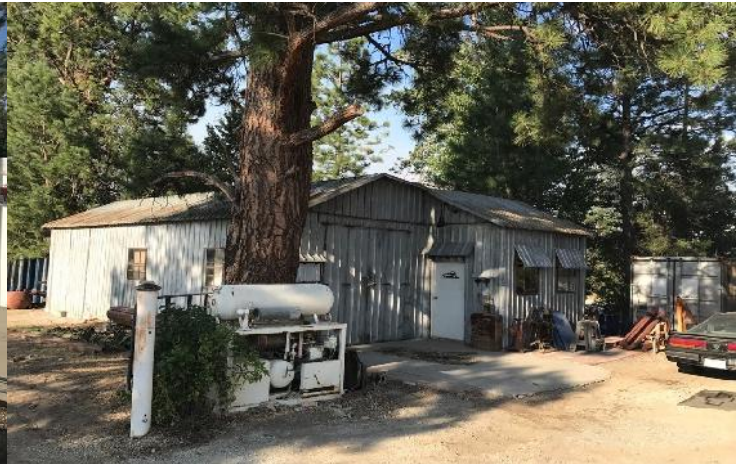
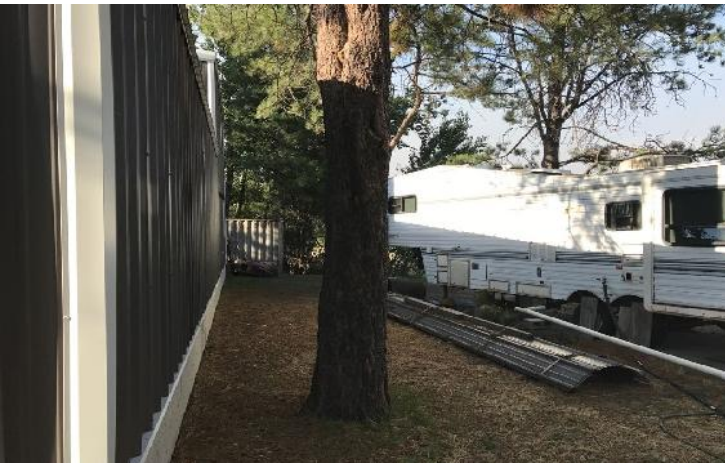
Structure Number:
Structure Name: 4916 Hobbit Lane
SubDivision: Larry Creek
GPS Location, Lat. 46 35.51184
GPS Location, Long. 114 5.54952
Safety Zone Present: Yes
Type of Structure: Residential
Surrounding Fuels: Grass, Timber
Structure Triage Category: Defensible, Stand Alone
Roof Material: Metal
Heat Traps:
Electrical Power: Underground
Hazards: Fuels
Access to Site: T1 Engine
Comm with ICP: Radio, Cell Service
Water Source: Faucet / Hose
Mitigation Time: None Needed
Notes: -Faucet on E side of house.

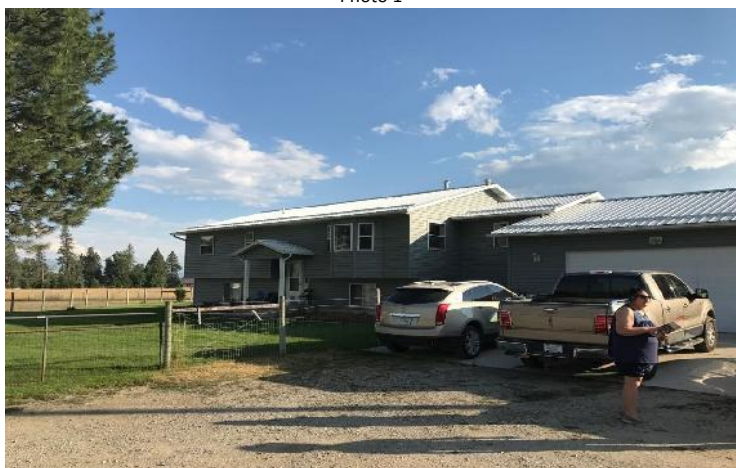
Structure Number:
Structure Name: 4927 Hoblitt Lane South
SubDivision: Larry Creek
GPS Location, Lat. 46 35.56932
GPS Location, Long. 114 5.67294
Safety Zone Present: Yes
Type of Structure: Residential
Surrounding Fuels: Grass,Shrub
Structure Triage Category: Defensible, Stand Alone
Roof Material: Metal
Heat Traps: Open Eaves,Wood Deck,Rain Gutters,Other Receptor
Electrical Power: Overhead,Underground
Hazards: Animals
Access to Site: T3/4 Engine
Comm with ICP: Radio,Cell Service
Water Source: Faucet / Hose
Mitigation Time: Less Than An Hour
Notes: Bud Larocque
406-531-5348

Collected By: Propane tank to east of structure.
E-96 Corvallis
Photo 1

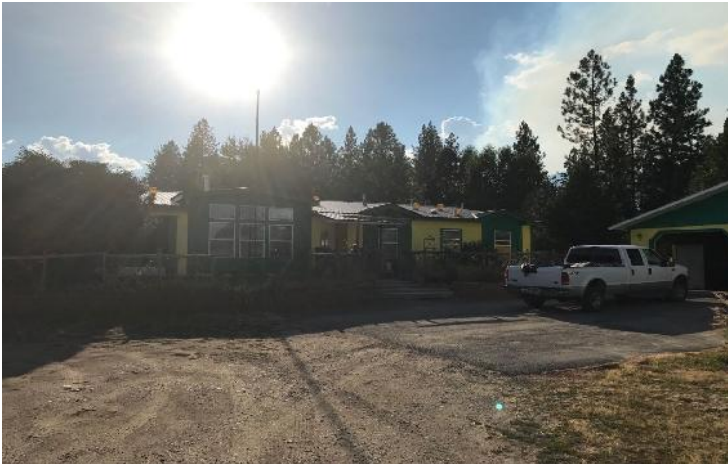
Structure Number:
Structure Name: 4929 Hoblitt Lane South
SubDivision: Larry Creek
GPS Location, Lat. 46 35.5827
GPS Location, Long. 114 5.68338
Safety Zone Present: Yes
Type of Structure: Residential
Surrounding Fuels: Grass,Shrub,Timber
Structure Triage Category: Defensible, Stand Alone
Roof Material: Metal
Heat Traps: Open Eaves,Other Receptor
Electrical Power: Overhead,Underground
Hazards: Terrain,Fuels
Access to Site: T3/4 Engine
Comm with ICP: Radio,Cell Service
Water Source: Faucet / Hose
Mitigation Time: Less Than An Hour
Notes: Propane tank located on north side of structure.

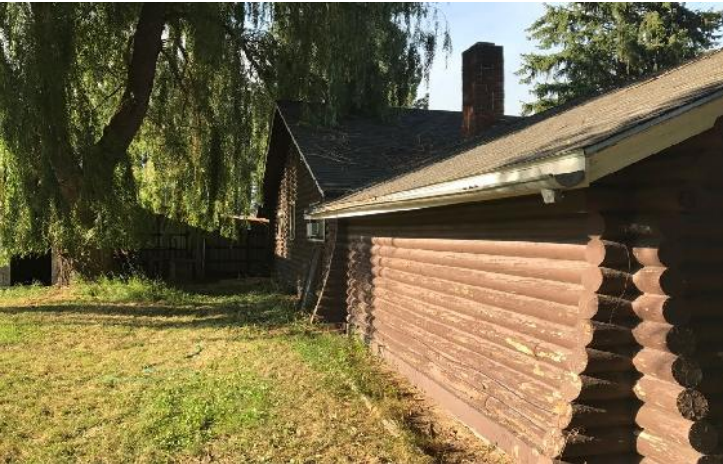
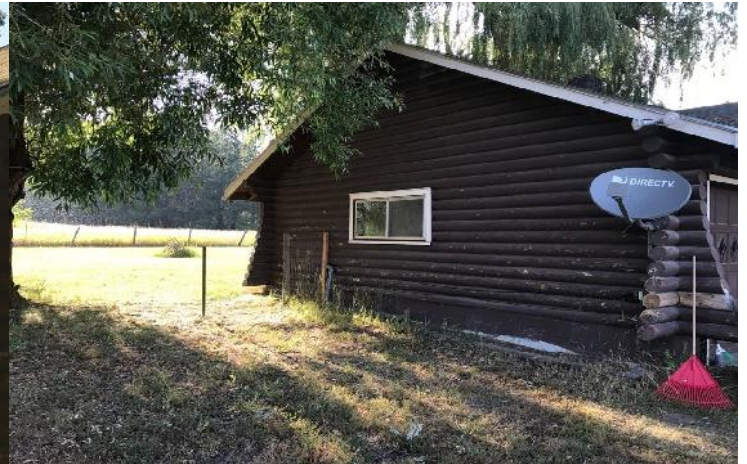
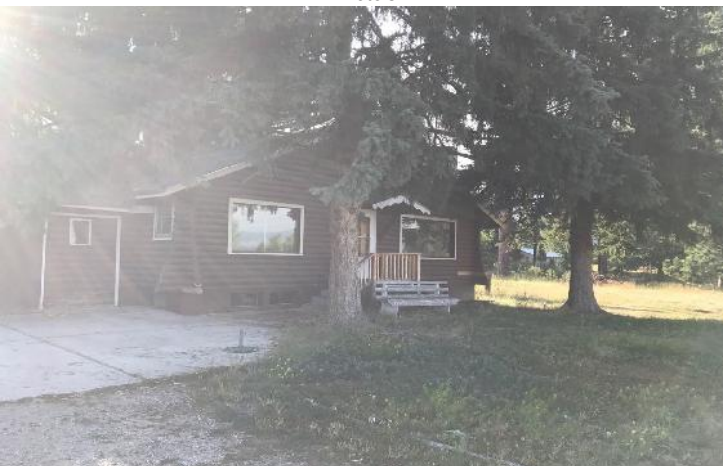
Structure Triage Category: Defensible, Prep and Hold
Roof Material: Composite
Heat Traps: Rain Gutters
Electrical Power: Overhead
Hazards: Fuels

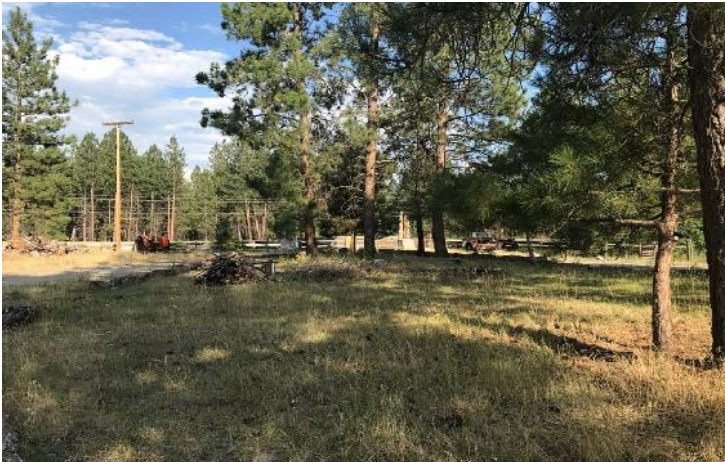
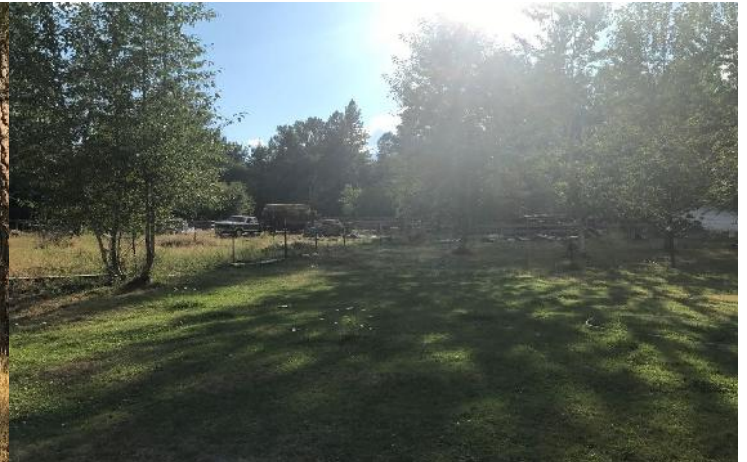
Structure Number:
Structure Name: 5089 Hwy 93
SubDivision: Larry Creek
GPS Location, Lat. 46 36.30618
GPS Location, Long. 114 5.54604
Safety Zone Present: Yes **Where is Safety Zone:** Hwy 93 and out.
Type of Structure: Residential **Primary Structures:** **Outbuildings:**
Surrounding Fuels: Grass, Timber **Defensible Space:** 30-50 Feet
Structure Triage Category: Defensible, Prep and Hold
Roof Material: Metal **Siding Material:** Vinyl
Heat Traps: Wood Deck
Electrical Power: Underground **Gas to Structure:** Aboveground
Hazards: Fuels, Septic Tank
Access to Site: T1 Engine **Best Access From:** Hwy 93
Comm with ICP: Radio, Cell Service
Water Source: Faucet / Hose
Mitigation Time: 2-3 Hours
Other Resources Needed to Protect: Crew to prep, engine to hold.
Notes: Multiple trailers, piles of wood. Lots of items around structures in the way of protection.

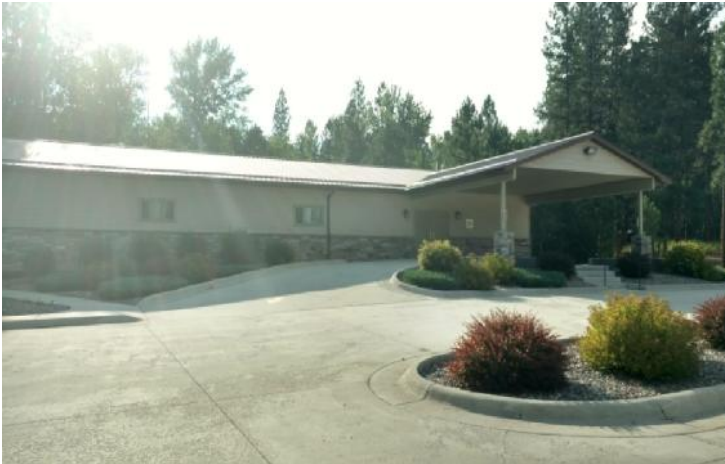
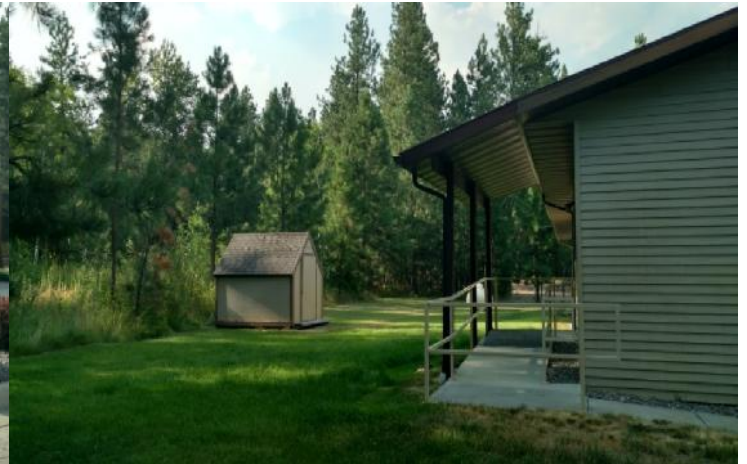
Structure Number:
Structure Name: 5135 Highway 93
SubDivision: Larry Creek
GPS Location, Lat. 46 36.35292
GPS Location, Long. 114 5.52876
Safety Zone Present: No **Where is Safety Zone:** Highway 93
Type of Structure: Commercial **Primary Structures:** **Outbuildings:**
Surrounding Fuels: Grass, Timber **Defensible Space:** 30-50 Feet
Structure Triage Category: Defensible, Prep and Hold
Roof Material: Metal **Siding Material:** Metal
Heat Traps:
Electrical Power: Underground **Gas to Structure:** Aboveground
Hazards: Fuels
Access to Site: T1 Engine **Best Access From:** highway 93
Comm with ICP: Radio, Cell Service
Water Source: Faucet / Hose
Mitigation Time: Less Than An Hour
Other Resources Needed to Protect: One engine, one sprinkler kit, portable pump, portable water source
Notes: Forested area around property is thick and overgrown 15 to 20 foot defensible space covered with green grass.

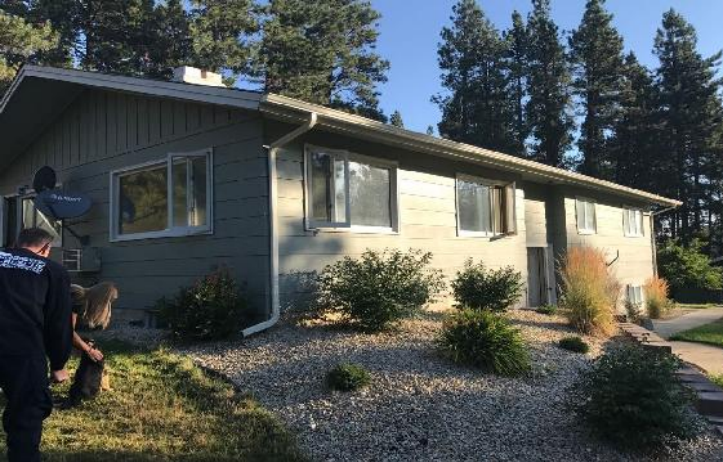
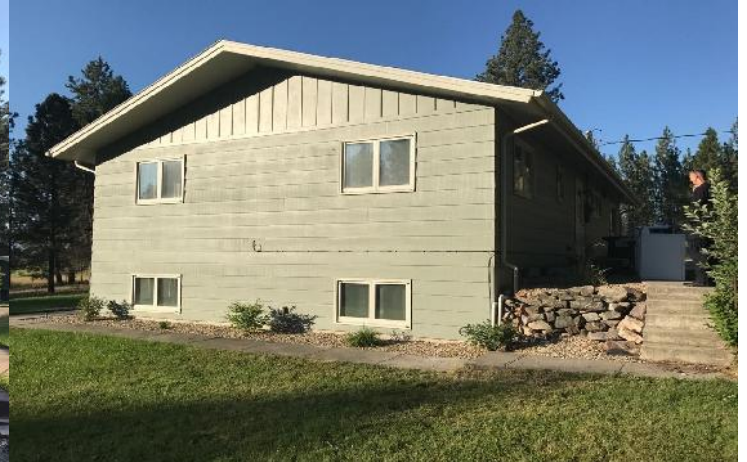
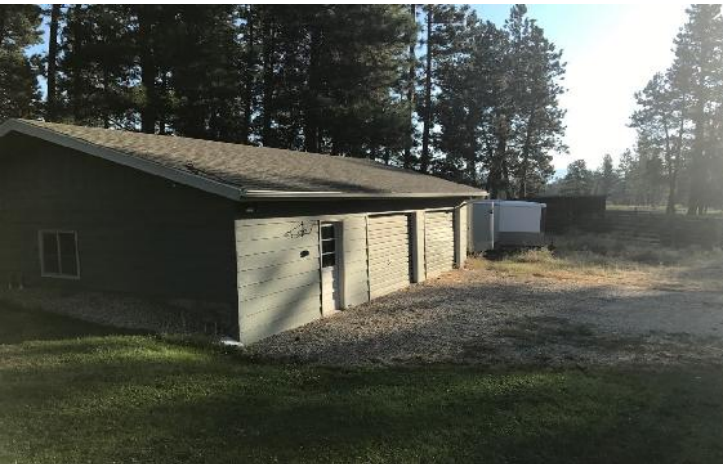
Structure Triage Category: Defensible, Stand Alone
Roof Material: Composite
Heat Traps: Rain Gutters
Electrical Power: Overhead
Hazards: Fuels, Septic Tank
Access to Site: T1 Engine
Comm with ICP: Radio, Cell Service
Water Source: Faucet / Hose
Mitigation Time: None Needed
Other Resources Needed to Protect: -1 engine crew, sprinklers.

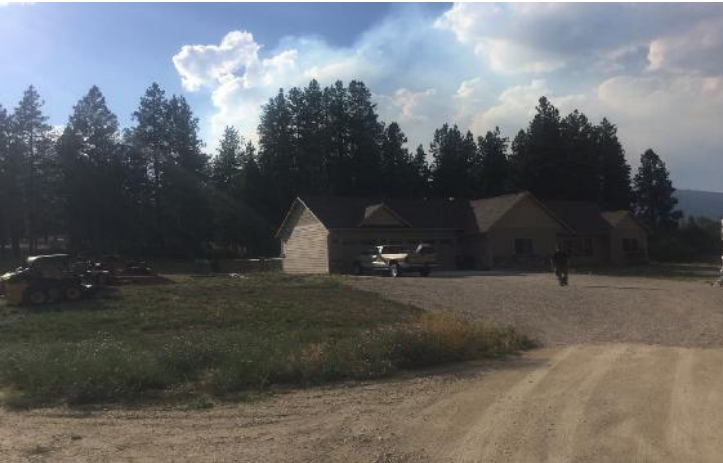
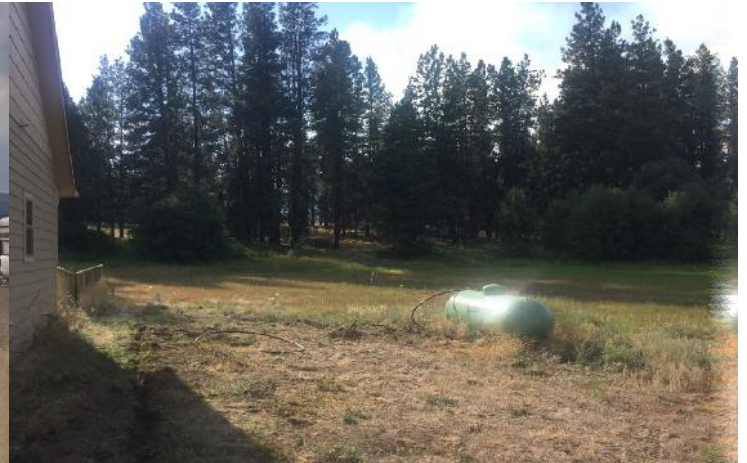
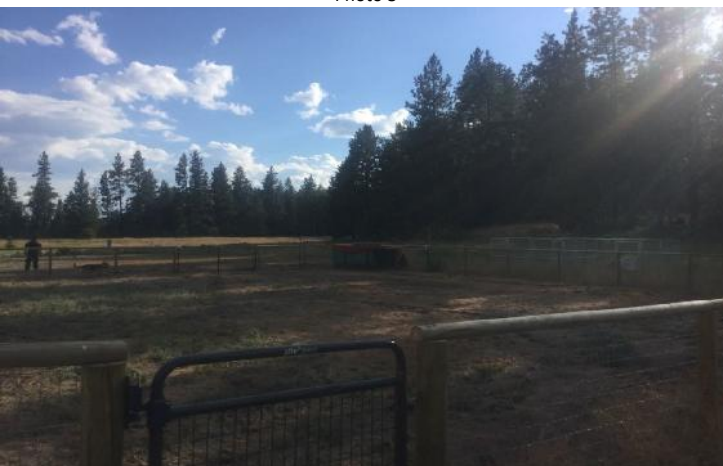
Structure Number:
Structure Name: 538 Sunrider LN
SubDivision: Larry Creek
GPS Location, Lat. 46 35.6877
GPS Location, Long. 114 5.77044
Safety Zone Present: No
Type of Structure: Residential
Surrounding Fuels: Grass,Shrub,Timber
Structure Triage Category: Defensible, Prep and Hold
Roof Material: Composite
Heat Traps: Rain Gutters
Electrical Power: Underground
Hazards: Animals,Septic Tank
Access to Site: T1 Engine
Comm with ICP: Radio,Cell Service
Water Source: Faucet / Hose
Mitigation Time: None Needed
Collected By: Prescott 951
