STRUCTURE
PROTECTION PLAN
FOR
ELK CREEK BLOCK
07/27/2017

Structure Protection Plan

OZ Ranch

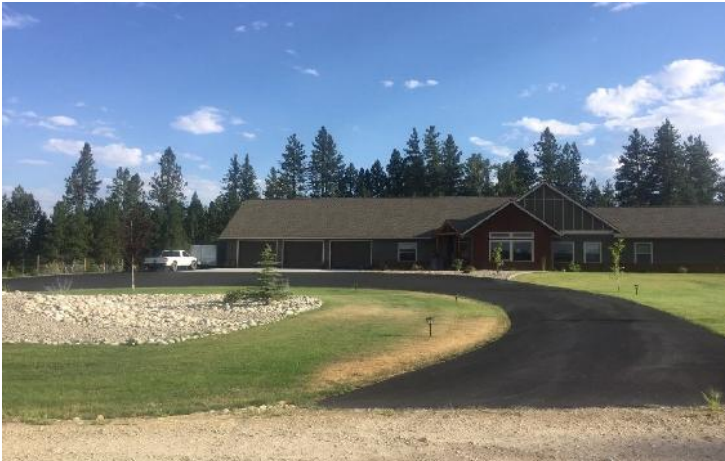
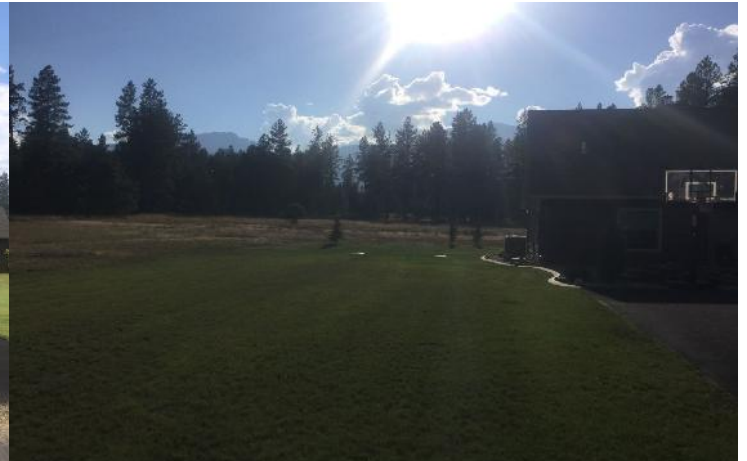
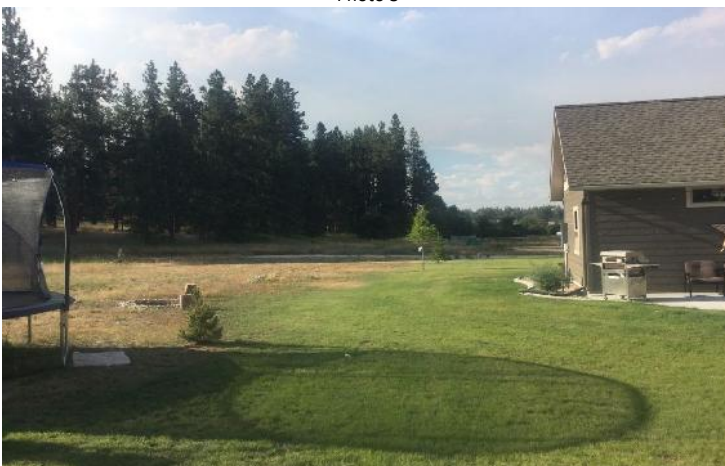
Structure Number:
Structure Name: 563 Sunrider LN
SubDivision: Larry Creek
GPS Location, Lat. 46 35.64912
GPS Location, Long. 114 5.77044
Safety Zone Present: No
Type of Structure: Residential
Surrounding Fuels: Grass, Timber
Structure Triage Category: Defensible, Stand Alone
Roof Material: Composite
Heat Traps: Rain Gutters
Electrical Power: Underground
Hazards: Septic Tank
Access to Site: T1 Engine
Comm with ICP: Radio, Cell Service
Water Source: Faucet / Hose
Mitigation Time: None Needed
Collected By: Prescott 951

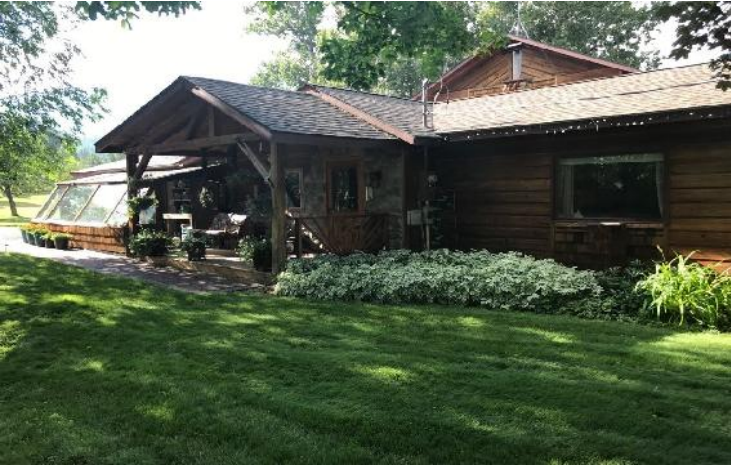
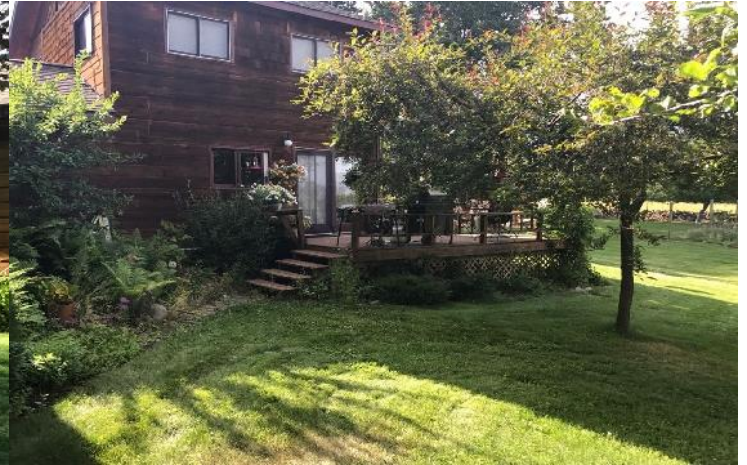
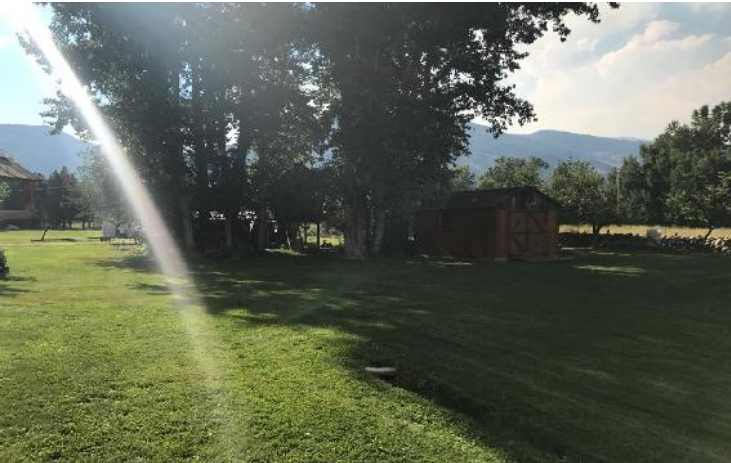
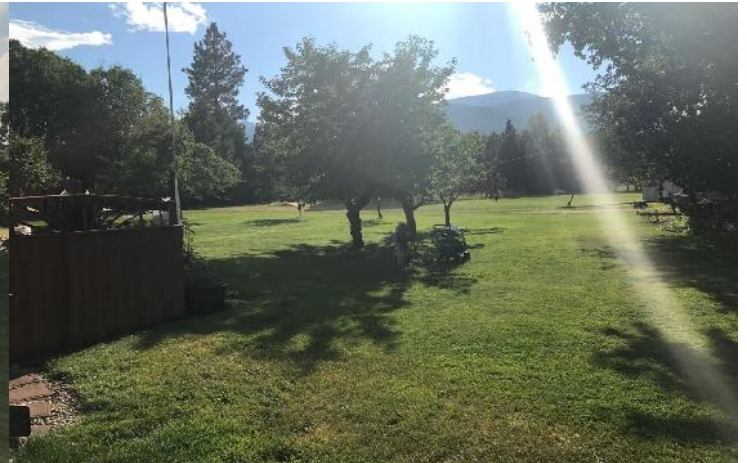
Structure Number:
Structure Name: 622 Sweeney Creek Loop
SubDivision: Larry Creek
GPS Location, Lat. 46 36.38448
GPS Location, Long. 114 6.6081
Safety Zone Present: Yes
Type of Structure: Residential
Surrounding Fuels: Grass, Timber
Structure Triage Category: Defensible, Stand Alone
Roof Material: Composite
Heat Traps: Wood Deck, Rain Gutters
Electrical Power: Overhead
Hazards:
Access to Site: T3/4 Engine
Comm with ICP: Radio, Cell Service
Water Source: Faucet / Hose
Mitigation Time: None Needed
Other Resources Needed to Protect: Type 3
Collected By: AZ-TNF 1265
Photo 1

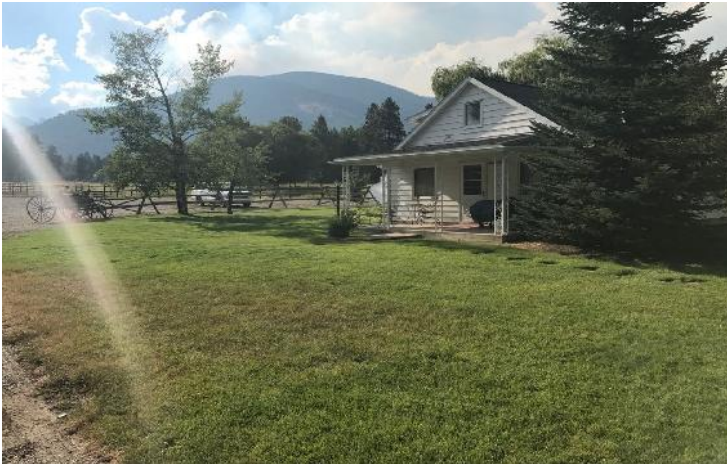
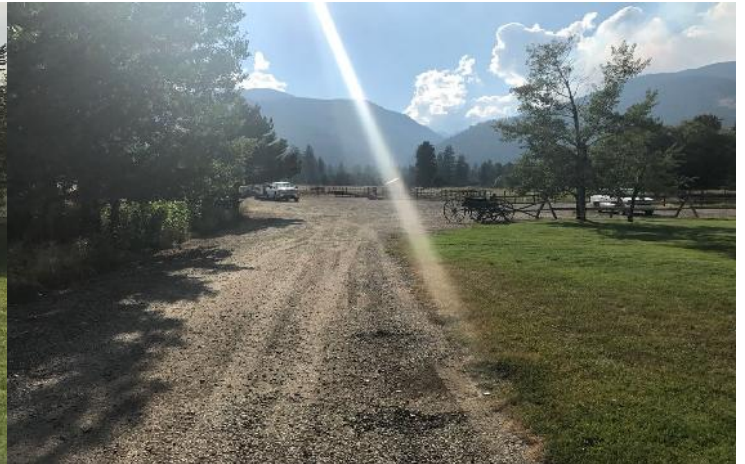
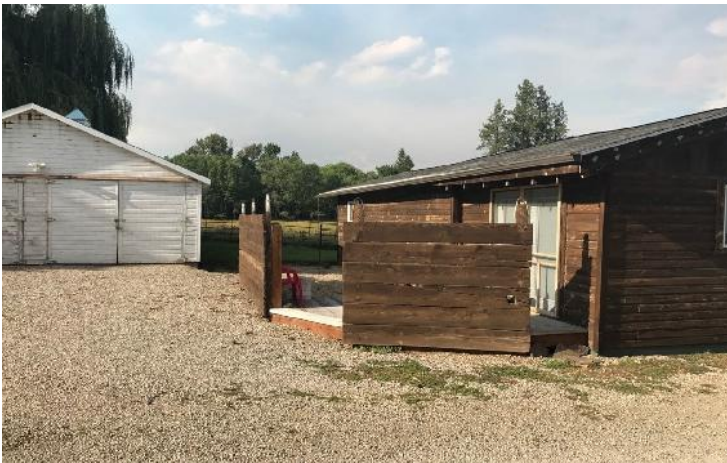
Structure Number:
Structure Name: 634/632 Sweeney Creek Loop
SubDivision: Larry Creek
GPS Location, Lat. 46 36.318
GPS Location, Long. 114 6.7044
Safety Zone Present: Yes **Where is Safety Zone:** Fields surrounding property. Safety zone is in field in front of the house.
Type of Structure: Residential **Primary Structures:** **Outbuildings:**
Surrounding Fuels: Grass **Defensible Space:** >100 Feet
Structure Triage Category: Defensible, Stand Alone
Roof Material: Composite **Siding Material:** Wood
Heat Traps: Rain Gutters
Electrical Power: Underground **Gas to Structure:** Aboveground
Hazards:
Access to Site: T3/4 Engine **Best Access From:** Sweeney Creek Loop
Comm with ICP: Radio, Cell Service
Water Source: Faucet / Hose
Mitigation Time: None Needed
Notes: Both houses share the same driveway.

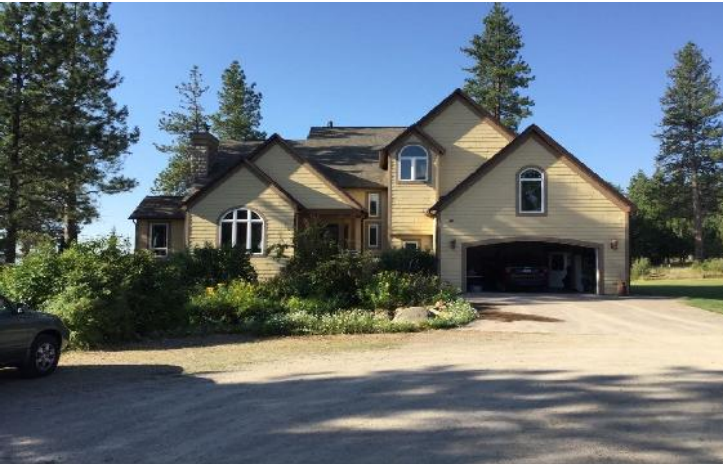
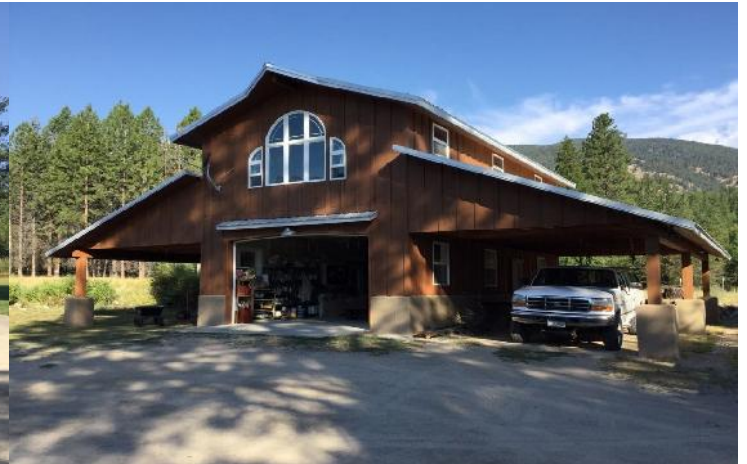
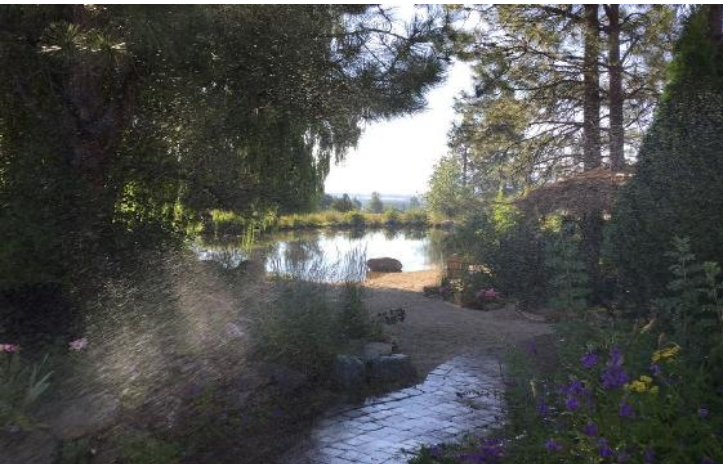
Structure Number:
Structure Name: 640 Outback Road
SubDivision: Larry Creek
GPS Location, Lat. 46 36.41862
GPS Location, Long. 114 6.99066
Safety Zone Present: Yes **Where is Safety Zone:** Field to NE of house and behind house.
Type of Structure: Residential **Primary Structures:** **Outbuildings:**
Surrounding Fuels: Grass, Timber **Defensible Space:** >100 Feet
Structure Triage Category: Defensible, Prep and Hold
Roof Material: Composite **Siding Material:** Wood
Heat Traps: Wood Deck, Rain Gutters
Electrical Power: Overhead, Underground **Gas to Structure:** Aboveground
Hazards: Animals, Septic Tank, HazMat
Access to Site: T3/4 Engine **Best Access From:** Outback road off of Sweeney circle.
Comm with ICP: Radio, Cell Service
Water Source: Faucet / Hose, Large Pond, Creek
Mitigation Time: 2-3 Hours
Other Resources Needed to Protect: Sprinklers
Notes: Owner has small pond on east side of house, limited water. Large pond few hundred yards to south of house. Creek North side of property. Lawn sprinklers.

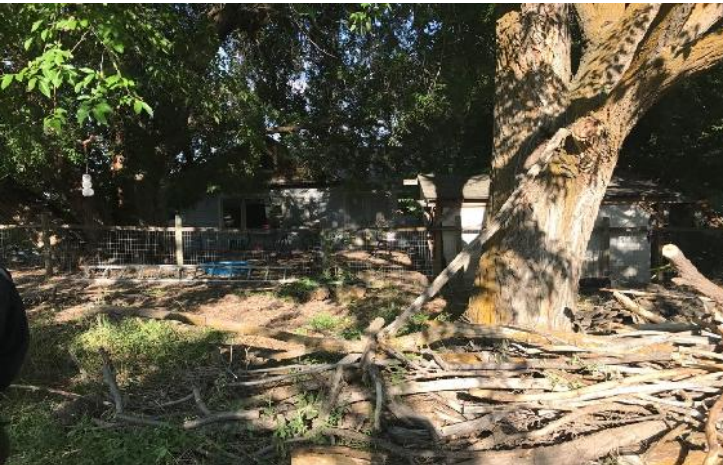
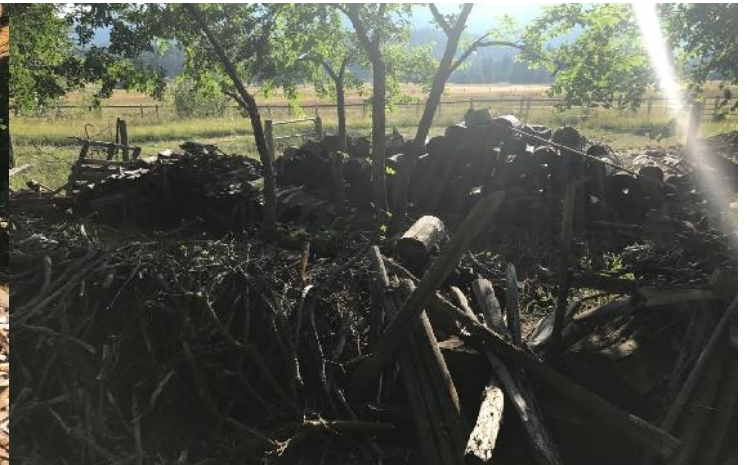
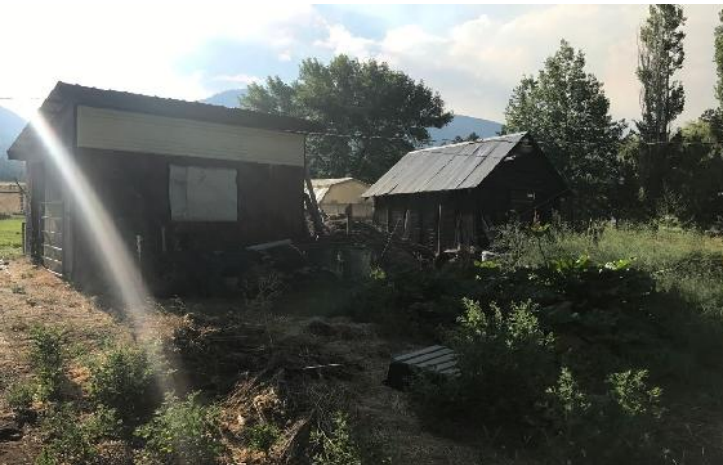
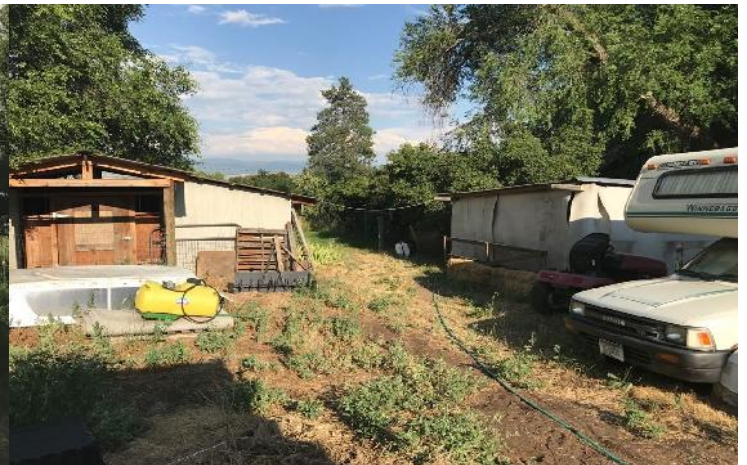
Structure Number:
Structure Name: 642 Sweeney Creek Loop
SubDivision: Larry Creek
GPS Location, Lat. 46 36.27012
GPS Location, Long. 114 6.60522
Safety Zone Present: Yes
Type of Structure: Residential
Surrounding Fuels: Grass
Structure Triage Category: Defensible, Prep and Hold
Roof Material: Composite
Heat Traps: Rain Gutters
Electrical Power: Overhead
Hazards: Fuels
Access to Site: T3/4 Engine
Comm with ICP: Radio, Cell Service
Water Source: Faucet / Hose
Mitigation Time: 1-2 Hours
Other Resources Needed to Protect: Type 6 for extra set of hands to move the wood.
Collected By: AZ-TNF 1265
Photo 1

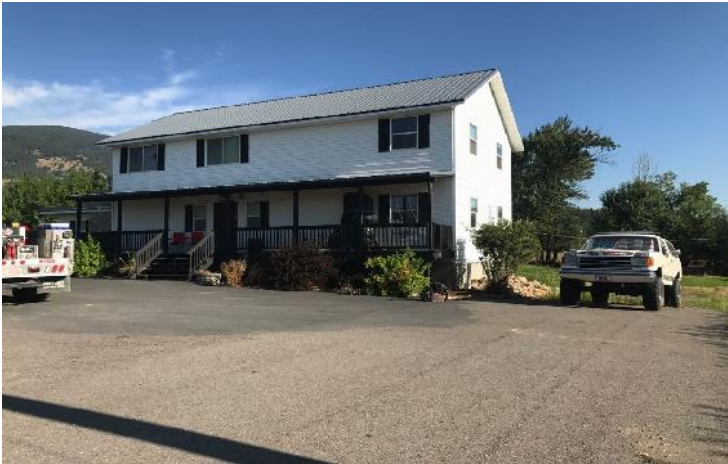
Structure Number:
Structure Name: 657 Sweeney Creek Loop
SubDivision: Larry Creek
GPS Location, Lat. 46 36.30042
GPS Location, Long. 114 6.58188
Safety Zone Present: Yes
Type of Structure: Residential
Surrounding Fuels: Grass
Structure Triage Category: Defensible, Stand Alone
Roof Material: Metal
Heat Traps: Open Eaves, Wood Deck
Electrical Power: Overhead
Hazards: Septic Tank
Access to Site: T1 Engine
Comm with ICP: Radio, Cell Service
Water Source: Faucet / Hose, Creek
Mitigation Time: None Needed
Notes: Draftable Creek along Sweeney Creek Loop, west of residence.

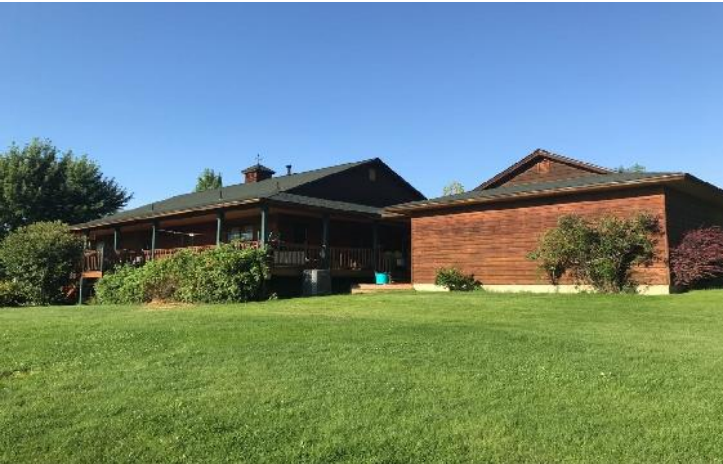
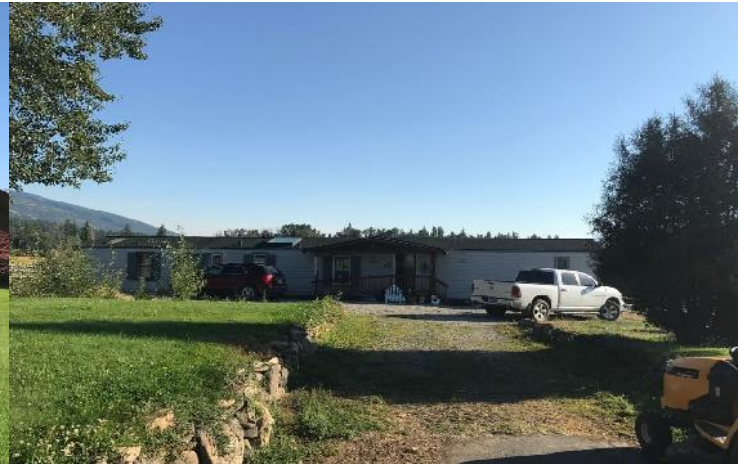
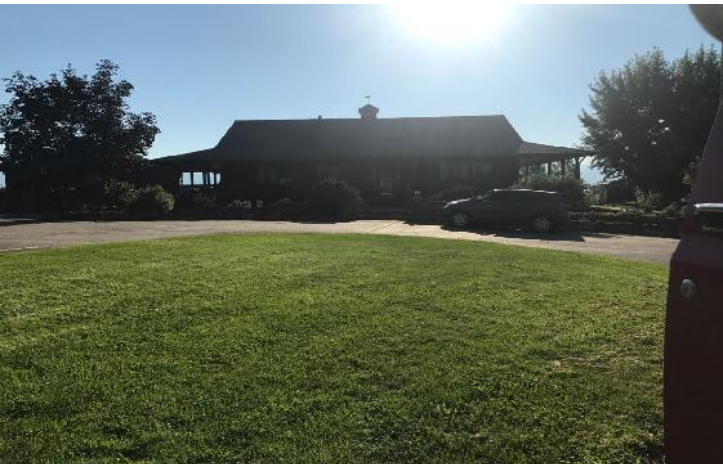
Structure Number:
Structure Name: 738 Sweeney Creek Loop
SubDivision: Larry Creek
GPS Location, Lat. 46 35.9526
GPS Location, Long. 114 6.25926
Safety Zone Present: Yes
Type of Structure: Residential
Surrounding Fuels: Grass
Structure Triage Category: Defensible, Stand Alone
Roof Material: Composite
Heat Traps: Open Eaves, Wood Deck
Electrical Power: Underground
Hazards:
Access to Site: T3/4 Engine
Comm with ICP: Radio, Cell Service
Water Source: Faucet / Hose, Large Pond
Mitigation Time: None Needed
Other Resources Needed to Protect: Sprinklers...possible hand crew to cut garden shrubs around structure...

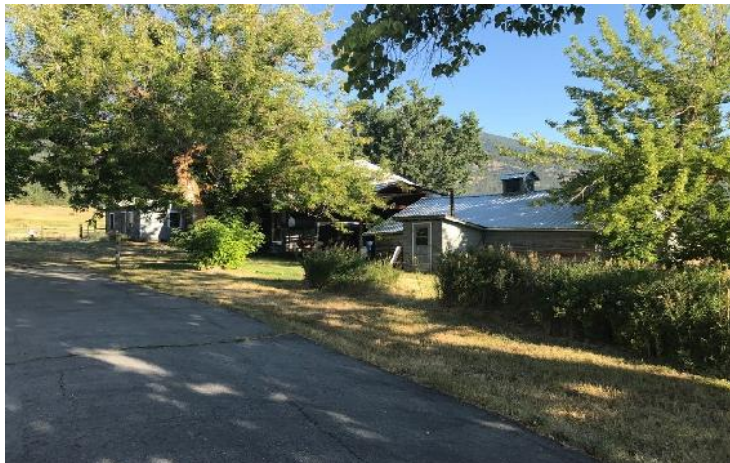
Structure Number:
Structure Name: 746 Sweeney Creek Loop
SubDivision: Larry Creek
GPS Location, Lat. 46 35.81706
GPS Location, Long. 114 6.23928
Safety Zone Present: No
Type of Structure: Residential
Surrounding Fuels: Grass
Structure Triage Category: Defensible, Prep and Hold
Roof Material: Composite
Heat Traps: Wood Deck, Rain Gutters
Electrical Power: Underground
Hazards: Fuels
Access to Site: T3/4 Engine
Comm with ICP: Radio, Cell Service
Water Source: Faucet / Hose
Mitigation Time: 3-4 Hours
Notes: Mitigation of field to the west with brush hog.

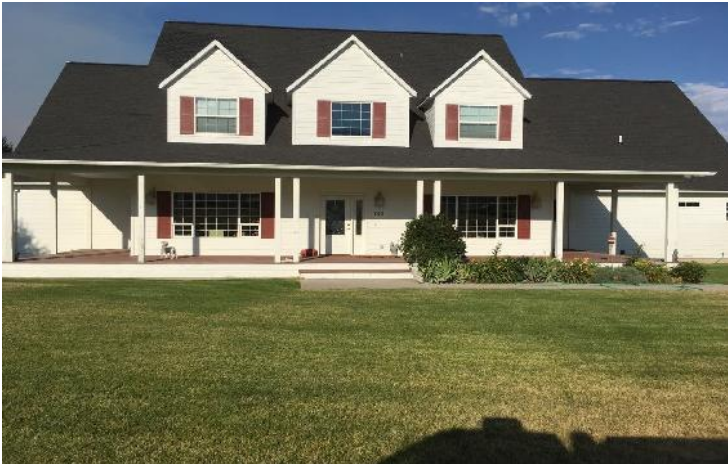
Structure Number:
Structure Name: 763 Sweeney Creek Loop
SubDivision: Larry Creek
GPS Location, Lat. 46 35.78982
GPS Location, Long. 114 6.62418
Safety Zone Present: Yes
Type of Structure: Mixed Use
Surrounding Fuels: Grass
Structure Triage Category: Defensible, Prep and Hold
Roof Material: Wood
Heat Traps: Open Eaves
Electrical Power: Overhead,Underground
Hazards:
Access to Site: T1 Engine
Comm with ICP: Radio,Cell Service
Water Source: Faucet / Hose,Creek
Mitigation Time: 1-2 Hours
Other Resources Needed to Protect: Sprinklers for wood shake shingles...creek at entrance of driveway...easy to dam and about 50 gpm...possible irrigation ditch...
Collected By: E-27 Florence
Photo 1

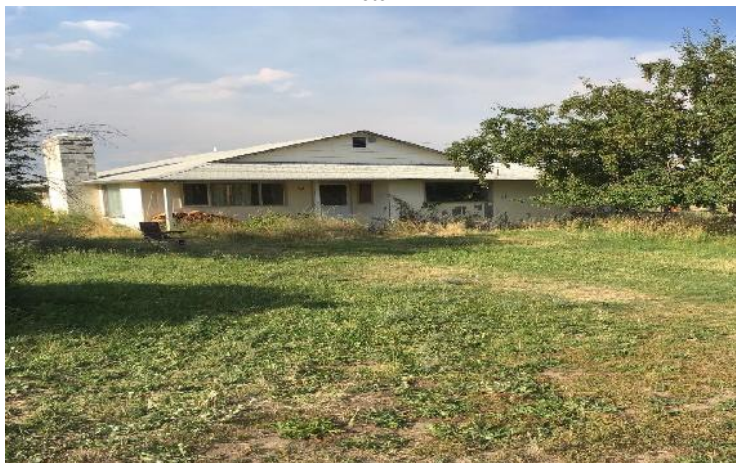
Structure Number:
Structure Name: 810 Sweeney Creek Loop
SubDivision: Larry Creek
GPS Location, Lat. 46 35.5515
GPS Location, Long. 114 6.32328
Safety Zone Present: Yes
Type of Structure: Residential
Surrounding Fuels: Grass
Structure Triage Category: Defensible, Stand Alone
Roof Material: Composite
Heat Traps: Rain Gutters
Electrical Power: Underground
Hazards:
Access to Site: T1 Engine
Comm with ICP: Radio, Cell Service
Water Source: Faucet / Hose, Creek
Mitigation Time: None Needed
Notes: Not sure if it is a primary residence, but looks like a livable structure. Irrigation ditch along driveway

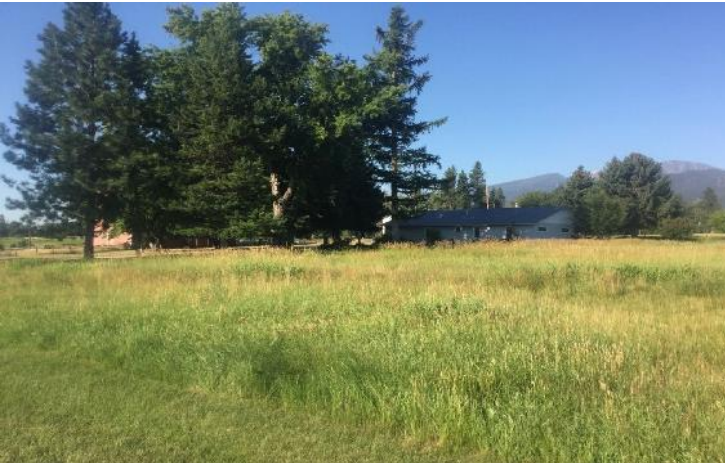
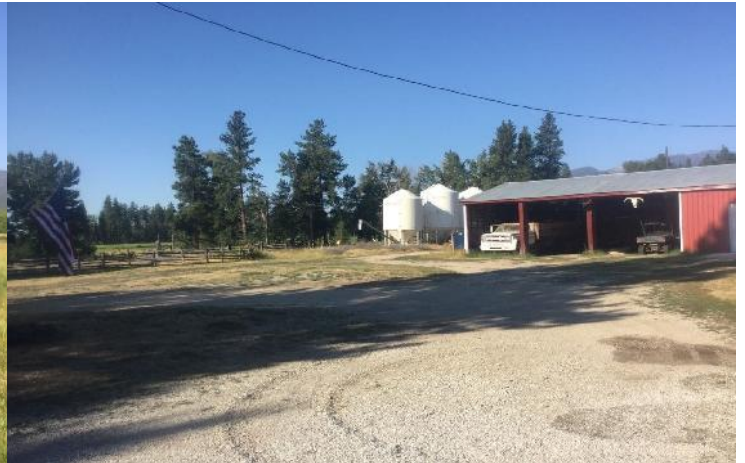
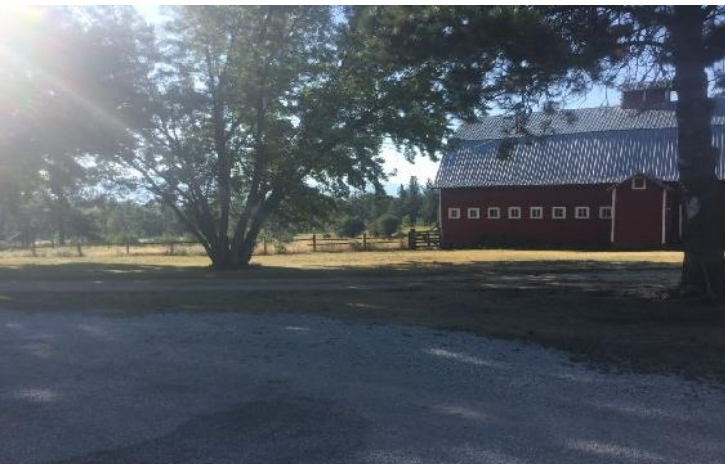
Structure Number:
Structure Name: 132 Hoblitt Lane South
SubDivision: Bass Creek
GPS Location, Lat. 46 34.48362
GPS Location, Long. 114 5.95986
Safety Zone Present: Yes
Type of Structure: Residential
Surrounding Fuels: Grass
Structure Triage Category: Defensible, Stand Alone
Roof Material: Composite
Heat Traps: Wood Deck
Electrical Power: Underground
Hazards:
Access to Site: T1 Engine
Comm with ICP: Radio, Cell Service
Water Source: Faucet / Hose, Large Pond
Mitigation Time: Less Than An Hour
Other Resources Needed to Protect: Engine mod, Weedwhack and dig line around the back of hay barn
Notes: Large pond east of house

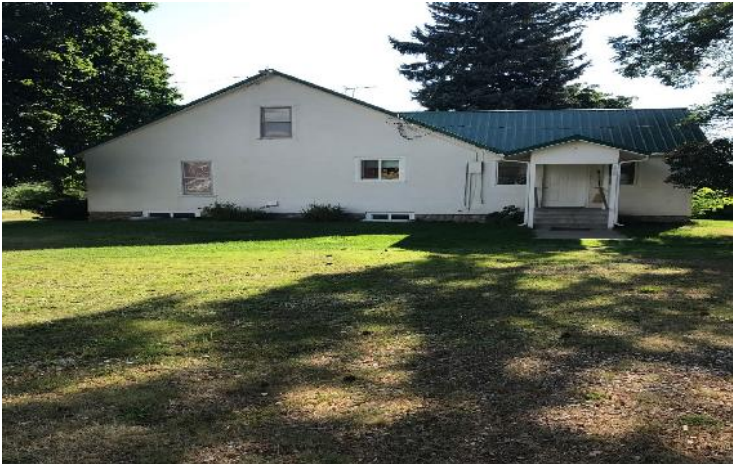
Structure Number:
Structure Name: 240 Bass Creek Road
SubDivision: Bass Creek
GPS Location, Lat. 46 34.46004
GPS Location, Long. 114 6.63972
Safety Zone Present: Yes
Type of Structure: Residential
Surrounding Fuels: Grass
Structure Triage Category: Defensible, Stand Alone
Roof Material: Composite
Heat Traps: Open Eaves, Wood Deck, Rain Gutters
Electrical Power: Overhead
Hazards: Septic Tank
Access to Site: T1 Engine
Comm with ICP: Radio, Cell Service
Water Source: Faucet / Hose, Creek
Mitigation Time: None Needed
Notes: High flowing irrigation ditch in driveway. Shares same driveway as 238 Bass Creek Road, and is on same property.

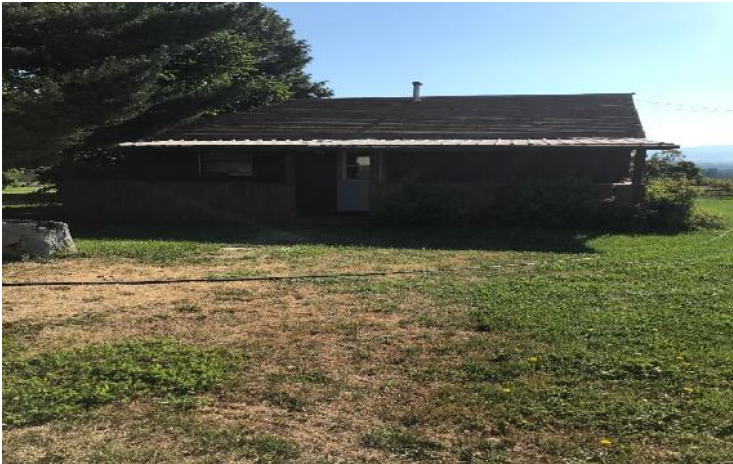
Structure Number:
Structure Name: 310 Bass CK RD
SubDivision: Bass Creek
GPS Location, Lat. 46 34.44822
GPS Location, Long. 114 6.94974
Safety Zone Present: Yes
Type of Structure: Residential
Surrounding Fuels: Grass
Structure Triage Category: Defensible, Stand Alone
Roof Material: Metal
Heat Traps:
Electrical Power: Overhead
Hazards: Animals,Septic Tank,HazMat
Access to Site: T1 Engine
Comm with ICP: Radio,Cell Service
Water Source: Faucet / Hose,Creek
Mitigation Time: None Needed
Notes: Irrigation ditch on site near start of driveway next to Bass CK RD.

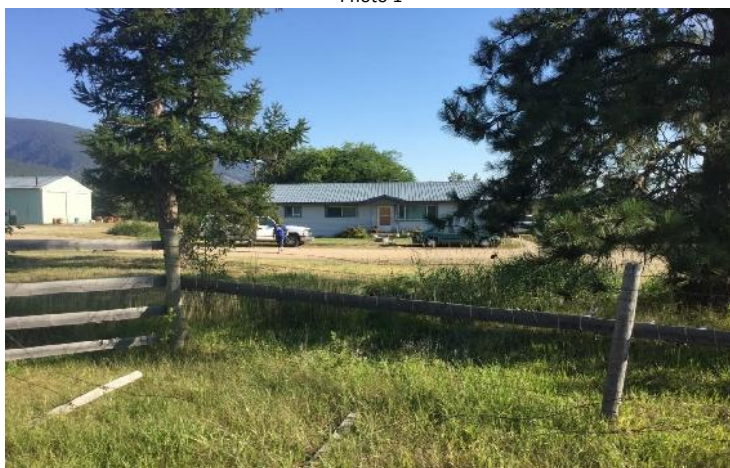
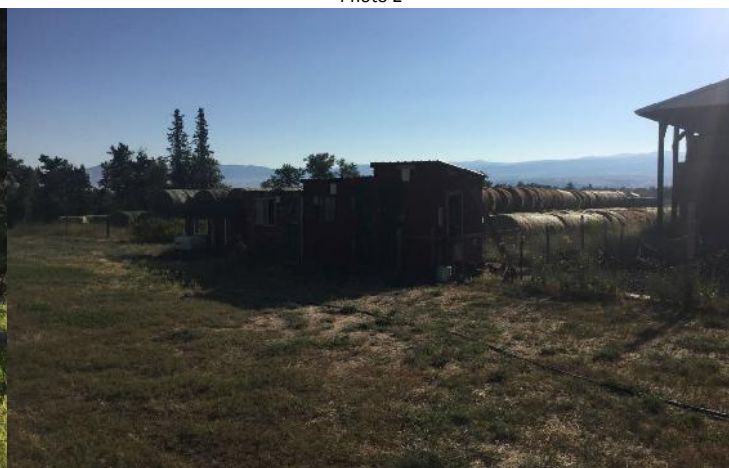
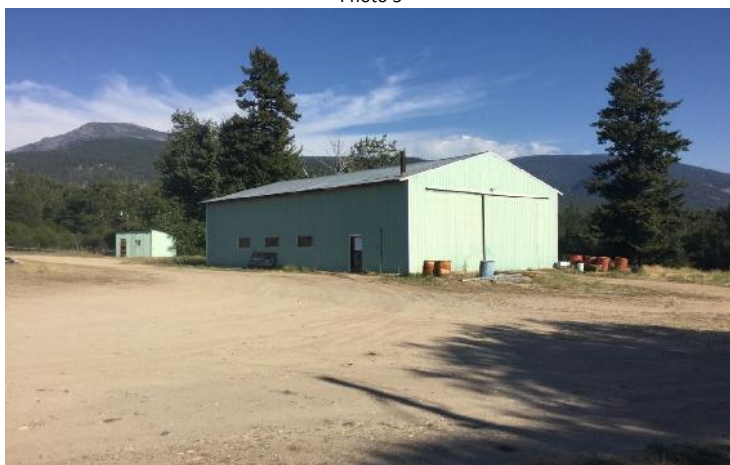
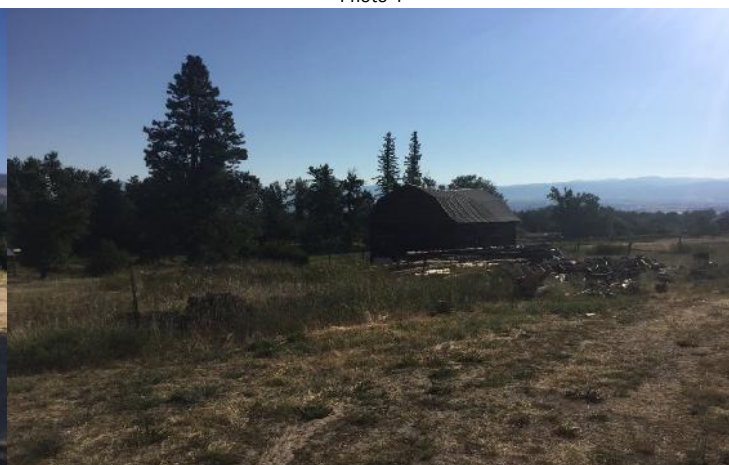
Structure Number:
Structure Name: 311 Bass Creek Road
SubDivision: Bass Creek
GPS Location, Lat. 46 34.41936
GPS Location, Long. 114 7.02606
Safety Zone Present: Yes
Type of Structure: Residential
Surrounding Fuels: Grass
Structure Triage Category: Defensible, Stand Alone
Roof Material: Metal
Heat Traps: Rain Gutters
Electrical Power: Overhead
Hazards:
Access to Site: T1 Engine
Comm with ICP: Radio, Cell Service
Water Source: Faucet / Hose
Mitigation Time: Less Than An Hour
Other Resources Needed to Protect: Engine mod, quick weed trimming around barn
Collected By: Engine 951
Photo 1

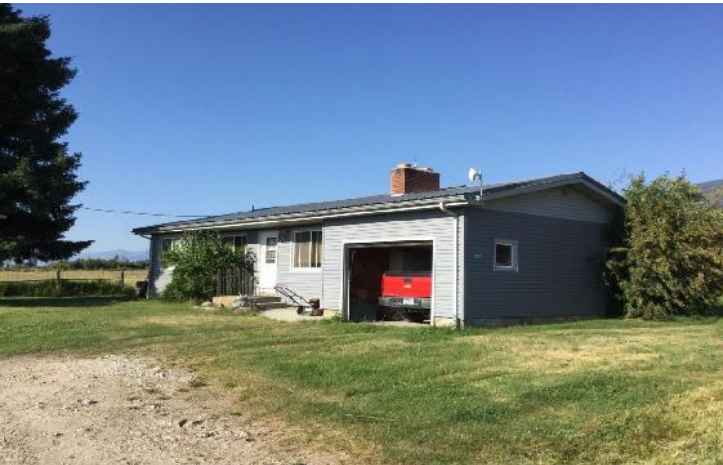
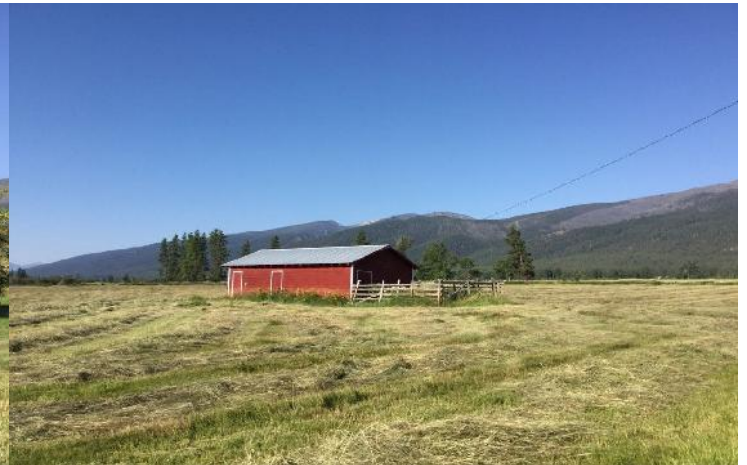
Structure Number:
Structure Name: 312 Bass CK RD
SubDivision: Bass Creek
GPS Location, Lat. 46 34.43346
GPS Location, Long. 114 7.08984
Safety Zone Present: Yes
Type of Structure: Residential
Surrounding Fuels: Grass
Structure Triage Category: Defensible, Prep and Hold
Roof Material: Metal
Heat Traps: Open Eaves, Wood Deck
Electrical Power: Underground
Hazards: Septic Tank
Access to Site: T1 Engine
Comm with ICP: Radio, Cell Service
Water Source: Faucet / Hose, Creek
Mitigation Time: None Needed
Notes: Irrigation ditch next to Bass CK RD and drive way.

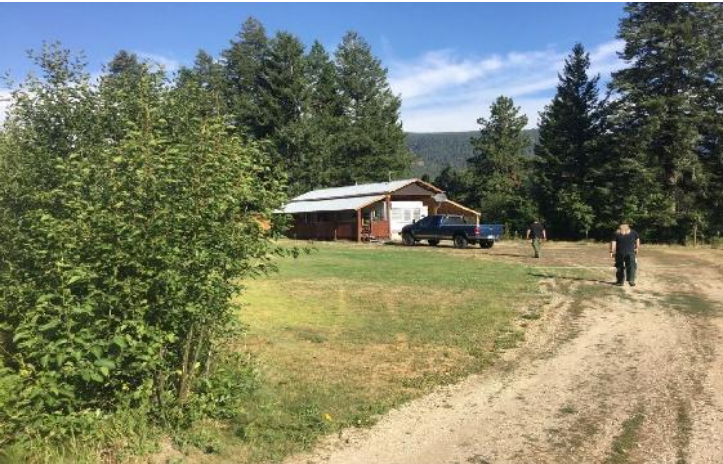
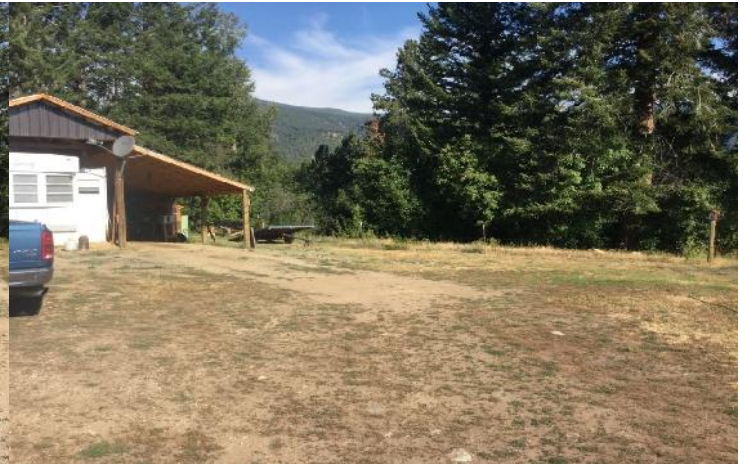
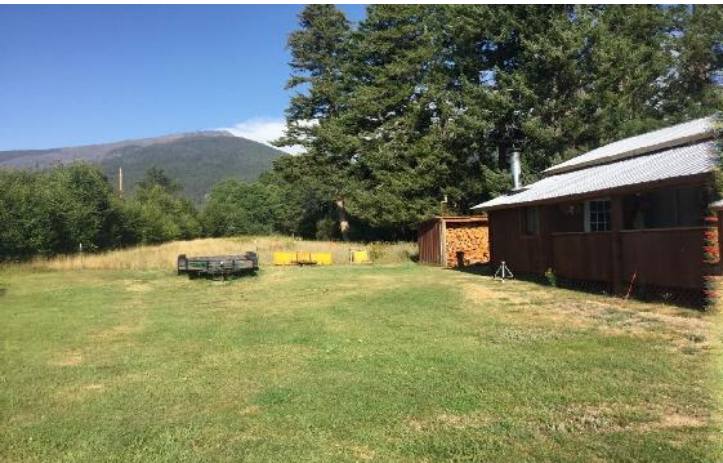
Structure Number:
Structure Name: 372 Bass CK RD
SubDivision: Bass Creek
GPS Location, Lat. 46 34.42962
GPS Location, Long. 114 7.43586
Safety Zone Present: Yes
Type of Structure: Residential
Surrounding Fuels: Grass, Timber
Structure Triage Category: Defensible, Prep and Hold
Roof Material: Composite
Heat Traps: Wood Deck, Rain Gutters
Electrical Power: Overhead
Hazards: Animals, Septic Tank
Access to Site: T1 Engine
Comm with ICP: Radio, Cell Service
Water Source: Faucet / Hose
Mitigation Time: None Needed
Notes: Wooden fence around property. Wood pile next to house.

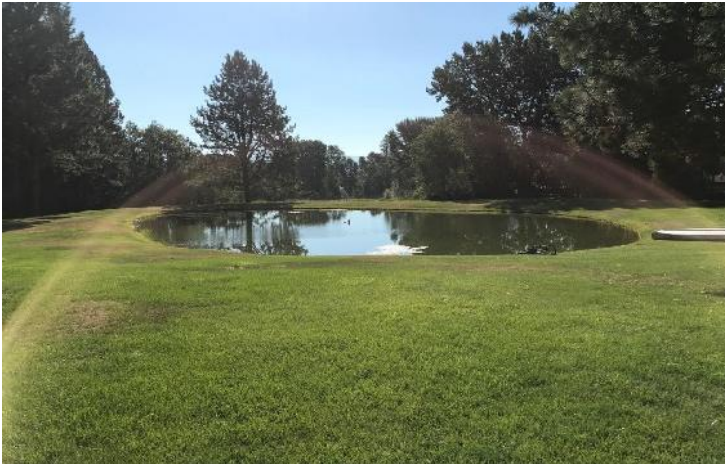
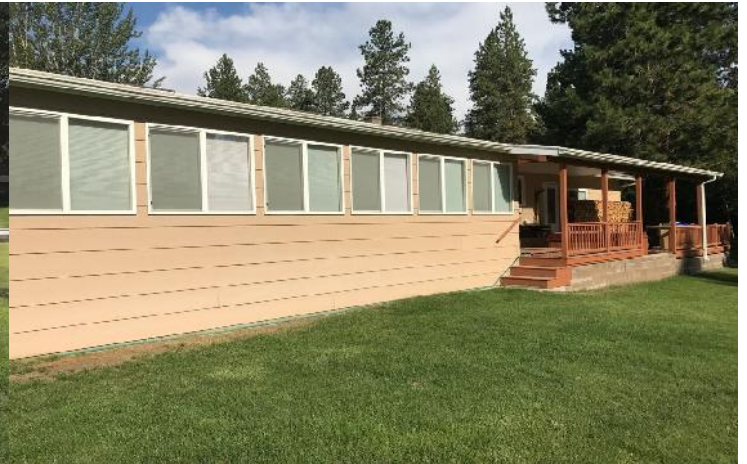
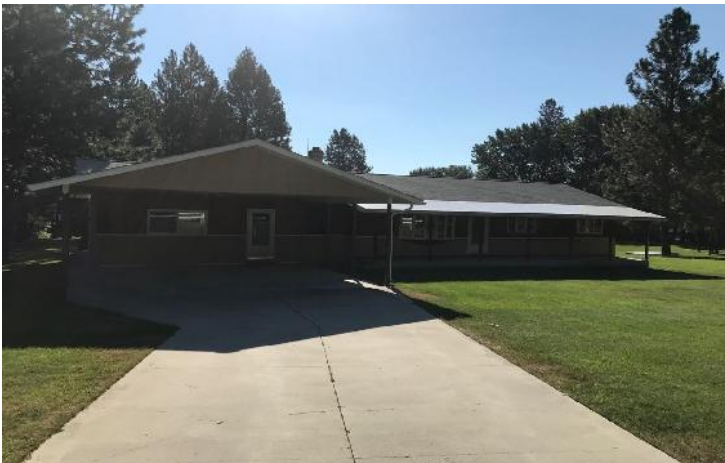
Structure Number:
Structure Name: 4618 Watt Lane
SubDivision: Bass Creek
GPS Location, Lat. 46 34.5132
GPS Location, Long. 114 7.35018
Safety Zone Present: Yes **Where is Safety Zone:** Highway 93
Type of Structure: Residential **Primary Structures:** **Outbuildings:**
Surrounding Fuels: Grass, Timber **Defensible Space:** 30-50 Feet
Structure Triage Category: Defensible, Prep and Hold
Roof Material: Composite **Siding Material:** Wood
Heat Traps: Open Eaves, Wood Deck, Rain Gutters, Other Receptor
Electrical Power: Overhead, Underground **Gas to Structure:** None
Hazards: Fuels
Access to Site: T1 Engine **Best Access From:** Highway 93 to Bass Creek Road to Watt Lane.
Comm with ICP: Radio, Cell Service
Water Source: Faucet / Hose, Large Pond, Creek
Mitigation Time: Less Than An Hour
Notes: Large pond with pump on south east side of structure. Large creek to north and east of property also with irrigation pump. Underground irrigation.

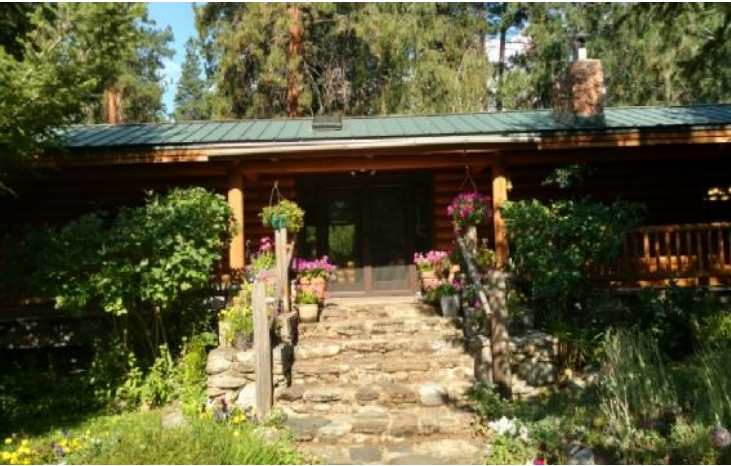
Structure Number:
Structure Name: 4627 Watt lane
SubDivision: Bass Creek
GPS Location, Lat. 46 34.5297
GPS Location, Long. 114 7.46532
Safety Zone Present: No **Where is Safety Zone:** Out to Watt In then to Bass Creek Rd then to highway 93
Type of Structure: Residential **Primary Structures:** **Outbuildings:**
Surrounding Fuels: Grass, Timber **Defensible Space:** 50-100 Feet
Structure Triage Category: Defensible, Prep and Hold
Roof Material: Metal **Siding Material:** Wood
Heat Traps: Open Eaves, Wood Deck, Rain Gutters
Electrical Power: Underground **Gas to Structure:** None
Hazards: Fuels, Animals, Septic Tank
Access to Site: T1 Engine **Best Access From:** Out to Watt lane to Bass Creek Rd to highway 93
Comm with ICP: Radio, Cell Service
Water Source: Faucet / Hose, Creek
Mitigation Time: 2-3 Hours
Other Resources Needed to Protect: An engine crew could do a little bit of prep around home and structures

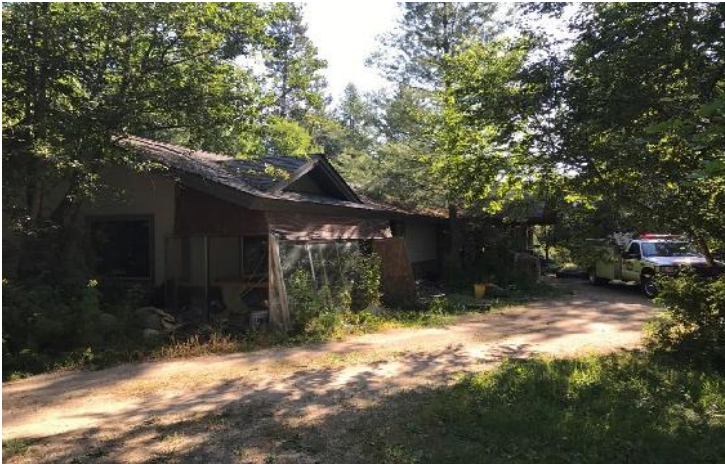
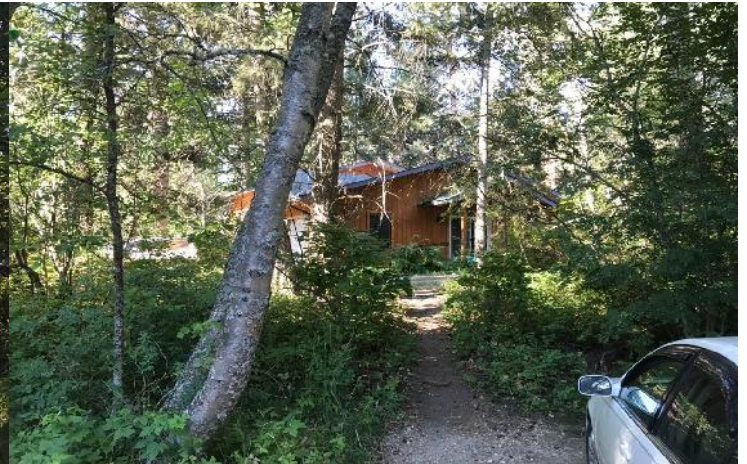
Structure Number:
Structure Name: 4640 Watt Lane
SubDivision: Bass Creek
GPS Location, Lat. 46 34.55628
GPS Location, Long. 114 7.31172
Safety Zone Present: Yes **Where is Safety Zone:** Highway 93
Type of Structure: Residential **Primary Structures:** **Outbuildings:**
Surrounding Fuels: Grass,Shrub,Timber **Defensible Space:** 30-50 Feet
Structure Triage Category: Defensible, Prep and Hold
Roof Material: Composite **Siding Material:** Masonry
Heat Traps: Open Eaves,Rain Gutters,Other Receptor
Electrical Power: Underground **Gas to Structure:** Aboveground
Hazards: Fuels
Access to Site: T6 Engine **Best Access From:** Highway 93 to Bass Creek Road to Watt Lane.
Comm with ICP: Radio,Cell Service
Water Source: Faucet / Hose,Creek
Mitigation Time: 3-4 Hours
Other Resources Needed to Protect: Mark 3 sprinkler kits
Notes: Creek to North of structure. Handicap license plates indicating possible need for help evacuating.

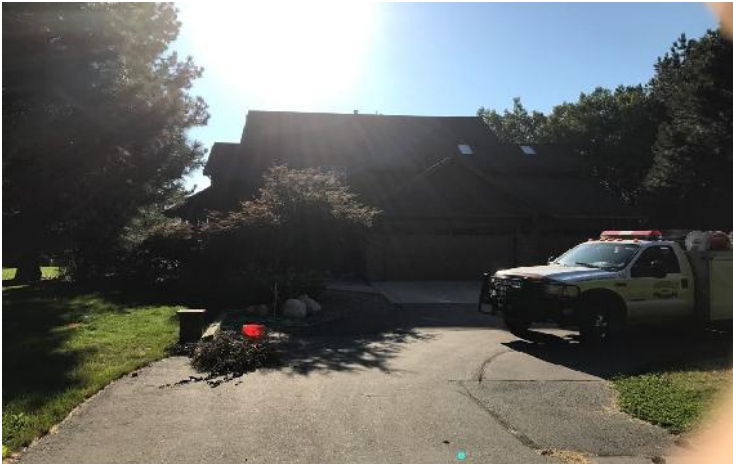
Structure Number:
Structure Name: 4652 Watt Lane
SubDivision: Bass Creek
GPS Location, Lat. 46 34.51854
GPS Location, Long. 114 7.20894
Safety Zone Present: Yes **Where is Safety Zone:** Highway 93
Type of Structure: Residential **Primary Structures:** **Outbuildings:**
Surrounding Fuels: Grass,Shrub,Timber **Defensible Space:** 30-50 Feet
Structure Triage Category: Defensible, Prep and Hold
Roof Material: Composite **Siding Material:** Wood
Heat Traps: Open Eaves,Wood Deck,Rain Gutters
Electrical Power: Underground **Gas to Structure:** Underground
Hazards: Fuels
Access to Site: T1 Engine **Best Access From:** Highway 93 to Bass Creek Road to Watt Lane
Comm with ICP: Radio,Cell Service
Water Source: Faucet / Hose,Creek
Mitigation Time: Less Than An Hour
Notes: Underground propane on North side of structure. Multiple creeks under driveway with two concrete bridges.

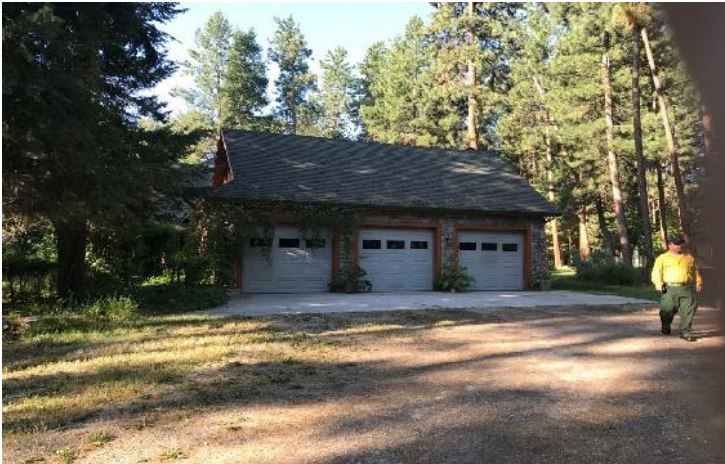
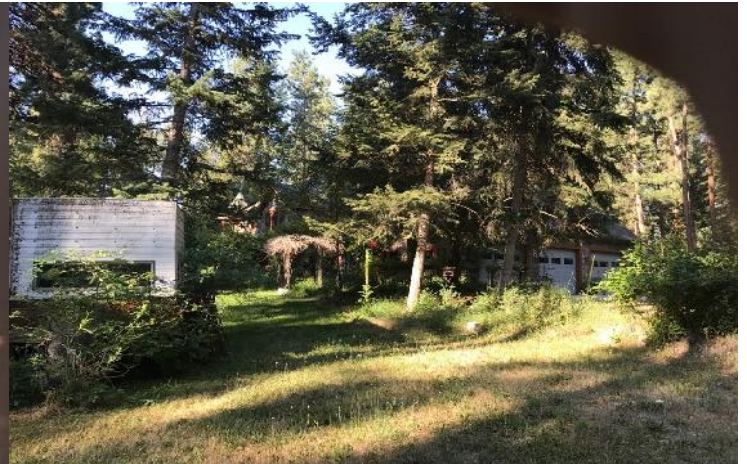
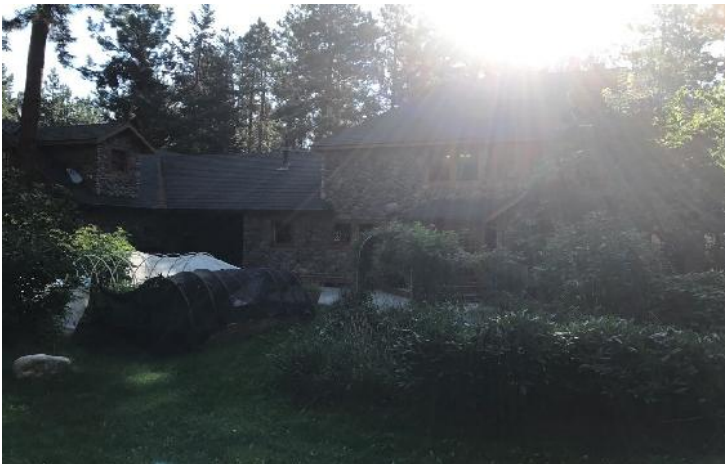
Structure Number:
Structure Name: 4655 Watt Lane
SubDivision: Bass Creek
GPS Location, Lat. 46 34.6038
GPS Location, Long. 114 7.42008
Safety Zone Present: Yes **Where is Safety Zone:** Highway 93
Type of Structure: Residential **Primary Structures:** **Outbuildings:**
Surrounding Fuels: Grass,Shrub,Timber **Defensible Space:** 30-50 Feet
Structure Triage Category: Defensible, Prep and Hold
Roof Material: Composite **Siding Material:** Masonry
Heat Traps: Rain Gutters,Other Receptor
Electrical Power: Underground **Gas to Structure:** Aboveground
Hazards: Fuels
Access to Site: T3/4 Engine **Best Access From:** Highway 93 to Bass Creek Road to Watt Lane
Comm with ICP: Radio,Cell Service
Water Source: Faucet / Hose,Creek
Mitigation Time: 2-3 Hours
Other Resources Needed to Protect: Mark 3 sprinkler kits.
Notes: Creek to south of structure as well as wood shed. Wood piles to north of structure as well. Propane tank to West of structure by outbuilding.

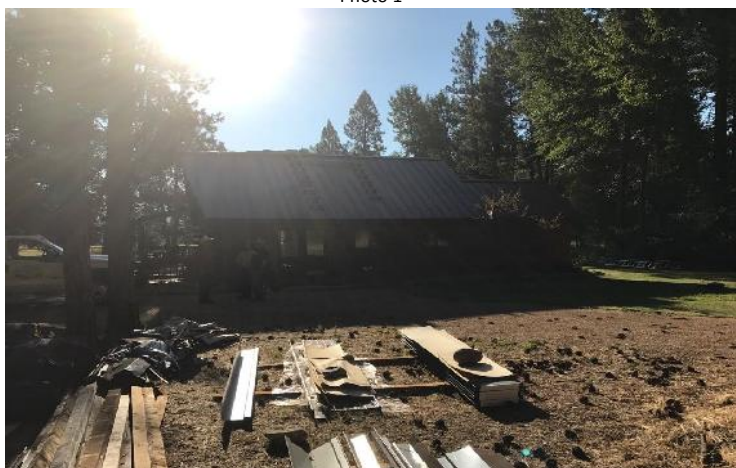
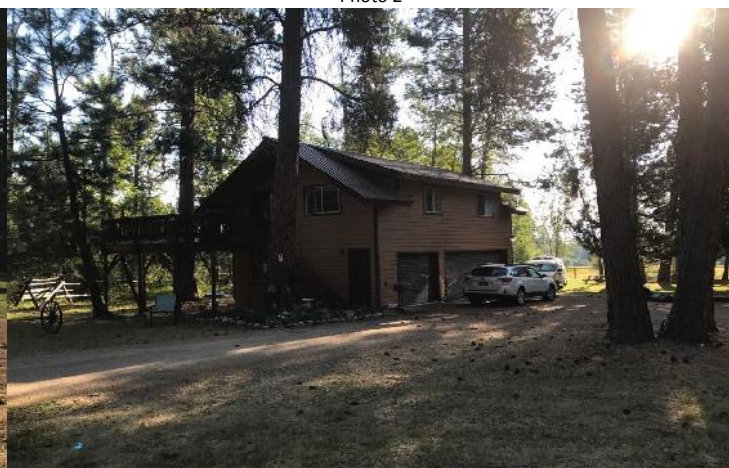
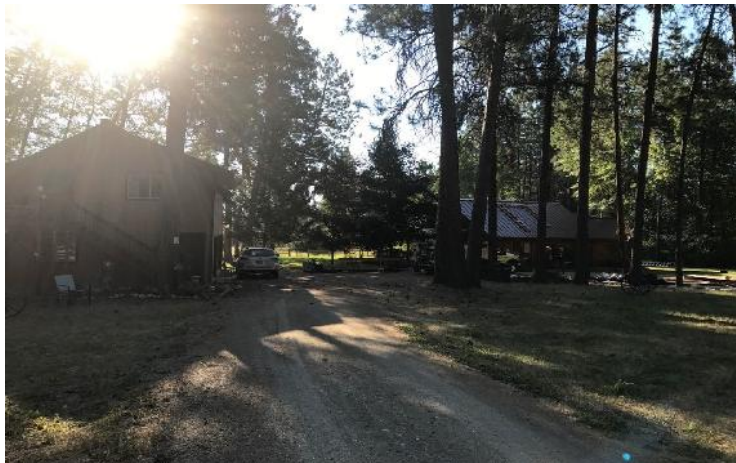
Structure Number:
Structure Name: 4664 Watt Lane
SubDivision: Bass Creek
GPS Location, Lat. 46 34.68936
GPS Location, Long. 114 7.25142
Safety Zone Present: Yes **Where is Safety Zone:** Highway 93
Type of Structure: Residential **Primary Structures:** **Outbuildings:**
Surrounding Fuels: Grass,Shrub,Timber,Slash **Defensible Space:** 30-50 Feet
Structure Triage Category: Defensible, Prep and Hold
Roof Material: Metal **Siding Material:** Wood
Heat Traps: Wood Deck,Rain Gutters,Other Receptor
Electrical Power: Underground **Gas to Structure:** Underground
Hazards: Fuels
Access to Site: T3/4 Engine **Best Access From:** Highway 93 to Bass Creek Road to Watt Lane
Comm with ICP: Radio,Cell Service
Water Source: Faucet / Hose,Creek
Mitigation Time: 1-2 Hours
Notes: Underground propane on south west corner of structure. Wrap around driveway. Multiple tall pine trees scatter property. Irrigation Creek on West side of structure equipped with gas pump. Sprinklers laid out on grass.

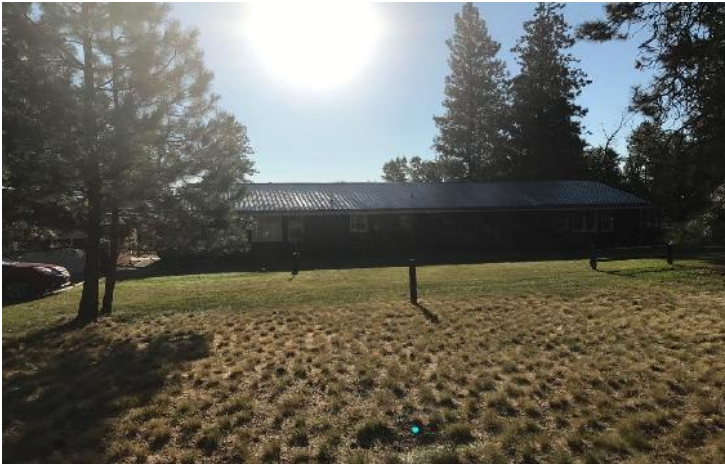
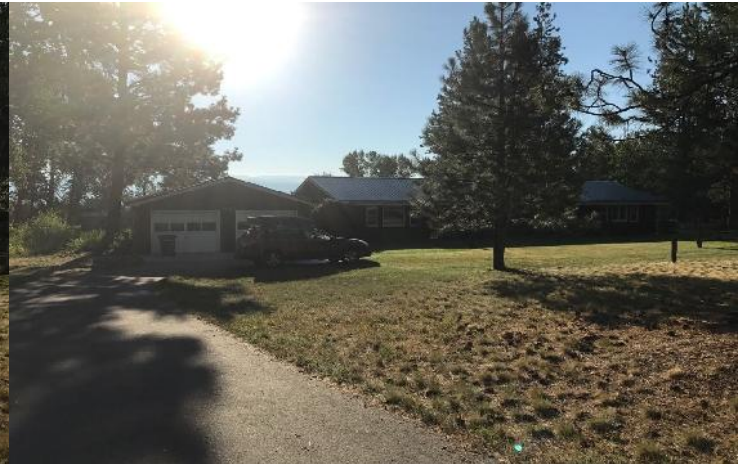
Structure Number:
Structure Name: 4694 Watt Lane
SubDivision: Bass Creek
GPS Location, Lat. 46 34.77114
GPS Location, Long. 114 7.28124
Safety Zone Present: Yes **Where is Safety Zone:** Highway 93
Type of Structure: Residential **Primary Structures:** **Outbuildings:**
Surrounding Fuels: Grass,Shrub,Timber **Defensible Space:** 30-50 Feet
Structure Triage Category: Defensible, Prep and Hold
Roof Material: Metal **Siding Material:** Wood
Heat Traps: Open Eaves,Wood Deck,Rain Gutters,Other Receptor
Electrical Power: Underground **Gas to Structure:** Aboveground
Hazards: Animals
Access to Site: T3/4 Engine **Best Access From:** Highway 93 to Bass Creek Road to Watt Lane
Comm with ICP: Radio,Cell Service
Water Source: Faucet / Hose
Mitigation Time: 1-2 Hours
Notes: Propane tank to south of structure. Underground irrigation.
