STRUCTURE
PROTECTION PLAN
FOR
ELK CREEK BLOCK
07/27/2017

Structure Protection Plan

OZ Ranch

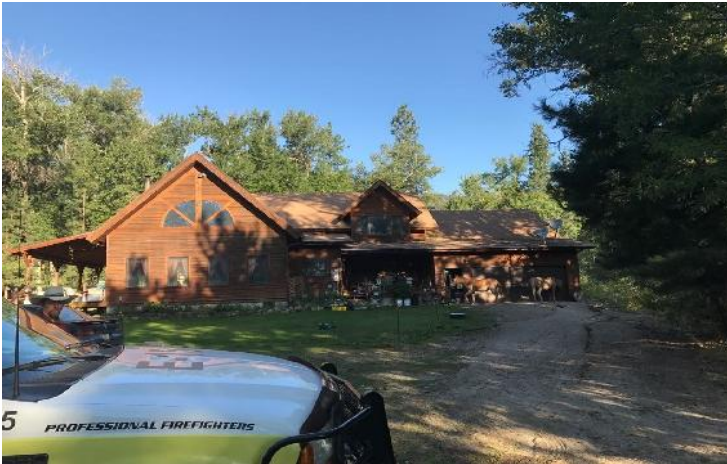
Structure Number:
Structure Name: 4695 Watt Lane
SubDivision: Bass Creek
GPS Location, Lat. 46 34.80624
GPS Location, Long. 114 7.41222
Safety Zone Present: Yes **Where is Safety Zone:** Highway 93
Type of Structure: Residential **Primary Structures:** **Outbuildings:**
Surrounding Fuels: Grass,Shrub,Timber **Defensible Space:** 30-50 Feet
Structure Triage Category: Defensible, Prep and Hold
Roof Material: Composite **Siding Material:** Wood
Heat Traps: Wood Deck,Rain Gutters
Electrical Power: Underground **Gas to Structure:** Aboveground
Hazards: Animals
Access to Site: T3/4 Engine **Best Access From:** Highway 93 to Bass Creek Road to Watt Lane.
Comm with ICP: Radio,Cell Service
Water Source: Faucet / Hose
Mitigation Time: 3-4 Hours
Other Resources Needed to Protect: Mark 3 sprinkler kits
Notes: Gate at entrance. Propane tank on South end of structure. Underground irrigation. Scattered vehicles on property. Misc. junk throughout property.

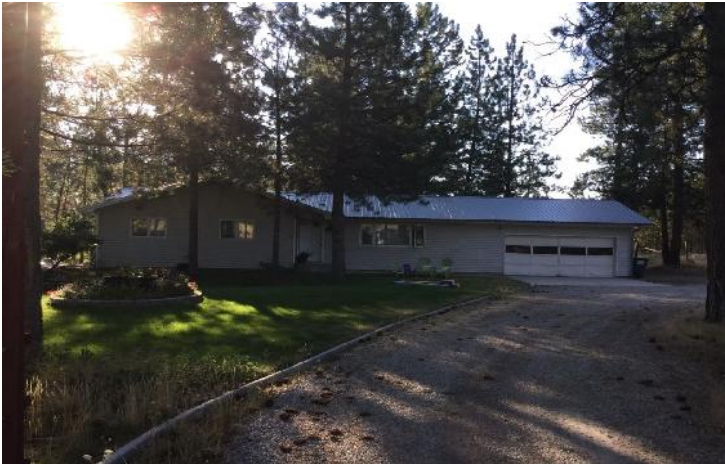
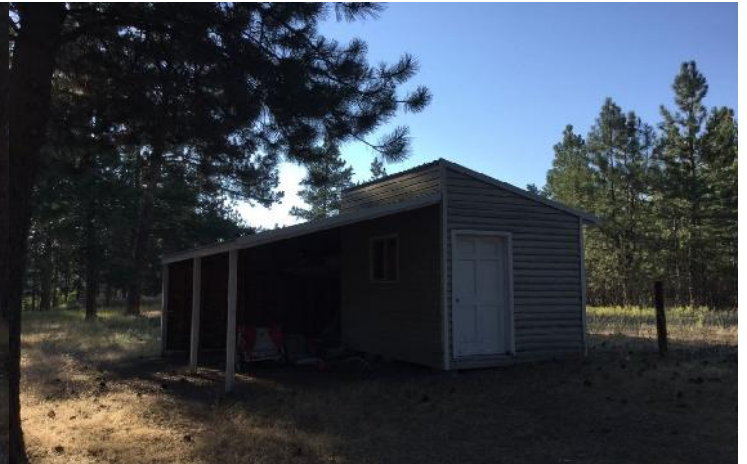
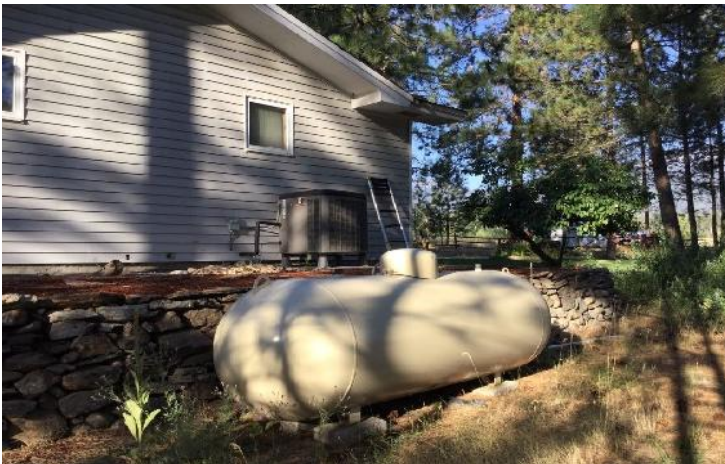
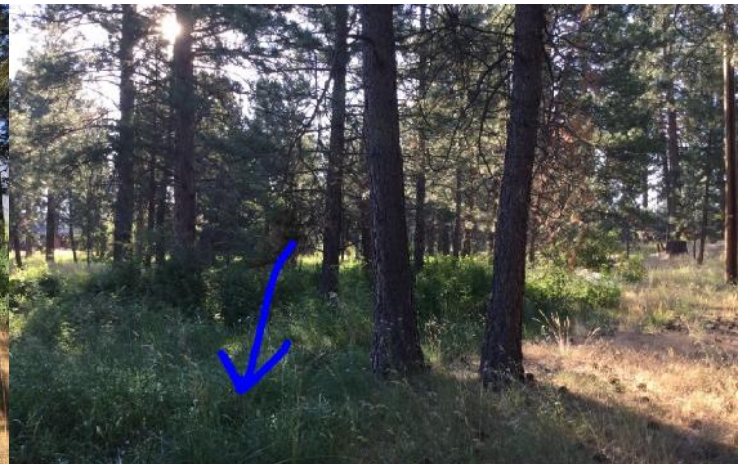
Structure Number:
Structure Name: 4710 Hoblitt Lane South
SubDivision: Bass Creek
GPS Location, Lat. 46 34.60806
GPS Location, Long. 114 5.73654
Safety Zone Present: Yes
Type of Structure: Residential
Surrounding Fuels: Grass, Timber
Structure Triage Category: Defensible, Stand Alone
Roof Material: Metal
Heat Traps: Rain Gutters
Electrical Power: Overhead, Underground
Hazards:
Access to Site: T1 Engine
Comm with ICP: Radio, Cell Service
Water Source: Faucet / Hose, Creek
Mitigation Time: 1-2 Hours
Other Resources Needed to Protect: Engine mod. Weed eating around outbuilding, and by propane tank
Notes: Creek north of house

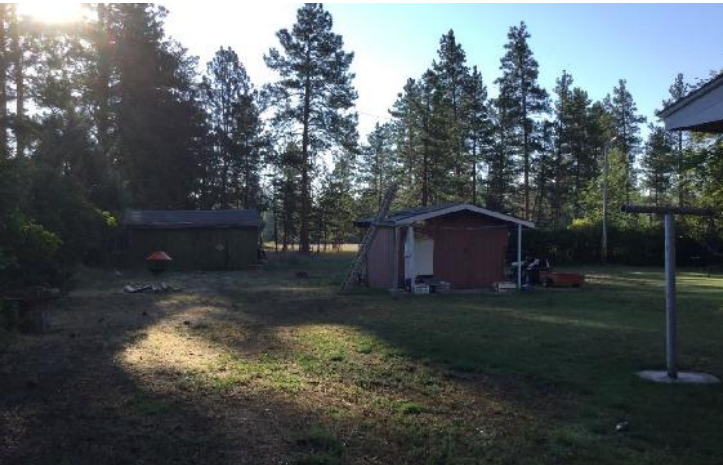
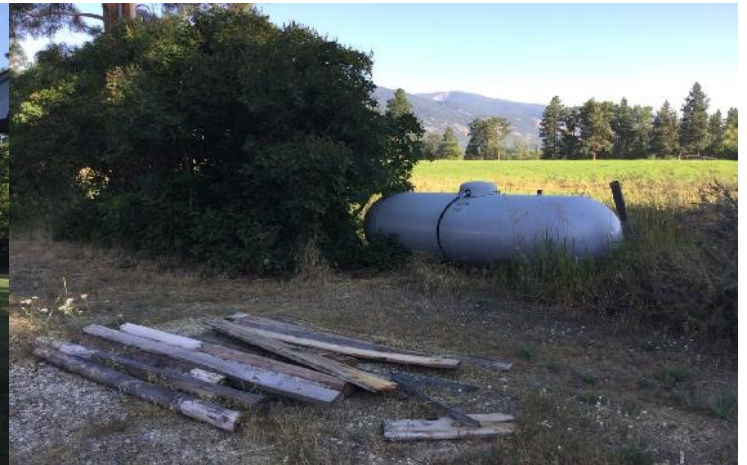
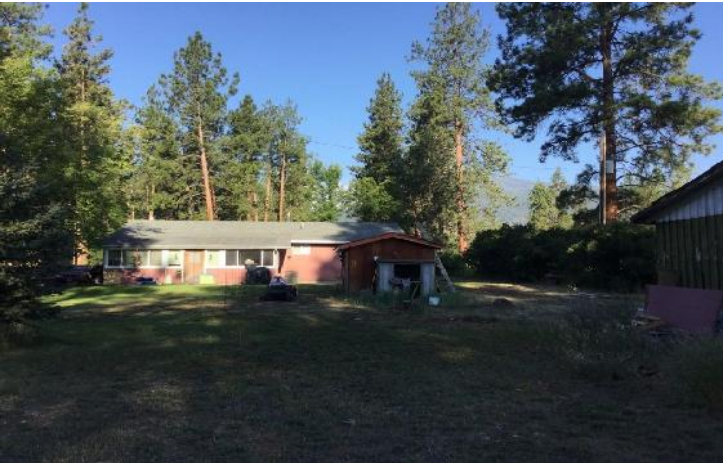
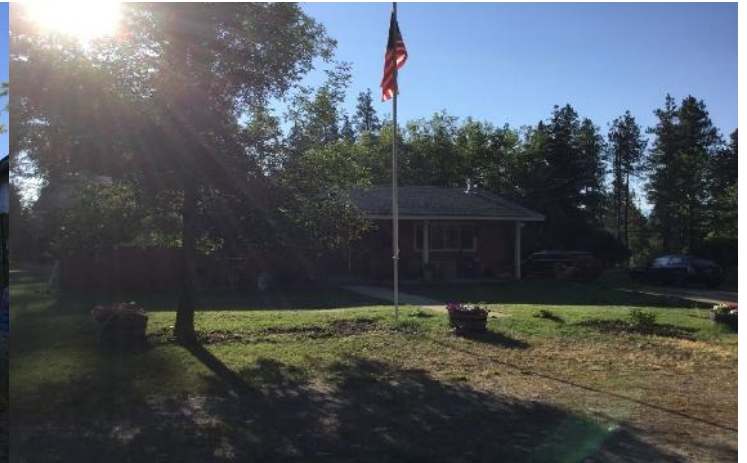
Structure Number:
Structure Name: 4718 Hoblitt Lane South
SubDivision: Bass Creek
GPS Location, Lat. 46 34.63932
GPS Location, Long. 114 5.6004
Safety Zone Present: Yes
Type of Structure: Residential
Surrounding Fuels: Grass,Shrub,Timber
Structure Triage Category: Defensible, Stand Alone
Roof Material: Composite
Heat Traps: Rain Gutters
Electrical Power: Overhead,Underground
Hazards:
Access to Site: T1 Engine
Comm with ICP: Radio,Cell Service
Water Source: Faucet / Hose
Mitigation Time: 1-2 Hours
Other Resources Needed to Protect: Clearing wood from and trimming around propane tank, clearing wood and trimming around outbuilding.
Collected By: Engine 951

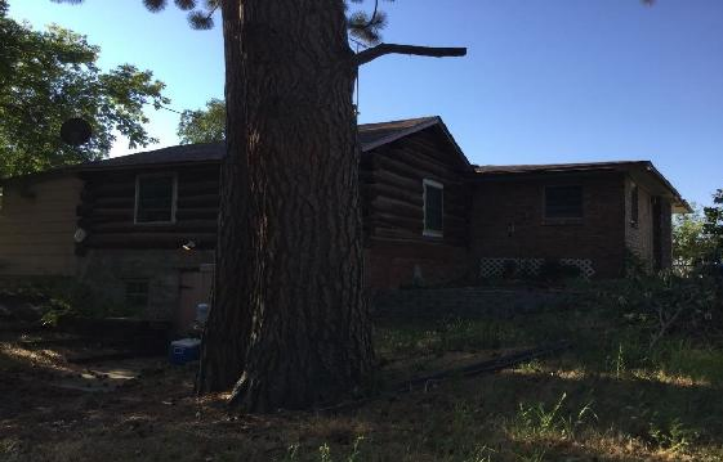
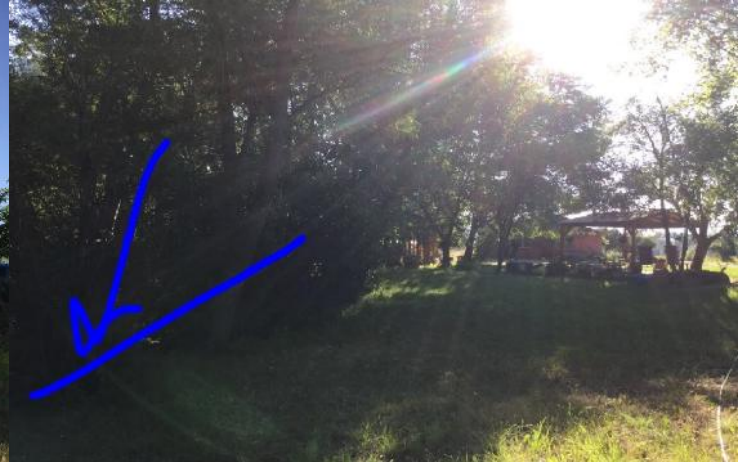
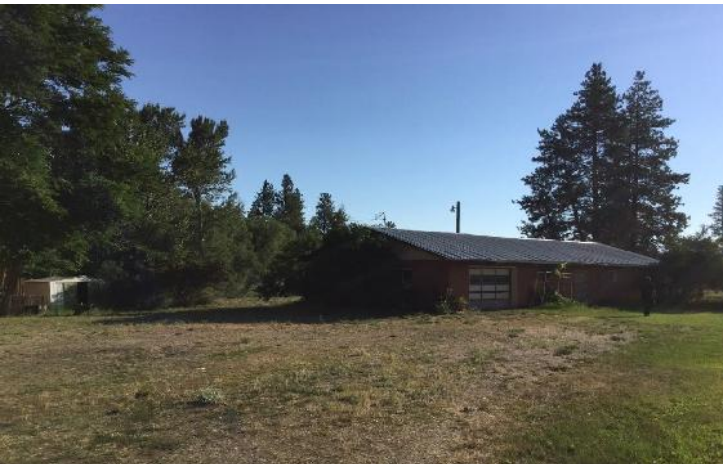
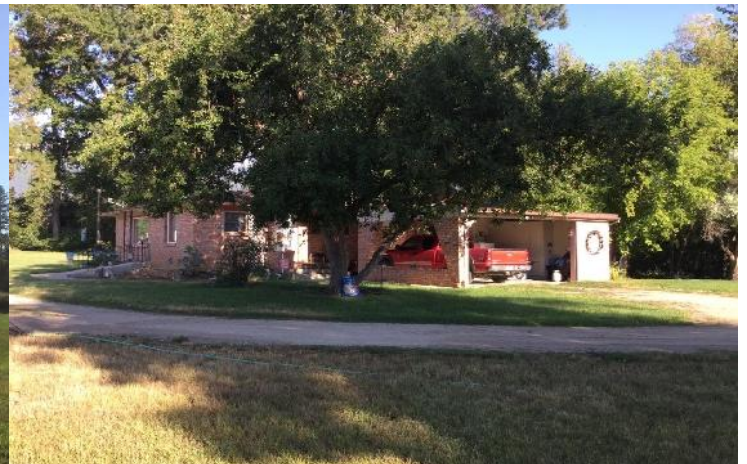
Structure Number:
Structure Name: 4750Hoblitt Lane South
SubDivision: Bass Creek
GPS Location, Lat. 46 34.77966
GPS Location, Long. 114 5.66802
Safety Zone Present: Yes
Type of Structure: Residential
Surrounding Fuels: Grass,Shrub,Timber
Structure Triage Category: Defensible, Stand Alone
Roof Material: Composite
Heat Traps: Rain Gutters
Electrical Power: Overhead,Underground
Hazards:
Access to Site: T1 Engine
Comm with ICP: Radio,Cell Service
Water Source: Creek
Mitigation Time: 1-2 Hours
Other Resources Needed to Protect: Engine mod, cut line around wood shed, trim around garage, minimal trimming around north side of house
Notes: Creek north of house, plenty of water, safety zone south of house

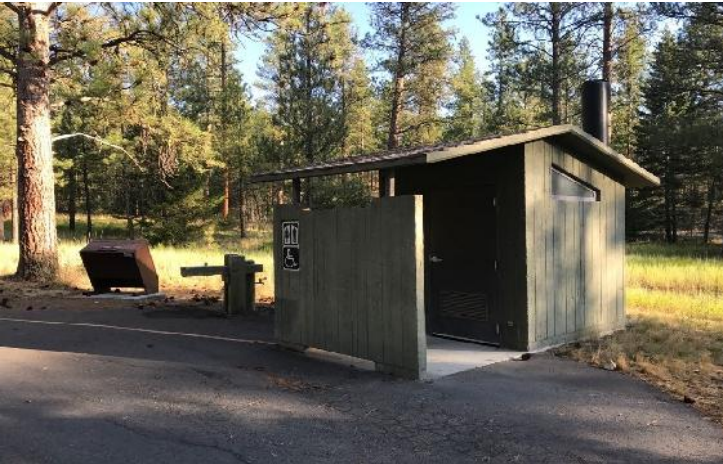
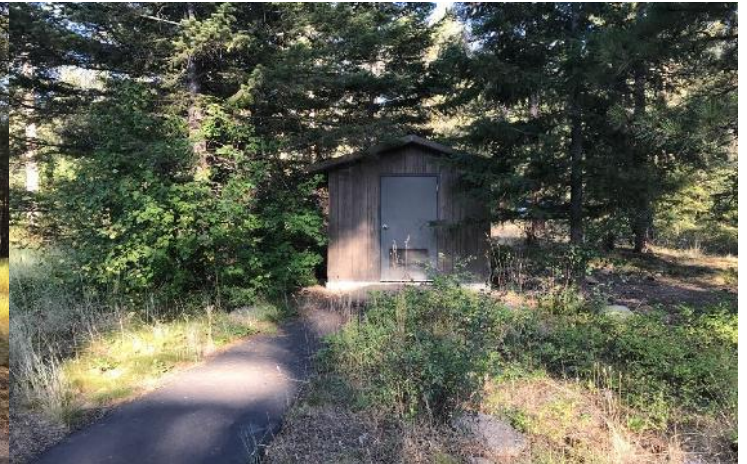
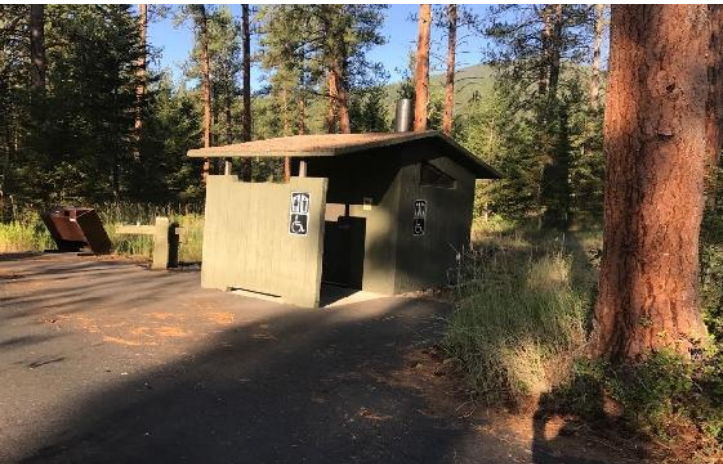
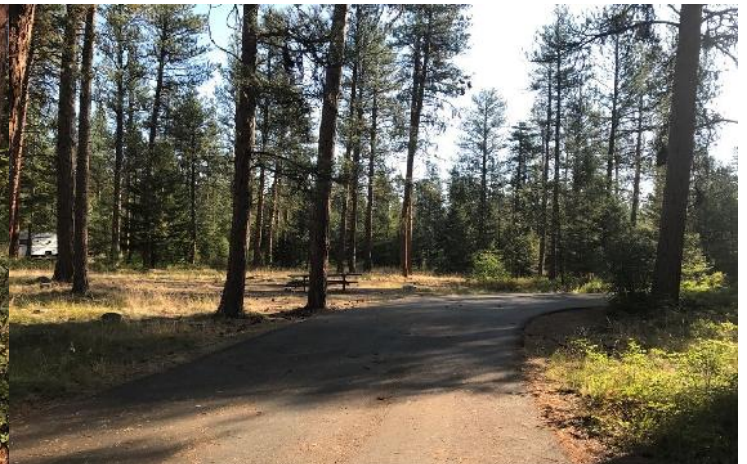
Structure Number:
Structure Name: Charles Water Campground
SubDivision: Bass Creek
GPS Location, Lat. 46 34.55988
GPS Location, Long. 114 8.28642
Safety Zone Present: No **Where is Safety Zone:** -Safety zone
Type of Structure: Residential **Primary Structures:** **Outbuildings:**
Surrounding Fuels: Grass,Shrub,Timber **Defensible Space:** None
Structure Triage Category: Non-Defensible, Prep and Leave
Roof Material: Wood **Siding Material:** Wood
Heat Traps:
Electrical Power: Overhead,Underground **Gas to Structure:** None
Hazards: HazMat
Access to Site: T1 Engine **Best Access From:**
Comm with ICP: Radio,Cell Service
Water Source:
Mitigation Time: More Than 5 Hours
Other Resources Needed to Protect: Hotshot crew, multiple engines
Notes: With dispersed timber and lots of under storage fuel this area would need several days with lots of personnel (at least one hotshot crew) for a successful protection of the camp ground. There is easy water access to the bass creek drainage to assist in p

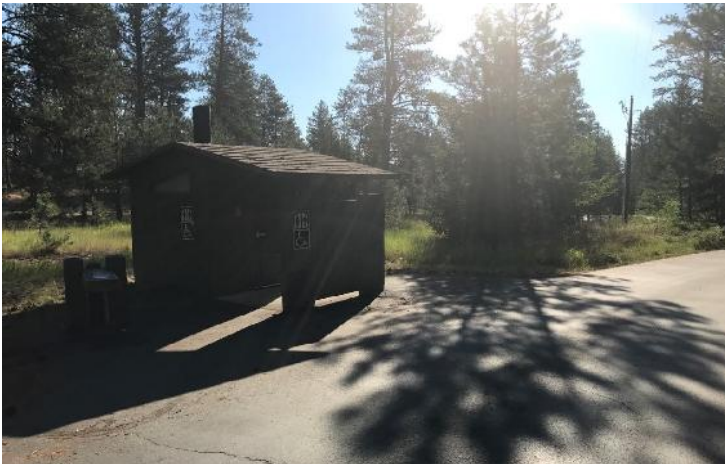
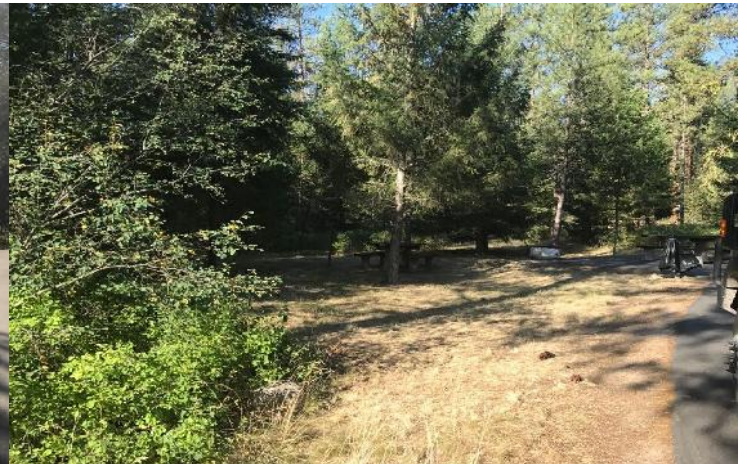
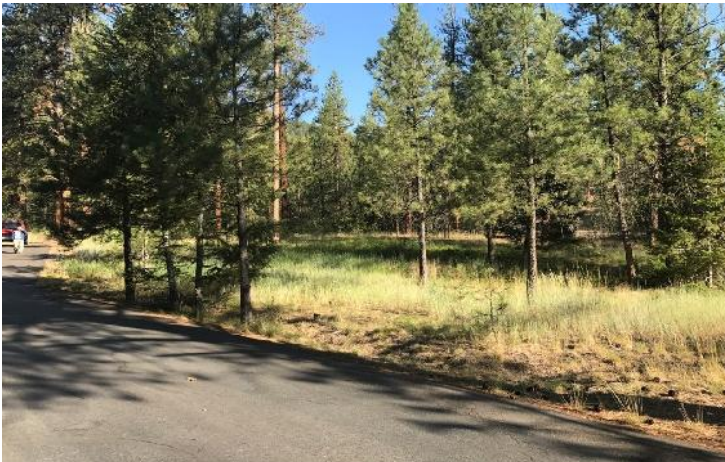
Structure Number:
Structure Name: Charles Waters Camp Ground
SubDivision: Bass Creek
GPS Location, Lat. 46 34.494
GPS Location, Long. 114 8.58726
Safety Zone Present: Yes **Where is Safety Zone:** Take Bass Creek RD East to 93. 10 minutes.
Type of Structure: Other **Primary Structures:** **Outbuildings:**
Other Type of Structure: Camp Ground
Surrounding Fuels: Grass,Shrub,Timber **Defensible Space:** 30-50 Feet
Structure Triage Category: Non-Defensible, Prep and Leave
Roof Material: **Siding Material:**
Heat Traps: **Gas to Structure:**
Electrical Power:
Hazards:
Access to Site: T3/4 Engine **Best Access From:** Hwy 93 to Bass Creek RD East.
Comm with ICP: Radio,Cell Service
Water Source: Faucet / Hose,Creek
Mitigation Time: 3-4 Hours
Other Resources Needed to Protect: Hand crew would be of good use for prep work.
Notes: Paved road around camp Ground to the west.

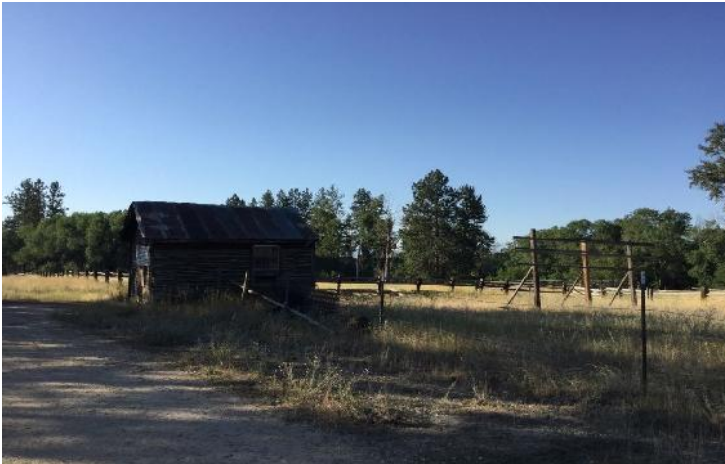
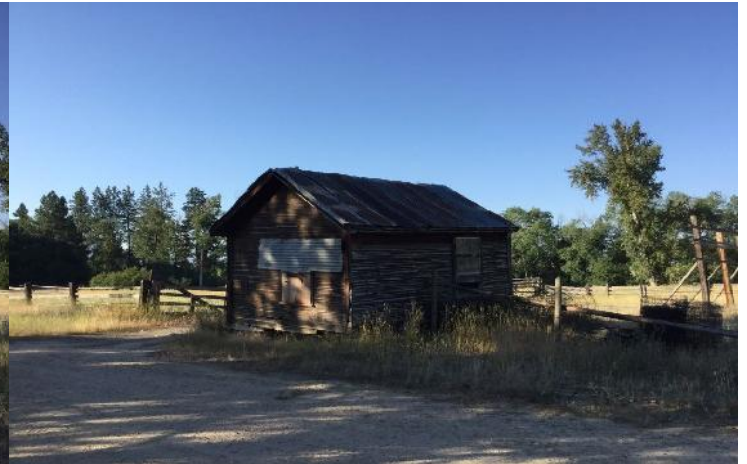
Structure Number:
Structure Name: ? Hoblitt Lane South
SubDivision: Bass Creek
GPS Location, Lat. 46 34.554
GPS Location, Long. 114 5.76768
Safety Zone Present: Yes
Type of Structure: Residential
Surrounding Fuels: Grass
Structure Triage Category: Defensible, Stand Alone
Roof Material: Metal
Heat Traps: Open Eaves, Other Receptor
Electrical Power: None
Hazards:
Access to Site: T1 Engine
Comm with ICP: Radio, Cell Service
Water Source: None
Mitigation Time: Less Than An Hour
Other Resources Needed to Protect: Engine mod, dig line and trim around house.
Notes: Old wooden structure, east of Hoblitt lane, near south end of road

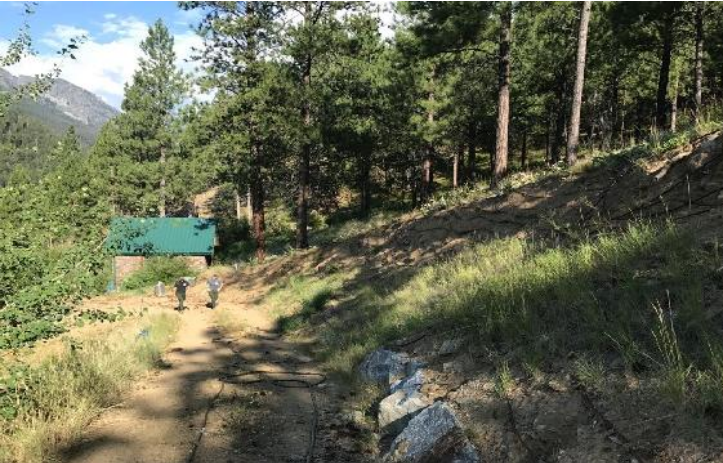
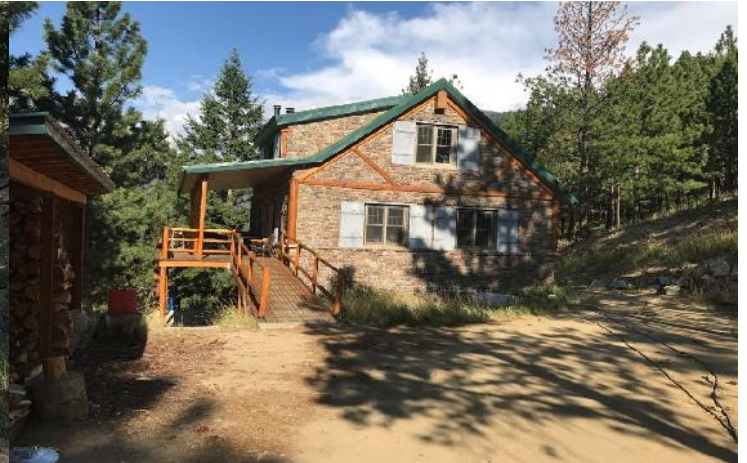
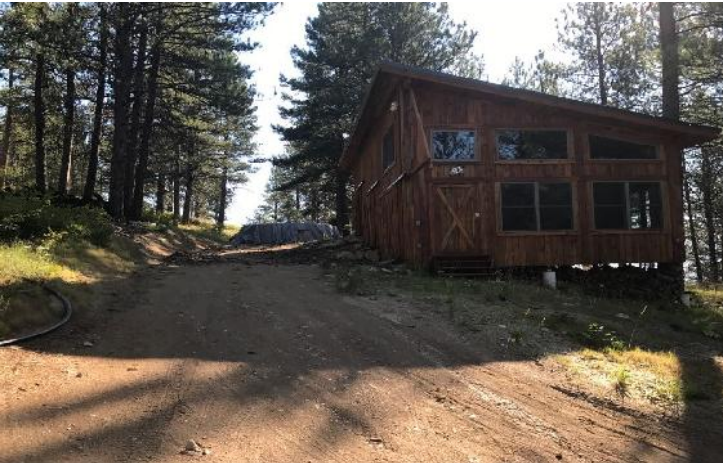
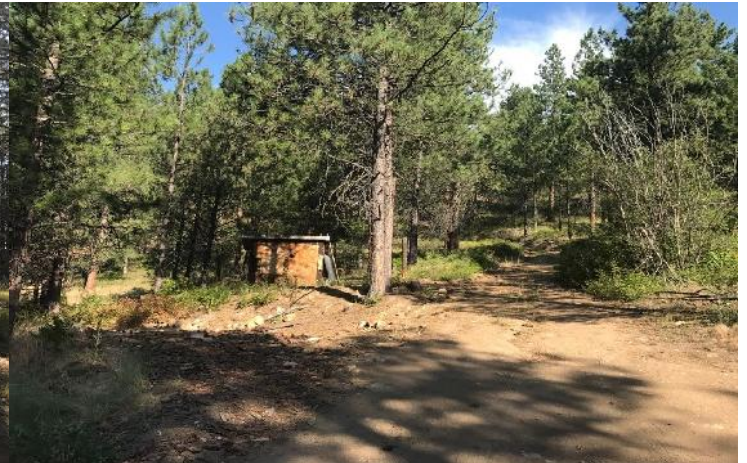
Structure Number:
Structure Name: Pollock Inholding. FS RD 1136
SubDivision: Bass Creek
GPS Location, Lat. 46 34.6911
GPS Location, Long. 114 9.16206
Safety Zone Present: Yes
Type of Structure: Residential
Surrounding Fuels: Grass,Shrub,Timber
Structure Triage Category: Defensible, Stand Alone
Roof Material: Metal
Heat Traps: Wood Deck,Rain Gutters
Electrical Power: Underground
Hazards: Terrain,HazMat
Access to Site: T3/4 Engine
Comm with ICP: Radio,Cell Service
Water Source: Faucet / Hose
Mitigation Time: 2-3 Hours
Other Resources Needed to Protect: A type 3 engine. Sprinkler kit and construction material to patch 8 10inx10in holes in a structure.
Collected By: Lolo 632

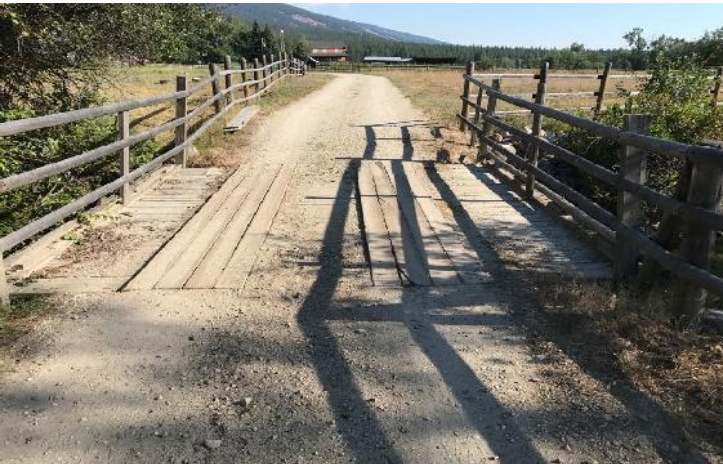
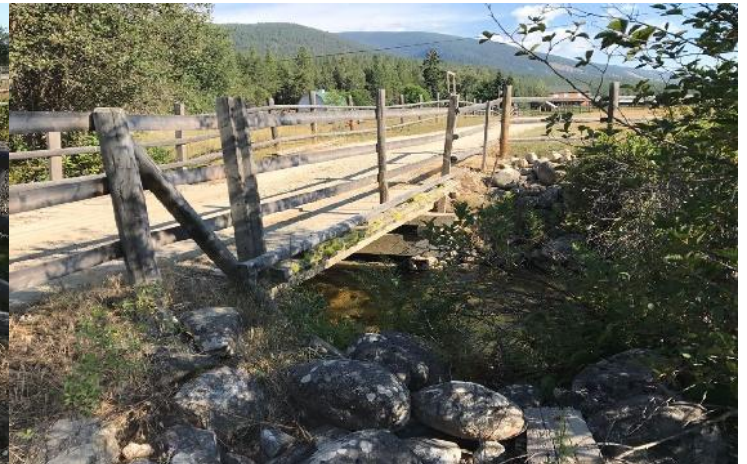
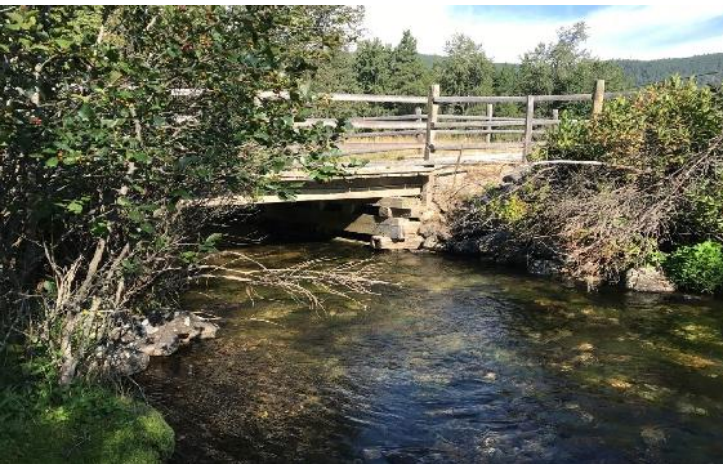
Safety Zone Present: Yes
Type of Structure: Residential
Surrounding Fuels: Grass,Shrub,Slash
Structure Triage Category: Defensible, Prep and Hold
Roof Material:
Heat Traps: Wood Deck
Electrical Power: None
Hazards: Fuels,Bridge Load Limits
Access to Site: T6 Engine
Comm with ICP: Radio,Cell Service
Water Source: Creek
Mitigation Time: Less Than An Hour
Other Resources Needed to Protect: Engine patrolling 420 home can hold bridge too.
Notes: Wooden bridge at entrance to 420 Bass Rd.
