ACCIDENT PREVENTION BULLETIN

No. IA APB 12-01

Subject: Wind Effects on Idling Rotorcraft

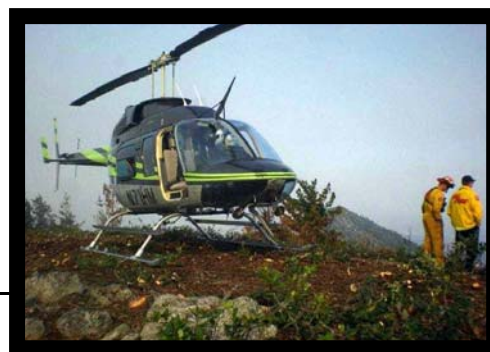
- Be aware of the affects of wind blowing from below the rotor disc and plan your landing site selection accordingly.
 - Rising terrain can generate orographic turbulence and greatly accelerate wind velocity as the air travels over the top. This should be accounted for in the preflight planning process.
